SUSITNA HYDROELECTRIC PROJECT

1980 - 81 GEOTECHNICAL REPORT

VOLUME 2
APPENDIX A-F
FINAL DRAFT

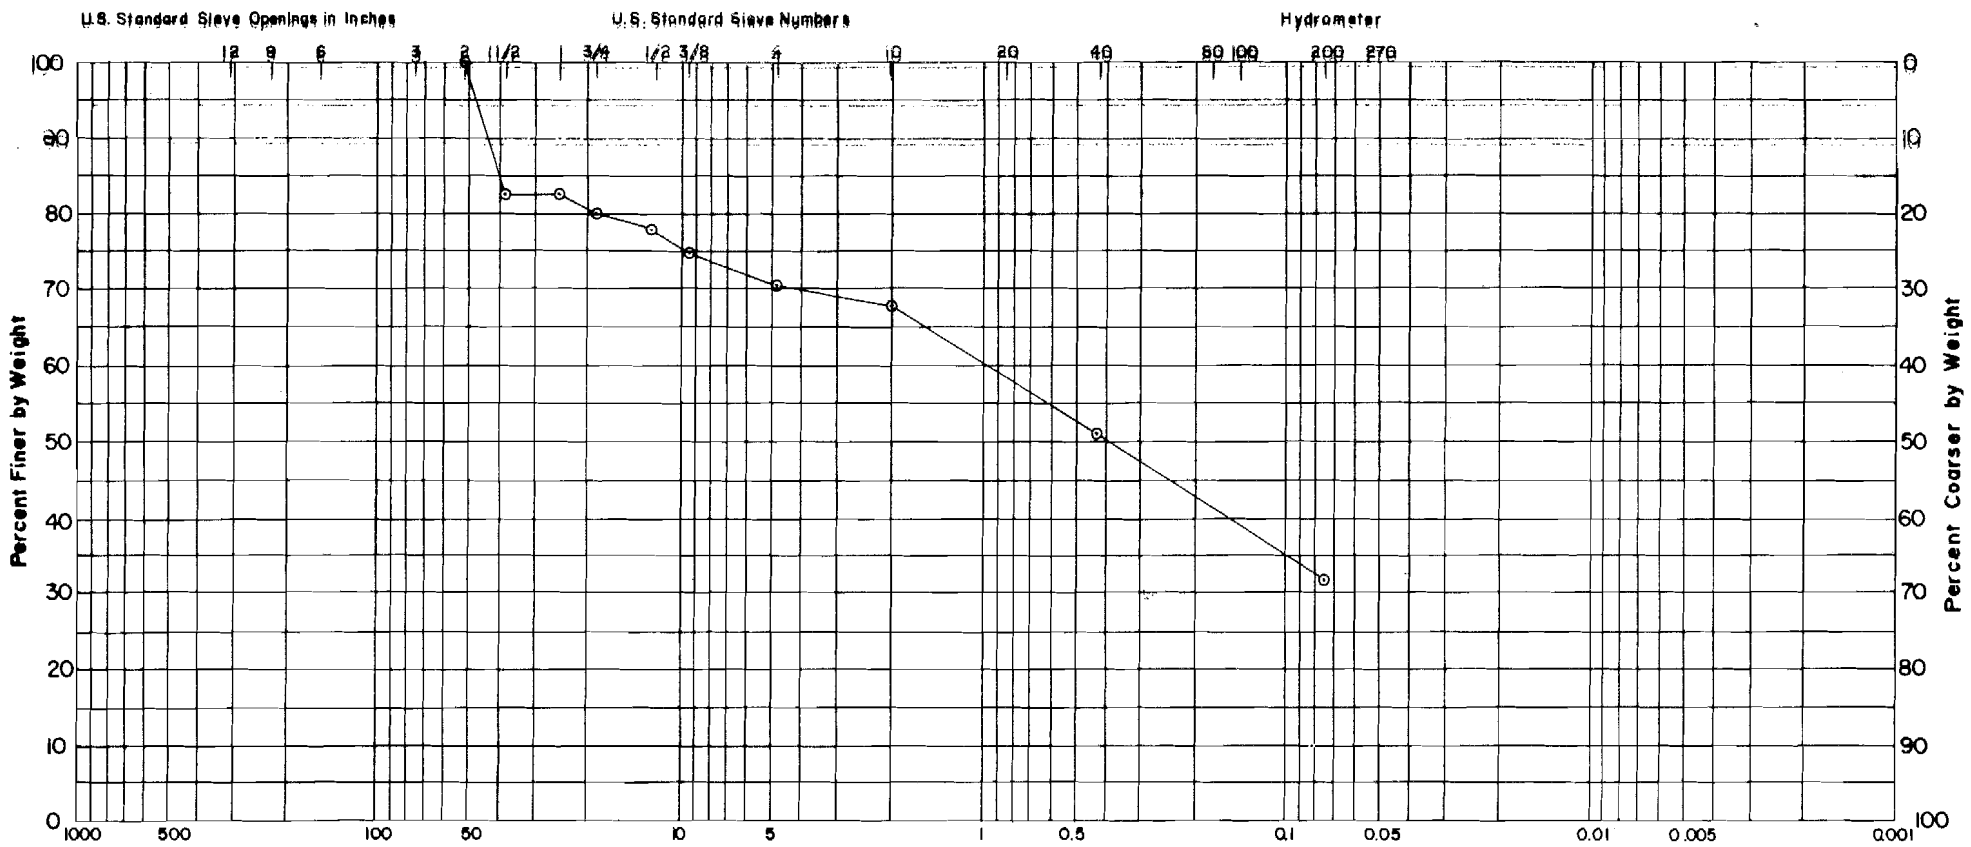
BORROW AREA D
AUGER HOLE AH-D6

SAMPLE NO.	MOISTURE CONTENT	DRY DENSITY	LL	PI	CLASS	CLASSIFICATION & DESCRIPTION
AH-D6 - 10	9		15	NP	SM	SILTY SAND WITH SOME GRAVEL

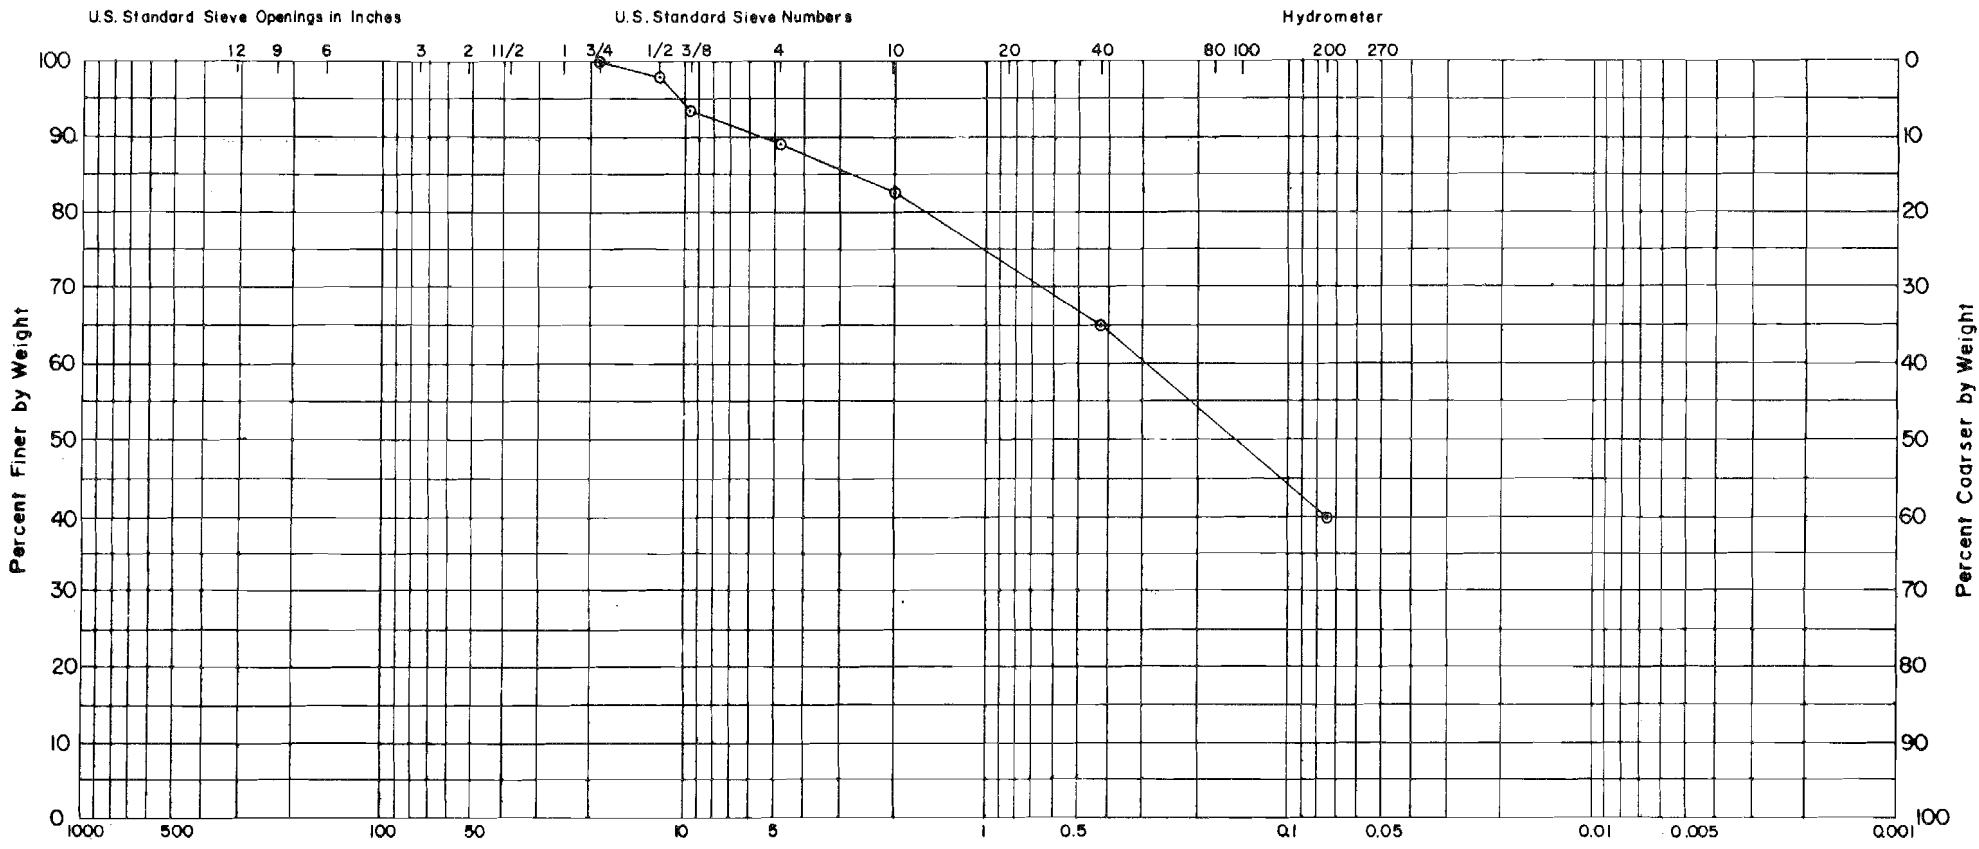
BORROW AREA D
AUGER HOLE AH-D6

SAMPLE NO.	MOISTURE CONTENT	DRY DENSITY	LL	PI	CLASS	CLASSIFICATION & DESCRIPTION
AH-D6 - 12	9		17	NP	SM	SILTY SAND WITH TRACE GRAVEL

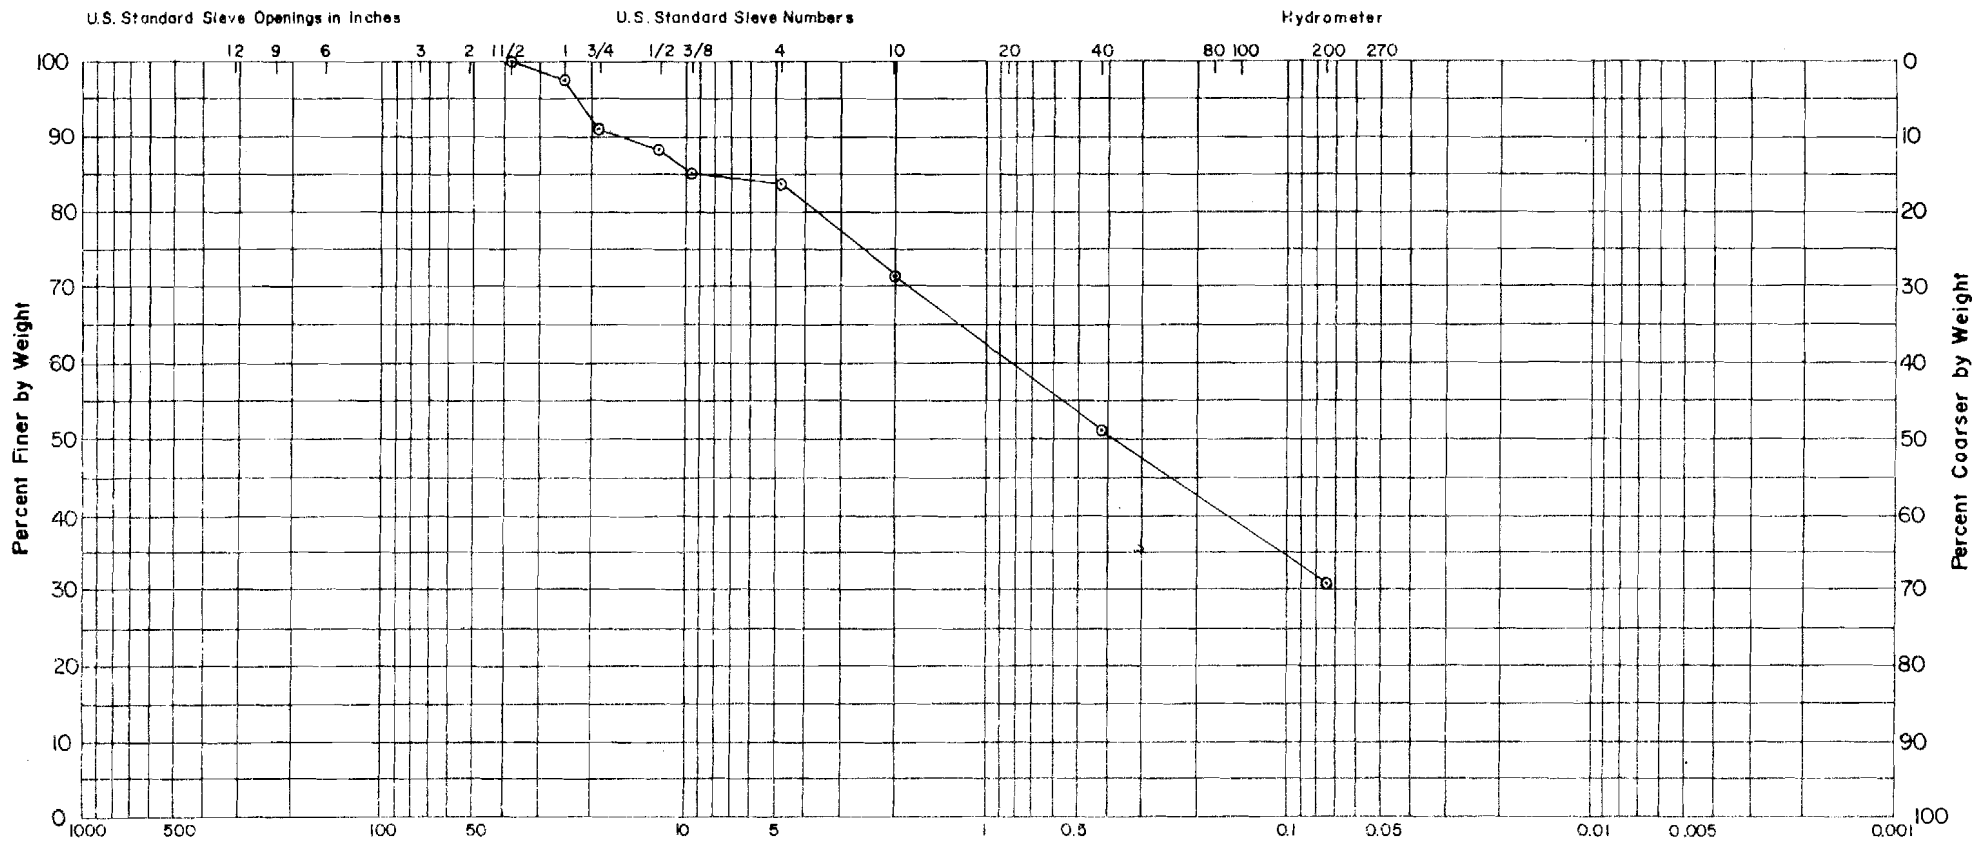
BORROW AREA D
AUGER HOLE AH-D6

SAMPLE NO.	MOISTURE CONTENT	DRY DENSITY	LL	PI	CLASS	CLASSIFICATION & DESCRIPTION
AH-D7 - 4,5	12,11				SM	SILTY SAND WITH SOME GRAVEL

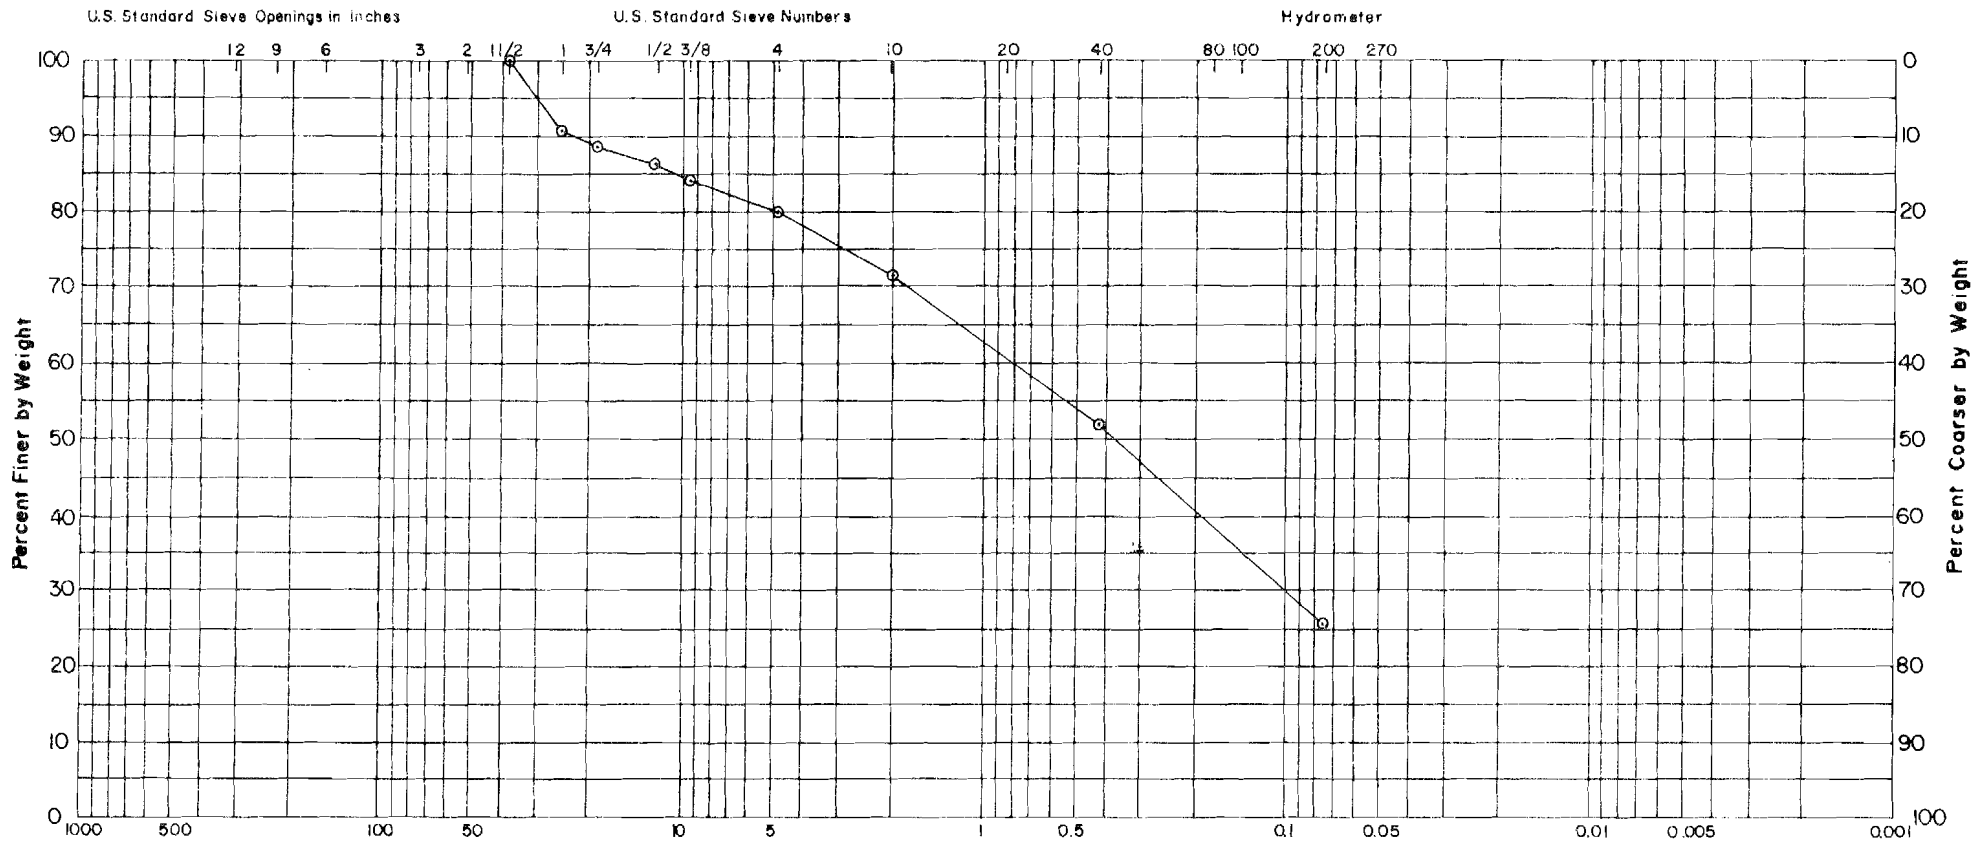
BORROW AREA D
AUGER HOLE AH-D7

SAMPLE NO.	MOISTURE CONTENT	DRY DENSITY	LL	PI	CLASS	CLASSIFICATION & DESCRIPTION
AH-D7 - 6	10				SM	SAND WITH SOME SILT AND GRAVEL

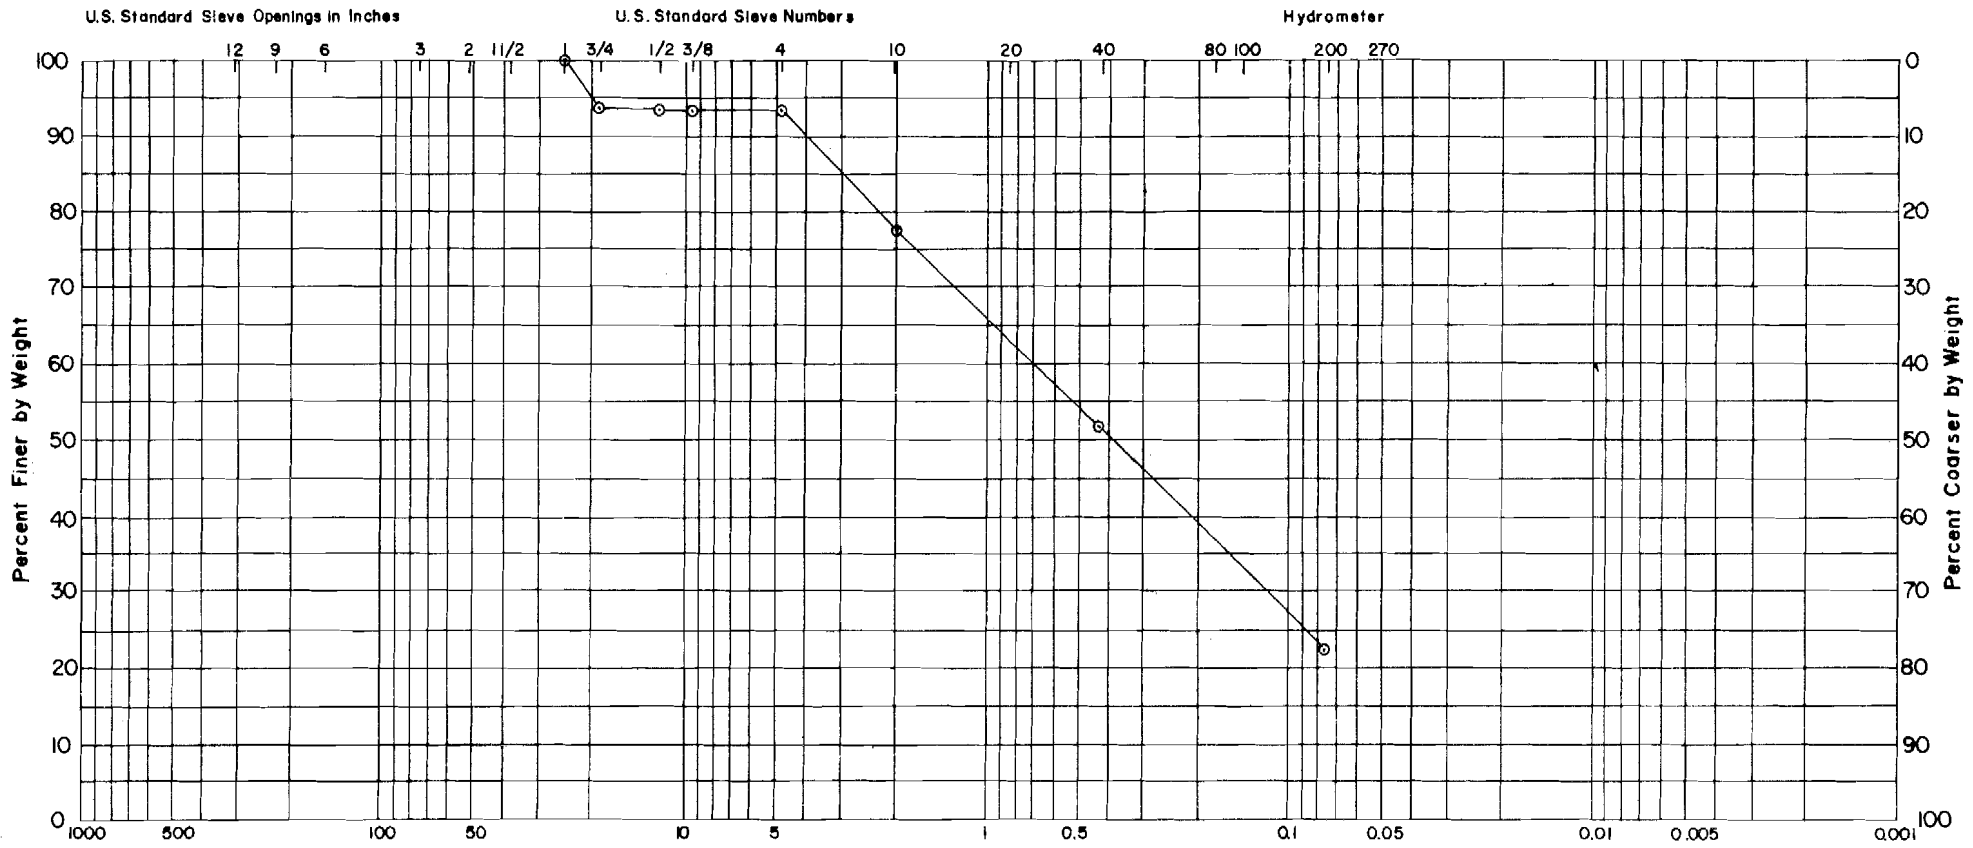
BORROW AREA D
AUGER HOLE AH-D7

SAMPLE NO.	MOTISTURE CONTENT	DRY DENSITY	LL	PI	CLASS	CLASSIFICATION & DESCRIPTION
AH-D7 - 8	9				SM	SAND WITH SOME SILT, TRACE GRAVEL

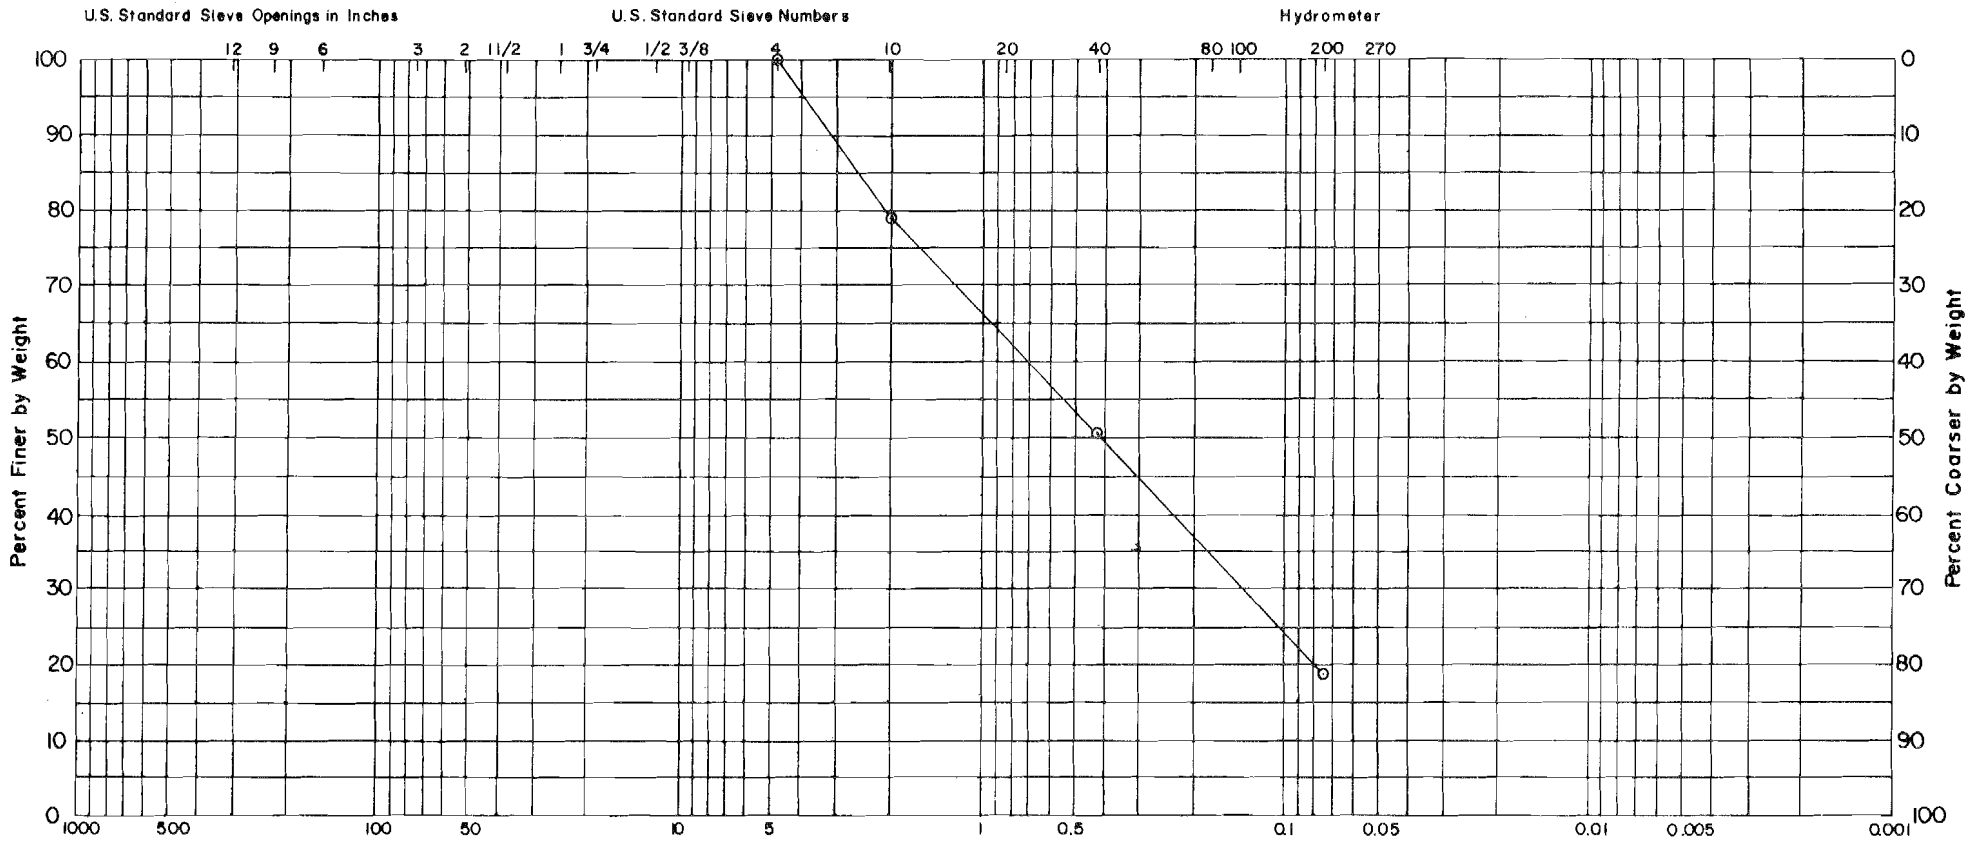
BORROW AREA D
AUGER HOLE AH-D7

SAMPLE NO.	MOISTURE CONTENT	DRY DENSITY	LL	PI	CLASS	CLASSIFICATION & DESCRIPTION
AH-D7 - 10	9				SM	SAND WITH SOME SILT

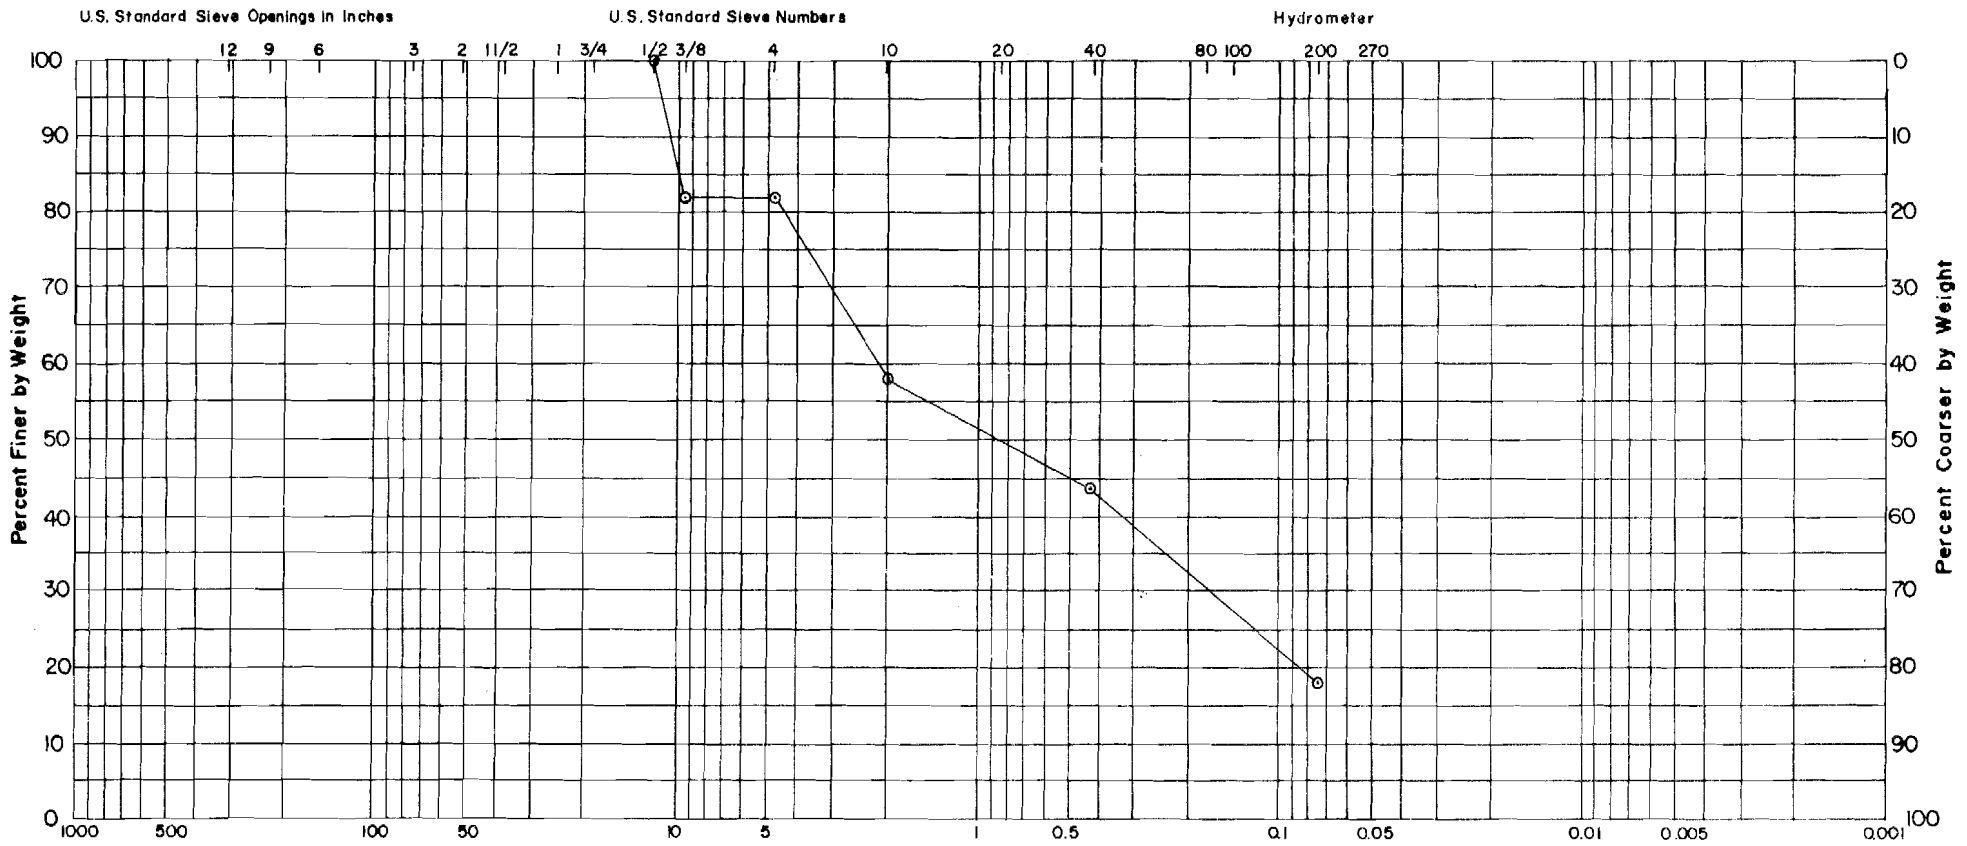
BORROW AREA D
AUGER HOLE AH-D7

SAMPLE NO.	MOISTURE CONTENT	DRY DENSITY	LL	PI	CLASS	CLASSIFICATION & DESCRIPTION
AH-D8 - 5	15		14	NP	SM	SAND WITH SOME GRAVEL AND SILT

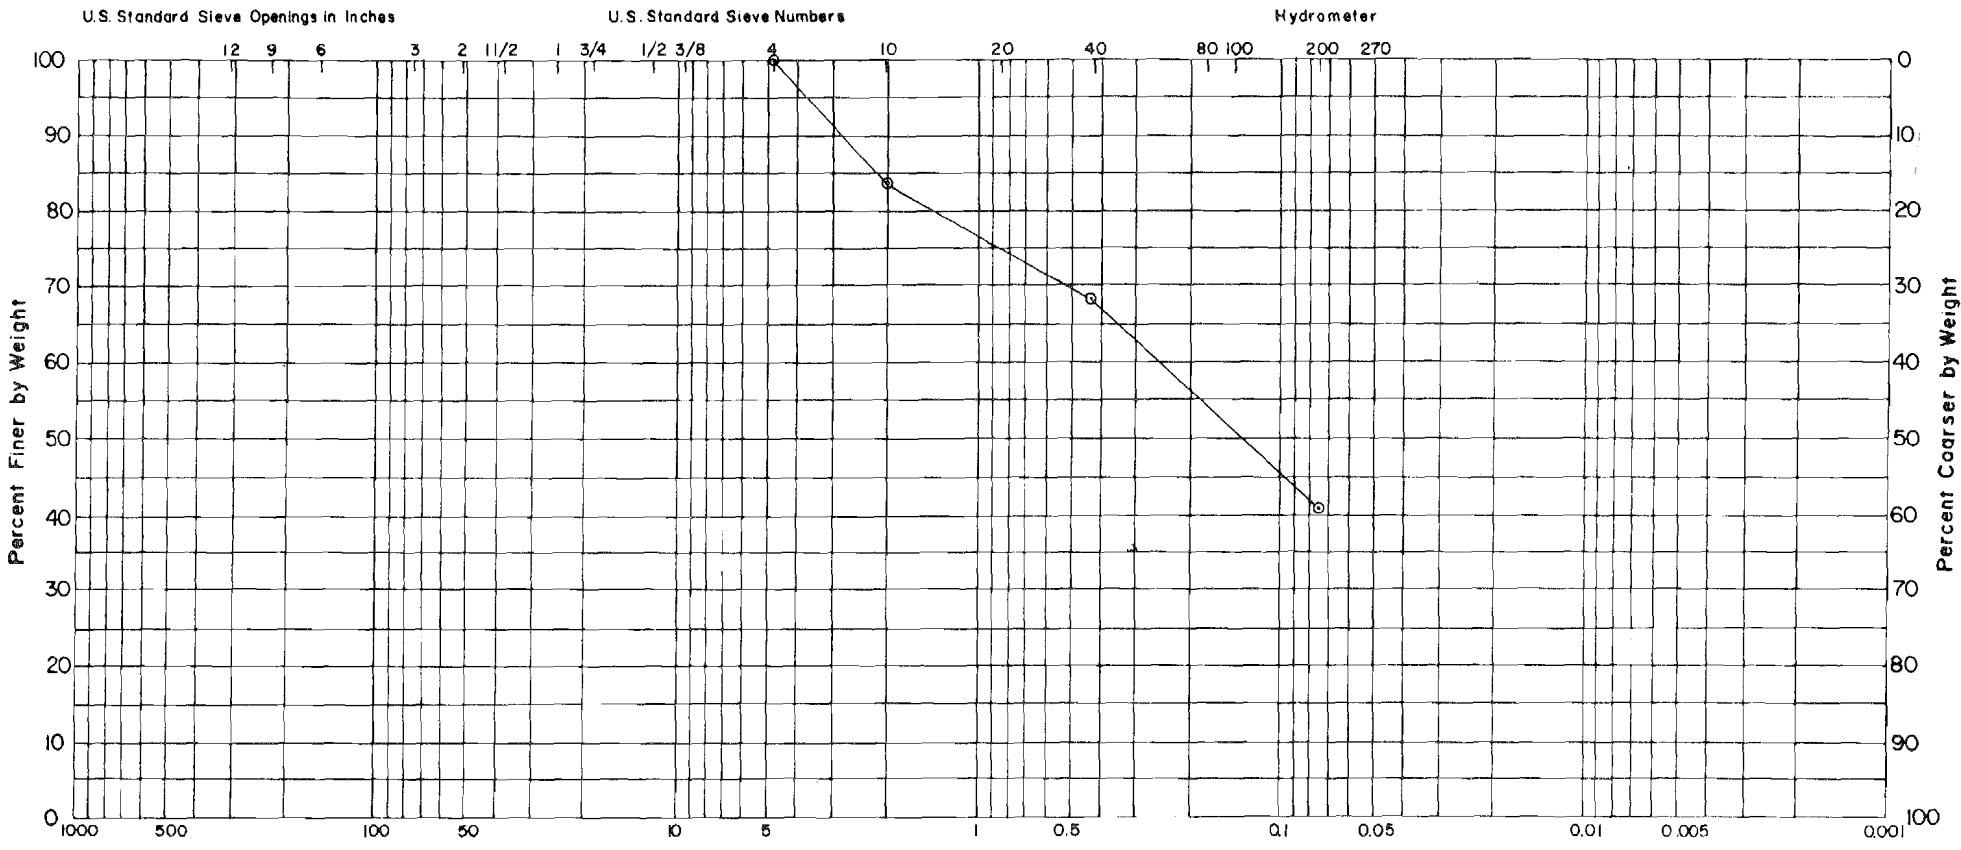
BORROW AREA D
AUGER HOLE AH-D8

SAMPLE NO.	MOISTURE CONTENT	DRY DENSITY	LL	PI	CLASS	CLASSIFICATION & DESCRIPTION
AH-D8 - 8	14		14	NP	SM-ML	SILTY SAND

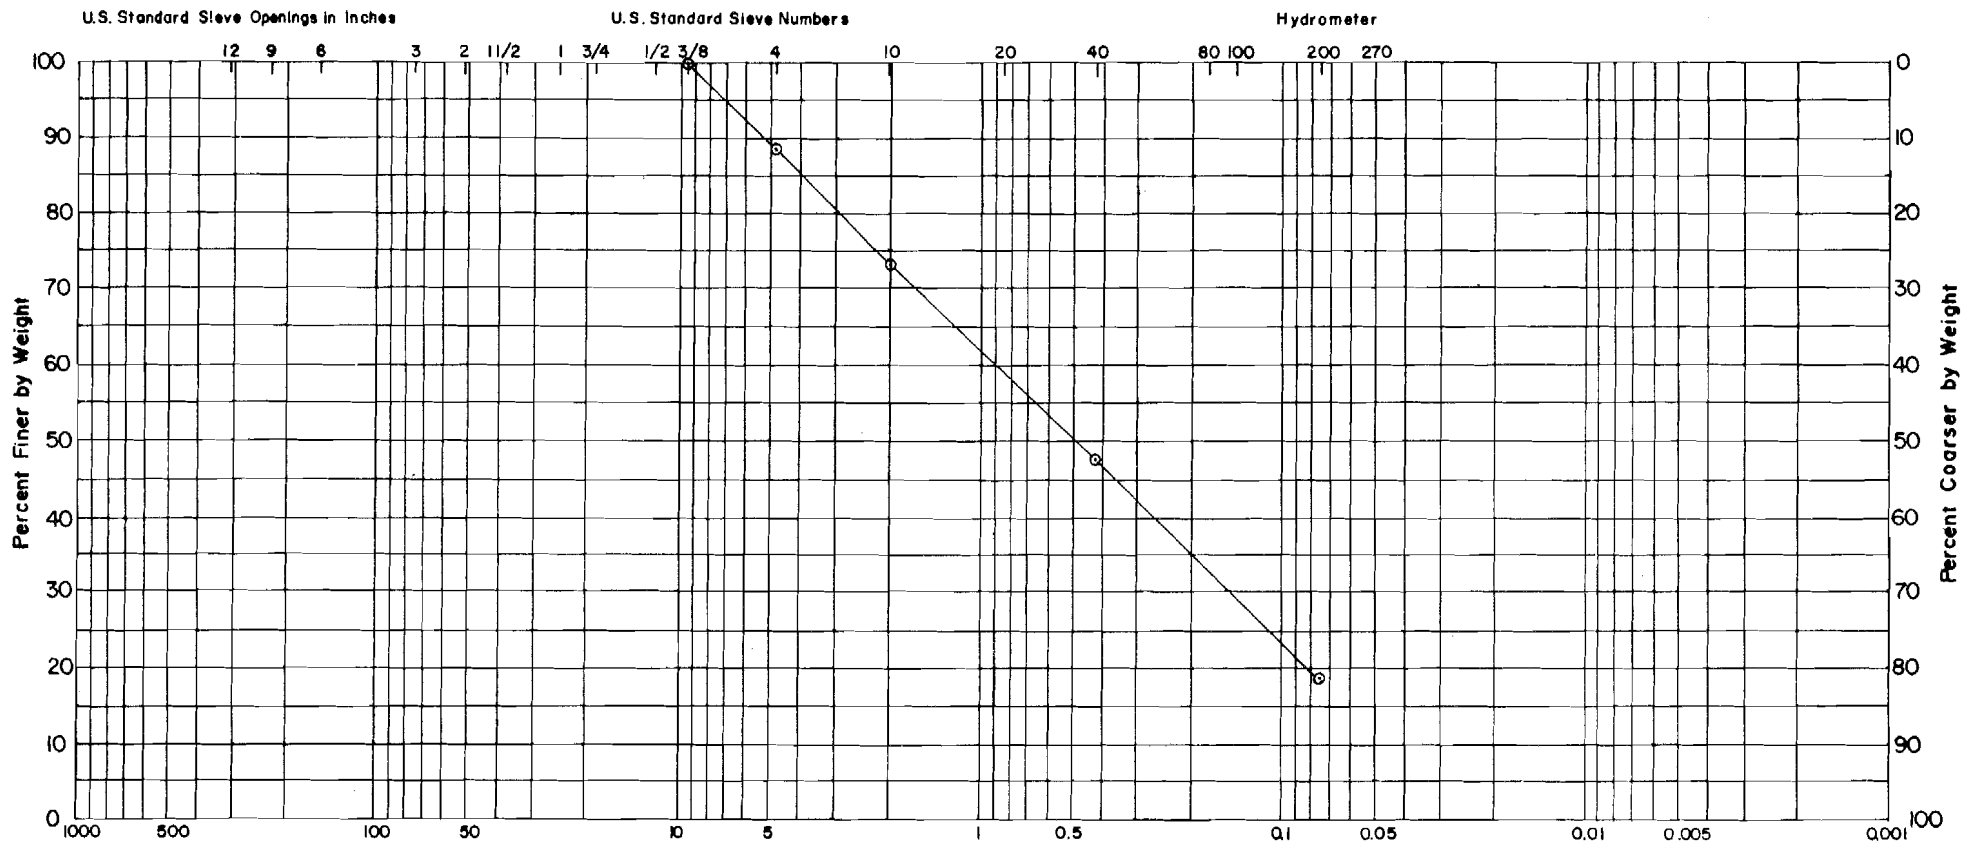
BORROW AREA D
 AUGER HOLE AH-D8

SAMPLE NO.	MOISTURE CONTENT	DRY DENSITY	LL	PI	CLASS	CLASSIFICATION & DESCRIPTION
AH-D8 - 9					SM	SAND WITH SOME GRAVEL AND SILT

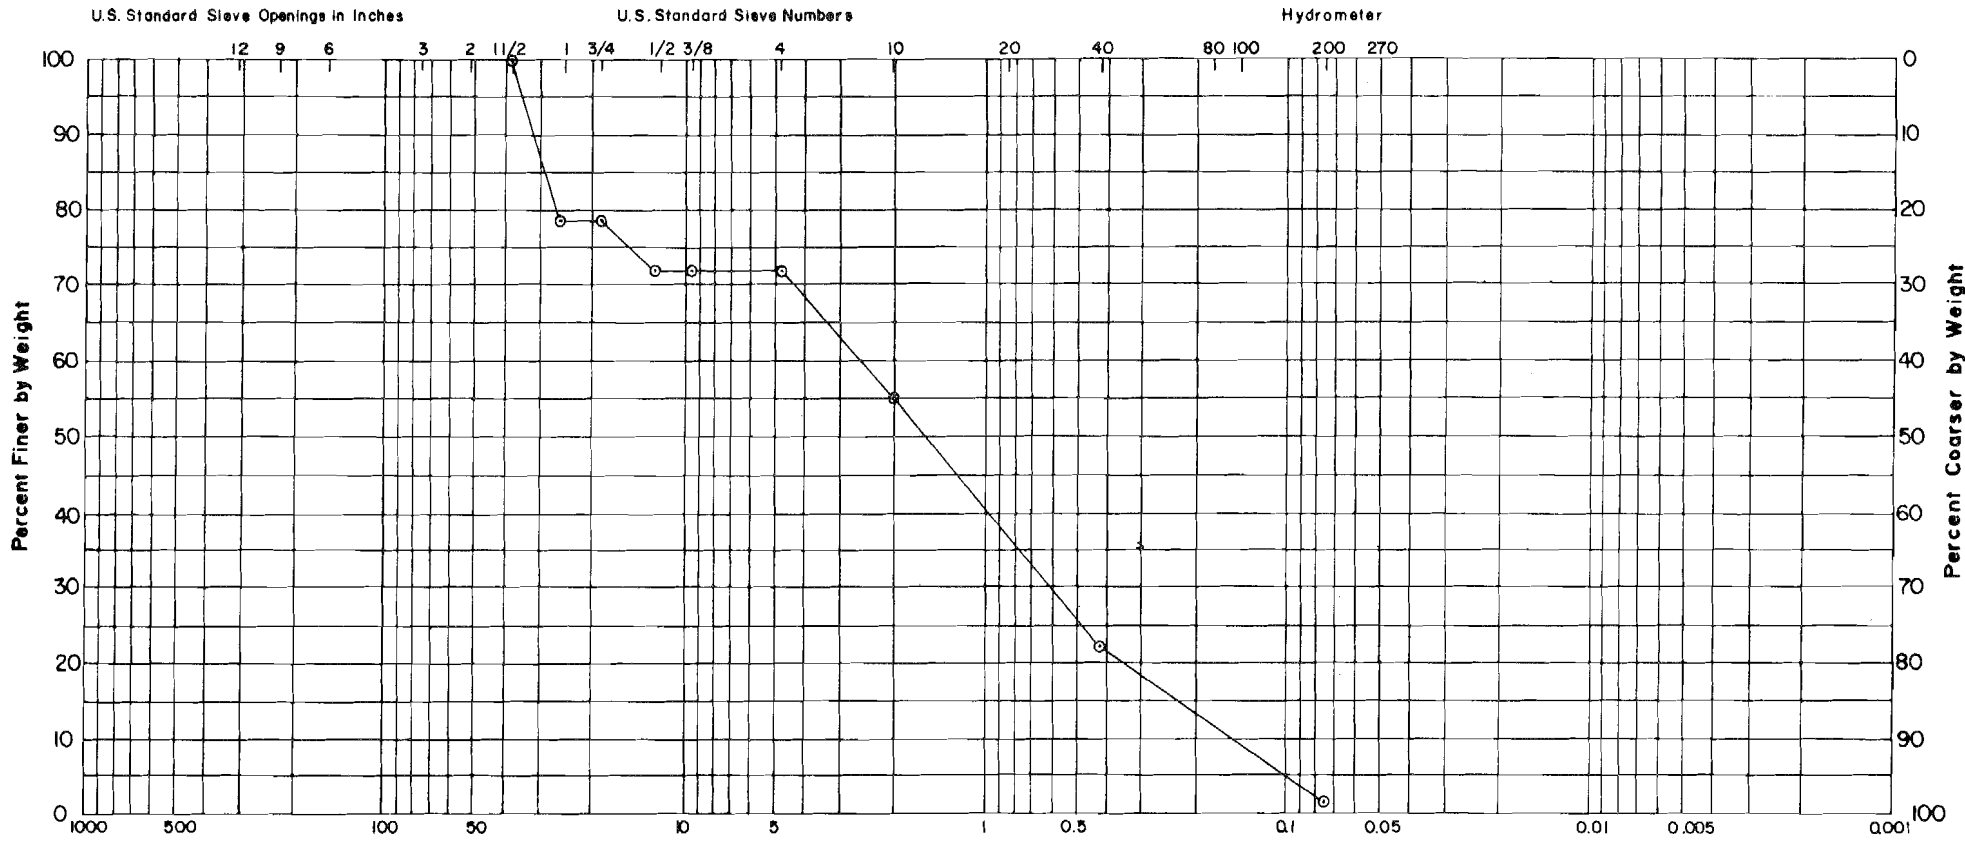
BORROW AREA D
AUGER HOLE AH-D8

SAMPLE NO.	MOISTURE CONTENT	DRY DENSITY	LL	PI	CLASS	CLASSIFICATION & DESCRIPTION
AH-D8 - 11	10		18	5	SP	SAND WITH SOME GRAVEL

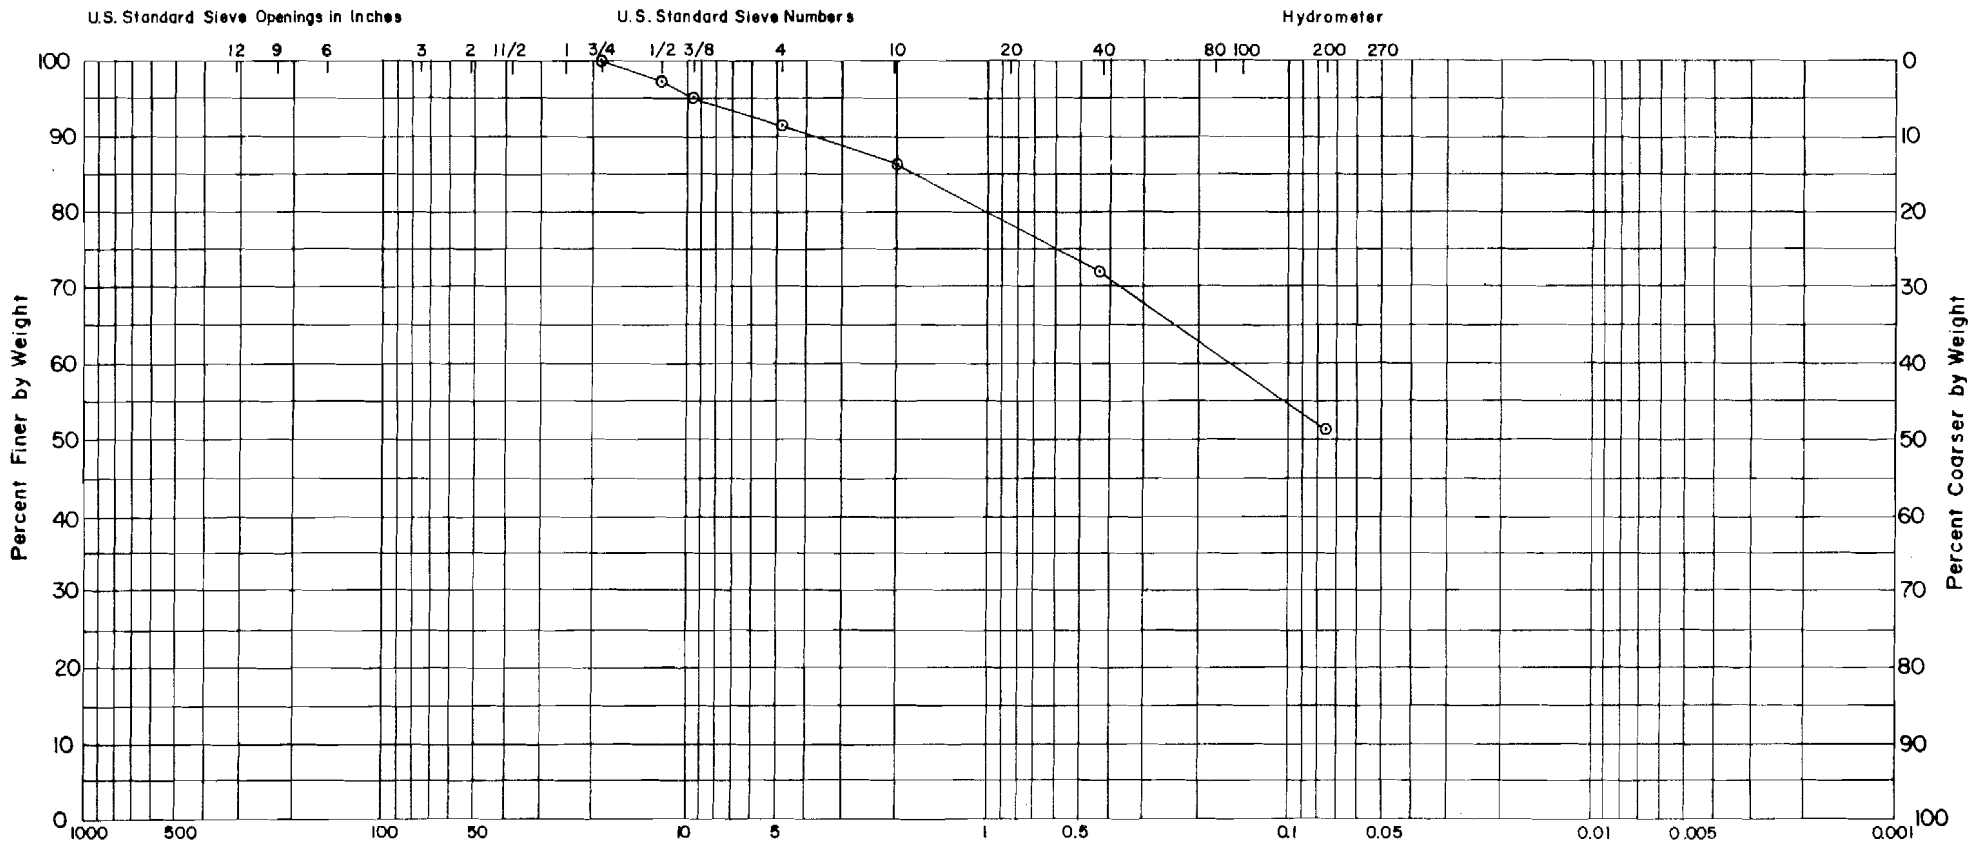
BORROW AREA D
AUGER HOLE AH-D8

SAMPLE NO.	MOISTURE CONTENT	DRY DENSITY	LL	PI	CLASS	CLASSIFICATION & DESCRIPTION
AH-D8 - 13	13				ML	SANDY SILT WITH SOME TO TRACE CLAY AND TRACE GRAVEL

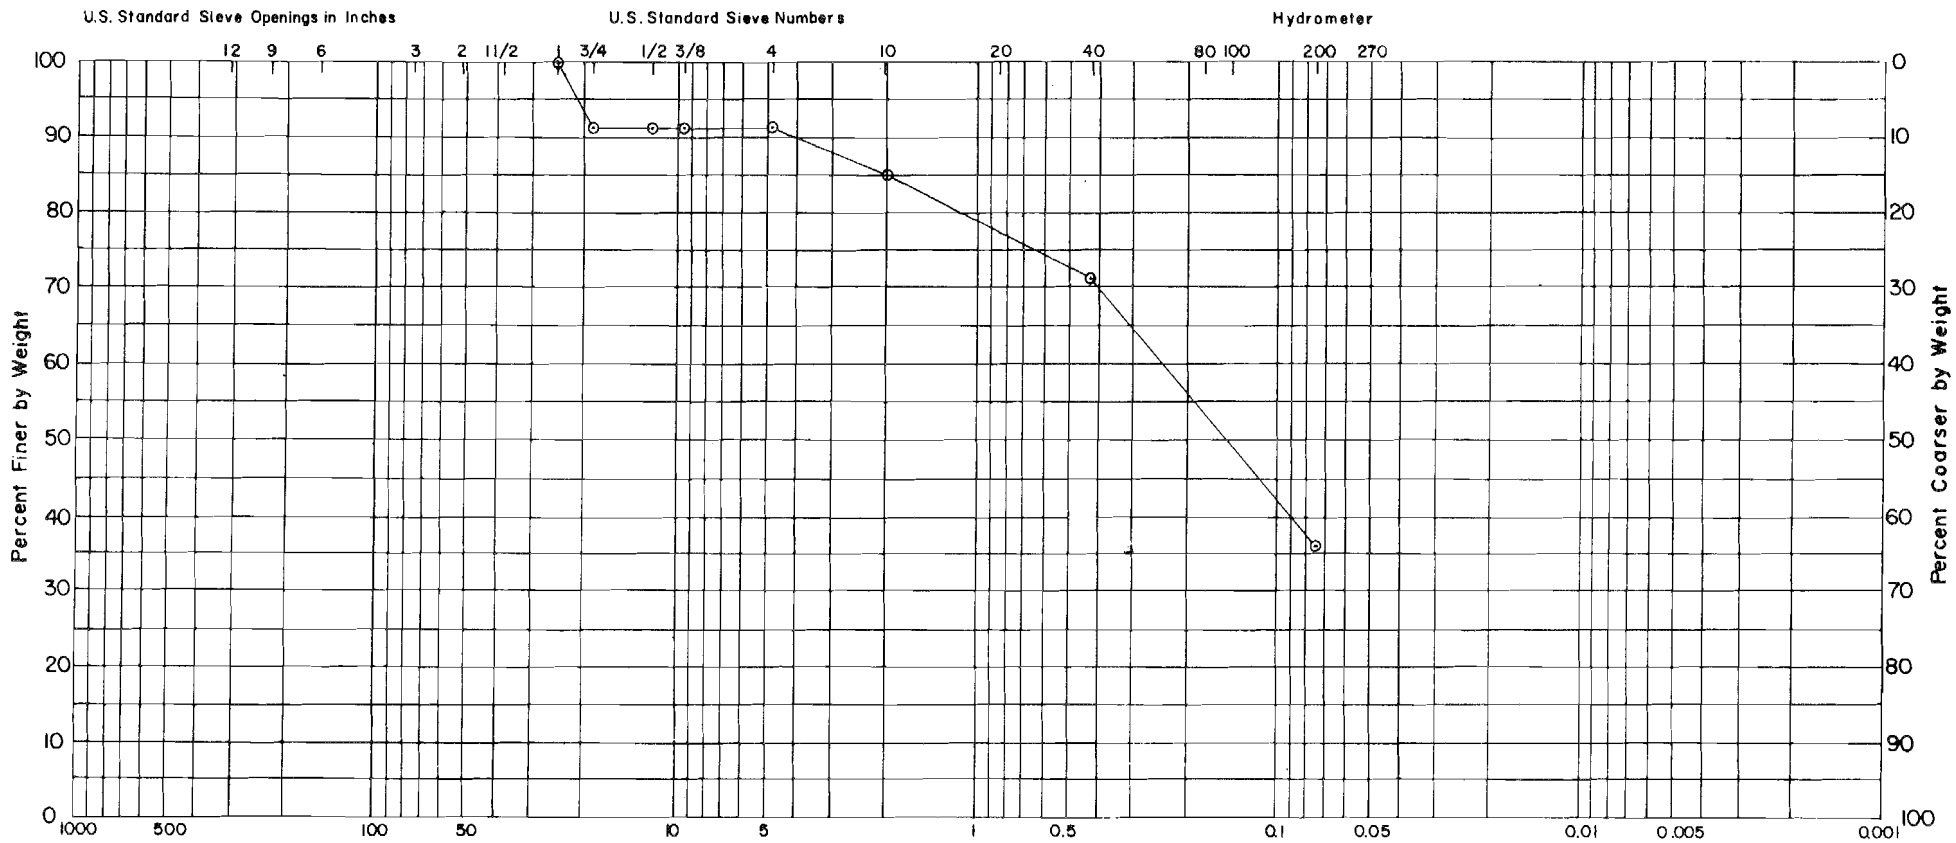
BORROW AREA D
AUGER HOLE AH-D8

SAMPLE NO.	MOISTURE CONTENT	DRY DENSITY	LL	PI	CLASS	CLASSIFICATION & DESCRIPTION
AH-D9 - 2					SM	SILTY SAND WITH TRACE GRAVEL

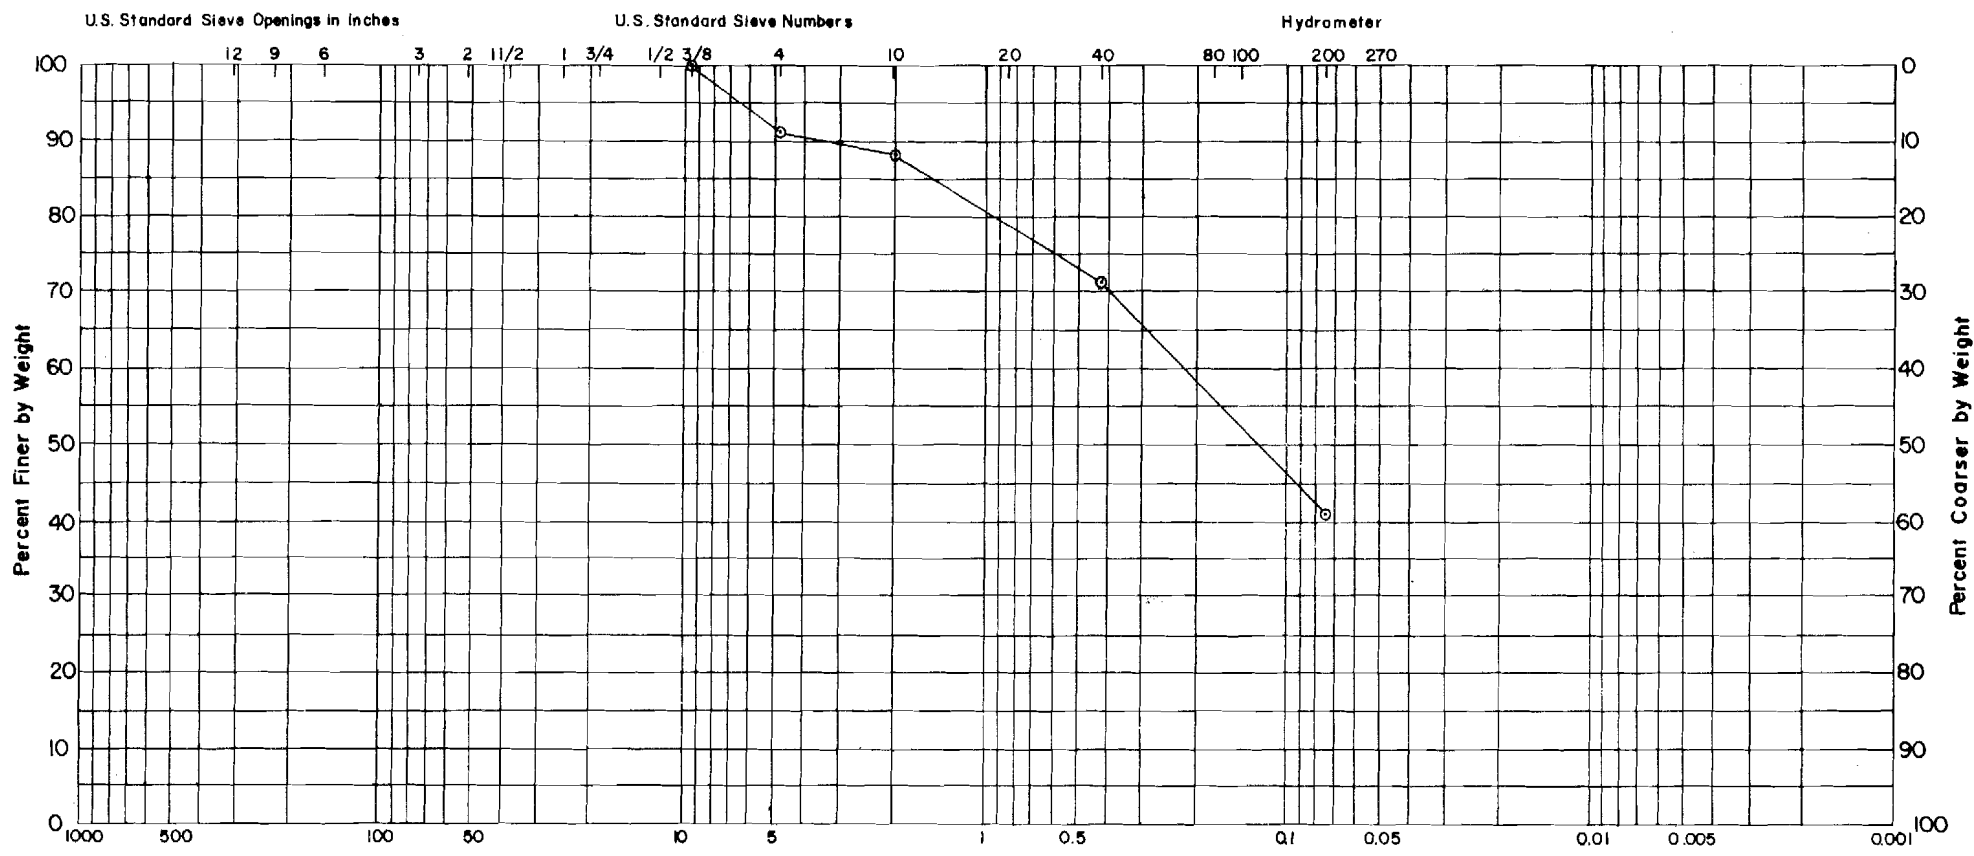
BORROW AREA D
AUGER HOLE AH-D9

SAMPLE NO.	MOISTURE CONTENT	DRY DENSITY	LL	PI	CLASS	CLASSIFICATION & DESCRIPTION
AH-D9 - 3					SM	SILTY SAND WITH TRACE GRAVEL
