SUSITNA HYDROELECTRIC PROJECT

1980 - 81 GEOTECHNICAL REPORT

VOLUME 2
APPENDIX A-F
FINAL DRAFT

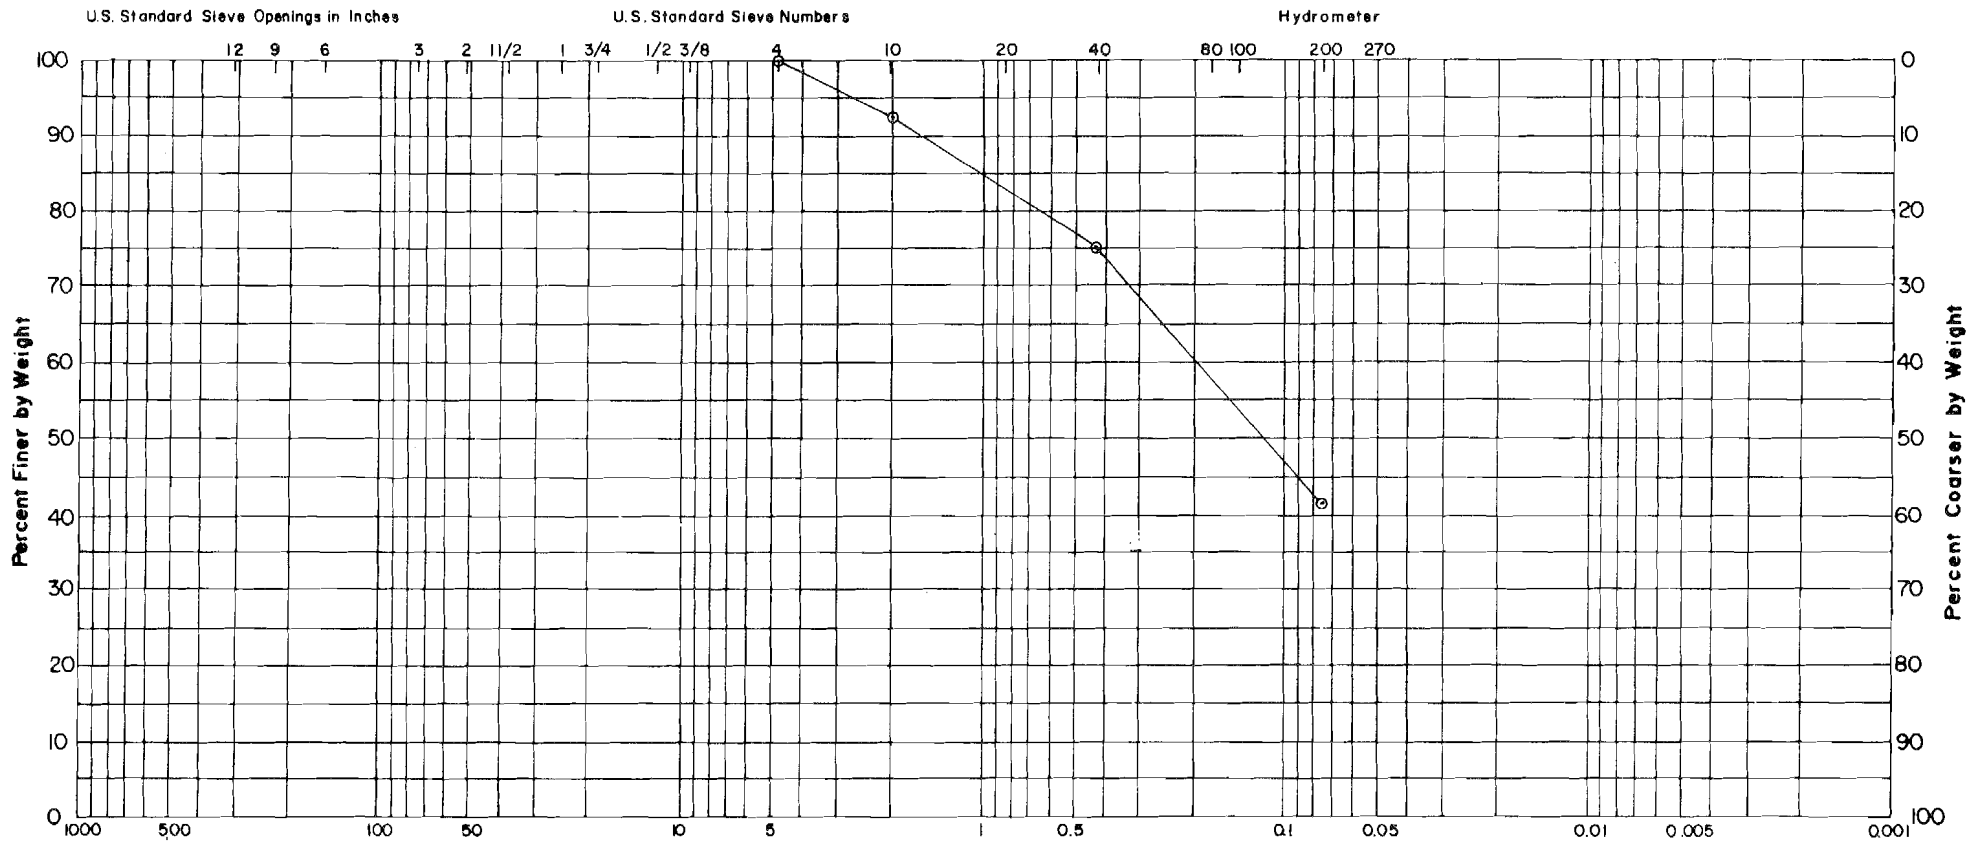
BORROW AREA D
AUGER HOLE AH-D9

SAMPLE NO.	MISTURE CONTENT	DRY DENSITY	LL	PI	CLASS	CLASSIFICATION & DESCRIPTION
AH-D9 - 4					SM	SILTY SAND

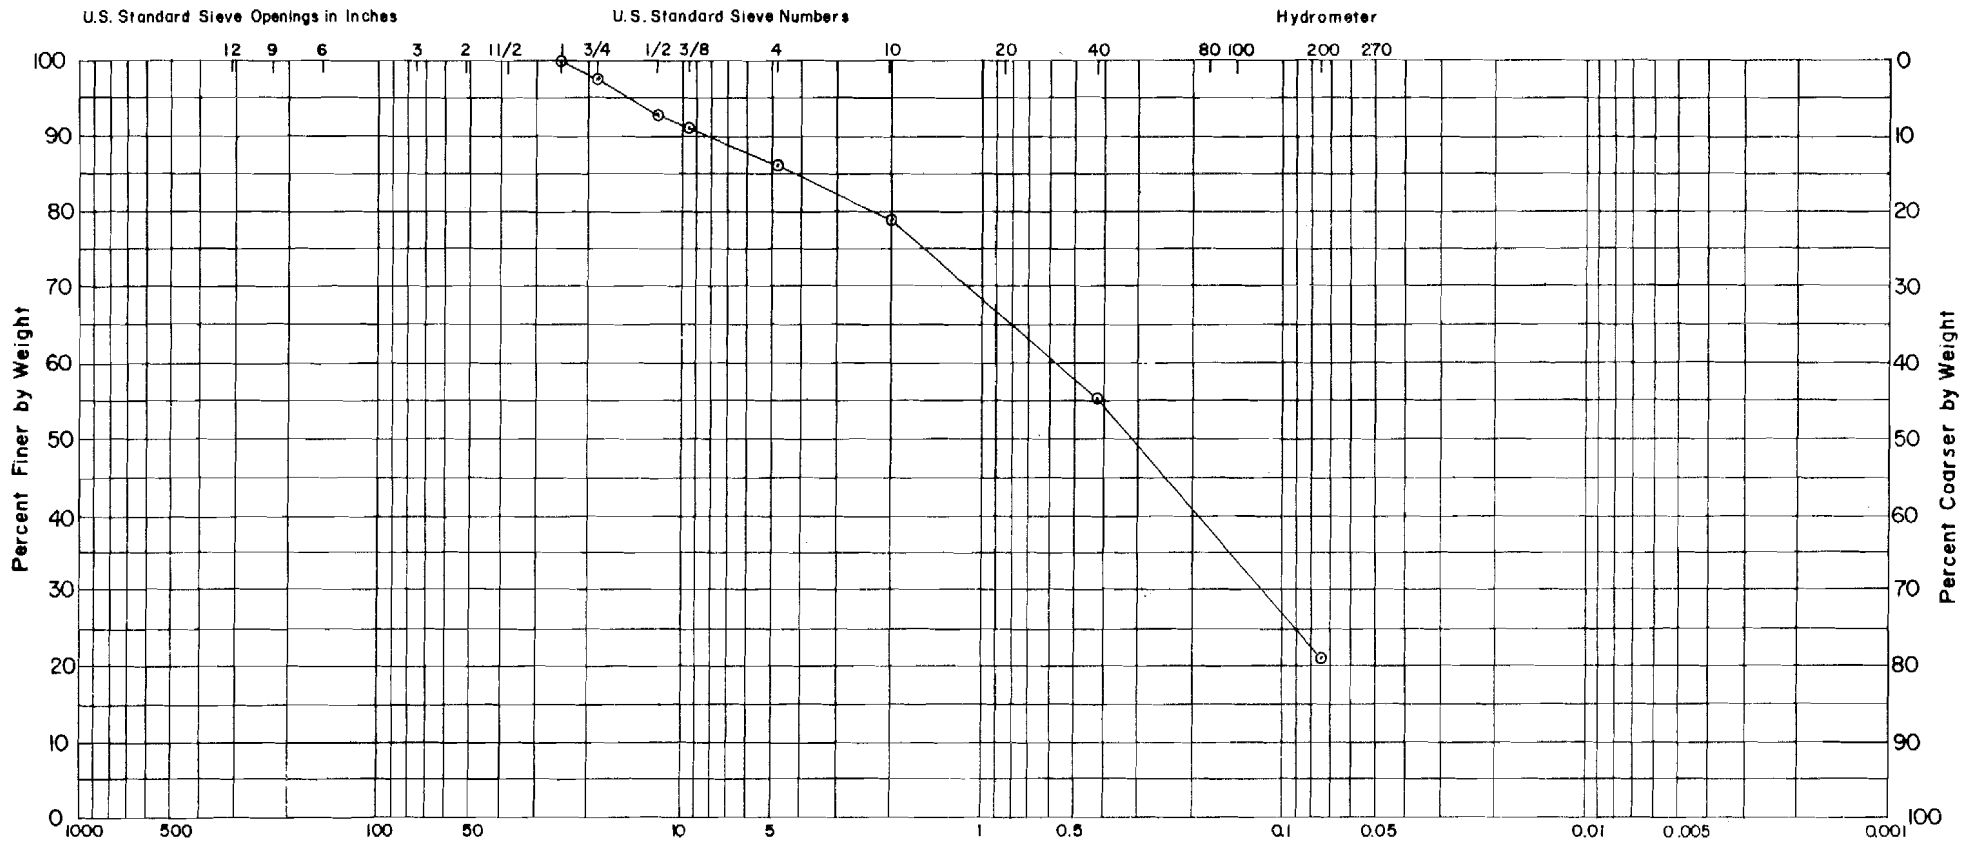
BORROW AREA D
AUGER HOLE AH-D9

SAMPLE NO.	MOISTURE CONTENT	DRY DENSITY	LL	PI	CLASS	CLASSIFICATION & DESCRIPTION
AH-D9 - 5					SM	SAND WITH SOME SILT AND GRAVEL

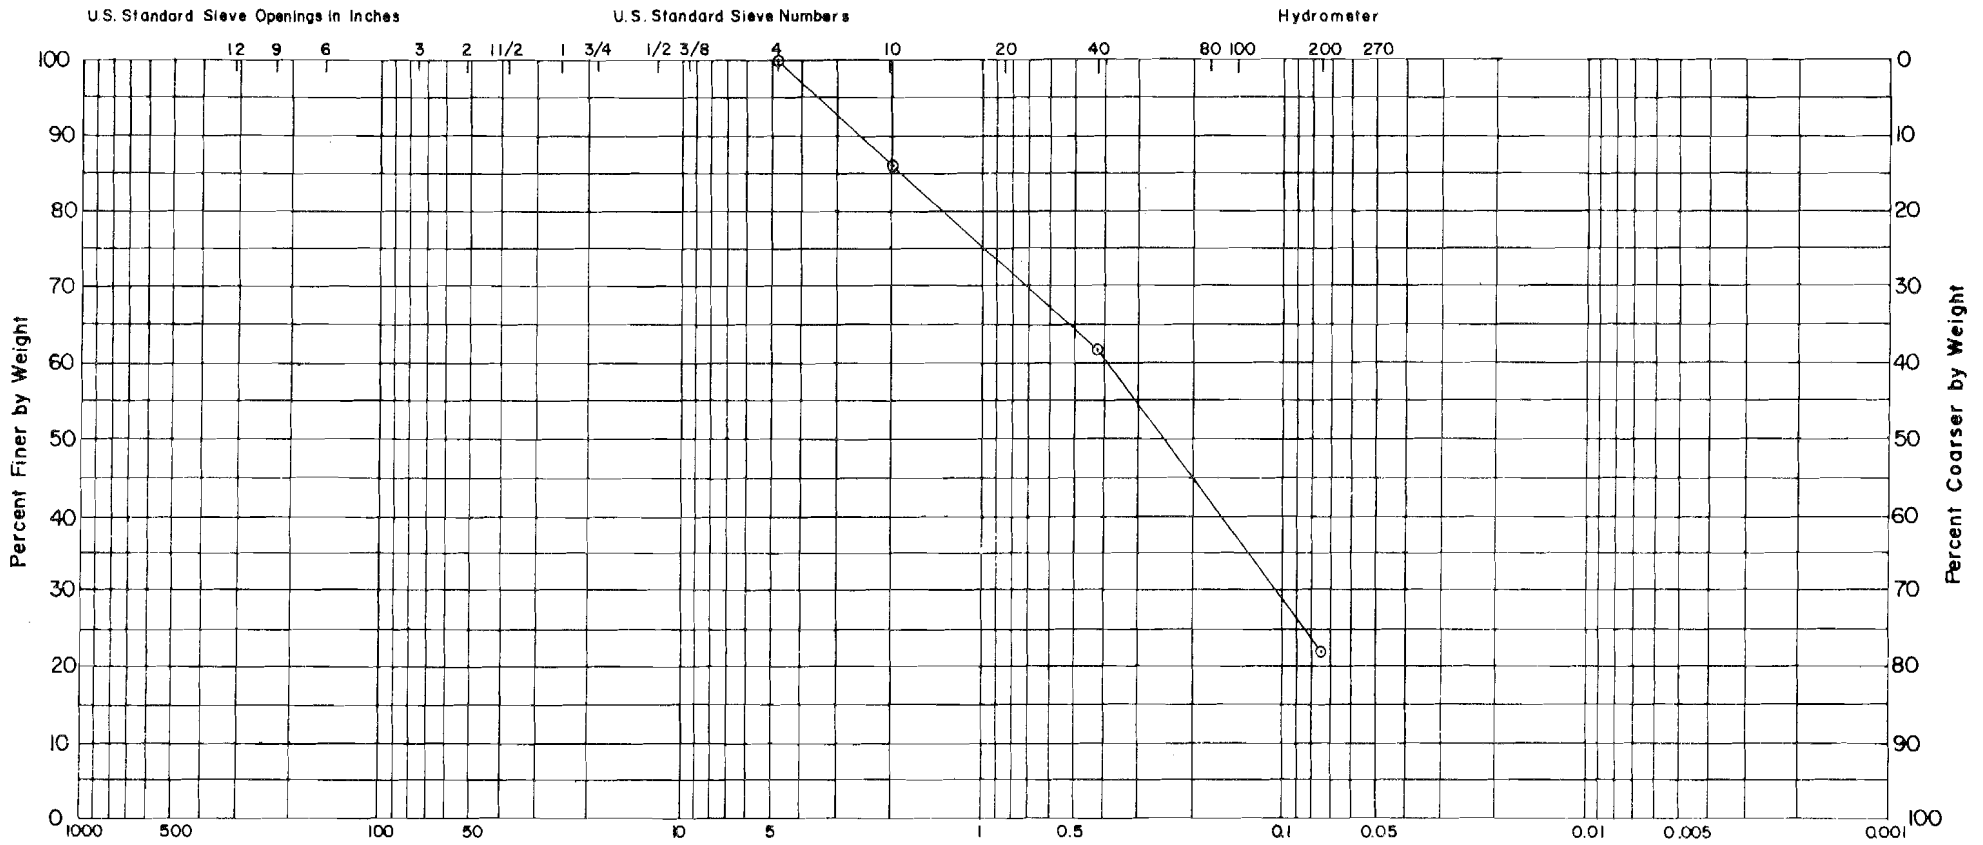
BORROW AREA D
AUGER HOLE AH-D9

SAMPLE NO.	MOTISTURE CONTENT	DRY DENSITY	LL	PI	CLASS	CLASSIFICATION & DESCRIPTION
AH-D9 - 6					SM	SAND WITH SOME SILT

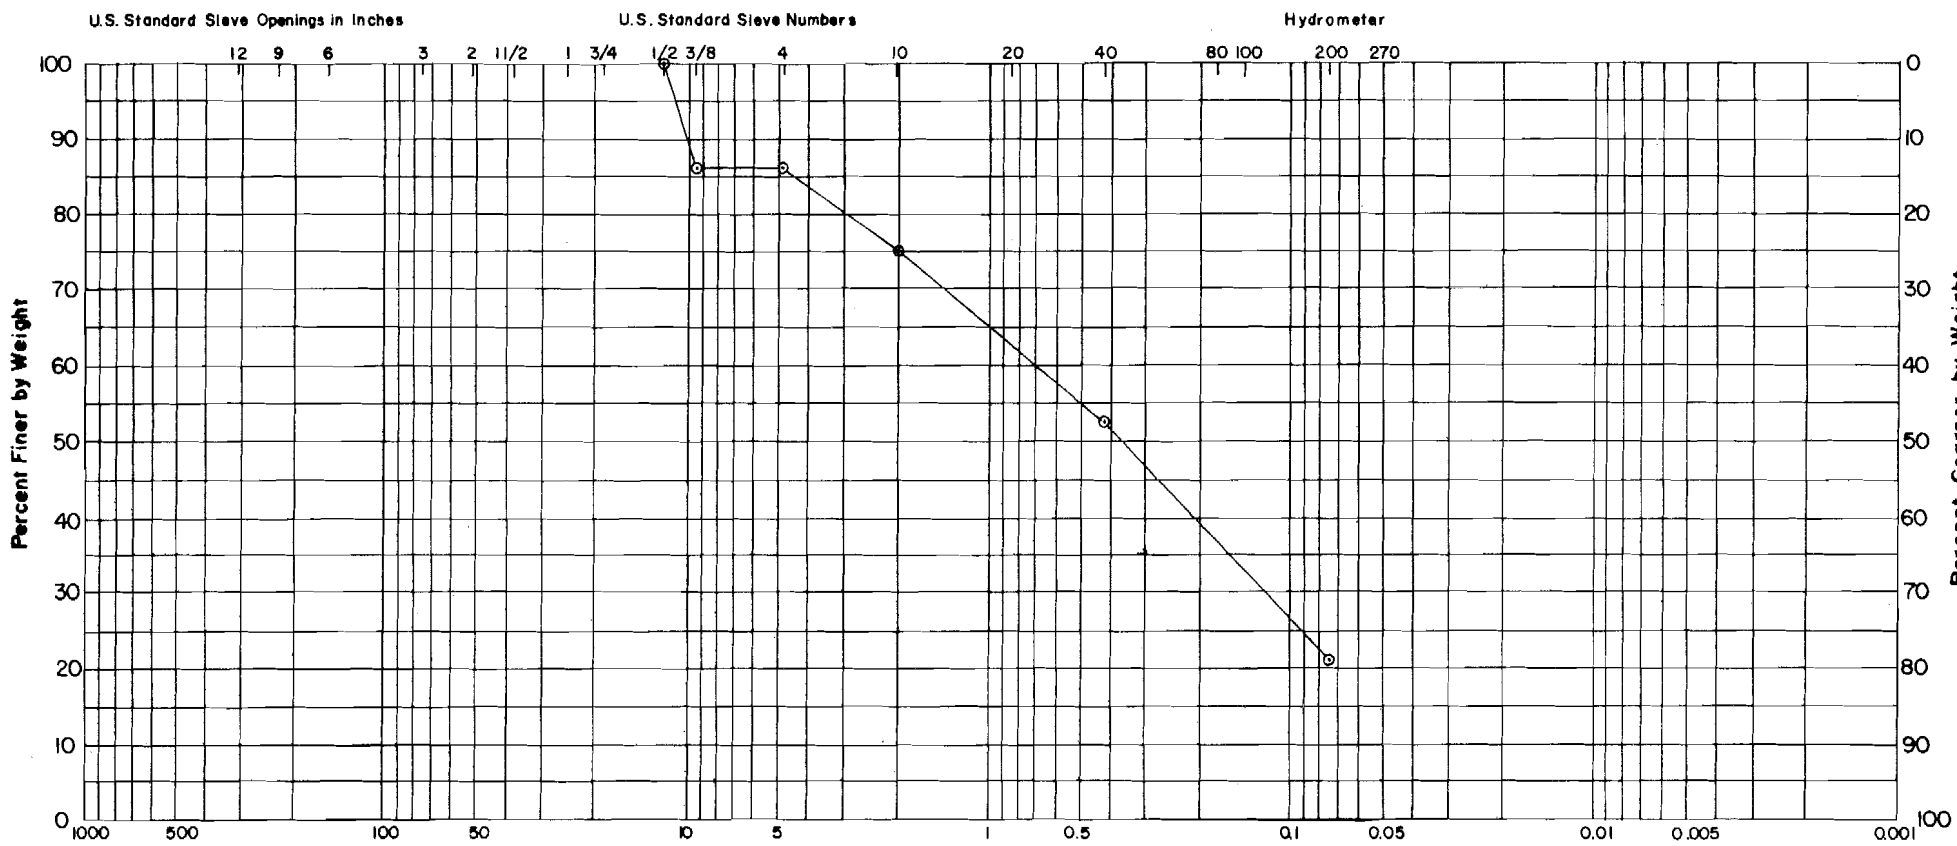
BORROW AREA D
AUGER HOLE AH-D9

SAMPLE NO.	MOISTURE CONTENT	DRY DENSITY	LL	PI	CLASS	CLASSIFICATION & DESCRIPTION
AH-D9 - 7					SM	SAND WITH SOME SILT AND GRAVEL

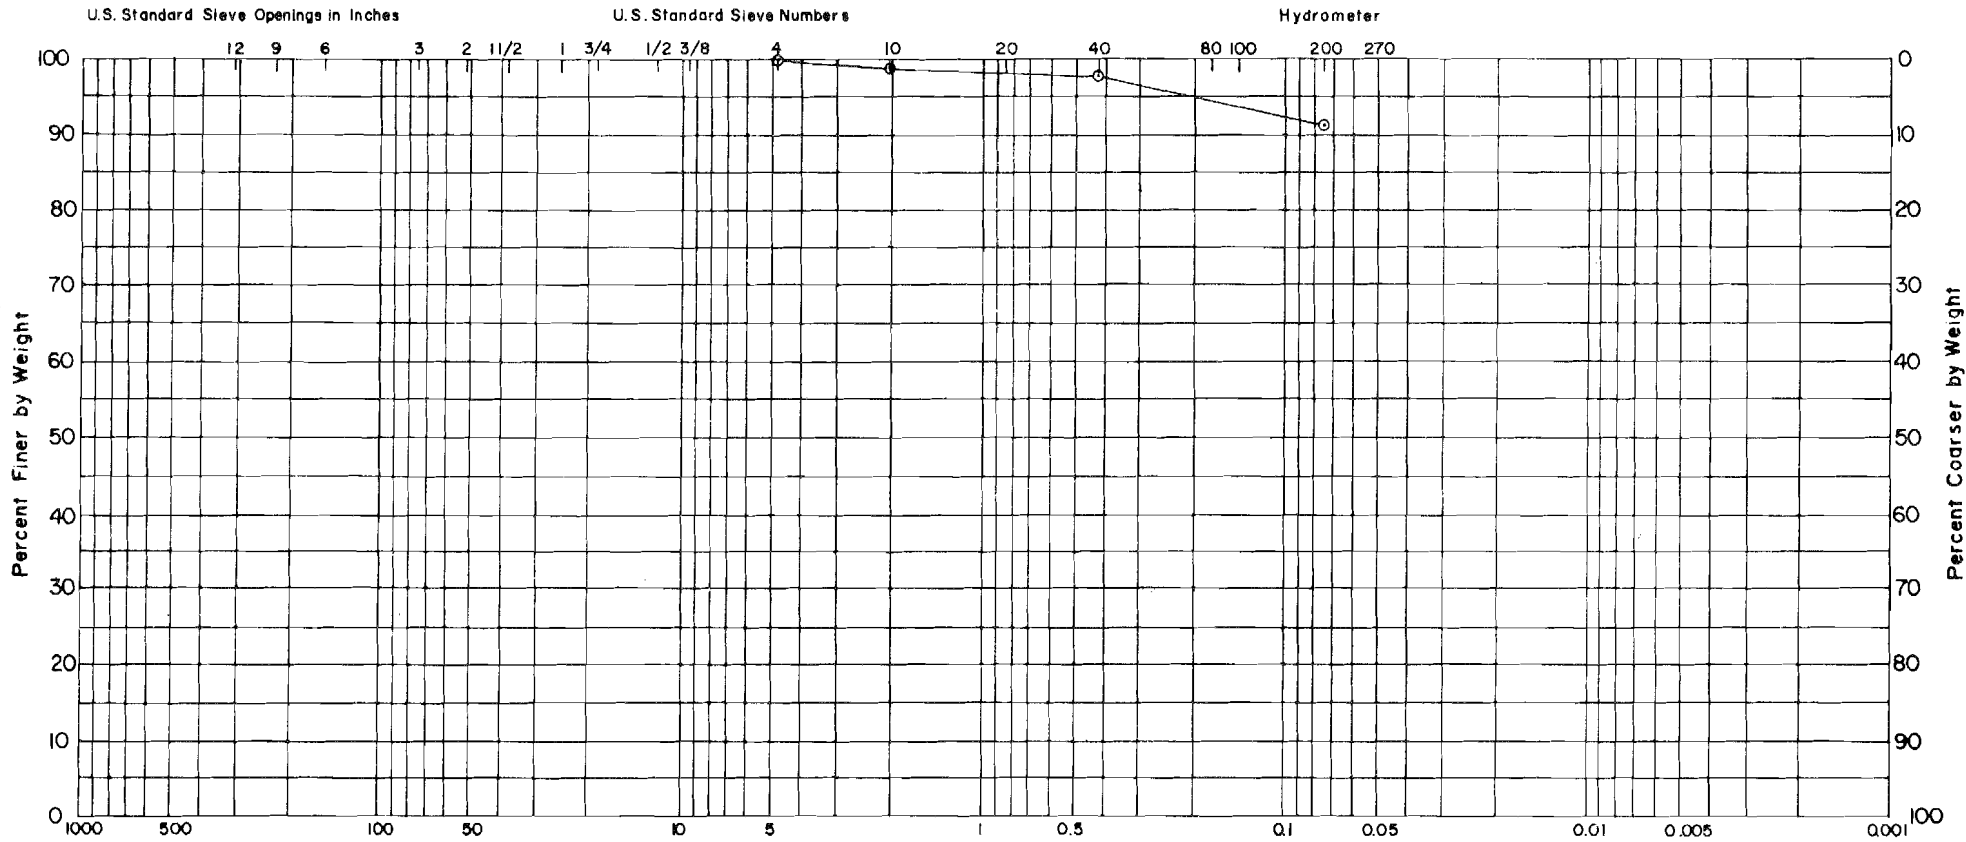
BORROW AREA D
AUGER HOLE AH-D9

SAMPLE NO.	MOISTURE CONTENT	DRY DENSITY	LL	PI	CLASS	CLASSIFICATION & DESCRIPTION
AH-D9 - 13	21		21	NP	ML	SILT WITH TRACE SAND AND TRACE TO SOME CLAY

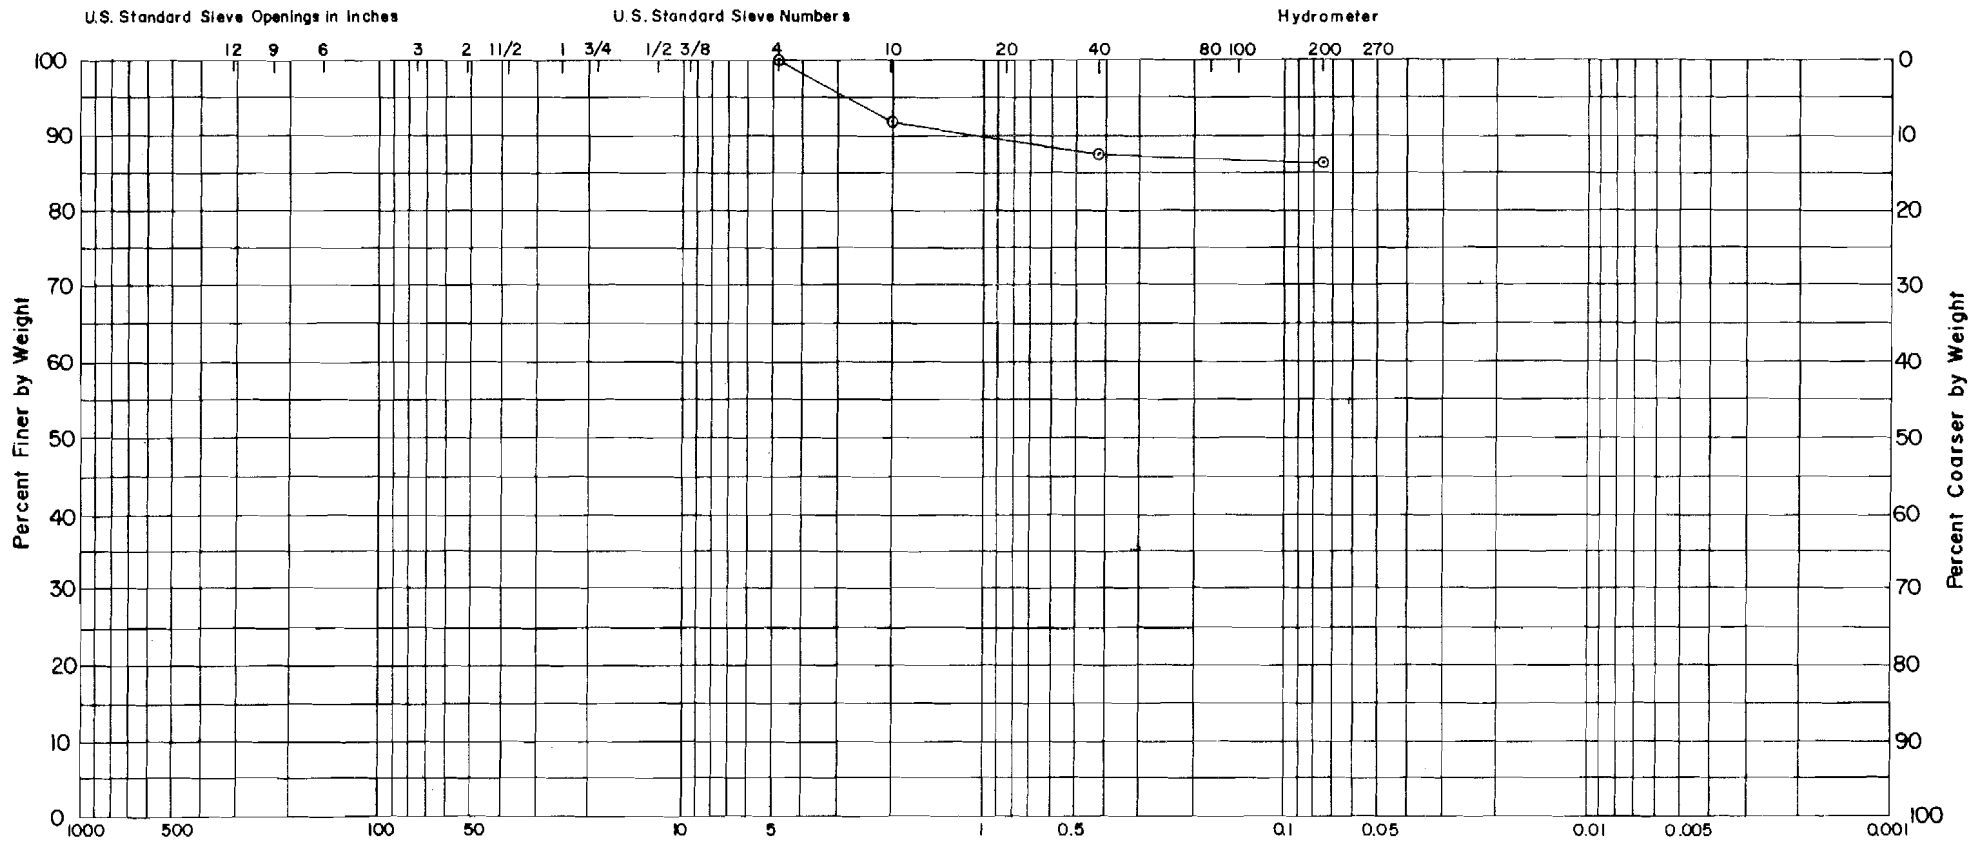
BORROW AREA D
AUGER HOLE AH-D9

SAMPLE NO.	MOISTURE CONTENT	DRY DENSITY	LL	PI	CLASS	CLASSIFICATION & DESCRIPTION
AH-D9 - 14	25		35	7	ML	SILT WITH SOME SAND AND TRACE TO SOME CLAY

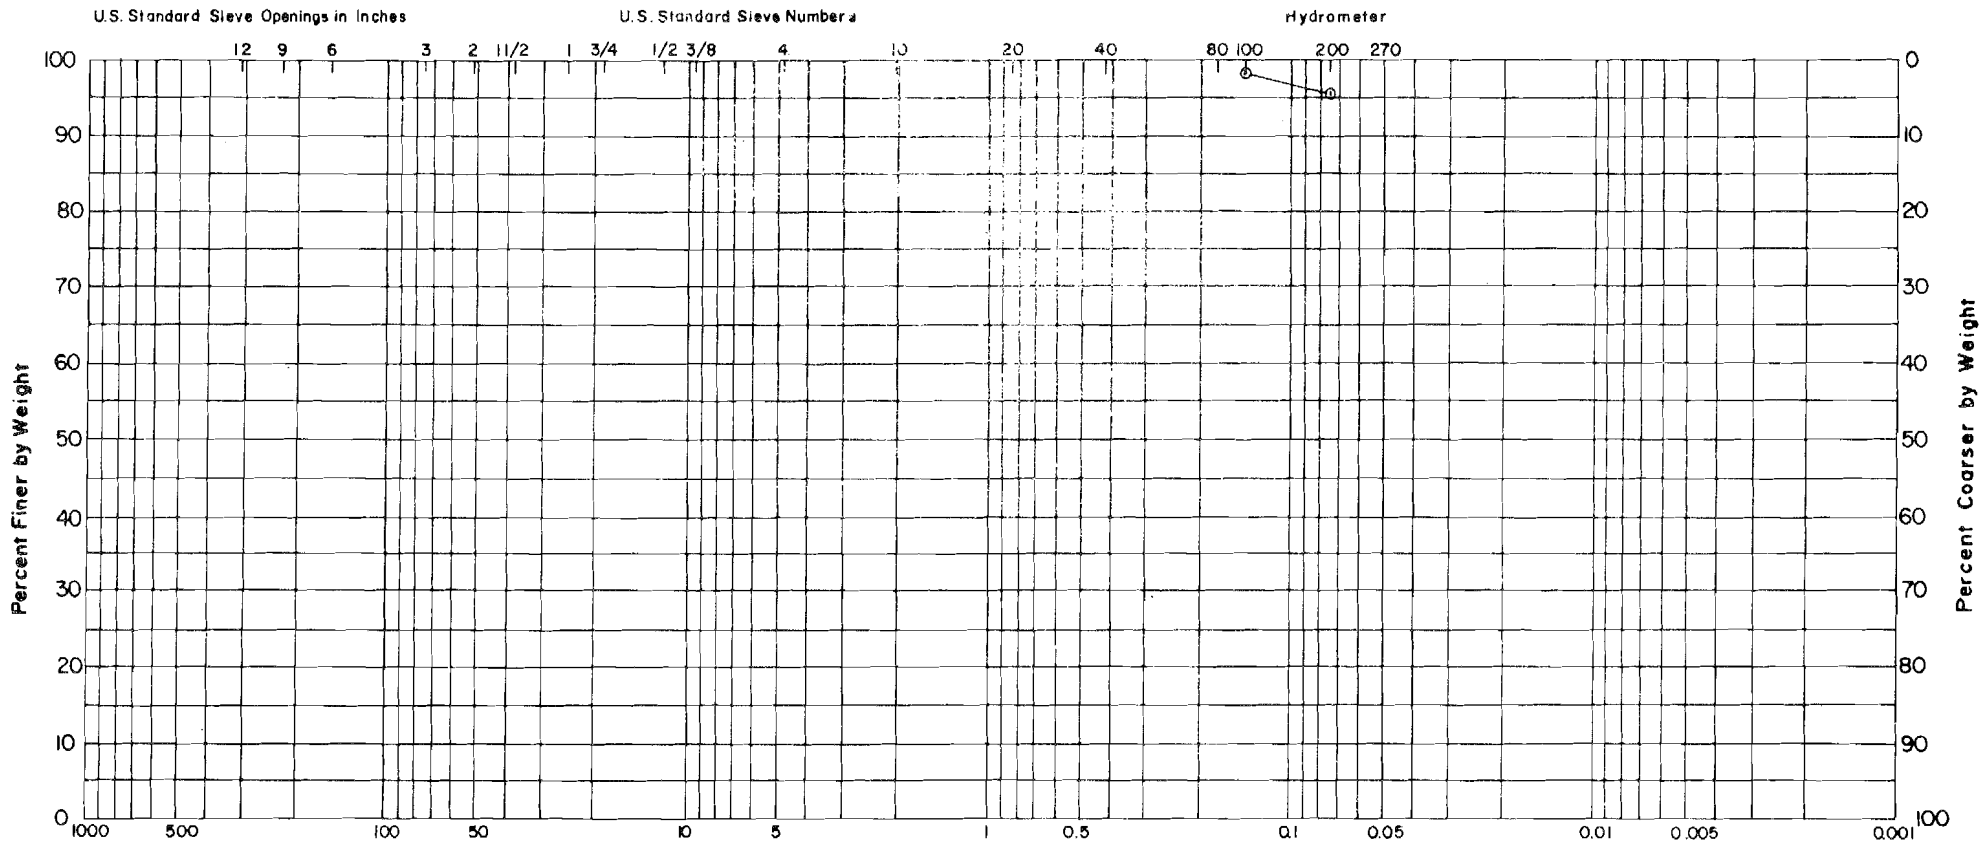
BORROW AREA D
AUGER HOLE AH-D9

SAMPLE NO.	MOISTURE CONTENT	DRY DENSITY	LL	PI	CLASS	CLASSIFICATION & DESCRIPTION
BORROW D BULK			59	23	MH	SILT WITH SOME TO TRACE CLAY AND TRACE SAND OR CLAYEY SILT WITH TRACE SAND

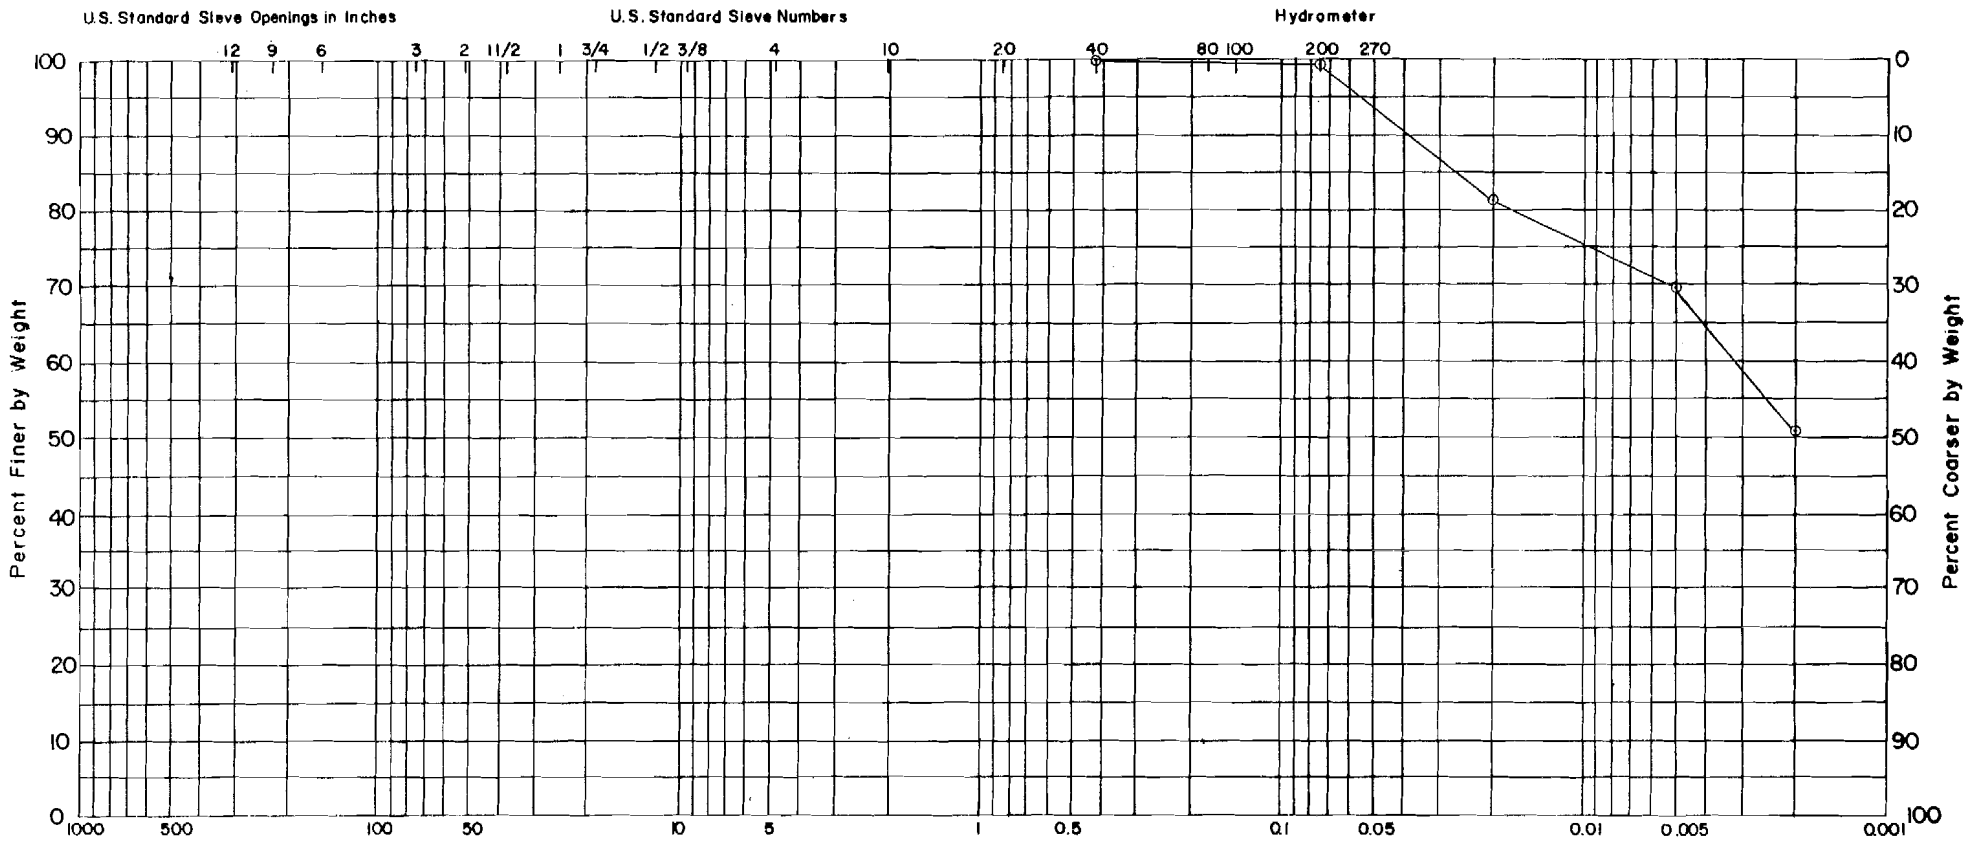
BORROW AREA D
BULK SAMPLE

SAMPLE NO.	MOISTURE CONTENT	DRY DENSITY	LL	PI	CLASSIFICATION & DESCRIPTION
W-80-282 (Grab Sample)	42.1%		55.9	33.2	CL-CH SILT AND CLAY Medium to High Plasticity

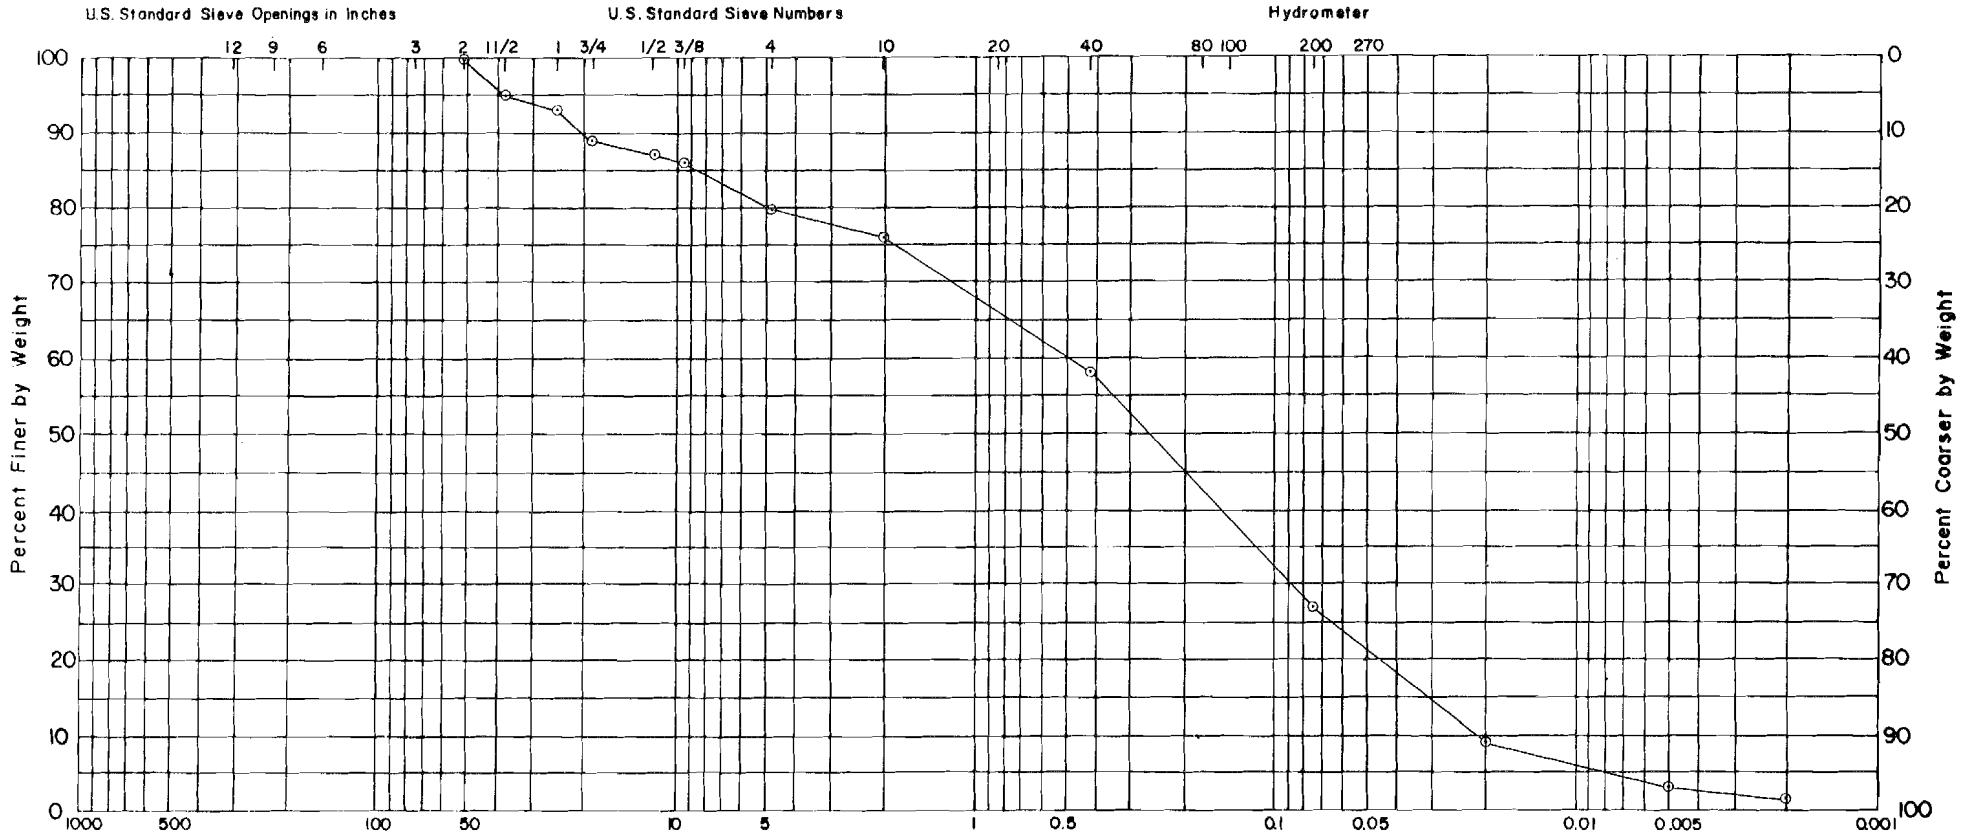
DEADMAN BORROW AREA

SAMPLE NO.	MOISTURE CONTENT	DRY DENSITY	LL	PI		CLASSIFICATION & DESCRIPTION
W-80-300 (Grab Sample)	6.6%		NV	NP	SM	Sandy 'Till' with non plastic fines GRAVELLY SILTY SAND WITH TRACE CLAY Well graded

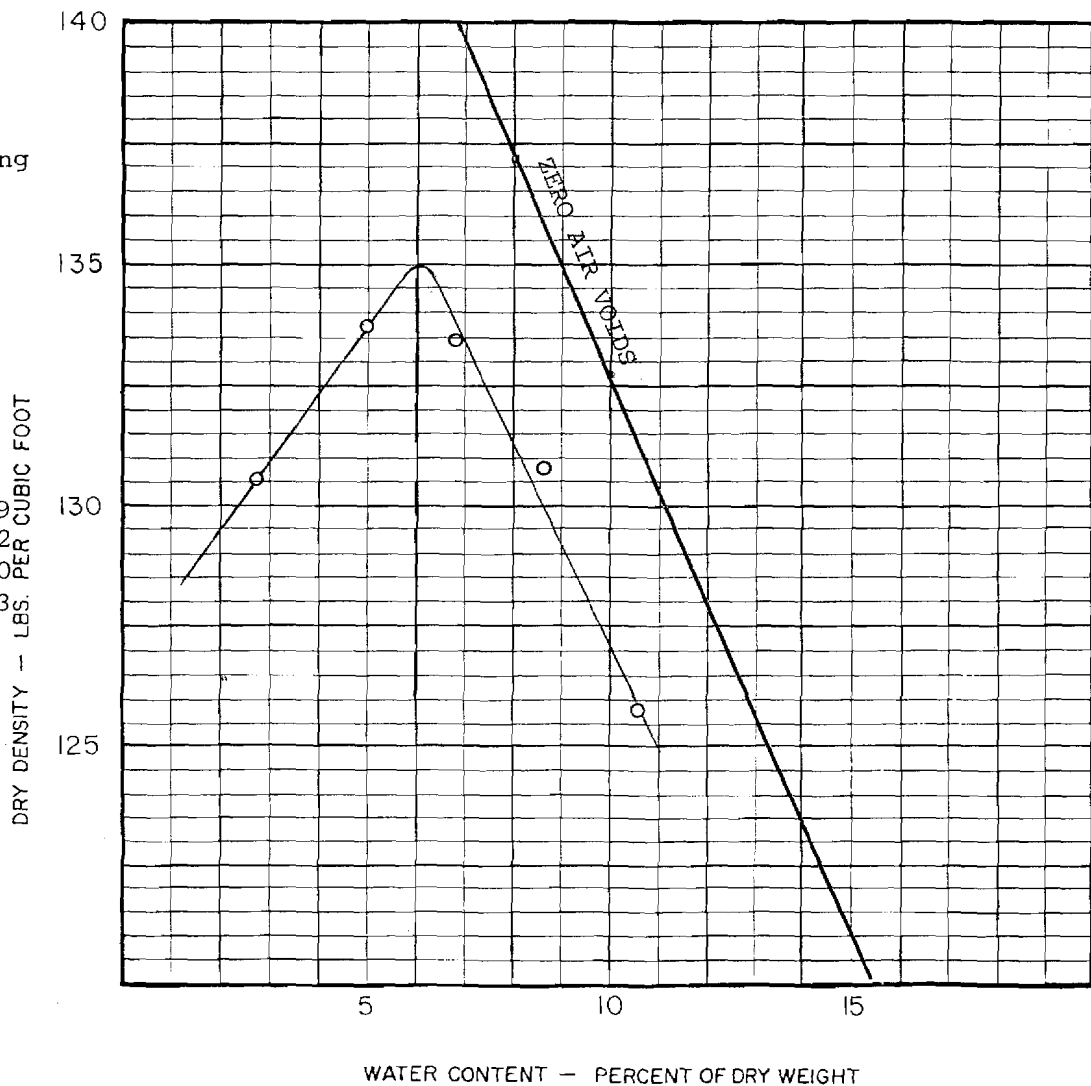
Size % Passing

2 "	100
1½ "	95
1 "	93
¾ "	89
½ "	87
⅜ "	86
# 4	80
# 10	76
# 40	58
# 200	26.9
.02mm	9.2
.005	3.0
.002	1.3

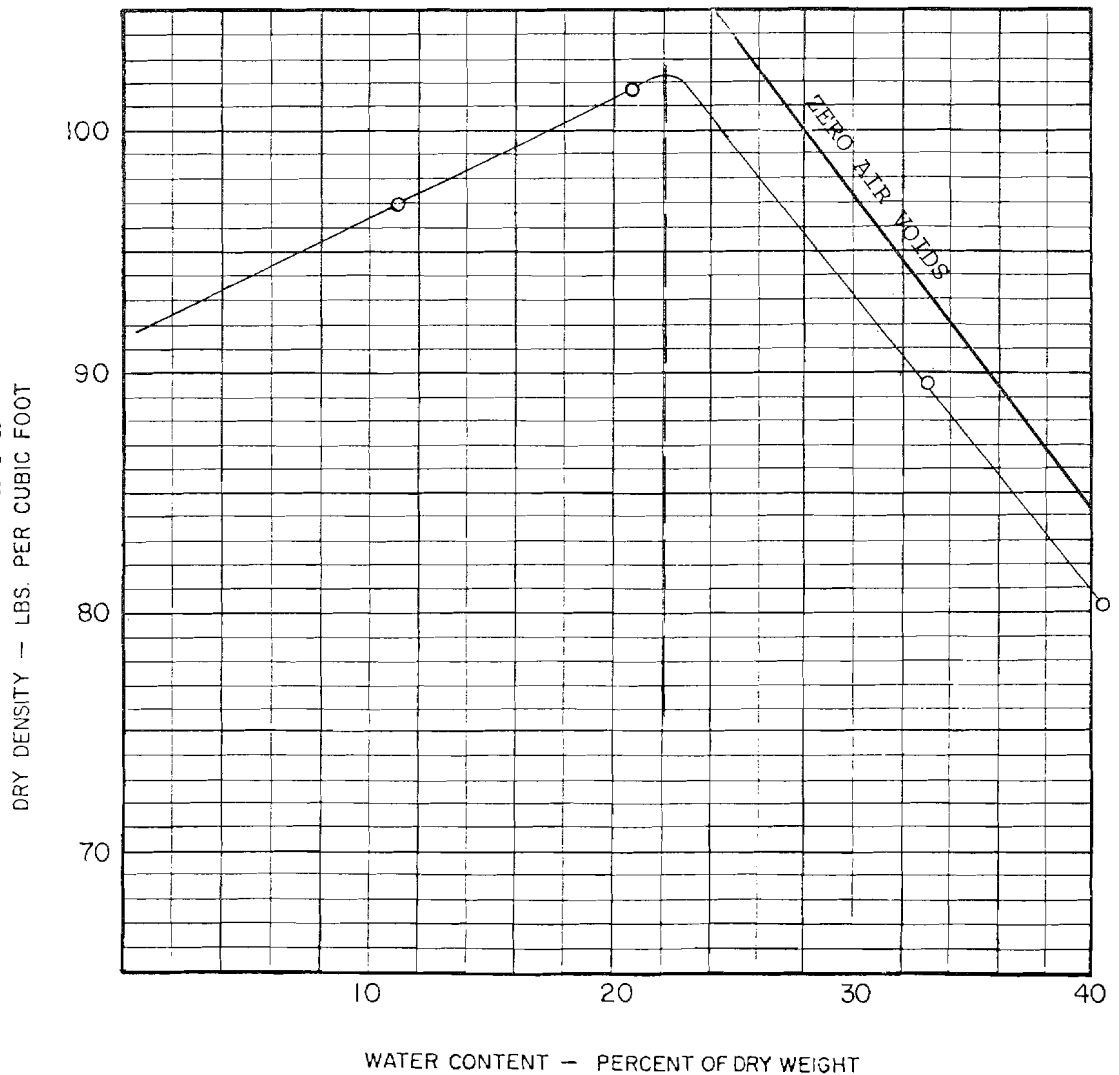
Sieve Analysis

Size	% Passing
# 40	100
#200	99.5
.02mm	81.3
.005	69.6
.002	50.8

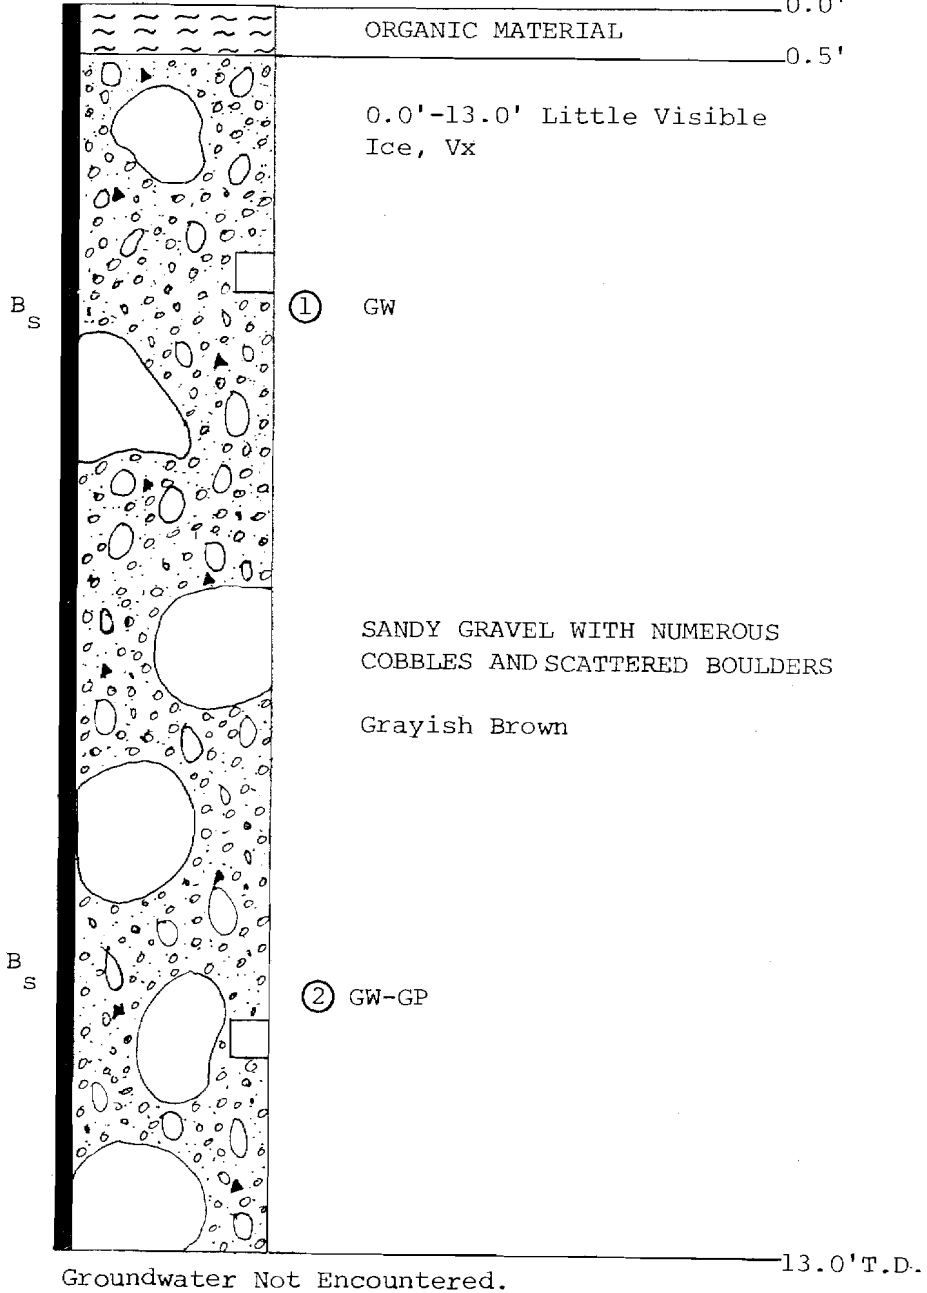
TP-E3
4/17/81

Elevation: 1464.2'
0.0'

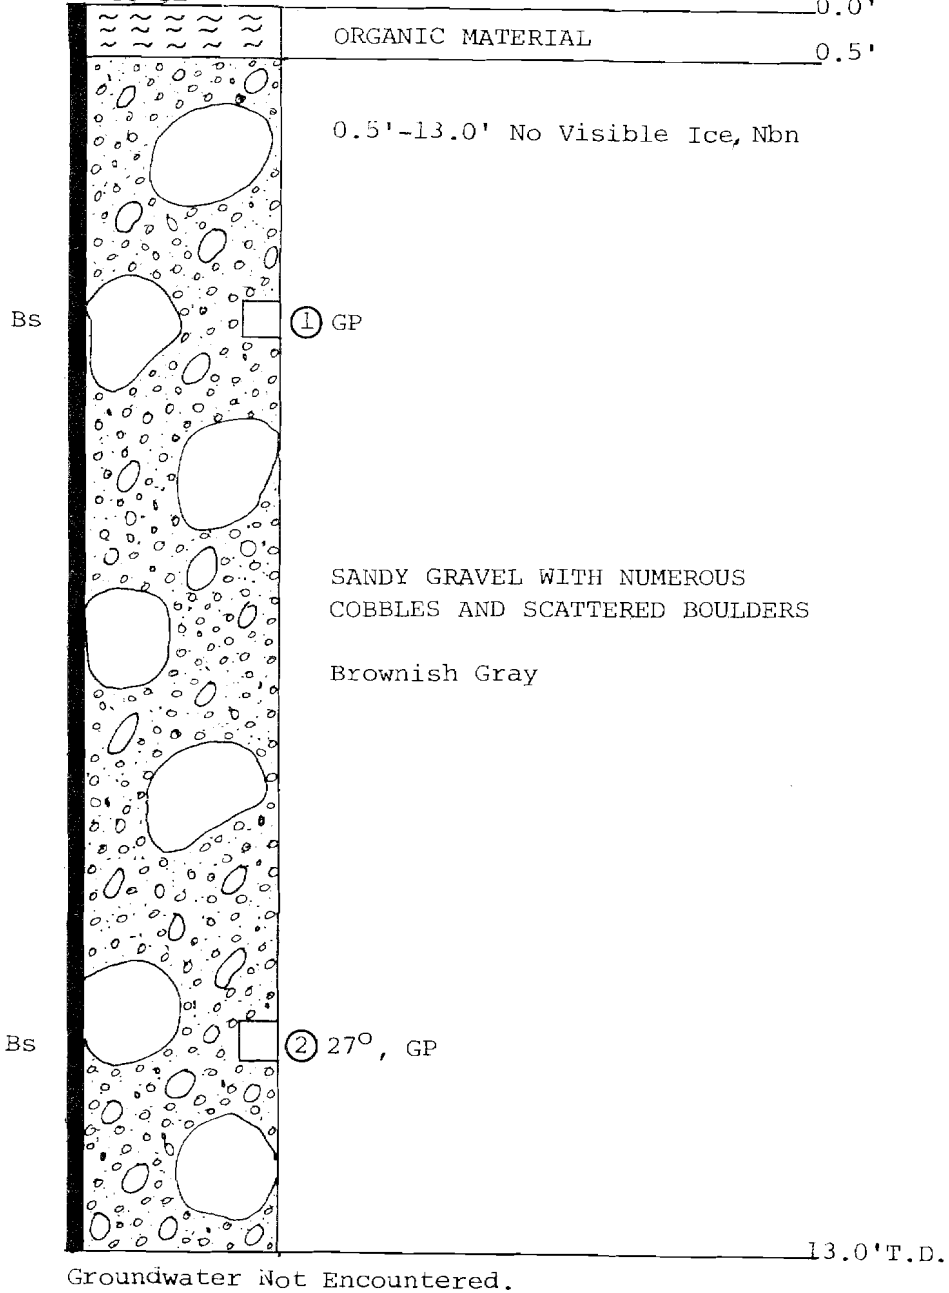
TP-E4
4-18-81

Elevation: 1454.9'
0.0'

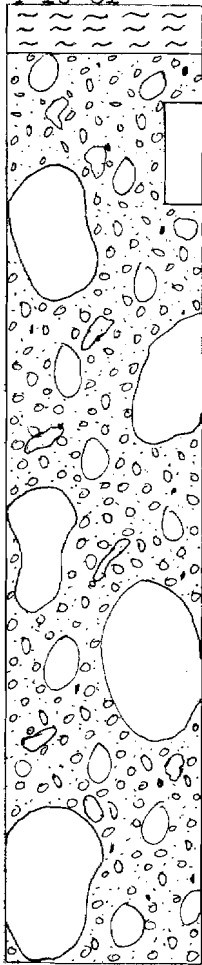
① GW-GP

SANDY GRAVEL WITH NUMEROUS
COBBLES AND SCATTERED
BOULDERS
Brownish Gray

10.0' T.D.

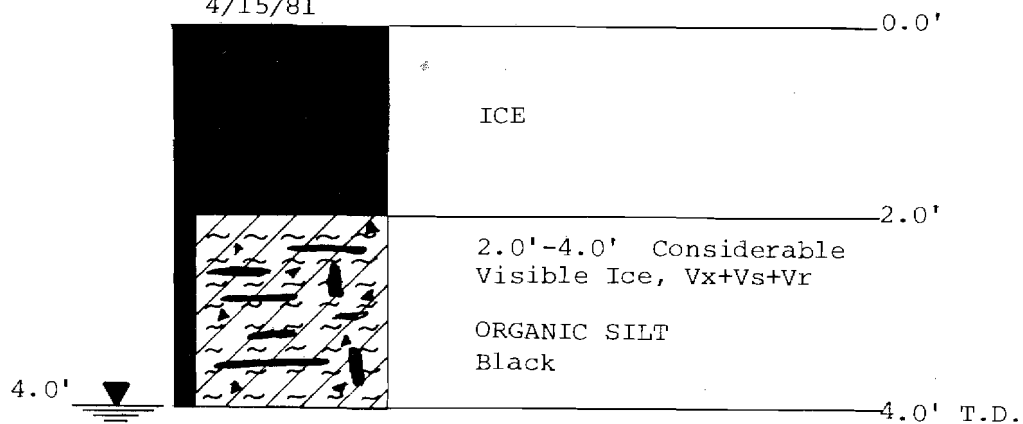
TP-E7
4/15/81

Elevation: 1450.7'

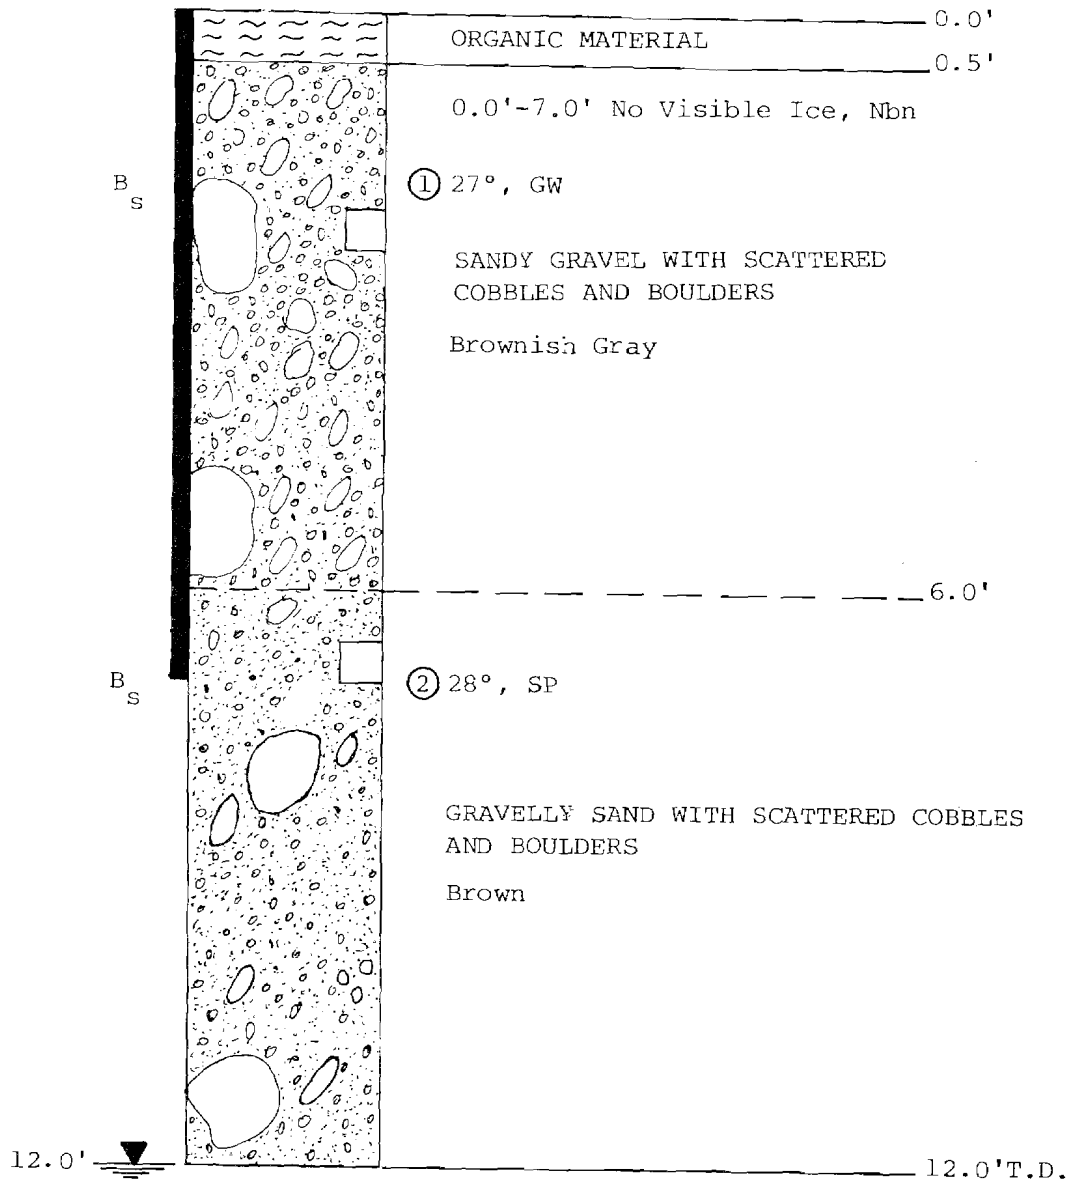
TP-E8
4/20/81

Elevation: 1450.2'

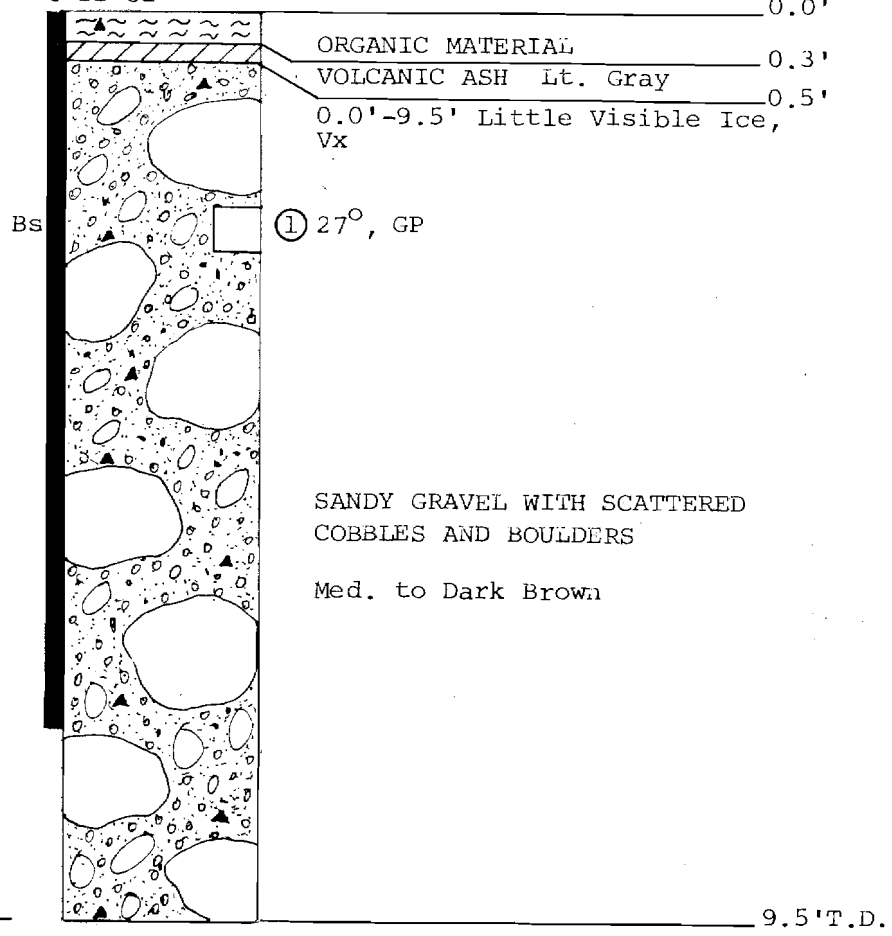
TP-E10B
4-22-81

Elevation: 1493.7'
