SUSITNA HYDROELECTRIC PROJECT

1980 - 81 GEOTECHNICAL REPORT

VOLUME 2
APPENDIX A-F
FINAL DRAFT

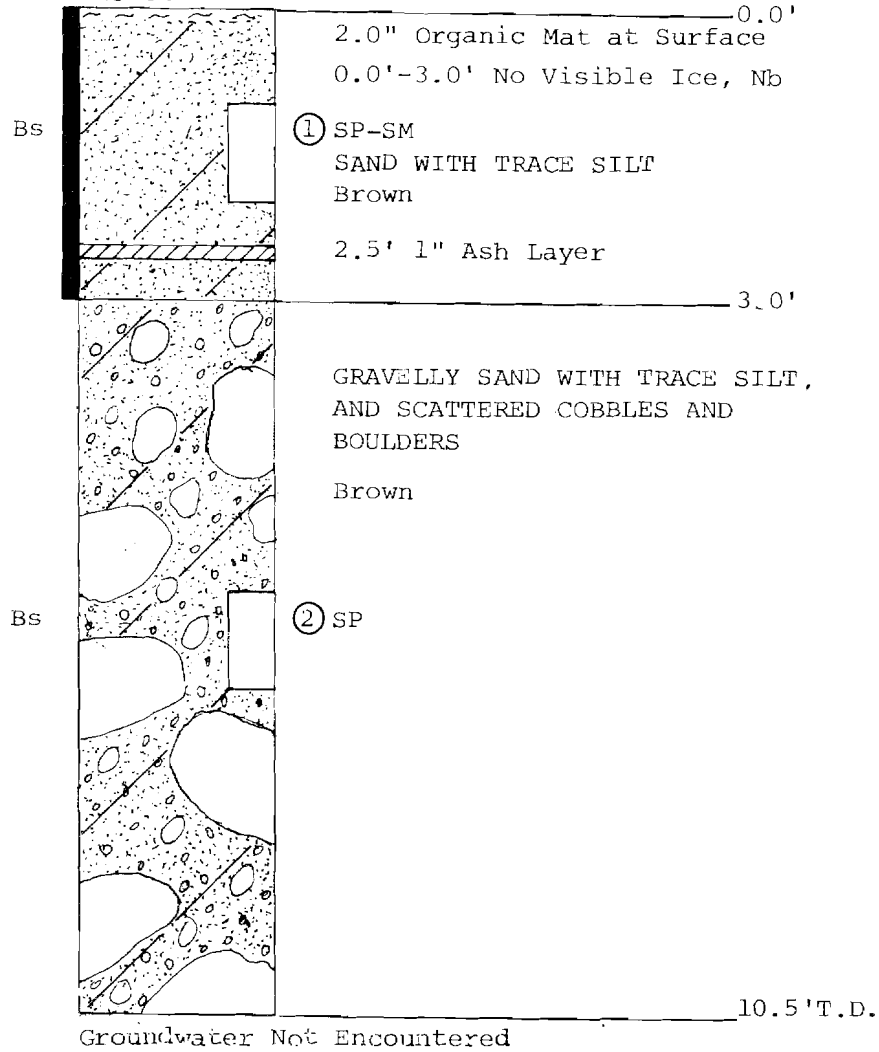
TP-E14
4-26-81

Elevation: 1503.0'

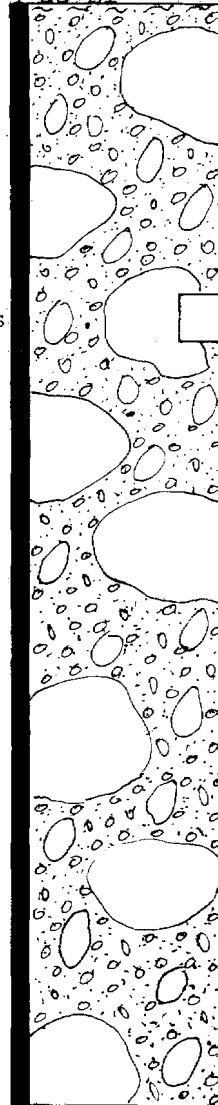
2.0" Organic Mat at Surface

0.0'-11.5' No Visible Ice, Nf

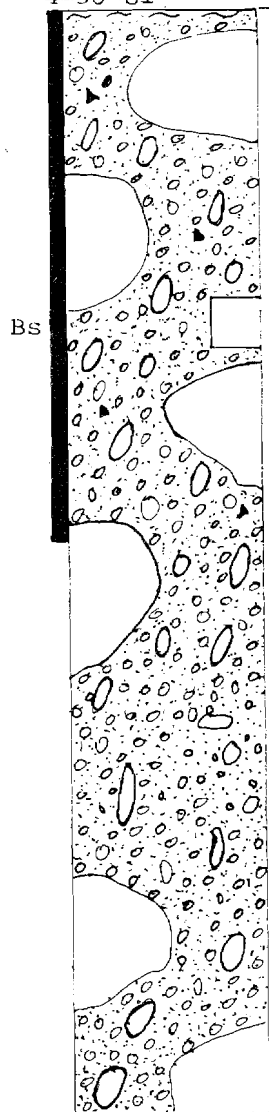
Elevation: 1463.8'

1.0" Organic Mat at Surface
1.0" Clayey Silt Beneath
Organic Mat

0.0'-5.5' Little to No
Visible Ice, Vx and Nbn

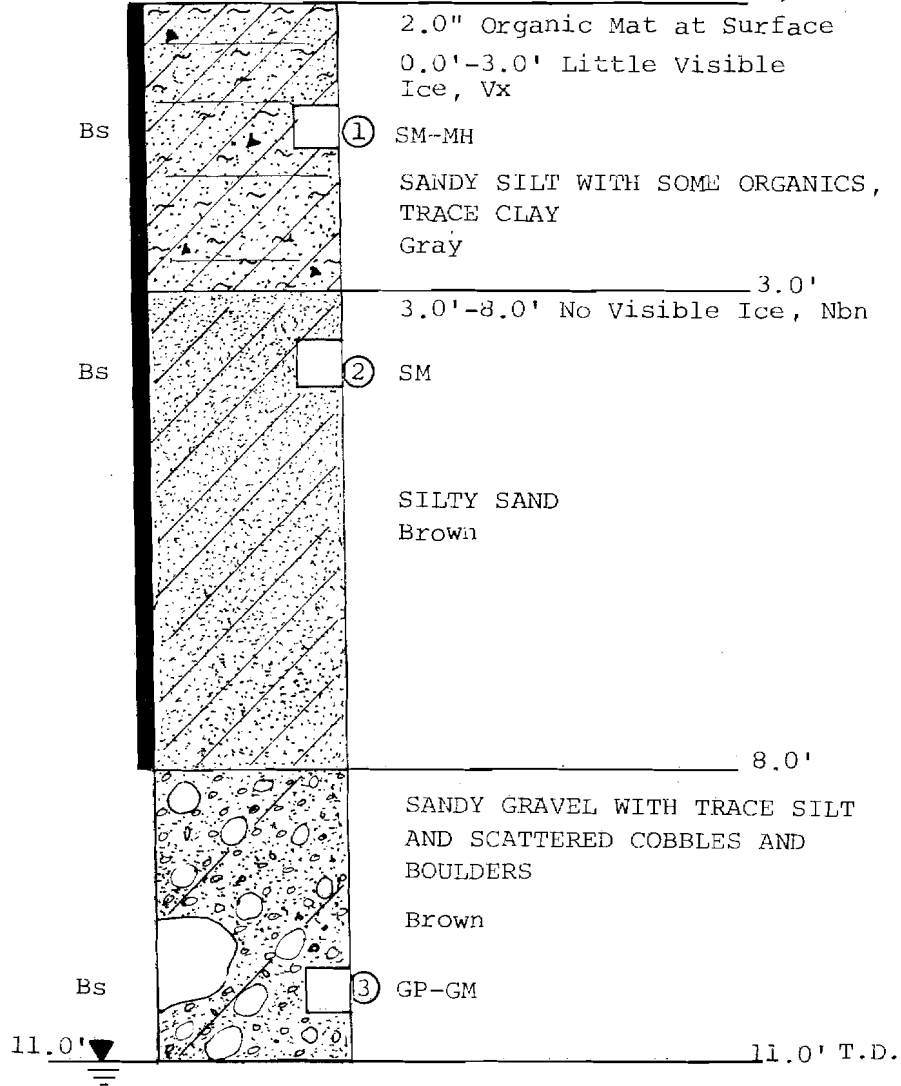
TP-E17
5-01-81

Elevation: 1441.7'
0.0'

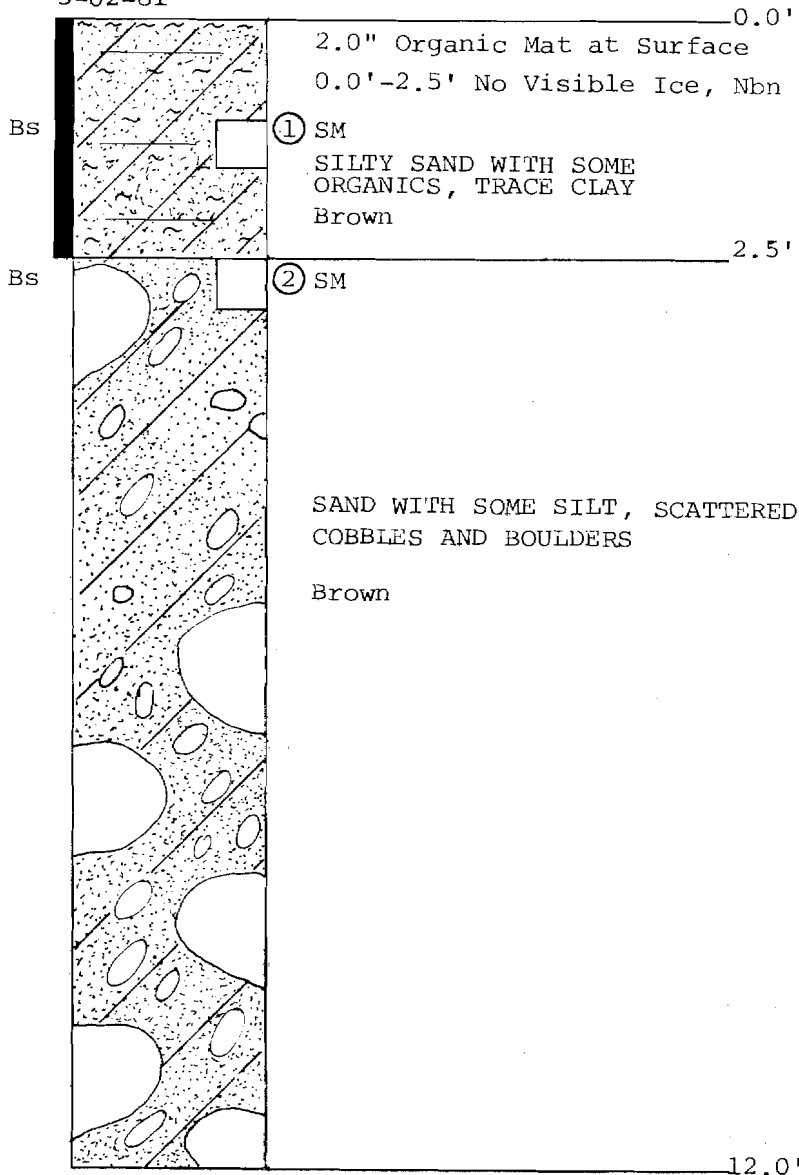
TP-E19
5-02-81

Elevation: 1464.7'

Groundwater Not Encountered.

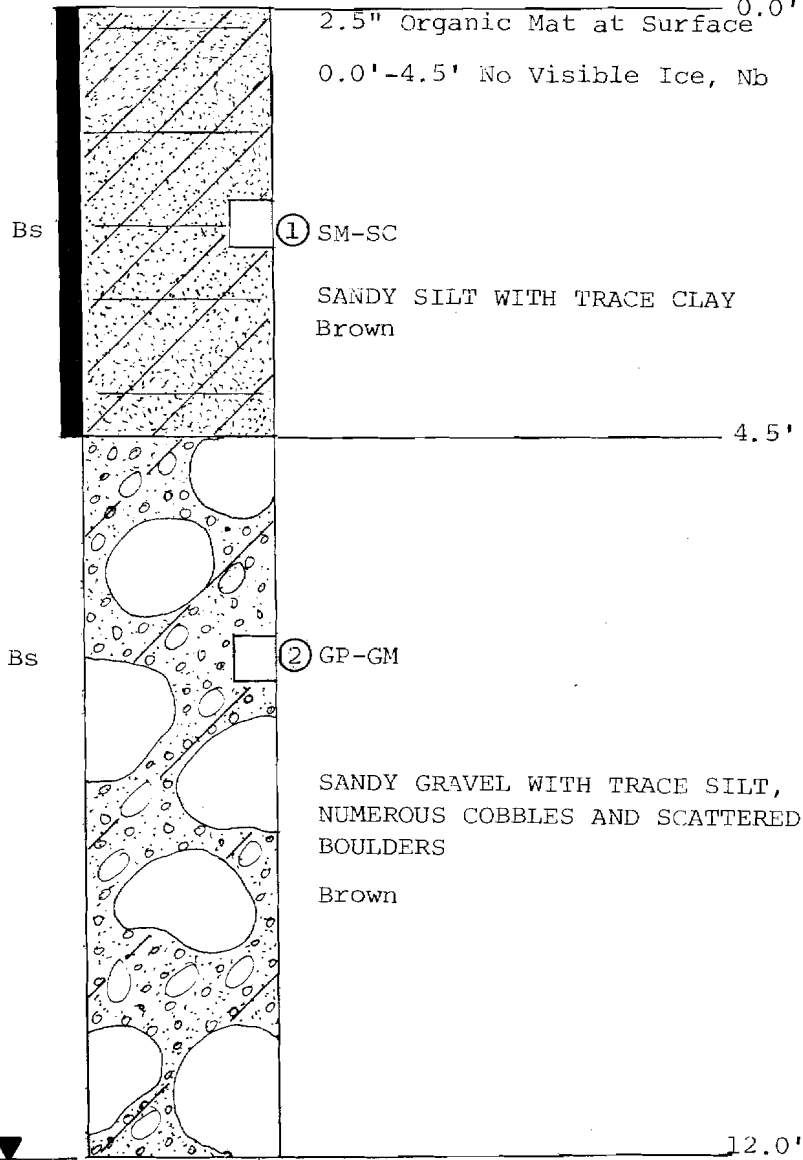
TP-E21
5-03-81

Elevation: 1425.4'

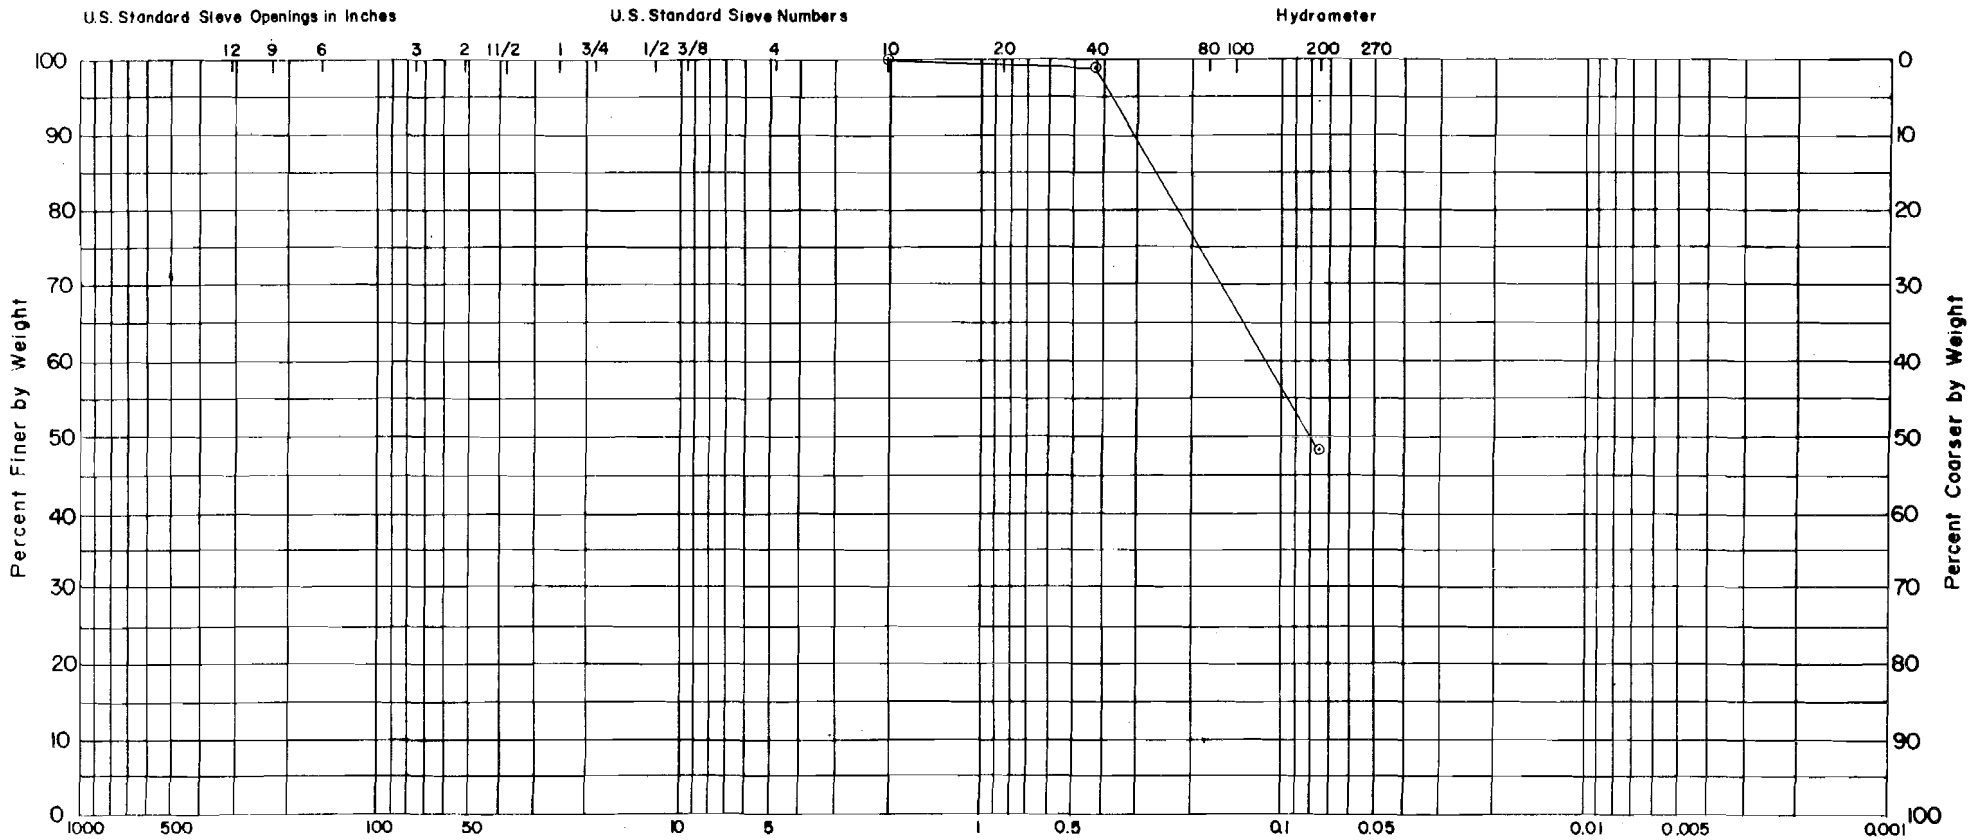
BORROW AREA E

SAMPLE NO.	MOISTURE CONTENT	DRY DENSITY	LL	PI	CLASSIFICATION & DESCRIPTION
AH-E1-3 (1.0-1.5')	19.6%				SM SILTY SAND

LAB NO.	BORING NO.	SAMPLE NO.	DEPTH	4"	3"	2"	1½"	1"	¾"	½"	⅜"	#4	#10	#40	#200	.02	.005	.002	% Moist.	LL	PI	Unified Class.
AH-E1		3	1.0'- 1.5'										100	99	48.0				19.6			SM
AH-E1		4	2.0'- 3.5'										100	98	59.5				27.3			ML*
AH-E3		6	4.5'- 6.0'		100	89	89	83	80	76	72	62	52	28	6.2				4.4			SP-SM
AH-E3		7	6.5'- 8.0'			**	100	90	76	62	57	40	31	16	3.7				0.7			GW
AH-E4		6	5.0'- 6.5'							100	99	98	92	66	22.2				17.6			SM
AH-E7		3	2.0'- 3.0'				100	85	73	56	49	39	31	12	2.1				2.3			GP
AH-E9		2	1.5'- 3.0'										100	99	28.6				15.7			SM
AH-E9		6	6.5'- 8.0'				100	95	87	79	57	44	33	17.0					4.4			GM

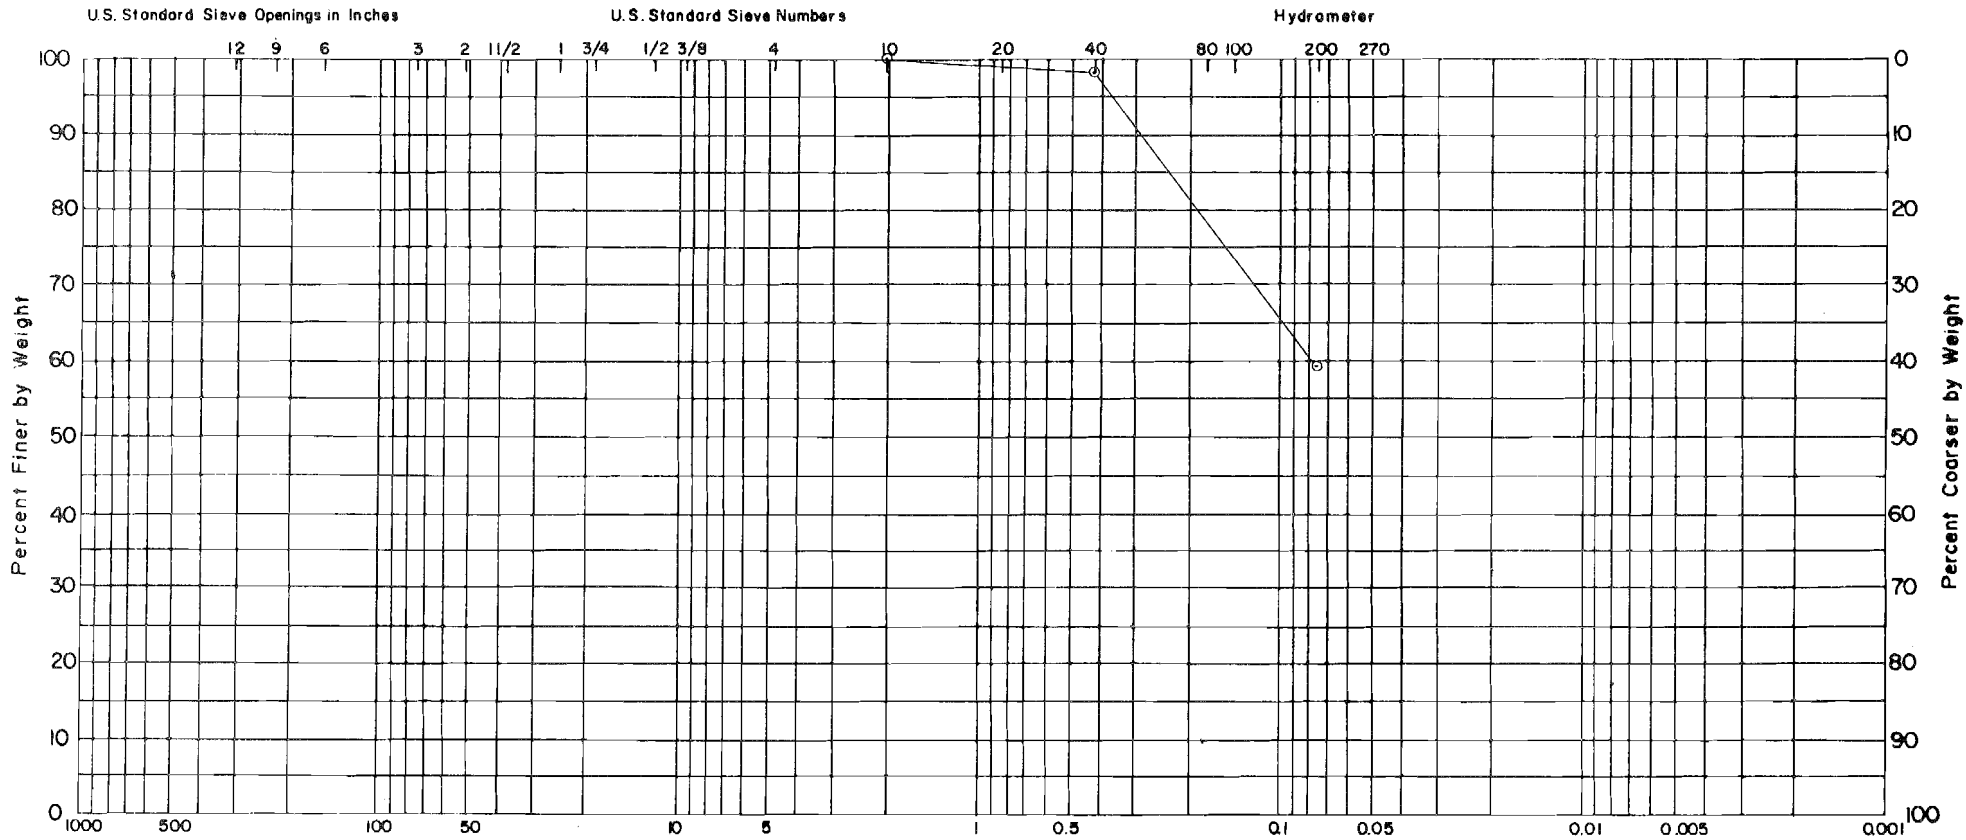
BORROW AREA E

SAMPLE NO.	MOISTURE CONTENT	DRY DENSITY	LL	PI	CLASSIFICATION & DESCRIPTION	
AH-E1-4 (2.0-3.5')	27.3%				ML	SANDY SILT

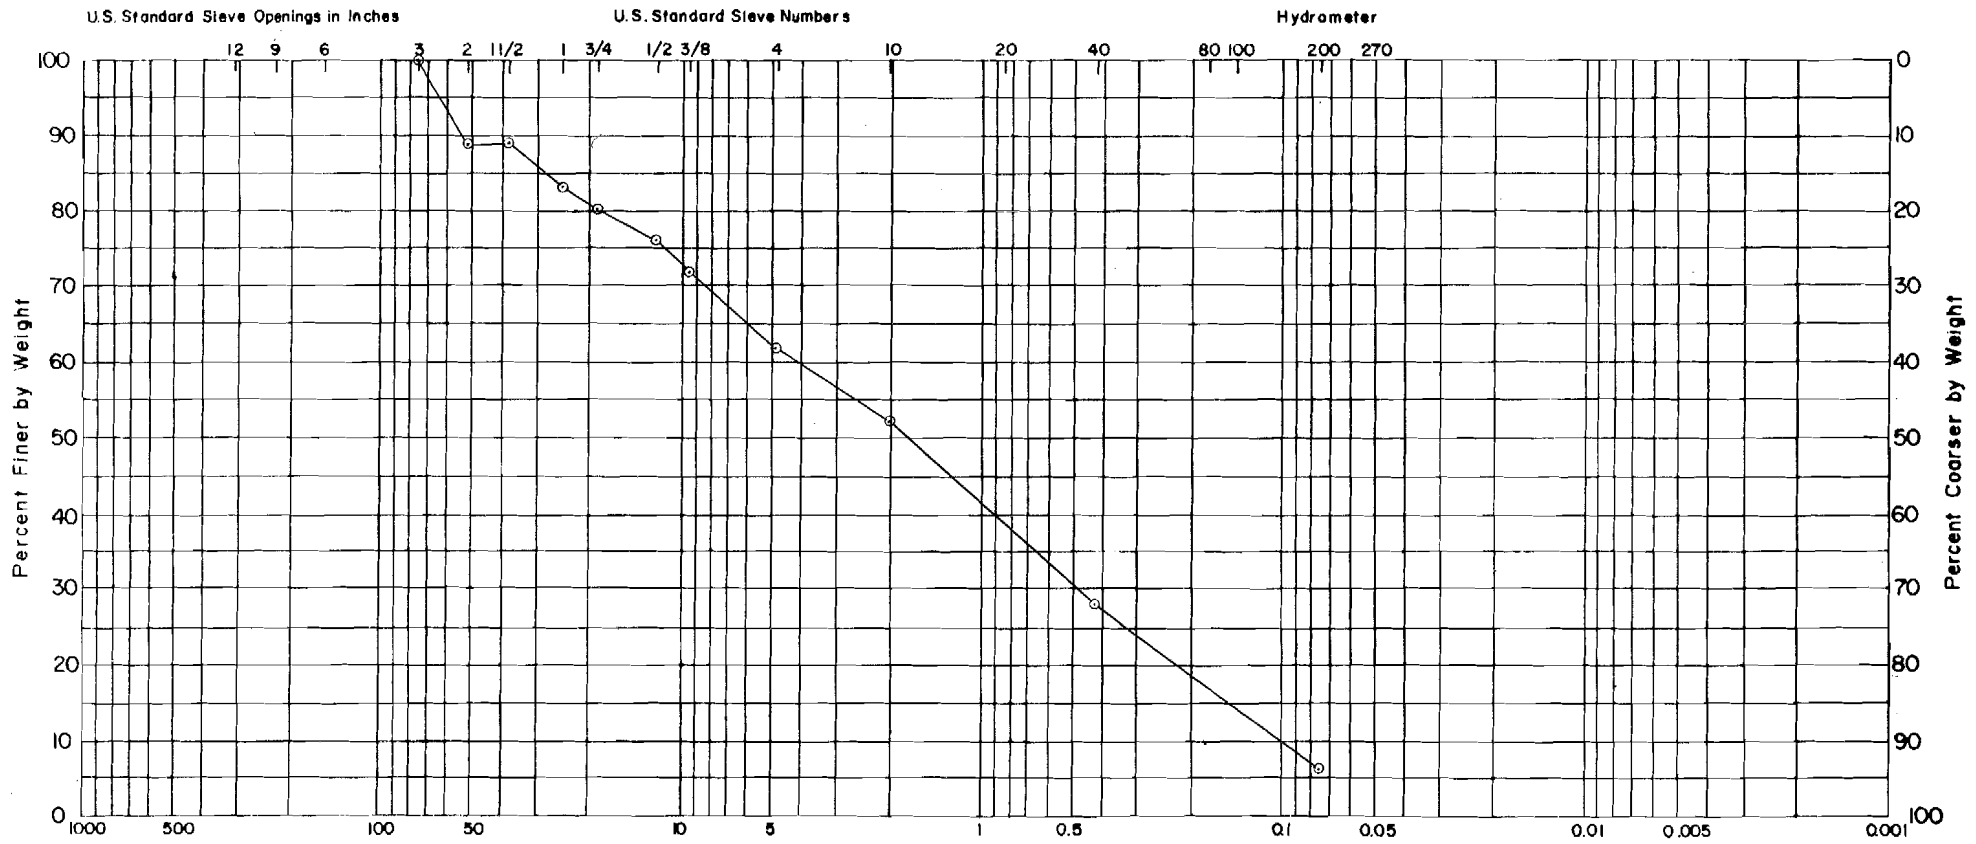
BORROW AREA E

SAMPLE NO.	MOISTURE CONTENT	DRY DENSITY	LL	PI	CLASSIFICATION & DESCRIPTION
AH-E3-6 (4.5-6.0')	4.4%				SP-SM GRAVELLY SAND Poorly Graded

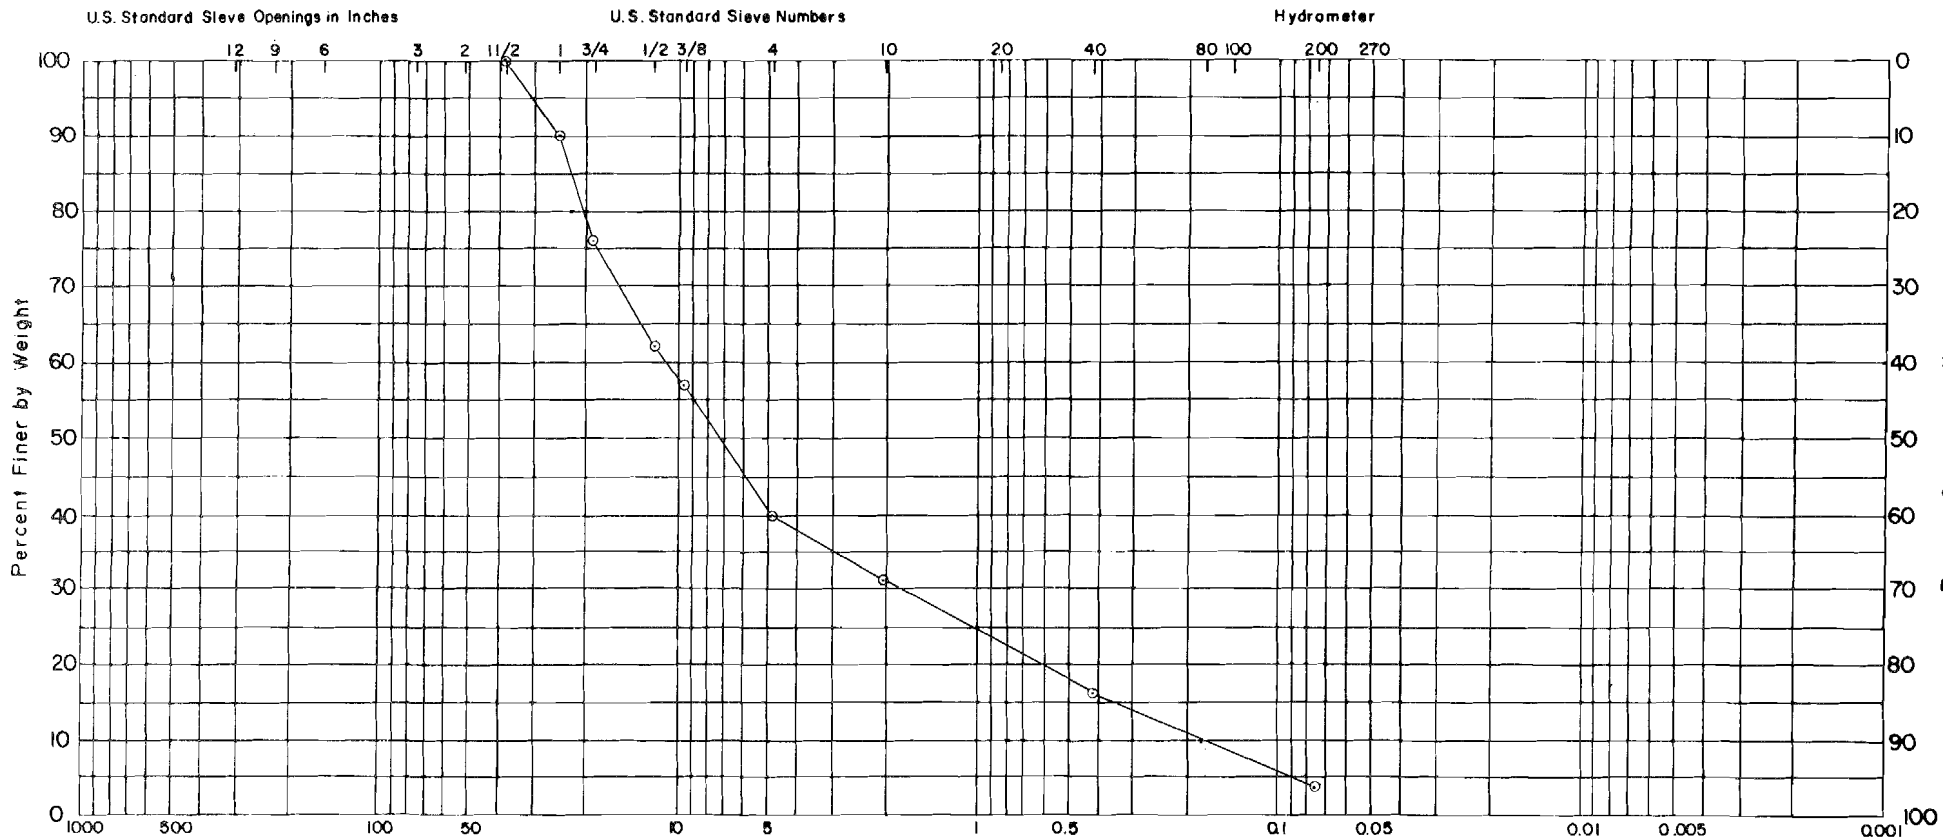
BORROW AREA E

SAMPLE NO.	MOISTURE CONTENT	DRY DENSITY	LL	PI	CLASSIFICATION & DESCRIPTION	
AH-E3-7 (6.5-8.0')	0.7%				GW	SANDY GRAVEL Well Graded

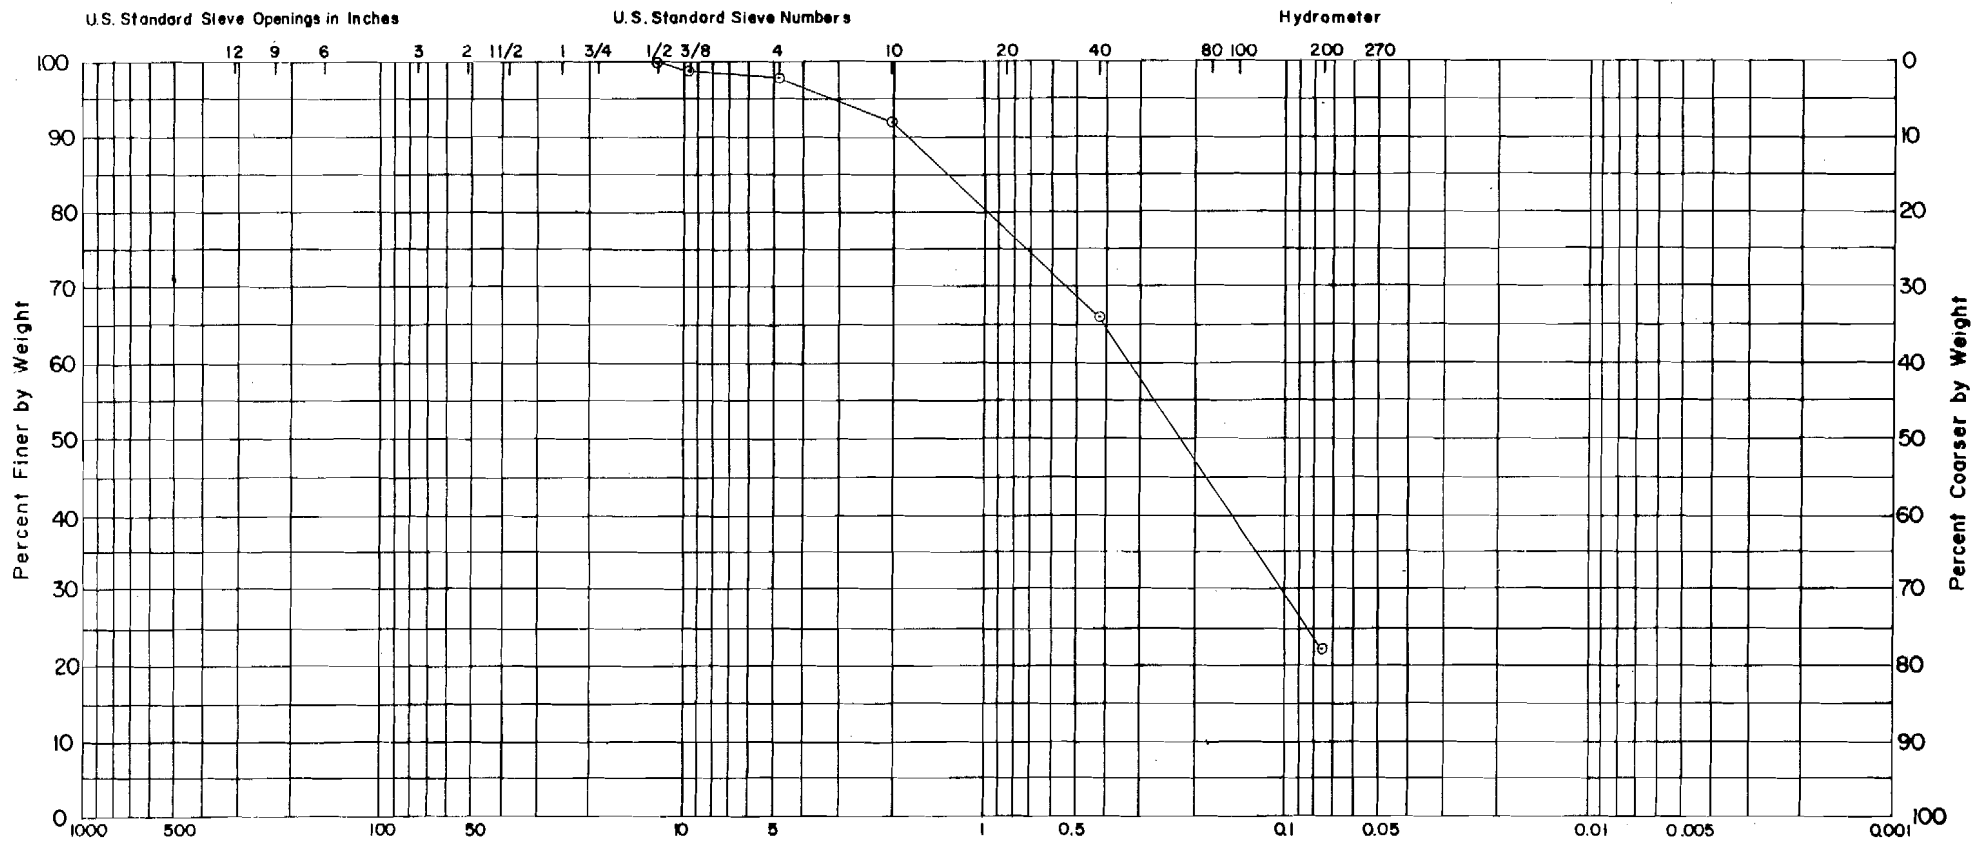
BORROW AREA E

SAMPLE NO.	MOISTURE CONTENT	DRY DENSITY	LL	PI	CLASSIFICATION & DESCRIPTION
AH-E4-6 (5.0-6.5')	17.6%				SM SILTY SAND WITH TRACE GRAVEL

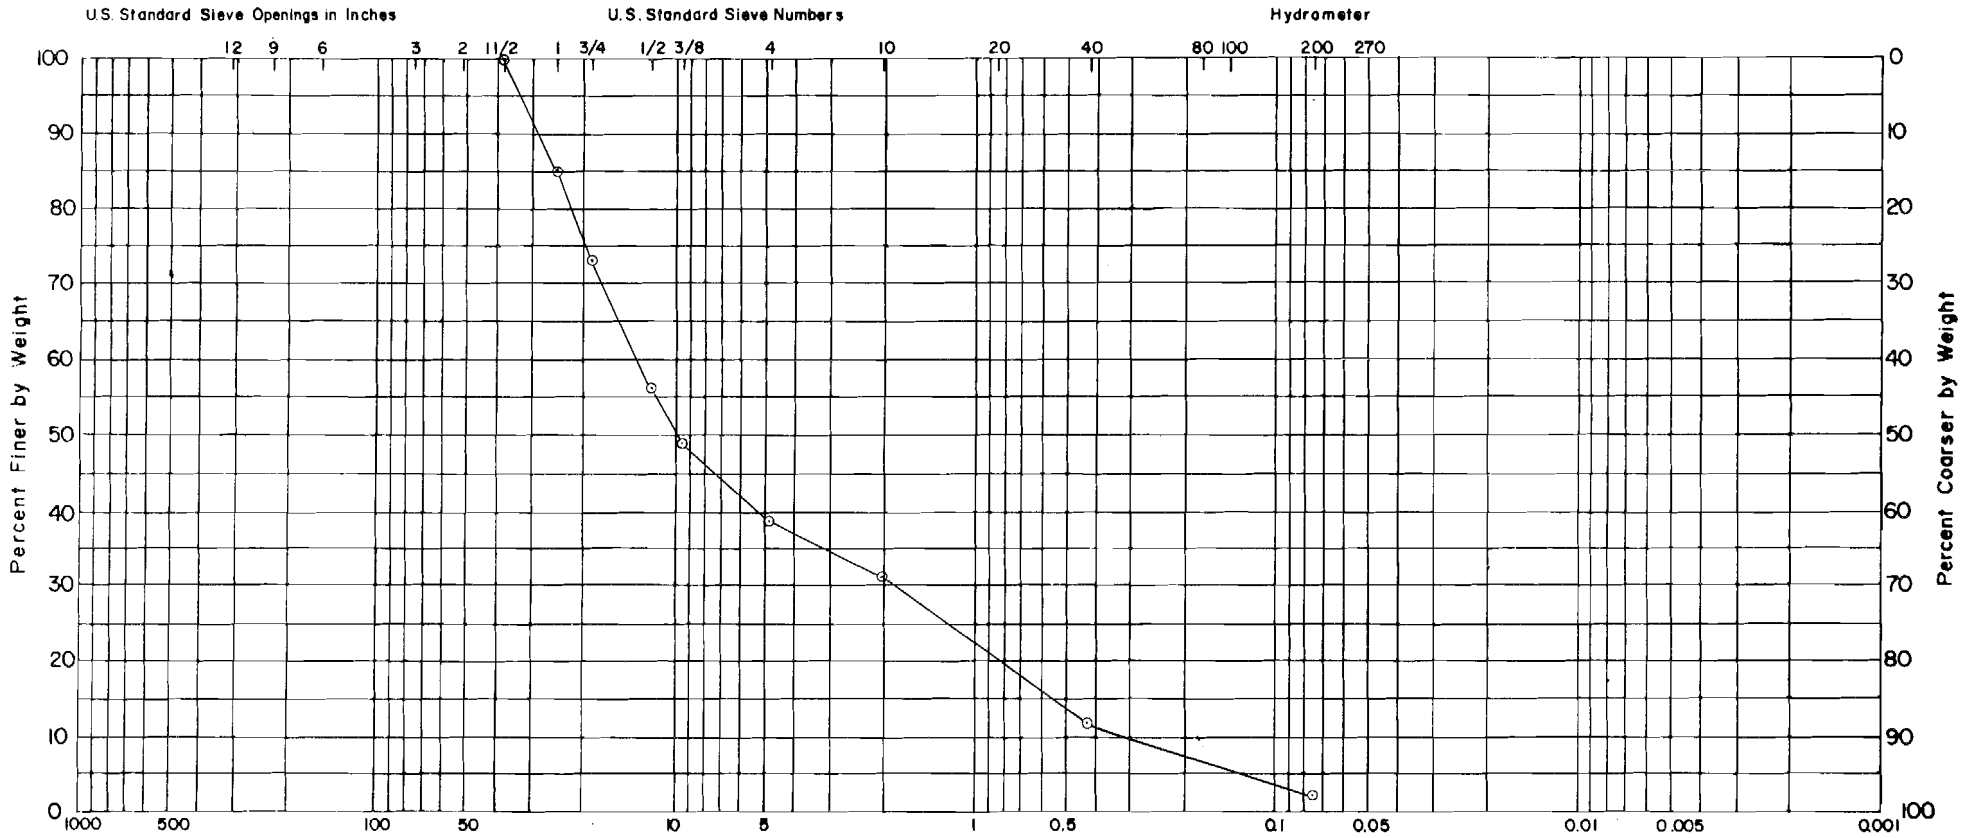
BORROW AREA E

SAMPLE NO.	MOISTURE CONTENT	DRY DENSITY	LL	PI	CLASSIFICATION & DESCRIPTION
AH-E7-3 (2.0-3.0")	2.3%				GP SANDY GRAVEL WITH TRACE SILT

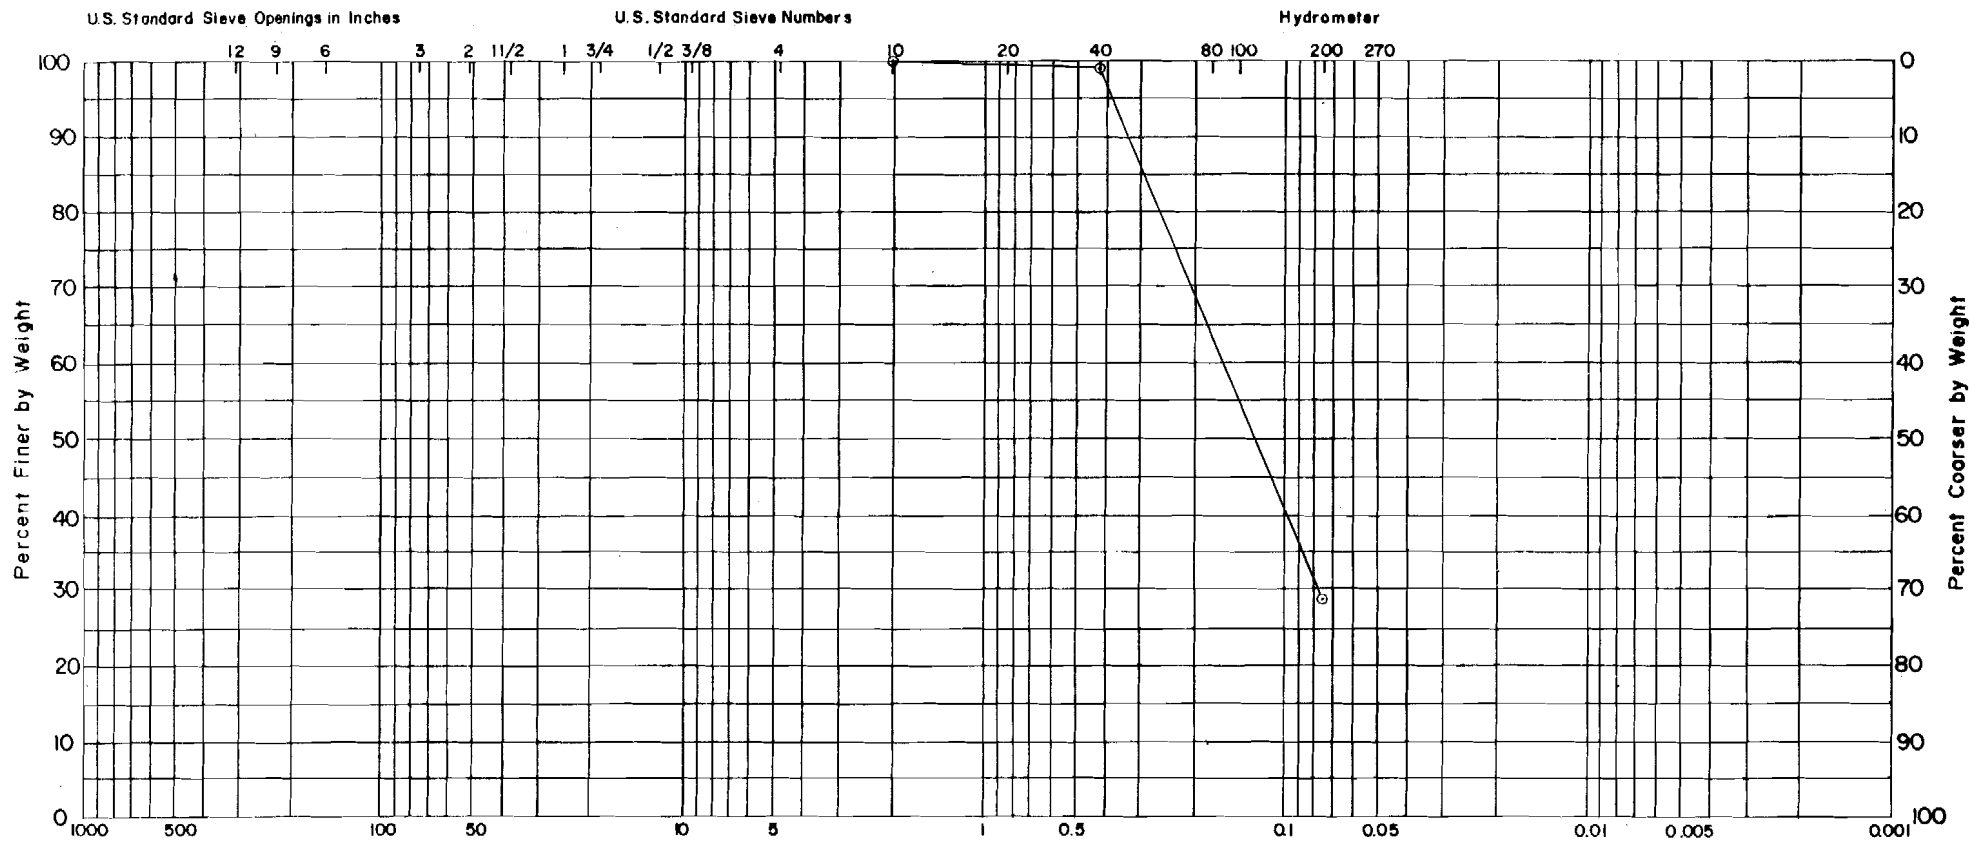
BORPOW AREA E

SAMPLE NO.	MOISTURE CONTENT	DRY DENSITY	LL	PI	CLASSIFICATION & DESCRIPTION
AH-E9-2 (1.5-3.0')	15.7%				SM SILTY SAND Poorly Graded

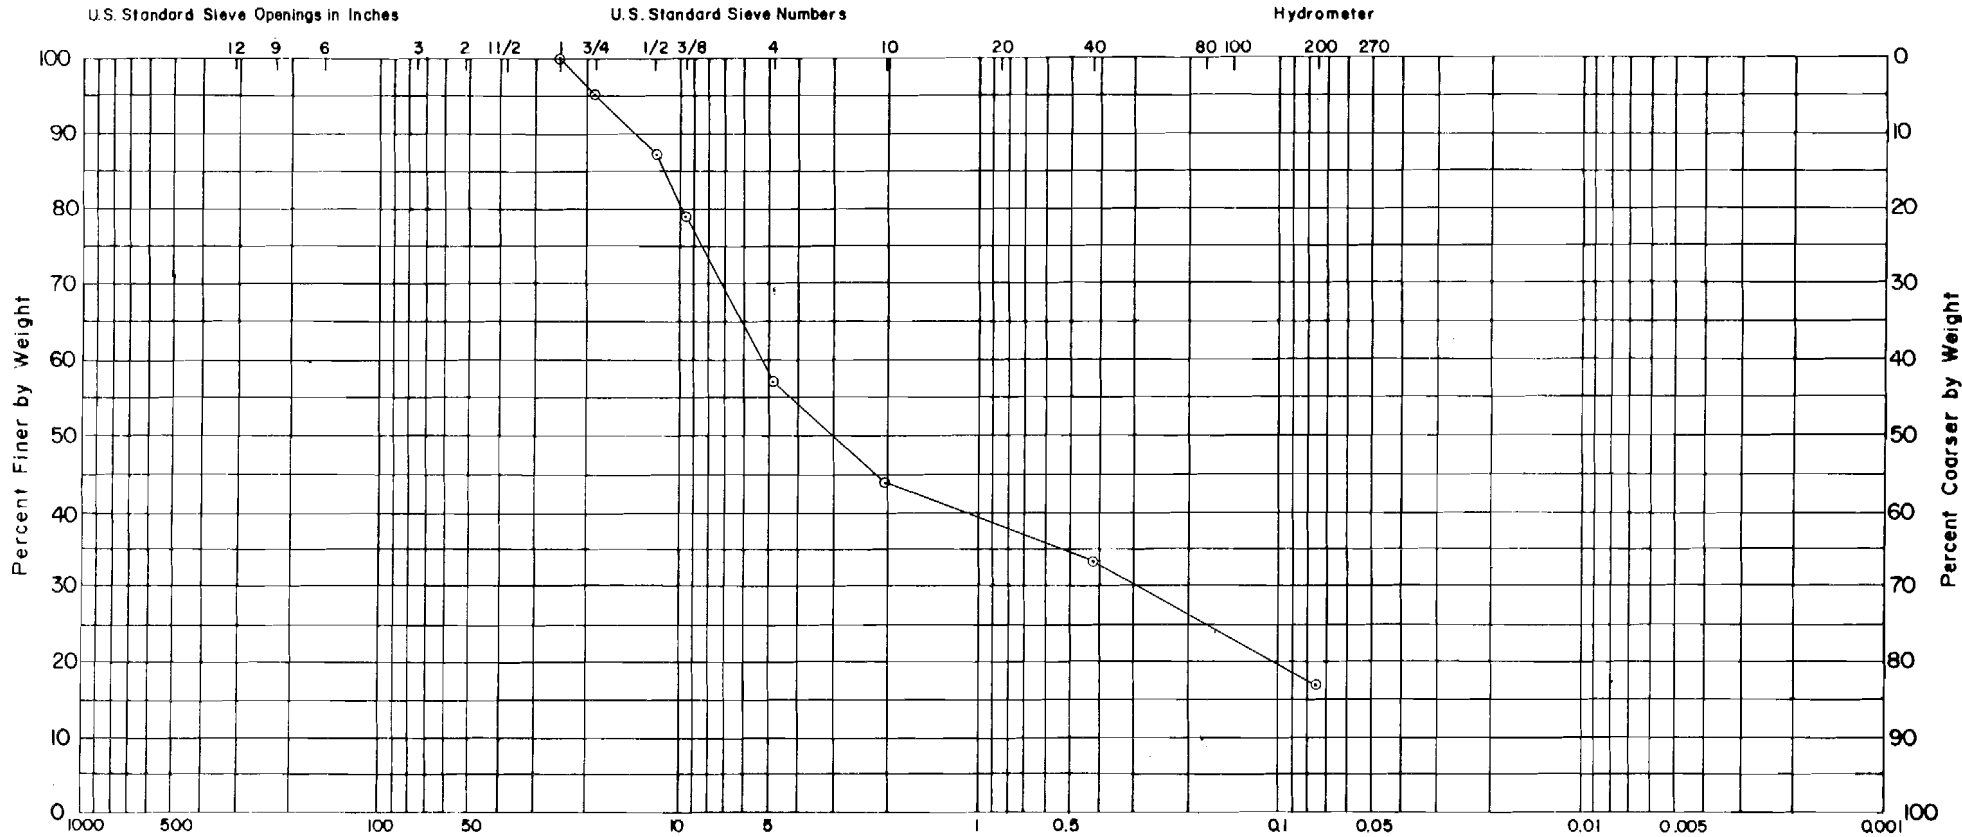
BORROW AREA E

SAMPLE NO.	MOISTURE CONTENT	DRY DENSITY	LL	PI	CLASSIFICATION & DESCRIPTION	
AH-E9-6 (6.5-8.0')	4.4%				GM	SANDY GRAVEL WITH SOME SILT

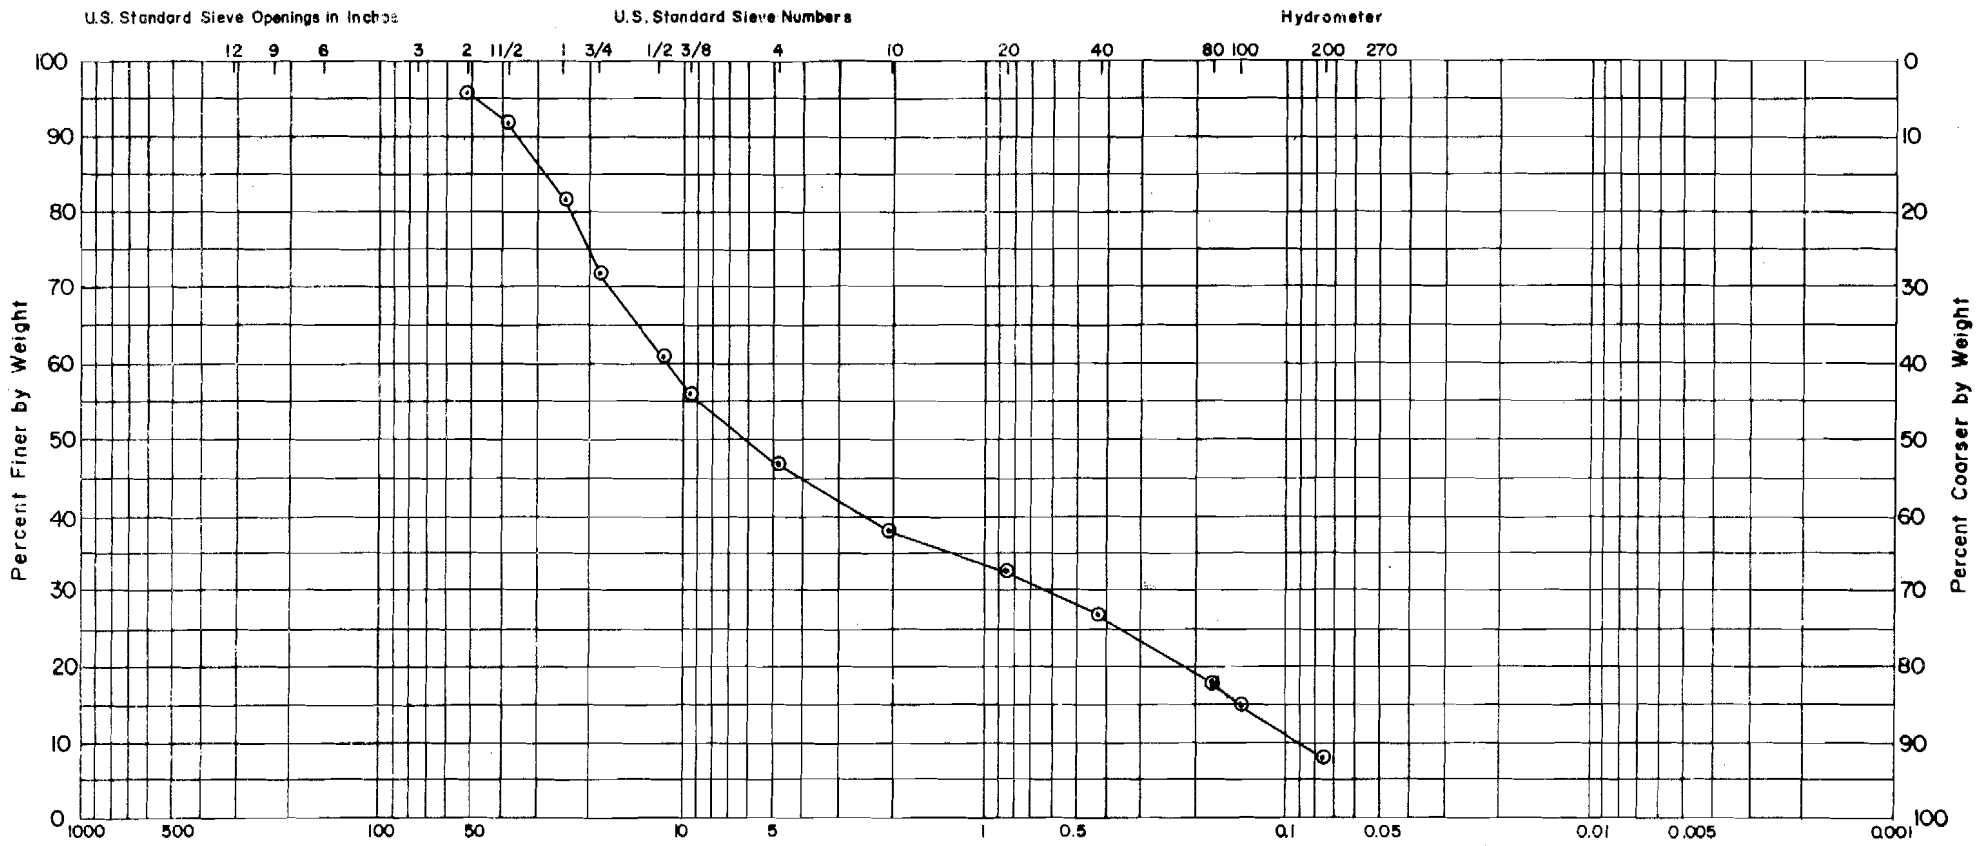
Borrow Area E
Test Pit TP-E1

SAMPLE NO.	MOISTURE CONTENT	DRY DENSITY	LL	PI	CLASS	CLASSIFICATION & DESCRIPTION
TP-E1 #1					GP-GM	SANDY GRAVEL WITH TRACE SILT

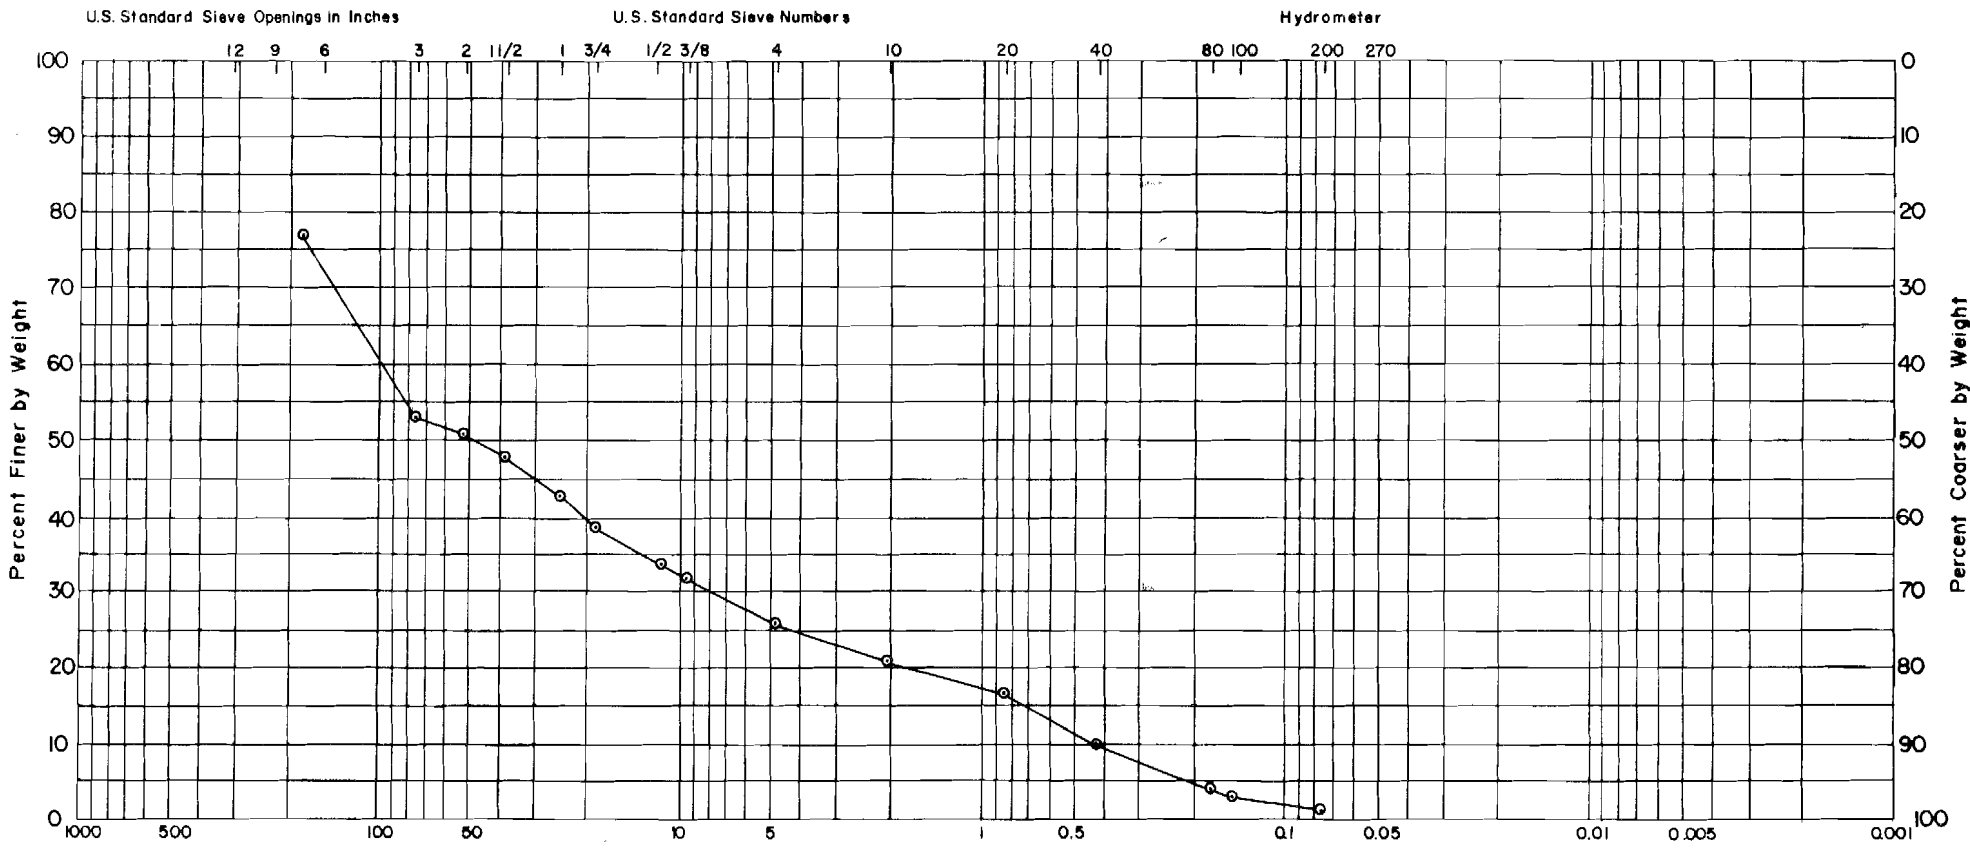
BORROW AREA E
TEST PIT TP-E1

SAMPLE NO.	MOISTURE CONTENT	DRY DENSITY	LL	PI	CLASS	CLASSIFICATION & DESCRIPTION
TP-E1 #2					GP	SANDY GRAVEL WITH NUMEROUS COBBLES AND SCATTERED BOULDERS

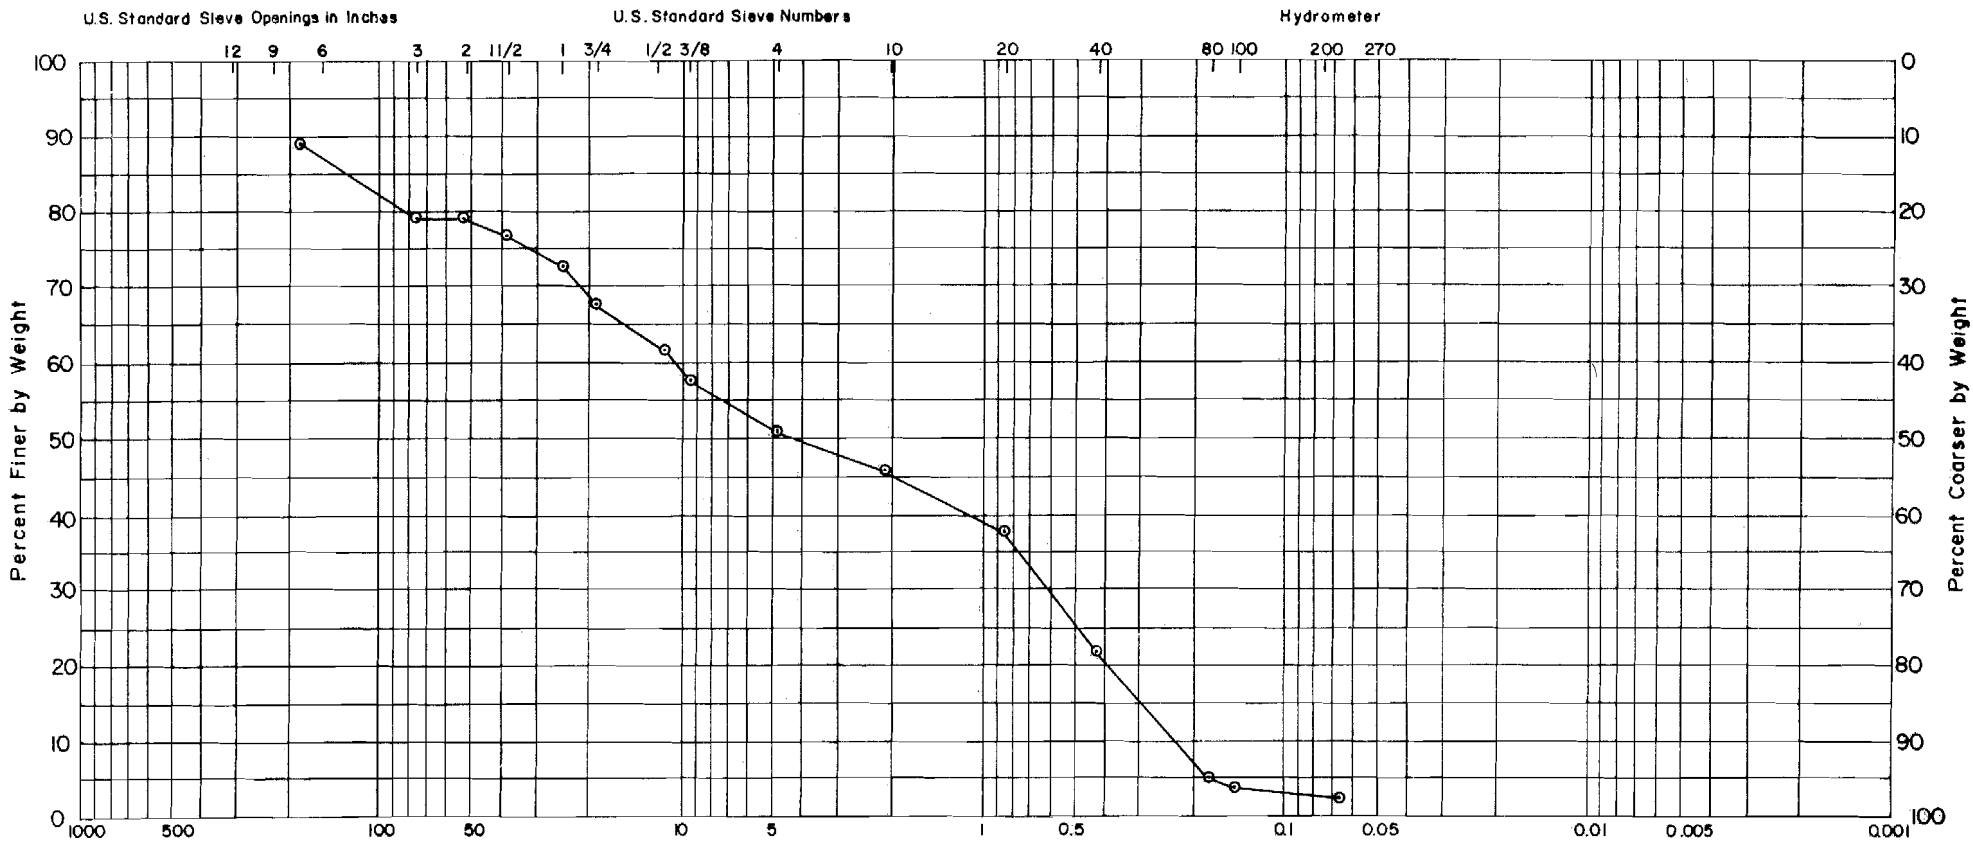
BORROW AREA E
TEST PIT TP-E2

SAMPLE NO.	MOISTURE CONTENT	DRY DENSITY	LL	PI	CLASS	CLASSIFICATION & DESCRIPTION
TP-E2 #1					SP	GRAVELLY SAND WITH SCATTERED COBBLES
