SUSITNA HYDROELECTRIC PROJECT

1980 - 81 GEOTECHNICAL REPORT

VOLUME 2
APPENDIX A-F
FINAL DRAFT

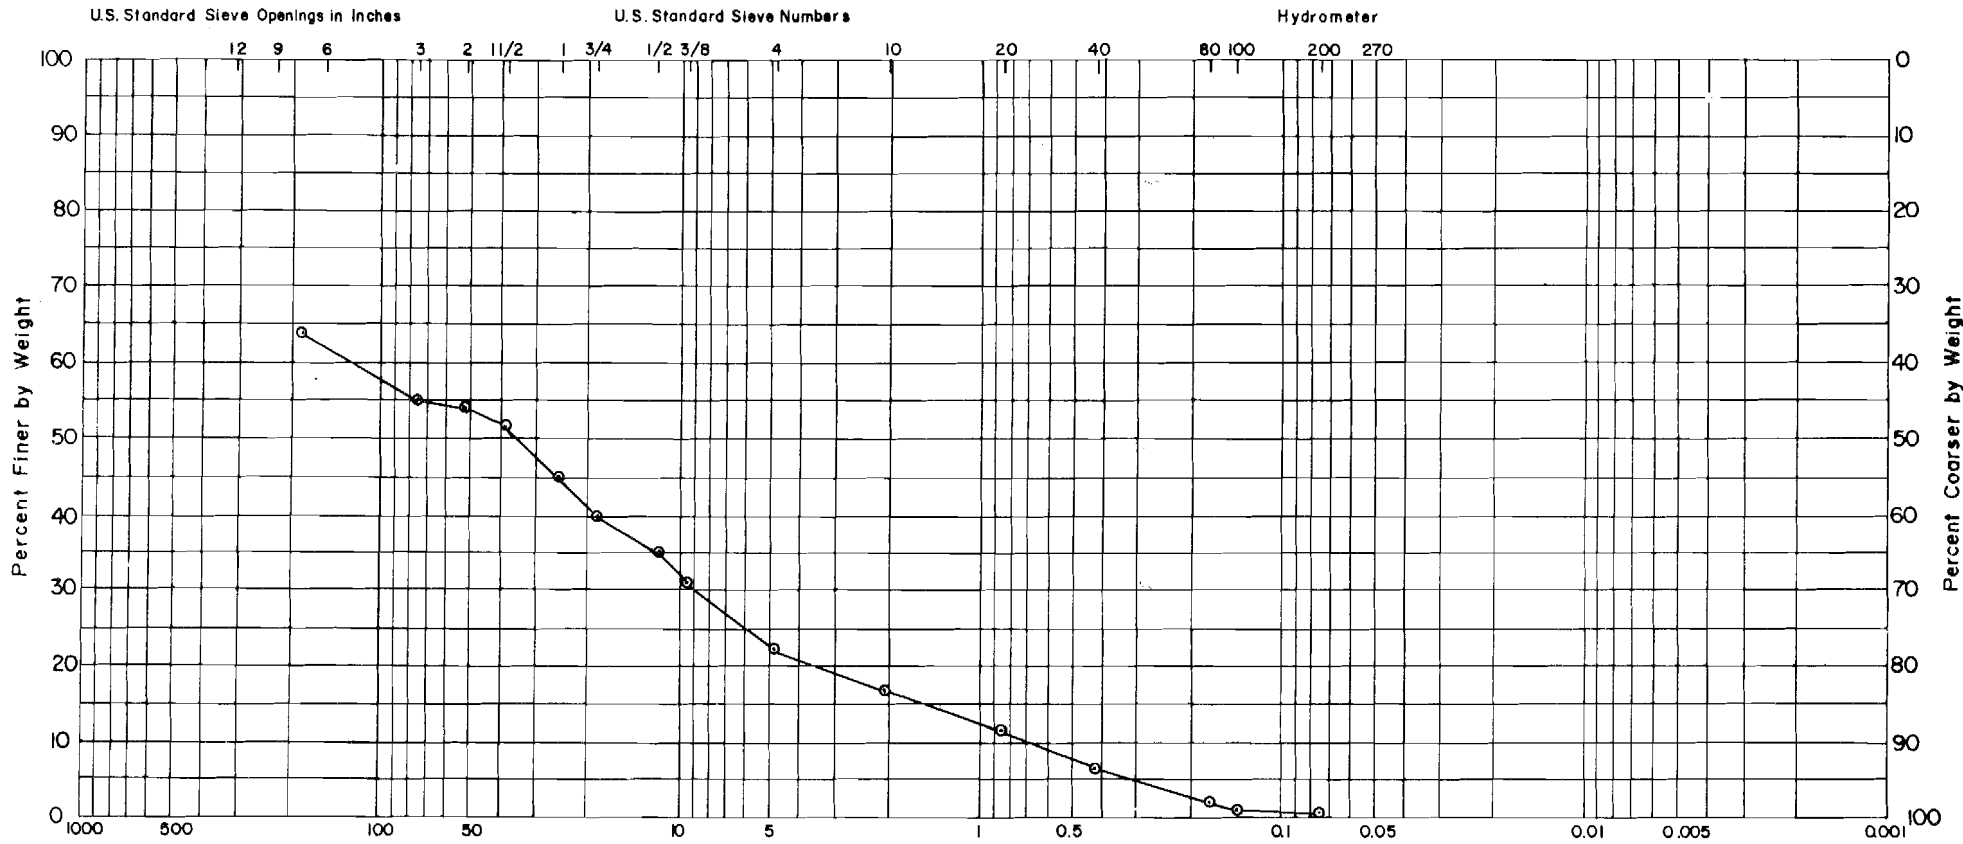
BORROW AREA E
TEST PIT TP-E2

SAMPLE NO.	MOISTURE CONTENT	DRY DENSITY	LL	PI	CLASS	CLASSIFICATION & DESCRIPTION
TP-E2 #2					GW	SANDY GRAVEL WITH NUMEROUS COBBLES AND SCATTERED BOULDERS

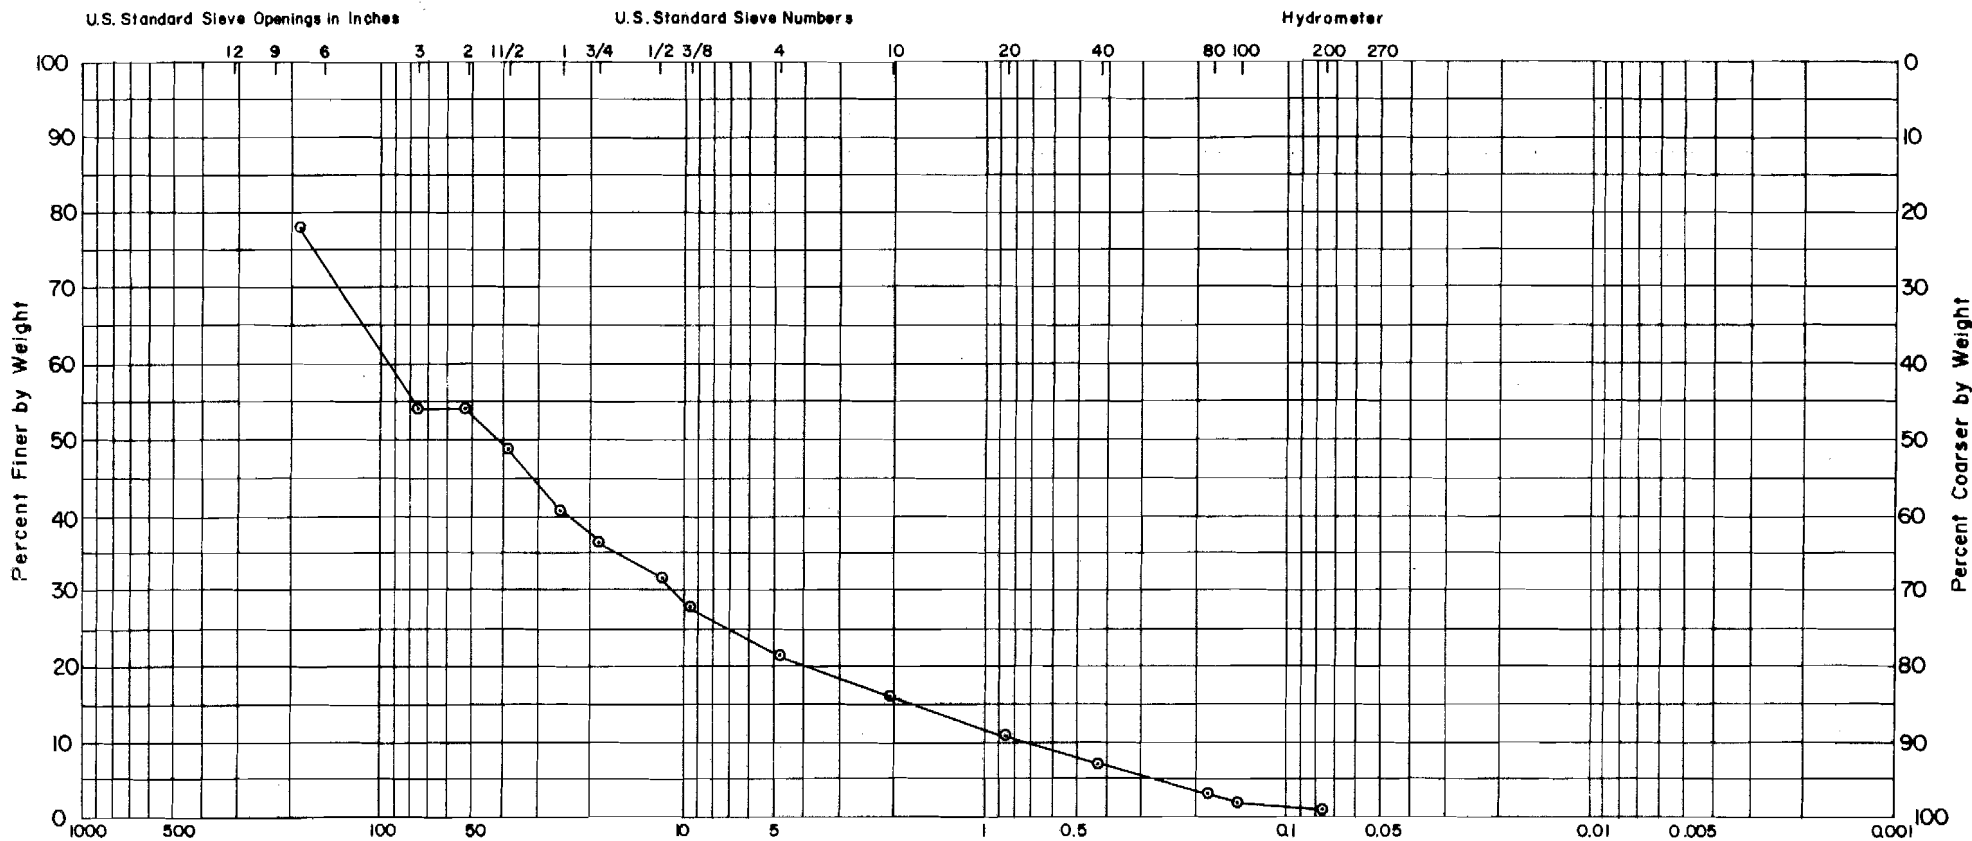
BORROW AREA E
TEST PIT TP-E3

SAMPLE NO.	MOISTURE CONTENT	DRY DENSITY	LL	PI	CLASS	CLASSIFICATION & DESCRIPTION
TP-E3 #1					GW	SANDY GRAVEL WITH NUMEROUS COBBLES AND SCATTERED BOULDERS

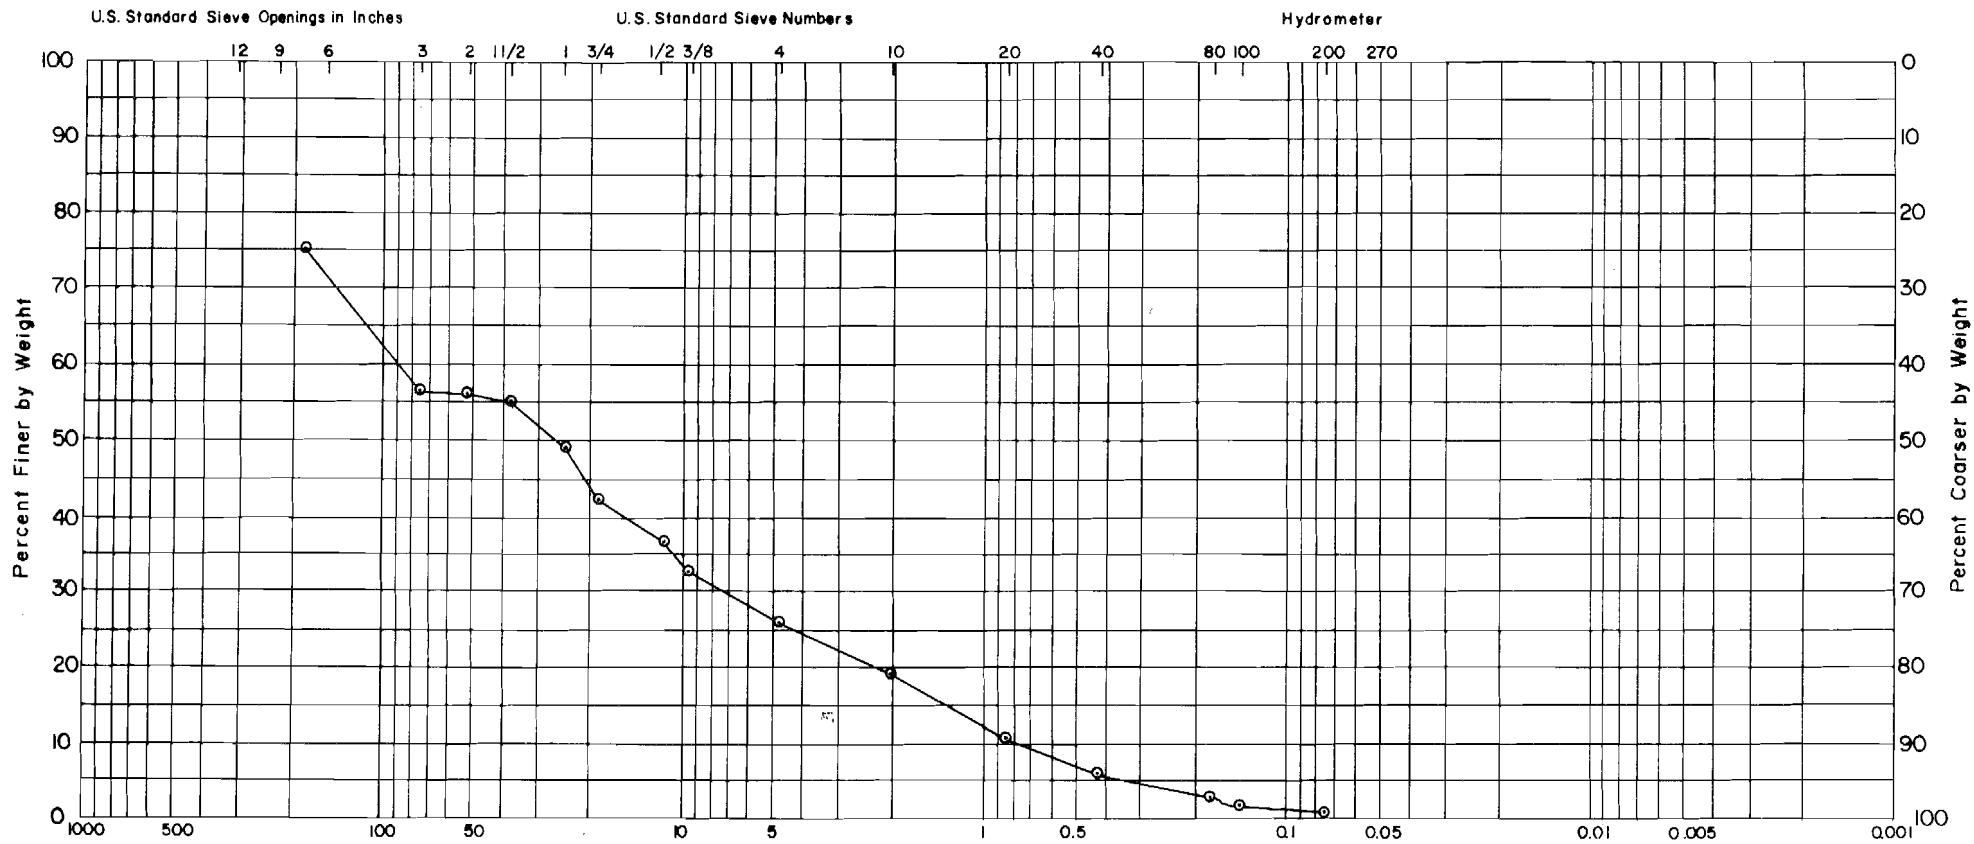
BORROW AREA E
TEST PIT TP-E3

SAMPLE NO.	MOISTURE CONTENT	DRY DENSITY	LL	PI	CLASS	CLASSIFICATION & DESCRIPTION
TP-E3 #2					GW-GP	SANDY GRAVEL WITH NUMEROUS COBBLES AND SCATTERED BOULDERS

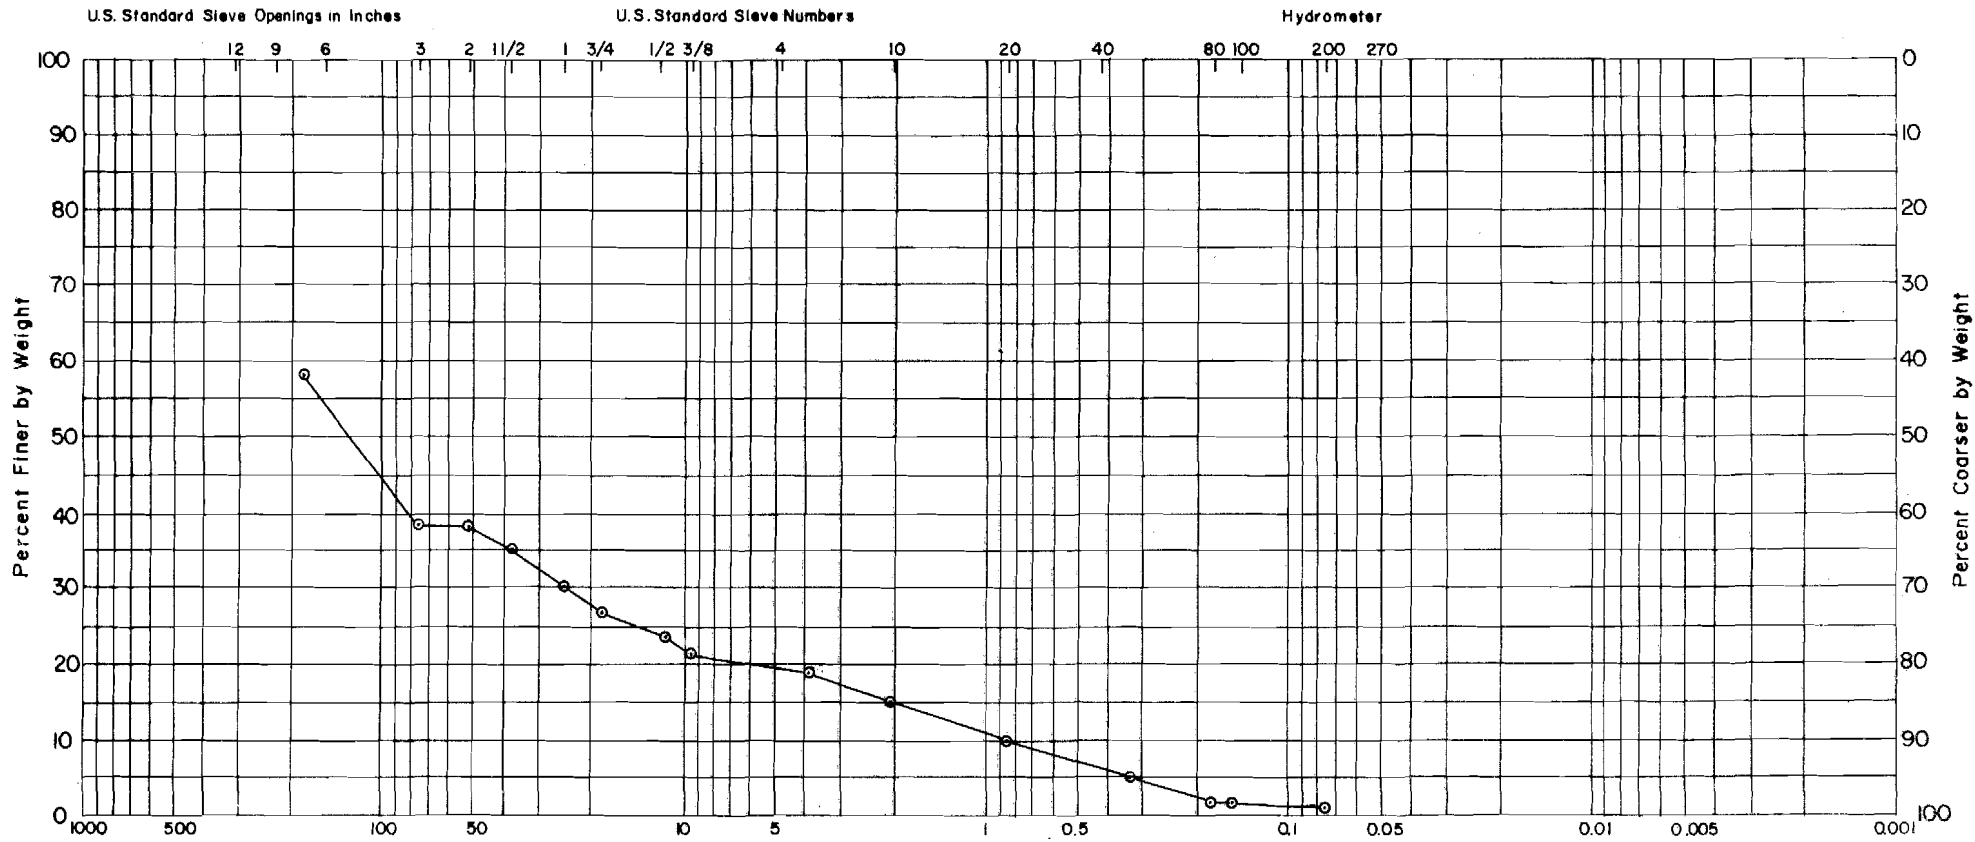
BORROW AREA E
TEST PIT TR-E4

SAMPLE NO.	MOISTURE CONTENT	DRY DENSITY	LL	PI	CLASS	CLASSIFICATION & DESCRIPTION
TP-E4 #1					GP	SANDY GRAVEL WITH NUMEROUS COBBLES AND SCATTERED BOULDERS

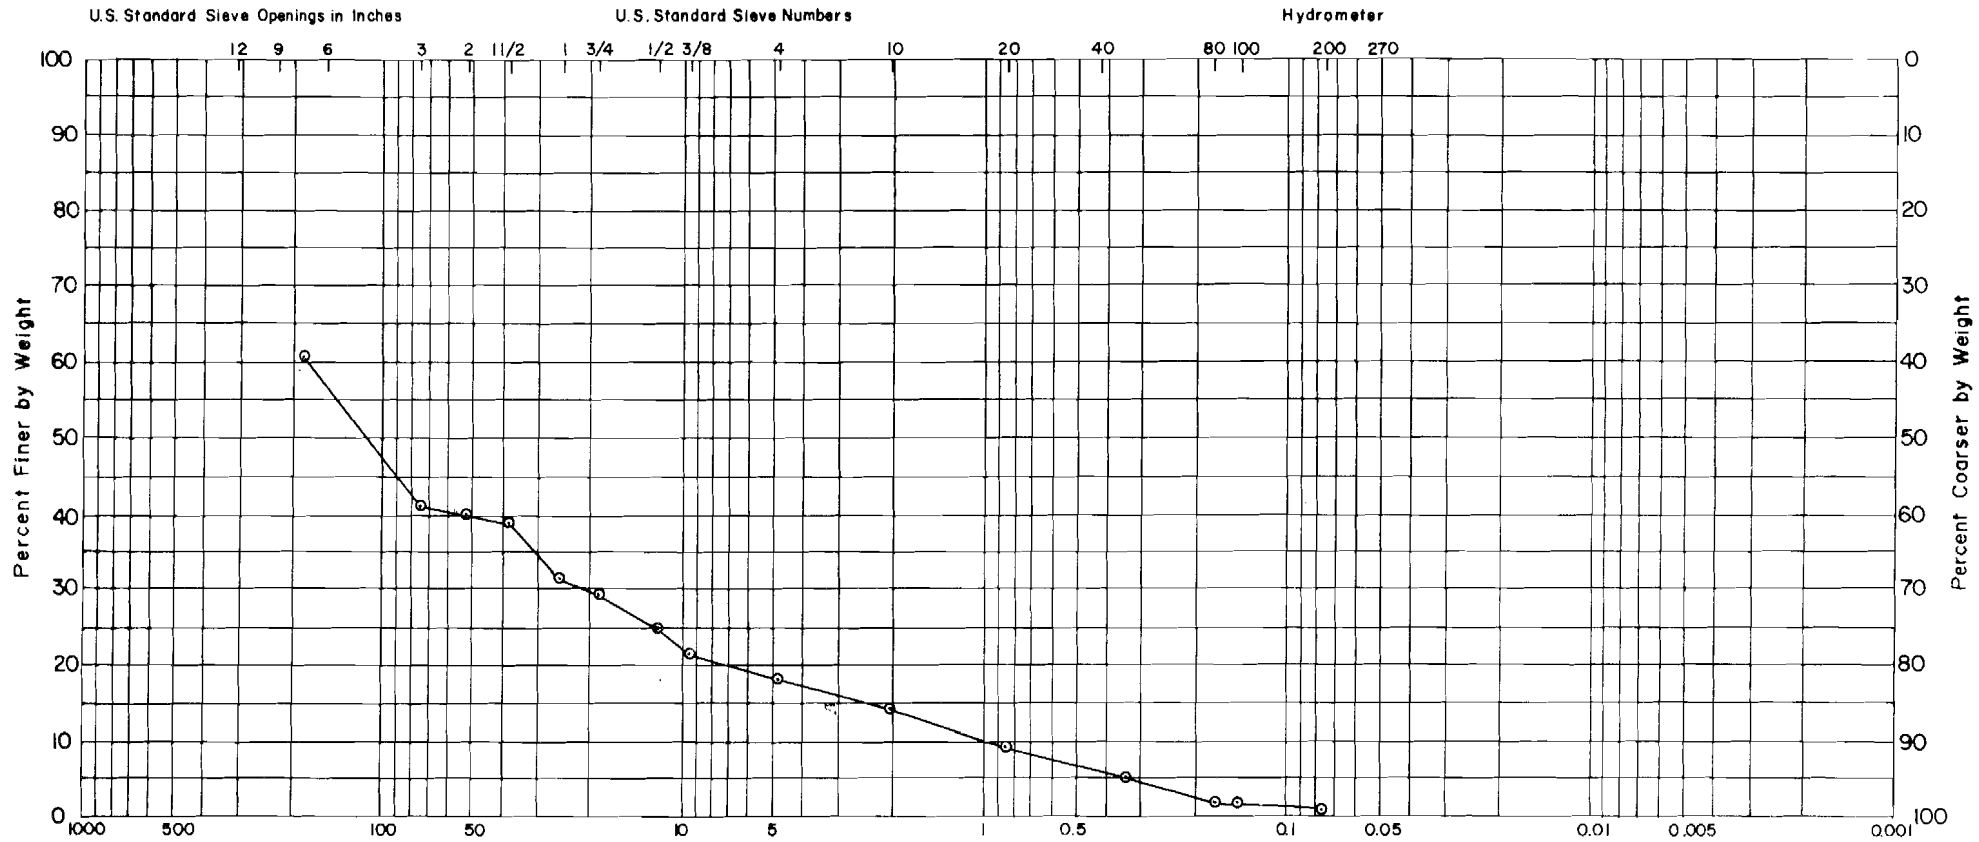
BORROW AREA E
TEST PIT TP-E4

SAMPLE NO.	MOISTURE CONTENT	DRY DENSITY	LL	PI	CLASS	CLASSIFICATION & DESCRIPTION
TP-E4 #2					GP	SANDY GRAVEL WITH NUMEROUS COBBLES AND SCATTERED BOULDERS

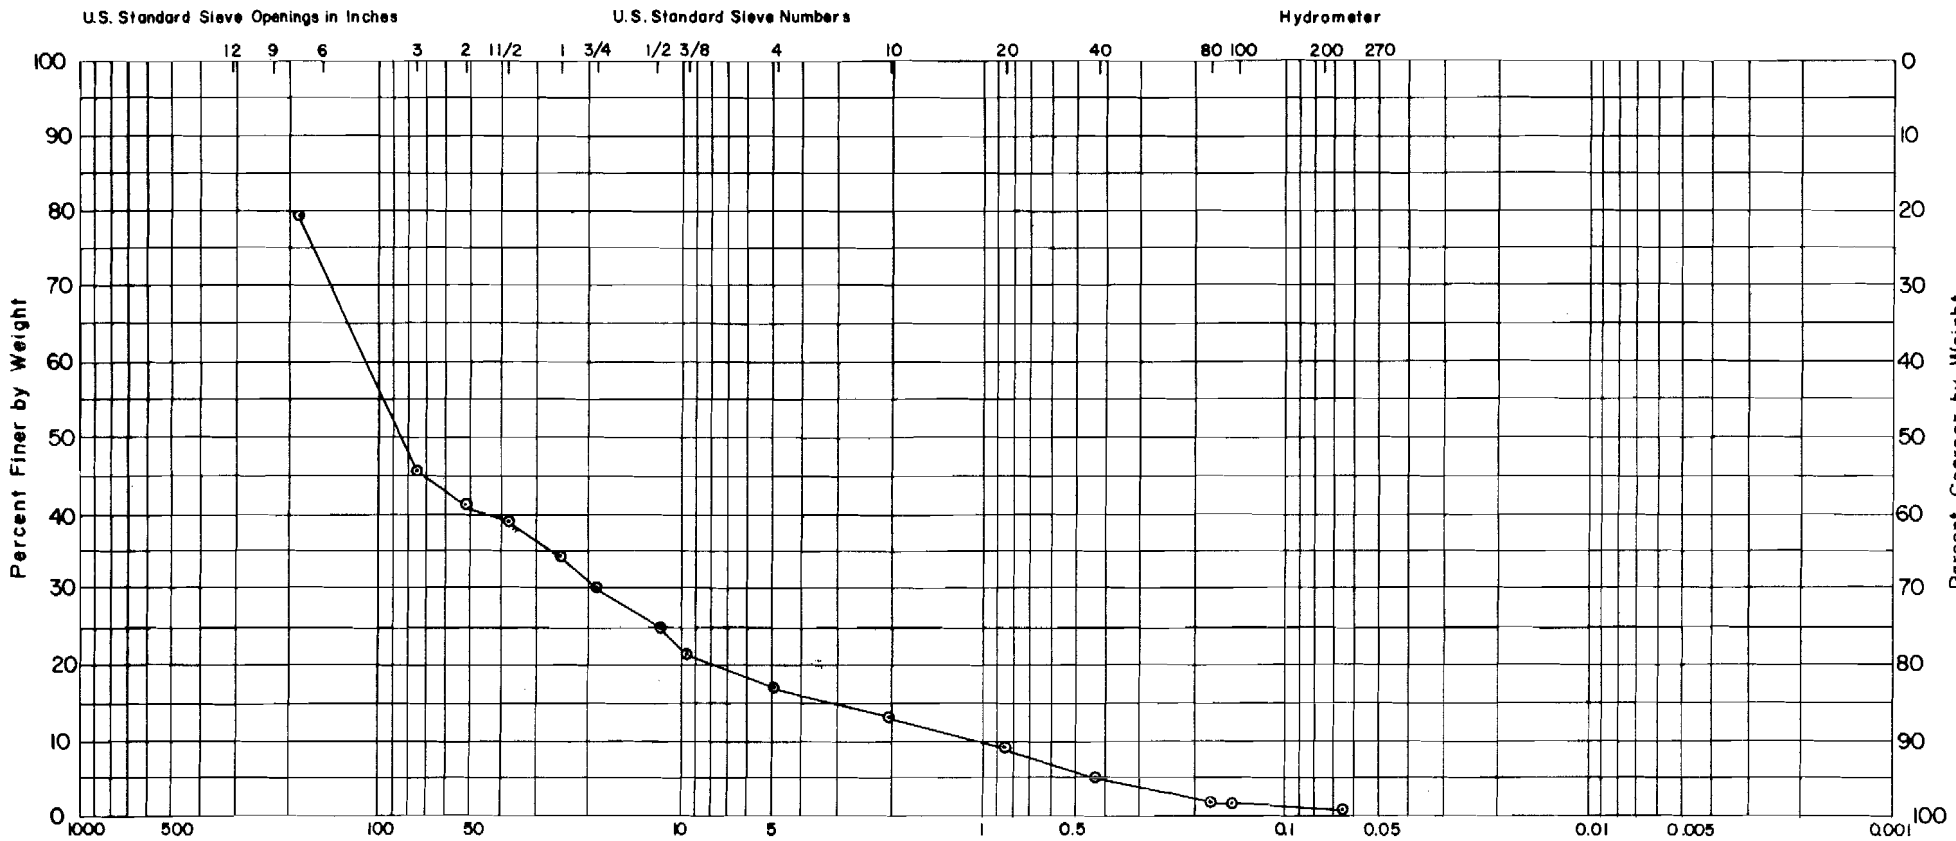
BORROW AREA E
TEST PIT TP-E5

SAMPLE NO.	MOISTURE CONTENT	DRY DENSITY	LL	PI	CLASS	CLASSIFICATION & DESCRIPTION
TP-E5 #1					GW-GP	SANDY GRAVEL WITH NUMEROUS COBBLES AND SCATTERED BOULDERS

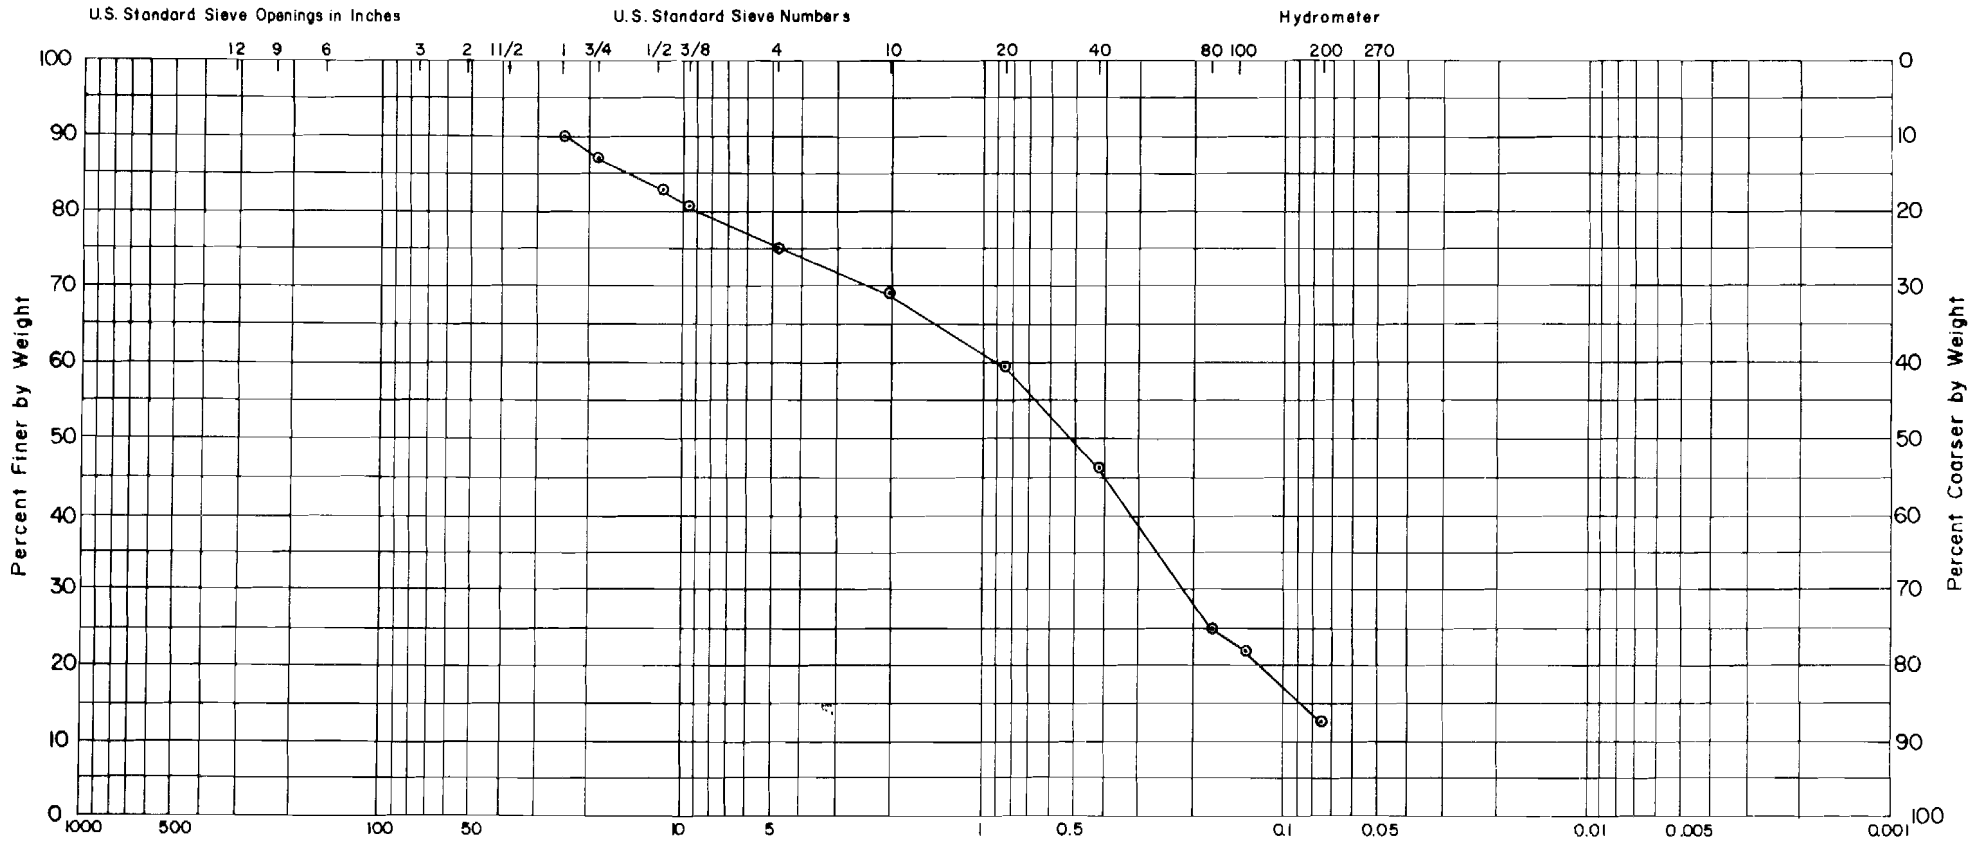
BORROW AREA E
TEST PIT TP-E6

SAMPLE NO.	MOISTURE CONTENT	DRY DENSITY	LL	PI	CLASS	CLASSIFICATION & DESCRIPTION
TP-E6 #1					SM	SAND WITH SOME GRAVEL AND SILT

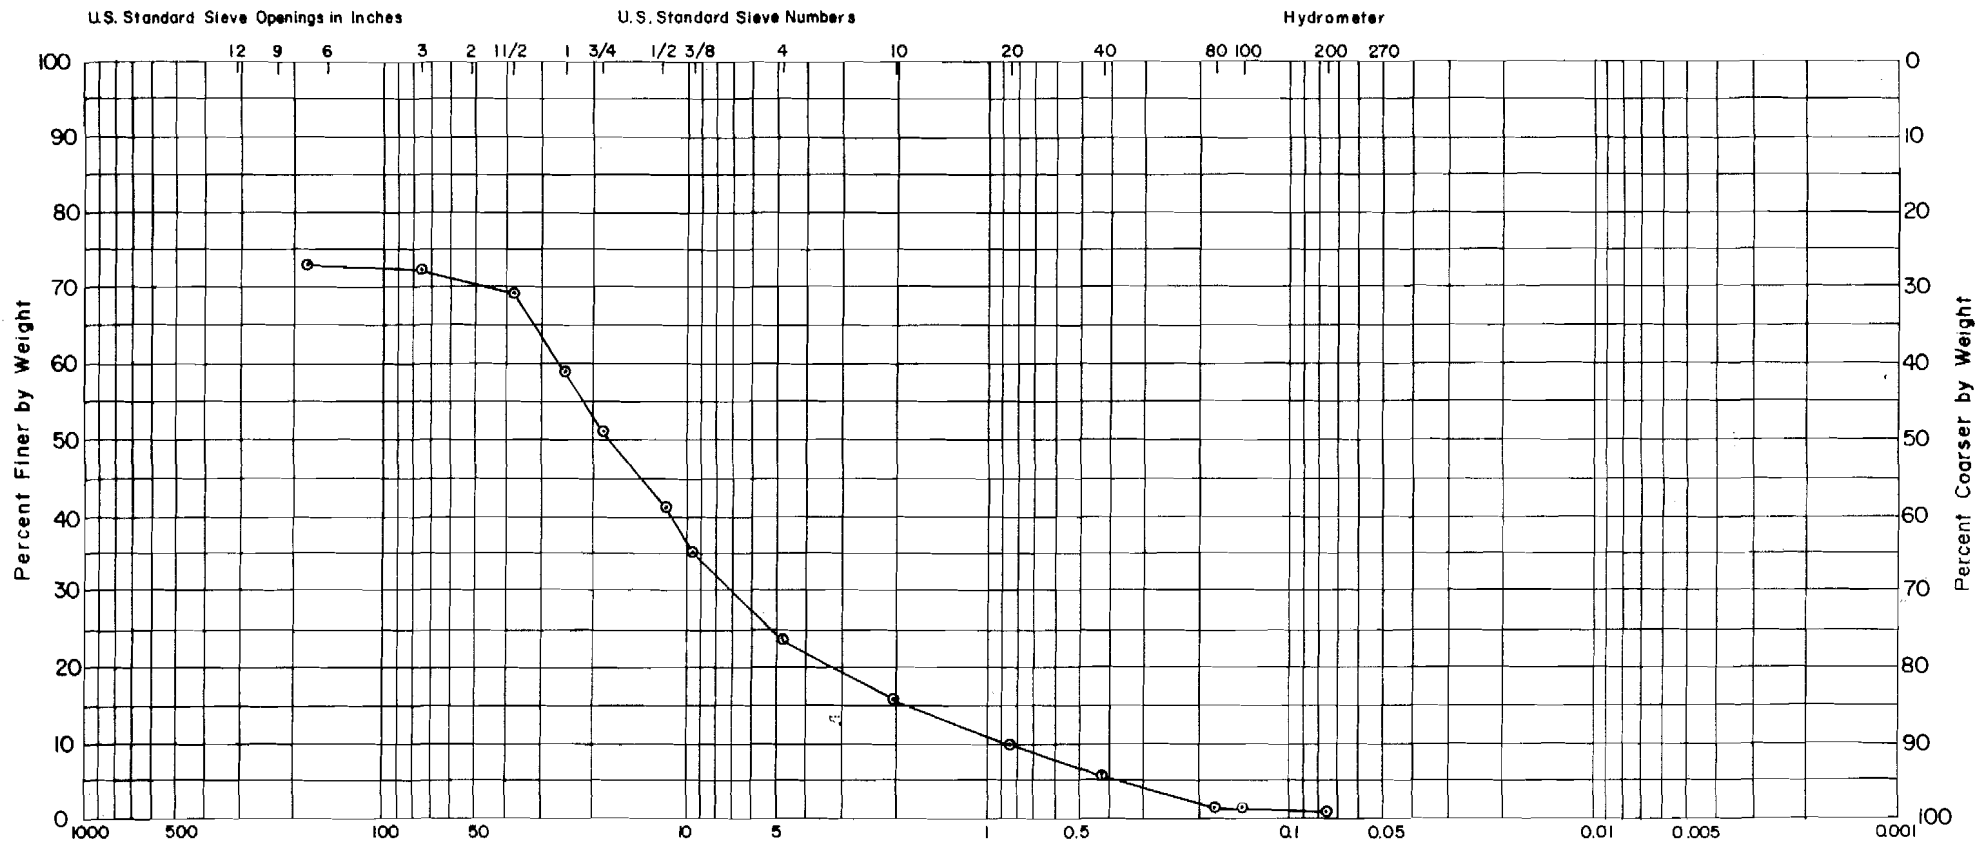
BORROW AREA E
TEST PIT TP-E8

SAMPLE NO.	MOISTURE CONTENT	DRY DENSITY	LL	PI	CLASS	CLASSIFICATION & DESCRIPTION
TP-E8 #1					GW	SANDY GRAVEL WITH SCATTERED COBBLES AND BOULDERS

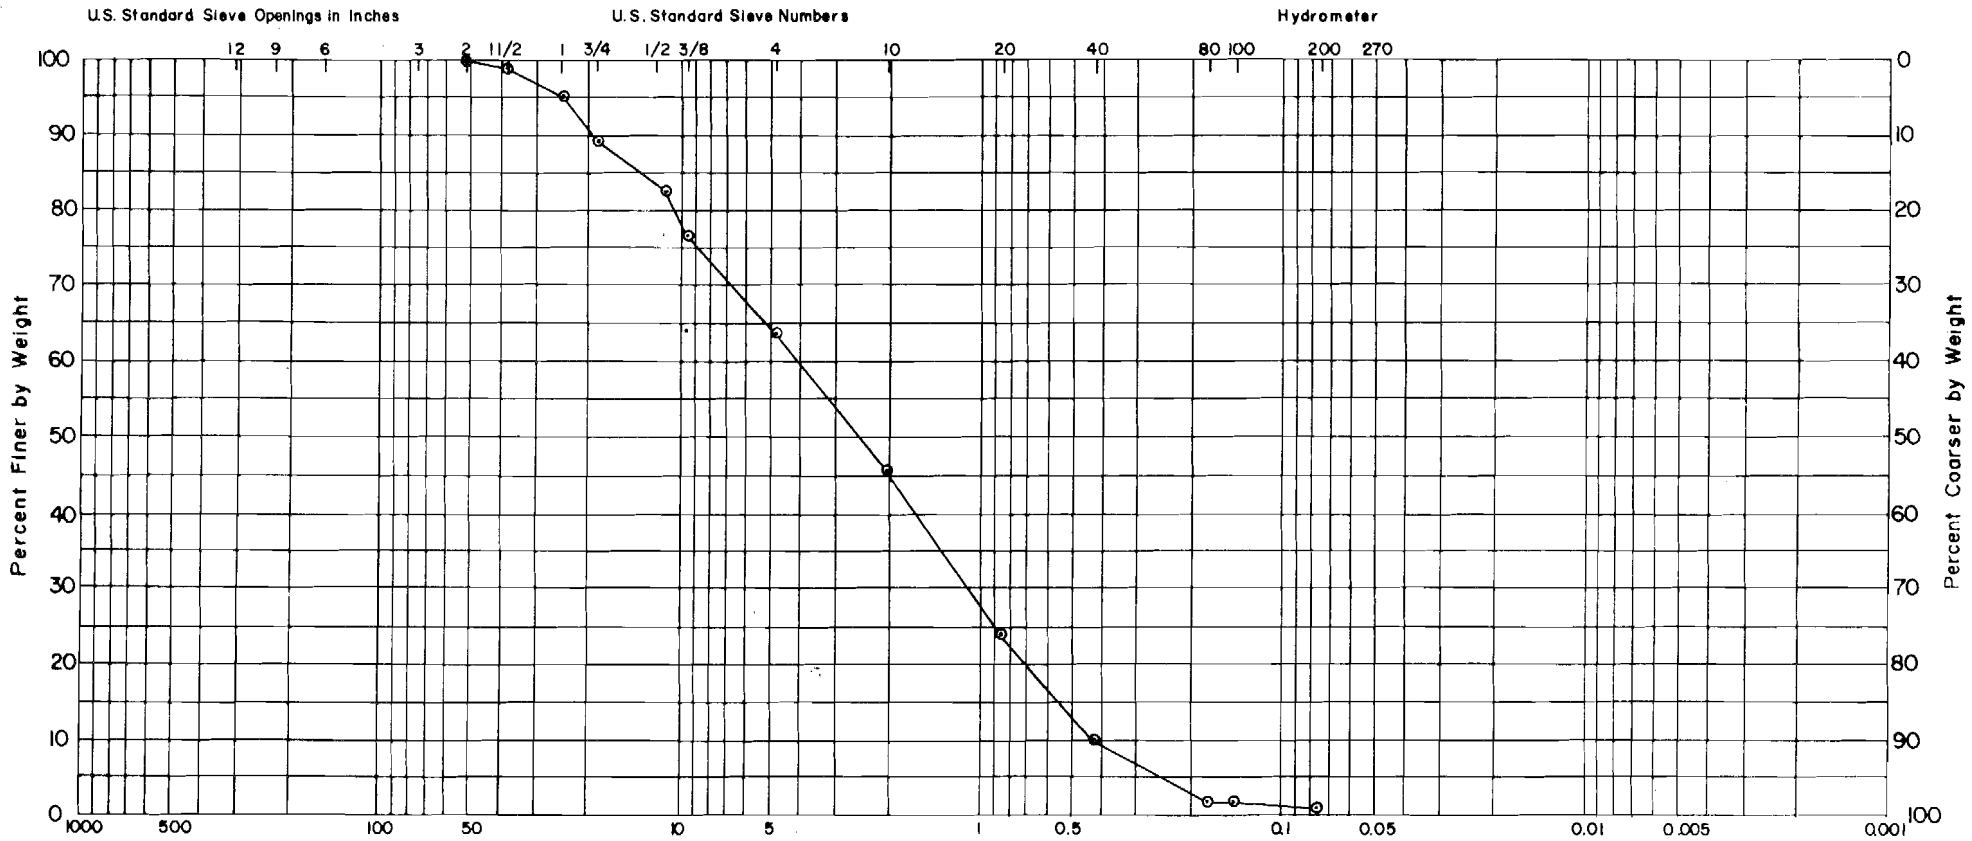
BORROW AREA E
TEST PIT TP-E8

SAMPLE NO.	MOISTURE CONTENT	DRY DENSITY	LL	PI	CLASS	CLASSIFICATION & DESCRIPTION
TP-E8 #2					SP	GRAVELLY SAND

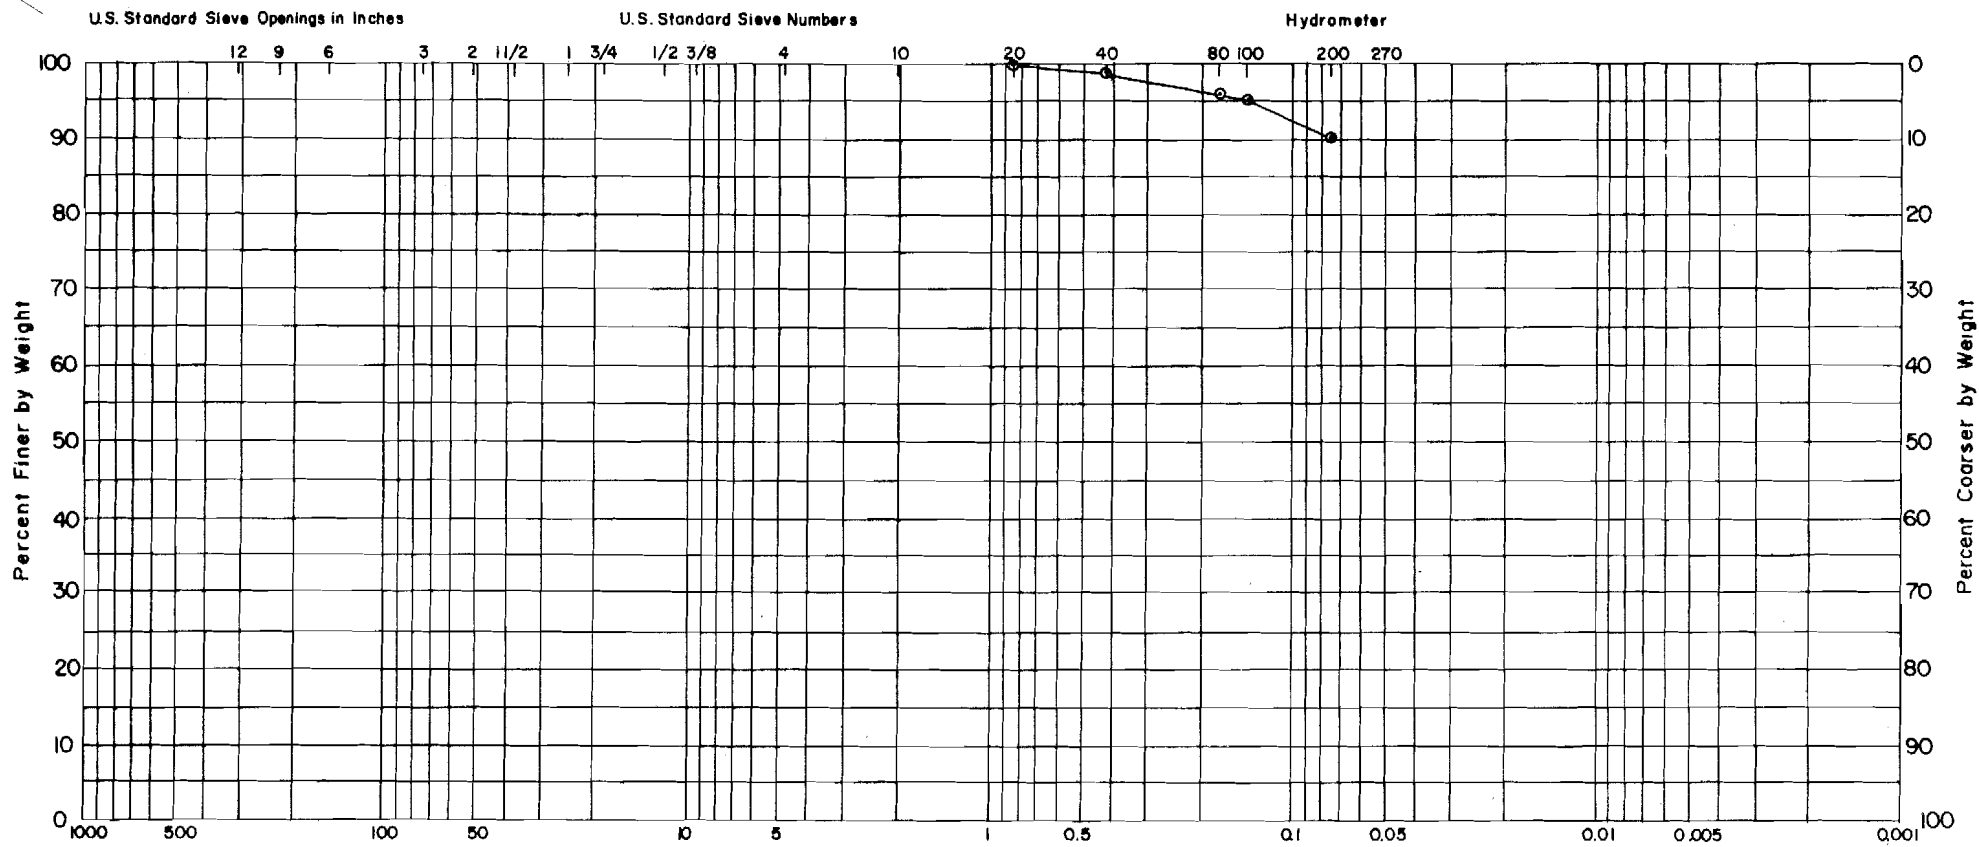
BORROW AREA E
TEST PIT TP-E9

SAMPLE NO.	MOISTURE CONTENT	DRY DENSITY	LL	PI	CLASS	CLASSIFICATION & DESCRIPTION
TP-E9 #1					ML	SILT WITH SOME TO TRACE CLAY AND TRACE SAND

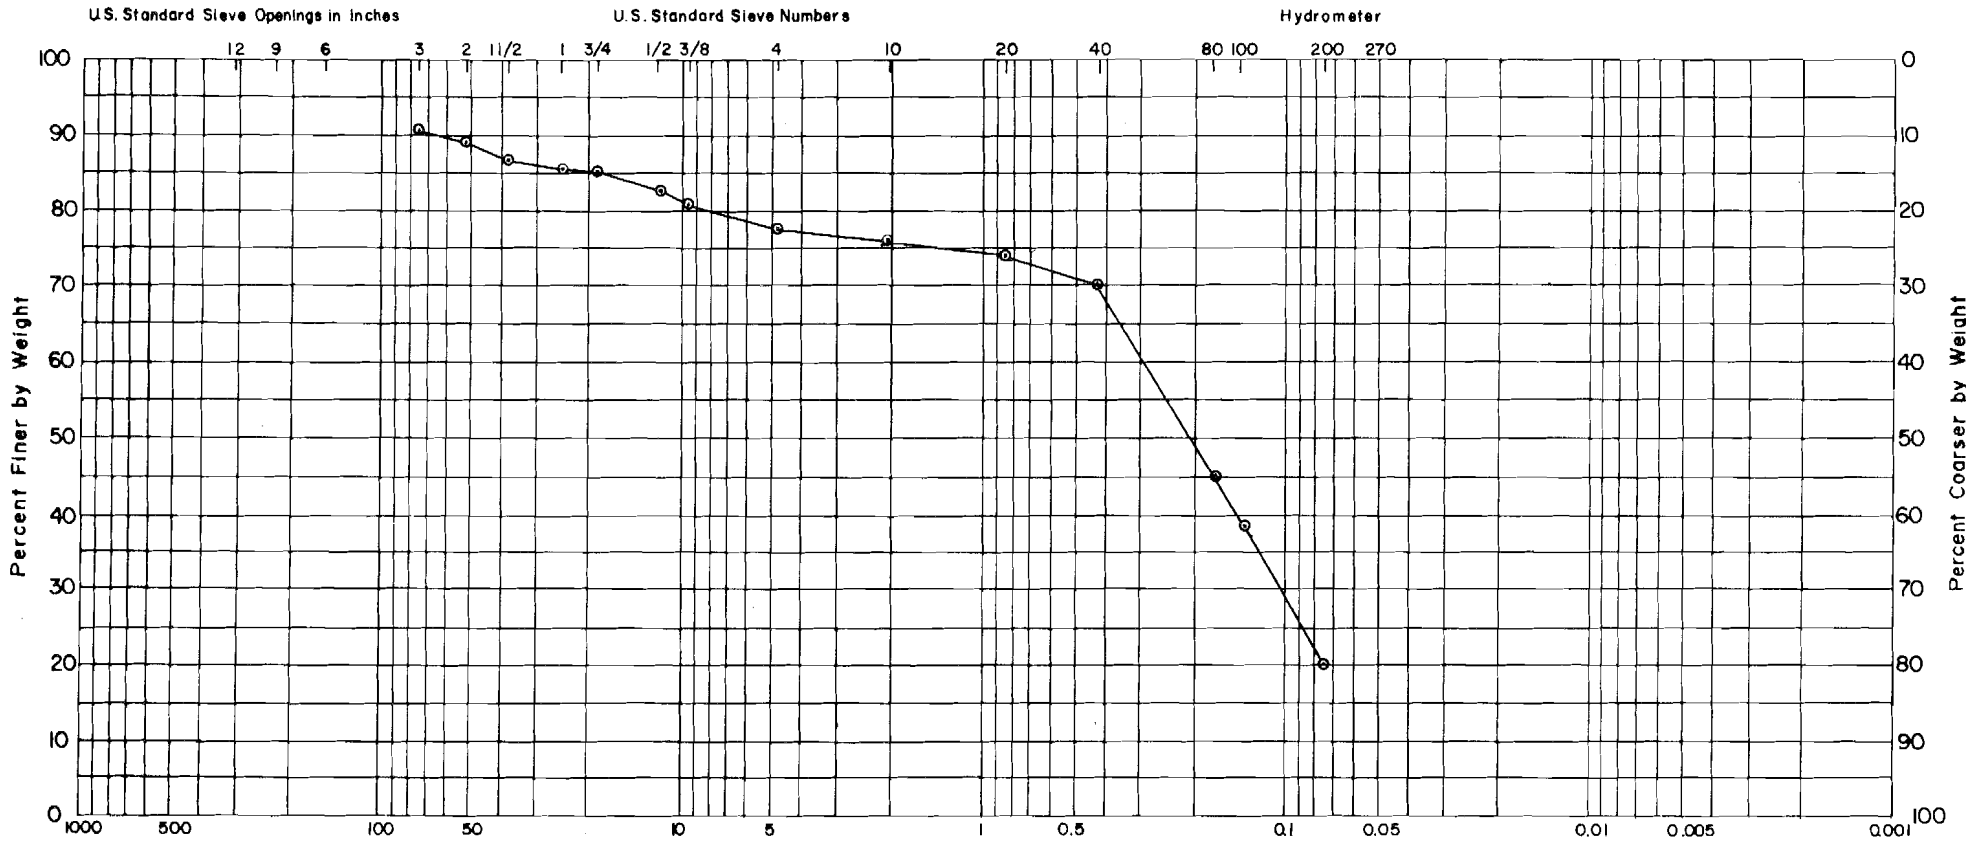
BORROW AREA E
TEST PIT TP-E9

SAMPLE NO.	MOISTURE CONTENT	DRY DENSITY	LL	PI	CLASS	CLASSIFICATION & DESCRIPTION
TP-E9 #2					SM	SAND WITH SOME GRAVEL AND SILT AND SCATTERED COBBLES

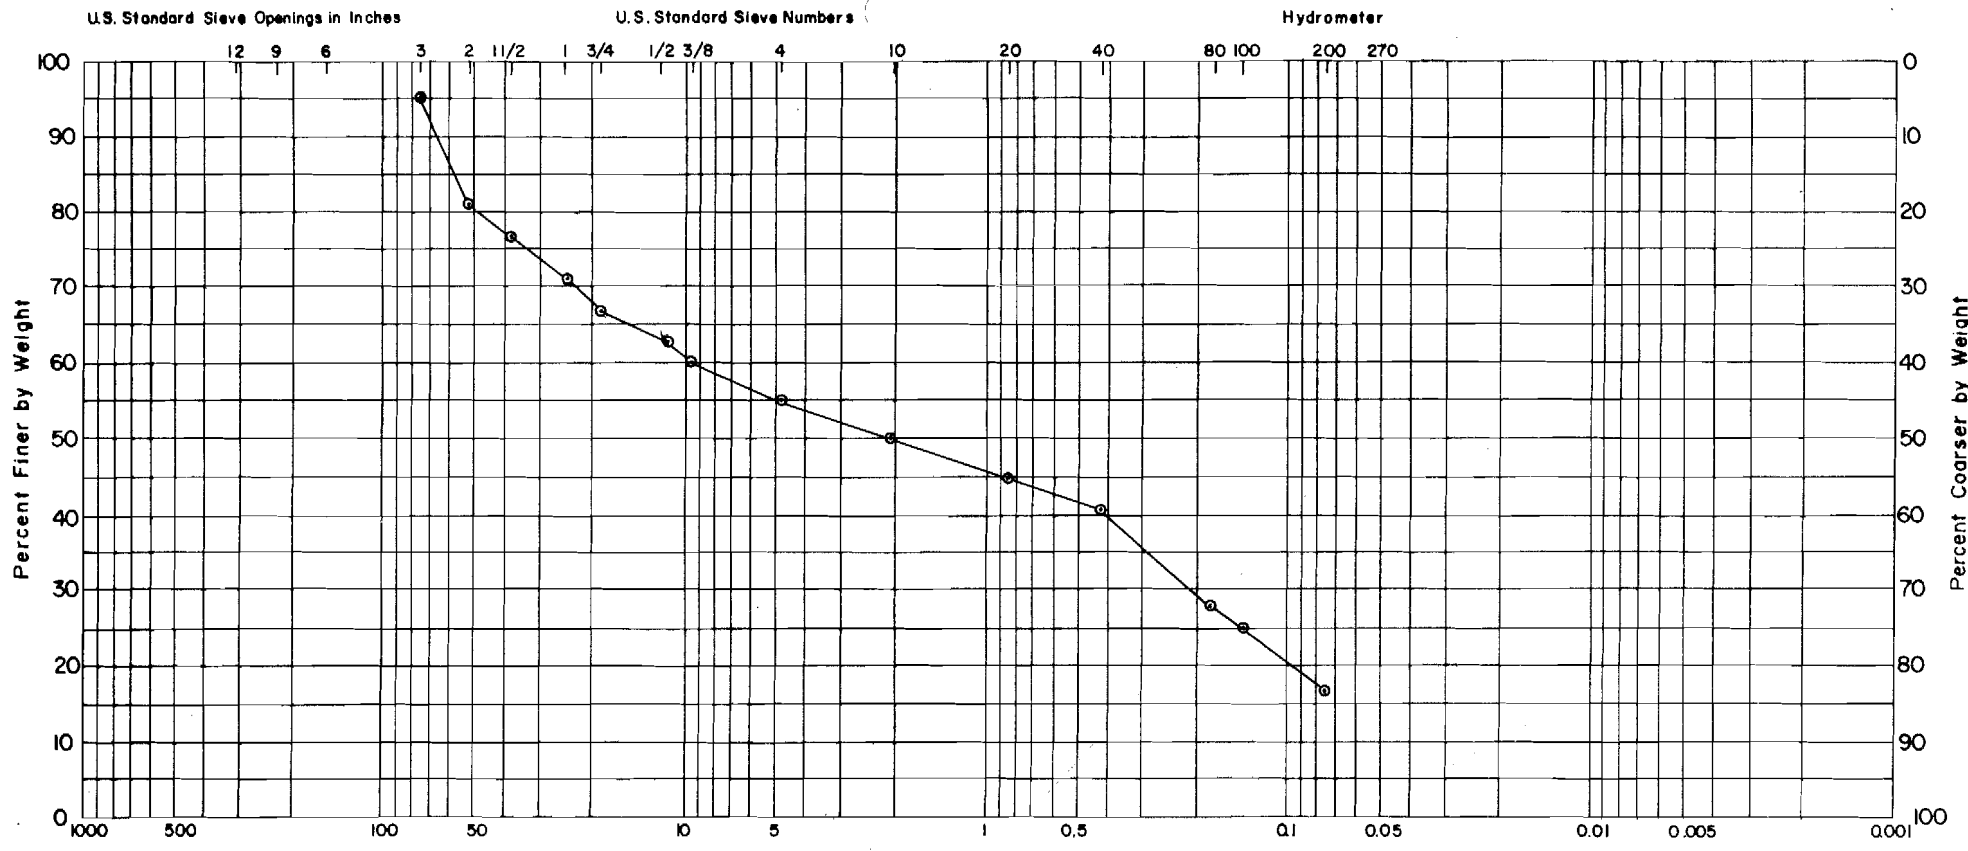
BORROW AREA E
TEST PIT TP-E9

SAMPLE NO.	MOISTURE CONTENT	DRY DENSITY	LL	PI	CLASS	CLASSIFICATION & DESCRIPTION
TP-E9 #3					GM	SANDY GRAVEL WITH SOME SILT AND SCATTERED COBBLES.

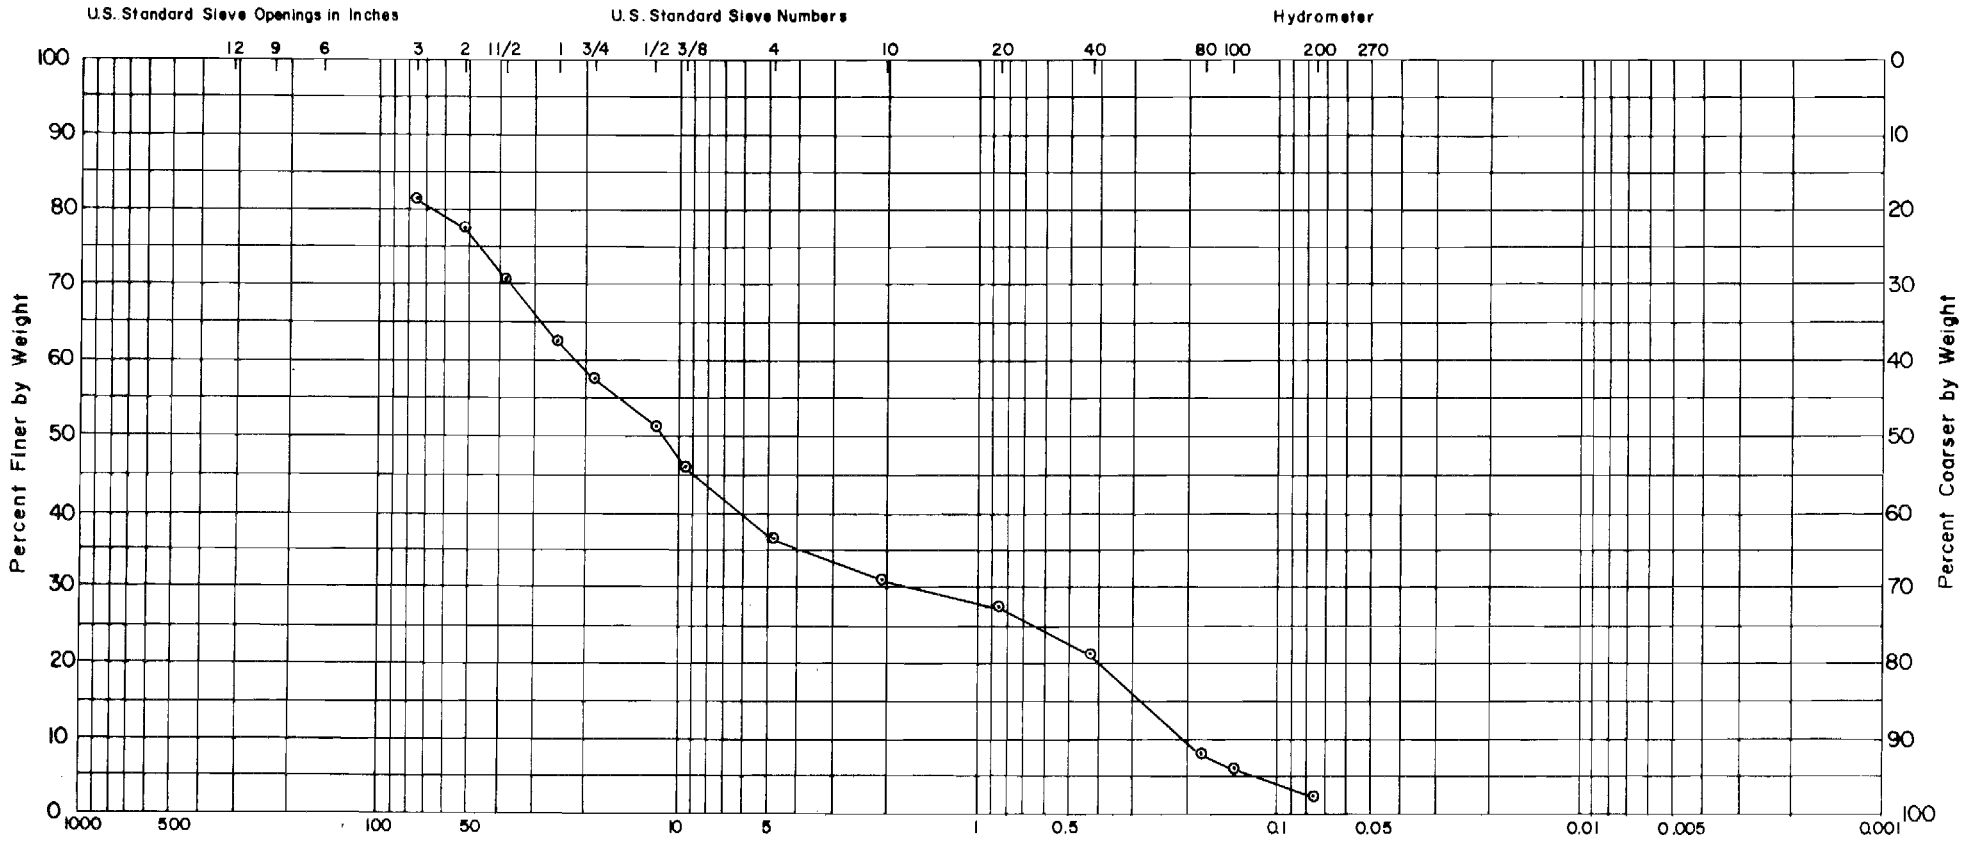
SAMPLE NO.	MOISTURE CONTENT	DRY DENSITY	LL	PI	CLASS	CLASSIFICATION & DESCRIPTION
TP-E10A #1					GP	SANDY GRAVEL WITH SCATTERED COBBLES
