SUSITNA HYDROELECTRIC PROJECT

1980 - 81 GEOTECHNICAL REPORT

VOLUME 2
APPENDIX A-F
FINAL DRAFT

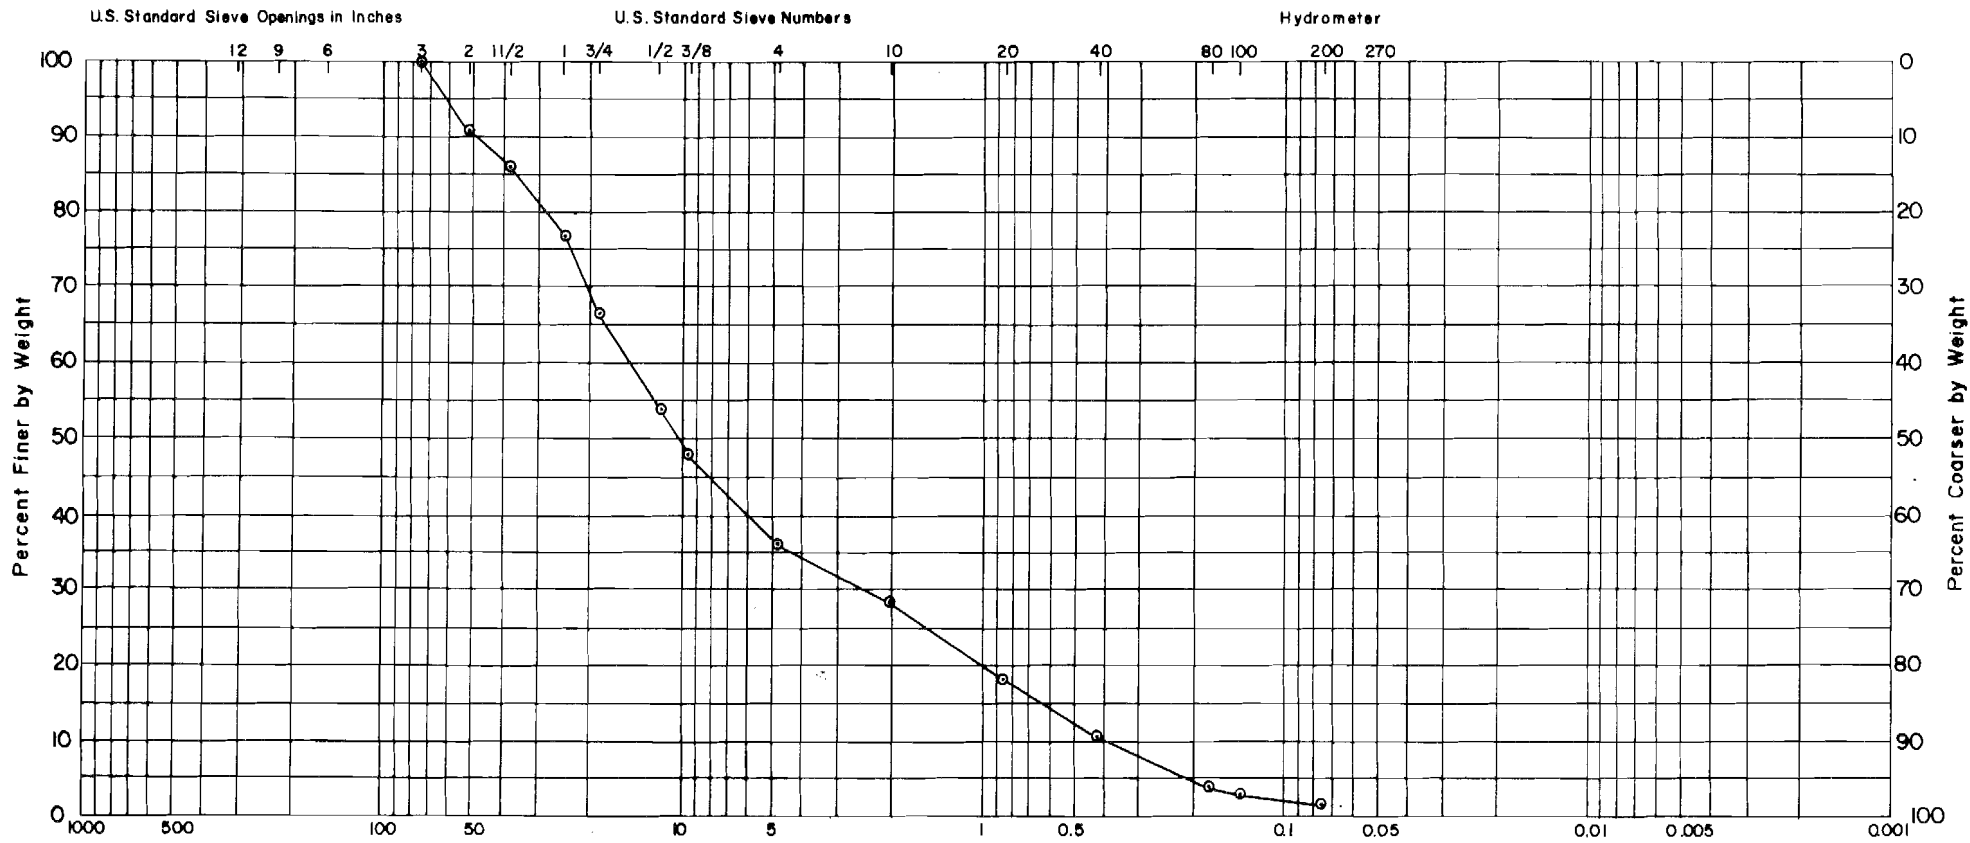
BORROW AREA E
TEST PIT TP-E10A

SAMPLE NO.	MOISTURE CONTENT	DRY DENSITY	LL	PI	CLASS	CLASSIFICATION & DESCRIPTION
TP-E10A #2					SM	SAND WITH SOME SILT

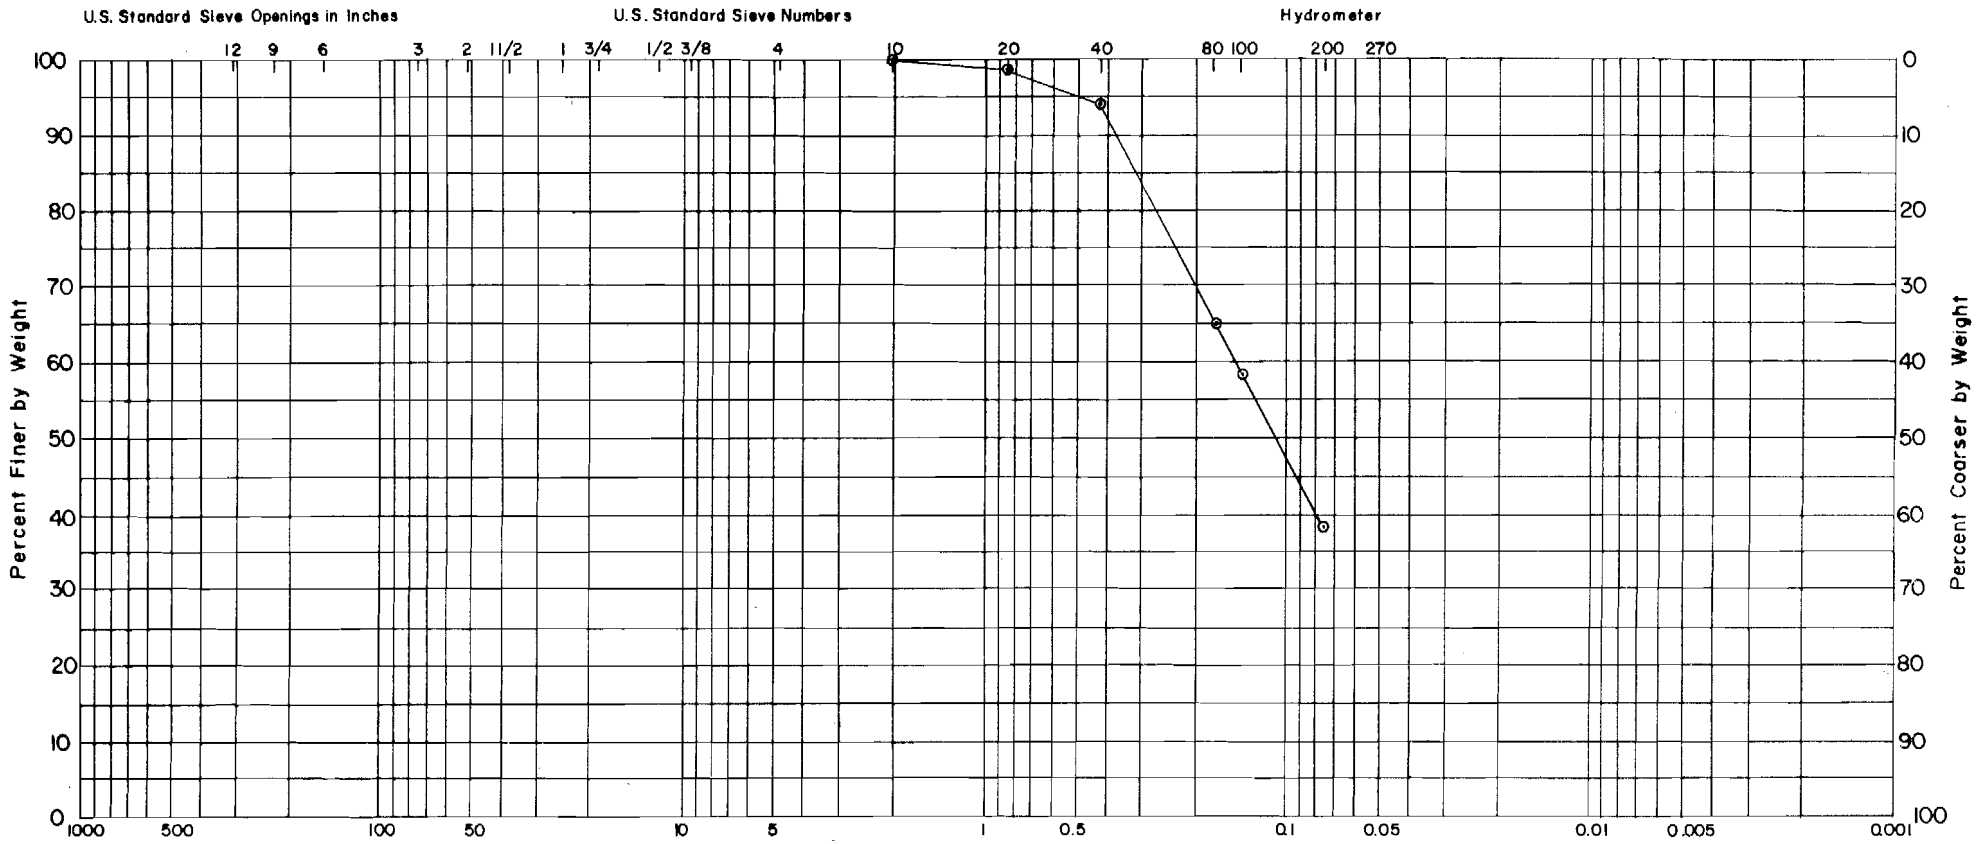
BORROW AREA E
TEST PIT TP-#10B

SAMPLE NO.	MOISTURE CONTENT	DRY DENSITY	LL	PI	CLASS	CLASSIFICATION & DESCRIPTION
TP-E10B #1					GP	SANDY GRAVEL

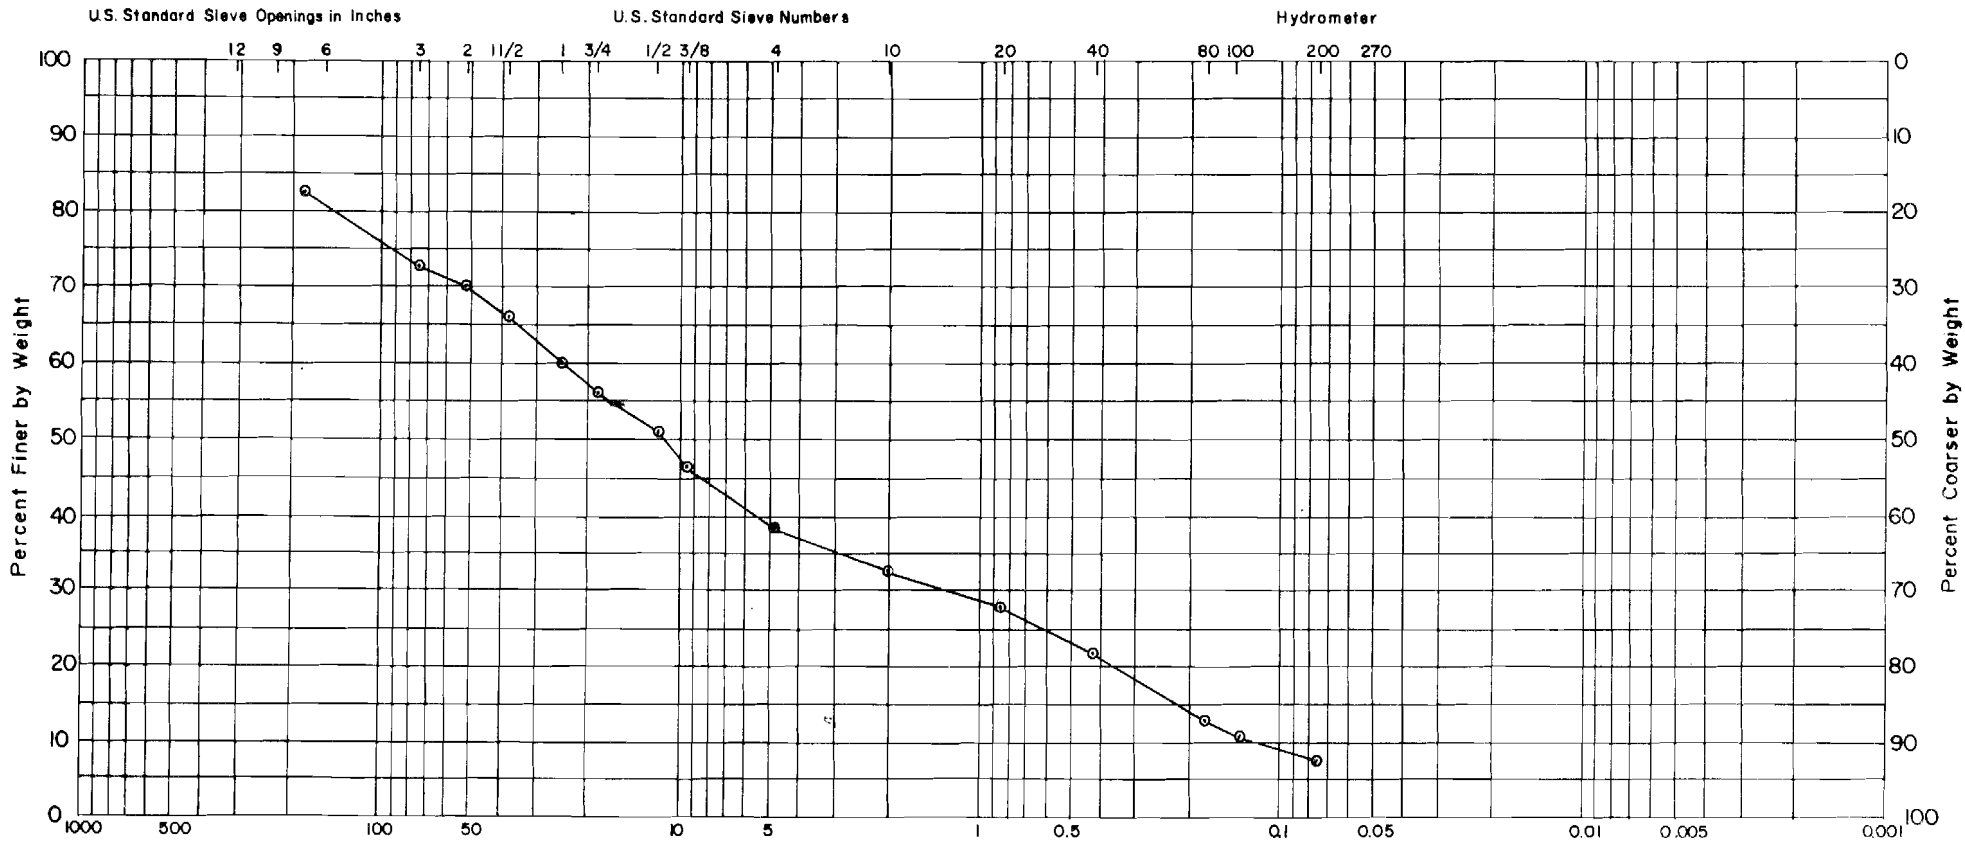
BORROW AREA E
TEST PIT TP-E11

SAMPLE NO.	MOISTURE CONTENT	DRY DENSITY	LL	PI	CLASS	CLASSIFICATION & DESCRIPTION
TP-E11 #1					SM	SILTY SAND

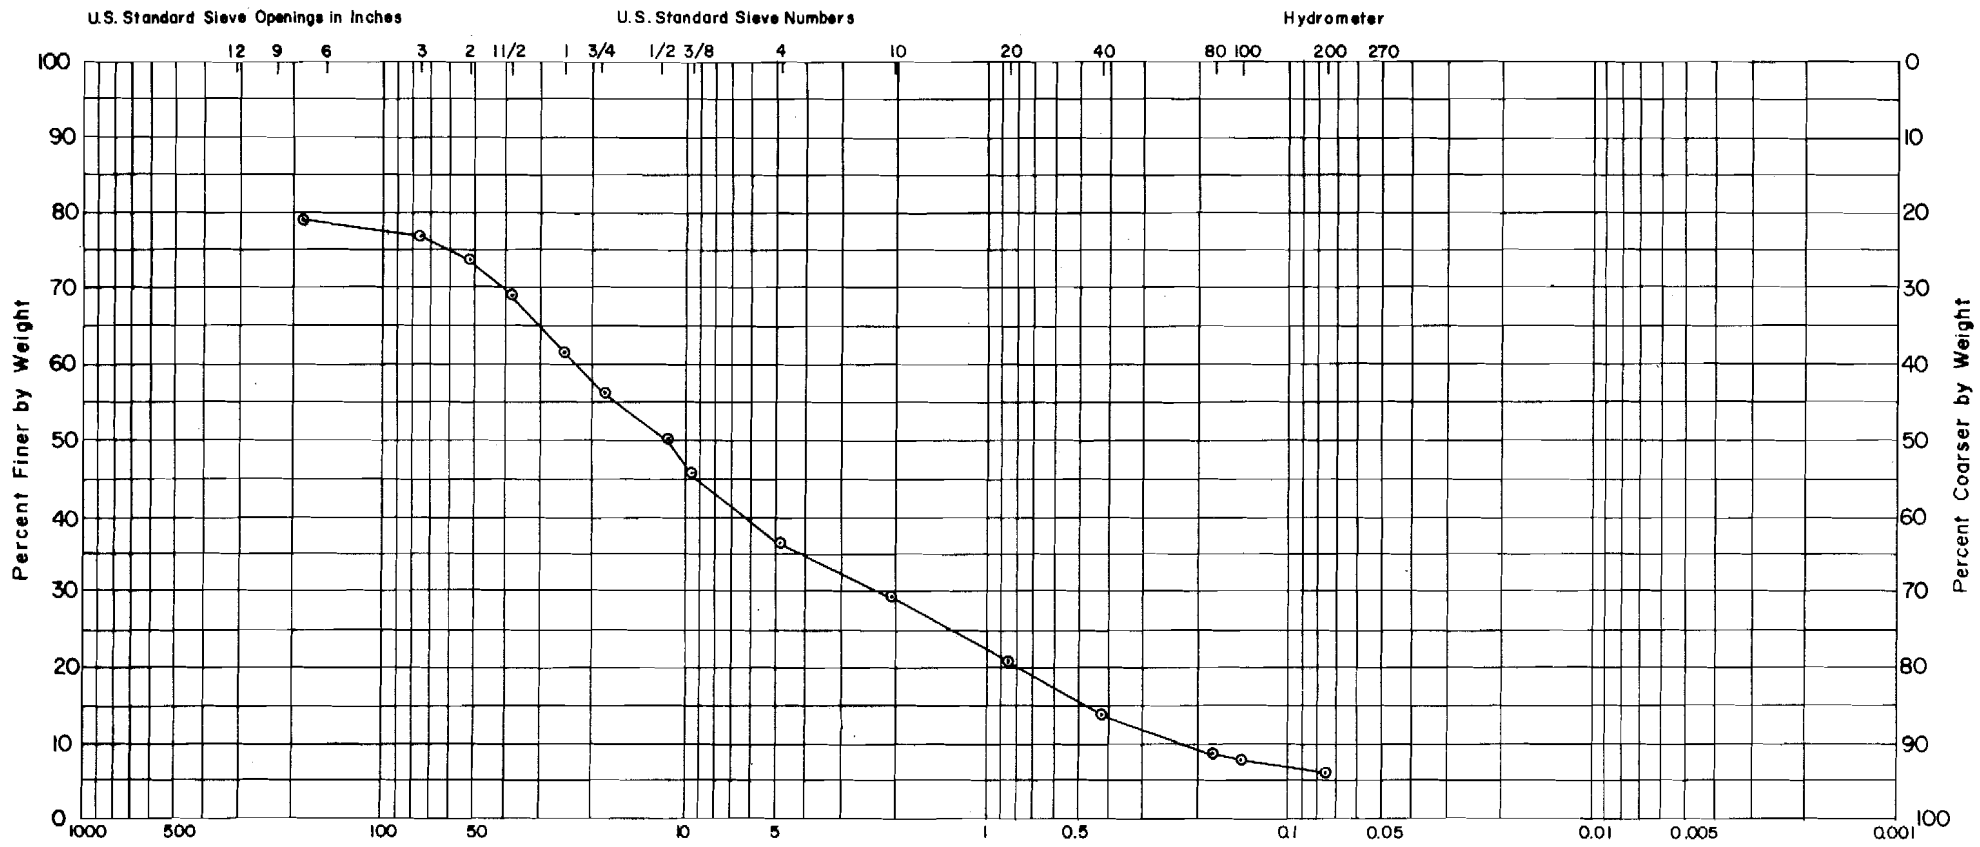
BORROW AREA E
TEST PIT TP-E11

SAMPLE NO.	MOISTURE CONTENT	DRY DENSITY	LL	PI	CLASS	CLASSIFICATION & DESCRIPTION
TP-E11 #2					GP-GM	SANDY GRAVEL WITH TRACE SILT AND SCATTERED COBBLES AND BOULDERS

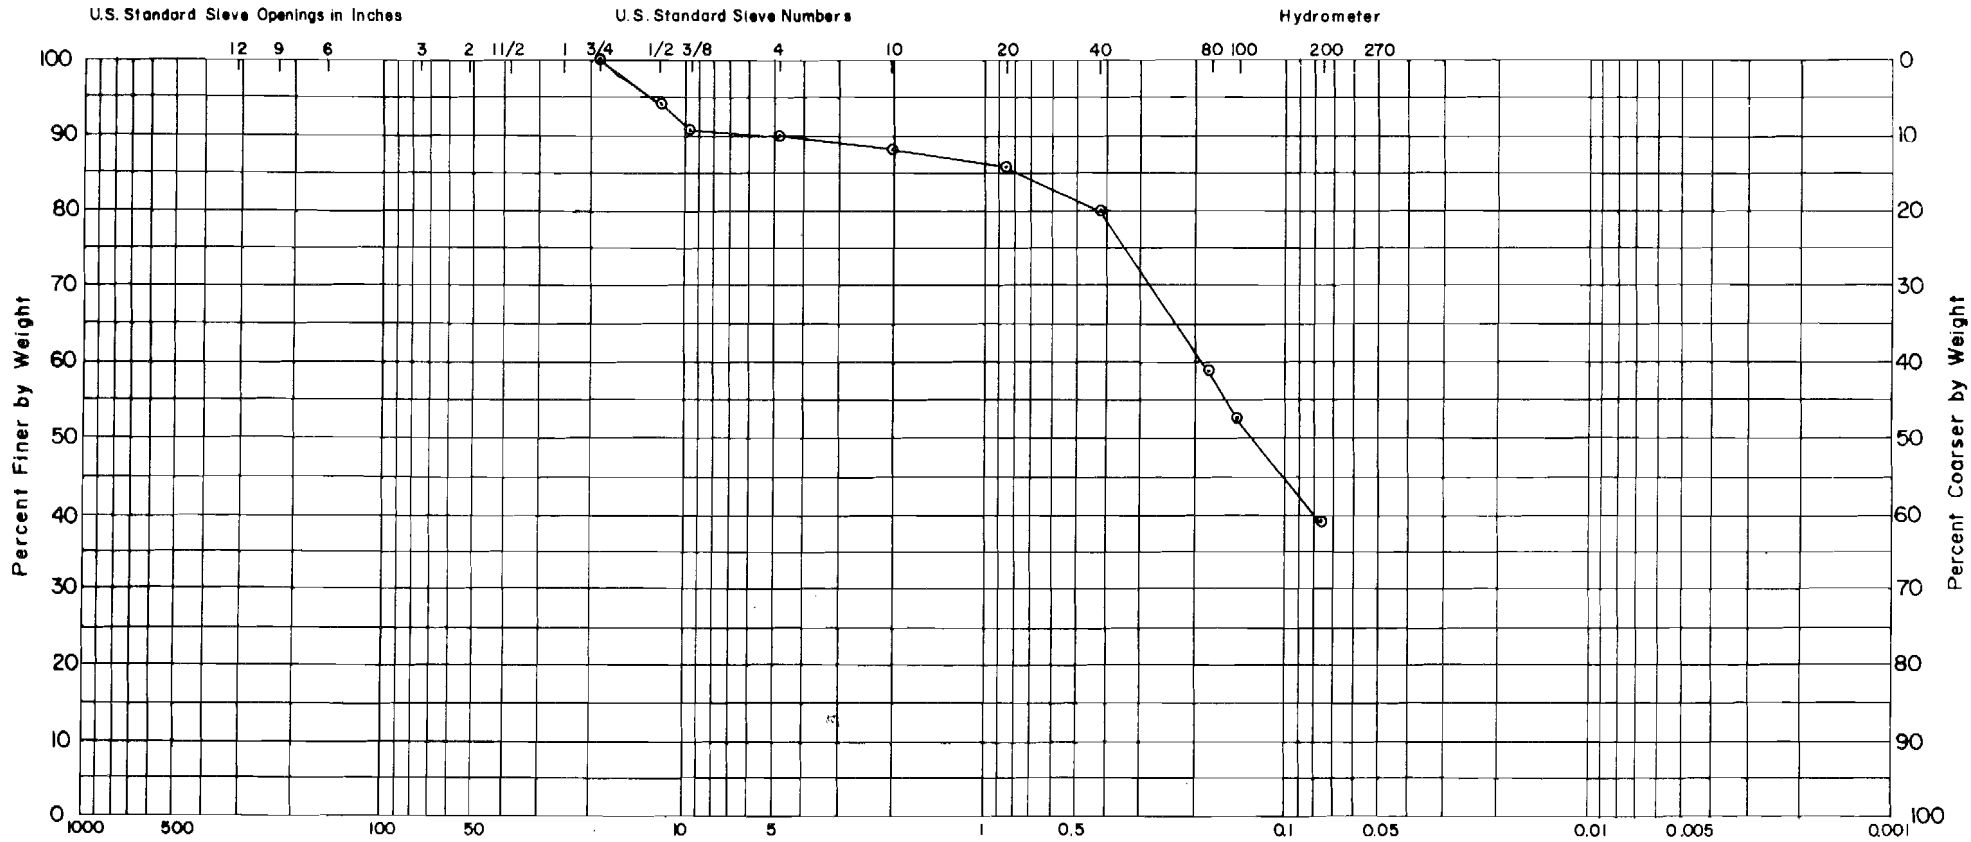
BORROW AREA E
TEST PIT TP-E12

SAMPLE NO.	MOISTURE CONTENT	DRY DENSITY	LL	PI	CLASS	CLASSIFICATION & DESCRIPTION
TP-E12 #1					GP-GM	SANDY GRAVEL WITH TRACE SILT AND SCATTERED COBBLES AND BOULDERS

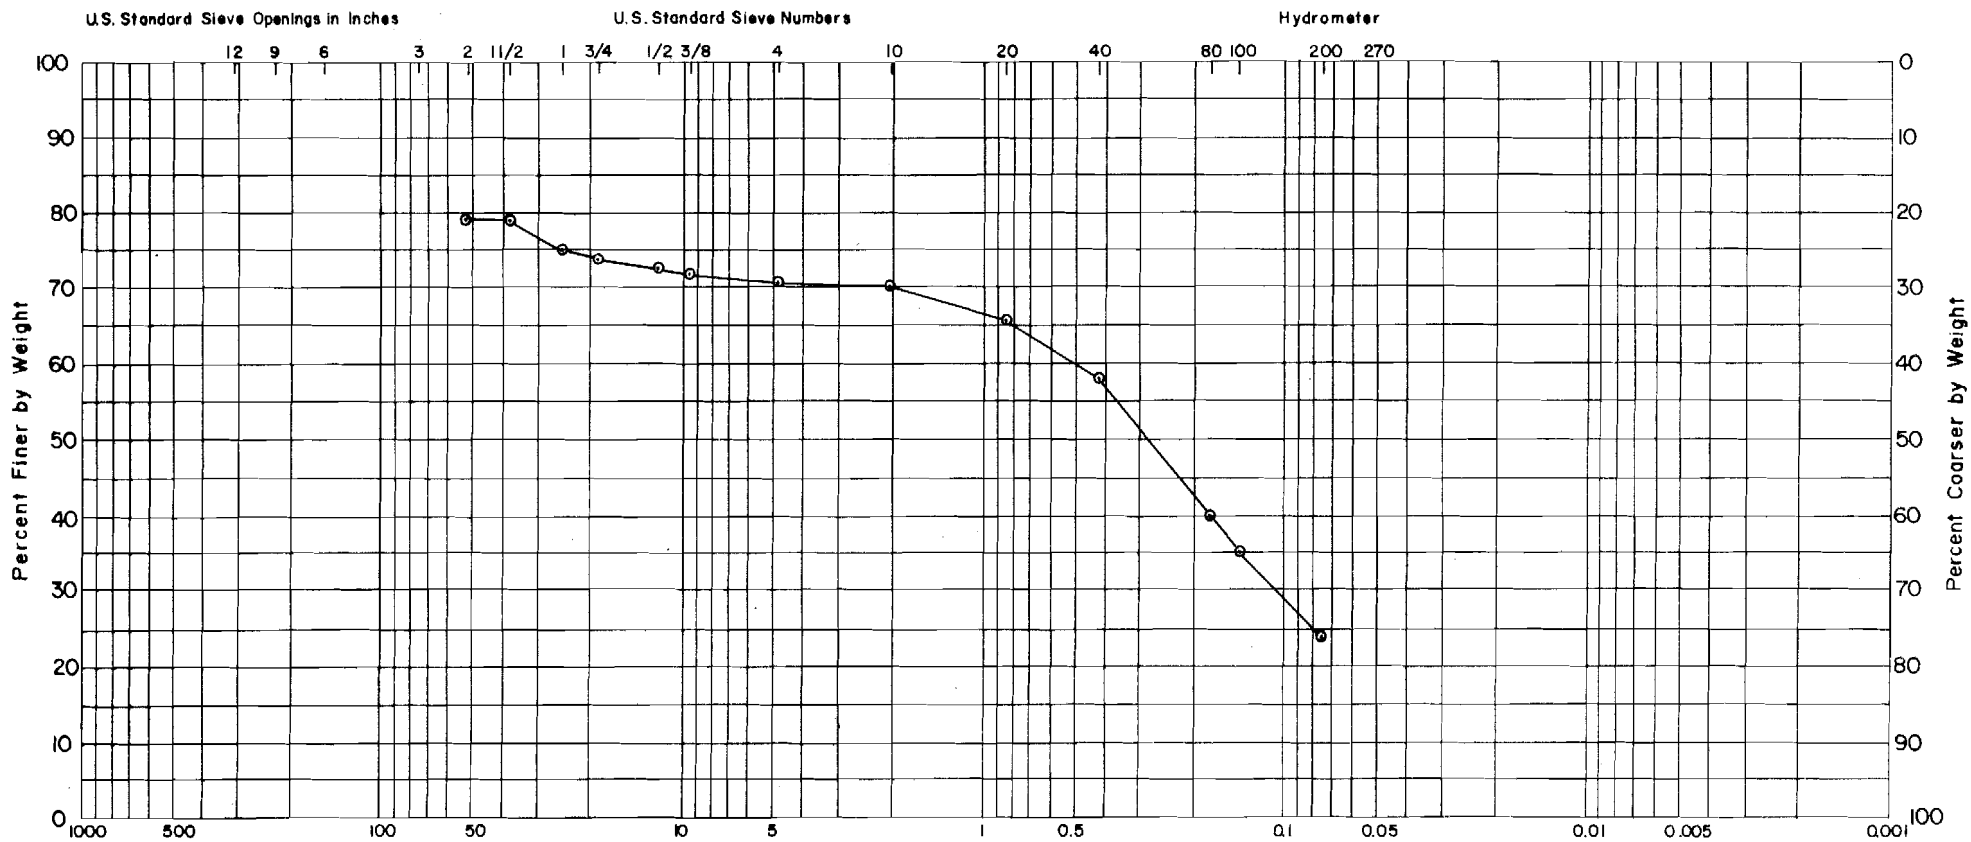
BORROW AREA E
TEST PIT TP-E12

SAMPLE NO.	MOISTURE CONTENT	DRY DENSITY	LL	PI	CLASS	CLASSIFICATION & DESCRIPTION
TP-E12 #2					SM	SILTY SAND WITH TRACE GRAVEL AND CLAY (FIELD GEOLOGIST NOTES TRACE ORGANICS)

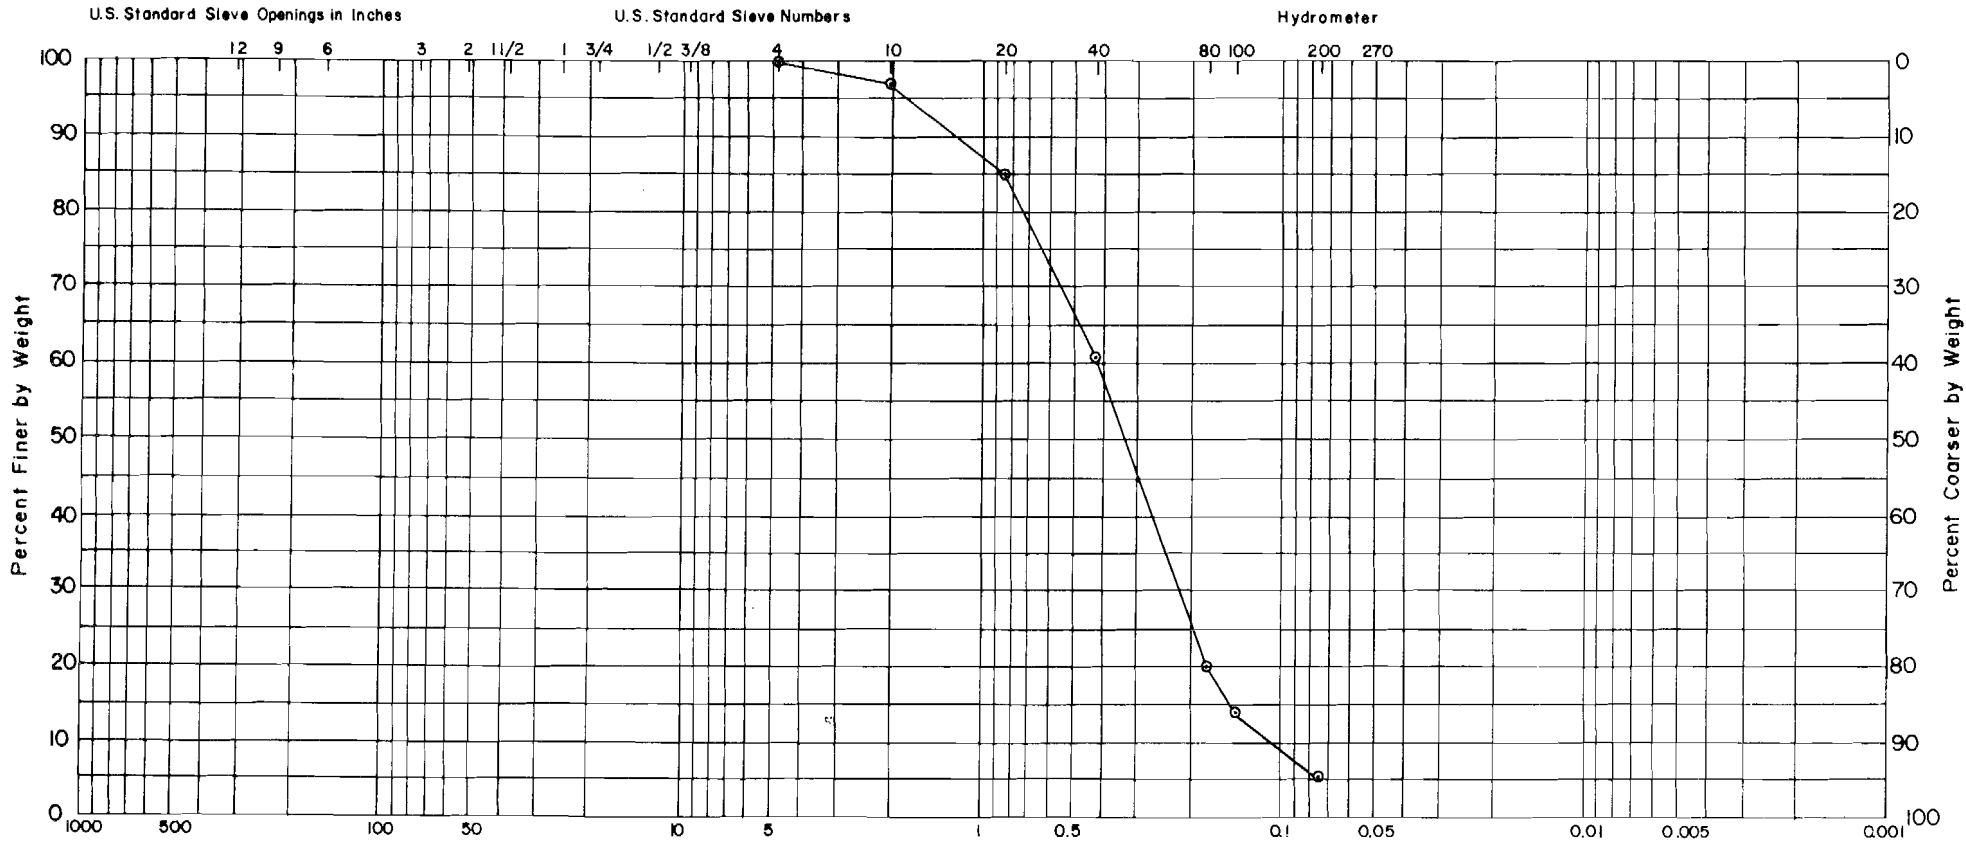
BORROW AREA E
TEST PIT TP-E12

SAMPLE NO.	MOISTURE CONTENT	DRY DENSITY	LL	PI	CLASS	CLASSIFICATION & DESCRIPTION
TP-E12 #3					SM	SAND WITH SOME SILT, TRACE GRAVEL AND SCATTERED COBBLES

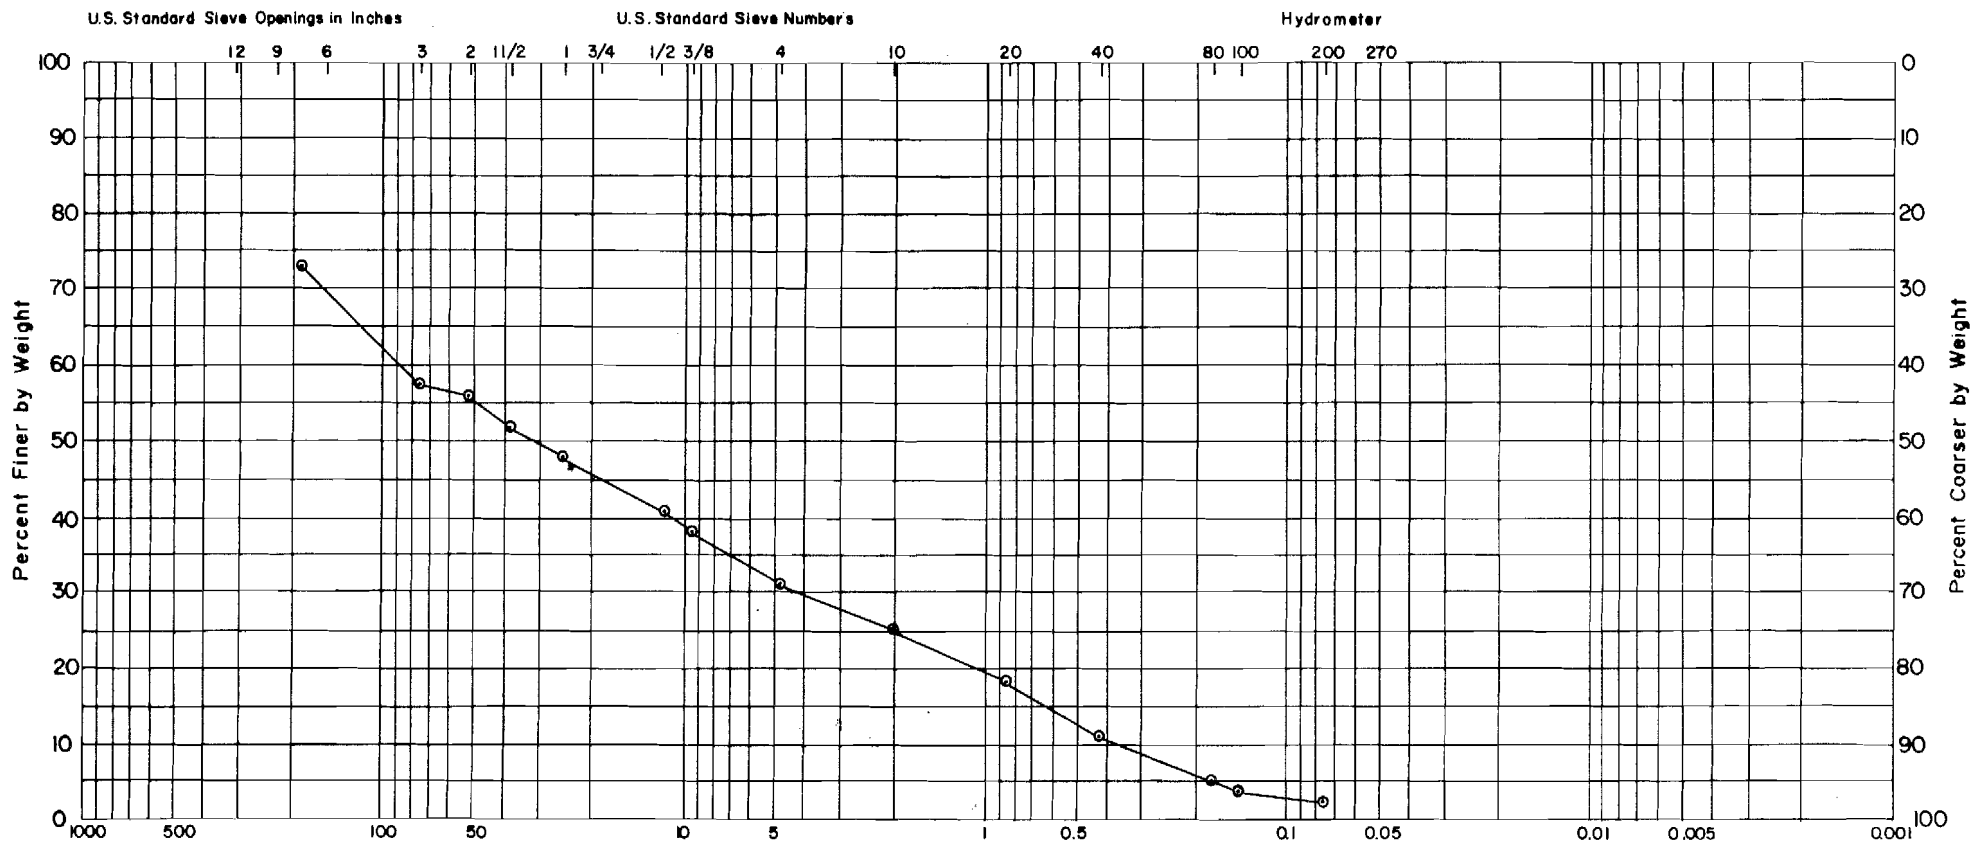
BORROW AREA E
TEST PIT TP-E14

SAMPLE NO.	MOISTURE CONTENT	DRY DENSITY	LL	PI	CLASS	CLASSIFICATION & DESCRIPTION
TP-E14 #1					SP-SM	SAND WITH TRACE SILT

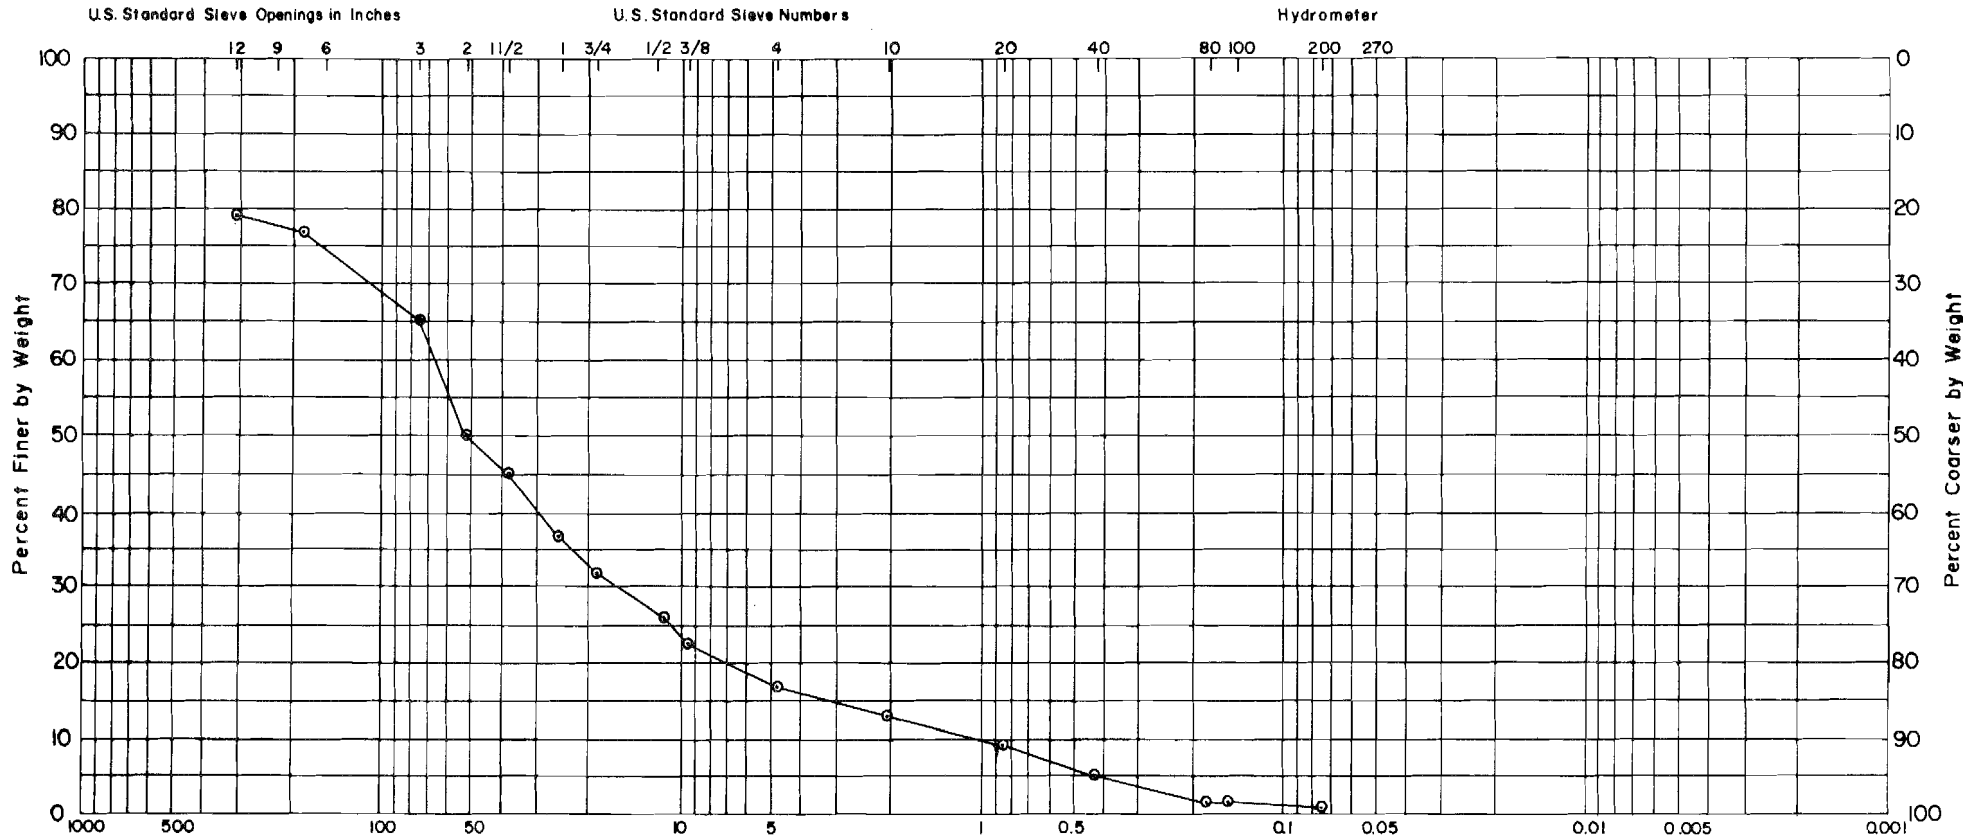
BORROW AREA E
TEST PIT TP-E14

SAMPLE NO.	MOISTURE CONTENT	DRY DENSITY	LL	PI	CLASS	CLASSIFICATION & DESCRIPTION
TP-E14 #2					SP	GRAVELLY SAND W/TRACE SILT, AND SCATTERED COBBLES AND BOULDERS

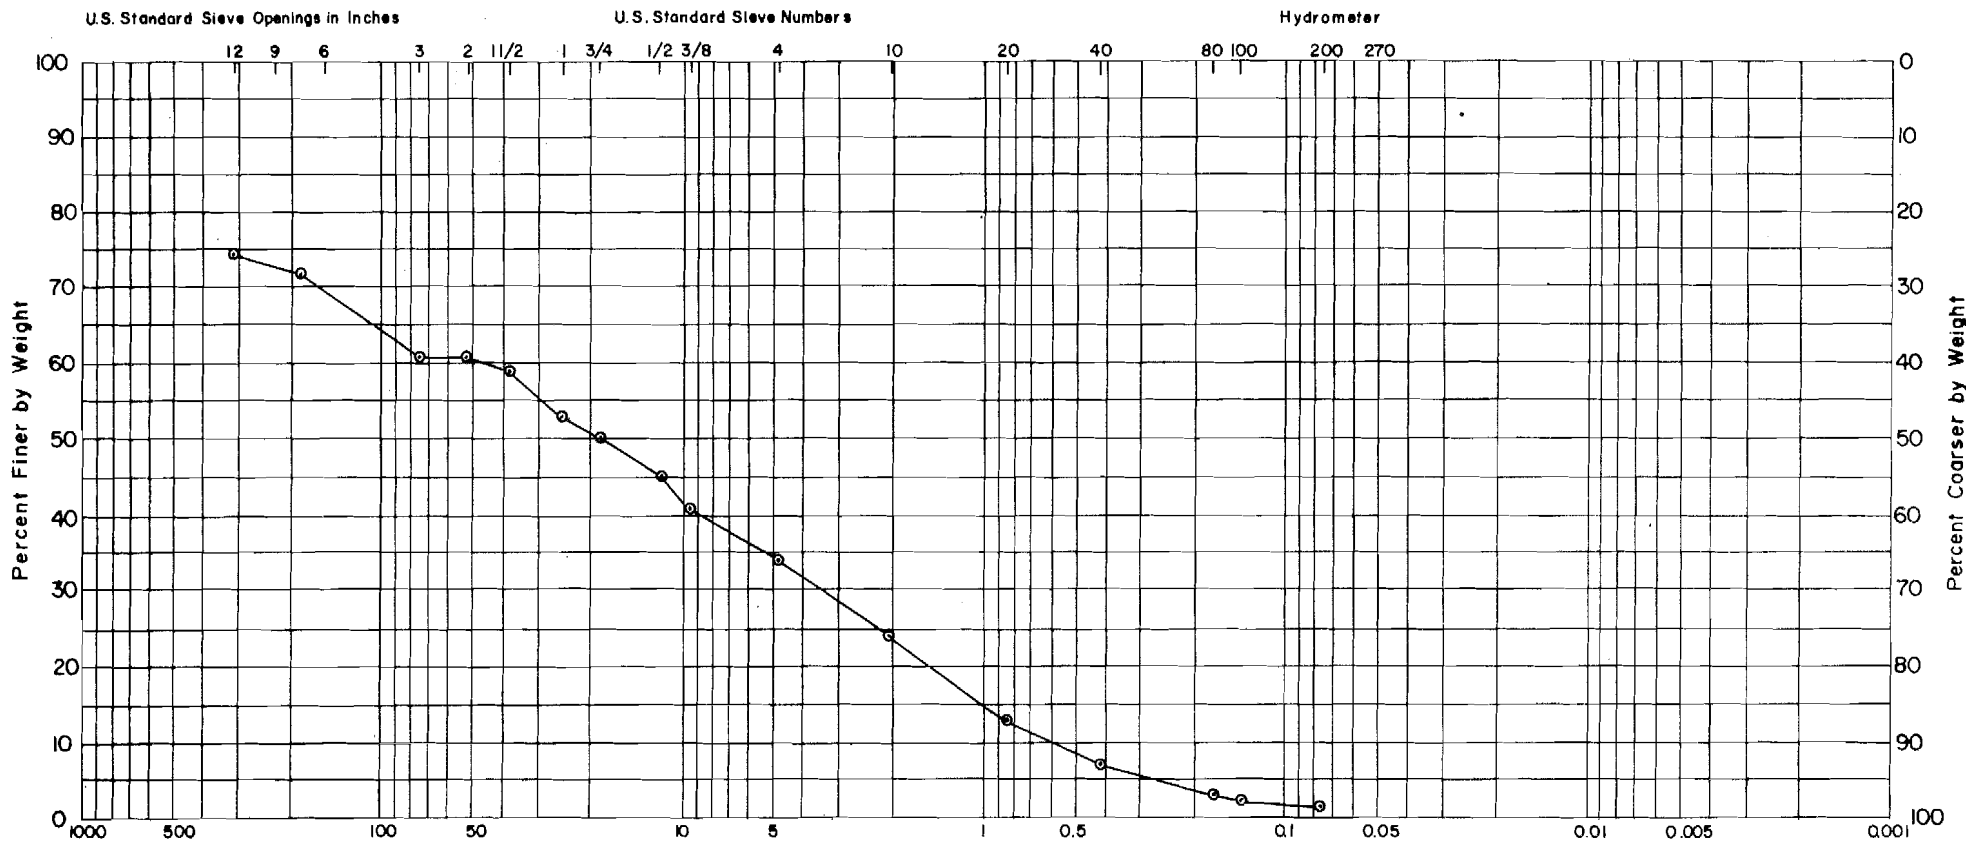
BORROW AREA E
TEST PIT TP-E15

SAMPLE NO.	MOISTURE CONTENT	DRY DENSITY	LL	PI	CLASS	CLASSIFICATION & DESCRIPTION
TP-E15 #1					GW	GRAVEL WITH SOME SAND AND SCATTERED COBBLES AND BOULDERS

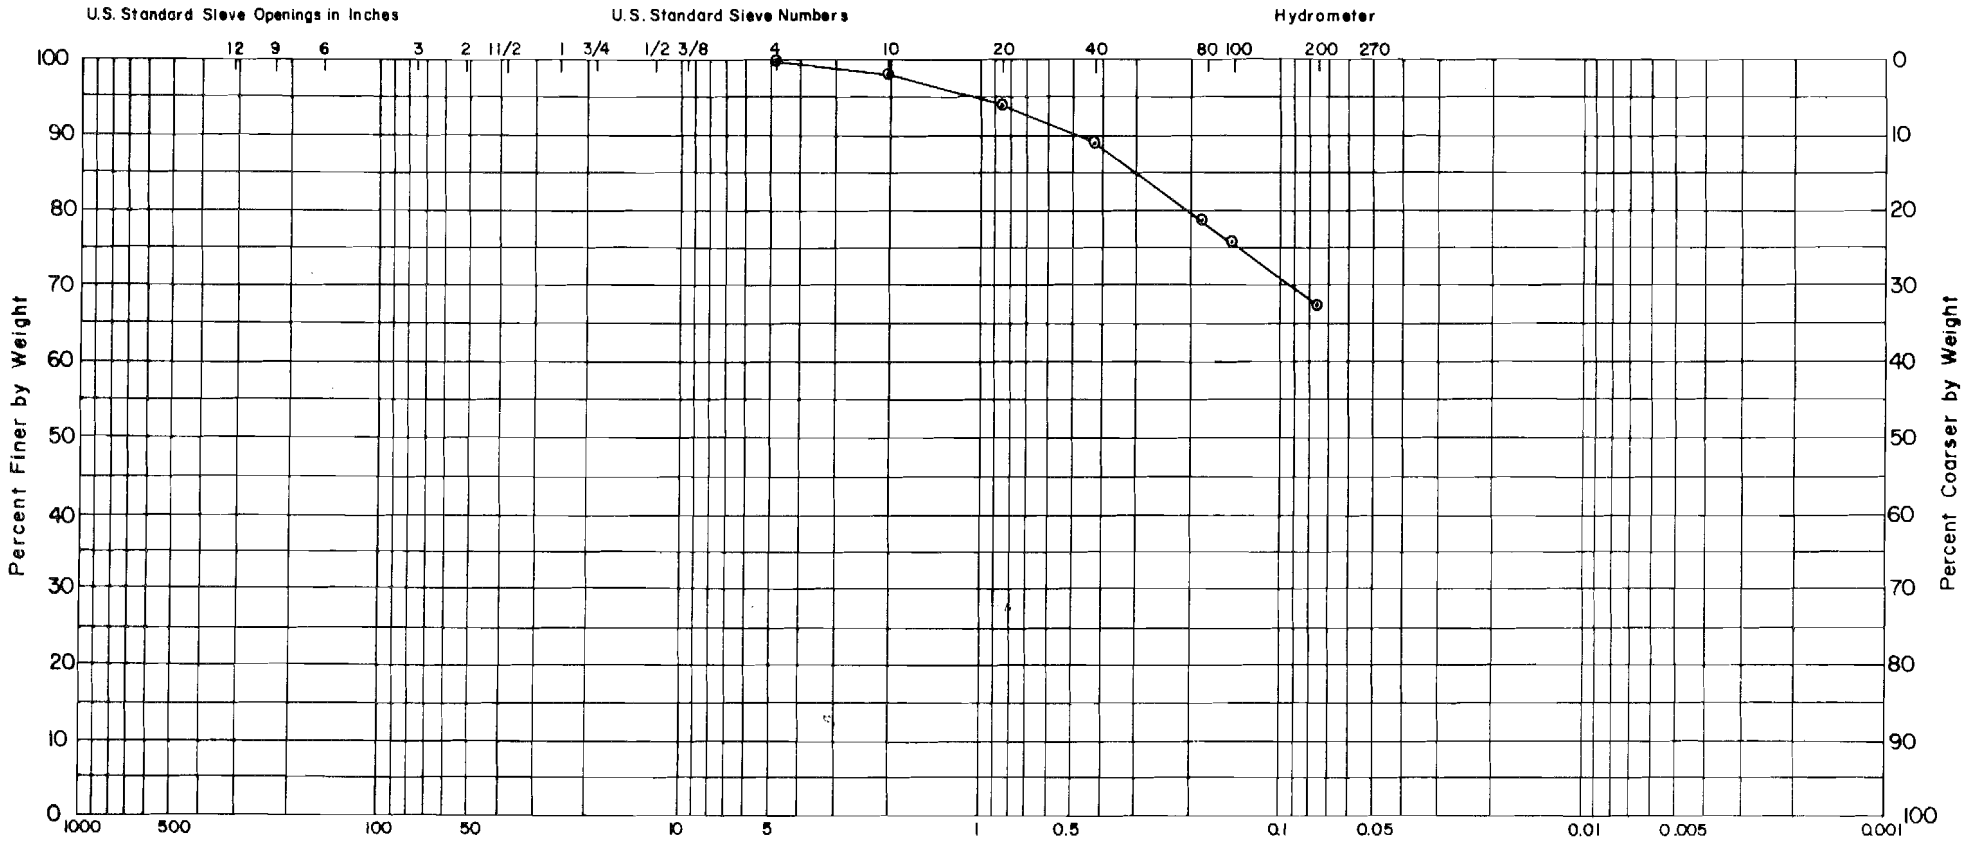
BORROW AREA E
TEST PIT TP-E16

SAMPLE NO.	MOISTURE CONTENT	DRY DENSITY	LL	PI	CLASS	CLASSIFICATION & DESCRIPTION
TP-E16 #1					SP	GRAVELLY SAND WITH SCATTERED COBBLES AND BOULDERS

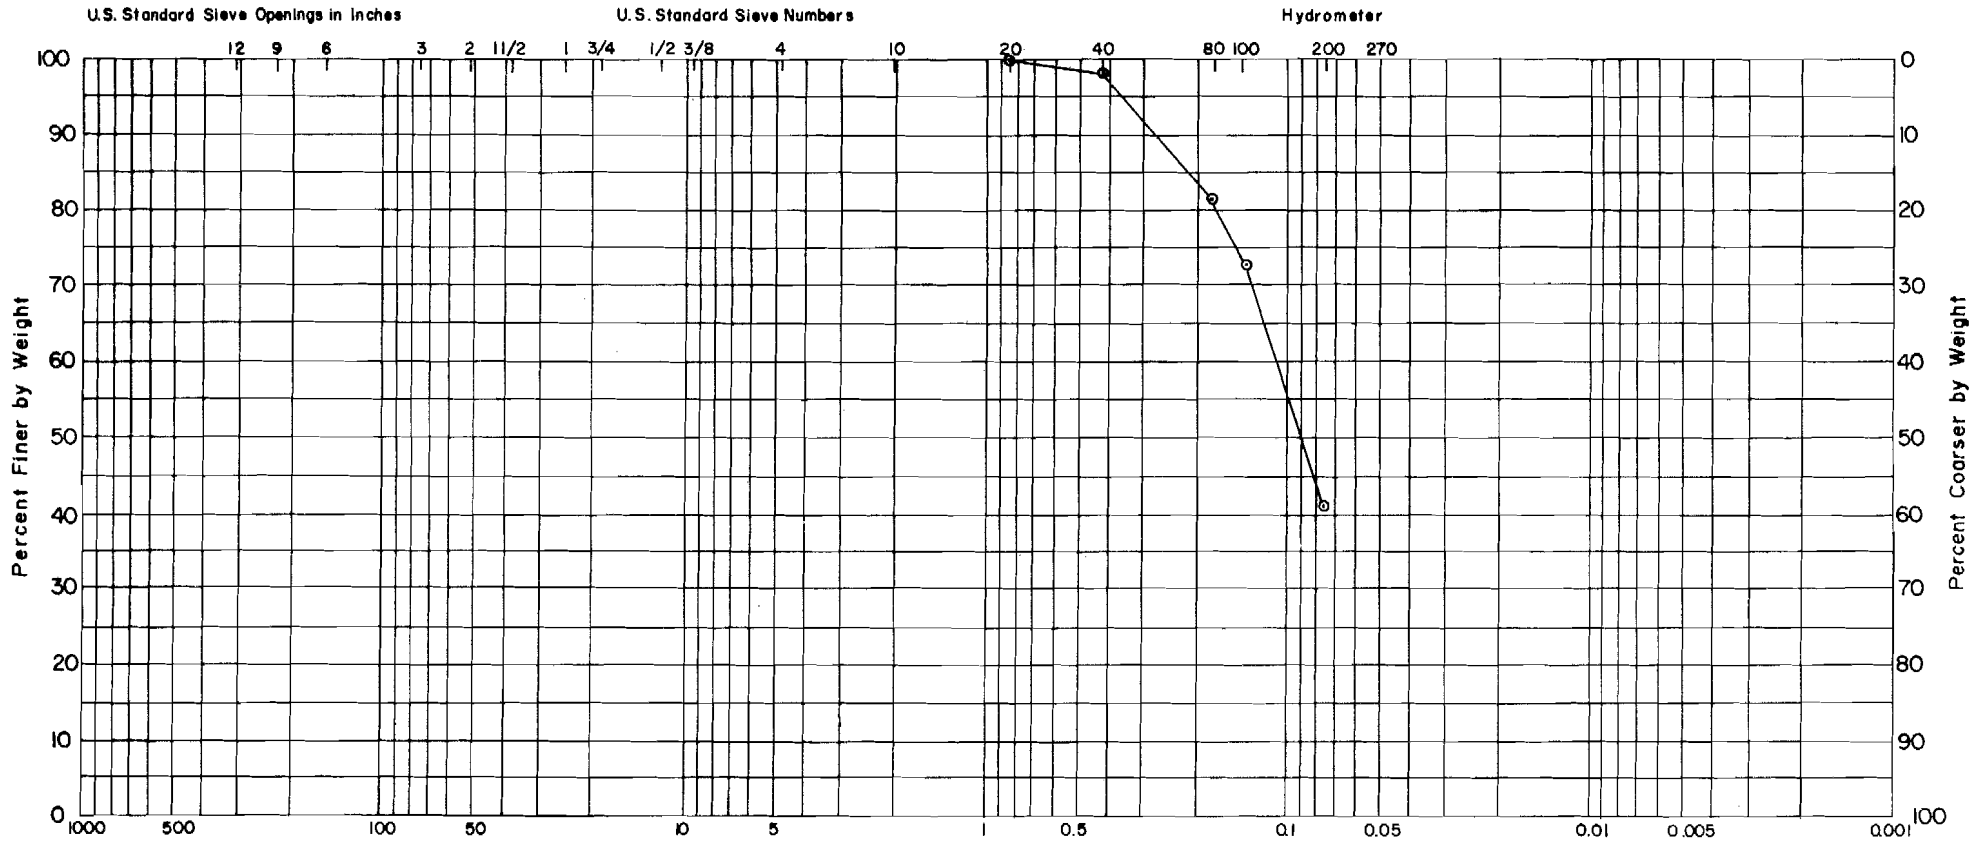
BORROW AREA E
TEST PIT TP-E17

SAMPLE NO.	MOISTURE CONTENT	DRY DENSITY	LL	PI	CLASS	CLASSIFICATION & DESCRIPTION
TP-E17 #1					SM-MH	SANDY SILT WITH SOME TO TRACE CLAY (FIELD GEOLOGIST NOTES SOME TO TRACE ORGANICS)

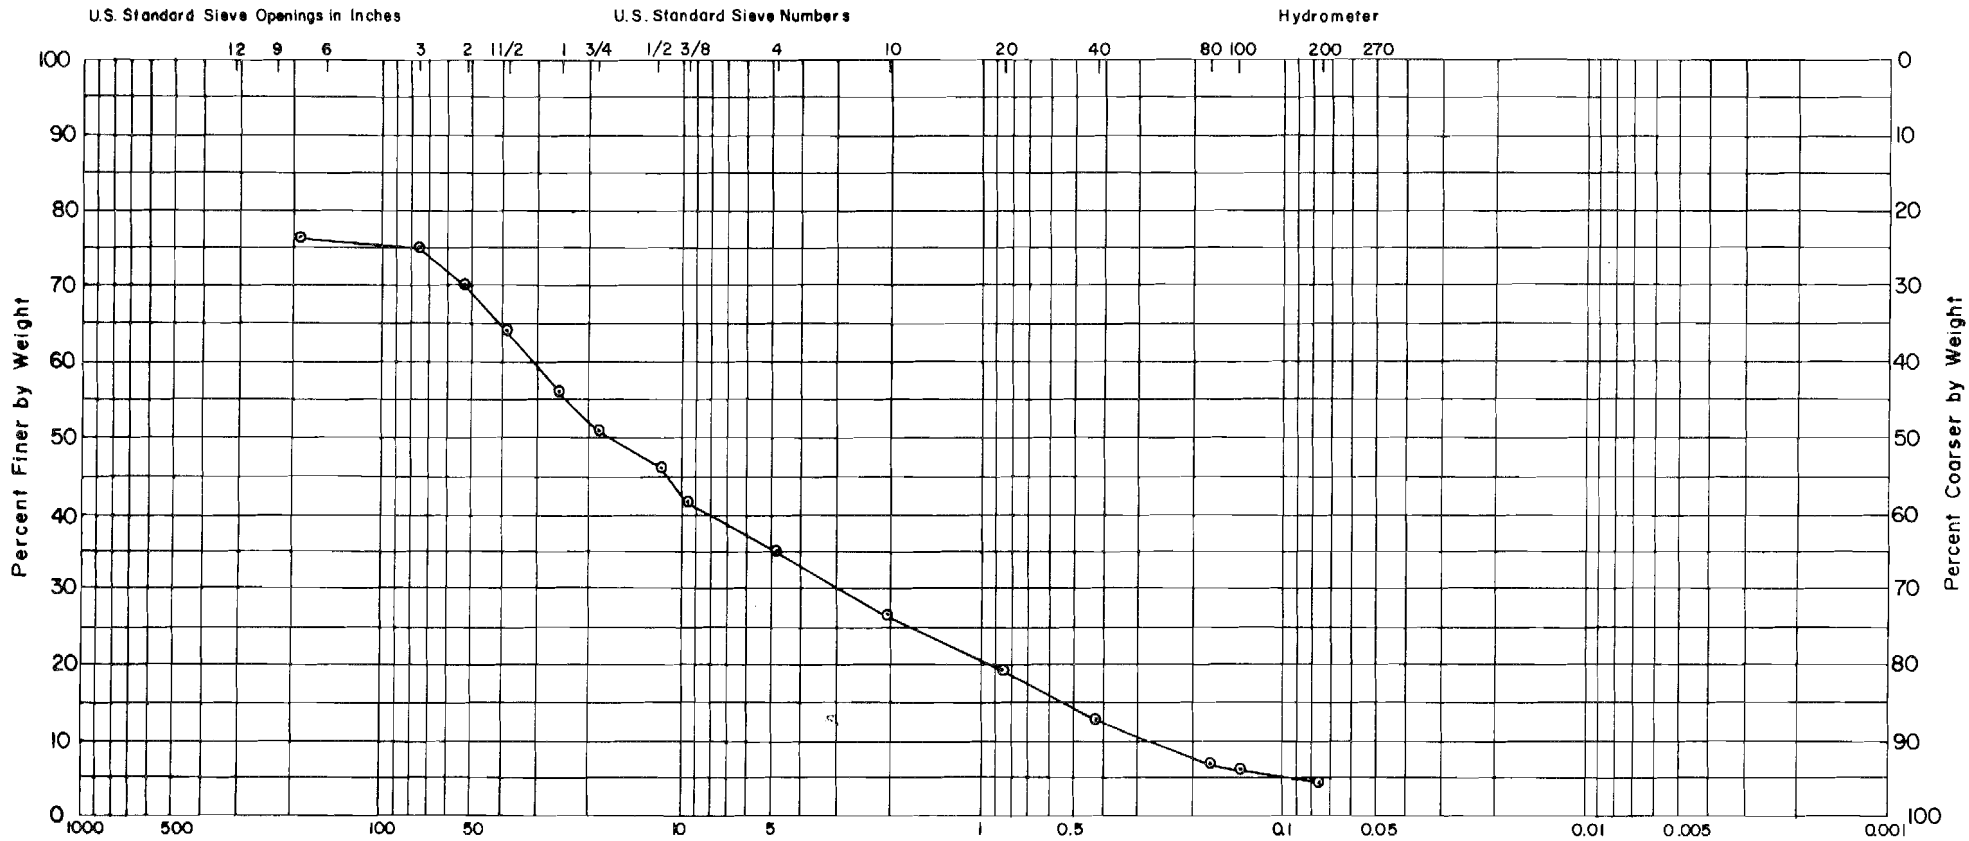
BORROW AREA E
TEST PIT TP-E17

SAMPLE NO.	MOISTURE CONTENT	DRY DENSITY	LL	PI	CLASS	CLASSIFICATION & DESCRIPTION
TP-E17 #2					SM	SILTY SAND
