SUSITNA HYDROELECTRIC PROJECT

1980 - 81 GEOTECHNICAL REPORT

VOLUME 2
APPENDIX A-F
FINAL DRAFT

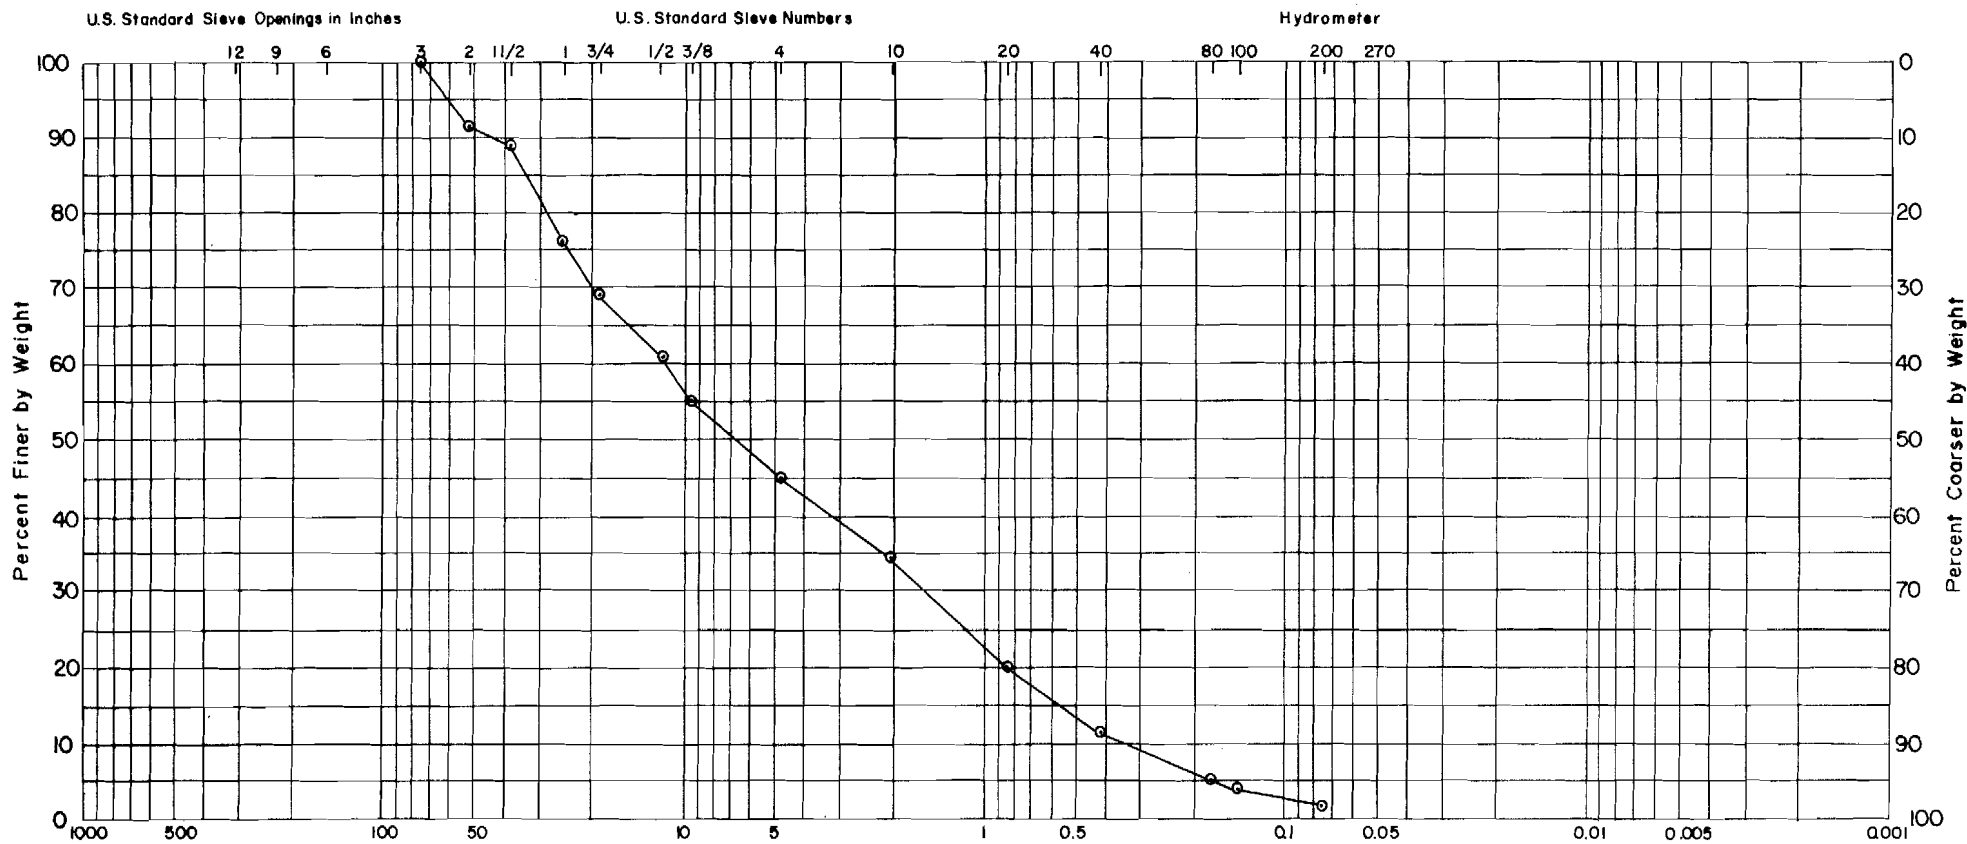
BORROW AREA E
TEST PIT TP-E17

SAMPLE NO.	MOISTURE CONTENT	DRY DENSITY	LL	PI	CLASS	CLASSIFICATION & DESCRIPTION
TP-E17 #3					GP-GM	SANDY GRAVEL WITH TRACE SILT, SCATTERED COBBLES AND BOULDERS

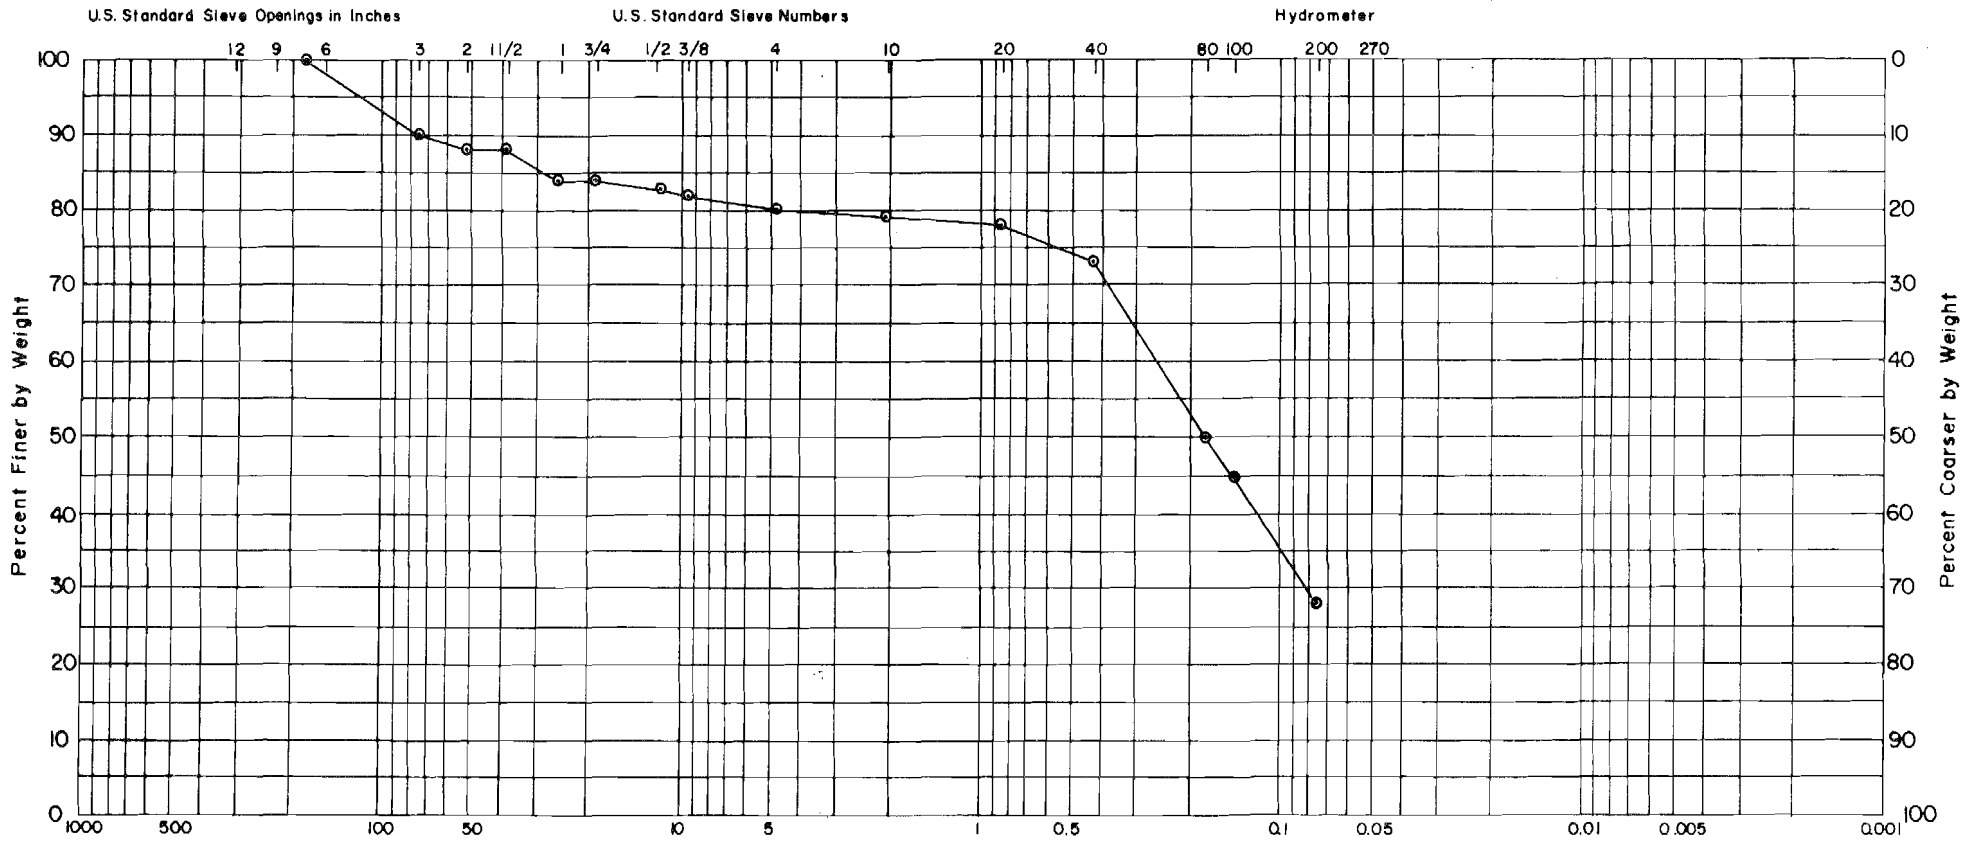
BORROW AREA E
TEST PIT TP-E18

SAMPLE NO.	MOISTURE CONTENT	DRY DENSITY	LL	PI	CLASS	CLASSIFICATION & DESCRIPTION
TP-E18 #1					GP	SANDY GRAVEL (FIELD GEOLOGIST NOTES SOME ORGANICS)

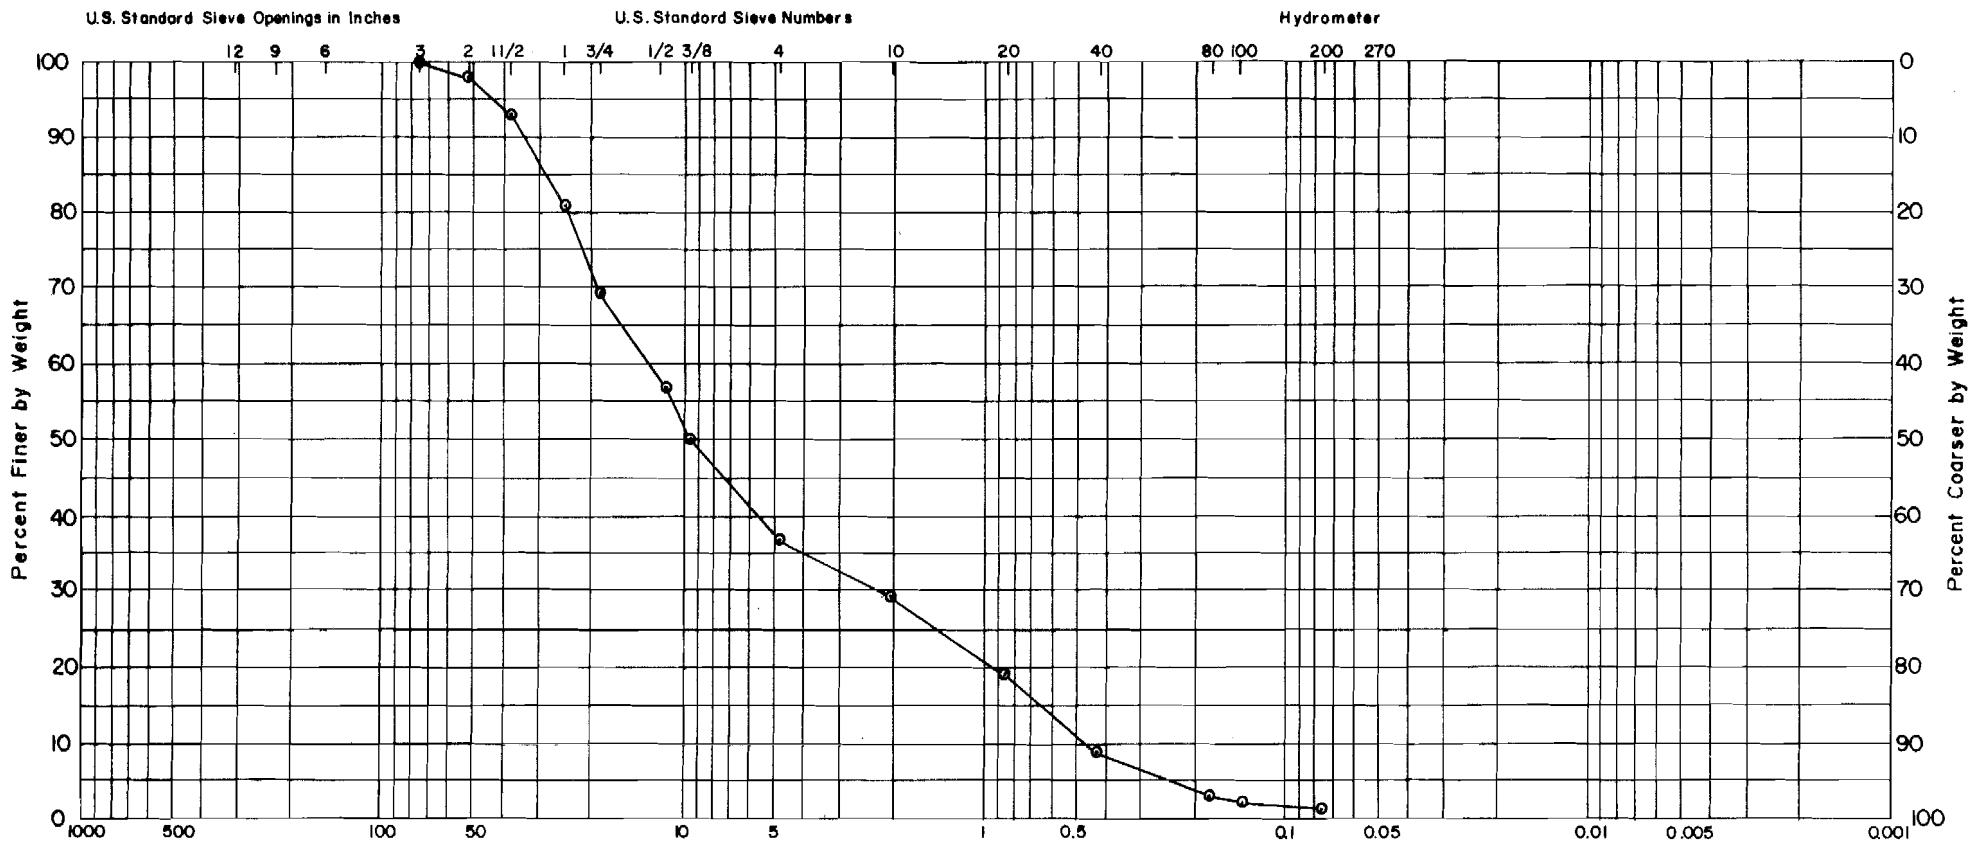
BORROW AREA E
TEST PIT TP-E18

SAMPLE NO.	MOISTURE CONTENT	DRY DENSITY	LL	PI	CLASS	CLASSIFICATION & DESCRIPTION
TP-E18 #2					SM	SAND WITH SOME SILT, TRACE GRAVEL AND SCATTERED COBBLES

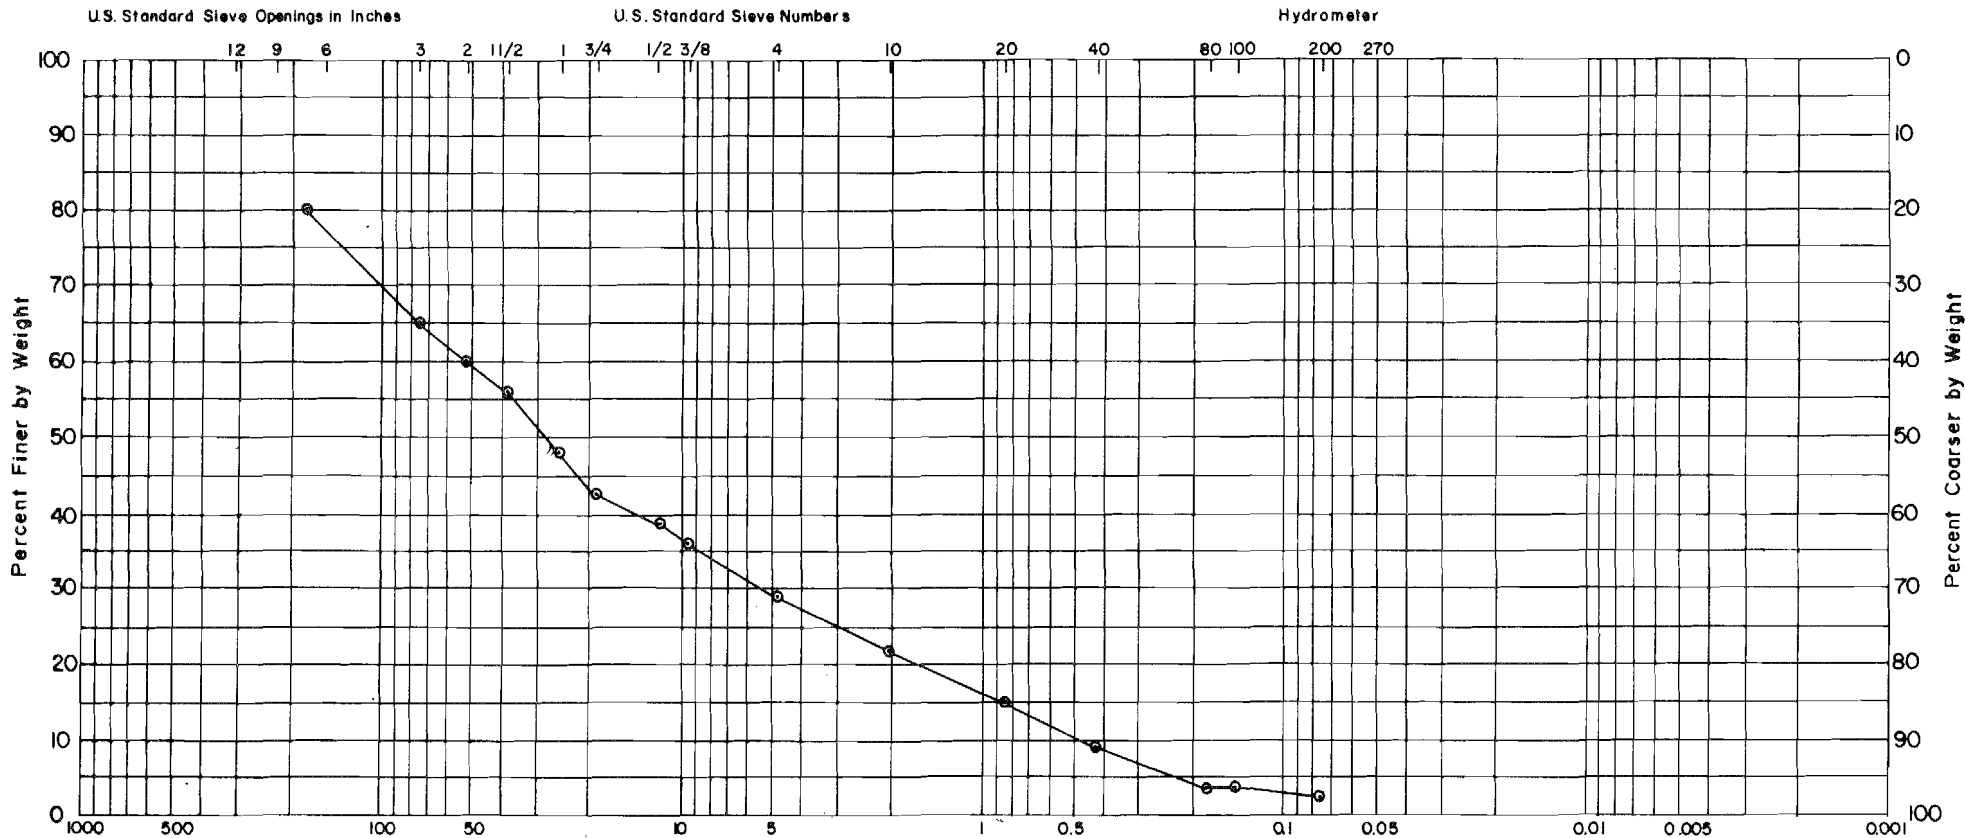
BORROW AREA E
TEST PIT TP-E18

SAMPLE NO.	MOISTURE CONTENT	DRY DENSITY	LL	PI	CLASS	CLASSIFICATION & DESCRIPTION
TP-E18 #3					GP	SANDY GRAVEL

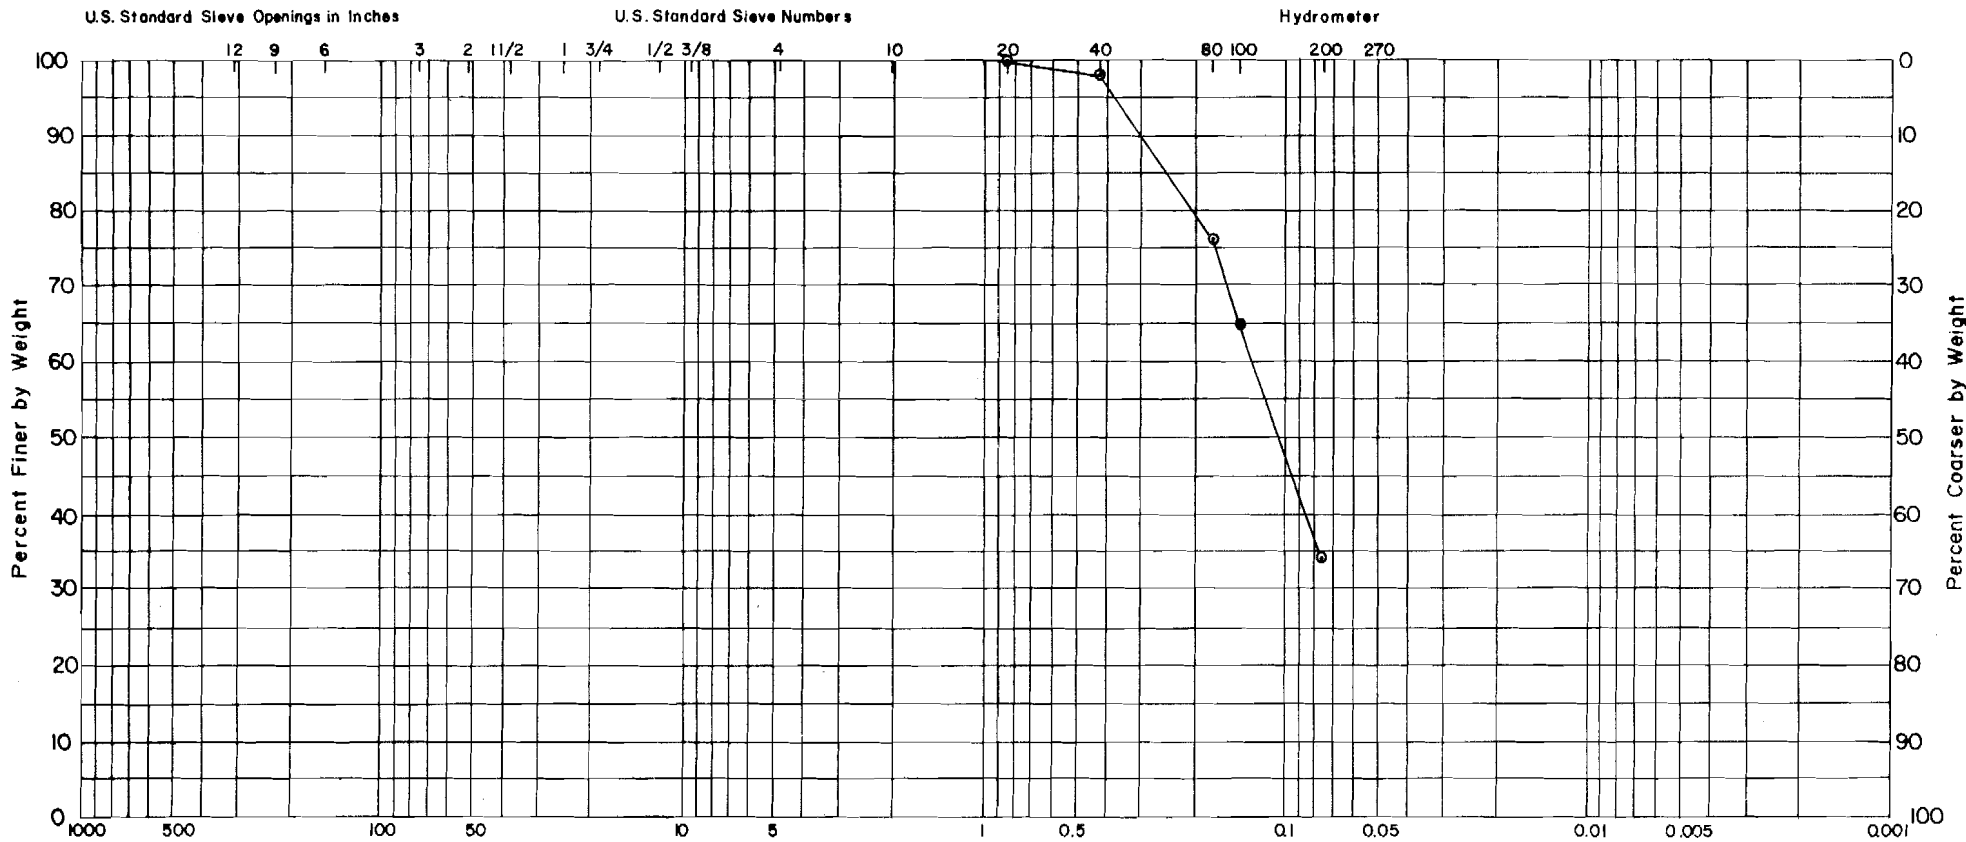
BORROW AREA E
TEST PIT TP-E18

SAMPLE NO.	MOISTURE CONTENT	DRY DENSITY	LL	PI	CLASS	CLASSIFICATION & DESCRIPTION
TP-E18 #4					GP	SANDY GRAVEL WITH SCATTERED COBBLES AND BOULDERS

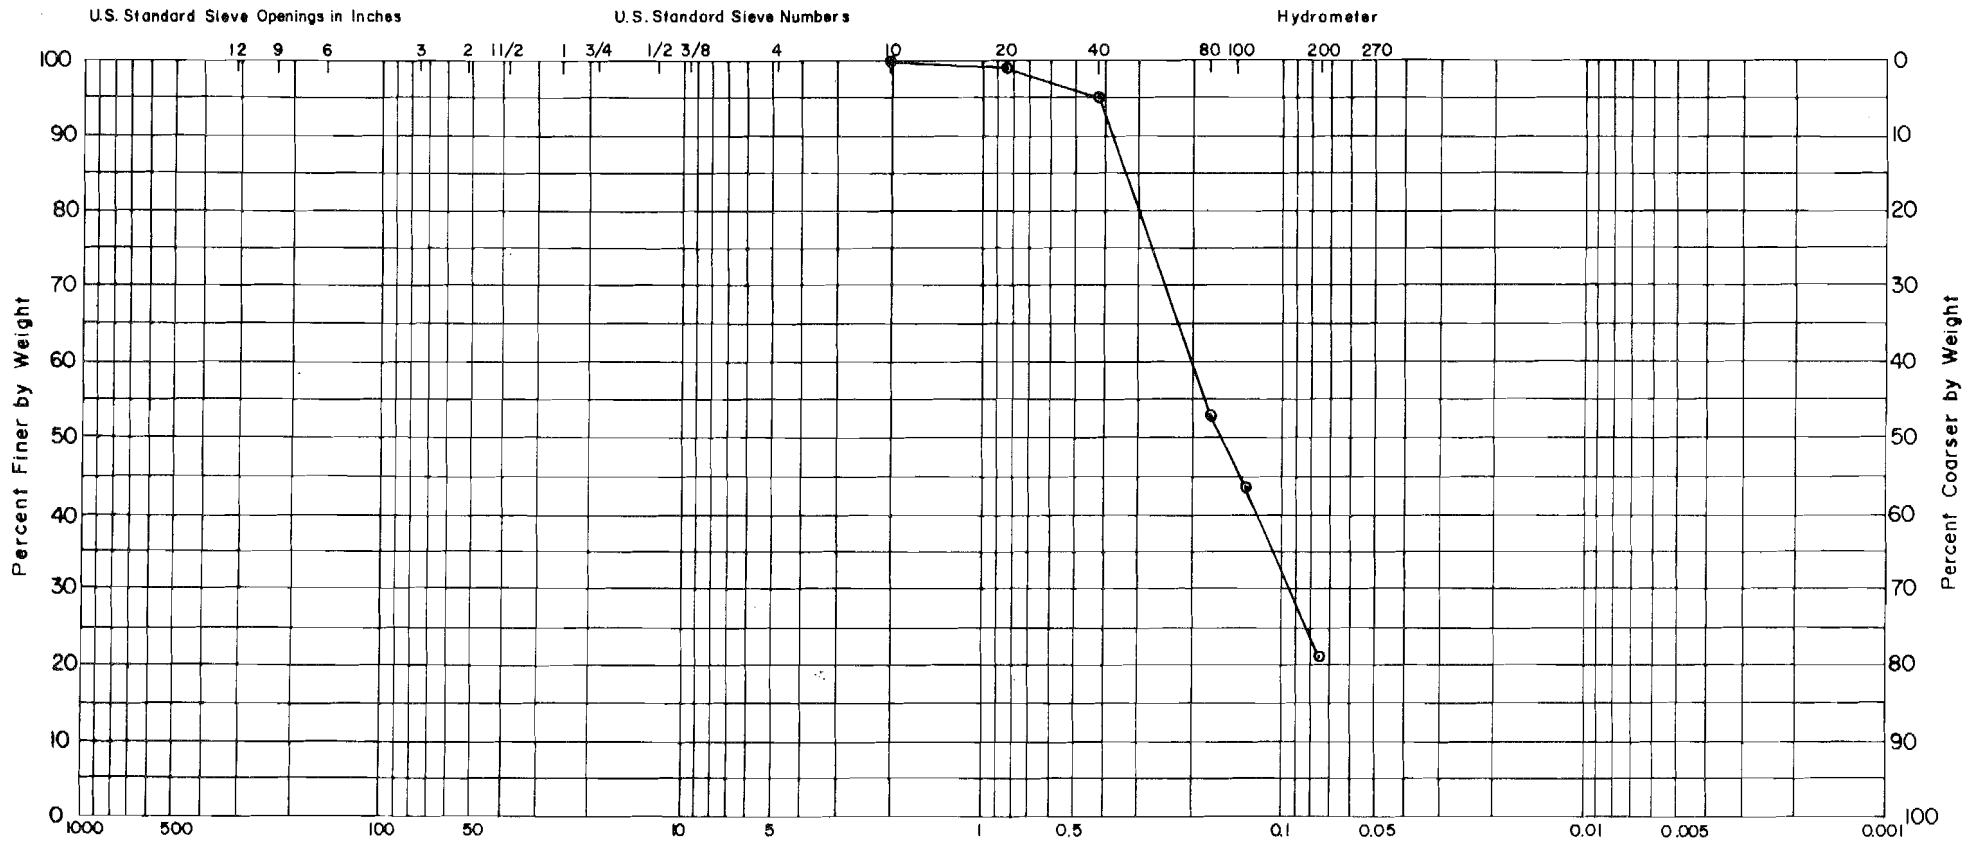
BORROW AREA E
TEST PIT TP-E19

SAMPLE NO.	MOISTURE CONTENT	DRY DENSITY	LL	PI	CLASS	CLASSIFICATION & DESCRIPTION
TP-E19 #1					SM	SILTY SAND WITH TRACE CLAY. (FIELD GEOLOGIST NOTES TRACE ORGANICS)

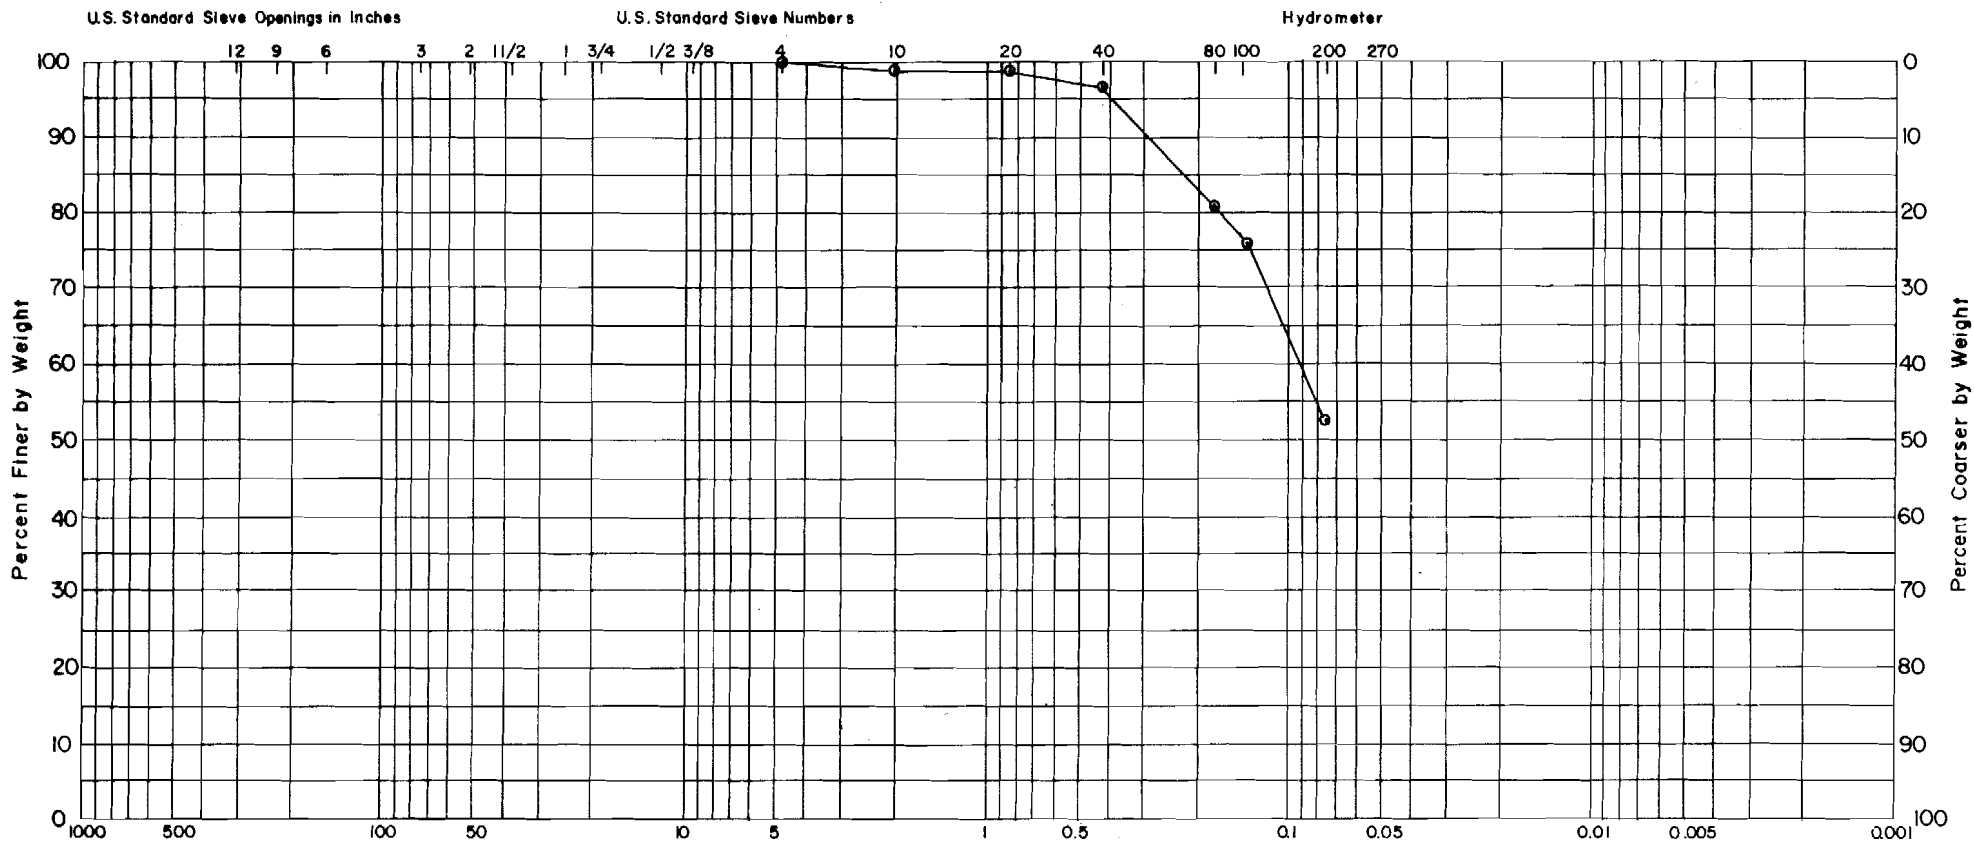
BORROW AREA E
TEST PIT TP-19

SAMPLE NO.	MOISTURE CONTENT	DRY DENSITY	LL	PI	CLASS	CLASSIFICATION & DESCRIPTION
TP-E19 #2					SM	SAND WITH SOME SILT,

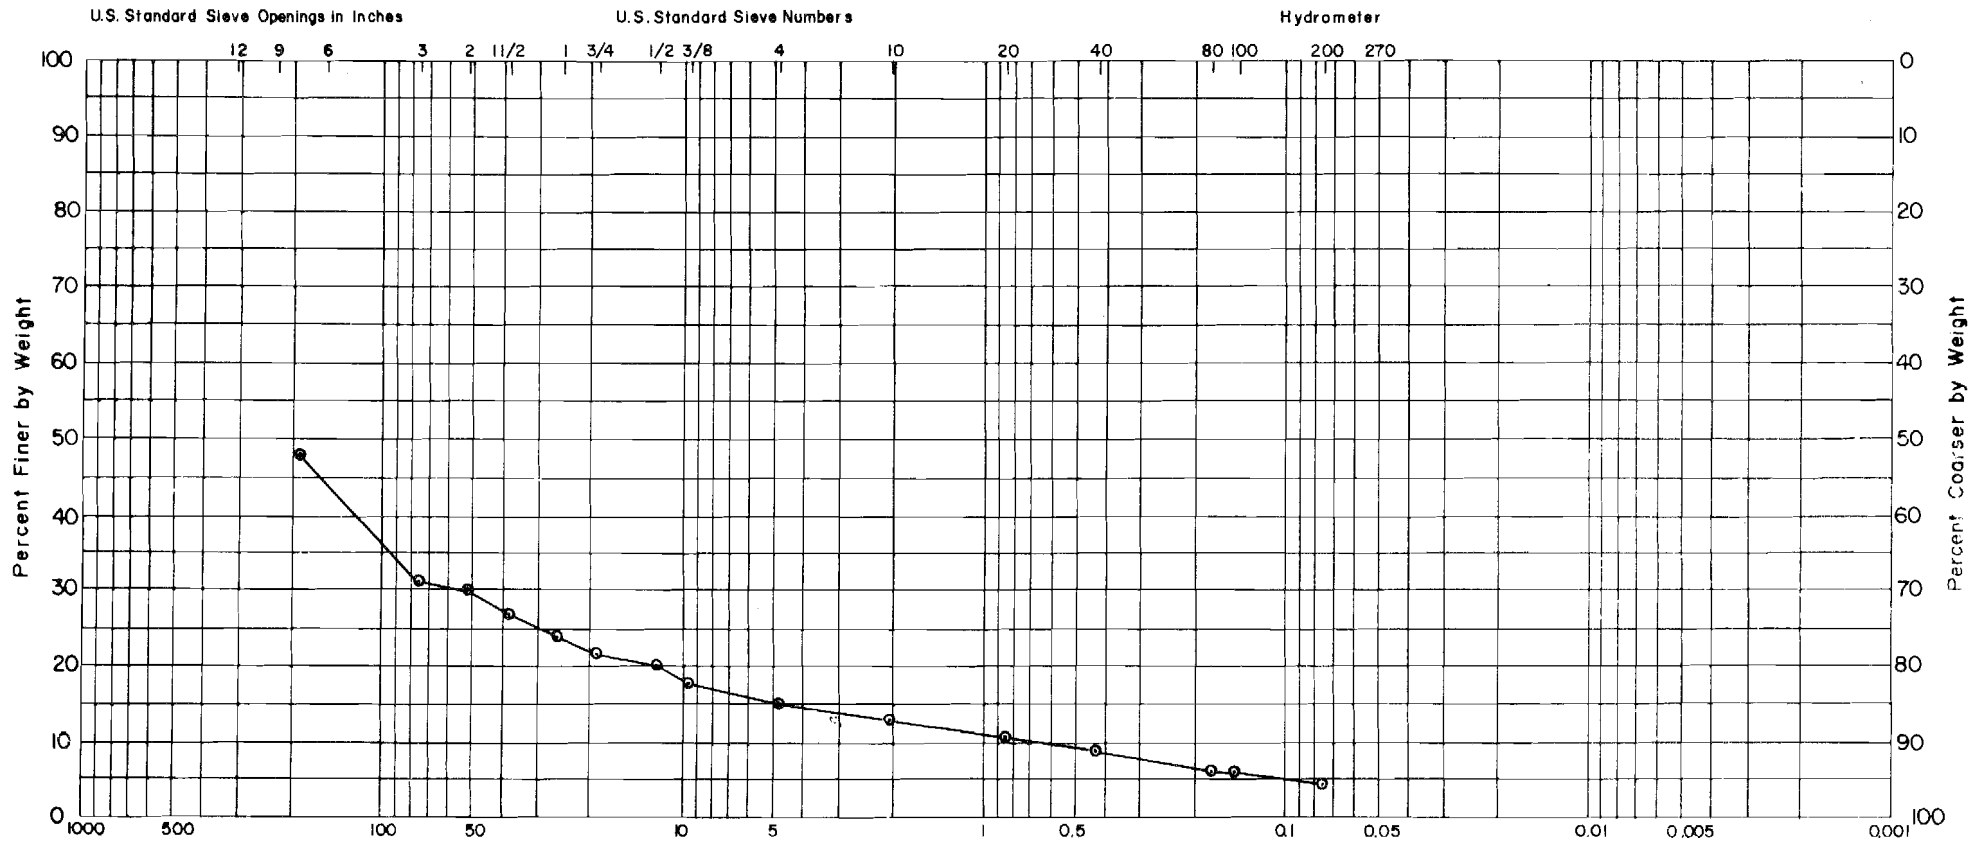
BORROW AREA E
TEST PIT TP-E21

SAMPLE NO.	MOISTURE CONTENT	DRY DENSITY	LL	PI	CLASS	CLASSIFICATION & DESCRIPTION
TP-E21 #1					SM-SC	SANDY SILT WITH TRACE CLAY

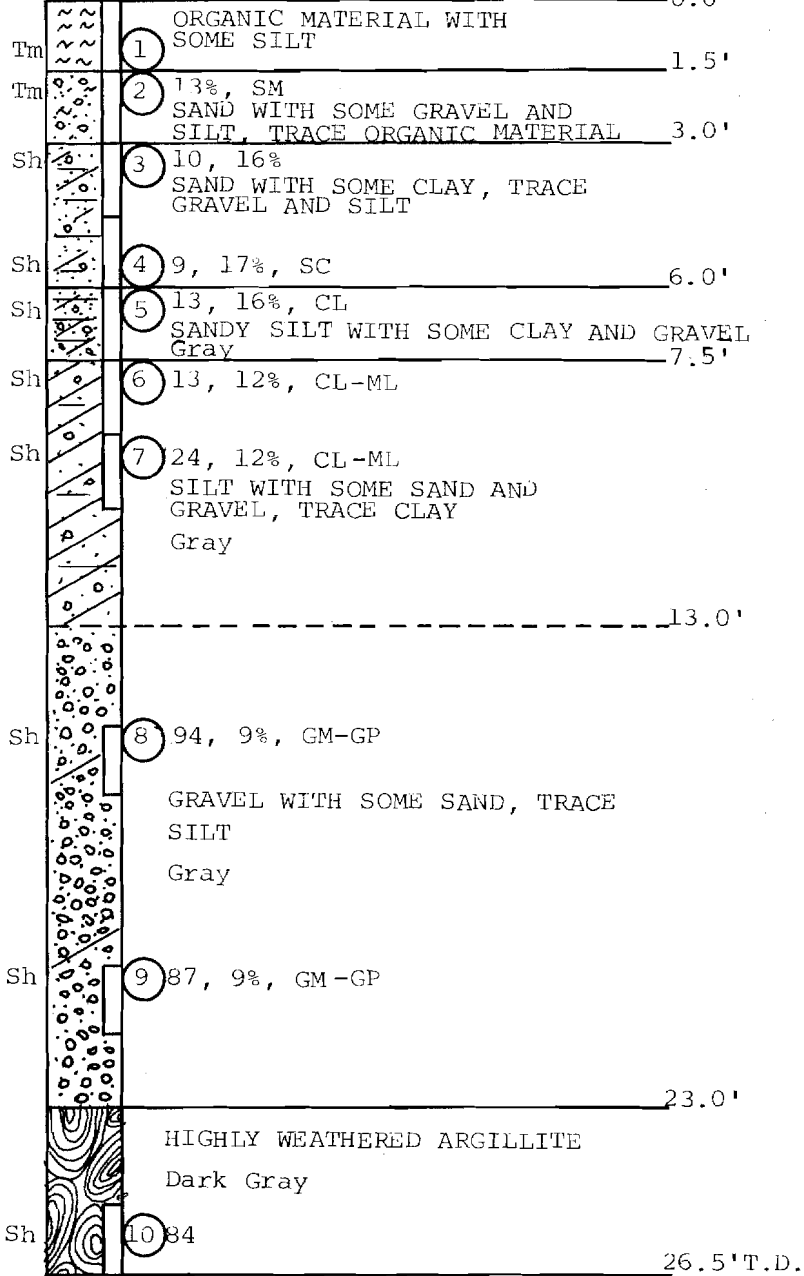
AH-H1
7-16-81

Elevation 2127.5'

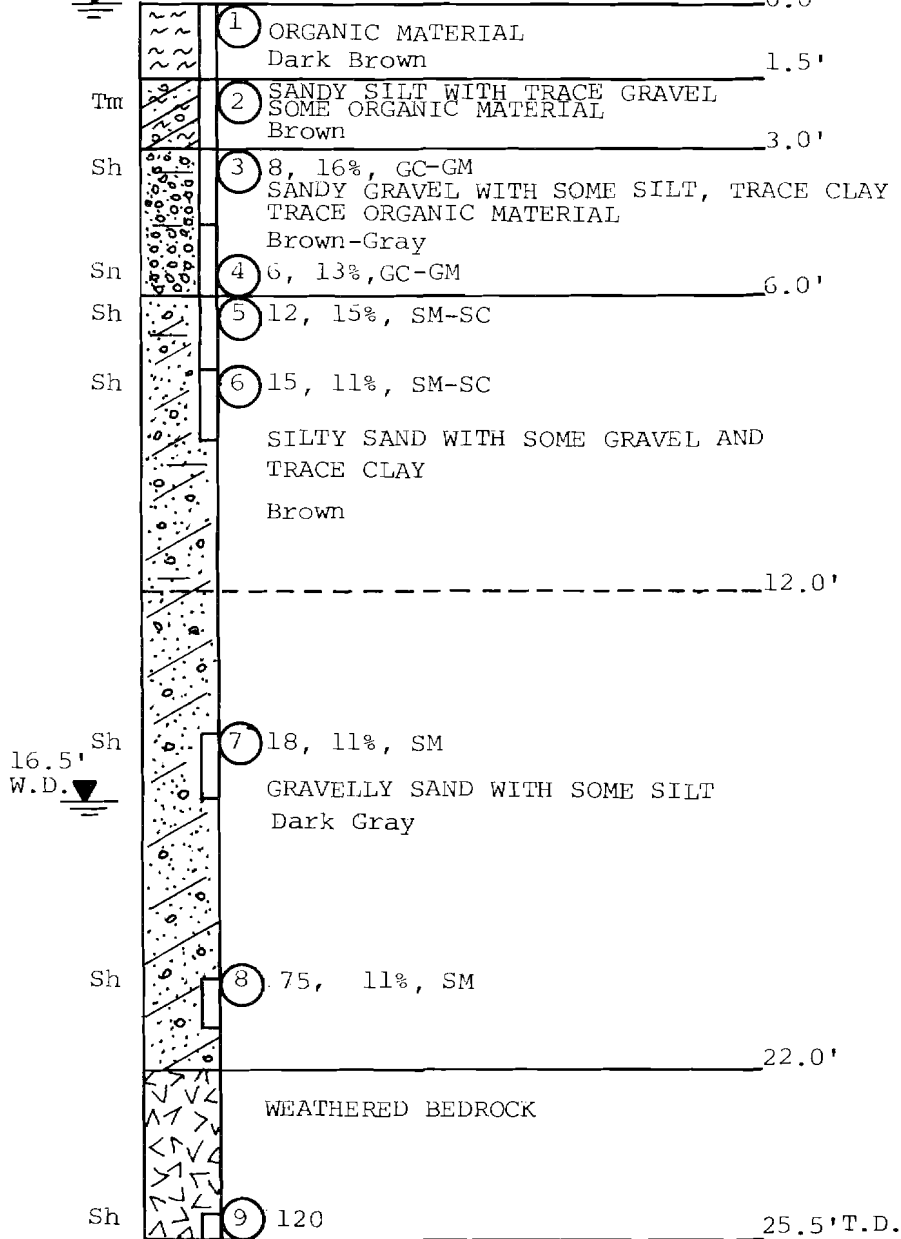
0.0' AH-H4 Elevation 2064.5'
 A.B. 7-14-81

Thermal Probe Installed to 25.0'

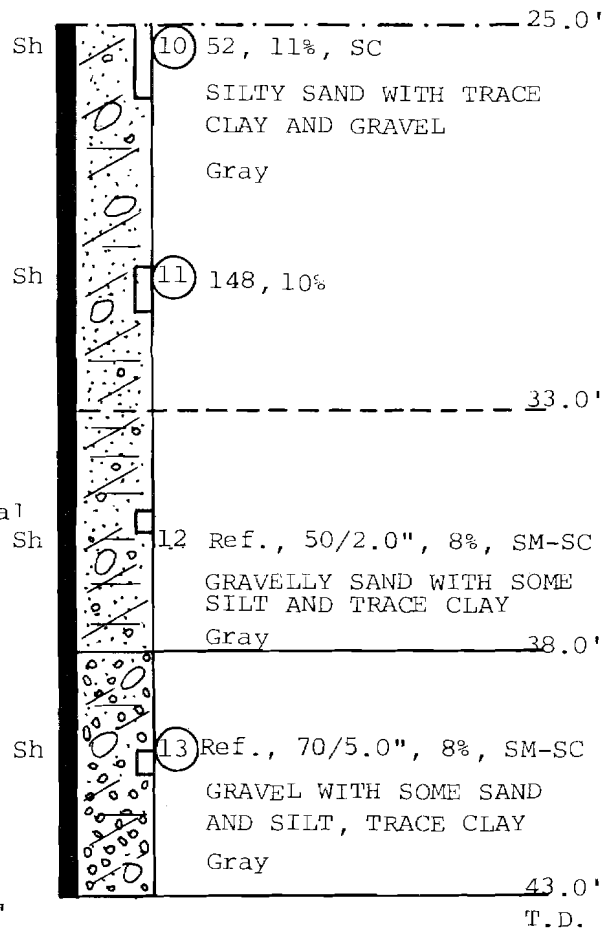
0.0' Elevation 2181.0'
 A.B. AH-H6
 7-12-81

Thermal Probe Installed to 43.0'

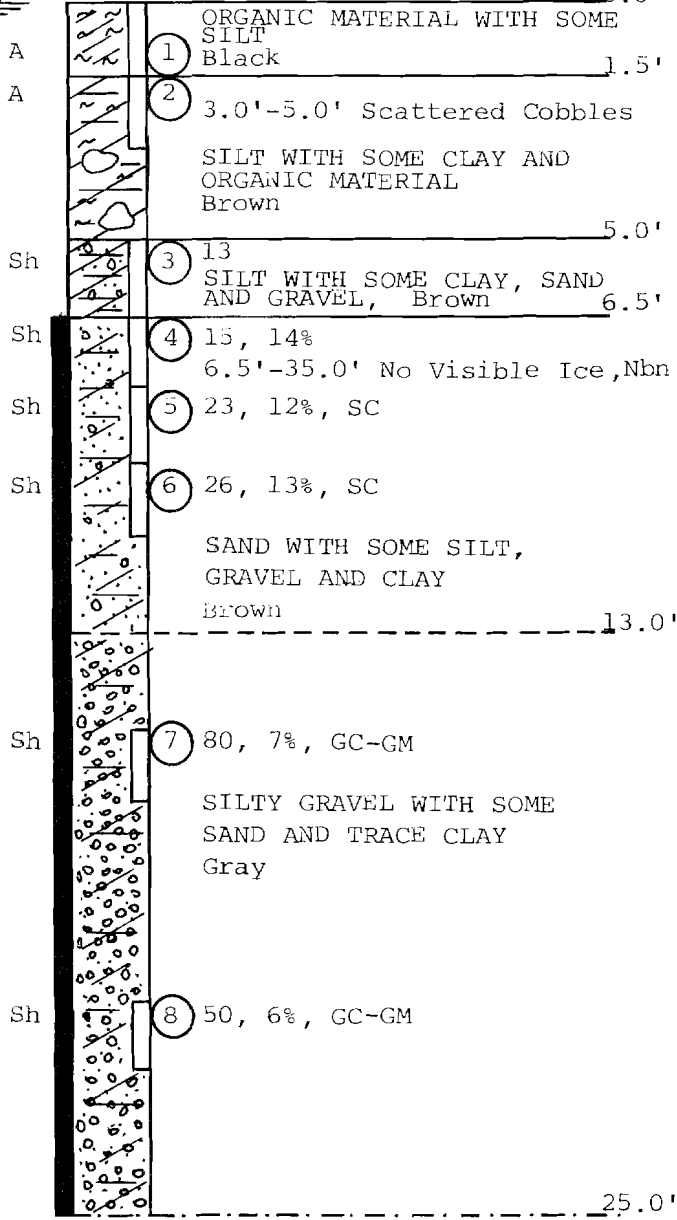
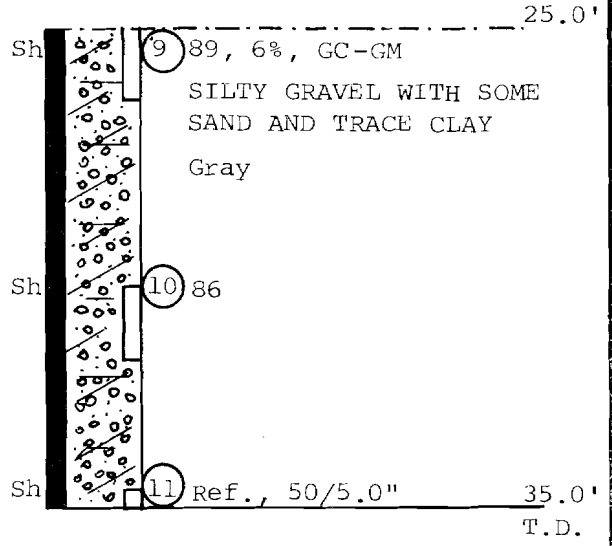
0.0' AH-H8 Elevation 2093.5'
 A.B. 7-17-81 0.0'

Thermal Probe Installed to 35.0'

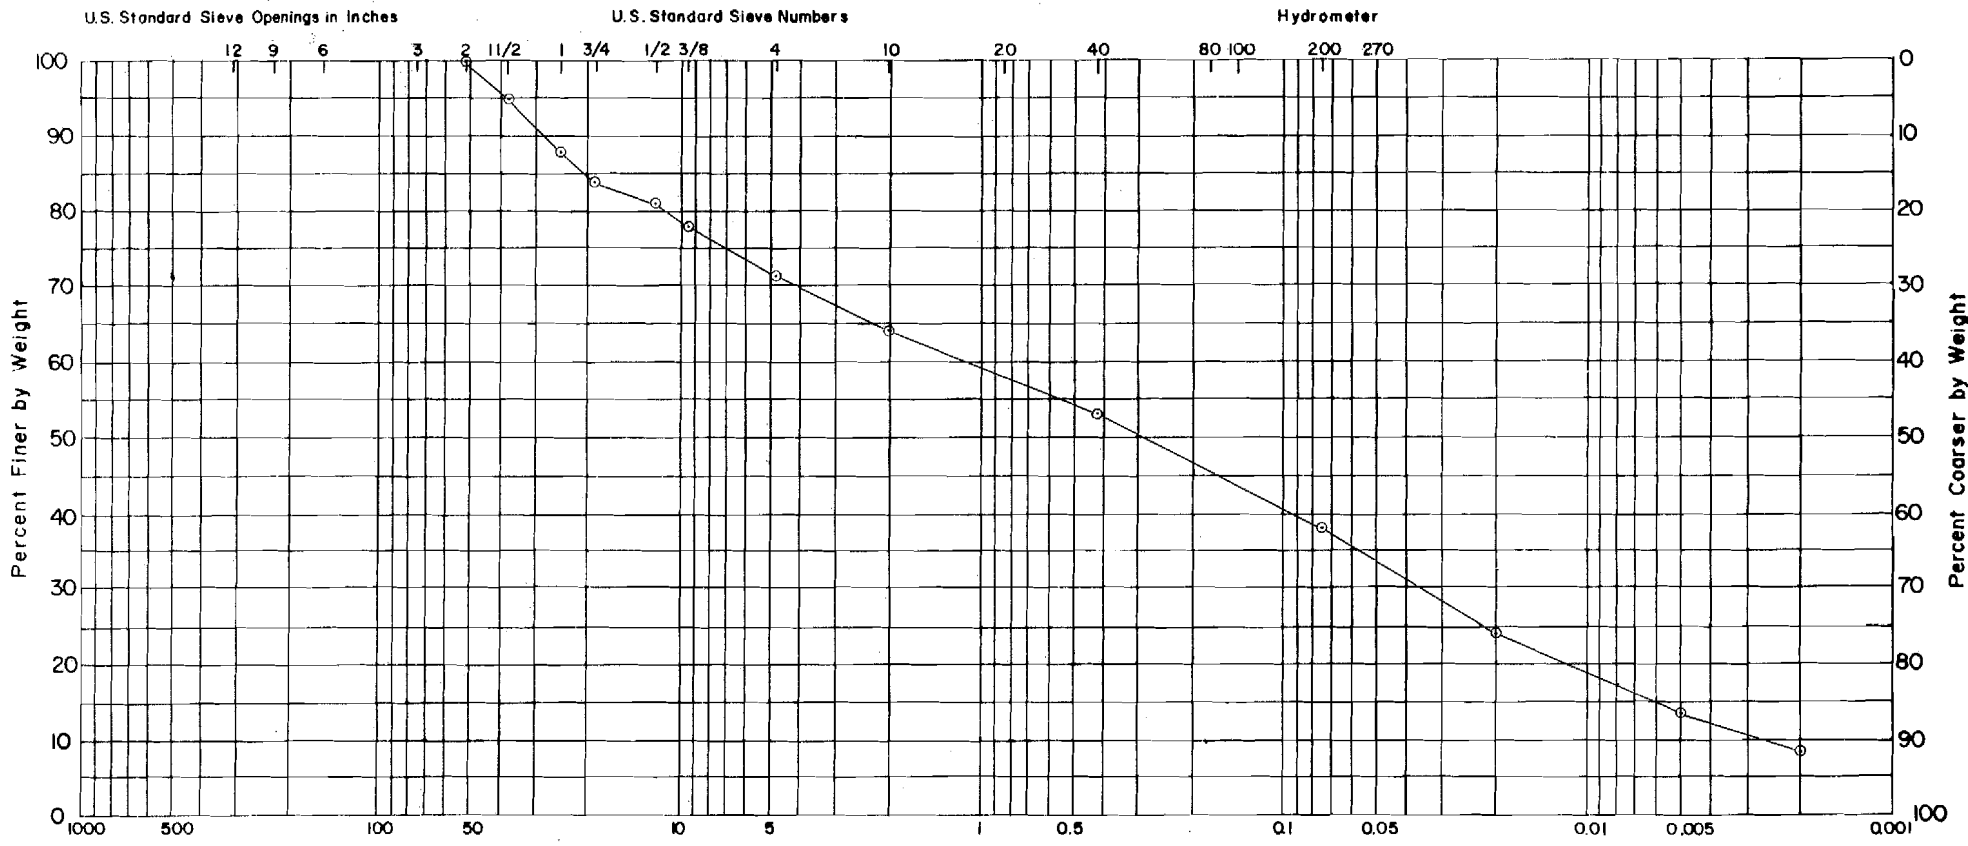
BORROW AREA H

SAMPLE NO.	MOISTURE CONTENT	DRY DENSITY	LL	PI	CLASSIFICATION & DESCRIPTION	
W-80-256 (Grab Sample)	10.9%		21.7	9.2	GC-SC	Poorly graded 'Till' with low Plasticity SILTY GRAVEL AND SAND WITH TRACE CLAY

DESCRIPTION			4"	3"	2"	1½"	1"	¾"	½"	¾"	#4	#10	#40	#200	.02	.005	.002	% Moist.	LL	PI	Unified Class.	
BORROW	H	W-80-256			100	95	88	84	81	78	71	64	53	38.2	24.3	13.6	8.6	10.9	21.7	9.2	GC-SC	
		(Grab Sample)																			GM-SM	
BORROW	H	W-80-257			100	97	92	89	84	81	73	66	54	36.0	19.6	8.9	5.2	12.3	17.1	2.5	GM-SM	
		(Grab Sample)

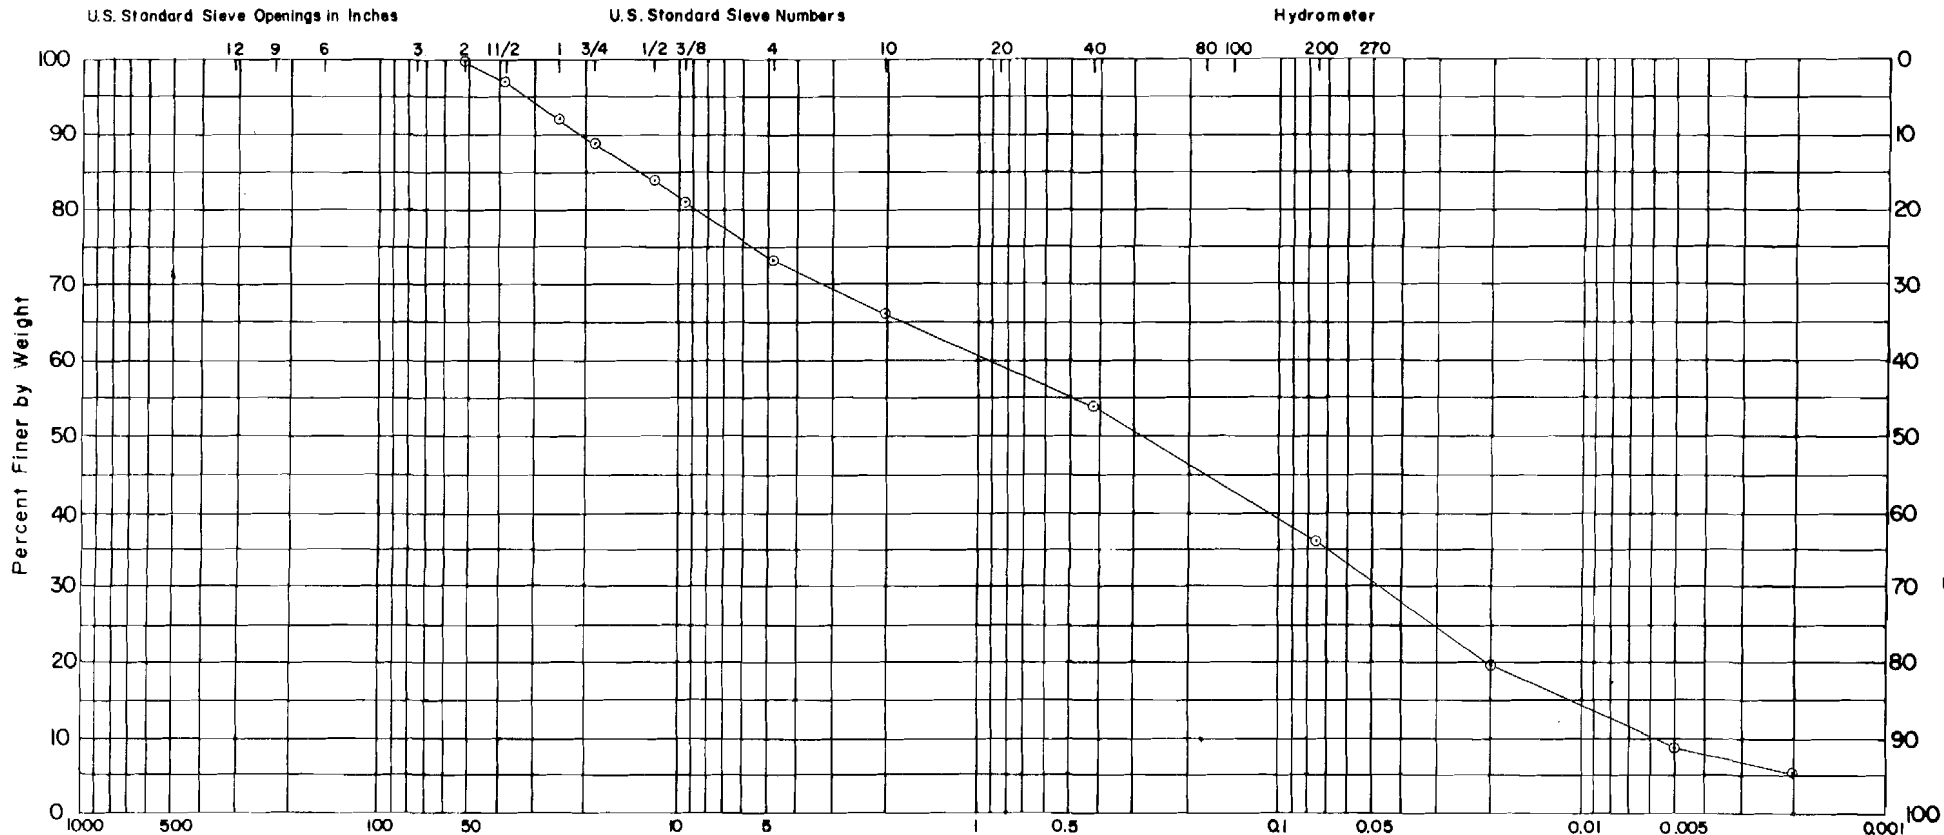
SAMPLE NO.	MOISTURE CONTENT	DRY DENSITY	LL	PI	CLASSIFICATION & DESCRIPTION	
W-80-257	12.3%		17.1	2.5	GM-SM	Poorly graded 'Till' with Non-Plastic Fines
(Grab Sample)						SILTY GRAVEL AND SAND WITH TRACE CLAY

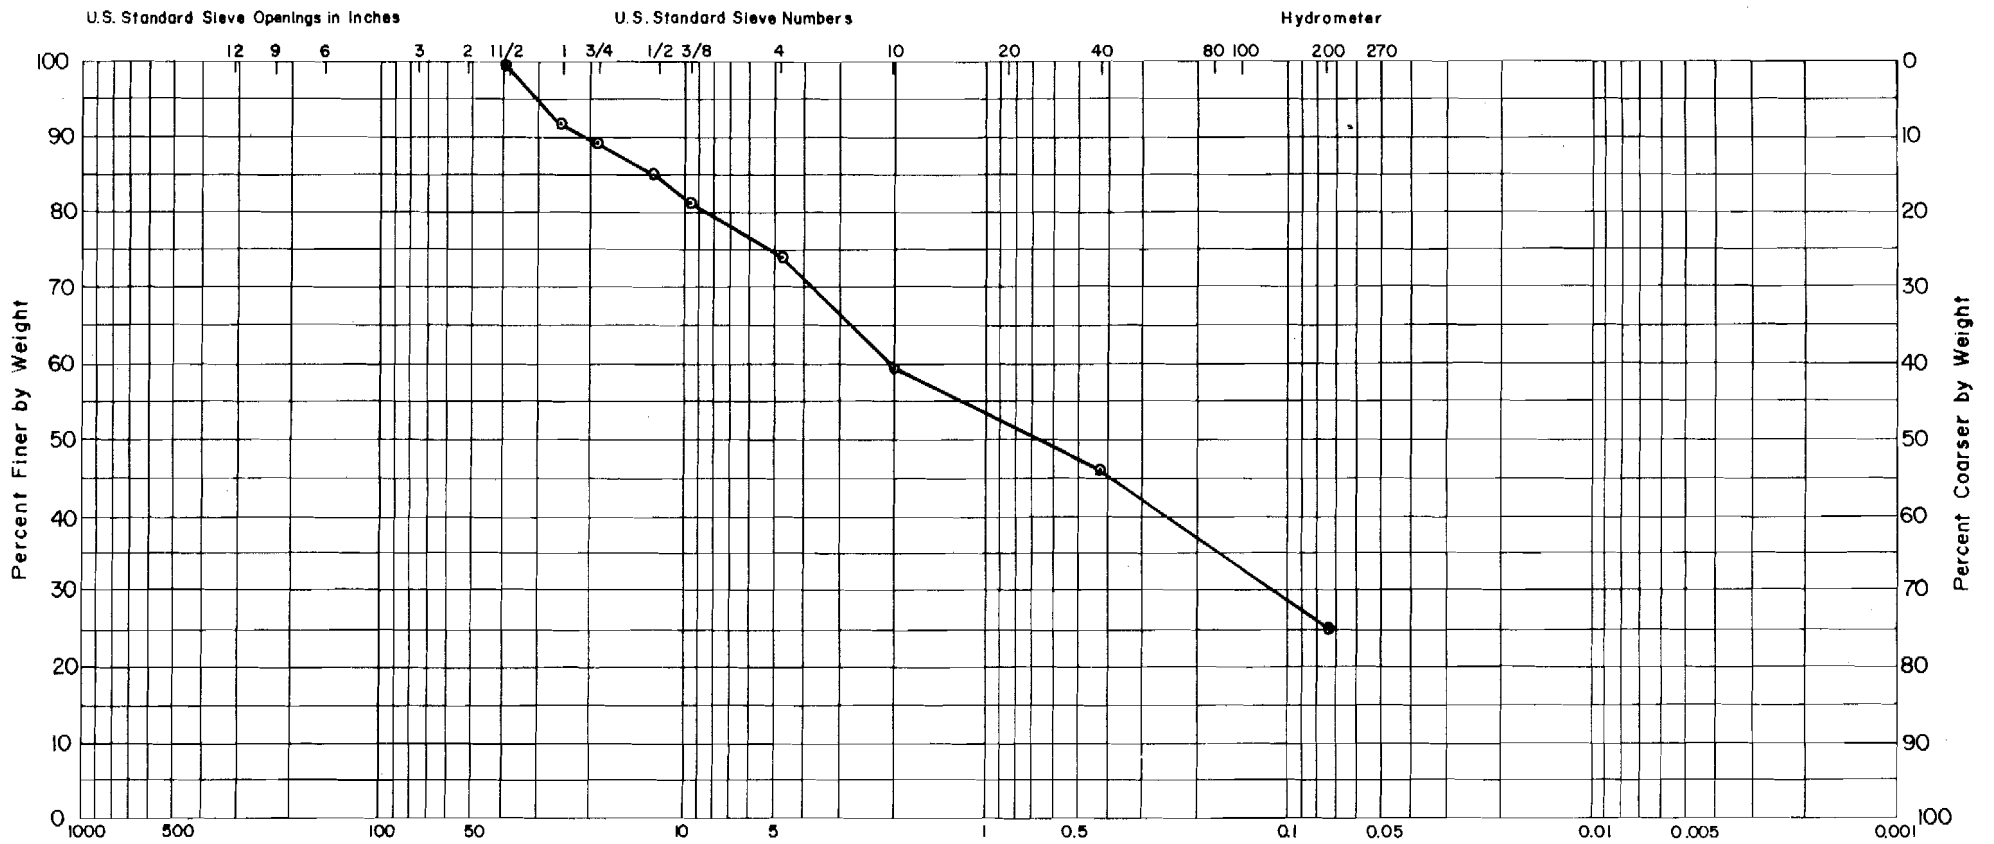
BORROW AREA H
AUGER HOLE AH-H1

SAMPLE NO.	MOISTURE CONTENT	DRY DENSITY	LL	PI	CLASSIFICATION & DESCRIPTION
AH-H1 #2	13			SM	SAND WITH SOME GRAVEL AND SILT, TRACE ORGANIC MATERIAL
