SUSITNA HYDROELECTRIC PROJECT

1980 - 81 GEOTECHNICAL REPORT

VOLUME 2
APPENDIX A-F
FINAL DRAFT

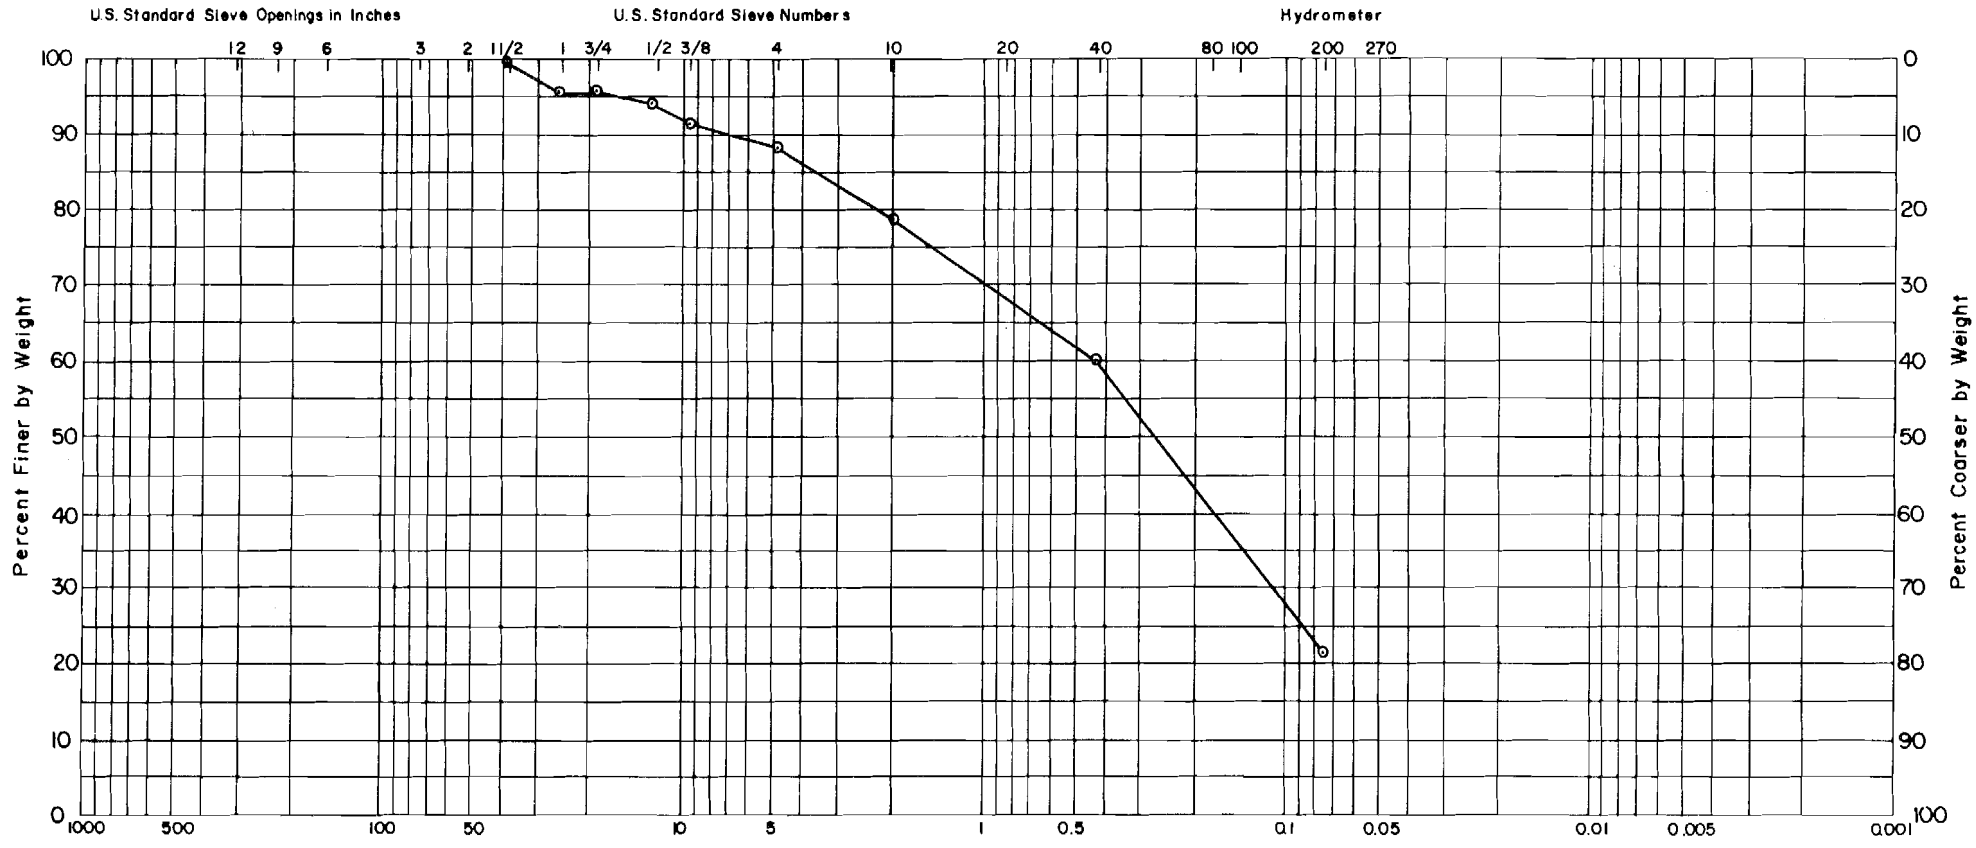
BORROW AREA H
AUGER HOLE AH-H1

SAMPLE NO.	MOISTURE CONTENT	DRY DENSITY	LL	PI	CLASSIFICATION & DESCRIPTION	
AH-H1 #4	17		32	17	SC	SAND WITH SOME CLAY, TRACE GRAVEL AND SILT

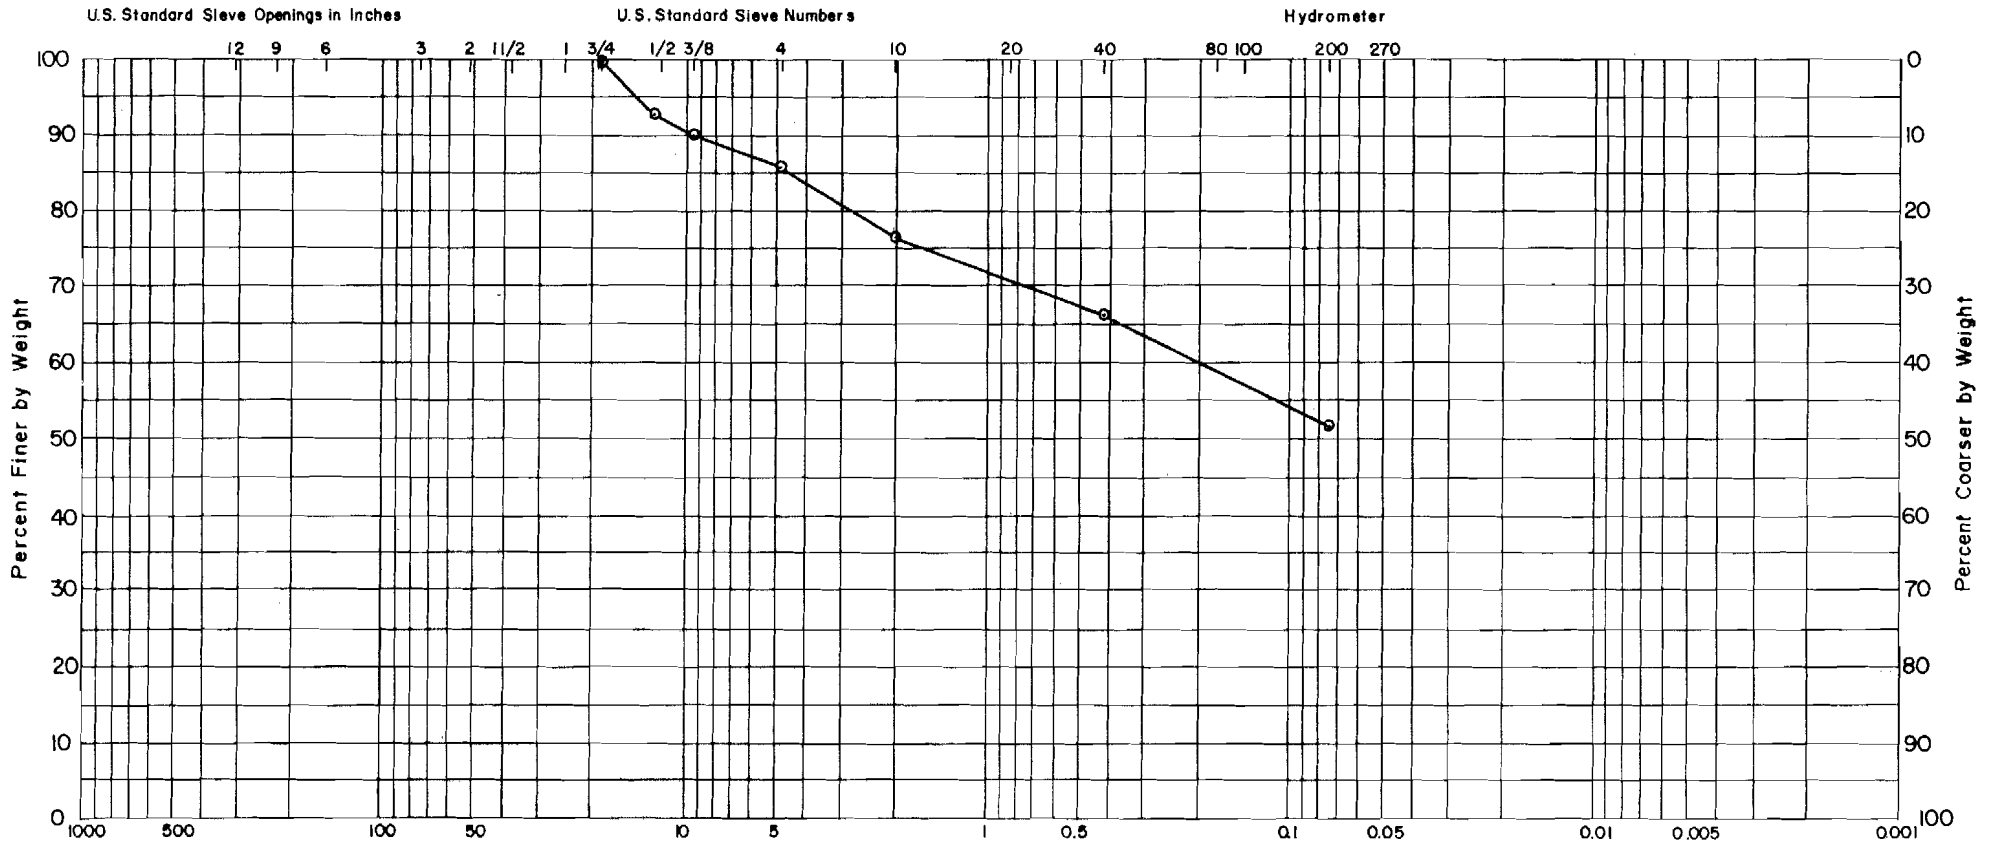
BORROW AREA H
AUGER HOLE AH-H1

SAMPLE NO.	MOISTURE CONTENT	DRY DENSITY,	LL	PI	CLASSIFICATION & DESCRIPTION
AH-H1 #5	16		34	21	CL SANDY SILT WITH SOME CLAY AND GRAVEL

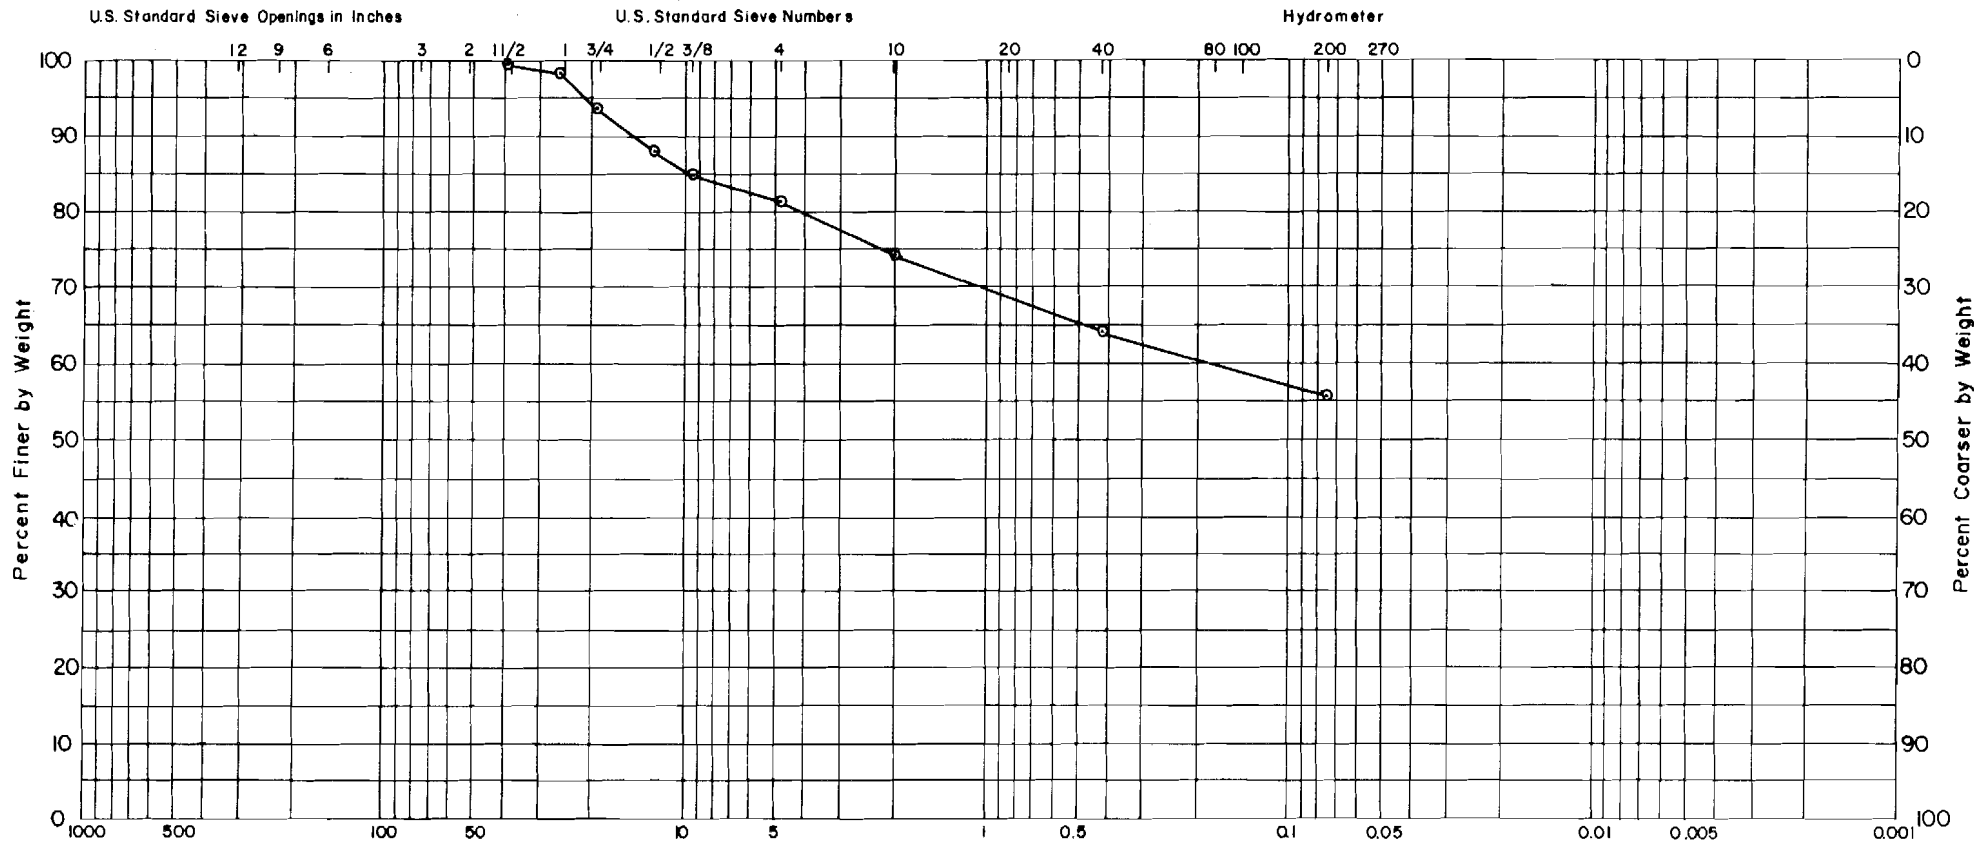
BORROW AREA H
 AUGER HOLE AH-H1

SAMPLE NO.	MOISTURE CONTENT	DRY DENSITY	LL	PI	CLASSIFICATION & DESCRIPTION
AH-H1 #6,7	12,12		25	7	CL-ML SILT WITH SOME SAND AND GRAVEL, TRACE CLAY

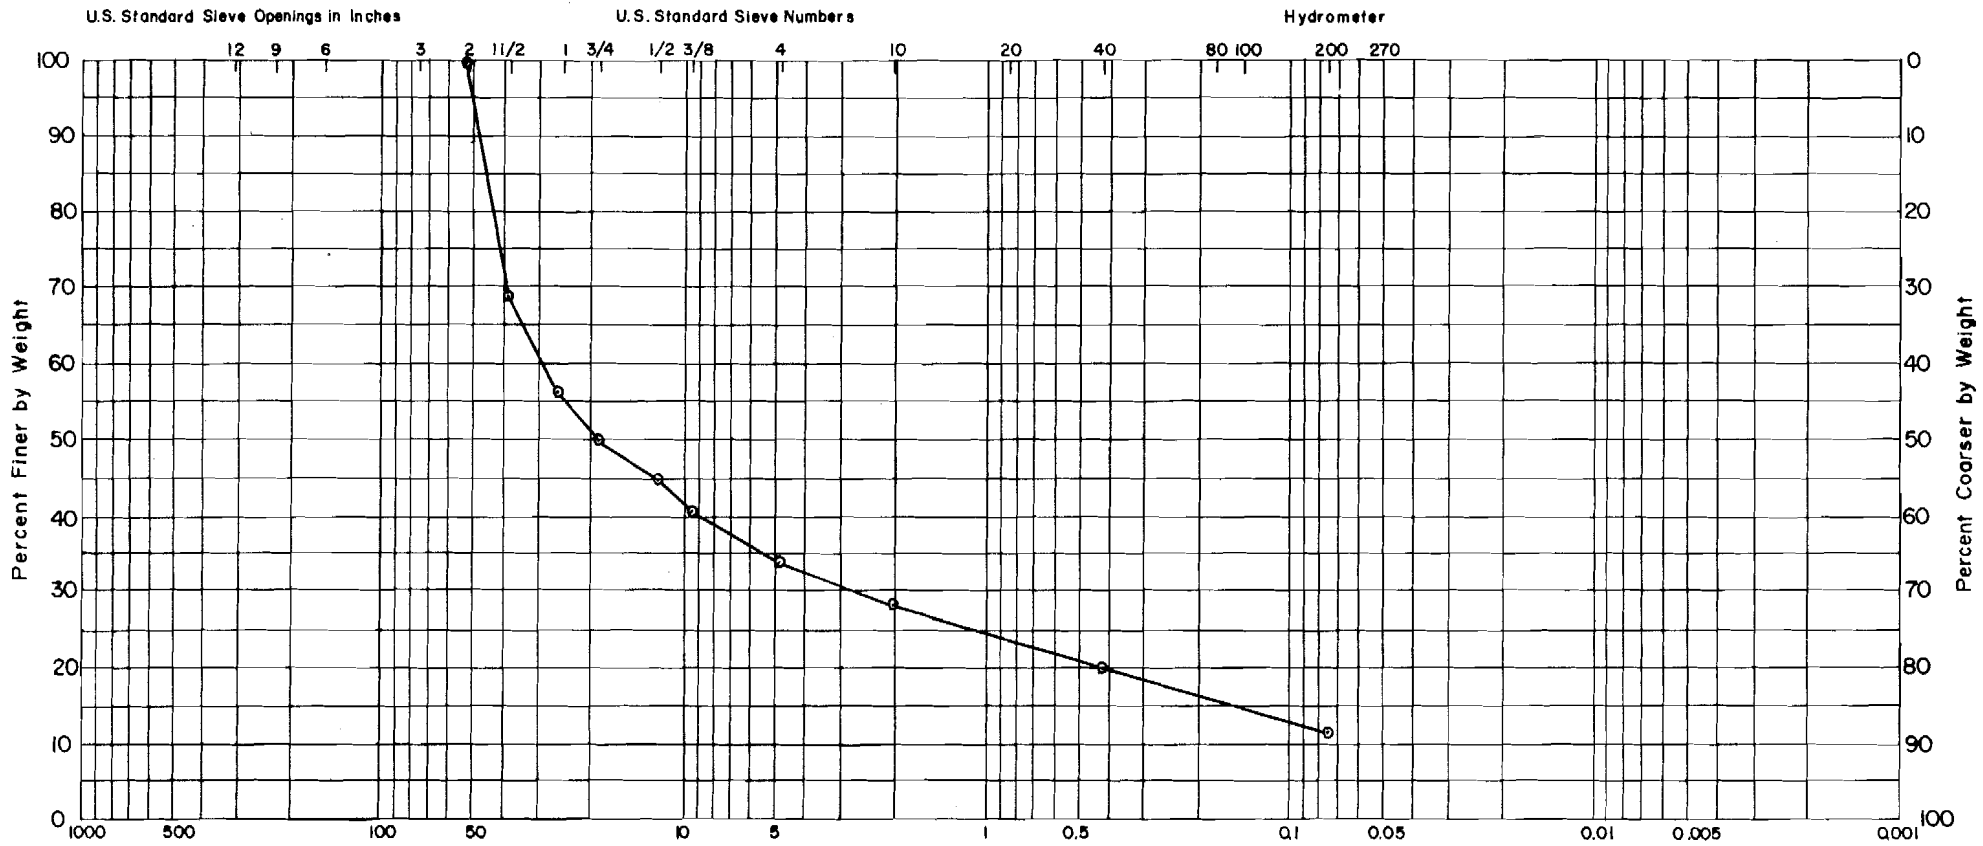
BORROW AREA H
AUGER HOLE AH-H1

SAMPLE NO.	MOISTURE CONTENT	DRY DENSITY	LL	PI	CLASSIFICATION & DESCRIPTION
AH-H1 #8,9	9		21	NP	GP-GM GRAVEL WITH SOME SAND, TRACE SILT

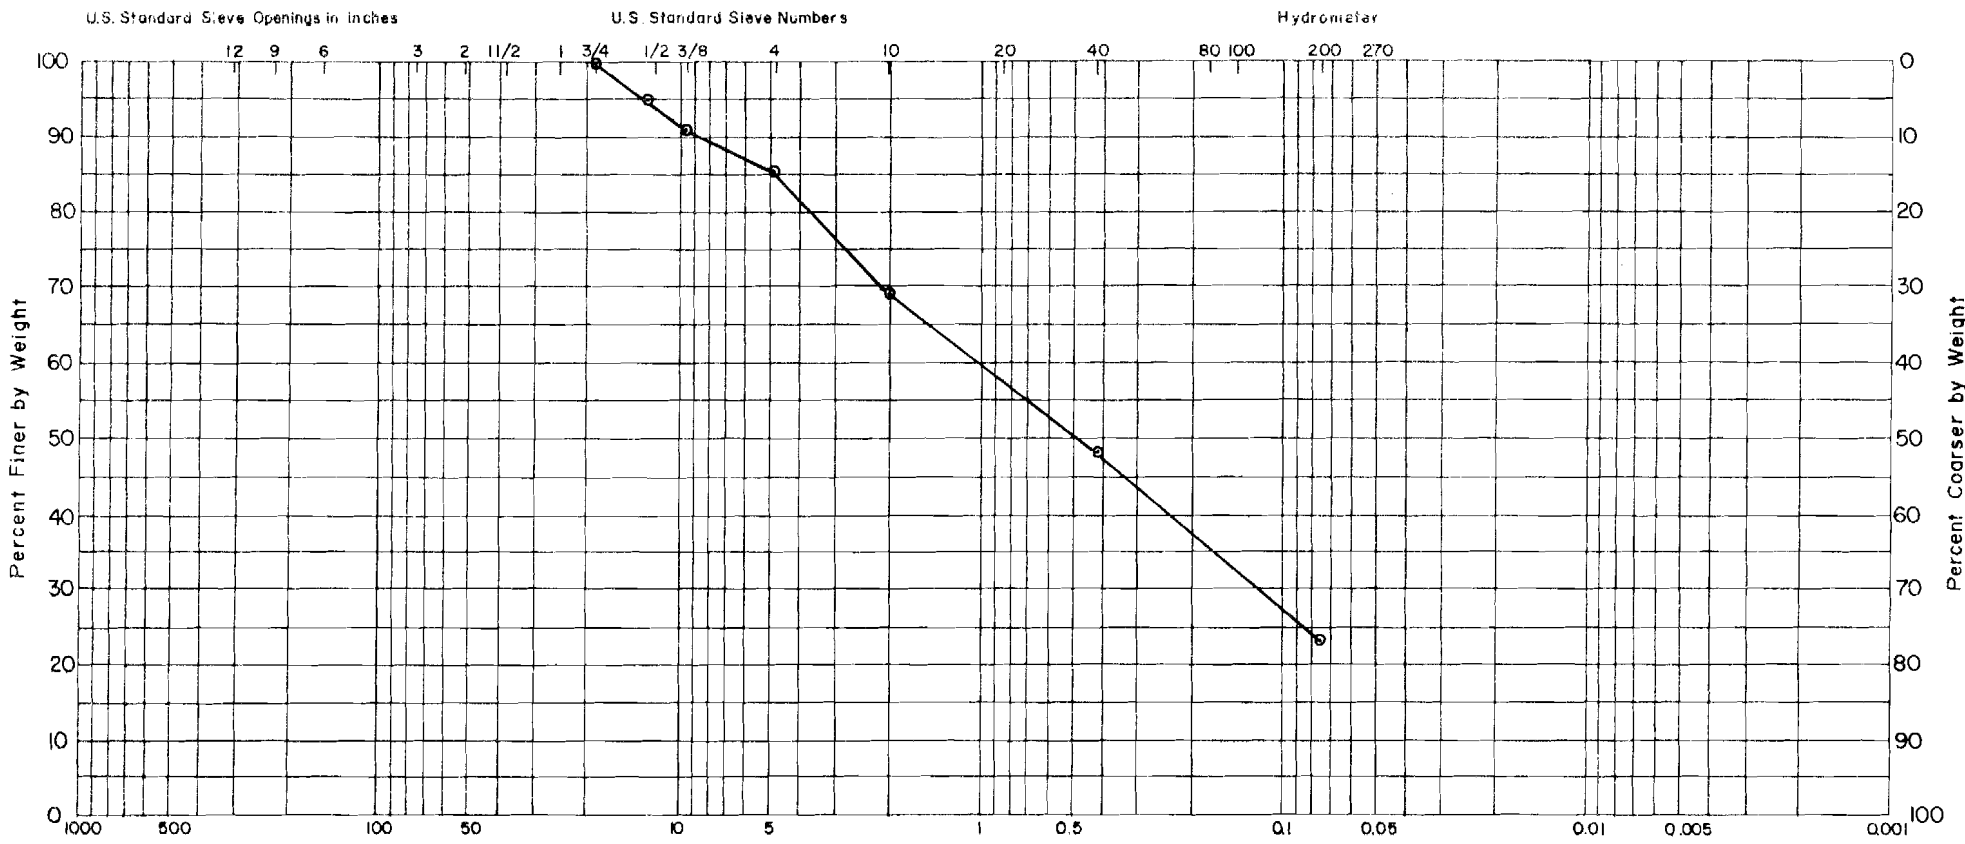
BORROW AREA H
AUGER HOLE AH-H2

SAMPLE NO.	MOISTURE CONTENT	DRY DENSITY	LL	PI	CLASSIFICATION & DESCRIPTION	
AH-H2 #2, 3, 4	23, 17, 20		NV	NP	SM	SAND WITH SOME SILT AND GRAVEL

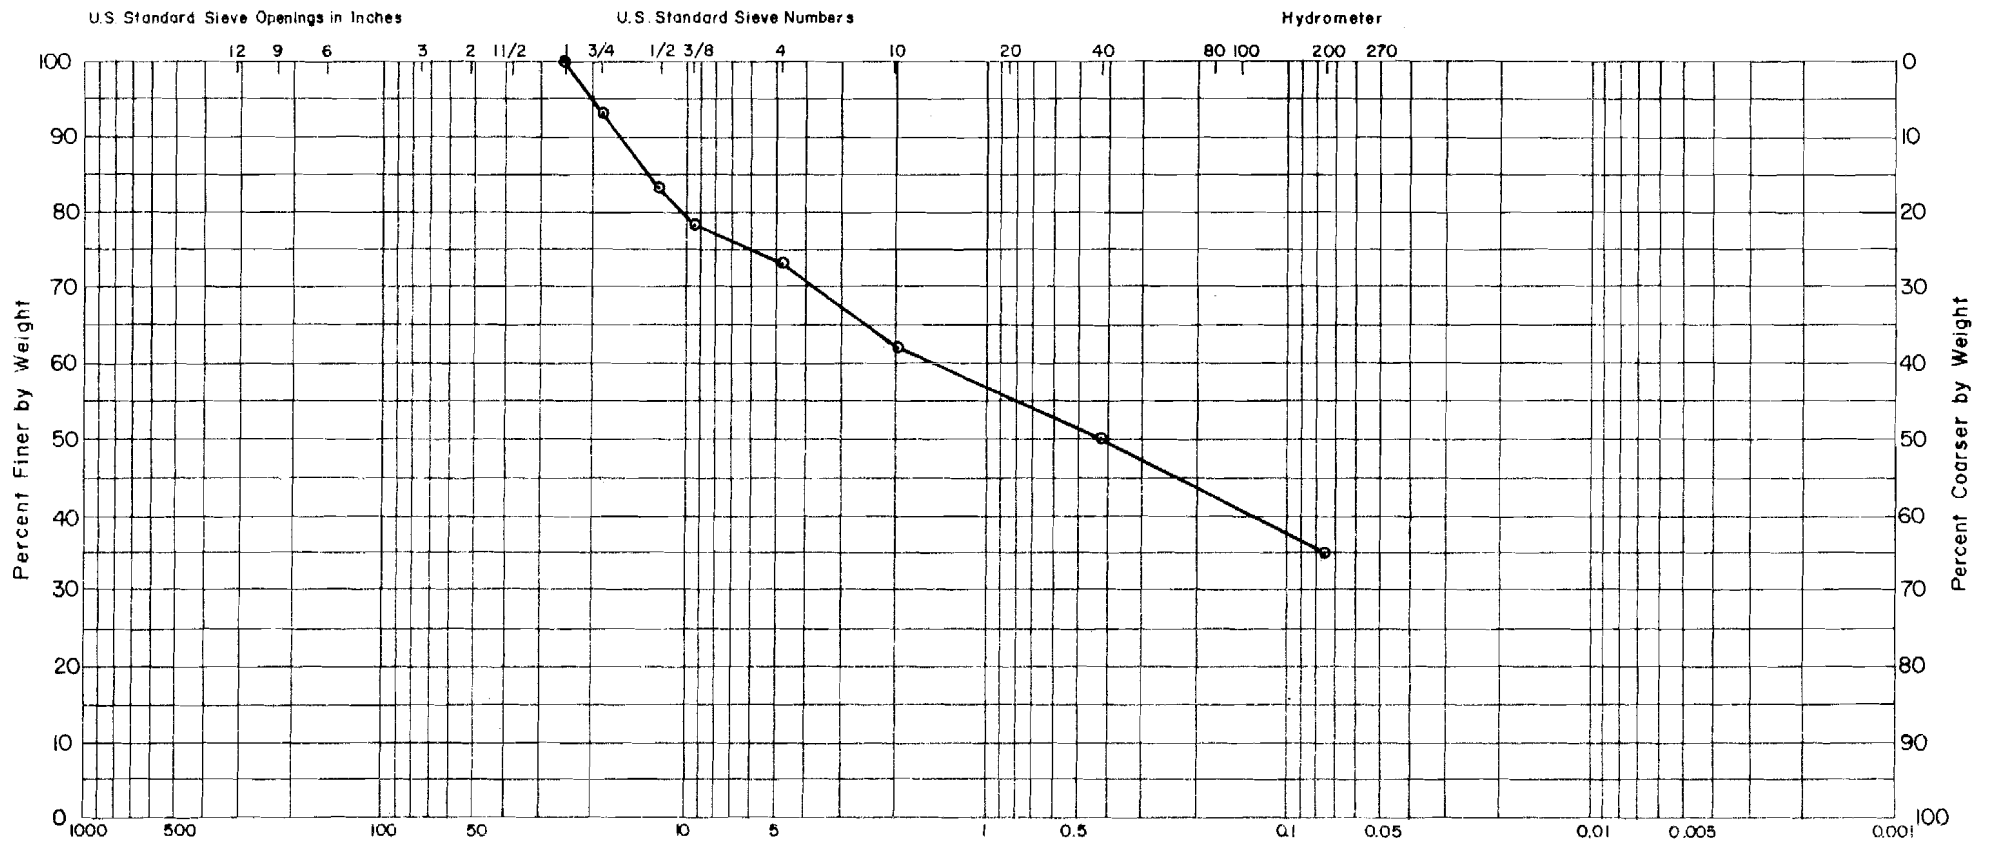
BORROW AREA H
AUGER HOLE AH-H2

SAMPLE NO.	MOISTURE CONTENT	DRY DENSITY	LL	PI	CLASSIFICATION & DESCRIPTION
AH-H2 #5,6,7	7,11,11		18	NP	SM SILTY SAND WITH SOME GRAVEL

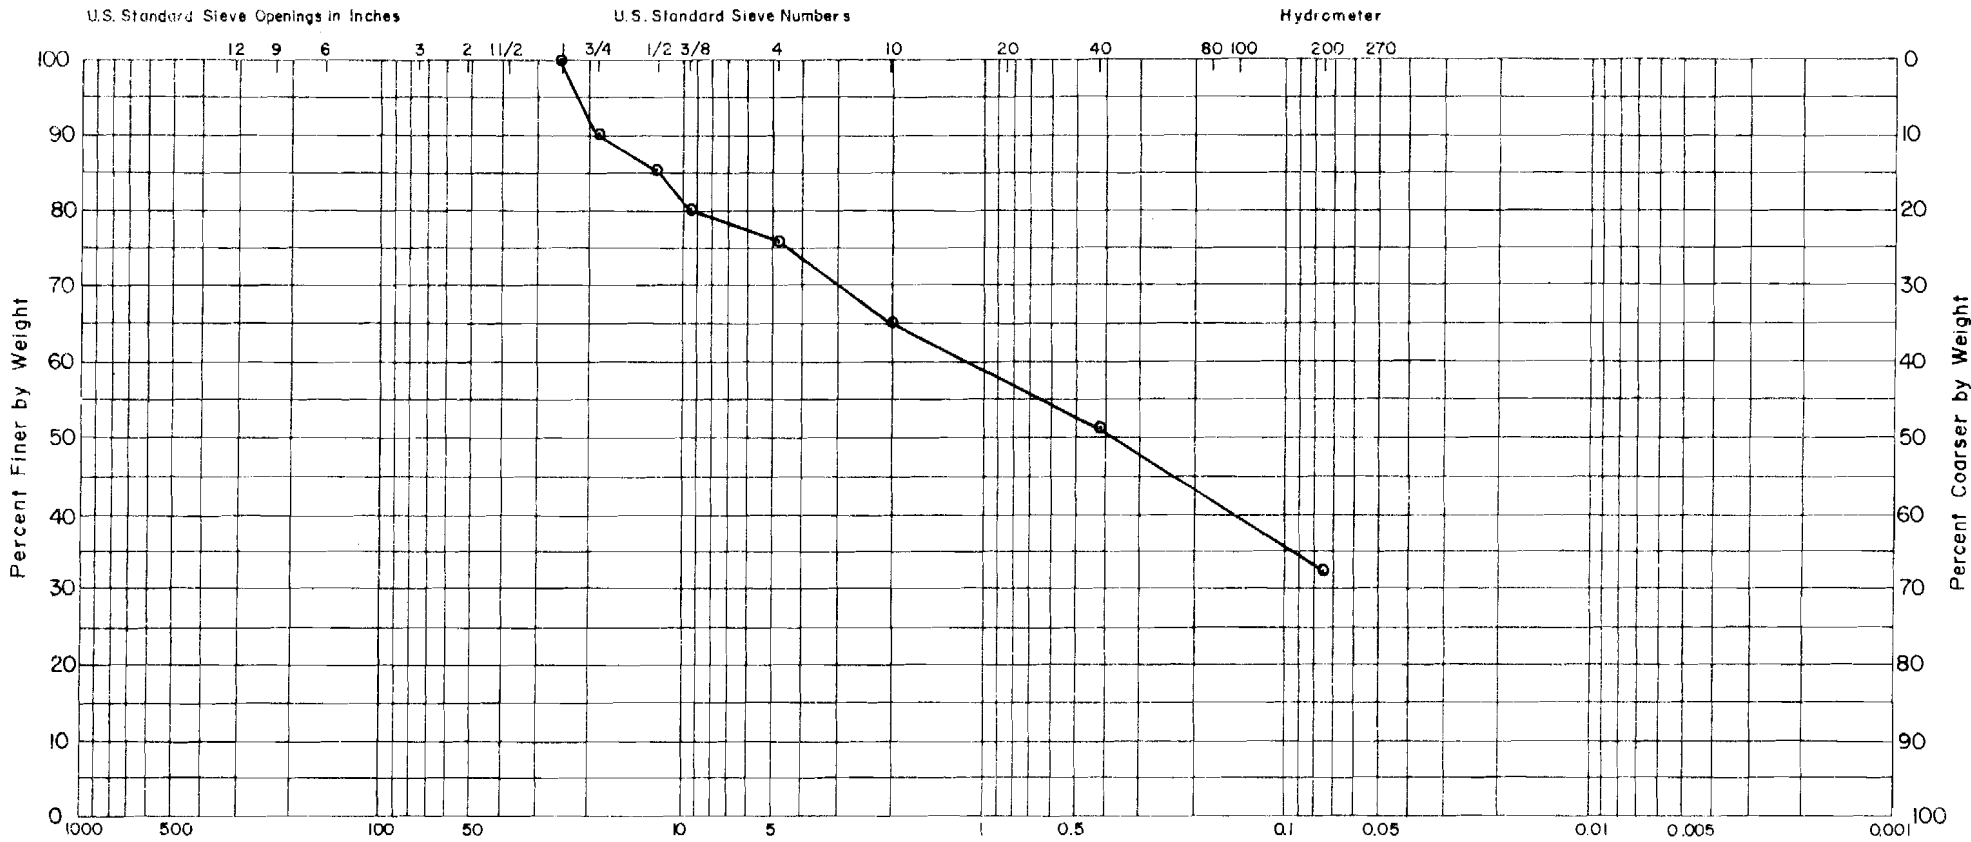
BORROW AREA H
AUGER HOLE AH-H2

SAMPLE NO.	MOISTURE CONTENT	DRY DENSITY	LL	PI	CLASSIFICATION & DESCRIPTION
AH-H2 #8	10			SM	SILTY SAND WITH SOME GRAVEL

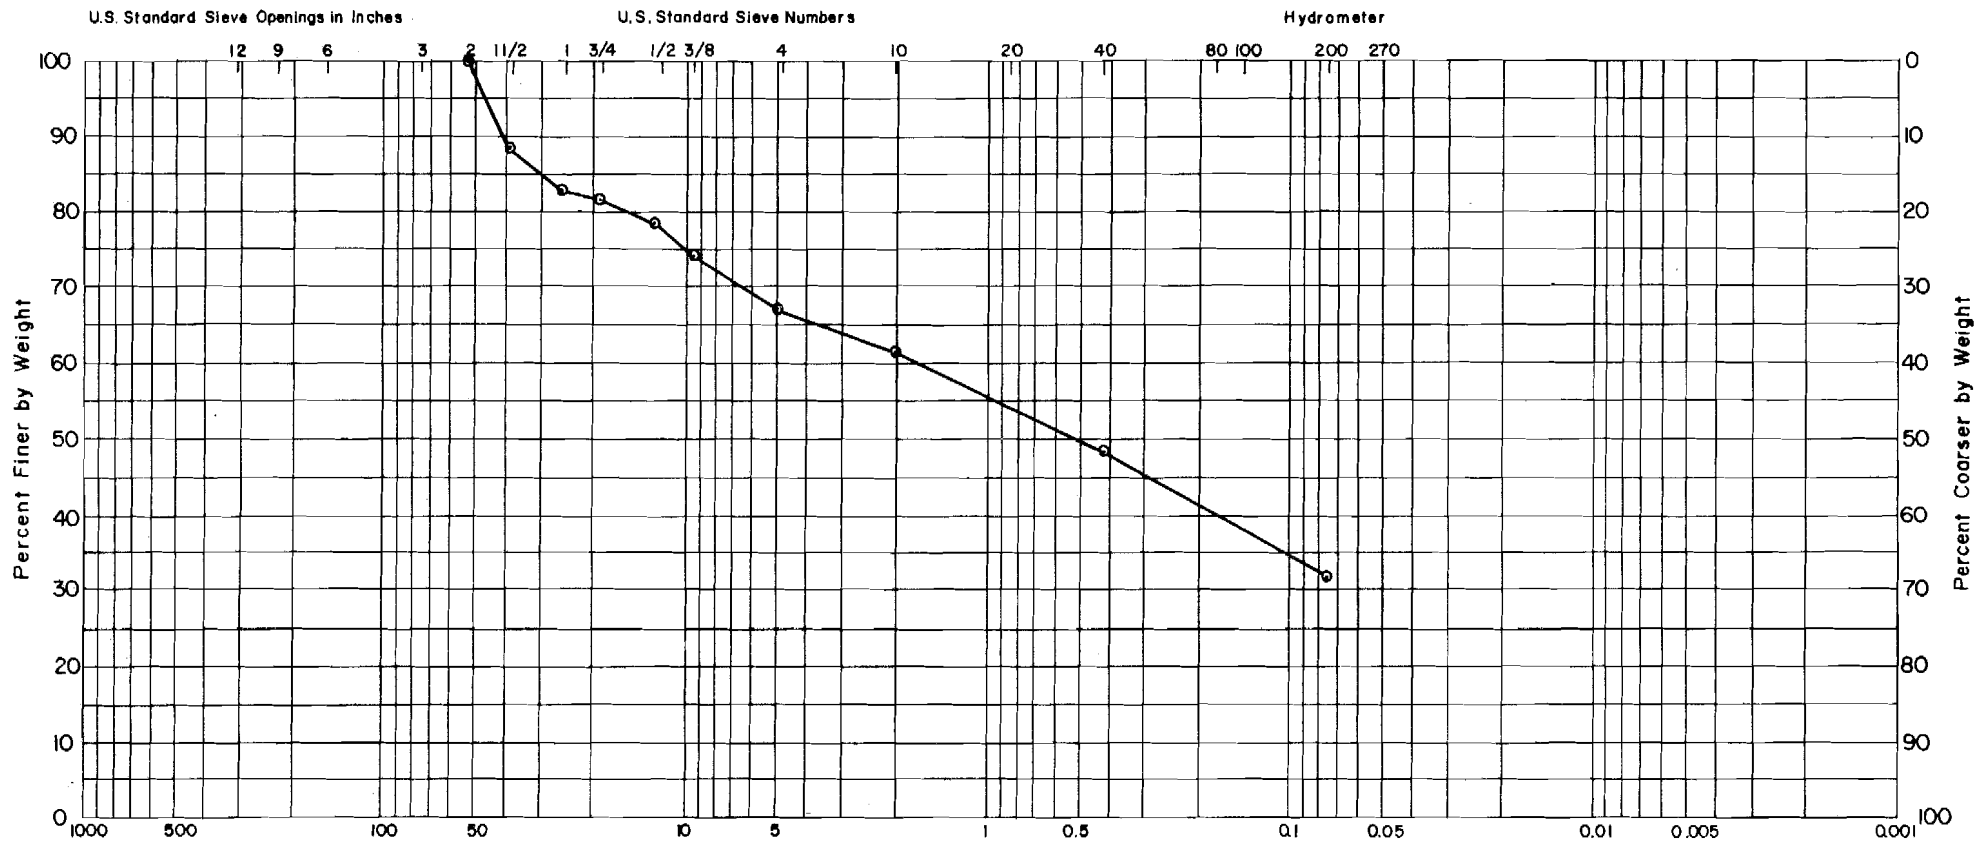
BORROW AREA H
AUGER HOLE AH-H2

SAMPLE NO.	MOISTURE CONTENT	DRY DENSITY	LL	PI	CLASSIFICATION & DESCRIPTION
AH-H2 #9,10	9,6		17	NP	SM SILTY, GRAVELLY SAND

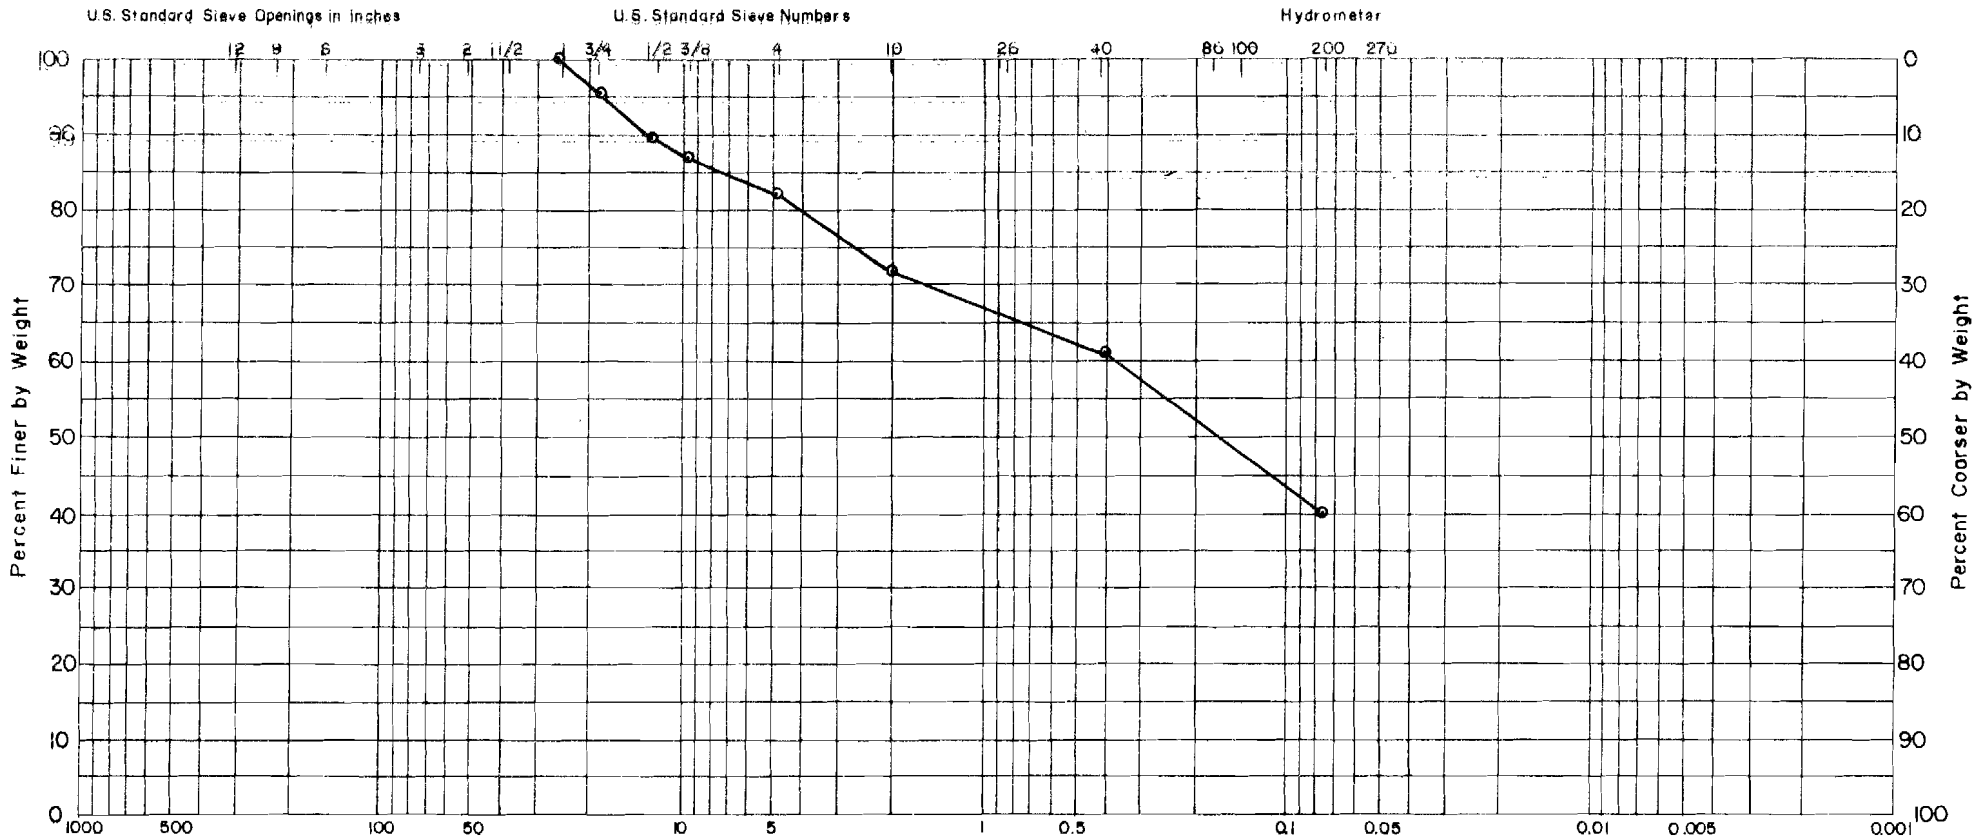
BORROW AREA H
AUGER HOLE AH-H2

SAMPLE NO.	MOISTURE CONTENT	DRY DENSITY	LL	PI	CLASSIFICATION & DESCRIPTION
AH-H2 #11,12,13	8, 8, 7		18	5	SM-SC SILTY SAND WITH SOME GRAVEL, TRACE CLAY

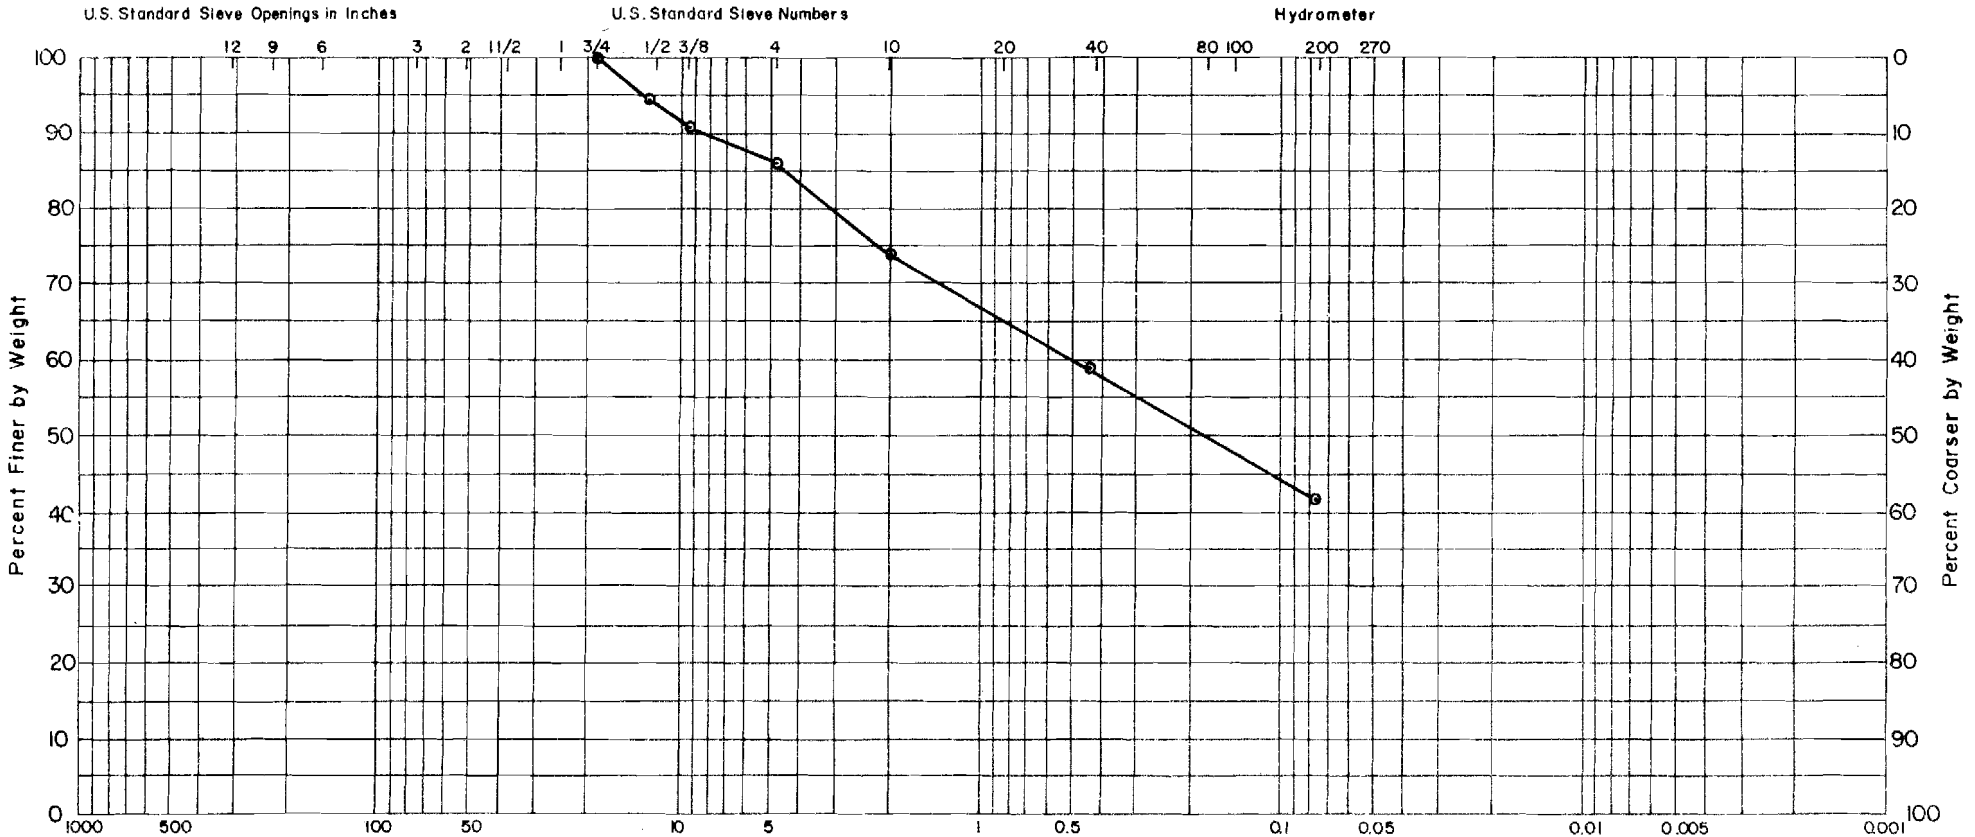
BORROW AREA H
 AUGER HOLE AH-H3

SAMPLE NO.	MOTISTURE CONTENT	DRY DENSITY	LL	PI	CLASSIFICATION & DESCRIPTION
AH-H3 #4, 5	19, 14		18	5	SM-SC SILTY SAND WITH SOME GRAVEL, TRACE CLAY

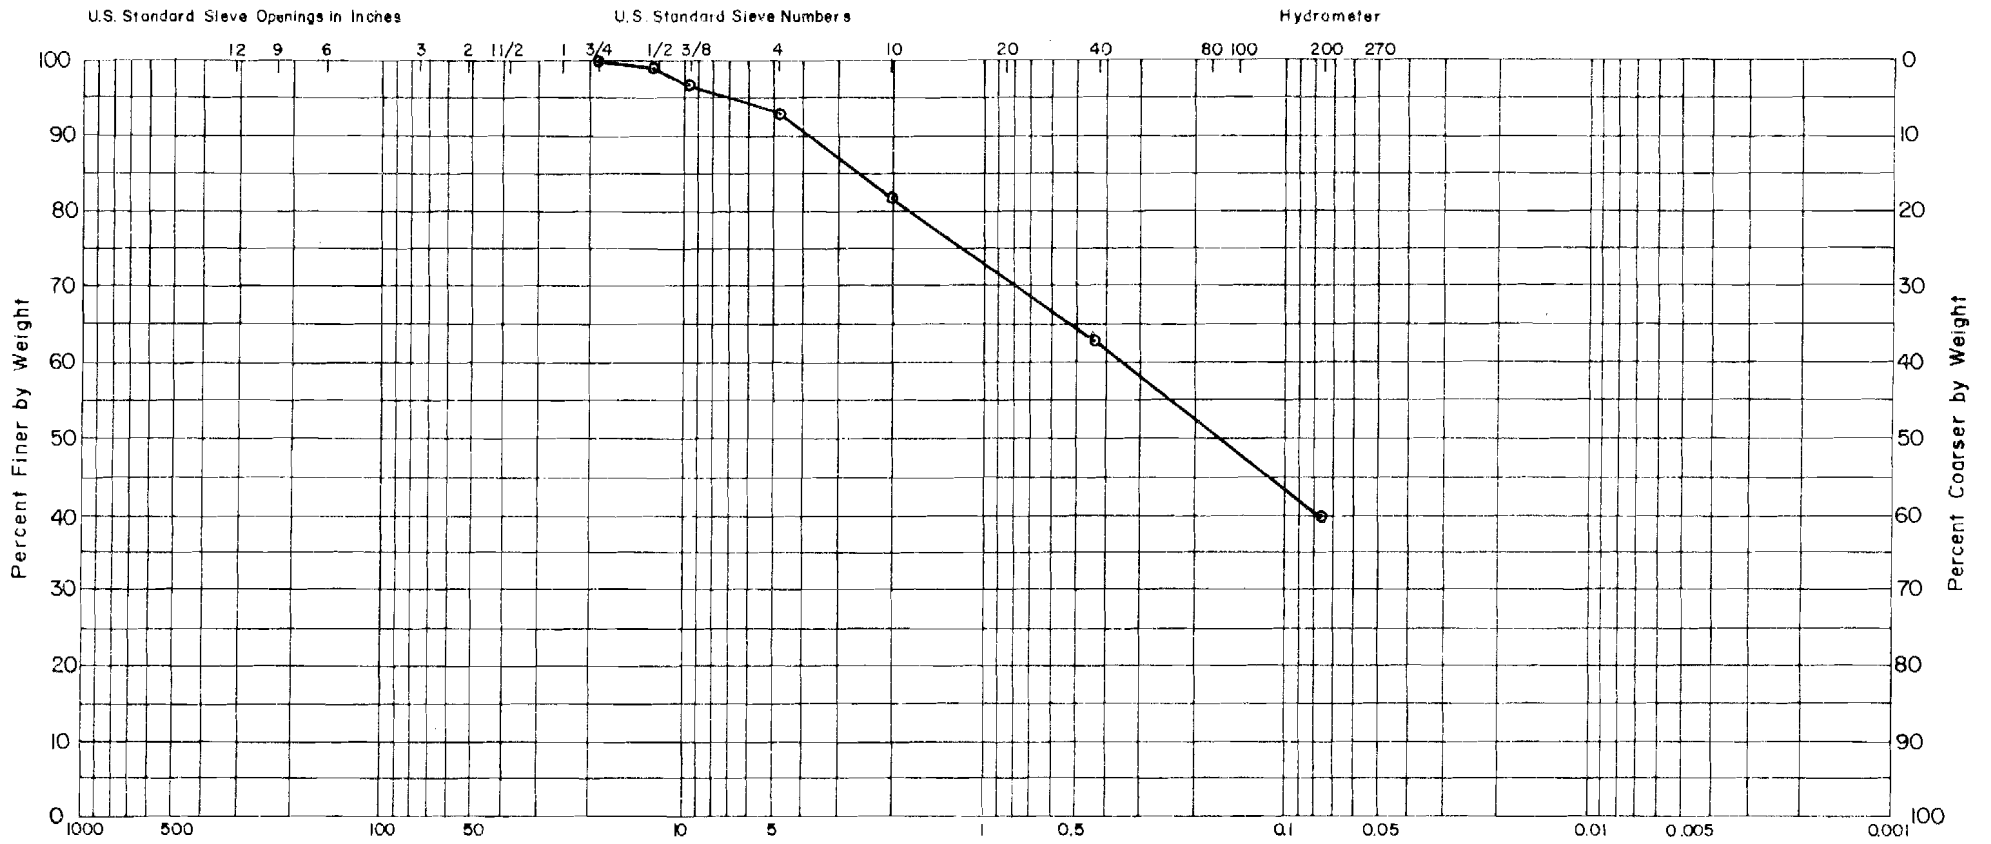
BORROW AREA H
AUGER HOLE AH-H3

SAMPLE NO.	MOISTURE CONTENT	DRY DENSITY	LL	PI	CLASSIFICATION & DESCRIPTION
AH-H3 #7	12		NV	NP	SM SILTY SAND WITH TRACE GRAVEL

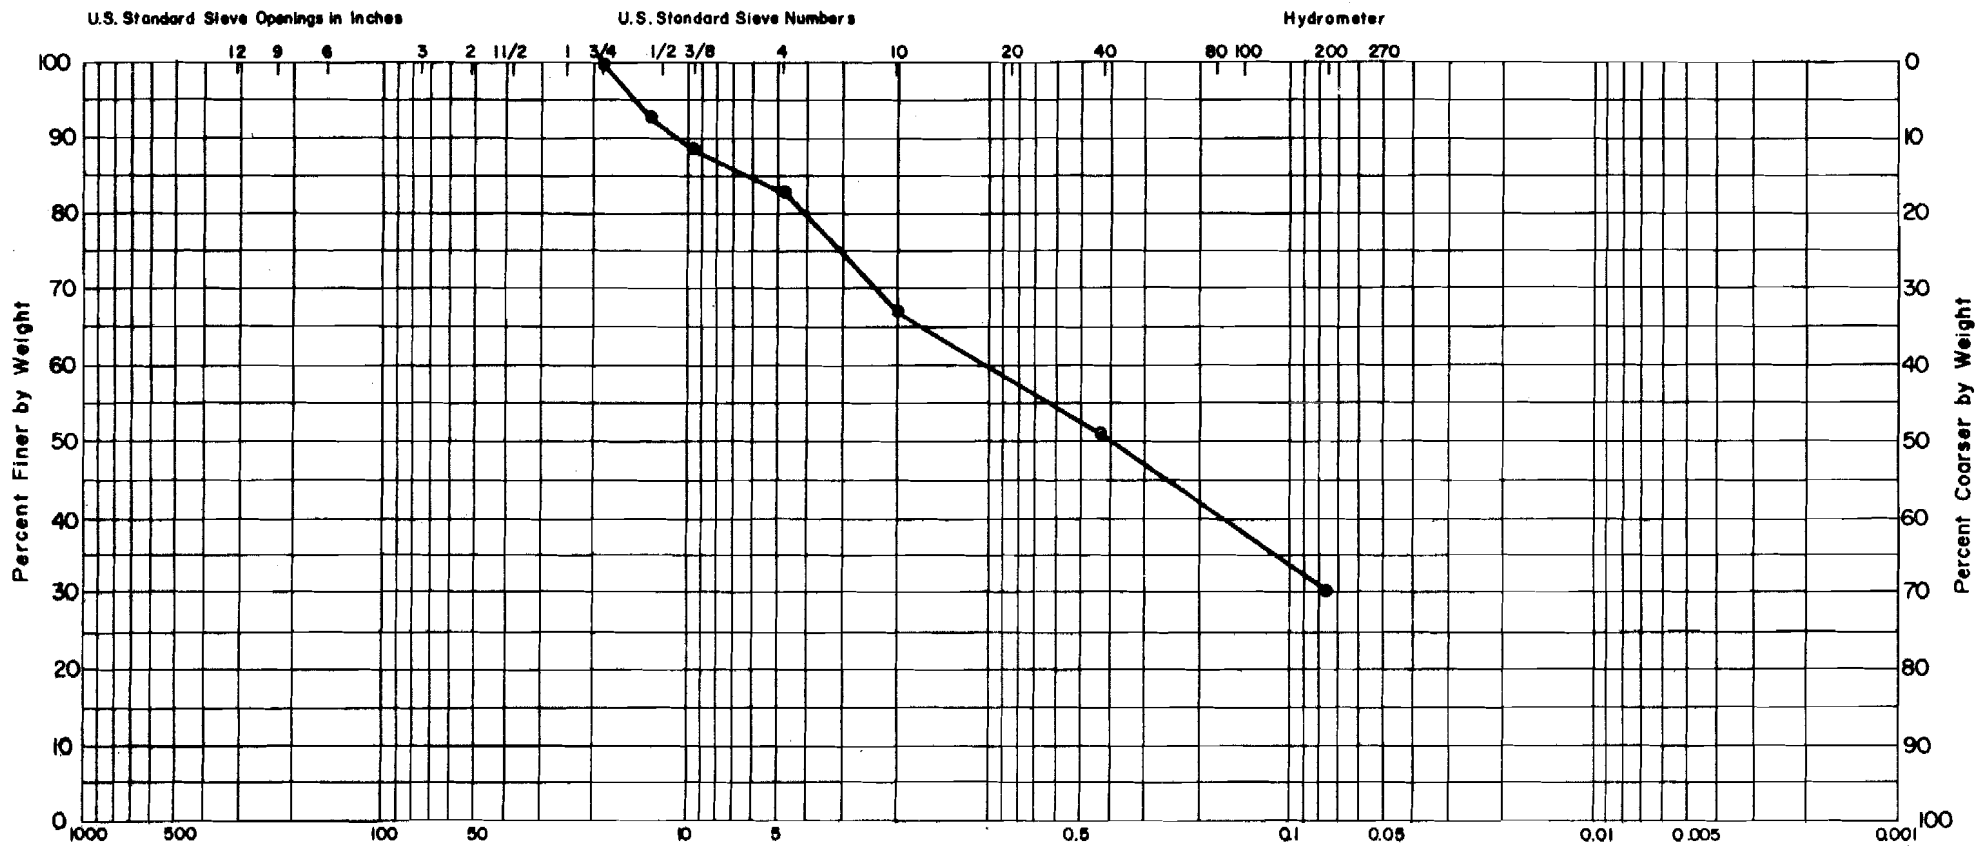
BORROW AREA H
AUGER HOLE AH-H3

SAMPLE NO.	MOISTURE CONTENT	DRY DENSITY	LL	PI	CLASSIFICATION & DESCRIPTION	
AH-H3 #8	9		14	NP	SM	SILTY SAND WITH SOME GRAVEL

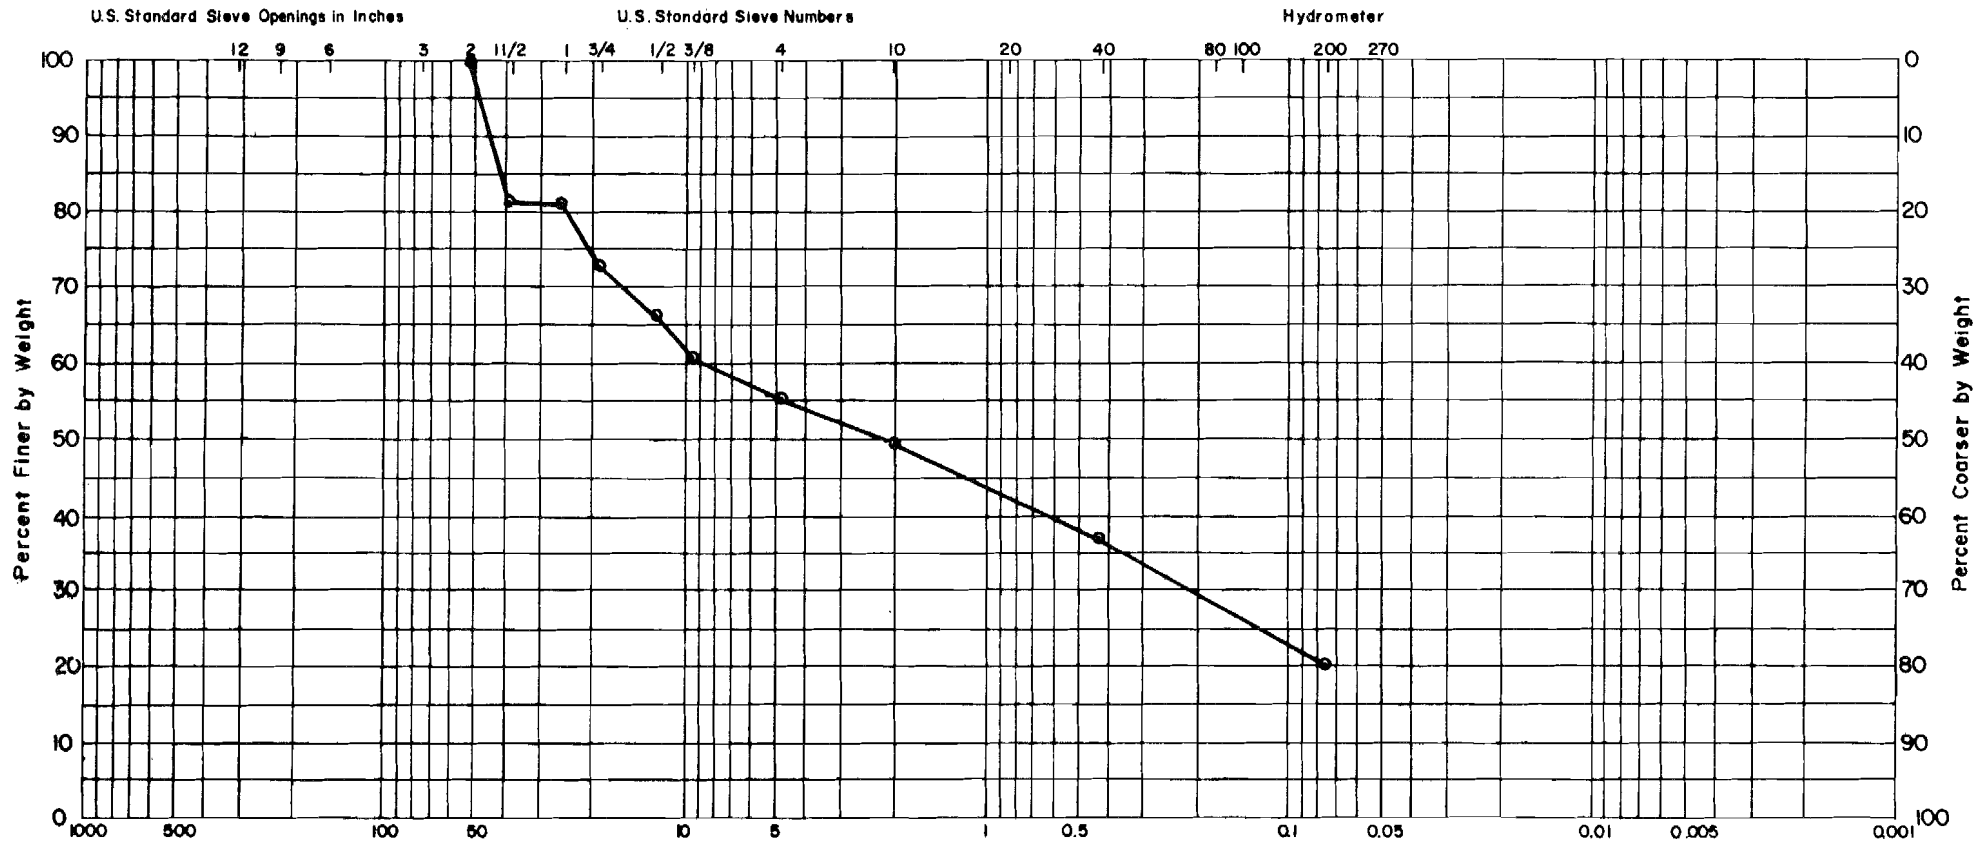
BORROW AREA H
AUGER HOLE AH-H4

SAMPLE NO.	MOISTURE CONTENT	DRY DENSITY	LL	PI	CLASSIFICATION & DESCRIPTION	
AH-H4 #3,4	16,13		23	7	GC-GM	SANDY GRAVEL WITH SOME SILT AND TRACE CLAY
