SUSITNA HYDROELECTRIC PROJECT

1980 - 81 GEOTECHNICAL REPORT

VOLUME 2
APPENDIX A-F
FINAL DRAFT

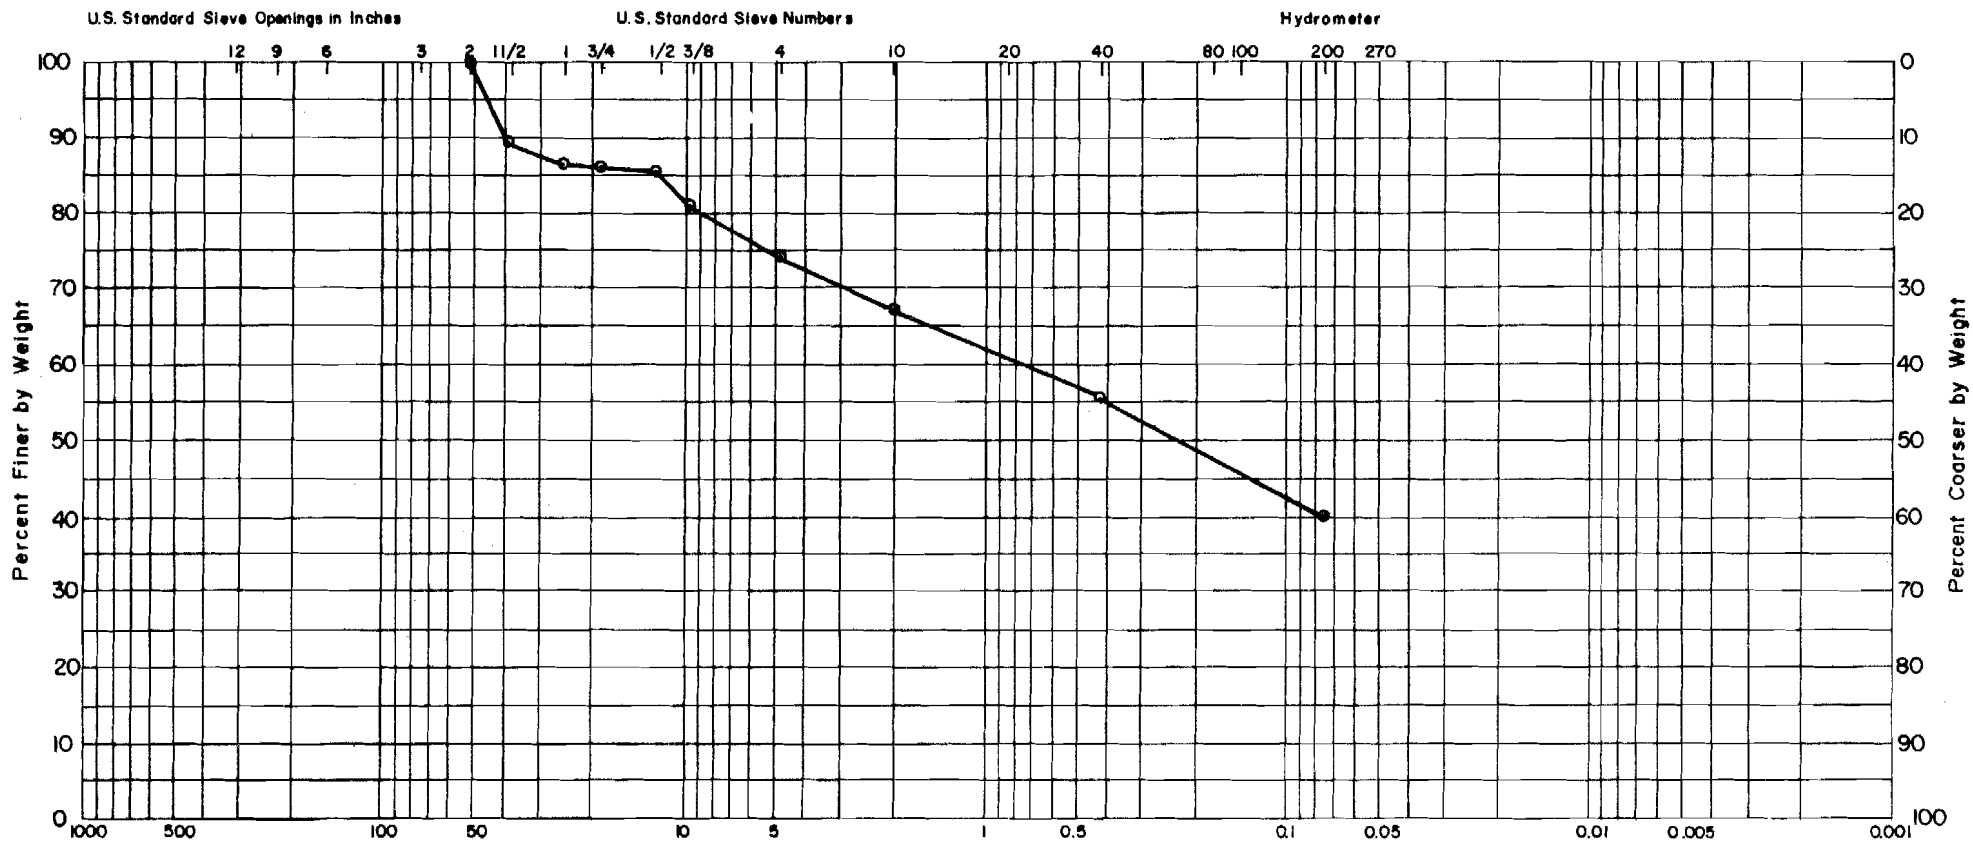
BORROW AREA H
AUGER HOLE AH-H4

SAMPLE NO.	MOISTURE CONTENT	DRY DENSITY	LL	PI	CLASSIFICATION & DESCRIPTION
AH-H4 #5,6	15, 11		20	4	SM-SC SILTY SAND WITH SOME GRAVEL, AND TRACE CLAY

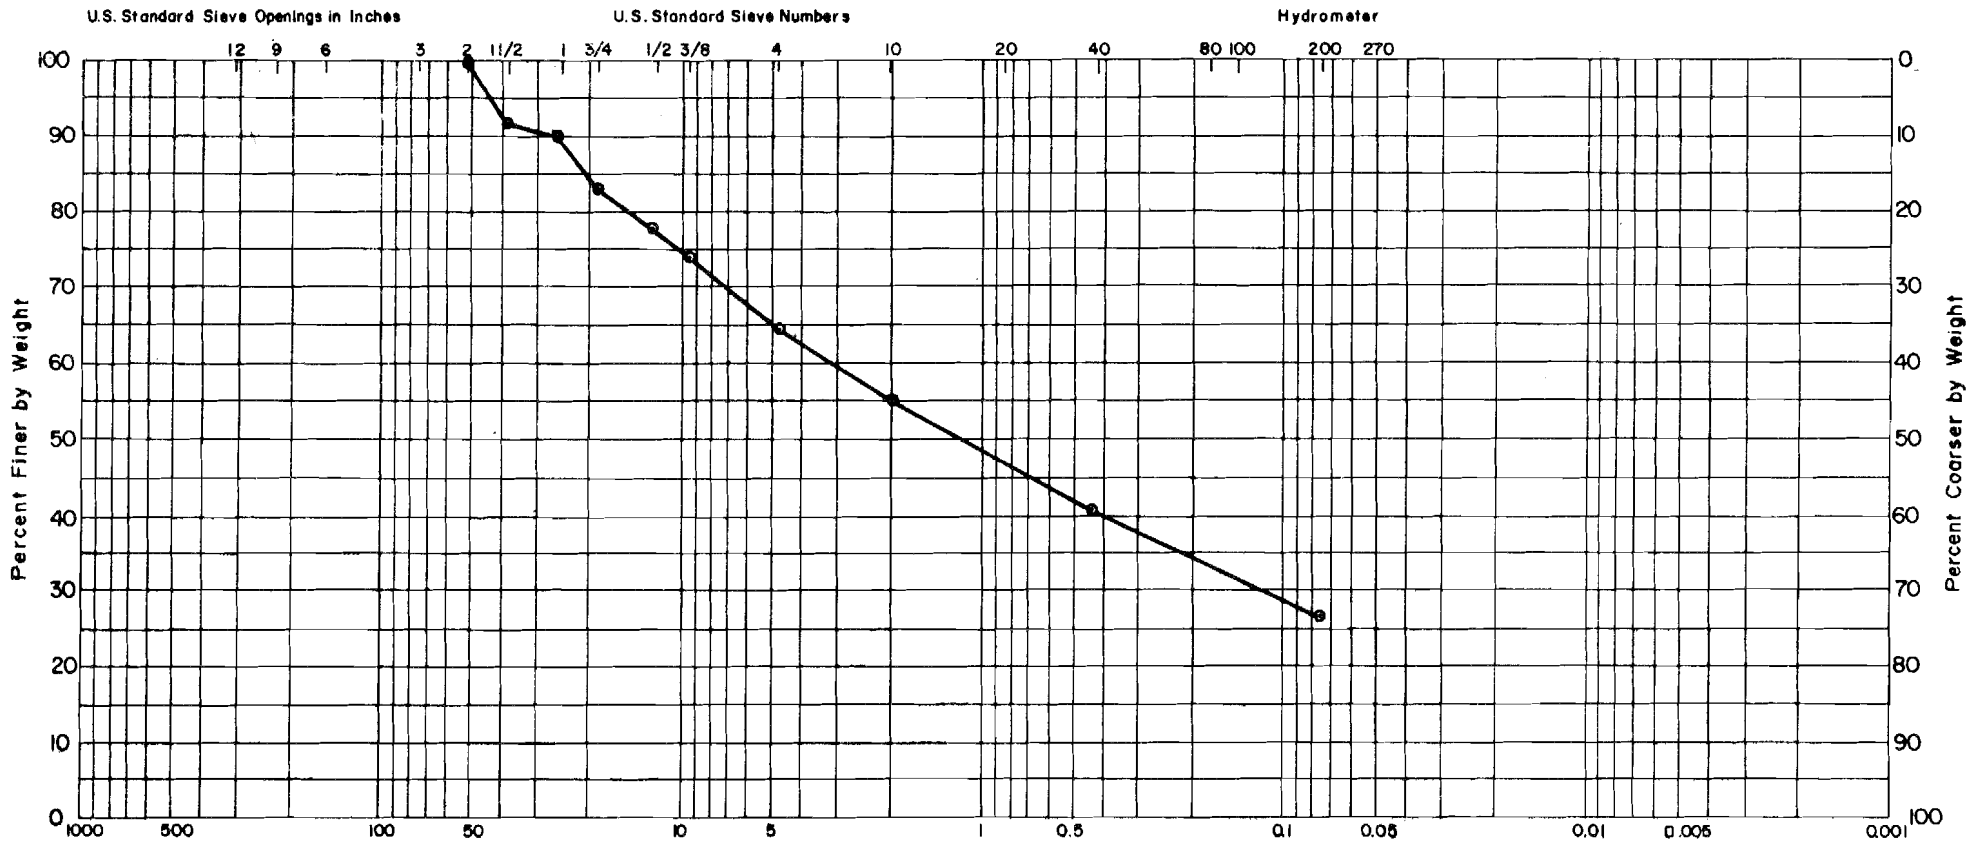
BORROW AREA H
AUGER HOLE AH-H4

SAMPLE NO.	MOISTURE CONTENT	DRY DENSITY	LL	PI	CLASSIFICATION & DESCRIPTION
AH-H4 #7,8	11		22	NP	SM GRAVELLY SAND WITH SOME SILT

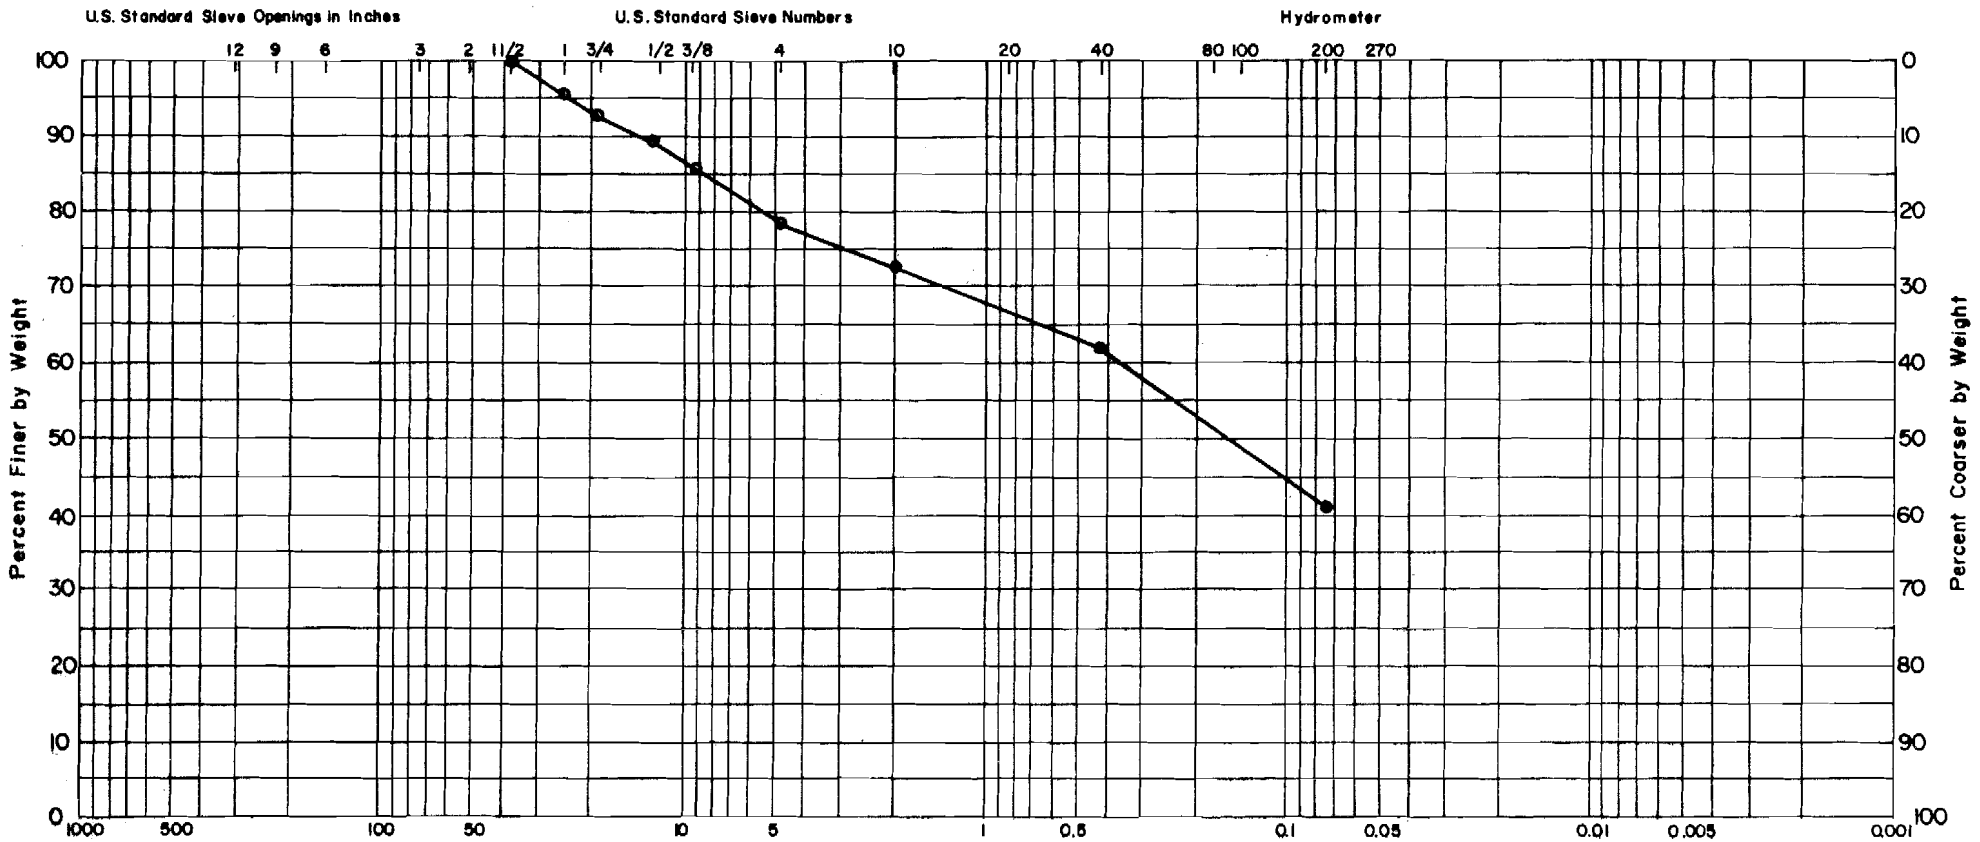
BORROW AREA H.
AUGER HOLE AH-H5

SAMPLE NO.	MOISTURE CONTENT	DRY DENSITY	LL	PI	CLASSIFICATION & DESCRIPTION	
AH-H5 #4	16		23	6	SM-SC	SILTY SAND WITH SOME GRAVEL AND TRACE CLAY

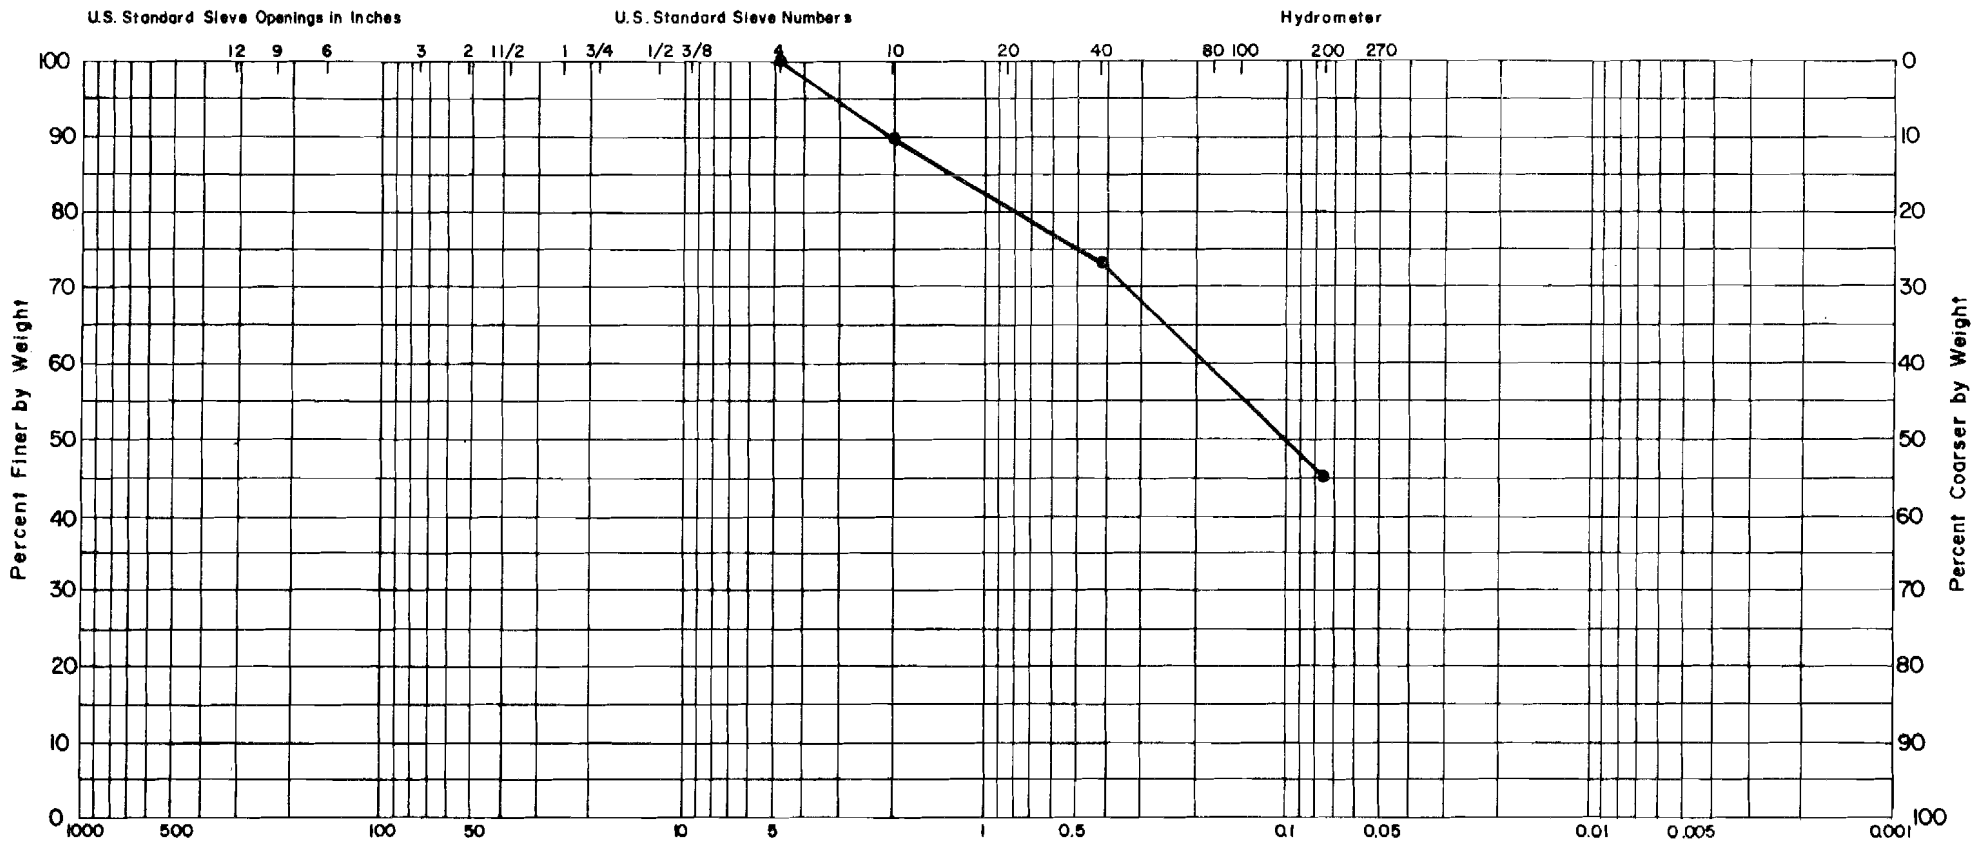
BORROW AREA H
AUGER HOLE AH-H5

SAMPLE NO.	MOISTURE CONTENT	DRY DENSITY	LL	PI	CLASSIFICATION & DESCRIPTION	
AH-H5 #5	17		22	6	SM-SC	SILTY SAND WITH TRACE CLAY

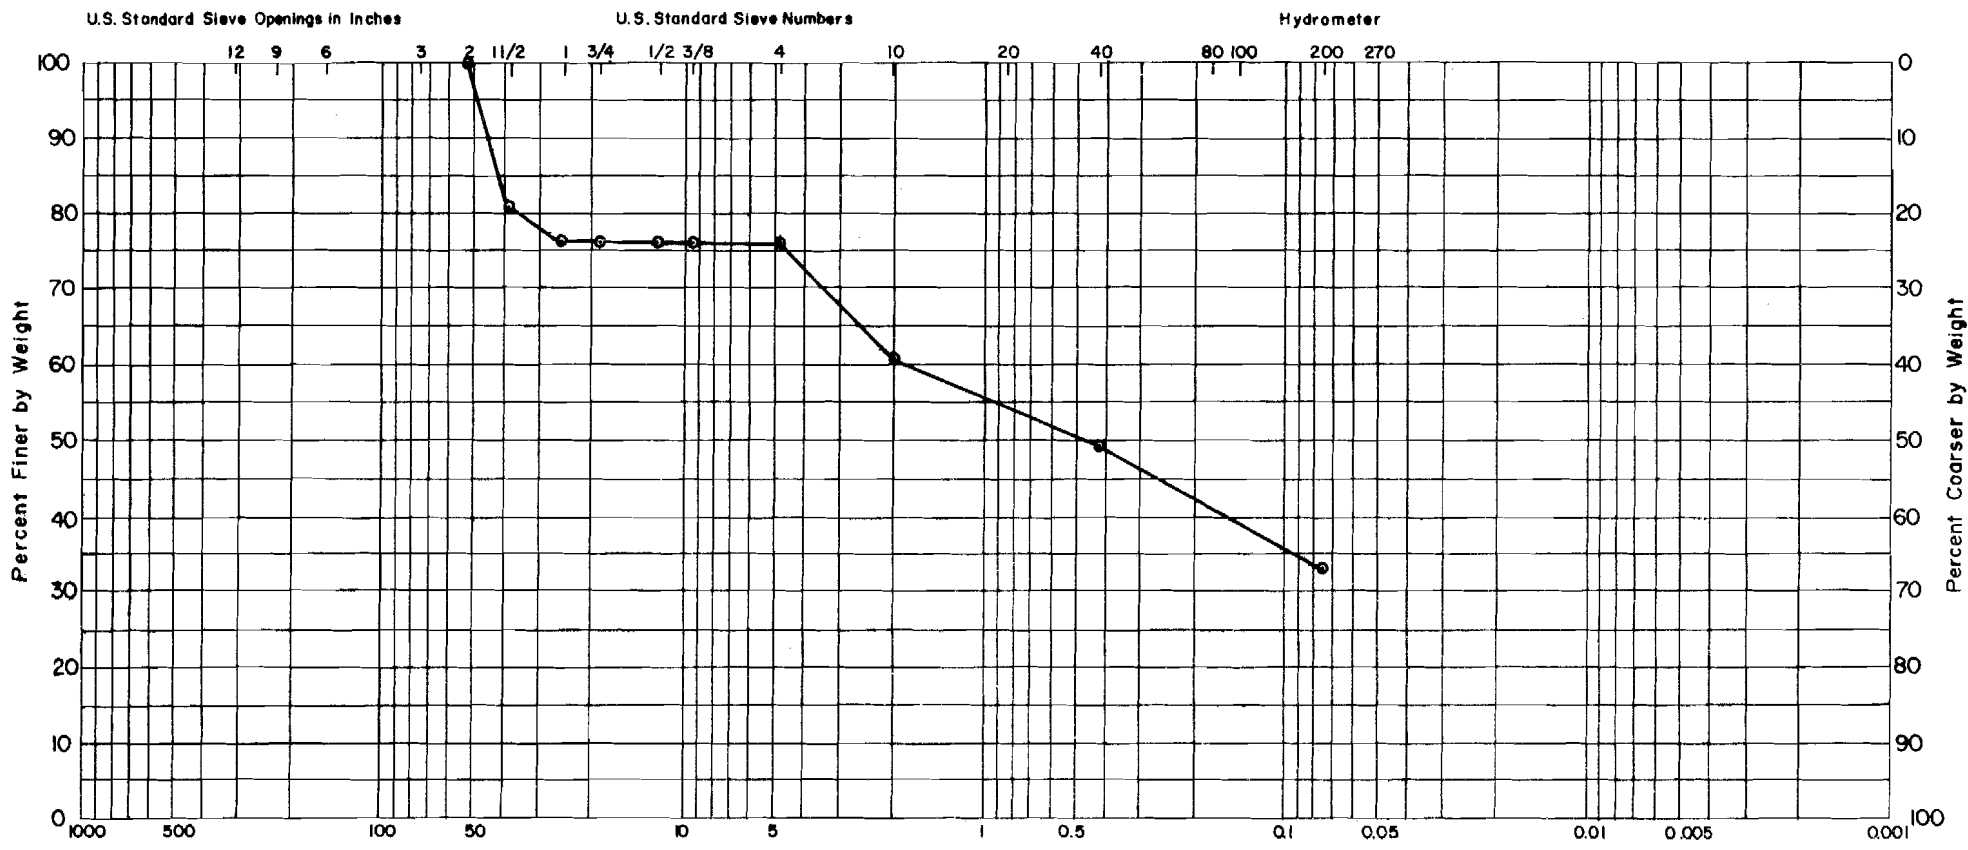
BORROW AREA H
AUGER HOLE AH-H5

SAMPLE NO.	MOISTURE CONTENT	DRY DENSITY	LL	PI	CLASSIFICATION & DESCRIPTION
AH-H5 #6,7	10.9		21	4	SM-SC SILTY SAND WITH SOME GRAVEL AND TRACE CLAY

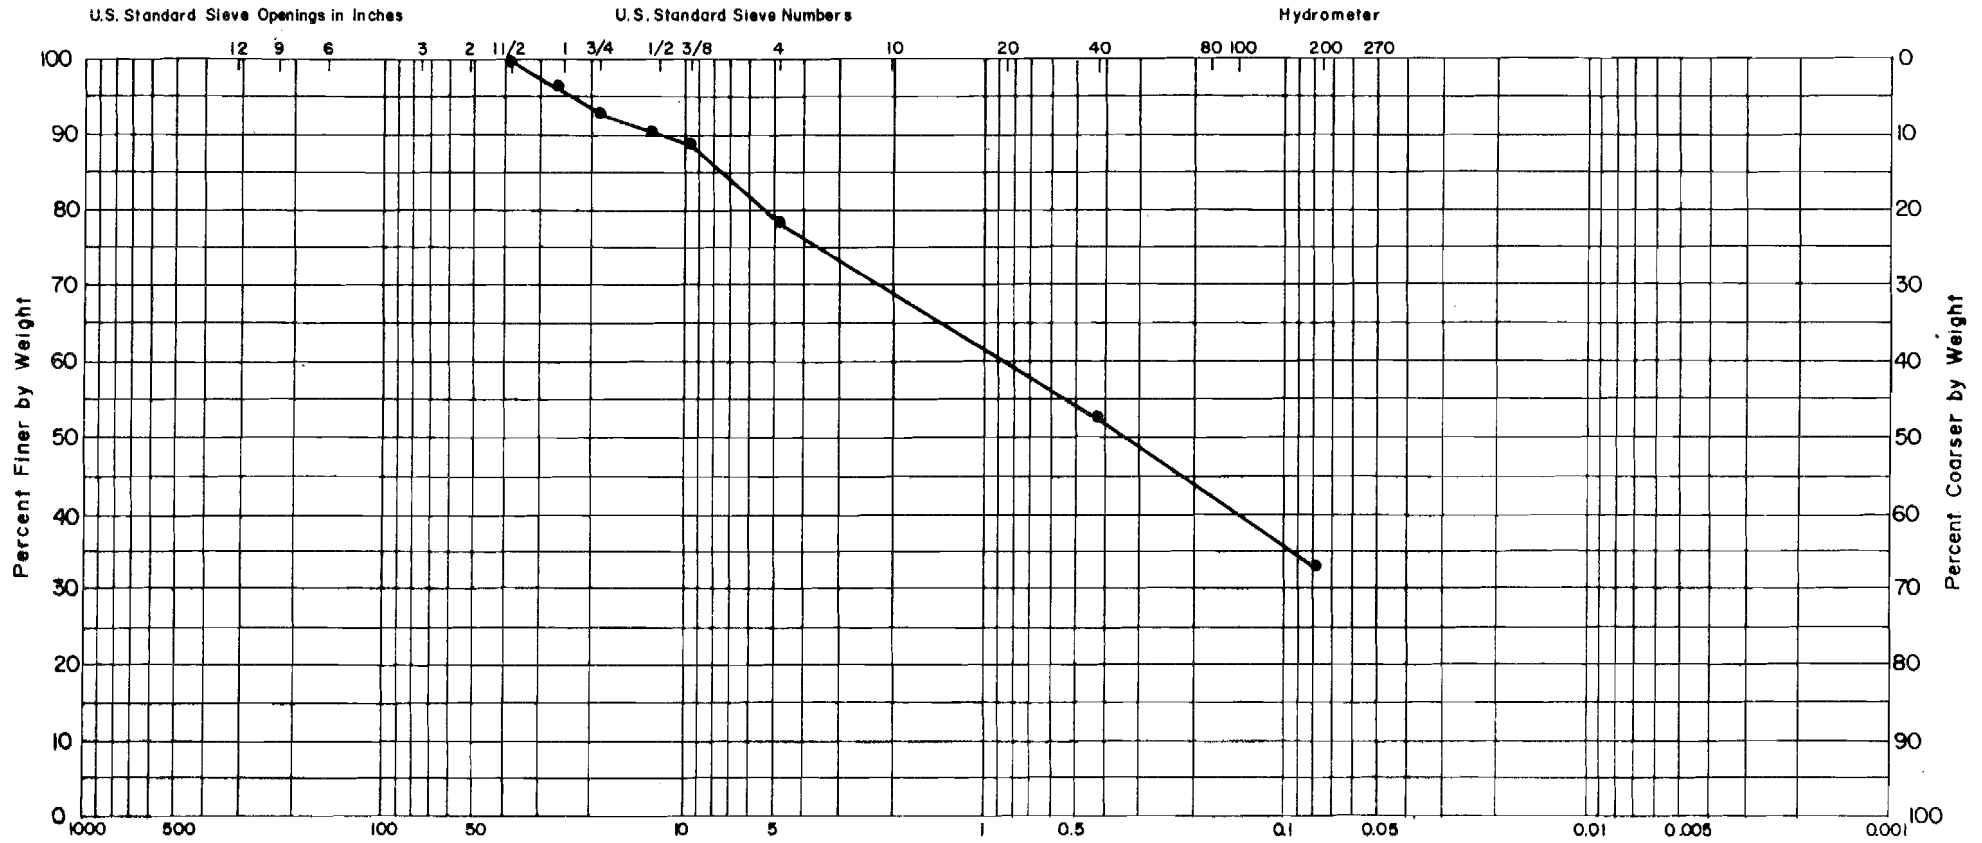
BORROW AREA H
AUGER HOLE AH-H6

SAMPLE NO.	MOISTURE CONTENT	DRY DENSITY	LL	PI	CLASSIFICATION & DESCRIPTION
AH-H6 #6,7	13, 12		NV	NP	SM
					SILTY SAND WITH SOME GRAVEL

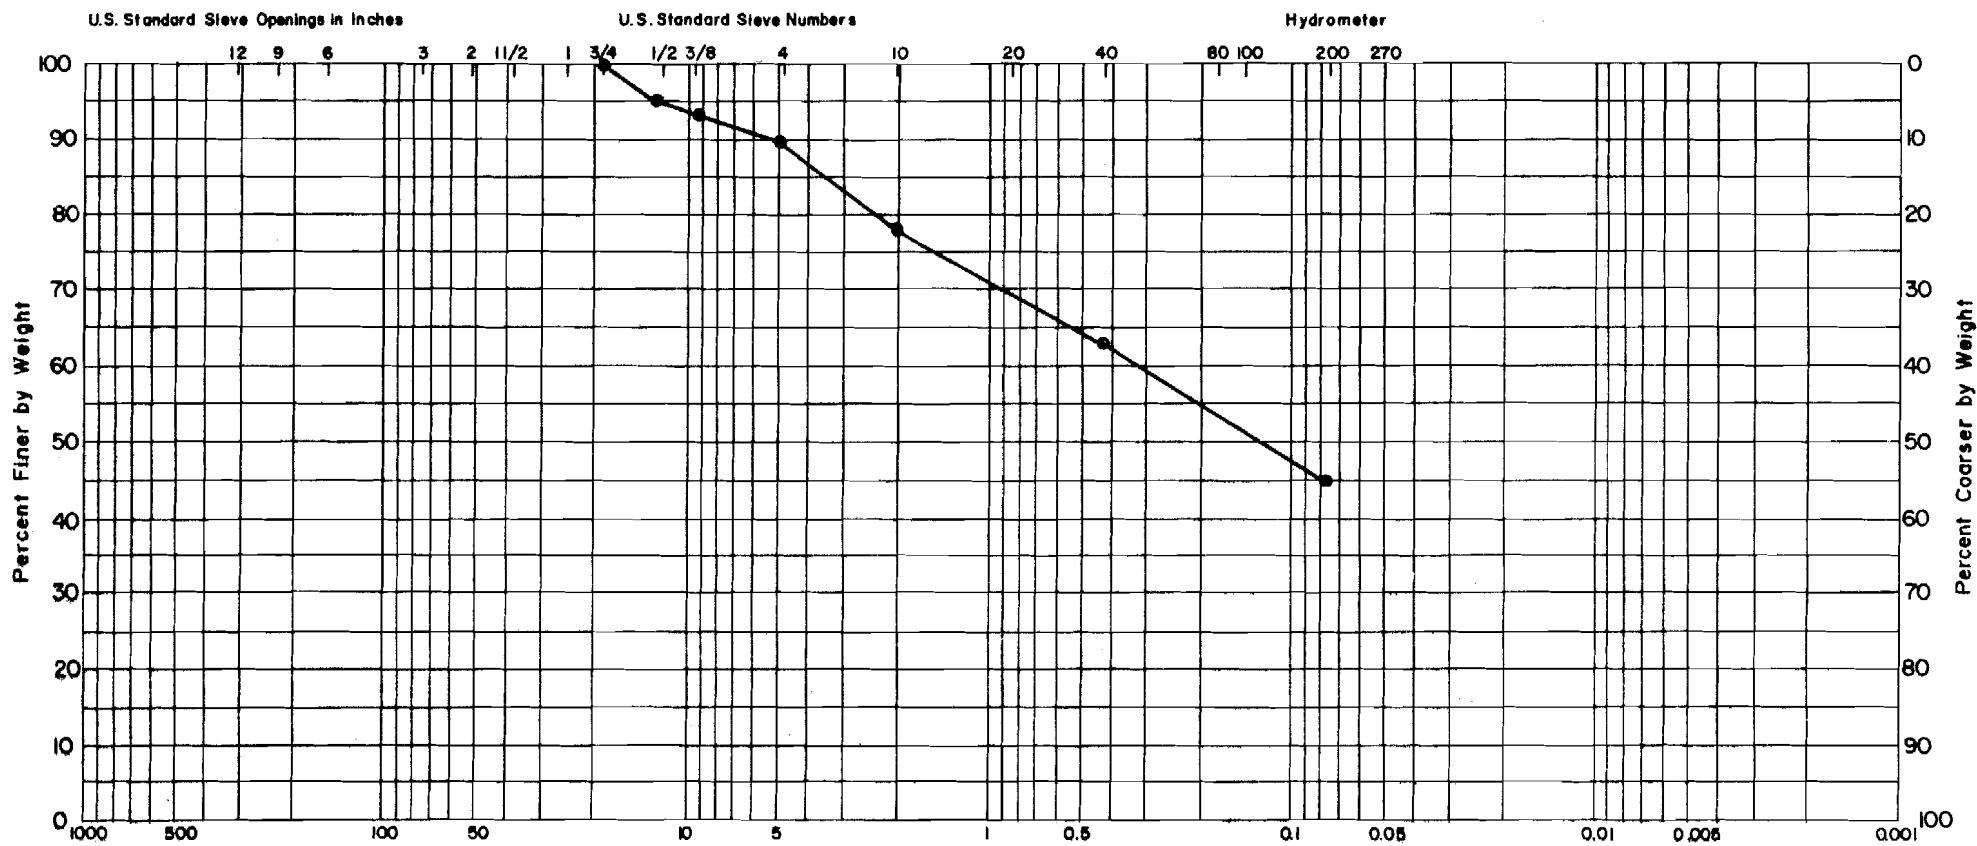
BORROW AREA H
AUGER HOLE AH-H6

SAMPLE NO.	MOISTURE CONTENT	DRY DENSITY	LL	PI	CLASSIFICATION & DESCRIPTION	
AH-H6 #10	11		23	9	SC	SILTY SAND WITH TRACE GRAVEL AND CLAY

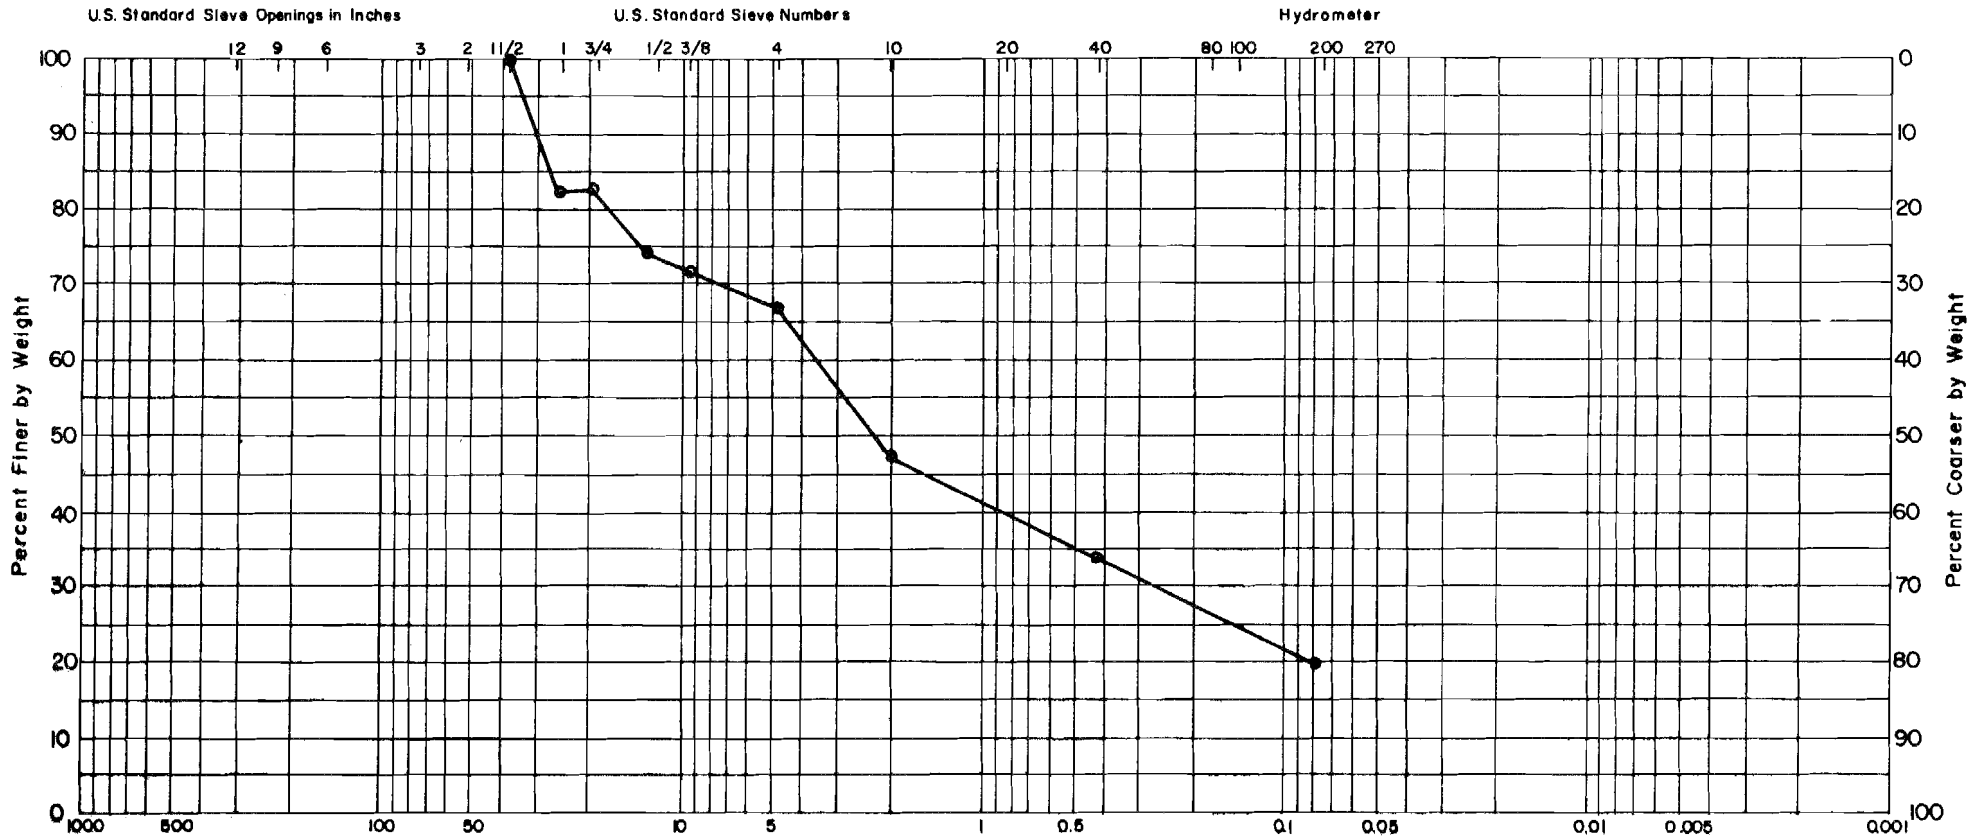
BORROW AREA H
 AUGER HOLE AH-H6

SAMPLE NO.	MOISTURE CONTENT	DRY DENSITY	LL	PI	CLASSIFICATION & DESCRIPTION
AH-H6 #12	8		21	6	SM-SC GRAVELLY SAND WITH SOME SILT, TRACE CLAY

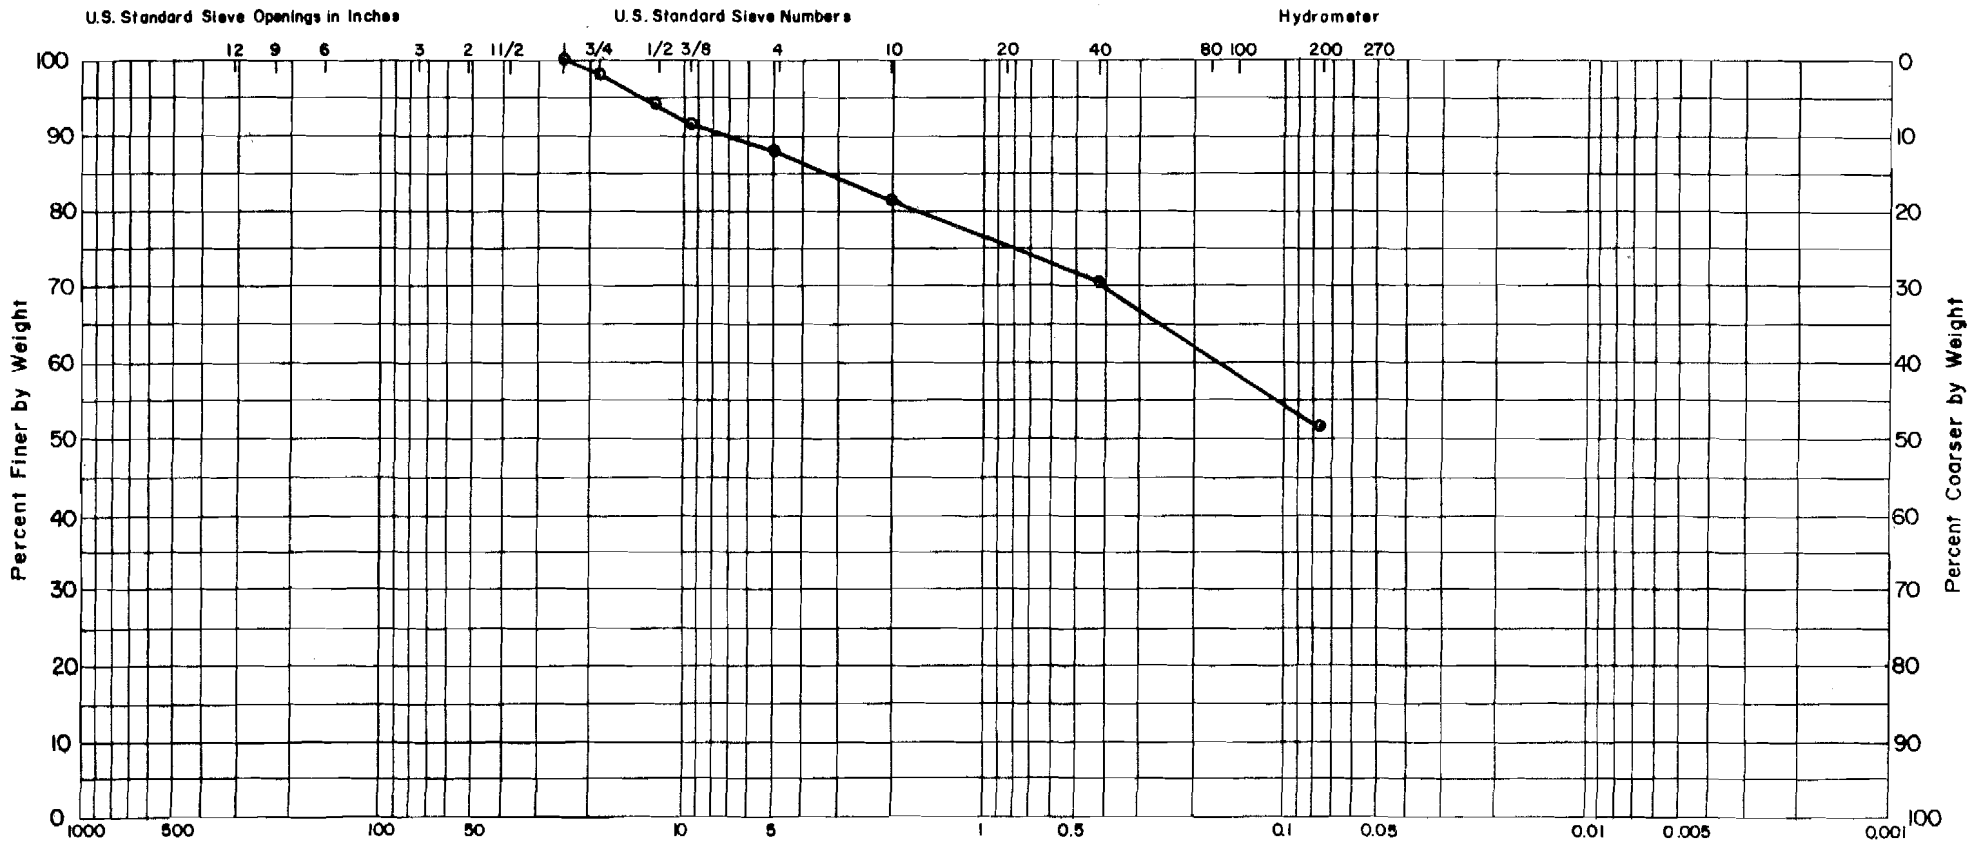
BORROW AREA H
 AUGER HOLE AH-H7

SAMPLE NO.	MOISTURE CONTENT	DRY DENSITY	LL	PI	CLASSIFICATION & DESCRIPTION	
AH-H7 #5,6	14,17		17	4	ML-CL	SANDY SILT WITH TRACE GRAVEL AND CLAY

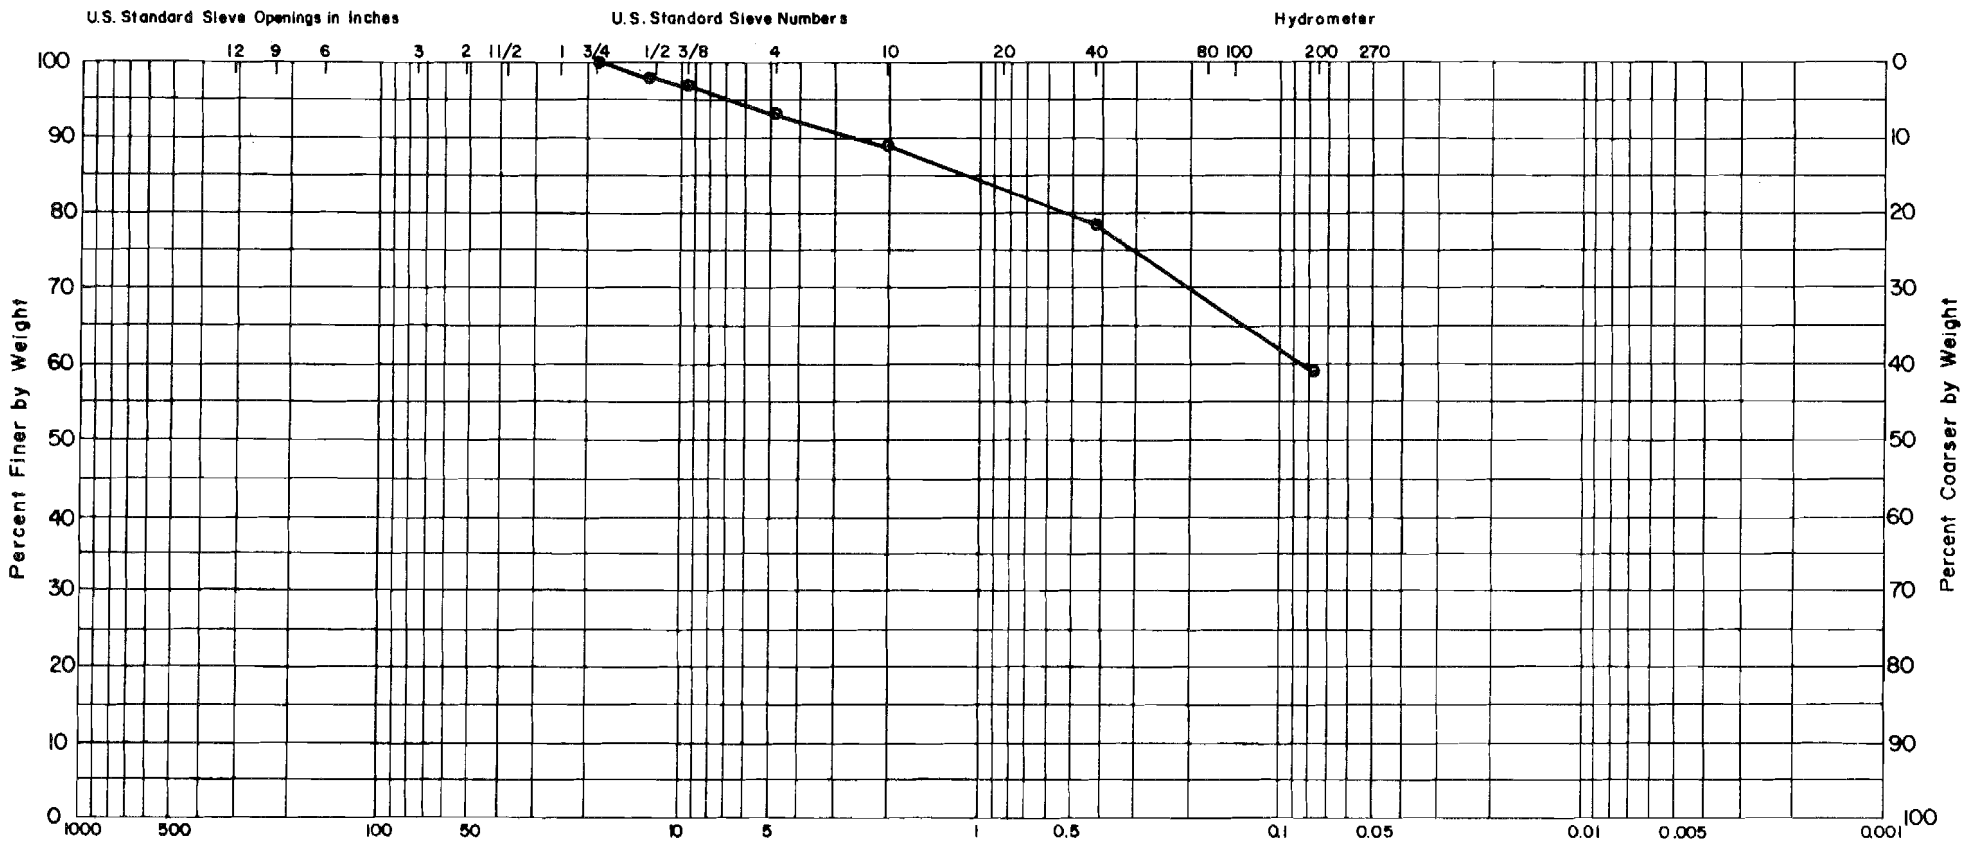
BORROW AREA H
AUGER HOLE AH-H7

SAMPLE NO.	MOISTURE CONTENT	DRY DENSITY	LL	PI	CLASSIFICATION & DESCRIPTION
AH-H7 #7	16		29	14	CL SANDY SILT WITH SOME CLAY AND TRACE GRAVEL

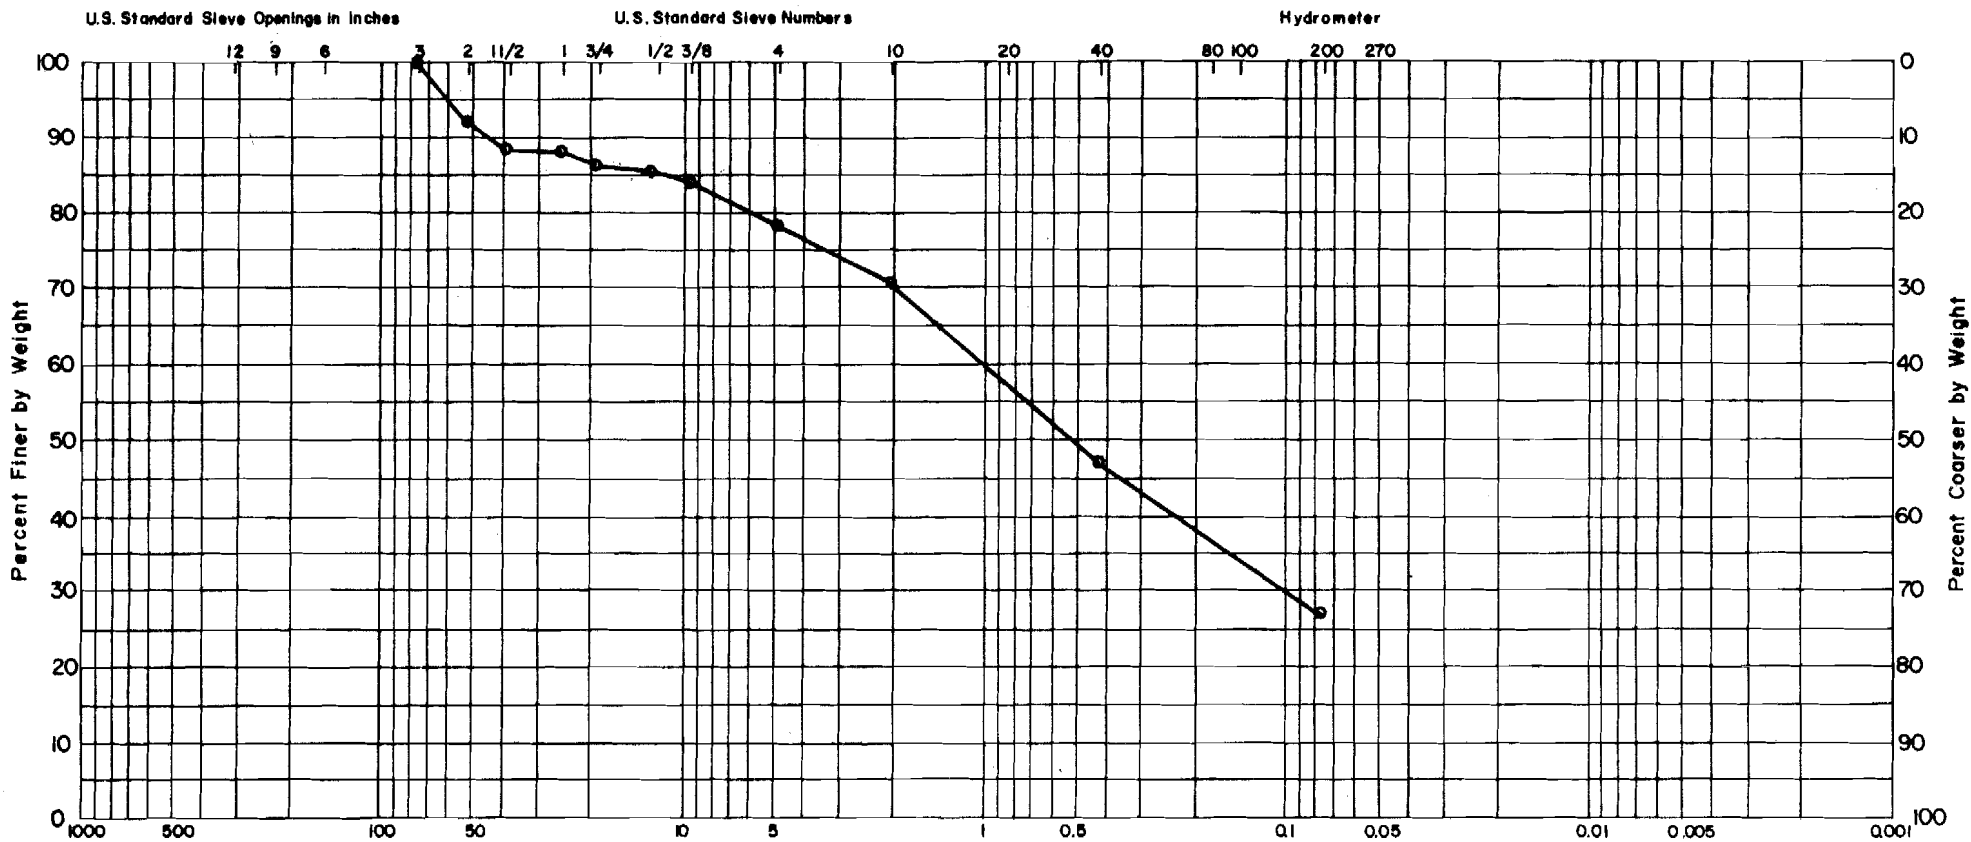
BORROW AREA H
 AUGER HOLE AH-H7

SAMPLE NO.	MOISTURE CONTENT	DRY DENSITY	LL	PI	CLASSIFICATION & DESCRIPTION
AH-H7 #9,10	13, 13		33	19	SC SAND WITH SOME CLAY, GRAVEL, AND SILT

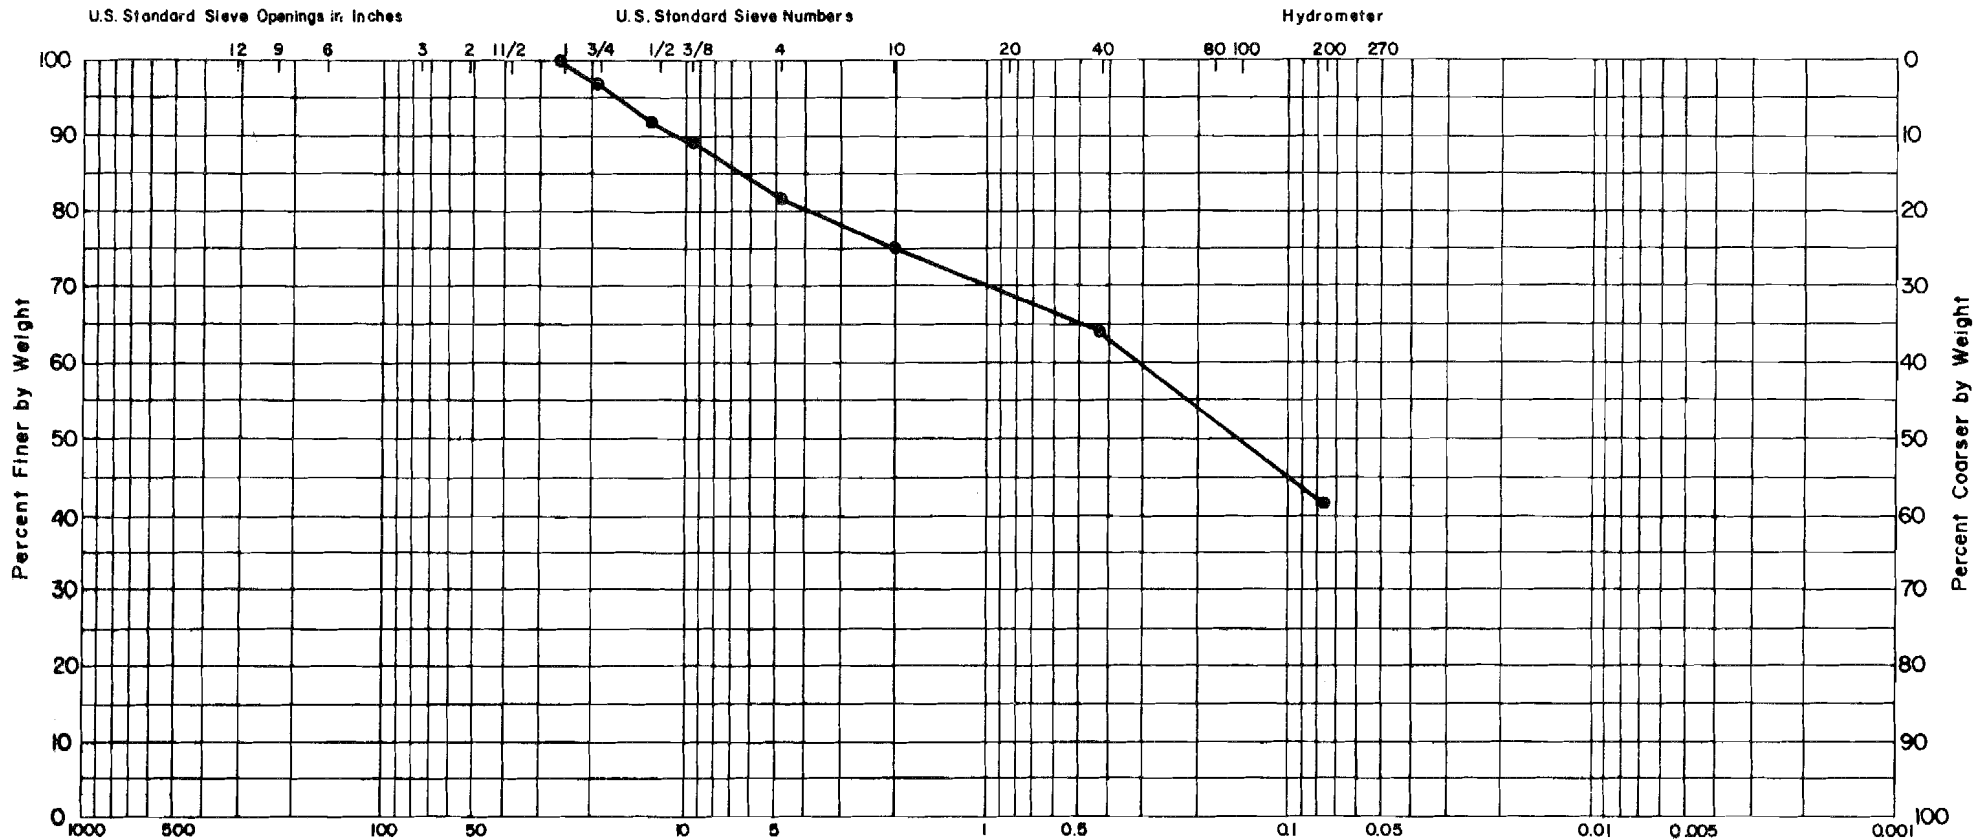
BORROW AREA H
 AUGER HOLE -AH-H8

SAMPLE NO.	MOISTURE CONTENT	DRY DENSITY	LL	PI	CLASSIFICATION & DESCRIPTION
AH-H8 #5,6	12,13		25	11	SC SAND WITH SOME SILT, GRAVEL, AND CLAY

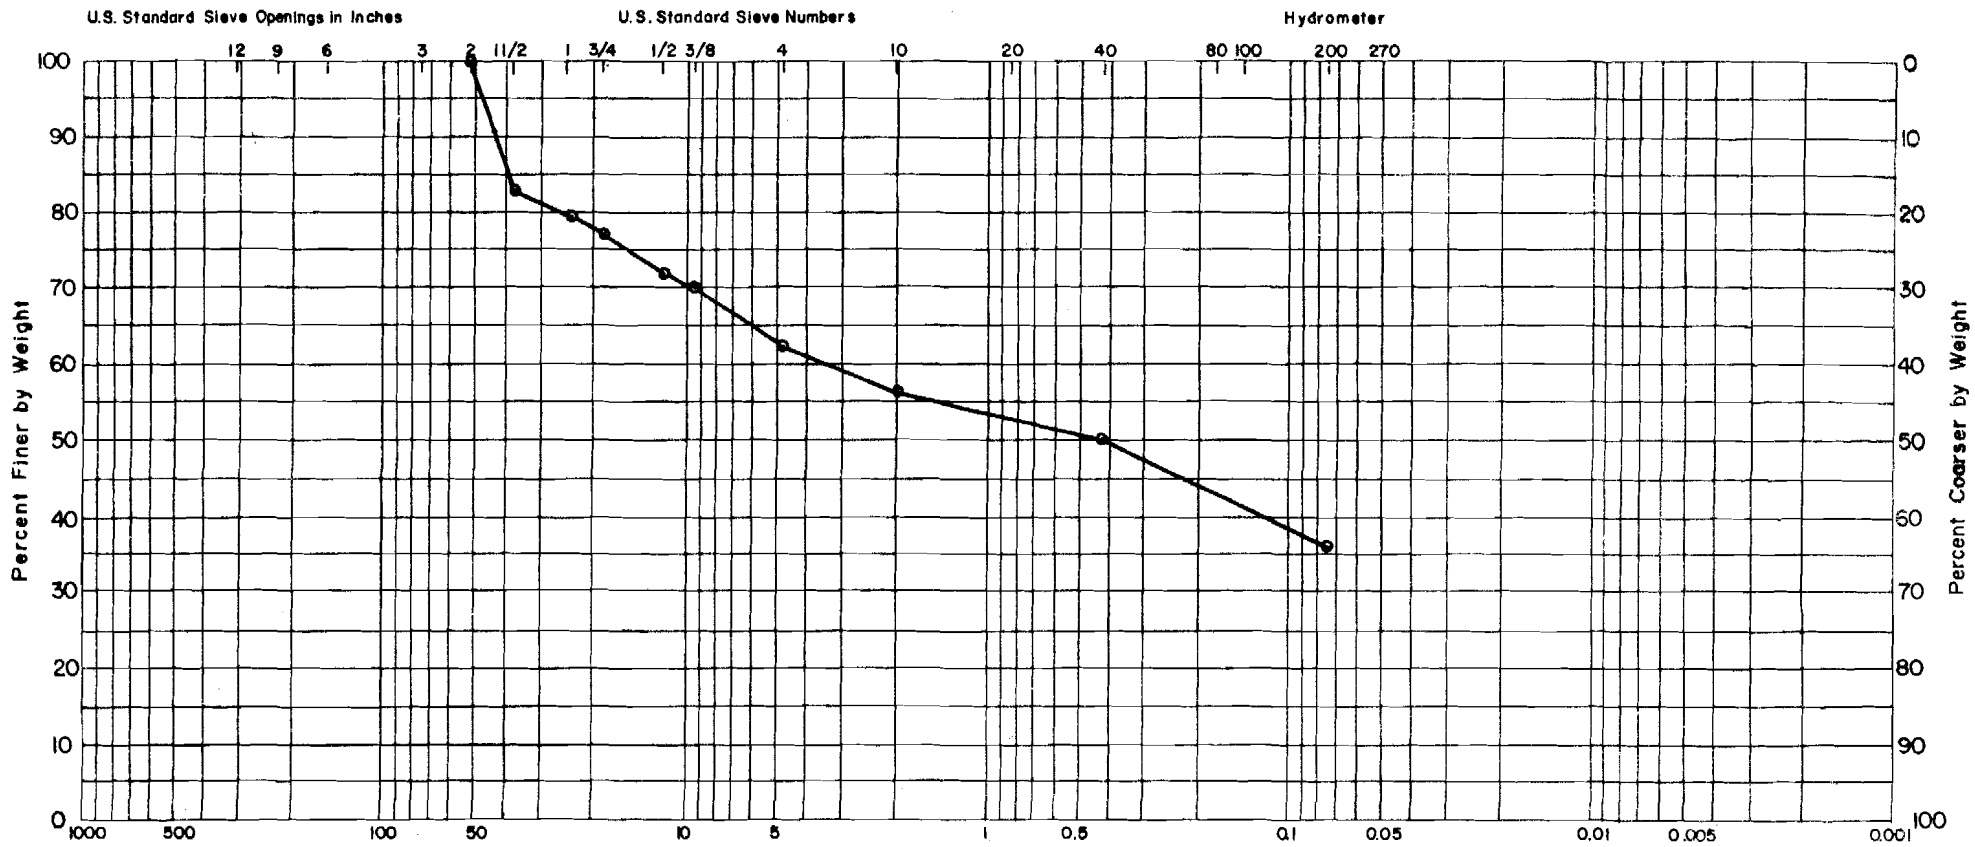
BORROW AREA H
AUGER HOLE AH-H8

SAMPLE NO.	MOISTURE CONTENT	DRY DENSITY	LL	PI	CLASSIFICATION & DESCRIPTION
AH-H8 #7	7		21	7	GC-GM SILTY GRAVEL WITH SOME SAND, TRACE CLAY
