SUSITNA HYDROELECTRIC PROJECT

1980 - 81 GEOTECHNICAL REPORT

VOLUME 2
APPENDIX A-F
FINAL DRAFT

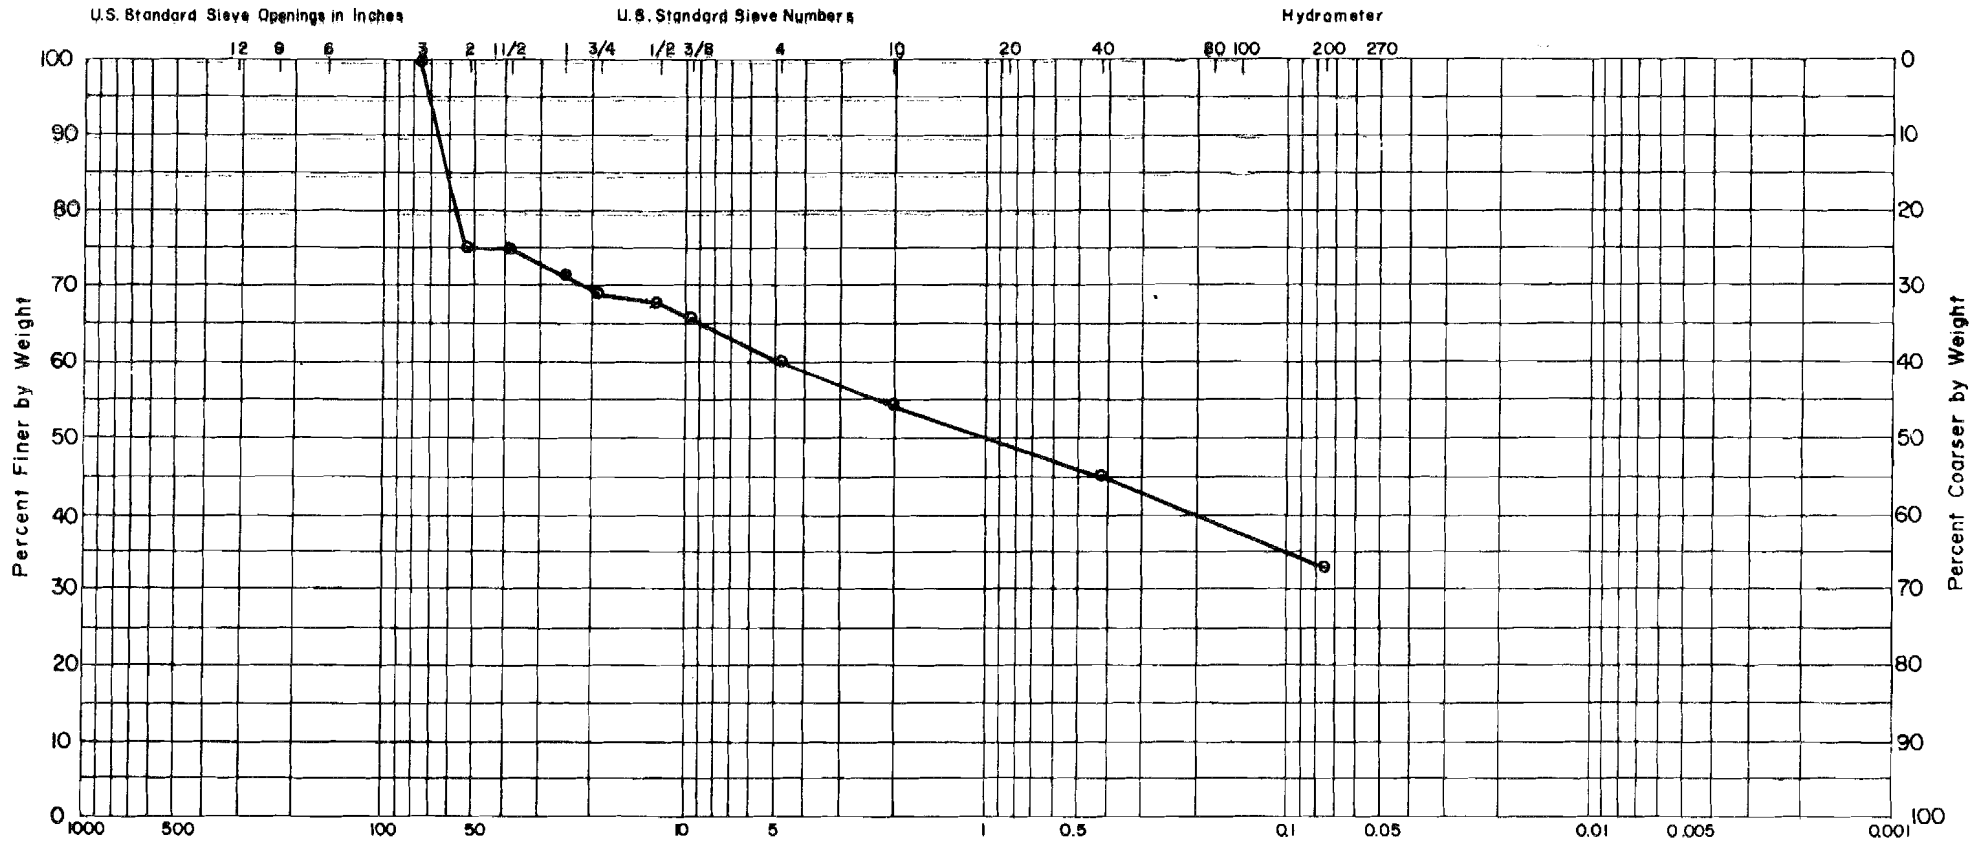
SAMPLE NO.	MOISTURE CONTENT	DRY DENSITY	LL	PI	CLASSIFICATION & DESCRIPTION	
AH-H8 #8,9	6,6		21	7	GC-GM	GRAVEL WITH SOME SAND, SILT, AND TRACE CLAY

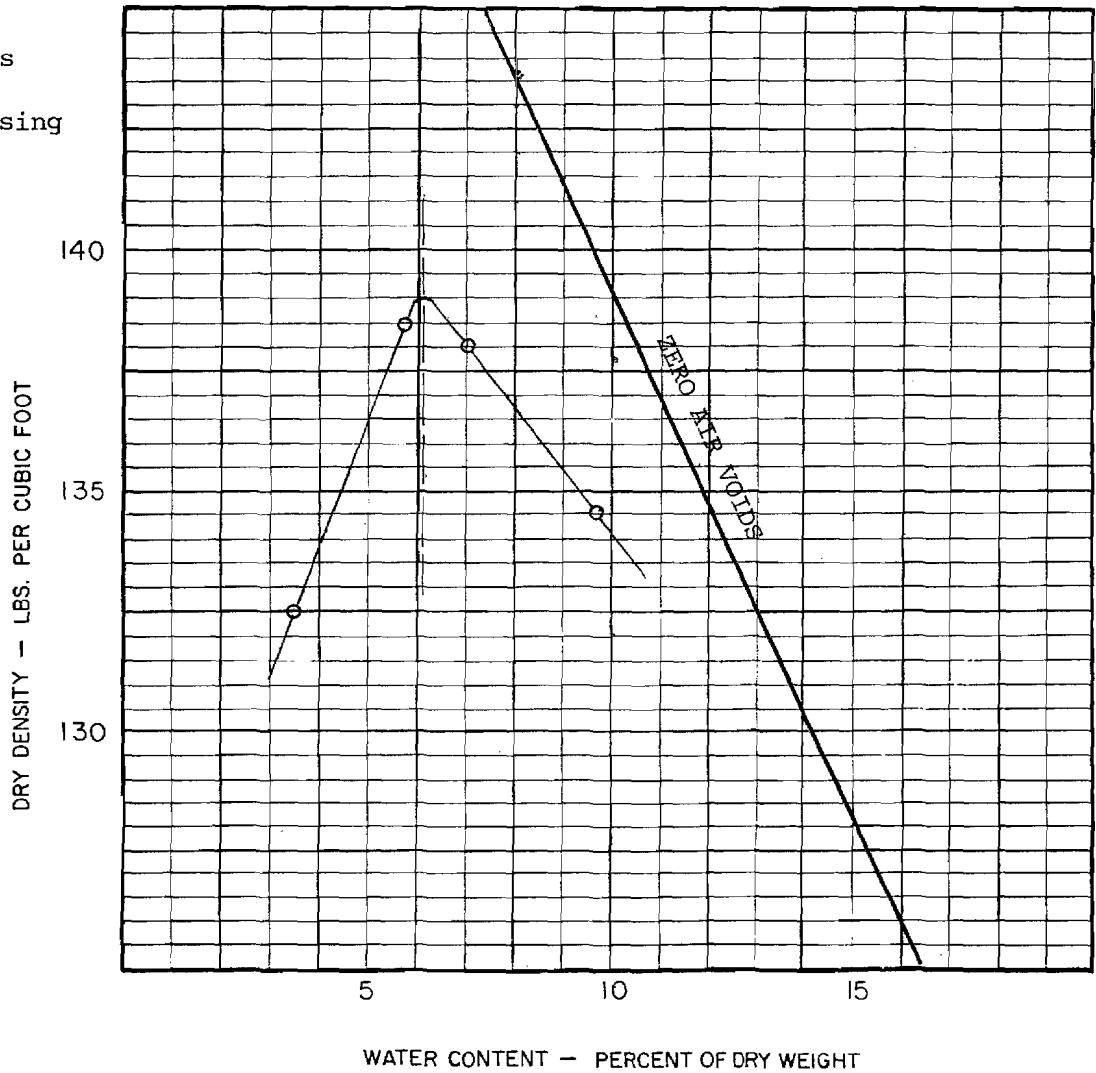
Sieve Analysis

Size	% Passing
2 "	100
1 1/2 "	95
1 "	88
3/4 "	84
1/2 "	81
3/8 "	78
# 4	71
# 10	64
# 40	53
#200	38.2
.02mm	24.3
.005	13.6
.002	8.6

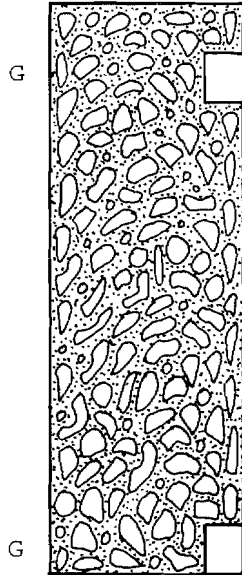
TP-R13
9-19-81

SANDY GRAVEL
Brown

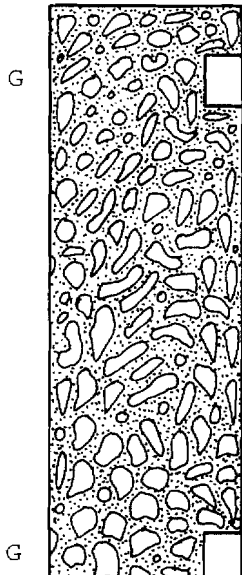
TP-R14
9-19-81

① GW

SANDY GRAVEL
Brown

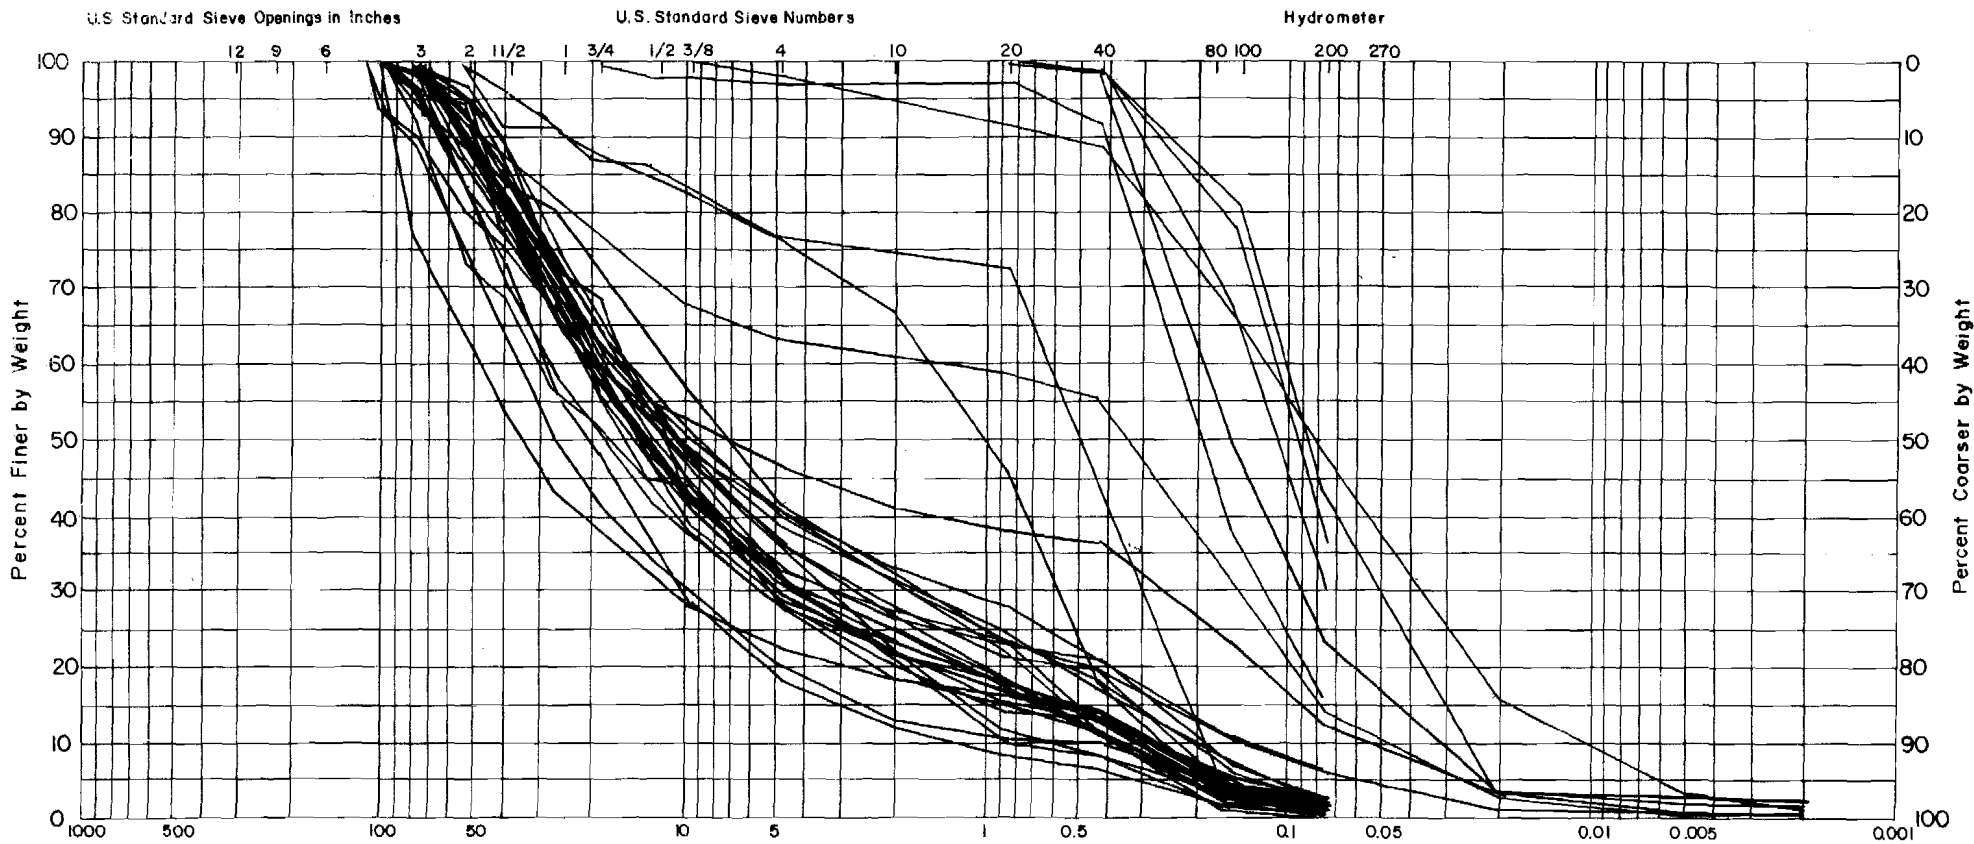
RIVER ALLUVIUM
COMPOSITE GRADATION CURVE

REMARKS: River Alluvium Test Pits, Watana Area

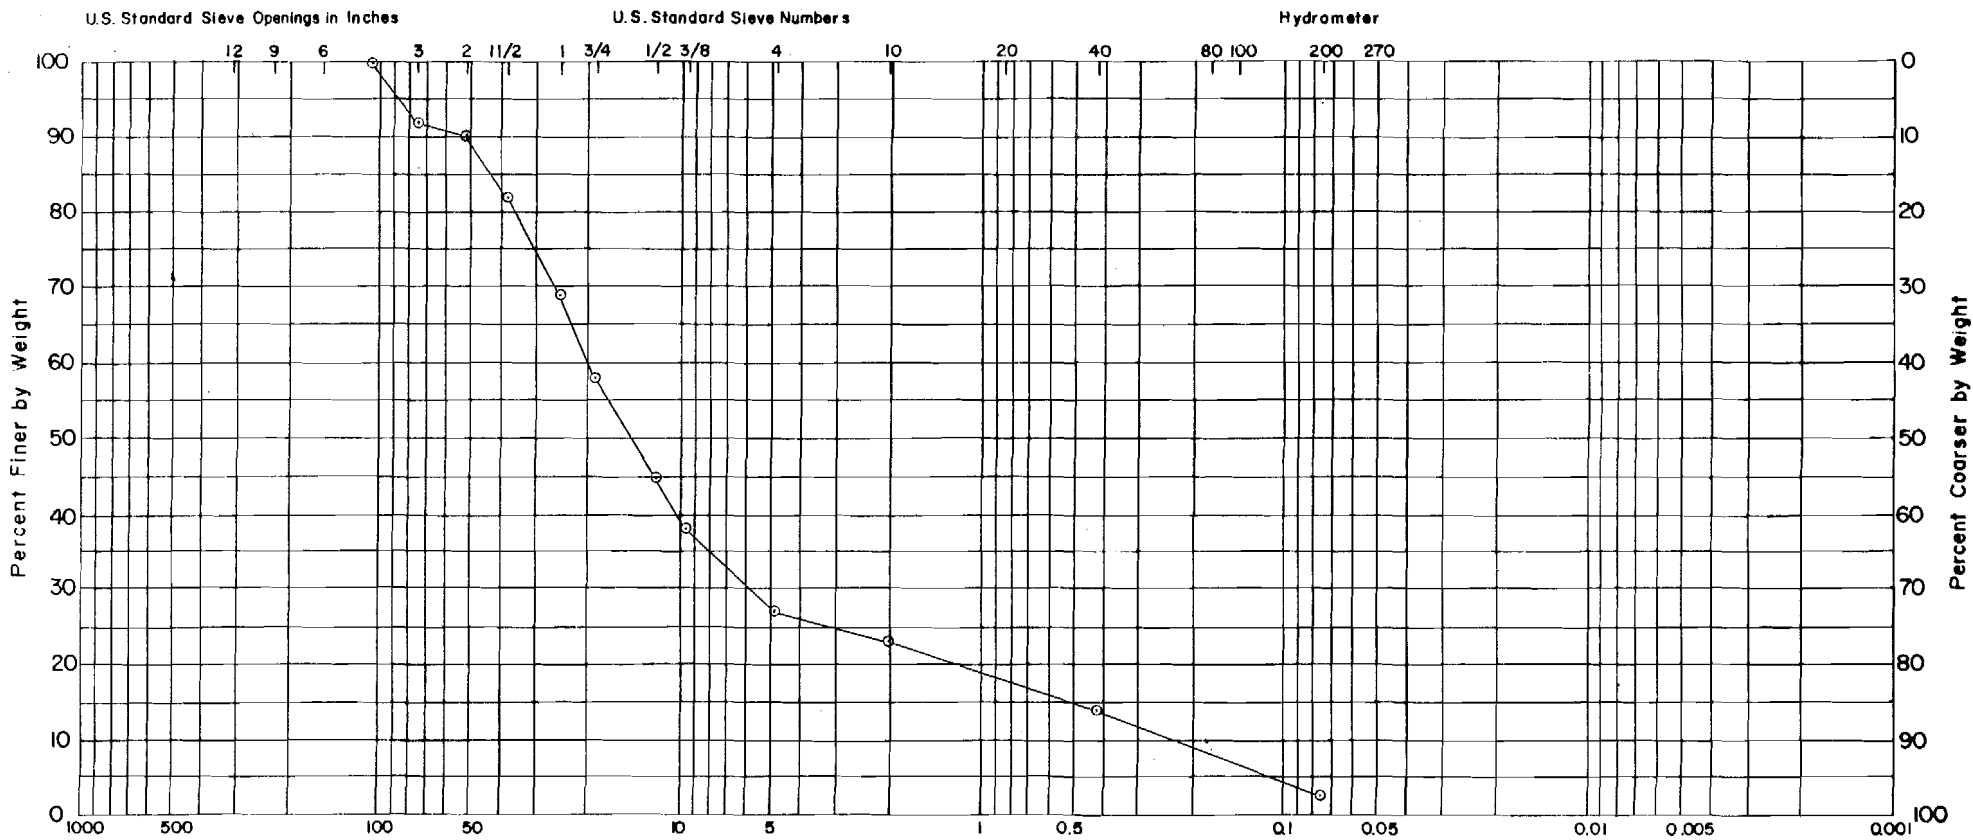
STREAM ALUVIUM

SAMPLE NO.	MOISTURE CONTENT	DRY DENSITY	LL	PI	CLASSIFICATION & DESCRIPTION	
W-80-302					GP	SANDY GRAVEL W/TRACE SILT
(Grab Sample)						Poorly Graded

DESCRIPTION		4"	3"	2"	1½"	1"	¾"	½"	⅜"	#4	#10	#40	#200	.02	.005	.002	% Moist.	LL	PI	Unified Class.	
STREAM ALLUVIUM	W-80-302	100	92	90	82	69	58	45	38	27	23	14	2.6							GP	
	(Crab Sample)

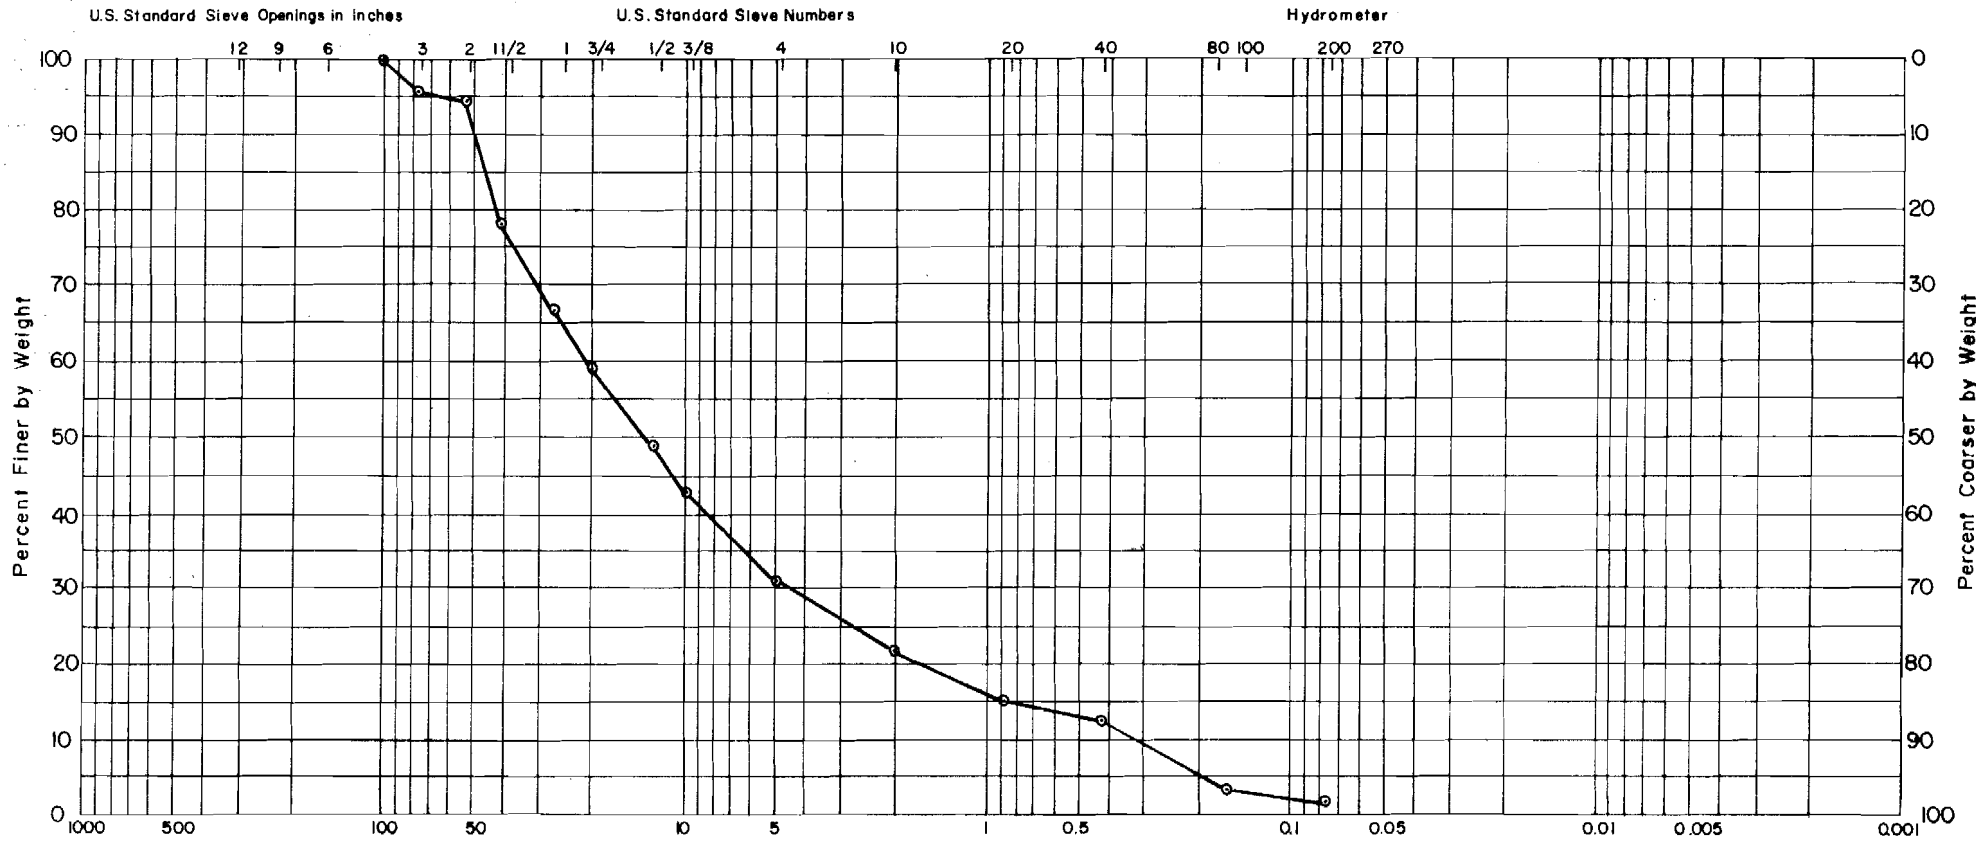
RIVER ALLUVIUM
TEST PIT TP-R1

SAMPLE NO.	MOISTURE CONTENT	DRY DENSITY	LL	PI	CLASSIFICATION & DESCRIPTION
TP-R1 #2				GP	GRAVEL WITH SOME SAND AND SCATTERED COBBLES

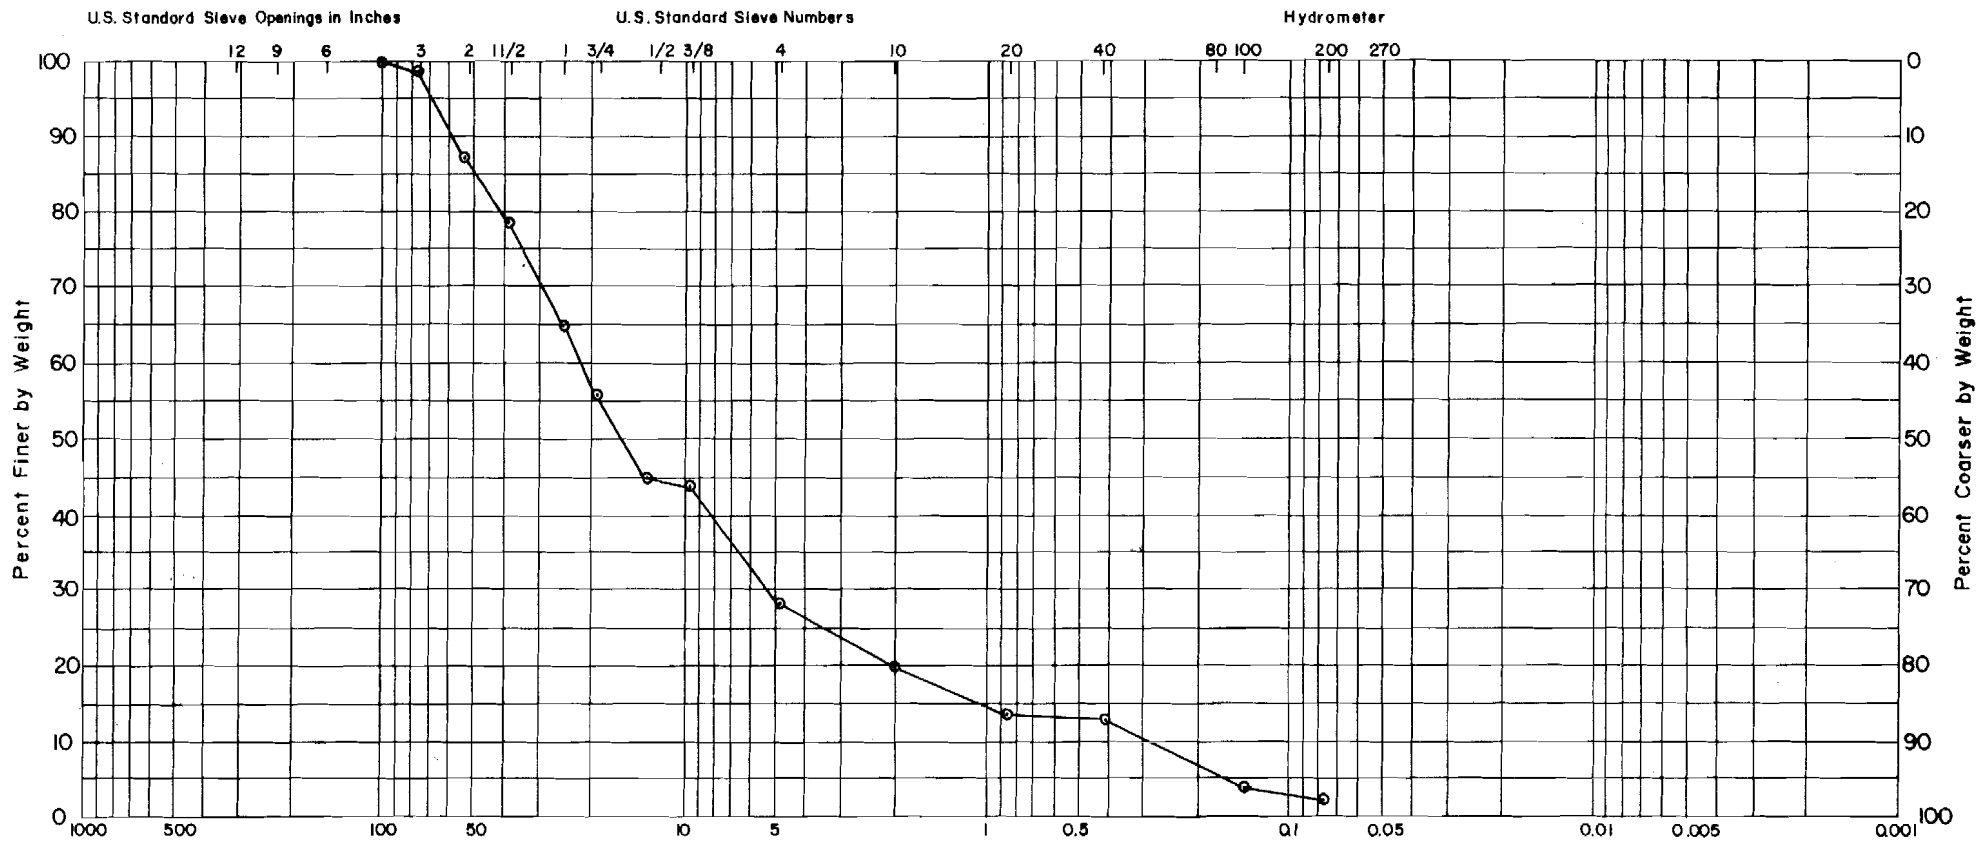
RIVER ALLUVIUM
TEST PIT TP-R1

SAMPLE NO.	MOISTURE CONTENT	DRY DENSITY	LL	PI	CLASSIFICATION & DESCRIPTION
TP-R1 #4				GP	GRAVEL WITH SOME SAND AND SCATTERED COBBLES

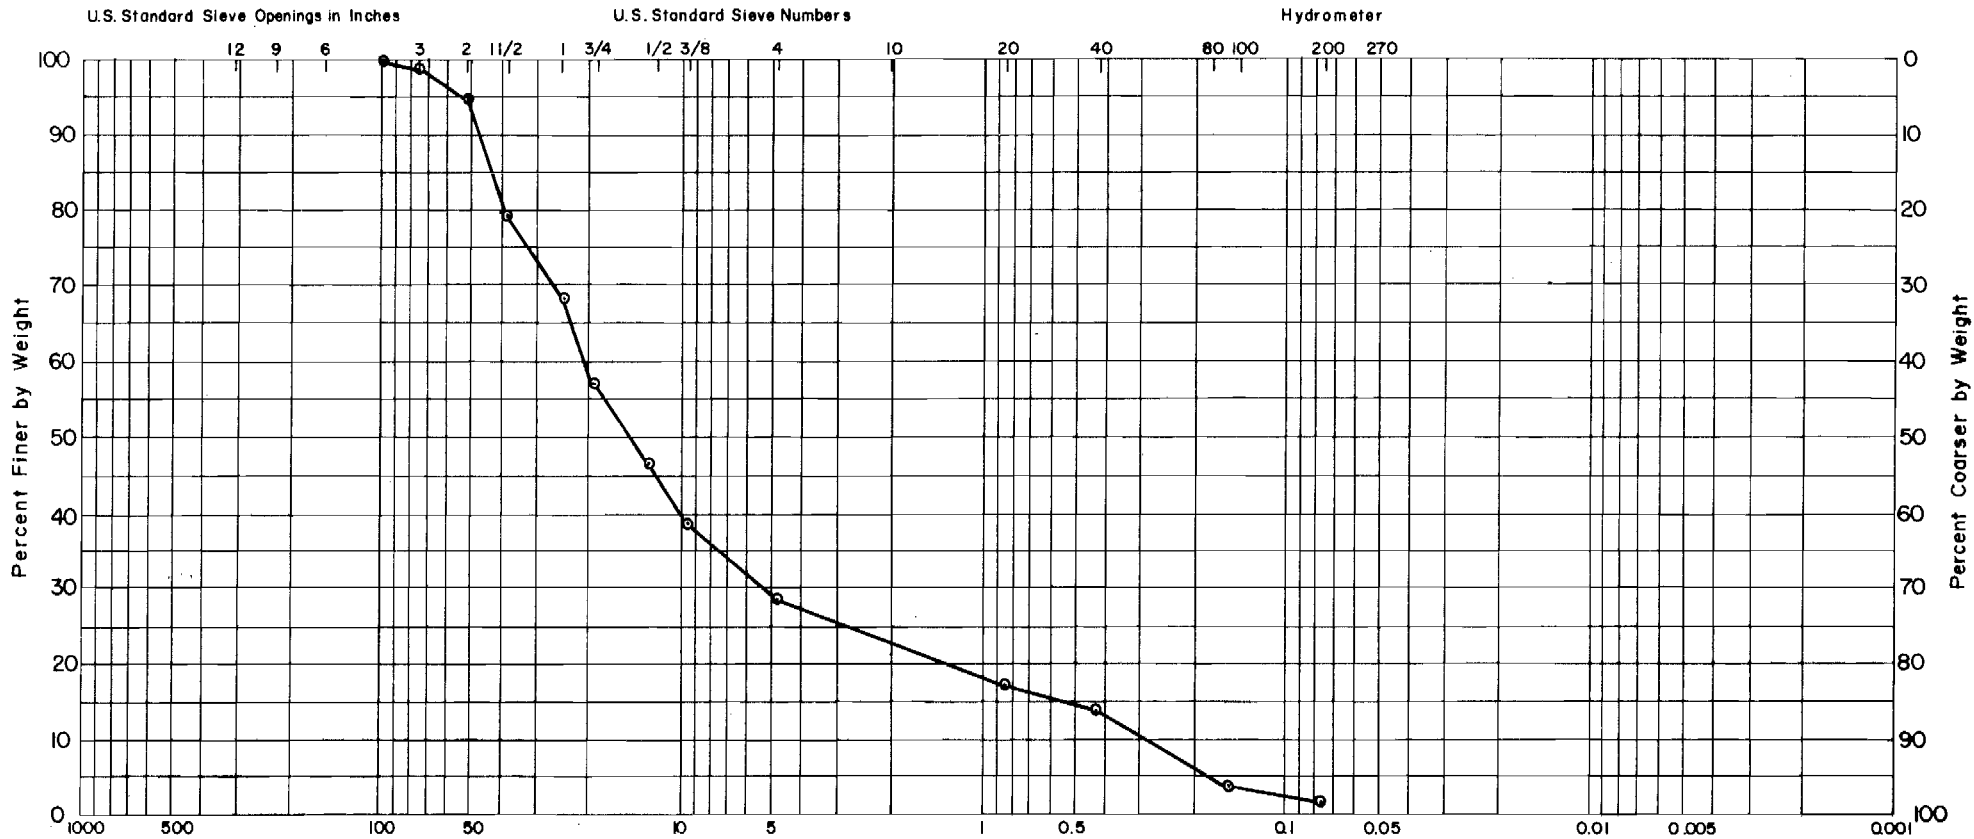
RIVER ALLUVIUM
TEST PIT TP-R1

SAMPLE NO.	MOISTURE CONTENT	DRY DENSITY	LL	PI	CLASSIFICATION & DESCRIPTION
TP-R1 #5				GP	GRAVEL WITH SOME SAND AND SCATTERED COBBLES

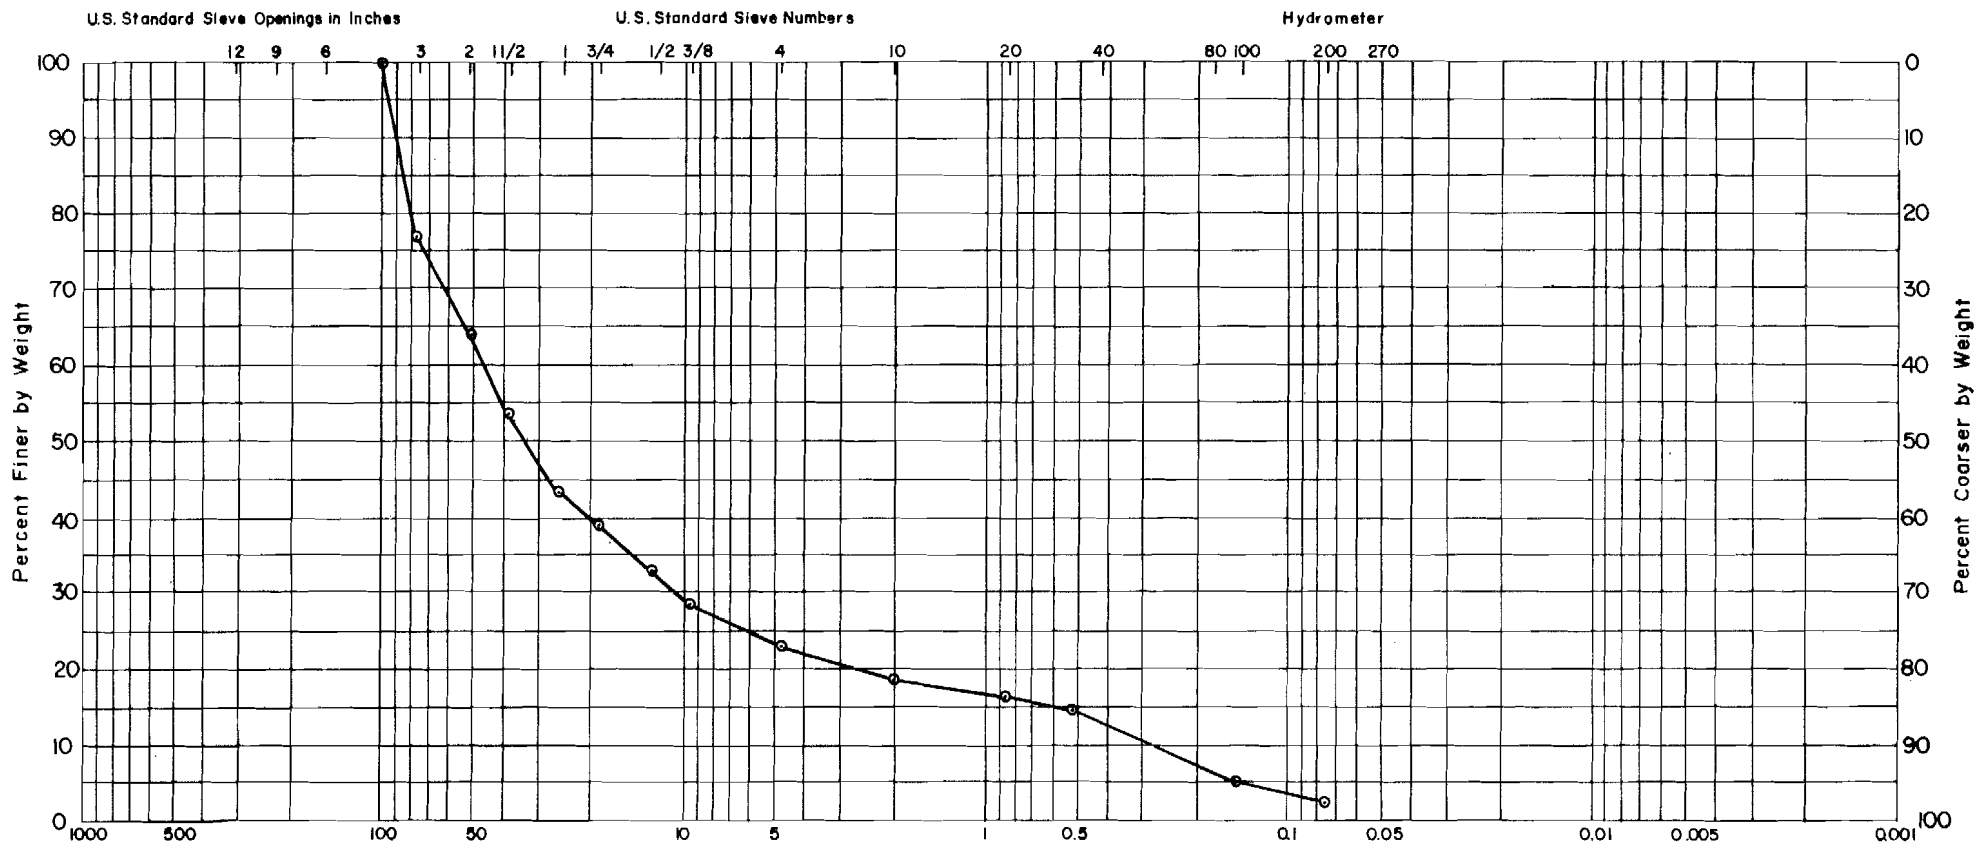
RIVER ALLUVIUM
TEST PIT TP-R2

SAMPLE NO.	MOISTURE CONTENT	DRY DENSITY	LL	PI	CLASSIFICATION & DESCRIPTION
TP-R2 #1				GP	GRAVEL WITH SOME SAND AND SCATTERED COBBLES

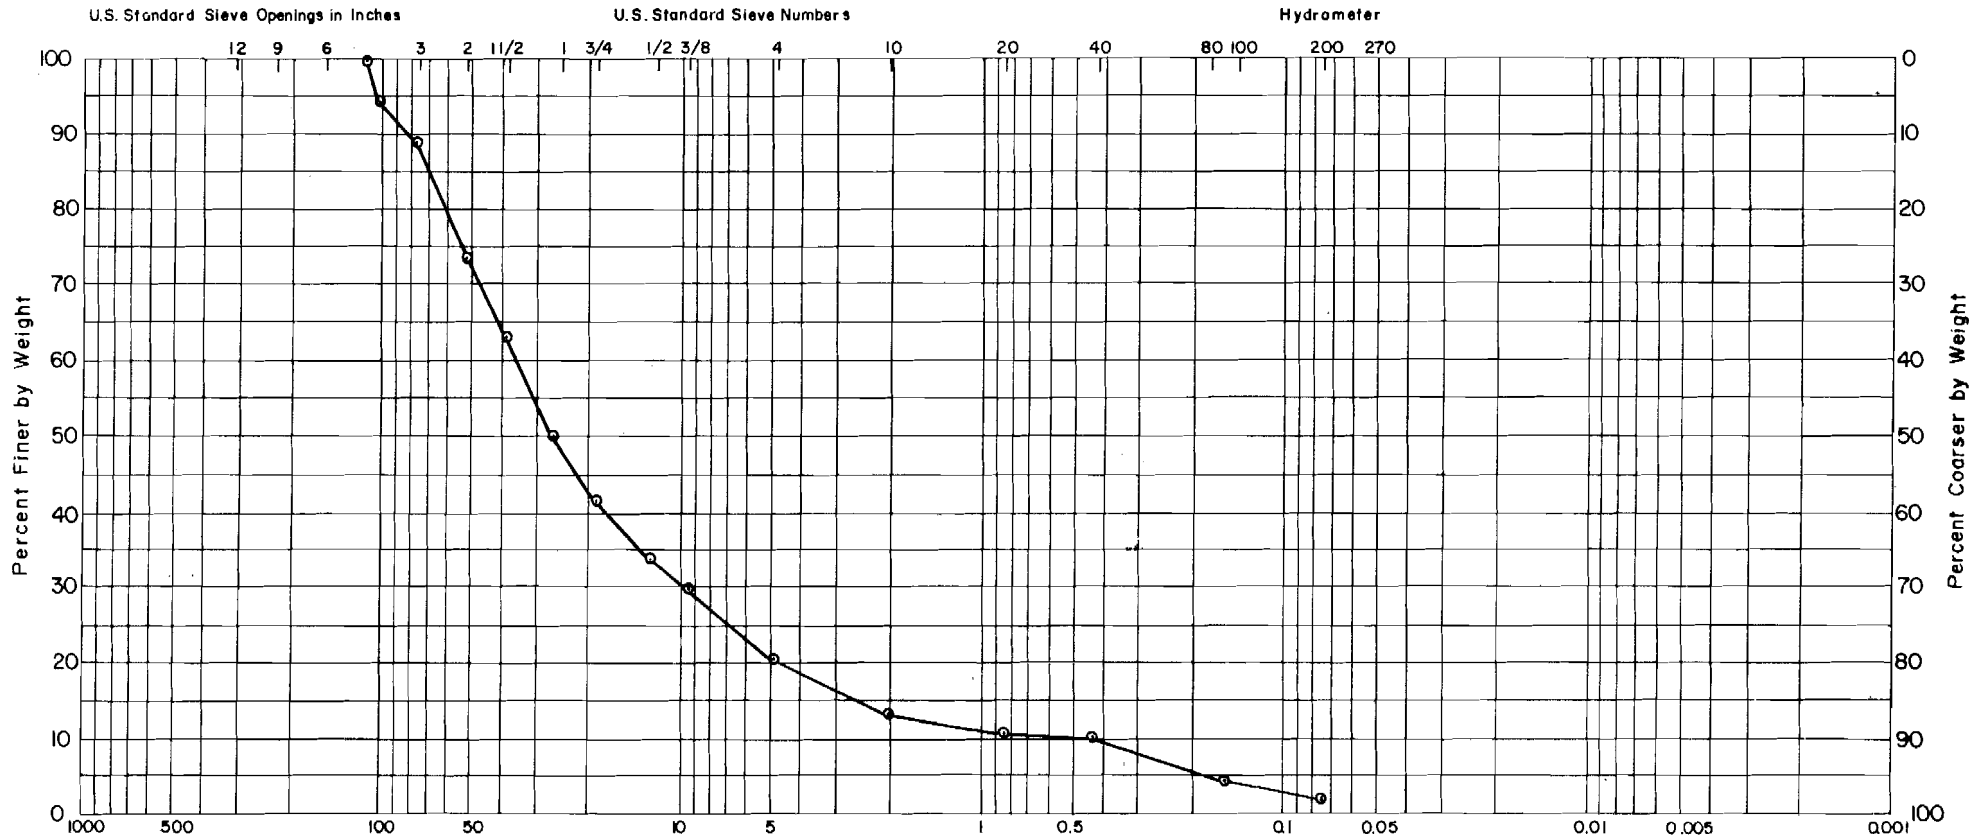
RIVER ALLUVIUM
TEST PIT TP-R2

SAMPLE NO.	MOISTURE CONTENT	DRY DENSITY	LL	PI	CLASSIFICATION & DESCRIPTION
TP-R2. #2					GP GRAVEL WITH SOME SAND AND SCATTERED COBBLES

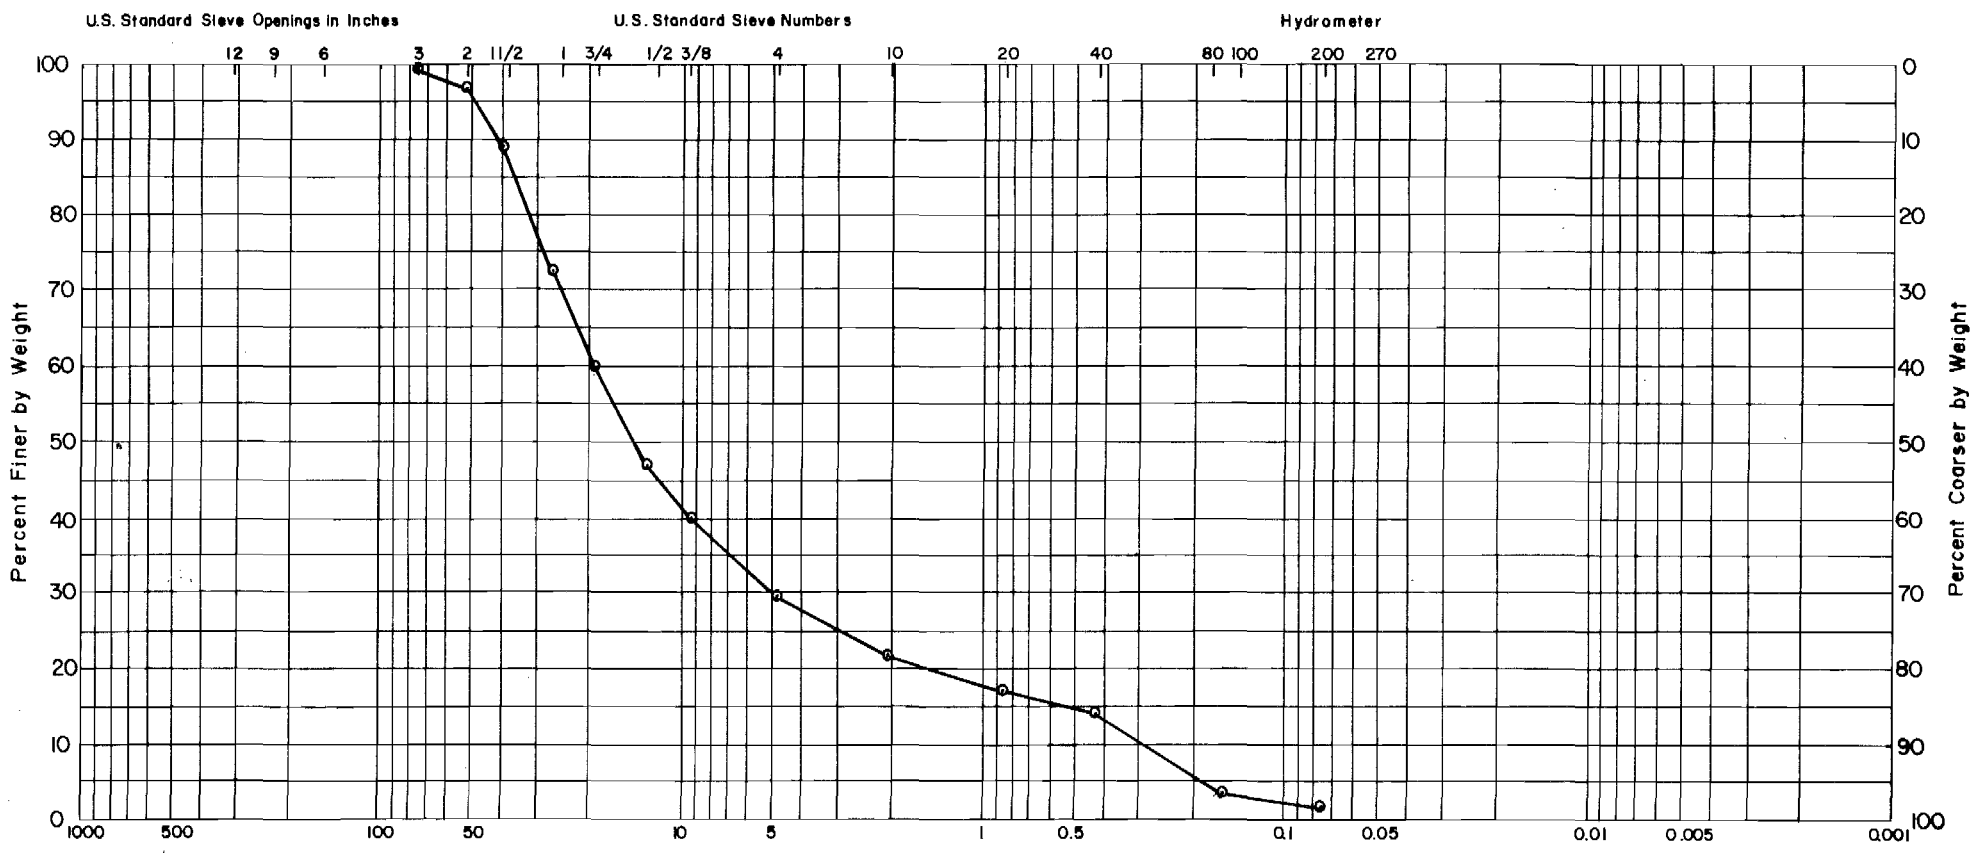
RIVER ALLUVIUM
TEST PIT TP-R3

SAMPLE NO.	MOISTURE CONTENT	DRY DENSITY	LL	PI	CLASSIFICATION & DESCRIPTION
TP-R3 #2					GP GRAVEL WITH SOME SAND

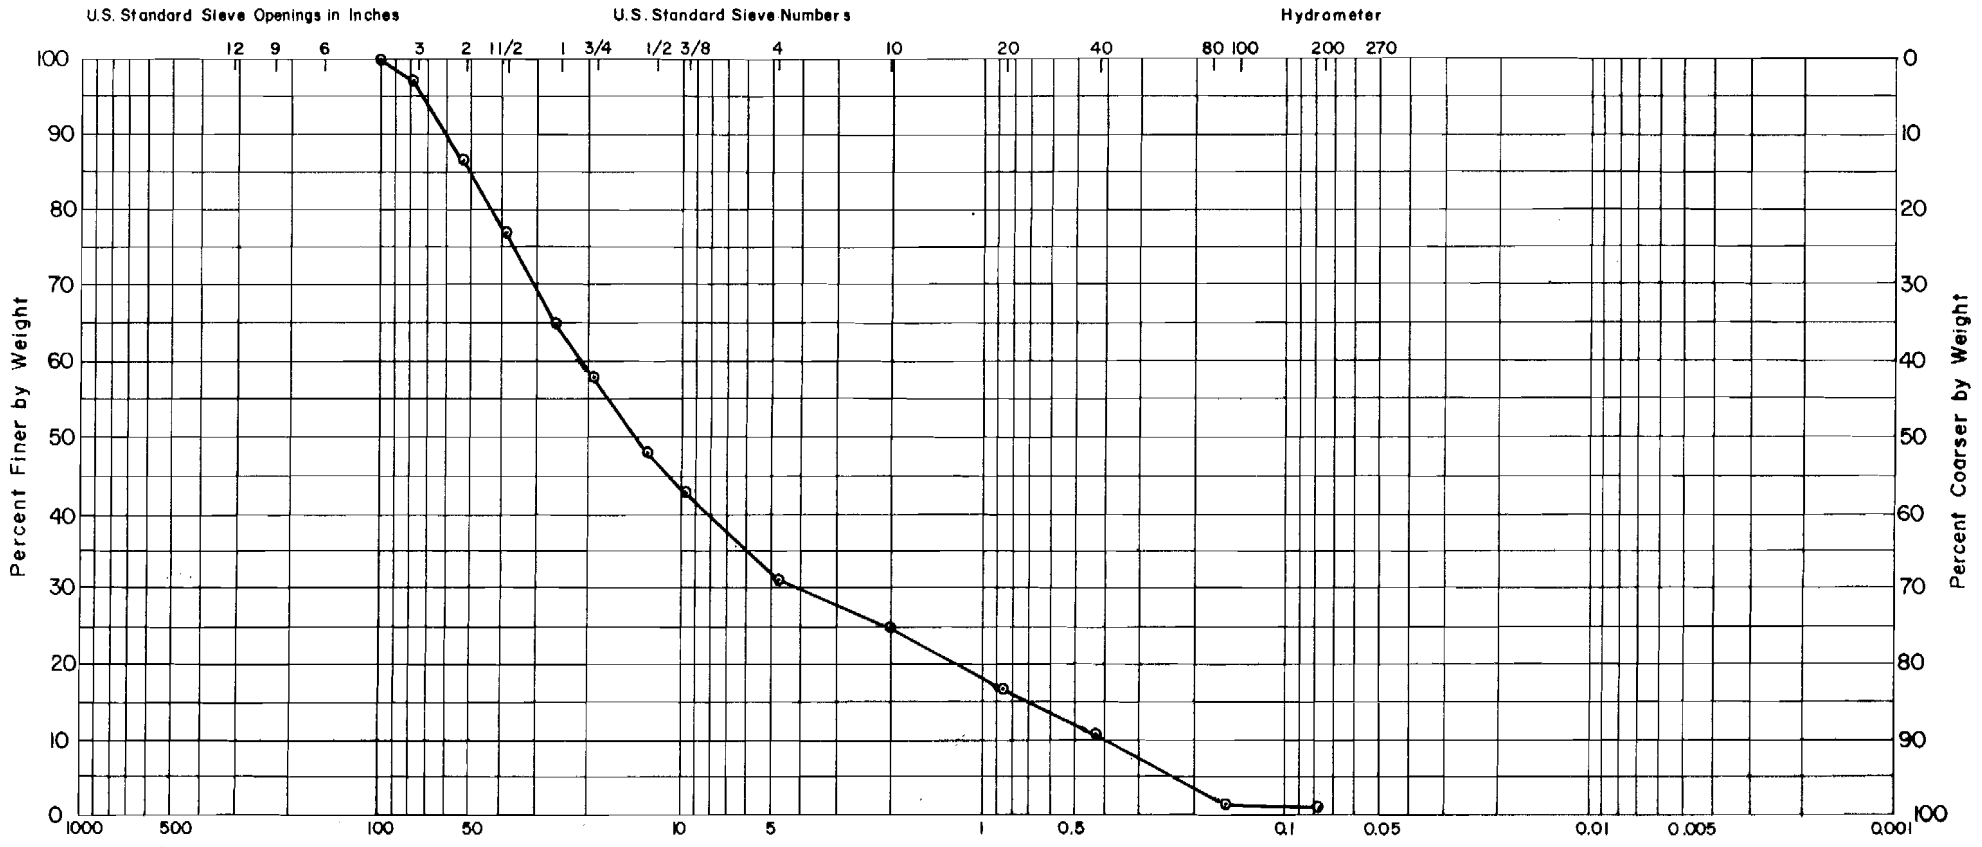
RIVER ALLUVIUM
TEST PIT TP-R4

SAMPLE NO.	MOISTURE CONTENT	DRY DENSITY	LL	PI	CLASSIFICATION & DESCRIPTION
TP-R4 #2					GP SANDY GRAVEL WITH SCATTERED COBBLES

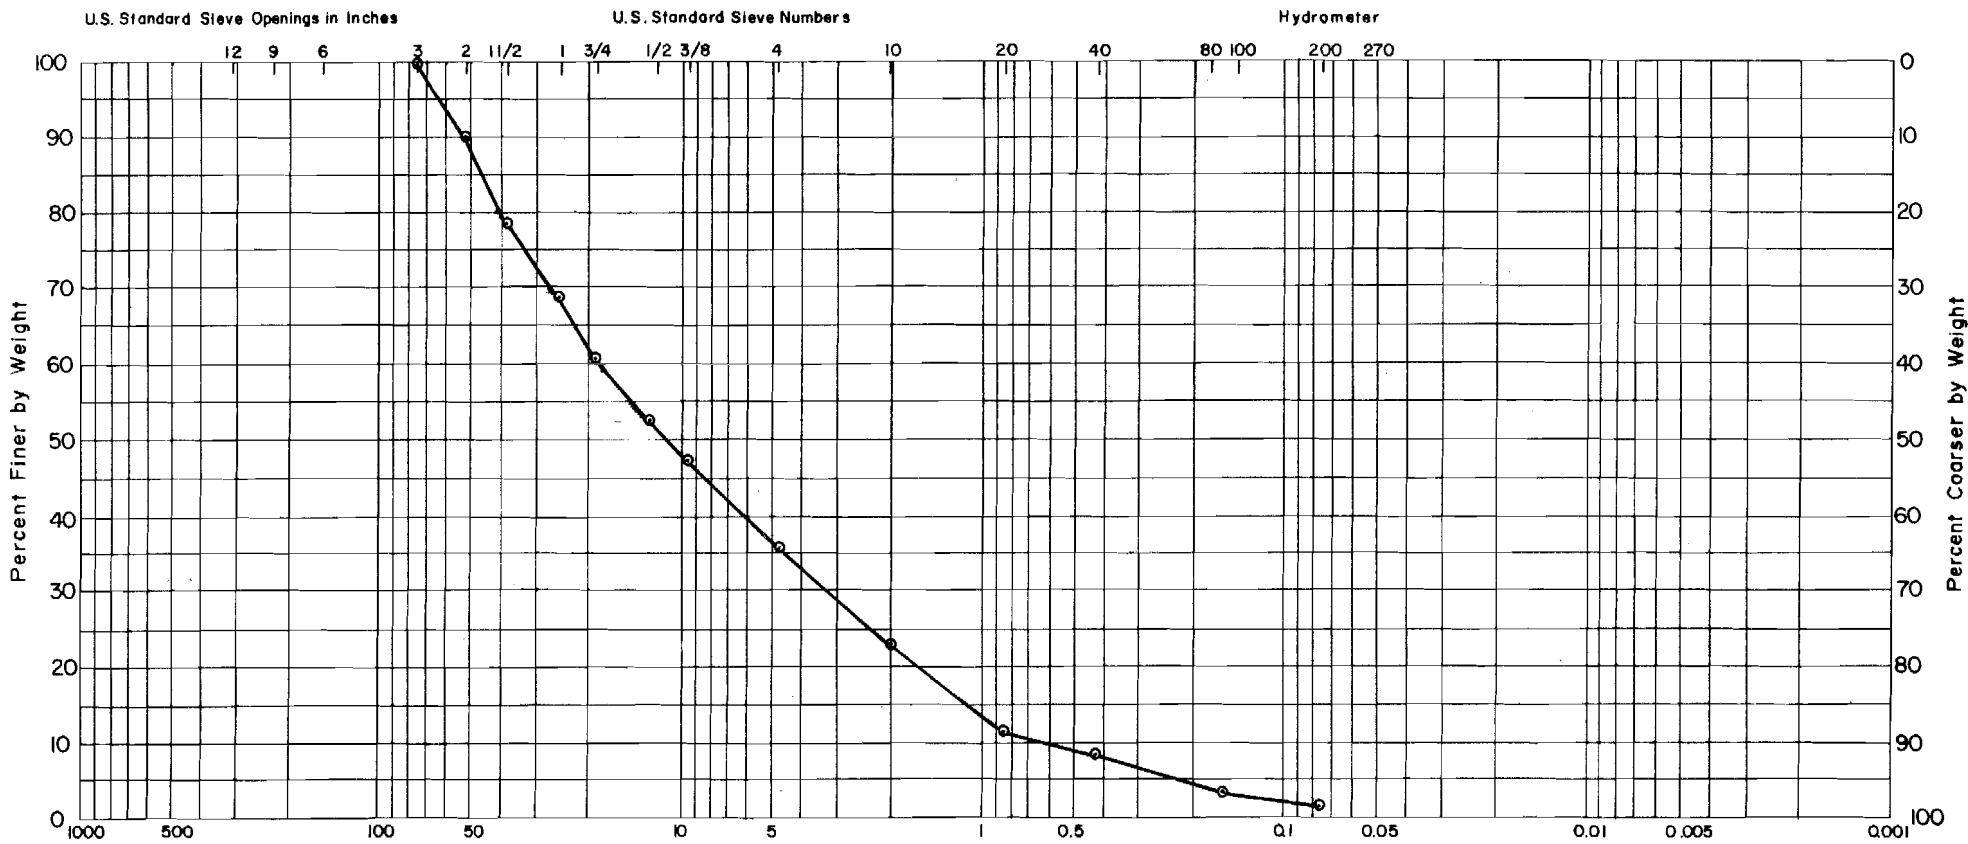
RIVER ALLUVIUM
TEST PIT TP-R5

SAMPLE NO.	MOISTURE CONTENT	DRY DENSITY	LL	PI	CLASSIFICATION & DESCRIPTION
TP-R5 #1				GW	SANDY GRAVEL

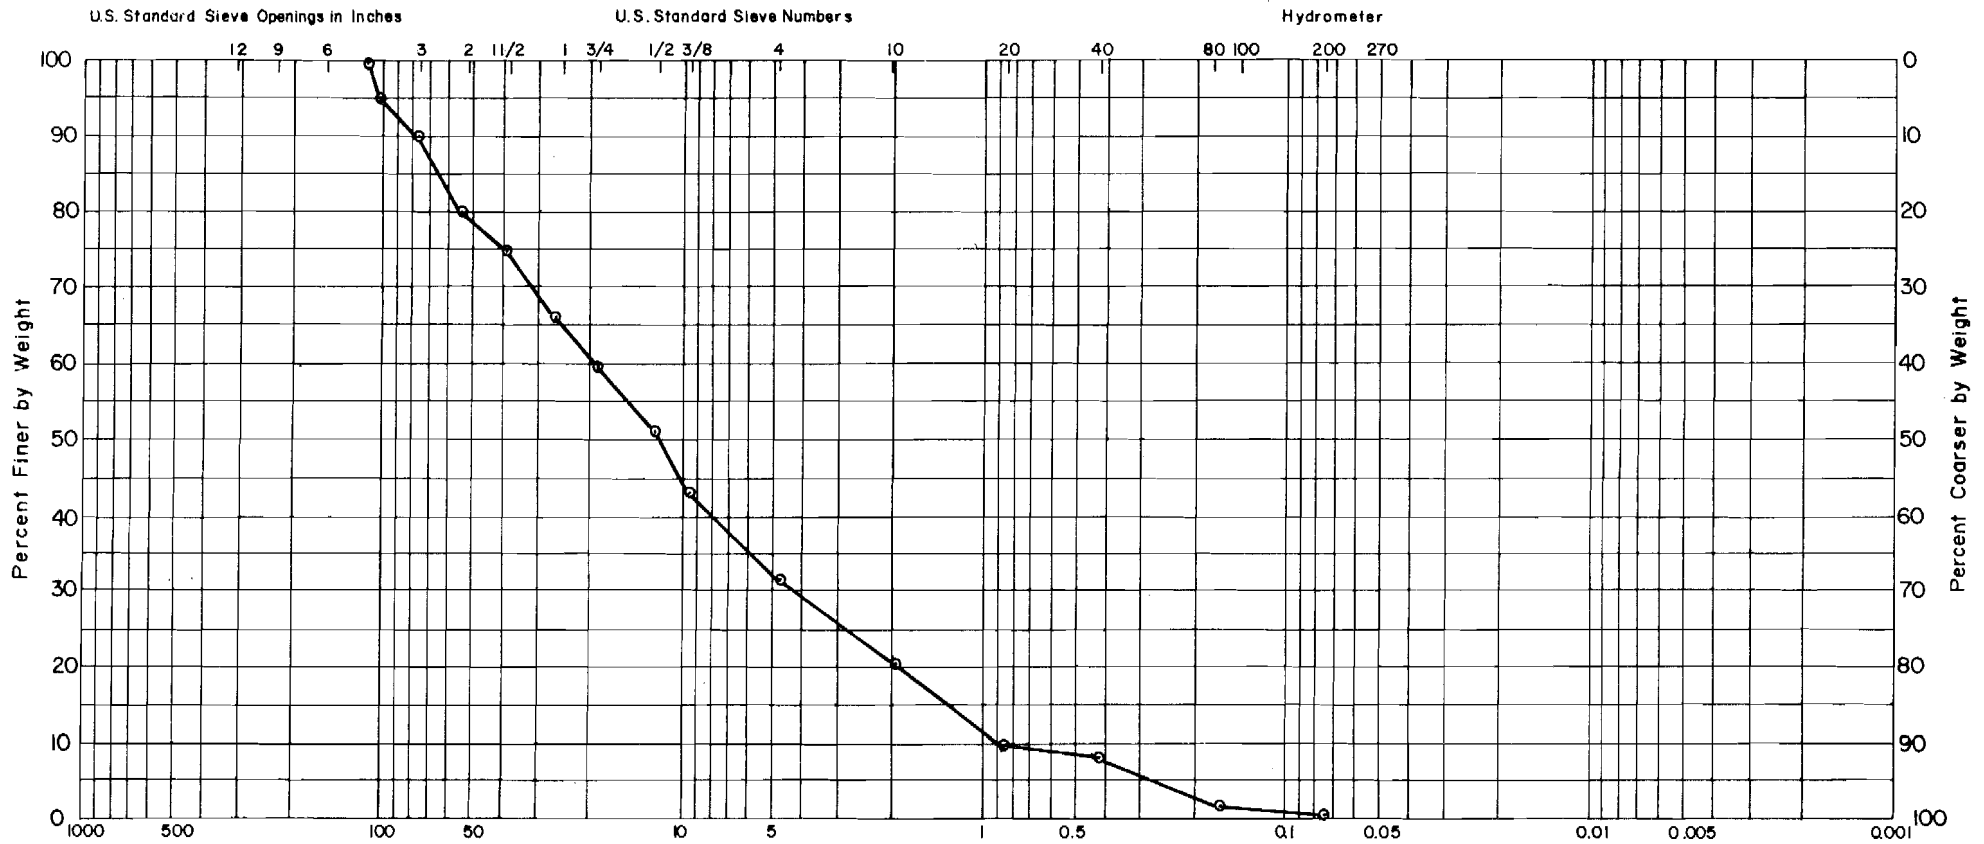
RIVER ALLUVIUM
TEST PIT TP-R5

SAMPLE NO.	MOISTURE CONTENT	DRY DENSITY	LL	PI	CLASSIFICATION & DESCRIPTION
TP-R5 #2				GW	SANDY GRAVEL WITH SCATTERED COBBLES
