SUSITNA HYDROELECTRIC PROJECT

1980 - 81 GEOTECHNICAL REPORT

VOLUME 2
APPENDIX A-F
FINAL DRAFT

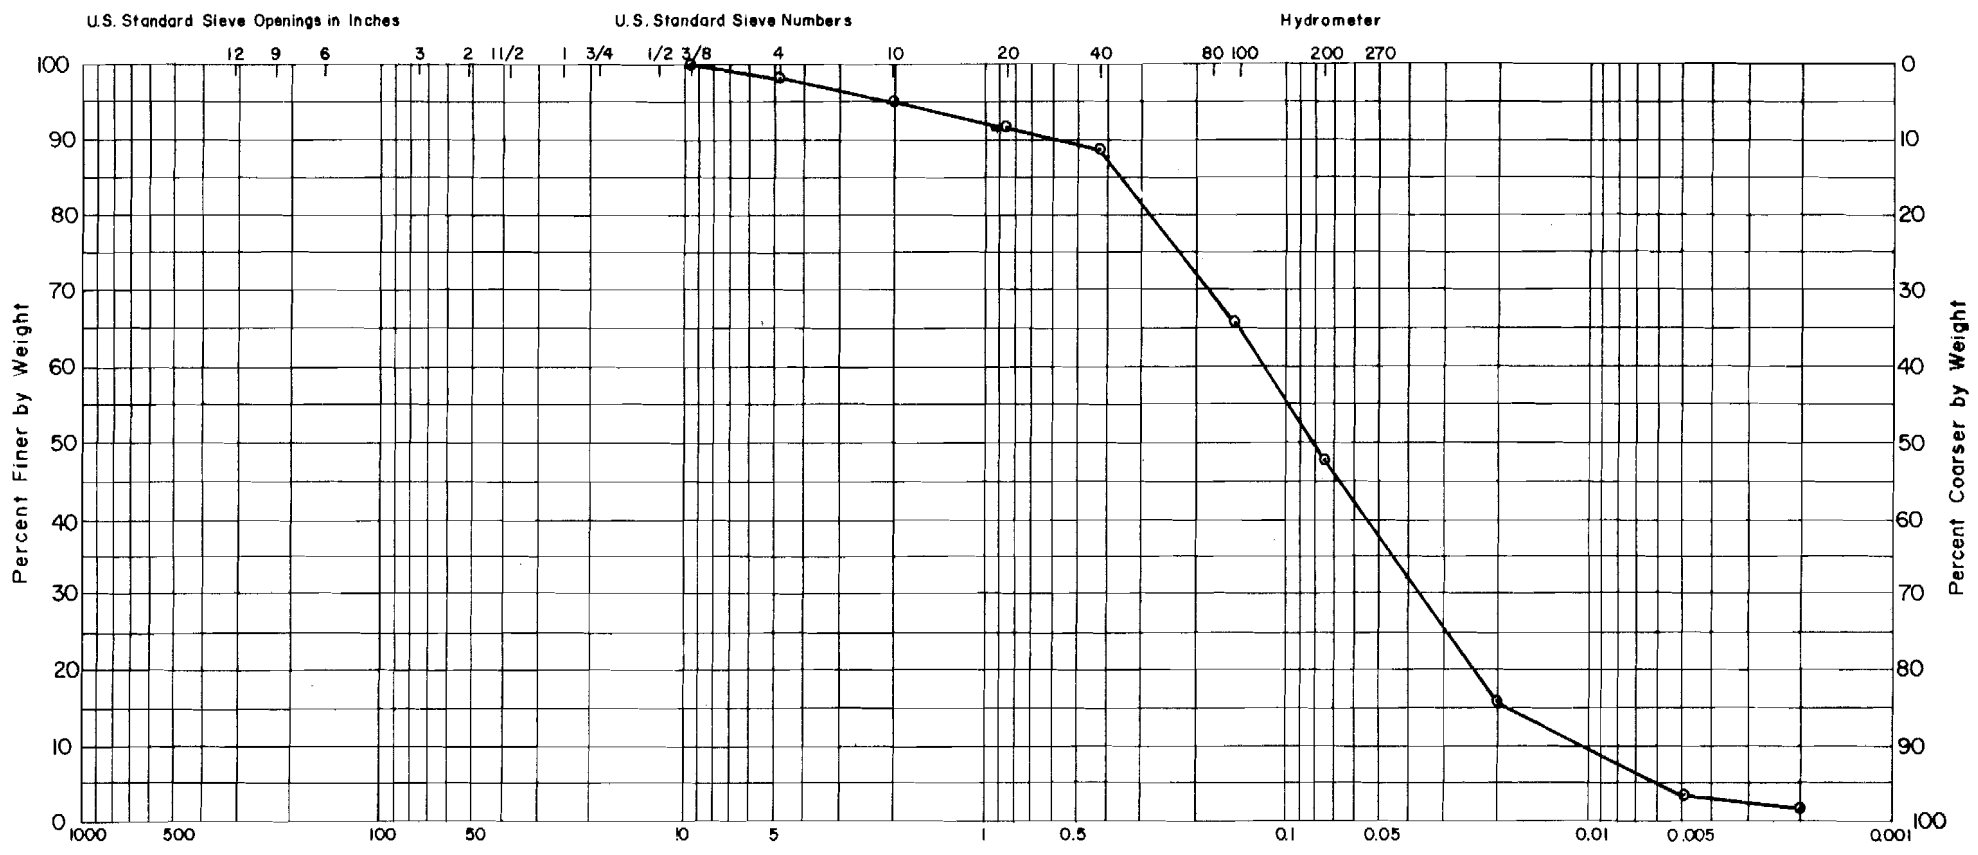
RIVER ALLUVIUM
TEST PIT TP-R6

SAMPLE NO.	MOISTURE CONTENT	DRY DENSITY	LL	PI	CLASSIFICATION & DESCRIPTION
TP-R6 #2				ML-SM	SILTY SAND (FIELD GEOLOGIST NOTES TRACE ORGANICS)

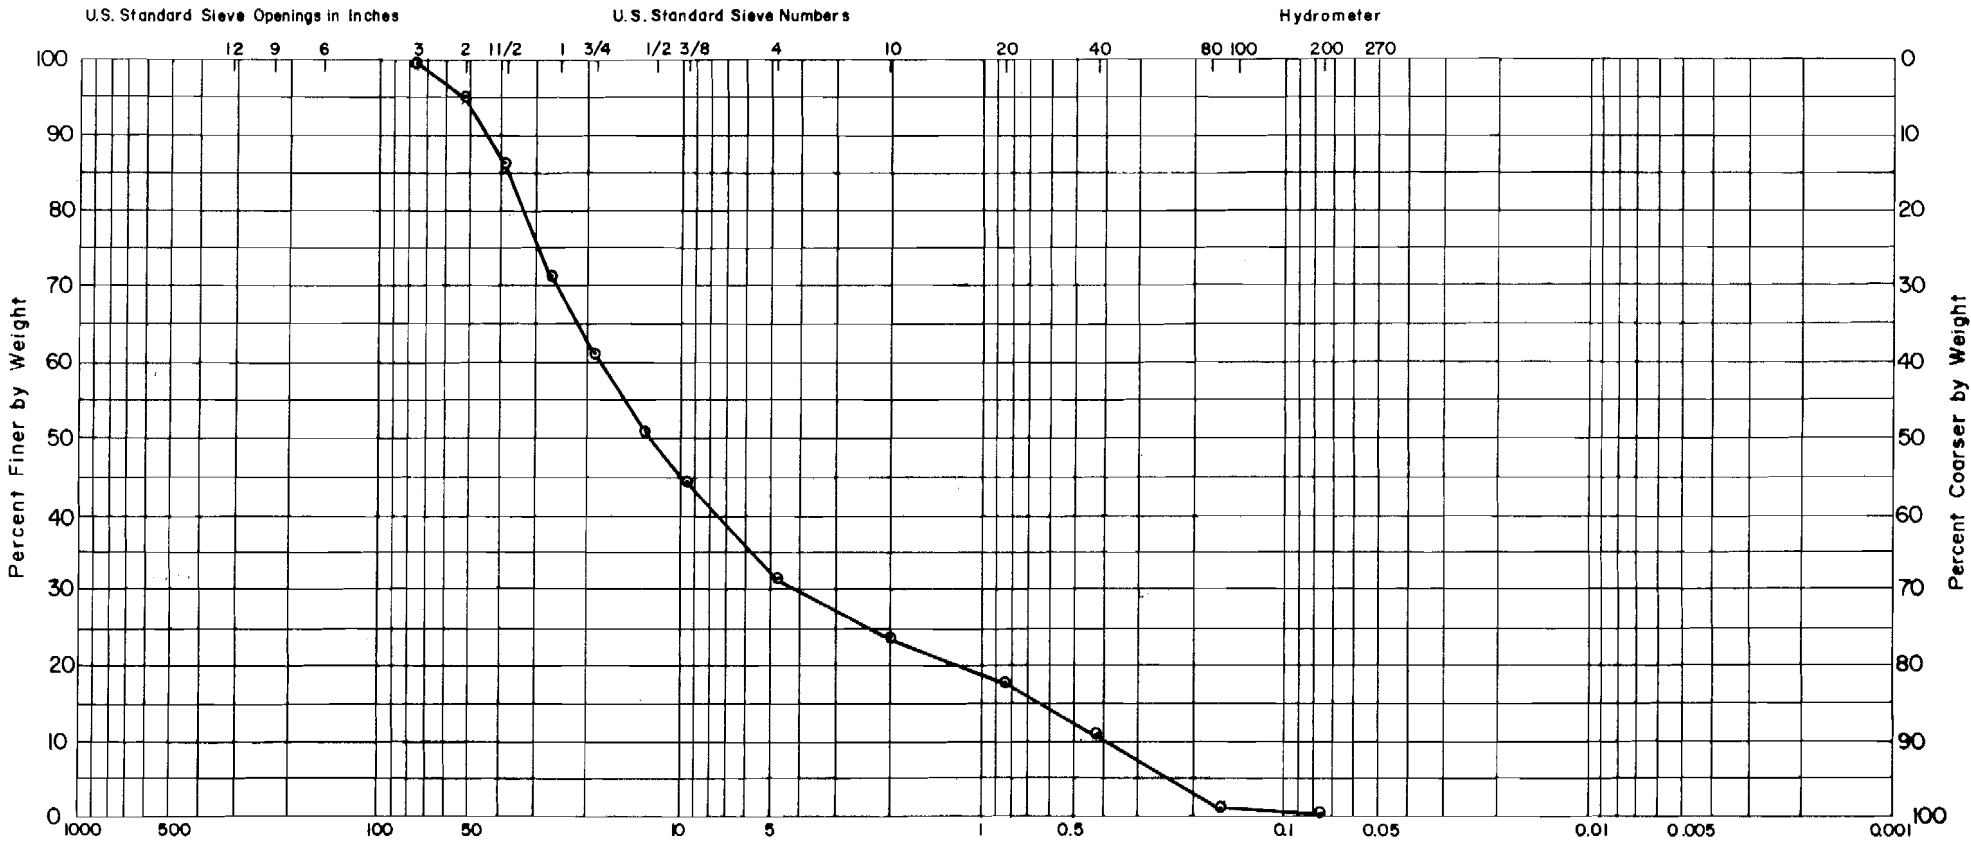
RIVER ALLUVIUM
TEST PIT TP-R7

SAMPLE NO.	MOISTURE CONTENT	DRY DENSITY	LL	PI	CLASSIFICATION & DESCRIPTION
TP-R7 #1					GW SANDY GRAVEL

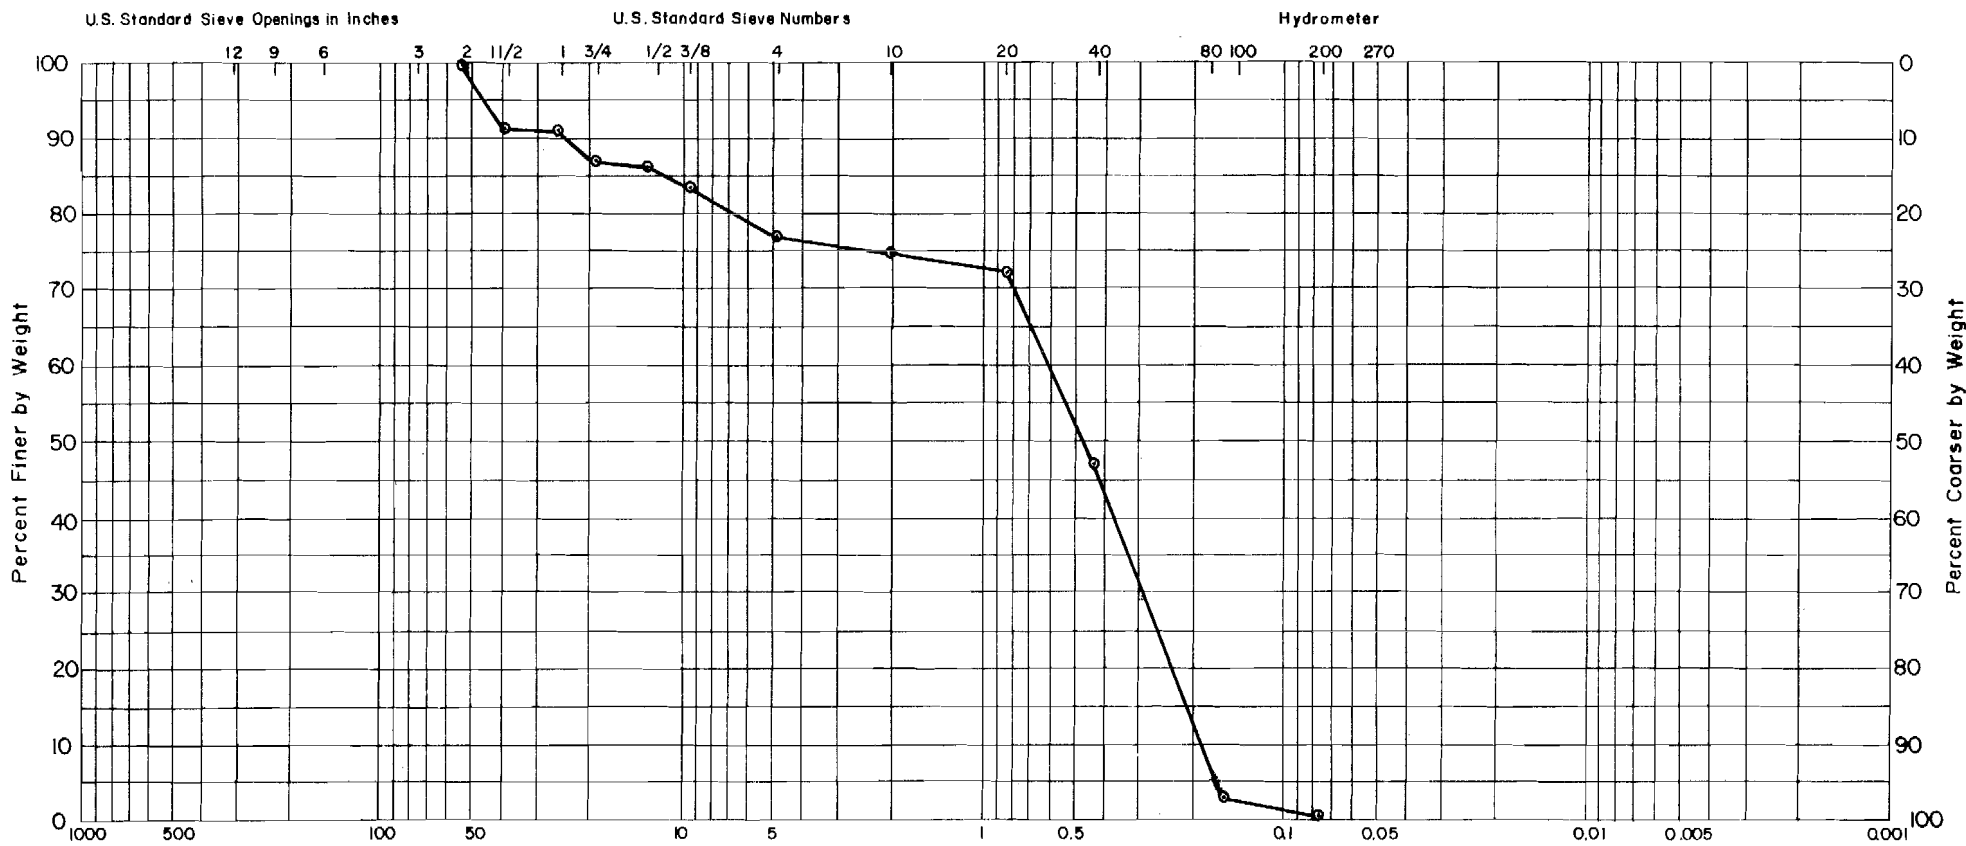
RIVER ALLUVIUM
TEST PIT TP-R7

SAMPLE NO.	MOISTURE CONTENT	DRY DENSITY	LL	PI	CLASSIFICATION & DESCRIPTION	
TP-R7 #2					SP	SAND WITH SOME GRAVEL

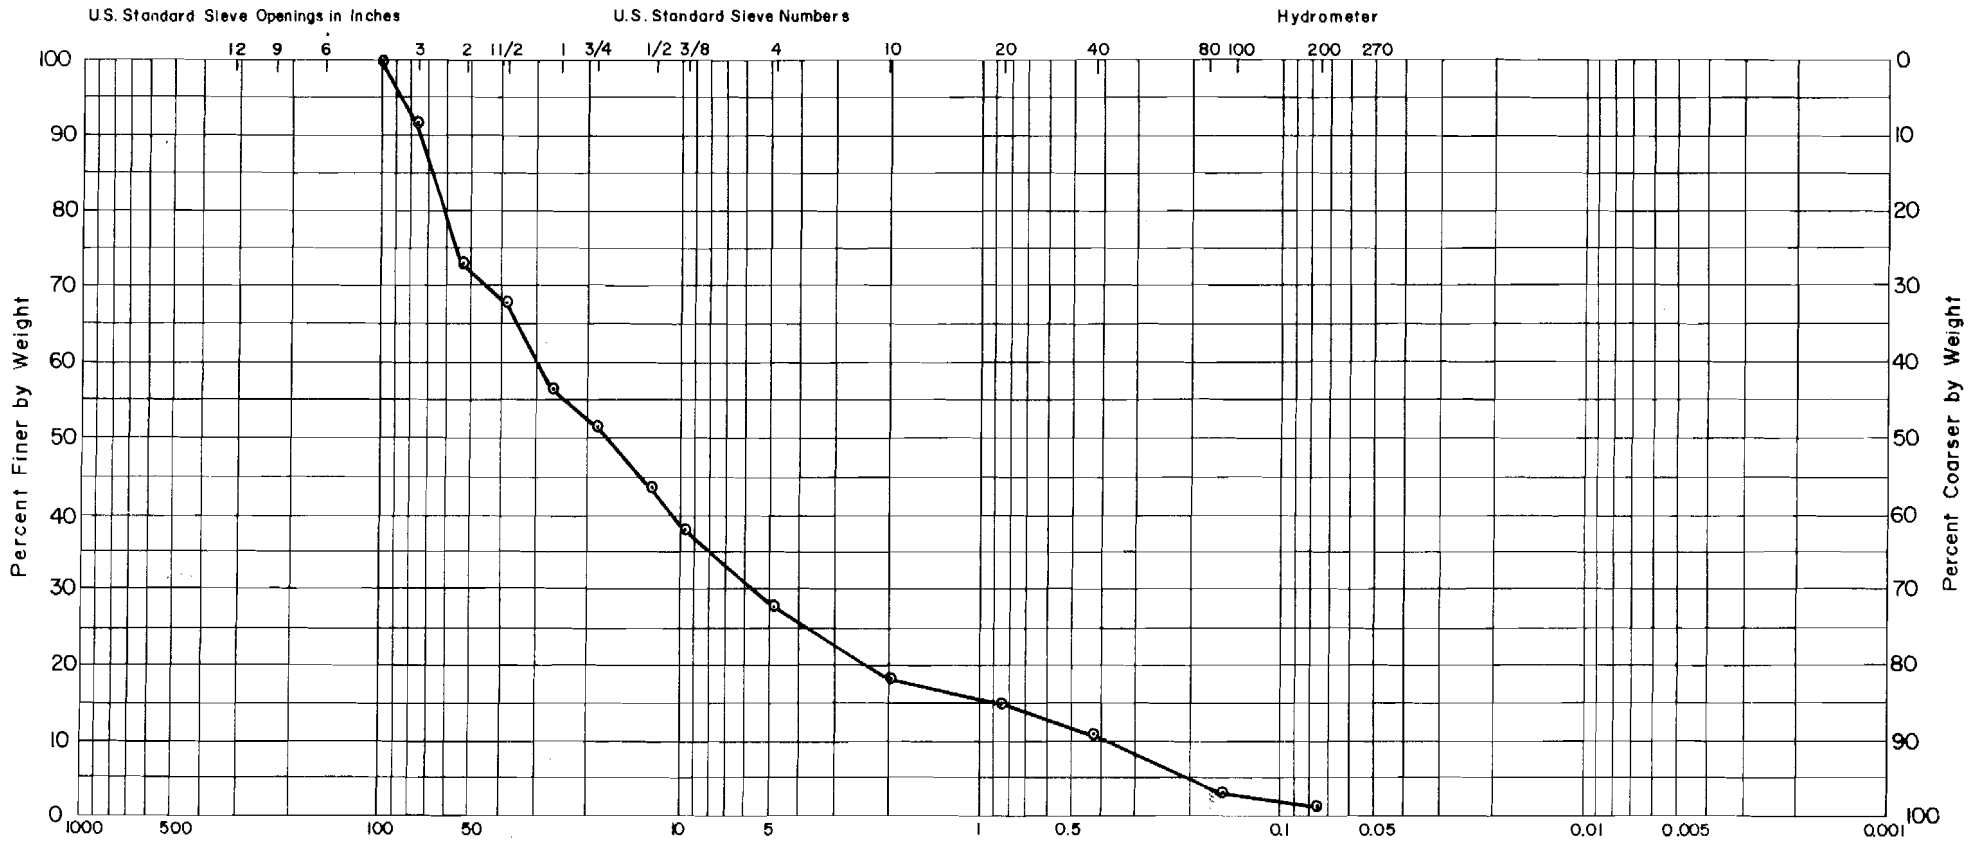
RIVER ALLUVIUM
TEST PIT TP-R3

SAMPLE NO.	MOISTURE CONTENT	DRY DENSITY	LL	PI	CLASSIFICATION & DESCRIPTION
TP-R3 #1					GW GRAVEL WITH SOME SAND AND SCATTERED COBBLES

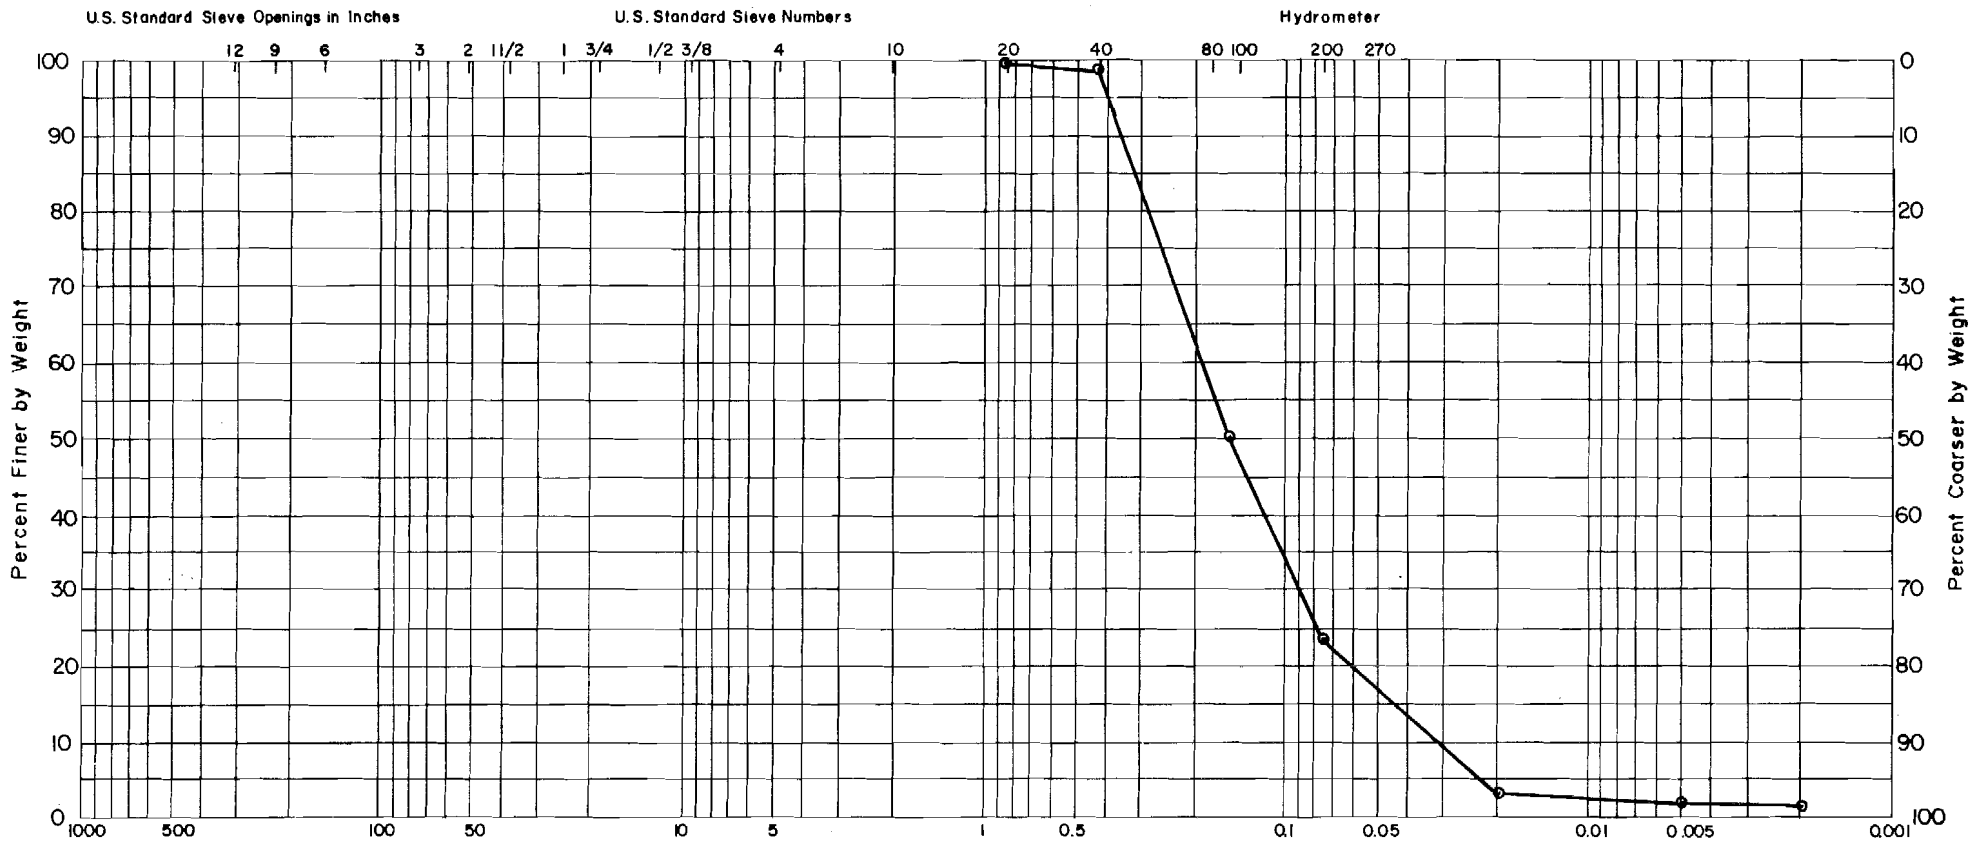
RIVER ALLUVIUM
TEST PIT TP-R9

SAMPLE NO.	MOISTURE CONTENT	DRY DENSITY	LL	PI	CLASSIFICATION & DESCRIPTION
TP-R9 #1				SM	SAND WITH SOME SILT (FIELD GEOLOGIST NOTES TRACE ORGANICS)

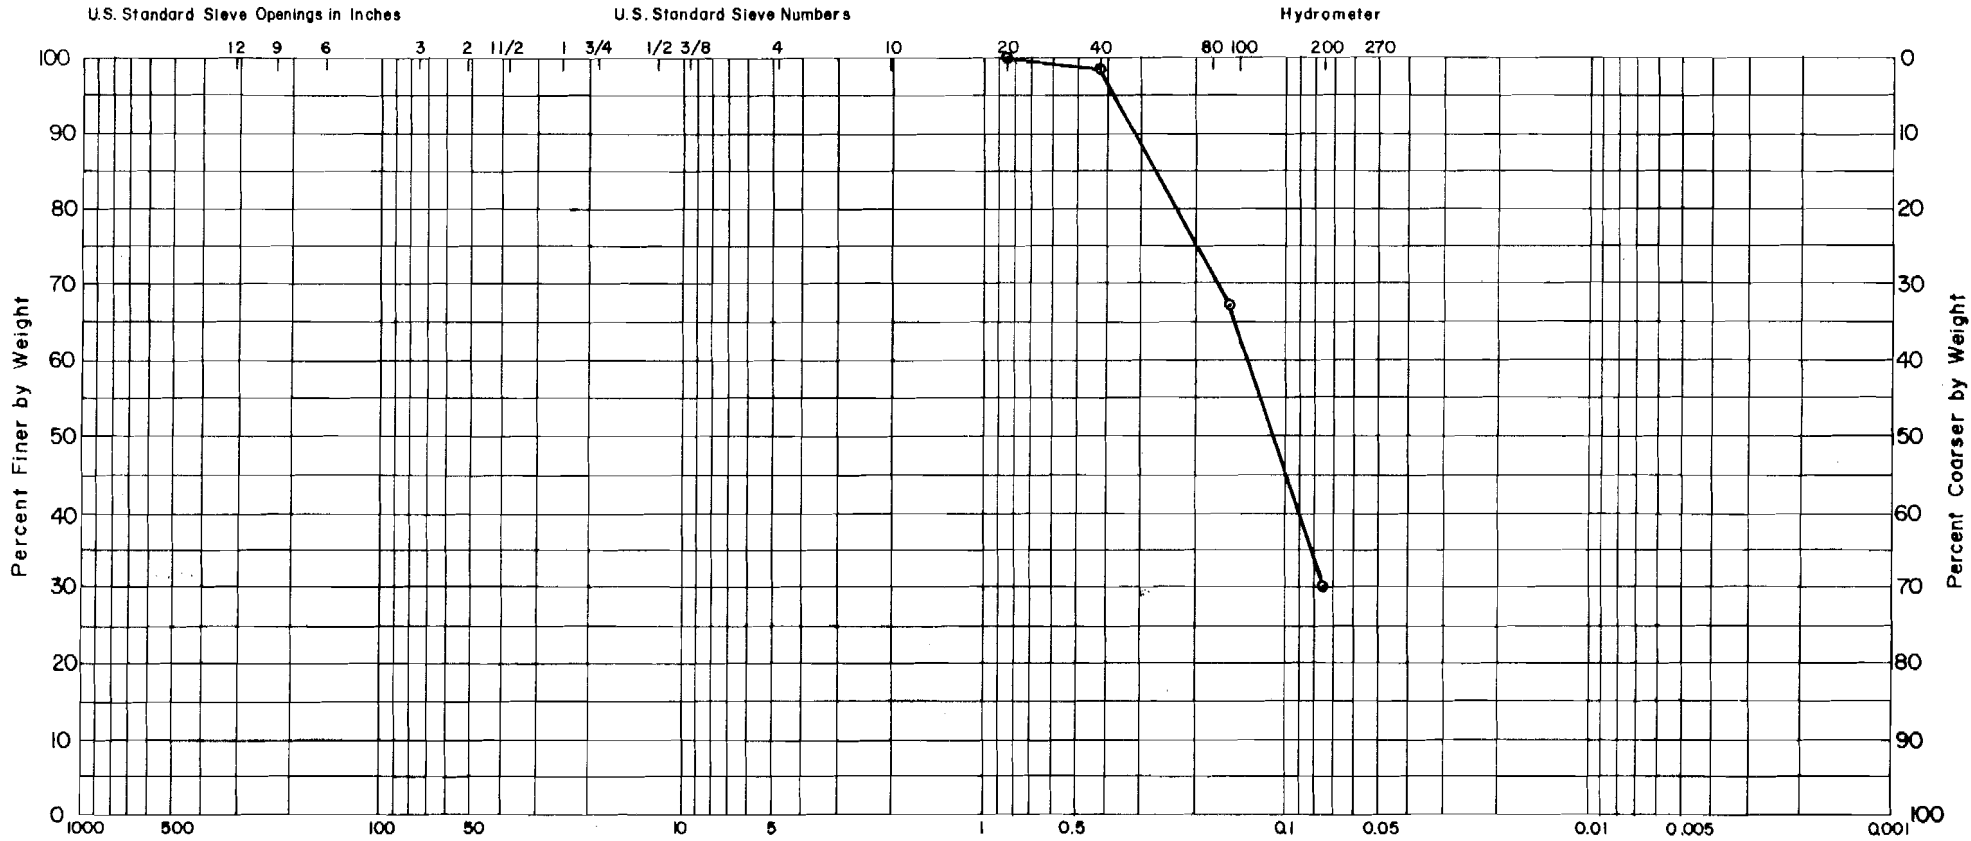
RIVER ALLUVIUM
TEST PIT TP-R10

SAMPLE NO.	MOISTURE CONTENT	DRY DENSITY	LL	PI	CLASSIFICATION & DESCRIPTION	
TP-R10 #1					SM	SILTY SAND

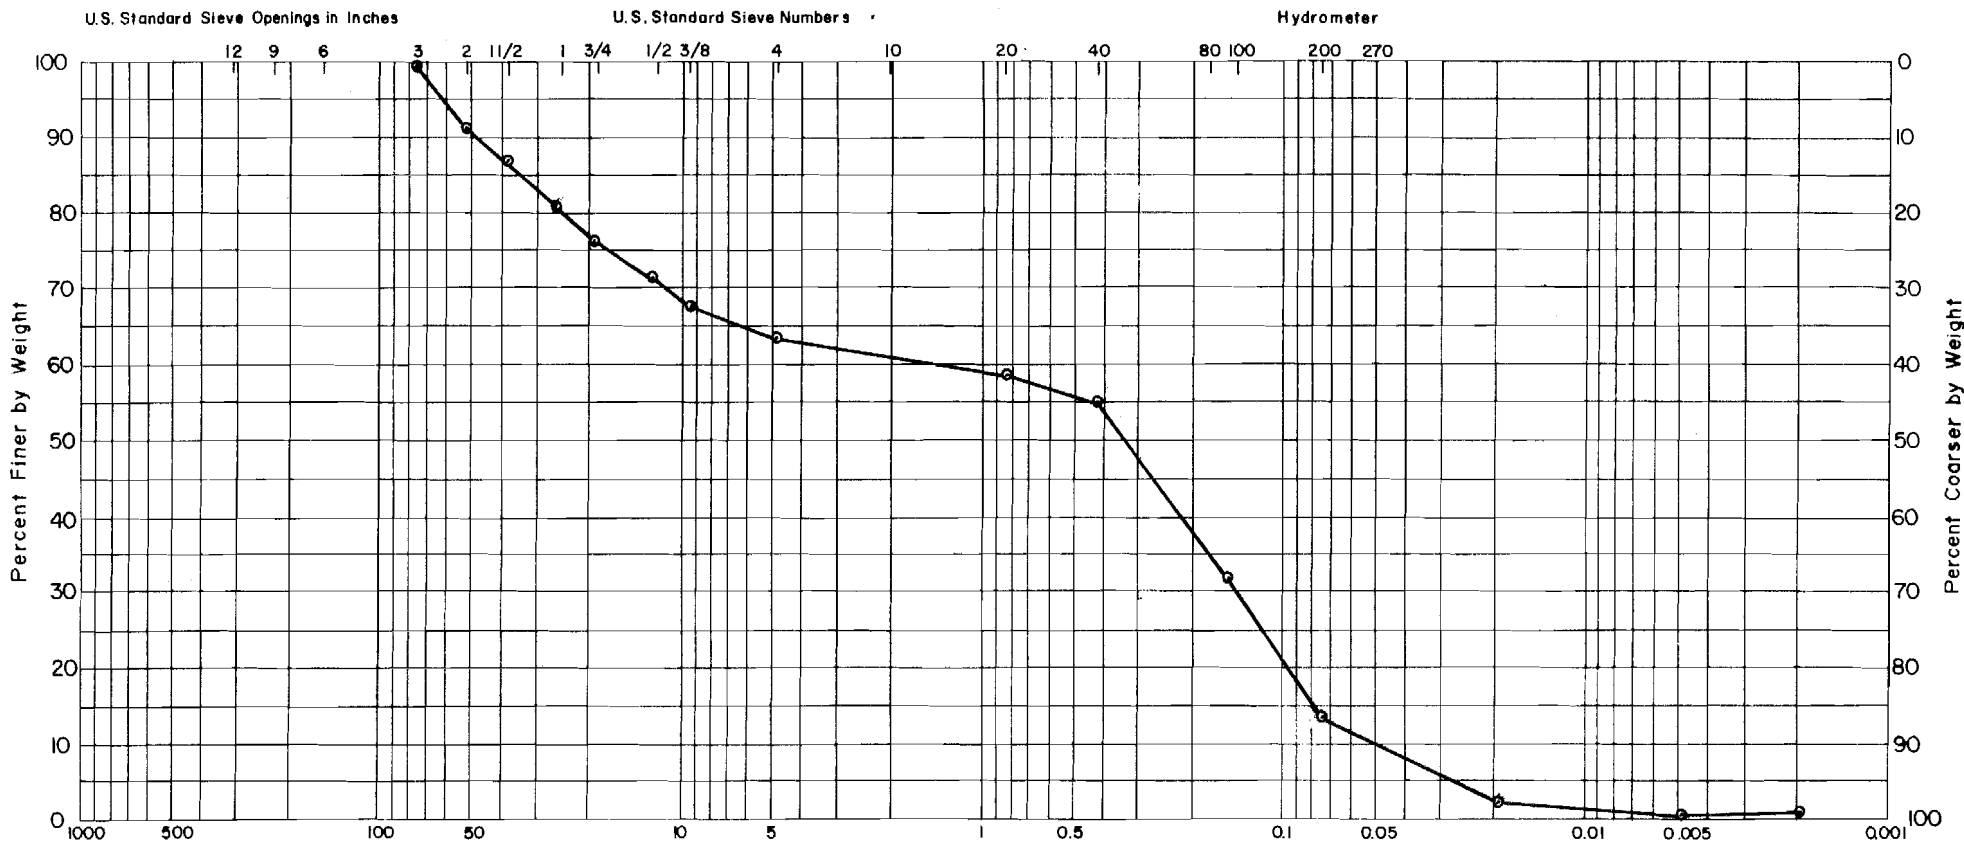
RIVER ALLUVIUM
TEST PIT TP-R10

SAMPLE NO.	MOISTURE CONTENT	DRY DENSITY	LL	PI	CLASSIFICATION & DESCRIPTION
TP-R10 #2					SM-SP GRAVELLY SAND WITH SOME SILT

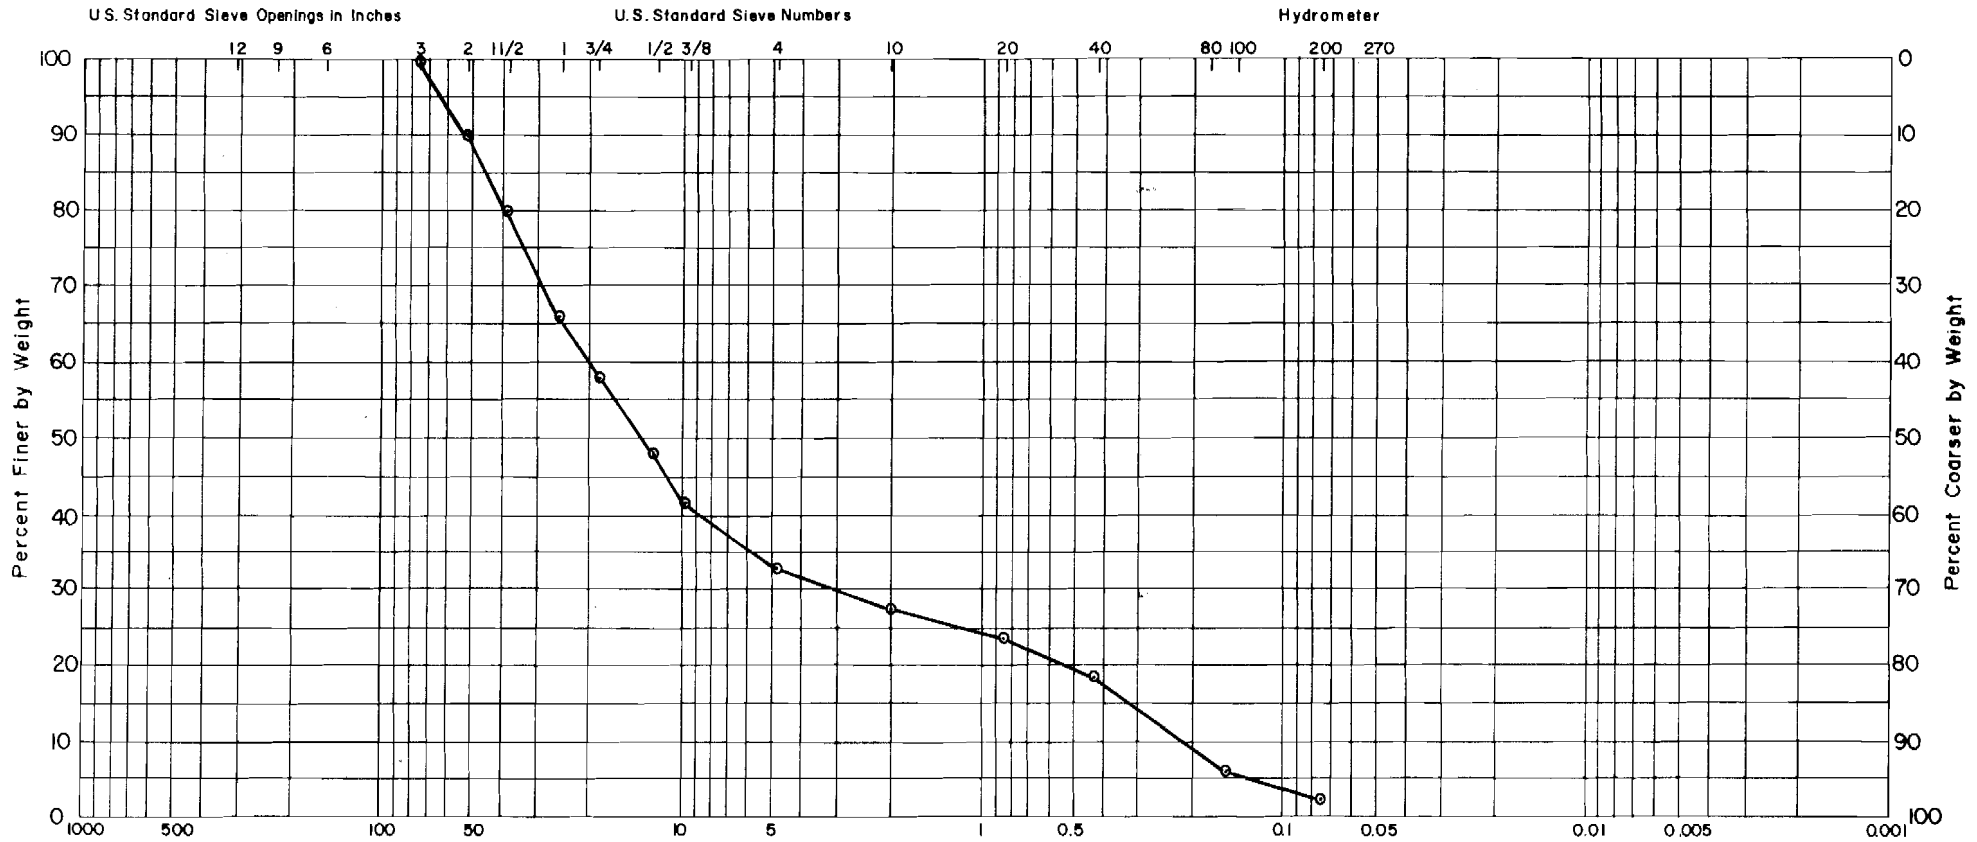
RIVER ALLUVIUM
TEST PIT TP-R11

SAMPLE NO.	MOISTURE CONTENT	DRY DENSITY	LL	PI	CLASSIFICATION & DESCRIPTION
TP-R11 #1					GP SANDY GRAVEL

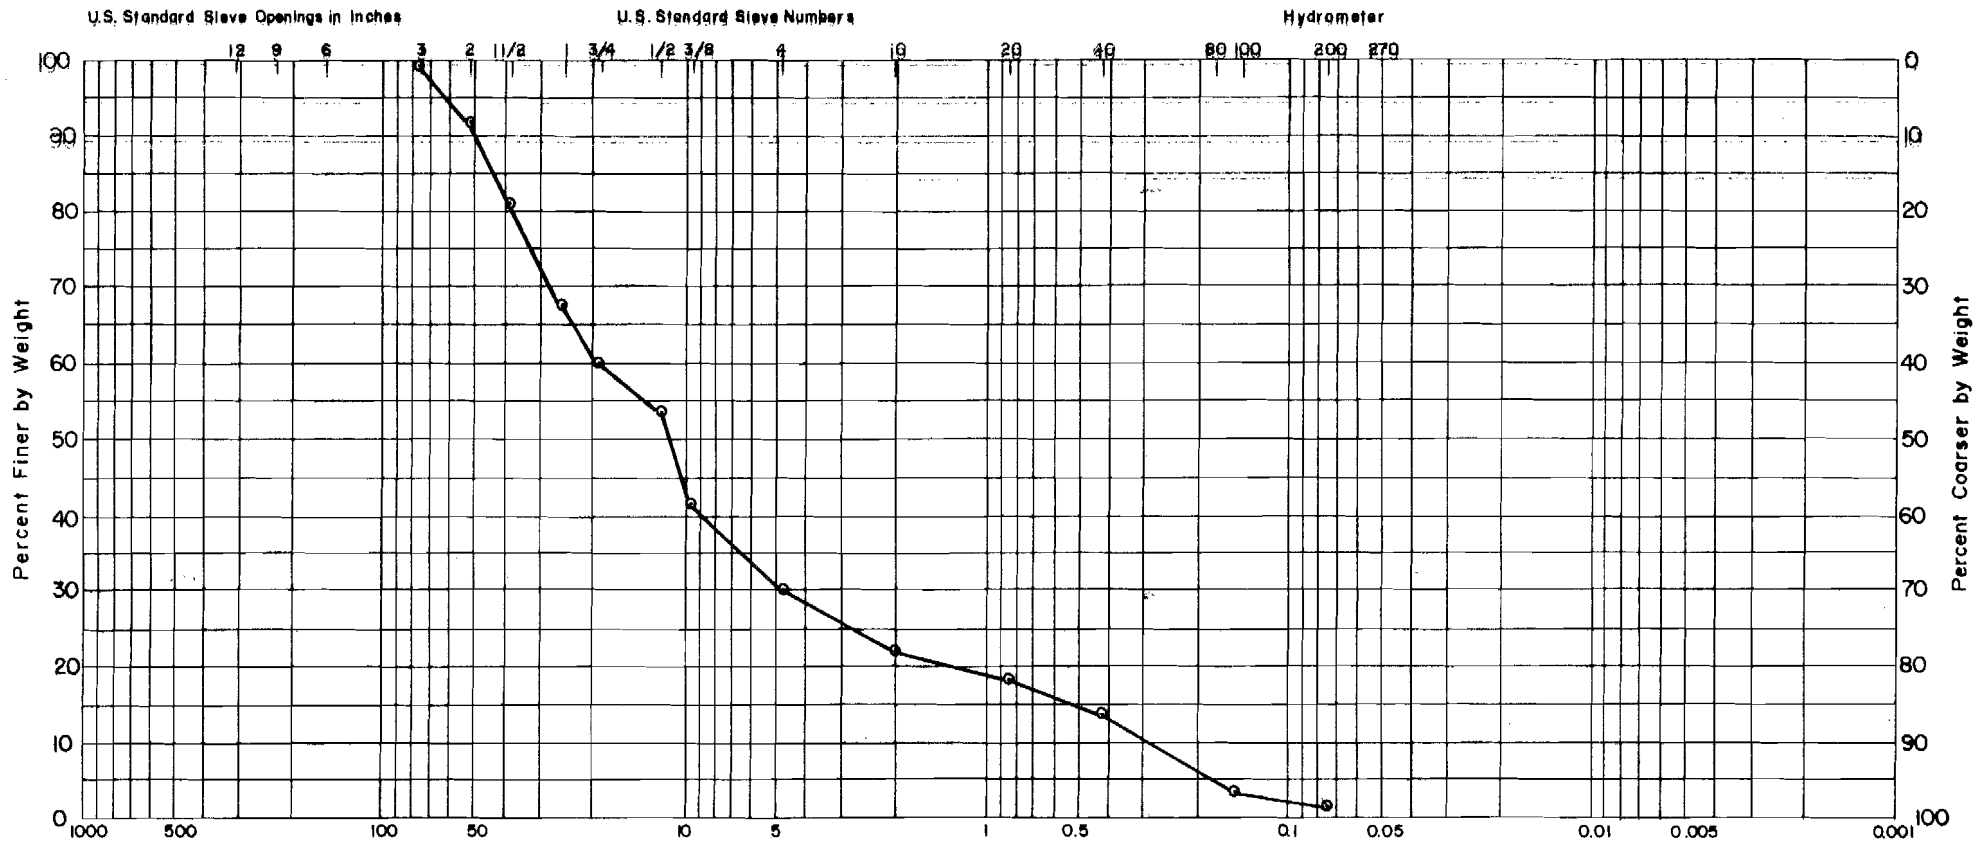
RIVER ALLUVIUM
TEST PIT TP-R11

SAMPLE NO.	MOISTURE CONTENT	DRY DENSITY	LL	PI	CLASSIFICATION & DESCRIPTION
TP-R11 #2					GRAVEL WITH SOME SAND

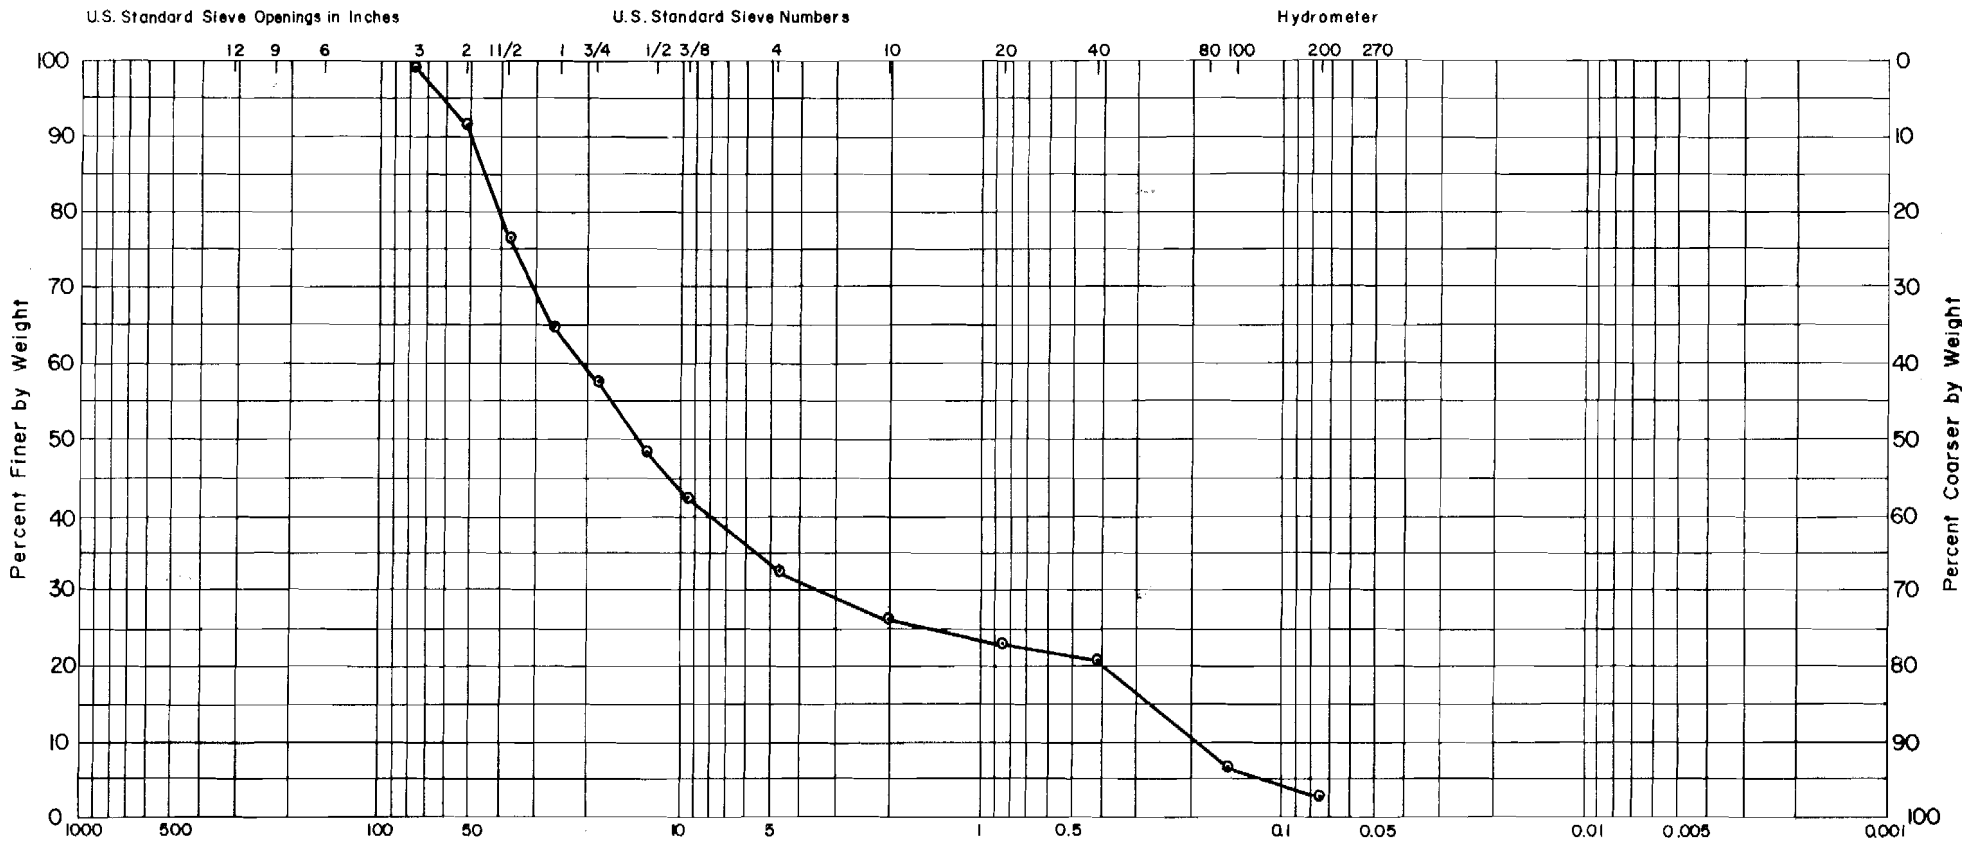
RIVER ALLUVIUM
TEST PIT TP-R12

SAMPLE NO.	MOISTURE CONTENT	DRY DENSITY	LL	PI	CLASSIFICATION & DESCRIPTION
TP-R12 #1				GP	SANDY GRAVEL

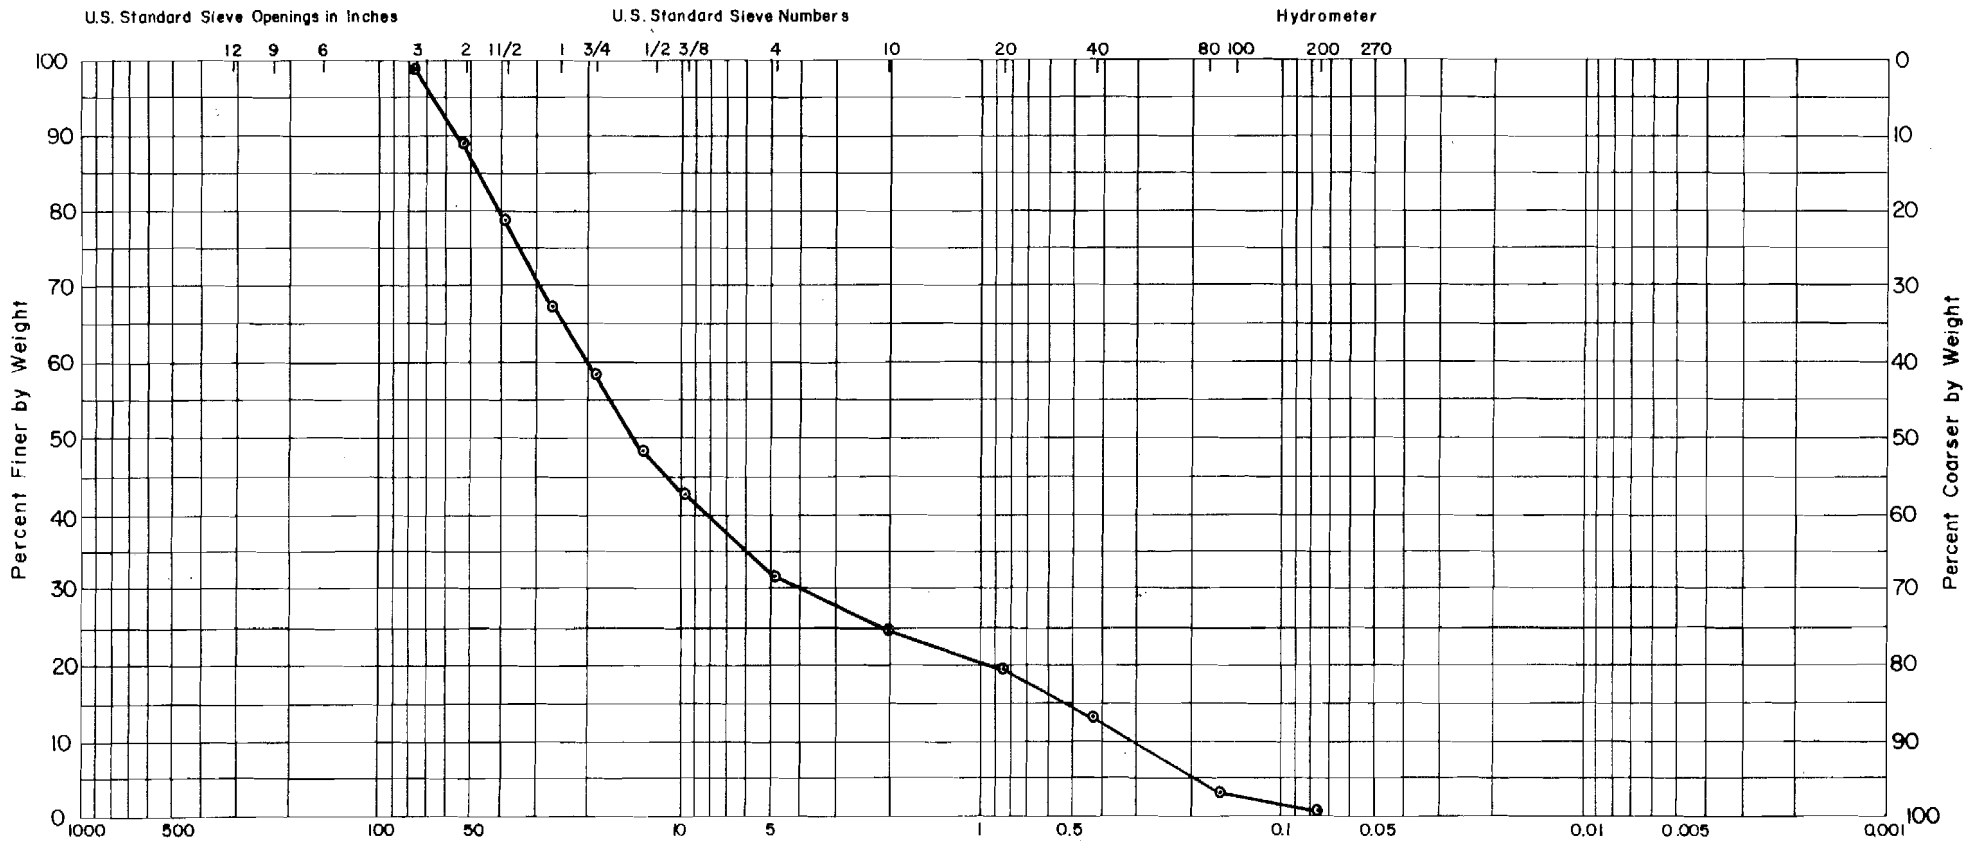
RIVER ALLUVIUM
TEST PIT TP-R12

SAMPLE NO.	MOISTURE CONTENT	DRY DENSITY	LL	PI	CLASSIFICATION & DESCRIPTION
TP-R12 #2					GW SANDY GRAVEL

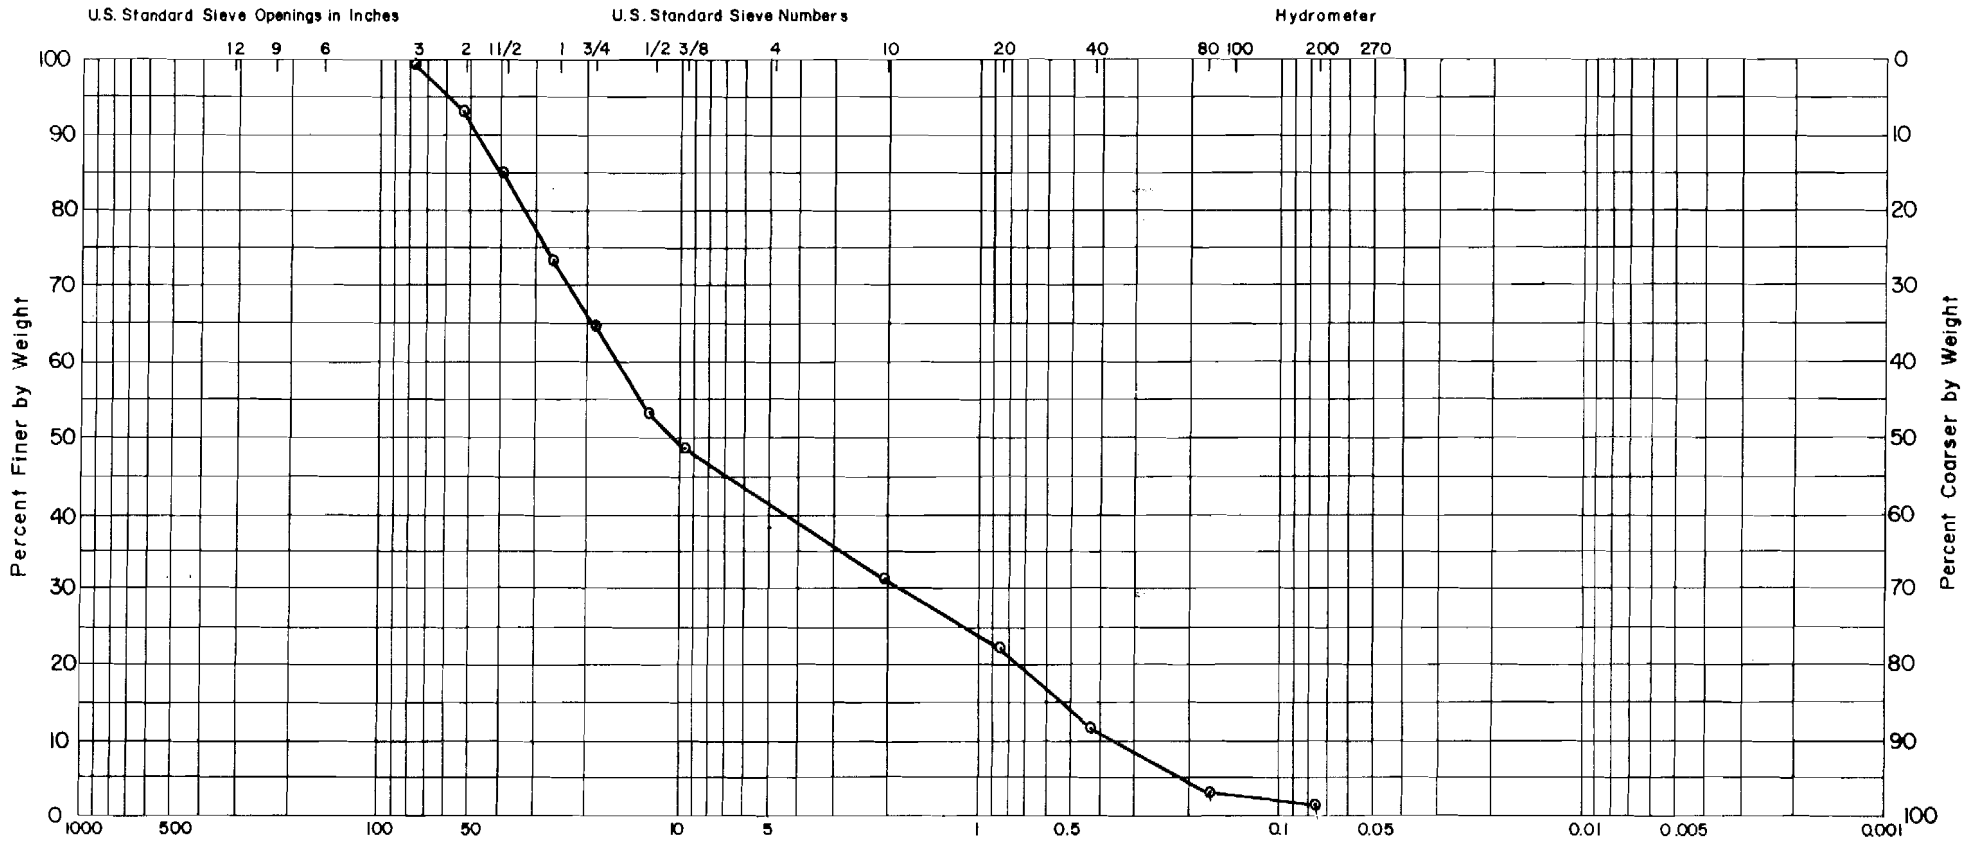
RIVER ALLUVIUM
TEST PIT TP-R13

SAMPLE NO.	MOISTURE CONTENT	DRY DENSITY	LL	PI	CLASSIFICATION & DESCRIPTION
TP-R13 #2				GP	SANDY GRAVEL

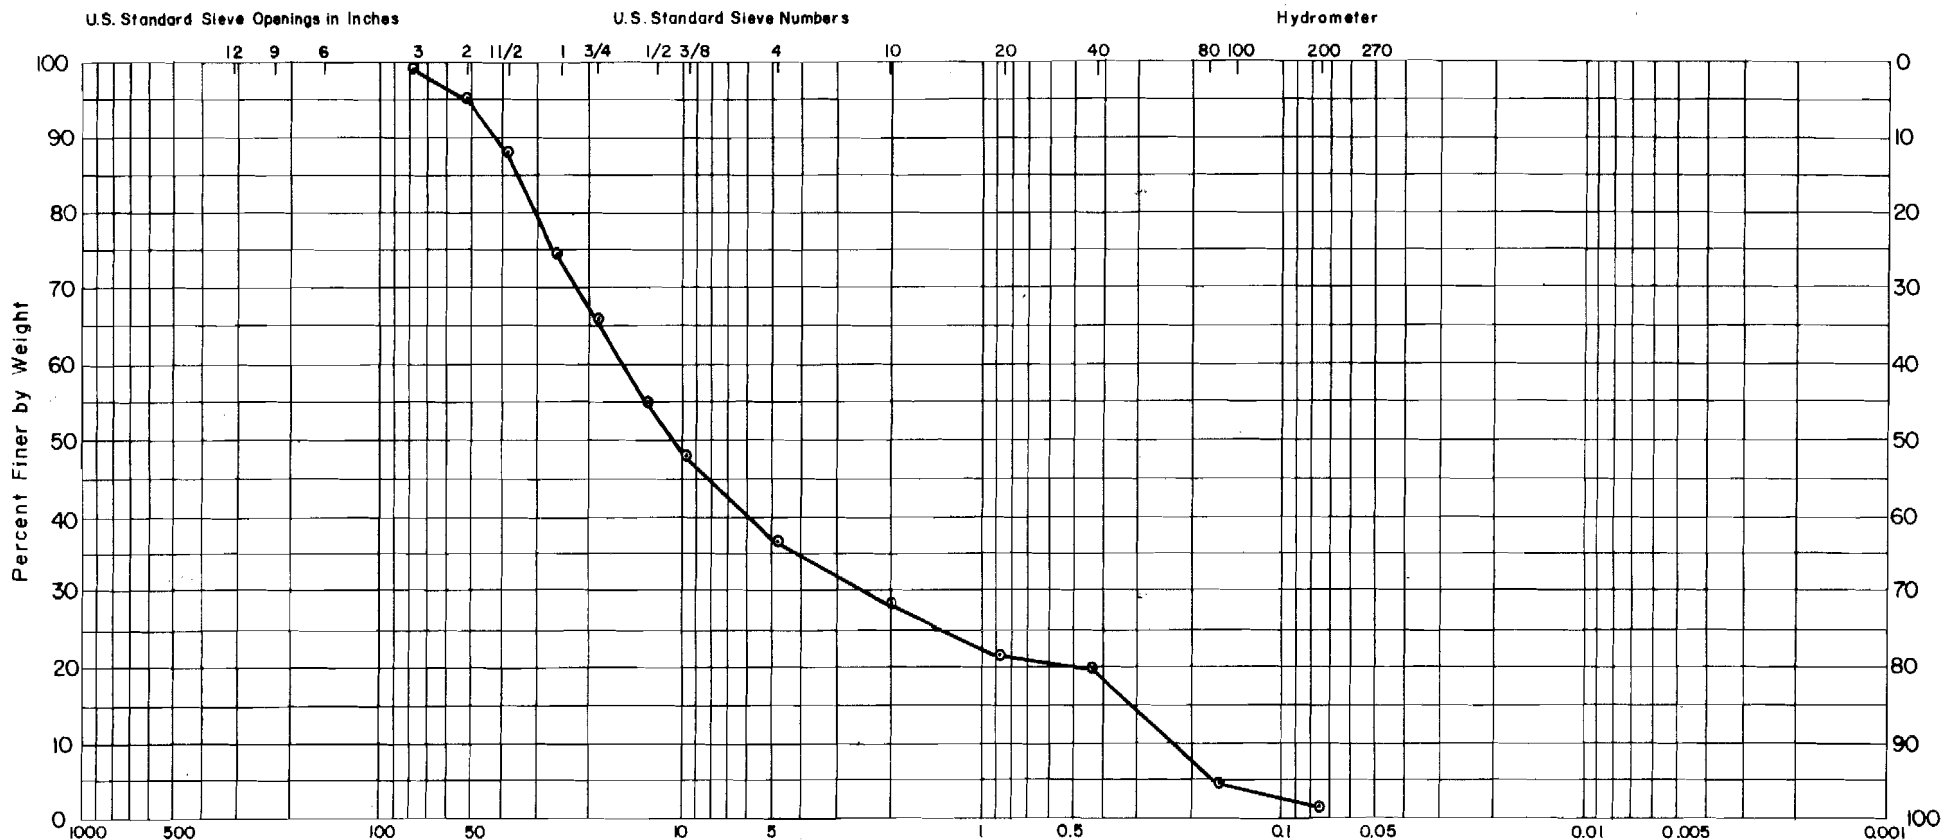
RIVER ALLUVIUM
TEST PIT TP-R14

SAMPLE NO.	MOISTURE CONTENT	DRY DENSITY	LL	PI	CLASSIFICATION & DESCRIPTION	
TP-R14 #1					GW	SANDY GRAVEL
