SUSITNA HYDROELECTRIC PROJECT

1980 - 81 GEOTECHNICAL REPORT

VOLUME 2
APPENDIX A-F
FINAL DRAFT

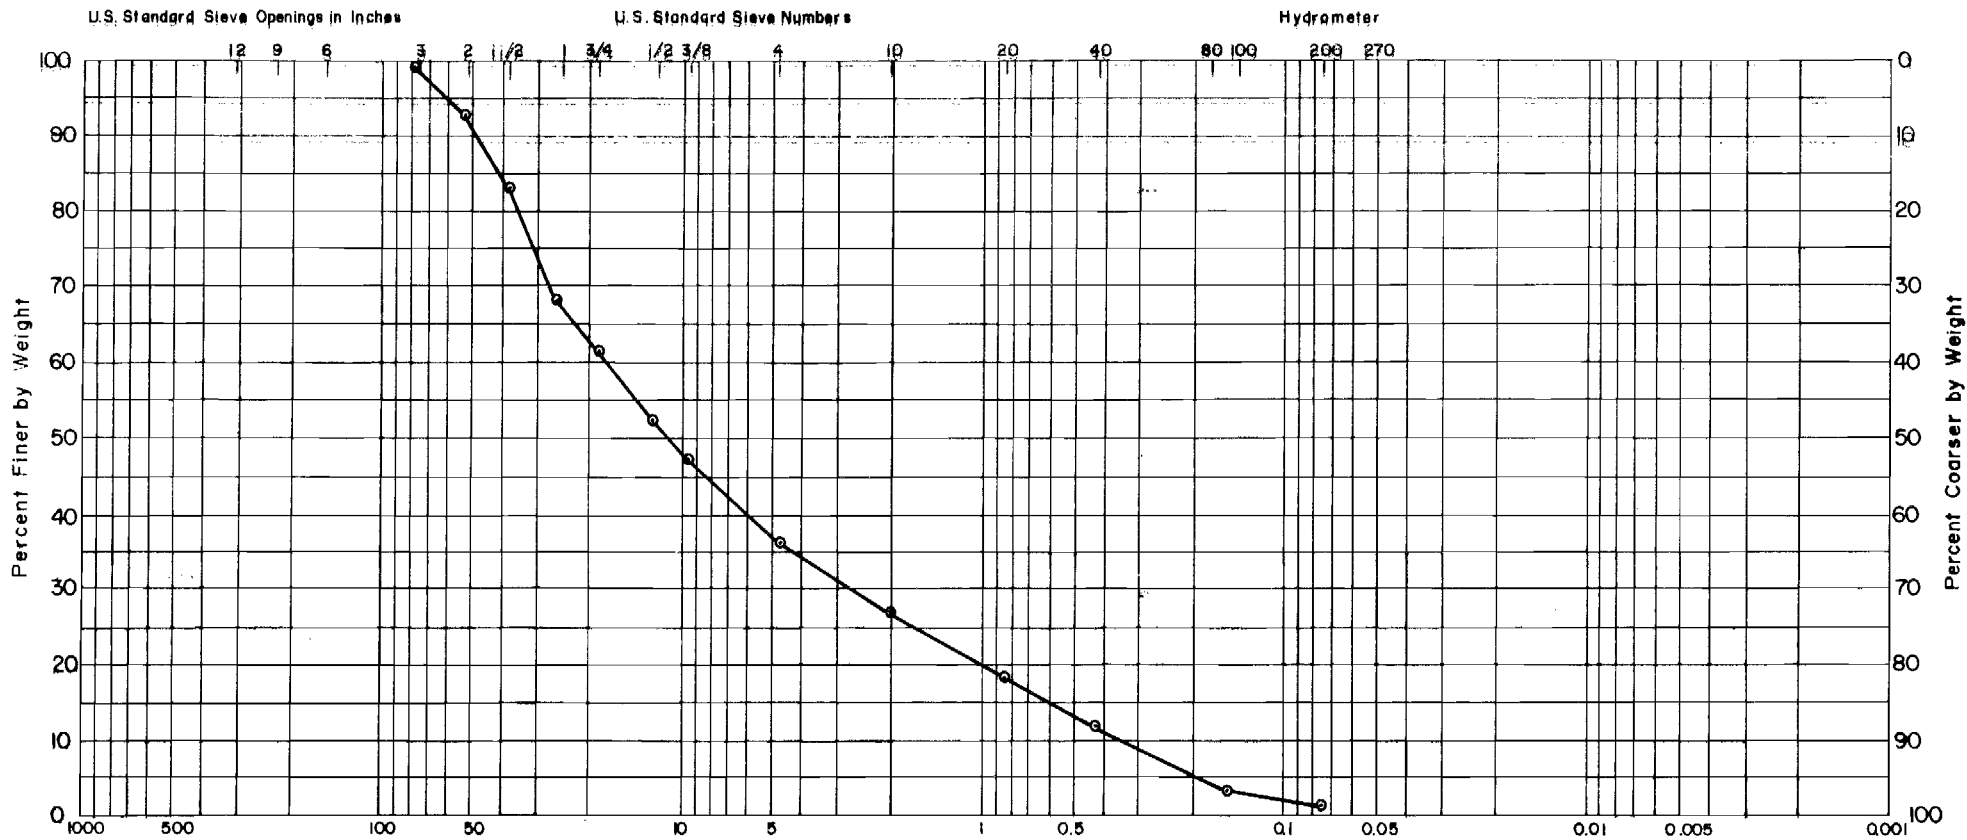
RIVER ALLUVIUM
TEST PIT TP-R14

SAMPLE NO.	MOISTURE CONTENT	DRY DENSITY	LL	PI	CLASSIFICATION & DESCRIPTION
TP-R14 #2					GP SANDY GRAVEL

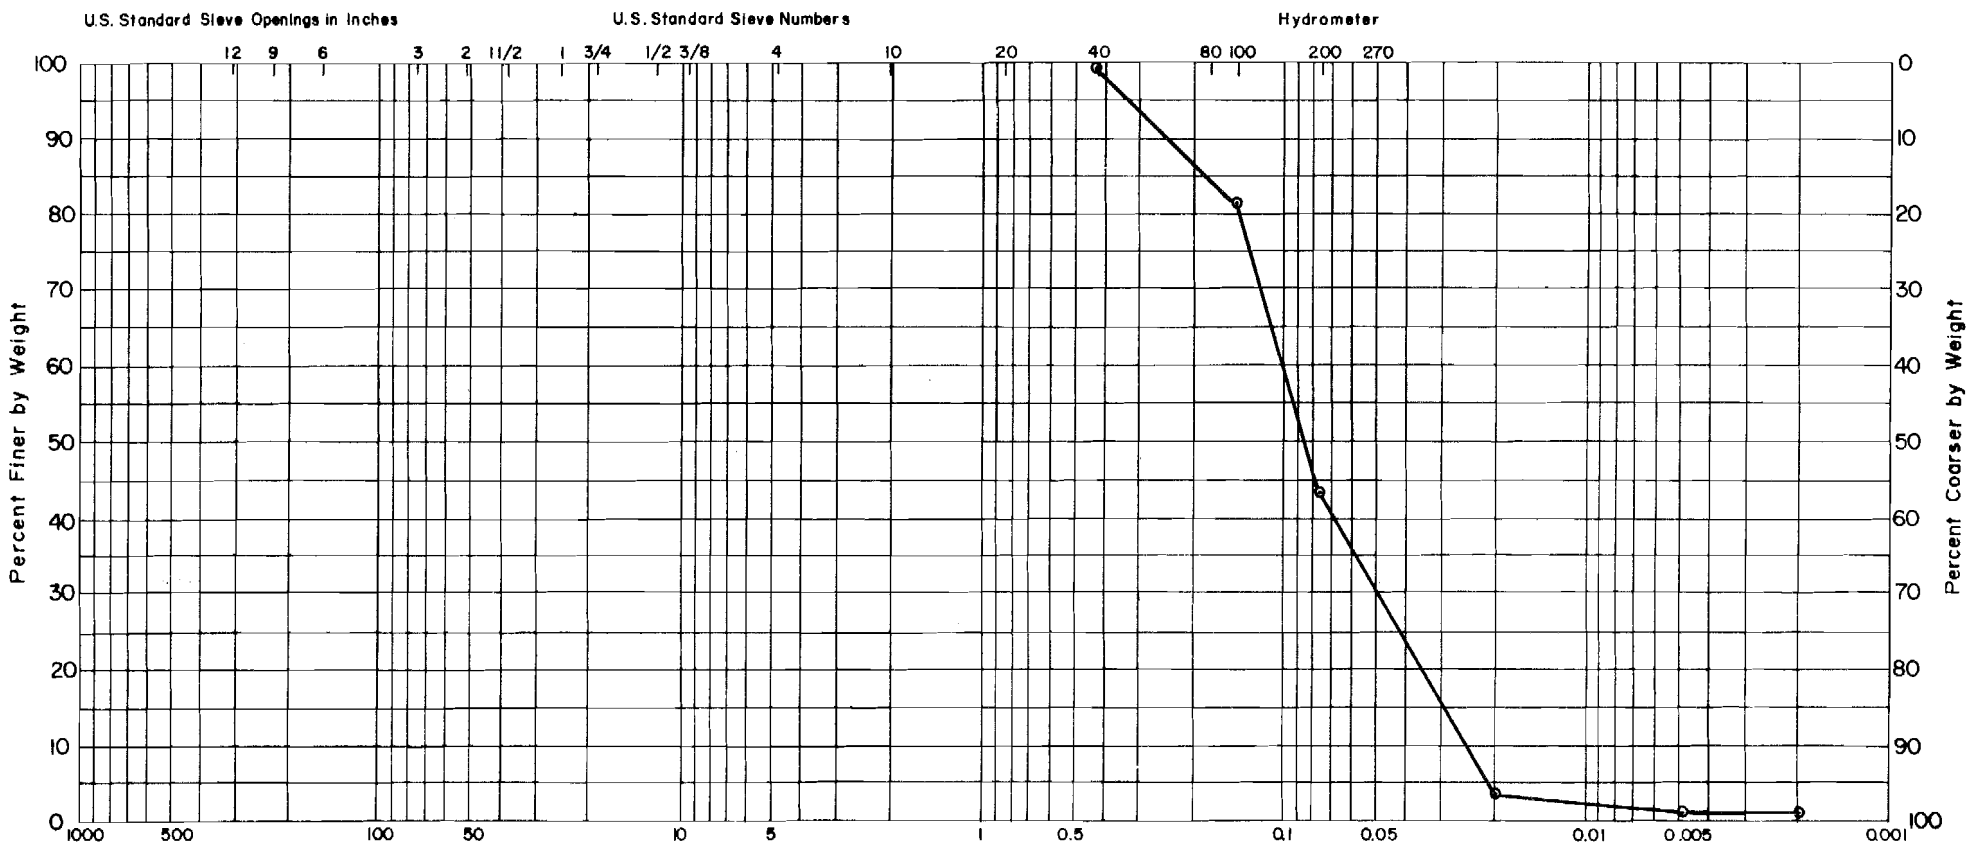
RIVER ALLUVIUM
TEST PIT TP-R15

SAMPLE NO.	MOISTURE CONTENT	DRY DENSITY	LL	PI	CLASSIFICATION & DESCRIPTION
TP-R15 #2				SM	SILTY SAND (FIELD GEOLOGIST NOTES TRACE ORGANICS)

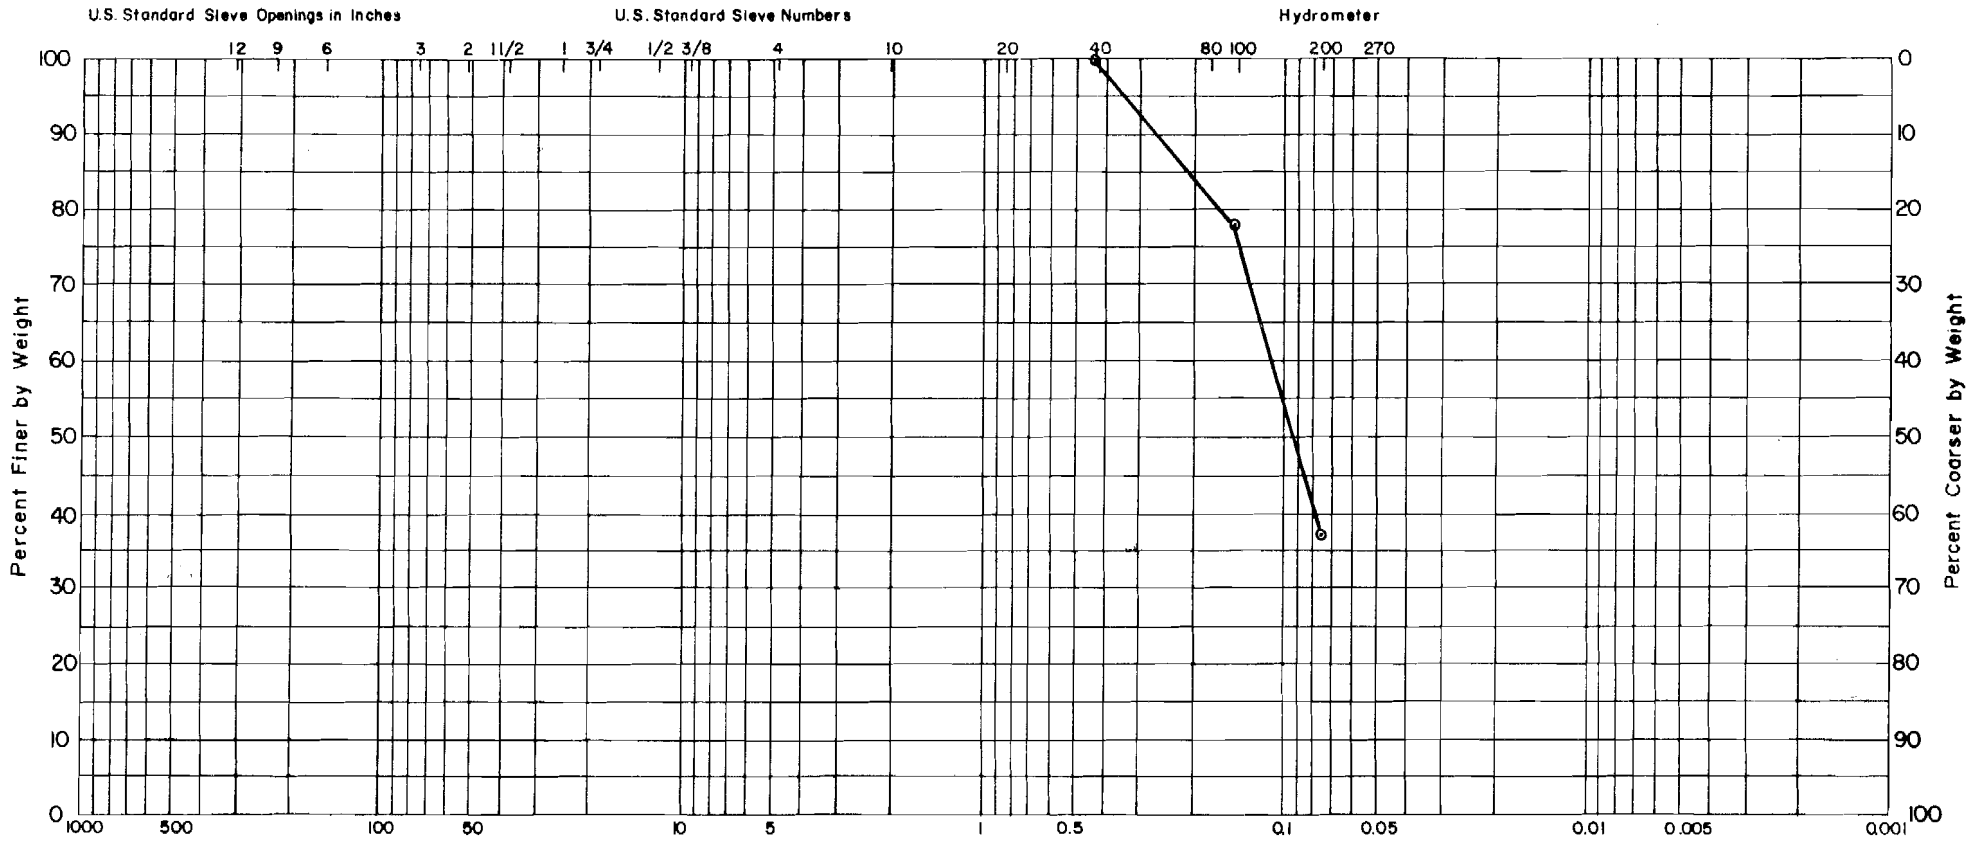
RIVER ALLUVIUM
TEST PIT TP-R16

SAMPLE NO.	MOISTURE CONTENT	DRY DENSITY	LL	PI	CLASSIFICATION & DESCRIPTION	
TP-R16 #1					SM	SILTY SAND (FIELD GEOLOGIST NOTES TRACE ORGANICS)

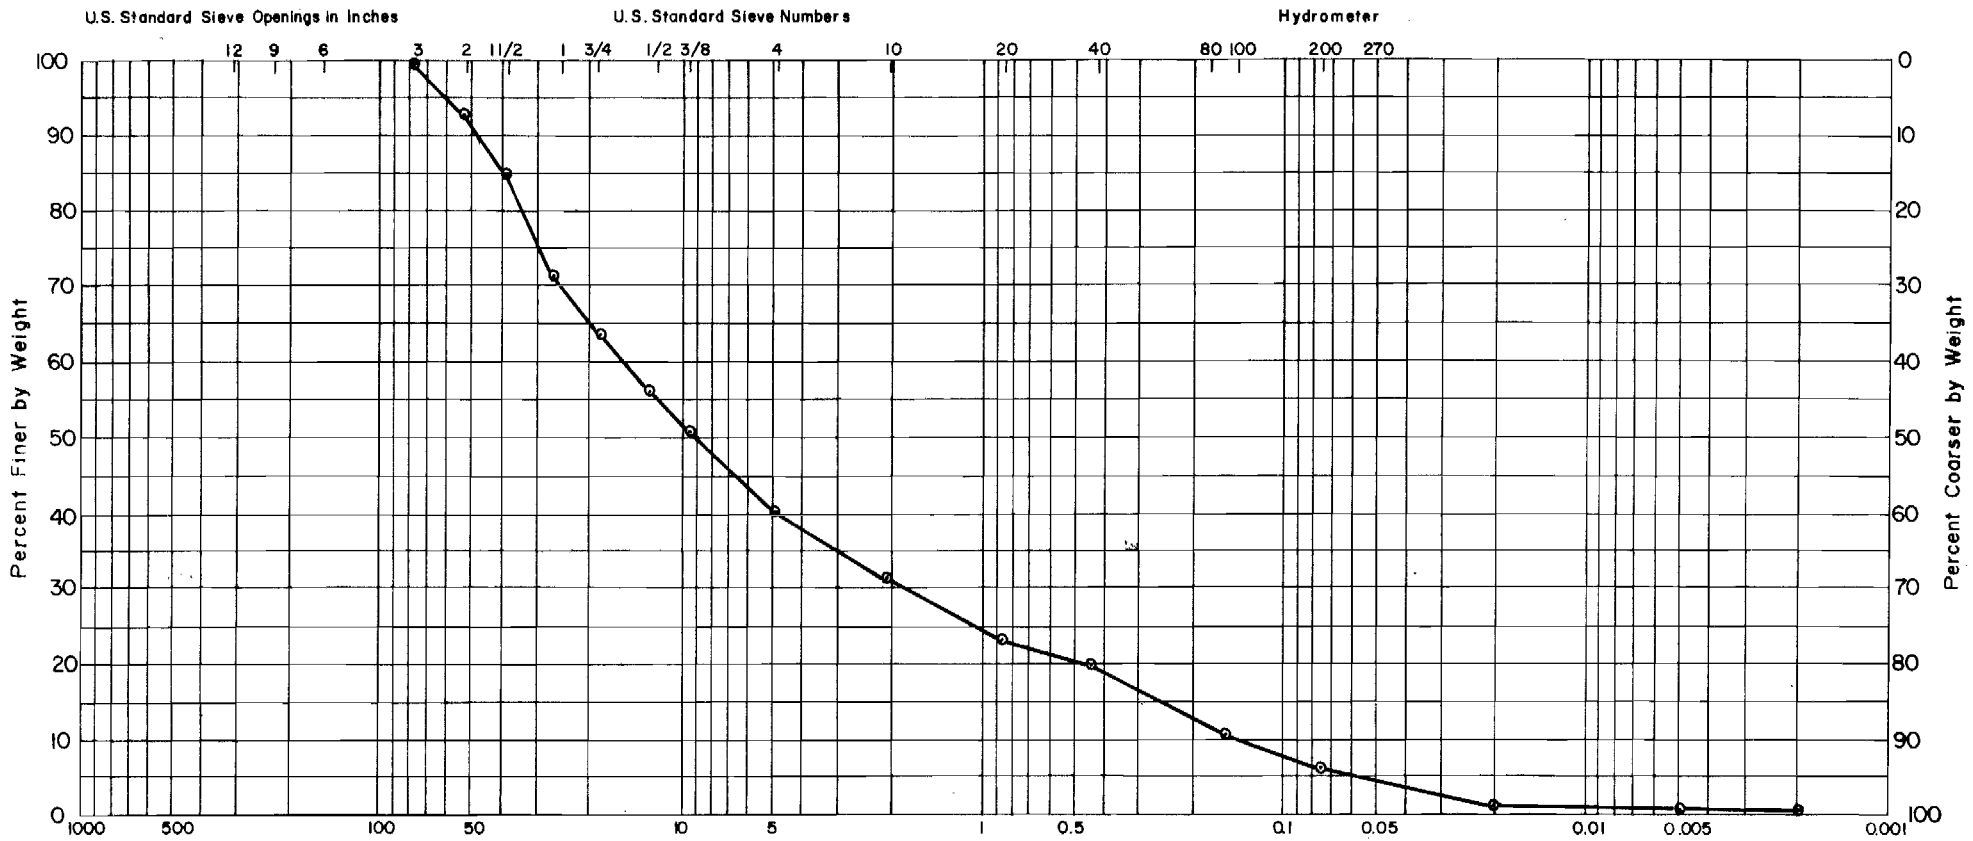
SAMPLE NO.	MOISTURE CONTENT	DRY DENSITY	LL	PI	CLASSIFICATION & DESCRIPTION
TP-R16 #2					GW-GM SANDY GRAVEL WITH TRACE SILT

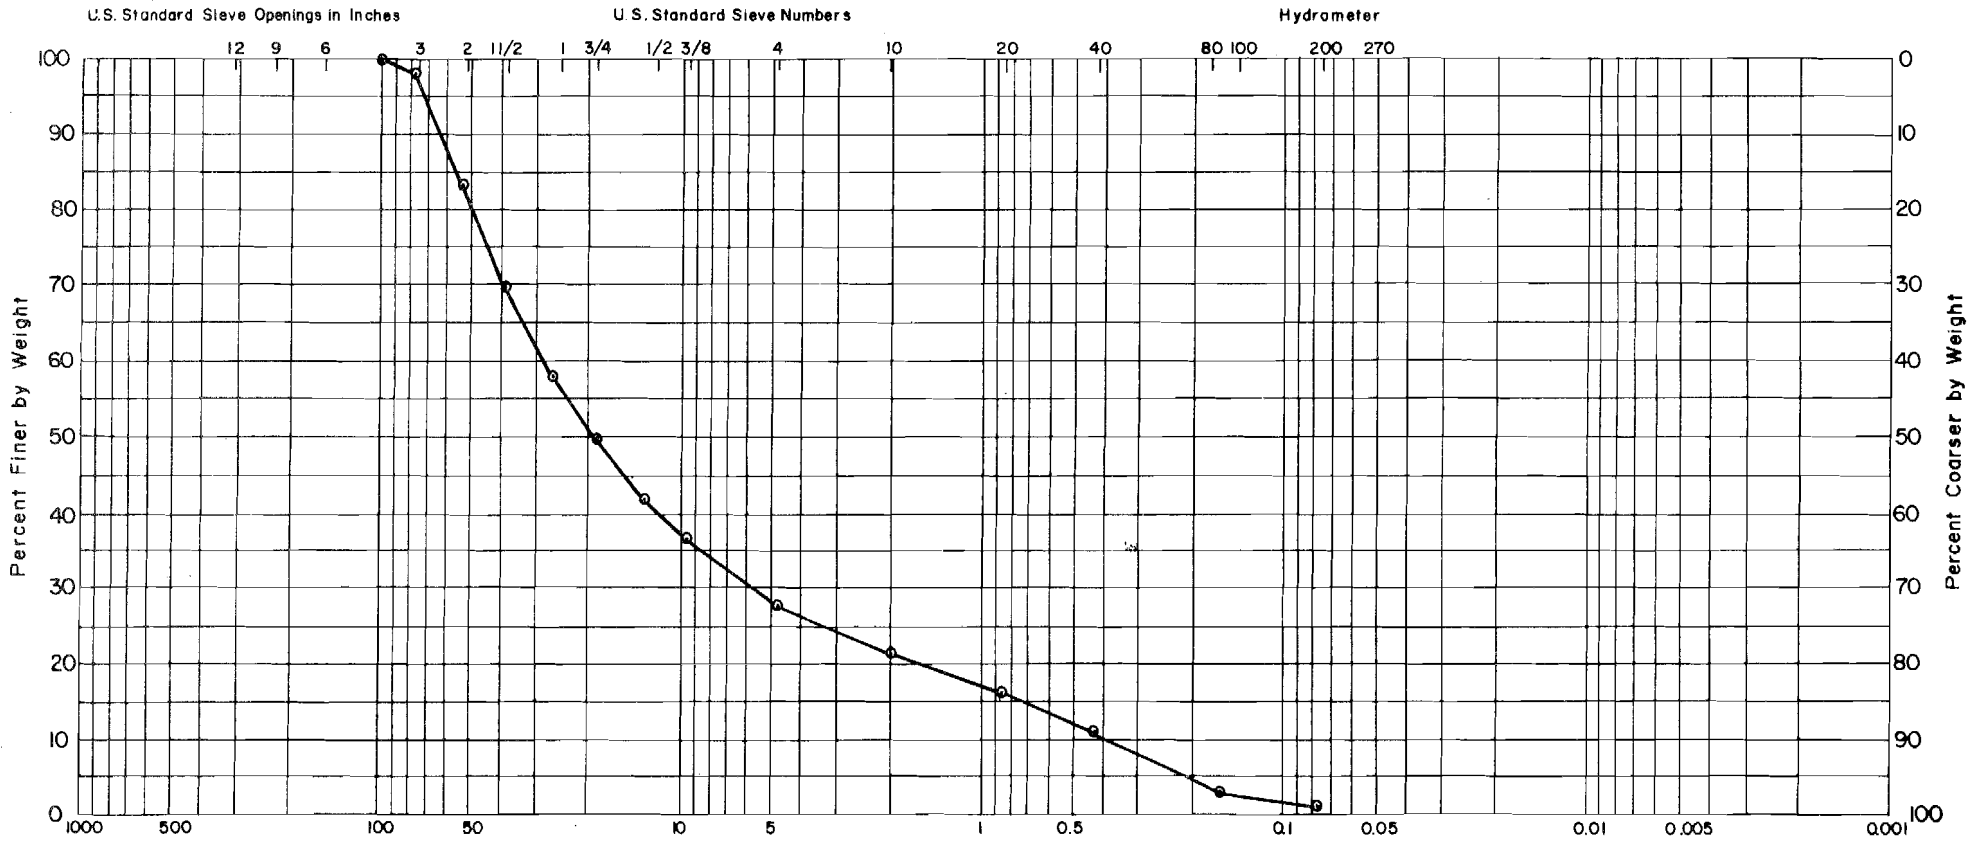
RIVER ALLUVIUM
TEST PIT TP-R17

SAMPLE NO.	MOISTURE CONTENT	DRY DENSITY	LL	PI	CLASSIFICATION & DESCRIPTION	
TP-R17 #1					GW	GRAVEL WITH SOME SAND AND SCATTERED COBBLES

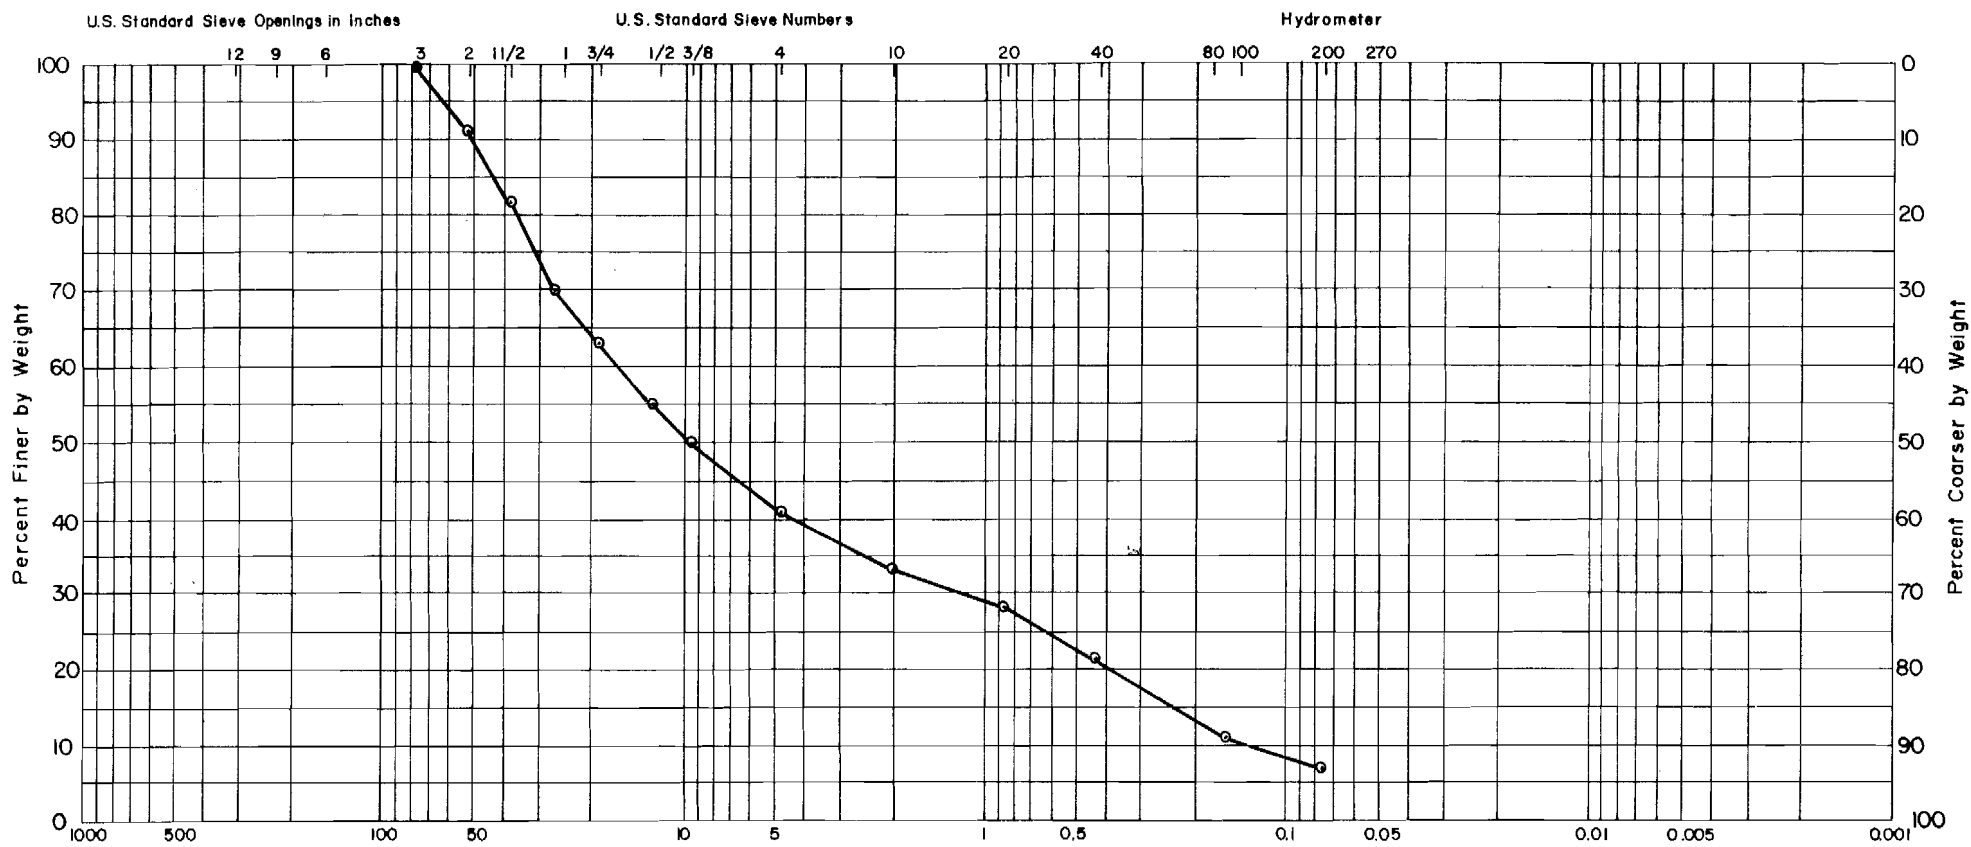
RIVER ALLUVIUM
TEST PIT TP-R17

SAMPLE NO.	MOISTURE CONTENT	DRY DENSITY	LL	PI	CLASSIFICATION & DESCRIPTION	
TP-R17 #2					GP-GM	SANDY GRAVEL WITH TRACE SILT

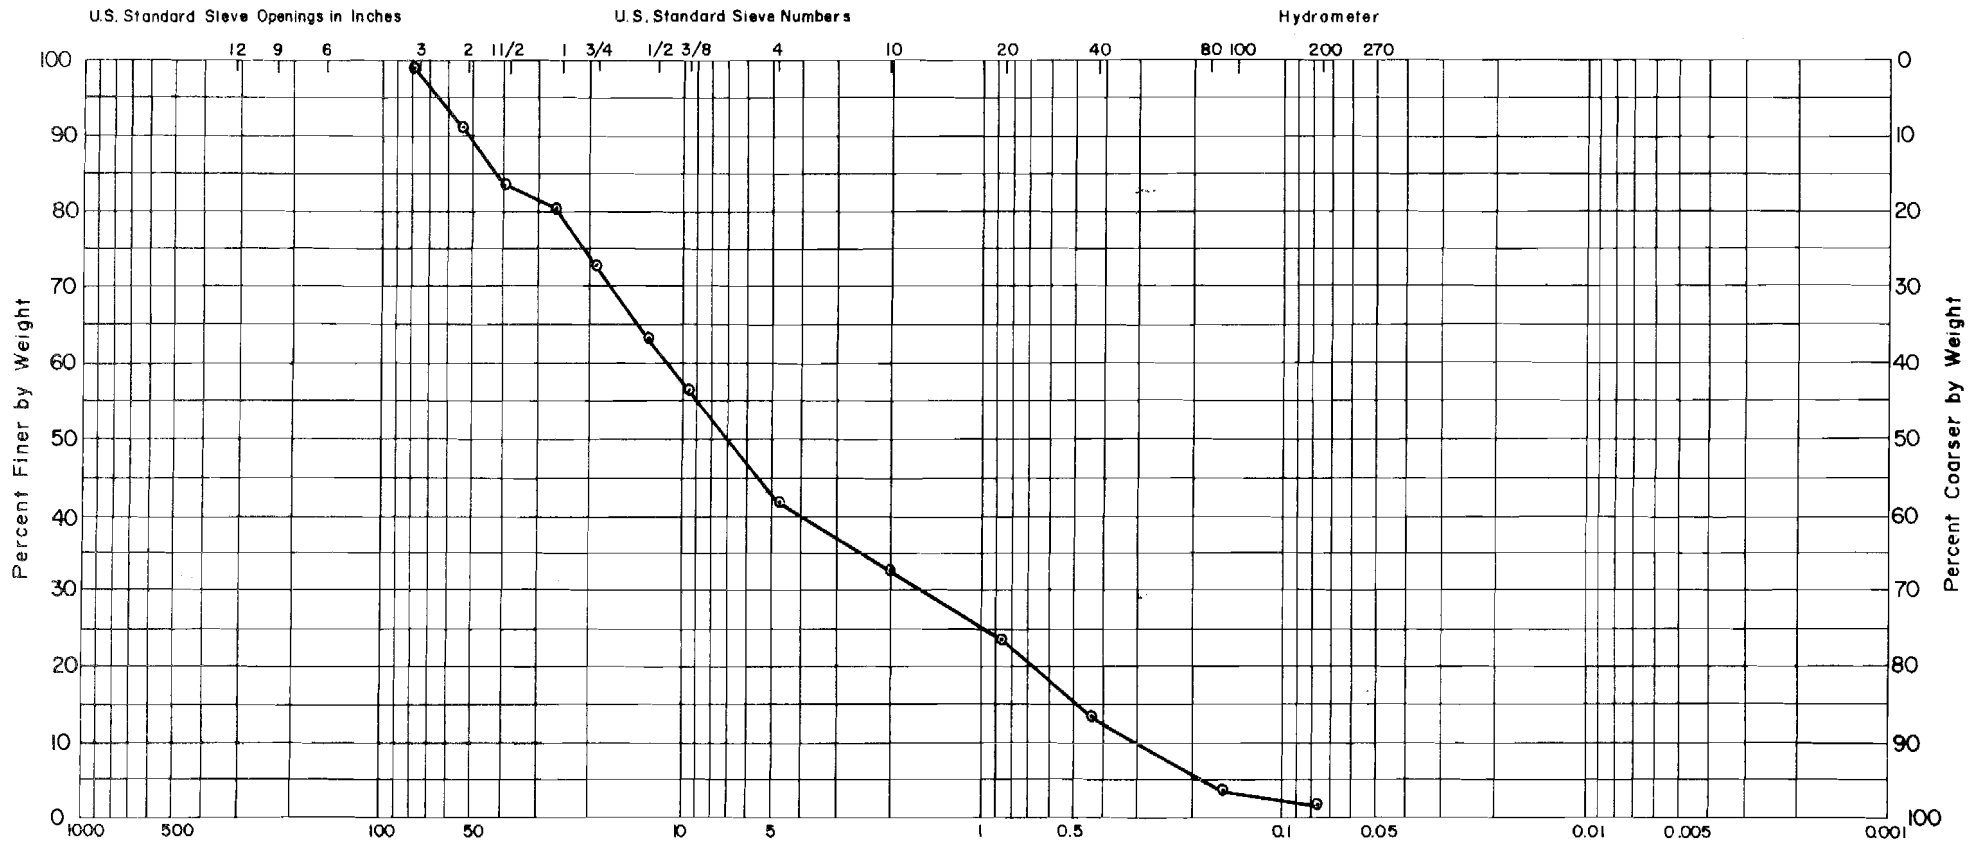
RIVER ALLUVIUM
TEST PIT TP-R18

SAMPLE NO.	MOISTURE CONTENT	DRY DENSITY	LL	PI	CLASSIFICATION & DESCRIPTION
TP-R18 #2					GP SANDY GRAVEL

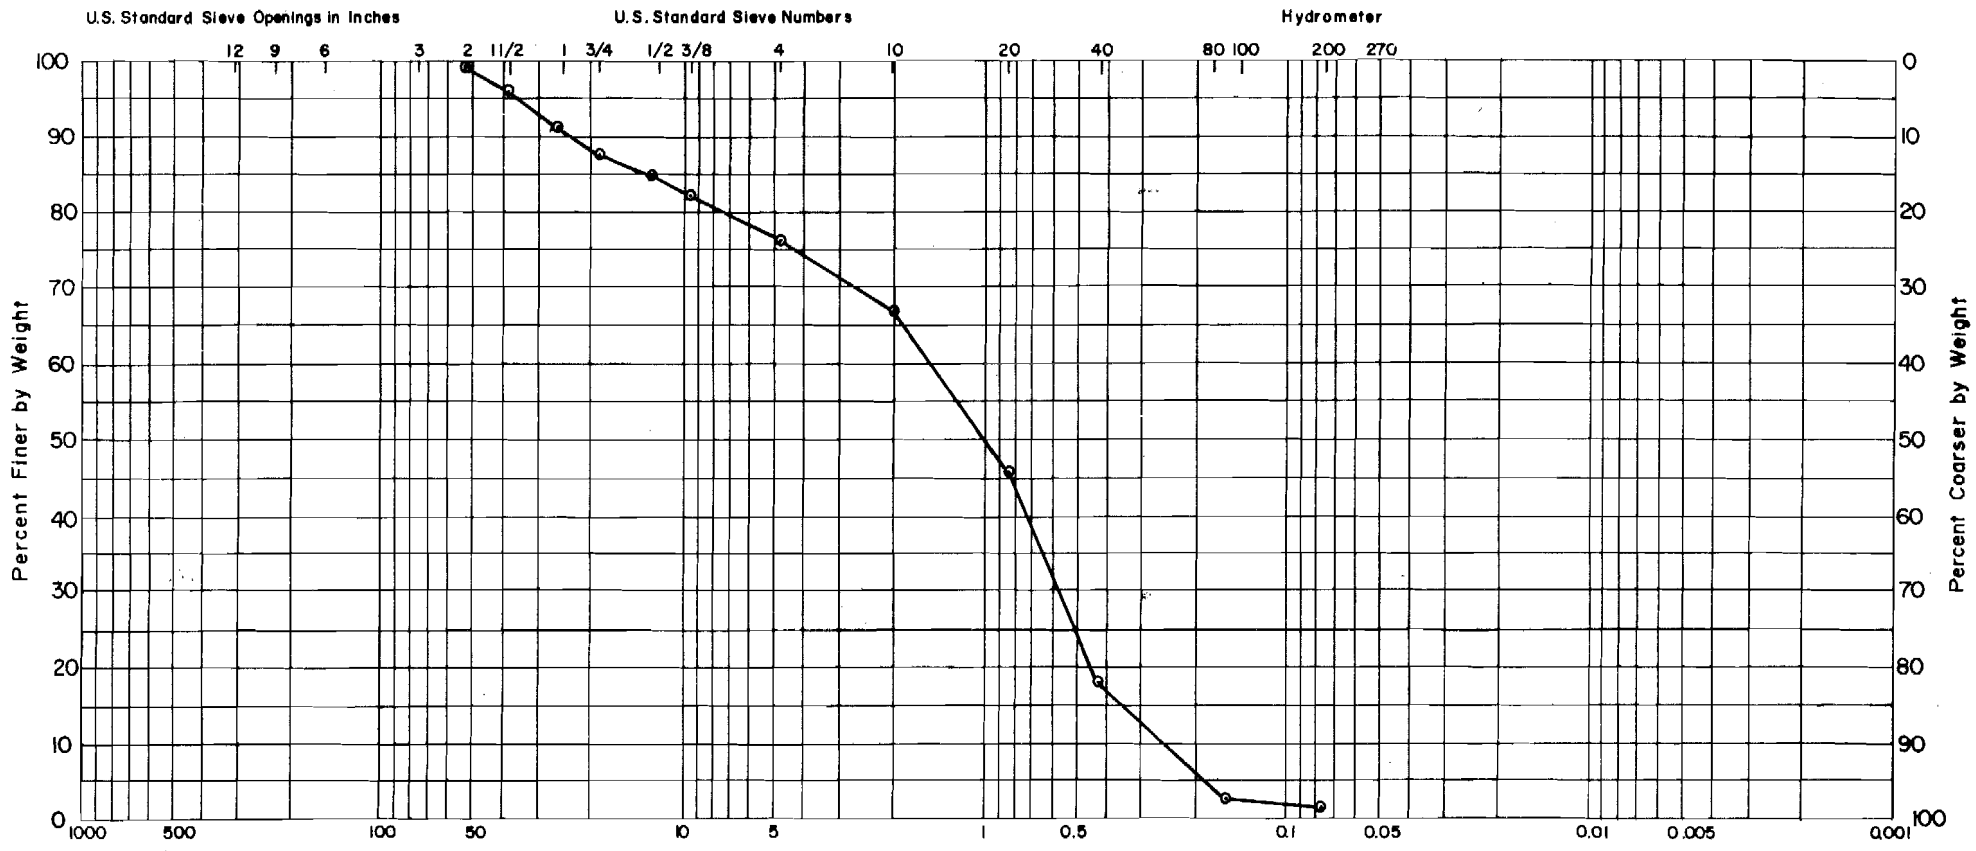
RIVER ALLUVIUM
TEST PIT TP-R19

SAMPLE NO.	MOISTURE CONTENT	DRY DENSITY	LL	PI	CLASSIFICATION & DESCRIPTION
TP-R19 #2					SW-SP SAND WITH SOME GRAVEL

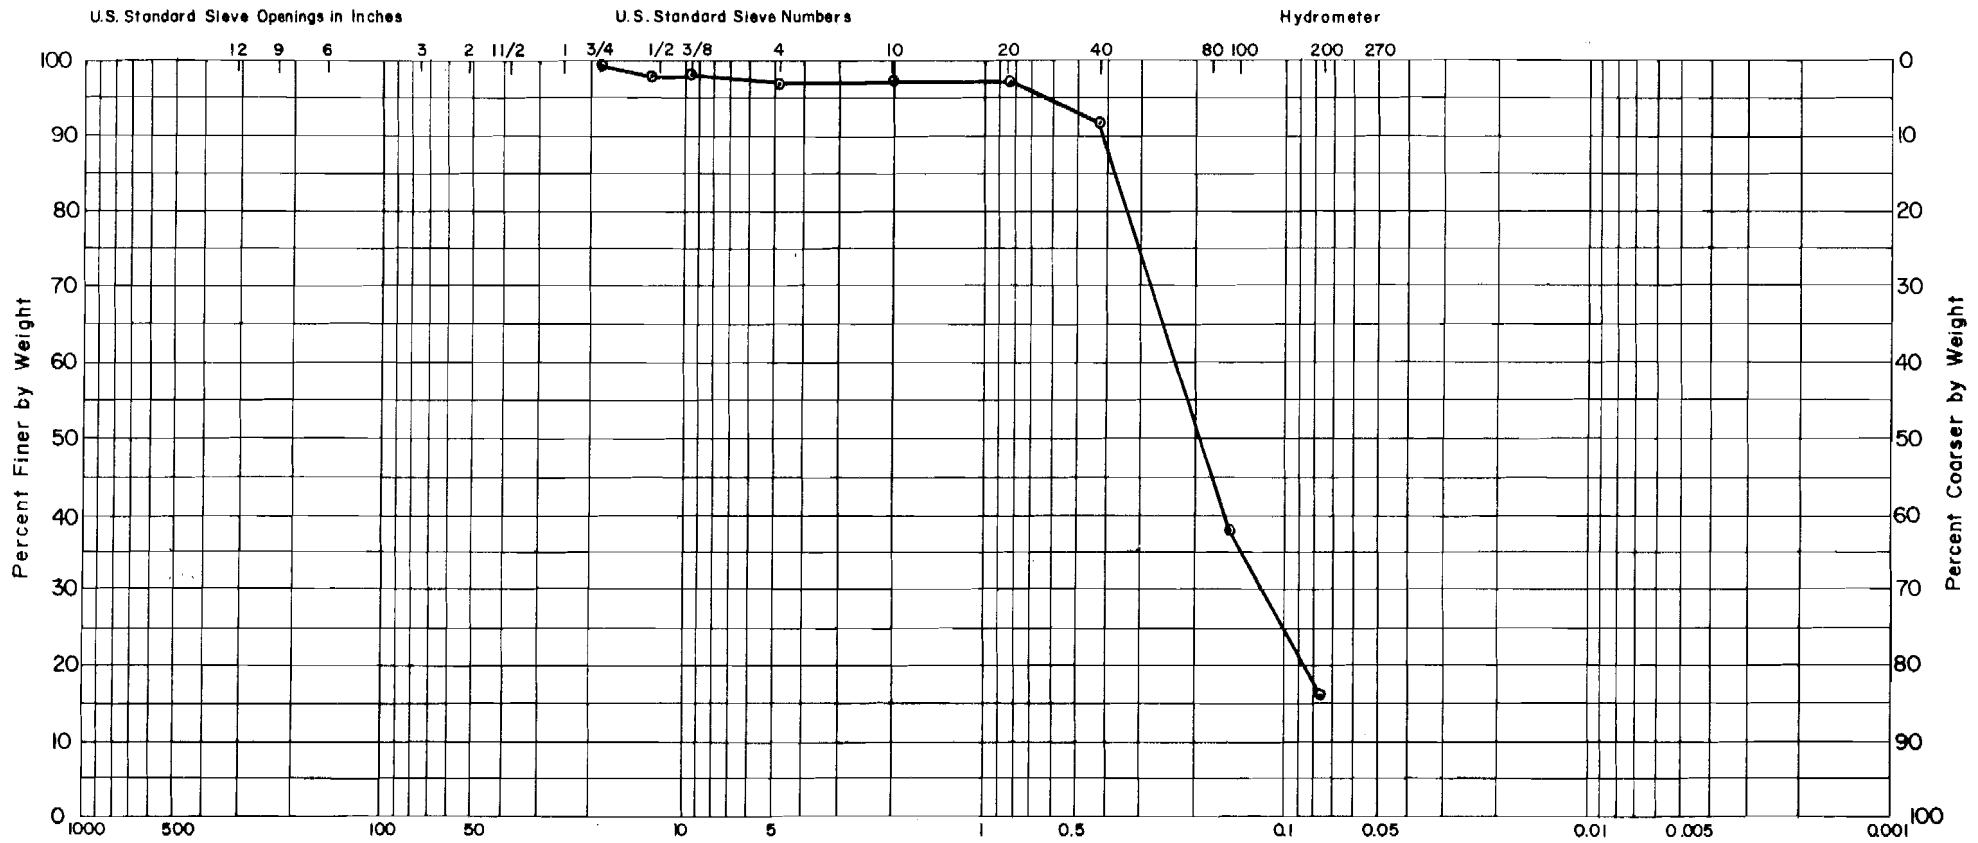
RIVER ALLUVIUM
TEST PIT TP-R20

SAMPLE NO.	MOISTURE CONTENT	DRY DENSITY	LL	PI	CLASSIFICATION & DESCRIPTION	
TP-R20 #1					SM-SP	SAND WITH SOME SILT AND TRACE GRAVEL (FIELD GEOLOGIST NOTES TRACE ORGANICS)

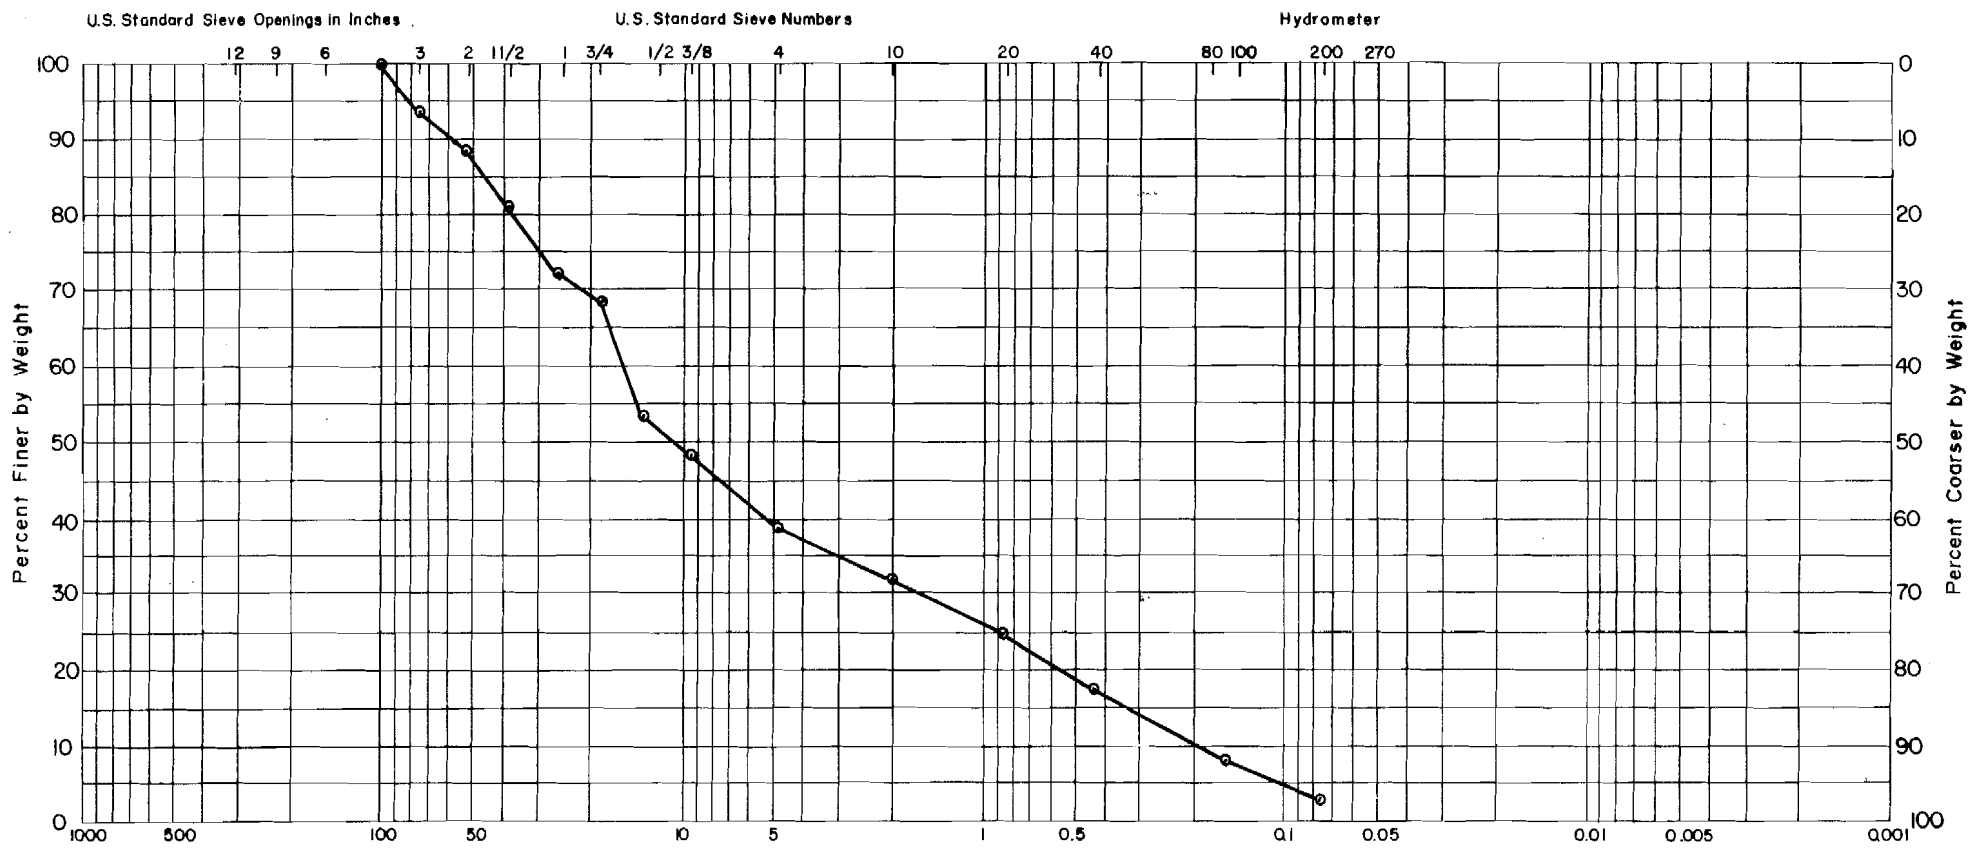
RIVER ALLUVIUM
TEST PIT TP-R20

SAMPLE NO.	MOISTURE CONTENT	DRY DENSITY	LL	PI	CLASSIFICATION & DESCRIPTION
TP-R20 #2					GW SANDY GRAVEL WITH TRACE SILT AND SCATTERED COBBLES

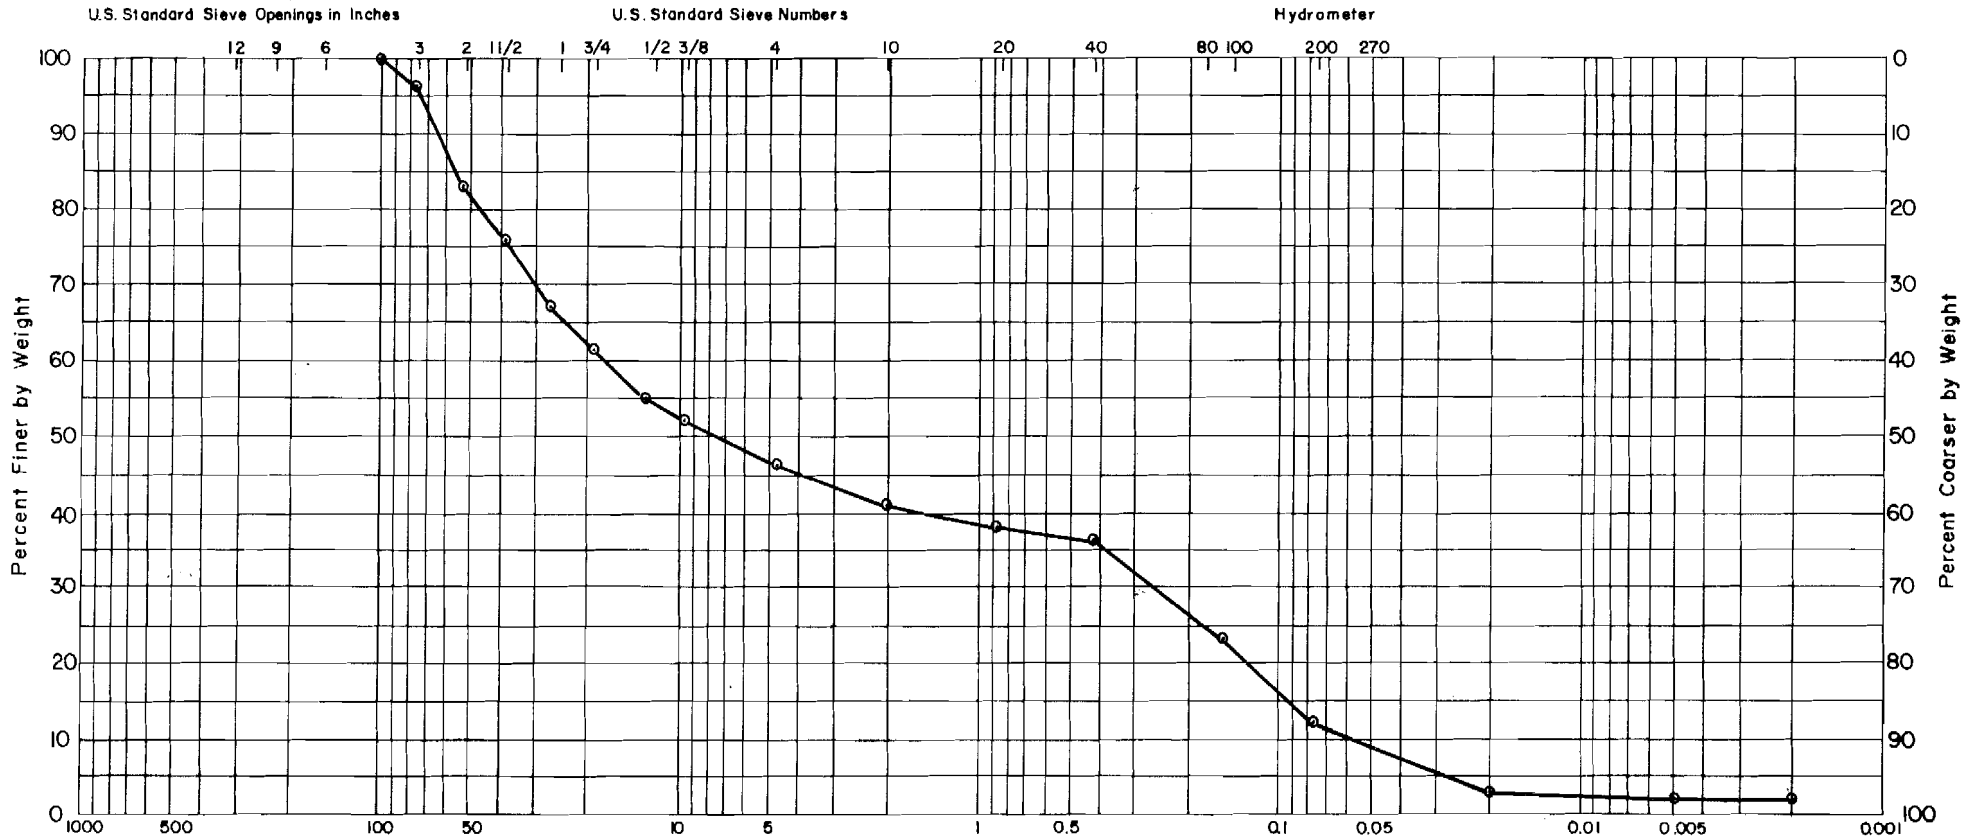
RIVER ALLUVIUM
TEST PIT TP-R22

SAMPLE NO.	MOISTURE CONTENT	DRY DENSITY	LL	PI	CLASSIFICATION & DESCRIPTION	
TP-R22 #1					GP-GM	SANDY GRAVEL WITH SOME SILT AND SCATTERED COBBLES

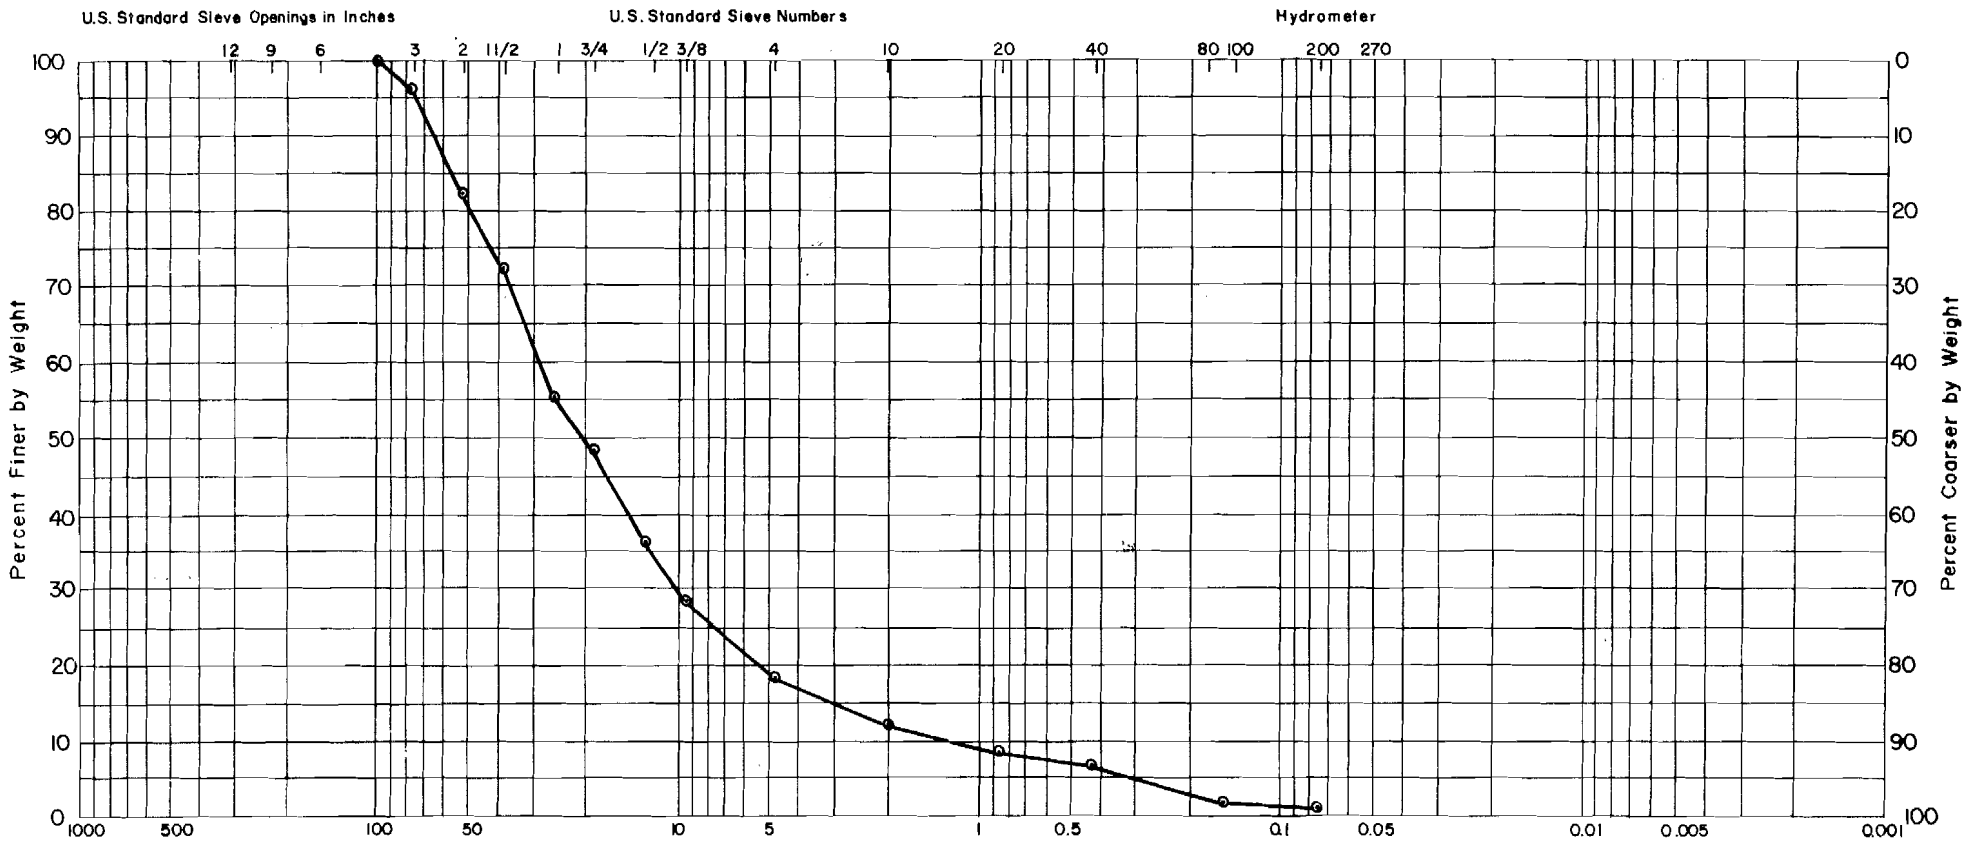
SAMPLE NO.	MOISTURE CONTENT	DRY DENSITY	LL	PI	CLASSIFICATION & DESCRIPTION
TP-R22 #2				GW	GRAVEL WITH SOME SAND AND SCATTERED COBBLES
