**SUSITNA
HYDROELECTRIC PROJECT**

**FEDERAL ENERGY REGULATORY COMMISSION
PROJECT No. 7114**

**ALASKA POWER AUTHORITY
RESPONSE TO
FEDERAL ENERGY REGULATORY COMMISSION
DATA REQUEST
OF OCTOBER 11, 1984**

**DAM BREAK ANALYSIS
WATANA AND DEVIL CANYON**

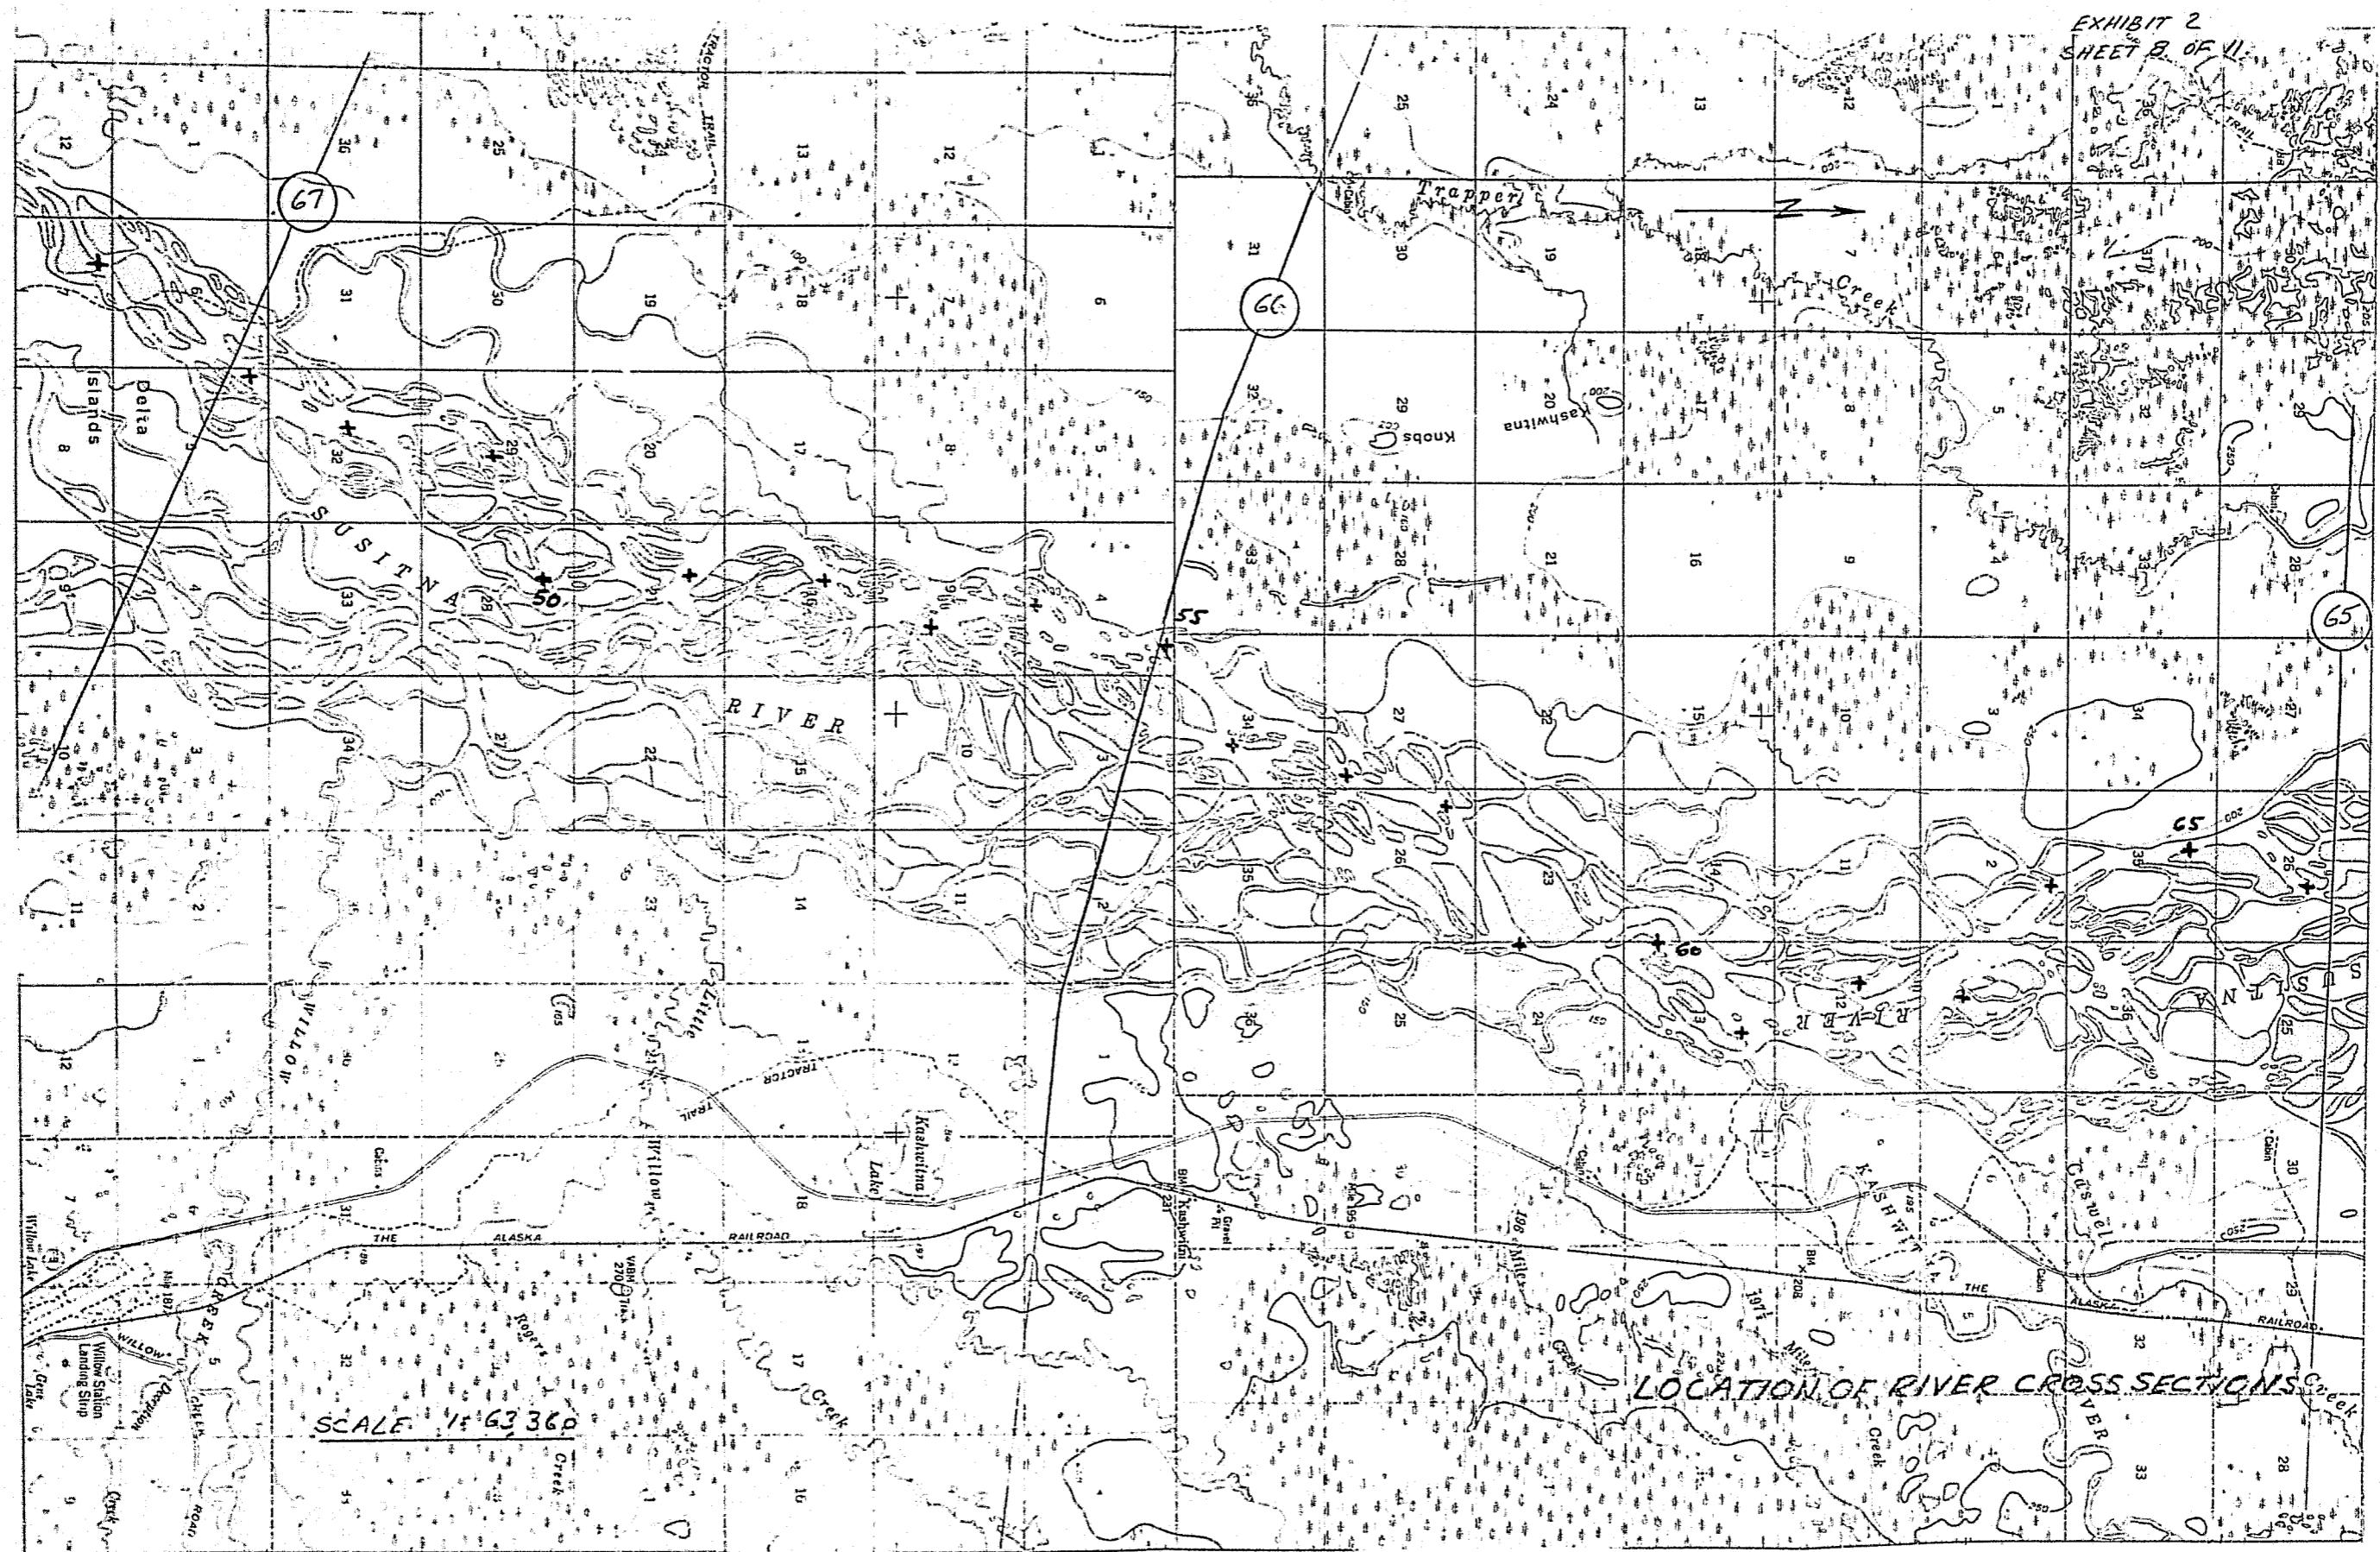
EXHIBIT 2
HEET 8. OF VI

LOCATION OF RIVER CROSS SECTIONS

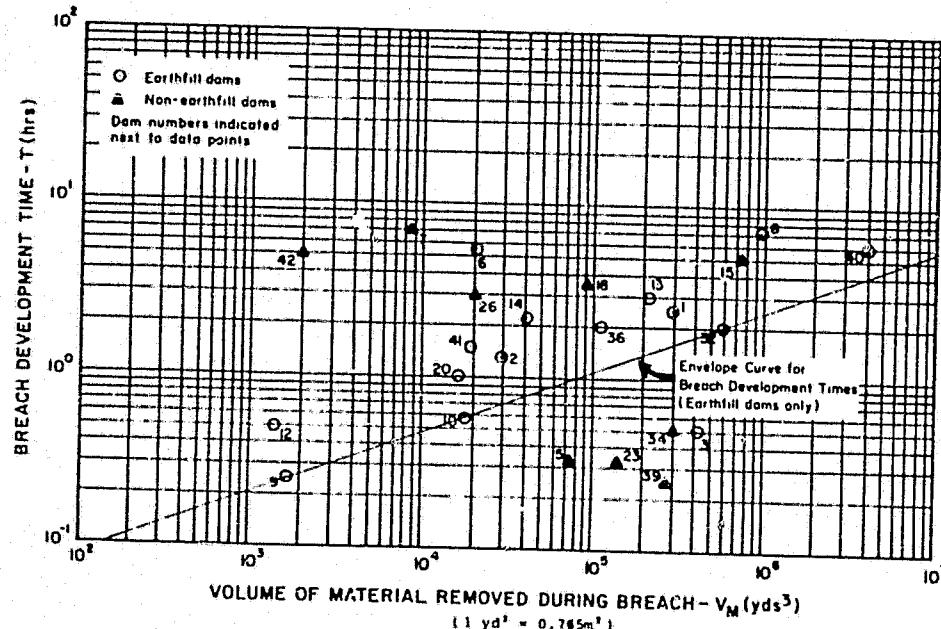
FIG. 2.—Breach Size versus Breach Development Time

Plots of the maximum breach development times for the "non-earthfill" dams are also shown in Fig. 2. These plots do not vary in a con-

The selected 10-hour time of failure for Watana is considered to be conservative because Figure 2 of Attachment A provides time for earthfill dams. A rockfill dam will take longer time to erode. Secondly, in the case of Teton dam, about 4 million cubic yard of material, about 1/10 of the volume of the material assumed to be eroded during failure of Watana was eroded in 6-hour period. By this proportion, the time of failure for Watana should be much longer than 10 hours.

Breach Development Time.—Analyses of the data in Table 2 indicate that, except for Buffalo Creek and Schaeffer Dams, the maximum breach development times of "earthfill" dams varied in a consistent manner with the volumes of material removed during the breach. Plots of the maximum breach development times versus breach volumes are presented in Fig. 2 along with an envelope curve that includes all "earthfill" dams except Buffalo Creek and Schaeffer Dams. This curve is probably more indicative of actual breach development times but, because it is an envelope of maximums, may still give high estimates of actual development times. The data for Buffalo Creek and Schaeffer Dams are not included in the envelope curve because it is suspected that these dams failed unusually fast for the reasons presented in the preceding section.

The remaining variable needed as input for the computer analysis is the development time of the breach. This development time is estimated using the breach volume determined from Fig. 1 and the envelope curve shown in Fig. 2.

3. For "earthfill" embankments, the time for breach development can be estimated using the relationship presented in Fig. 2 and the estimated breach volume.

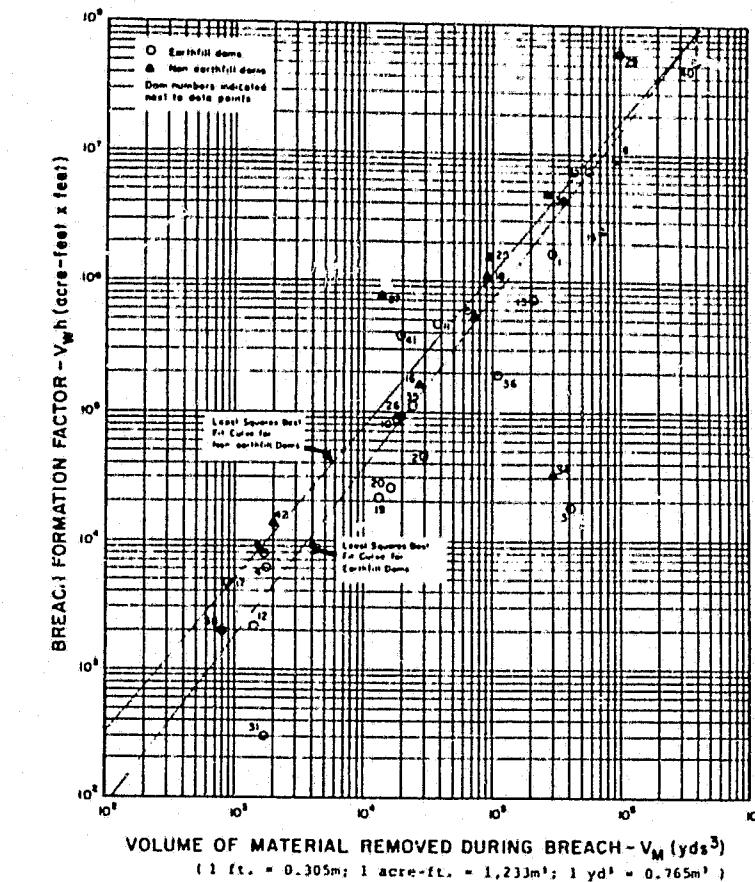
FIG. 1.—Outflow Characteristics versus Breach Size

Various combinations of the variables presented in Table 2 that describe flow characteristics during the breach were plotted against the estimated volume of breach material that was removed. It was found that the product of the outflow volume of water and the difference in elevation of the peak reservoir water surface and breach base ($V_w \times h$), when plotted against the volume of breach material removed, resulted in a minimum amount of scatter of the data and is a reasonably consistent variable for predicting breach volume. Hereinafter this variable for predicting breach volume is called the Breach Formation Factor (BFF).

The relationships presented in Figs. 1 and 2 for predicting breach characteristics were used with the HEC-1 computer program to calculate outflow hydrographs for three hypothetical failures of two dams and reservoirs. The peak outflows of the calculated hydrographs are shown on Fig. 3 for comparison with the peak outflows of historical dam failures. These comparisons indicate that the methodology that was developed provides reasonable estimates of dam failure flood hydrographs. The analyses and results of these verification studies are described in the following paragraphs.

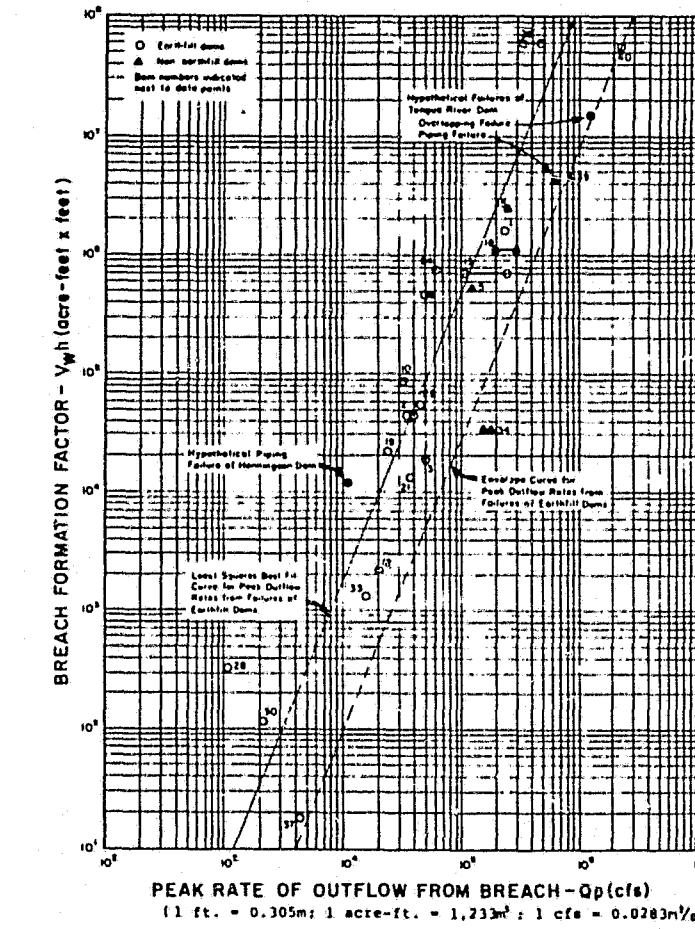
FIG. 3.—Outflow Characteristics versus Peak Rate of Outflow

Also plotted in Fig. 3 are estimated peak outflows from "non-earthfill" dams. In general, peak rates of outflow from the "non-earthfill" dam failures are higher than would be predicted from the data on "earthfill" dam failures. This would be expected if the breaches were formed partly by erosion and partly by the sudden collapse of a section of the embankment. A least squares best fit curve for "non-earthfill" dams is not presented in Fig. 3 because of the limited amount of data.

Peak Outflows.—Analyses of the estimated peak outflows from dam failures presented in Table 2 were made to develop a relationship that can be used to verify the methodology and to verify results of dam safety studies. Studies by Hagen (24) found that there is a good correlation between the peak rate of outflow from a dam breach and a variable very similar to the BFF. The data in Table 2 were used to develop the relationship between peak outflow and the BFF presented in Fig. 3. This relationship is essentially identical to that developed by Hagen.

The estimated peak outflows from Buffalo Creek and Schaeffer Dams are plotted in Fig. 3 but are not included in the calculated least squares best fit curve for "earthfill" dams. As previously reviewed, these two dams apparently failed very quickly, and washed out unusually large amounts of embankment material. Thus, it would be reasonable to expect unusually large peak outflows from these dam failures but, the data indicate that these outflows are only on the high side of the scatter of data. This could probably be explained by the large scatter of the data, i.e., had the breaches been smaller and developed at a slower rate, the

Relevant data used in the analyses of Tongue River Dam and Henningson Dam along with the results of the HEC-1 analyses are presented in Table 3. Calculated peak outflows from the assumed breaches are the last item listed in Table 3. These outflows are plotted in Fig. 3 for comparison with peak outflows from historical dam failures.

A third independent relationship was developed that relates the BFF and the peak rate of outflow from historic dam breaches. This relationship is presented in Fig. 3 and was developed for use in verifying that the methodology gives reasonable estimates of peak outflows from theoretical dam breaches that are analyzed in dam safety studies.

Analyses of hypothetical failures of large and small "earthfill" dams were made using the relationships presented in Figs. 1 and 2, the methodology that was developed, and the Corps of Engineers' computer program HEC-1. The calculated peak outflows from these hypothetical failures are consistent with the independent relationship for peak outflows presented in Fig. 3, thereby indicating that the methodology for analysis of "earthfill" dam failures gives reasonable results.
