SUSITNA HYDROELECTRIC PROJECT

RESPONSE OF AQUATIC HABITAT SURFACE AREAS TO MAINSTEM DISCHARGE IN THE YENTNA RIVER CONFLUENCE TO TALKEETNA REACH OF THE SUSITNA RIVER

PAM CONSULTANTS, INC.

DRAFT REPORT April 1985

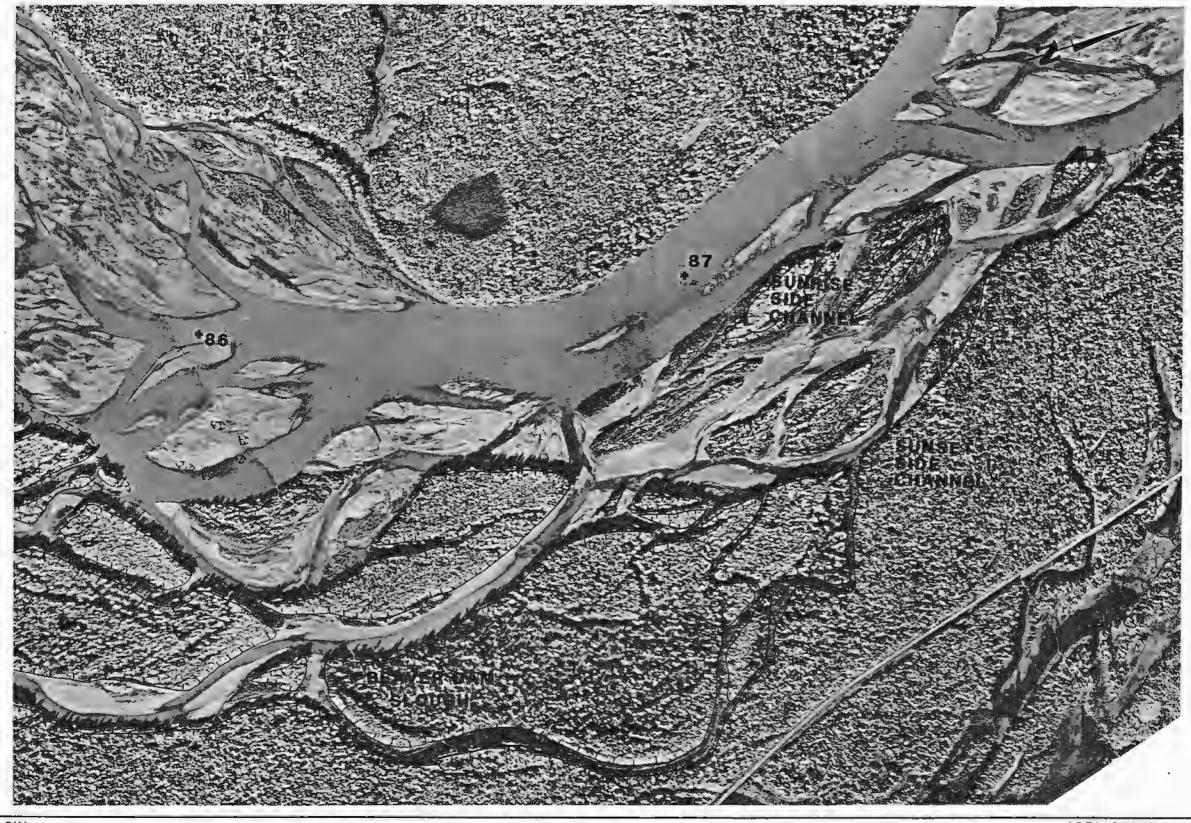
FIGURE 4.6

COMPARISON OF VEGETATED RIVERBANKS AND ISLANDS 1951, 1962 and 1983: SUNSHINE SLOUGH 2 of 2

Sucker Side Channel has become narrower with vegetation encroaching on the channel (Figure 4.6). The islands near the ADF&G Sunrise and Sunset study sites have become more stable, transitioning from gravel bars to vegetated islands from 1951 to 1984 (Figure 4,6). The head of Beaver Dam Slough has become more stable. The main channel has shifted slightly east so it impinges on the side channel complex and has caused relatively rapid erosion at point A (Figure 4.6). Debris jams within the side channel complex are causing areas of aggradation, increasing the stability of the gravel bars.

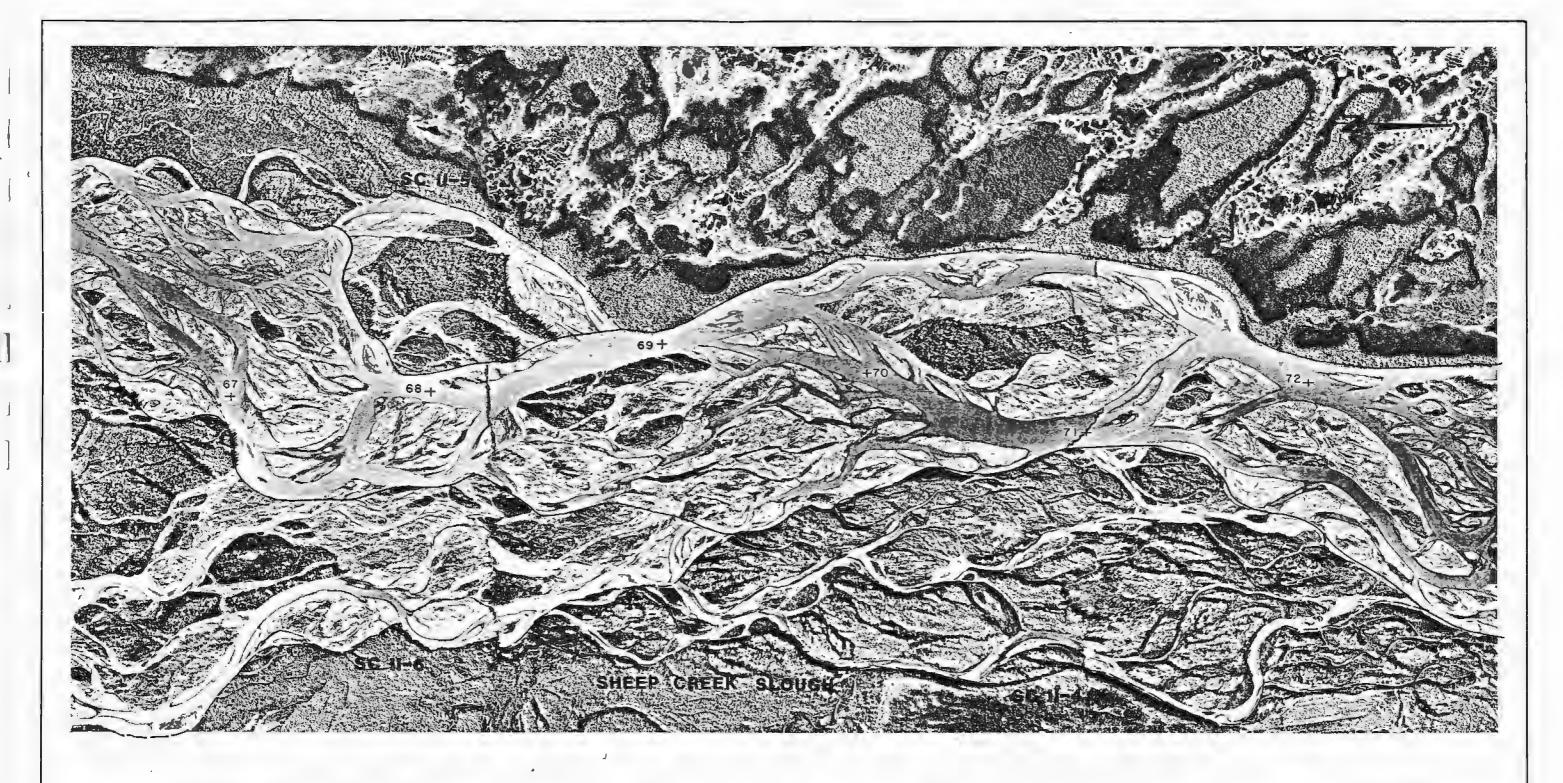
FIGURE A-7

RIVER-MILE 87 TO 72

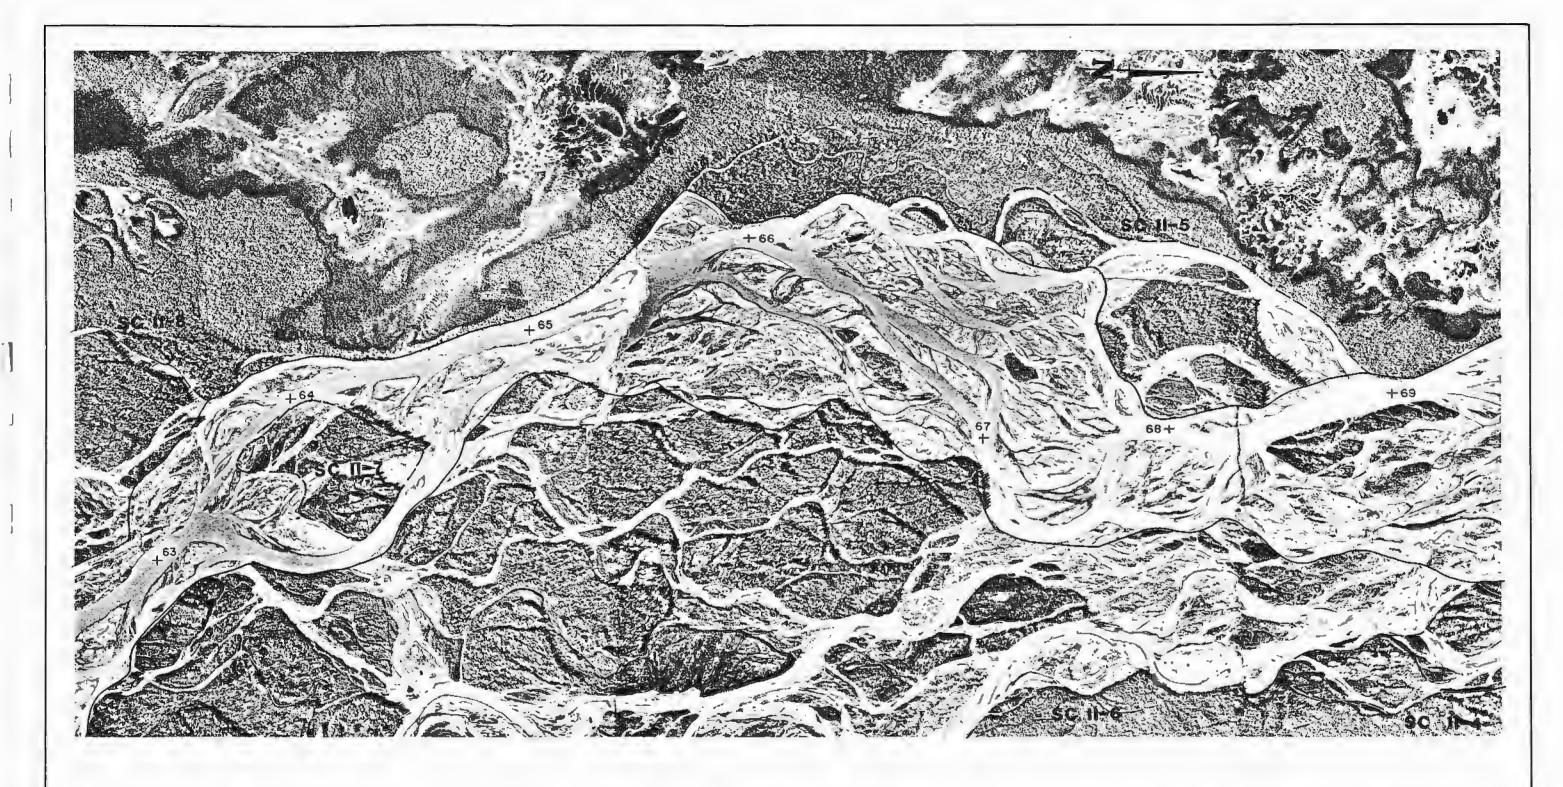
FIGURE A-8

RIVER MILE 63 TO 69

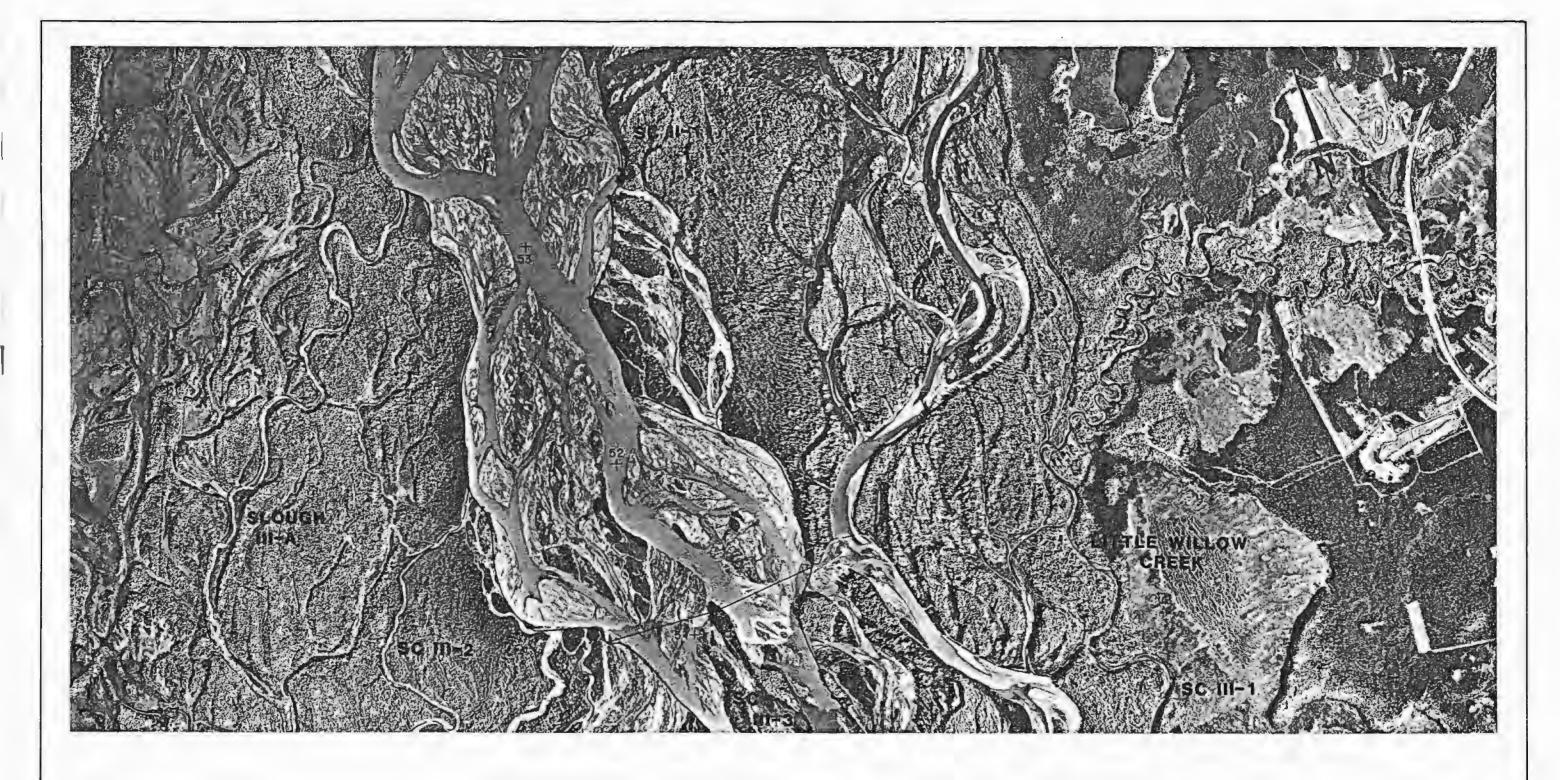
FIGURE A-12

RIVER MILE 51 TO 53

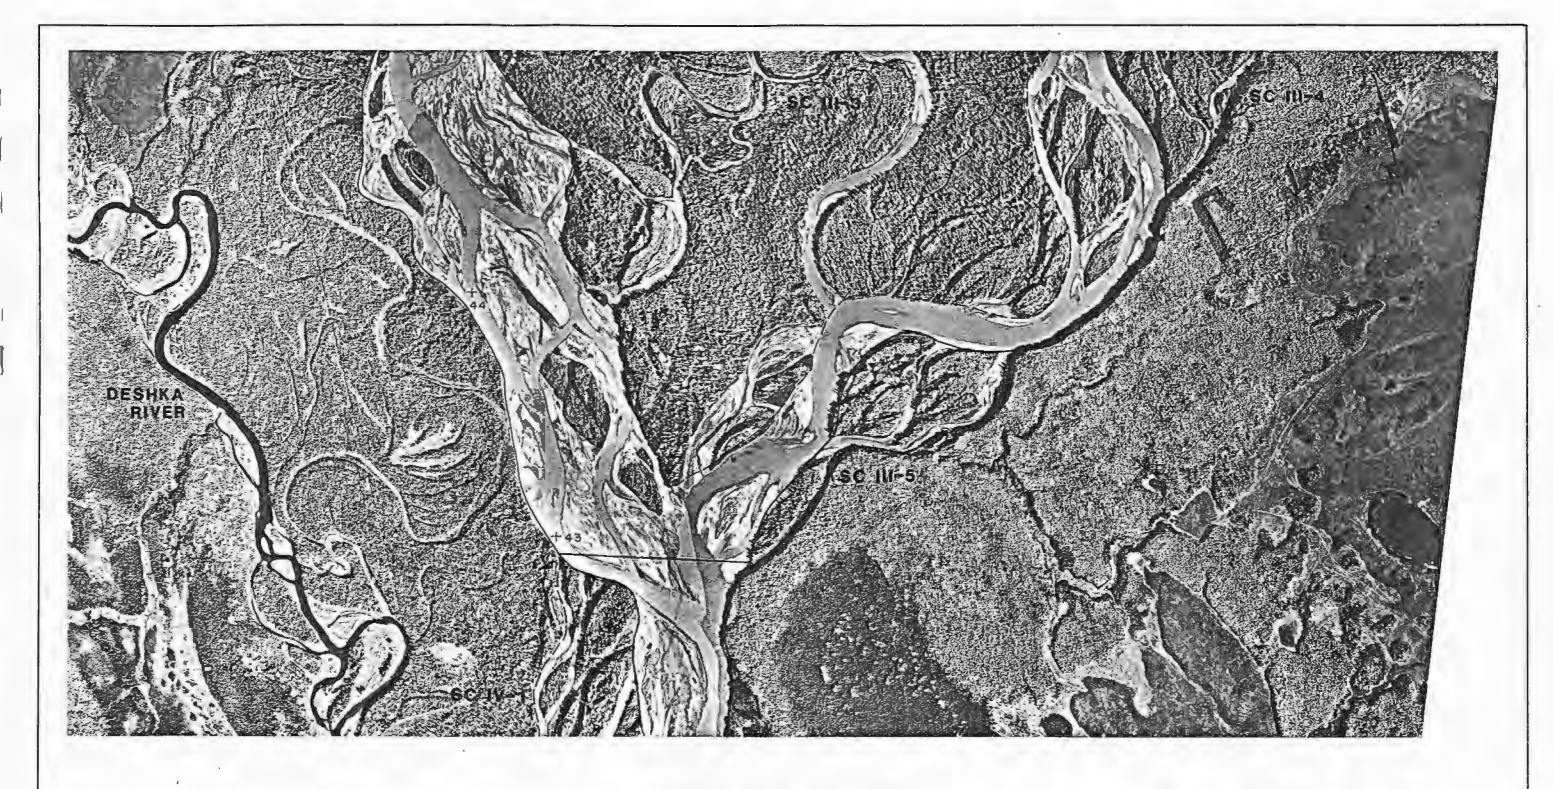
FIGURE A-15

RIVER MILE 43 TO 44

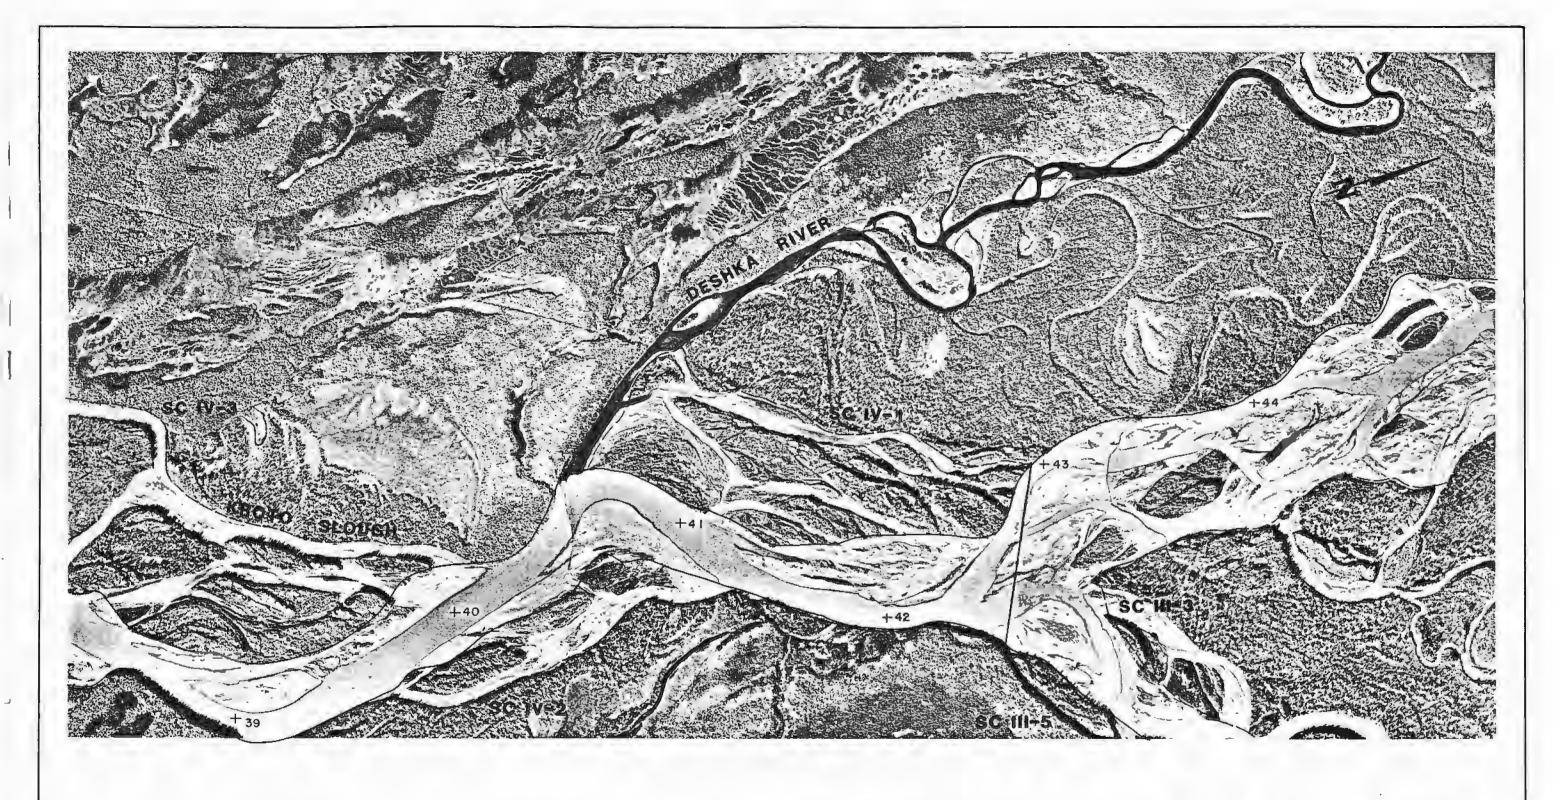
FIGURE A-16

RIVER MILE 39 TO 44

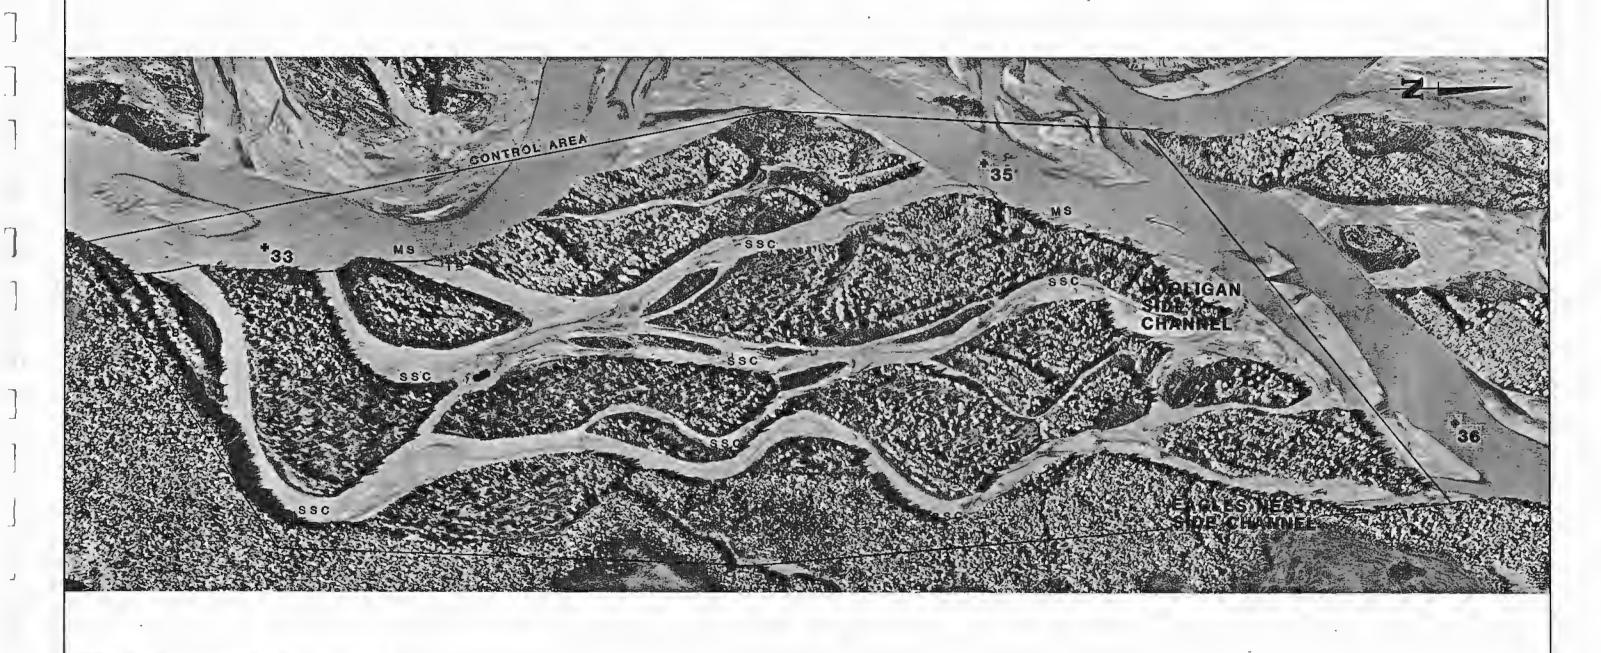
FIGURE B-3

SC IV-4

DISCHARGE AT SUNSHINE: 36,600 cfs

DATE OF PHOTOGRAPHY: 9/8/83

Whether the photographs were taken on a rising, falling or steady stage influences the habitat type found, specifically whether a given channel is a clearwater area or turbid backwater. On a rising stage an intermediate side channel could be a clearwater area or side slough if there has been sufficient time between periods of overtopping flow for the channel water to clear up. On a falling limb an intermediate side channel could be a turbid backwater if the aerial photography were taken immediately after the berm dewatered. If the channel was influenced by upwelling then as the discharge continued to drop, the turbid backwater would transition to a side slough. If it was not influenced by upwelling, the channel would remain a turbid backwater until the water cleared by settling out of the sediment. This was noticed at SC IV-4 between the 36,600 cfs and 21,100 cfs photographs.

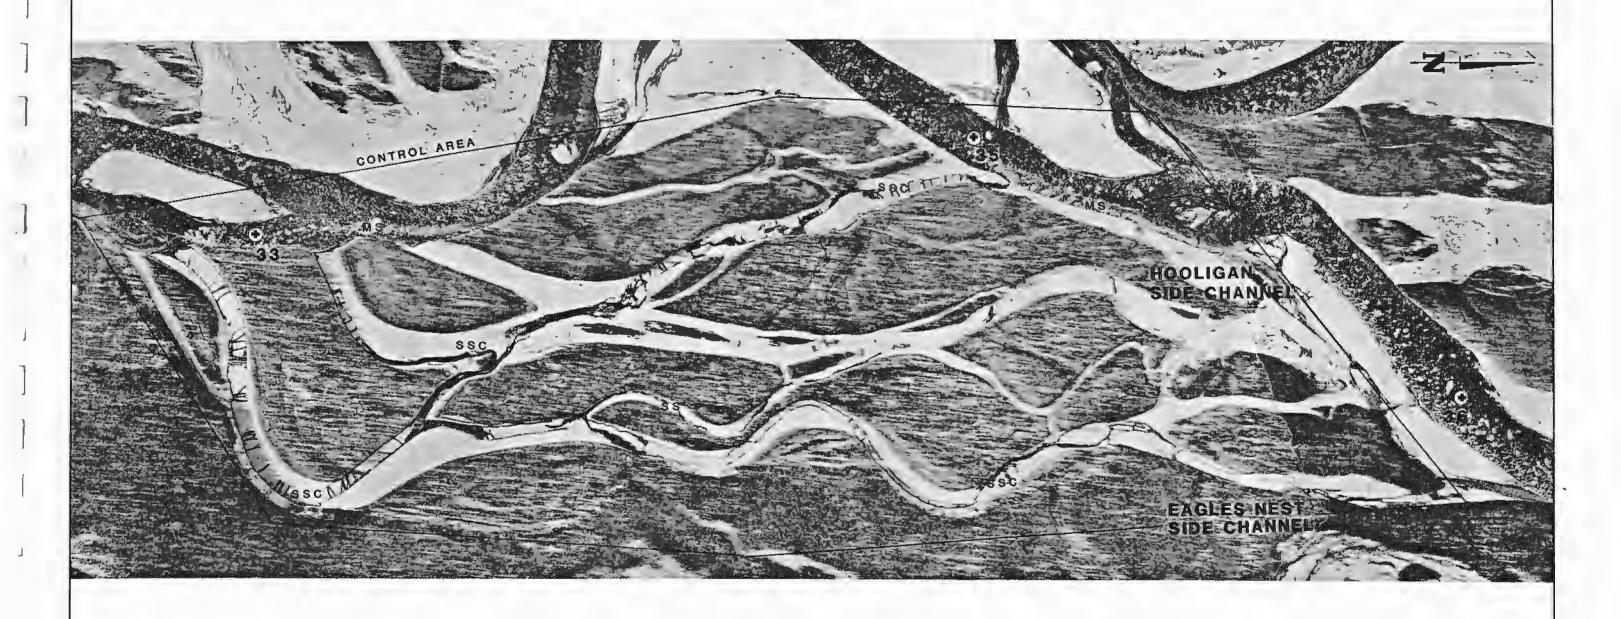
FIGURE B-4

SC IV-4

DISCHARGE AT SUNSHINE: 21,100 cfs

DATE OF PHOTOGRAPHY: 9/16/83

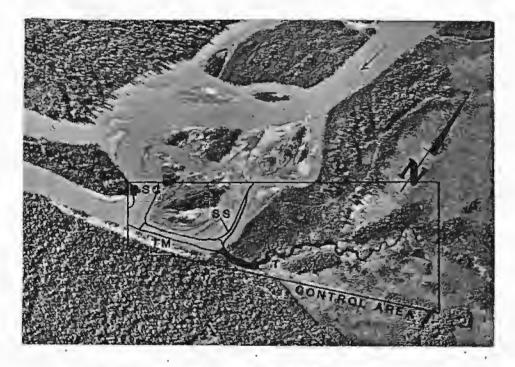
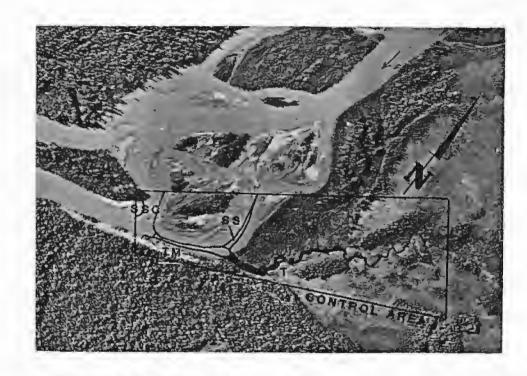
FIGURE B-12

WETTED SURFACE AREA FOR 21,100

WETTED SURFACE AREA FOR 13,900

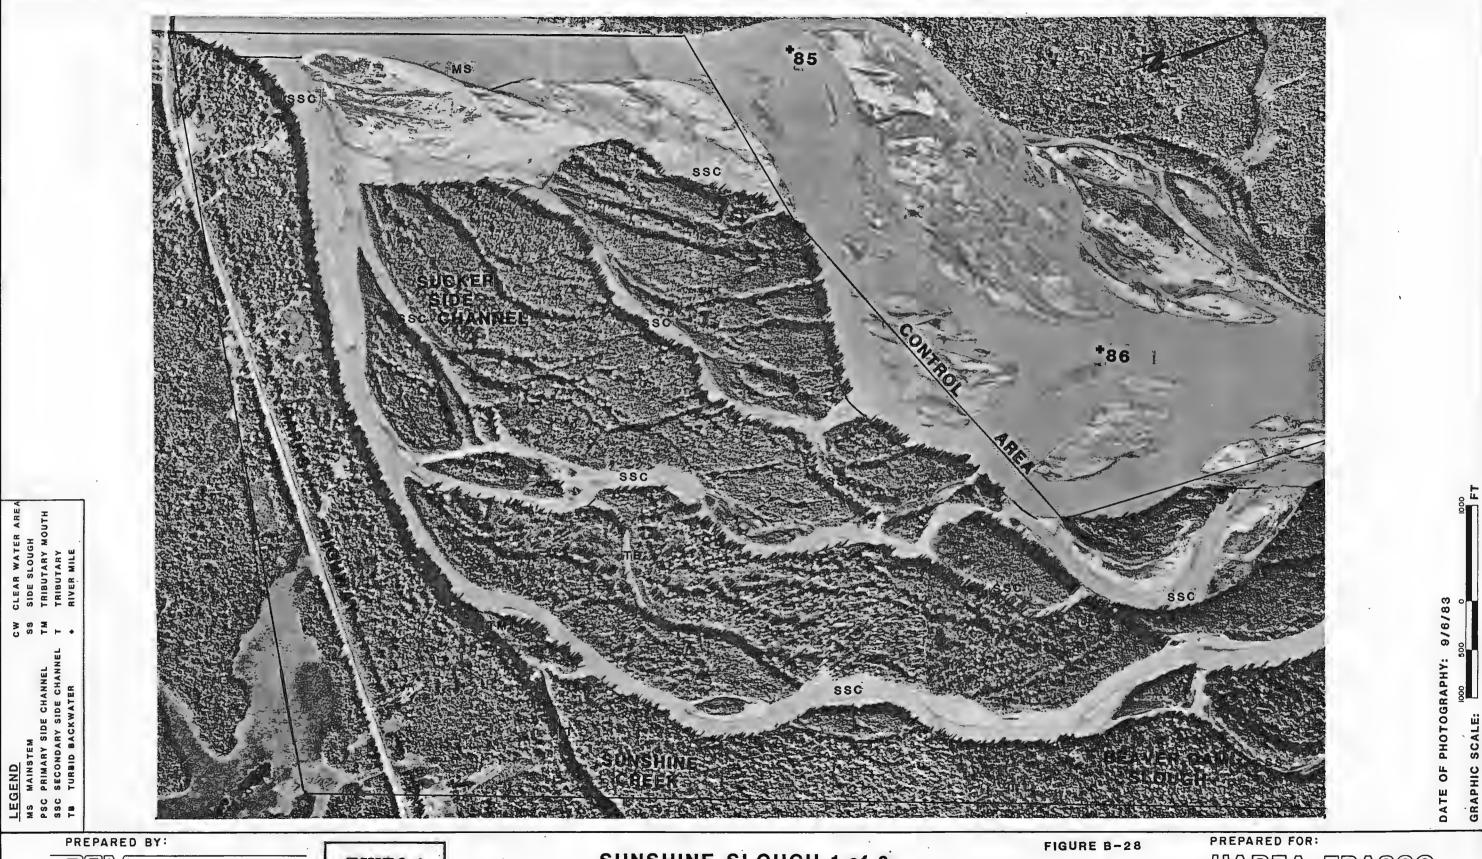
DISCHARGE AT SUNSHINE: 36,600 cfs

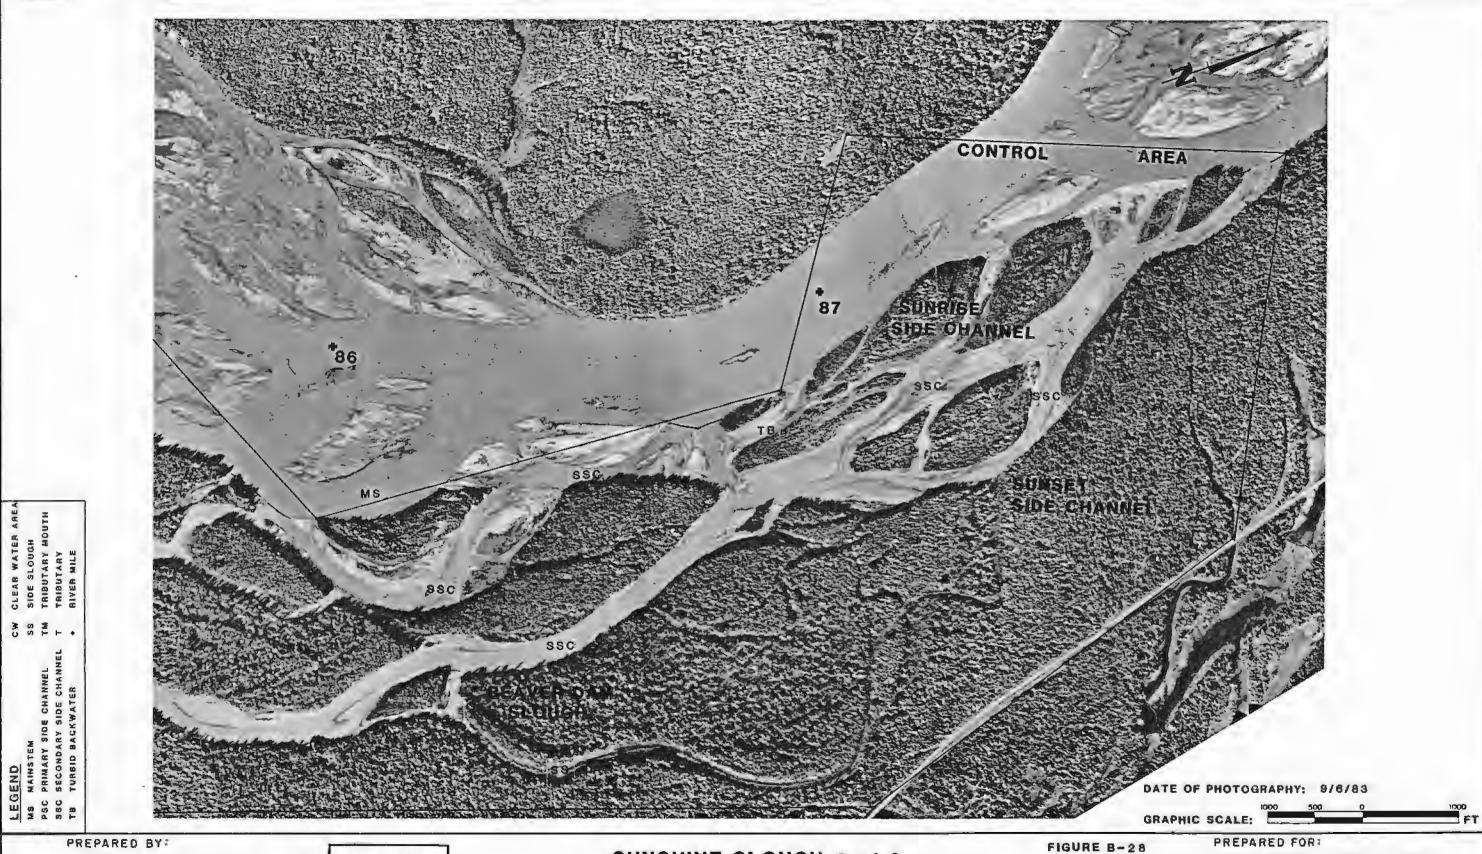
EWT&A WOODS FRIRES 4 #5500 14175 SUNSHINE SLOUGH 2 of 2

DISCHARGE AT SUNSHINE: 36,600 cfs
