## **6. SUSITNA BASIN AND DAM SITE CHARACTERISTICS**

### **6.1. Climatology**

## 6.2. Hydrology

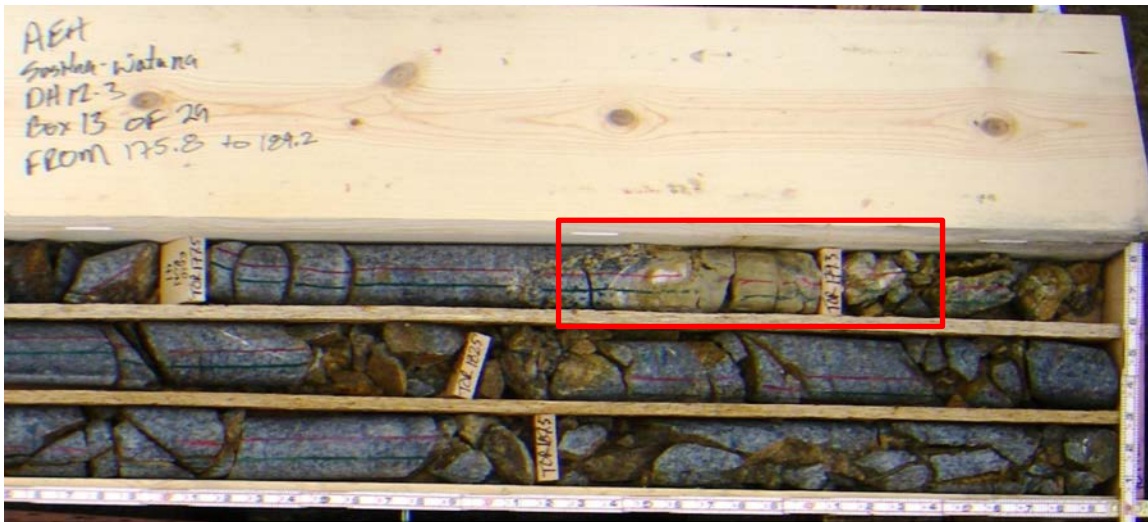
**Figure 6.3-22. Rock Core from DH12-3 with Closely Fractured Rock and Shear Zone at Depth of about 179 ft. (red box)**

Although fracture zones are not readily observed at the ground surface, the conditions are better represented in the rock cores. Several fracture zones with breccia and gouge can be observed in the rock core from DH12-3, which is believed to cross several fractures zones comprising GF4B on the north abutment. For example, at a depth of 179 ft. a northwest-southeast trending fracture zone consisting of close to very closely fractured rock and eight-inch thick zone of clay gouge shown in Figure 6.3-22 was encountered. Although these fracture and shear zones are considered relatively minor features with respect to the dimensions of the dam, the project structures have been moved slightly downstream, to reduce the potential that this or similar structural features will impact the dam or require foundation treatment.

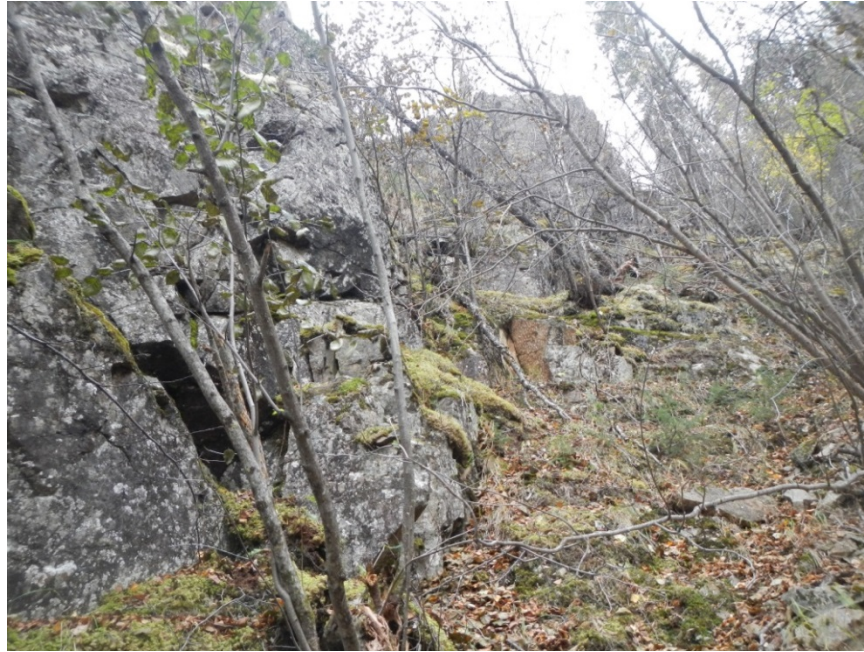
**Figure 6.3-23. 75 ft. High Cliff on Right Abutment Forming the Downstream (Southwest) Boundary of GF5**

GF5 is located downstream of GF4A and GF4B and consists of multiple fracture zones with some minor shear zones that cross the dam footprint on the lower right abutment. The geologic structures comprising GF5 are similar to those of GF4B and trend northwest-southeast ( $310^{\circ}$  to  $320^{\circ}$ ). The structures are steeply dipping, and were anticipated to be encountered in the dam foundation, diversion tunnel, and spillway excavations. On the north bank of the river, GF5 is interpreted to fall within a 100-foot wide gully that extends from the shoreline to about El. 1700 ft., bound by the 75-ft-high rock face (Figure 6.3-23) immediately downstream. On the south abutment, GF5 was interpreted to extend to the SW to about El. 2100 ft. Overall, the fracture zones with evidence of shearing (e.g., breccia and gouge) are shown to extend across the dam site over a distance of up to 1,500 ft.

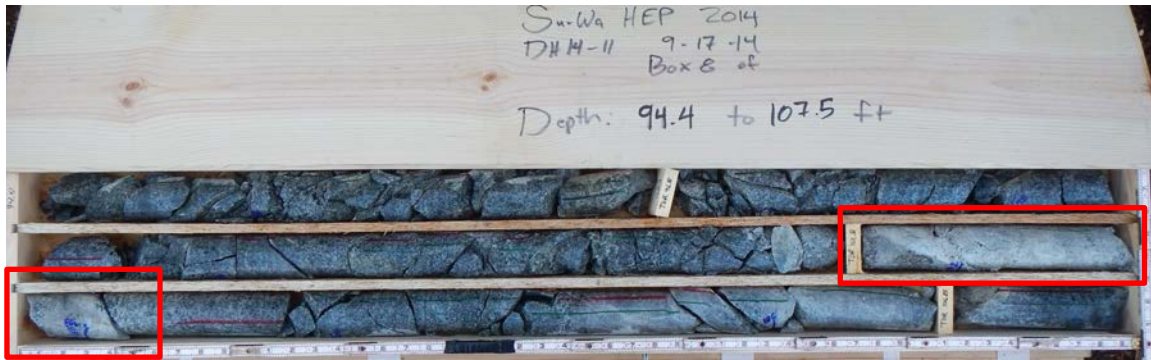
**Figure 6.3-24. Rock Core from DH14-11 with Closely Fractured Rock and Shear Zone at Depth of about 102 ft. (red box)**

Because fracture zones in GF5 are readily observed at the ground surface, the conditions are best observed in the rock cores. In DH14-11 at a depth of 102 ft. a northwest-southeast trending fracture zone consisting of close to very closely fractured rock and approximately 20 inch wide shear zone (apparent width) of moderately to completely weathered and friable and brecciated rock as shown Figure 6.3-24. Although considered relatively minor features with respect to the dimensions of the dam, due to the location and trend of this and similar fracture zones and shear zones in GF4B, the project structures were moved slightly downstream, to reduce the potential impacts that this or similar structural features could have on the dam foundation.

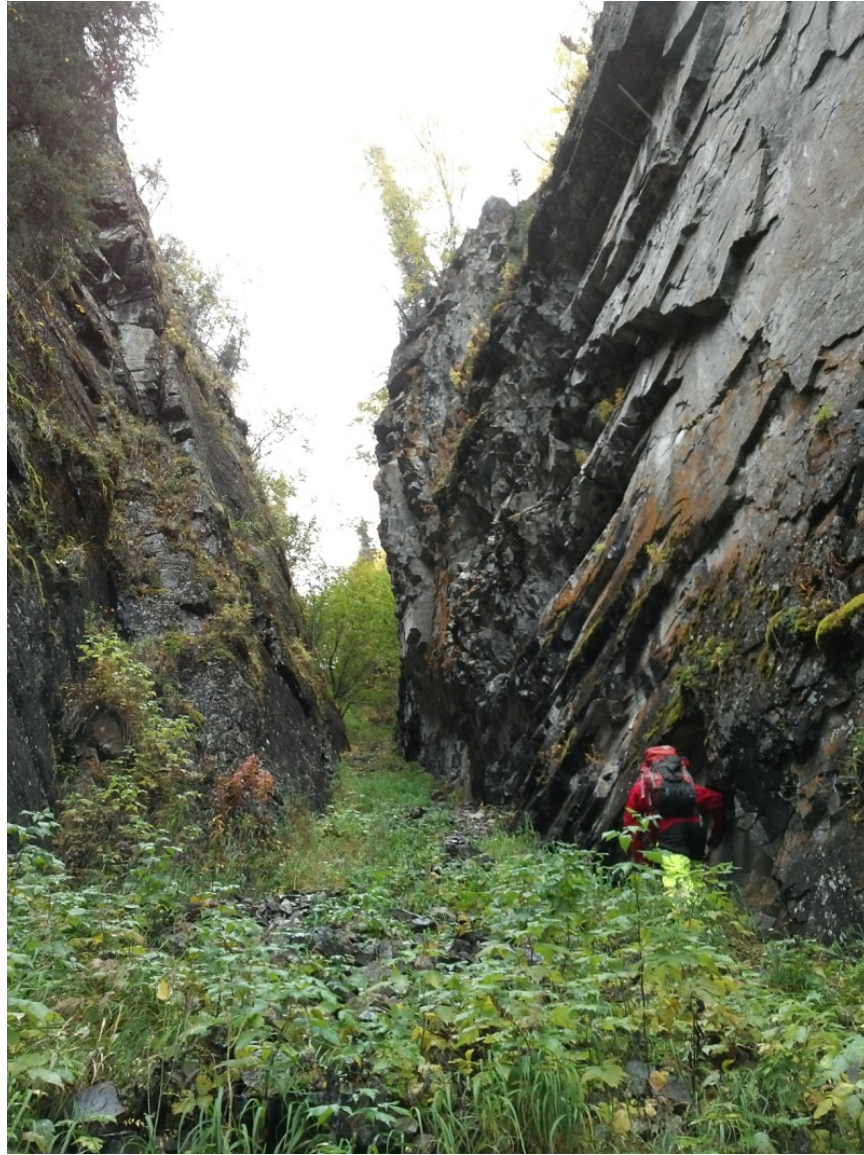
**Figure 6.3-26. Narrow Gully in Area of GF1**

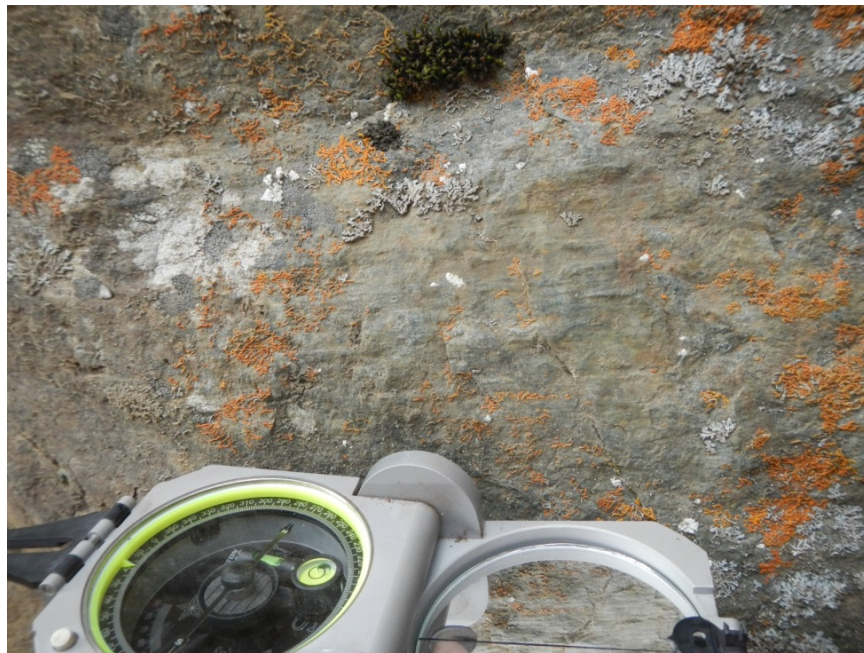
**Figure 6.3-27. Subhorizontal Slickensides along Outcrop Surface near GF7Q**

The presence of slickensides with different relative movements from one side of the river to the other suggests there may be multiple features with a relatively limited area or complex relative motions.

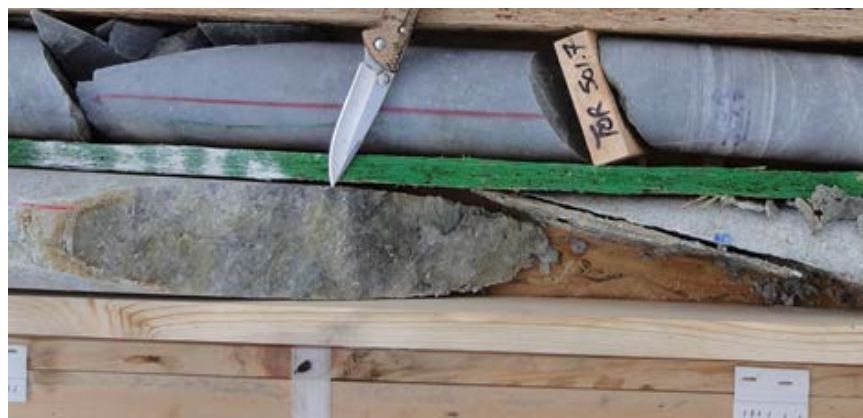
**Figure 6.3-29. Close-up of Shear Zone with Slickensides in DH14-10 at Depth of 507 ft.**

with one to two inches of brecciated rock and clay gouge were encountered in DH14-9b at about 146 ft., 633 ft., and 660 ft. depth and in DH14-10 at depths of about 142 ft., 225 ft., and 507 ft. (Figure 6.3-28 and Figure 6.3-29), and included slickensides. These shear or shear/alterated zones are not anticipated to be sources of major structural weaknesses in the otherwise sound bedrock foundation. The drilling encountered no large-scale shears zones or faulting beneath the river.
