## SUSITNA HYDROELECTRIC PROJECT

1980 - 81 GEOTECHNICAL REPORT

VOLUME 2
APPENDIX A-F
FINAL DRAFT

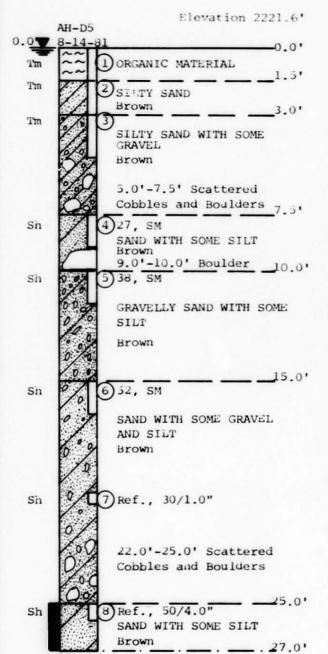
\_----27.0 (9)94, 13%, SM Sh SAND WITH SOME SILT Brown 25.0'-48.3' No Visible Ice. 35.0' 10 72, 16%, SM-SC Sn SILTY SAND WITH SOME TO TRACE CLAY Gray 35.0'-40.0' Scattered Cobbles 40.0 11) 78, 12%, CL Sh SANDY SILT WITH SOME TO TRACE CLAY AND TRACE GRAVEL Gray \_\_45.0' 70, 9%, SM-SC SAND WITH SOME GRAVEL AND SILT, TRACE CLAY AND SCATTERED COBBLES 50/3.0" 48.3'T.D. Thermal Probe Installed to 50.0' Stand Pipe Piezometer Installed to

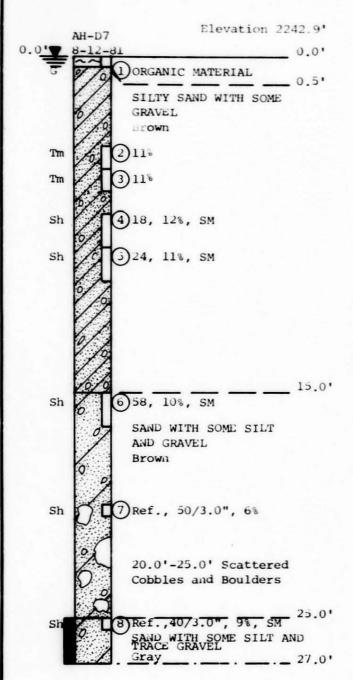
..\_\_\_ 27.0 30.0'-31.5' Boulder SAND WITH SOME SILT AND TRACE GRAVEL Gray (9) Ref.,50/2.0", 9% Sh 25.0'-48.3' No Visible Ice, Nbn \_\_ 40.0' (10) Ref.,50/3.0",9%,SM Sh SAND WITH SOME SILT Gray 44.0'-48.0' Boulders Ref.,50/3.0" 48.3'

Thermal Probe Installed to 48.0' Stand Pipe Piezometer Installed to 27.0'.

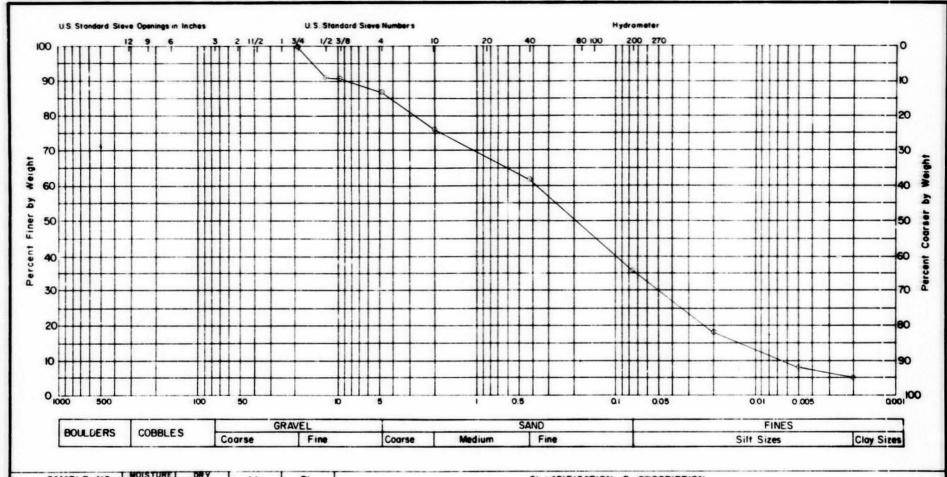
BORROW AREA D

SAMPLE NO	CONTENT	DENSITY	LL	PI		CLASSIFICATION & DESCRIPTION	
AH-D1-7	6.6%				SM	SILTY SAND WITH SOME GRAVEL, TRACE CLAY	
(10.0-10.3')							
	-			-			
	-			-			
	1						
						DRA	WN BY DL

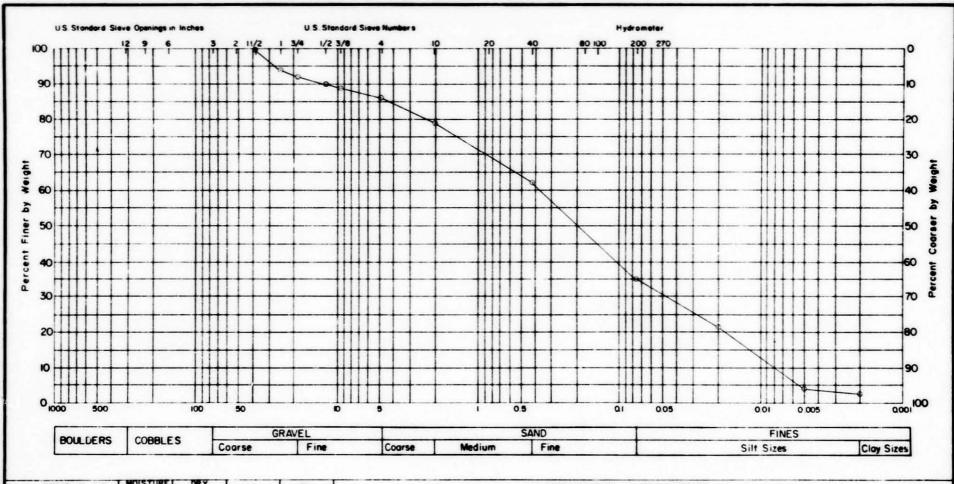
BOPROW AREA D

SAMPLE NO	CONTENT	DRY	LL	PI		CLASSIFICATION & DESCRIPTION
AH-D2-4	11.4%		13.9	NP	Sli	SILTY SAND WITH SOME CRAVEL, TRACE CLAY
(3.0-4.5')						Non Plastic
	•				*

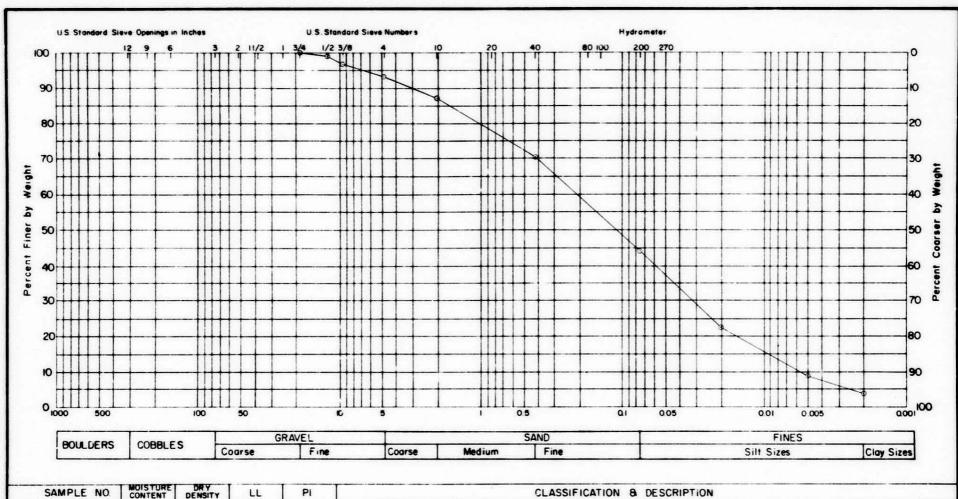
SAMPLE NO.	MOISTURE	DRY	LL	PI		CLASSIFICATION & DESCRIPTION	
AE-D2-S	11.3%		15.5	2.2	SM	SILTY SAND WITH TRACE GRAVEL, TRACE CLAY	
(15.0-16.5')							
							DRAWN BY: DL
		1//	X			BORROW AREA D	APPROVED BY

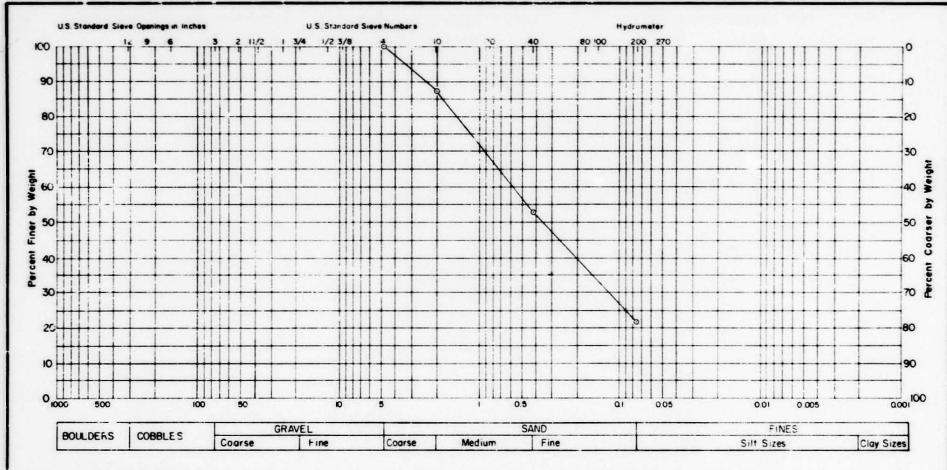
SAMPLE NO	CONTENT	DENSITY	LL	PI	CLASS	CLASSIFICATION & DESCRI	PTION
H-D5 - 4					SM	SAND WITH SOME SILT	
-							
							DRAWN BY P.T.
					. +4	BORROW AREA D	APPROVED BY: W.O.S.E

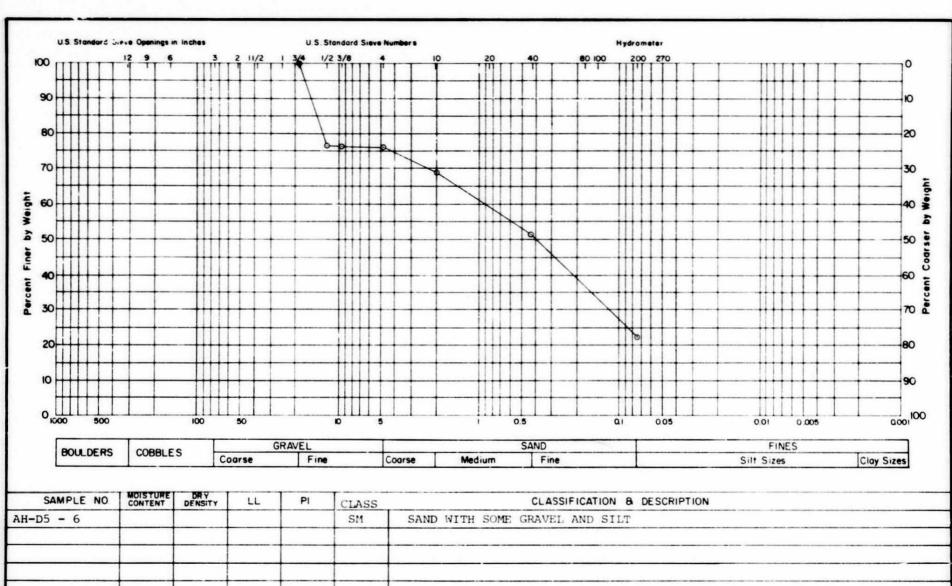
AUGER HOLE AH-D5

SAMPLE NO.	CONTENT	DRY	LL	PI	CLASS	CLASSIFICATION & DESCR	RIPTION
AH-D5 - 6					SM	SAND WITH SOME GRAVEL AND SILT	
					1		DRAWN BY P.T.
		1/4	4	4		BORROW AREA D	APPROVED BY W.O.S.E.

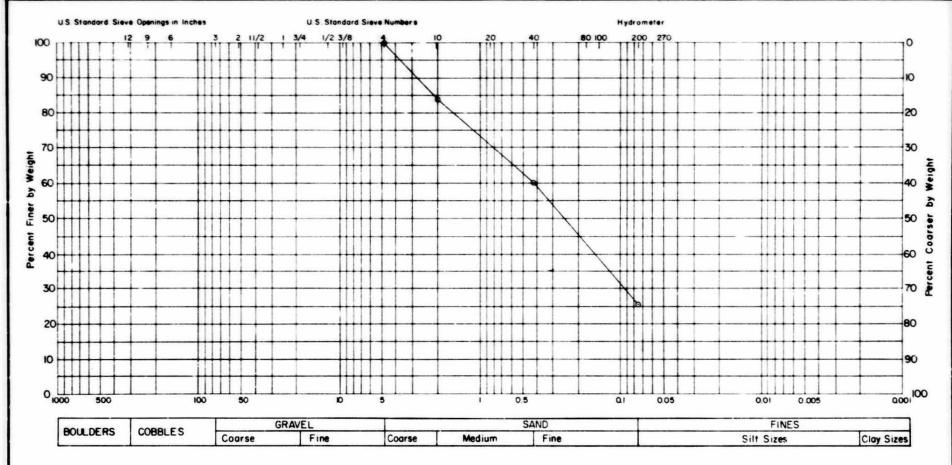
BORROW AREA D AUGER HOLE AH-D5 APPROVED BY: W.O.S.E.

SAMPLE NO.	CONTENT	DENSITY	LL	PI	CLASS	CLASSIFICATION & DESCRIPTION	
AH-D5 - 9	13		14	NP	SM	SAND WITH SOME SILT	
	-			-			
	-			-			
				-	+-+		
	-				+		
	1			-	+ +		
						DRAWN BY P	T

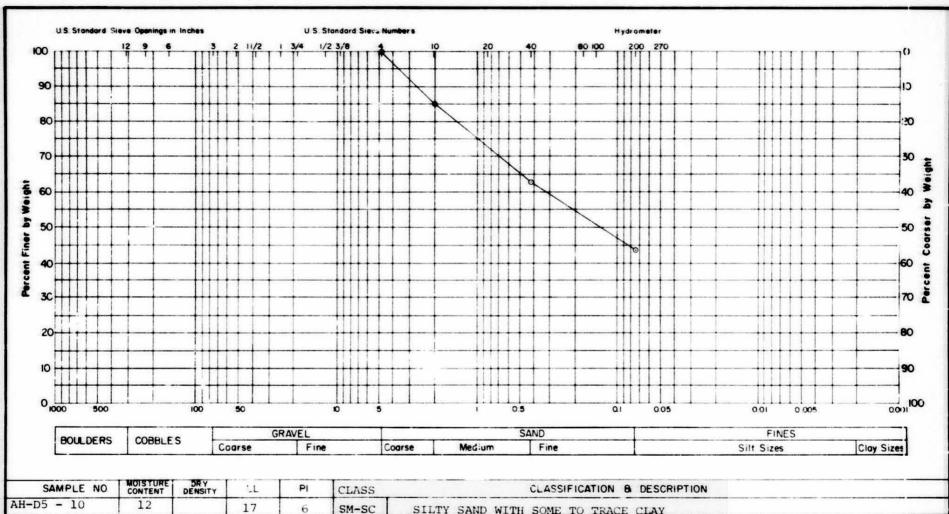
BORROW AREA D AUGER HOLE AH-D5 DRAWN BY P.T.

SAMPLE NO	CONTENT	DENSITY	LL	PI	CLASS	CLASSIFICATION & DESCRIPTION
AH-D5 - 10	12		17	6	SM-SC	SILTY SAND WITH SOME TO TRACE CLAY
				<b></b>	+-+	
					++	
	+				++	<del></del>
					-

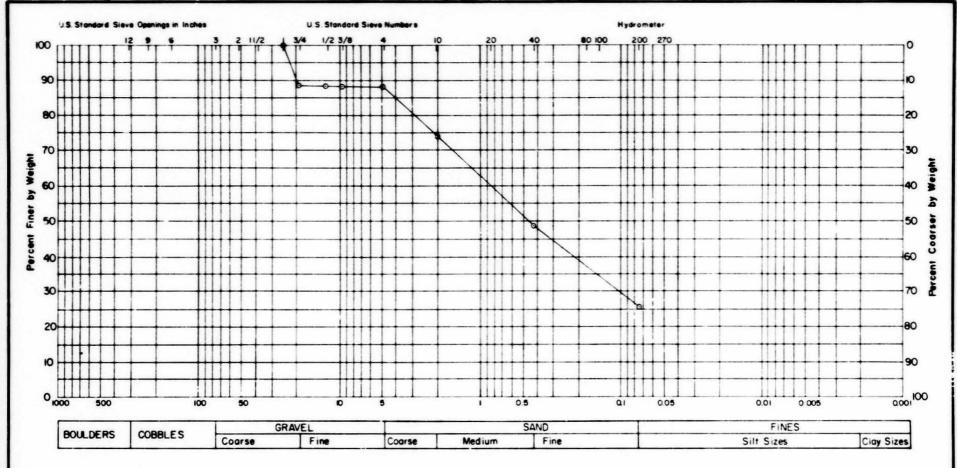
AUGER HOLE AH-D5

SAMPLE NO	CONTENT	DENSITY	LL	PI	CLASS	CLASSIFICATION & DESCRIPTION	
AH-D5 - 12	9		39	14	SM-SC	SAND WITH SOME GRAVEL AND SILT AND TRACE CLAY	
				İ			
				<u> </u>	1		
Mary 112 - September 1		A Constant	or and	Zancii den 3	and the		DRAWN BY P.T.
				100		BORROW AREA D	APPROVED BY: W.O.S.E

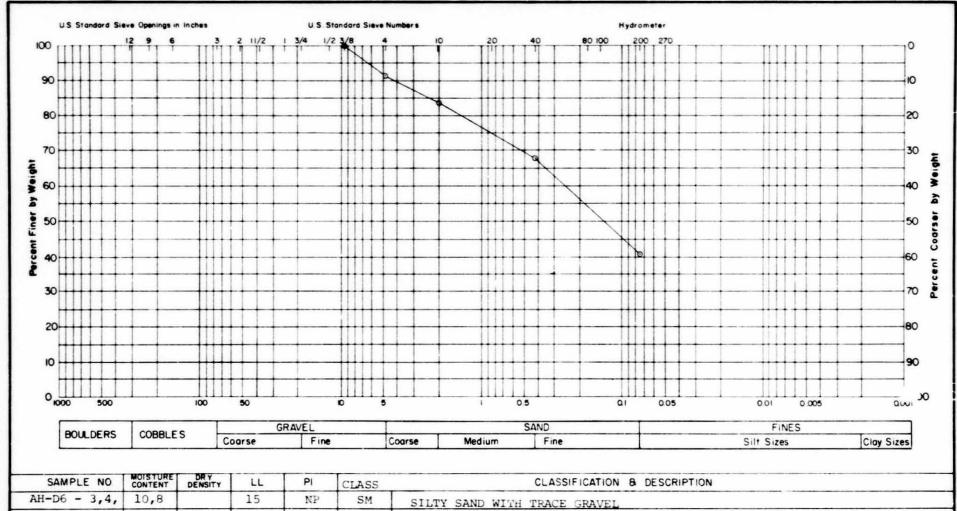
SAMPLE NO	CONTENT	DRY	LL	PI	CLASS	CLASSIFICATION & DESCRIPTION	
AH-D6 - 3,4,	10,8		15	NP	SM	SILTY SAND WITH TRACE GRAVEL	
	-						
							DRAWN BY P.T.
To an all a	RI	M				BORROW AREA D AUGER HOLE AH-D6	APPROVED BY: W.O.S.I

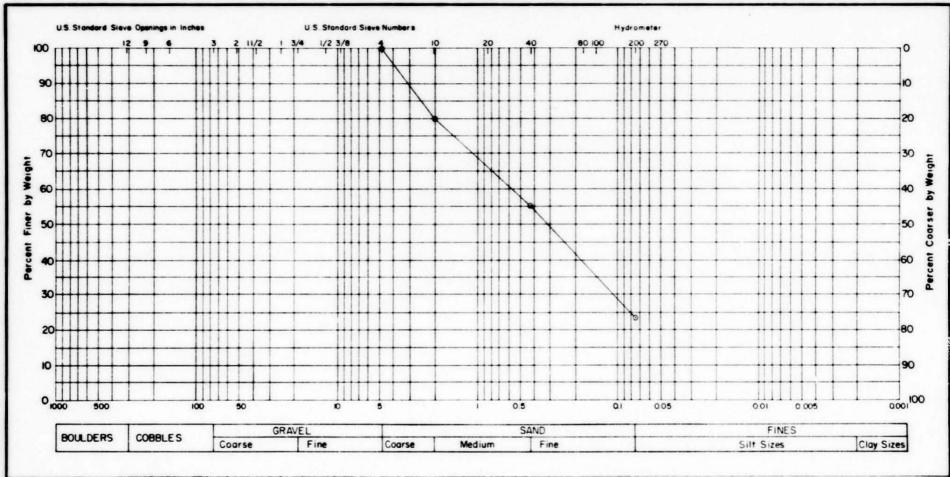
AUGER HOLE AH-D6

SAMPLE NO	CONTENT	DENSITY	LL	PI	CLASS	CLASSIFICATION & DESCRIPT	TION
AH-D6 - 6,7	12,11		13	NP	SM	SAND WITH SOME SILT	
			-		ļi		
	-			-	-		
	1						
C. Mariner of desirable		A Property	Asset No.	Maio M.	Settle 1		DRAWN BY P.T.
						BORROW AREA D	APPROVED BY: N.O.S.

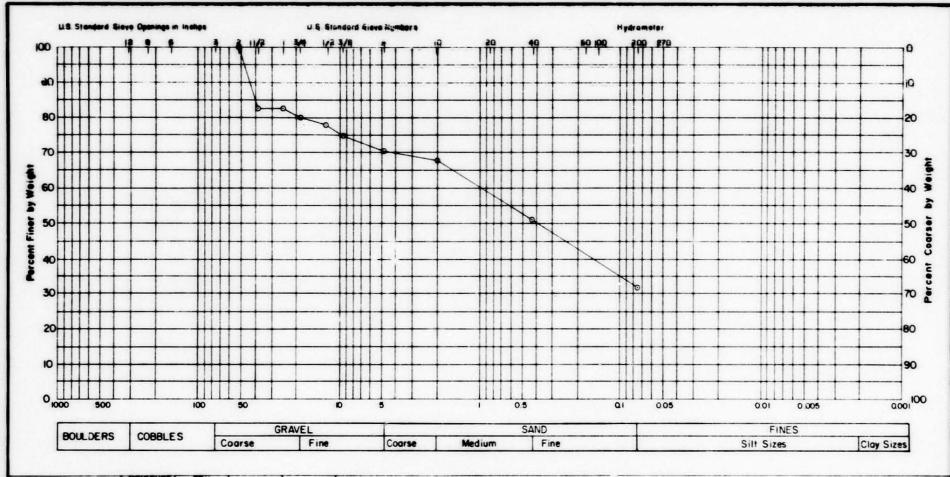
BORROW AREA D AUGER HOLE AH-D6

SAMPLE NO	CONTENT	DENSITY	LL	PI	CLASS	CLASSIFICATION & DESCRIPTION
AH-D6 - 10	9		15	NP	SM	SILTY SAND WITH SOME GRAVEL
					+ +	
		-		-	+ - +

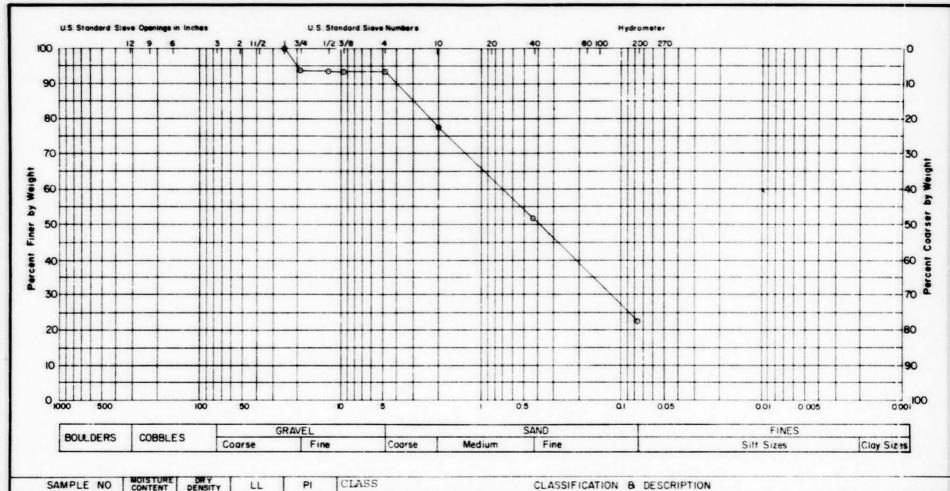
AUGER HOLE AH-D7

SAMPLE NO	CONTENT	DENSITY	LL	PI	CLASS	CLASSIFICATION & DESC	RIPTION
AH-D7 - 8	9				SM	SAND WITH SOME SILT, TRACE GRAVEL	
	-				+		
					+		
							DRAWN BY P.T.
						BORROW AREA D	APPROVED BY W.O.S.E

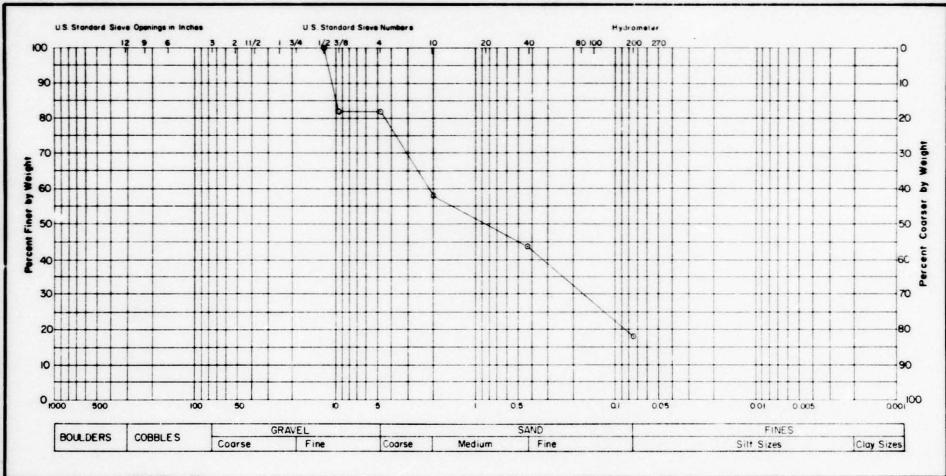
BORROW AREA D AUGER HOLE AH-D8 DRAWN BY P.T.
APPROVED BY W.O.S.E.
DATE 12/81
PROJECT NO 052505

SAMPLE NO	CONTENT	DENSITY	LL	PI	CLASS	CLASSIFICATION & DESCRIPTION
AH-D8 - 5	15		14	NP	SM	SAND WITH SOME GRAVEL AND SILT

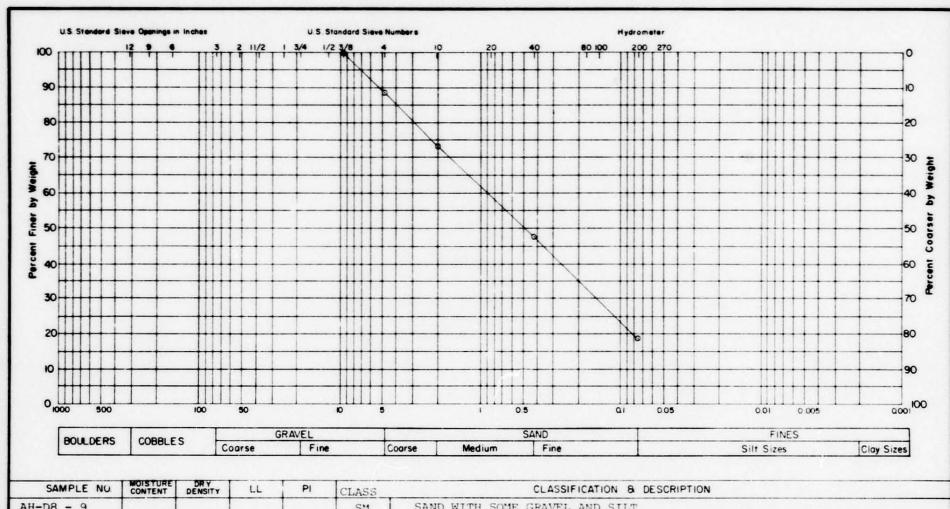
BORROW AREA D AUGER HOLE AH-D8 APPROVED BY V.O.S.E.
DATE 12/81
PROJECT NO 052506

SAMPLE NO.	CONTENT	DENSITY	L.L	PI	CLASS	CLASSIFICATION & DESCRIPTION	
AH-D8 - 9					SM	SAND WITH SOME GRAVEL AND SILT	
	-				-		
					+		
	-				+		
	1				<u> </u>	DRAWN BY P.T.

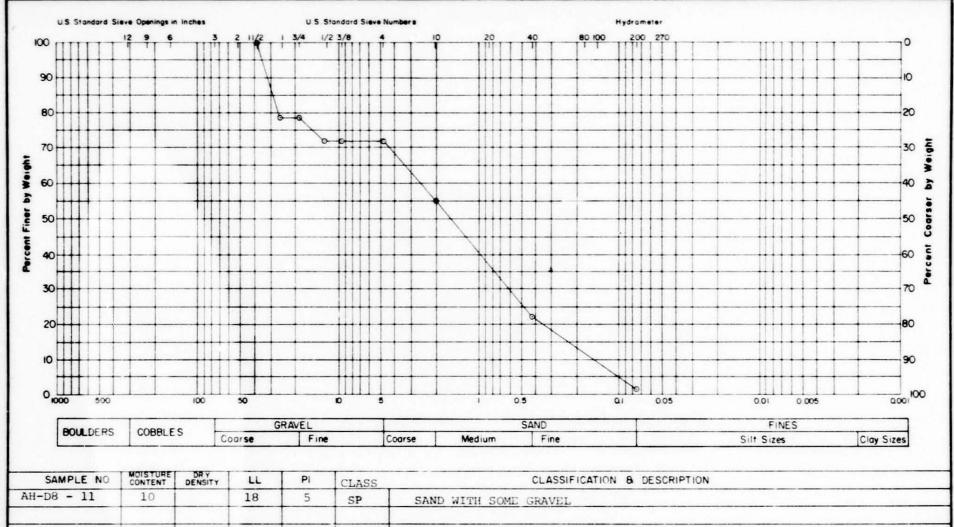
BORROW AREA D AUGER HOLE AH-D8 DRAWN BY P.T.

SAMPLE NO	CONTENT	DENSITY	LL	Pi	CLASS	CLASSIFICATION & DESCRIP	TION
AH-D8 - 11	10		18	5	SP	SAND WITH SOME GRAVEL	
	-	-			-		
CONTRACTOR STATE			1 300				DRAWN BY P.T.
		A DEE	1 1	2.4	4	BORROW AREA D	APPROVED BY N.O.S.

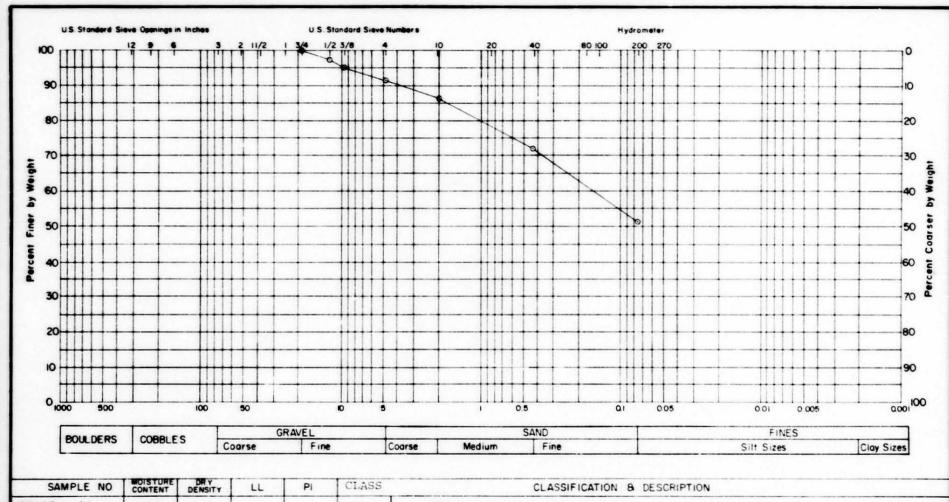
BORROW AREA D AUGER HOLE AH-D8 DRAWN BY P.T.

SAMPLE NO	CONTENT	DENSITY	LL	Pi	CLASS	CLASSIFICATION & DESCRIPTION
AH-D8 - 13	13				ML	SANDY SILT WITH SOME TO TRACE CLAY AND TRACE GRAVEL
	-				+	
	-					
						DRAWN BY P.T.

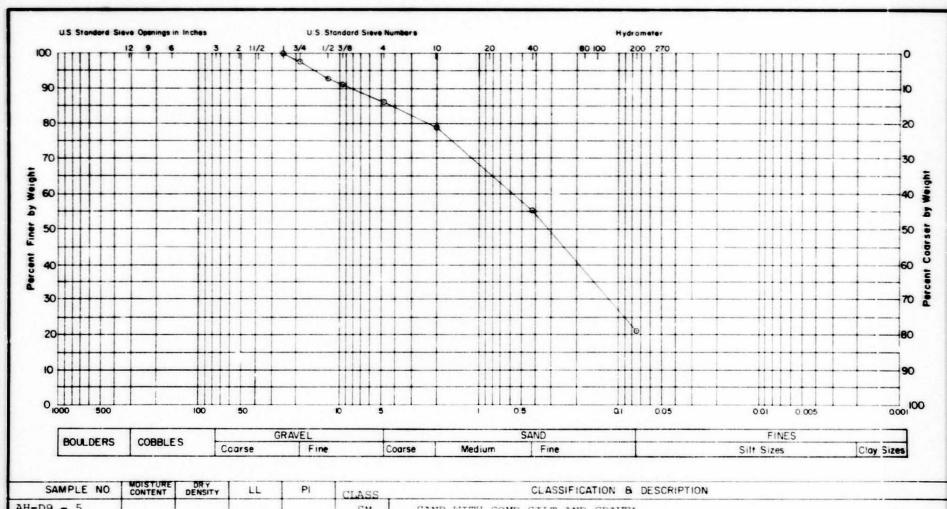
BORROW AREA D

SAMPLE NO	CONTENT	DENSITY	LL	PI	CLASS	CLASSIFICATION & DESCRIPTION
AH-D9 - 5					SM	SAND WITH SOME SILT AND GRAVEL
						DRAWN BY P.T.

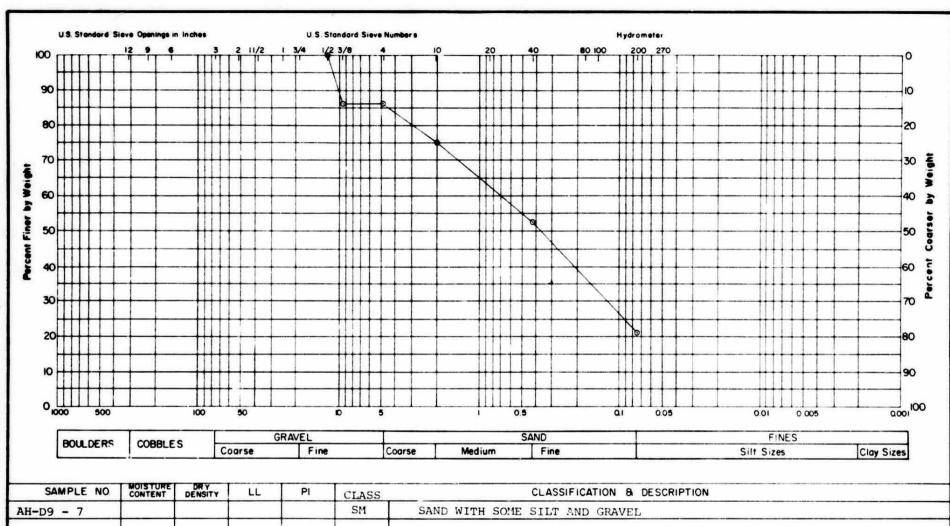
SAMPLE NO.	CONTENT	DENSITY	LL	PI	CLASS	CLASSIFICATION & DESCRIPTION
AH-D9 - 7					SM	SAND WITH SOME SILT AND GRAVEL
				ļ		
	-				+	
					+	
	L

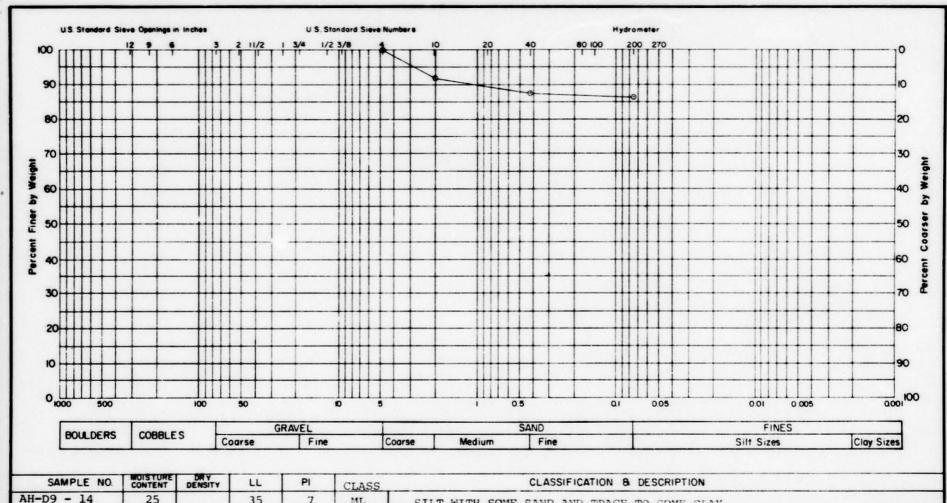
SAMPLE NO.	CONTENT	DENSITY	LL	PI	CLASS	CLASSIFICATION & DESCRIPTION
AH-D9 - 14	25		35	7	ML	SILT WITH SOME SAND AND TRACE TO SOME CLAY
					1	
					-	
					++	
	-				+	
			-		++	
					1	DRAWN BY P.T.

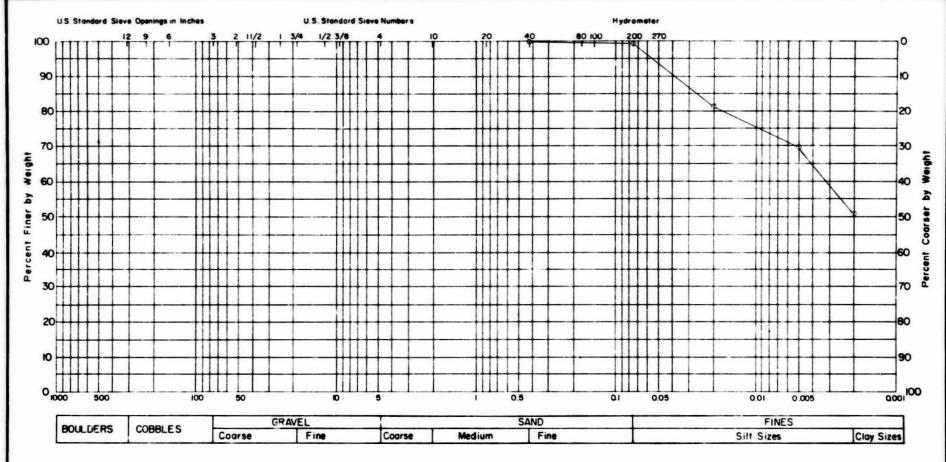
DEADMAN BORROW AREA

SAMPLE NO.	CONTENT	DENSITY	LL	PI			CLASSIFICATION & DESCRIPTION	
W-80-282	42.1%		55.9	33.2	CL-CH	SILT AND CLAY	Medium to High Plasticity	
(Grab Sample)

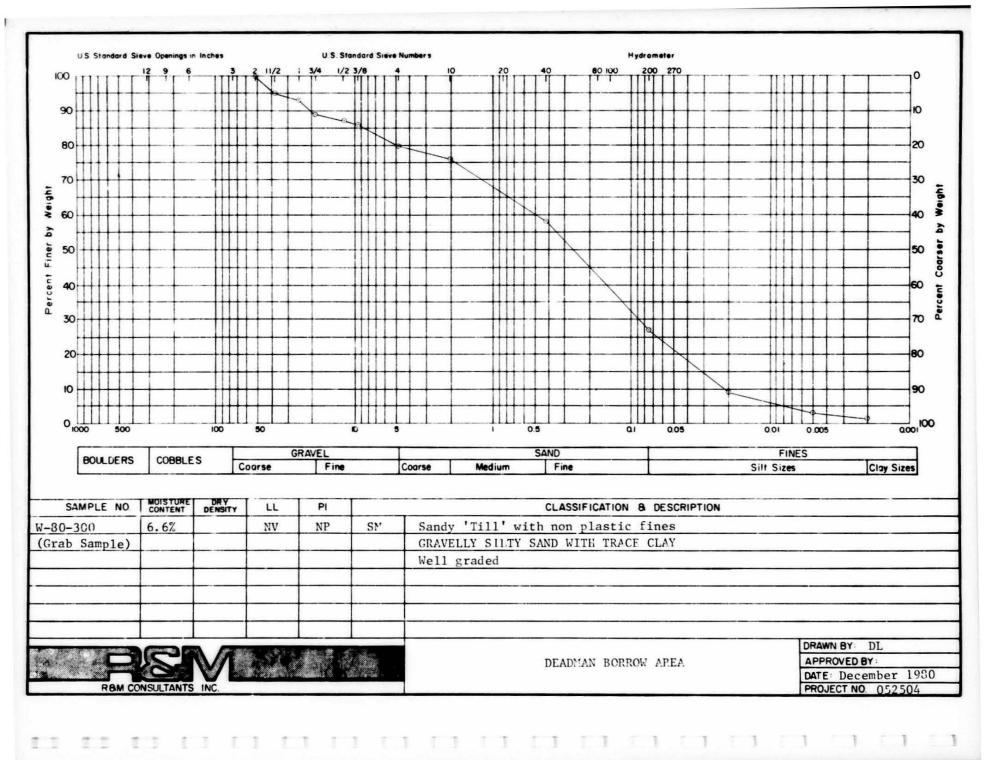
## R&M Consultant Inc. LABORATORY COMPACTION CONTROL REPORT

Jo	b Name and Location Susitna (Watana Dam	n Site)		
Ar	chitect or Engineer Acres American Inc.			
Со	ntractor			
А	Description of Soil: Well Graded 'Till'- G	GRAVELLY, SILTY	SAND W/TRAC	E CLAY
	Material MarkB	Unified Classification	SM	AASHO _Classification
	Source of Moterial Deadman Creek Sample N	W-80-300		
	Natural Water Content 6.6 % Natural D	ry Density	PCF Speci	fic Gravity
	Liquid Limit Non Viscous % Plastic Limit	% P10	asticity Index	Non Plastic
B.	Test Procedure UsedT-180 "D" - AASH	HTO		
С	Test Results Maximum Dry Density 135.0	PCF	Optimum Water	Content 6.0 %

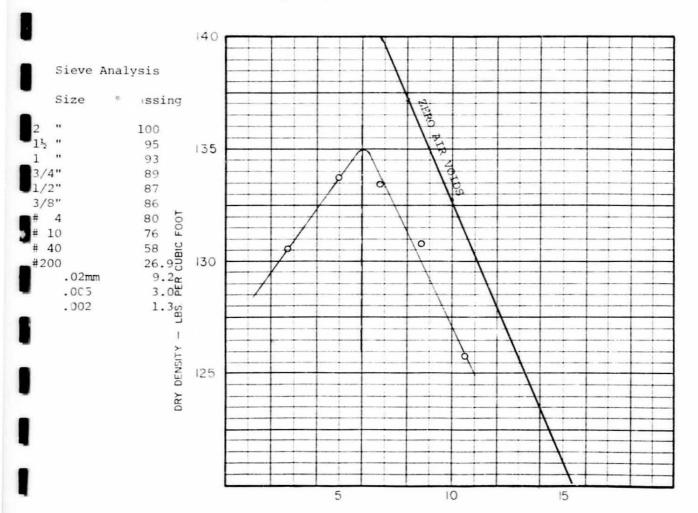
## LABORATORY COMPACTION CONTROL REPORT

Jo	b Name and Location_	Susitna (	Watana Dan	n Site)		
Ar	chitect or Engineer	Acres Americ	an Inc.			
Со	ntractor					****
Д	Description of Soil_	SILT AND C	LAY			
	Material Mark	A		Unified Classification_	CL-CH	AASHOClassification
	Source of Material	Deadman Cre	ek Sample	No. W-80-282		
	Natural Water Conten	42.1%	% Natural Dr	ry Density	PCF Spe	ecific Gravity
	Liquid Limit	55.9 % P	lastic Limit_	% P	lasticity Index_	33.2
В.	Test Procedure Used	T-180 M	ethod "A"	- AASHTO		
С	Test Results Maximu	m Dry Density	102.5	PCF	Optimum Wate	er Content 22.0%

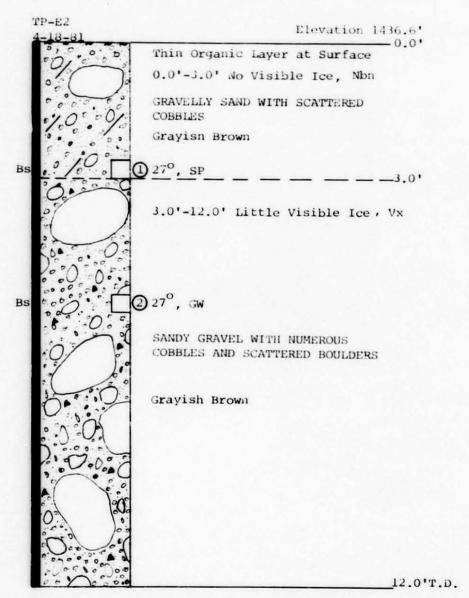
BORROW AREA E TEST PIT TP-E2

Groundwater Not Encountered.

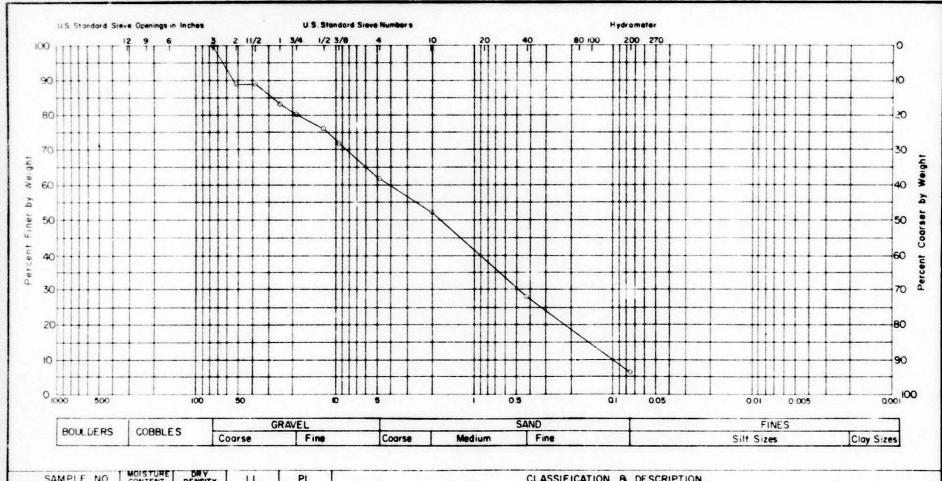
BORROW AREA E

SAMPLE NO	CONTENT	DENSITY	LL	PI	CLASSIFICATION & DESCRIPTION						
AH-E3-6	4.4%				SP-SN	GRAVELLY SAND					
(4.5-6.0')						Poorly Craded					
							DRAWN BY DL

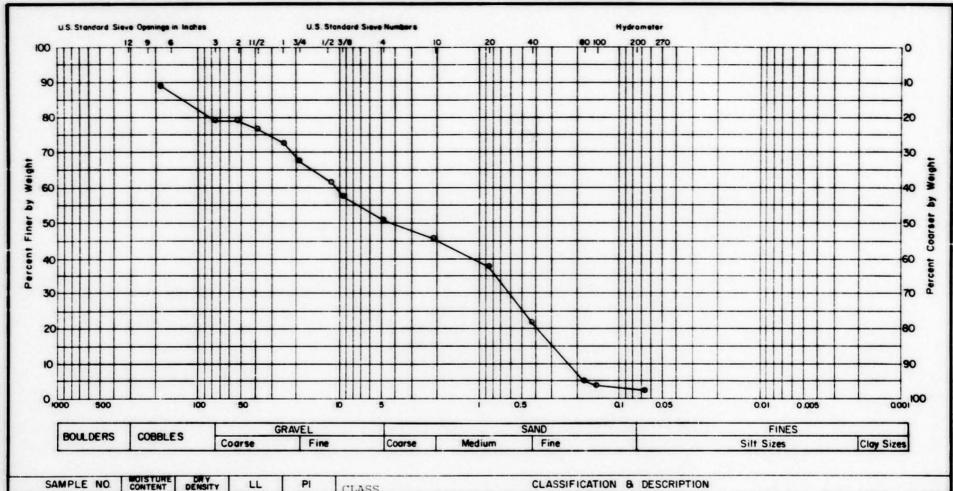
BORROW AREA E TEST PIT TP-E2

TP-E2 #1 SP GRAVELLY SAND WITH SCATTERED COBBLES	SAMPLE NO.	CONTENT	DENSITY	LL	PI	CLASS	CLASSIFICATION & DESCRIPTION
	TP-E2 #1					SP	GRAVELLY SAND WITH SCATTERED COBBLES
			100				
					TYPE N

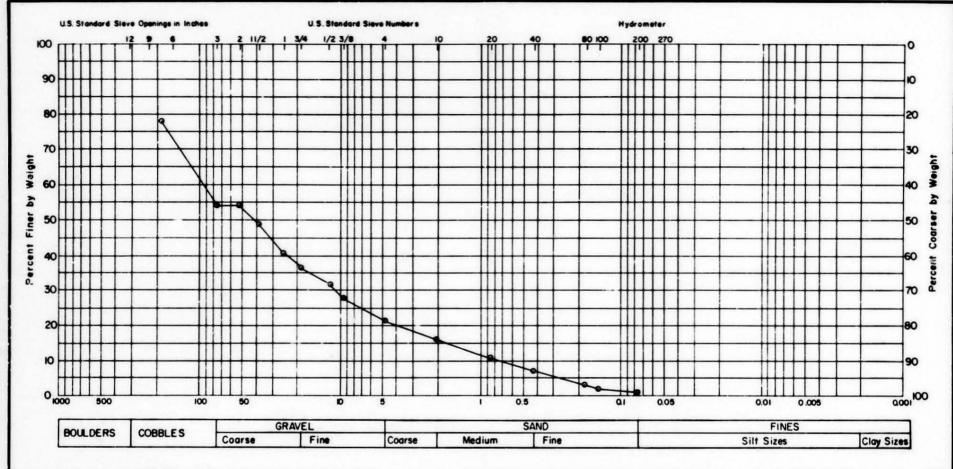
BORROW AREA E TEST PIT TP-E3 APPROVED BY: T.1.

SAMPLE NO.	CONTENT	DENSITY	LL	PI	CLASS	CLASSIFICATION & DESCRIPTION
TP-E3 #1					GW	SANDY GRAVEL WITH NUMEROUS COBBLES AND SCATTERED BOULDERS
No. 20 5 1 2 15 10 10 10 10 10 10 10 10 10 10 10 10 10		To the		and the latest and th		DRAWN BY: J.M.

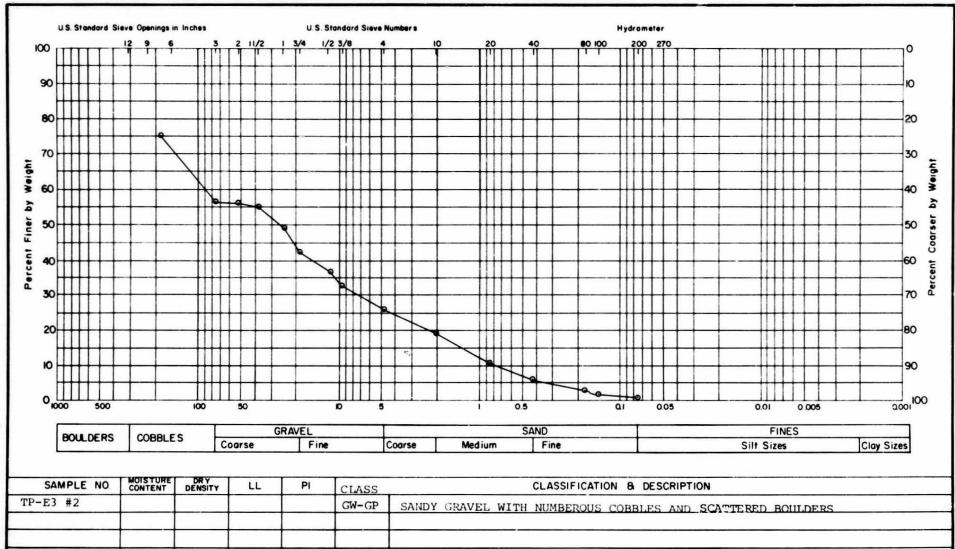
BORROW AREA E TEST PIT TP-E3

SAMPLE NO.	CONTENT	DENSITY	LL	PI	CLASS	CLASSIFICATION & DESCR	RIPTION
ГР-E3 #2					GW-GP	SANDY GRAVEL WITH NUMBEROUS COBBLES A	ND SCATTERED BOULDERS
					+		
						BORROW AREA F	DRAWN BY: J.M.

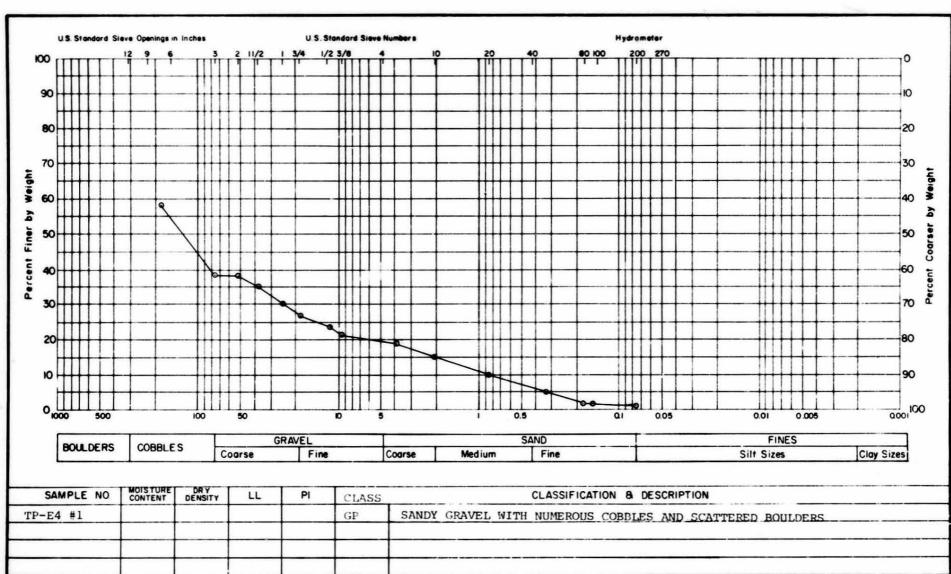
TEST PIT TR-E4

SAMPLE NO	CONTENT	DENSITY	LL	PI	CLASS	CLASSIFICATION & DESCRI	PTION
TP-E4 #1					GP	SANDY GRAVEL WITH NUMEROUS COBBLES AND	D_SCATTERED_BOULDERS
							DRAWN BY: J.M.
						BORROW AREA E	APPROVED BY: T.I.

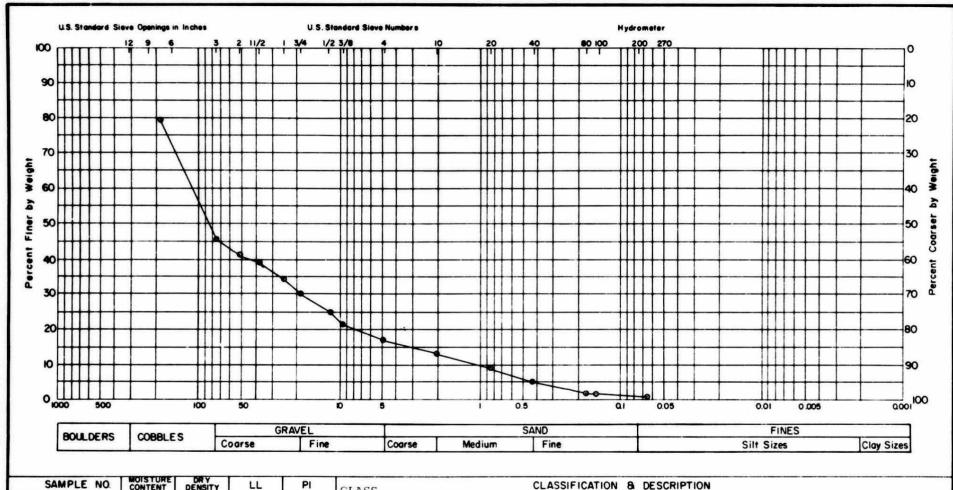
BORROW AREA E TEST PIT TP-E5

SAMPLE NO.	CONTENT	DENSITY	LL	PI	CLASS	CLASSIFICATION & DESCRIPTION
P-E5 #1					GW-GP	SANDY GRAVEL WITH NUMEROUS COBBLES AND SCATTERED BOULDERS
					1

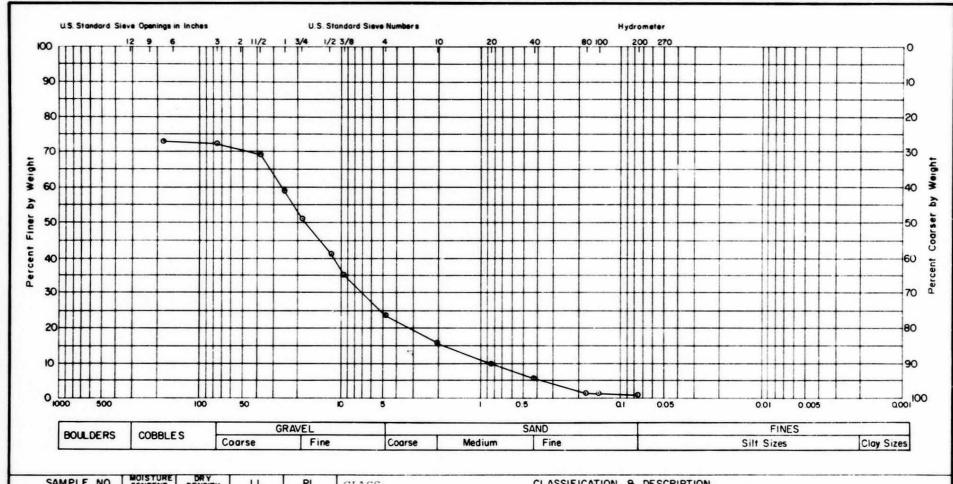
BORROW AREA E TEST PIT TP-E8

TP-E3 #1				
	 		GW	SANDY GRAVEL WITH SCATTERED COBBLES AND BOULDERS
		-

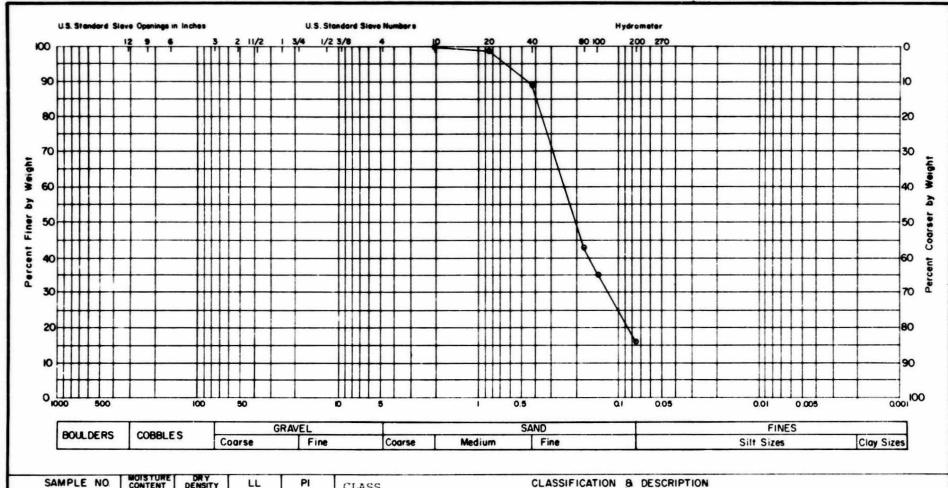
BORROW AREA E TEST PIT TP-E10A

SAMPLE NO	CONTENT	DENSITY	LL	PI	CLASS	CLASSIFICATION & DESCRIPTION
TP-E10A #2					SM	SAND WITH SOME SILT
			,

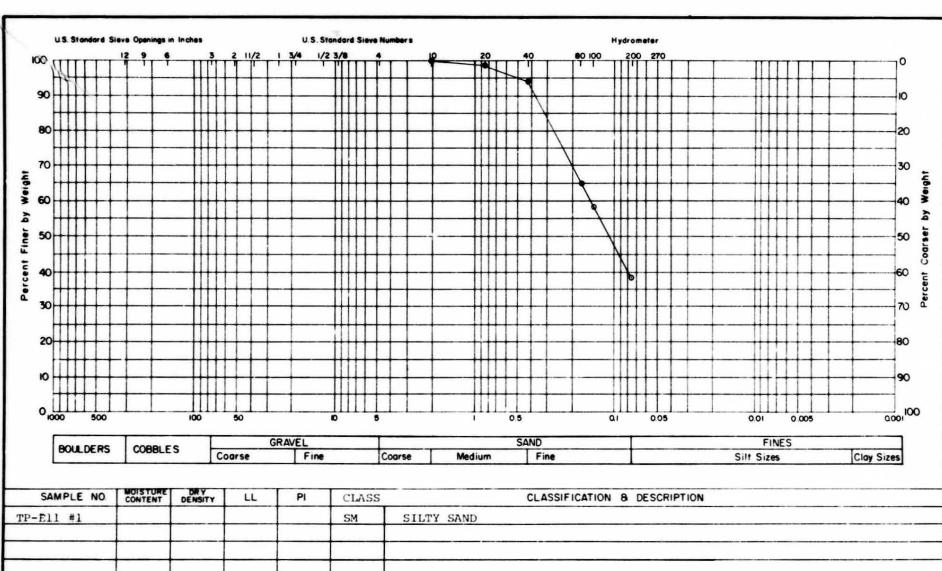
BORROW AREA E TEST PIT TP-E11

SAMPLE NO	CONTENT	DENSITY	LL	PI	CLASS	CLASSIFICATION & DESCRIPTIO	N
TP-E11 #1					SM	SILTY SAND	
	-						
							Inquiri ov

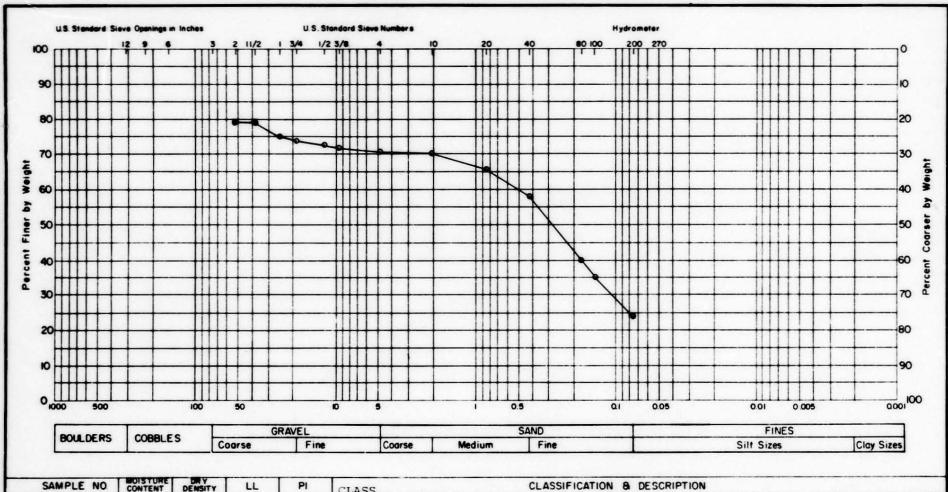
BORROW AREA E TEST PIT TP-E12 DRAWN BY J.M.

SAMPLE NO	CONTENT	DENSITY	LL	PI	CLASS	CLASSIFICATION & DESCRIPTION
TP-E12 #3					SM	SAND WITH SOME SILT, TRACE GRAVEL AND SCATTERED COBBLES
					-	
	-				-	
						DRAWN BY

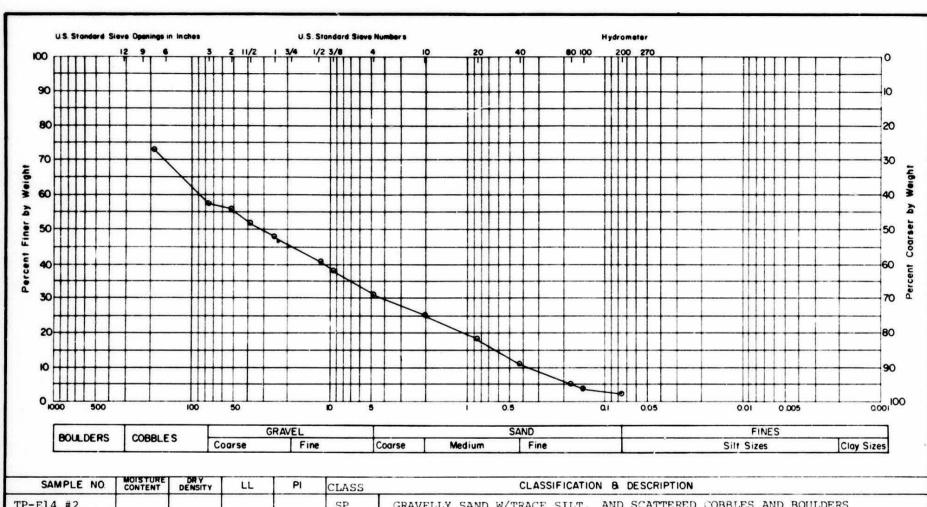
BORROW AREA E TEST PIT TP-E14 DRAWN BY: J.M.

SAMPLE NO.	CONTENT	DENSITY	LL	PI	CLASS	CLASSIFICATION & DESCRIPTION
TP-E14 #2					SP	GRAVELLY SAND W/TRACE SILT, AND SCATTERED COBBLES AND BOULDERS
						•
			B) \$0. * *\$2		AND THE RESIDENCE	DRAWN BY: J.M

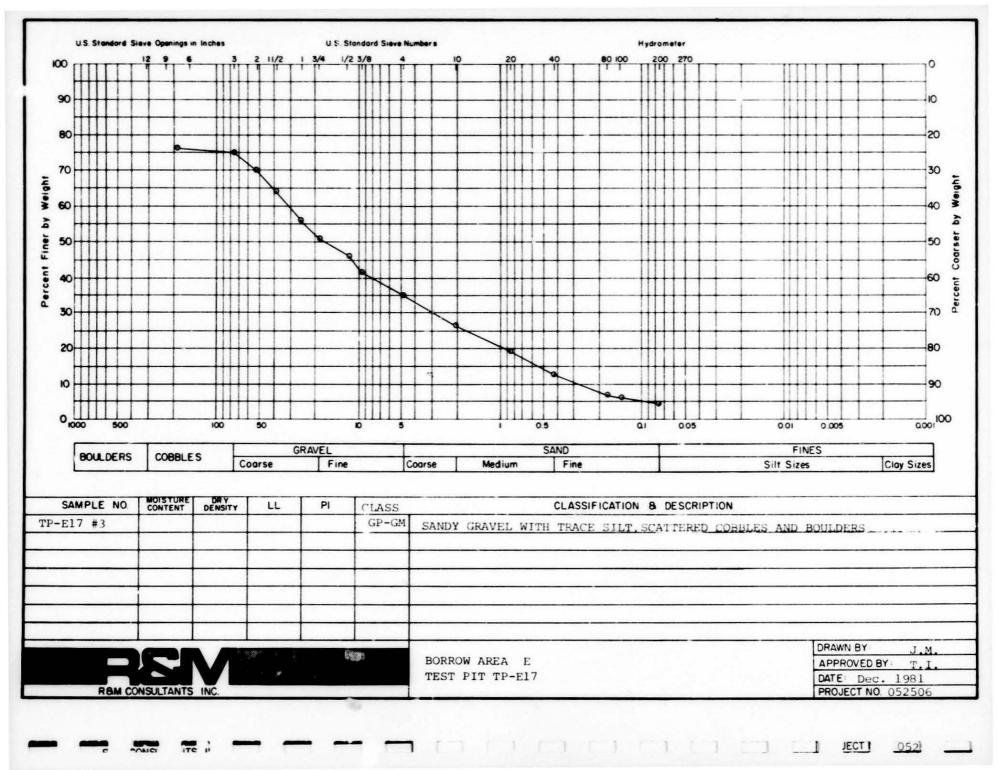
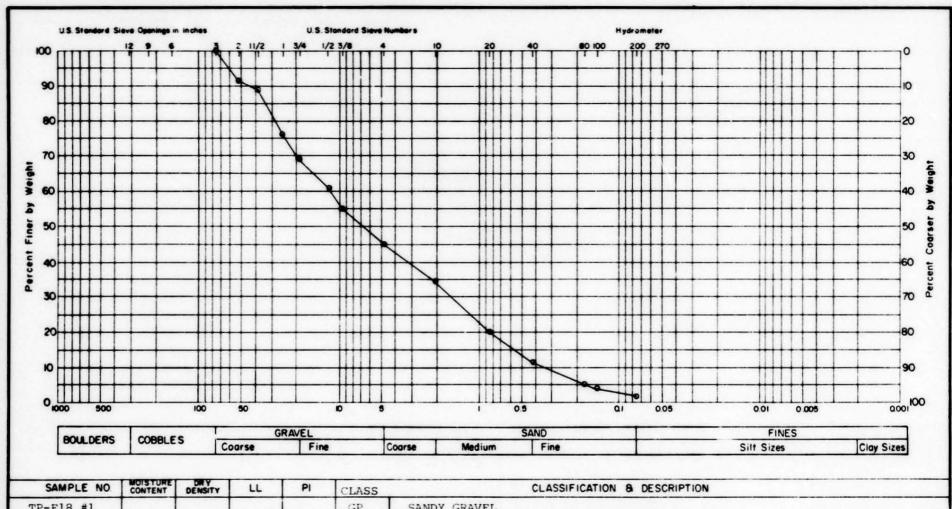
TEST PIT TP-E18

SAMPLE NO.	CONTENT	DENSITY	LL	PI	CLASS	CLASSIFICATION & DESCRIPTION		
P-E18 #1					GP	SANDY GRAVEL		
						(FIELD GEOLOGIST NOTES SOME ORGANICS)		
					1		*****	
					1	· <del></del>	DRAWN BY	J.M.

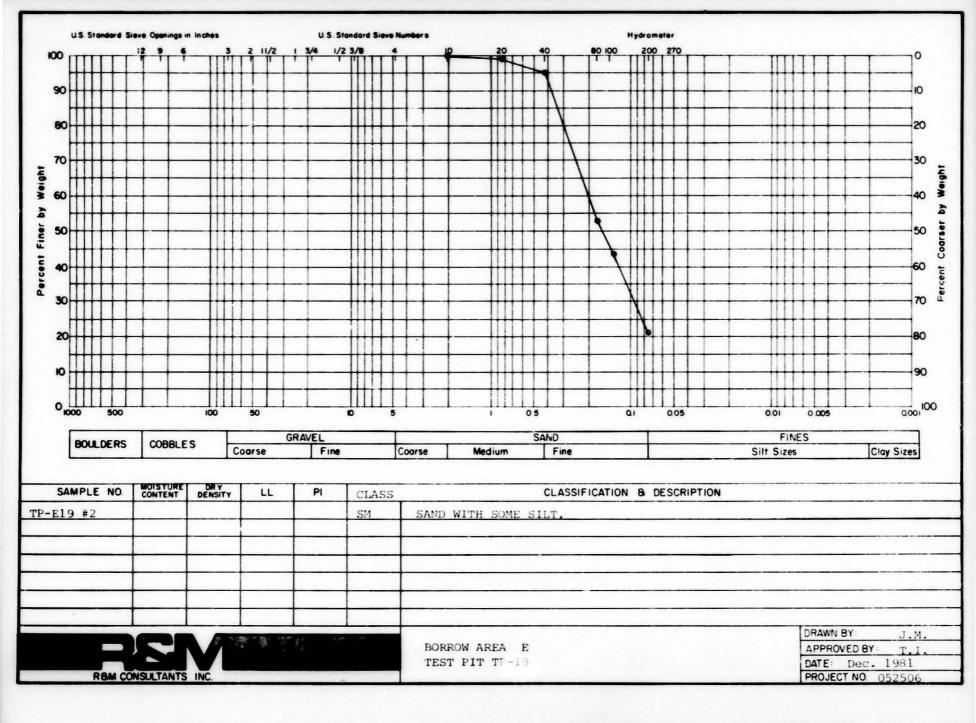
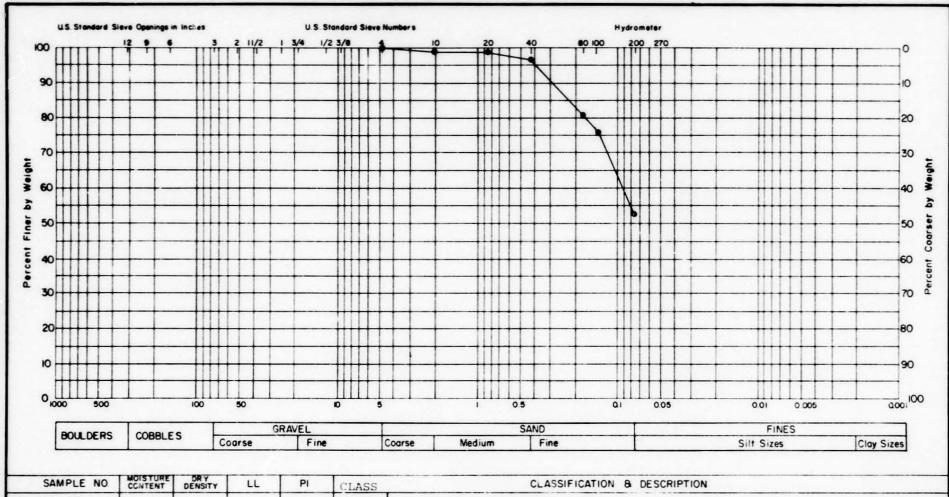
BORROW AREA E TEST PIT TP-E20 DRAWN BY: J.M.

SAMPLE NO	CONTENT	DENSITY	LL	PI	CLASS	CLASSIFICATION & DESCRIPTION
TP-E20 #1					SM-ML	SANDY SILT WITH TRACE CLAY
						(FIELD GEOLOGIST NOTES TRACE ORGANICS)
					1	CDANIA DV. T. M.

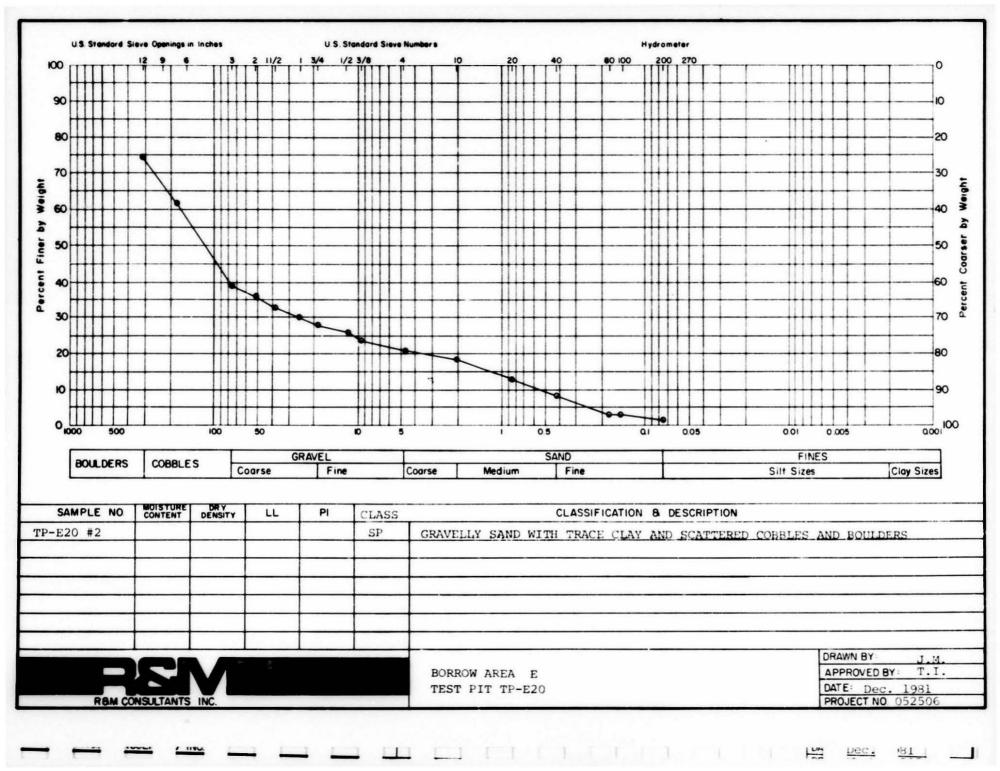
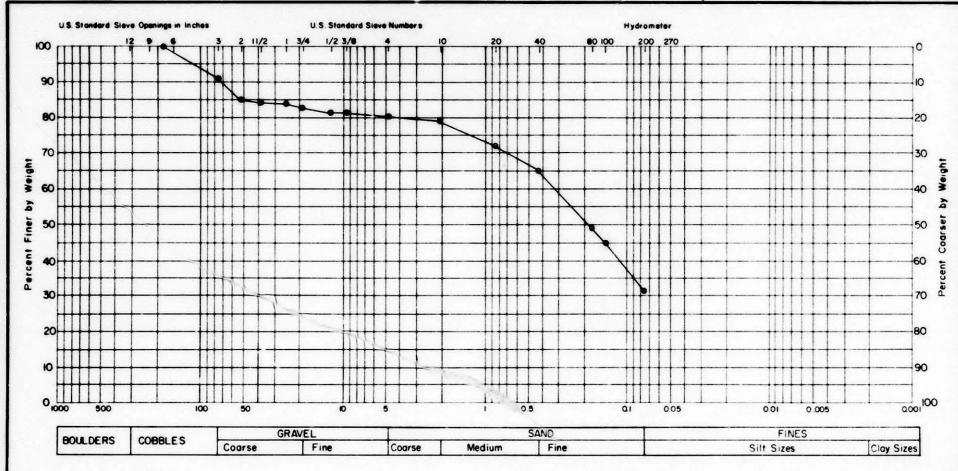
BORROW AREA E TEST PIT TP-E20 DRAWN BY J.M.

SAMPLE NO	CONTENT	DENSITY	LL	PI	CLASS	CLASSIFICATION & DESCRIPTION
TP-E20 #3					SM	SILTY SAND WITH TRACE CLAY AND GRAVEL AND SCATTERED COBBLES
				ļ		
	L	1
