## SUSITNA HYDROELECTRIC PROJECT

1980 - 81 GEOTECHNICAL REPORT

VOLUME 2
APPENDIX A-F
FINAL DRAFT

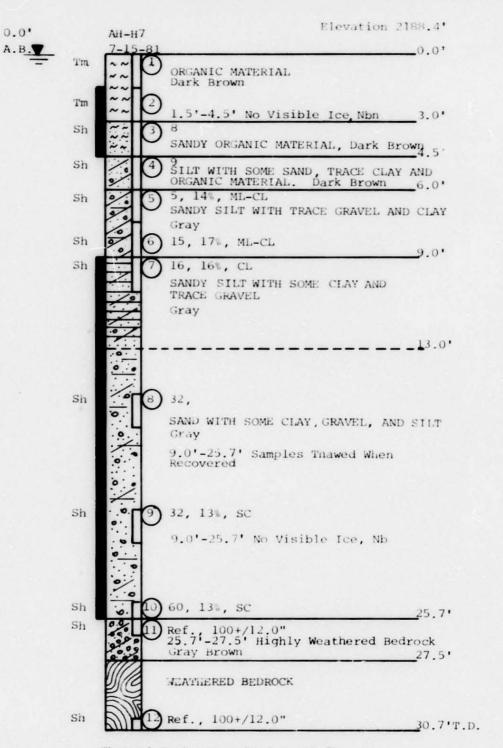
Thermal Probe Installed to 30.7'

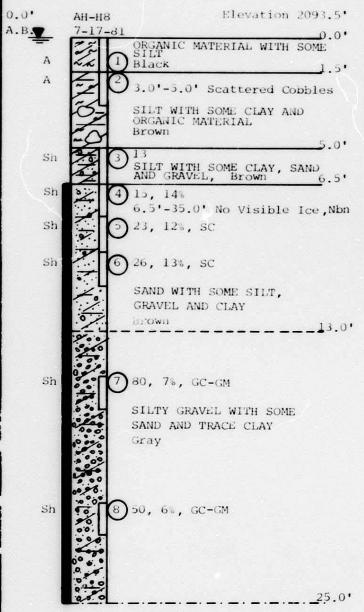
Thermal Probe Installed to 35.0'

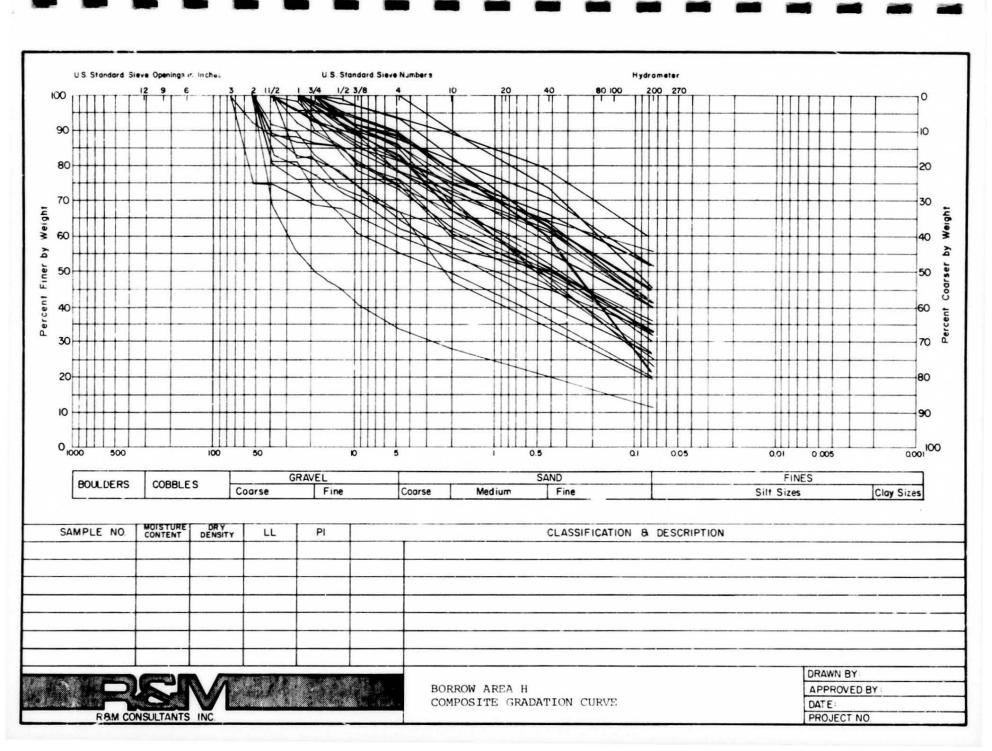
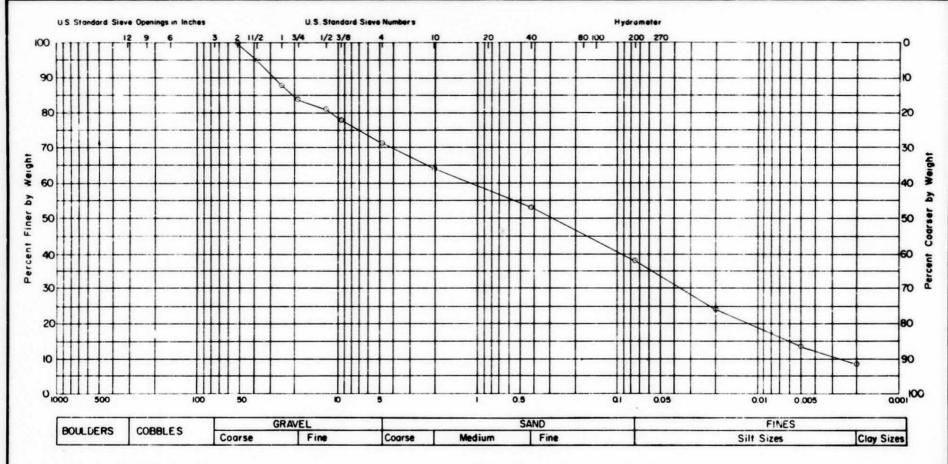
BORPOW AREA H

SAMPLE NO.	CONTENT	DENSITY	LL	PI		CLASSIFICATION & DESCRIPTION
W-80-256	10.9%		21.7	9.2	GC-SC	Poorly graded 'Till' with low Plasticity
(Grab Sample)						SILTY CRAVEL AND SAND WITH TRACE CLAY
					-

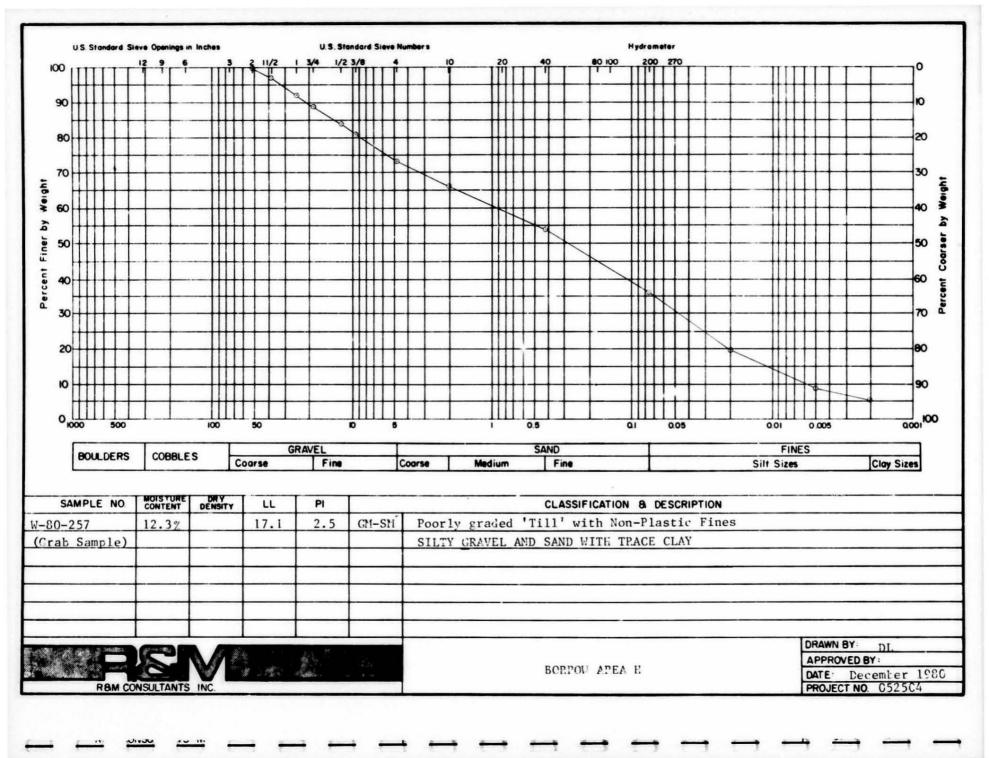
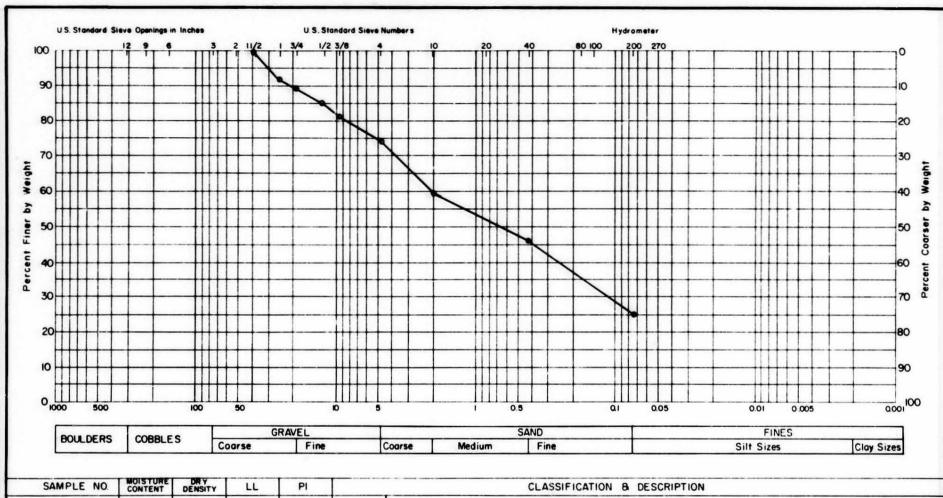
BORROW AREA H AUGER HOLE AH-H1

SAMPLE	NO.	CONTENT	DENSITY	LL	PI		CLASSIFICATION & DESCRIPTION
AH-Hl	#2	13				SM	SAND WITH SOME GRAVEL AND SILT, TRACE ORGANIC MATERIAL
						-	
		-				-	
	-					-	
						+	
						-

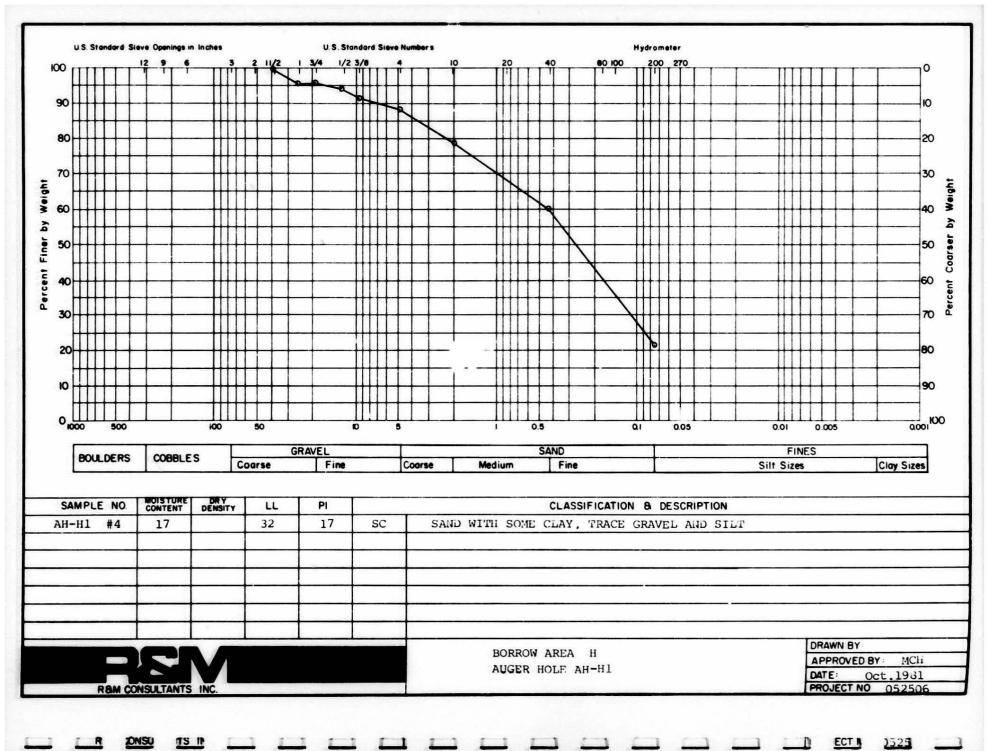
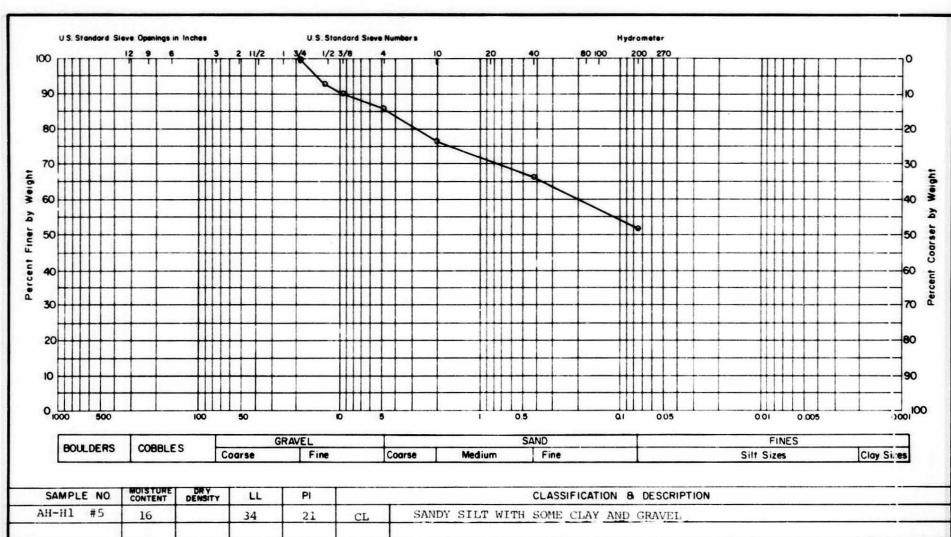
BORROW AREA H AUGER HOLE AH-H1 APPROVED BY: MCh
DATE: Oct. 19d1
PROJECT NO 052506

AH-H1 #5 16 34 21 CL SANDY SILT WITH SOME CLAY AND GRAVEL	AH-H1 #5 16 34 21 CL SANDY SILT WITH SOME CLAY AND GRAVEL

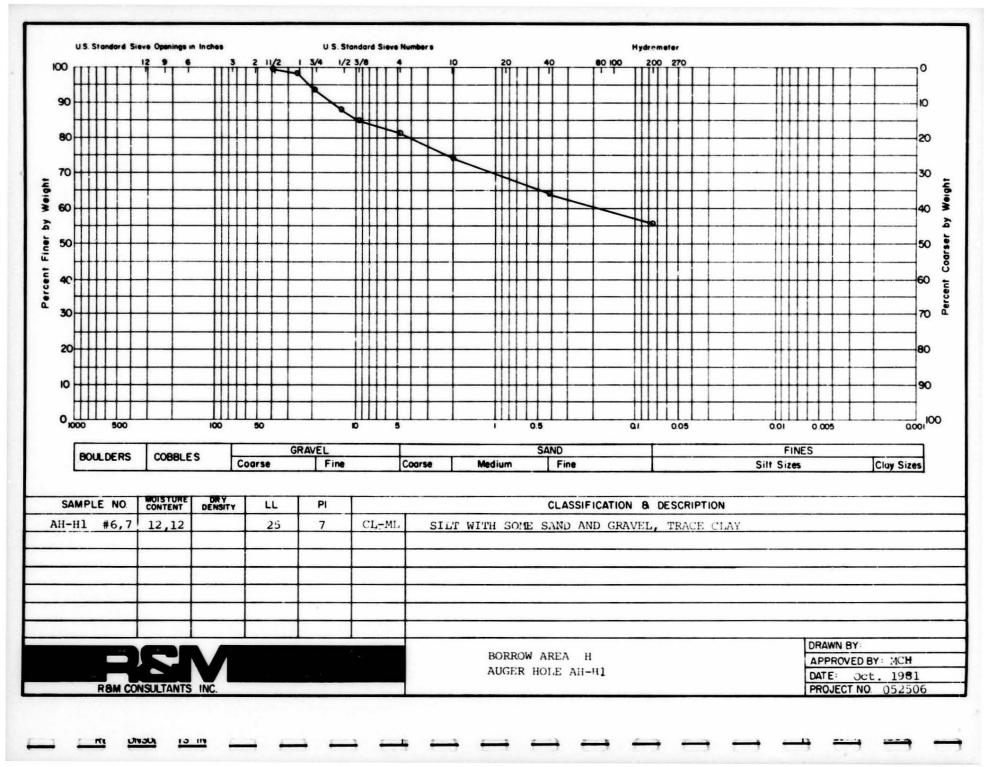
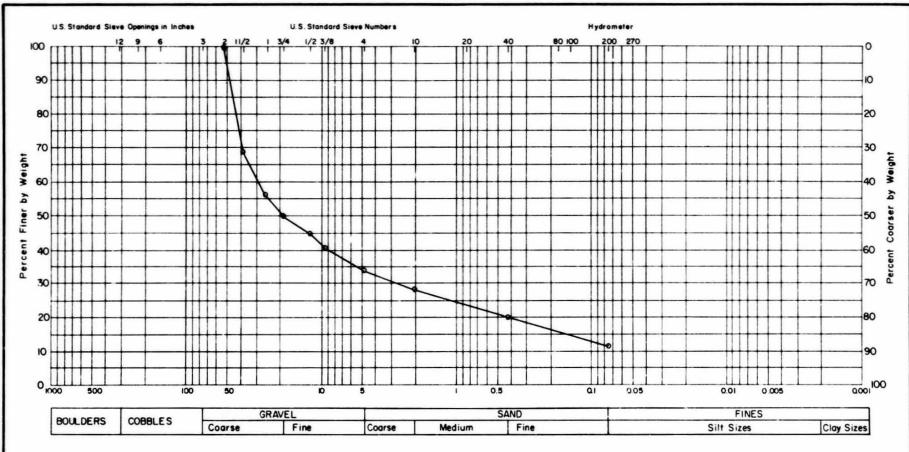
AUGER HOLE AH-H1

SAMPLE NO	CONTENT	DRY	LL	PI		CLASSIFICATION & DESCRIPTION	
M-н1 #8,	9 9		21	ijР	GP-GM	GRAVEL WITH SOME SAND, TRACE SILT	
	+				++		
					-		
	1			1			DRAWN BY:

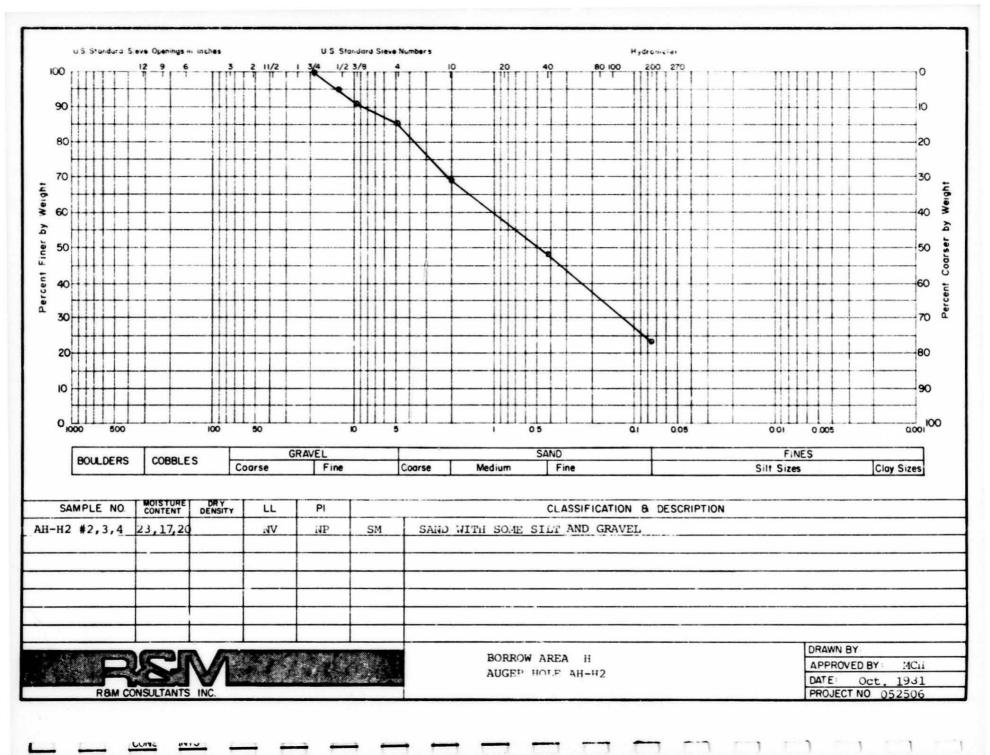
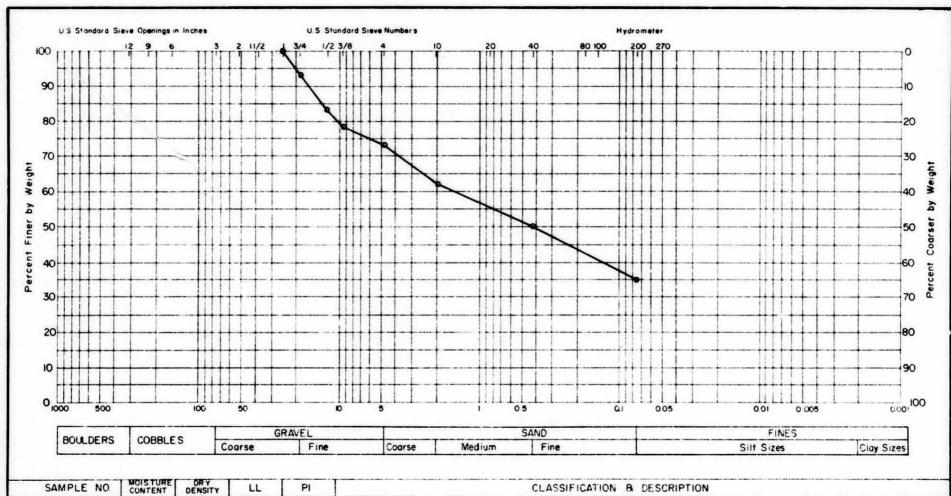
BORROW AREA H AUGER HOLE AH-II2 APPROVED BY MCH DATE: Oct. 1981 PROJECT NO 052506

АН-Н2 #5,6,7		DRY DENSITY	LL	PI NP	CLASSIFICATION 8 DESCRIPTION			
H 112 #3,0,7	7,11,11		18		SM	SILTY SAND WITH SOME GRAVEL		
				<del> </del>				
	1		-	-	1

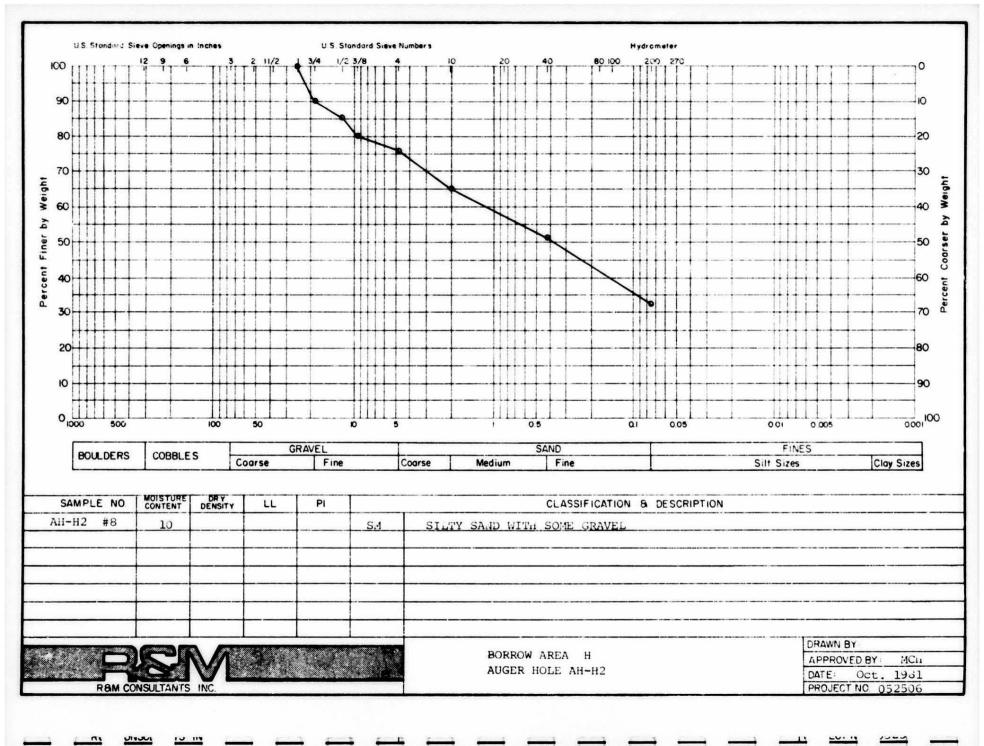
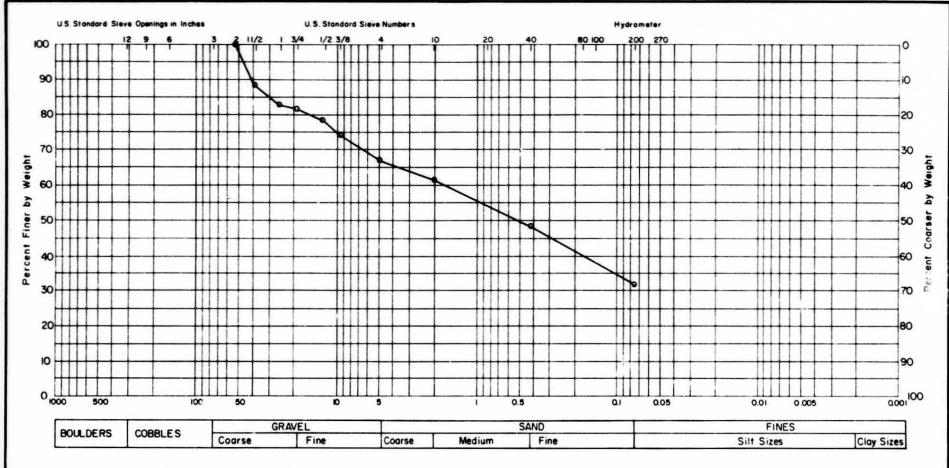
BORROW AREA H AUGER HOLE AH-H2

SAMPLE NO.	CONTENT	DENSITY	LL	PI		CLASSIFICATION & DESCRIPTION
AH-H2 #9,10	9,6		17	MP	SM	SILTY, GRAVELLY SAND
	-

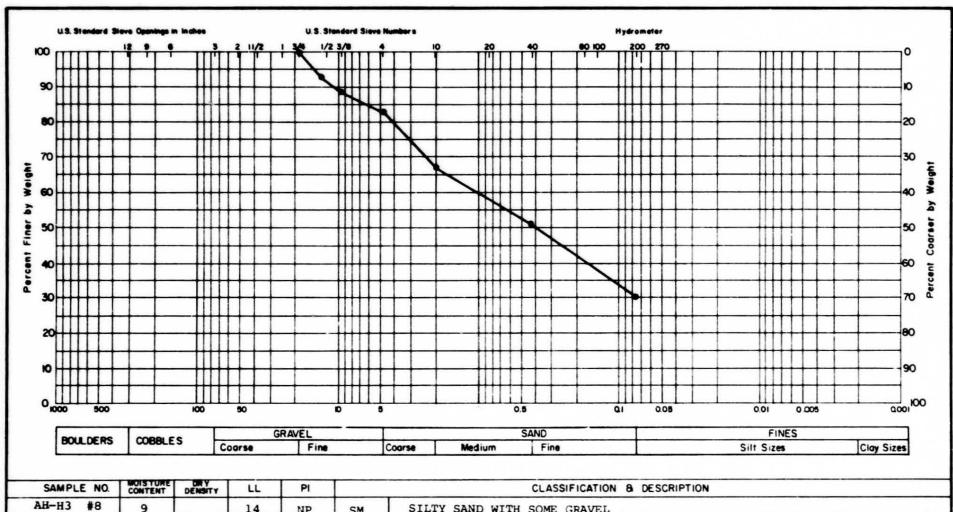
BORROW AREA H AUGER HOLE AH-H3

SAMPLE	E NO.	CONTENT	DENSITY	LL	PI		CLASSIFICATION & DESCRIPTION
н-нз	#8	9		14	NP	SM	SILTY SAND WITH SOME GRAVEL
					-	<b>-</b>	
			-

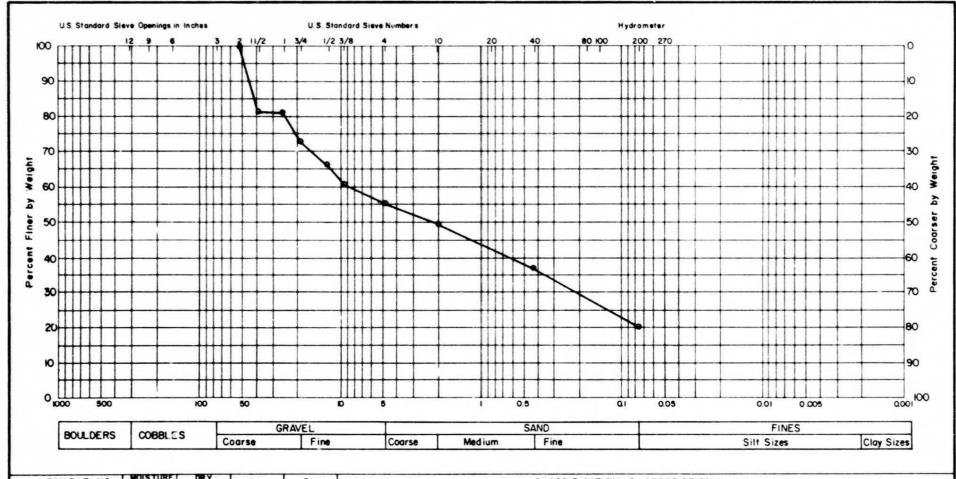
BORROW AREA H AUGER HOLE AH-H4

SAMPL	E NO.	CONTENT	DENSITY	LL	PI		CLASSIFICATION & DESCRIPTION
АН-Н4	#3,4	16,13		23	7	GC-GM	SANDY GRAVEL WITH SOME SILT AND TRACE CLAY
						++	
						-

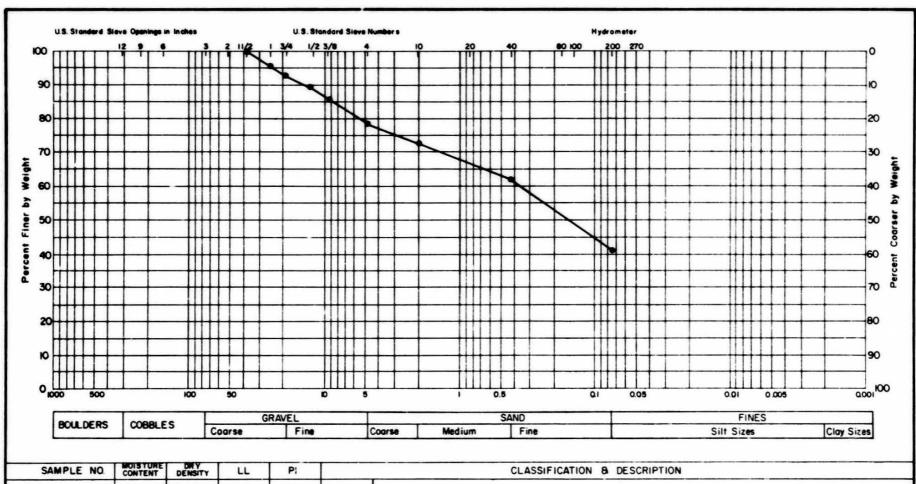
BORROW AREA H AUGER HOLE AH-H5 APPROVED BY: MCH
DATE: Oct. 1981
PROJECT NO 052506

SAMPLE NO.	CONTENT	DENSITY	LL	Pi		CLASSIFICATION & DESCRIPTION
AH-H5 #4	16		23	6	SM-SC	SILTY SAND WITH SOME GRAVEL AND TRACE CLAY
					1 1	
				-	+	
	11	1		L		DRAWN BY:

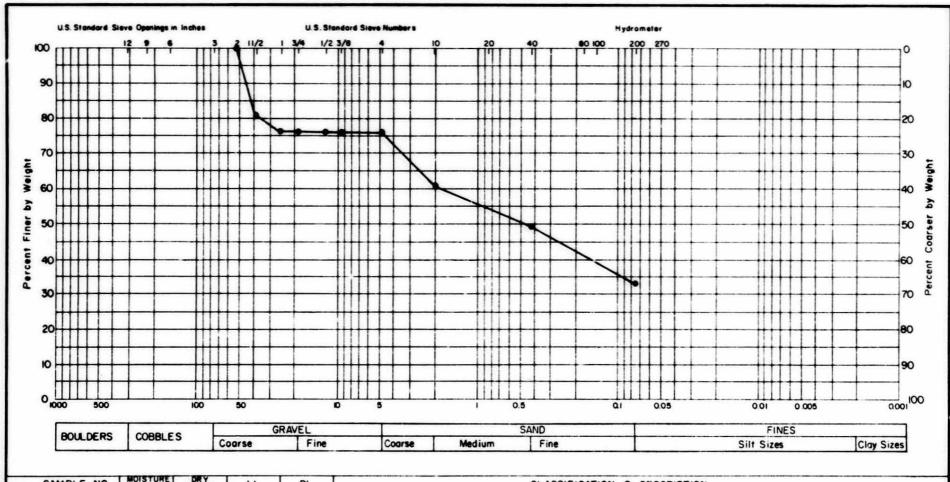
BORROW AREA H AUGER HOLE AH-H5

SAMPLE NO.	CONTENT	DENSITY	LL	PI		CLASSIFICATION & DESCRIPTION
AH-H5 #6,7	10,9		21	4	SM-SC	SILTY SAND WITH SOME GRAVEL AND TRACE CLAY
					++	
					1

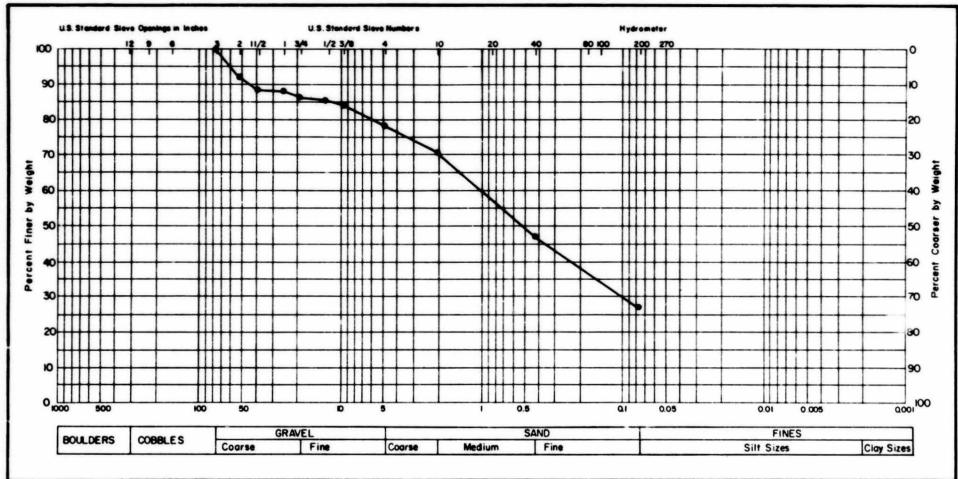
BORROW AREA H AUGER HOLE AH-H7

SAMPLE NO.	CONTENT	DENSITY	LL	PI		CLASSIFICATION & DESCRIPTION
AH-H7 #9,10	13,13		33	19	sc	SAND WITH SOME CLAY, GRAVEL, AND SILT
		-		-		
					+	
				<del></del>

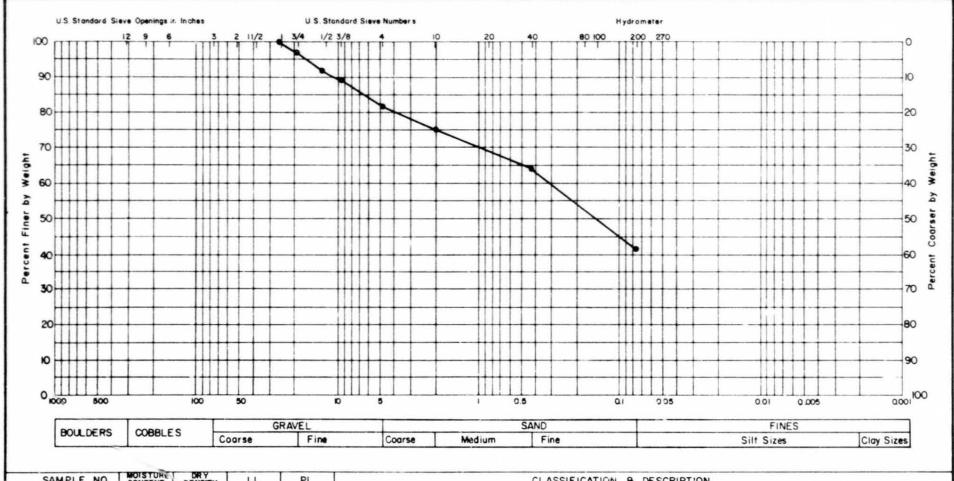
BORROW AREA H AUGER HOLE AH-H8

SAMPLE NO.	CONTENT	DRY	LL	PI		CLASSIFICATION & DESCRIPTION
AH-H8 #5,6	12,13	- 5	25	11	SC	SAND WITH SOME SILT, GRAVEL, AND CLAY
					-	
					-	
	-			-		
						DRAWN BY

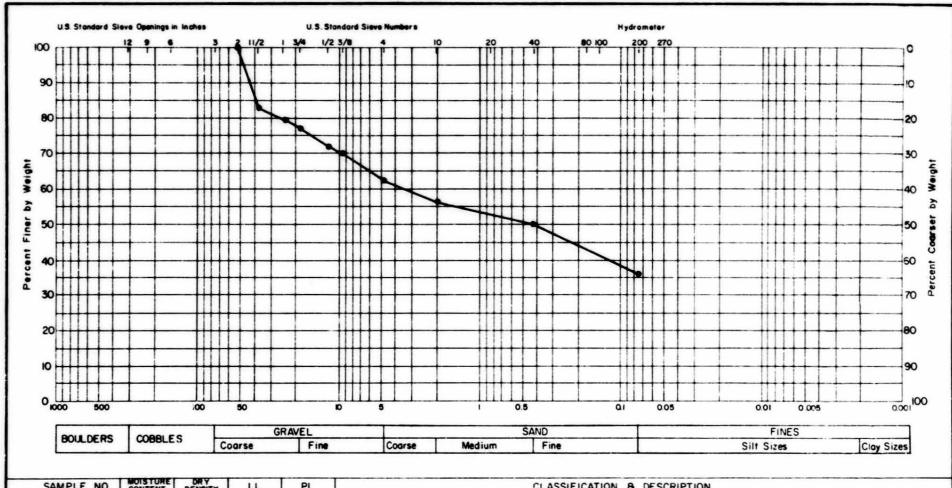
BORROW AREA H AUGER HOLE AH-H8

SAMPLE NO.	CONTENT	DENSITY	LL 21	PI 7	CLASSIFICATION & DESCRIPTION		
АН-Н8 #7	7				GÇ-GM	SILTY GRAVEL WITH SOME SAND, TRACE CLAY	
				-	+

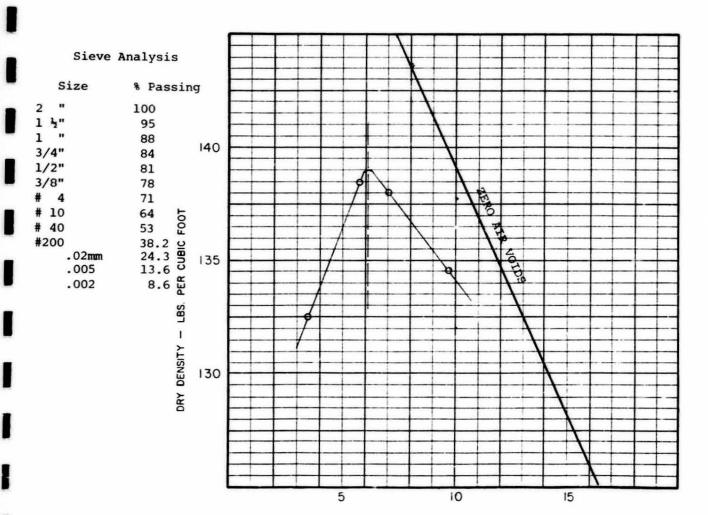
## R&M Consultant Inc. LABORATORY COMPACTION CONTROL REPORT

Jo	b Name and Location Susitna (Watana Dam S	ite)					
Architect or Engineer Acres American Inc.							
Co	ntractor						
A.	A Description of Soil: Poorly Graded 'Till', SILTY GRAVEL AND SAND W/TRACE CI						
	Material MarkC	Unified Classification	GC-SC	AASHO Classification			
	Source of Material Borrow Area H Sample	No. W-80-256					
	latural Water Content 10.9 % Natural Dry Density PCF Specific Gravity		fic Gravity				
	Liquid Limit% Plastic Limit	%PI	asticity Index	9.2			
В.	Test Procedure Used	- AASHTO					
C.	Test Results: Maximum Dry Density 139.0	PCF	Optimum Water	Content6.2%

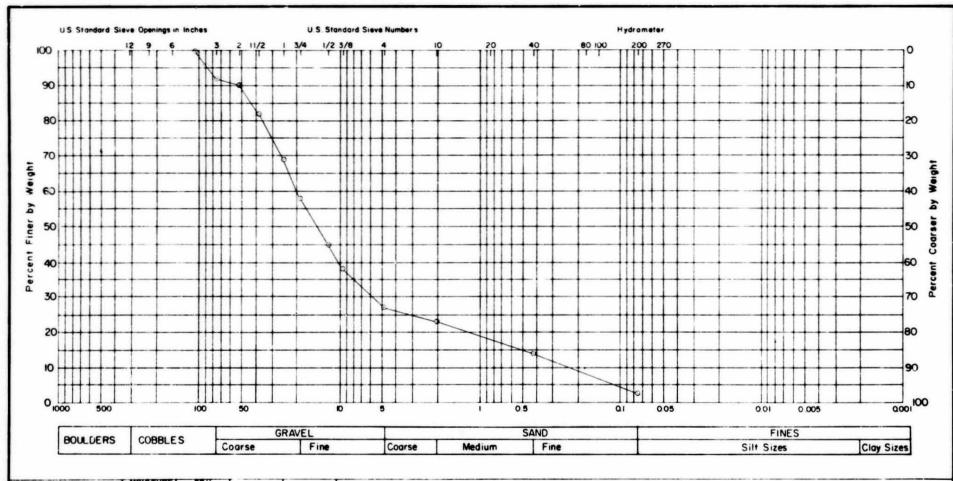
SAMPLE NO	CONTENT	DRY	LL	PI		CLASSIFICATION & DESCRIPTION	
W-80-302					GP	SANDY GRAVEL W/TRACE SILT	
(Grab Sample)						Poorly Graded

PROJECT NO. 05250 CLIENT: Acres Americ PROJECT NAME Susitna (Watana	an, In Hydro	elect	<b>tri</b> c			¢ M					TS, I	NC.	- ATA			Octobe			
DESCRIPTION	4"	3"	2"	112"	1"	3/4"	1/2"	3/8"	#4	#10	# 40	#200	.02	.005	.002	% Moist.	LL	PI	Unified Class.
STREAM ALLUVIUM W-80-302 (Crab Sampl	100 e)	92	90	82	69	58	45	38	27	23	14	2,6							GP

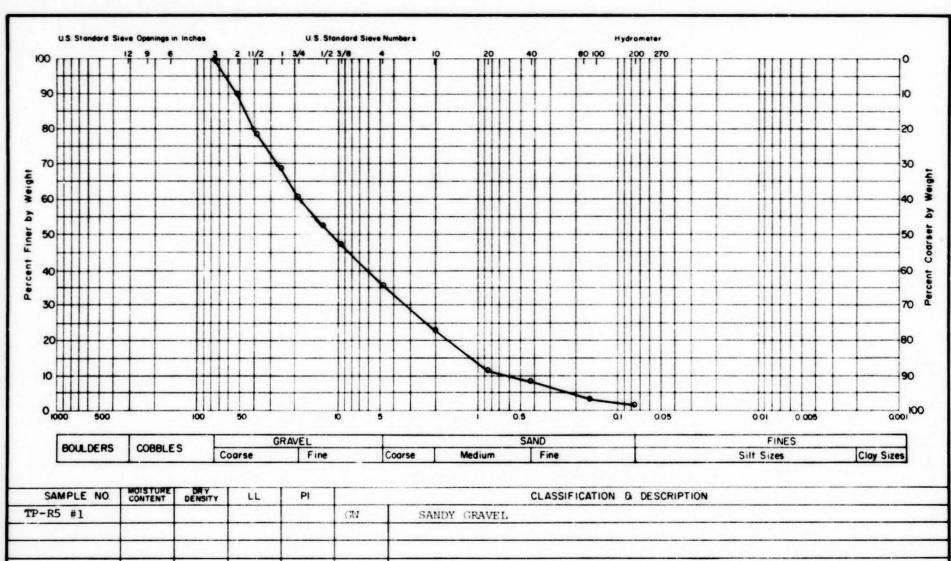
TEST PIT TP-R5

SAMPLE NO	CONTENT	DENSITY	LL	PI		CLASSIFICATION & DESCRIPTIO	N
TP-R5 #1					GW	SANDY GRAVEL	
	-						
	-						
	<b>+</b> ·						
v 4	120	Total State of the last of the	. 2.	484 5			DRAWN BY P.T.
1		1	18. 3	33.18	1 1	RIVER ALLUVIUM	APPROVED BY: T

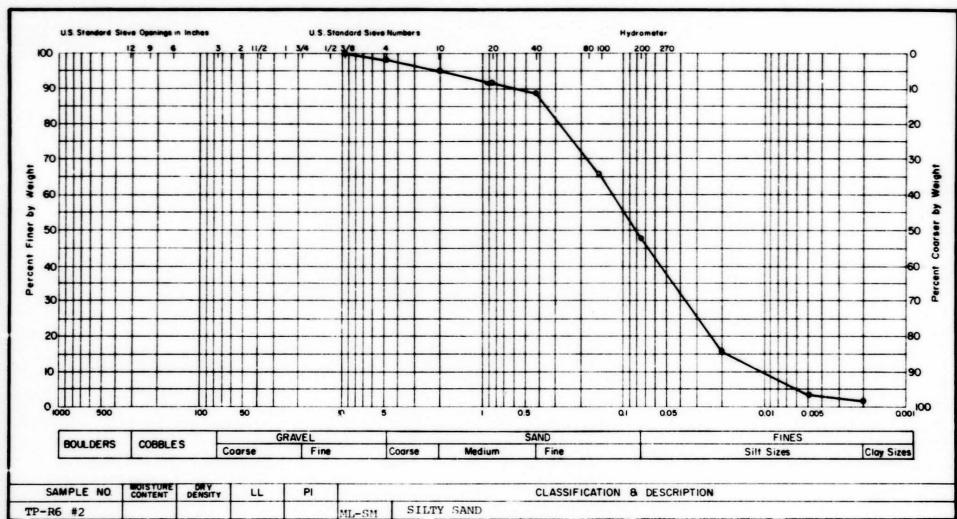
TEST PIT TP-R6

SAMPLE NO	CONTENT	DENSITY	LL	PI		CLASSIFICATION & DESCRIPTION		
TP-R6 #2					ML-SM	SILTY SAND		
						(FIELD GEOLOGIST NOTES TRACE ORGANICS)		
	-			-				
	-				-			
					-			
							DRAWN BY	P.T.
			1.000	577 An	388.7	RIVER ALLUVIUM	APPROVED BY:	T. T.

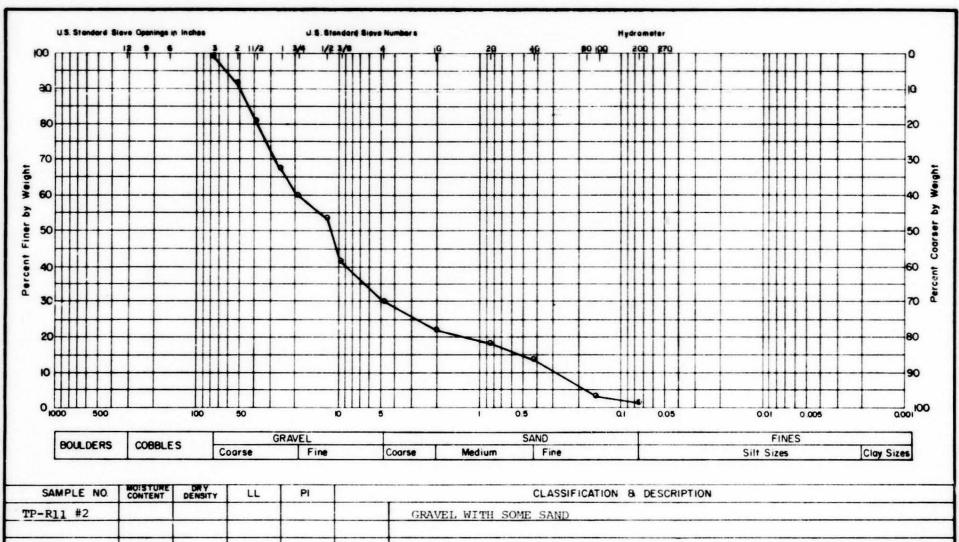
TEST PIT TP-R11

SAMPLE NO.	CONTENT	DENSITY	LL	PI	CLASSIFICATION & DESCRIPTION				
TP-R11 #2					GRAVEL WITH SOME SAND				
						DRAWN BY P.T.			
					RIVER ALLUVIUM	APPROVED BY: T.I.

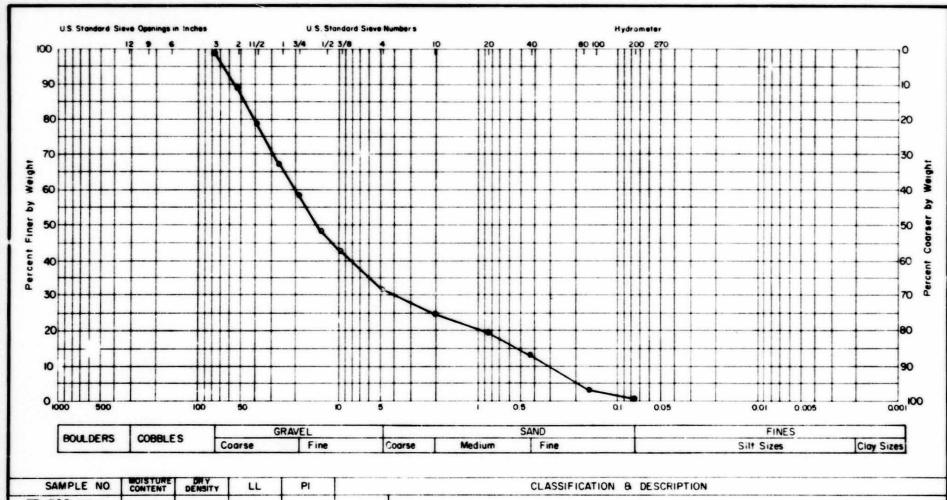
SAMPLE NO	CONTENT	DENSITY	LL	PI	CLASSIFICATION & DESCRIPTION		
TP-R12 #2					GM	SANDY GRAVEL	
	ļ						
					-		
	$\vdash$			-	-		
					-

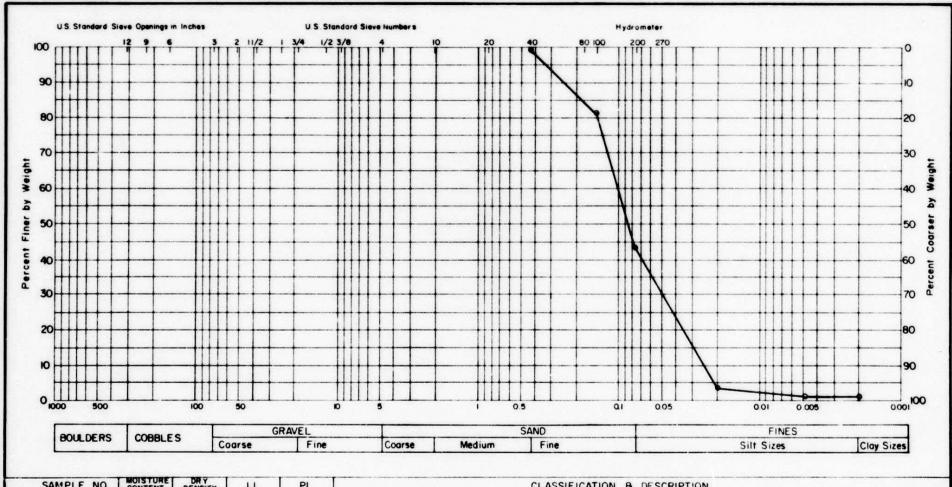
SAMPLE NO.	CONTENT	DENSITY	LL	PI		CLASSIFICATION & DESCRIPTION
TP-R15 #2					SM	SILTY SAND
						(FIELD GEOLOGIST NOTES TRACE ORGANICS)
				L	4	DRAWN BY: P. T.

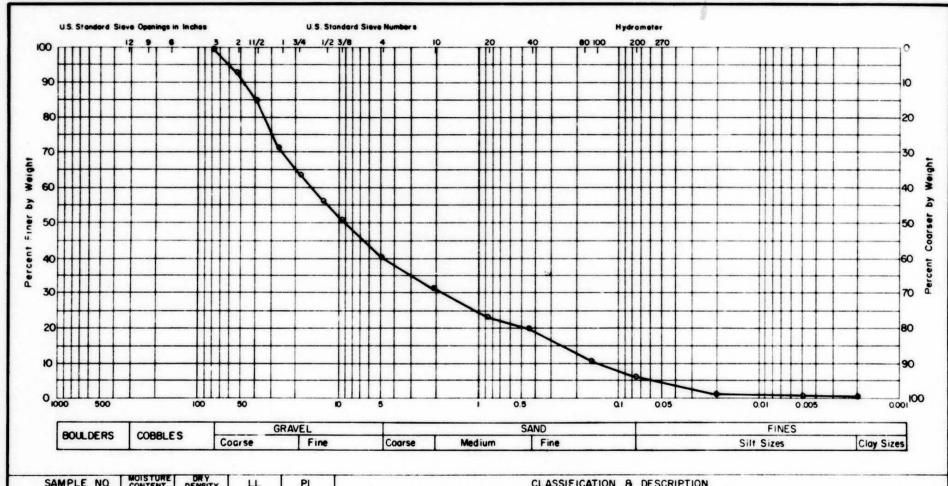
SAMPLE NO	CONTENT	DRY	LL		CLASSIFICATION & DESCRIPTION			
P-R16 #2					GW-GM	SANDY GRAVEL WITH TRACE SILT		
					1			
					-			
	11			L	44	DRAWN BY D. T.

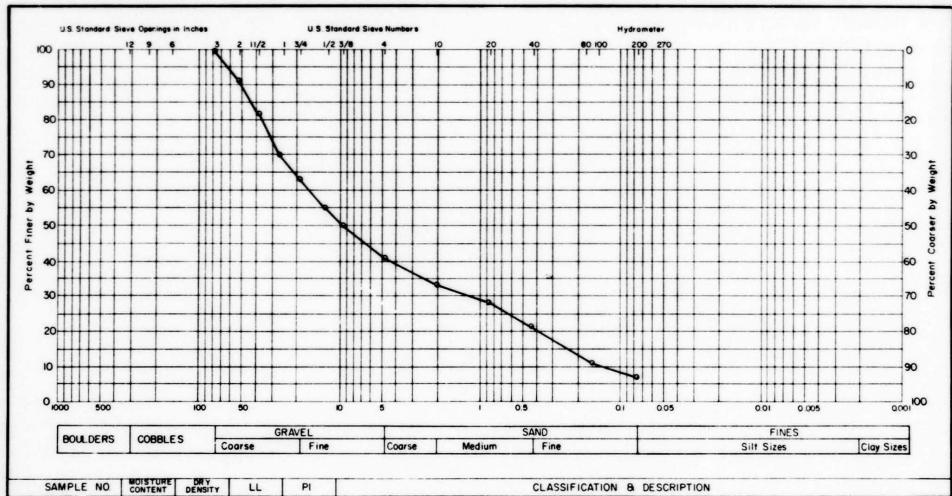
SAMPLE NO	CONTENT	DENSITY	LL	LL PI	CLASSIFICATION & DESCRIPTION			
TP-R17 #2					GP-GM	SANDY GRAVEL WITH TRACE SILT		
					-			
					+			
	1				+			
					1	· ·

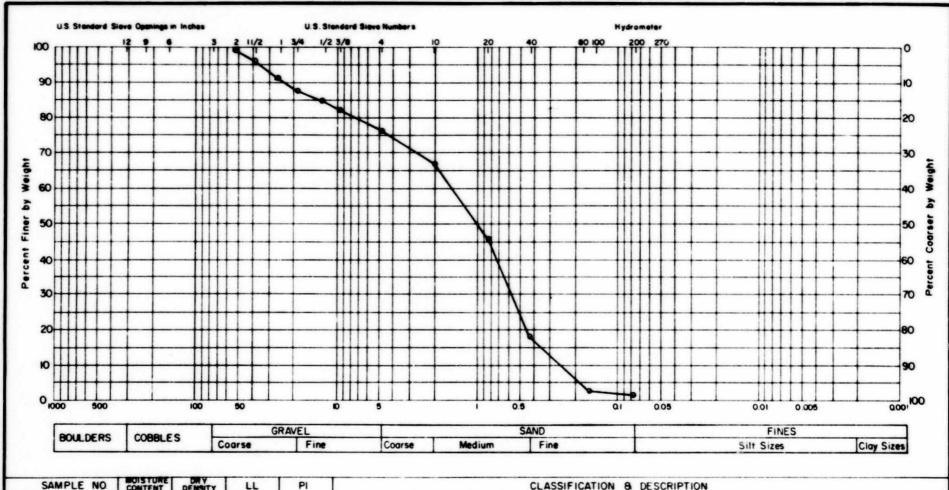
SAMPLE NO CONTENT		DENSITY	LL	PI	CLASSIFICATION & DESCRIPTION
TP-R19 #2				SW	-SP SAND WITH SOME GRAVEL
	-				
				-

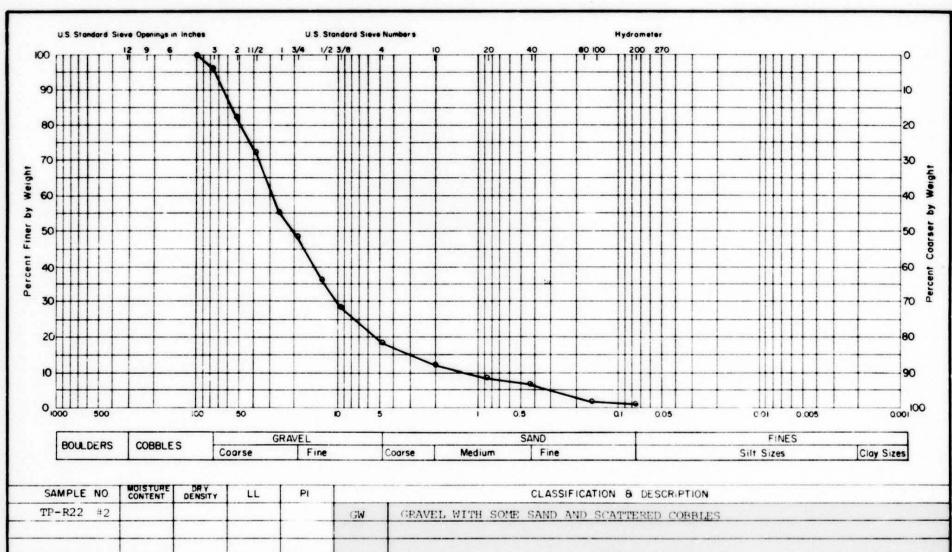
SAMPLE NO	CONTENT	DENSITY	LL	PI	CLASSIFICATION 8 DESCRIPTION		
TP-R22 #2					GW	GRAVEL WITH SOME SAND AND SCATTERED COBE	BLES
				200 m		DIVED ALTOUTOM	DRAWN BY P.T.
