**SUSITNA HYDROELECTRIC PROJECT**

**GEOMORPHIC CHANGE IN THE MIDDLE SUSITNA RIVER  
SINCE 1949**

Report by  
Arctic Environmental  
Information and Data Center

Final Report  
June 1985

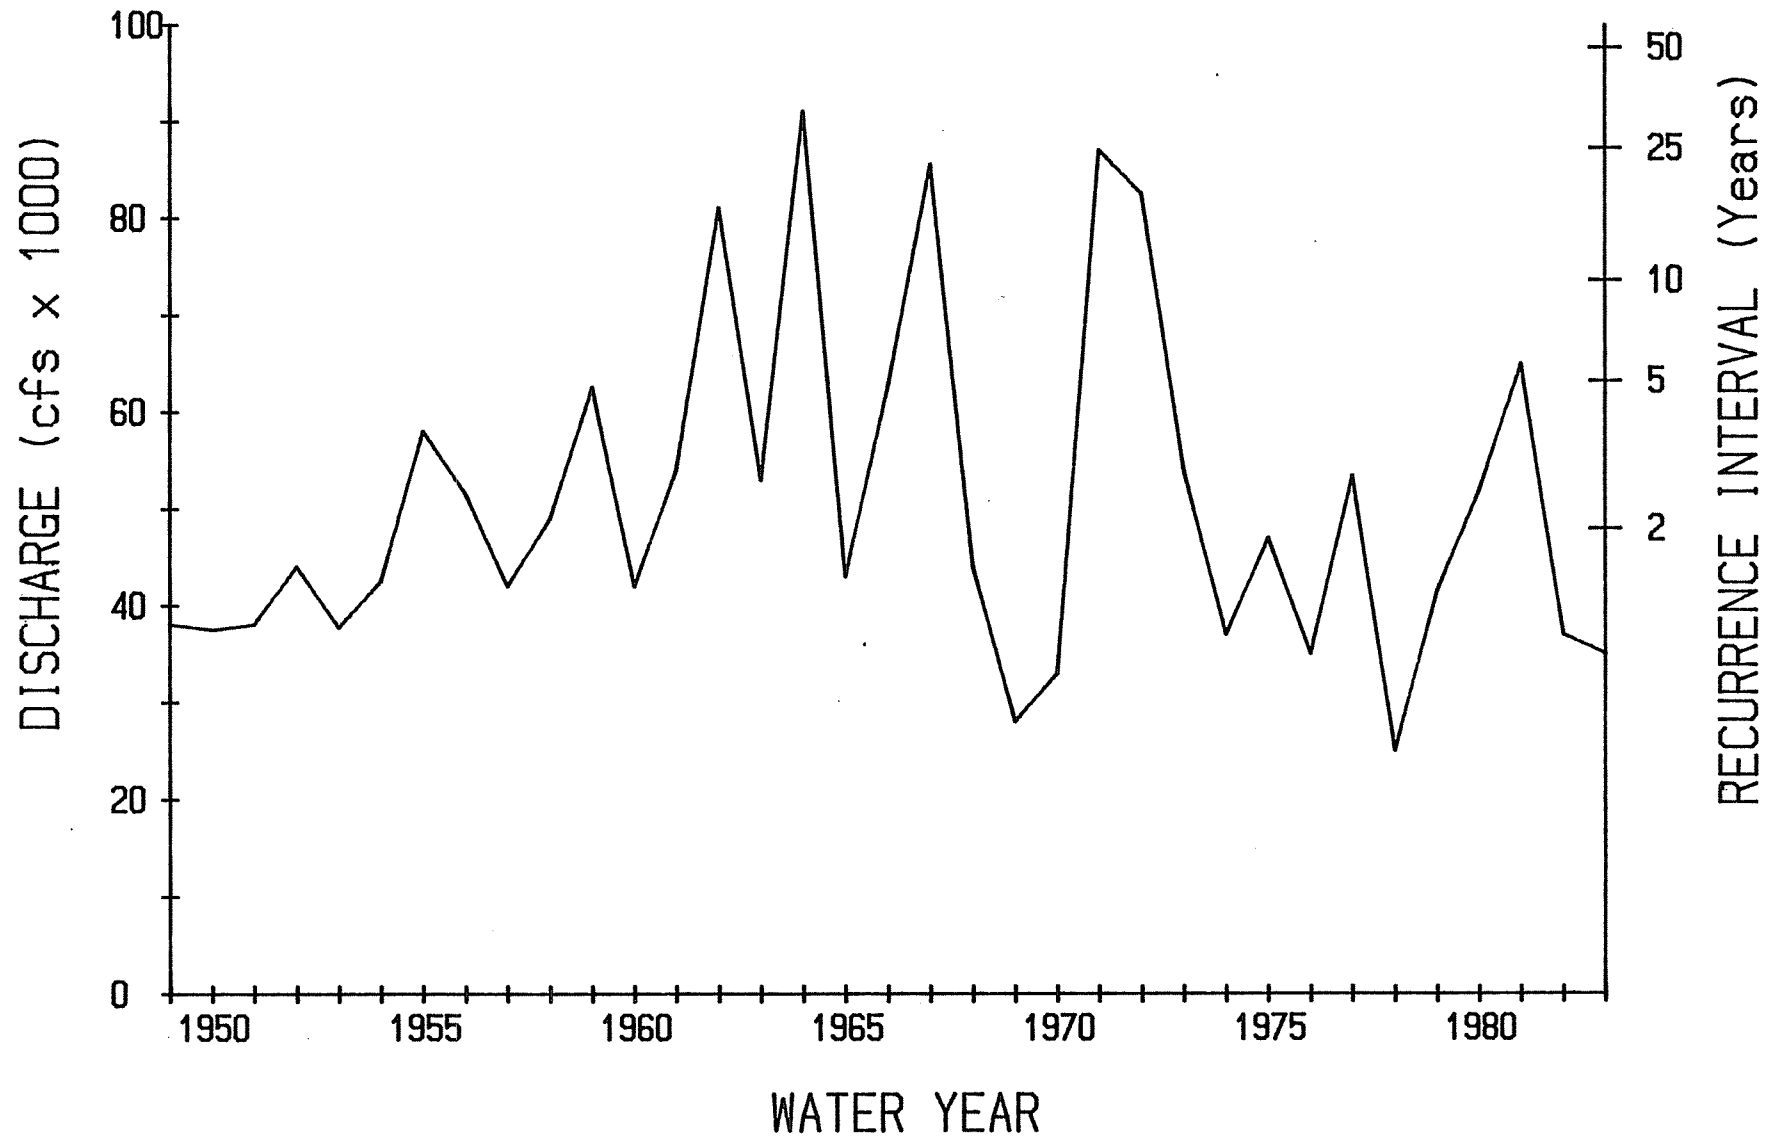
# ANNUAL FLOOD PEAK DISCHARGES

Susitna River at Gold Creek

Source: modified from H-E 1985A.

For several years after 1952-53, then, discharges in the middle Susitna River may have been somewhat higher than they would have been under normal conditions. A cursory look at Susitna river discharge data from Gold Creek did not reveal any notable increase, but climatic variability could have masked it. For this reason a statistical analysis of the data was conducted to look for any important variations in discharge that were not linked to climatic factors.

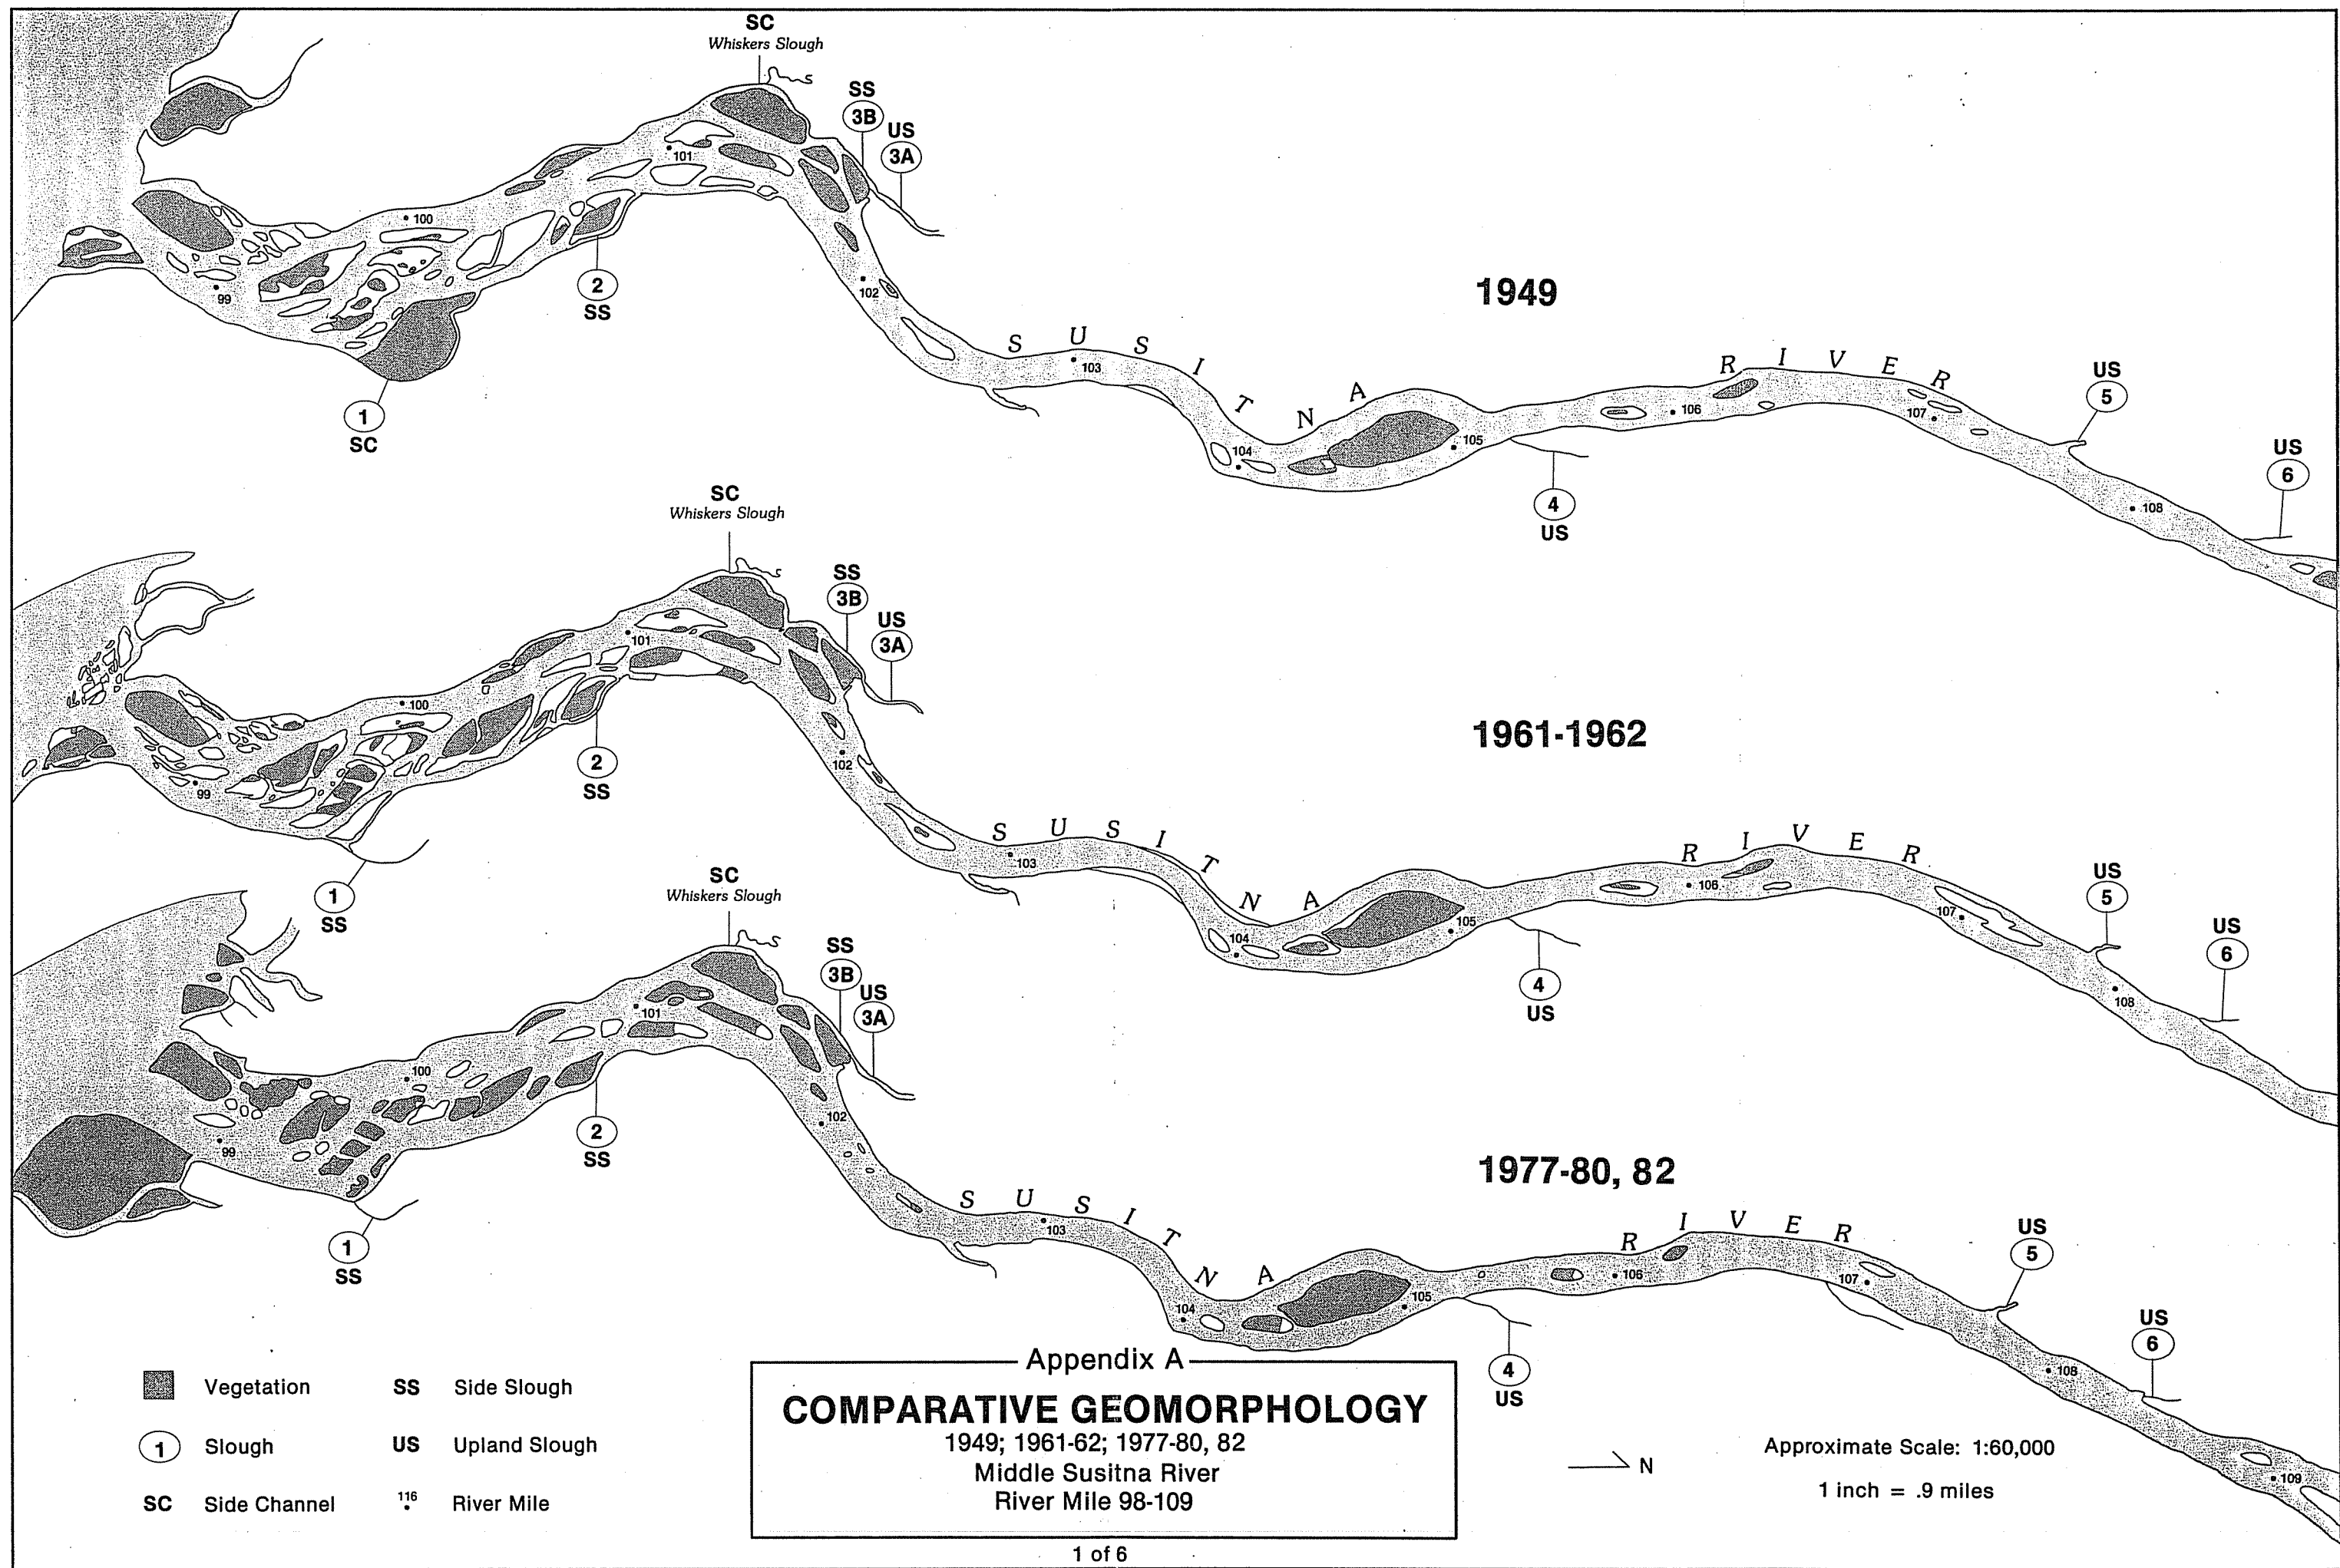
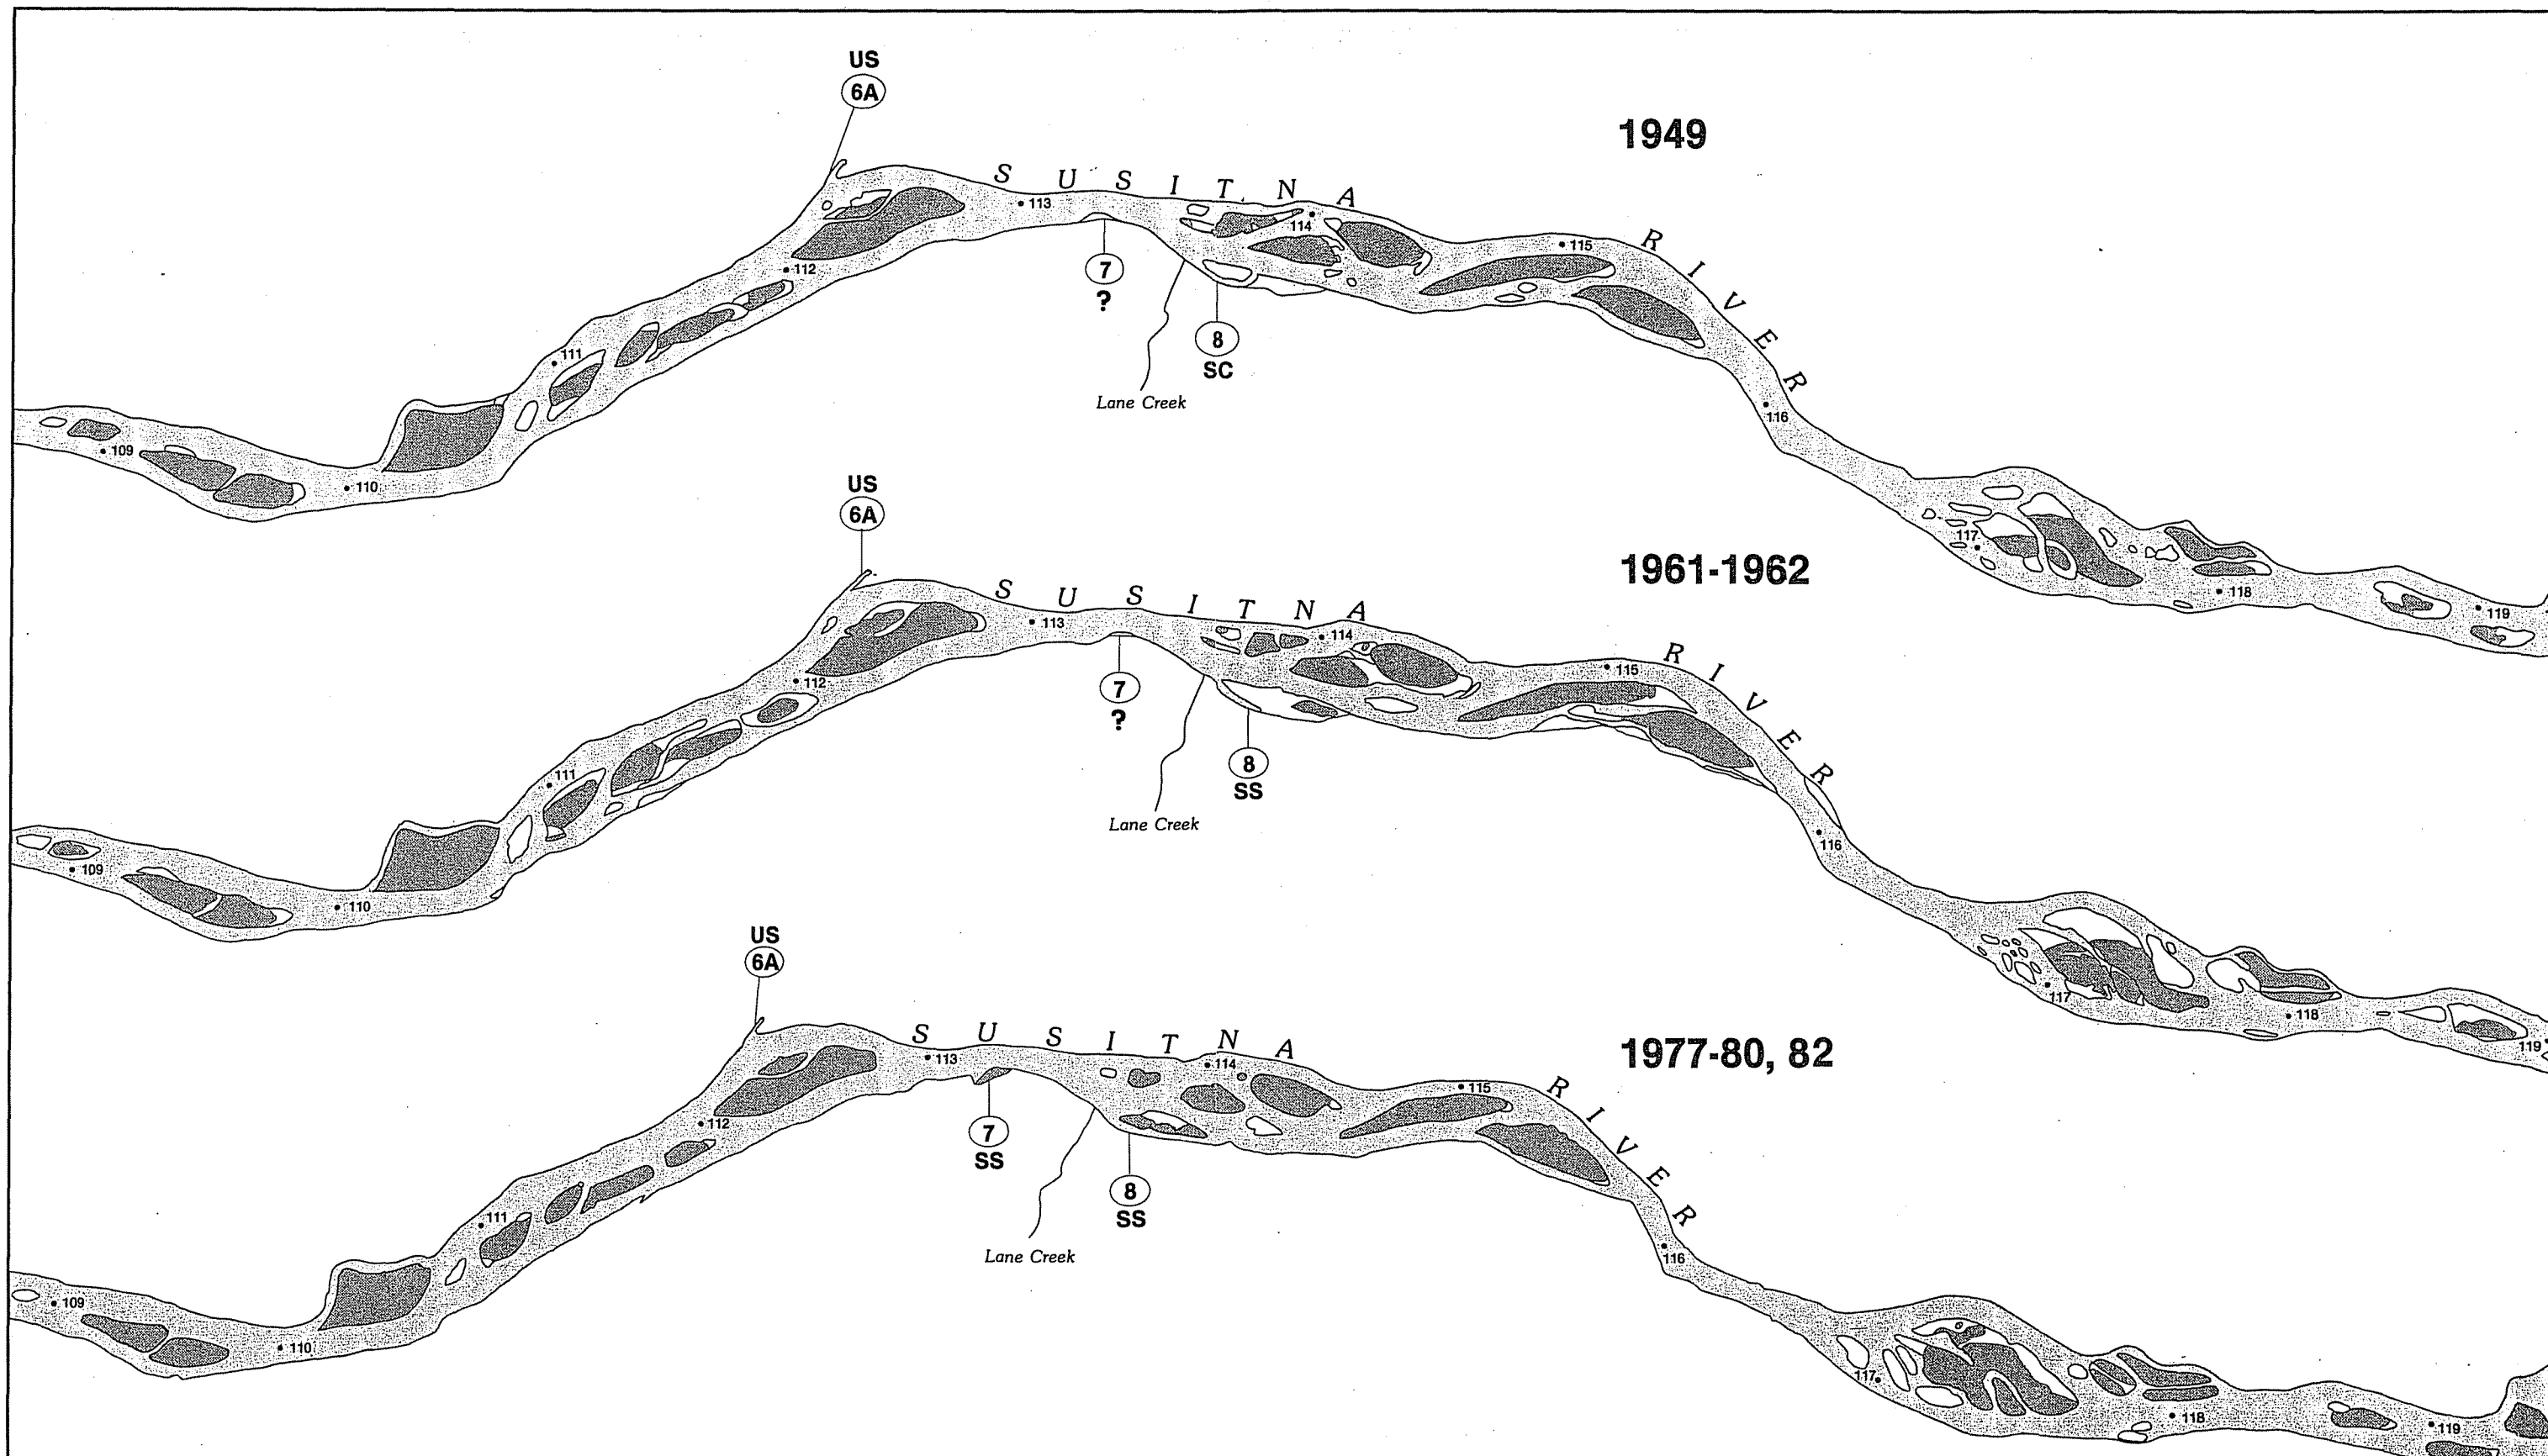
Approximate Scale: 1:60,000  
 1 inch = .9 miles

Due to these limitations it was difficult and, at times, impossible to portray each river feature accurately. Artistic license was taken at times in order to distinguish important features of the river that would be indistinguishable at true scale, since line widths often exceeded the actual size of features portrayed. The method of portrayal to achieve this end varied somewhat from one part of the river to another, and from year to year. All vegetation stands, regardless of successional stage, are shown on the drawings as black areas.

The drawings were not used by the authors in their analyses, and, in fact, were not finished until after the analyses were completed. The analyses were performed using a magnifying stereoscope utilizing overlapping stereo pairs of photographs. Without the three-dimensional images and magnification of features, many of the reported geomorphic changes could not have been distinguished. Accordingly, although the drawings do illustrate general change in the river, such as increased vegetation coverage and general changes in shape and area of certain features, the drawings should not be used by the reader to attempt to verify each geomorphic change reported in the text.

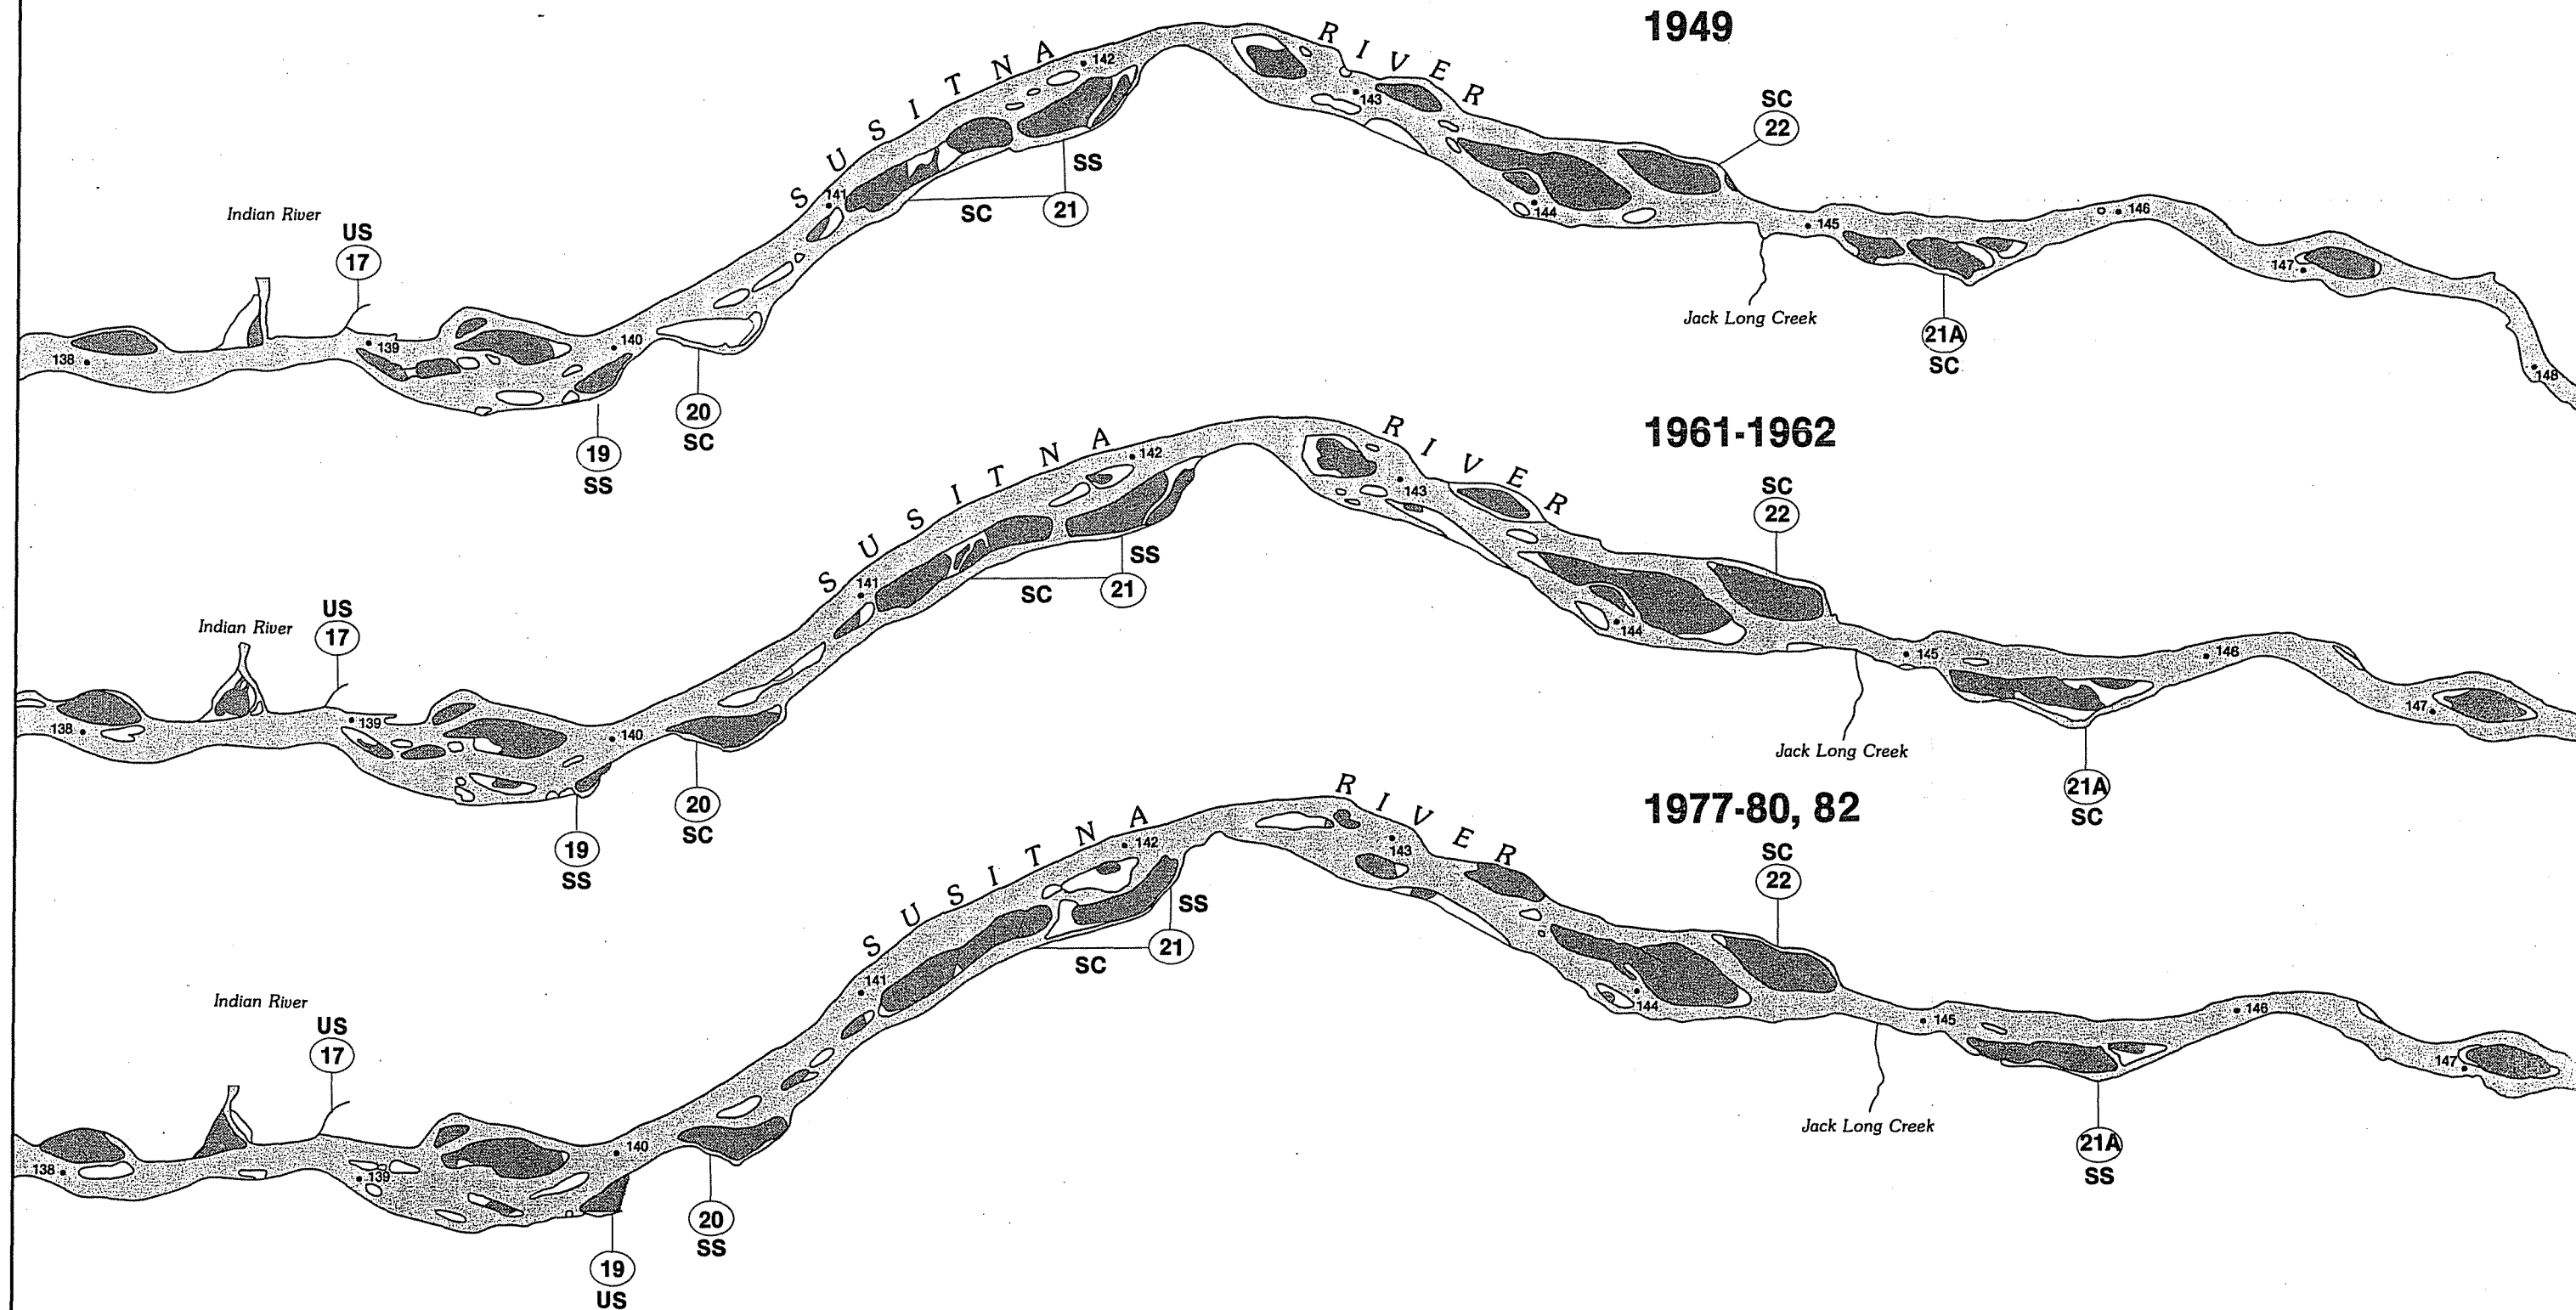
Approximate Scale: 1:60,000  
 1 inch = .9 miles
