SUSITNA HYDROELECTRIC PROJECT

RESERVOIR SLOPE STABILITY

SUBTASK 2.15 - SLOPE STABILITY AND EROSION STUDIES CLOSEOUT REPORT

FINAL DRAFT
MARCH 1982

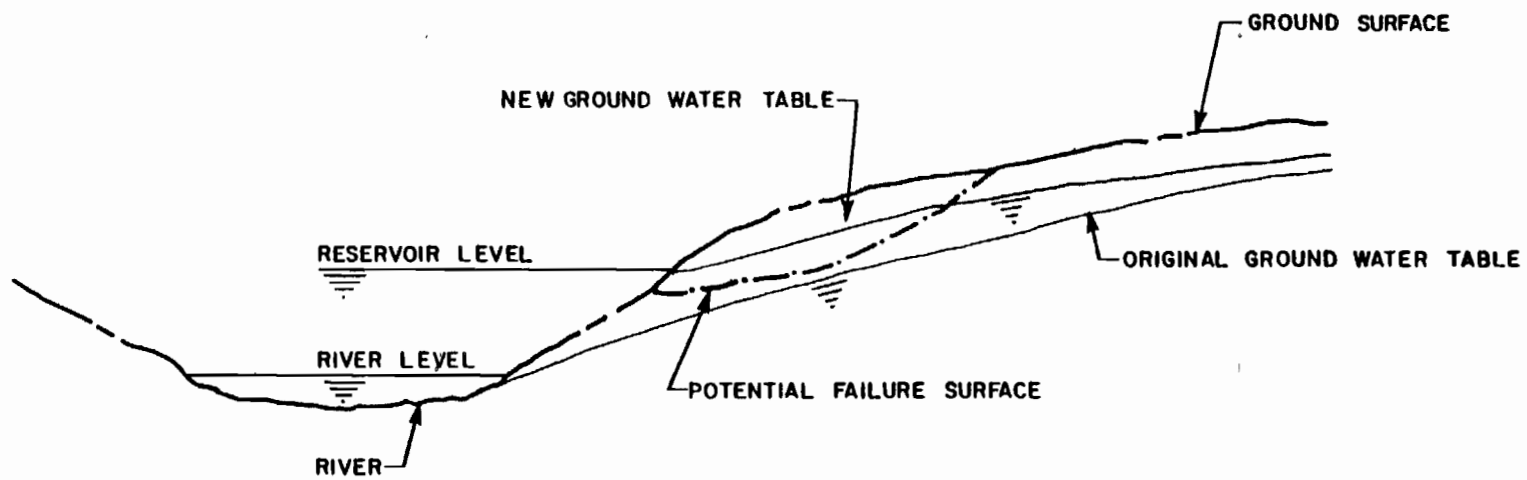
FIGURE 4.1

TYPICAL SLOPE FAILURE

When the reservoir rises to its maximum level the ground water table in the adjacent slope also rises as shown in Figure 4.1. The result is that a slope which, although previously stable and above the ground water table, can now be unstable since it is affected by the pore pressures and seepage forces existing because of higher ground water table. The slope shown in Figure 4.1 whether it is soil or rock is less stable than it was prior to the existence of the reservoir. This is not to say that this slope will necessarily fail since failure is dependent on the strength parameters on the soil or the strength along weakness planes in the rock. The potential for failure of such a slope could extend below the water level depending on the slope configuration and the magnitude of the driving force associated with the unsubmerged portion of the slope above the water table.

Figures 4.2 and 4.3 indicate that the unsubmerged dry slope and the submerged slope have identical factors of safety. Hence, there is no instability caused purely by submergence of a slope. However Figure 4.4 indicates that for the case of seepage parallel to the slope the factor of safety could be reduced by approximately 50 percent. Therefore, instability can be induced by raising the ground water table similar to Figure 4.1 or by drawdown of the reservoir.

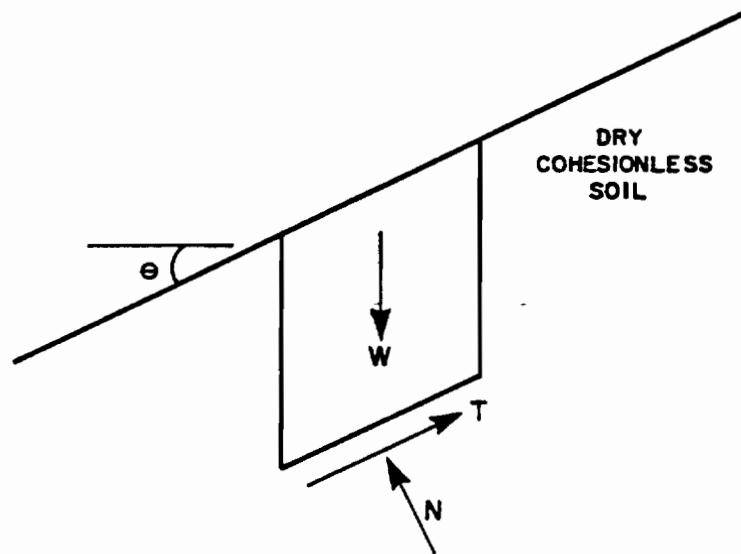
FIGURE 4.2

$$F.S. = \frac{\tan \phi}{\tan \theta}$$

FOR SHEAR STRENGTH FULLY MOBILIZED

**SLOPE CONDITIONS IN A
DRY COHESIONLESS SOIL**

The case of the newly submerged slope just below the reservoir level was examined as an infinite slope in three conditions in which it will exist. These are shown in Figures 4.2 through 4.4. The first case is the original slope, above the water table. The second is the submerged case and the third is the condition just above the reservoir level.

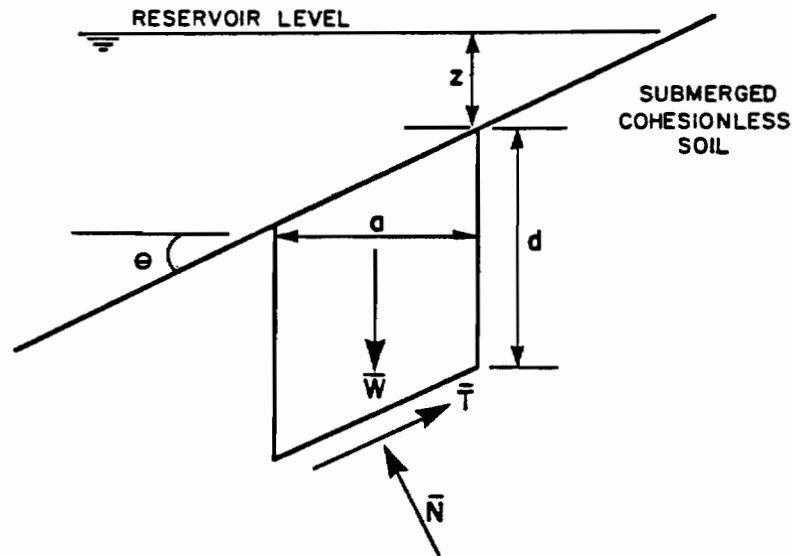
$$\bar{N} = ad\gamma_b \cos \theta$$

$$\bar{T} = ad\gamma_b \sin \theta$$

SUBMERGED SLOPE CONDITIONS
IN A COHESIONLESS SOIL

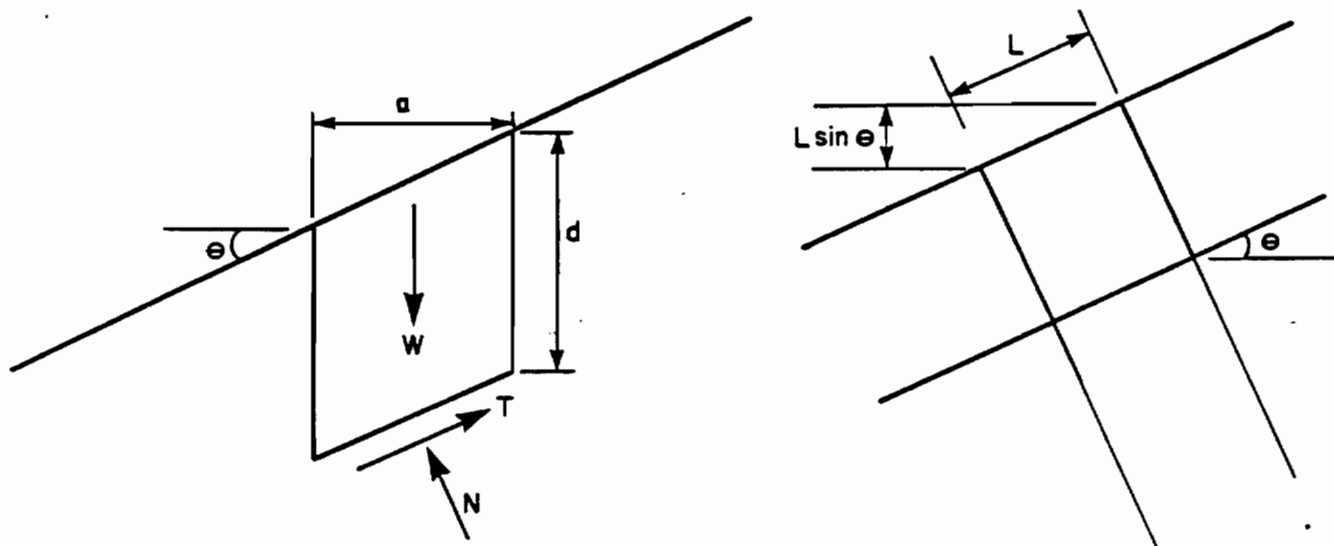
FIGURE 4.4

$$i = \frac{L \sin \theta}{L} = \sin \theta$$

$$\bar{N} = \gamma_b a d \cos \theta$$

SLOPE CONDITIONS, SEEPAGE PARALLEL
TO SLOPE IN COHESIONLESS SOIL

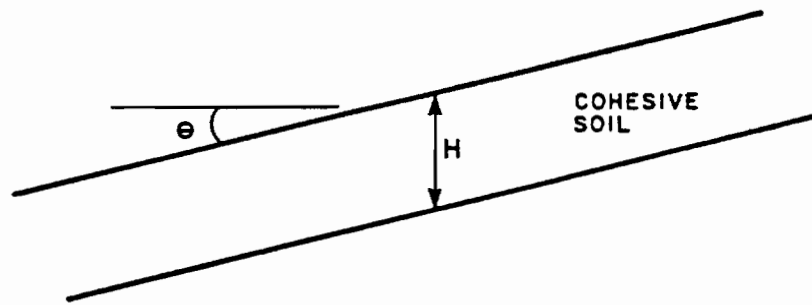
DRY SLOPE

$$F.S. = \frac{\bar{c} + \bar{\sigma} \tan \bar{\phi}}{\tau} = \frac{\bar{c} + \gamma_t H \cos^2 \theta \tan \bar{\phi}}{\gamma_t H \sin \theta \cos \theta}$$

SLOPE CONDITIONS IN A COHESIVE SOIL

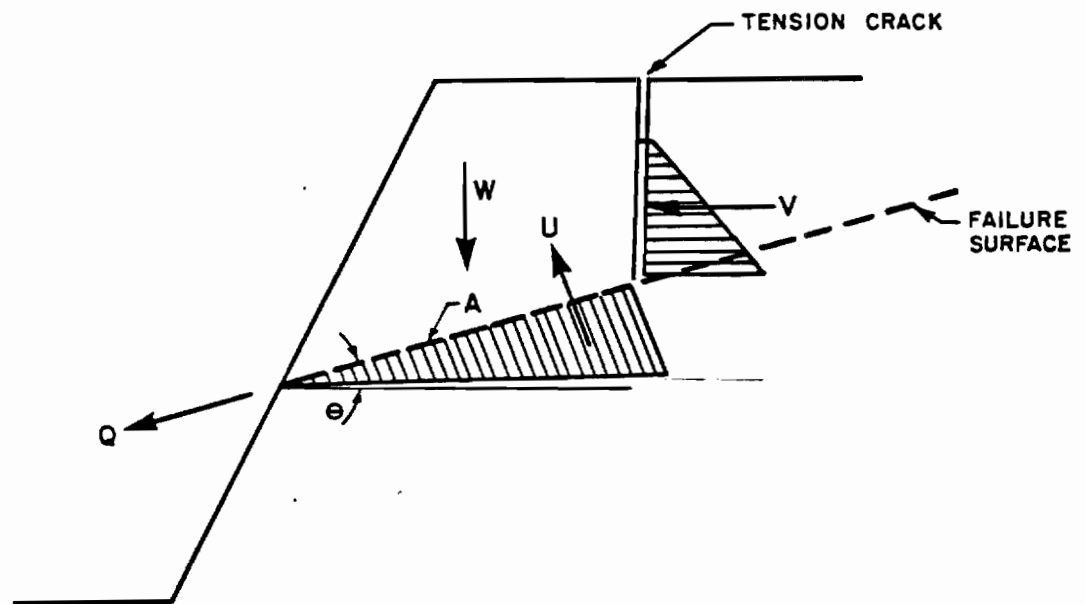
SEEPAGE PRESSURE CASE

$$F.S. = \frac{\bar{c}A + (W \cos \theta - U - V \sin \theta) \tan \bar{\phi}}{W \sin \theta + V \cos \theta}$$

- \bar{c} = COHESION OF THE ROCK MASS
- W = WEIGHT OF THE ROCK WEDGE
- U = UPLIFT PRESSURE ON THE ROCK WEDGE
- V = DRIVING FORCE OF THE WATER BEHIND THE ROCK WEDGE
- θ = ANGLE OF THE FAILURE PLANE
- $\bar{\phi}$ = ANGLE OF INTERNAL FRICTION OF THE ROCK
- \bar{W} = WEIGHT OF SUBMERGED ROCK WEDGE
- A = FAILURE PLANE AREA

SLOPE CONDITIONS IN ROCK

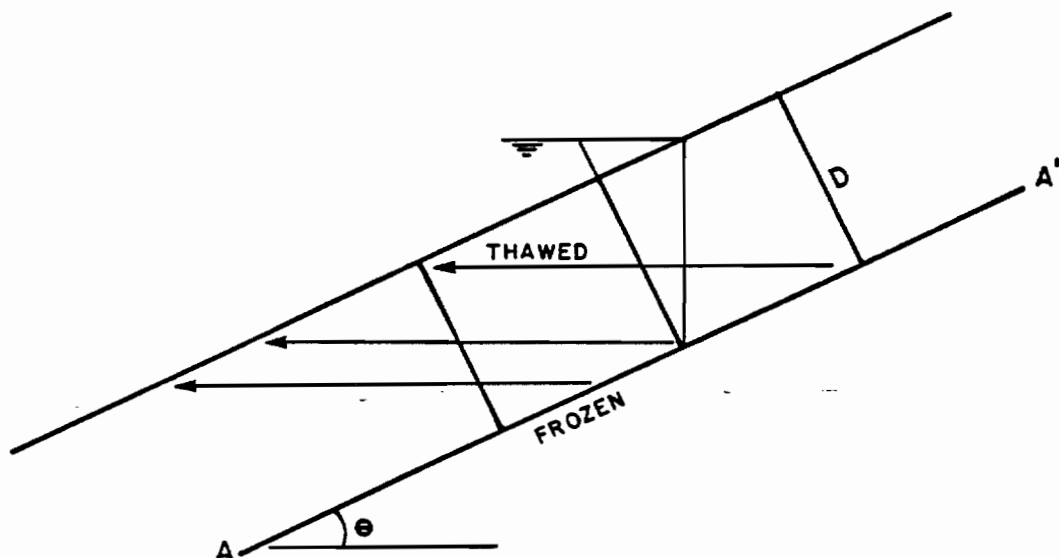
ON PLANE AA'

$$\text{PORE PRESSURE } u = \gamma_w D \cos \theta + \gamma_b D \cos \theta \left(\frac{1}{1 + \frac{1}{2R^2}} \right)$$

CONDITIONS IN A THAWING SLOPE

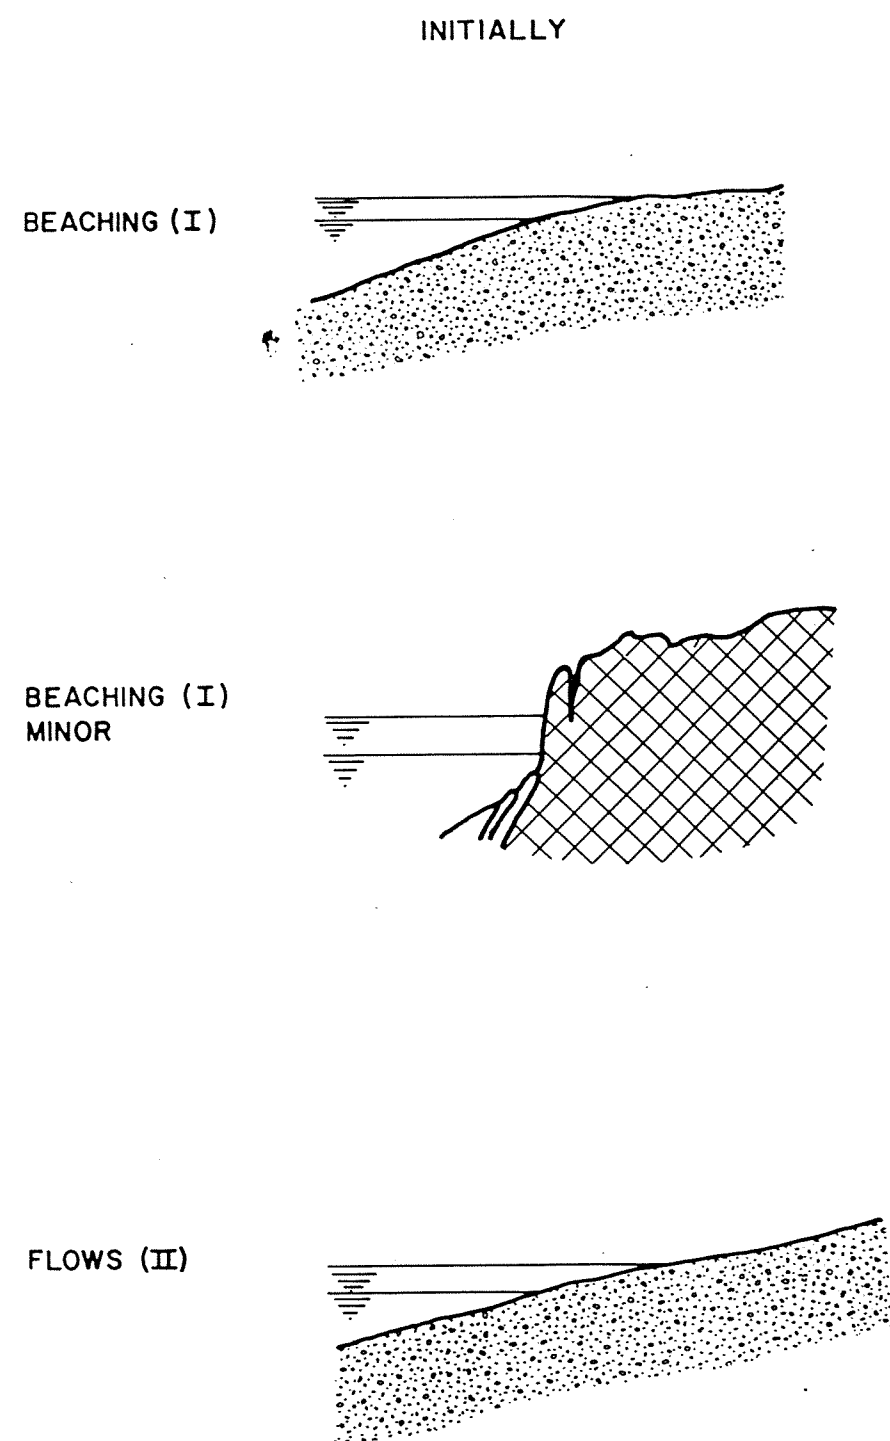
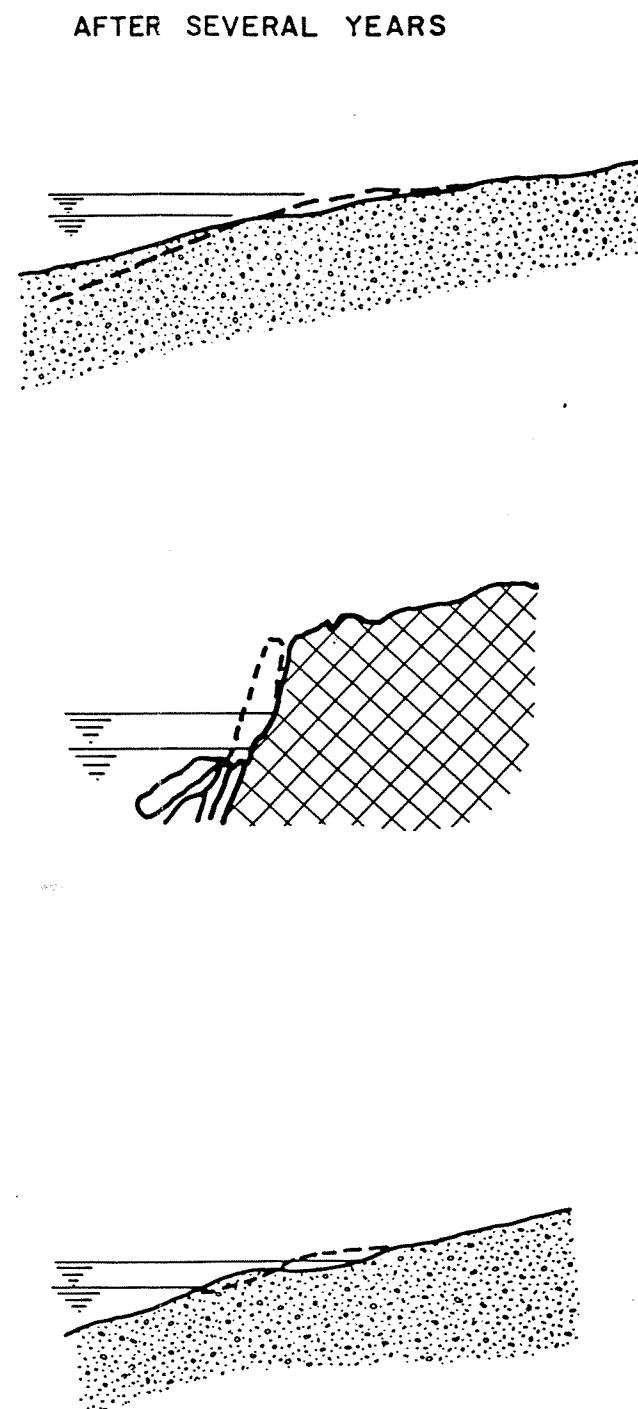
ASSUMPTIONS:

FLAT SLOPES.
COARSE GRAINED DEPOSITS OR UNFROZEN
TILL AND LACUSTRINE DEPOSITS.

STEEP BEDROCK SLOPES.
FLUCTUATION OF RESERVOIR AND
GROUNDWATER TABLE CAUSES FROST
WEDGING TO OCCUR CAUSING ROCKFALL.

SLOPE MODELS FOR THE WATANA
AND DEVIL CANYON RESERVOIRS

¹ As perceived to be in most cases.² Beaching vs mass movement over certain reaches of reservoir; where sliding occurs, can expect some potential beaching and flows.³ Potential of frost riving on rock slopes resulting in rockfall.⁴ Numerical values apply to slope models, see Figures 5.1 and 5.2.

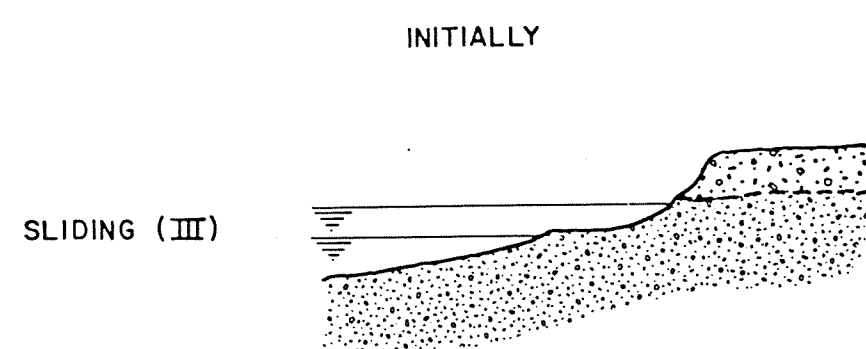
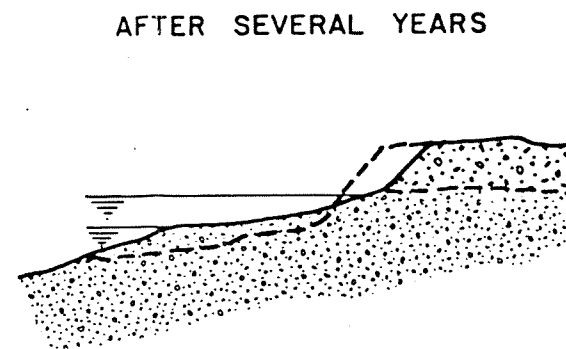
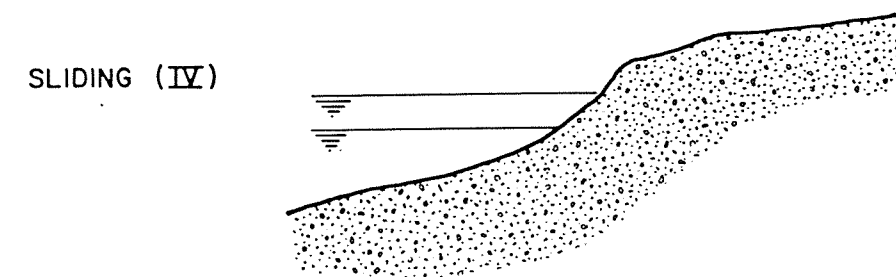
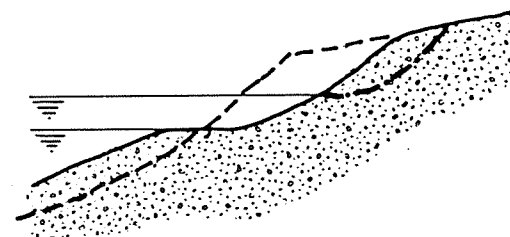
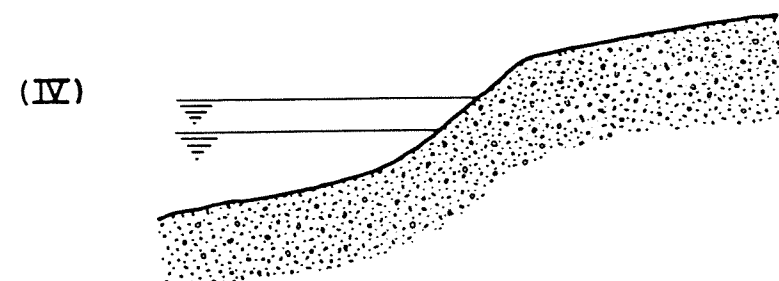
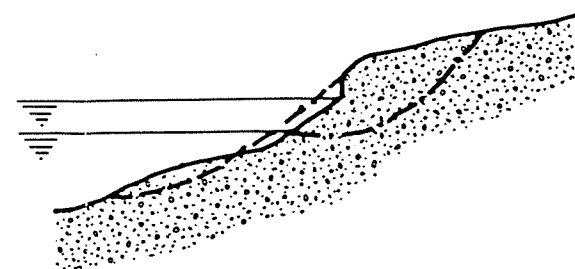
ASSUMPTIONS:

STEEP SLOPES.
TWO LAYER CASE, LOWER LAYER IS FINE
GRAINED AND FROZEN. UPPER LAYER IS
COARSER GRAINED, PARTLY TO COMPLETELY
FROZEN.
FLOWS IN LOWER LAYER ACCOMPANY SLOPE
DEGRADATION

STEEP SLOPES.
FINE GRAINED AND ~~UN~~FROZEN.
NOTE: POSSIBLE FURTHER SLIDING IF THAW
BULB EXTENDS INTO SLOPE WITH TIME.

SLOPE MODELS FOR THE WATANA
AND DEVIL CANYON RESERVOIRS

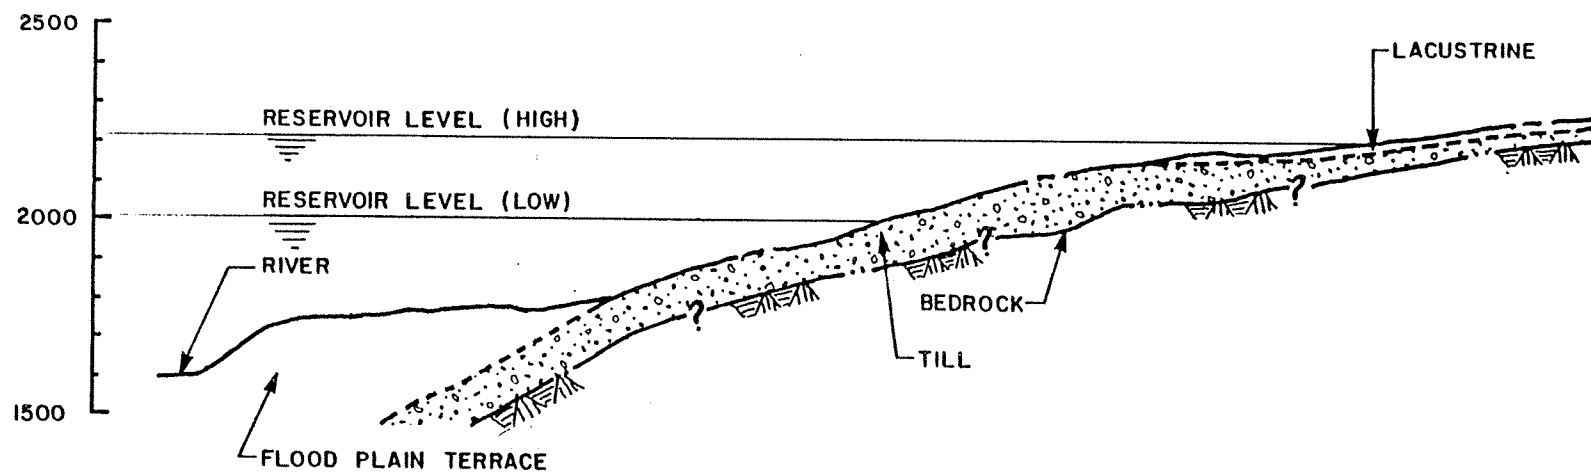
FIGURE 5.19

ASSUMPTIONS: BASAL TILL, PRIMARILY FROZEN

NOTE: SEE FIGURE 5.11 FOR
SECTION LOCATION

On the south abutment between the Watana damsite and Vee Canyon the shoreline of the reservoir is susceptible to a high potential for flows and shallow rotational slides (Figures 5.19 and 5.20). In contrast to the north abutment, the shoreline is almost exclusively in contact with frozen basal tills, overburden is relatively thick and steeper slopes are present. Thermal erosion, resulting in the erosion and thawing of the ice-rich fine grained soils will be the key factor influencing their stability. In the Watana Creek drainage area there is a thick sequence of lacustrine material overlying the basal till (Figure 5.21). Unlike the till, it appears that the lacustrine material is largely unfrozen. All four models are perceived to have the potential for occurring here, depending on where the seasonal drawdown zone is in contact with the aforementioned stratigraphy. Overall, the north abutment in contrast with the south abutment, doesn't have the constant steep slopes and the slopes are slightly better drained, which may be indicative of less continuous permafrost and/or slightly coarse material at the surface with a deeper active layer. In general, the potential for beaching is higher because the seasonal drawdown zone will be in contact with a thin veneer of colluvium over bedrock and in a number of areas, low slopes (Figure 5.22). In the Oshetna-Goose Creeks area there is a thick sequence of lacustrine material. Permafrost appears to be nearly

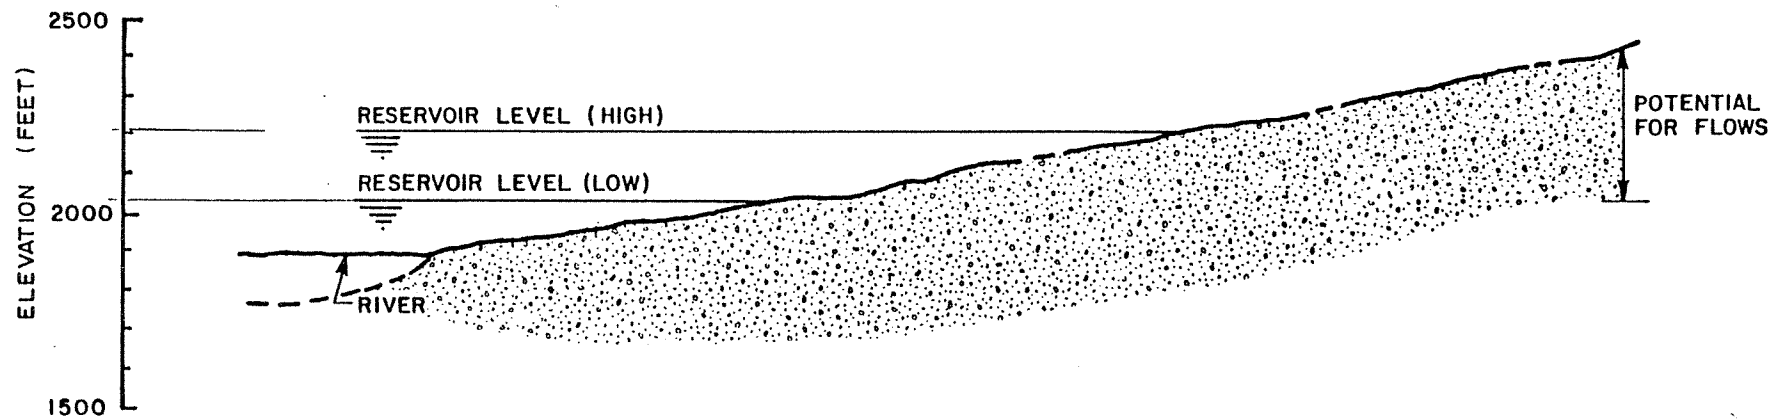
FIGURE 5.20

ASSUMPTIONS: SANDY MATERIAL, FROZEN

NOTE: SEE FIGURE 5.16 FOR
SECTION LOCATION

SECTION G-G
WATANA RESERVOIR
AREA OF FLOW FAILURES

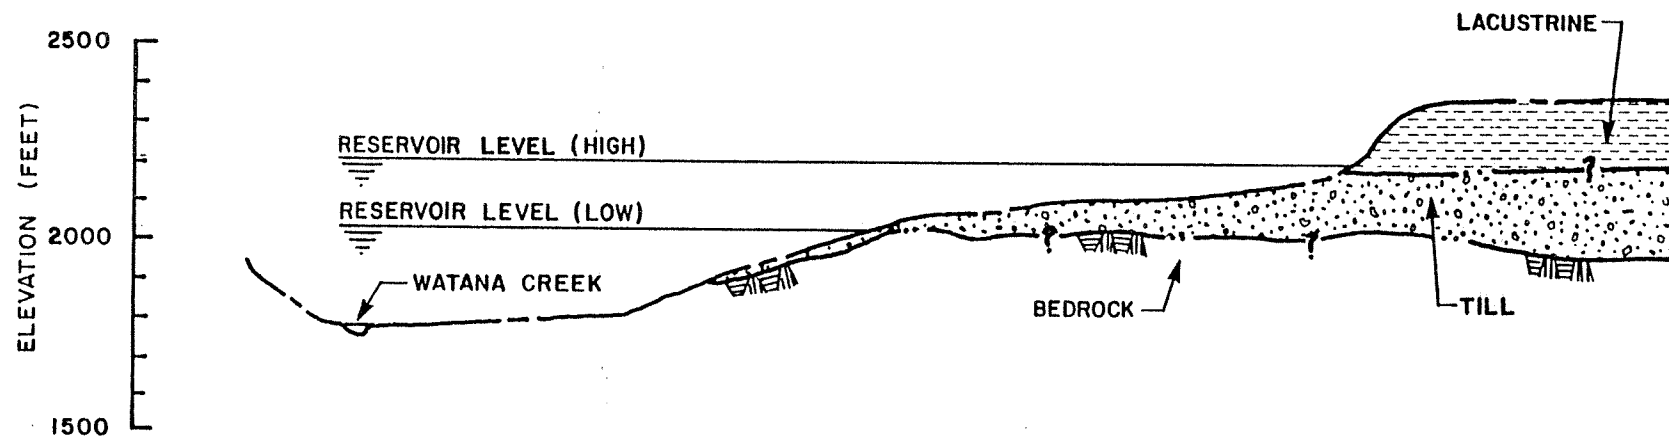
FIGURE 5.21

ASSUMPTIONS: STRATIGRAPHY CONSISTS OF GLACIO-LACUSTRINE SANDS AND SILTS, TILL. TILL IS FROZEN, LACUSTRINE MAY BE PARTLY FROZEN.

NOTE: SEE FIGURE 5.7 FOR SECTION LOCATION

SECTION E-E
WATANA RESERVOIR
AREA OF POTENTIAL FLOWS

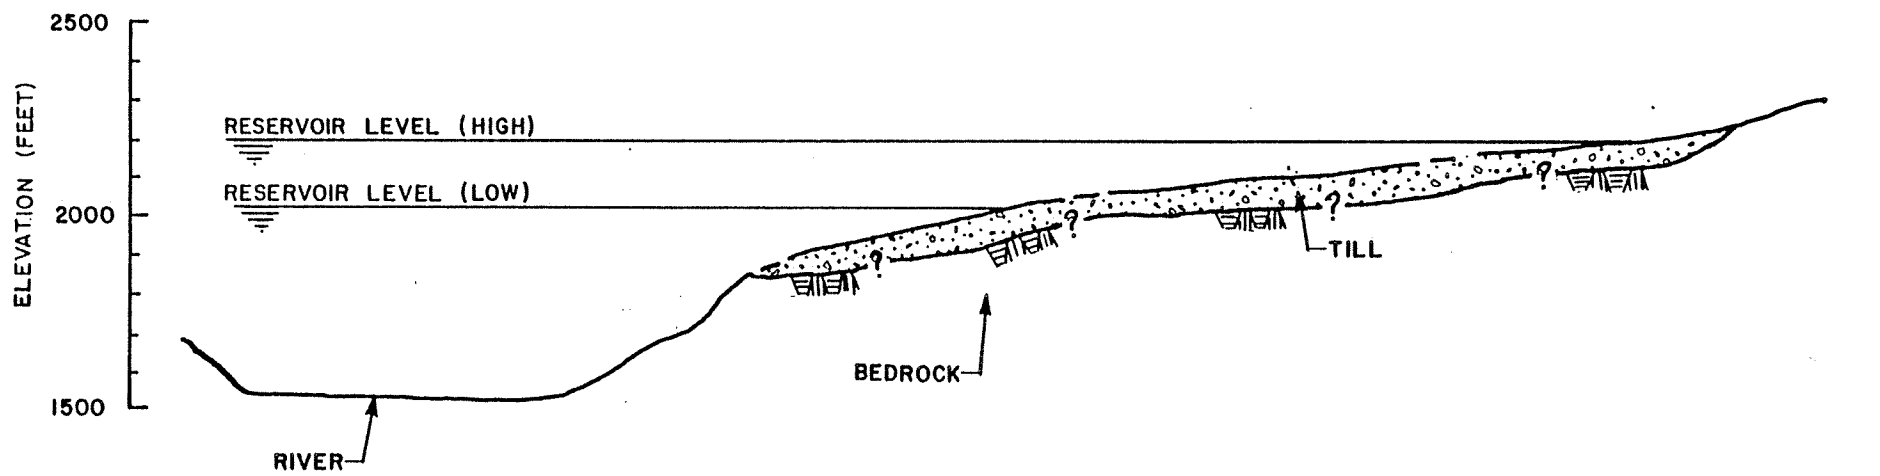
FIGURE 5.22

ASSUMPTIONS: BASAL TILL, THIN VENEER OF
LACUSTRINE MATERIAL FROZEN
IN PLACES.

NOTE: SEE FIGURE 5.6 FOR
SECTION LOCATION

SECTION D-D
WATANA RESERVOIR
POTENTIAL BEACHING

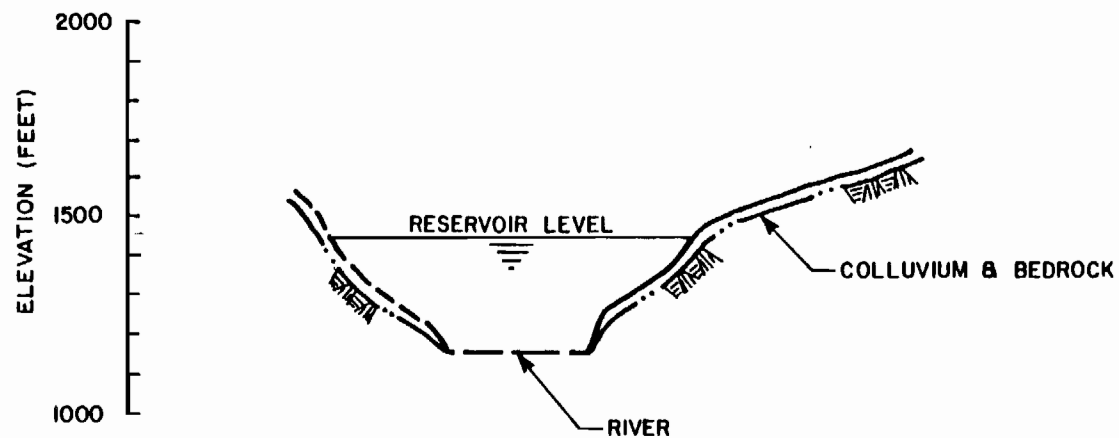
FIGURE 5.31

ASSUMPTIONS: COLLUVIUM, UNFROZEN BEDROCK PROBABLY IN CONTACT WITH THE RESERVOIR LEVEL

NOTE: SEE FIGURE 5.26 FOR SECTION LOCATION

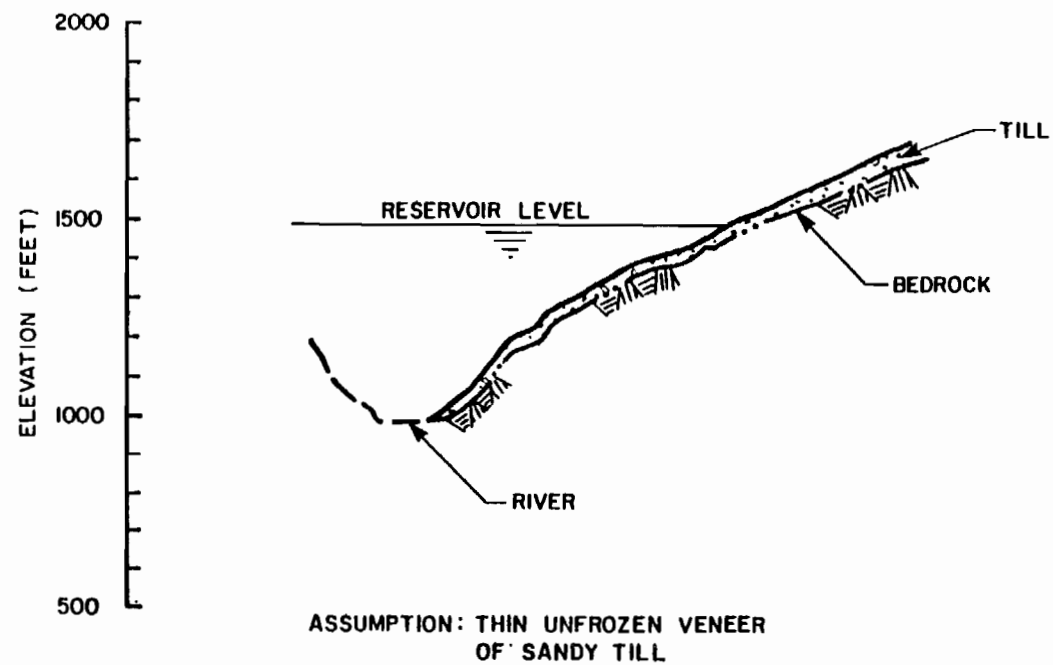
FIGURE 5.32

NOTE: SEE FIGURE 5.25 FOR
SECTION LOCATION

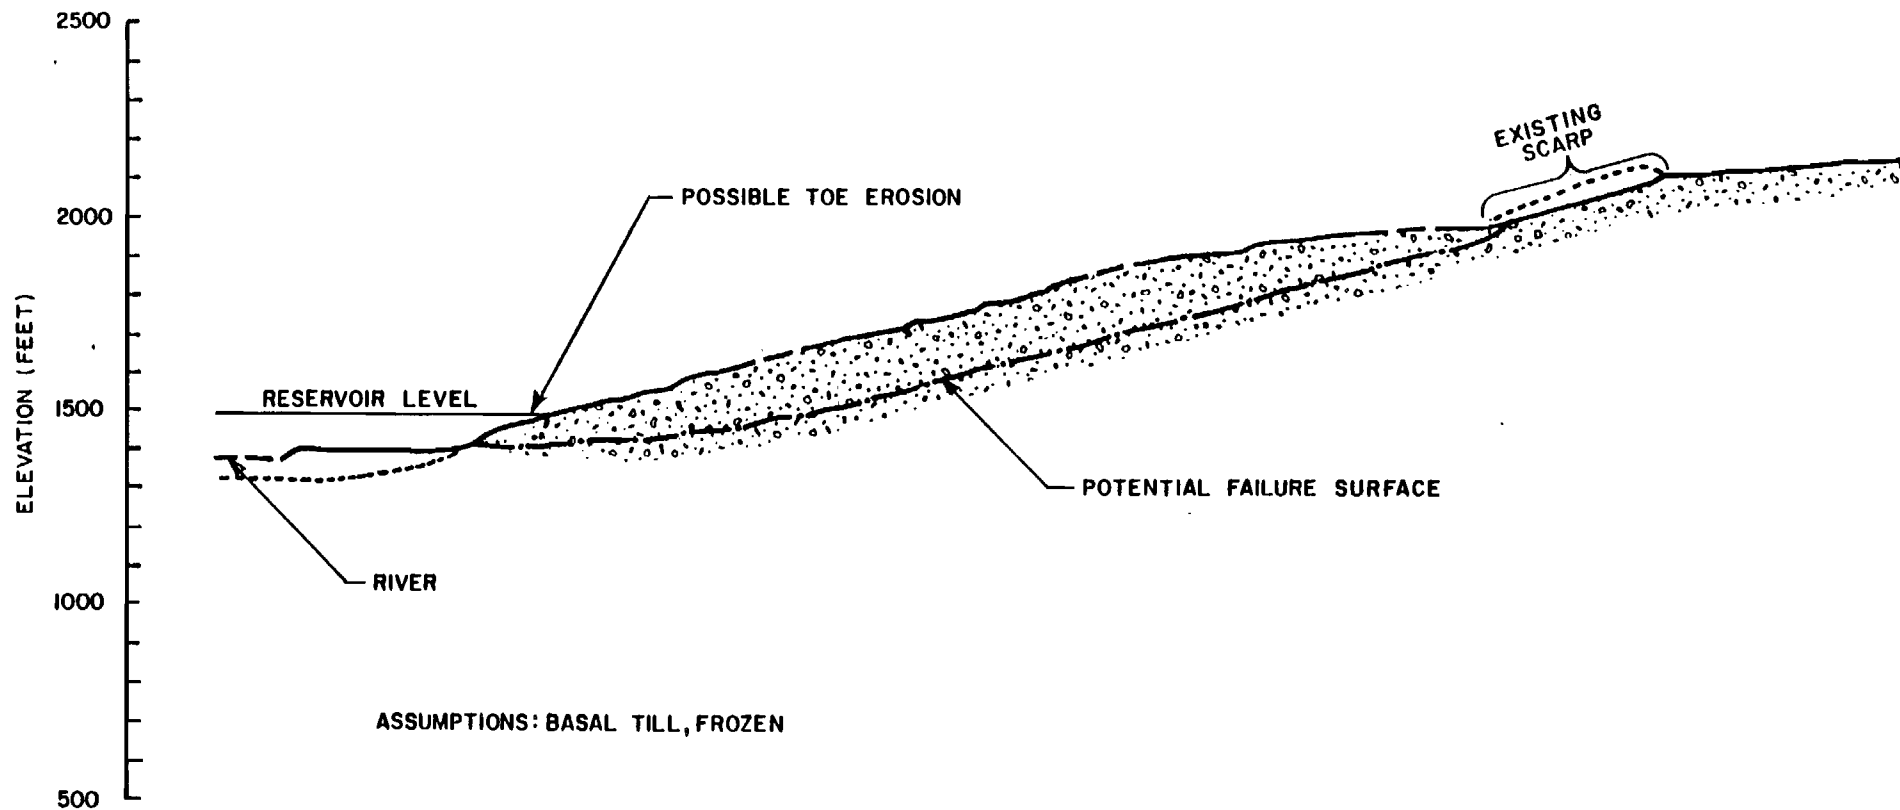
FIGURE 5.33

SECTION A-A
DEVIL CANYON RESERVOIR
POTENTIAL MINOR BEACHING

NOTE: SEE FIGURE 5.29 FOR
SECTION LOCATION
