SUSITNA HYDROELECTRIC PROJECT

1980-81 GEOTECHNICAL REPORT

VOLUME 1
TEXT
FINAL DRAFT

ALASKA POWER AUTHORITY

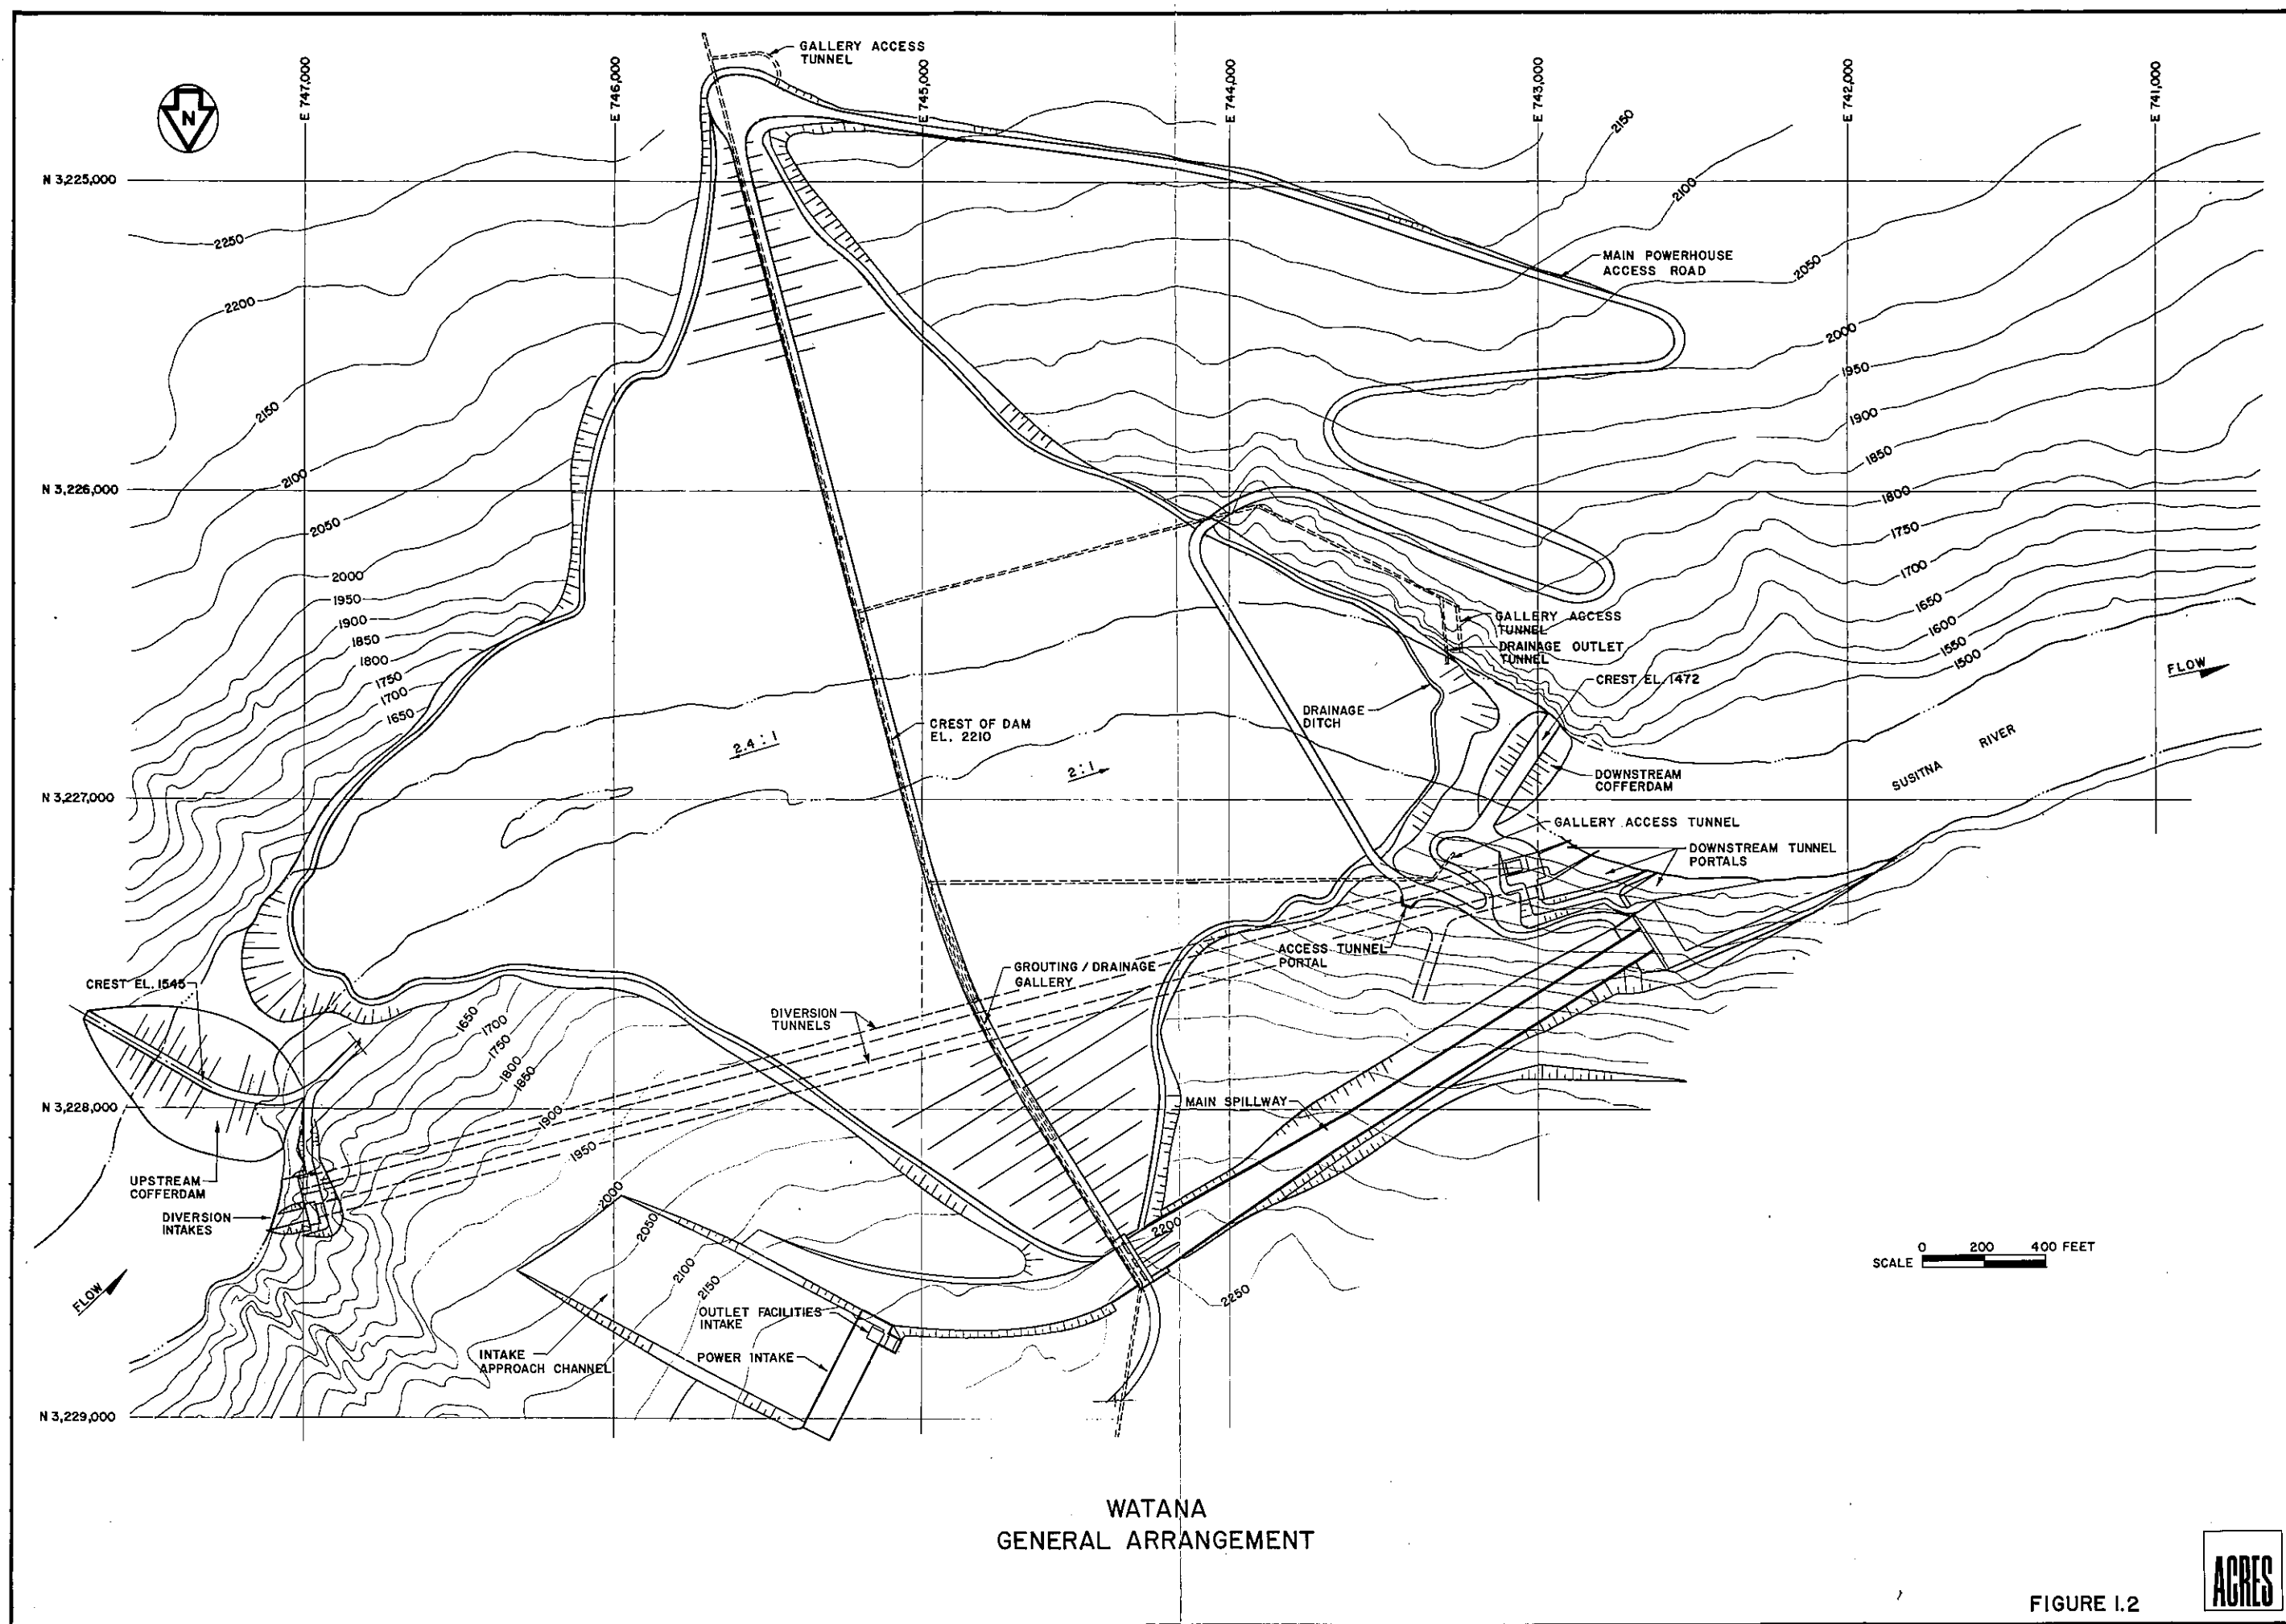
FIGURE I.2

WATANA
GENERAL ARRANGEMENT

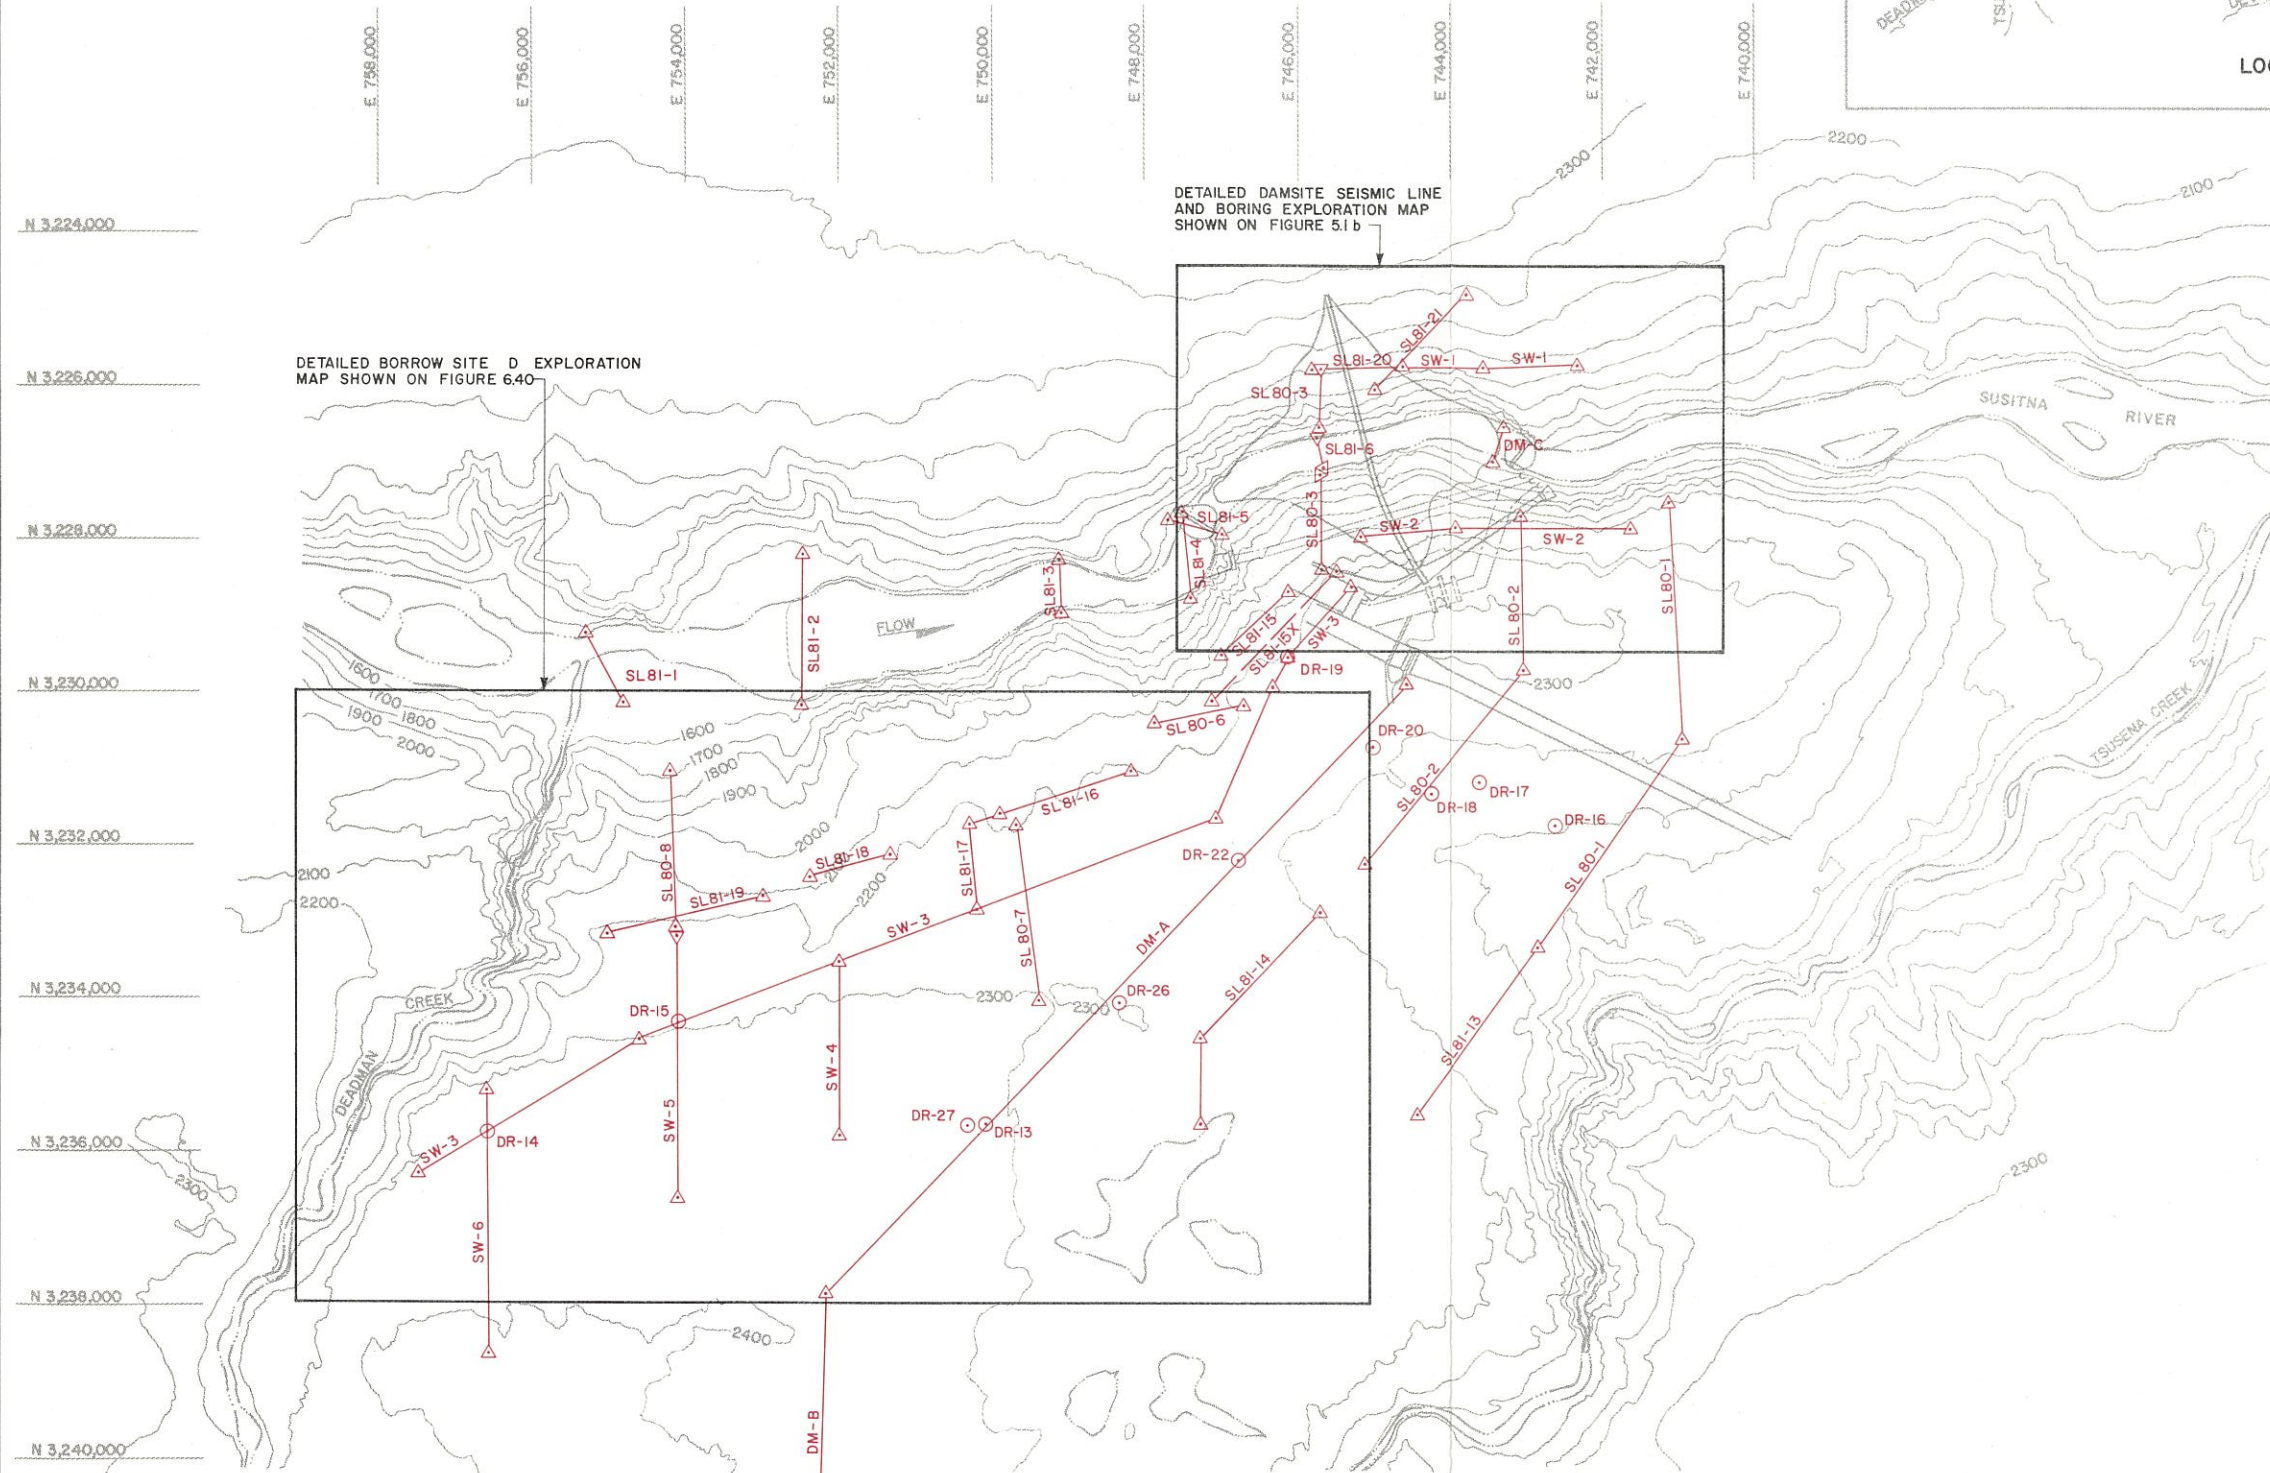
FIGURE 5.1a

1. DETAILED EXPLORATION MAP OF DAMSITE ON FIGURE 5.1b
2. BORROW SITE D TEST PITS AND AUGER HOLES, AS WELL AS SEISMIC LINES, SHOWN ON FIGURE 6.40.
3. DETAILED SECTION ON DM-A & B ON FIGURE 6.31.
4. RIVER ALLUVIUM TEST PITS SHOWN ON FIGURES 6.51 AND 6.52.
5. RELICT CHANNEL AREA MAP SHOWN ON FIGURE 6.35.
6. CONTOUR INTERVAL 100', ENLARGED AND TRACED FROM REFERENCED BASE MAP.
7. D & M SEISMIC LINE LOCATIONS CORRECTED PER COE SURVEY AND REFERENCED BASE MAPS.
8. S & W SEISMIC LINE LOCATIONS CORRECTED FROM ORIGINAL FIELD BOOKS AND S & W, 1978.
9. LINE DM-B CONTINUED 11,000 FEET NORTH OF TURNING POINT SHOWN.
10. COE EXPLORATION LOGS AND S & W SEISMIC PROFILES AS REFERENCED.
11. WCC SEISMIC REFRACTION DATA SHOWN IN APPENDICES H AND I.
12. NORTHING GRID LINES ARE IN ERROR BY APPROXIMATELY 50 FEET, NORTH, FROM STATION N 3,232,000 TO N 3,234,000.

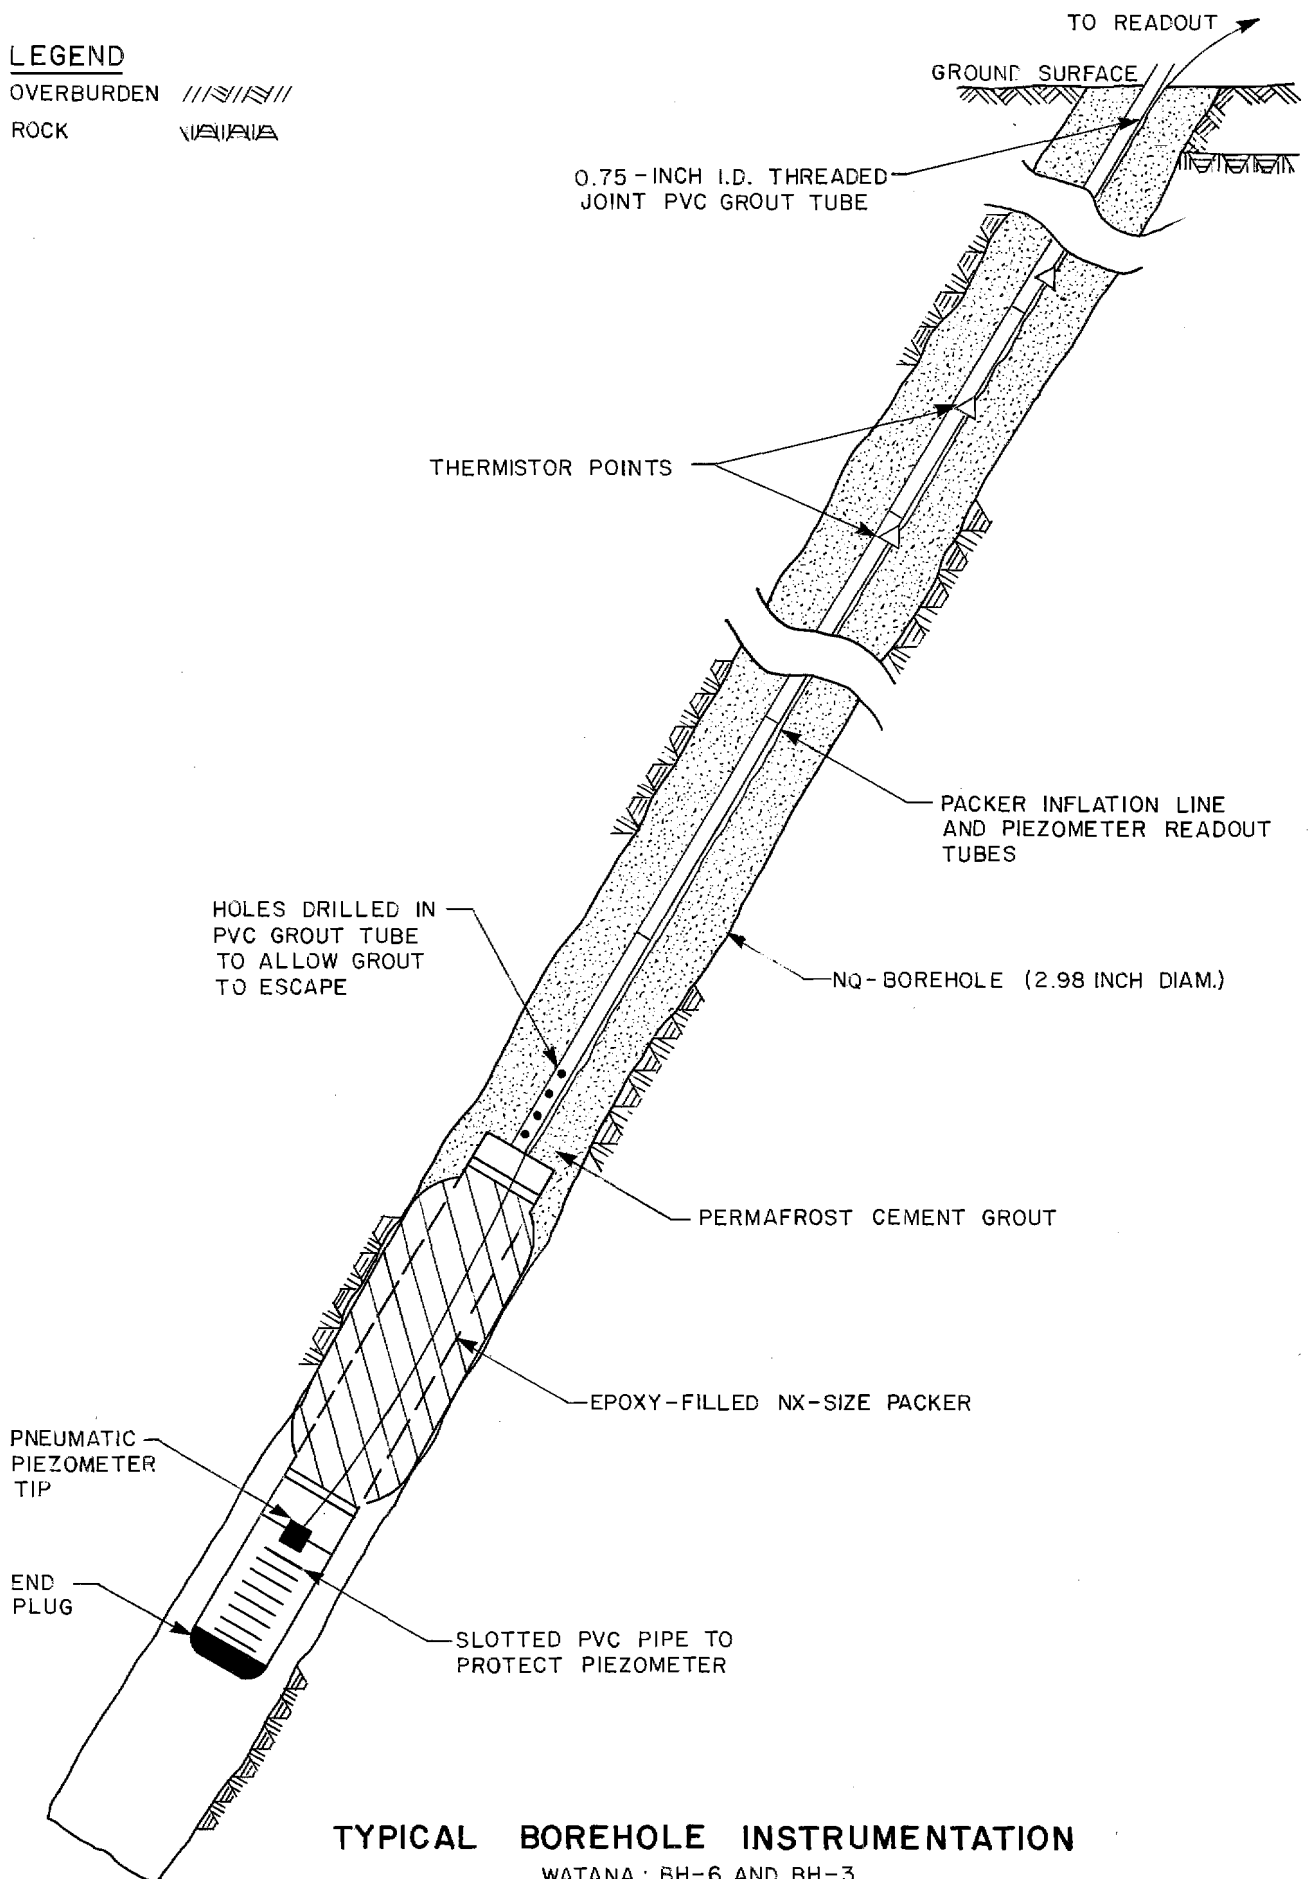
TYPICAL BOREHOLE INSTRUMENTATION

WATANA: BH-6 AND BH-3

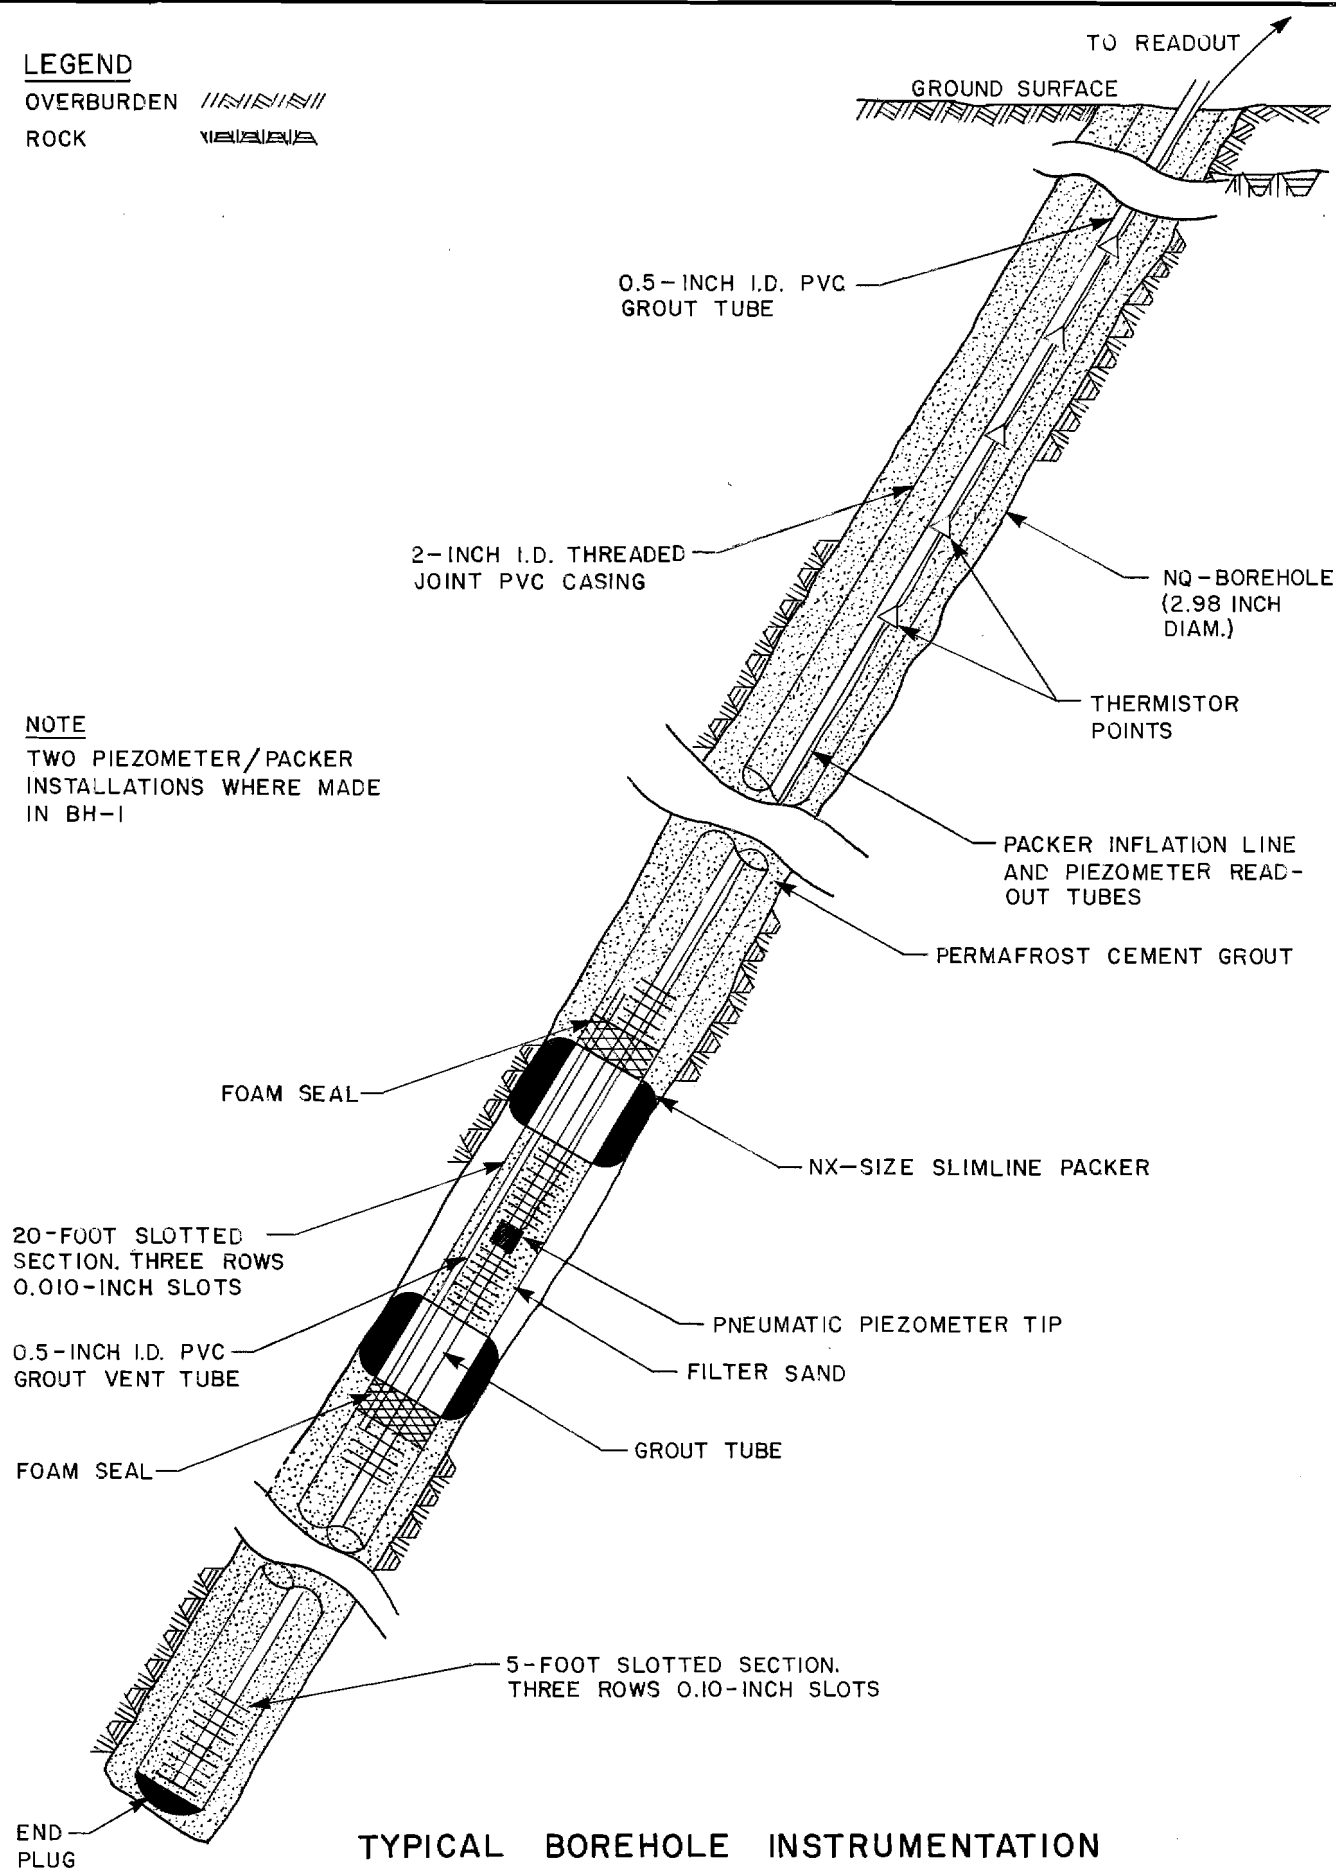
NOTE

TWO PIEZOMETER/PACKER
 INSTALLATIONS WERE MADE
 IN BH-1

TYPICAL BOREHOLE INSTRUMENTATION

DEVIL CANYON: BH-1 AND BH-4

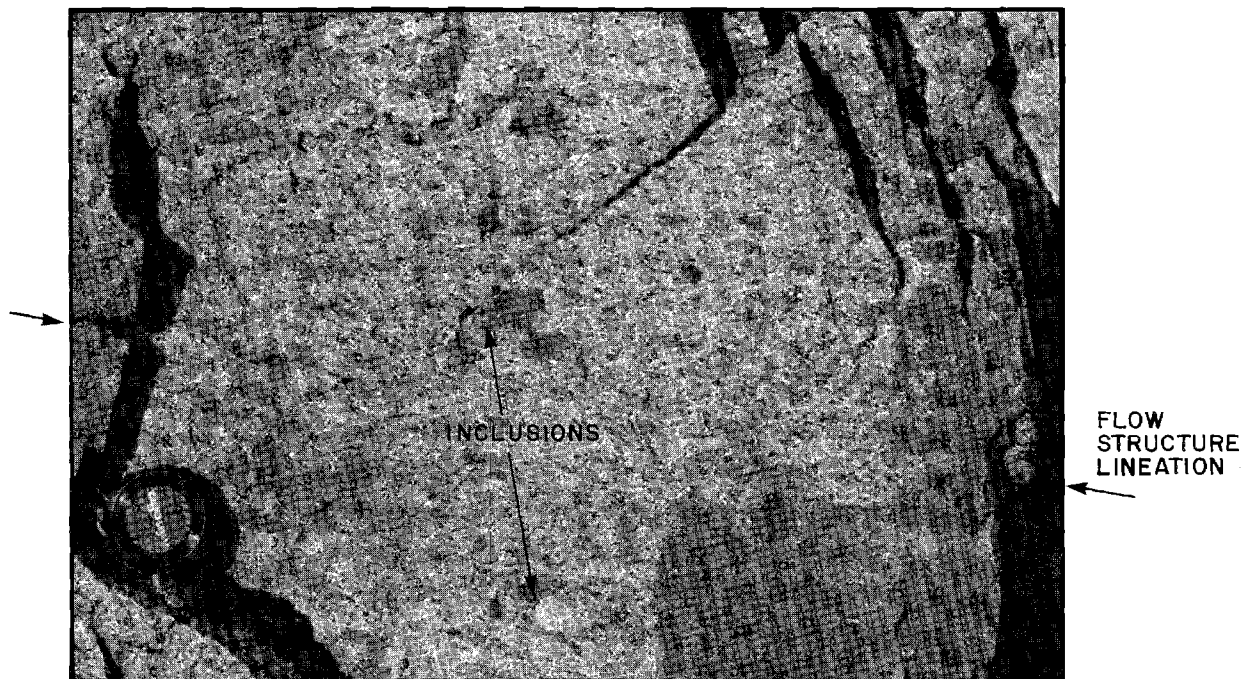
ANDESITE PORPHYRY OUTCROP
RIVER LEVEL - NORTH BANK
"FINGERBUSTER" AREA

WATANA
ANDESITE PORPHYRY FLOW STRUCTURE & INCLUSIONS

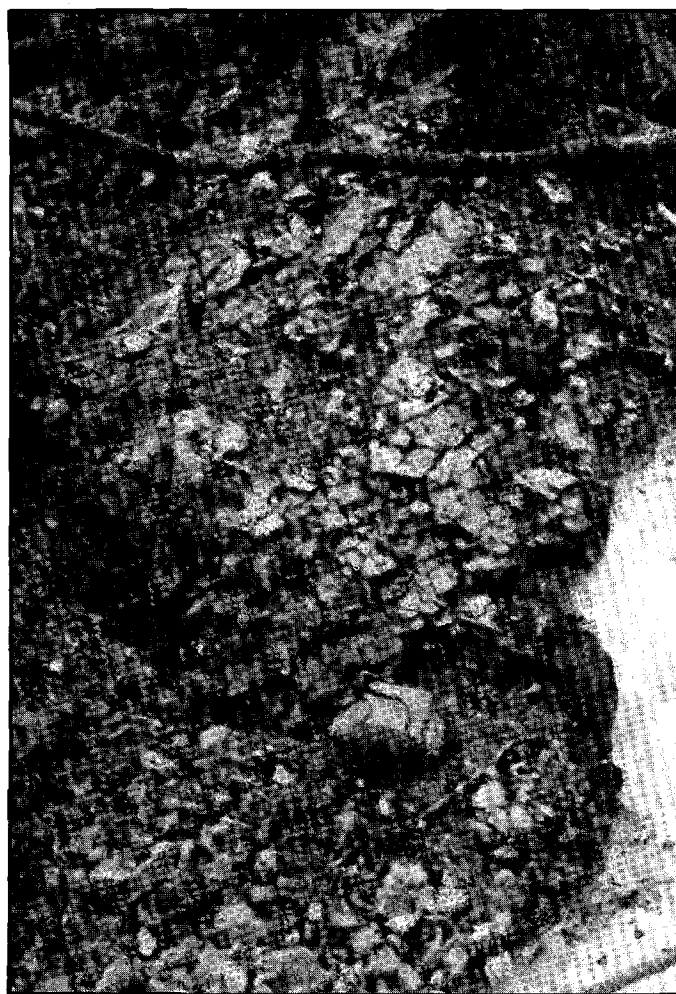
ANDESITE PORPHYRY
ABOVE DIORITE OUTCROP
APPROX. EL. 1800 FEET - SOUTH BANK

WATANA
FRACTURE ZONE IN ANDESITE PORPHYRY

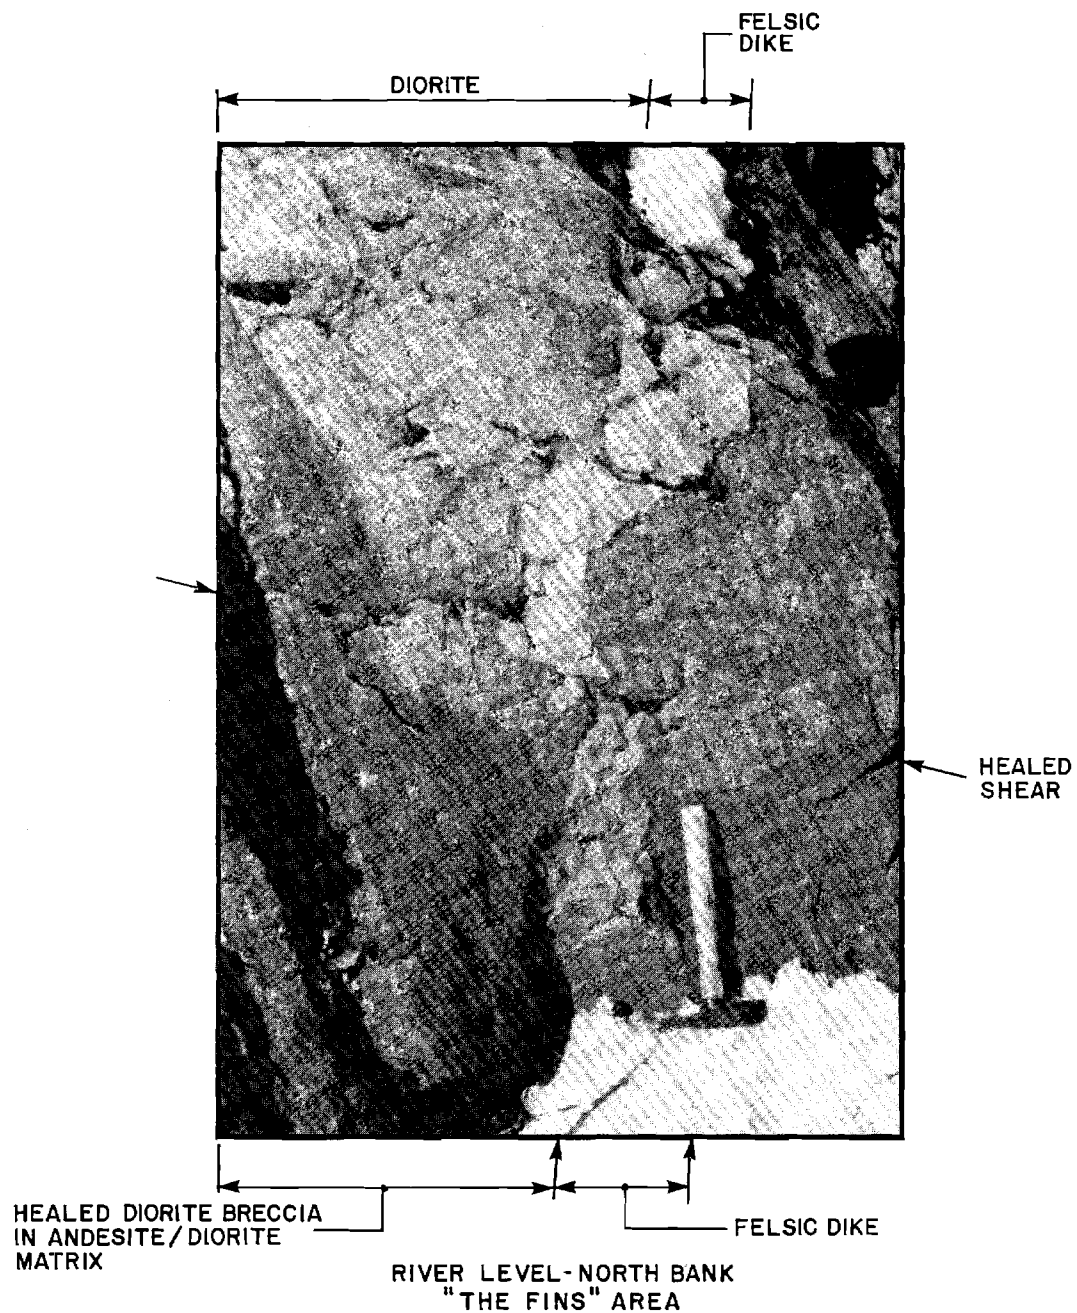
WATANA
FELSIC DIKE IN DIORITE

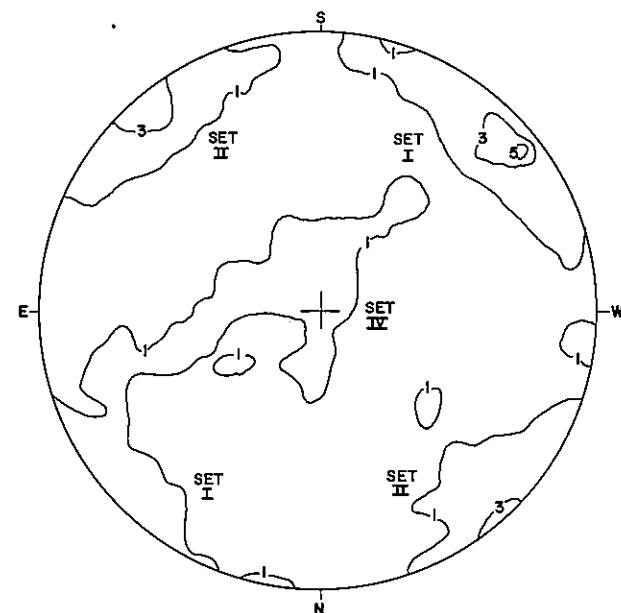
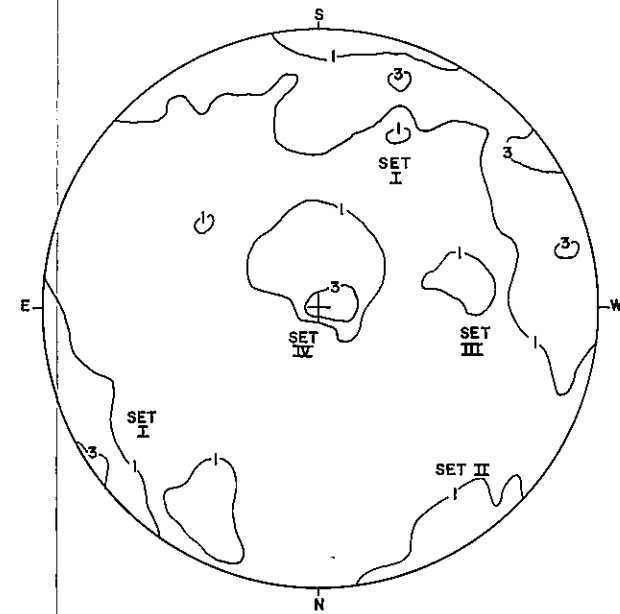
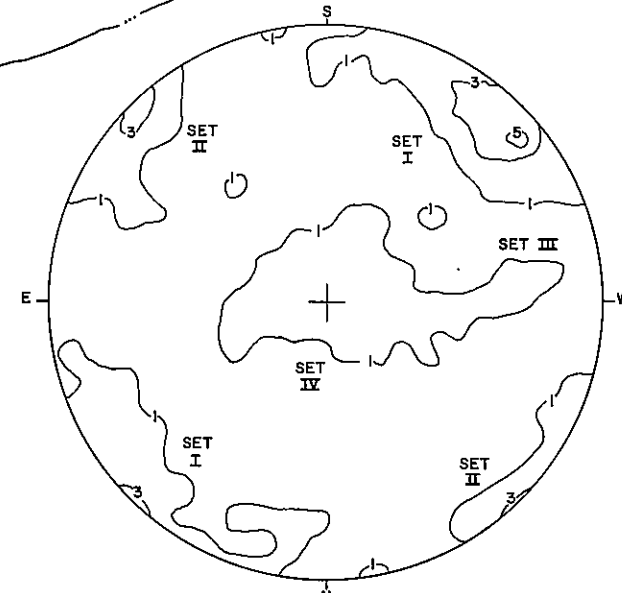
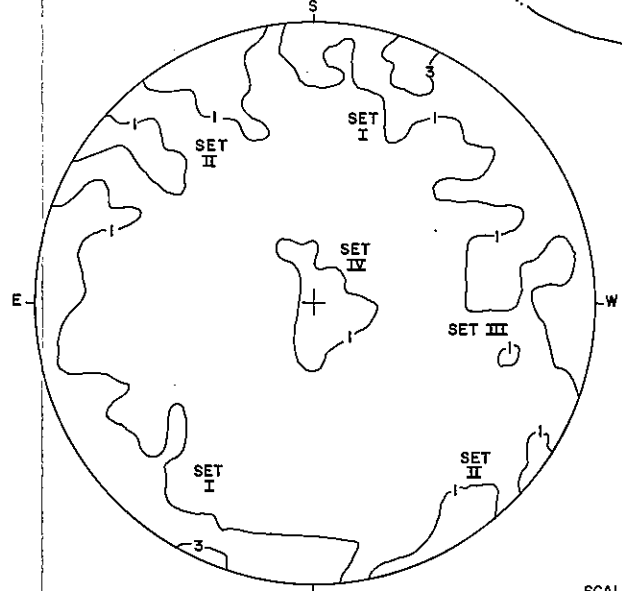
FIGURE 6.13

COMPOSITE JOINT PLOT
SOUTHEAST QUADRANT
N=721

COMPOSITE JOINT PLOT
SOUTHWEST QUADRANT
N=329

COMPOSITE JOINT PLOT
NORTHEAST QUADRANT
N=525

COMPOSITE JOINT PLOT
NORTHWEST QUADRANT
N=600

1. CONTOURS ARE PERCENT OF JOINTS PER 1% OF AREA.
CONTOURS SHOWN - 1, 3, & 5 %.
2. N EQUALS NUMBER OF DATA POINTS.
3. COMPOSITE PLOTS INCORPORATE ALL JOINT DATA FROM
THEIR RESPECTIVE QUADRANTS.
4. JOINT PLOTS FOR JOINT STATIONS (WJ-1, 2, 3, 4, 5, 6, 7, 8 & 9)
ON FIGURE 6.12
5. FOR JOINT PLOTTING METHOD SEE FIGURE 6.12

In addition to the joint station plots, composite joint plots were constructed from both joint station and outcrop data. The site was divided into four quadrants. A composite plot for each quadrant is shown in Figure 6.13.

Joint Set I is the most prominent set at Watana. The average orientation is 320° in the four quadrants (Figure 6.13). Dips average 80° northeast in the northeast and southeast quadrants and vertical in the northwest and southwest quadrants. Joint surfaces are planar and smooth to rough and have an average spacing of 2 feet. Joint surfaces in the diorite porphyry in "The Fins" are pitted and rough where feldspar and hornblende phenocrysts have weathered out. Minor carbonate deposits were found on Set I surfaces at joint stations WJ-4, WJ-6, and WJ-7 (Figure 6.12). The joints are continuous and generally tight. Open joints are found at the surface in fracture zones and shears. Set I parallels most major shears, fracture zones, and alteration zones found at the site.

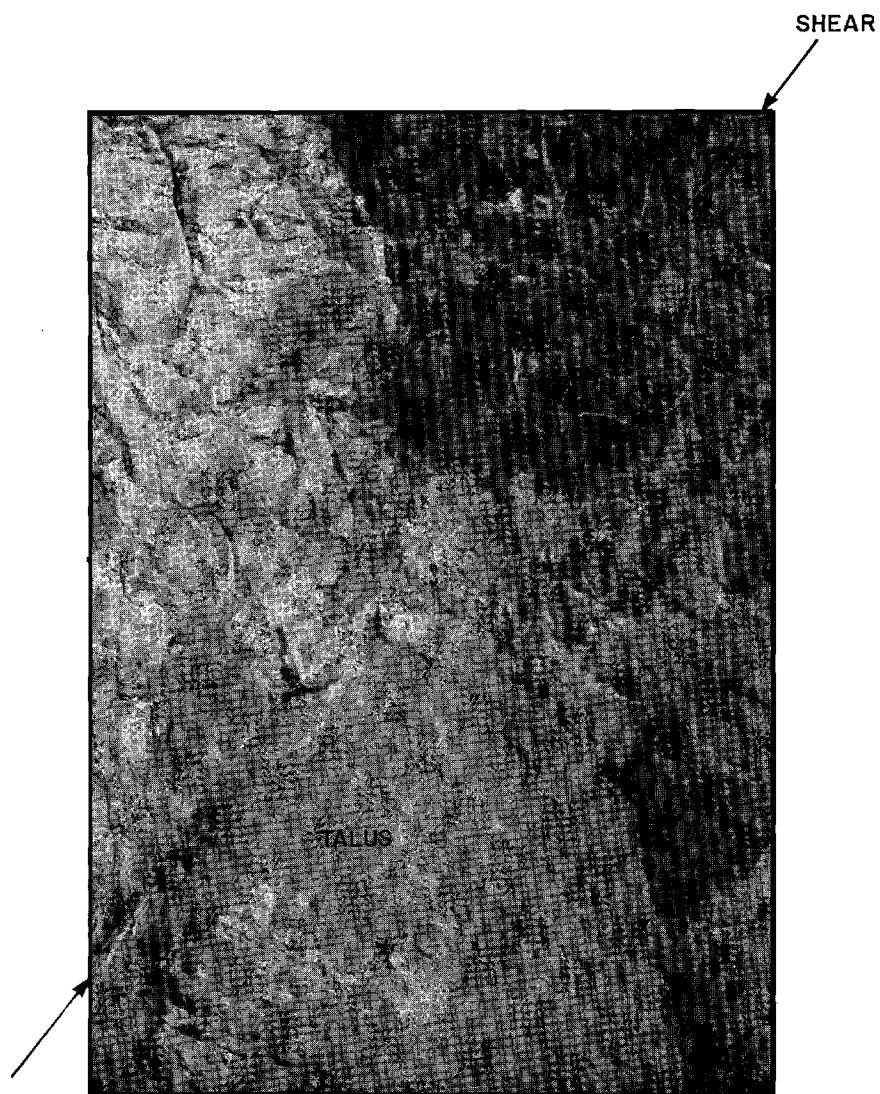
VIEW LOOKING NORTH ALONG STRIKE
OF SHEAR; DIP 57° WEST
RIVER LEVEL - NORTH BANK
"THE FINS" AREA

WATANA
TYPICAL SHEAR

CARBONATE
VEIN

UNALTERED DIORITE

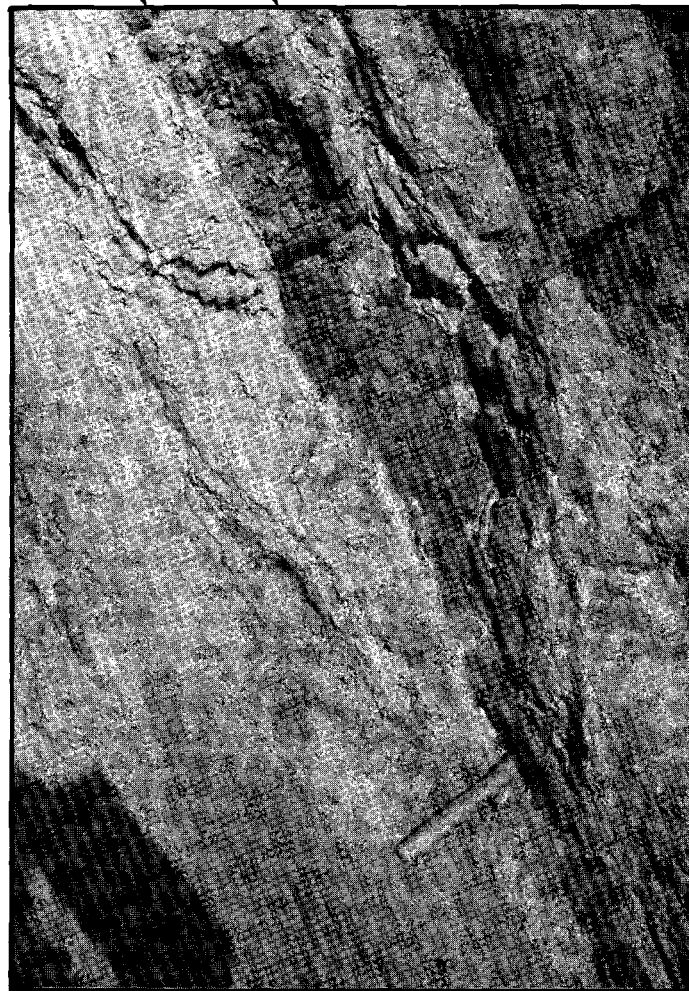
FIGURE 6.15

SHEARED & ALTERED DIORITE

EAST SIDE OF 55 FT. WIDE SHEAR/ALTERATION ZONE
RIVER LEVEL - NORTH BANK "THE FINS" AREA

WATANA
SHEAR/ALTERATION ZONE

Three major and numerous minor shear/alteration zones have been mapped in "The Fins." From upstream to downstream, the major zones consist of a 20-foot-wide zone in the area of the diorite and diorite porphyry contact; a 55-foot-wide zone; and a 30-foot-wide zone. These zones are separated by intact competent rock bands or ribs. Large gullies with thick talus have formed in these zones, resulting in poor rock exposure. These zones trend in a northwest-southeast direction and are near vertical. Figure 6.16 is an aerial photograph of "The Fins" looking northwest along the strike. The 55-foot-wide gully (as measured at river level) splits into two branches 20 to 30 feet wide at approximate Elevation 1650. A 10-foot-wide zone of altered and crushed rock is exposed near river level on the east side (Figure 6.15), and there is a 3-foot-wide zone of sheared/fractured and moderately to severely altered rocks on the west side of the main gully. The remainder of the gully is covered by talus. Based on these exposures, it has been assumed that the shear and alteration zones extend across the full 55-foot width of the gully.

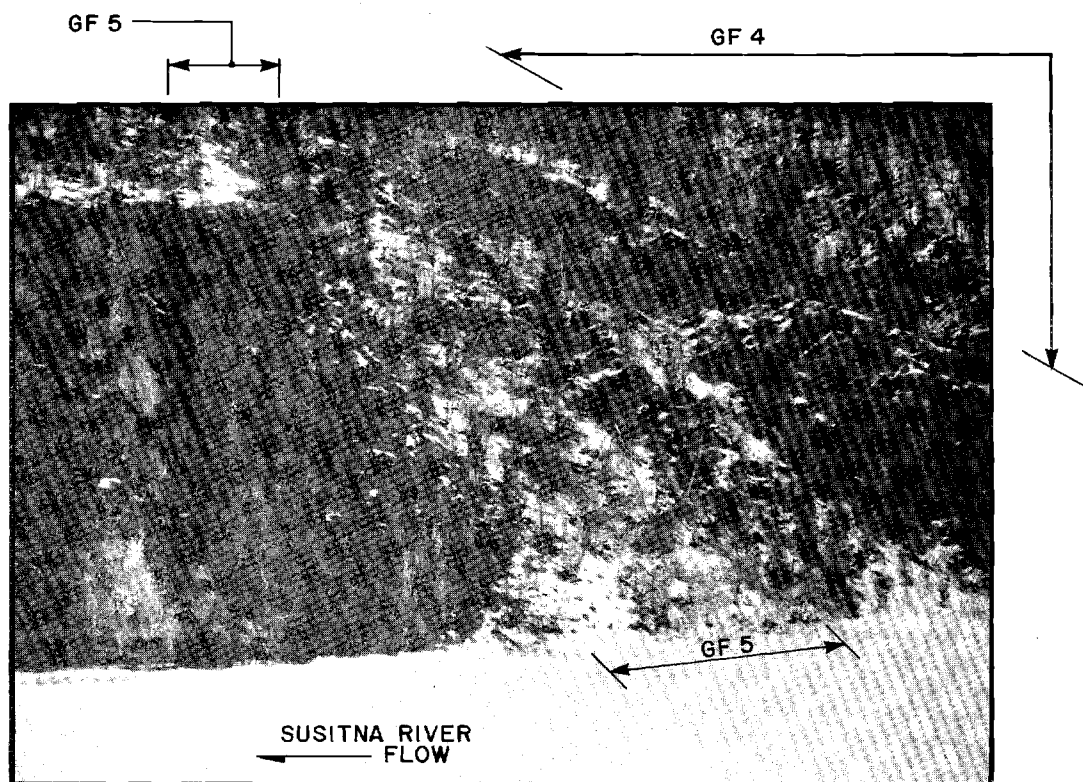
VIEW LOOKING NORTHEAST
NORTH BANK

NOTE:
GEOLOGIC FEATURES GF 4 AND GF 5 DESCRIBED
IN SECTION 6.I.

WATANA
GEOLOGIC FEATURES GF 4 AND GF 5

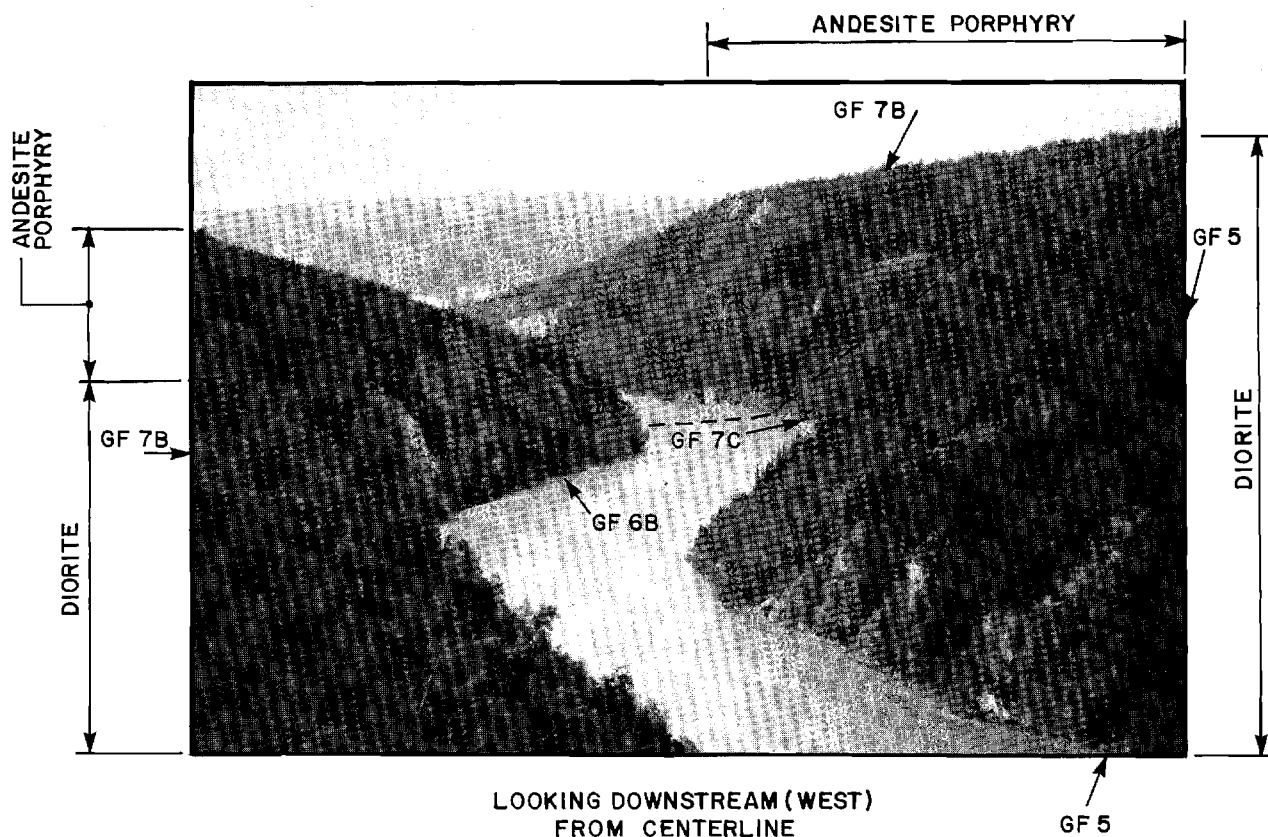
1. GEOLOGIC FEATURES GF 5, GF 6B, GF 7B, AND GF 7C DESCRIBED IN SECTION 6.1.
2. DASHED LINE IS ANDESITE PORPHYRY & DIORITE CONTACT.

WATANA
GEOLOGIC FEATURES DOWNSTREAM OF CENTERLINE

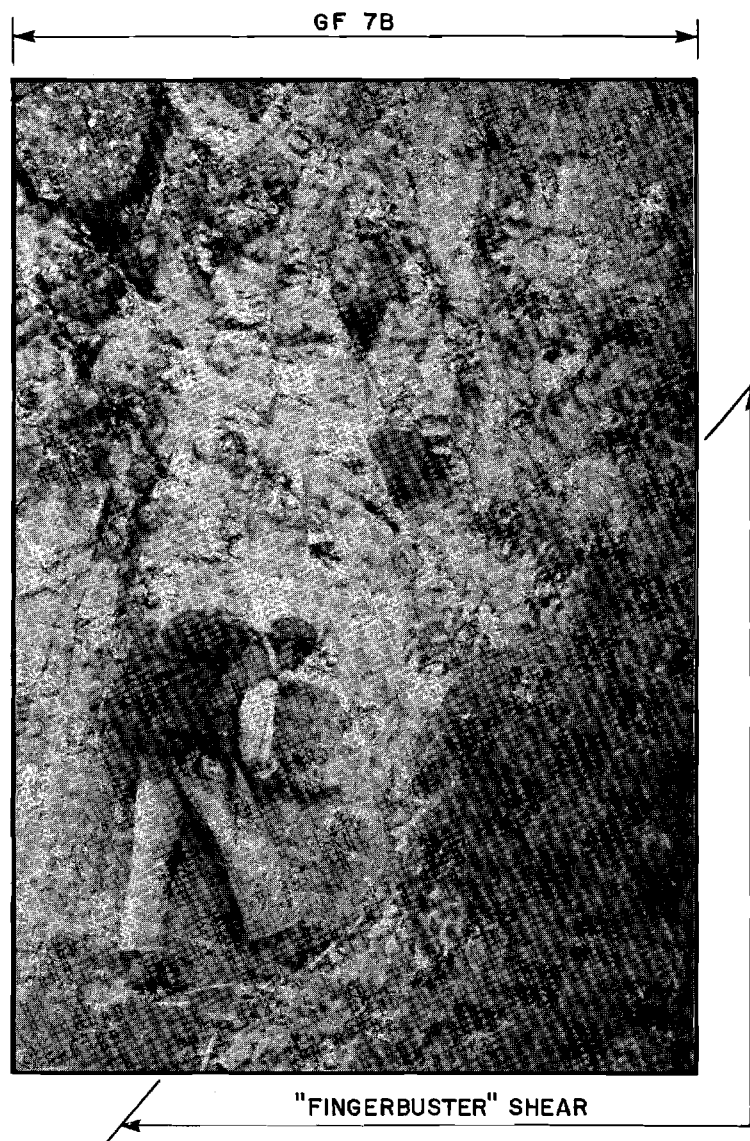
VIEW LOOKING NORTHWEST
ANDESITE PORPHYRY OUTCROP
RIVER LEVEL - NORTH BANK

NOTE:
GEOLOGIC FEATURES "FINGERBUSTER" AND GF 7B
DESCRIBED IN SECTION 6.1.
