SUSITNA HYDROELECTRIC PROJECT

1980-81 GEOTECHNICAL REPORT

VOLUME 1
TEXT
FINAL DRAFT

ALASKA POWER AUTHORITY

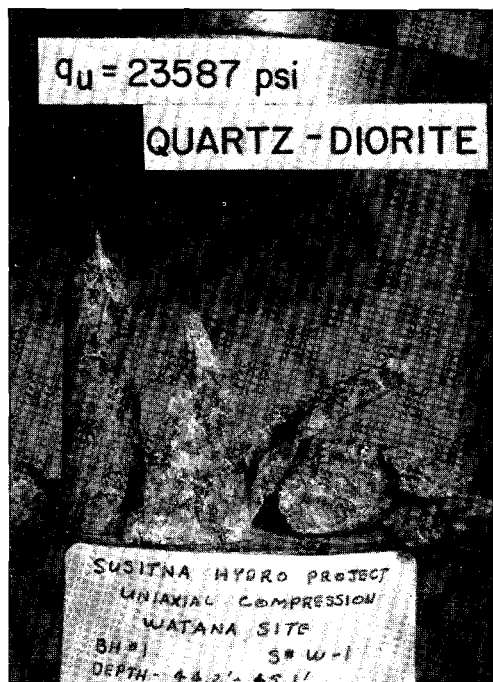
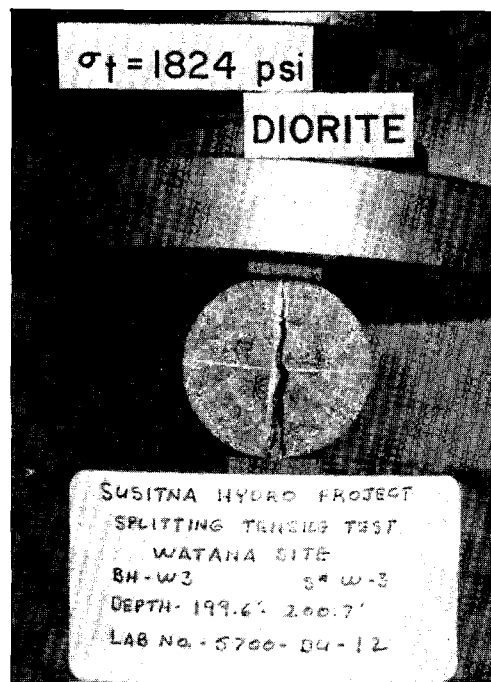
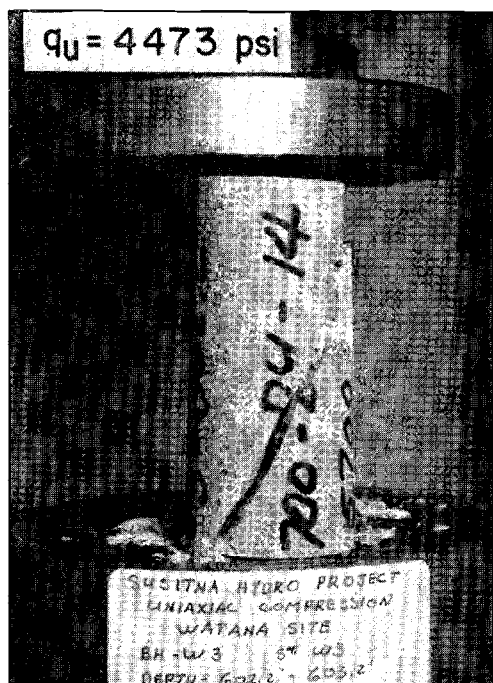
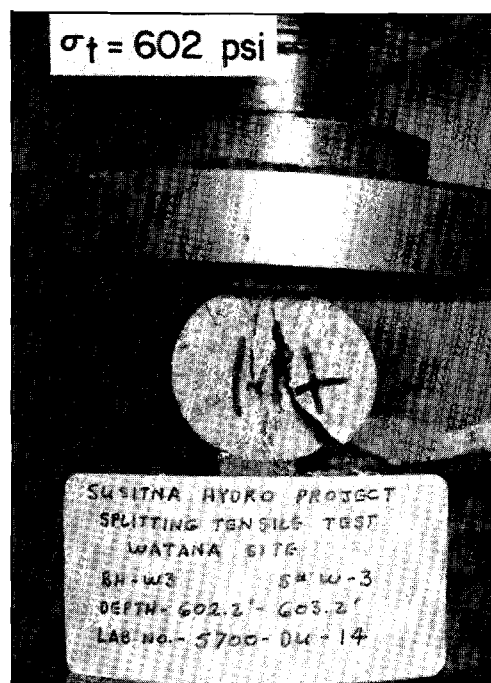
WATANA ROCK TESTS

TYPICAL COMPRESSION
TEST FAILURE

TYPICAL TENSILE
TEST FAILURE

ALTERED DIORITE -
COMPRESSION TEST

ALTERED DIORITE -
TENSILE TEST

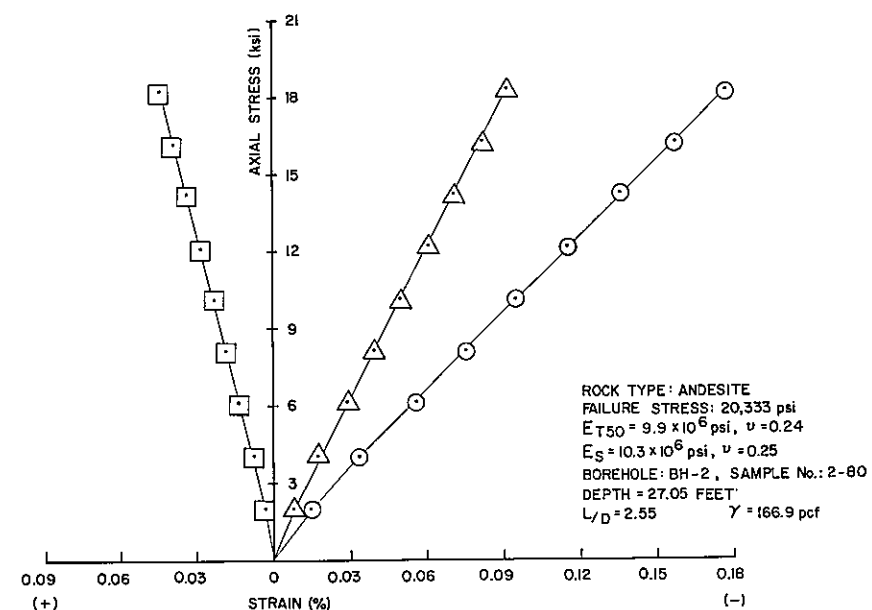
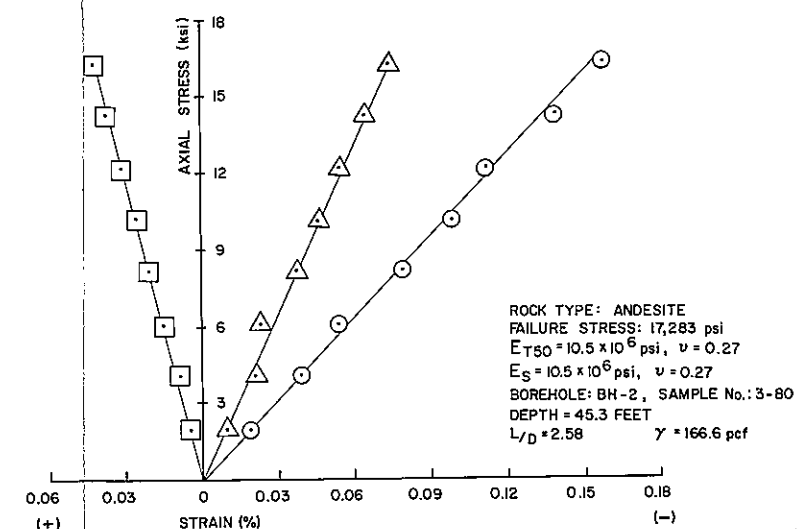
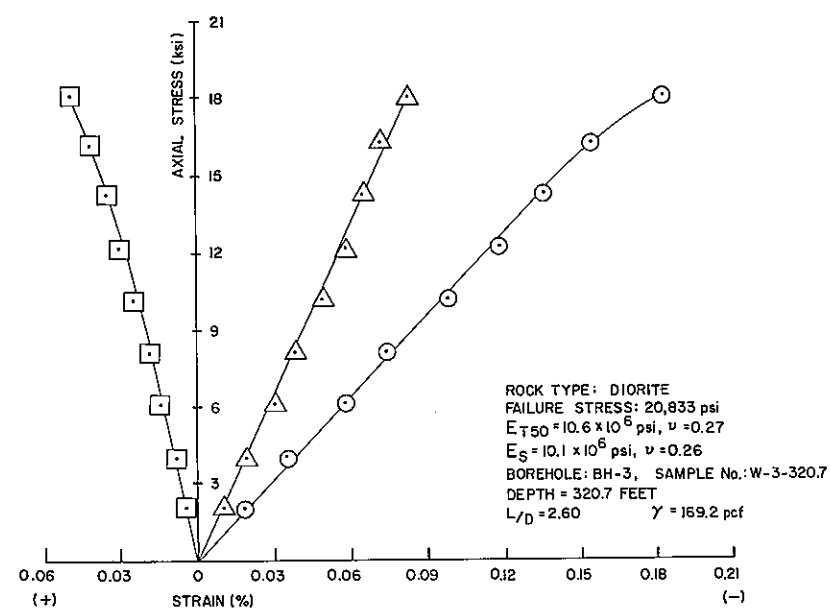
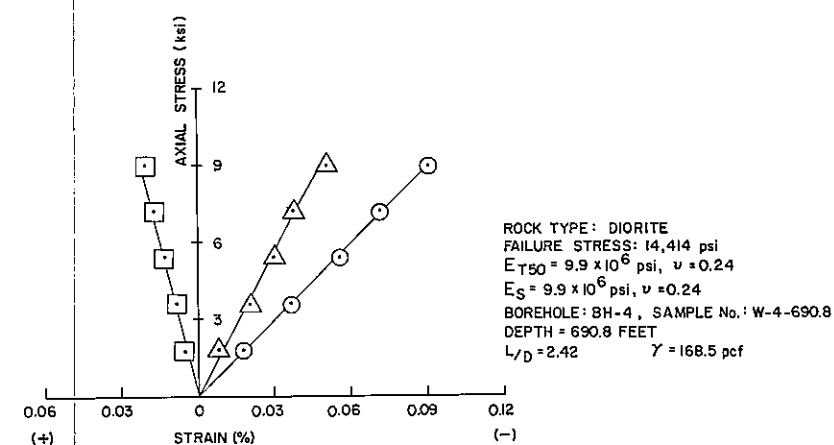
WATANA
 STATIC ELASTIC PROPERTIES
 FOR ANDESITE AND DIORITE

- AXIAL STRAIN
- △ VOLUMETRIC STRAIN
- DIAMETRIC STRAIN
- E_S SECANT MODULUS
- E_{T50} TANGENT MODULUS AT 50% FAILURE STRESS
- ν POISSONS RATIO
- γ UNIT WEIGHT
- L/D LENGTH/DIAMETER RATIO

SAMPLE DIAMETER = 1.77"

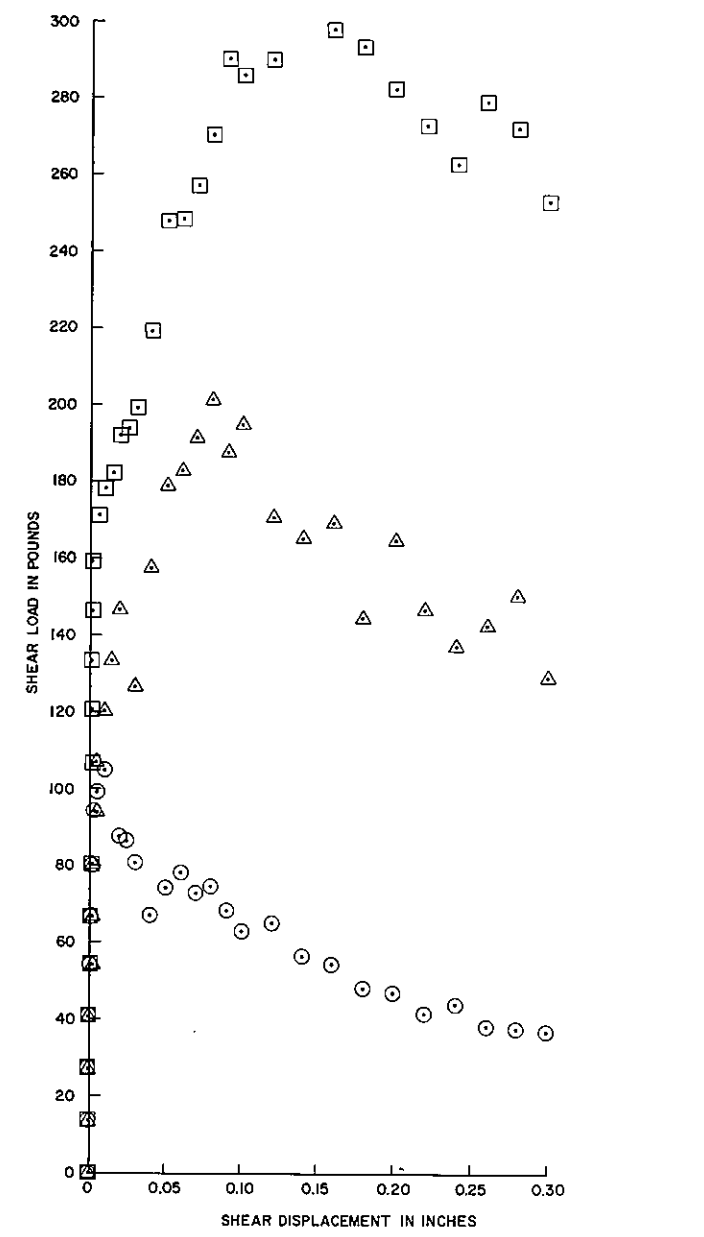
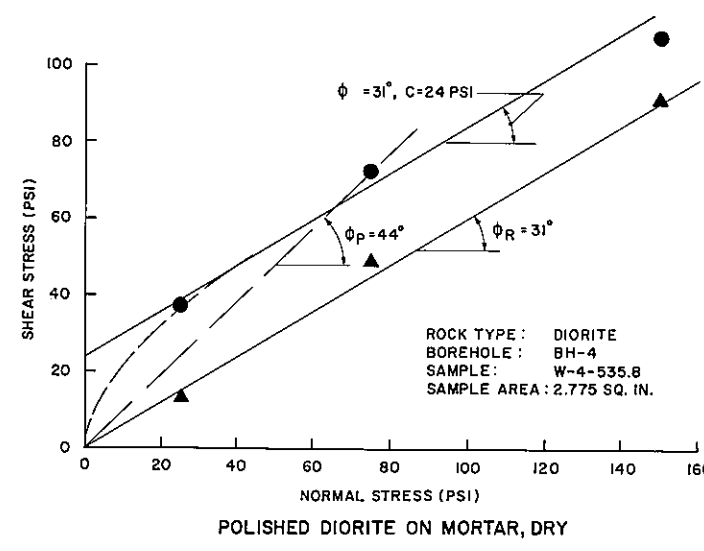
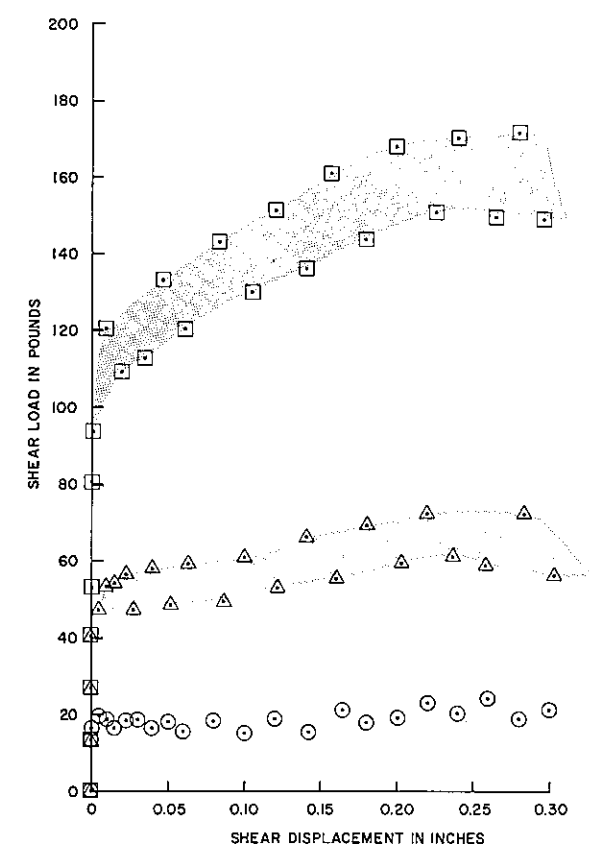
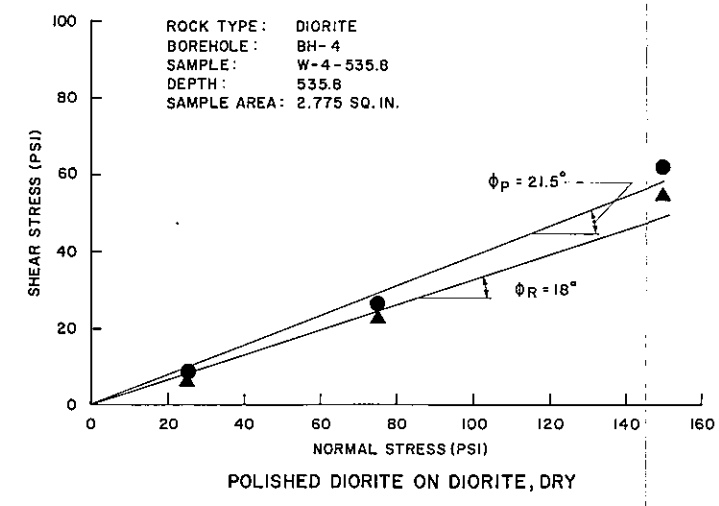
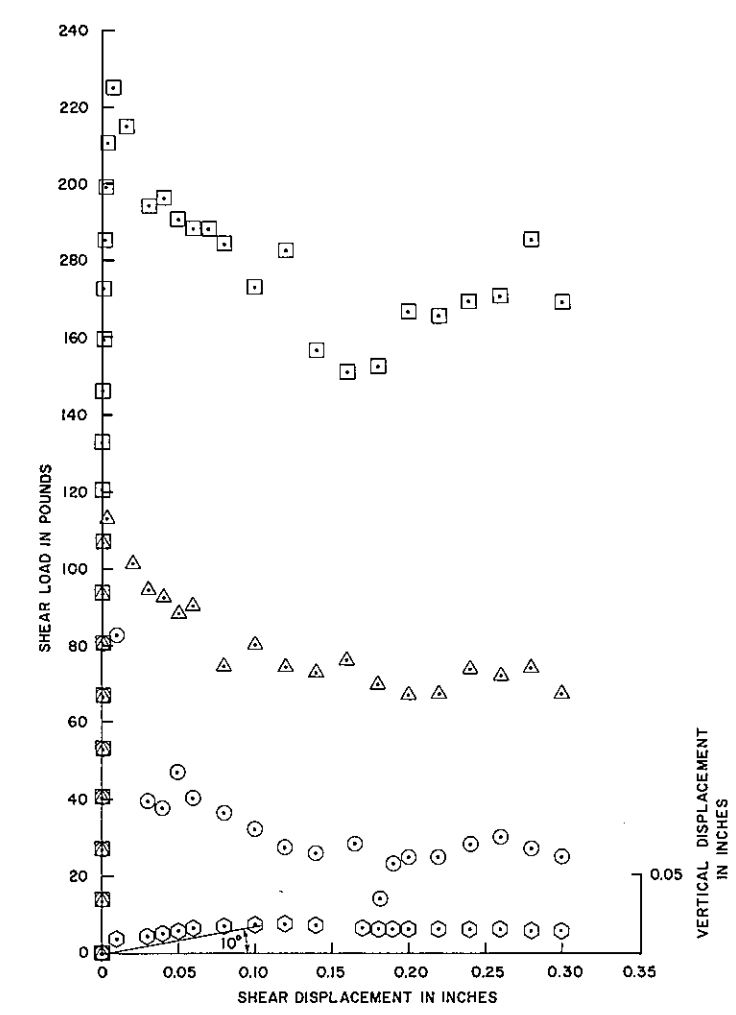
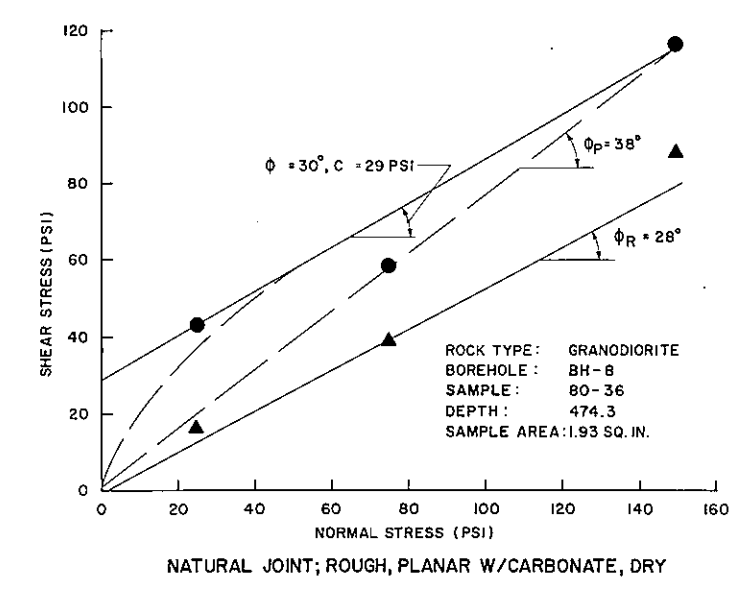
- LEGEND**
- ϕ_P PEAK FRICTION ANGLE
 - ϕ_R RESIDUAL FRICTION ANGLE
 - PEAK VALUES
 - ▲ RESIDUAL VALUES
 - VERTICAL DISPLACEMENT
 - NORMAL LOAD = 25 PSI
 - △ NORMAL LOAD = 75 PSI
 - NORMAL LOAD = 150 PSI
 - C APPARENT COHESION
 - ▨ FRICTION ANGLE ENVELOPE

- NOTES**
1. MAXIMUM SHEAR BOX DISPLACEMENT = 0.3 INCHES
 2. STRAIN RATE = 0.039 IN. / MIN.

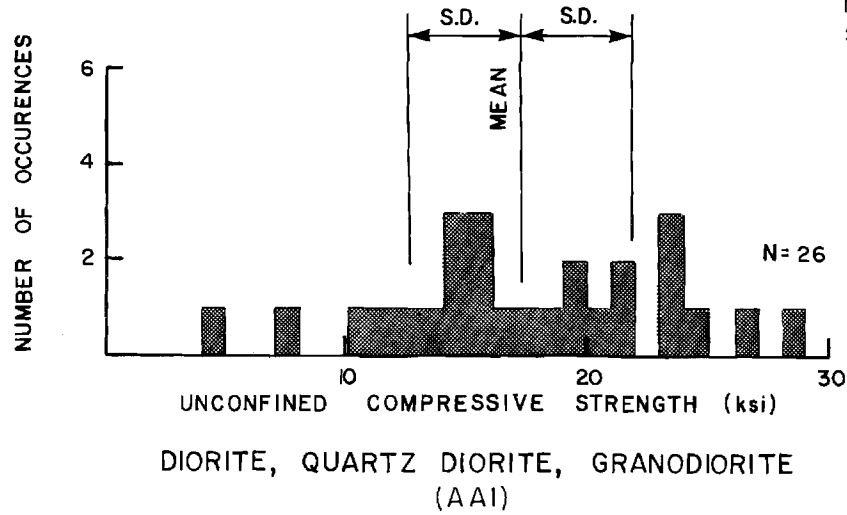
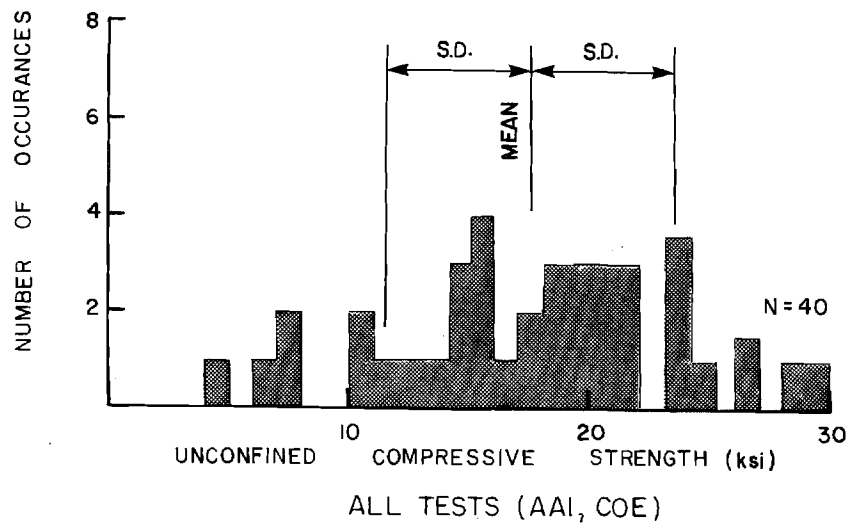
WATANA UNCONFINED COMPRESSIVE STRENGTH TEST RESULTS

N - NUMBER OF TESTS
S.D. - STANDARD DEVIATION

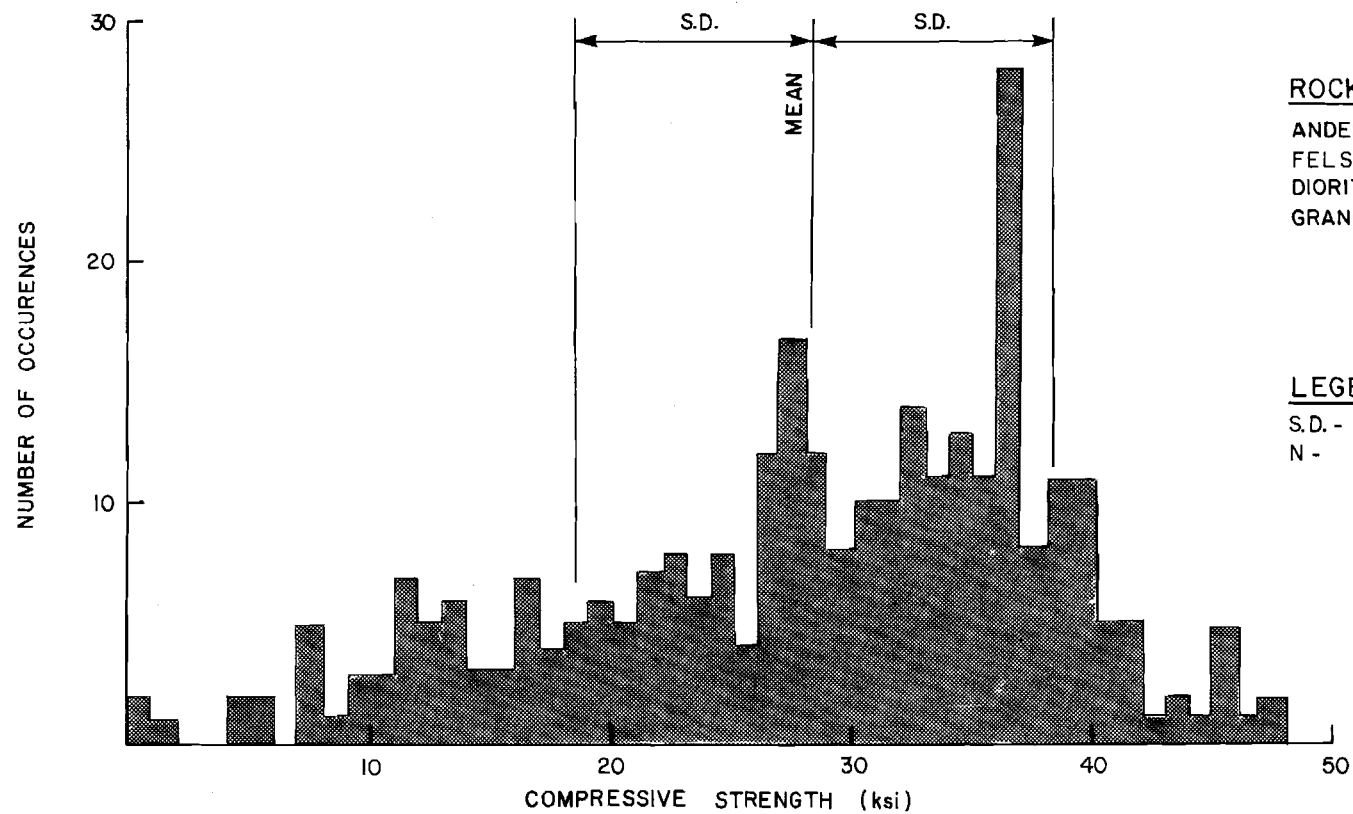
FIGURE 6.25

ALL DATA

WATANA
POINT LOAD TEST DATA

LEGEND
S.D. - STANDARD DEVIATION
N - NUMBER OF TESTS

Boreholes BH-6 and BH-8 were profiled at 15-to-20-foot intervals using a Terremetrics T-500 point load tester. Frequency plots (Figure 6.25) show 95 percent of all test results are more than 10,000 psi and, assuming a normal distribution, nearly 70 percent of all tests fall within the 18,114-to-38,390-psi range. No distinction between the various rock types could be noted.

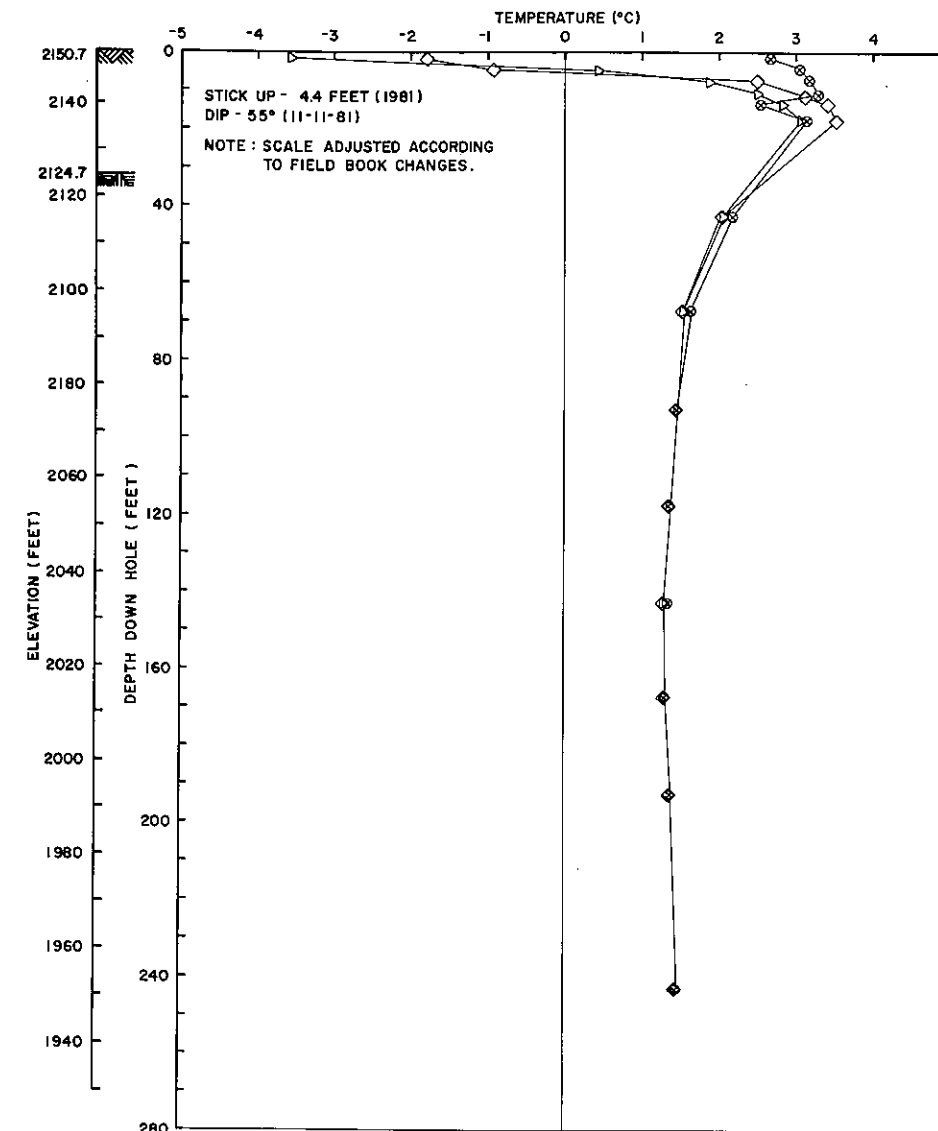
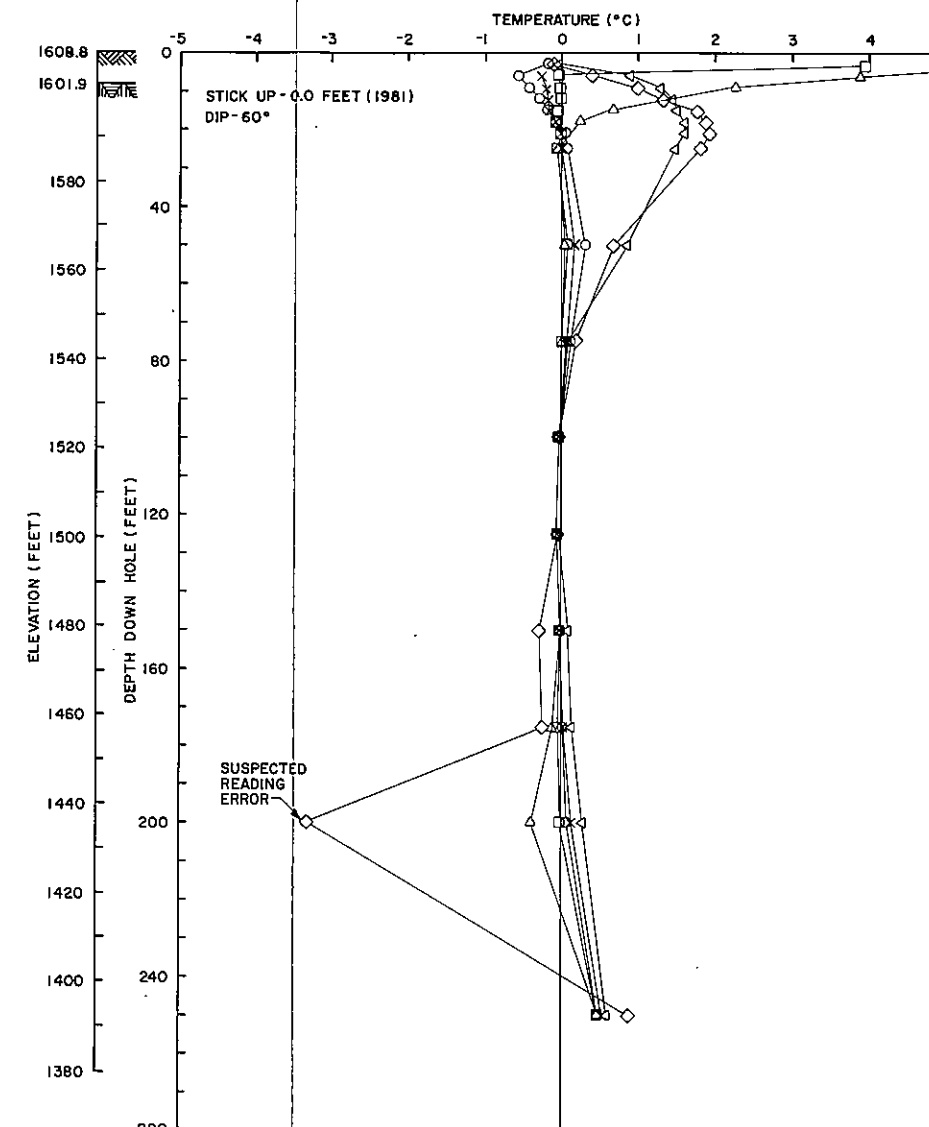
BH-3

BH-6

NOTE: DUE TO PROBLEMS ENCOUNTERED IN FIELD MEASUREMENTS, THE FOLLOWING ADJUSTMENTS WERE PERFORMED TO CONFORM TO EXISTING RELIABLE DATA. THESE FIXED LATERAL SHIFTS MAY NOT CORRECT THE FULL MAGNITUDE OF THE DISCREPANCIES.

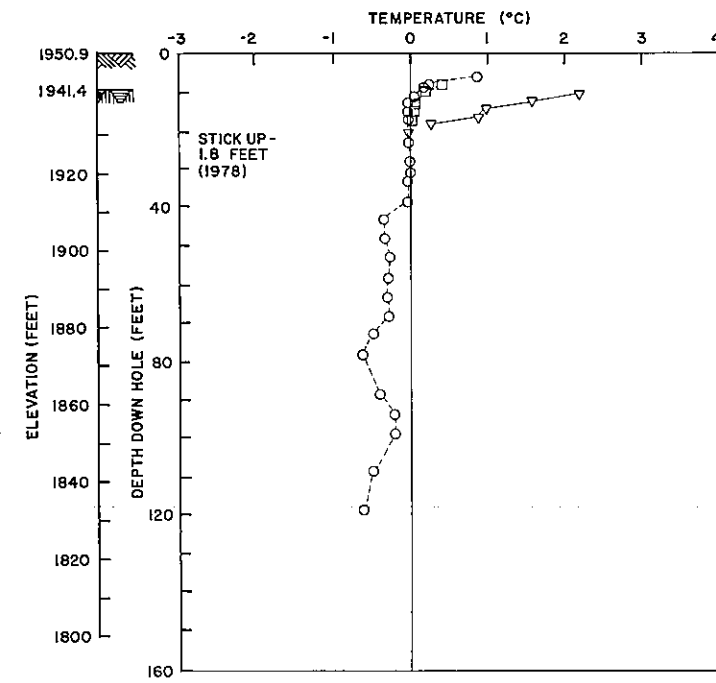
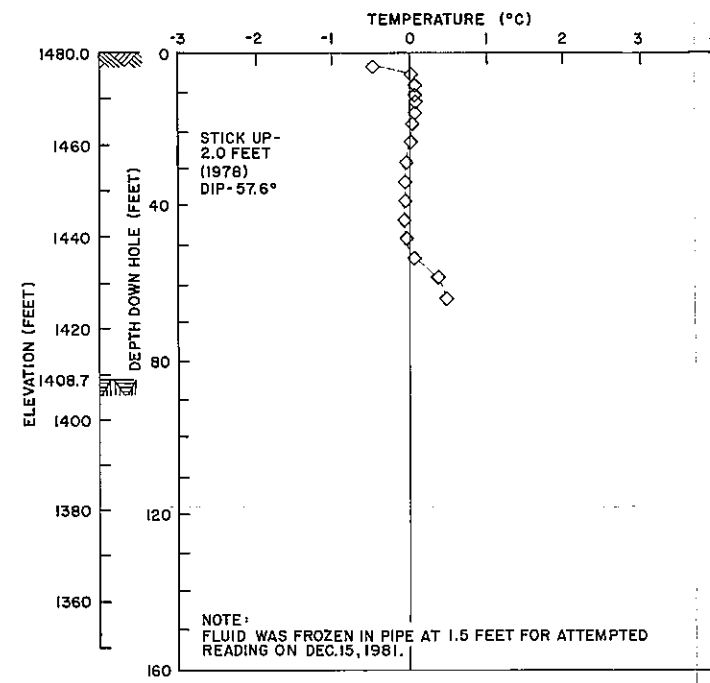
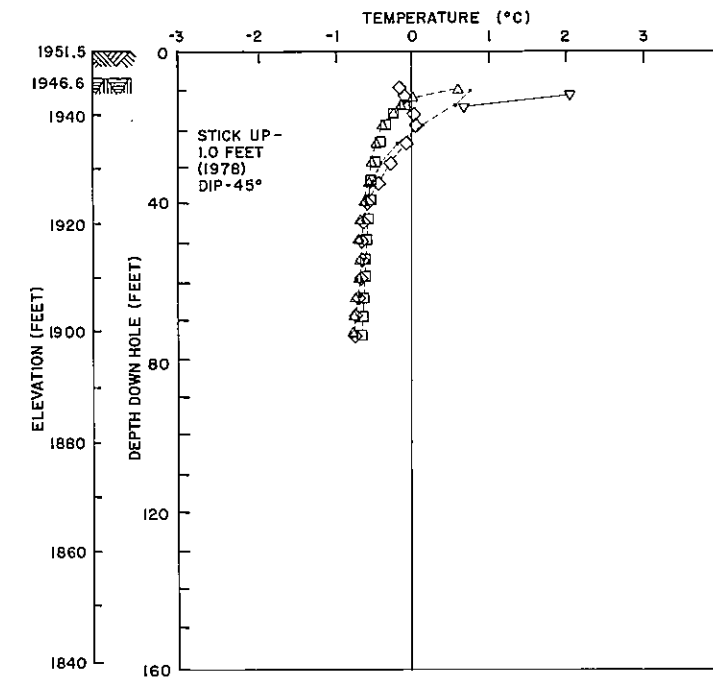
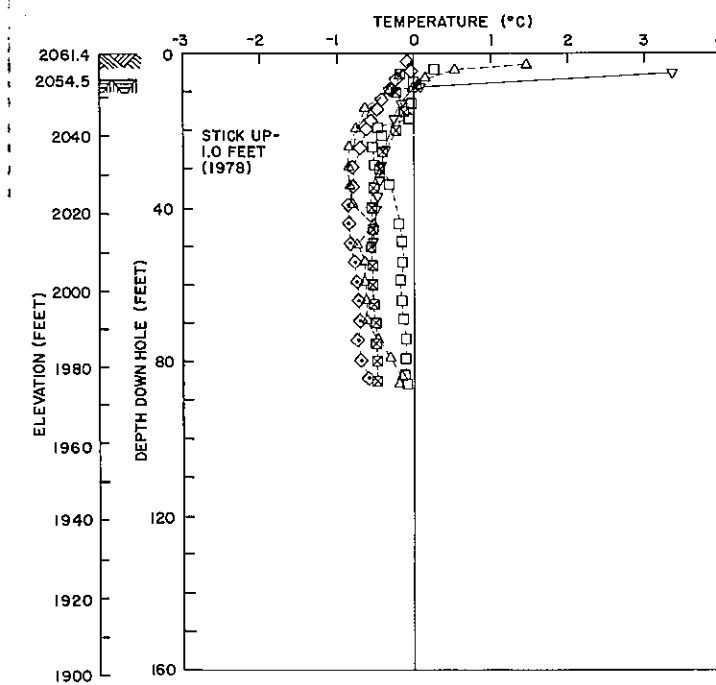
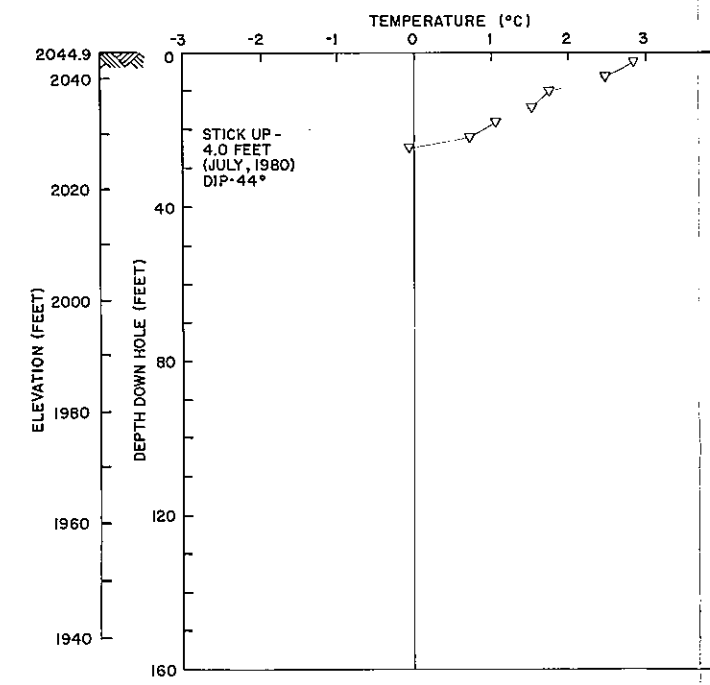
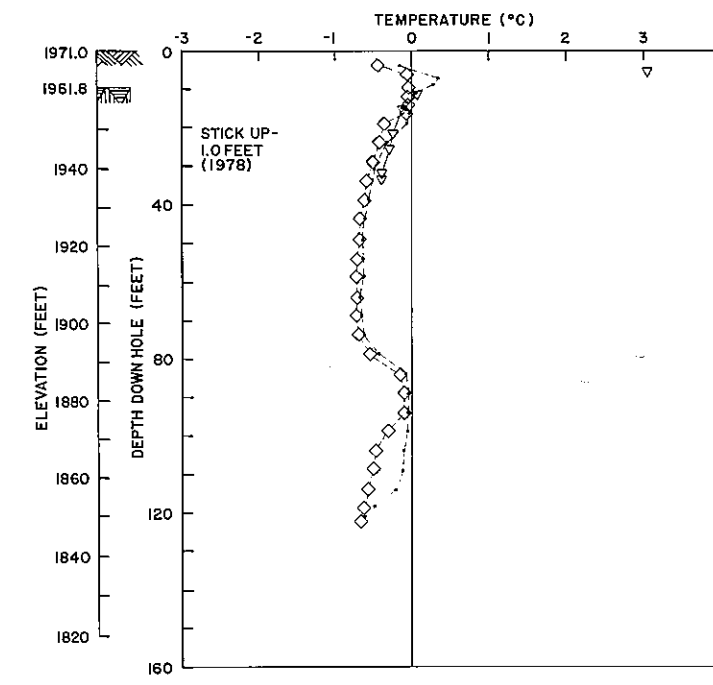
- LOCATION OF BORINGS SHOWN ON FIGURES 5.1a, 5.1b AND 6.40.
- THERMISTOR STRINGS MANUFACTURED BY INSTRUMENTATION SERVICES IN FAIRBANKS, ALASKA.
- BORINGS BH-3, BH-6 ARE PERMANENT MULTI-POINT THERMISTOR STRINGS WITH TWO THERMISTORS AT EACH READING POINT. DATA FOR TWO POINTS IS AVERAGED. ALL OTHER BORINGS ARE PVC PIPE, CAPPED AND FILLED WITH ANTIFREEZE (ETHYLENE GLYCOL) MIXTURE. READINGS TAKEN WITH A THERMISTOR CABLE FITTED WITH REDUNDANT (SINGLE PRIOR TO 1981) THERMISTOR.
- THERMISTOR READOUT BOX-KEITHLEY 172 A, USED FOR 1980 THRU 1982 READINGS.
- TOP OF ROCK ELEVATIONS SHOWN ONLY WHEN ENCOUNTERED.
- BORINGS ARE VERTICAL UNLESS A DIP IS SHOWN.

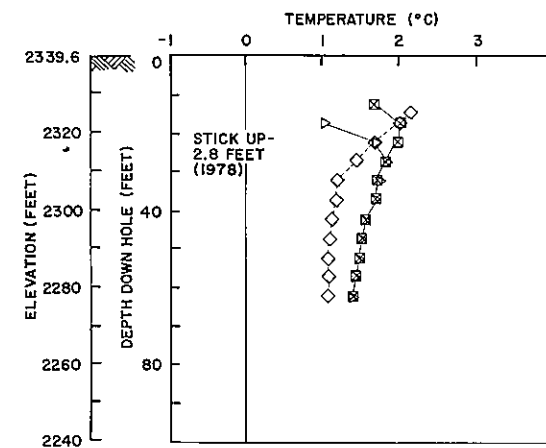
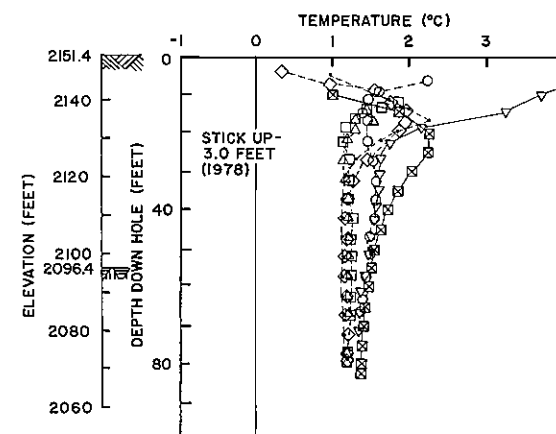
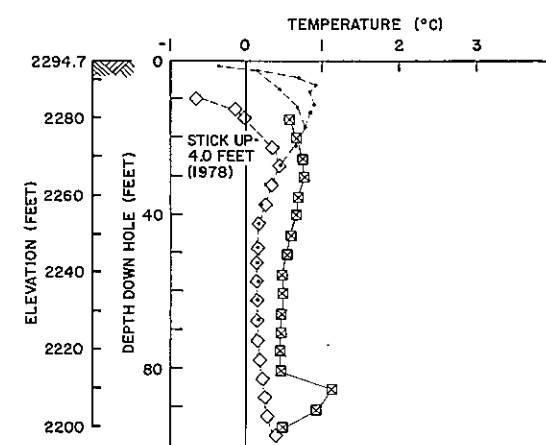
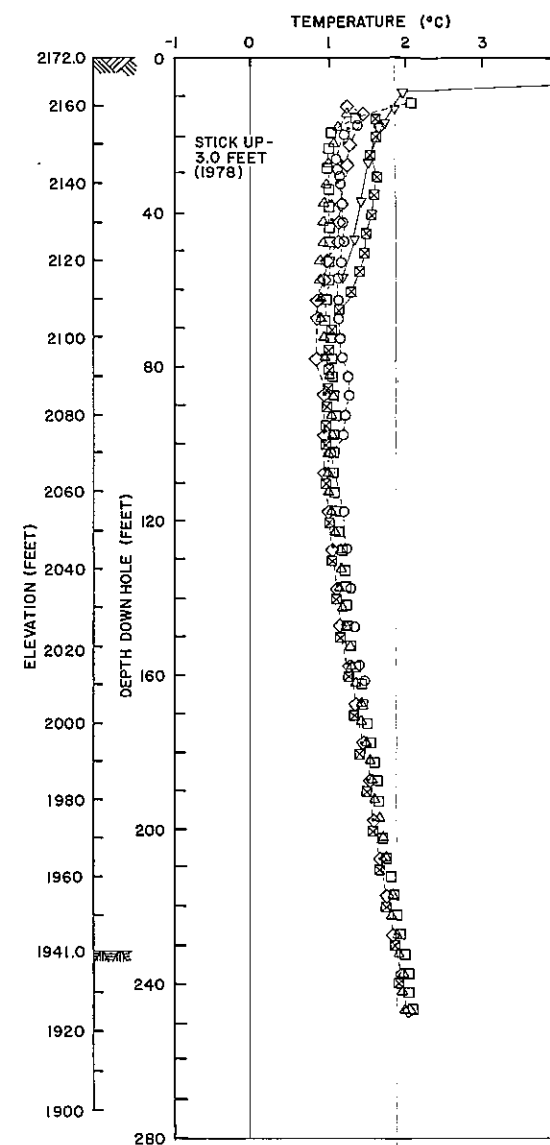
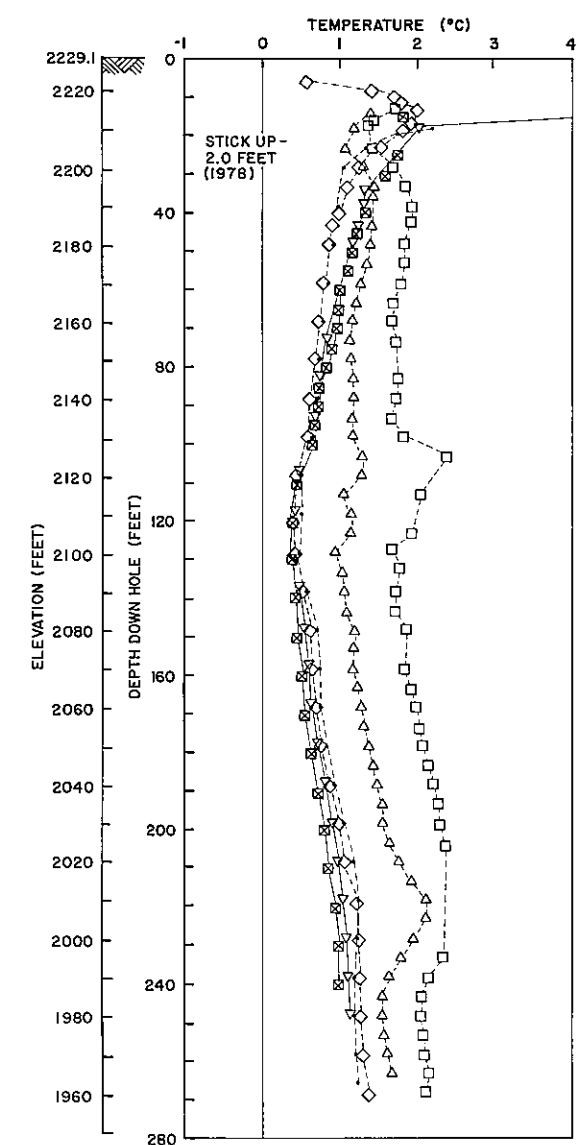
NOTE: TWO SETS OF OCT. 26, 1978 READINGS WERE TAKEN ON TWO DIFFERENT DIAMETER PROBES (DOTS WITH DASHED LINES).

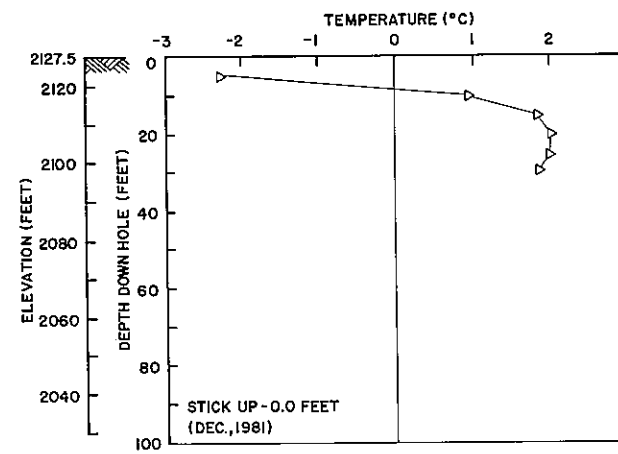
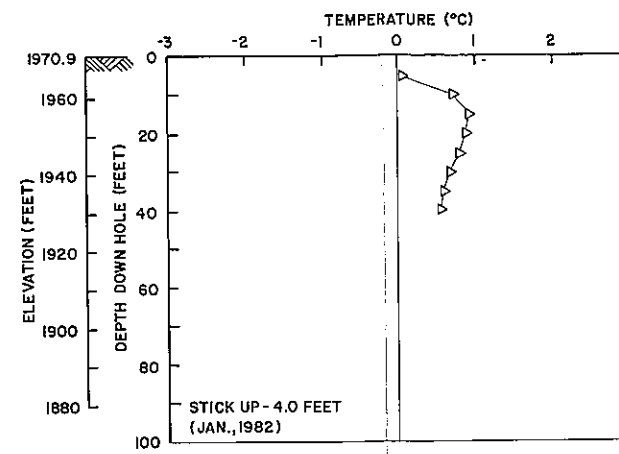
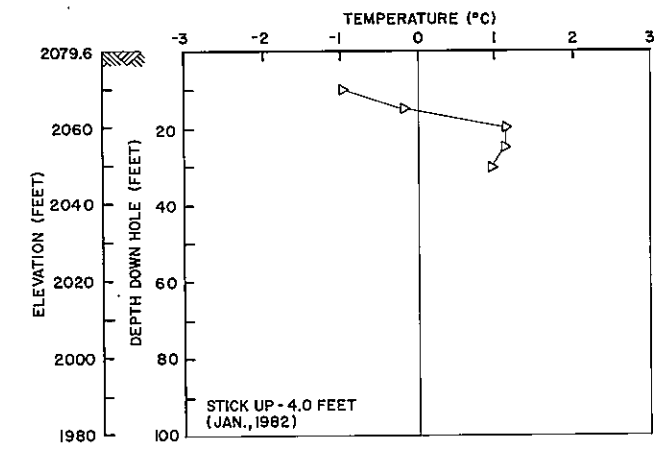
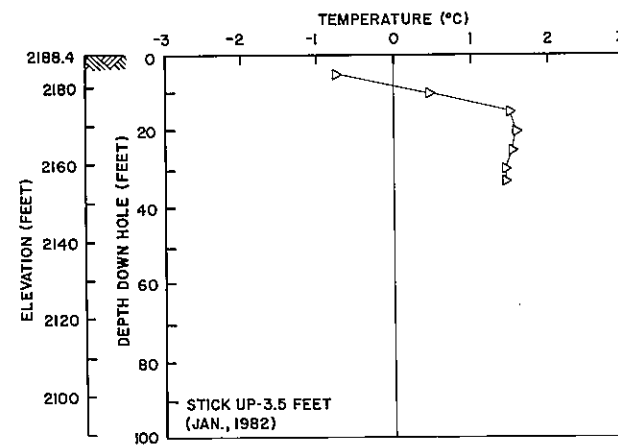
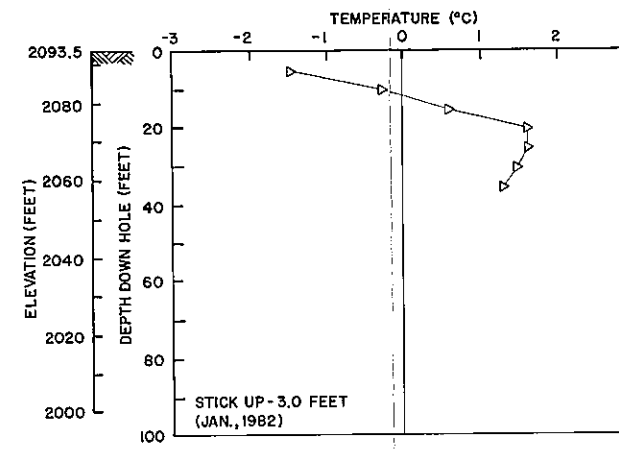
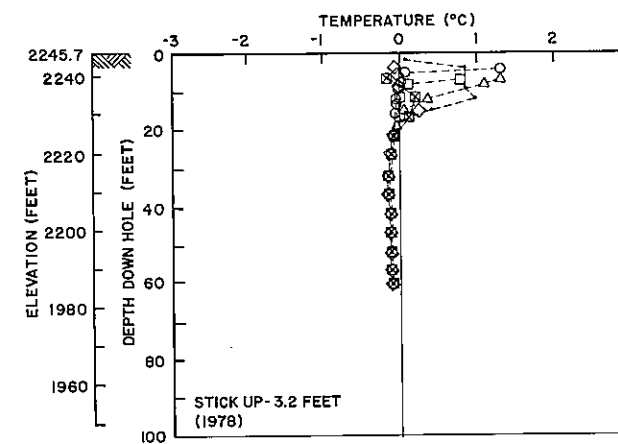
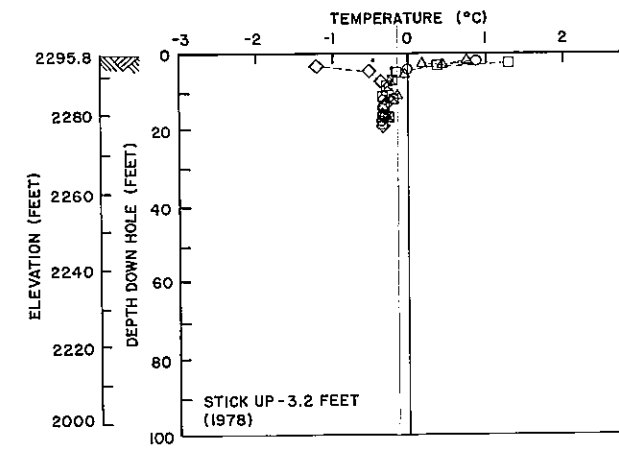
FIGURE 6.29

WATANA
THERMISTOR DATA - BORROW SITE H
& BORROW SITE D

Of the eight auger holes drilled in the site, six encountered permafrost at depths ranging from 0 to 14 feet in depth. All the holes but one showed the water table at or near the surface (Appendix F, Figure 6.48). All of the borings had temperature probes installed during the 1981 program; however, the instruments have not yet stabilized (Figure 6.29). Future readings are likely to show a cooling in the temperature plots.

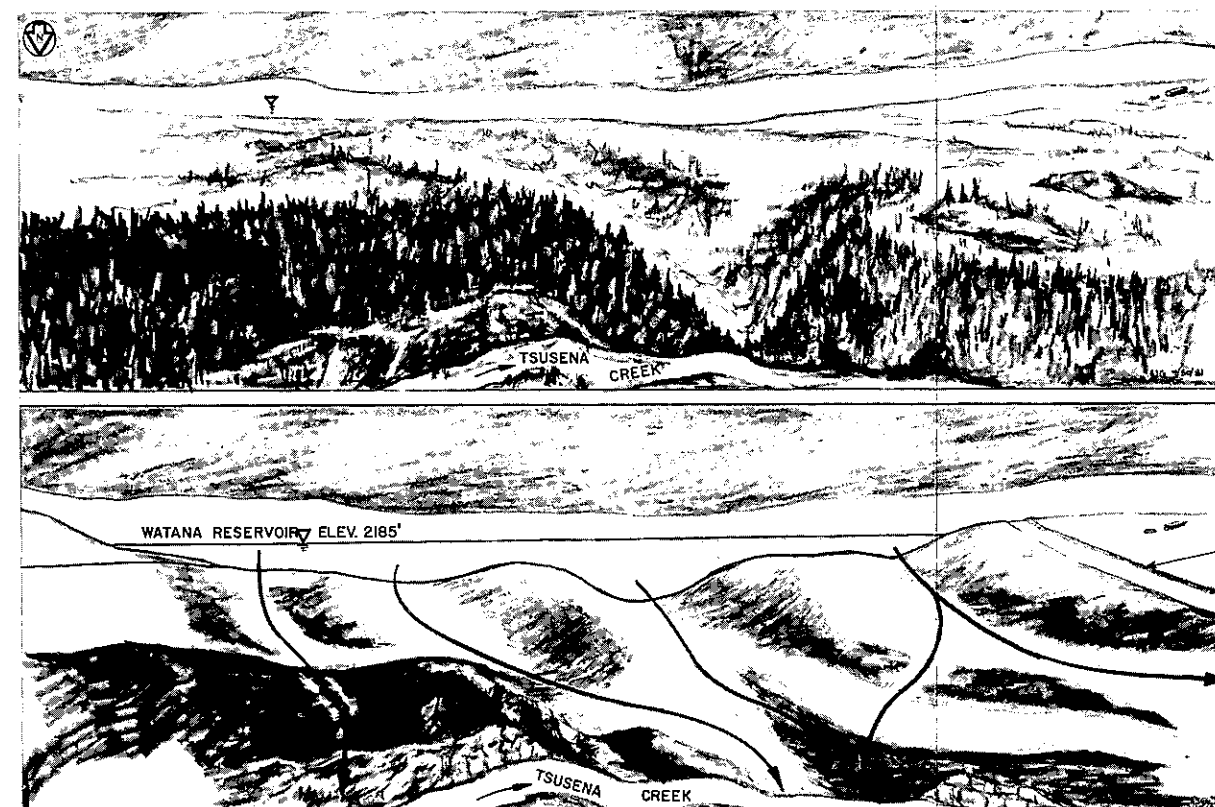
GENERAL VIEW OF INLET AREA
& WESTERN HALF OF OUTLET ZONE

SHORTEST FLOW PATH

1. RELICT CHANNEL PROFILES SHOWN ON FIGURES 6.31 AND 6.33
2. PHOTO LOCATIONS & RELICT CHANNEL TOP OF ROCK SHOWN ON FIGURES 6.30 AND 6.35
3. PHOTOS TAKEN SUMMER 1980 (LEFT) & SUMMER 1981 (RIGHT).
4. RIGHT PHOTO LOOKS DOWN SHORTEST POTENTIAL FLOW PATH. CLEARED SPOT NEAR CENTER OF PHOTO IS TOPOGRAPHIC LOW, EL. 2200 FEET. PHOTO LOCATION SHOWN ON LEFT PHOTO.
5. ARTIST'S SKETCH LOOKS OPPOSITE DIRECTION OF RIGHT PHOTO.

ARTIST'S SKETCH

WATANA
RELICT CHANNEL PHOTOS

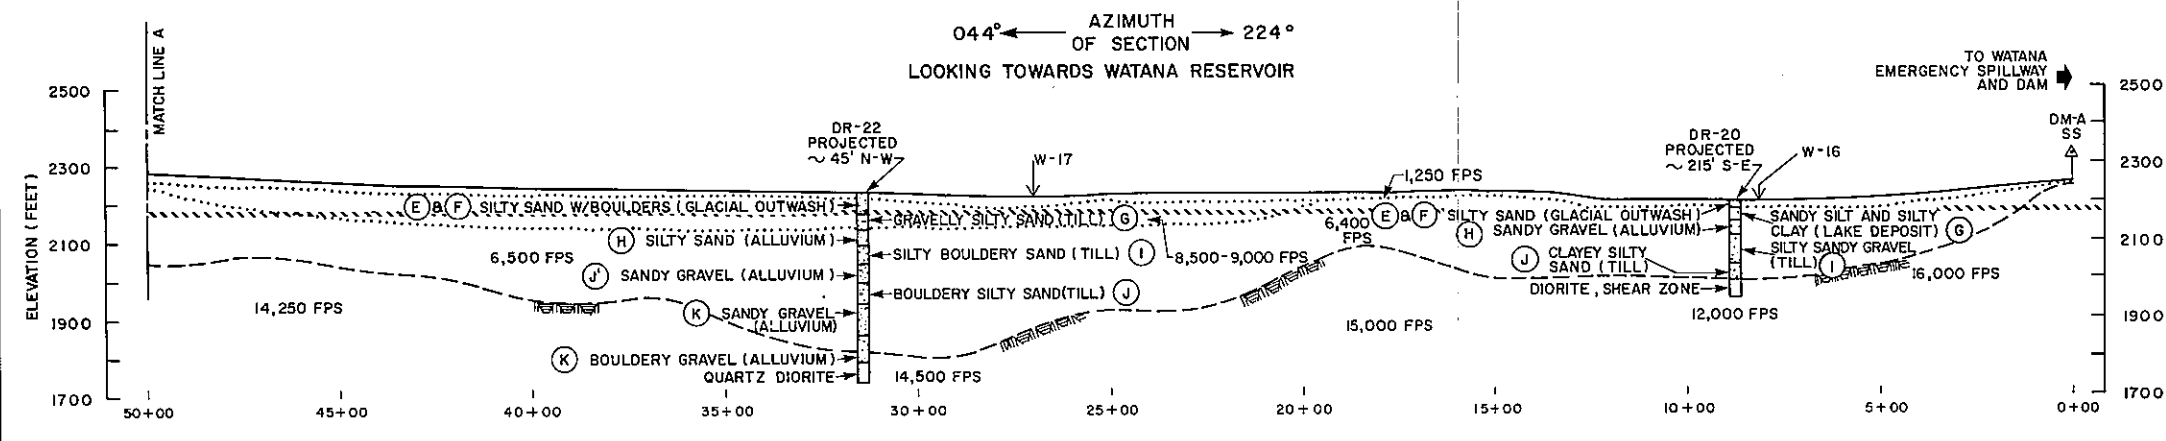
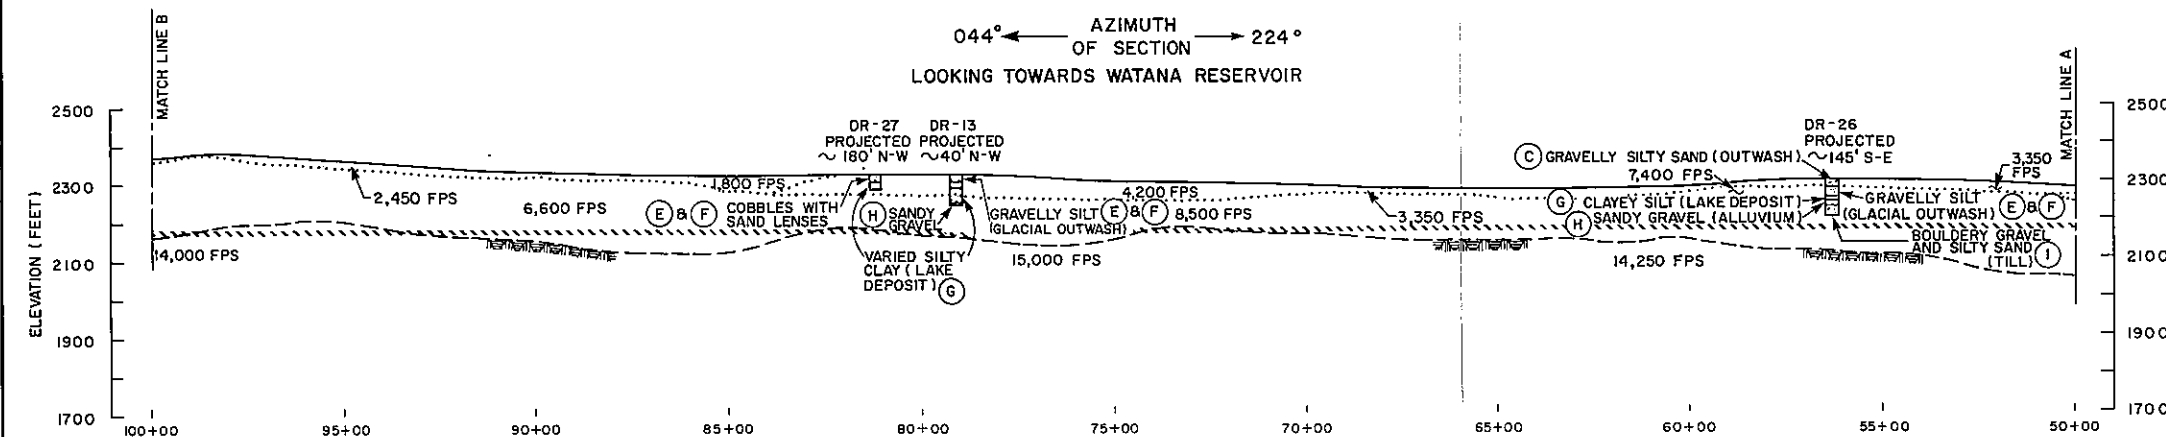
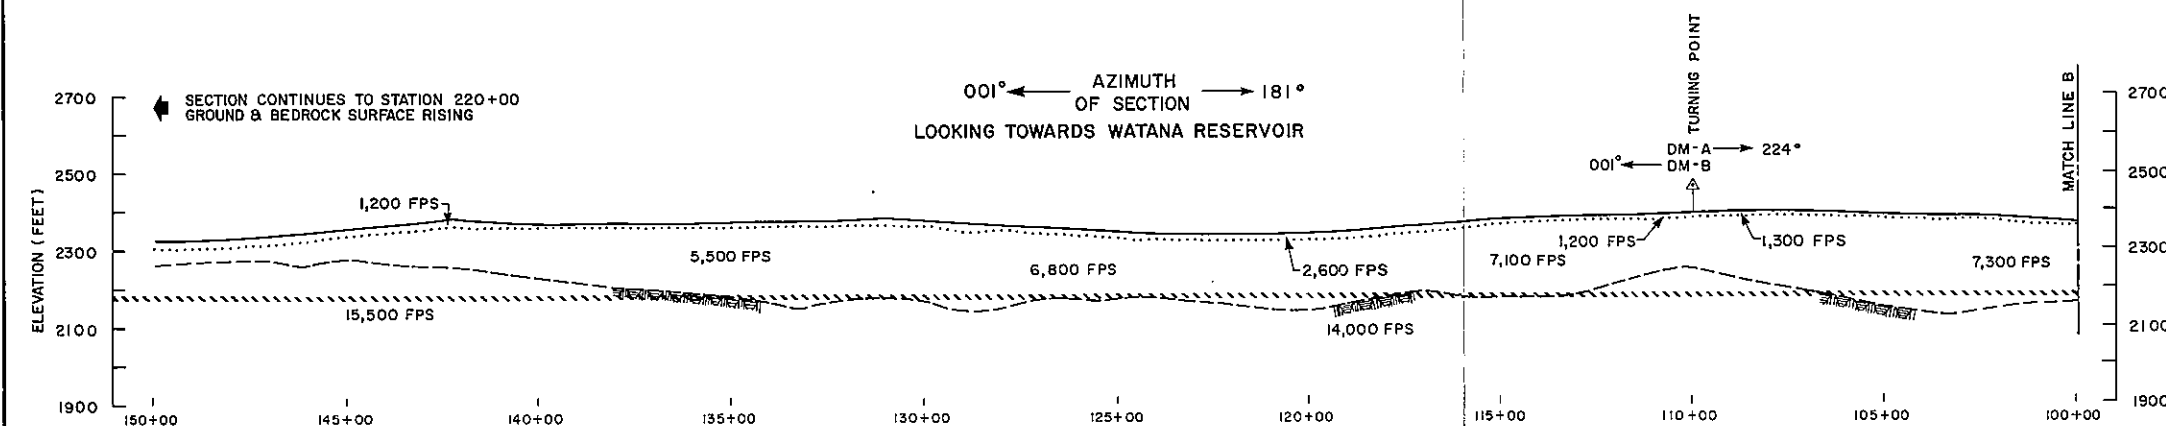
FIGURE 6.31

1. SECTIONS READ FROM TOP TO LOWER LEFT (STA. 0+00 TO 150+00) SEISMIC LINES DM-A & B
2. SECTION LOCATION SHOWN ON FIGURE 6.35.
3. SECTIONS W-16 & W-17 SHOWN ON FIGURE 6.35.
4. VERTICAL AND HORIZONTAL SCALE EQUAL.
5. SECTION ELEVATIONS FROM COE 1" = 200' TOPOGRAPHY, 1978.
6. SECTION COINCIDES CLOSELY WITH DIVIDE BETWEEN SUSITNA RIVER AND TSUSENA CREEK DRAINAGES. THIS SECTION REPRESENTS NARROWEST RELICT CHANNEL WIDTH WHERE GROUND SURFACE IS ABOVE MAXIMUM POOL ELEVATION.
7. SECTION LIES ON DAMES AND MOORE SEISMIC LINE DM-A AND DM-B, 1975.
8. SEISMIC LINE ELEVATIONS CORRECTED AS PER COE SURVEY AND NPAS AIR PHOTO MAPS, 1978.
9. REFER TO TABLE 6.1 FOR SEISMIC VELOCITY AND MATERIAL CORRELATION.
10. SEE FIGURE 6.32 FOR STRATIGRAPHIC COLUMN AND GENERAL NOTES.
