SUSITNA HYDROELECTRIC PROJECT

1980-81 GEOTECHNICAL REPORT

VOLUME 1
TEXT
FINAL DRAFT

ALASKA POWER AUTHORITY

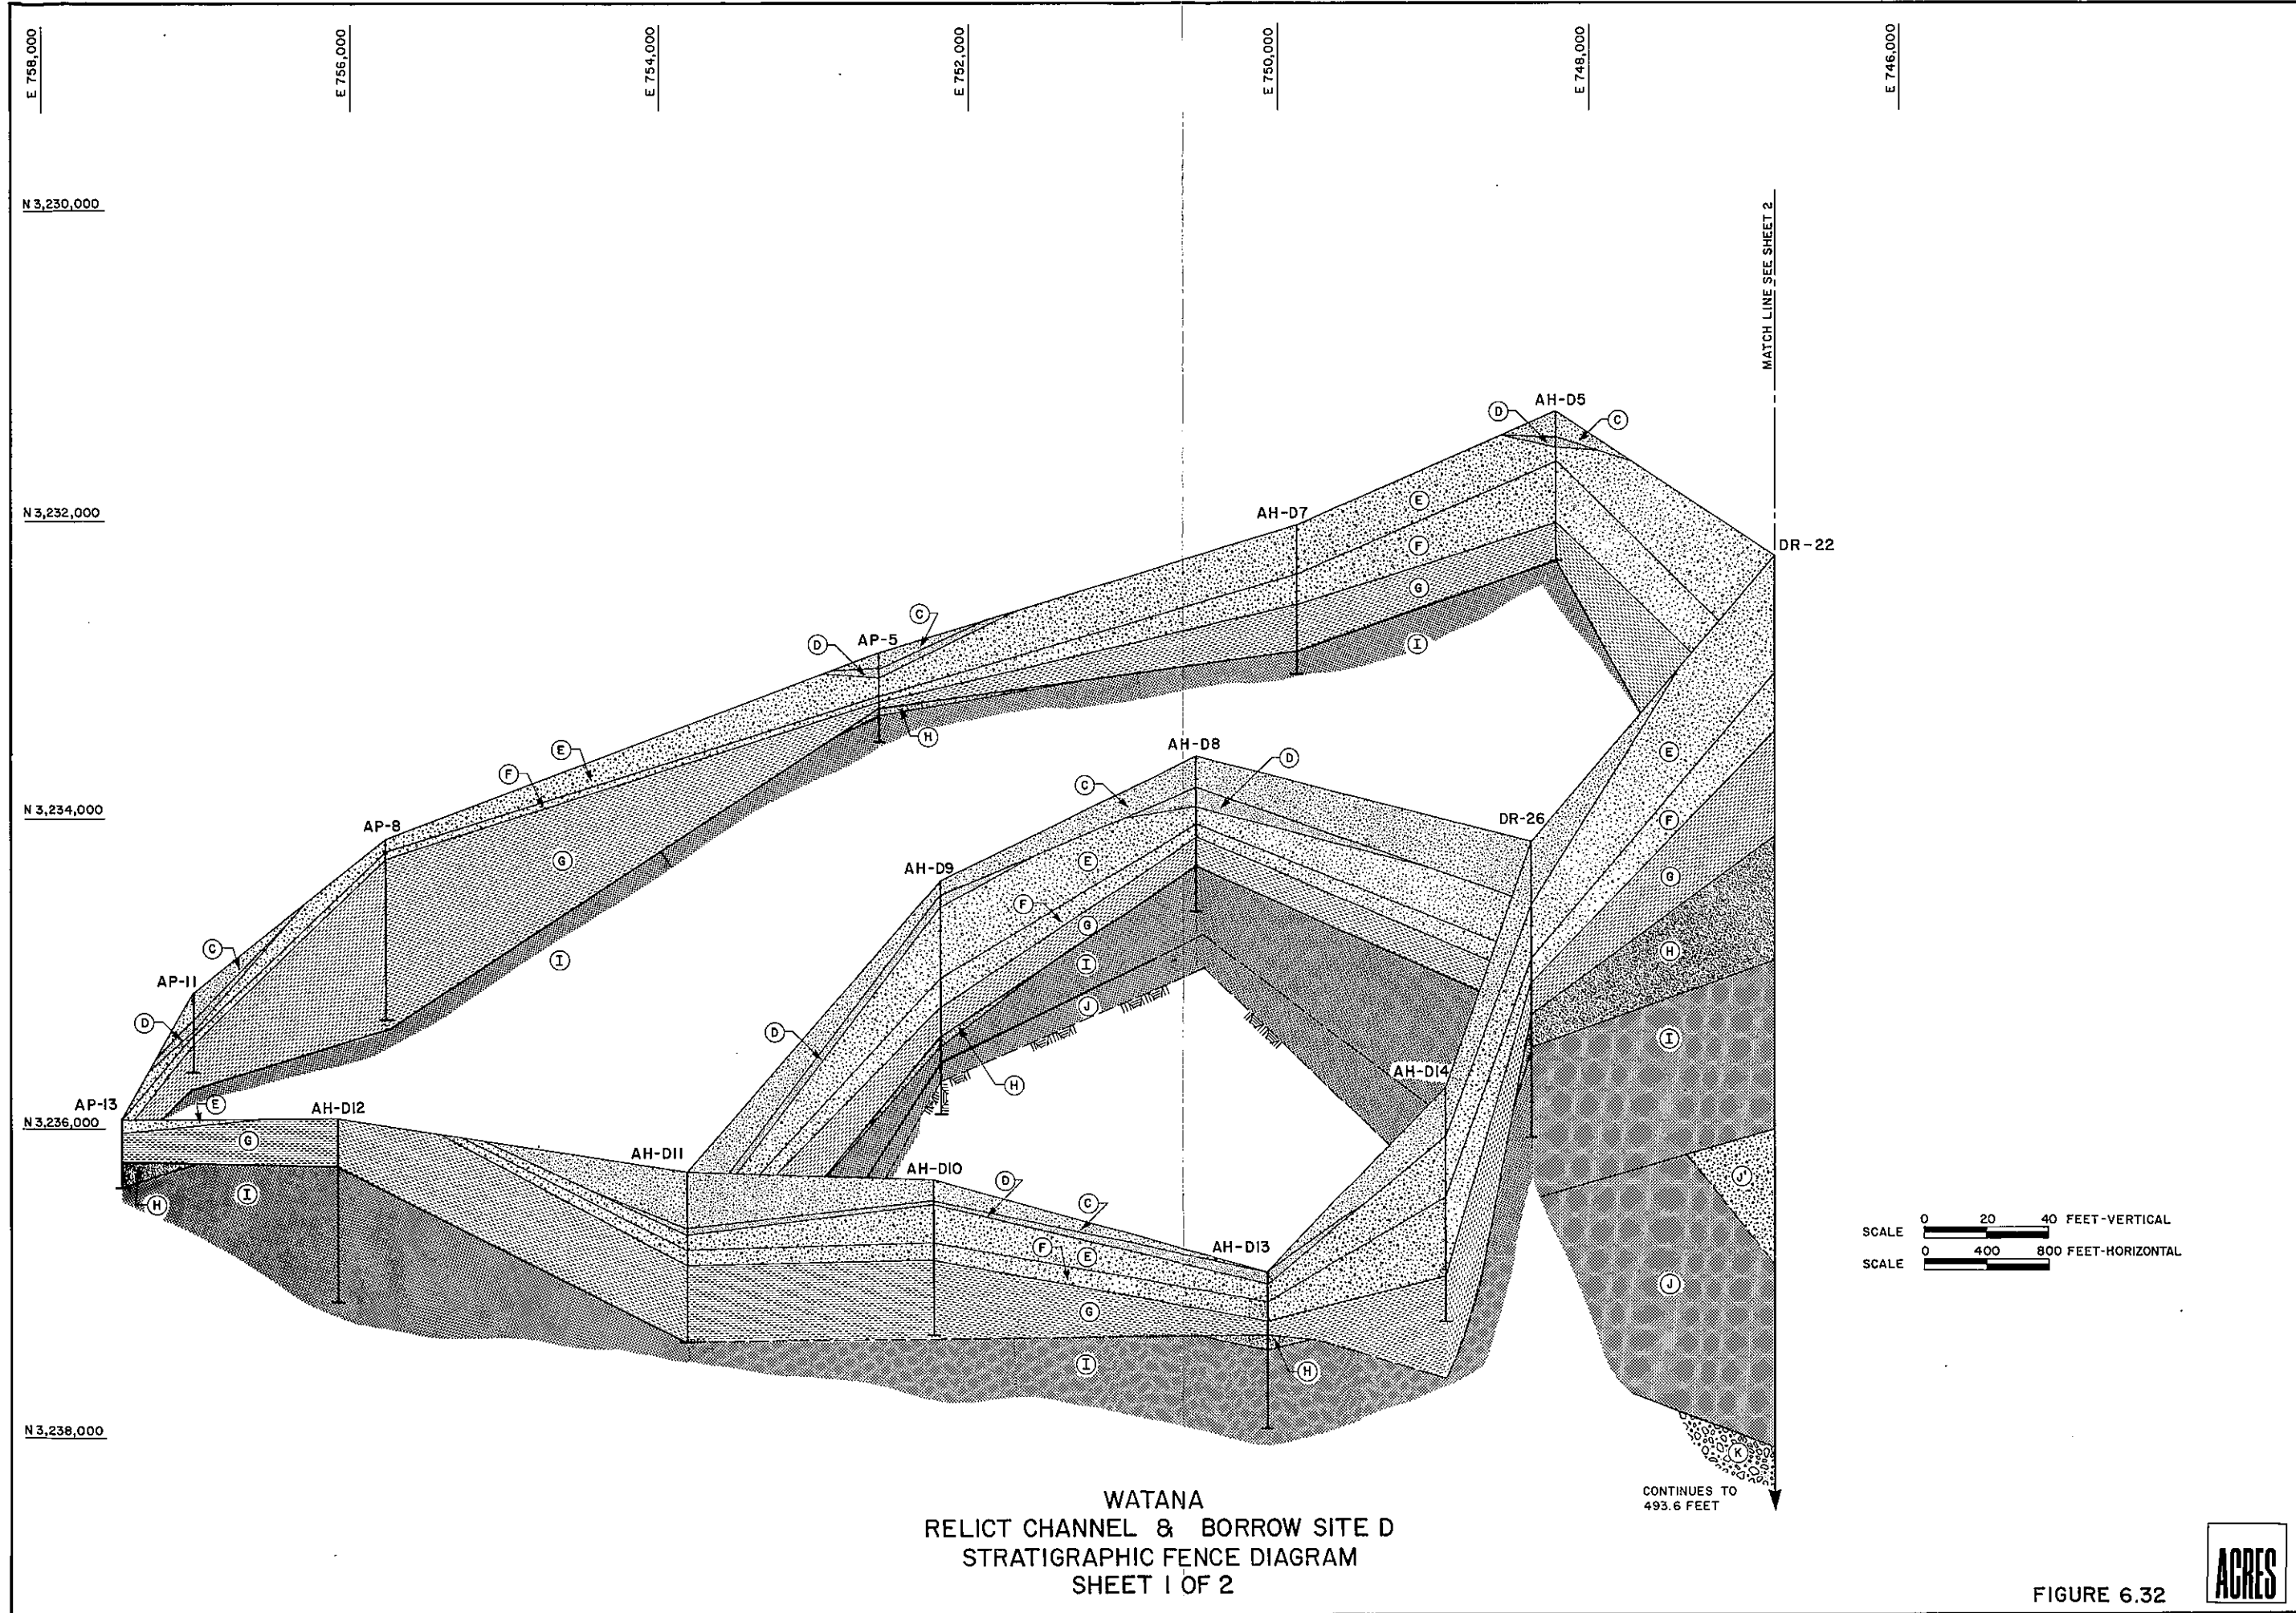
FIGURE 6.32

WATANA
RELICT CHANNEL & BORROW SITE D
STRATIGRAPHIC FENCE DIAGRAM
SHEET 1 OF 2

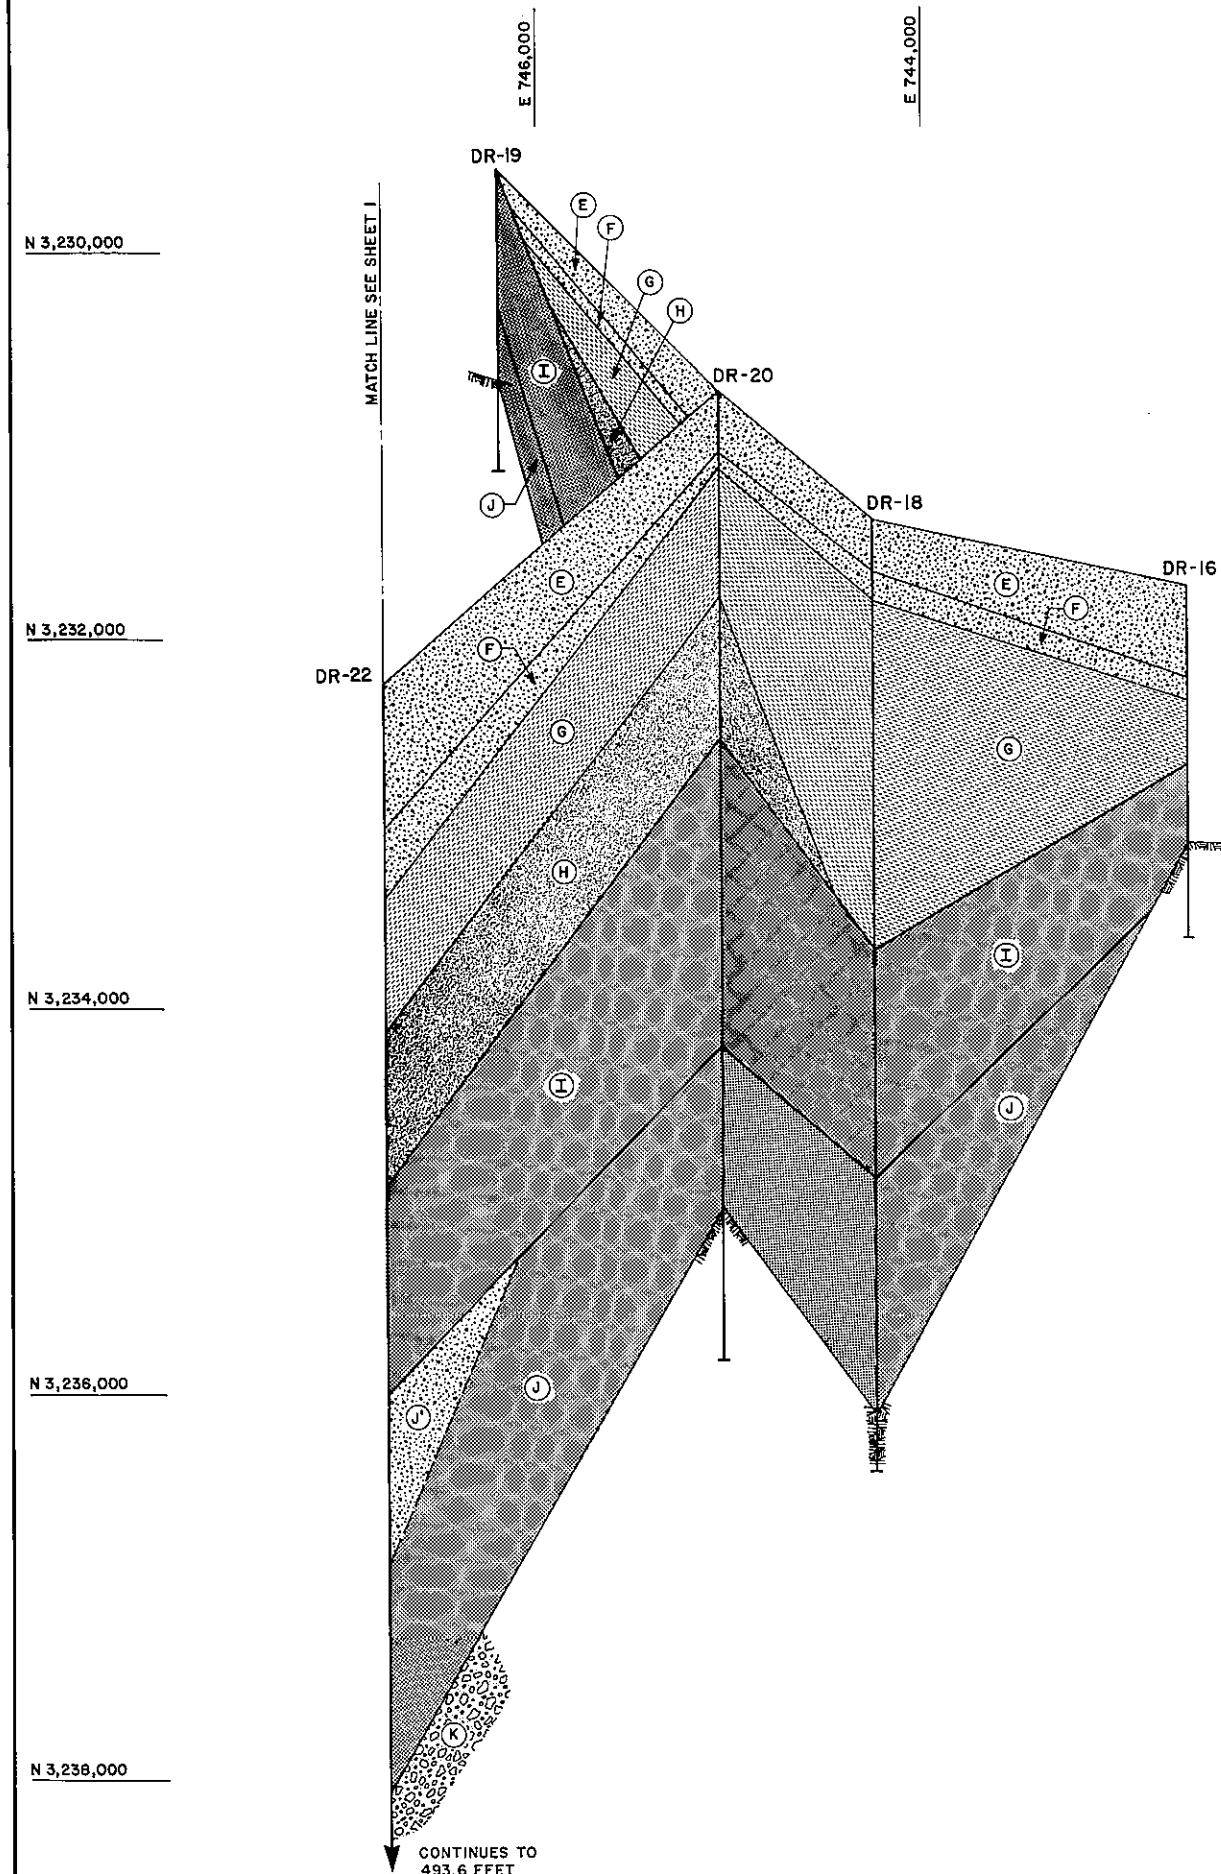
GENERALIZED STRATIGRAPHIC COLUMN BORROW SITE D AND RELICT CHANNEL

COLUMN UNIT:	ESTIMATED THICKNESS:	DESCRIPTION:
— SURFICIAL	0-5'	BOULDERS, ORGANIC SILTS AND SANDS.
C OUTWASH	0-18' 12' AVERAGE	SILTY SAND WITH SOME GRAVEL AND OCCASIONAL COBBLES. USUALLY BROWN, BECOMES GRAY IN LIMITED AREAS. THICKEST IN NORTHERN PORTIONS OF AREA. THINNING SOUTHWARD, OFTEN ABSENT NEAR SUSITNA RIVER.
D ALLUVIUM & FLUVIAL DEPOSITS	0-15'	SAND WITH SOME SILT, OCCASIONAL GRAVEL. GENERALLY BROWN, FOUND ONLY ALONG COURSE OF LIMITED DRAINAGE CHANNELS FORMED IN OUTWASH E. GENERALLY SORTED.
E OUTWASH & F	0-35' 15' AVERAGE	SAND, SILT, GRAVEL AND COBBLES, PARTLY SORTED, WITH FRAGMENTS SUB-ANGULAR TO ROUNDED. SILT AND SAND LENSES OFTEN PRESENT. BROWN TO GRAY BROWN WITH A COBBLE/BOULDER ZONE OFTEN PRESENT AT THE BASE OF UNIT F. CONTACT BETWEEN E & F IS OFTEN POORLY DEFINED.
G TILL / WATERLAIN TILL	2-50' 12' AVERAGE	CLAYEY, SILTY SAND, USUALLY GRAY, OFTEN PLASTIC. CONTAINS COBBLES AND GRAVEL IN MANY AREAS. OCCASIONALLY PRESENT AS A LACUSTRINE DEPOSIT SHOWING LAMINATIONS AND/OR VARVES. GENERALLY A TILL DEPOSITED THROUGH OR NEAR STANDING WATER.

H ALLUVIUM	0-40'	SAND, SILT, GRAVEL, PARTLY TO WELL SORTED. OFTEN ABSENT BETWEEN UNITS G & I. UNIT REPRESENTS PERIOD OF MELTING PRODUCING ALLUVIUM / OUTWASH BETWEEN THESE DEPOSITS. APPEARS AS NARROW BANDS REPRESENTING CHANNEL FILLINGS. THICKEST IN WESTERN PORTION OF THE AREA.
I & J TILL & ALLUVIUM	> 10' TO 65' 20' AVERAGE	POORLY SORTED SAND, SILT, GRAVEL AND COBBLES, OCCASIONALLY WITH CLAY. GENERALLY GRAY TO GRAY BROWN. CONTINUITY UNCERTAIN DUE TO LACK OF INFORMATION AT DEPTH. SILT OR SAND LAYER 2 INCHES - 6 INCHES THICK OFTEN FOUND IN CENTER OF UNIT I. BASE UNIT ON TOP OF BEDROCK, EXCEPT IN BURIED CHANNEL THALWEG. CONTACT BETWEEN I & J OFTEN POORLY DEFINED, AND LOCALLY INCLUDES AN ALLUVIUM DESIGNATED J'.
K ALLUVIUM	TO 160'	SAND, GRAVEL, COBBLES, BOULDERS, FEW FINES, PERMEABLE. FOUND ONLY IN THALWEG OF BURIED CHANNEL. TOP AT 292 FEET, EXTENDING TO ROCK AT 454 FEET IN DEPTH IN DR-22.
— BEDROCK, DIORITE

- EXPLORATION LOCATIONS SHOWN ON FIGURES 5.1 AND 6.40.
- FOR LEGEND OF SYMBOLS SEE FIGURE 6.33.
- EXPANDED SECTION FROM DR-13 THROUGH DR-20 SHOWN ON FIGURE 6.33.
- LETTERS USED TO DEFINE UNITS ARE ARBITRARY AND WERE USED FOR CORRELATION PURPOSES.
- THE ACCURACY AND THICKNESS OF SOIL AND ROCK STRATA IS SUBJECT TO VERIFICATION.
- THIS FIGURE IS GENERALIZED FOR GRAPHIC PRESENTATION. FOR MORE SPECIFIC INFORMATION REFER TO TEXT AND BORING LOGS.

WATANA
RELICT CHANNEL & BORROW SITE D
STRATIGRAPHIC FENCE DIAGRAM
SHEET 2 OF 2

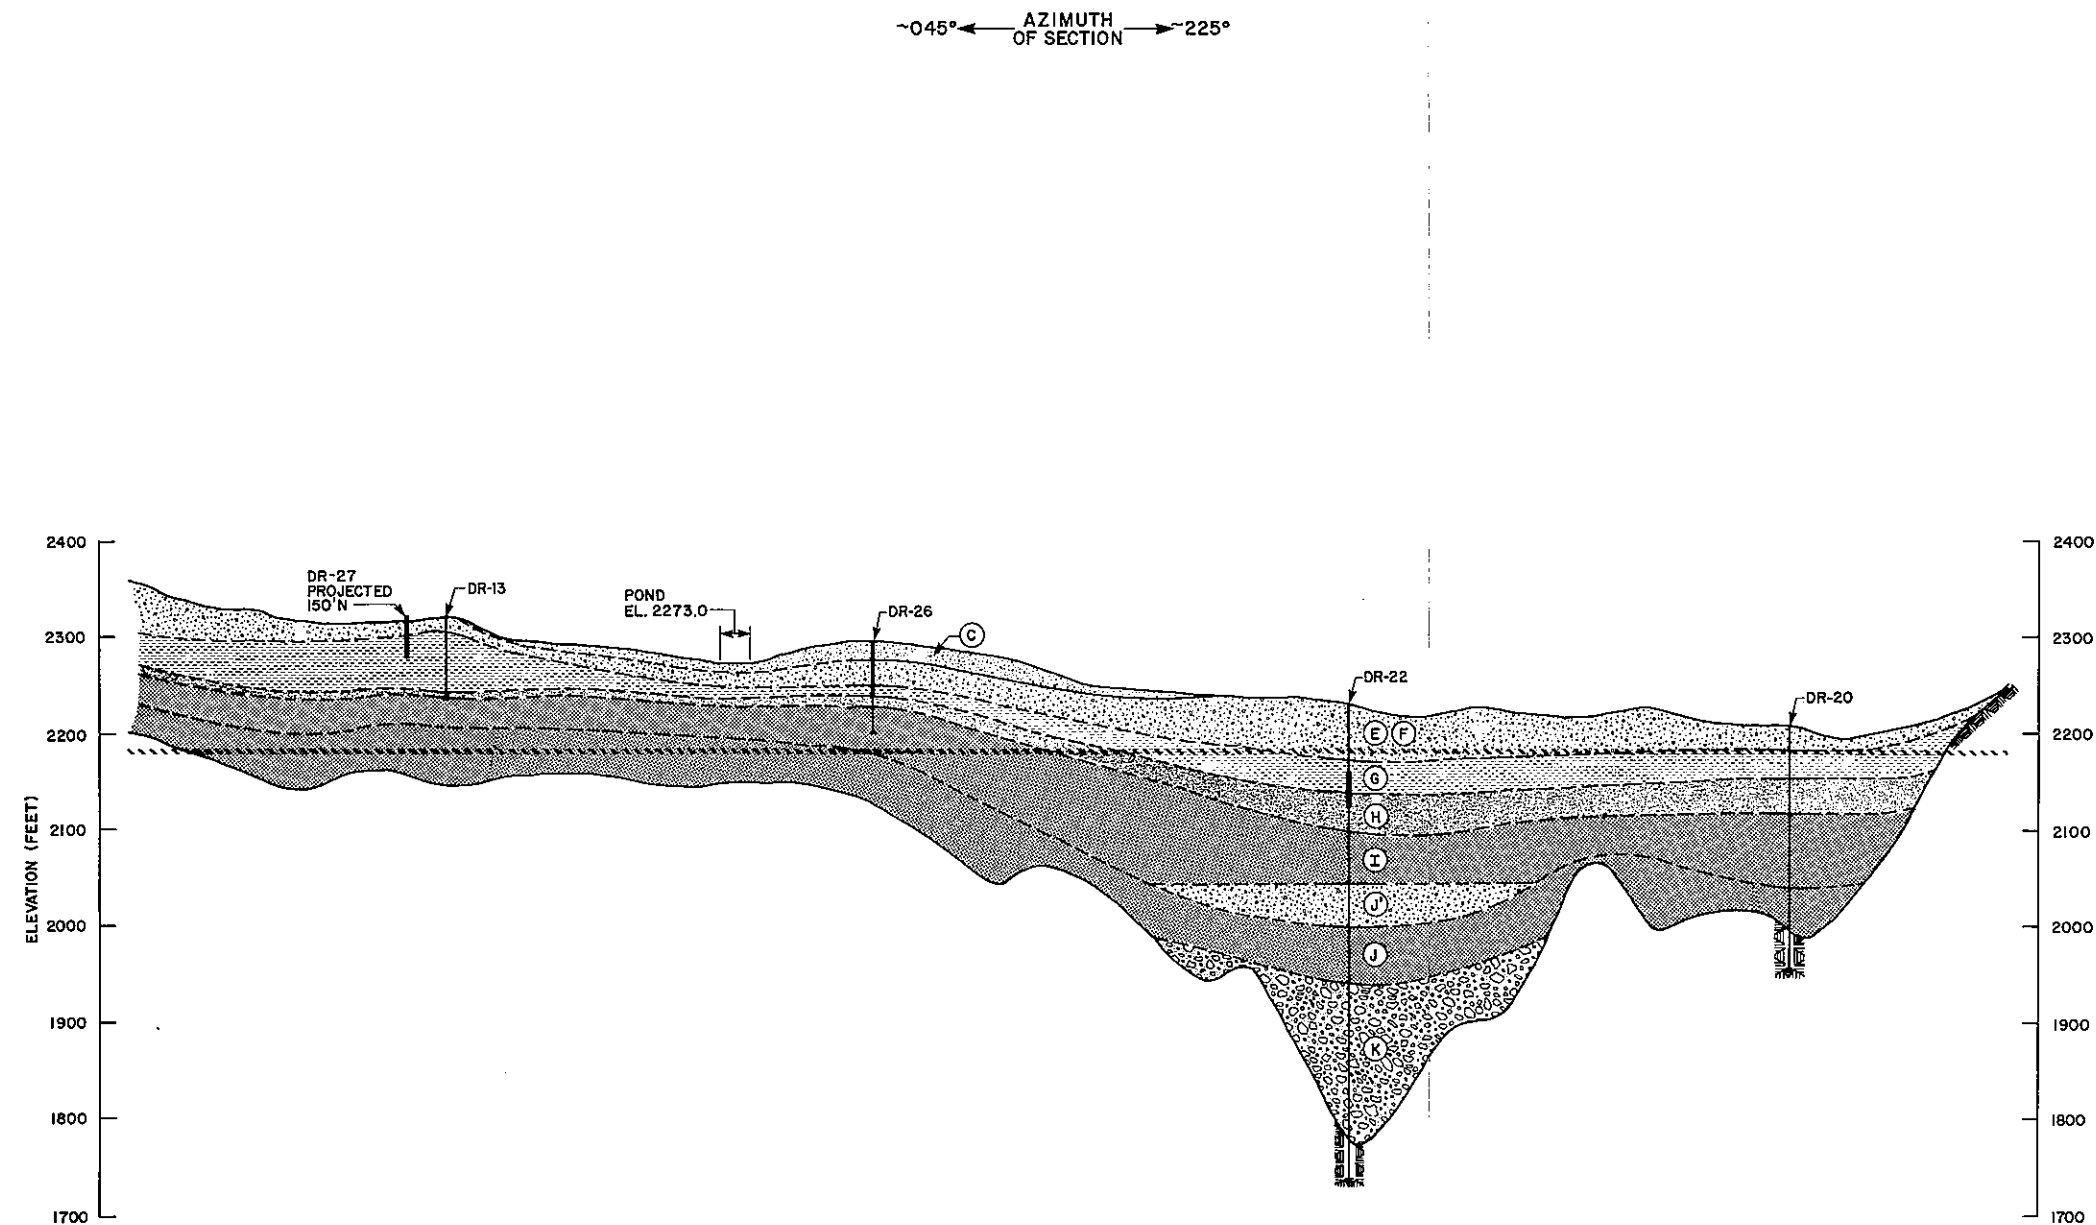
FIGURE 6.33

DR-26	COE ROTARY CORE BORINGS
□	NOTED AS FROZEN DURING DRILLING

- SEE FIGURE 6.32 FOR STRATIGRAPHIC COLUMN AND GENERAL NOTES.
- SEE FIGURE 6.31 FOR TRUE SCALE SECTION OF SAME GENERAL AREA.
- VERTICAL TO HORIZONTAL SCALES 5:1.
- PERMAFROST DATA (TEMPERATURE PLOTS ON FIGURE 6.28).
DR-13 NO TEMPERATURE DATA
DR-20 NO PERMAFROST
DR-22 FROZEN 72' TO 110'
DR-26 FROZEN 19' TO 55'
DR-27 FROZEN 0' TO 44'
- BEDROCK ELEVATIONS BASED ON SEISMIC REFRACTION DATA (FIG. 5.1)
- THE ACCURACY AND THICKNESS OF SOIL AND ROCK STRATA IS SUBJECT TO VERIFICATION.
- THIS FIGURE IS GENERALIZED FOR GRAPHIC PRESENTATION. FOR MORE SPECIFIC INFORMATION REFER TO TEXT AND BORING LOGS.

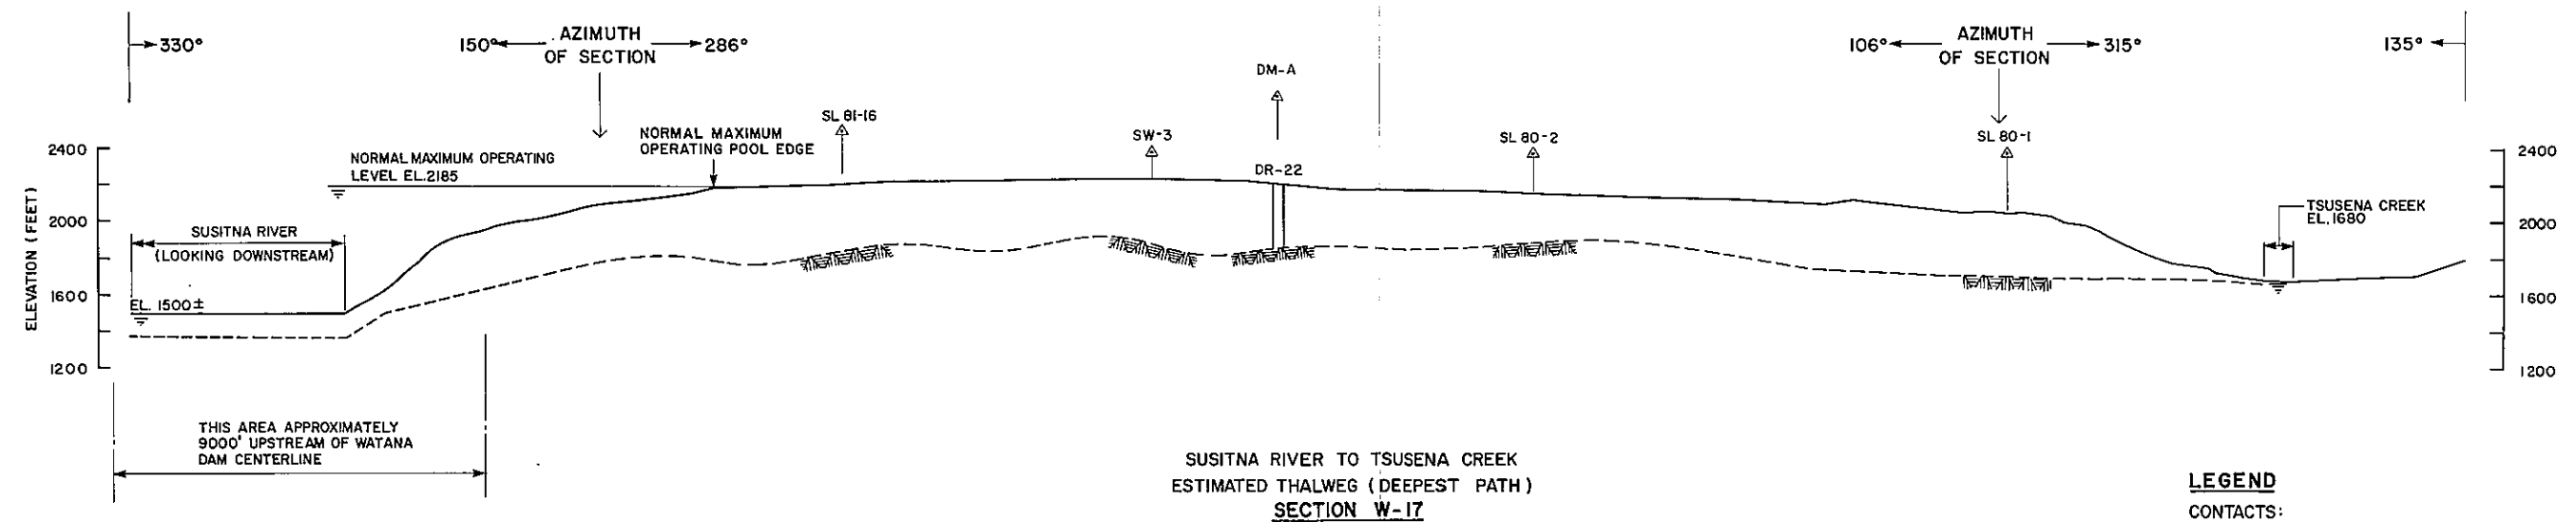
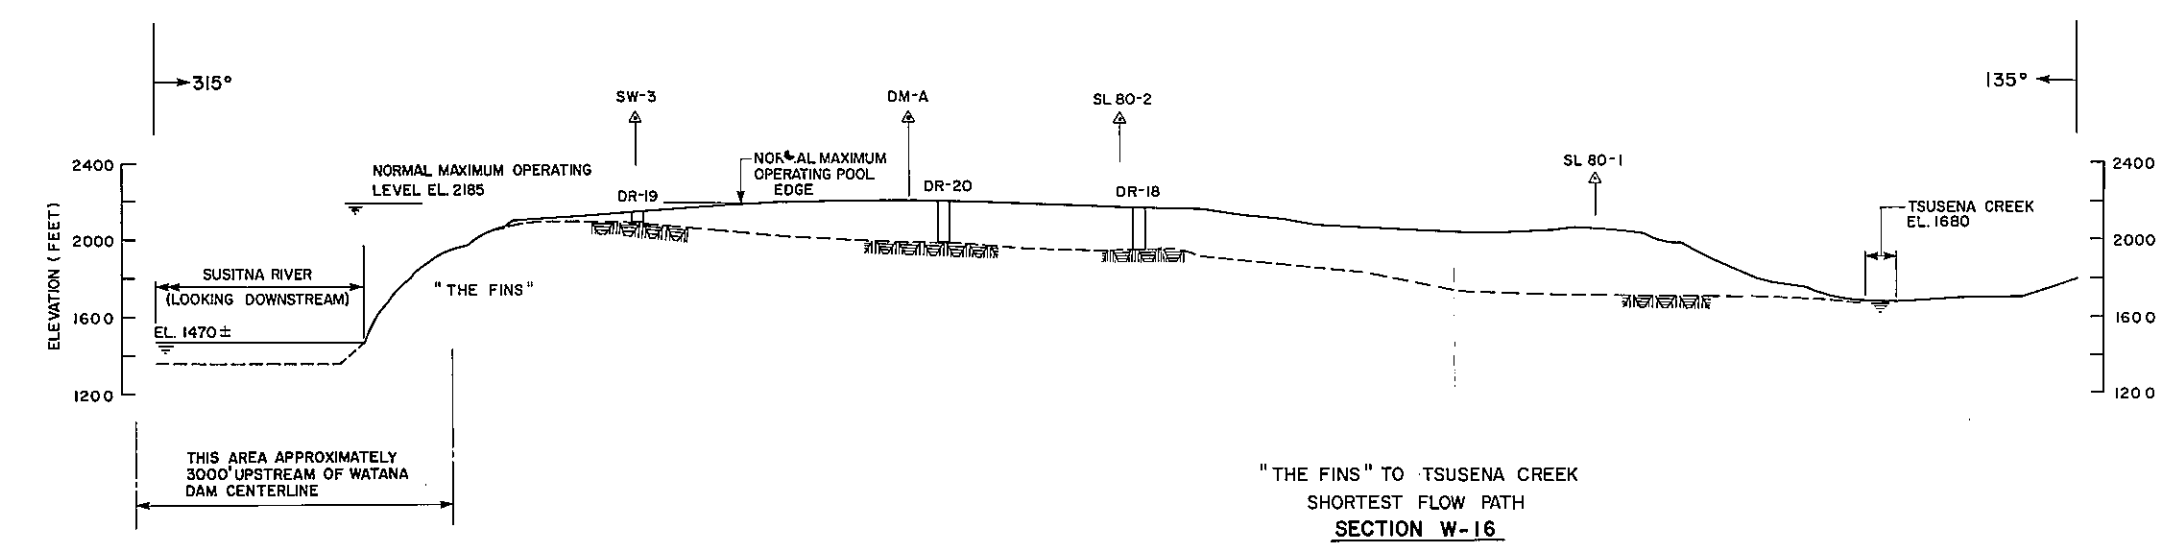
FIGURE 6.34

- LEGEND**
- CONTACTS:
----- APPROXIMATE TOP OF ROCK
- GEOPHYSICAL SURVEYS:
△ SW-1 INTERSECTION WITH SEISMIC REFRACTION LINE
DM-C 1975, DAMES & MOORE
SW-1 1978, SHANNON & WILSON
SL 80-1 1980, WOODWARD-CLYDE CONSULTANTS
SL 81-2 1981, WOODWARD-CLYDE CONSULTANTS
- BOREHOLES:
DR-19 COE ROTARY DRILL BORING

- NOTES**
1. PROFILE AND SEISMIC LINE LOCATIONS SHOWN ON FIGURE 6.35.
 2. SECTION ALONG DM-A SHOWN ON FIGURE 6.31.
 3. VERTICAL AND HORIZONTAL SCALE EQUAL.
 4. SURFACE PROFILE FROM 1"=200' TOPOGRAPHY, COE 1978 TOPOGRAPHY GENERALIZED TO ±25 FEET.
 5. TOP OF ROCK NORTHWEST OF SL 80-1 IS PROJECTED UP TO 300 FEET TO PORTRAY ACTUAL THALWEG PROFILE.

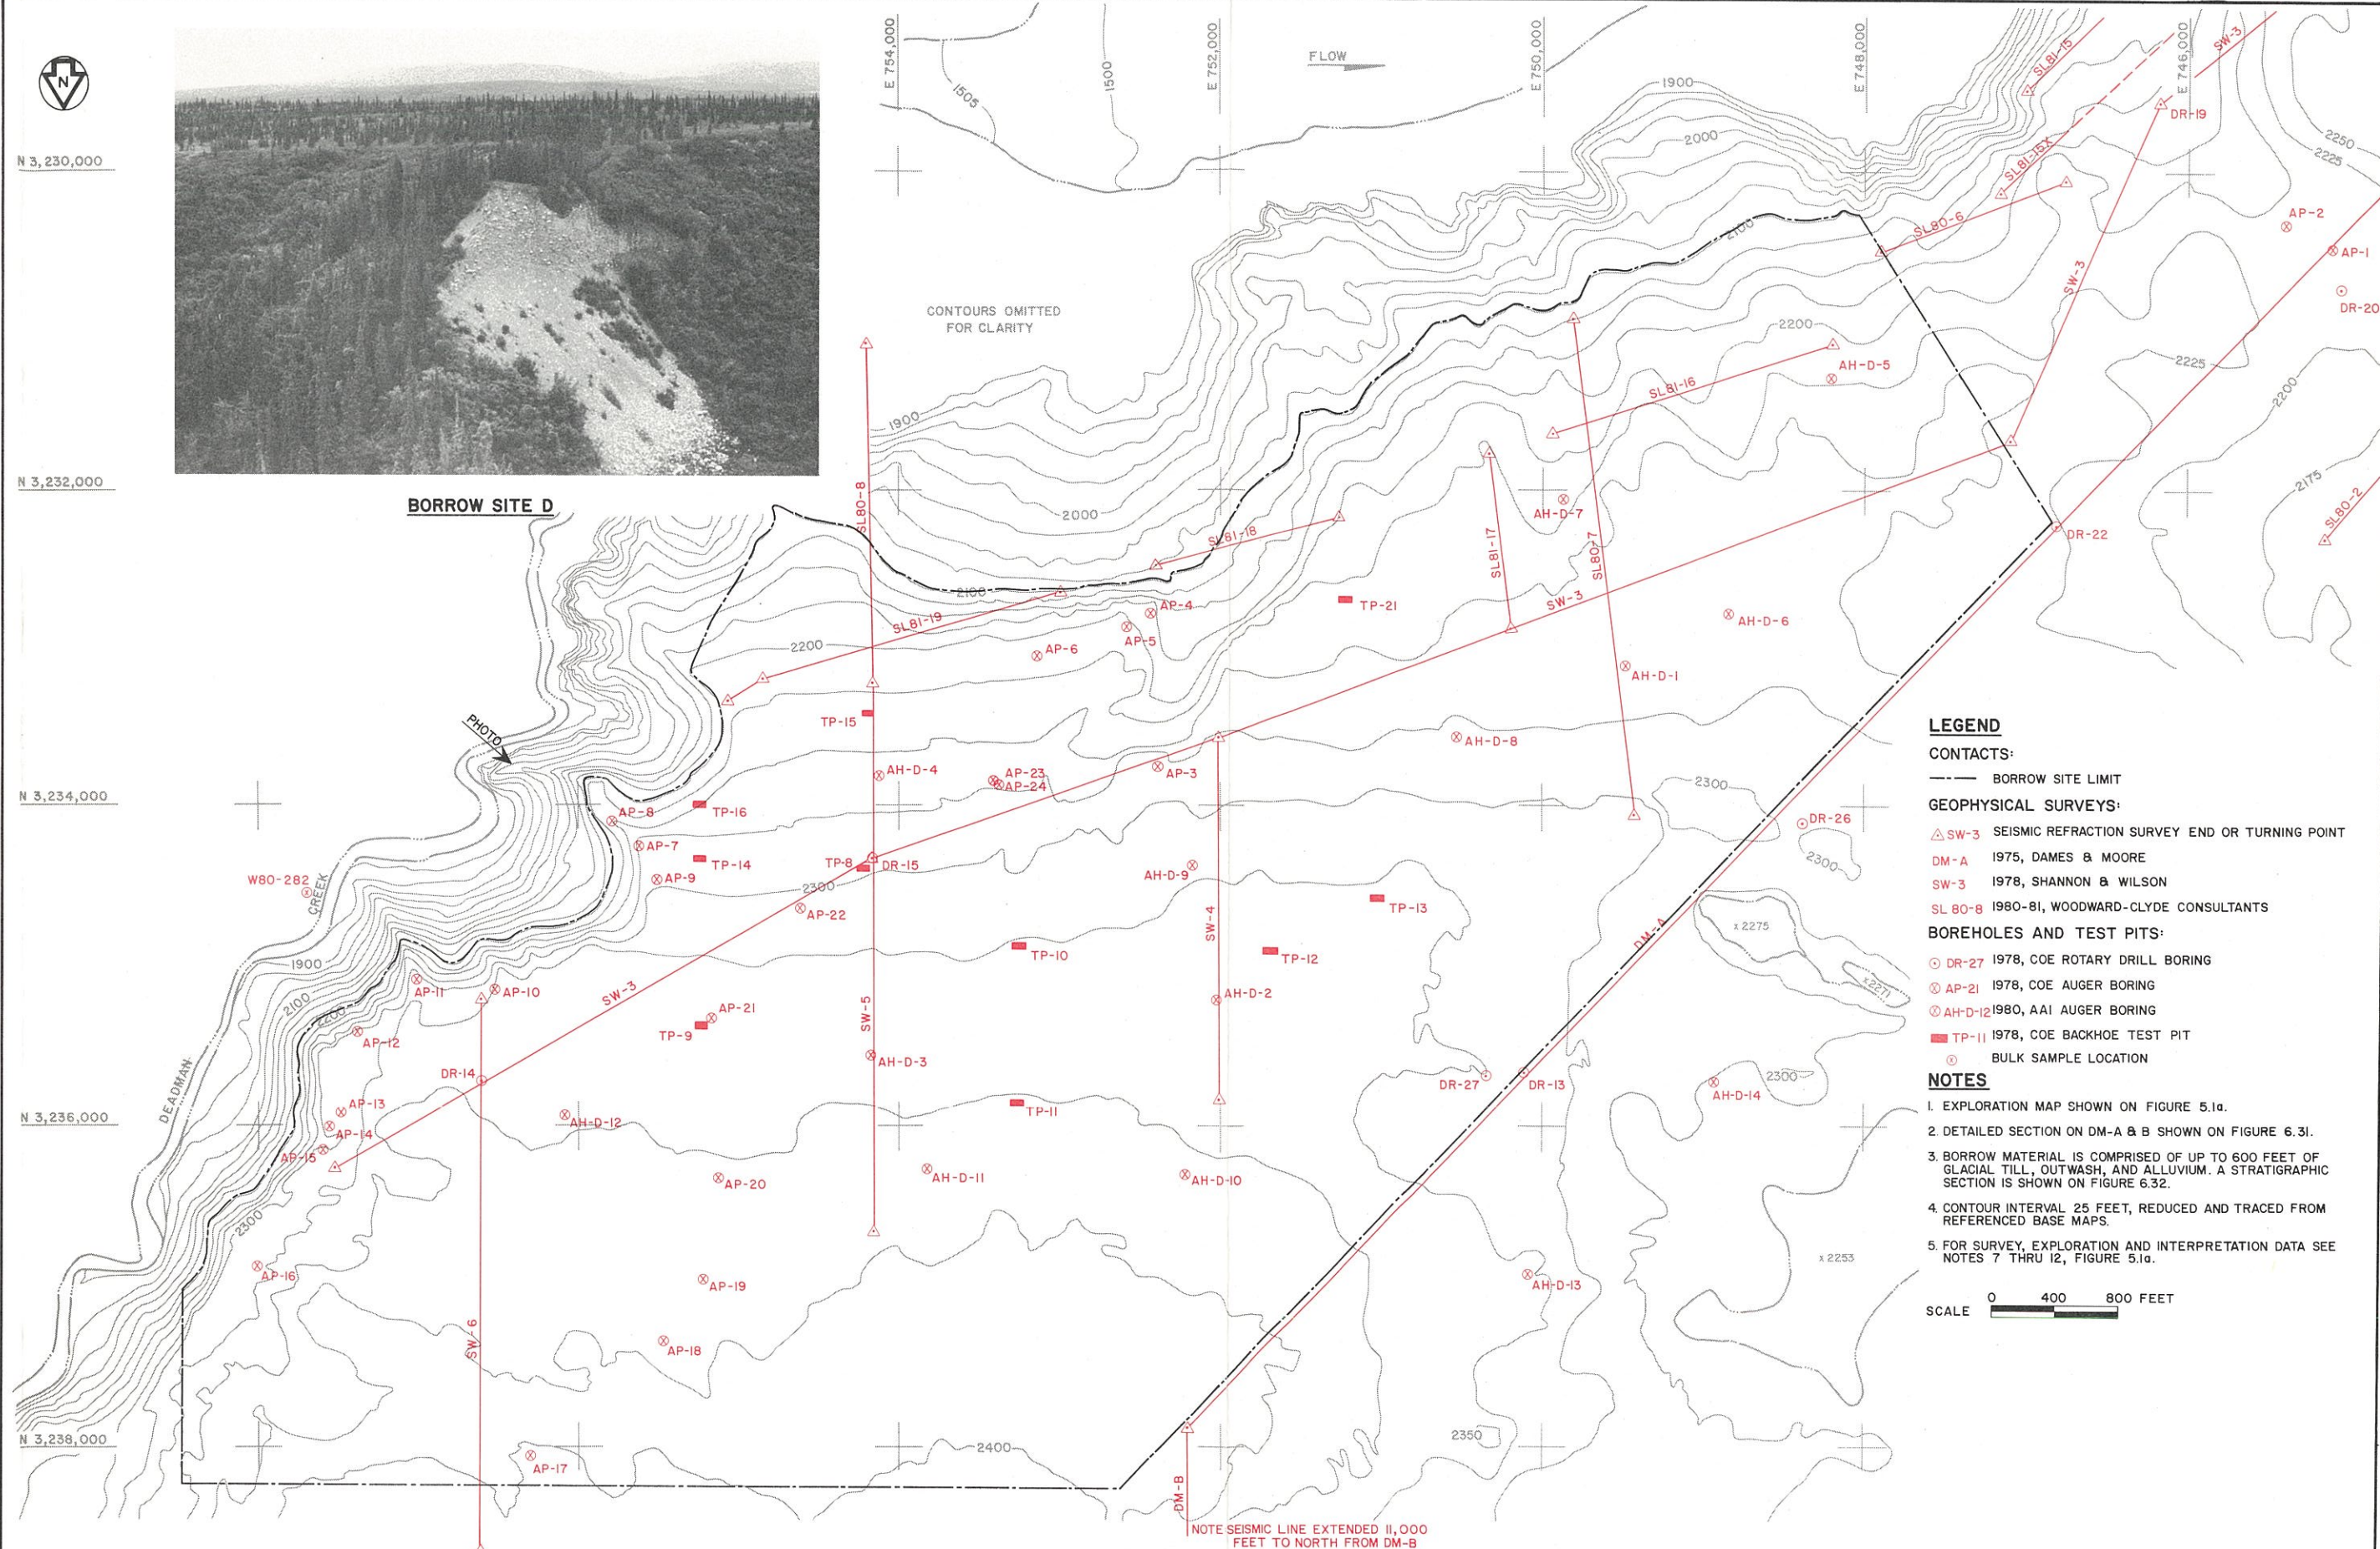
FIGURE 6.40

**WATANA
BORROW SITE D PLAN**

1. EXPLORATION MAP SHOWN ON FIGURE 5.1a.
2. DETAILED SECTION ON DM-A & B SHOWN ON FIGURE 6.31.
3. BORROW MATERIAL IS COMPRISED OF UP TO 600 FEET OF GLACIAL TILL, OUTWASH, AND ALLUVIUM. A STRATIGRAPHIC SECTION IS SHOWN ON FIGURE 6.32.
4. CONTOUR INTERVAL 25 FEET, REDUCED AND TRACED FROM REFERENCED BASE MAPS.
5. FOR SURVEY, EXPLORATION AND INTERPRETATION DATA SEE NOTES 7 THRU 12, FIGURE 5.1a.

The reserve estimates for Borrow Site D have assumed an average material thickness throughout the site limits (Figure 6.40). Based on the currently established boundaries (encompassing about 1,075 acres) and an excavation depth of 120 feet, a total of 200 mcy of material is available.

*Locations shown on Figure 6.40

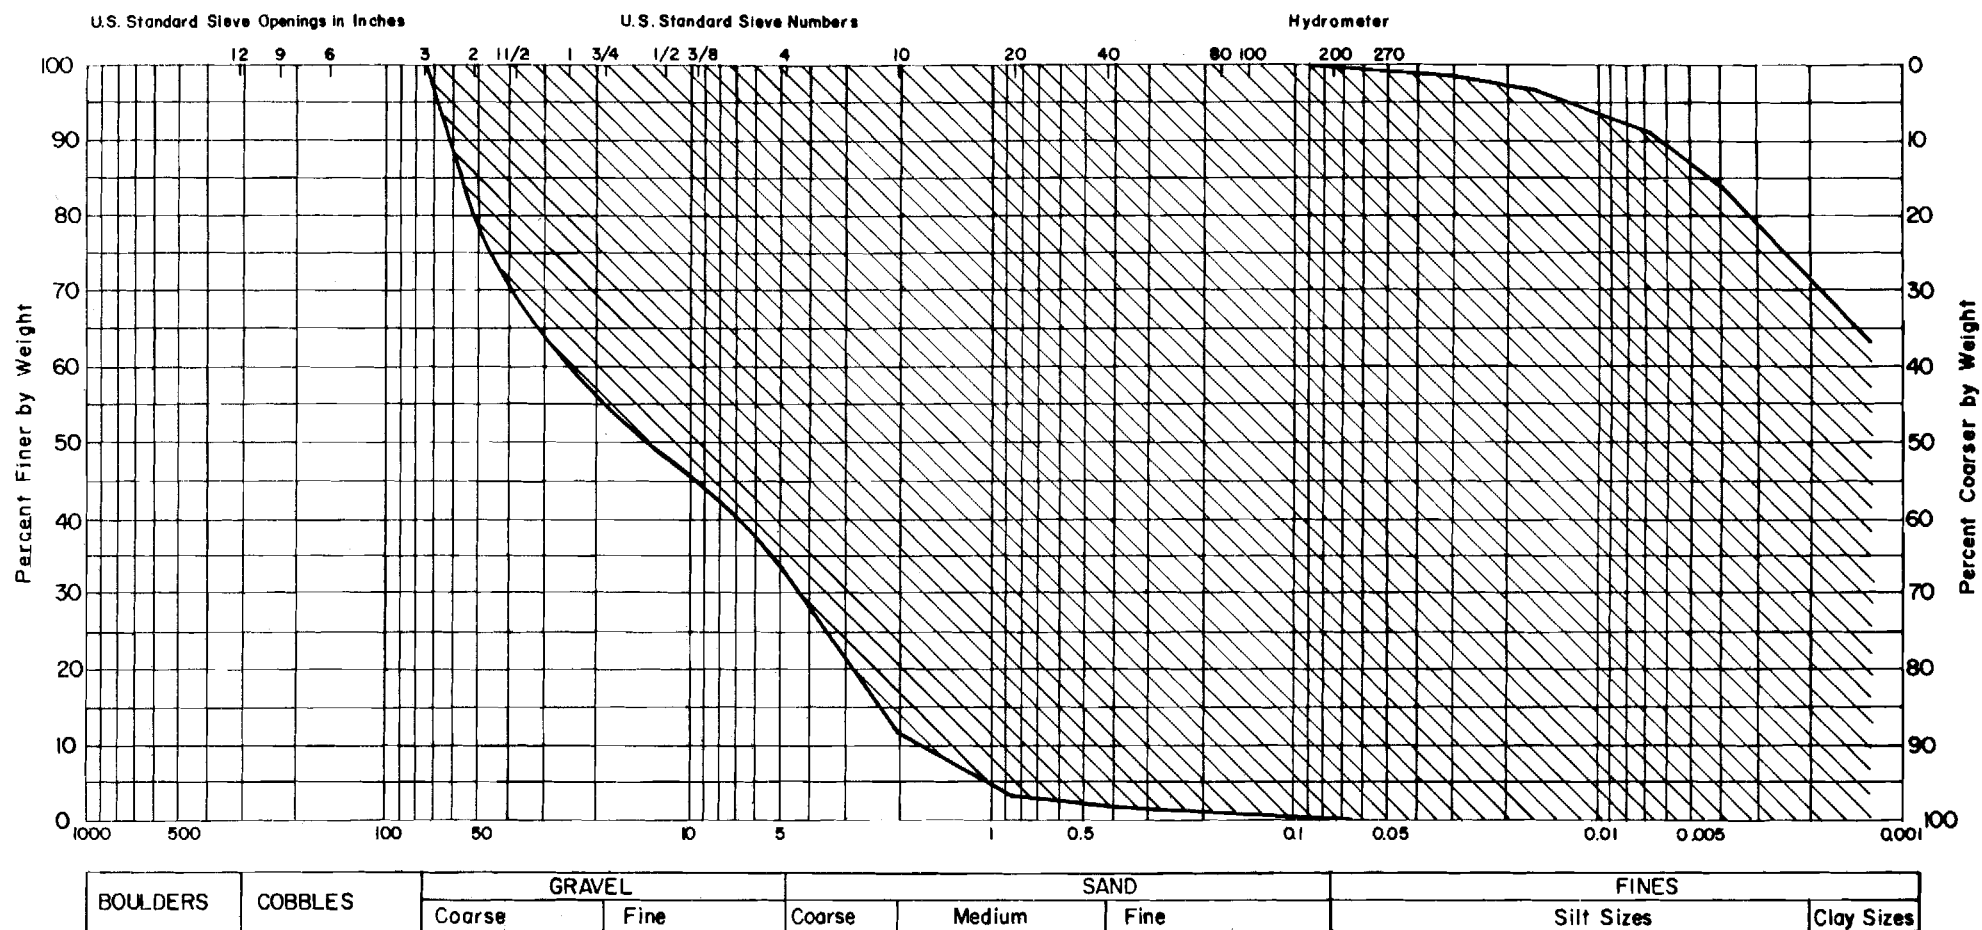
FIGURE 6.41

TOTAL NUMBER OF SAMPLES:146

**WATANA
BORROW SITE D
RANGE OF GRADATIONS**

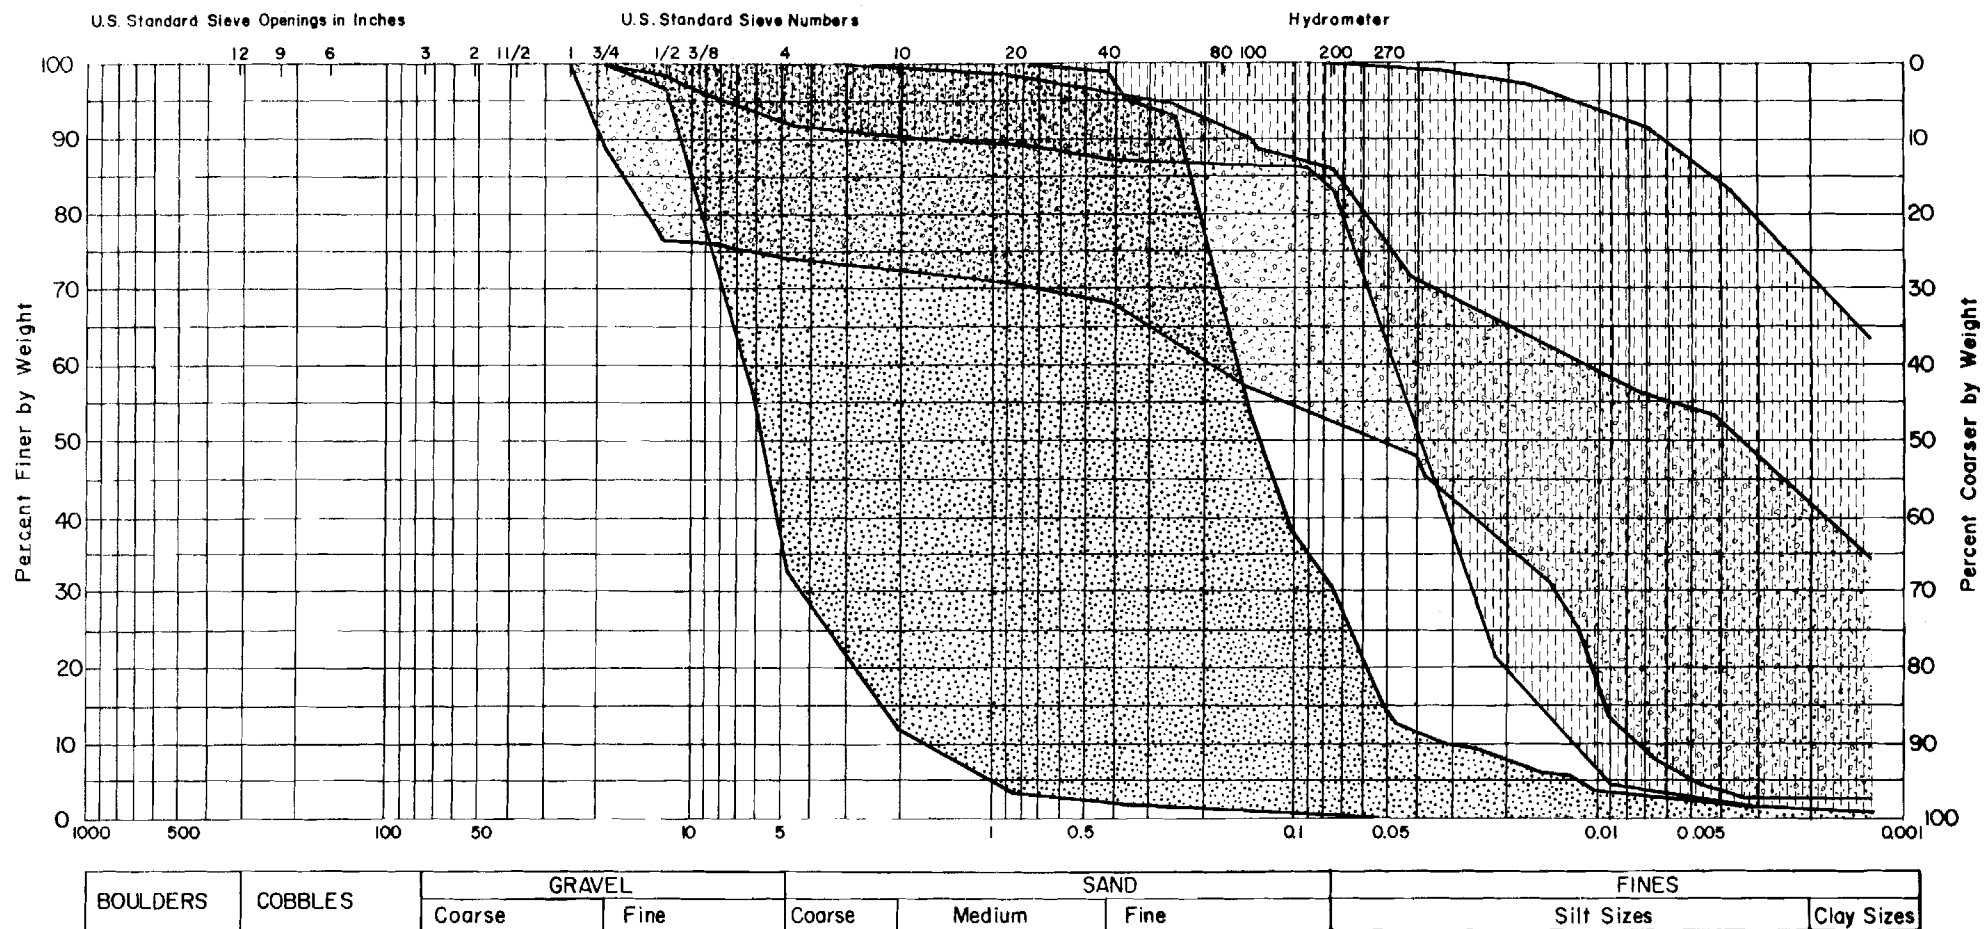
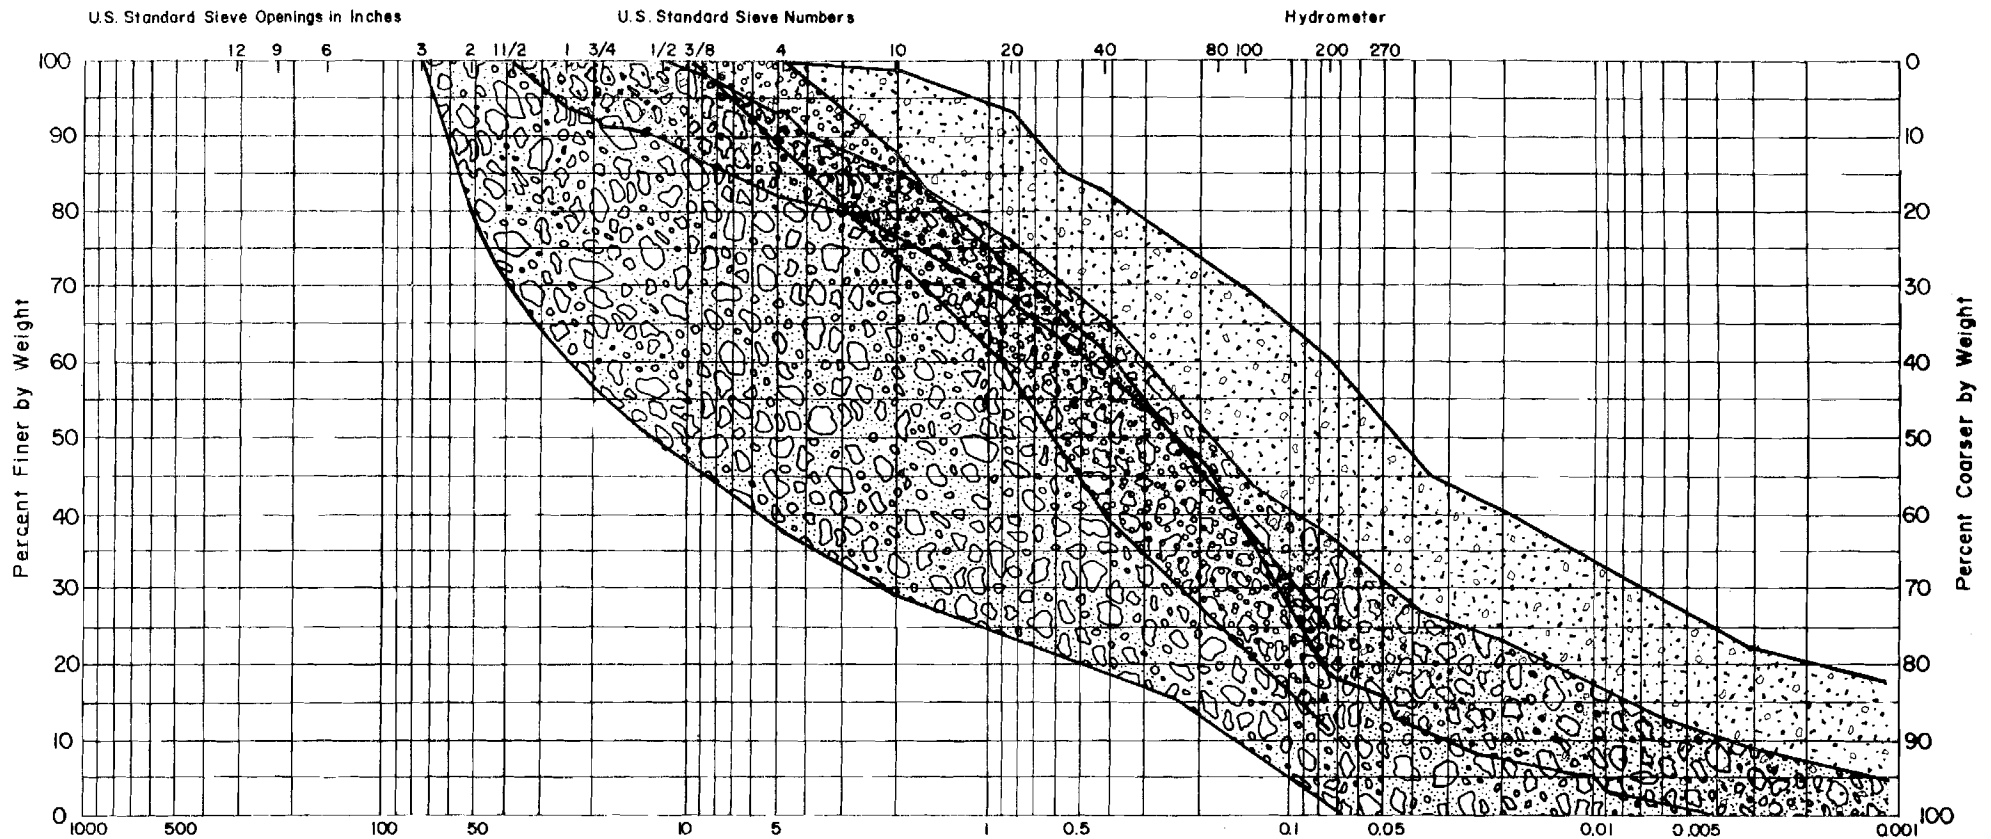
FIGURE 6.42

GRADATION TYPE	MATERIAL	NO. OF SAMPLES
1	SILTY CLAY, CLAYEY SILT WITH SAND	14
2	SILTY CLAY WITH SAND AND GRAVEL	24
3	SILTY SAND WITH GRAVEL	9

WATANA
BORROW SITE D
MATERIAL GRADATION TYPES
SHEET 1 OF 2

GRADATION TYPE	MATERIAL	NO. OF SAMPLES
	4 SILTY SAND WITH CLAY AND GRAVEL	41
	5 SILTY SAND WITH GRAVEL	8
	6 GRAVELLY SAND, SANDY GRAVEL	50
