SUSITNA HYDROELECTRIC PROJECT

1980-81 GEOTECHNICAL REPORT

VOLUME 1
TEXT
FINAL DRAFT

ALASKA POWER AUTHORITY

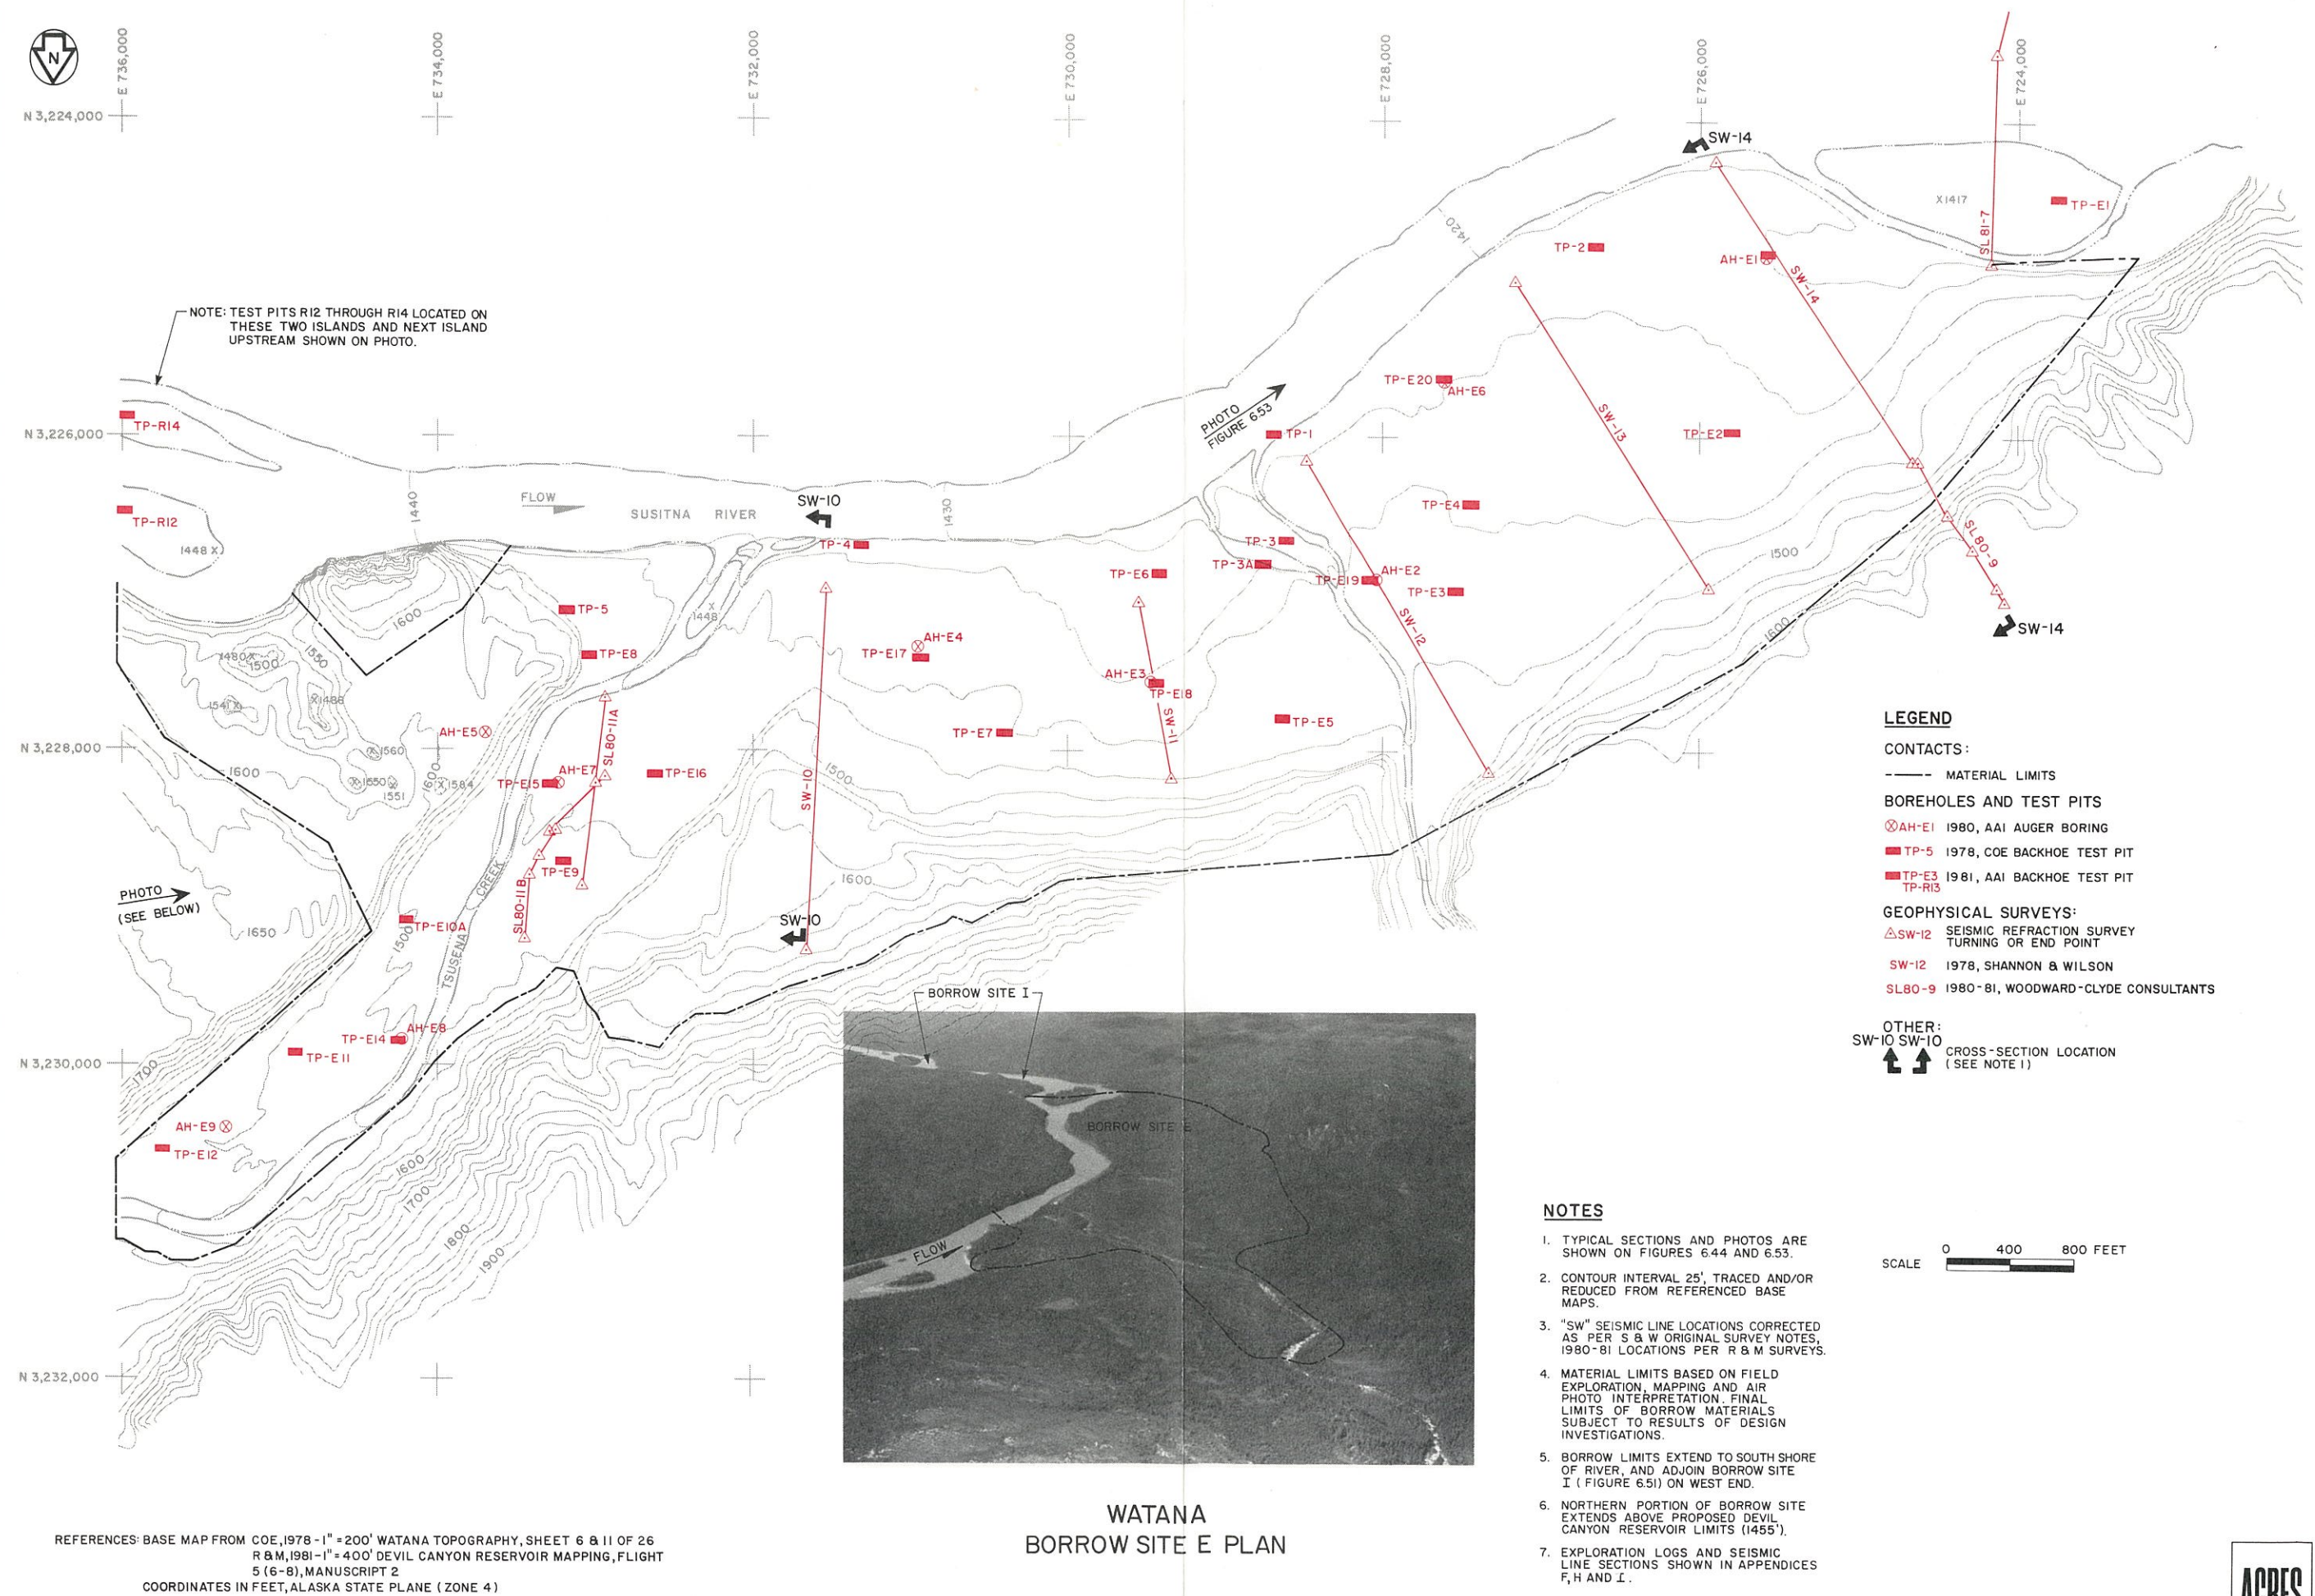
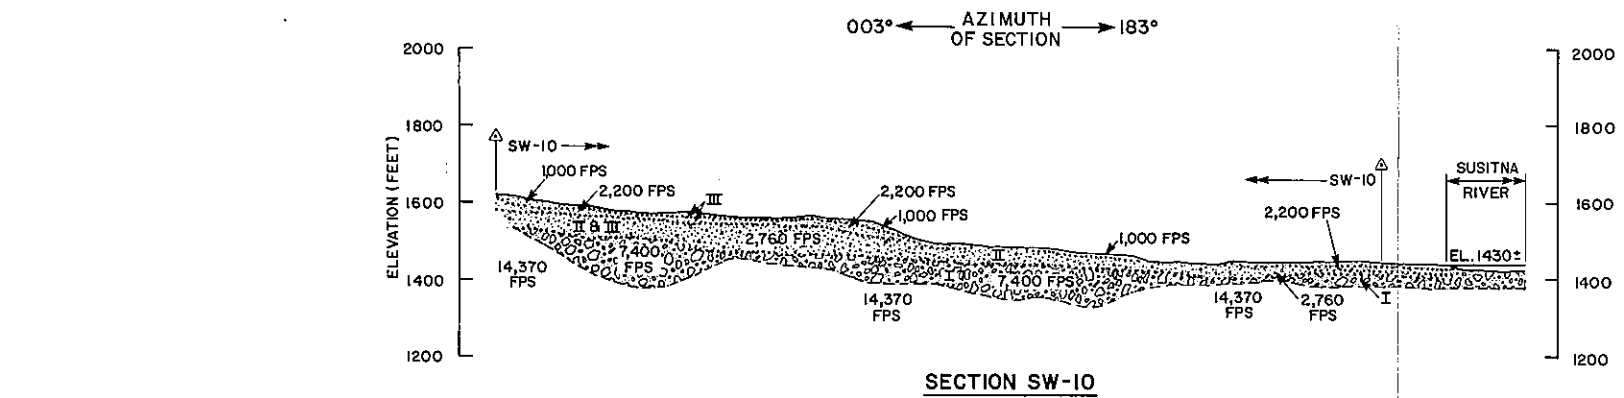
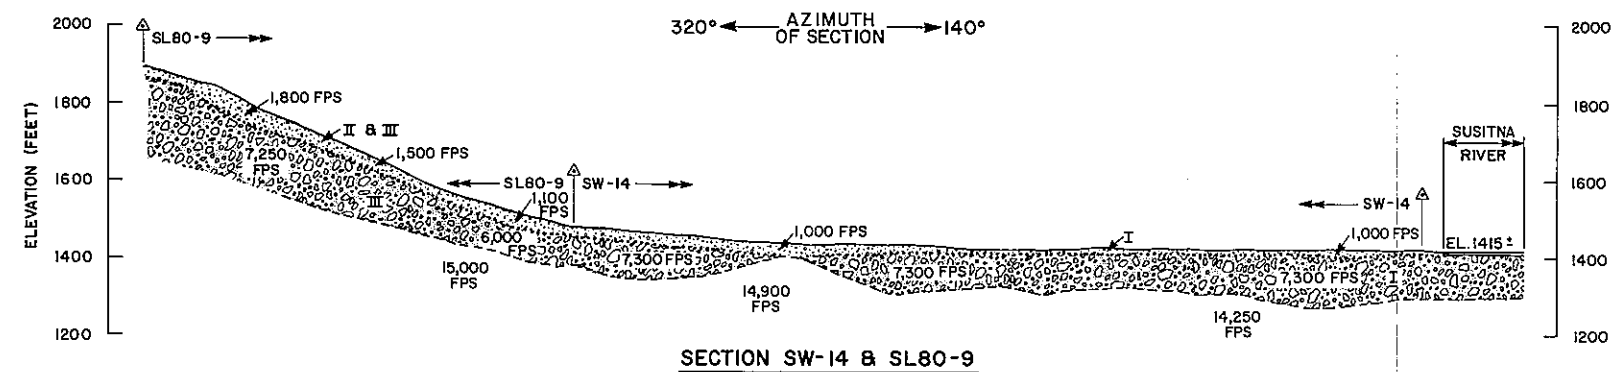
1. SECTION LOCATIONS SHOWN ON FIGURE 6.43
2. ALL SECTIONS LOOKING UPSTREAM (EAST).
3. VERTICAL AND HORIZONTAL SCALES EQUAL.
4. SECTION ELEVATIONS FROM REFERENCED BASE MAPS, TRACED AT 25' CONTOUR INTERVALS.
5. ADDITIONAL PHOTOS AND SKETCHES OF TYPICAL BORROW SITE CONDITIONS SHOWN ON FIGURE 6.53
6. ZONES INDICATE MATERIAL TYPES AS DESCRIBED IN TEXT. INFERRED ORIGINS ARE:
 - I. SUSITNA RIVER ALLUVIAL GRAVELS
 - II. TSUSENA CREEK BED ALLUVIAL GRAVELS
 - III. OUTWASH OR HIGH LEVEL HISTORIC GRAVEL & SAND TERRACES
7. SECTIONS LIE ON SHANNON & WILSON 1978 SEISMIC LINES, COE 1978, AND S & W 1978.
8. REFER TO TABLE 6.1 FOR SEISMIC VELOCITY AND MATERIAL CORRELATION.
9. PHOTOS TAKEN APRIL, AUGUST 1981.

WATANA
BORROW SITE E SECTIONS

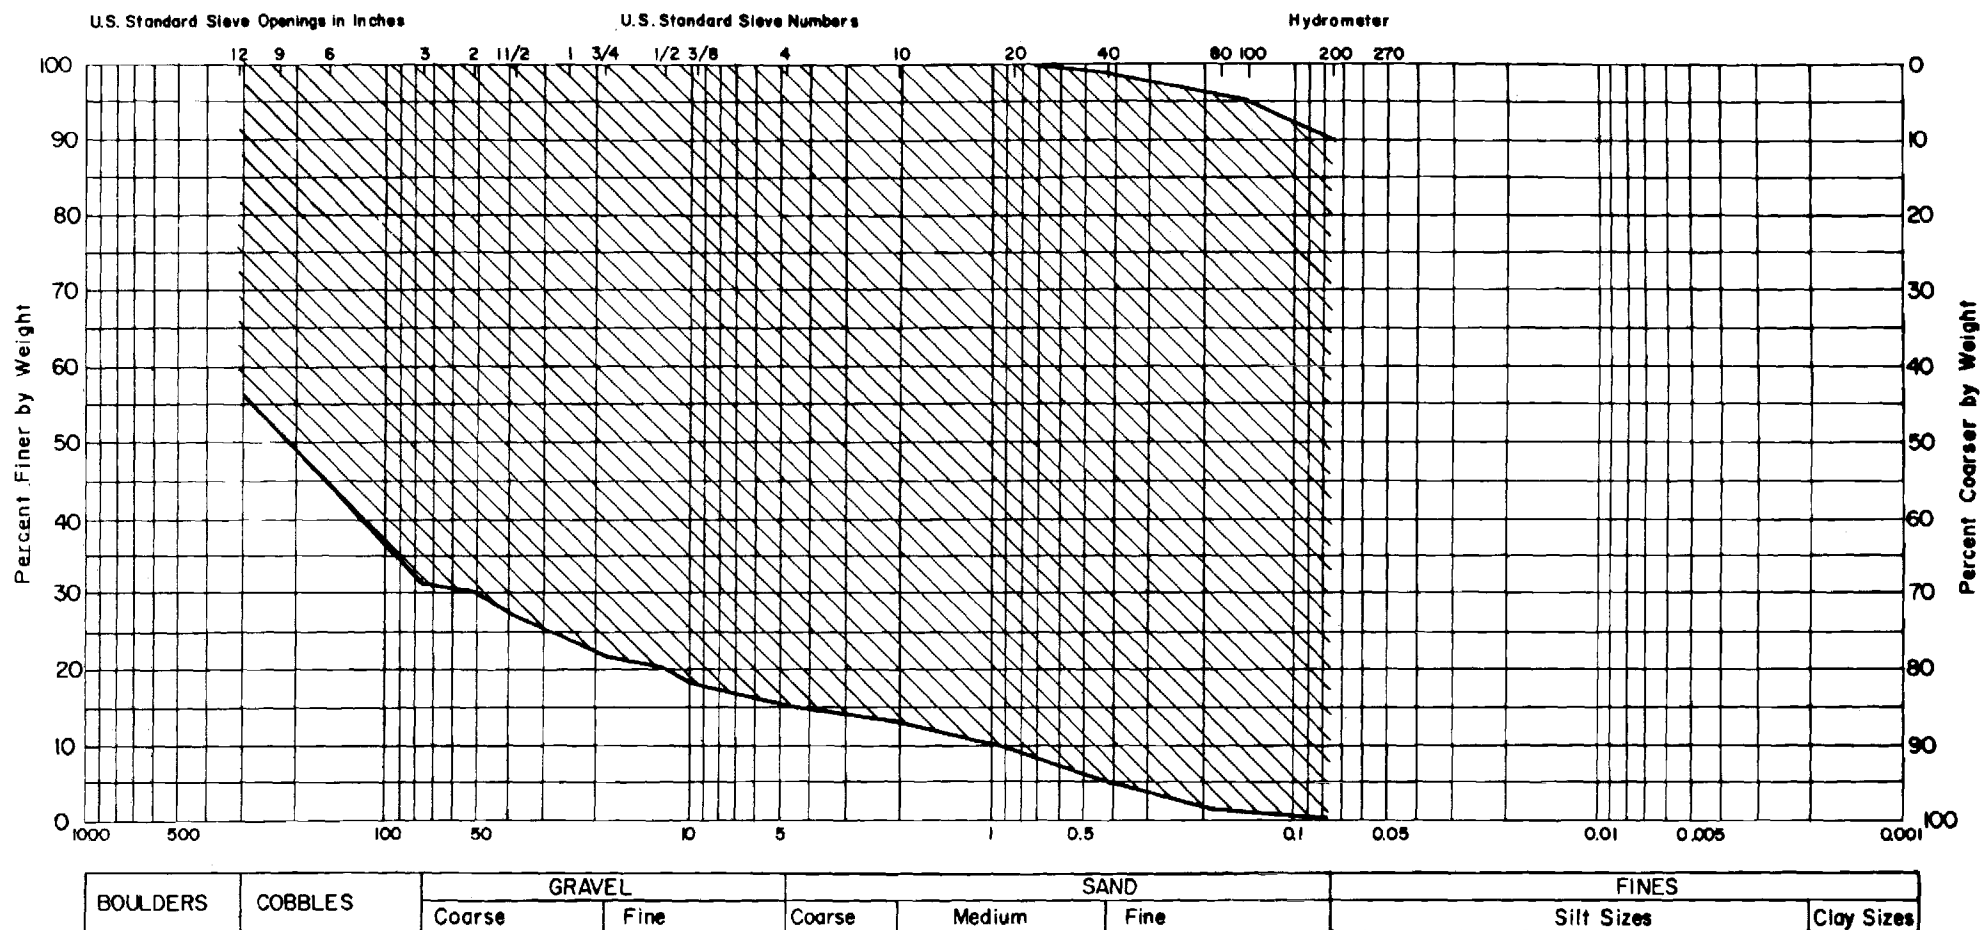
FIGURE 6.45

TOTAL NUMBER OF SAMPLES : 50

WATANA
BORROW SITE E
RANGE OF GRADATIONS

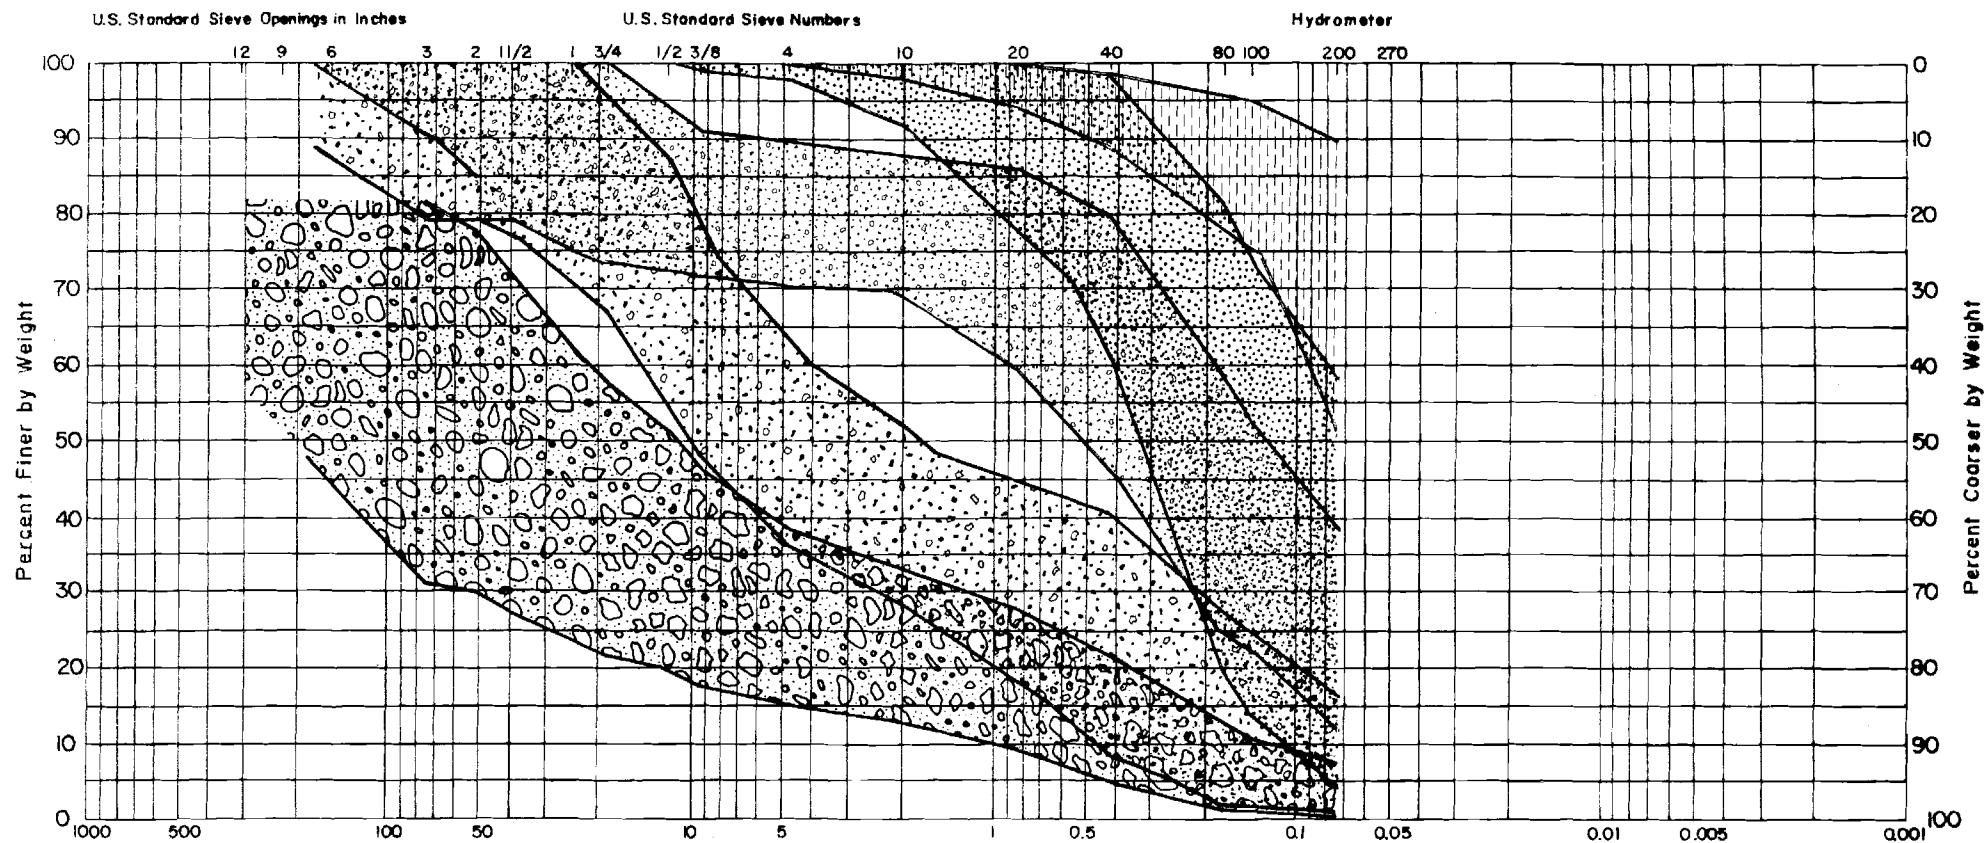
FIGURE 6.46

UNIT	MATERIAL	NO. OF SAMPLES	UNIT	MATERIAL	NO. OF SAMPLES
	A SANDY SILT WITH TRACE CLAY	4		D SANDY GRAVEL, GRAVELLY SAND	11
	B SILTY SAND	10		E SANDY GRAVEL WITH SILT, COBBLES, BOULDERS	19
	C SILTY SAND WITH CLAY, GRAVEL, COBBLES	6

WATANA
BORROW SITE E
STRATIGRAPHIC UNIT GRADATIONS

A summary of the samples and laboratory tests performed on selected materials from Borrow Site E are shown in Table 6.10. Details of the laboratory testing are provided in Appendix F. The soil units A through E range from coarse sandy gravel through gravelly sand, silty sand, cobbles and boulders, silty sand and silt (Figure 6.46). Several of these material units correlate well with the material in Sites I and J (Sections 6.3[h]). Moisture contents for the silts range from 25 to 30 percent; sand from 4 to 15 percent; and gravels from 1 to 5 percent. The percentage of material over 6 inches is roughly estimated at 10 percent with the over-12-inch estimated at 5 percent.

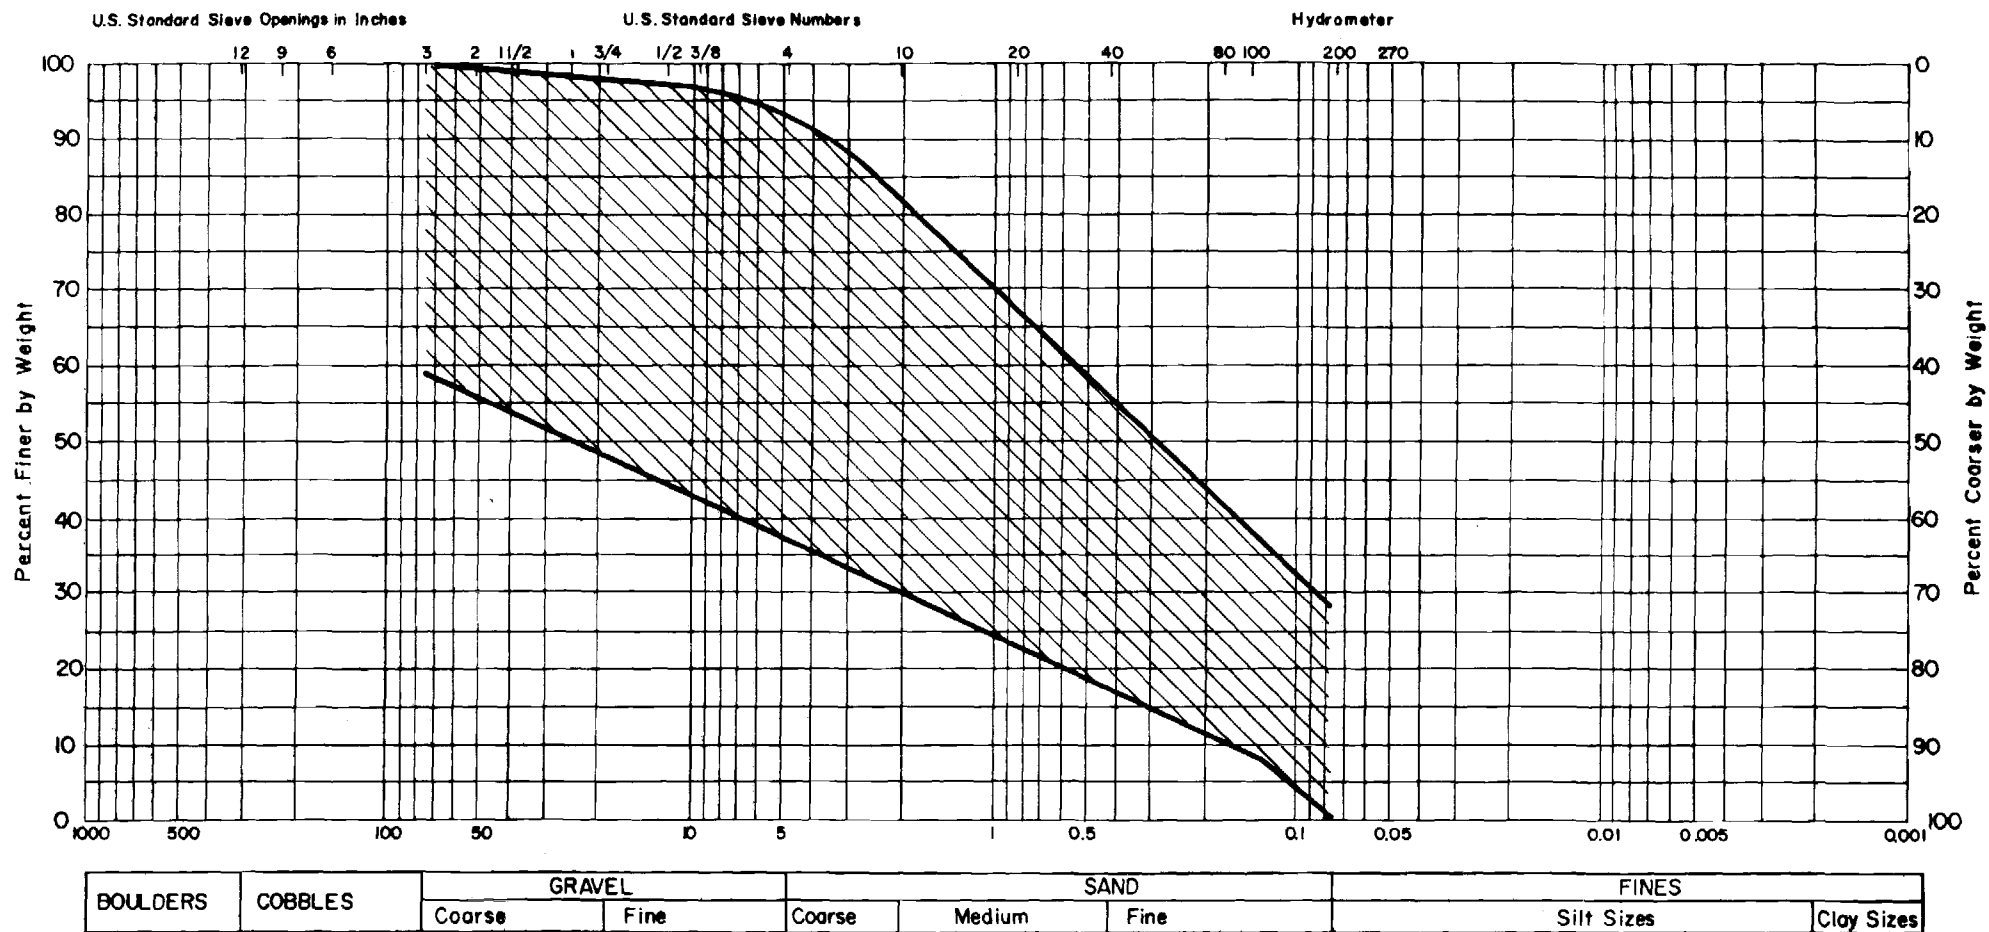
TOTAL NUMBER OF SAMPLES : 10

**WATANA
BORROW SITES C & F
RANGE OF GRADATIONS**

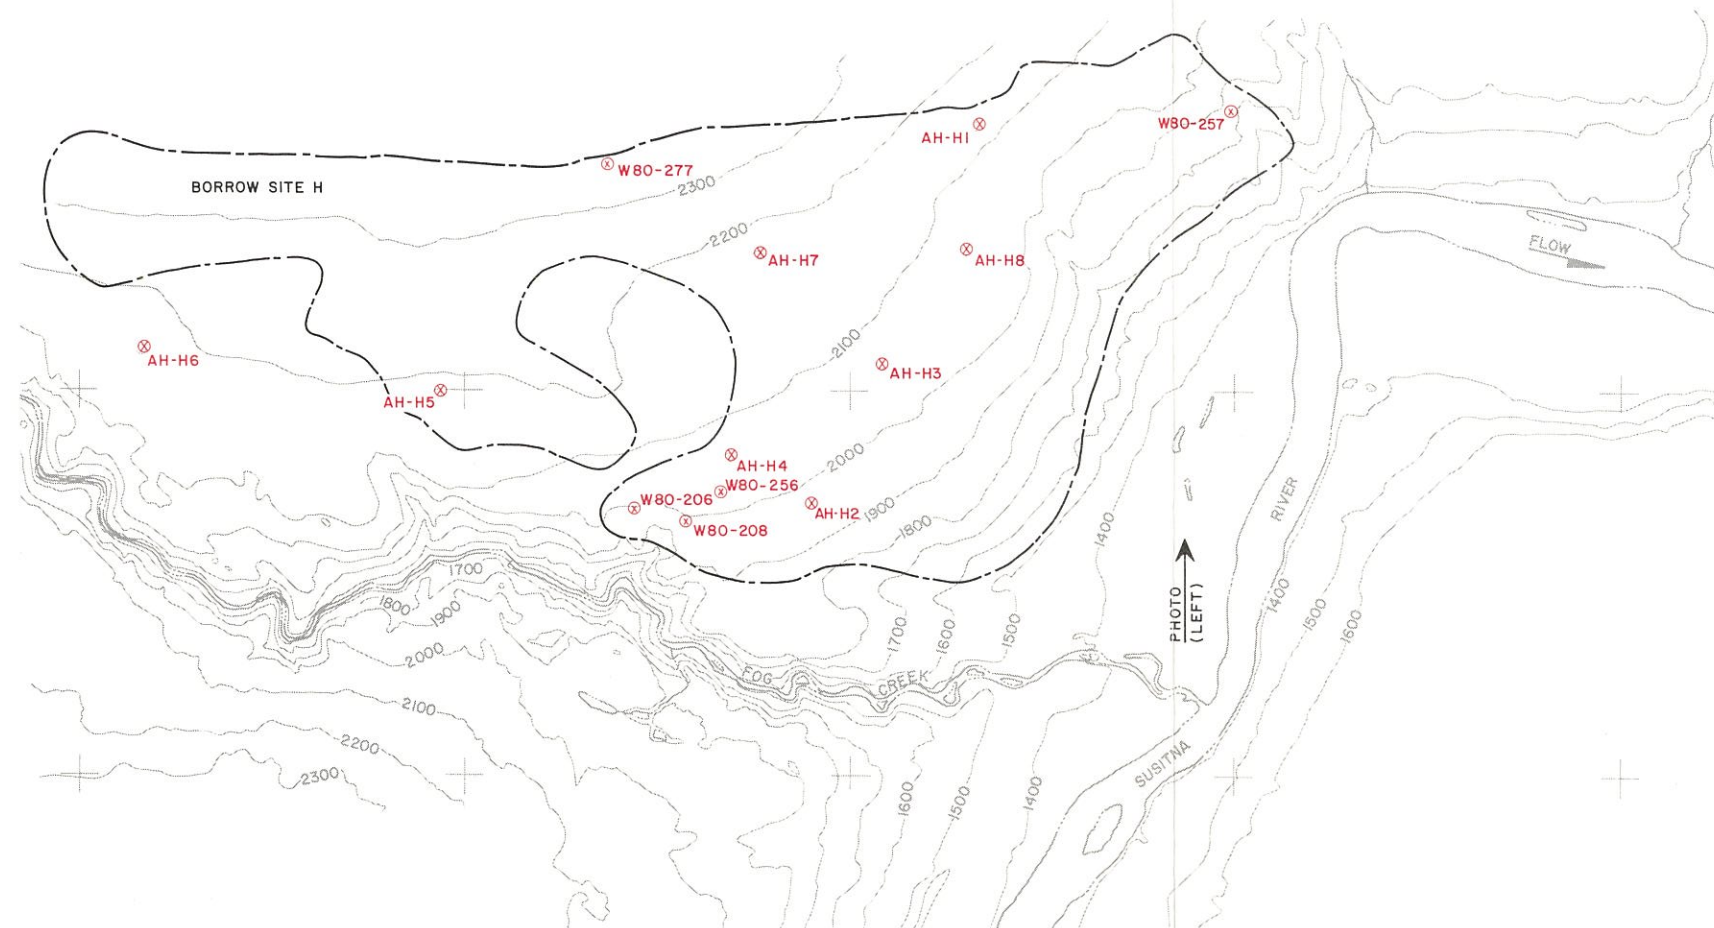
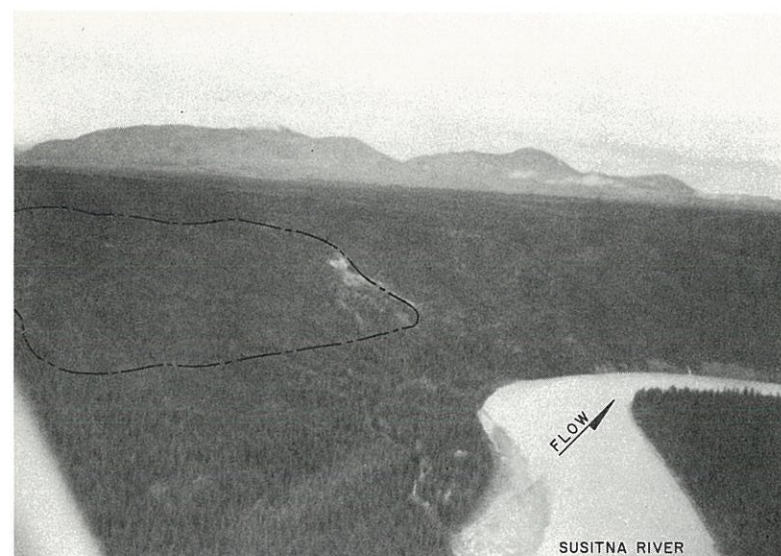
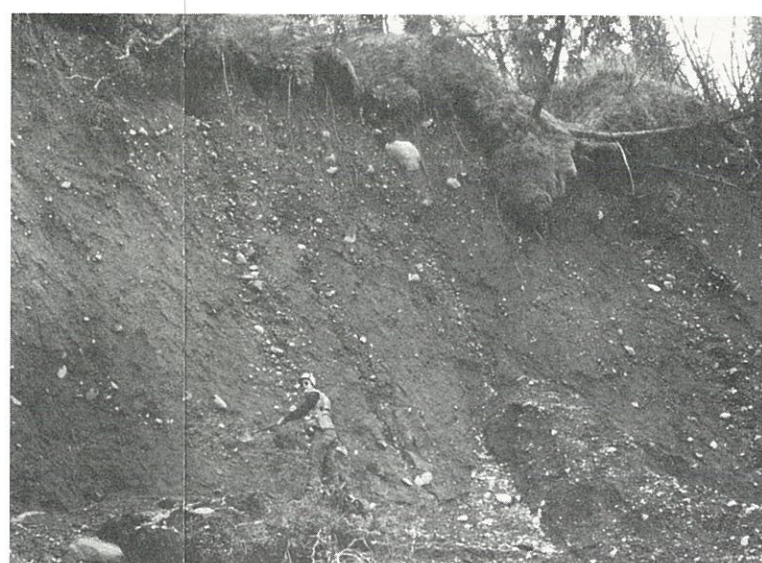
**WATANA
BORROW SITE H PLAN**

1. CONTOUR INTERVAL 100', TRACED FROM ENLARGED REFERENCED BASE MAP.
2. MATERIAL LIMITS BASED ON FIELD AND AIR PHOTO INTERPRETATION. FINAL MAPPED LIMITS OF BORROW SITE SUBJECT TO RESULTS OF DESIGN INVESTIGATIONS.
3. BORROW MATERIAL IS GLACIAL OUTWASH AND TILL OVERLYING BEDROCK. DEPTH TO BEDROCK ESTIMATED TO AVERAGE 40 - 50 FEET.
4. ENTIRE BORROW SITE LIES OUTSIDE OF PROPOSED WATANA AND DEVIL CANYON RESERVOIR LIMITS.
5. EXPLORATION LOGS SHOWN IN APPENDIX F.
6. PHOTOS TAKEN AUGUST 1981 (LEFT), SEPT. 1980 (RIGHT).

BORROW SITE H

TYPICAL BORROW MATERIAL EXPOSURE

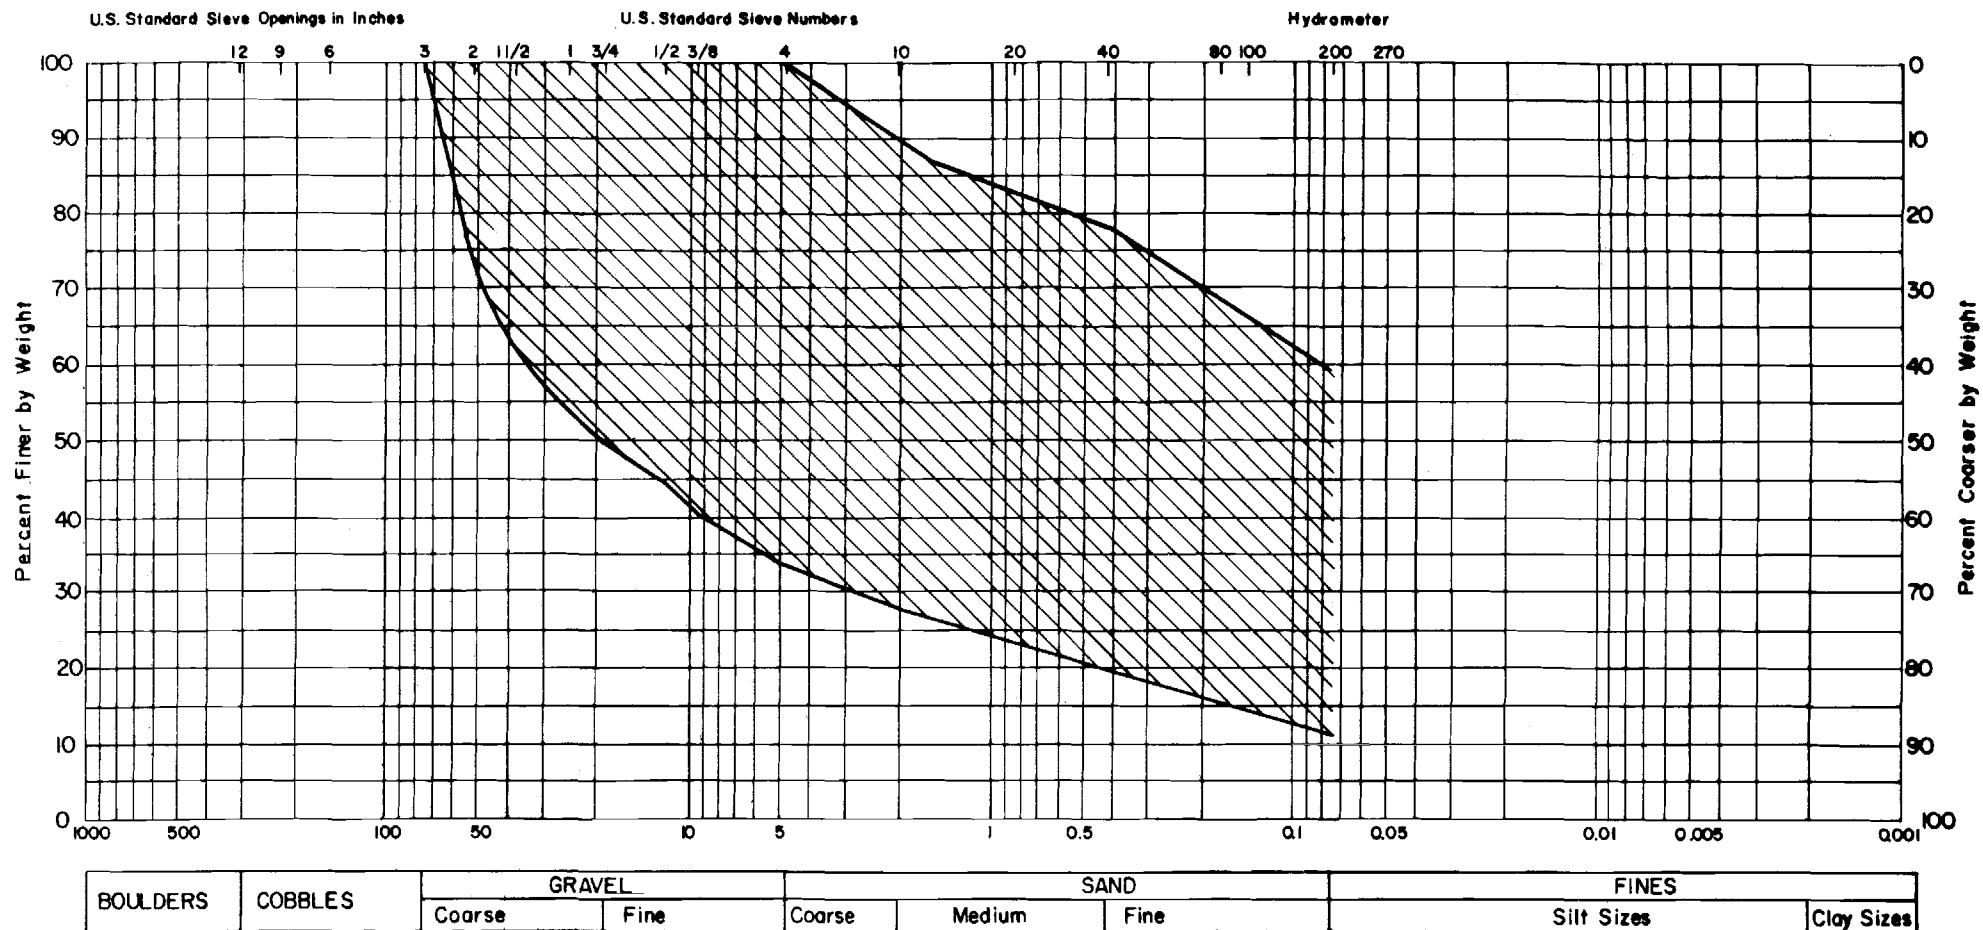
FIGURE 6.49

TOTAL NUMBER OF SAMPLES : 49

**WATANA
BORROW SITE H
RANGE OF GRADATIONS**

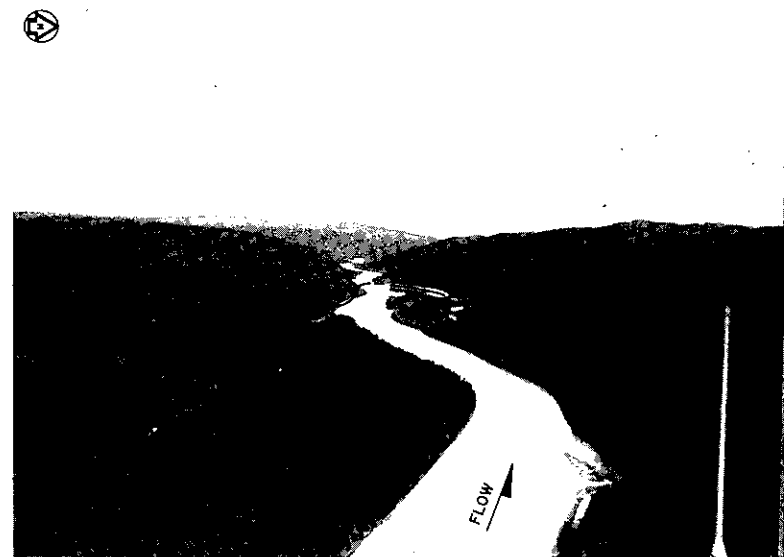
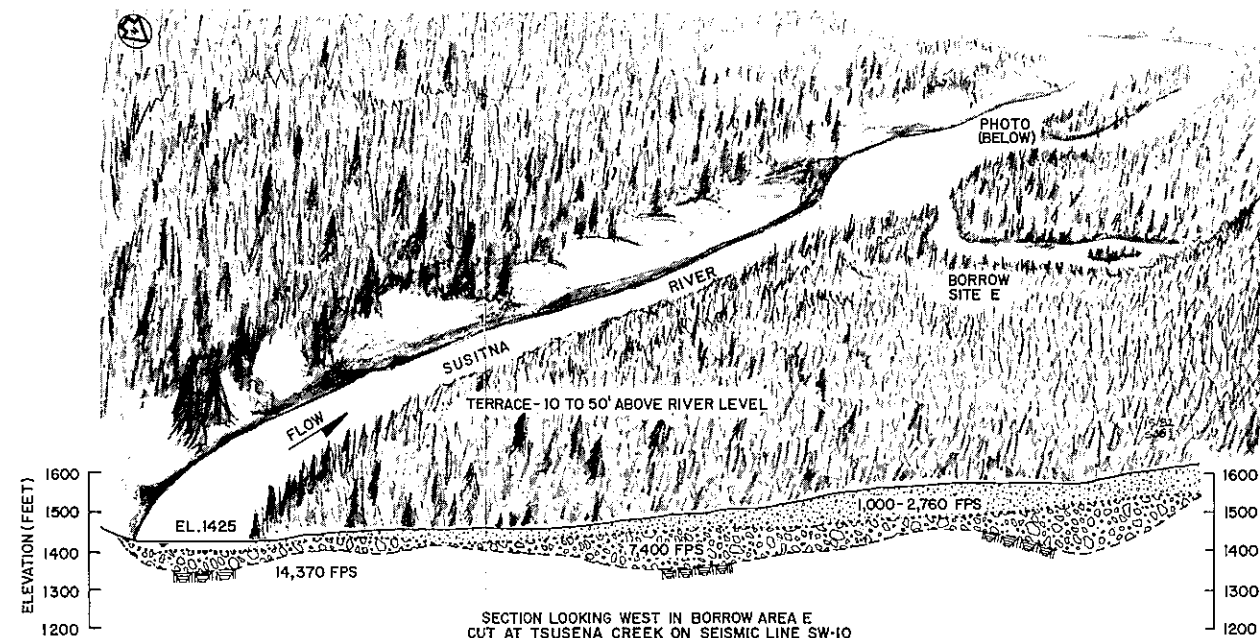
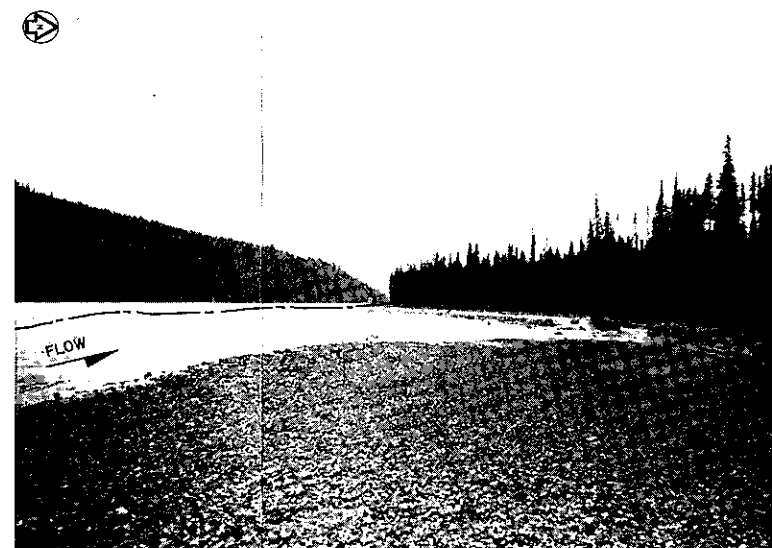
WATANA
BORROW SITES E, I & J
PHOTOS & TYPICAL SECTION

BORROW SITE I
(DOWNSTREAM OF WATANA)

BORROW SITE J
(UPSTREAM OF WATANA)

WATANA-RIVER ALLUVIUM
TYPICAL SECTION

BORROW SITES I & J
TYPICAL RIVER DEPOSIT
(PHOTO TAKEN IN BORROW SITE E
UPSTREAM OF SITE I
NOTED ON TYPICAL SECTION)

- PHOTO LOCATIONS & BORROW SITE MAPS SHOWN ON FIGURE 6.43 (SITE E), FIGURE 6.51 (SITE I), FIGURE 6.52 (SITE J), AND FIGURE 6.53.
- PHOTOS TAKEN AUGUST 1981.
- REFER TO TABLE 6.1 FOR SEISMIC VELOCITY AND MATERIAL CORRELATION.
- VERTICAL SCALE 2 TIMES HORIZONTAL.

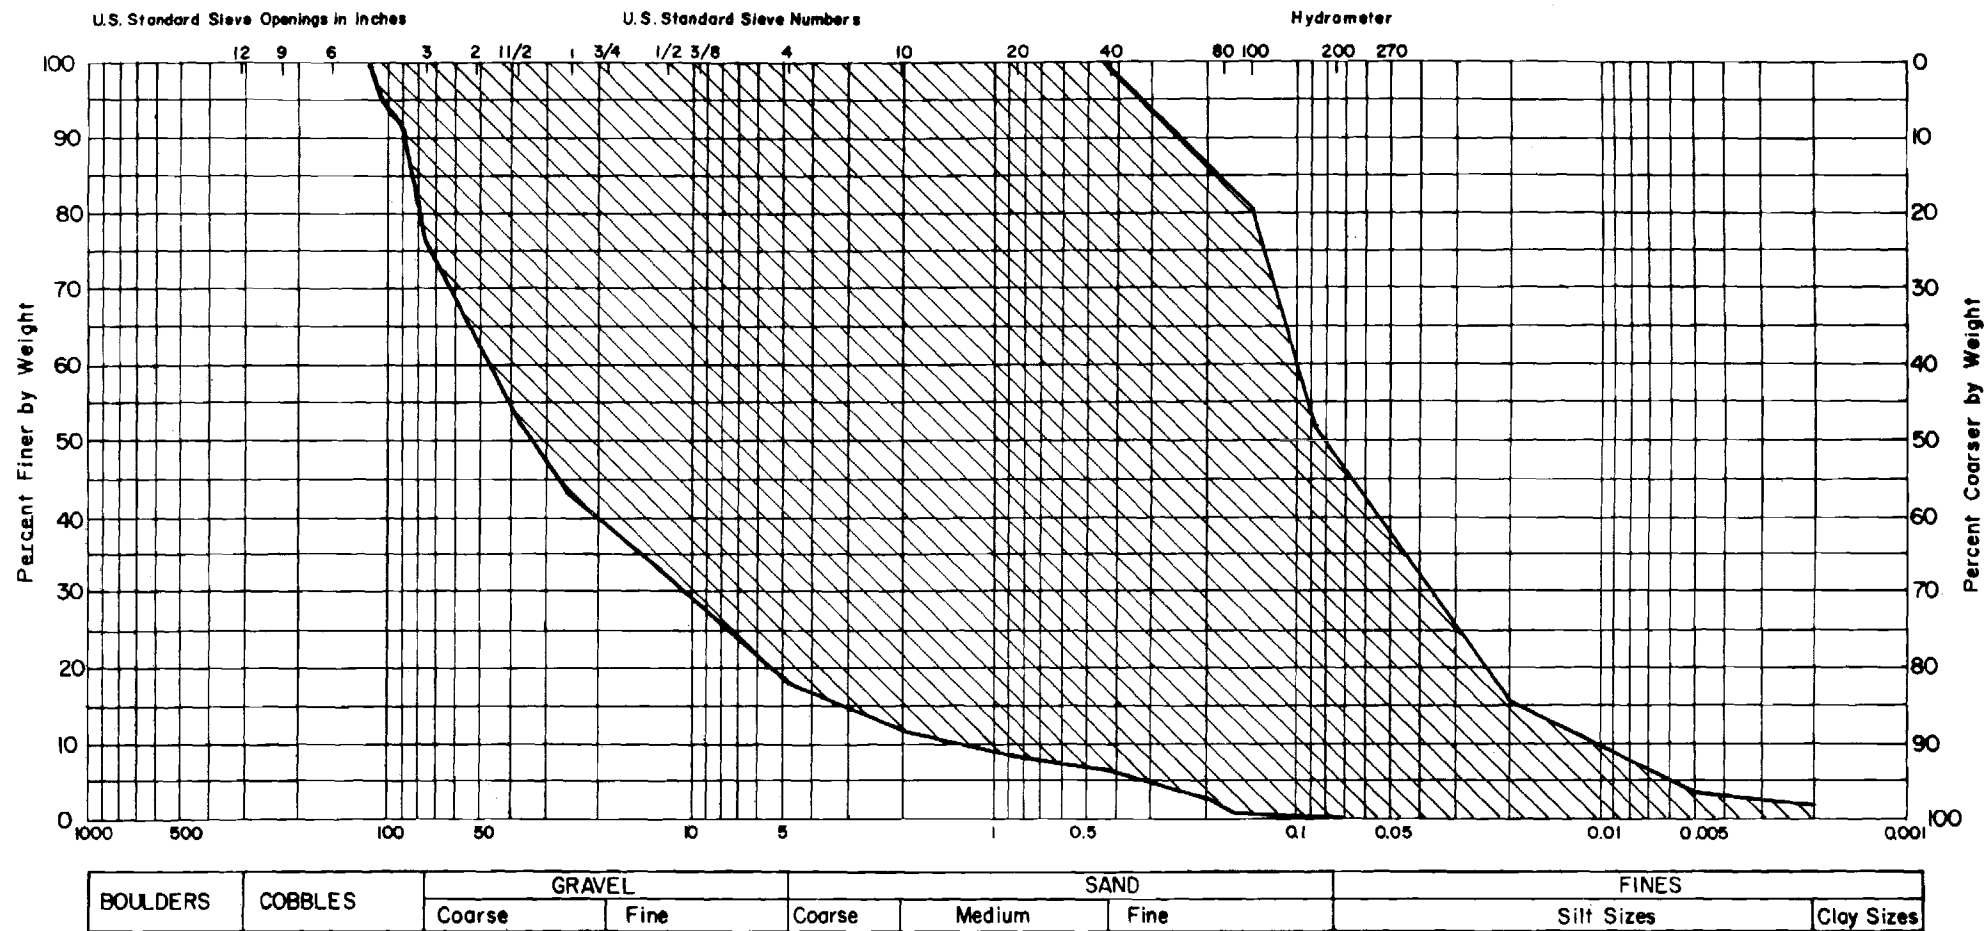
FIGURE 6.54

TOTAL NUMBER OF SAMPLES: 35

**WATANA
BORROW SITES I & J
RANGE OF GRADATIONS**

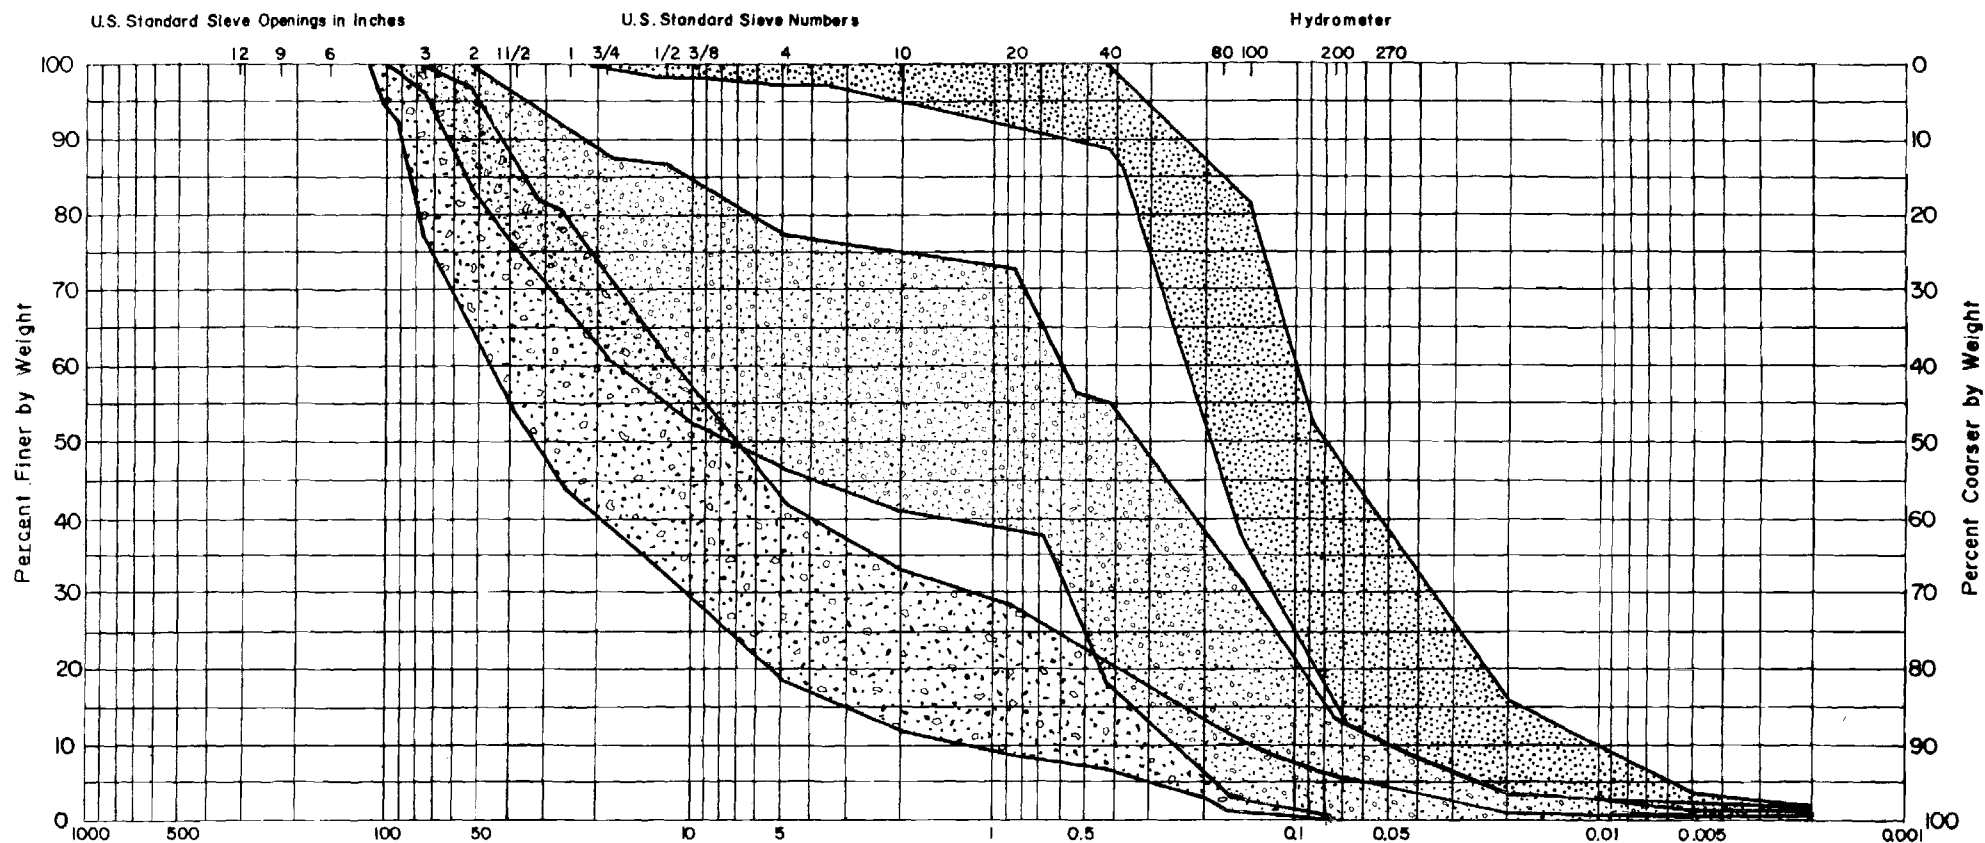
FIGURE 6.55

BOULDERS	COBBLES	GRAVEL		SAND			FINES	
		Coarse	Fine	Coarse	Medium	Fine	Silt Sizes	Clay Sizes

**WATANA
BORROW SITES I & J
STRATIGRAPHIC UNIT GRADATIONS**
