SUSITNA HYDROELECTRIC PROJECT

1980-81 GEOTECHNICAL REPORT

VOLUME 1
TEXT
FINAL DRAFT

ALASKA POWER AUTHORITY

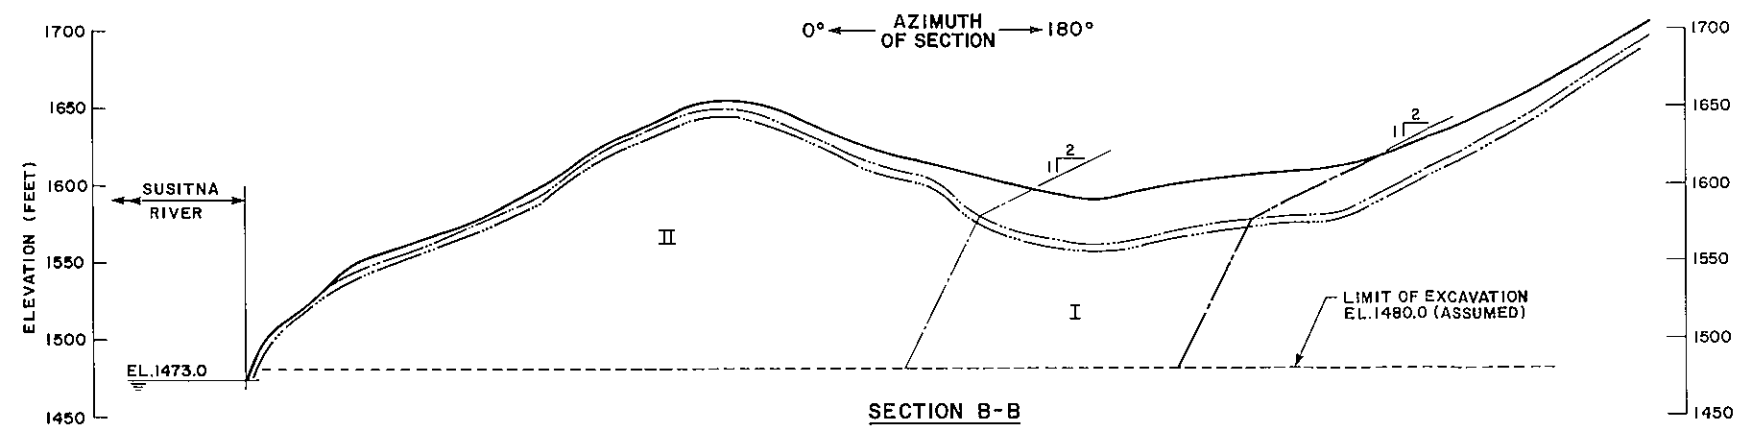
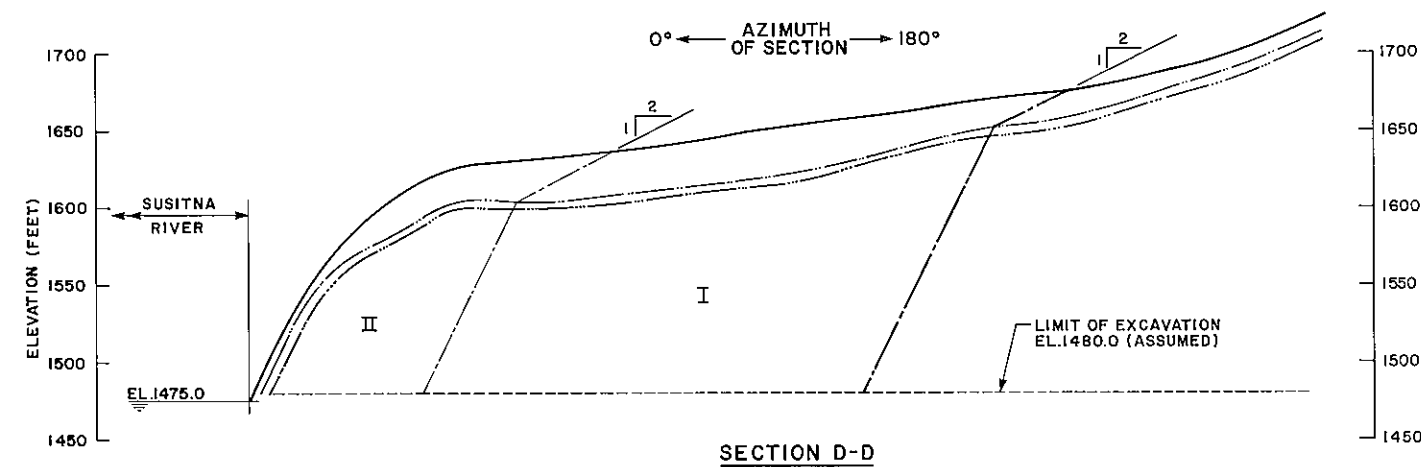
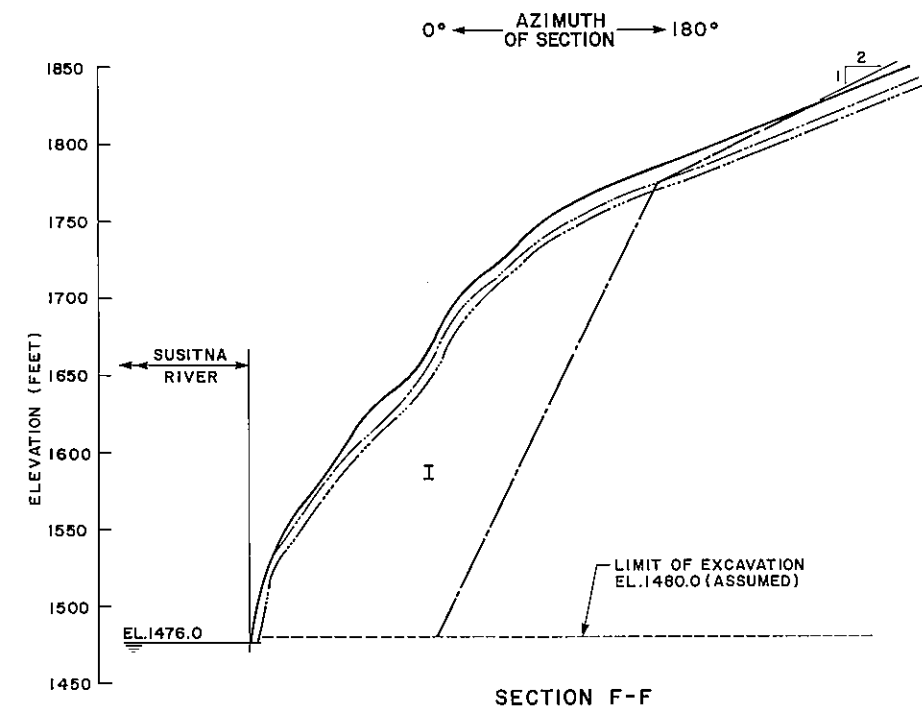
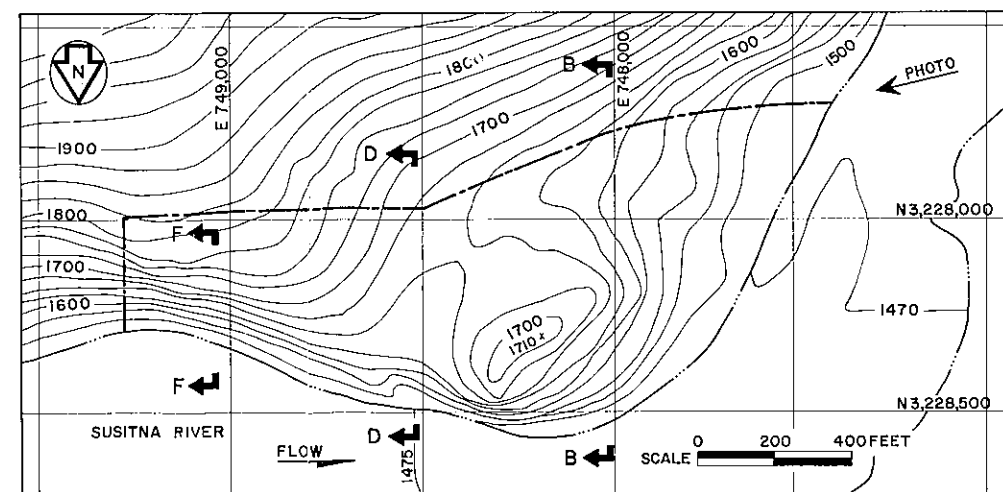
WATANA
QUARRY SITE L PLAN AND SECTIONS

QUARRY SITE L PHOTO

PLAN

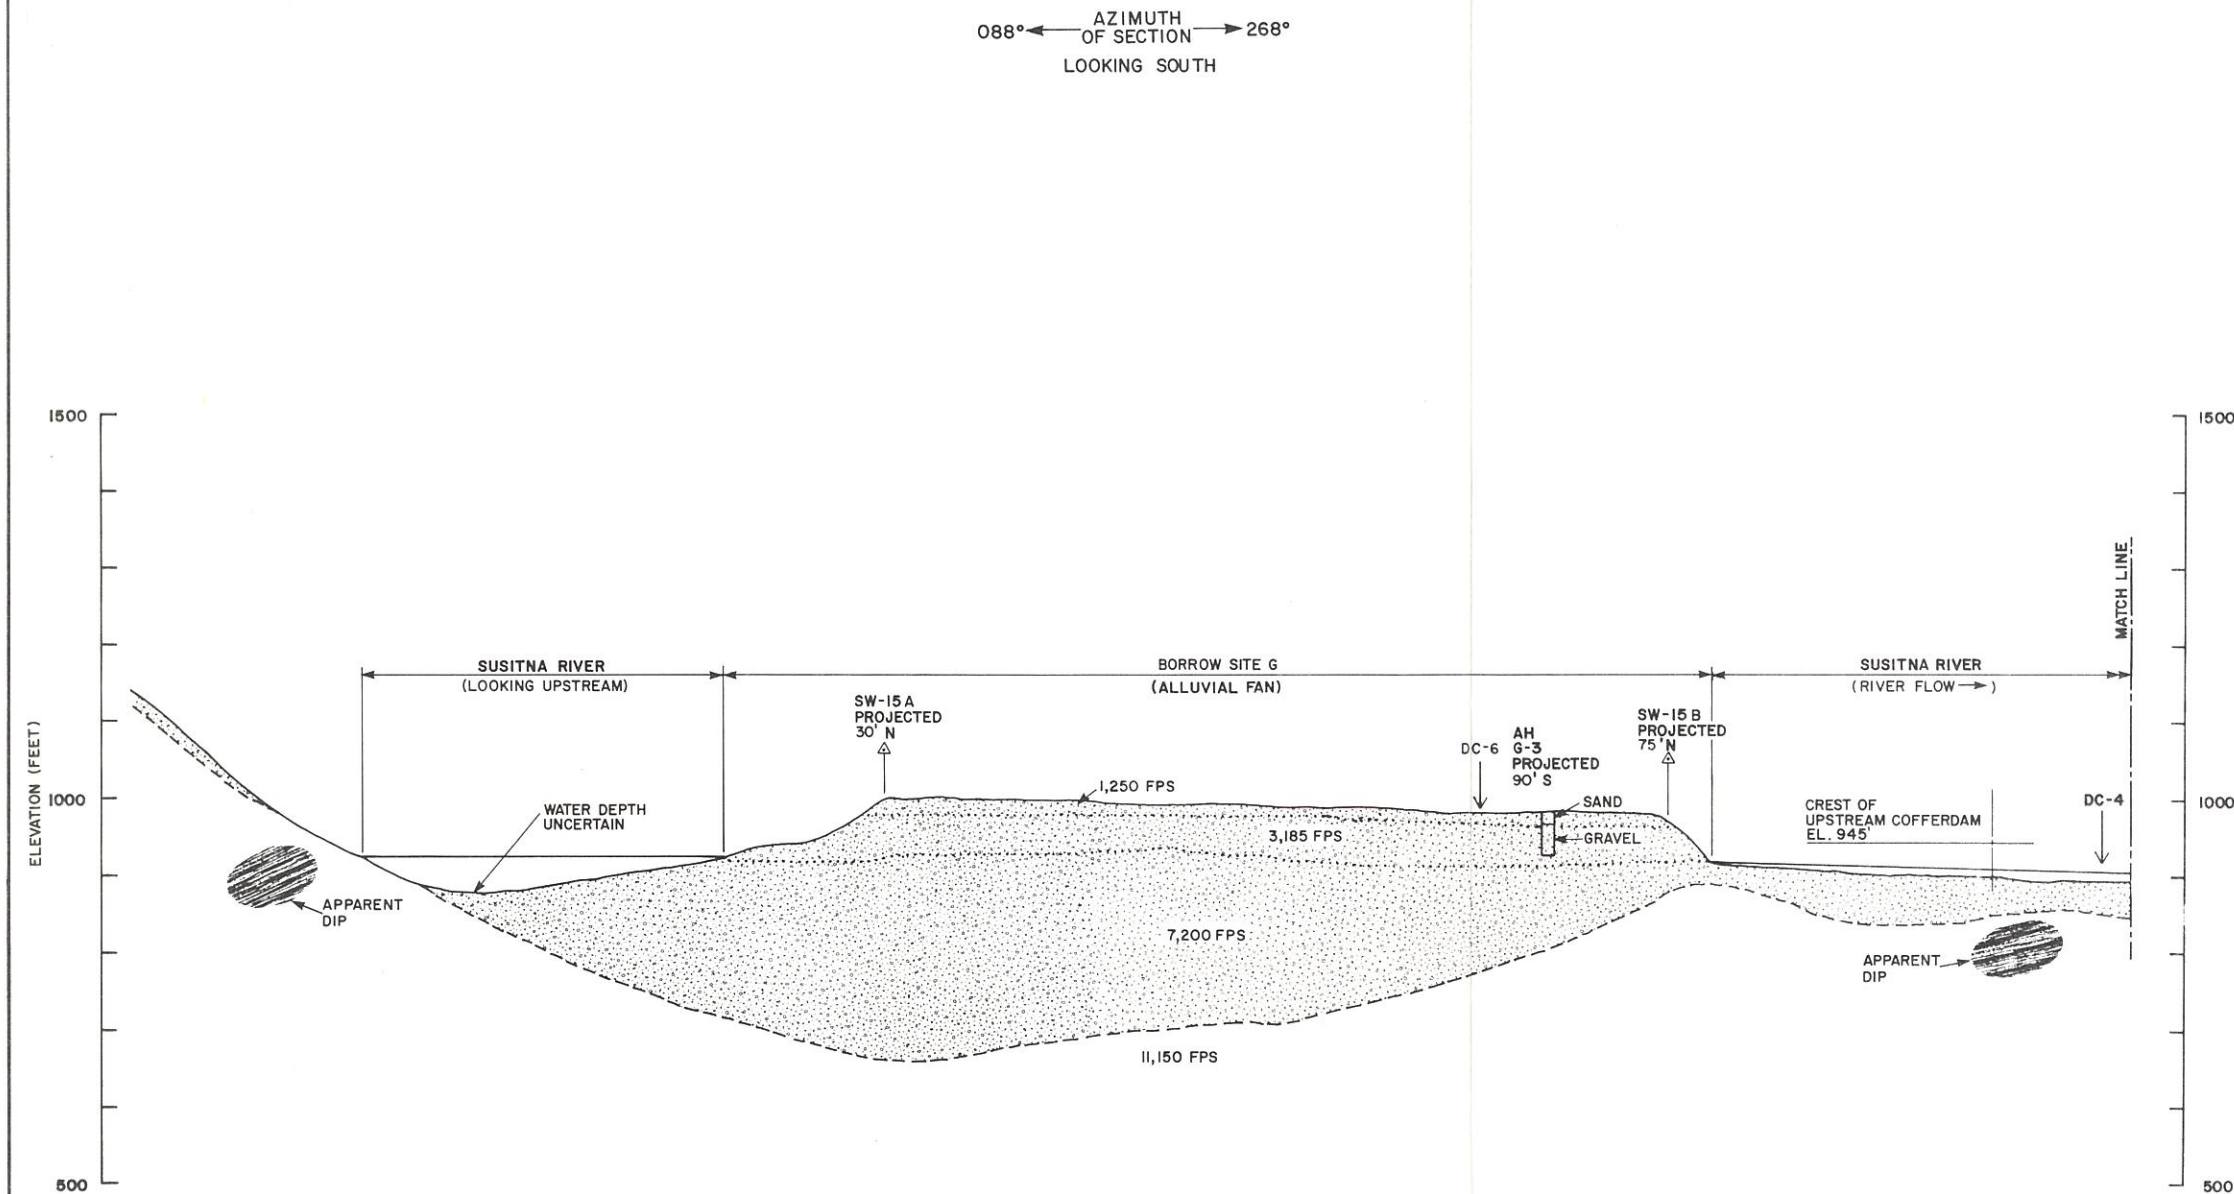
FIGURE 7.4

DEVIL CANYON
GEOLOGIC SECTION DC-1
SHEET 1 OF 2

This section discusses the shear and fracture zones mapped at the Devil Canyon site. These features are shown on the geologic map and geologic sections (Figures 7.4 through 7.10).

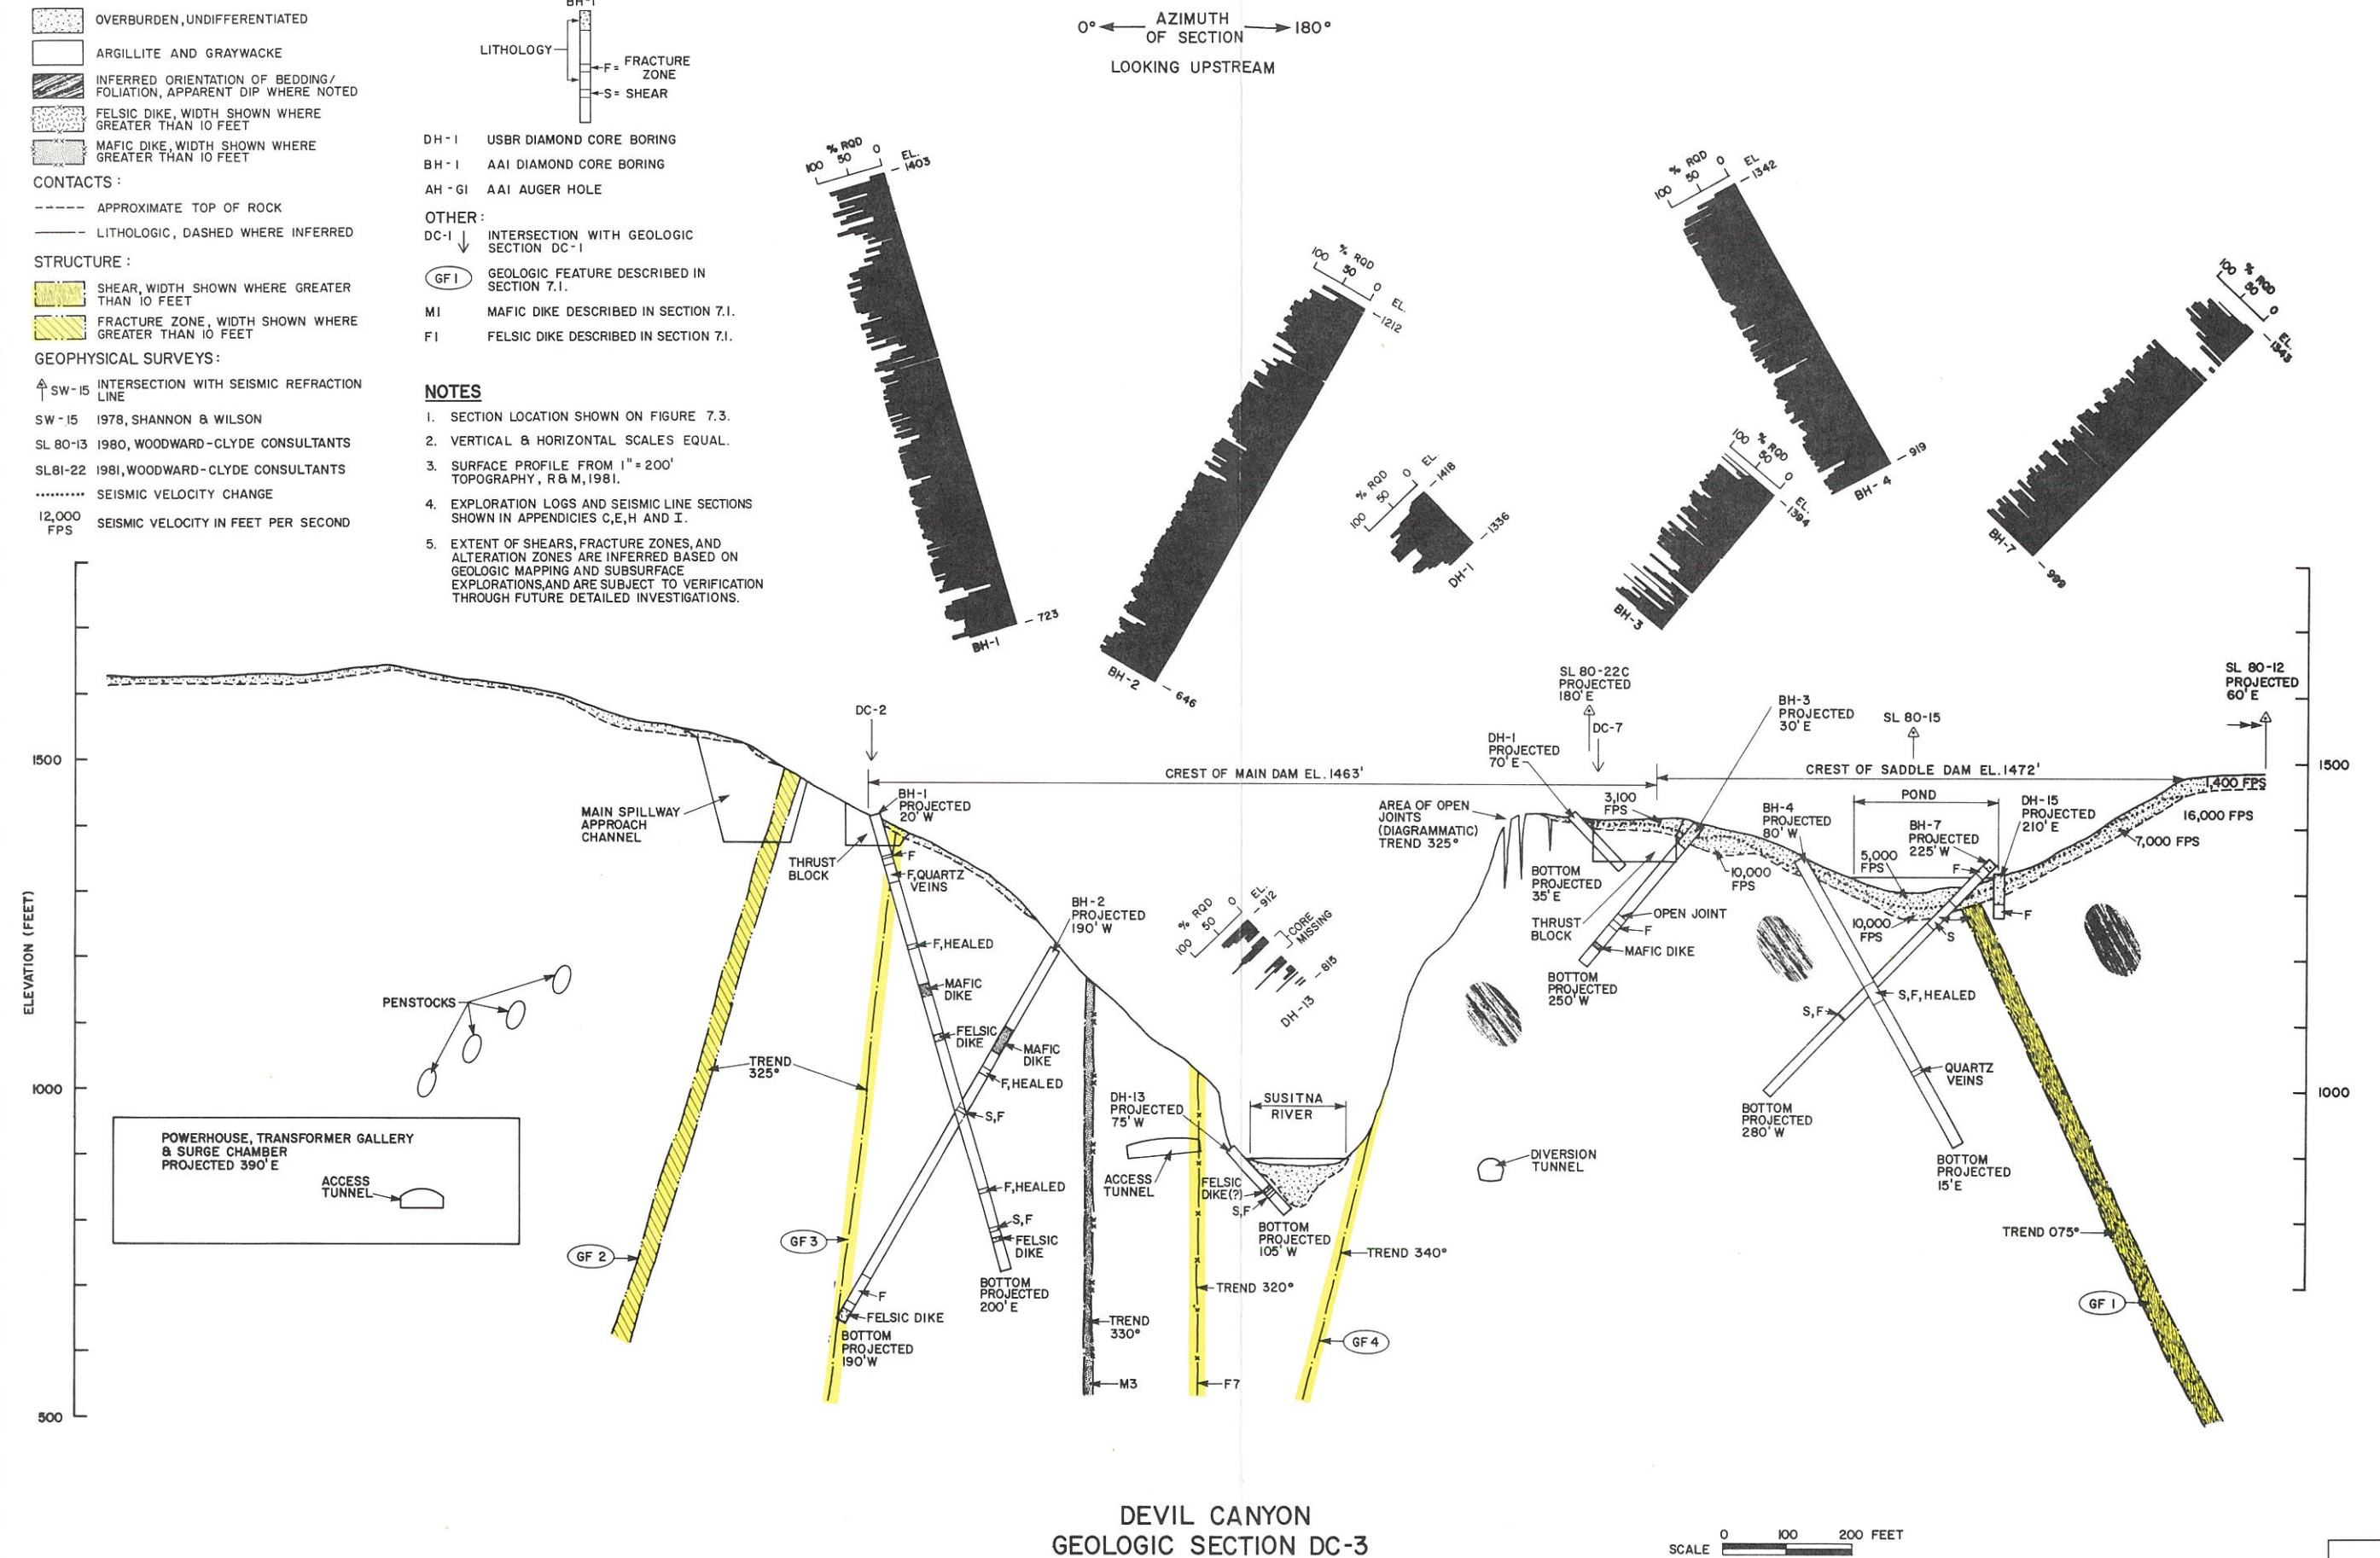
FIGURE 7.6

- SECTION LOCATION SHOWN ON FIGURE 7.3.
- VERTICAL & HORIZONTAL SCALES EQUAL.
- SURFACE PROFILE FROM 1" = 200' TOPOGRAPHY, R & M, 1981.
- EXPLORATION LOGS AND SEISMIC LINE SECTIONS SHOWN IN APPENDICES C, E, H AND I.
- EXTENT OF SHEARS, FRACTURE ZONES, AND ALTERATION ZONES ARE INFERRED BASED ON GEOLOGIC MAPPING AND SUBSURFACE EXPLORATIONS, AND ARE SUBJECT TO VERIFICATION THROUGH FUTURE DETAILED INVESTIGATIONS.

DEVIL CANYON
GEOLOGIC SECTION DC-3

Drill water was lost at a depth of 122.4 feet along the hole and never regained. RQDs for BH-3 were low, particularly near the bottom of the hole as it neared the cliff face (Figure 7.6). Open joints were also encountered in USBR Boreholes DH-1, DH-8, and DH-9 which were drilled subparallel and across Set I. High water losses and low RQDs were also encountered in these holes which reflected this open jointing.

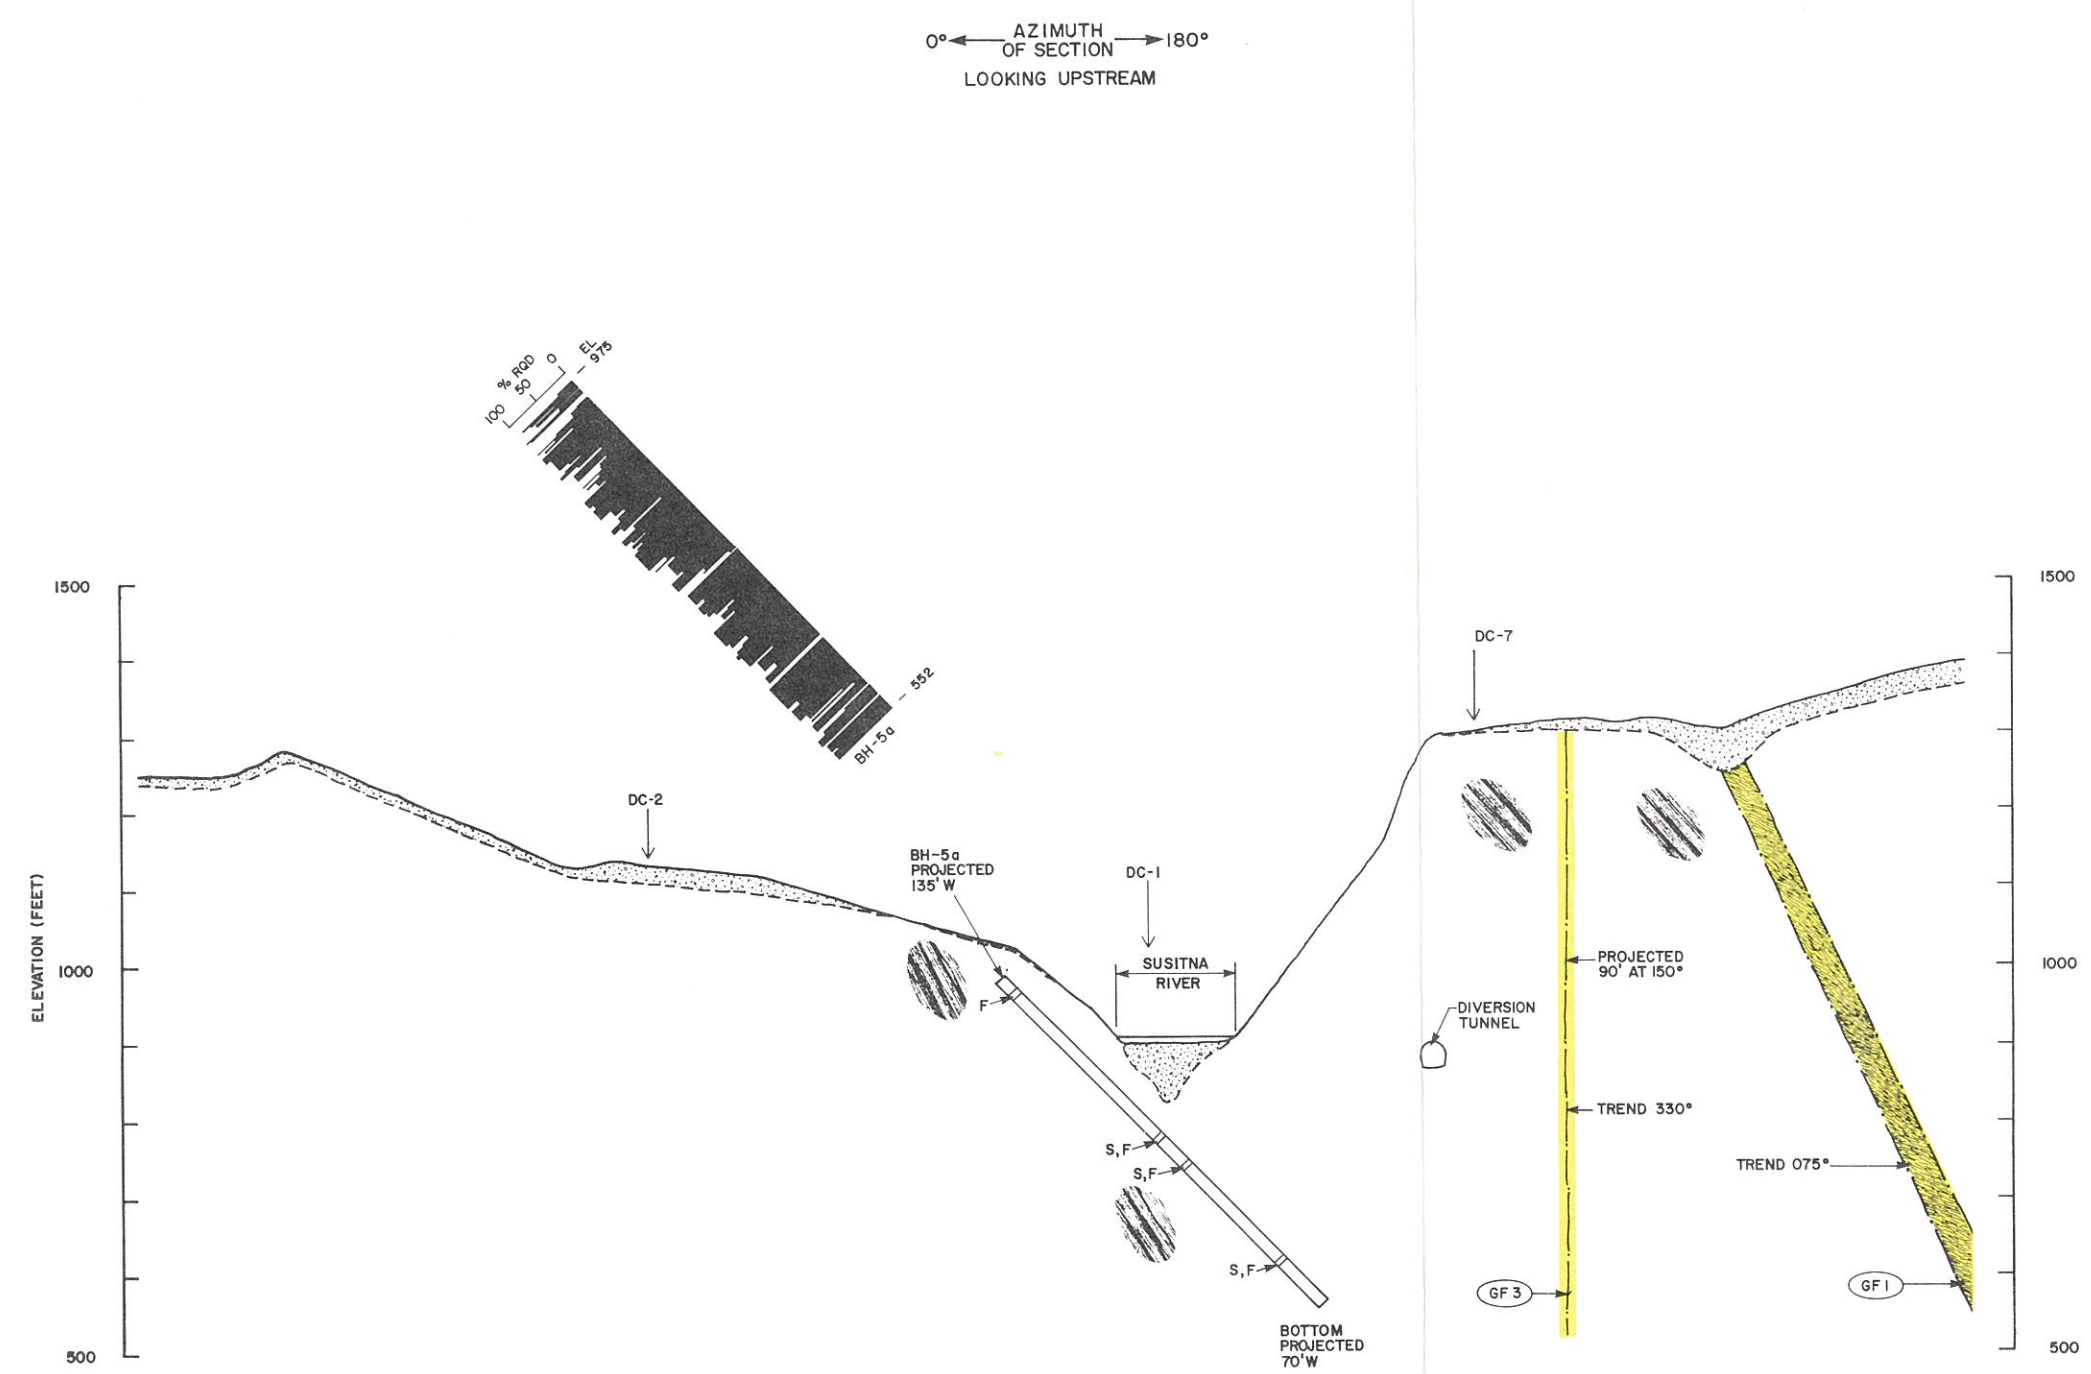
FIGURE 7.7

DEVIL CANYON
GEOLOGIC SECTION DC-4

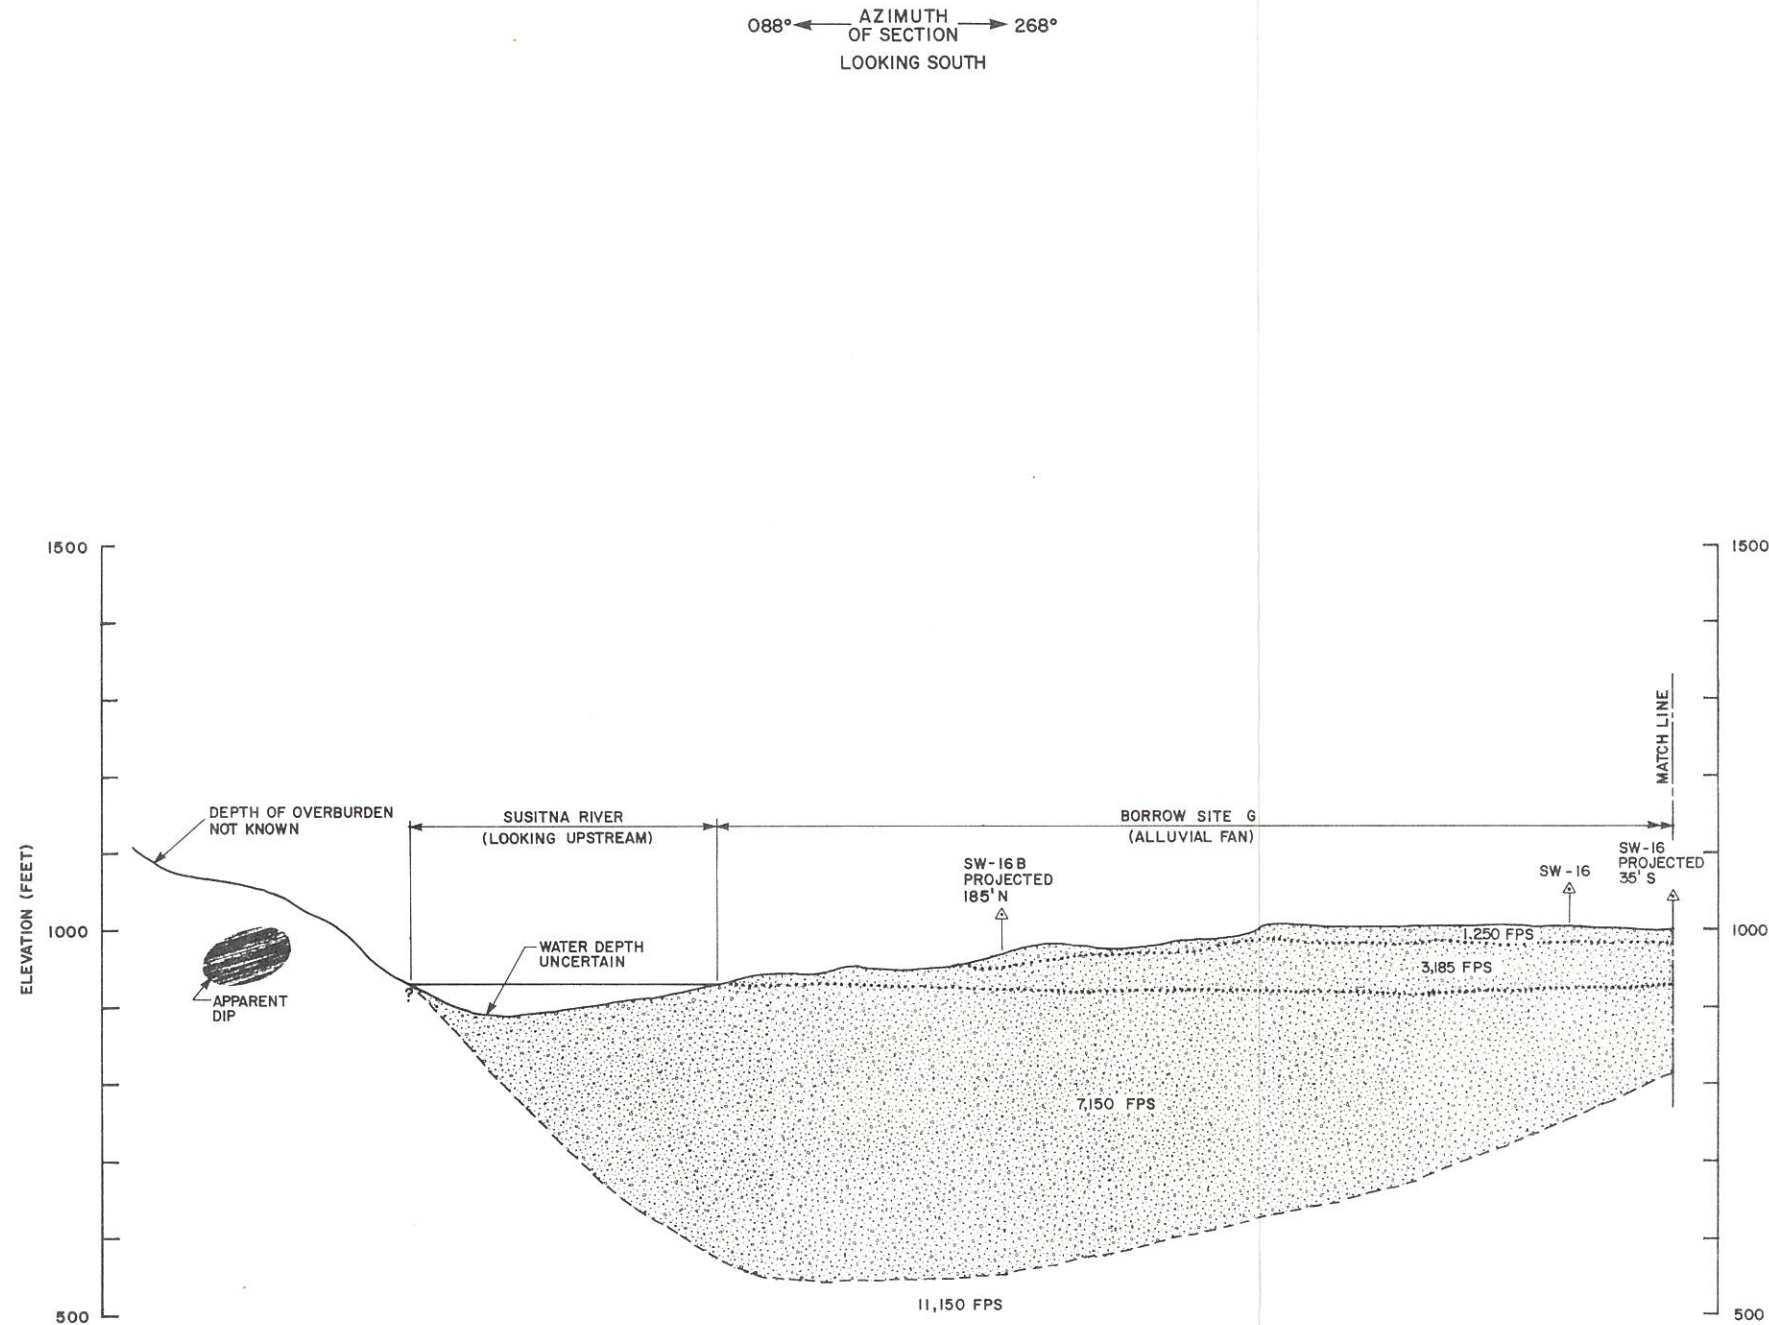
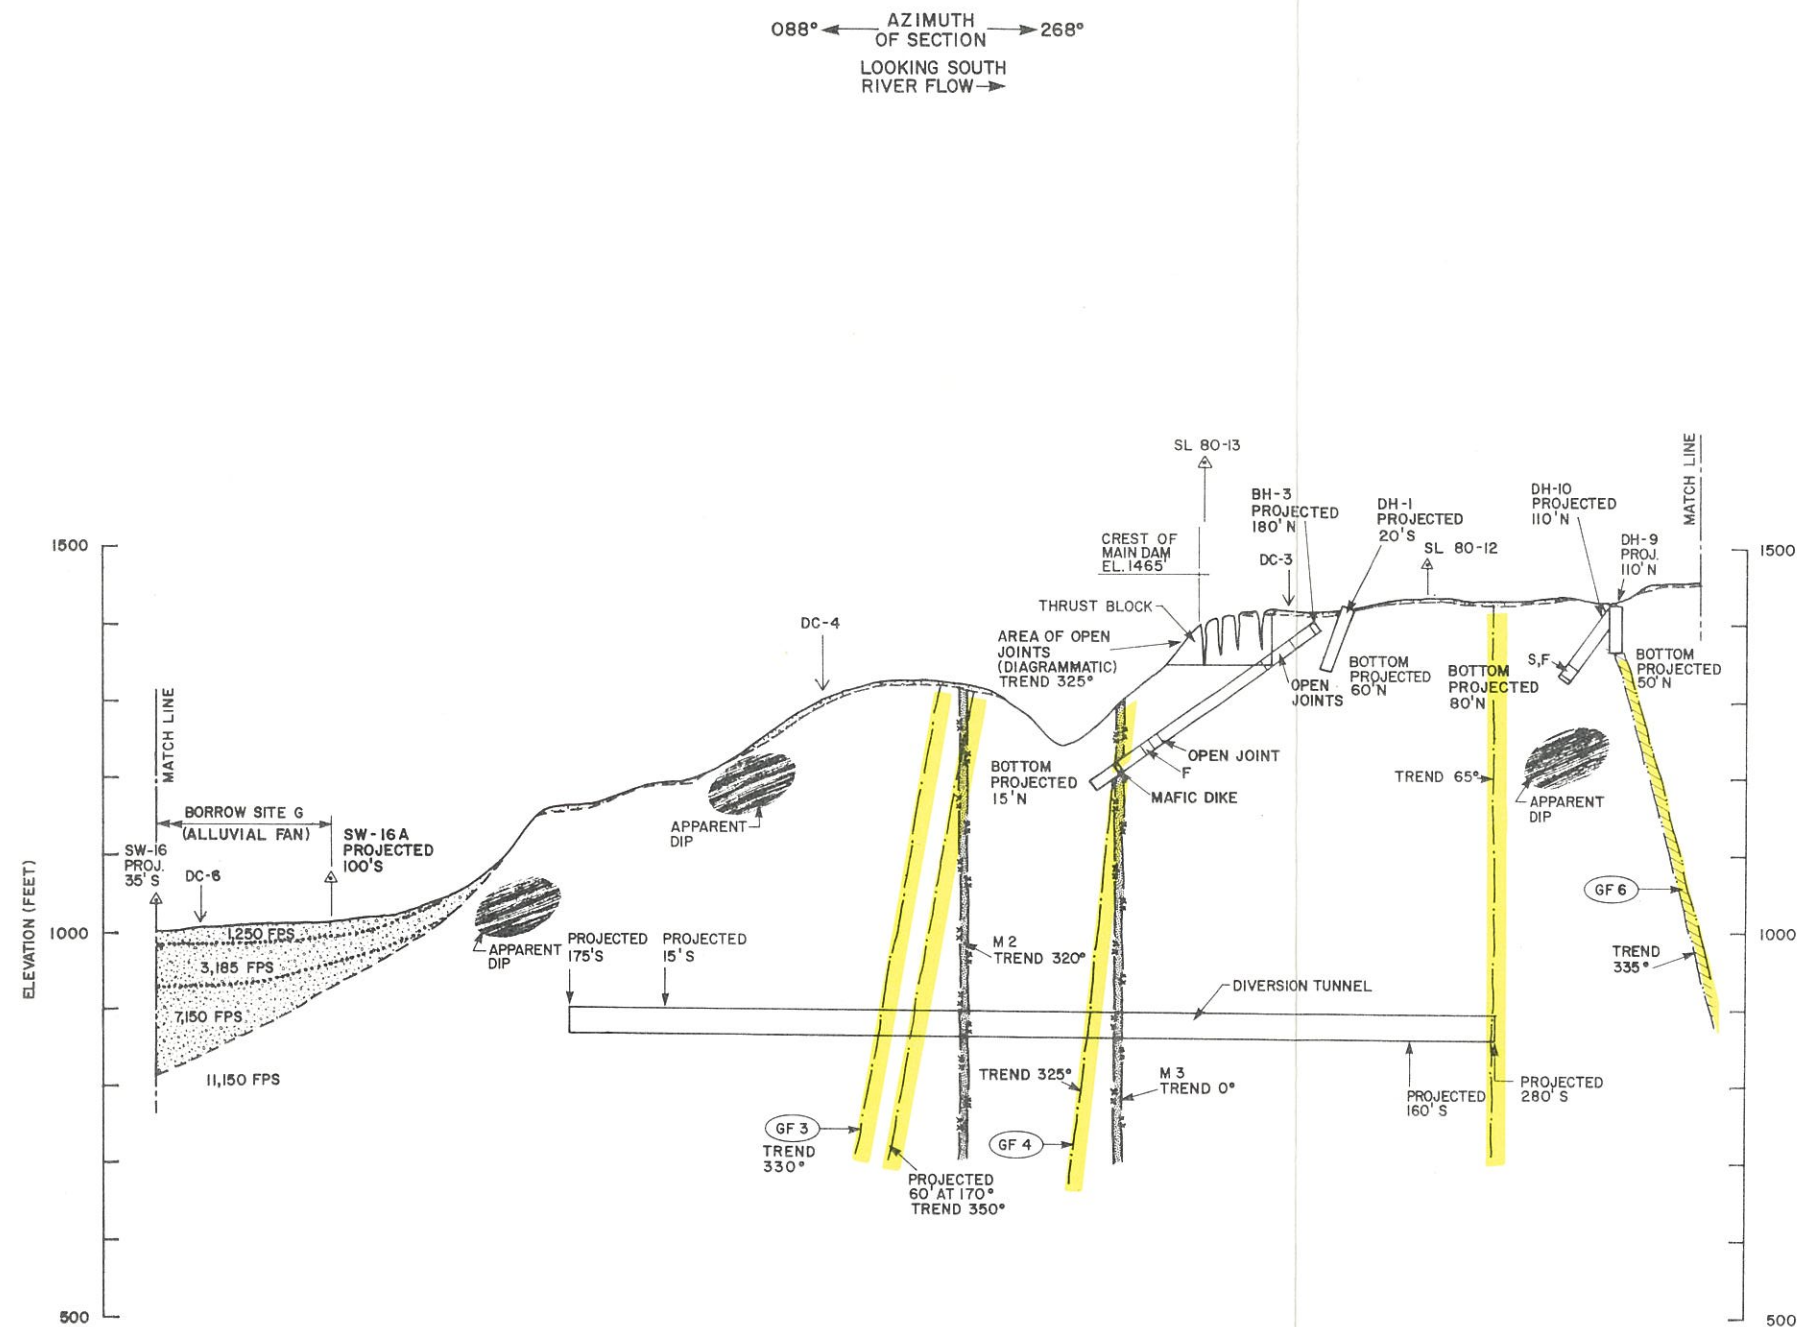
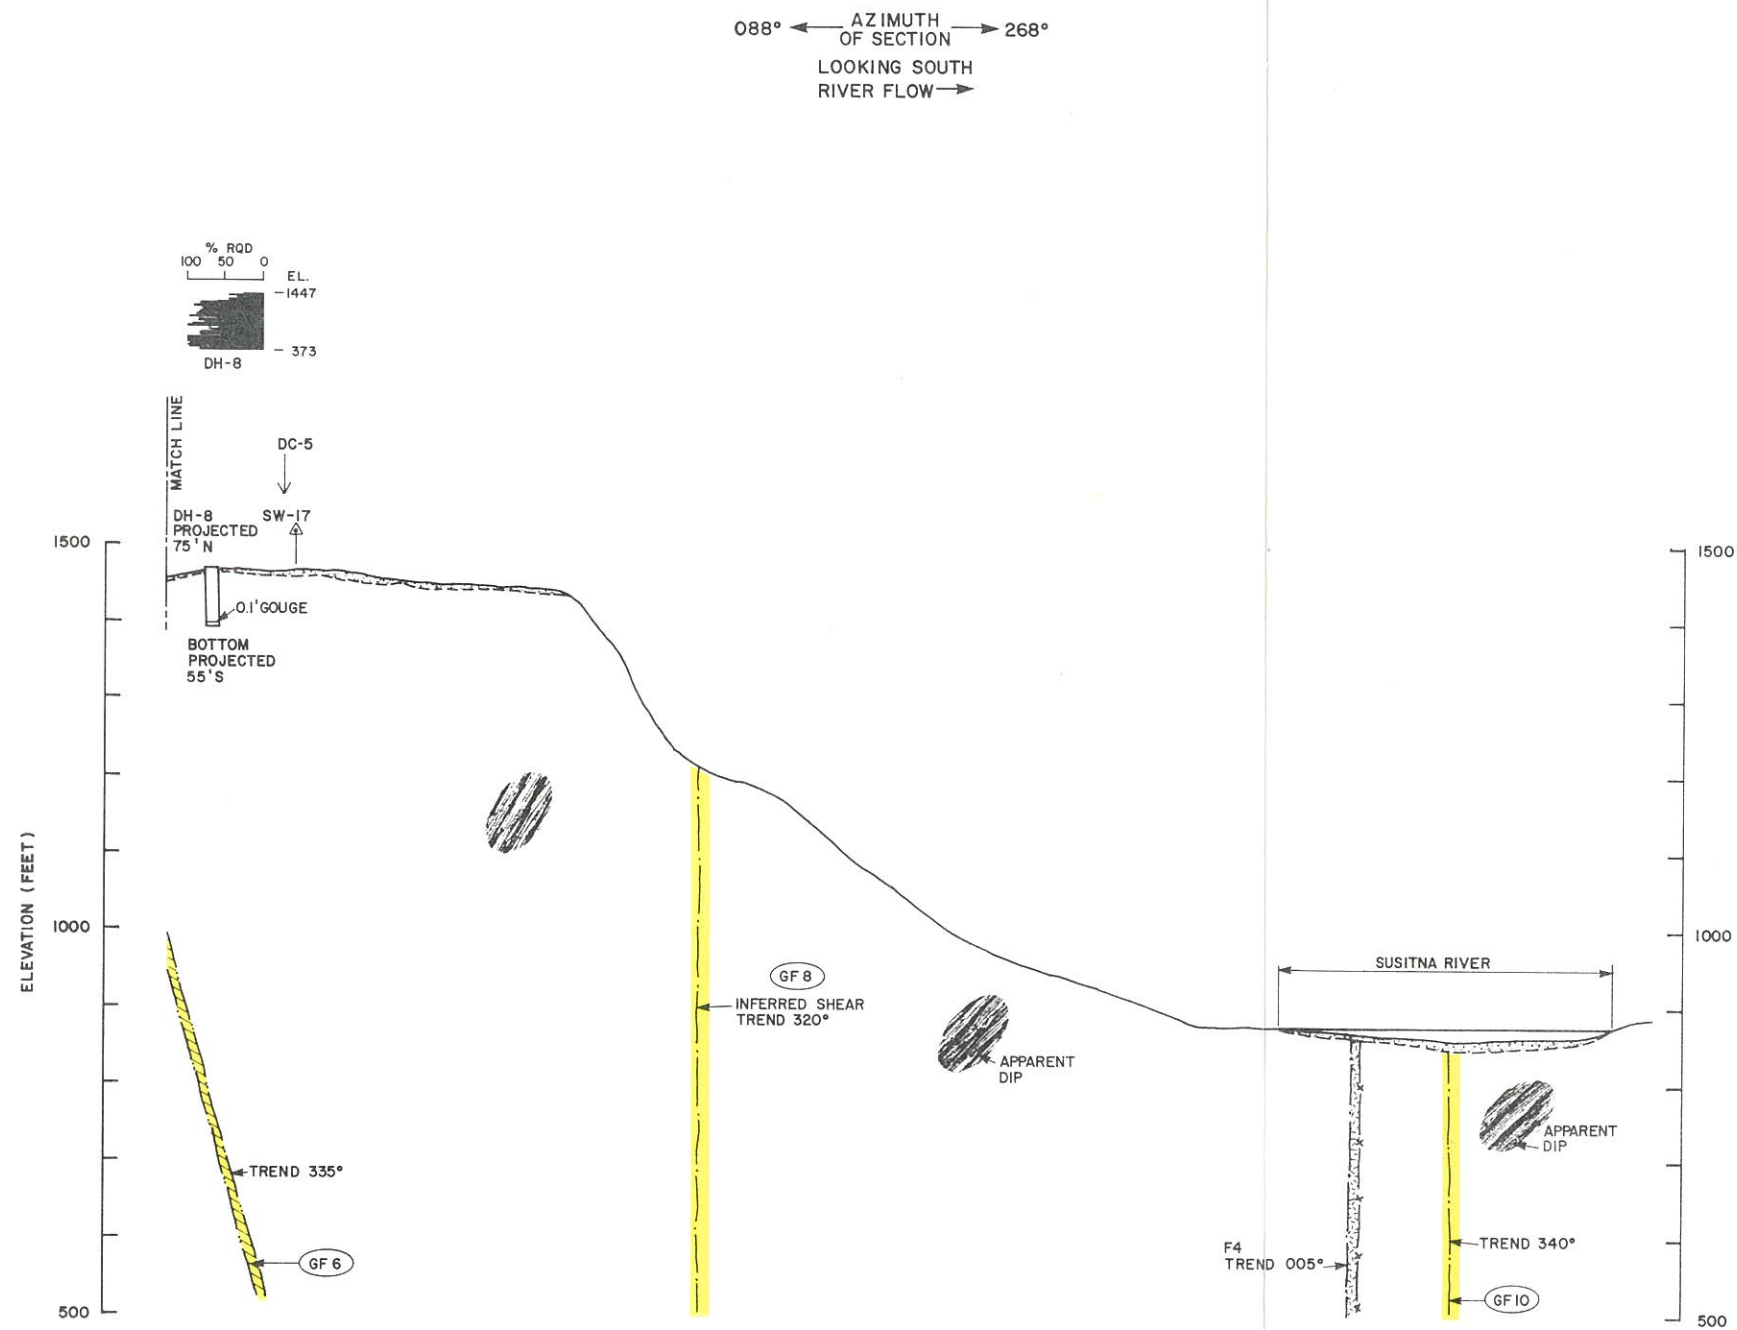
FIGURE 7.10

DEVIL CANYON
GEOLOGIC SECTION DC-7
SHEET 1 OF 3

DEVIL CANYON
GEOLOGIC SECTION DC-7
SHEET 2 OF 3

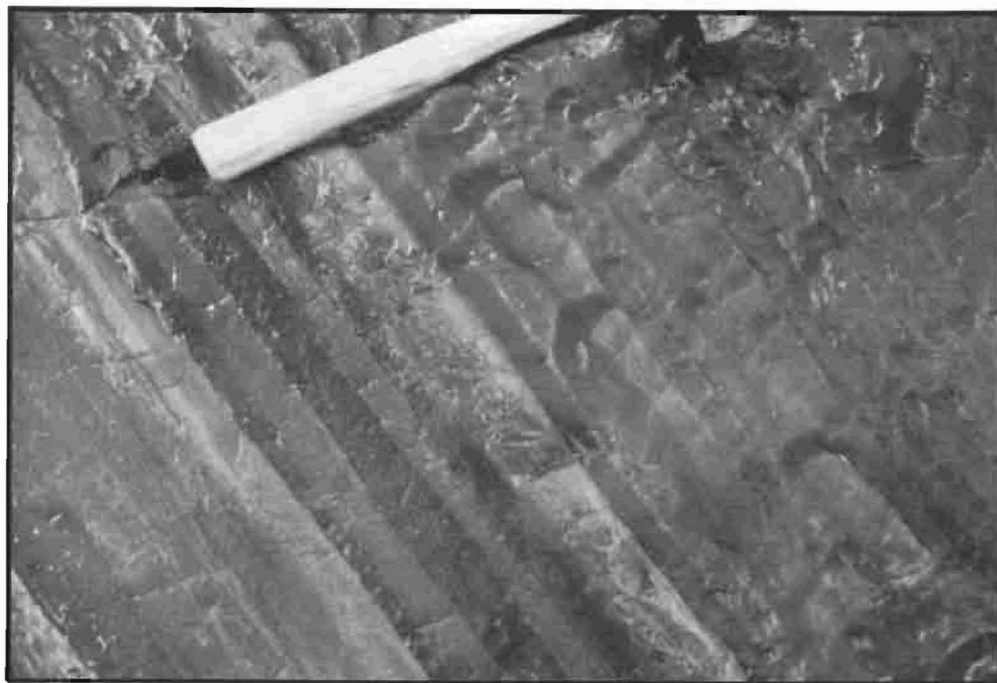
ACROSS RIVER FROM CHEECHAKO CREEK
RIVER LEVEL-NORTH BANK

1. GRADED BEDS OF ARGILLITE/GRAYWACKE.
2. STRATIGRAPHIC TOP TO LOWER LEFT.

DEVIL CANYON
TYPICAL ARGILLITE/GRAYWACKE

The argillite and graywacke interbeds range from less than 1 inch to greater than 10 feet thick, but are generally less than 6 inches. Figure 7.11 is a photograph of the typical interbedded argillite and graywacke found at the site. Contacts between the beds are sharp and tight with bedding parallel to foliation. The generally weak foliation is better developed in the argillite than the graywacke because of the effect of grain size. Foliation, as described here, refers to the planar structure of the rock resulting from the parallel alignment of platy and elongate grains. In most boreholes and in some outcrops, the foliation has developed a phyllitic sheen in the argillite beds. Bedding/foliation strikes northeast with dips to the southeast of generally 50° to 70°. The dip of the bedding/foliation is shown on the geologic map and sections. On the geologic sections, the apparent dip is indicated where appropriate.

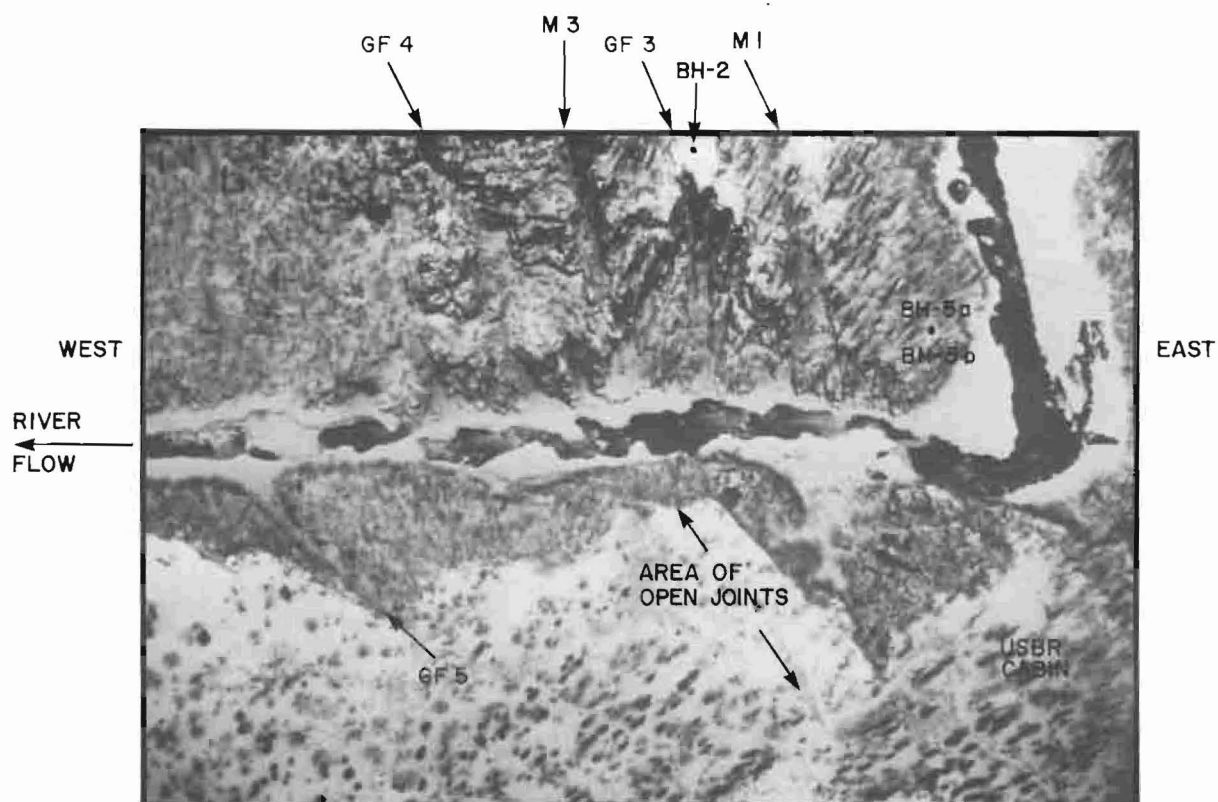
1. DIKES M 1 AND M 3 DESCRIBED IN SECTION 7.1.
2. GEOLOGIC FEATURES GF 3, GF 4, AND GF 5 DESCRIBED IN SECTION 7.1.

DEVIL CANYON
AERIAL VIEW OF SITE

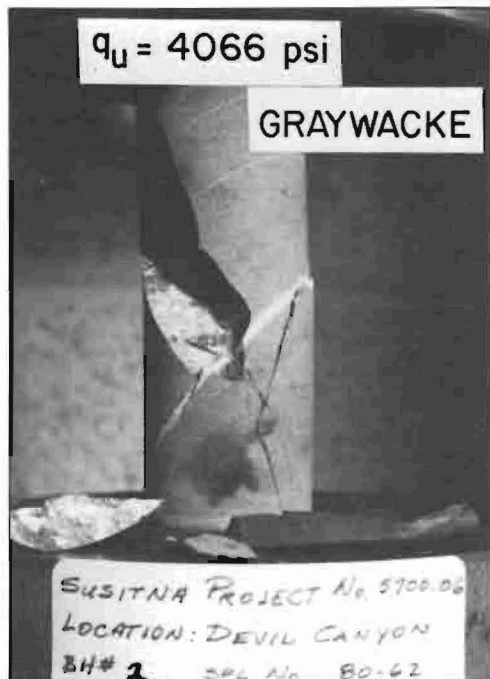
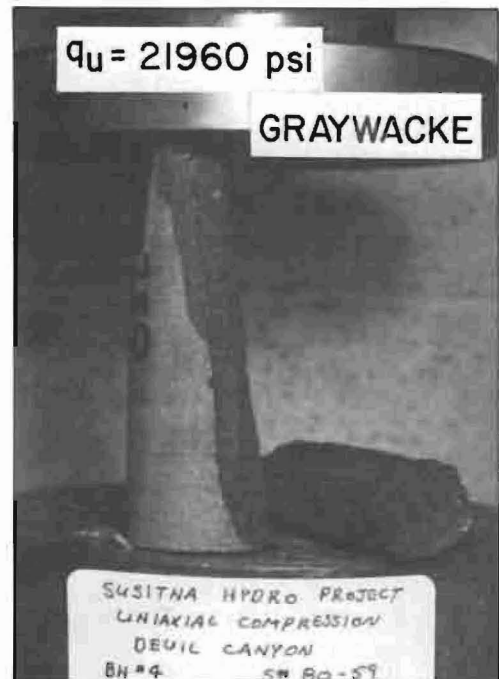
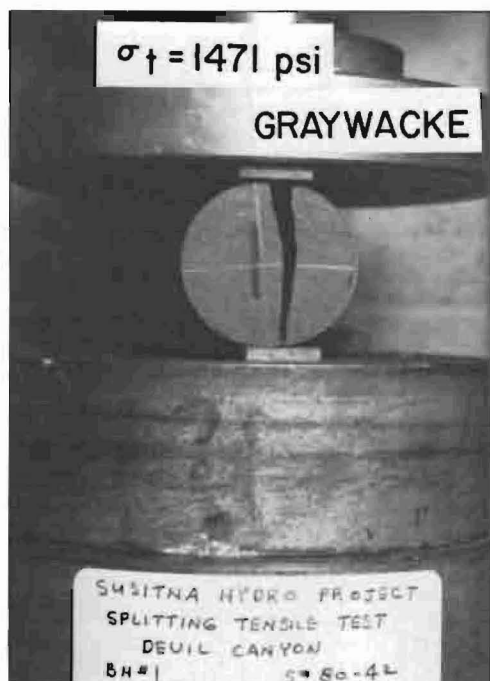
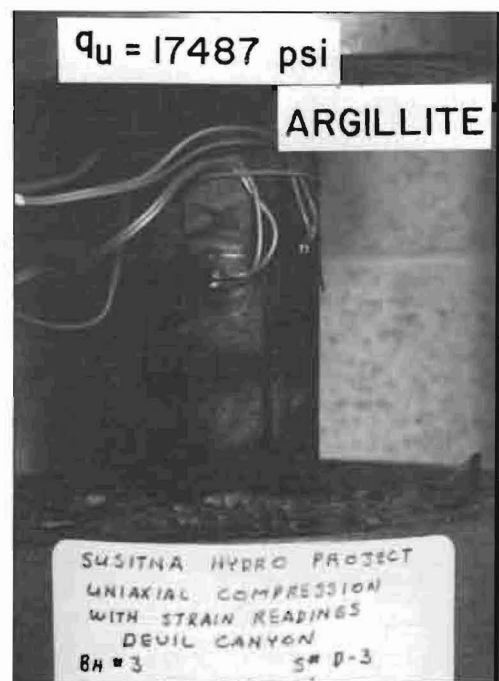
DEVIL CANYON ROCK TESTS

COMPRESSION TEST FAILURE
ALONG HEALED DISCONTINUITY

COMPRESSION TEST FAILURE
THROUGH INTACT ROCK

TYPICAL TENSILE STRENGTH TEST

TYPICAL COMPRESSION TEST
WITH STRESS-STRAIN READINGS
