SUSITNA HYDROELECTRIC PROJECT

1980-81 GEOTECHNICAL REPORT

VOLUME 1
TEXT
FINAL DRAFT

ALASKA POWER AUTHORITY

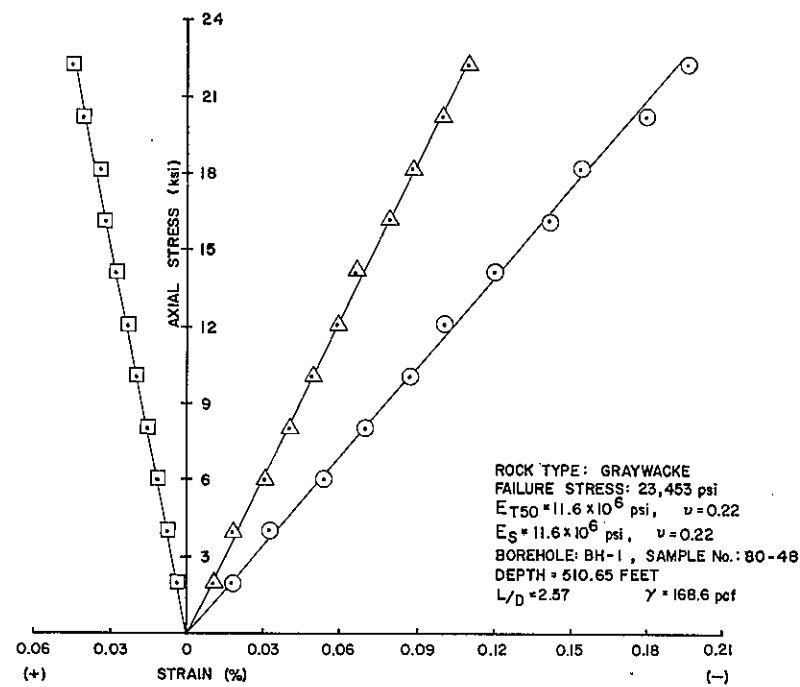
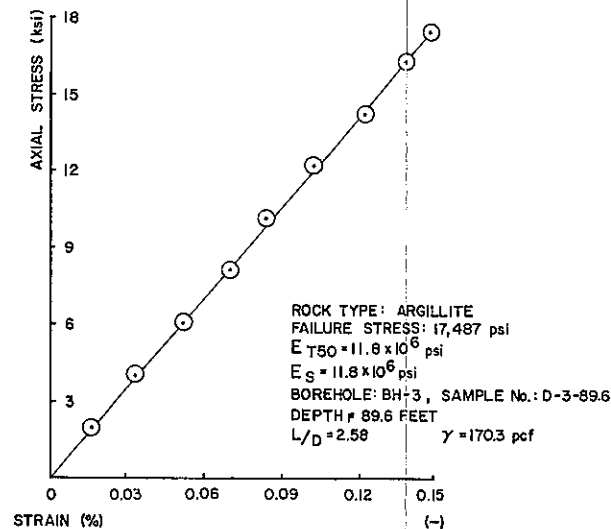
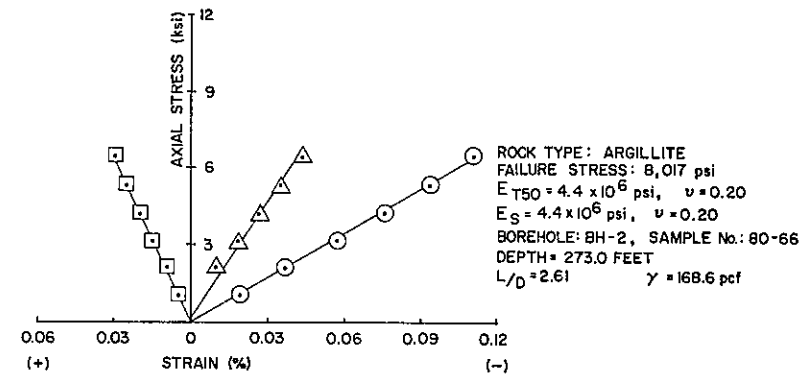
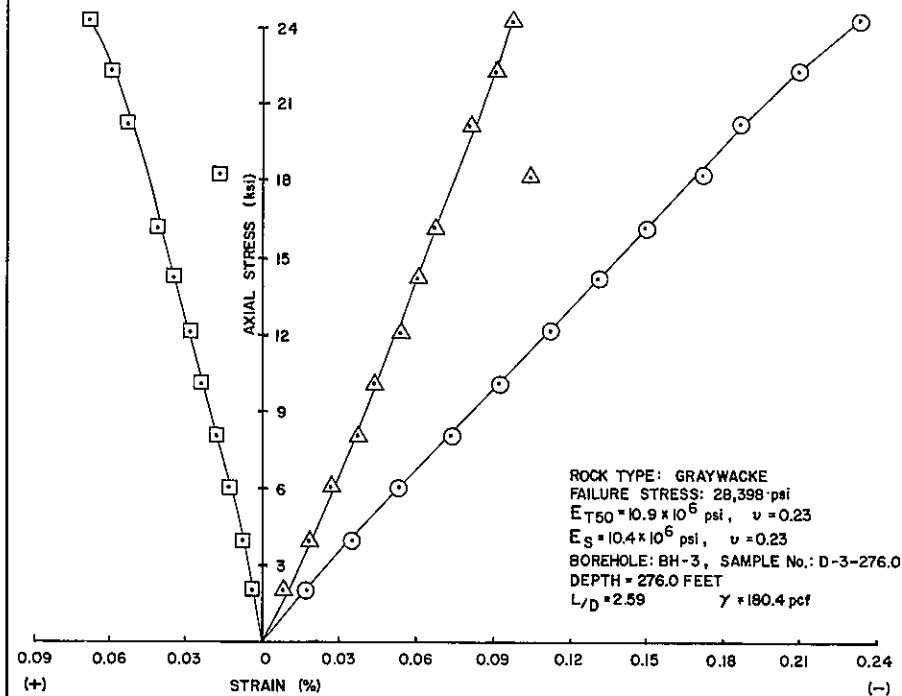
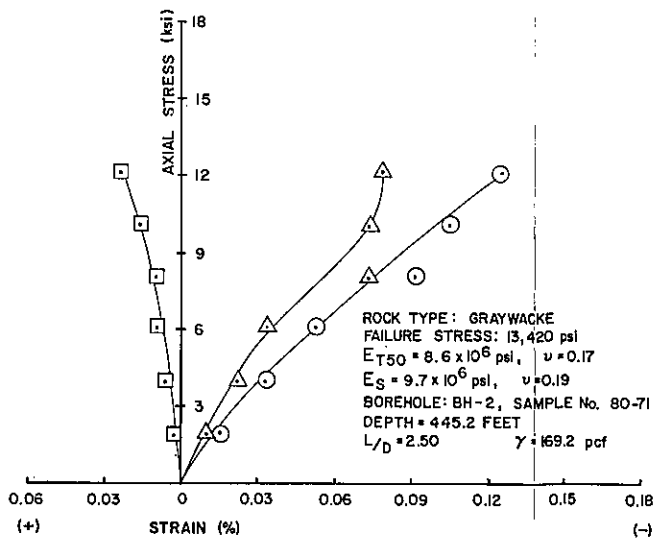
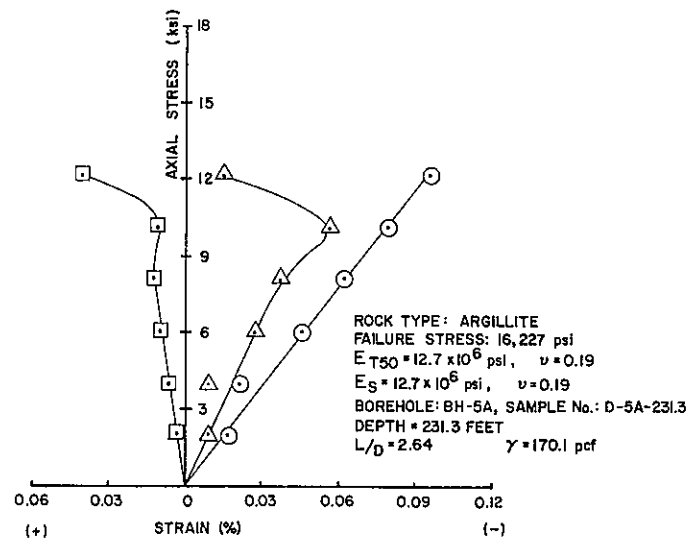
FIGURE 7.16

- AXIAL STRAIN
- △ VOLUMETRIC STRAIN
- DIAMETRIC STRAIN
- E_s SECANT MODULUS
- E_{T50} TANGENT MODULUS AT 50% FAILURE STRESS

SAMPLE DIAMETER = 1.77"

DEVIL CANYON
STATIC ELASTIC PROPERTIES
FOR ARGILLITE AND GRAYWACKE

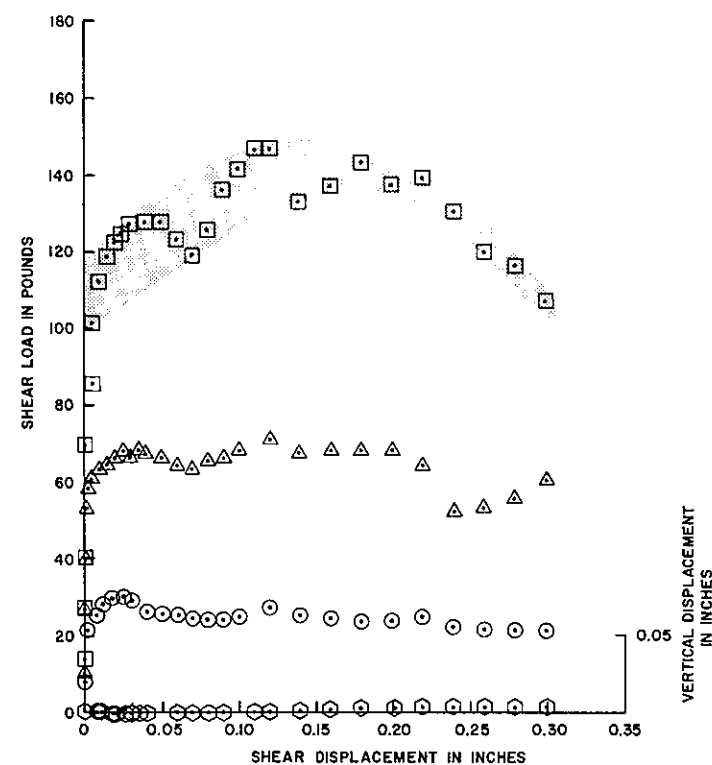
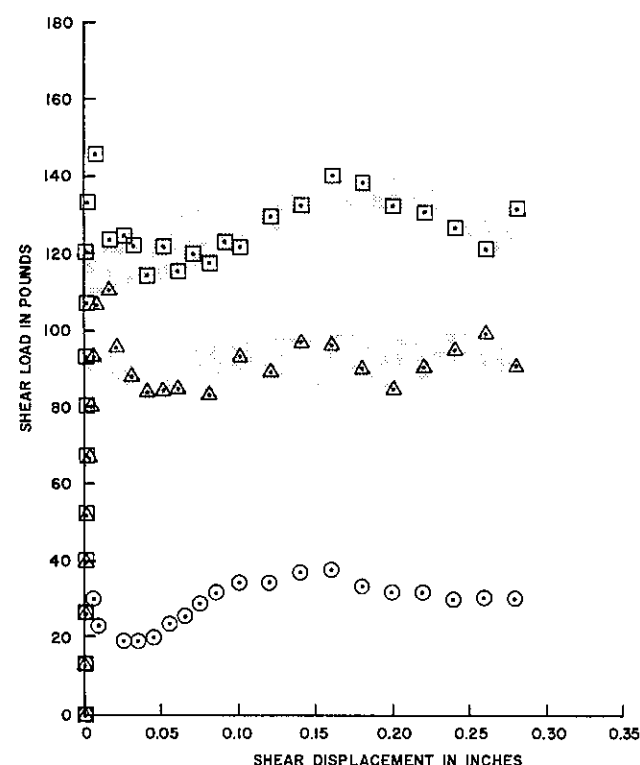
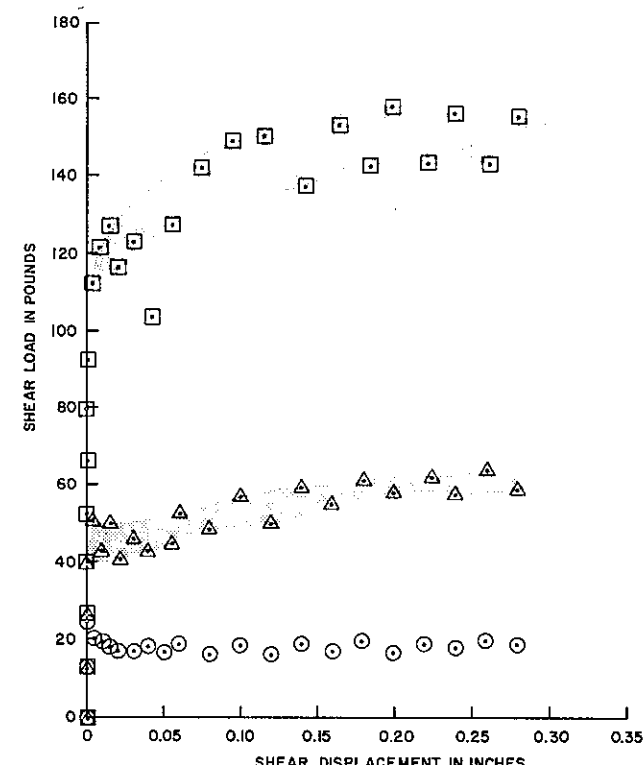
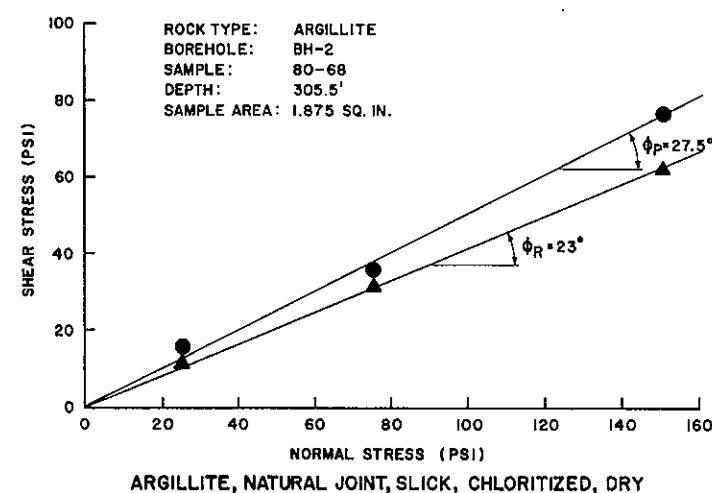
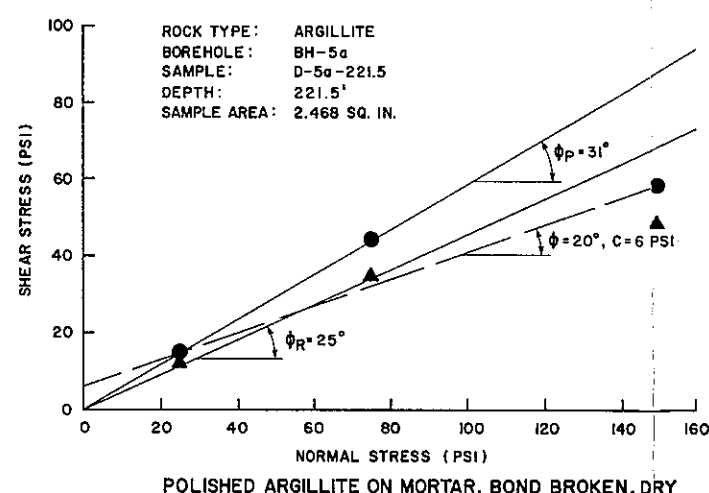
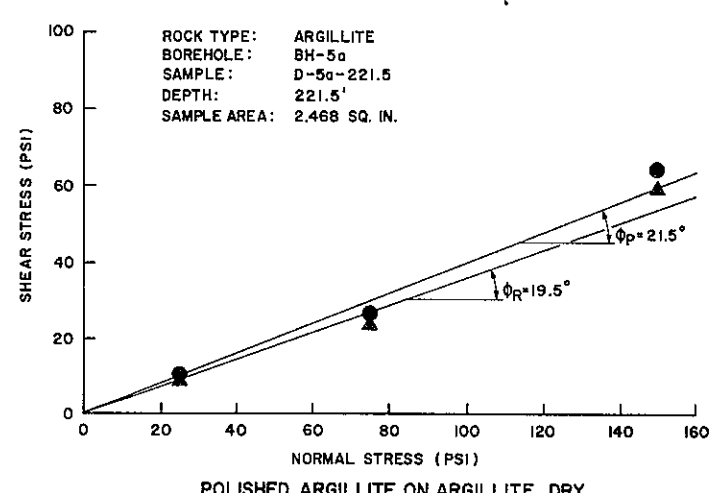
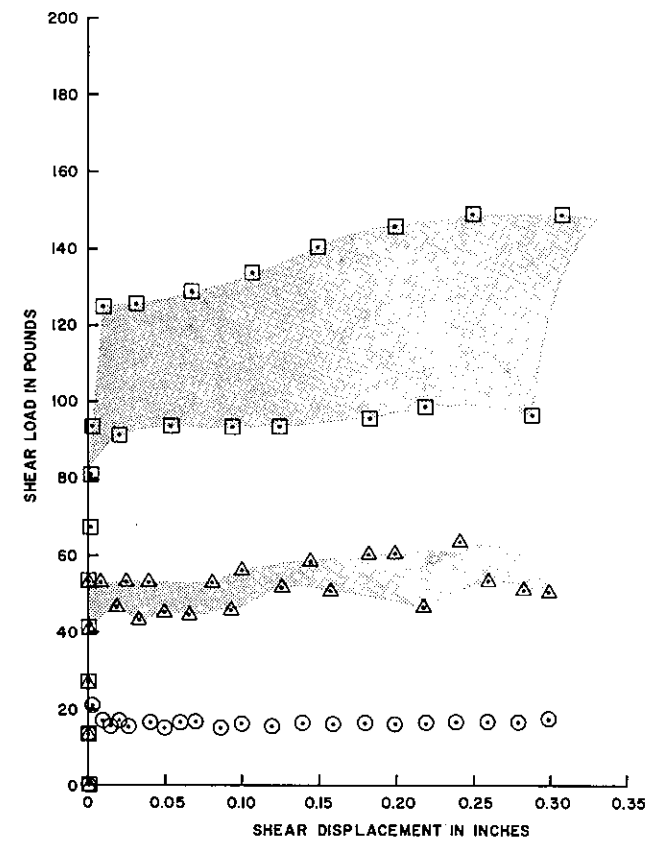
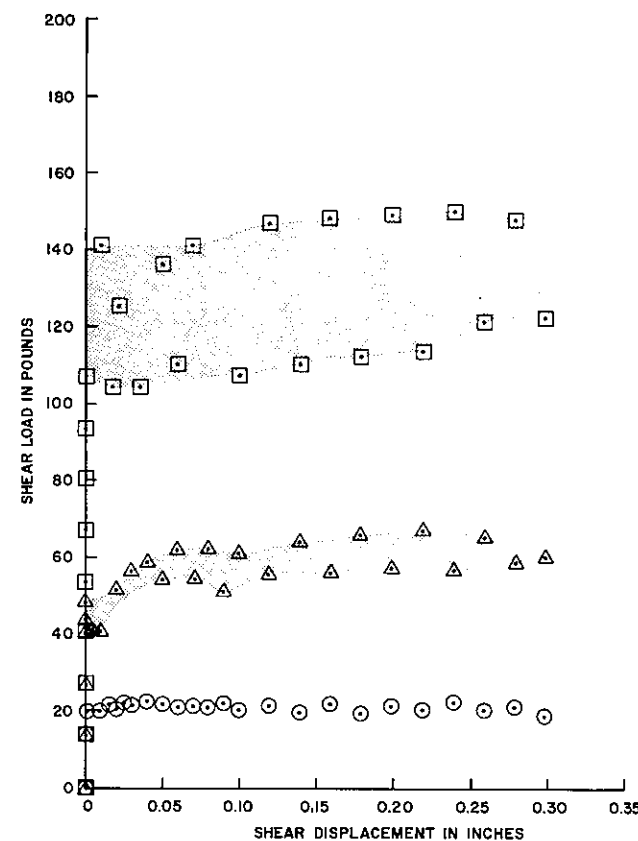
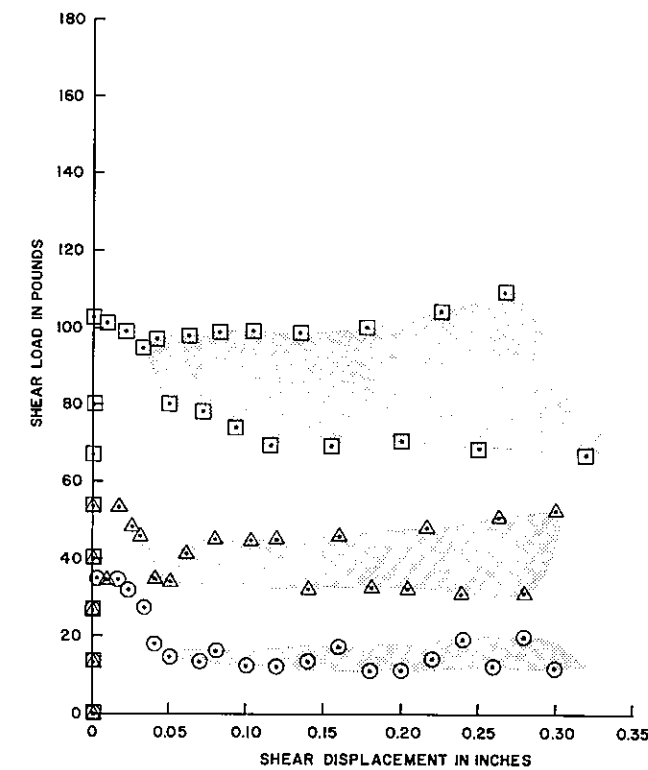
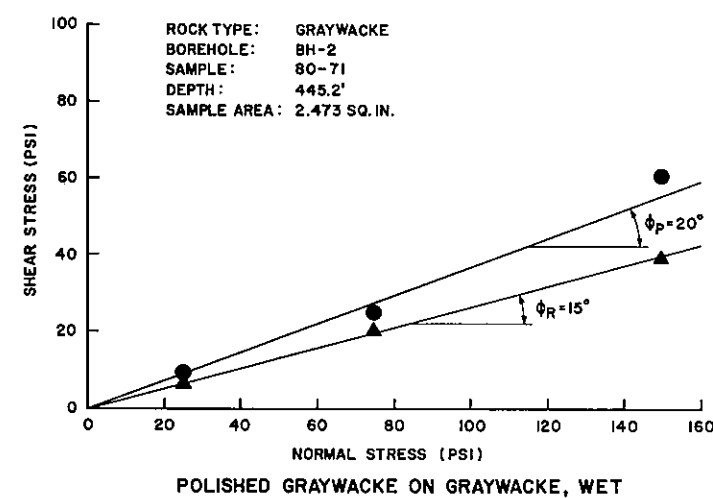
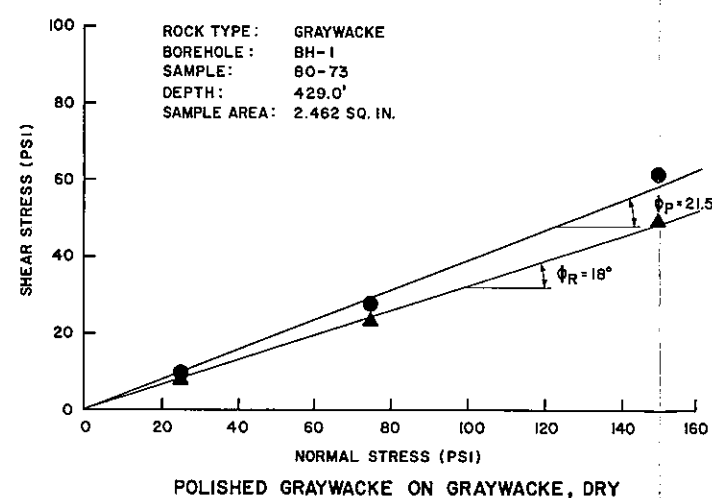
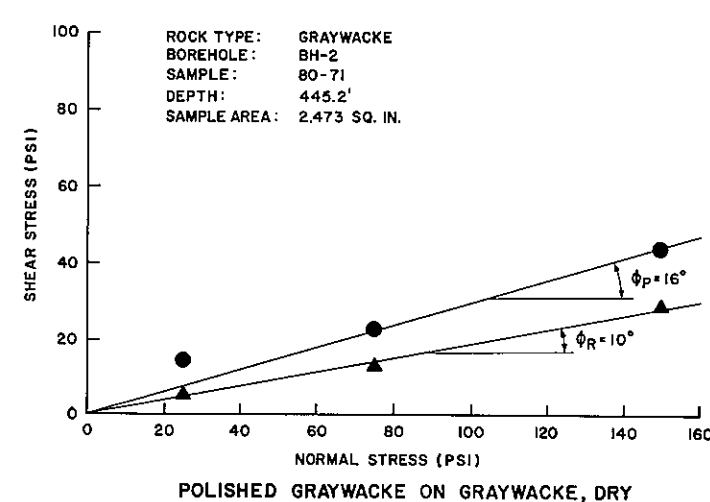
FIGURE 7.17

- ϕ_p PEAK FRICTION ANGLE
- ϕ_R RESIDUAL FRICTION ANGLE
- PEAK VALUES
- ▲ RESIDUAL VALUES
- VERTICAL DISPLACEMENT
- NORMAL LOAD = 25 PSI
- △ NORMAL LOAD = 75 PSI
- NORMAL LOAD = 150 PSI
- C APPARENT COHESION
- ▨ FRICTION ANGLE ENVELOPE

1. MAXIMUM SHEAR BOX DISPLACEMENT = 0.3 INCHES
2. STRAIN RATE = 0.039 IN./MIN.

DEVIL CANYON
DIRECT SHEAR TESTS
SHEET 2 OF 3

Test results are plotted in Figure 7.17. A summary of the results is as follows:

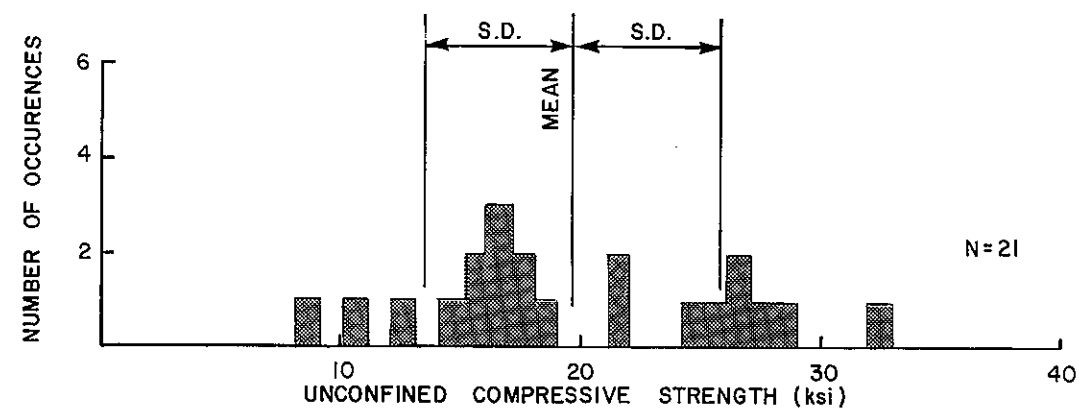
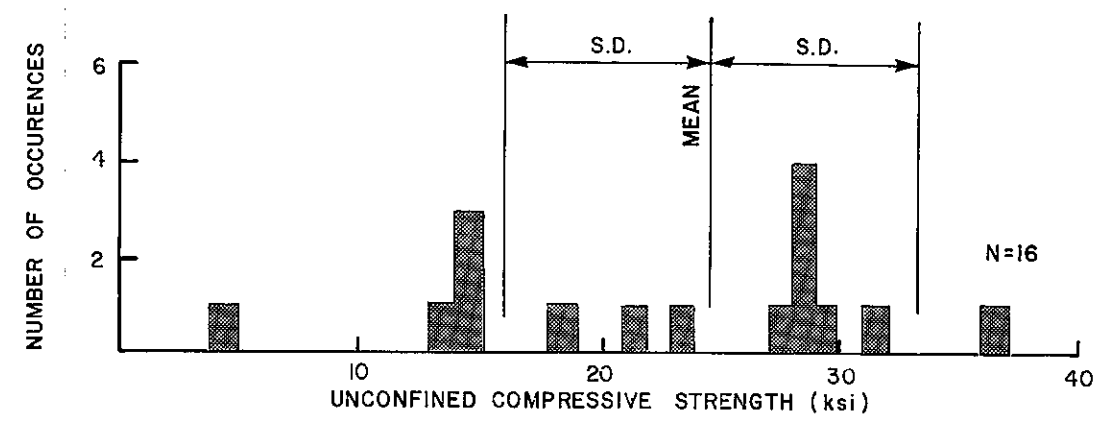
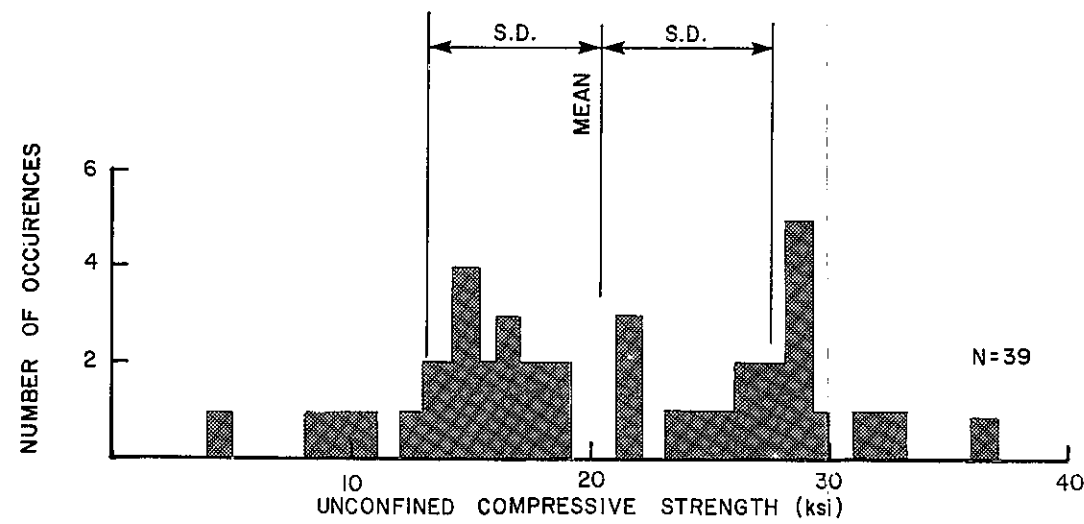
ARGILLITE (AAI, USBR)

GRAYWACKE (AAI, USBR)

ALL TESTS (AAI, USBR)

ROCK	N
ARGILLITE	21
GRAYWACKE	16
MAFIC DIKE	2
TOTAL = 39

DEVIL CANYON UNCONFINED COMPRESSIVE STRENGTH TEST RESULTS

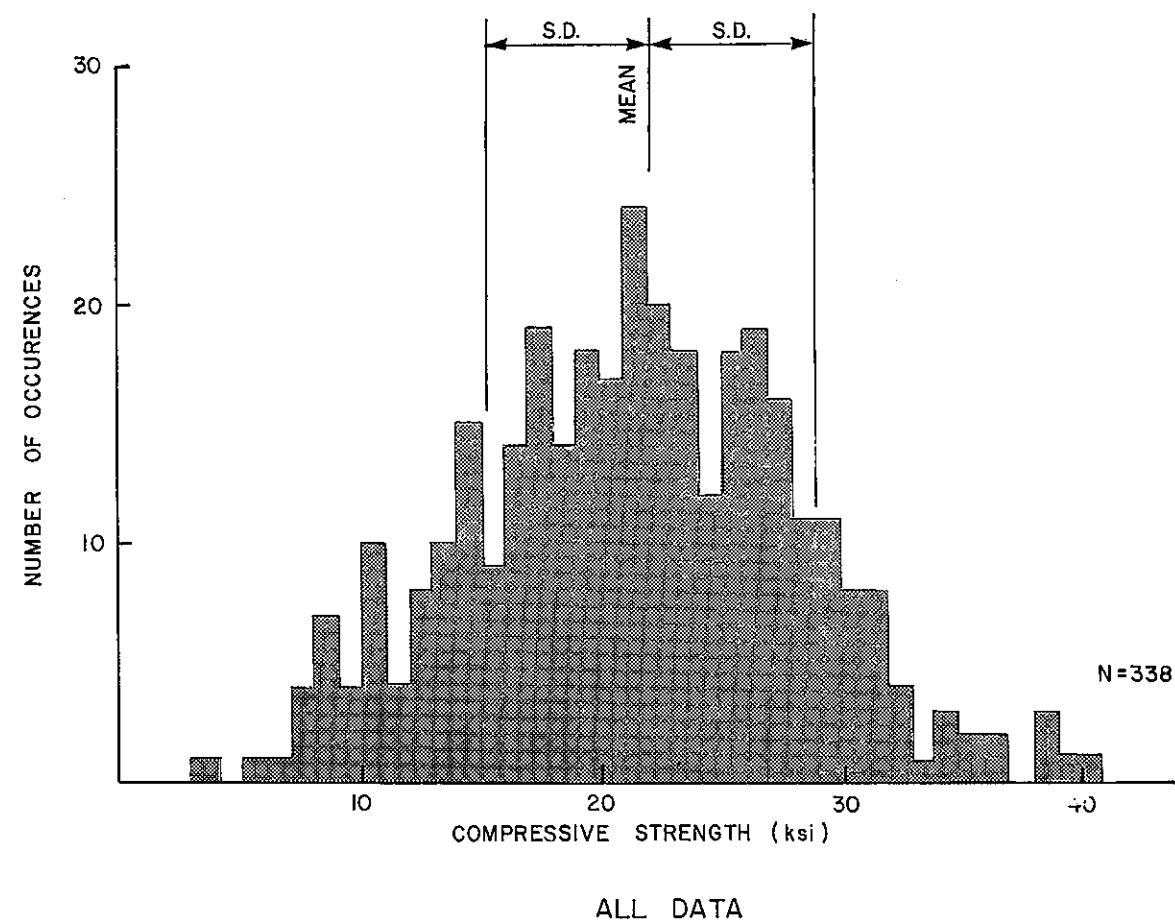
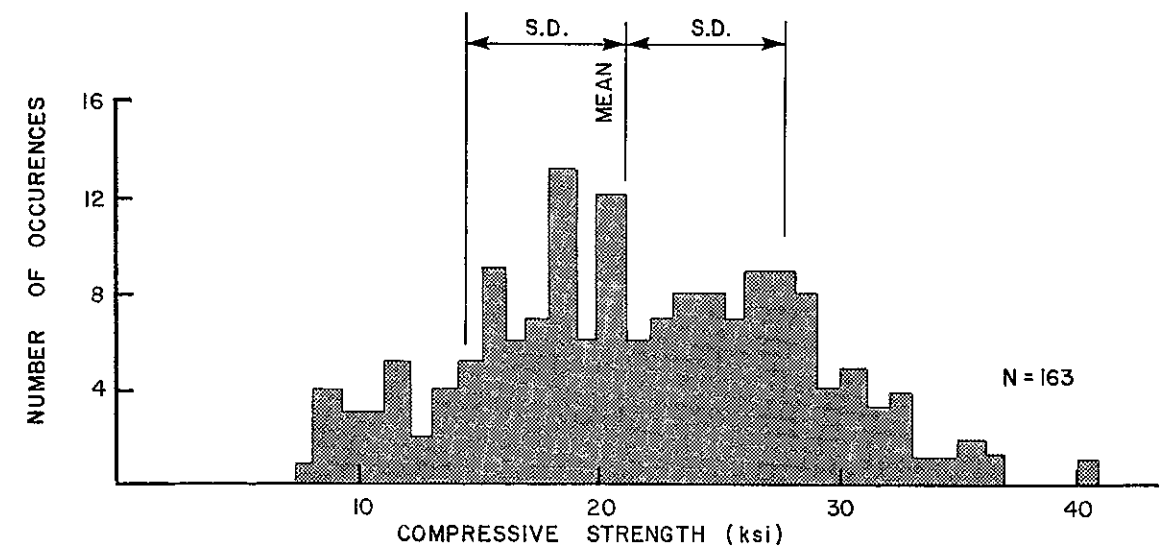
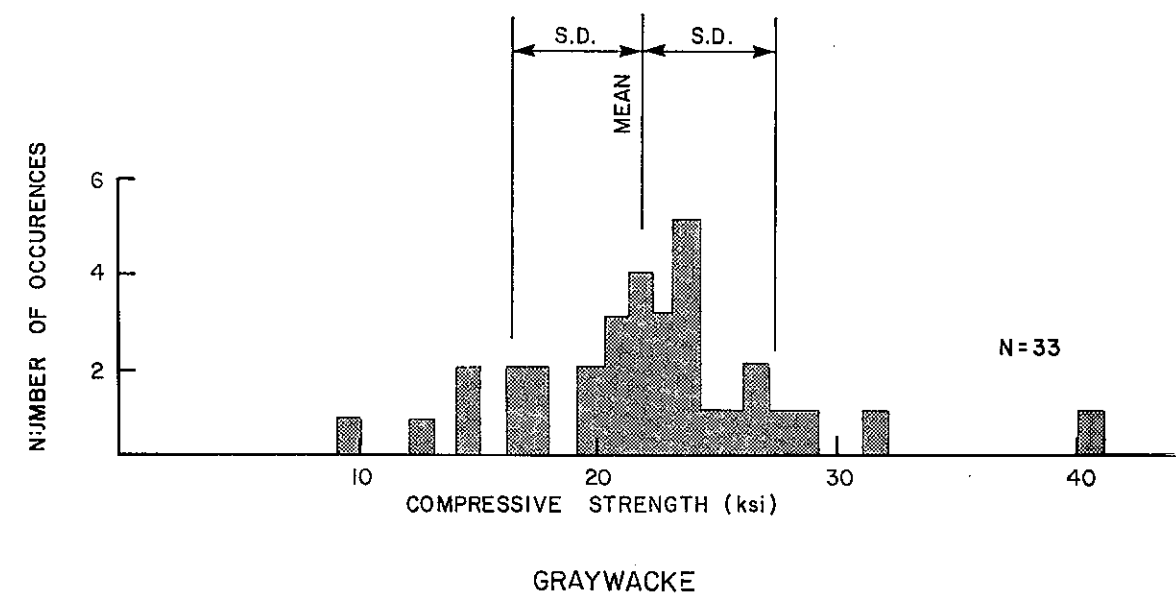
DEVIL CANYON
 POINT LOAD TEST DATA

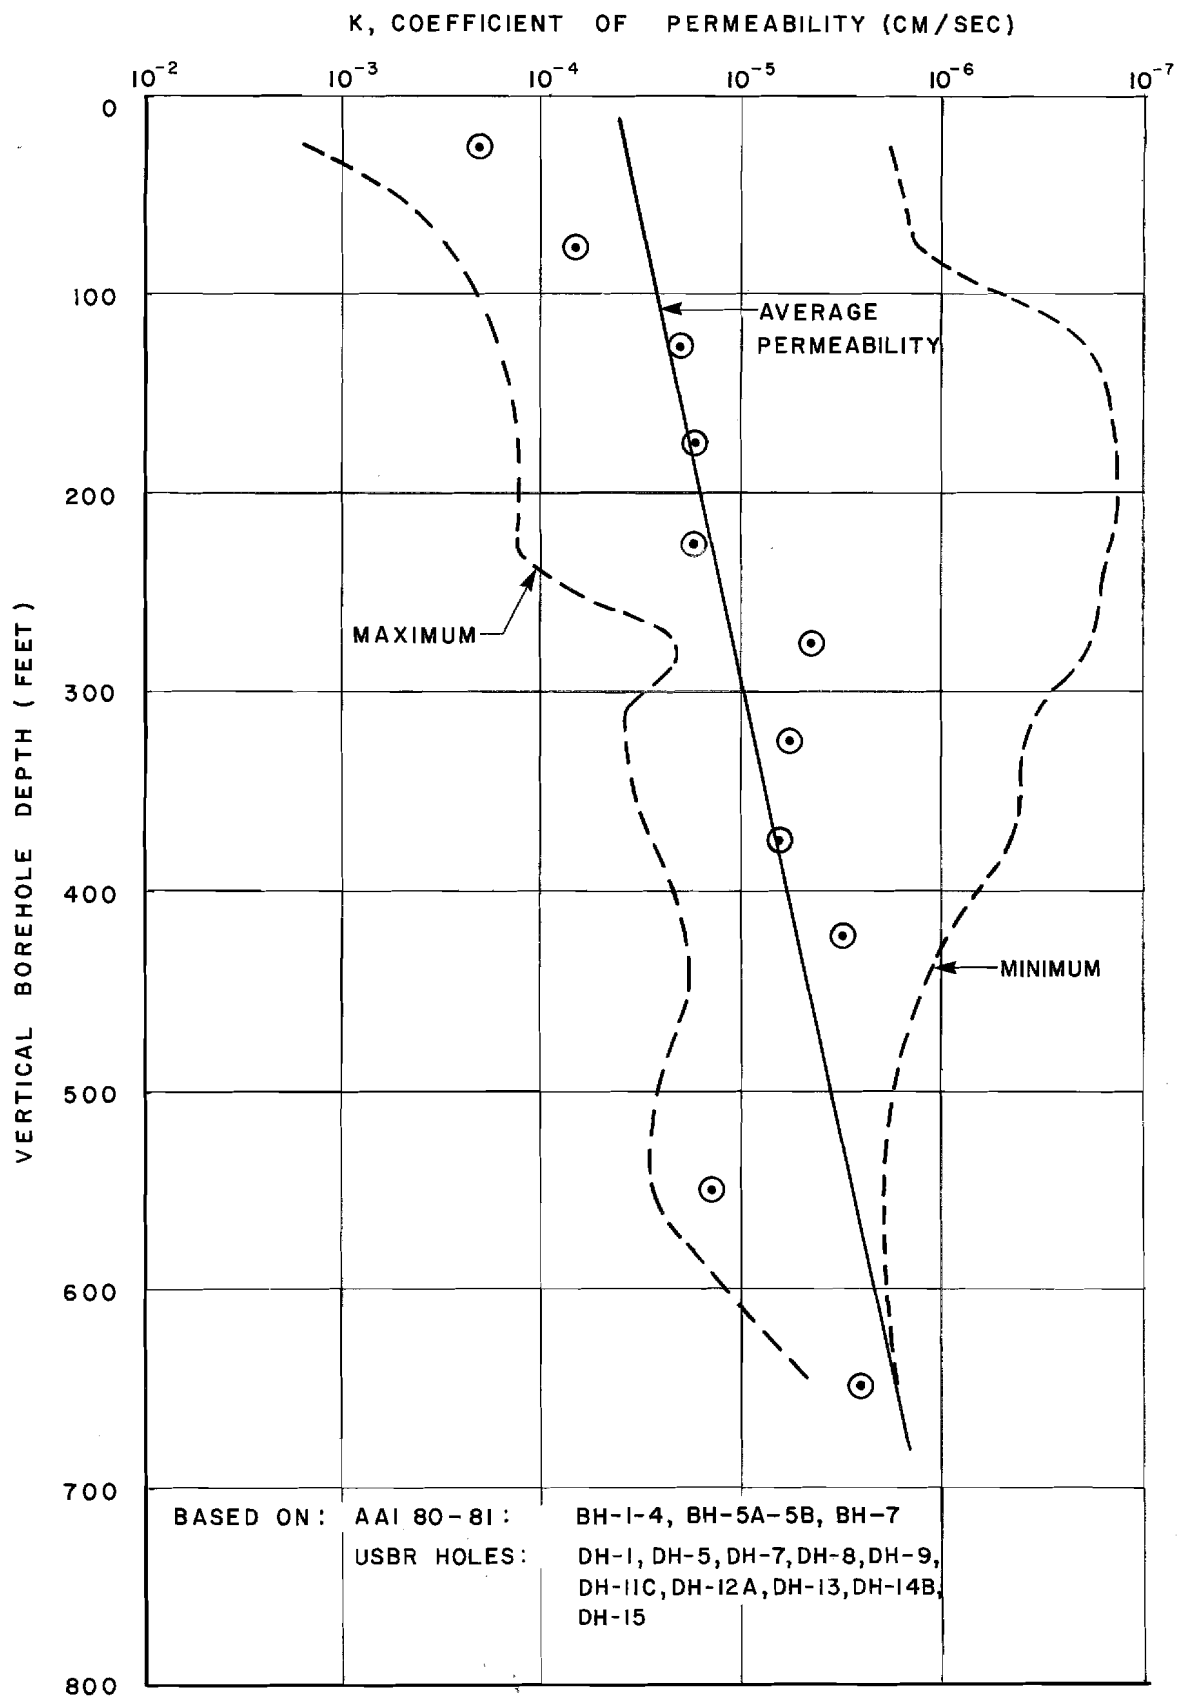
DEVIL CANYON ROCK PERMEABILITY

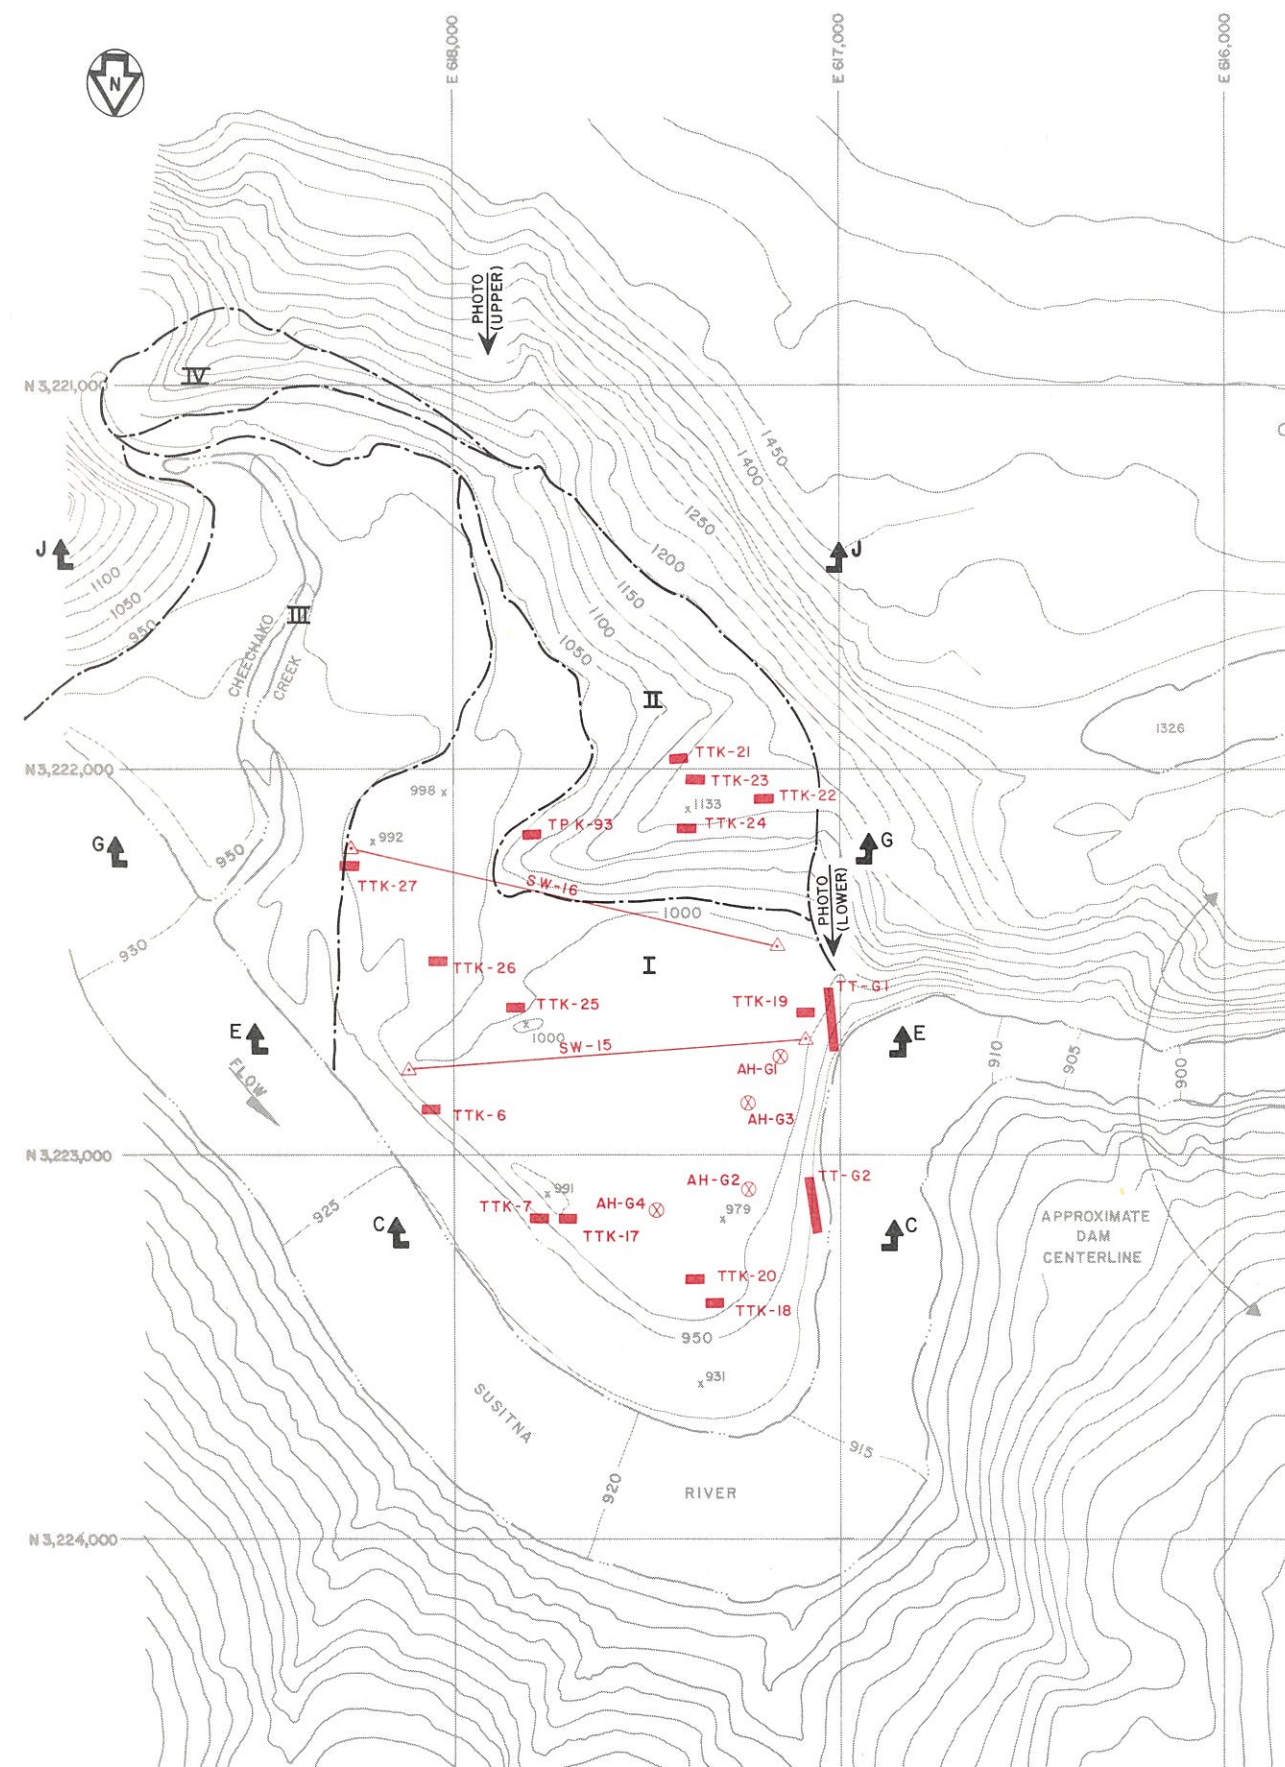
FIGURE 7.22

DEVIL CANYON BORROW SITE G PLAN

1. TYPICAL SECTIONS SHOWN ON FIGURE 7.23
2. FOR DETAILED GEOLOGY AND GEOLOGIC SECTIONS, SEE FIGURES 7.3 AND 7.4 THROUGH 7.10
3. SURFICIAL GEOLOGY SHOWN ON FIGURE 7.2
4. 25 FOOT CONTOUR INTERVAL ADDED FROM SOURCE MAP (REFERENCED) IN BORROW SITE ONLY.
5. BORROW SITE LIMITS BASED ON FIELD AND AIR PHOTO INTERPRETATION OF BORROW MATERIAL. FINAL LIMITS, SUBJECT TO RESULTS OF DESIGN INVESTIGATIONS.
6. BORROW MATERIAL ZONES INDICATE MAPPED VARIATIONS IN MATERIAL TYPE.
 - ZONE I ALLUVIAL FAN / TERRACE DEPOSIT OF SAND AND GRAVELS.
 - ZONE II RIVER TERRACES, SIMILAR TO MATERIAL I.
 - ZONE III CHEECHAKO CREEK OUTWASH, BOULDERY GRAVELS.
 - ZONE IV ARGILLITE / GRAYWACKE TALUS DEPOSITS.
7. ENTIRE BORROW SITE LIES WITHIN PROPOSED DEVIL CANYON RESERVOIR LIMITS.
8. USBR, COE EXPLORATION LOGS AS REFERENCED.
9. AAI EXPLORATION LOGS SHOWN IN APPENDIX G.
10. PHOTOS TAKEN AUGUST, 1981.

Borrow Site G was previously identified by the USBR and investigated to a limited extent by the COE (45,51) as a primary source for concrete aggregate. Because of its close proximity to the damsite and apparent large volume of material, it became a principal area for investigation during the 1980-81 program. The scope of the 1980-81 investigation in this borrow site is discussed in Section 5 and shown in Figure 7.22.

approximately 2,000 feet. The site extends for a distance of approximately 1,200 feet east-west (Figure 7.22). Cheechako Creek exits from a gorge and discharges into the Susitna River at the eastern edge of the borrow site. The fan is generally flat-lying at Elevation 1000, approximately 80 feet above river level. Higher terrace levels that form part of the borrow site are found along the southern edge of the site above Elevation 1100.

Vegetation is scattered brush with mixed deciduous trees found on the floodplain and fan portions. On the southern hillside portion of the borrow site, heavy vegetation is evident with dense trees and underbrush (Figure 7.22). The ground cover averages up to 0.5 foot in thickness and is generally underlain by 1 to a maximum of 6.5 feet of silts and silty sands. This silt layer averages 1.5 feet thick on the flat-lying deposits, and up to 2 feet thick on the hillsides above Elevation 950.

The borrow material has been classified into four basic types, based on the interpretation of field mapping and explorations. The four types of material or zones, as identified on the map (Figure 7.22), are: Susitna River alluvial gravels and sand (Zone I), ancient terraces (Zone II), Cheechako Creek alluvium (Zone III), and talus (Zone IV).

The borrow site quantities were broken down into zones as shown on the typical sections based on the exploration logs and test trench sections shown in Appendix G (Figure 7.22).

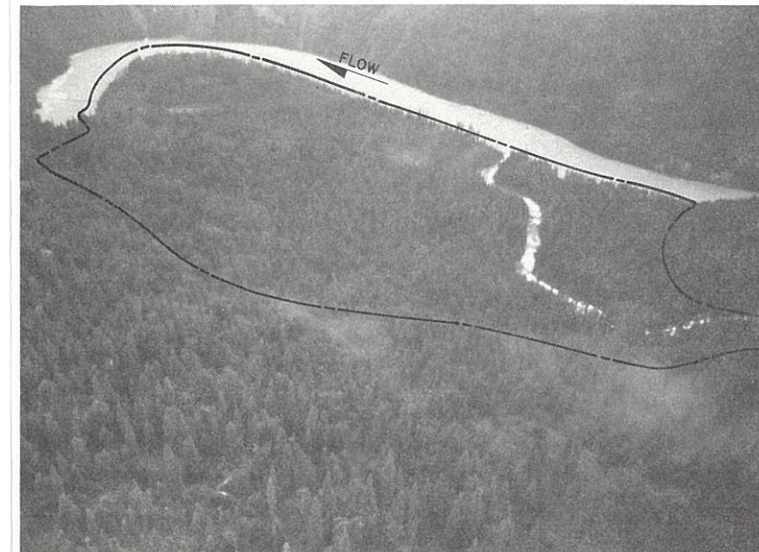
BORROW SITE G
(LOOKING NORTH)

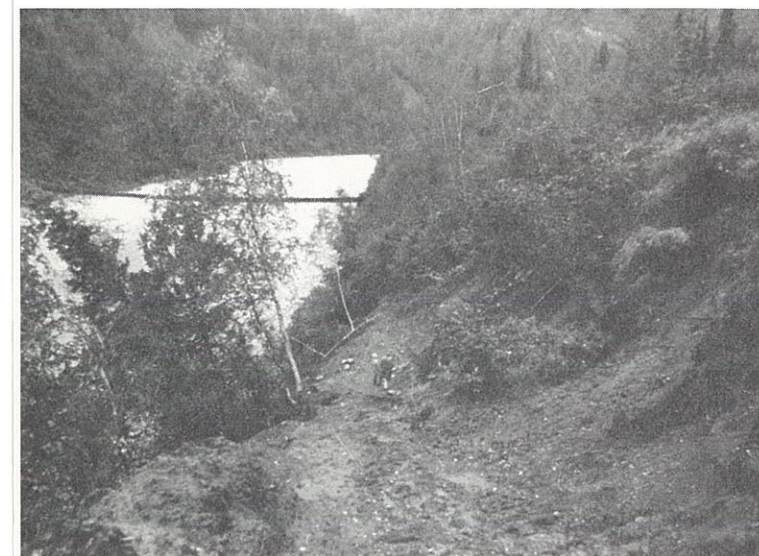
TEST TRENCH TT-G1
(LOOKING NORTH)

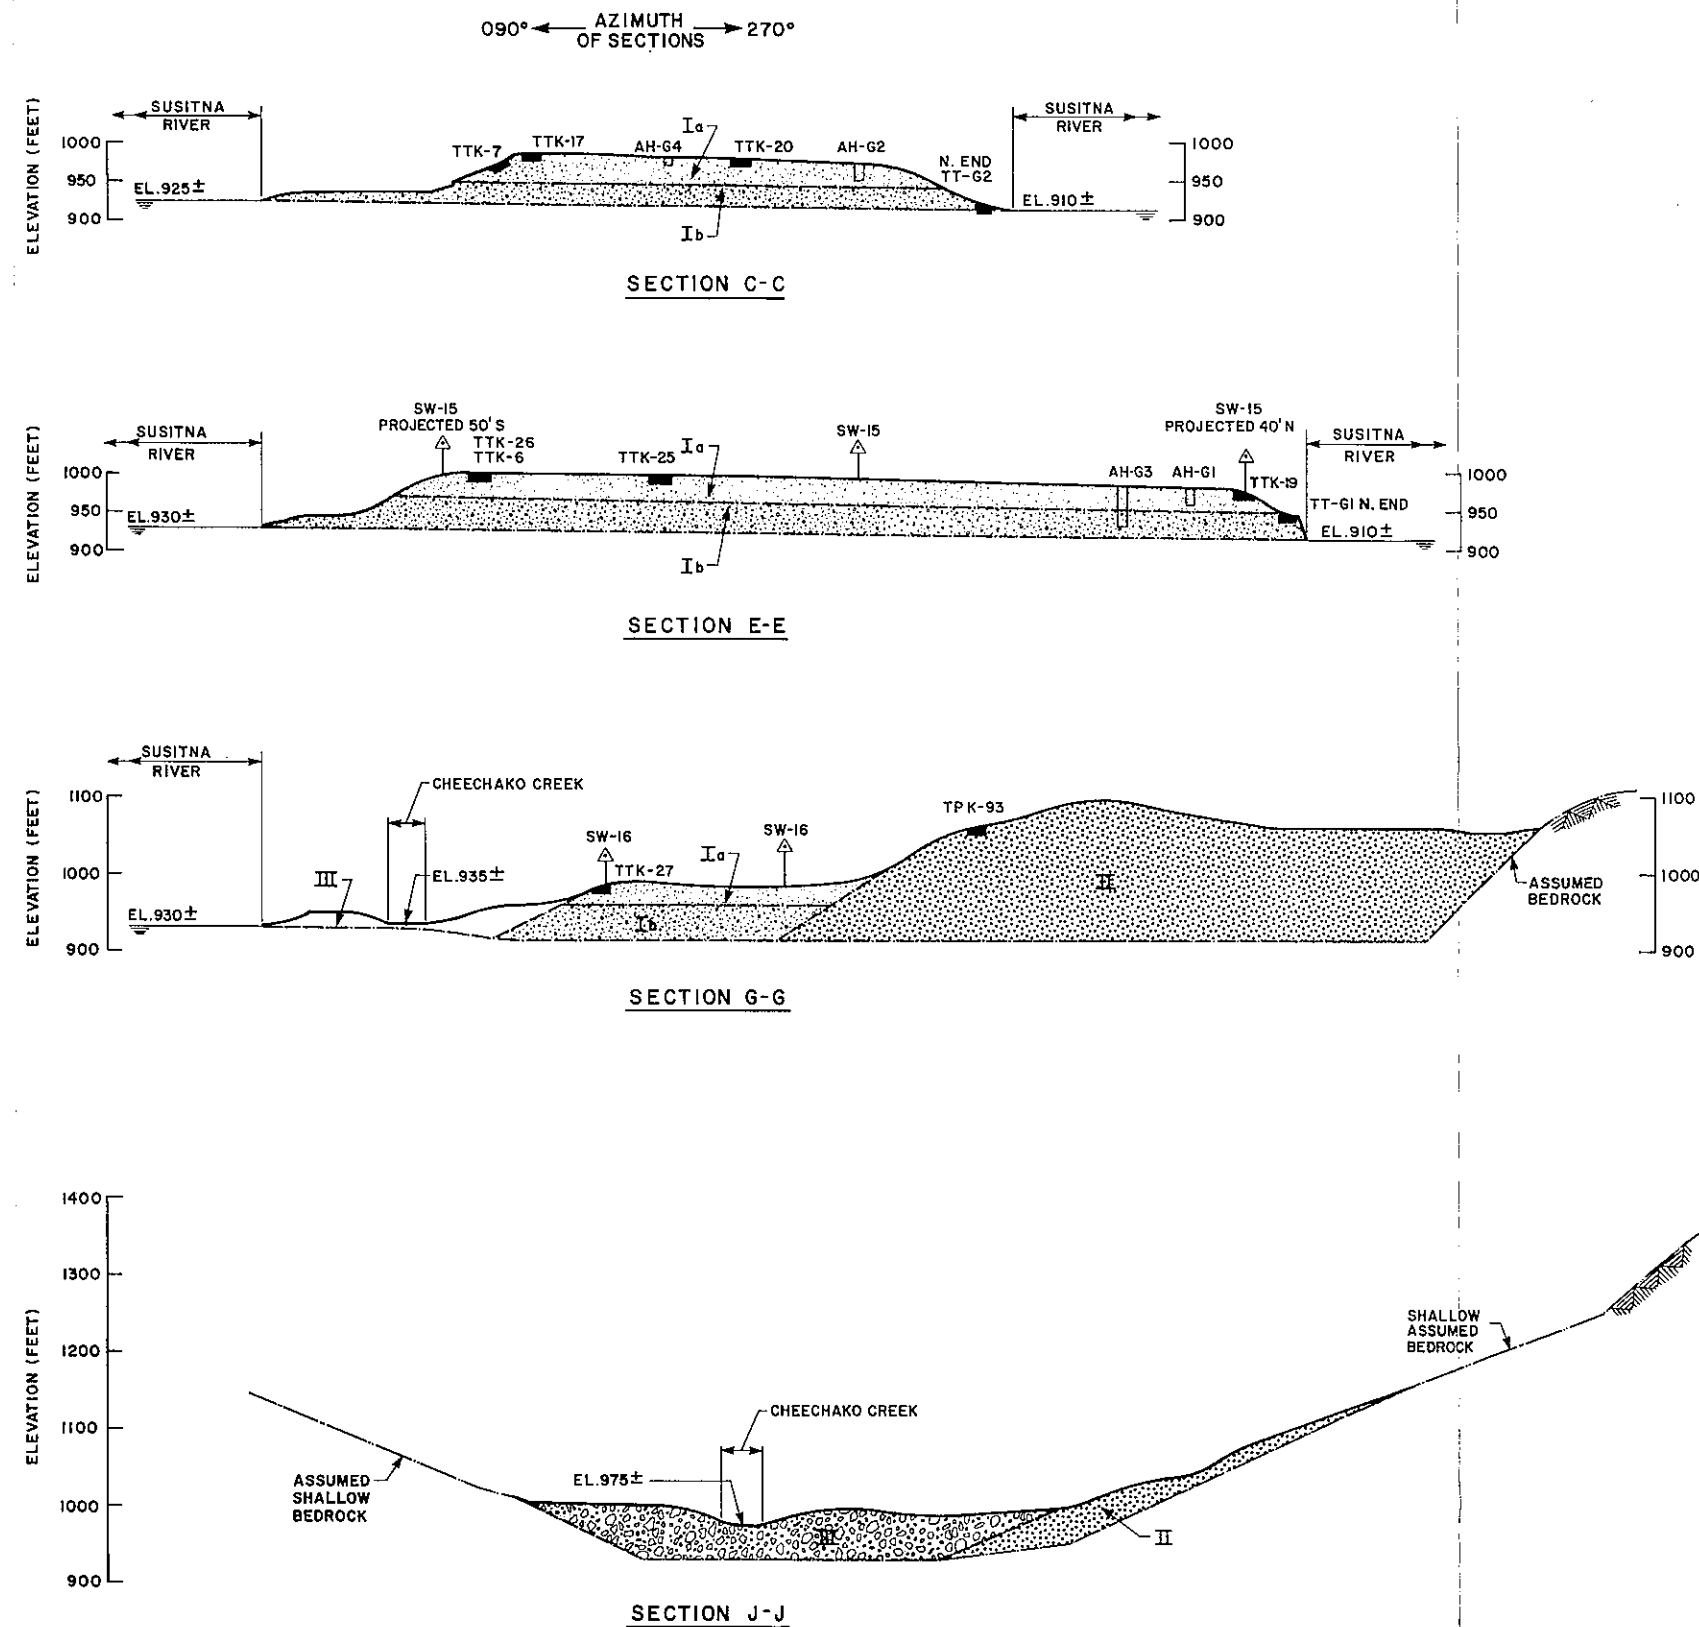
1. SECTION LOCATIONS AND BORROW SITE PHOTO SHOWN ON FIGURE 7.22.
2. FOR DETAILED GEOLOGY AND GEOLOGIC SECTIONS, SEE FIGURE 7.3 AND 7.4 THROUGH 7.10.
3. SURFICIAL GEOLOGY SHOWN ON FIGURE 7.2.

DEVIL CANYON
BORROW SITE G SECTIONS

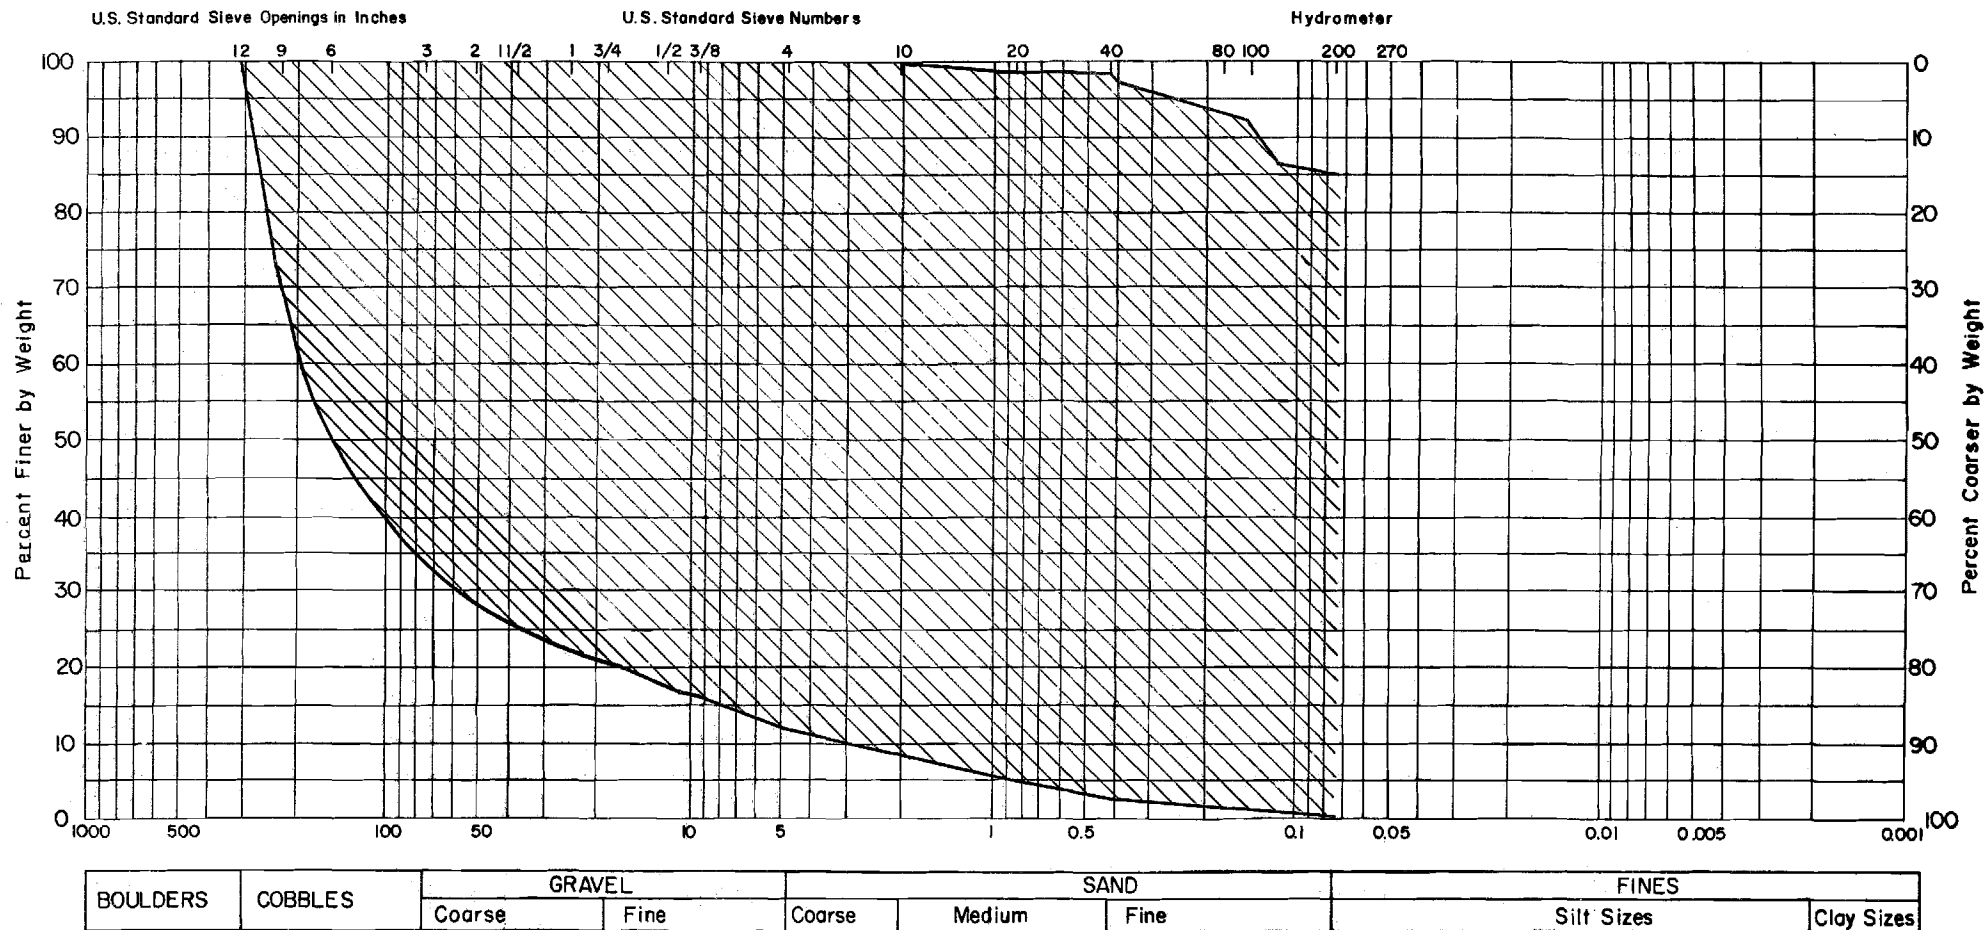
FIGURE 7.24

TOTAL NUMBER OF SAMPLES : 47

DEVIL CANYON
BORROW SITE G
RANGE OF GRADATIONS

Results of the laboratory tests performed for the project are summarized in Table 7.8. A composite grain size curve showing the wide range of gradations in Borrow Site G is shown in Figure 7.24. A more detailed breakdown of the
