SUSITNA HYDROELECTRIC PROJECT

1980-81 GEOTECHNICAL REPORT

VOLUME 1
TEXT
FINAL DRAFT

ALASKA POWER AUTHORITY

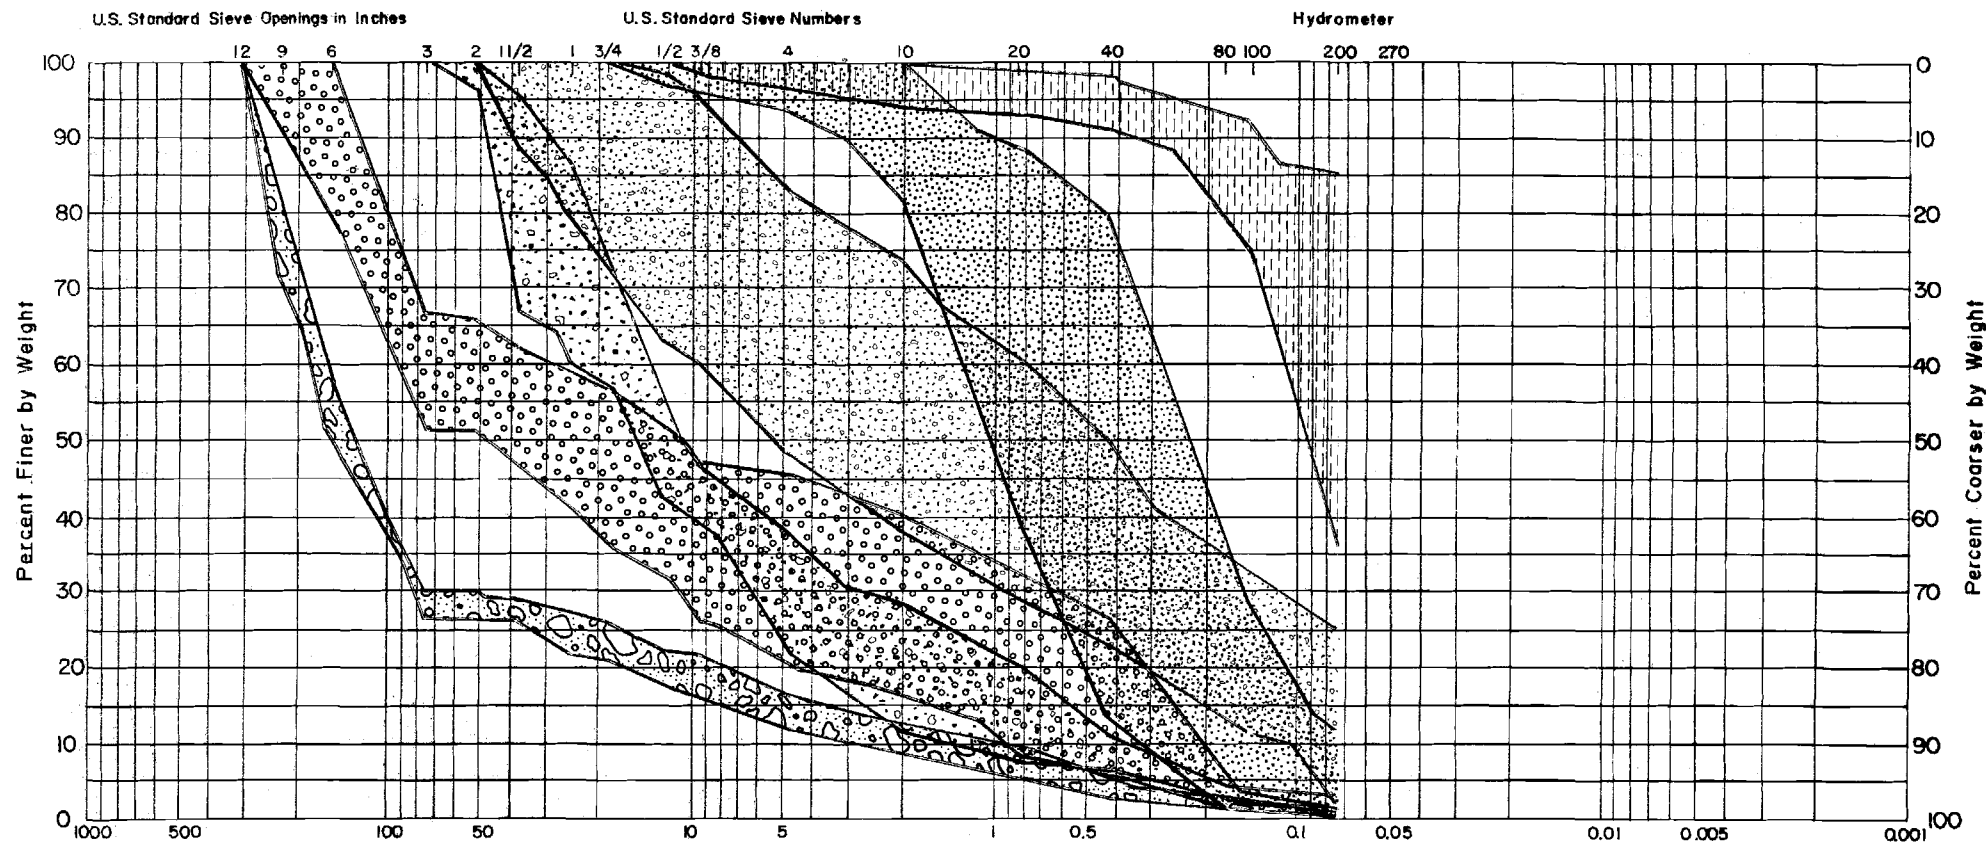
FIGURE 7.25

UNIT*	MATERIAL	NO. OF SAMPLES	UNIT*	MATERIAL	NO. OF SAMPLES
C	SILT WITH SAND, GRAVEL	4	O	SANDY GRAVEL	4
D	SAND WITH TRACE SILT	9	P	GRAVELLY SAND, SANDY GRAVEL	3
N	SANDY GRAVEL	3	Z	SANDY GRAVEL WITH SILT, COBBLES	24

various stratigraphic unit gradations is shown in Figure 7.25. Units identified in Figure 7.25 correspond with those units mapped in the test trenches (Appendix G). In summary, two distinct grain sizes are found in the site: (1) from the auger holes (Unit D), a fairly uniform, well sorted coarse sand with low fine content and (2) from the test trenches (Unit Z), a fairly well-graded gravelly sand averaging 10 percent passing No. 22 sieve. The principal reason that the auger drilling did not encounter the coarser material is likely reflective of the sampling technique where the auger sampling could not recover the coarser fractions.
