# Duck Creek Realignment Monitoring, 2012-2016 Final Report

***TECHNICAL REPORT NO. 17-08***

**DUCK CREEK REALIGNMENT MONITORING, 2012-2016**

**FINAL REPORT**

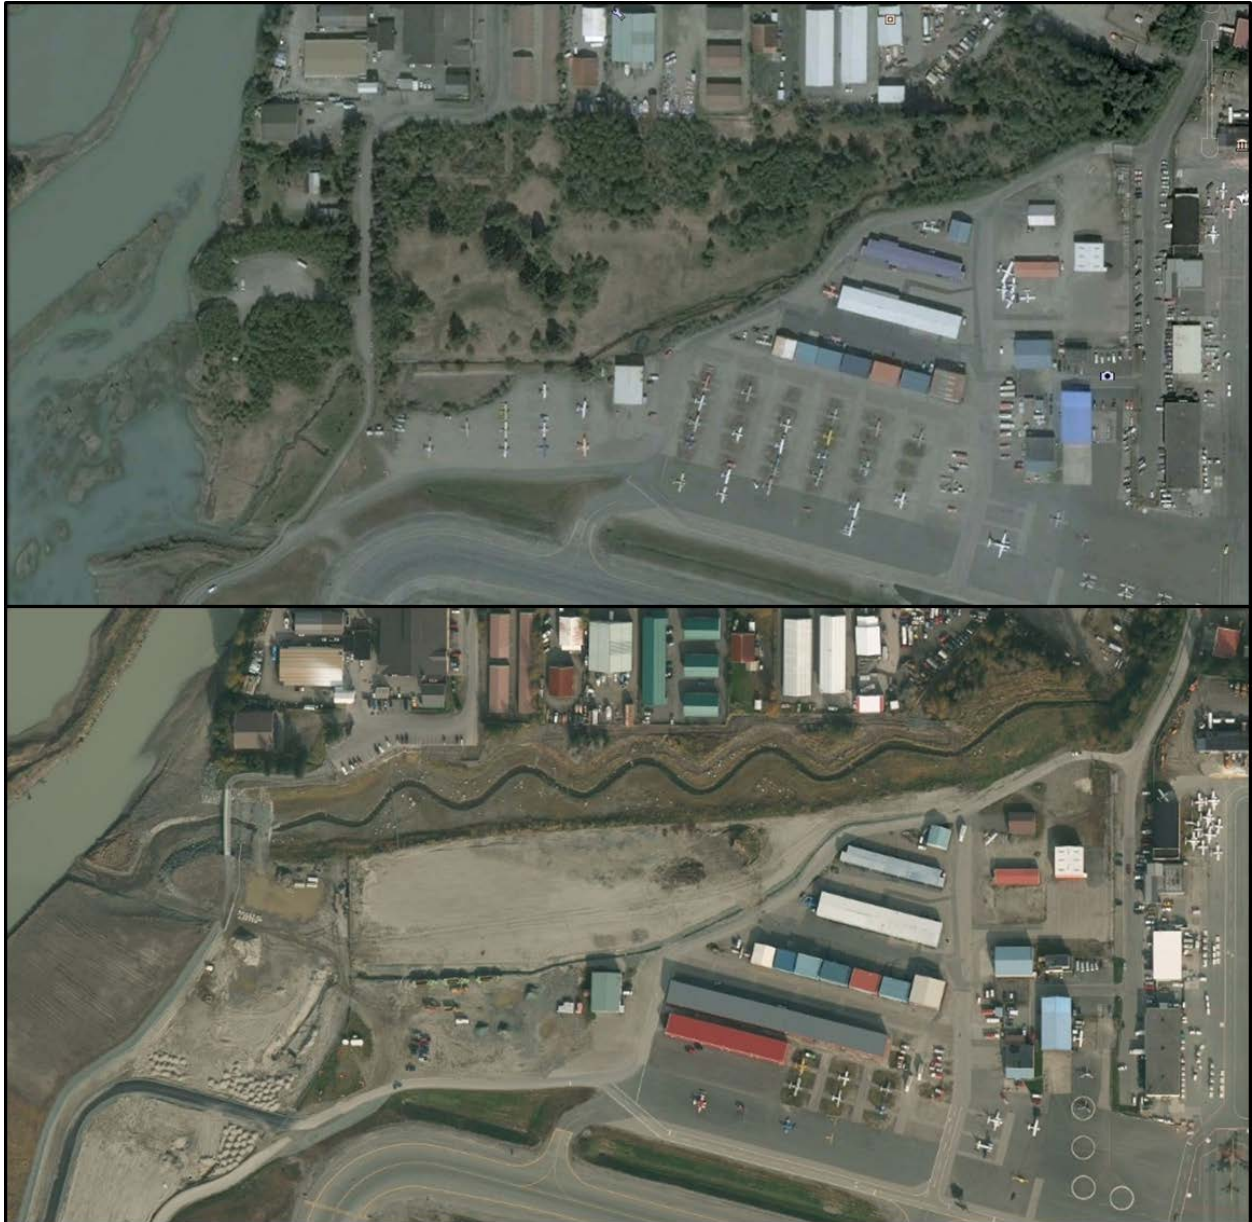
In 2010, JNU realigned Duck Creek about 100 m to the north to increase airport capacity and efficiency and to reduce risks posed to aviation from wildlife (Figure 1).

Figure 1.—Duck Creek before (top) and after (bottom) channel realignment.

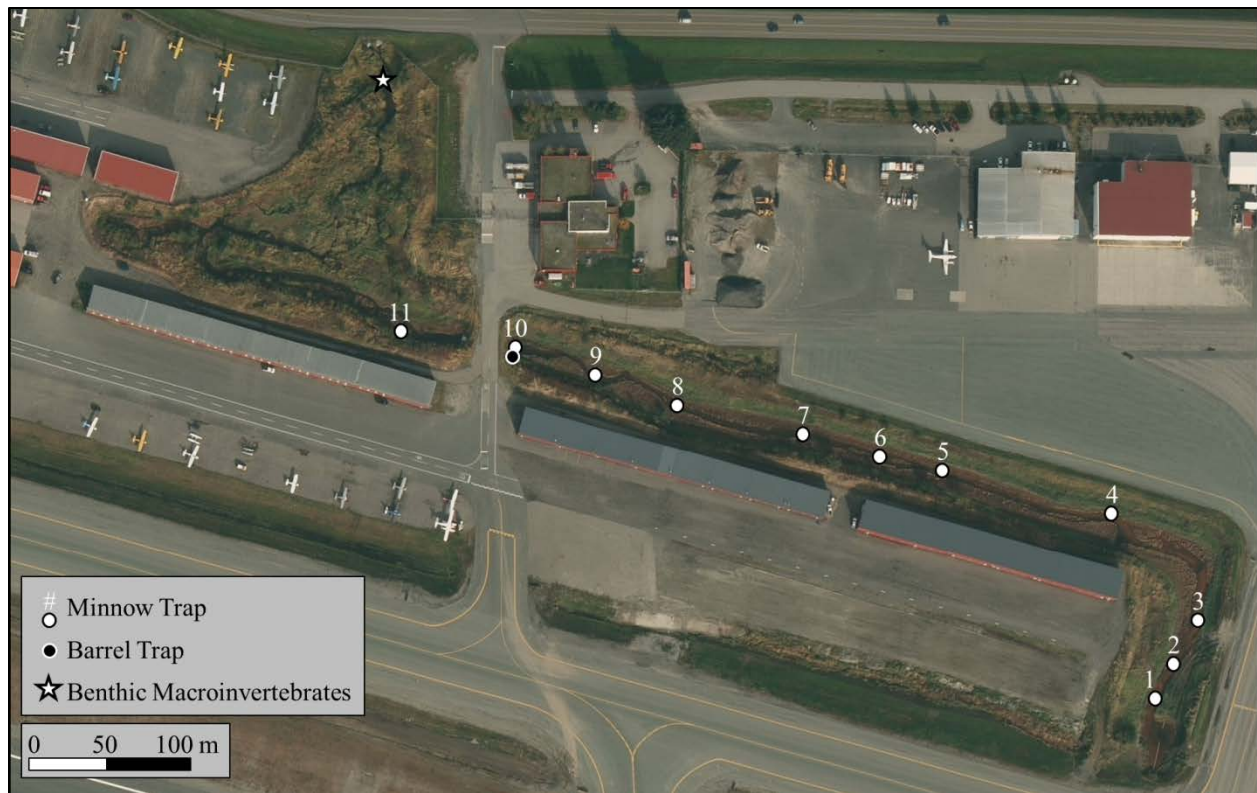
Figure 3.—Jordan Creek sampling locations.

We monitored the realigned Duck Creek physical, chemical, and biological parameters listed in Table 1 at the locations shown in Figure 2 from 2012–2016. We monitored the biological parameters listed in Table 1 in a previously realigned reach of Jordan Creek with comparable tidal influence at the locations shown in Figure 3.

We placed 11 minnow traps with 3 mm mesh and 22 mm diameter entrance, and one barrel trap with 3 mm mesh and 55 mm diameter entrance, at established locations between the Cessna Drive Culvert and the security fence<sup>e</sup> (Figure 2). In 2013 we began trapping the reach of Jordan Creek that is subject to similar tidal influence as a reference site (Figure 3). We baited the traps with freshly punctured Whirl-packs® containing disinfected salmon eggs and allowed them to soak for at least six hours before recording species caught. We measure dissolved oxygen (DO), stream temperature, and salinity with a YSI *Pro 2030* handheld unit during sampling events in the middle of the sampling reaches<sup>f</sup>. If established trapping sites were dewatered or frozen, we set traps as close as possible or delayed trapping until at least seven days of consecutive streamflow had occurred. We also recorded fish visually observed in the creek during trapping. We present our findings as CPUE in relation to drainage, trap location, and seasonality and provide data in Appendix B.

We used a 0.093 m<sup>2</sup> Surber stream bottom sampler with a 300 µm mesh net to collect three replicate samples of benthic macroinvertebrates from one site on Duck and Jordan Creeks (Figures 2, 3). We placed the sampler on the stream bottom in riffle or run habitat and disturbed sediments by hand to a depth of 10 cm, using a scrub brush to free invertebrates from larger rocks. We then transferred the sample from the cod end of the net into 500 mL bottles filled with 70% ethanol preservative.

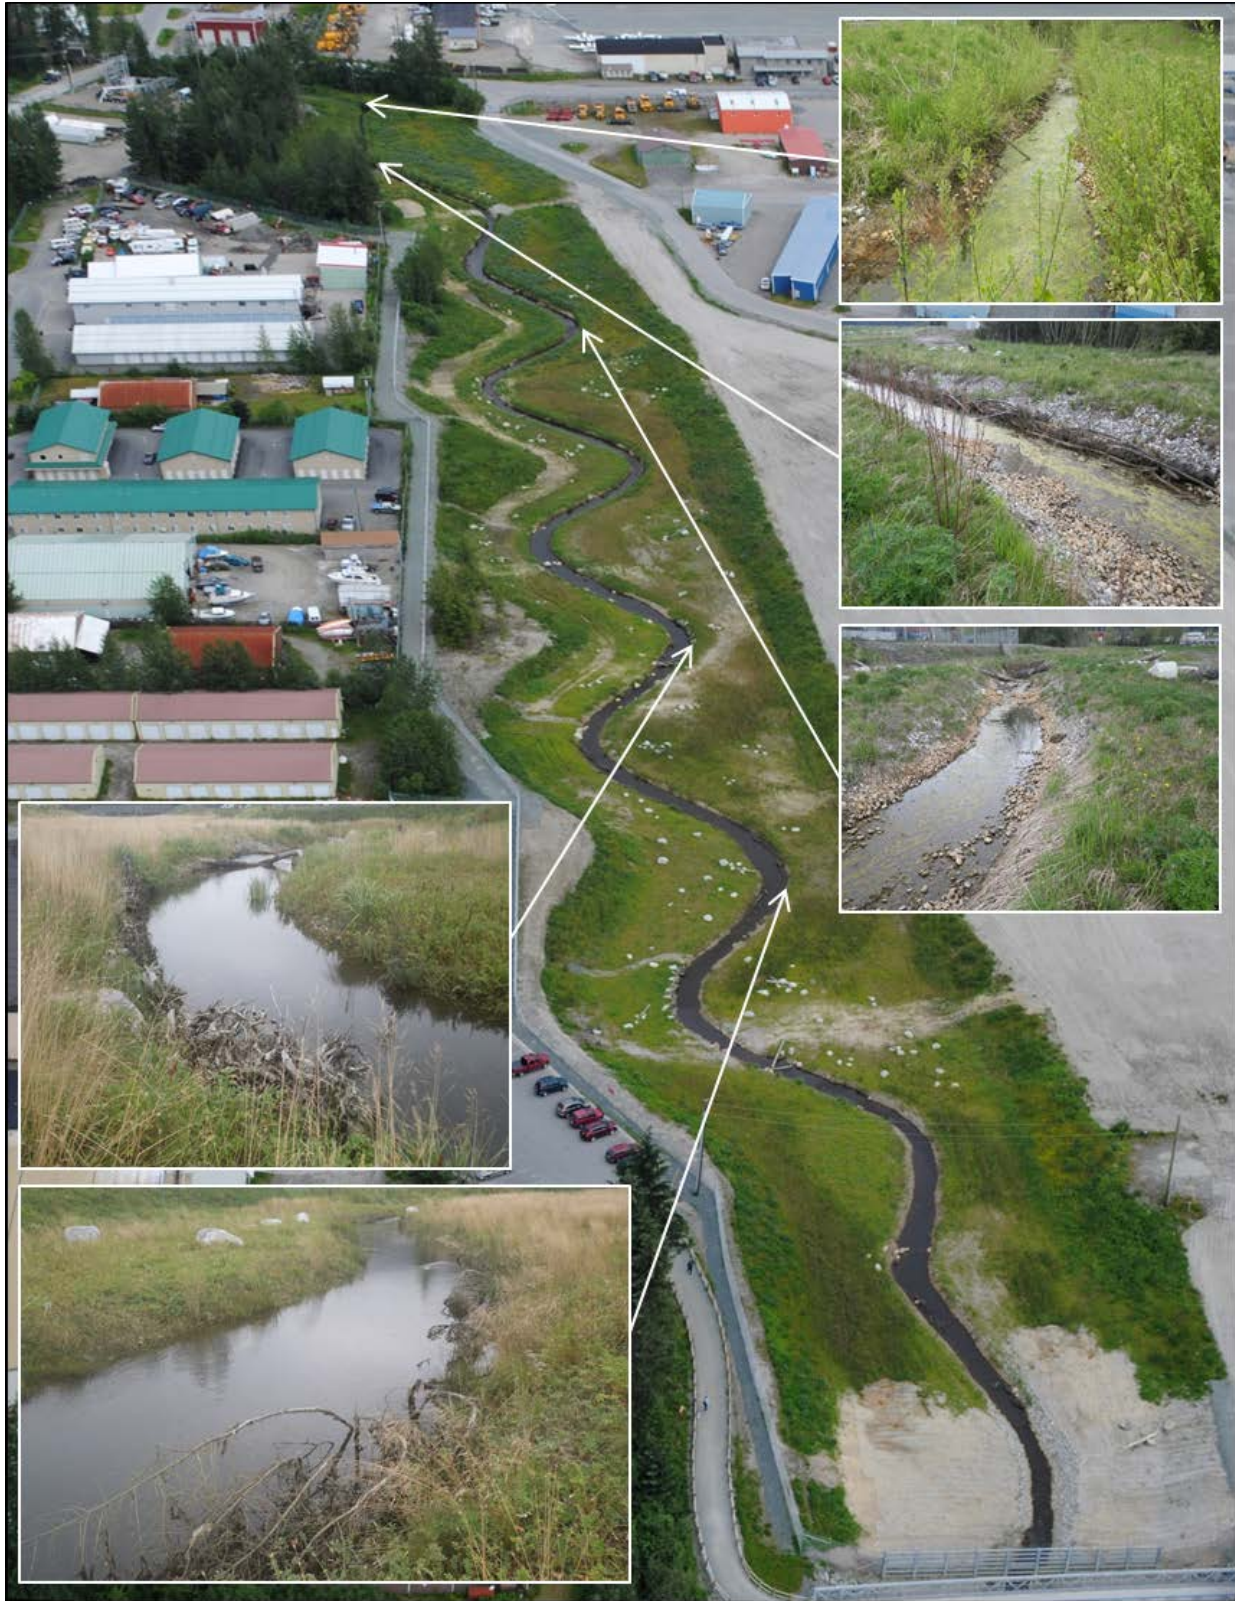
JNU realigned Duck Creek into a sinuous channel in 2010 and incorporated bioengineered bank treatments and instream structures (Figure 4). The floodplain was sloped to encourage salmon carcass flushing and was sown with native grass and wetland plant seed mixes. Upstream of the pedestrian bridge, the creek was lined with a bentonite clay layer and 60 cm of silt and sand to exclude groundwater and retain pools of surface water for fish passage and egg survival during low flows. A 30 cm layer of gravel and cobble substrate was placed on top of the silt and sand layer. The realigned channel and floodplain are subject to tidal influences above about 15 ft (Figure 5).

Figure 4.—Realigned channel and instream structures, July 2012.

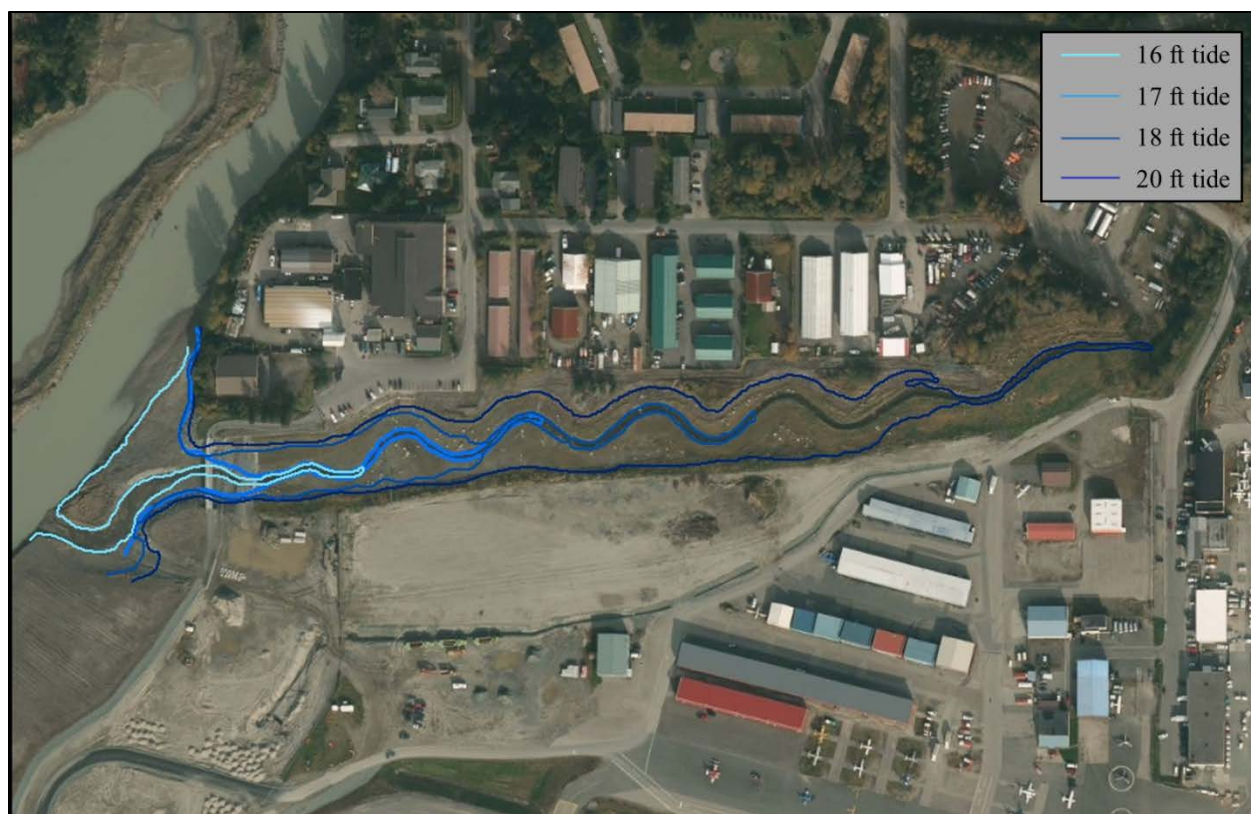
Figure 5.–Map showing tidal inundation.

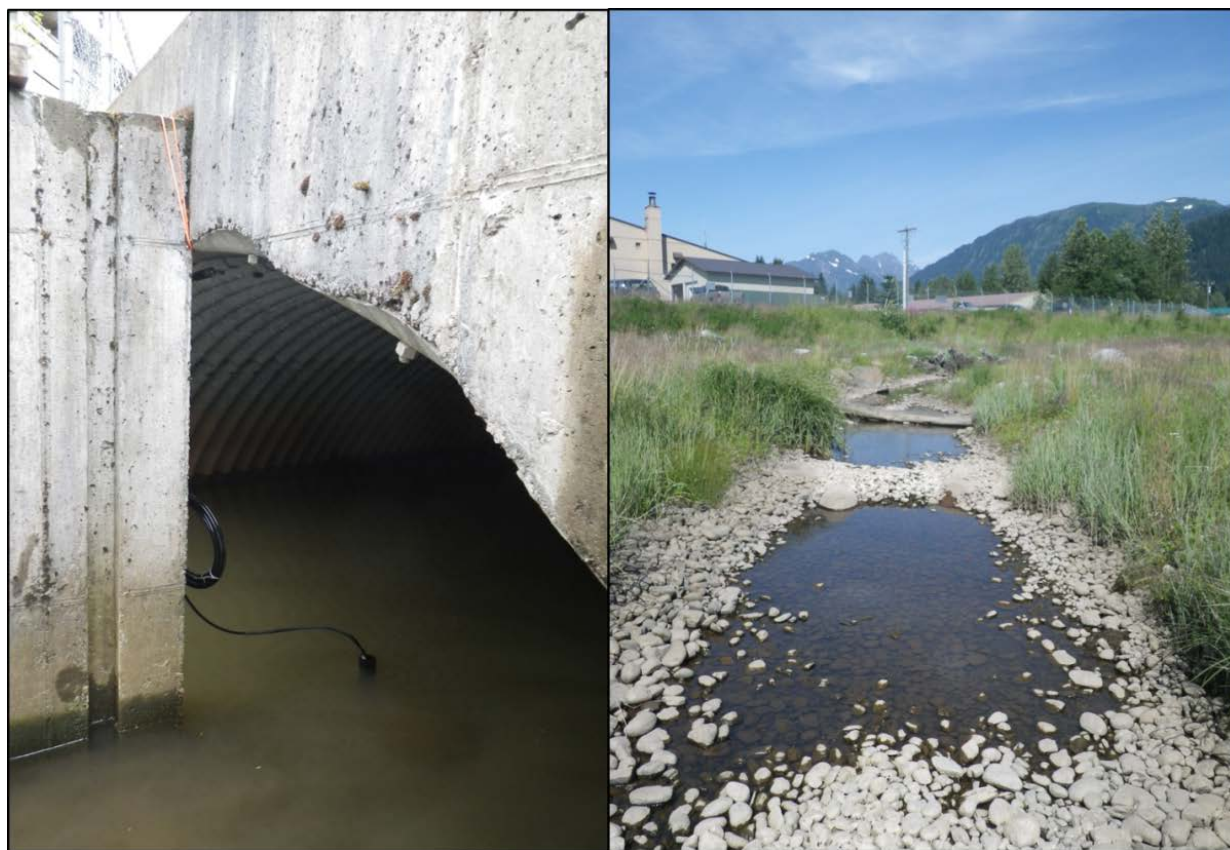
We mounted a YSI 600LS water quality sonde on a rebar stake driven into the streambed under the Cessna Drive Culvert to record hourly water temperature and depth measurements during the ice free season each year. We used a framing level and tape measure to check sonde height against a benchmark on a nearby concrete wall and calibrated stage data among years. We noted the time and date when discontinuous flow impeded fish passage in the realignment and correlated these events with sonde depth measurements to better understand how often low flow limits fish movement (Figure 6). We present graphed water level and temperature data along with the annual proportion of the recording period when fish passage was obstructed by low flow in a table.

Figure 6.—Water quality sonde (left) and discontinuous flow in the realignment (right).

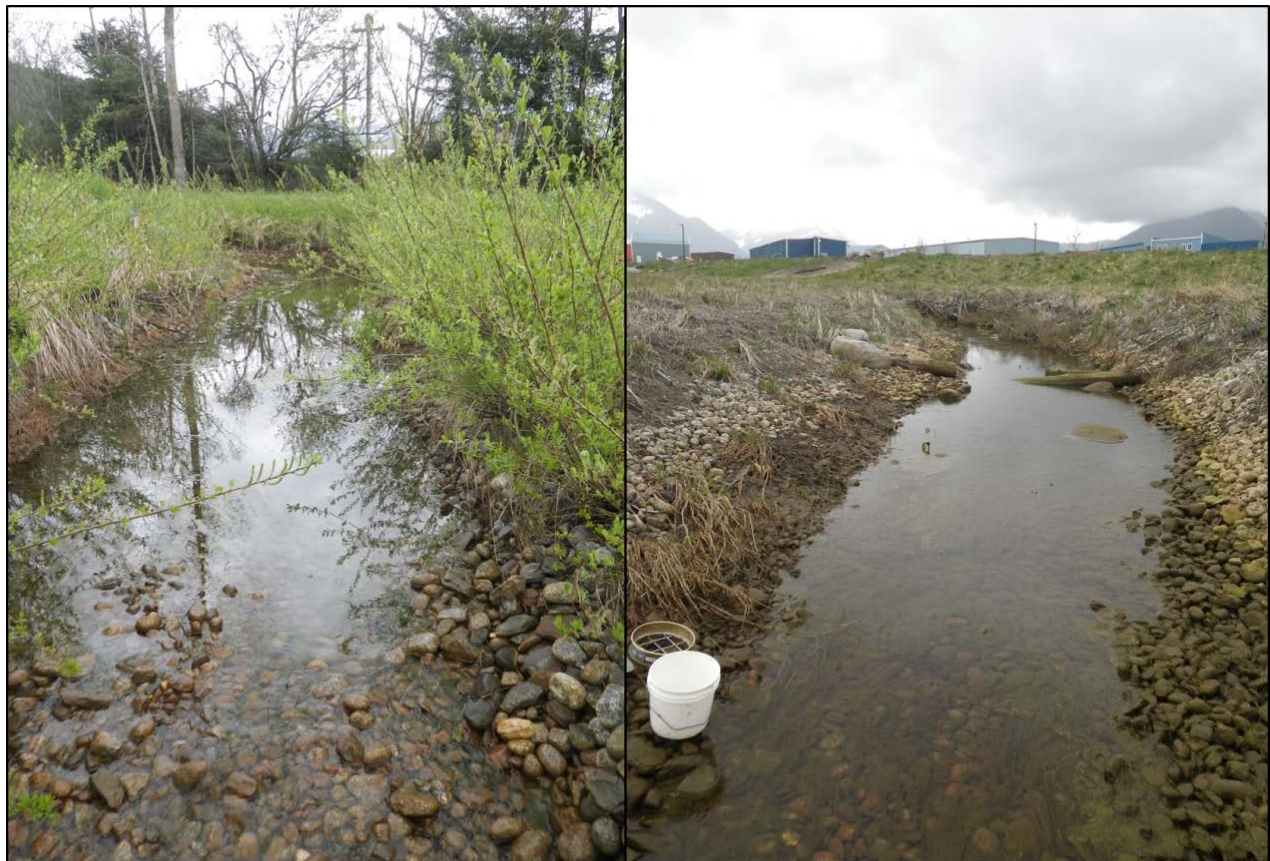
We measured spawning substrate size annually to assess spawning habitat quality and changes at two sites over time. Site 1 is located at the top of the realignment above the influence of tides less than 19.5 ft and site 2 is about 300 m downstream and is inundated with a mixture of brackish sea water and fresh water from the Mendenhall River at tides greater than 18 ft (Figures 2, 7). We used a McNeil sampler to take three replicate samples from sites directly downstream of pool tails in the thalweg of riffles where the water begins to accelerate (Valentine 1995). We worked the McNeil sampler into the substrate and excavated substrate in the basal core (15 cm

Figure 7.—Spawning substrate sampling sites 1 (left) and 2 (right).

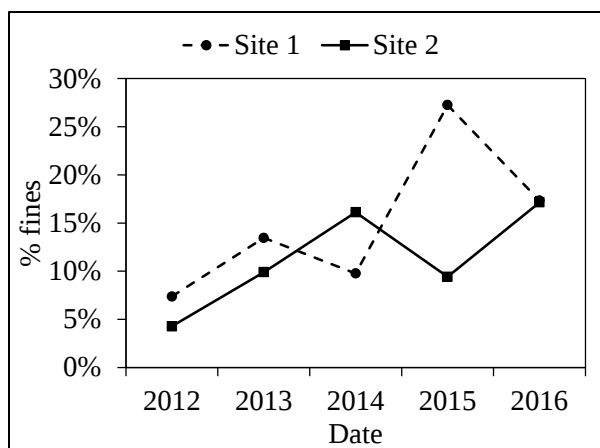
Mean values from three replicates sampled at Sites 1 and 2 showed trends of increasing percent fines (<2.36 mm) and decreasing mean particle diameter (Table 3; Figures 10, 11). We observed spawning substrate in the realignment lacked medium, fine, and very fine gravel size classes (2–18 mm diameter). Based on visual observations, substrate downstream of the security fence, which was not from the same source as upstream, appeared to contain all size classes and was imbedded in fine sediments about 5 cm below the surface making it difficult to excavate.

Figure 10.–Sites 1 and 2 mean percent fines, 2012–2016.

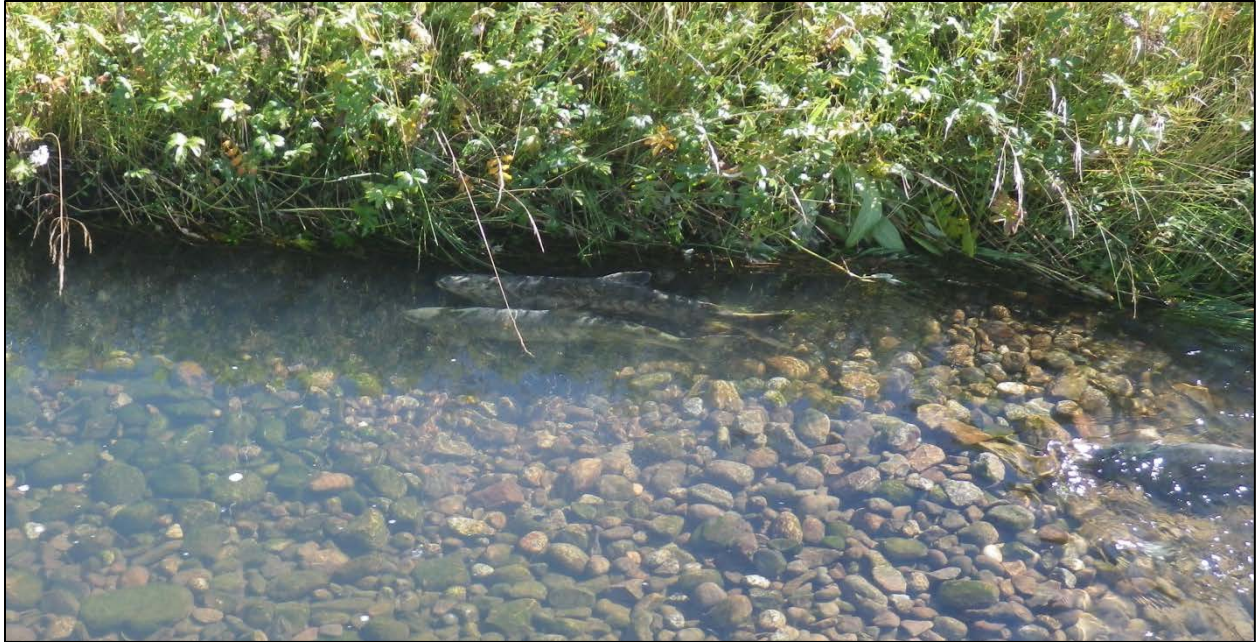
Figure 16.—Adult chum salmon constructing a redd, August 13, 2015.

We recorded live and dead adult chum and pink salmon in Duck Creek during weekly spawning surveys between July 15 and September 19, annually (Table 5). We observed redd construction by spawning pairs, adult fish trapped in pools during dry conditions, and loose eggs littering the creek bottom from pre-spawn mortalities (Figures 16, 17). Checks of fresh chum carcasses in 2013 and 2015 showed 21/24 and 19/32 fish died before spawning. Pink salmon observations were highest in 2015 with several hundred animals observed compared to all other years where counts ranged from 0–13.

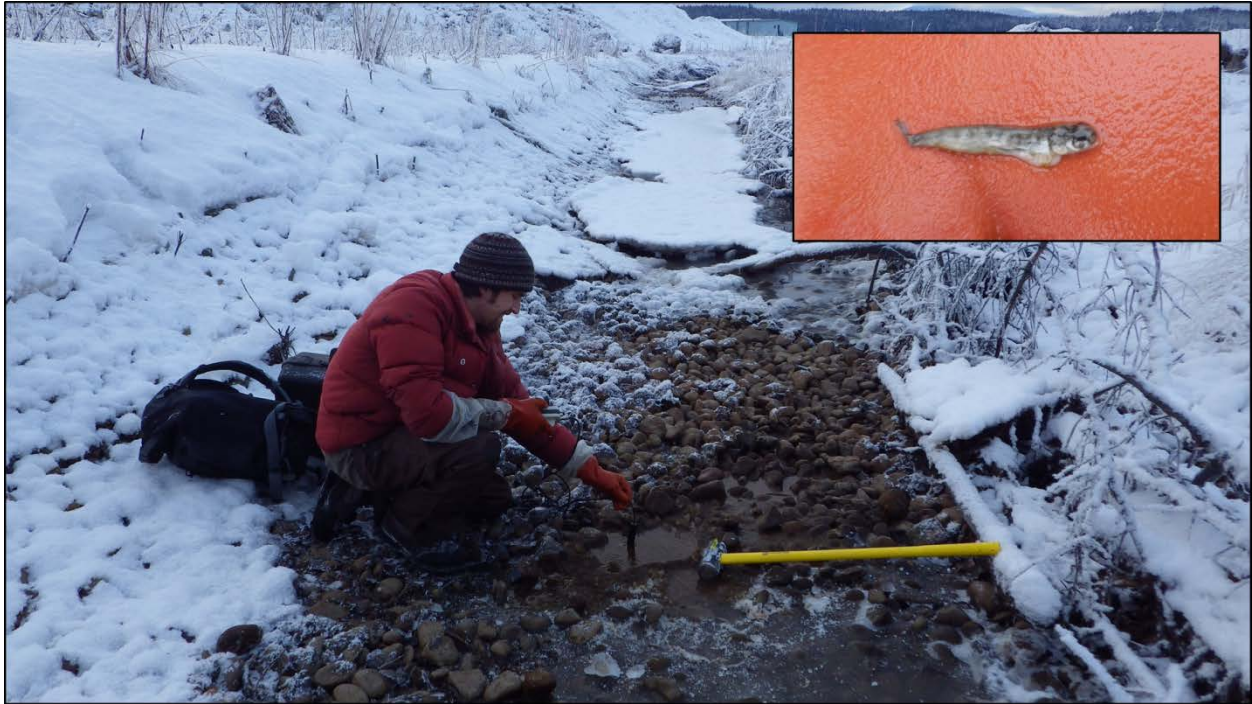
In November and December of 2012, 2013, and 2014, we sampled stream gravel throughout the realignment to assess egg viability (Figure 18; Table 6). In each year we found only dead and degraded salmon eggs and alevins. Ice was present during the surveys with some areas of the stream frozen solid into the gravel and others retaining stagnant water. We recorded DO values in stagnant water and found them generally increasing with movement downstream where tidal influence is more regular and ice cover was reduced (Table 6). Below the security fence, where

the bentonite liner is not present, the channel was consistently dry until water seeping from the Mendenhall River entered the stream 60 m from the mouth of Duck Creek.

Figure 18.—Redd excavation and dead chum fry (inset), December 18, 2012.

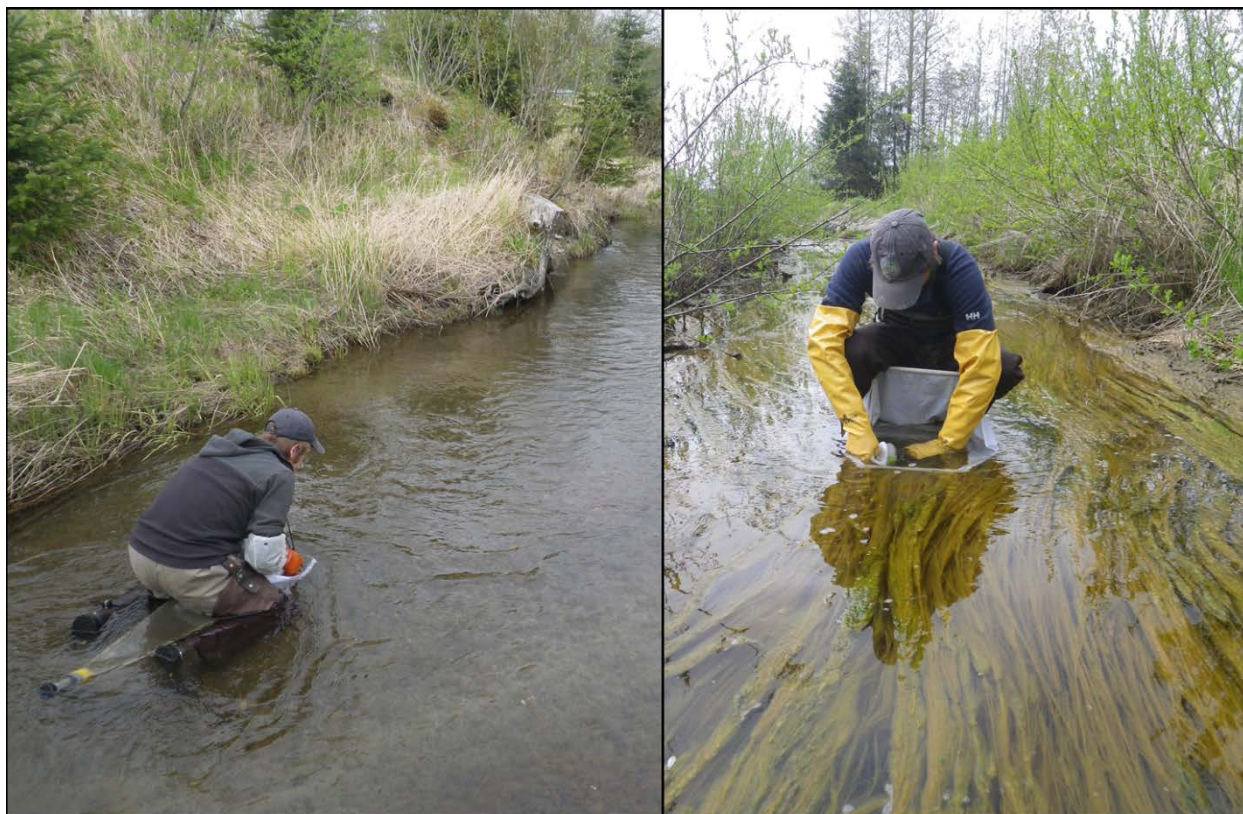
Figure 20.—Jordan Creek (left) and Duck Creek (right) benthic macroinvertebrate sampling sites.

We generally did not find environmentally sensitive EPT taxa in Duck Creek samples (0.0% EPT; Table 7; Figure 19; Appendix C). Pollution tolerant taxa, such as chironomids and annelids, were abundant. Shannon Diversity and Evenness, and % EPT values were consistently higher in Jordan Creek than Duck Creek (Table 7). We observed 25 taxonomic groups across all 5 years of Duck Creek sampling, including 2 EPT taxa. We observed 26 taxonomic groups across all 5 years of Jordan Creek sampling, including 10 EPT taxa (Appendix C). Invertebrates per m<sup>2</sup> ranged from 2,588–9,391 in Duck Creek and 1,495–9,133 in Jordan Creek across all years. The Jordan Creek site is 3 ft lower in elevation than the Duck Creek site, though field observations indicate tidal influence at the two sites produces similar salinity conditions (maximum recorded 0.4 ppt at both sites; Figure 20).

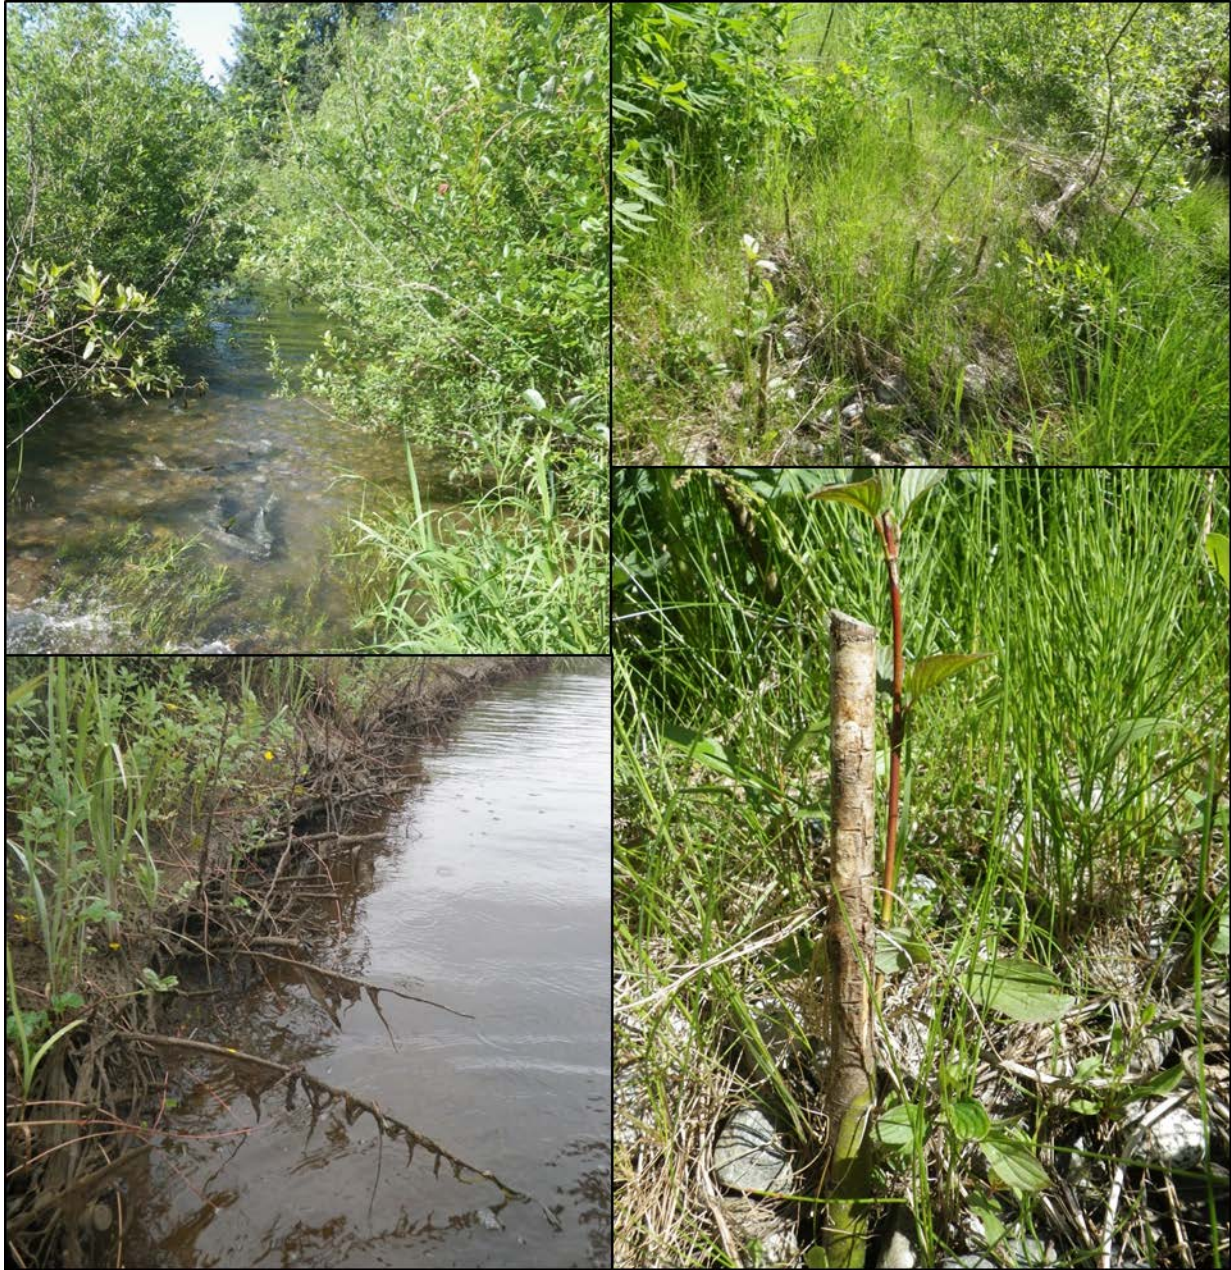
We observed seeding, willow staking, and bank treatments in Duck Creek produced mixed results for vegetative growth. Willow plantings upstream of photo point six grew well and have matured to form a canopy cover over the channel upstream of photo point two (Figure 21). Some willows that were not watered following planting<sup>i</sup> failed to regenerate and willow stakes downstream of photo point six failed to grow due to tidal flooding (Figure 21).

Figure 21.—Successful (top left, lower right), and unsuccessful (top right, bottom left) willow plantings.

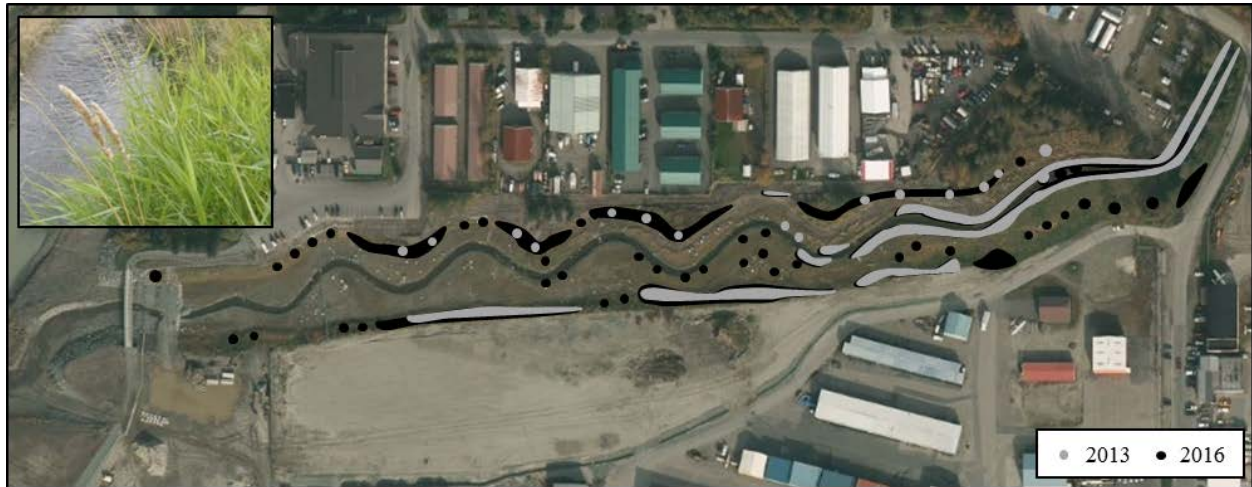
The hydroseed mix used above photo point eight has flourished with native species including bluejoint reedgrass *Calamagrostis canadensis* and lupine *Lupinus arcticus*. The invasive orange hawkweed *Hieracium aurantiacum* and reed canary grass, both present upstream, have established in the realignment. Reed canary grass has expanded its coverage through the realignment each year (Figure 22).

Figure 22.—Reed canary grass (inset) expansion map.

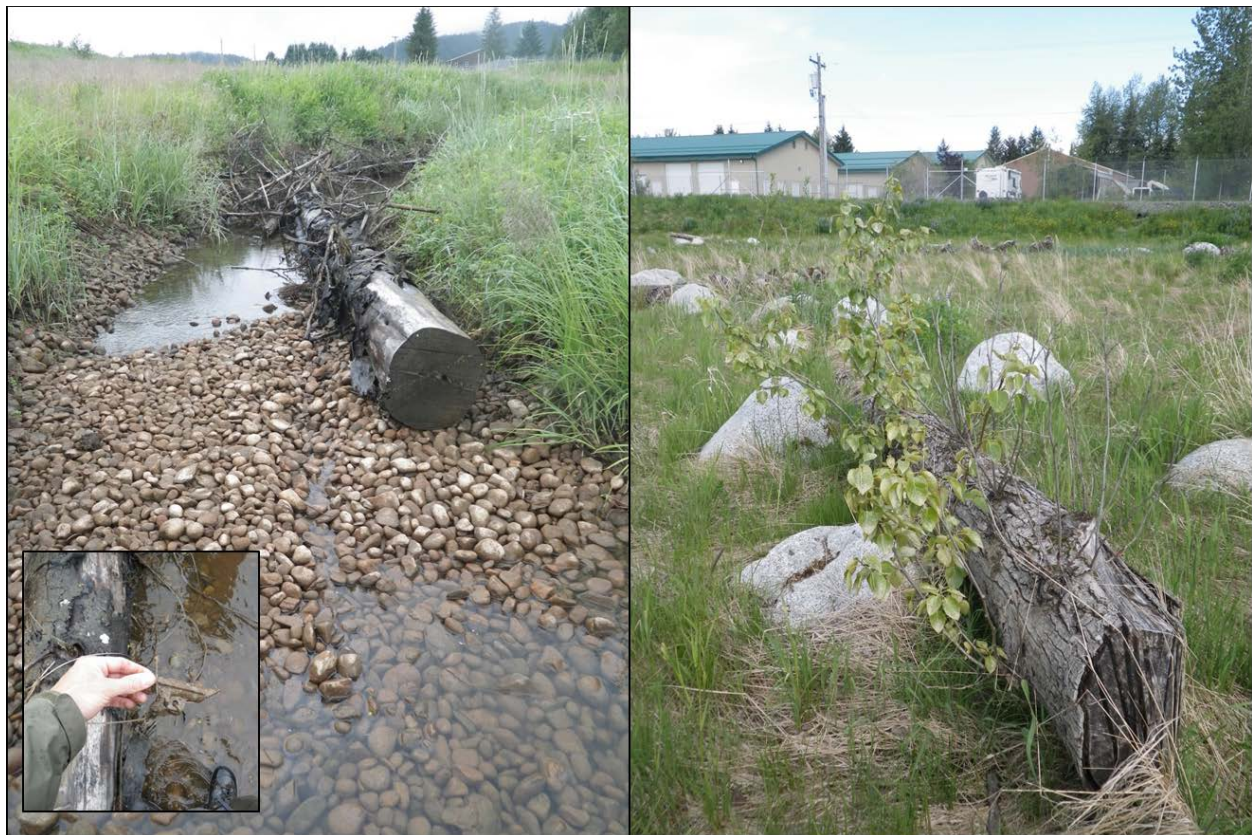
The cabled spruce visible at photo point 6A broke loose during February, 2013, when heavy icing and 19 ft tides occurred, but remains in the area providing habitat function (Figure 23). The cross log weir at minnow trap site two was lifted out of place following similar events and remains at the high tide line on the floodplain. The cabled spruce trees lost their needles within a few months of placement, but retained limbs (Photo points 5, 8, 9 in Appendix C). Cottonwood trees placed in the floodplain have generated new growth (Figure 23).

Figure 23.—Spruce tree anchor (inset) failure (left) and floodplain cottonwood (right).
