Environmental analysis of the Upper Susitna
River Basin using Landsat imagery

CRREL Report 80-4

L.W. Gatto C.J. Merry H.L. McKim and D.E. Lawson

January 1980

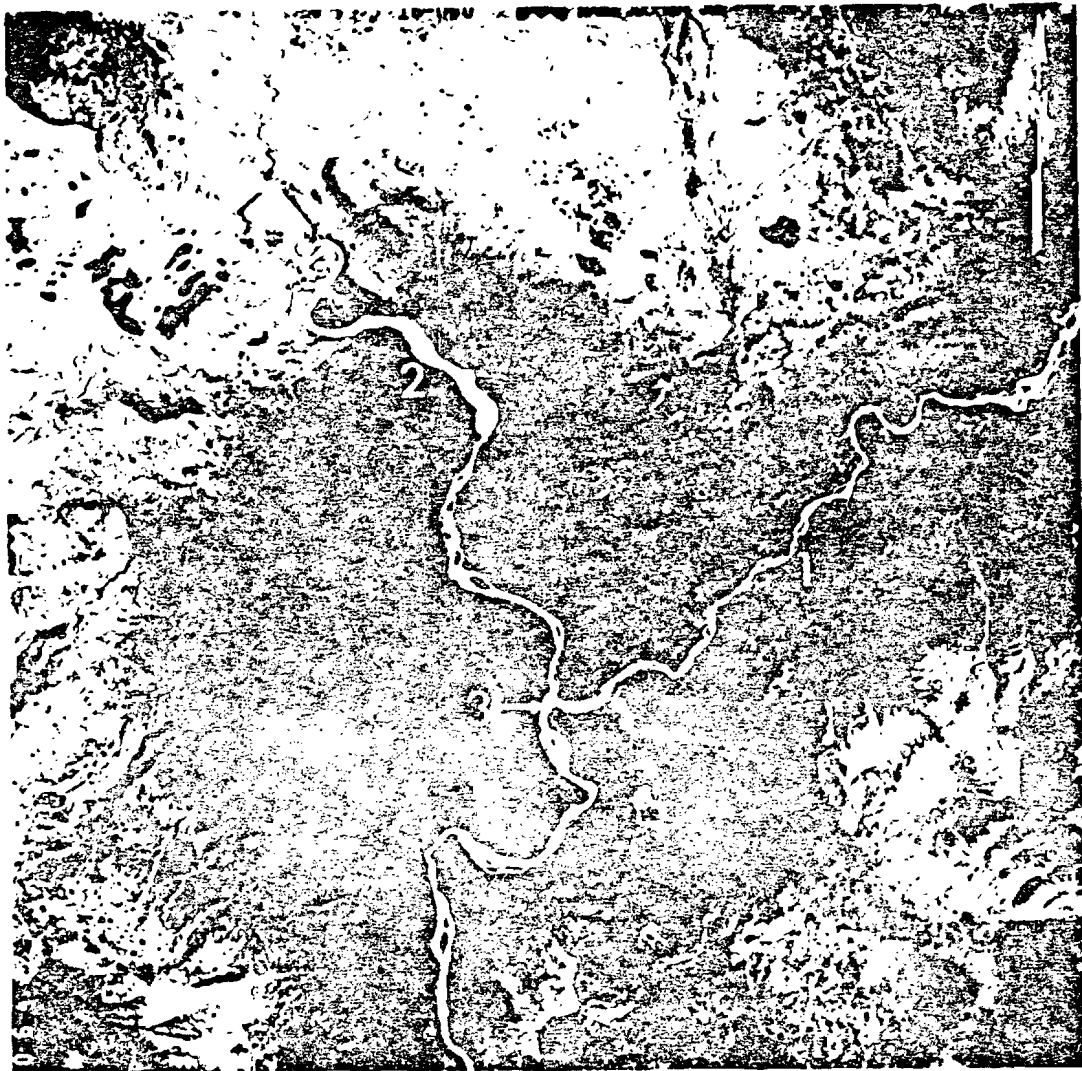
Figure 5. Confluence of the Susitna (2) and Maclaren (1) Rivers; note tonal difference (3); taken on 28 July 1977 during NASA mission 364; scale, 1:160,000.

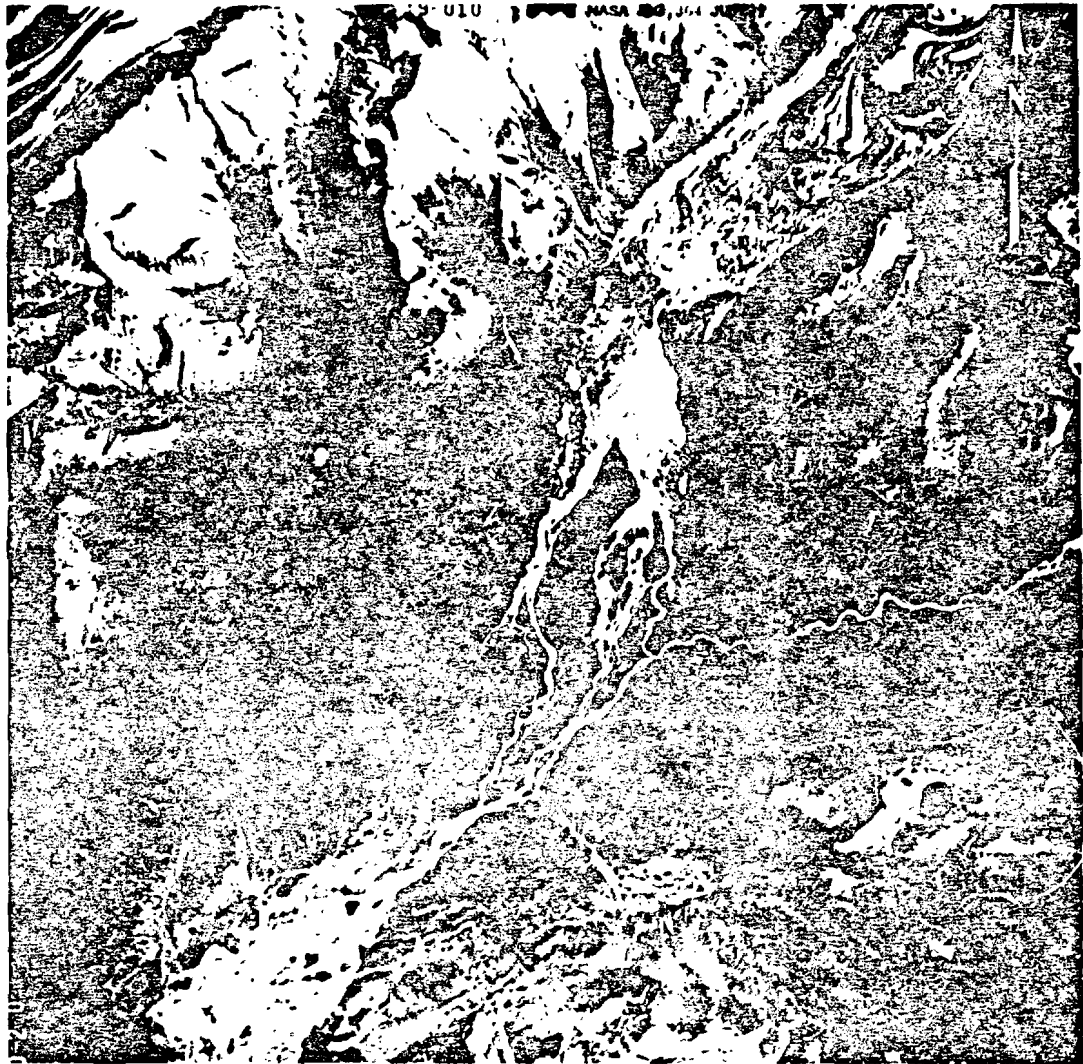
Figure 16. Terminus of the Susitna Glacier (1); taken on 29 July 1977 during NASA mission 364; scale, 1:160,000.

The lateral and medial moraines are well defined. Their patterns are evident on the Landsat image and NASA photographs. The patterns apparent on the Landsat EDIES image (Fig. 3) and NASA photographs 19-008 (Fig. 14), 19-012 (Fig. 15), and 19-010 (Fig. 16) show this comparison.
