# Susitna-Watana Hydroelectric Project Document

| <b>Title:</b><br>Baseline water quality study, Study plan Section 5.5 : Initial study report -- Appendices D-I | | <b>SuWa 223</b> |

## **Baseline Water Quality Study (5.5)**

### **Part A - Appendix D Baseline Water Quality Data**

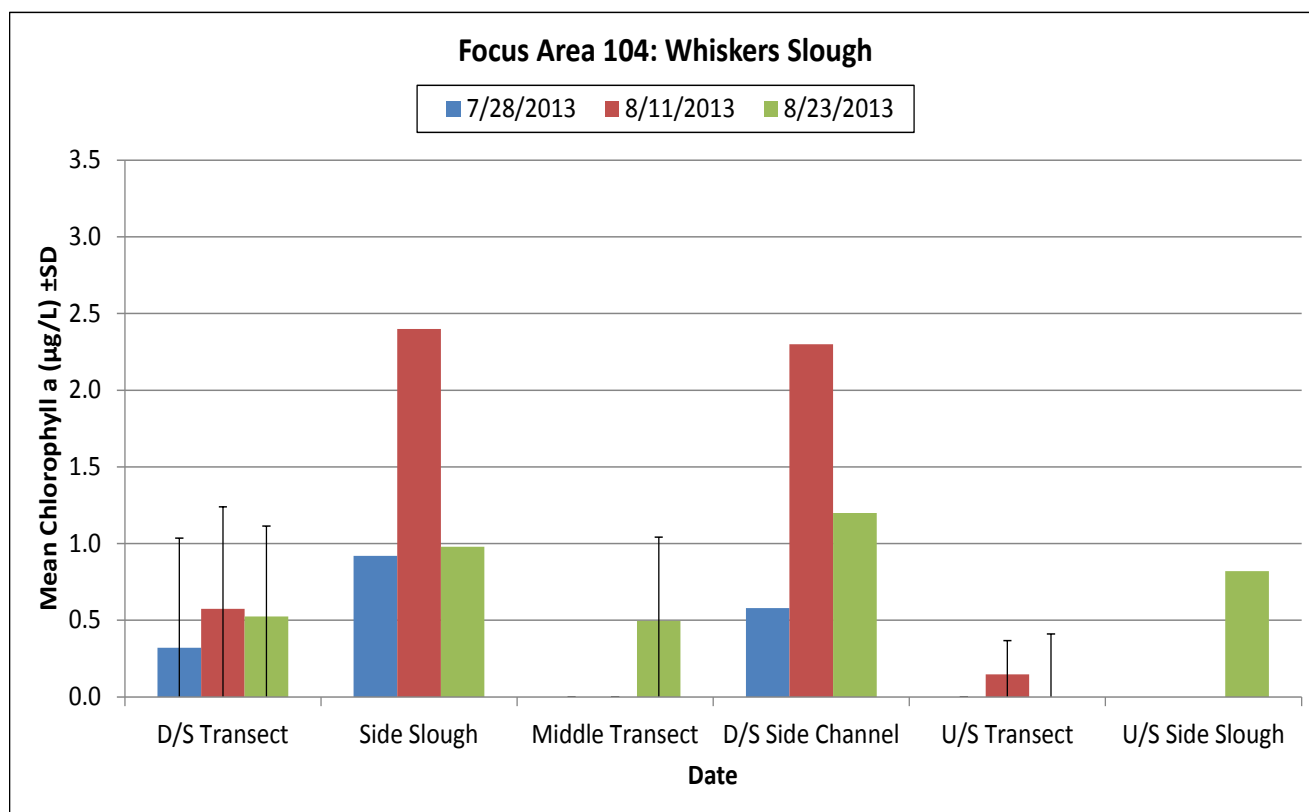
Figure H-1. Chlorophyll a Concentrations in Focus Areas in the Susitna River, 2013.

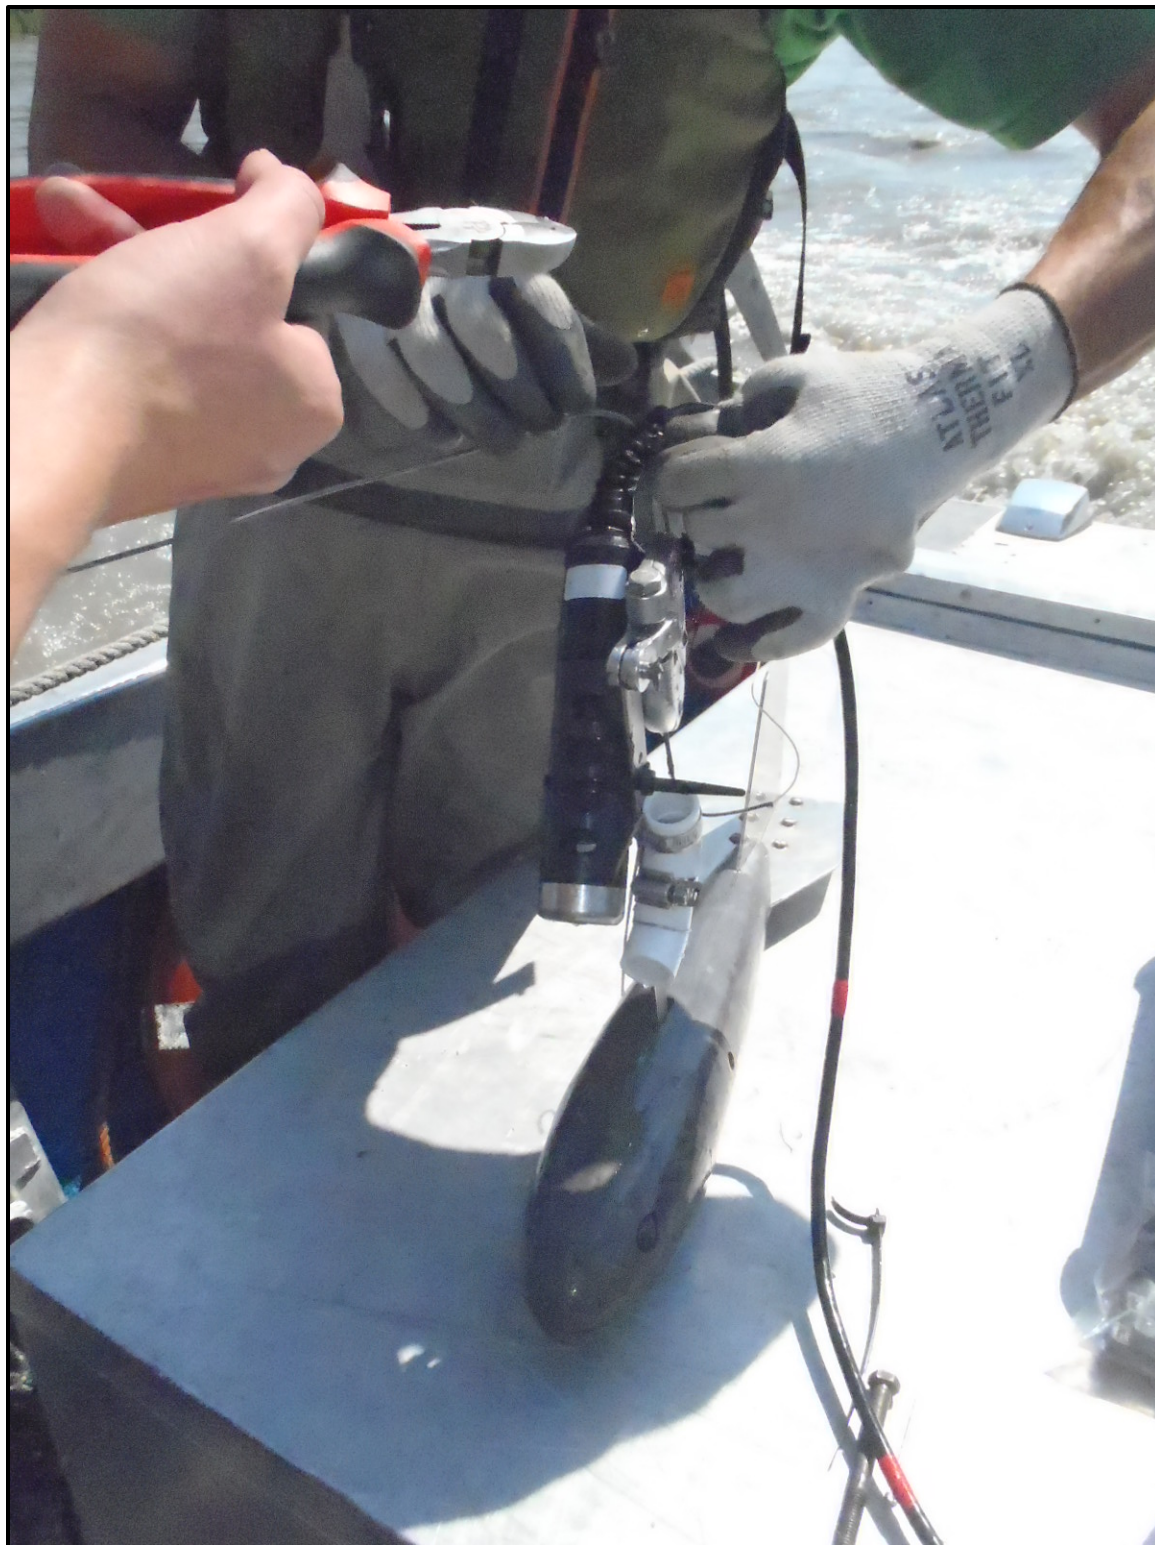
Photo I-1. Preparing water quality parameter probe for deployment from boat.

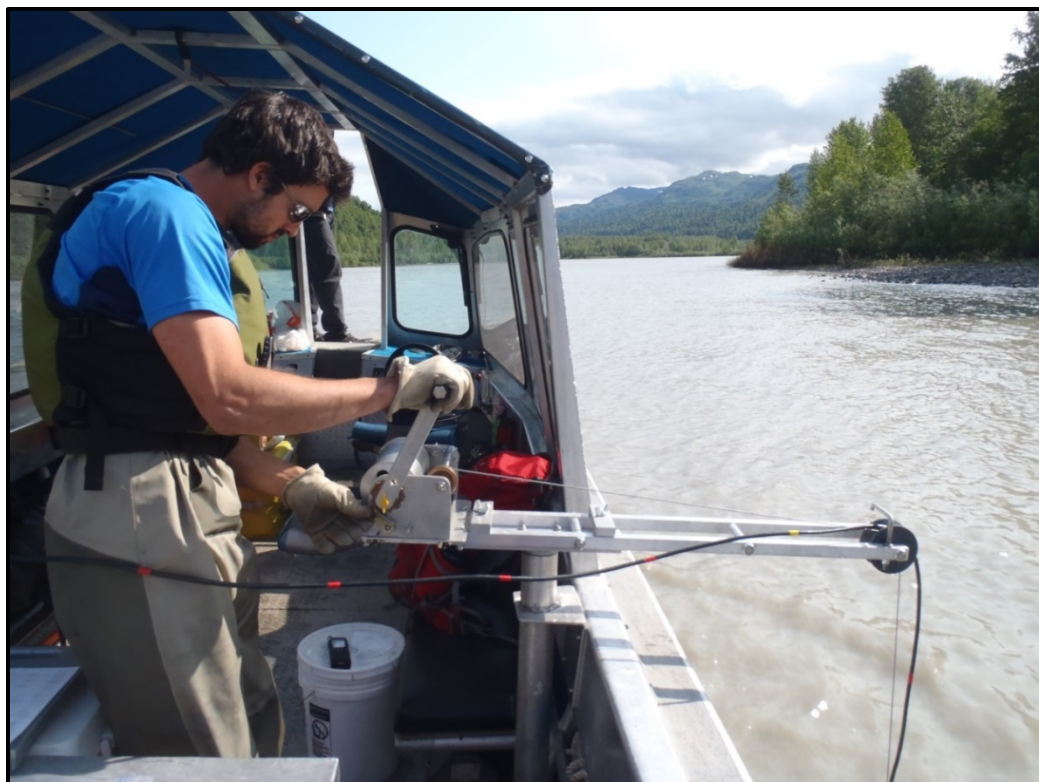
Photo I-2. Boom and hand reel used for deployment of water quality sampling equipment.

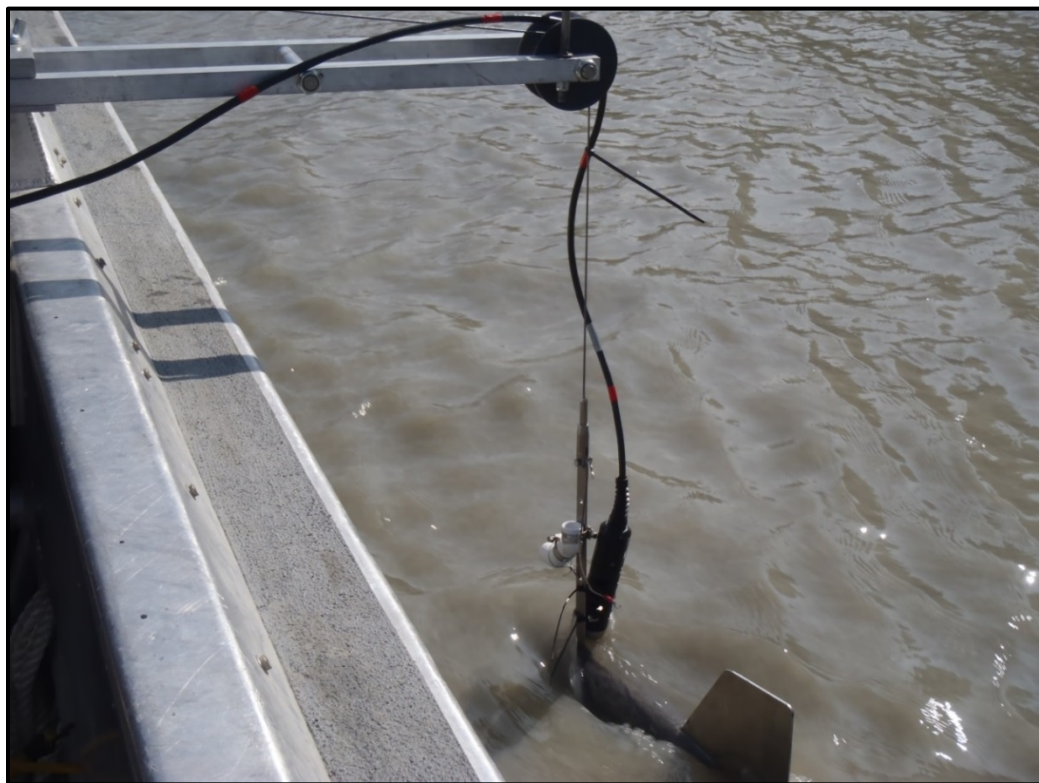
Photo I-3. Deploying water quality probe. Probe is attached to a 60 lb. lead fish.

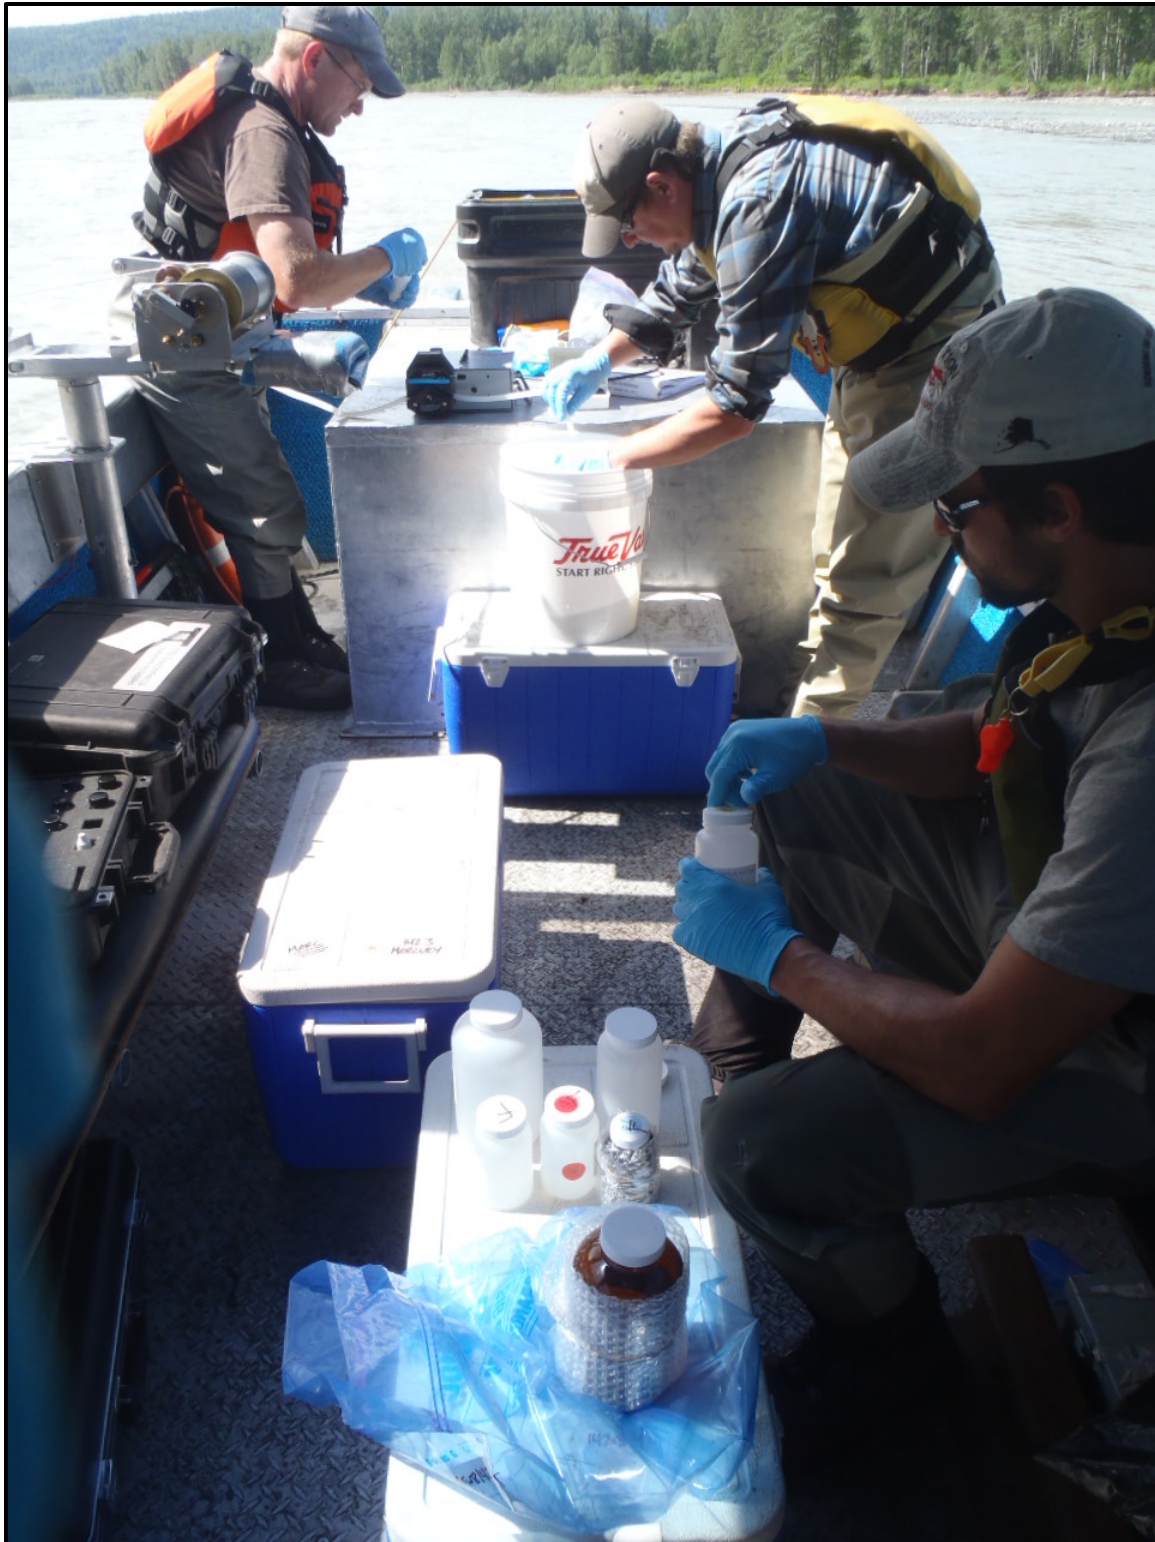
Photo I-4. Typical boat setup for collection of water quality samples.

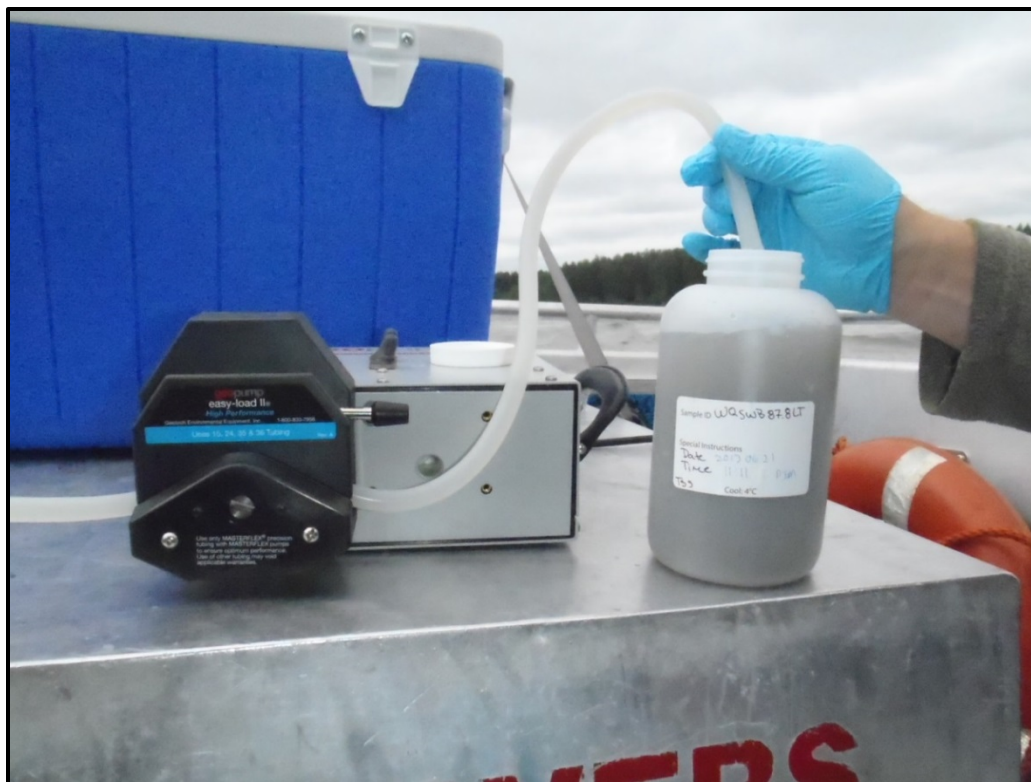
Photo I-5. Collecting non-filtered water sample using peristaltic pump

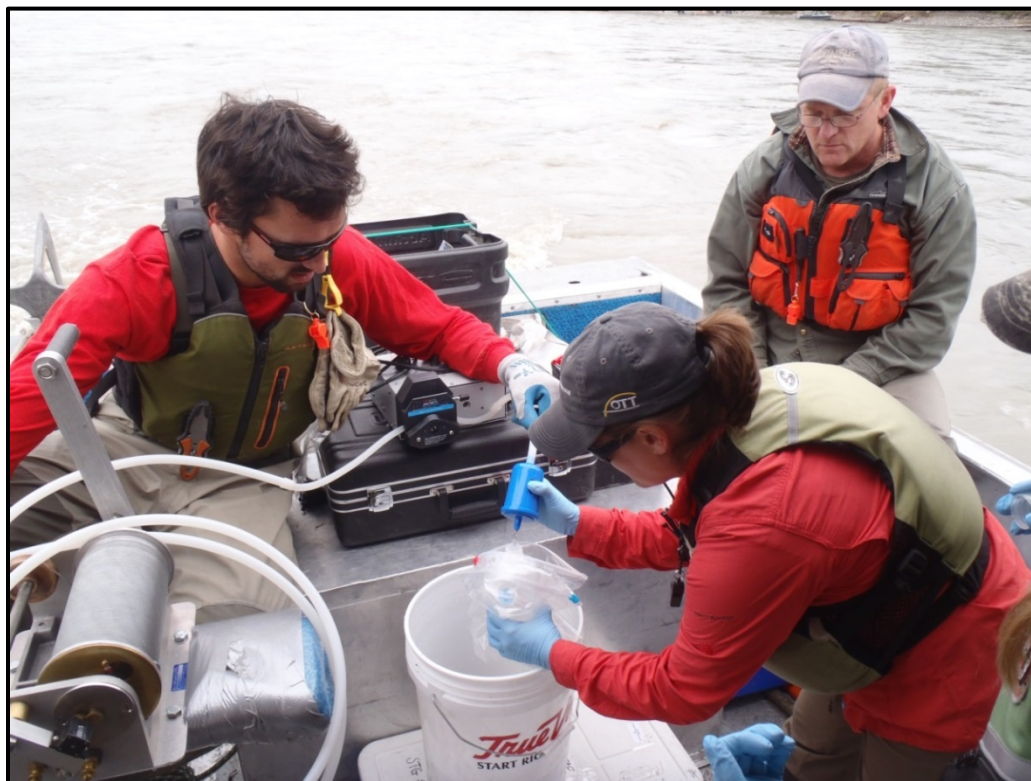
Photo I-6. Collection of filtered water quality sample.

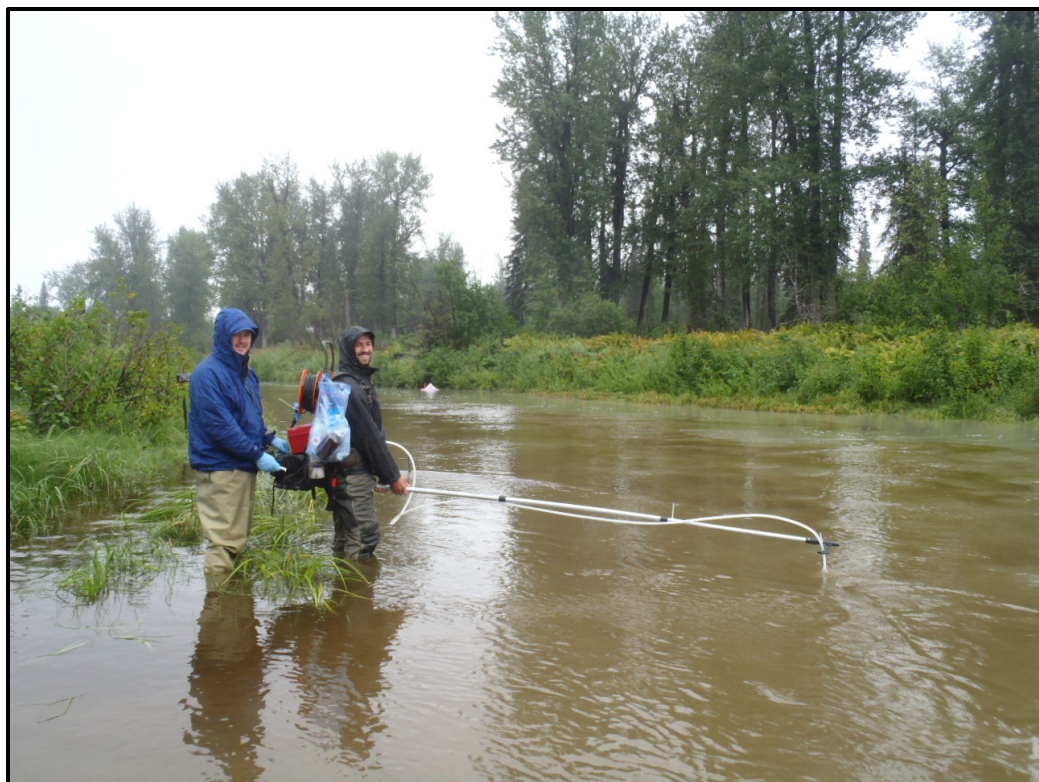
Photo I-7. Portable sampling equipment used for collection water quality samples in shallow water areas.

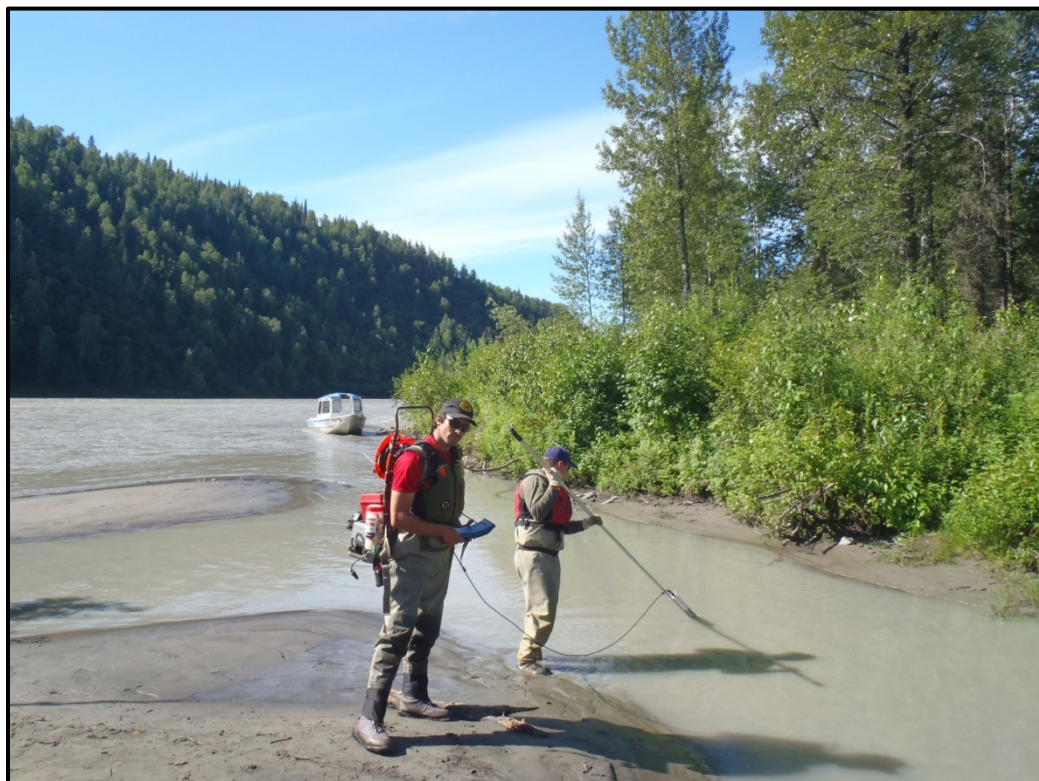
Photo I-8. Collecting water quality parameters in shallow slough area using backpack sampler.

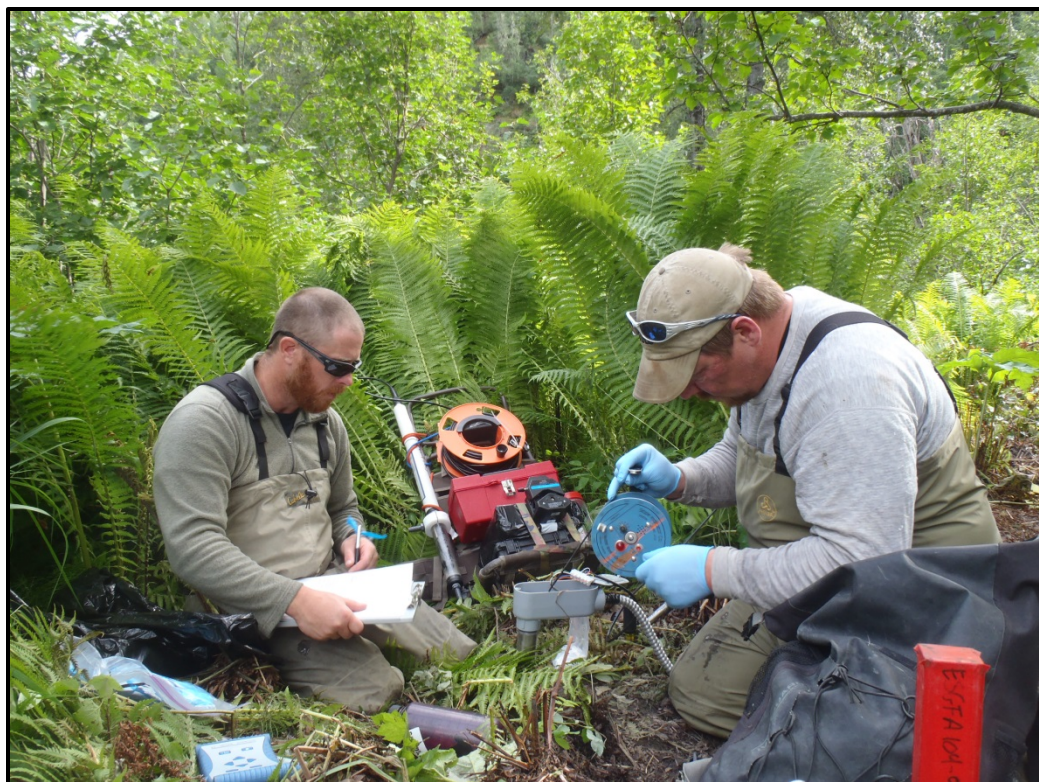
Photo I-9. Determining groundwater depth in Focus Area Study well

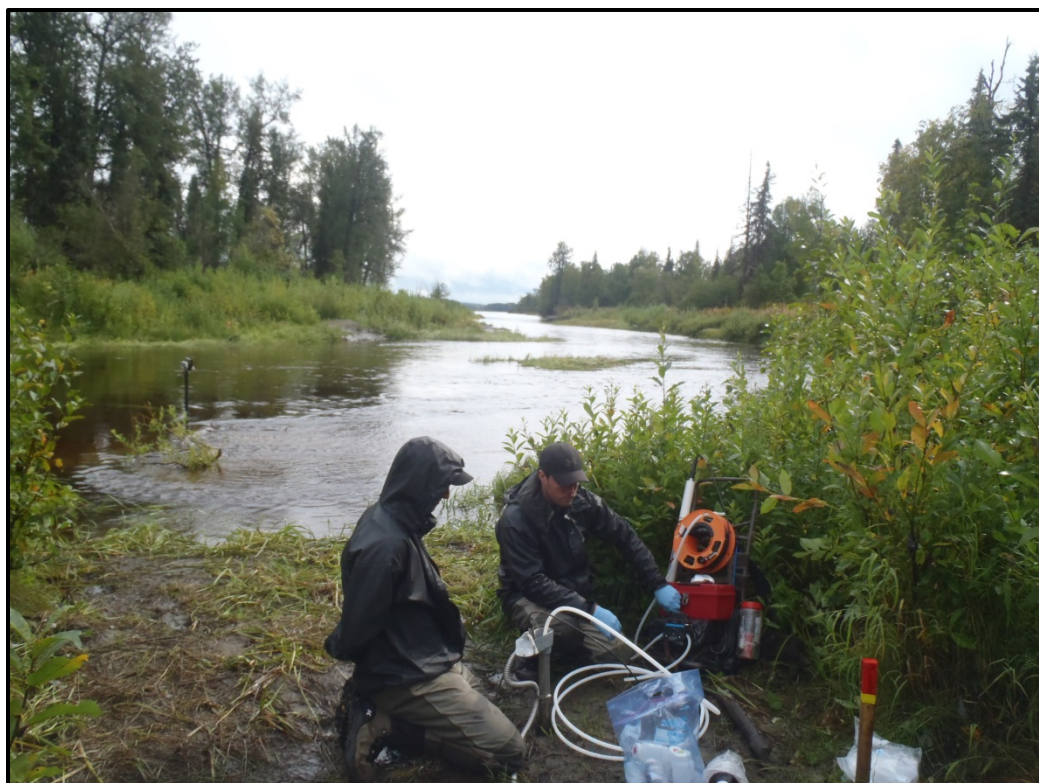
Photo I-10. Collecting water sample from Focus Area well.
