Source Water Assessment

A Hydrogeologic Susceptibility and
Vulnerability Assessment for
Pacifica House & Diane's Restaurant
Drinking Water System,
Bethel, Alaska

PWSID # 271982.001
February 2004

DRINKING WATER PROTECTION PROGRAM REPORT 1226
Alaska Department of Environmental Conservation

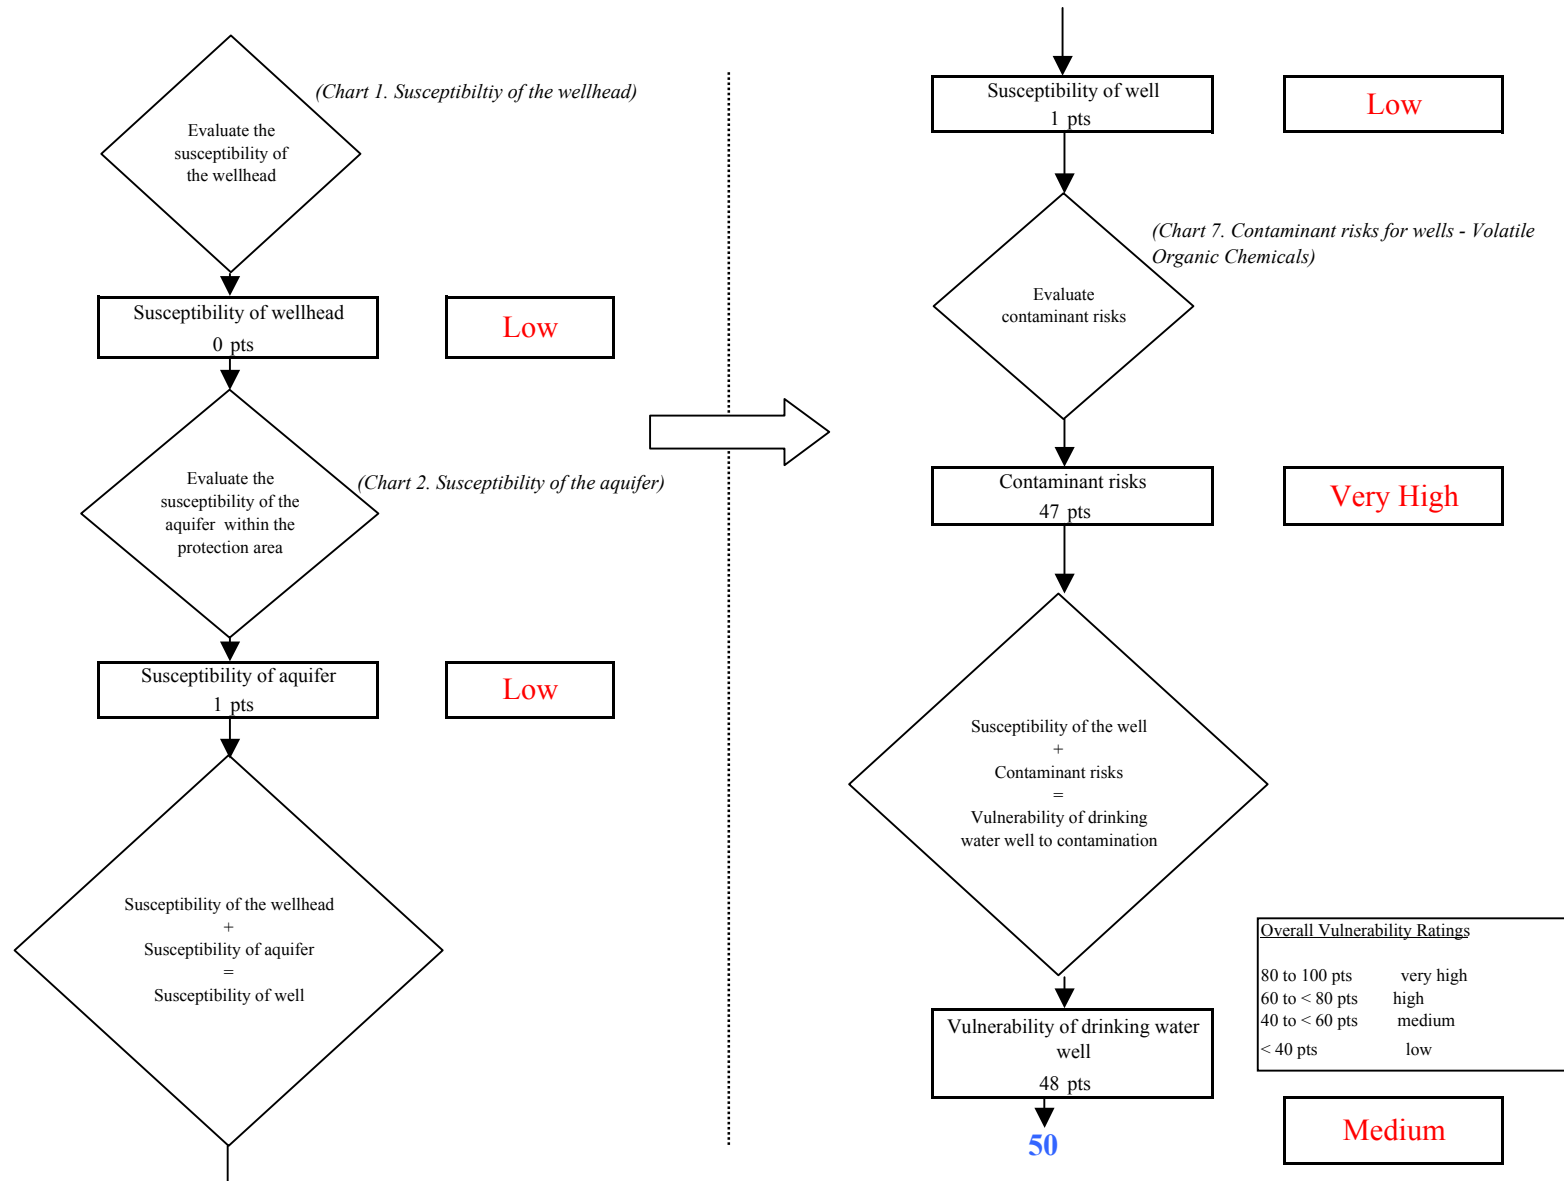
Chart 8. Vulnerability analysis for Pacifica House & Diane's Restaurant (PWS No. 271982.001) - Volatile Organic Chemicals

After combining the contaminant risk for volatile organic chemicals with the natural susceptibility of the well, the overall vulnerability of the well to contamination is **Medium**.
