Source Water Assessment

A Hydrogeologic Susceptibility and
Vulnerability Assessment for
Our Lady of the Lake Catholic Church
Public Drinking Water System,
Big Lake, Alaska
PWSID # 221004.001

DRINKING WATER PROTECTION REPORT 1655

January, 2009

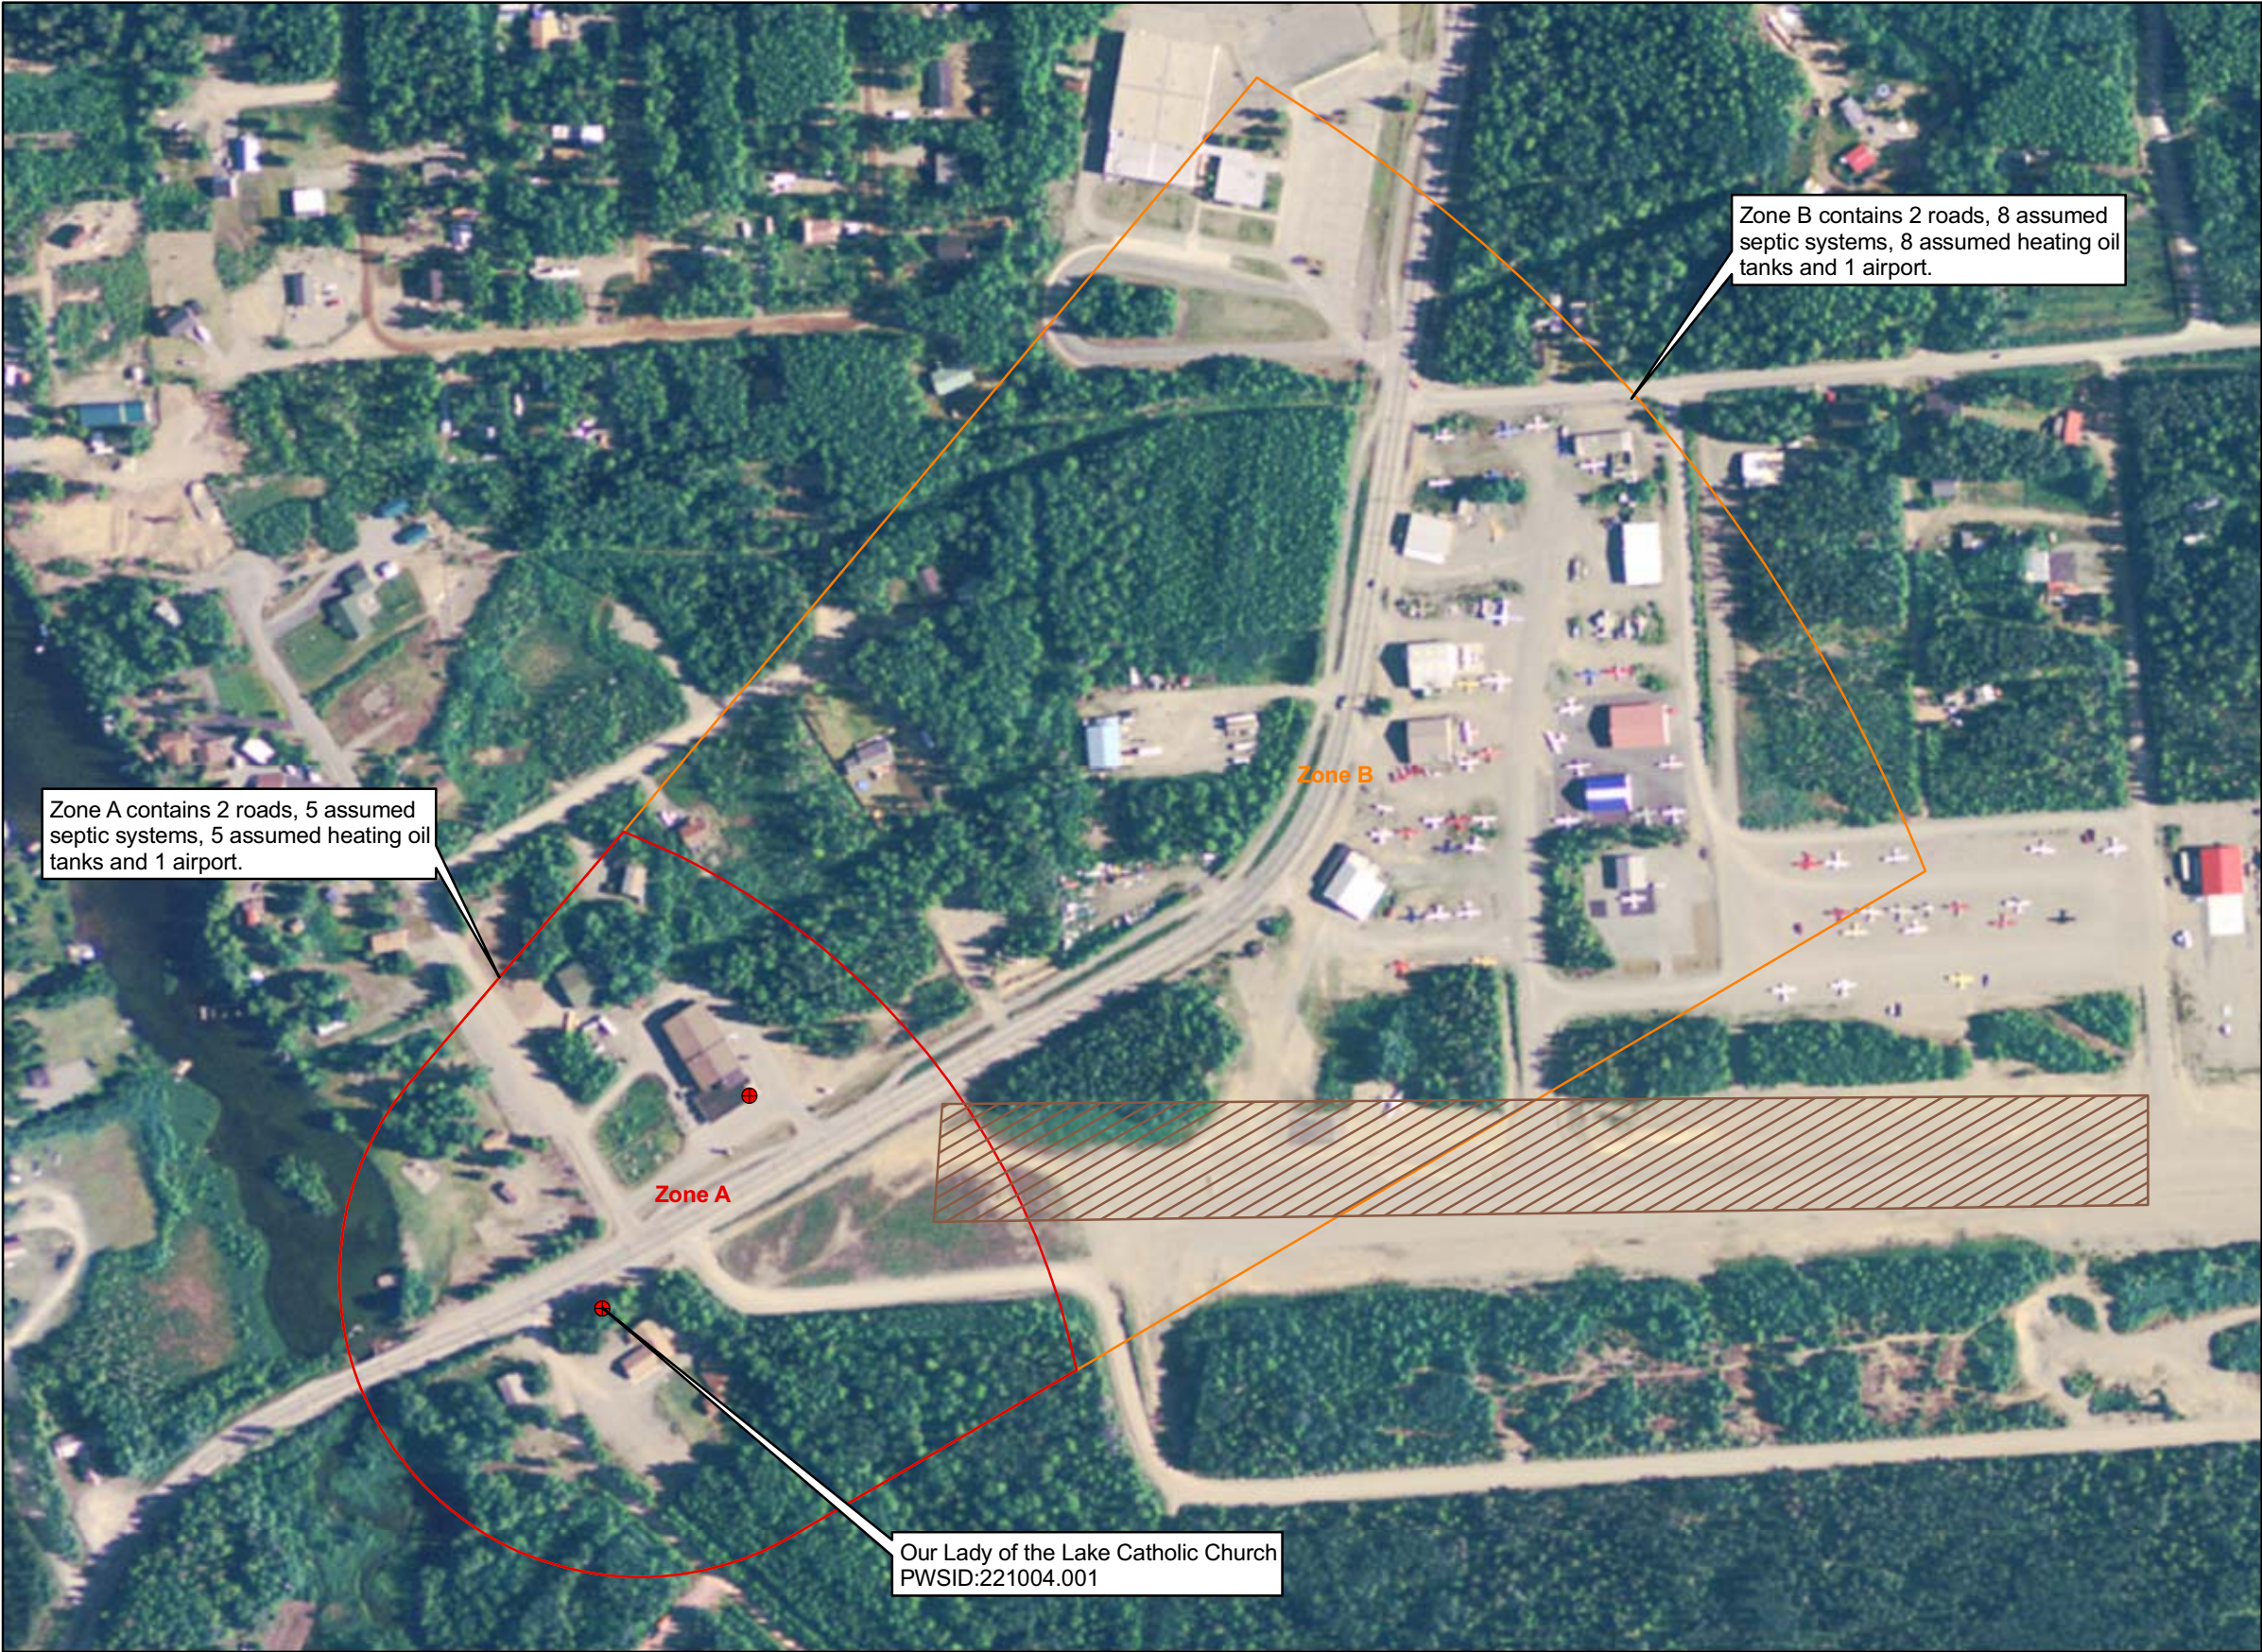
Our Lady of the Lake Catholic Church Drinking Water Protection Area and Potential and Existing Contaminant Sources (Map C)

The sources are displayed on Map C of Appendix C and summarized in Table 1 of Appendix B.

Public Water Well System for PWS #221004.001 Our Lady of the Lake Catholic Church
Showing Potential and Existing Sources of Contamination

DWP has completed an inventory of potential and existing sources of contamination within the Our Lady of the Lake Catholic Church drinking water protection area. This inventory was completed through a search of agency records and other publicly available information. Potential sources of contamination to the drinking water aquifer include a wide range of categories and types. Potential drinking water contaminants are found within agricultural, residential, commercial, and industrial areas, but can also occur within areas that have little or no development.

Contaminant Source Type	Contaminant Source ID	CS ID tag	Zone	Map Number	Comments
Septic systems (serves one single-family home)	R02	R02	A	C	5 assumed septic systems
Tanks, heating oil, residential (above ground)	R08	R08	A	C	5 assumed heating oil tanks
Airports	X14	X14	A	C	1 airport
Highways and roads, paved (cement or asphalt)	X20	X20	A	C	2 roads
Septic systems (serves one single-family home)	R02	R02	B	C	8 assumed septic systems
Tanks, heating oil, residential (above ground)	R08	R08	B	C	8 assumed heating oil tanks
Airports	X14	X14	B	C	1 airport
Highways and roads, paved (cement or asphalt)	X20	X20	B	C	2 roads
