Source Water Assessment

A Hydrogeologic Susceptibility and Vulnerability Assessment for Birchwood Camp Drinking Water System, Chugiak, Alaska Birchwood Camp #212152

DRINKING WATER PROTECTION PROGRAM REPORT 201 Alaska Department of Environmental Conservation

AUGUST 2002

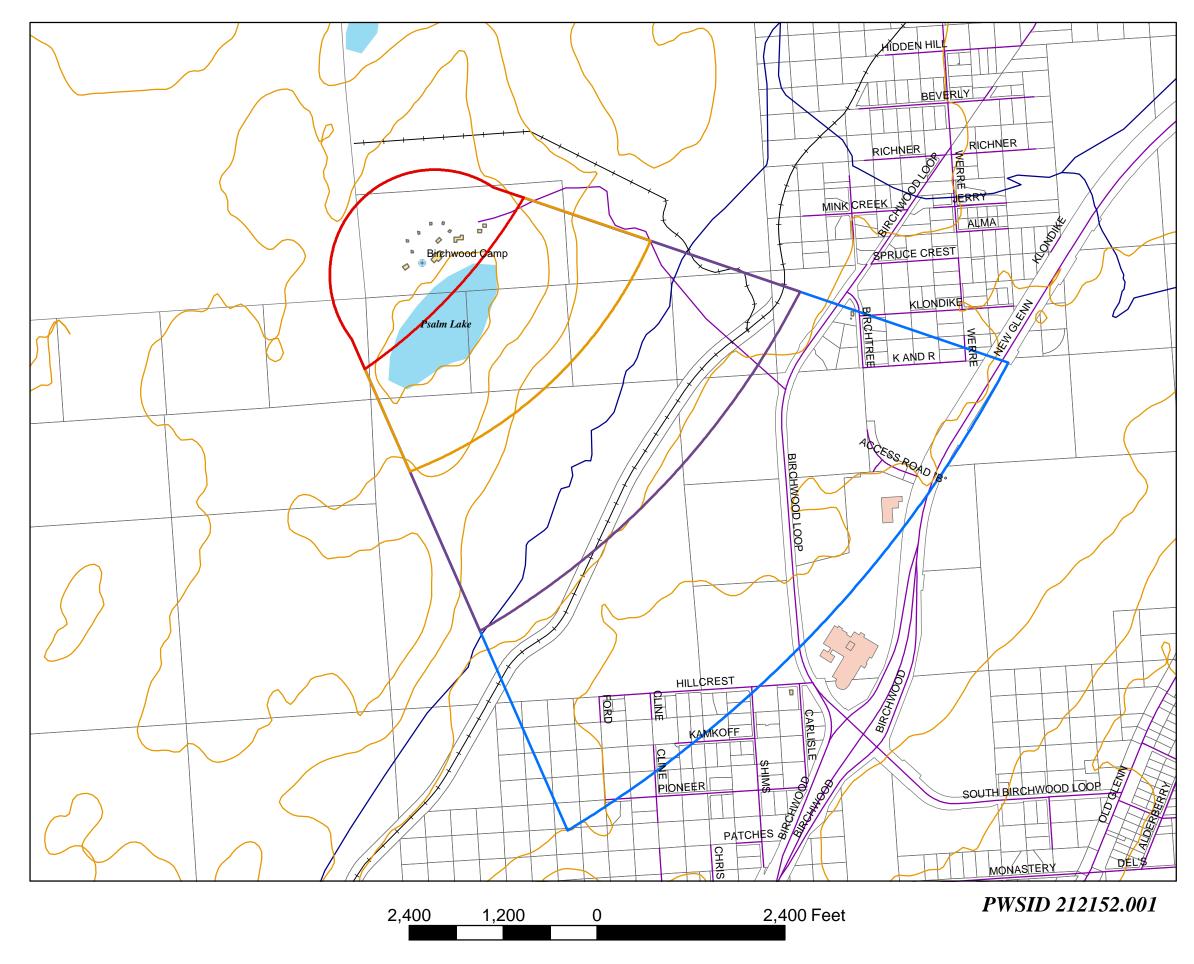
Birchwood Camp Drinking Water Protection Area (Map 1)

The most probable area for contamination to reach the drinking water well is the area that contributes water to the well, the groundwater recharge area. This area is designated as the Drinking Water Protection Area (DWPA). Because a release of contaminants within the DWPA are most likely to impact the drinking water well, this area will serve as the focus for voluntary protection efforts.

An analytical calculation was used to determine the size and shape of the DWPA. The input parameters describing the attributes of the aquifer in this calculation were adopted from the U.S. Geological Survey (*Patrick, Brabets, and Glass, 1989*), and State of Alaska Department of Water Resources. Additional methods were also used to take into account any uncertainties in groundwater flow and aquifer characteristics to arrive at a meaningful DWPA (Please refer to the Guidance Manual for Class B Public Water Systems for additional information).

The DWPAs established for wells by the ADEC are separated into four zones. These zones correspond to differences in the time-of-travel (TOT) of the water moving through the aquifer to the well. The TOT for contaminants within the water varies and is dependent on the physical and chemical characteristics of each contaminant. The following is a summary of the four DWPA zones and the calculated TOT for each:

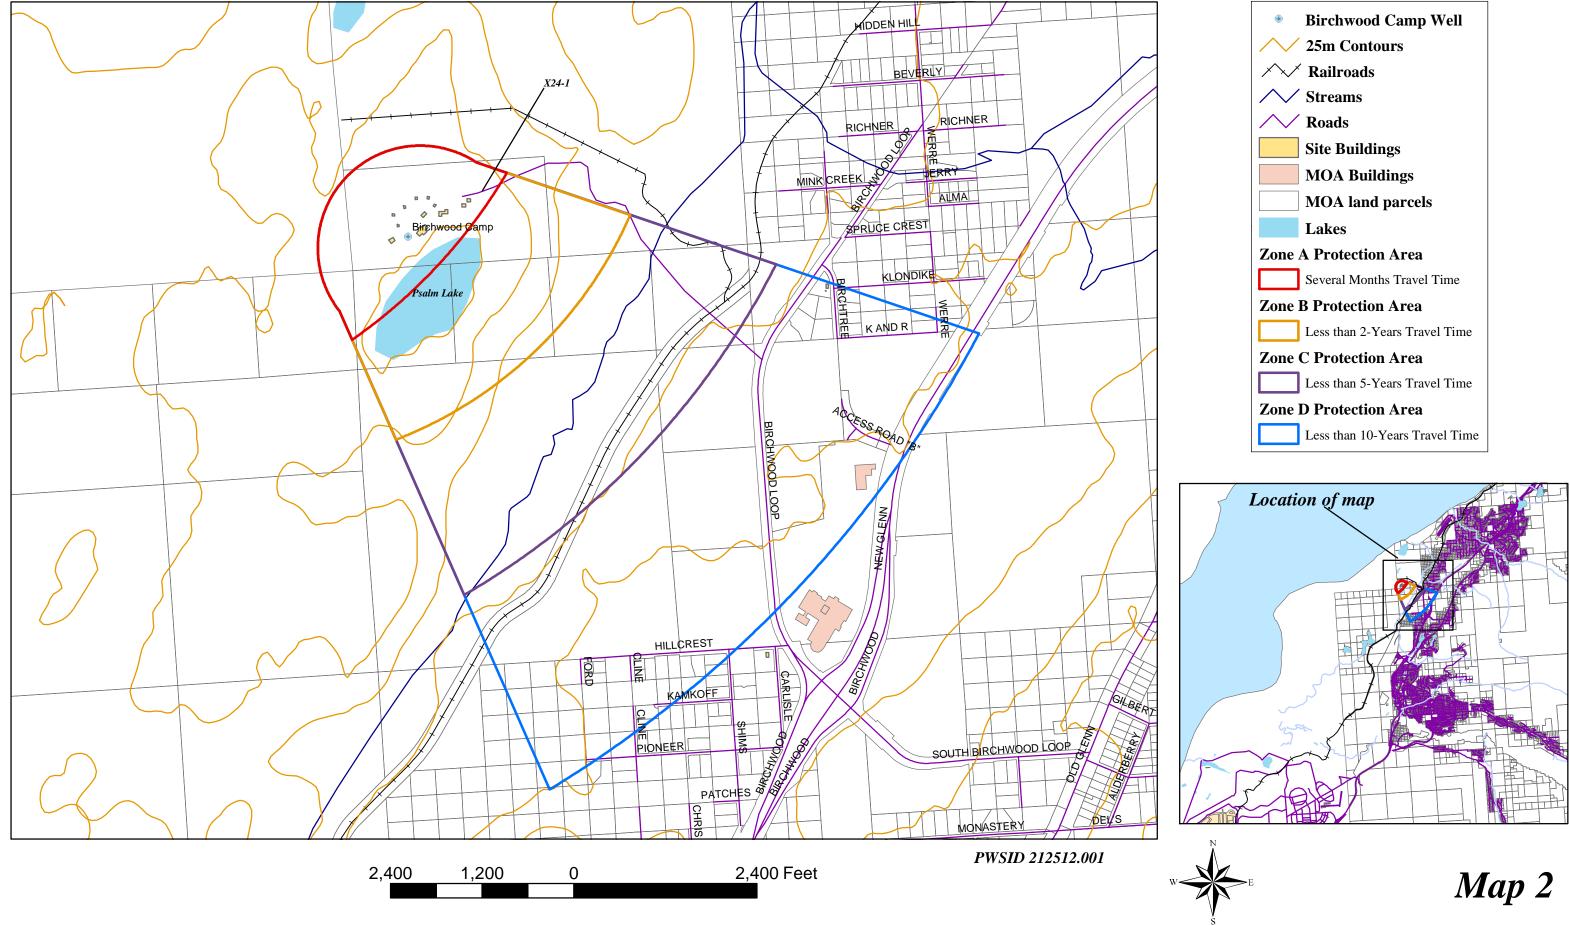
Drinking Water Protection Areas for Birchwood Camp and Potential and Existing Sources of Contamination

Birchwood Camp Well
• Tanks, heating oil, nonresidential (underground) (T14)
✓ 25m Contours
∕∕✓ Railroads
/ Streams
Noads
Site Buildings
MOA Buildings
MOA Land Parcels
Lakes
Municipal Parks (X4)
Zone A Protection Area
Several Months Travel Time
Zone B Protection Area
Less than 2-Years Travel Time
Zone C Protection Area
Less than 5-Years Travel Time
Zone D Protection Area
Less than 10-Years Travel Time

Contaminant Source Type	Contaminant Source ID	CS ID tag	Zone	Location	Map Number	Comments
Tanks, heating oil, nonresidential (aboveground)	T14	T14-1	А	Birchwood Camp, NE of well	3	
Highways and roads, dirt/gravel	X24	X24-1	А	Birchwood Camp Road - off Birchwood Loop Road	2	
Municipal or city parks (with green areas)	X04	X4-1	А	East of Birchwood Camp	3	
Rail corridors	X30	X30-1	С	SE of Birchwood Camp	3

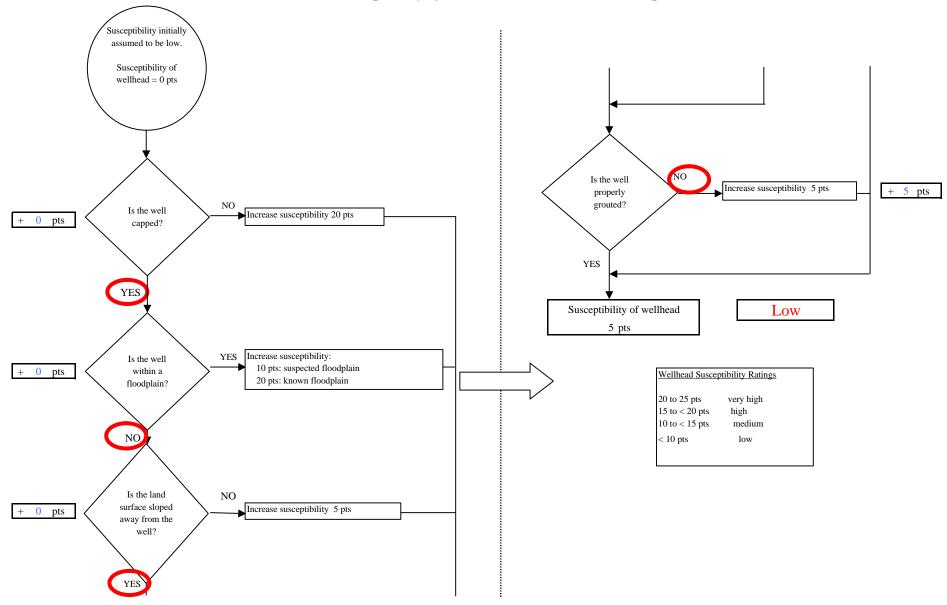
Chart 1. Susceptibility of the Wellhead - Birchwood Camp

Appendix D contains eight charts, which together form the 'Vulnerability Analysis' for a source water assessment for a public drinking water source. Chart 1 analyzes the 'Susceptibility of the Wellhead' to contamination by looking at the construction of the well and its surrounding area. Chart 2 analyzes the 'Susceptibility of the Aquifer' to contamination by looking at the naturally-occurring attributes of the water source and influences on the groundwater system that Chart 3 analyzes might lead to contamination. 'Contaminant Risks' for the drinking water source with respect to bacteria and viruses. The 'Contaminant Risks' portion of the analysis considers potential sources of contaminants as well as a review of contamination that has or may have occurred, but has not arrived or been detected at the well. Lastly, Chart 4 contains the 'Vulnerability Analysis for Bacteria and Viruses.' Charts 5 through 8 contain the Contaminant

Score	Rating
Susceptibility of the Wellhead	5	Low
Susceptibility of the Aquifer	11	Medium
Natural Susceptibility	16	Medium

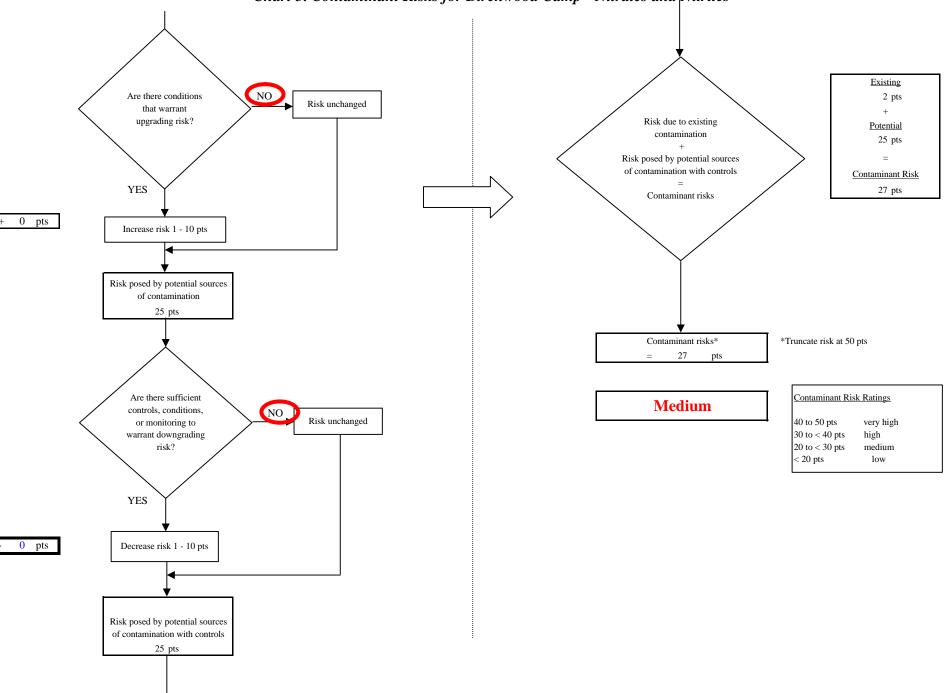
Chart 5. Contaminant Risks for Birchwood Camp - Nitrates and Nitrites

Sampling history for Birchwood Camp well indicates that low concentrations of nitrates have been detected (see Chart 5 - Contaminant Risks for Nitrates and/or Nitrites in Appendix D). The maximum reported existing nitrate concentration is approximately 0.380 mg/L or 4% of the Maximum Contaminant Level (MCL) of 10 mg/L. The MCL is the maximum level of contaminant that is allowed to exist in drinking water and still be consumed by humans without harmful health effects. Due to the high solubility and weak retention by soil, nitrates are very mobile, moving at approximately the same rate as water. Though existing nitrate contamination was detected at the site, concentrations remain at safe levels with respect to human health.

Category	Score	Rating
Bacteria and Viruses	25	Medium
Nitrates and/or Nitrites	27	Medium
Volatile Organic Chemicals	22	Medium

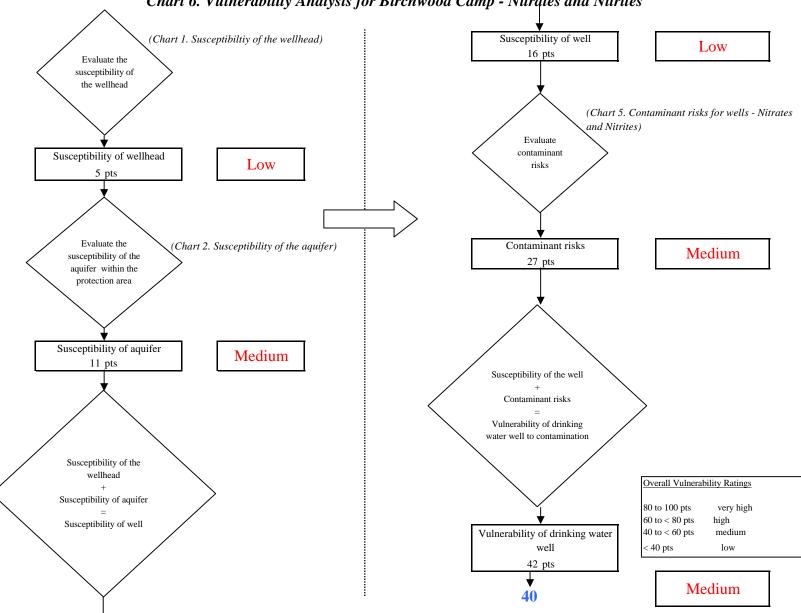
Chart 6. Vulnerability Analysis for Birchwood Camp - Nitrates and Nitrites

Risks and Vulnerability Analyses for nitrates and nitrites and volatile organic chemicals, respectively.

Category	Score	Rating
Bacteria and Viruses	40	Medium
Nitrates and Nitrites	45	Medium
Volatile Organic Chemicals	35	Low
