Source Water Assessment

A Hydrogeologic Susceptibility and
Vulnerability Assessment for
Gakona RV Park,
Gakona, Alaska
PWSID #381359

DRINKING WATER PROTECTION PROGRAM REPORT NO. 925

Alaska Department of Environmental Conservation

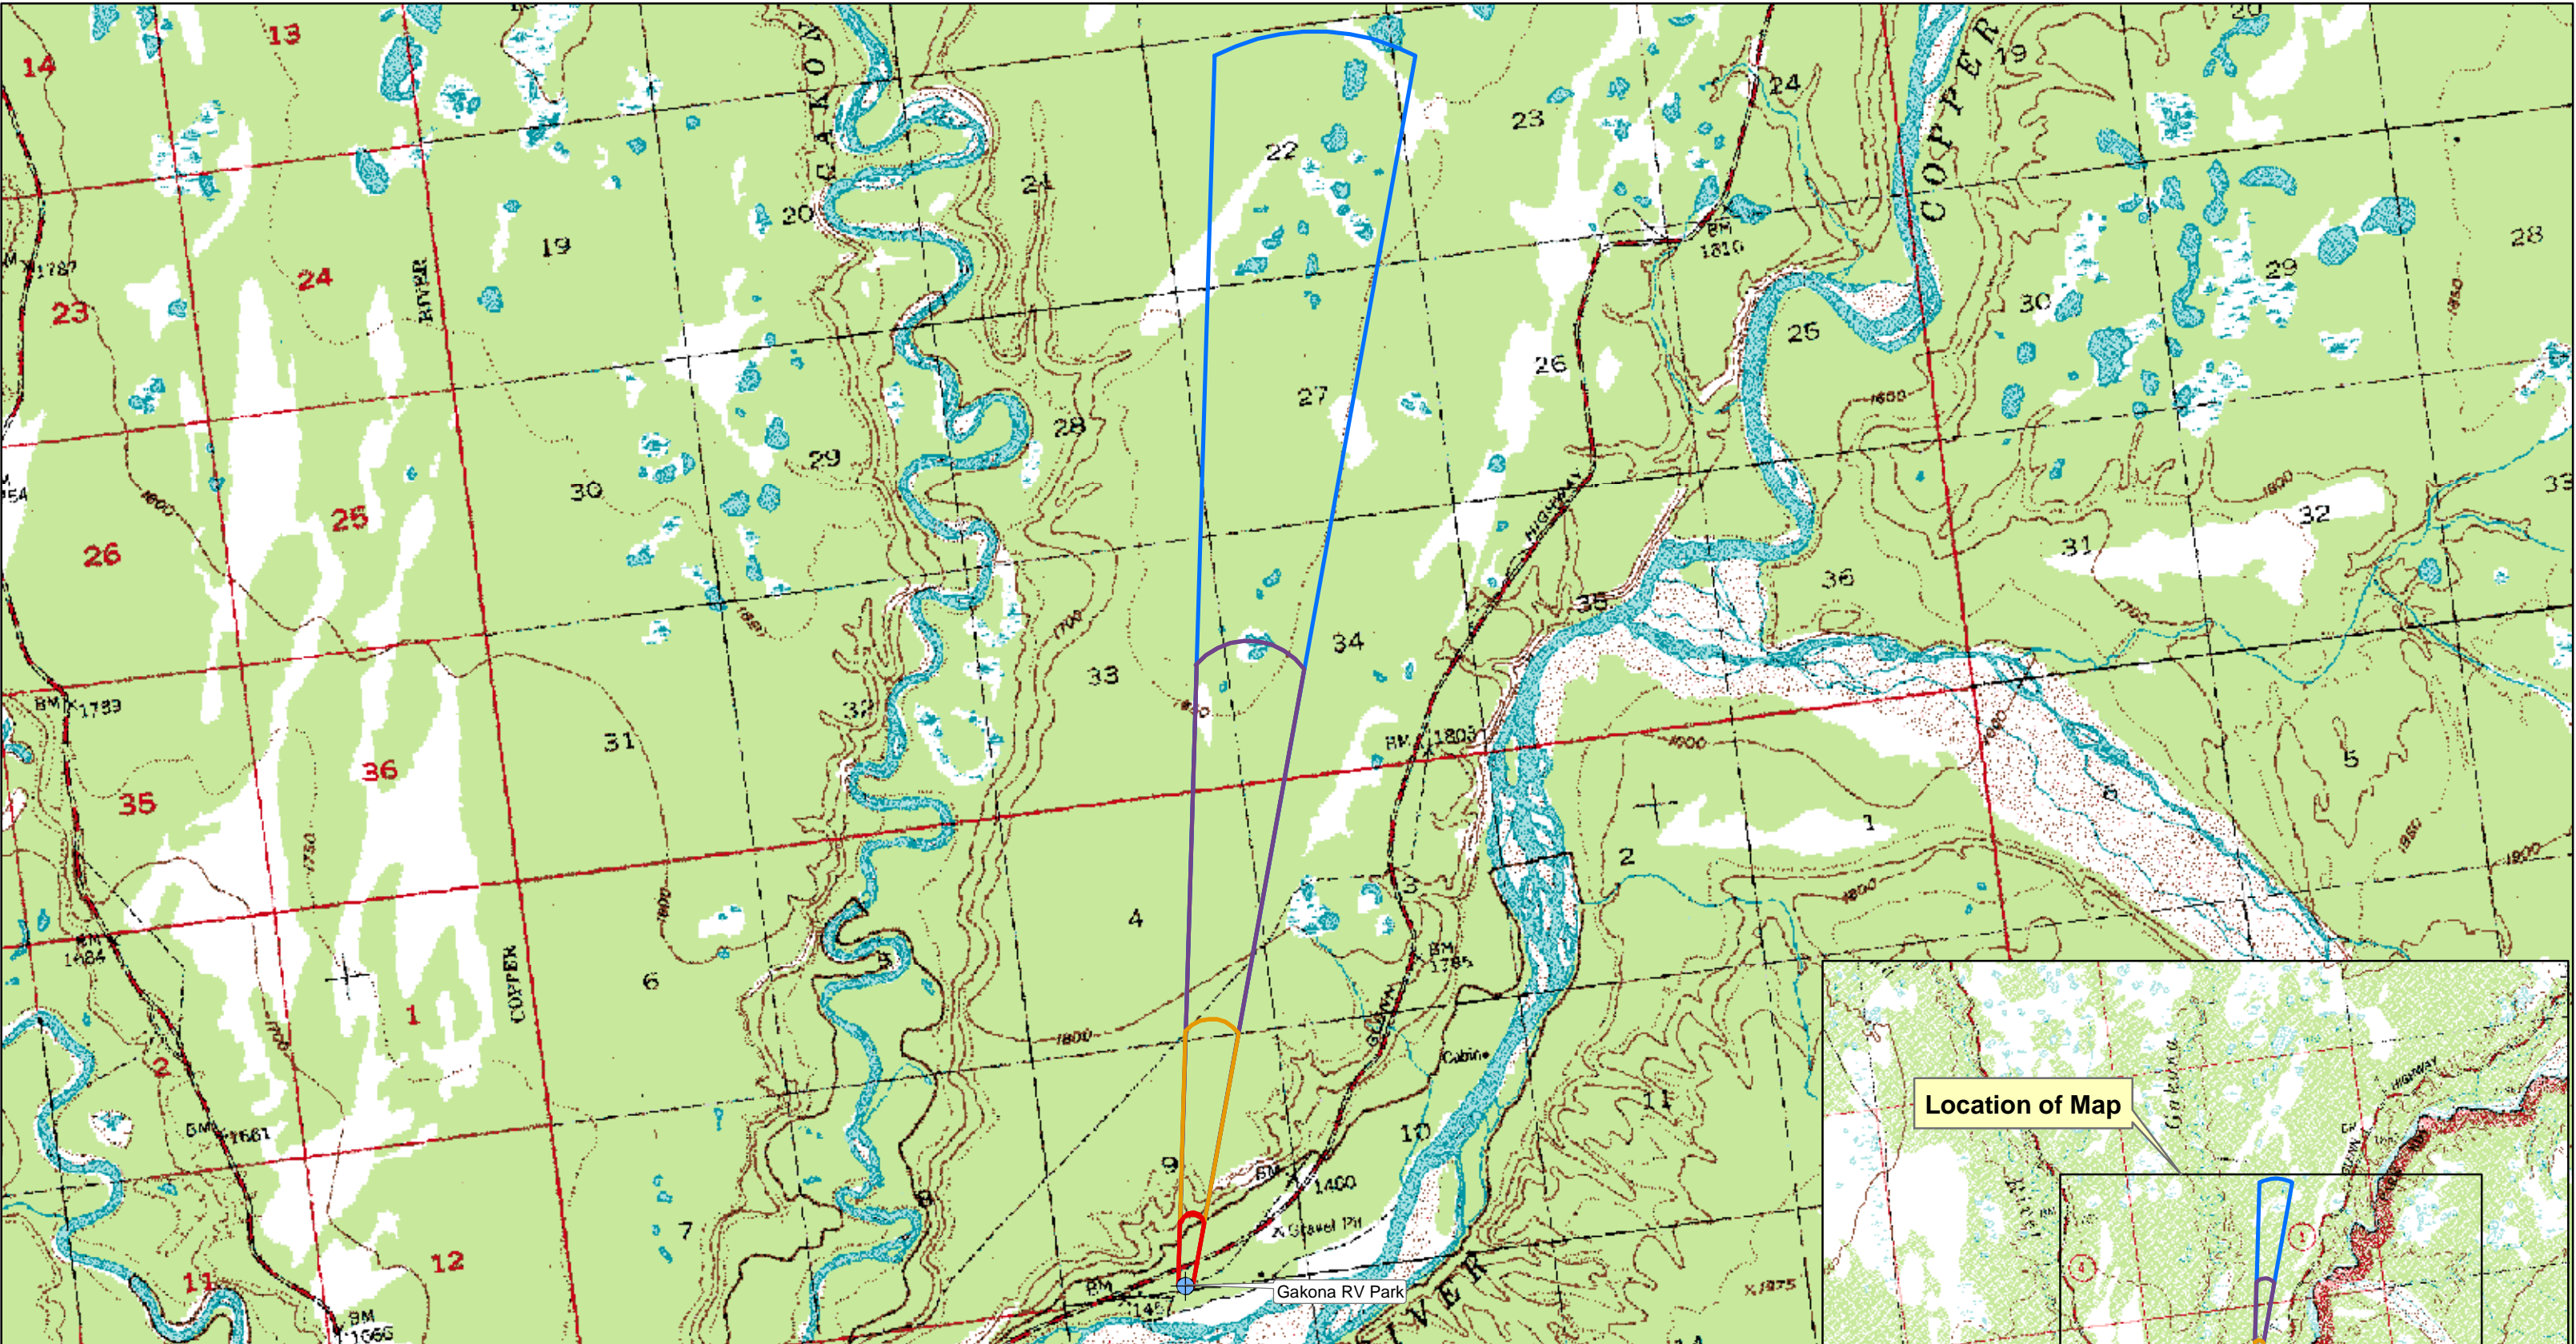
Map 1: Gakona RV Park Drinking Water Protection Areas

The DWPA for Gakona RV Park extends several miles north of the well. Development in the vicinity of the well is limited to only Zone A (See Map 1 of Appendix A).

Gakona RV Park public water system is a Class B (transient/non-community) water system. The system consists of one well located at Mile 4 of the Tok Cutoff, Gakona, Alaska (See Map 1 of Appendix A). Gakona is located at the confluence of the Copper and Gakona rivers, at Mile 2 on the Tok Cutoff to the Glenn Highway, 15 miles northeast of Glennallen. The population of Gakona is approximately 25.

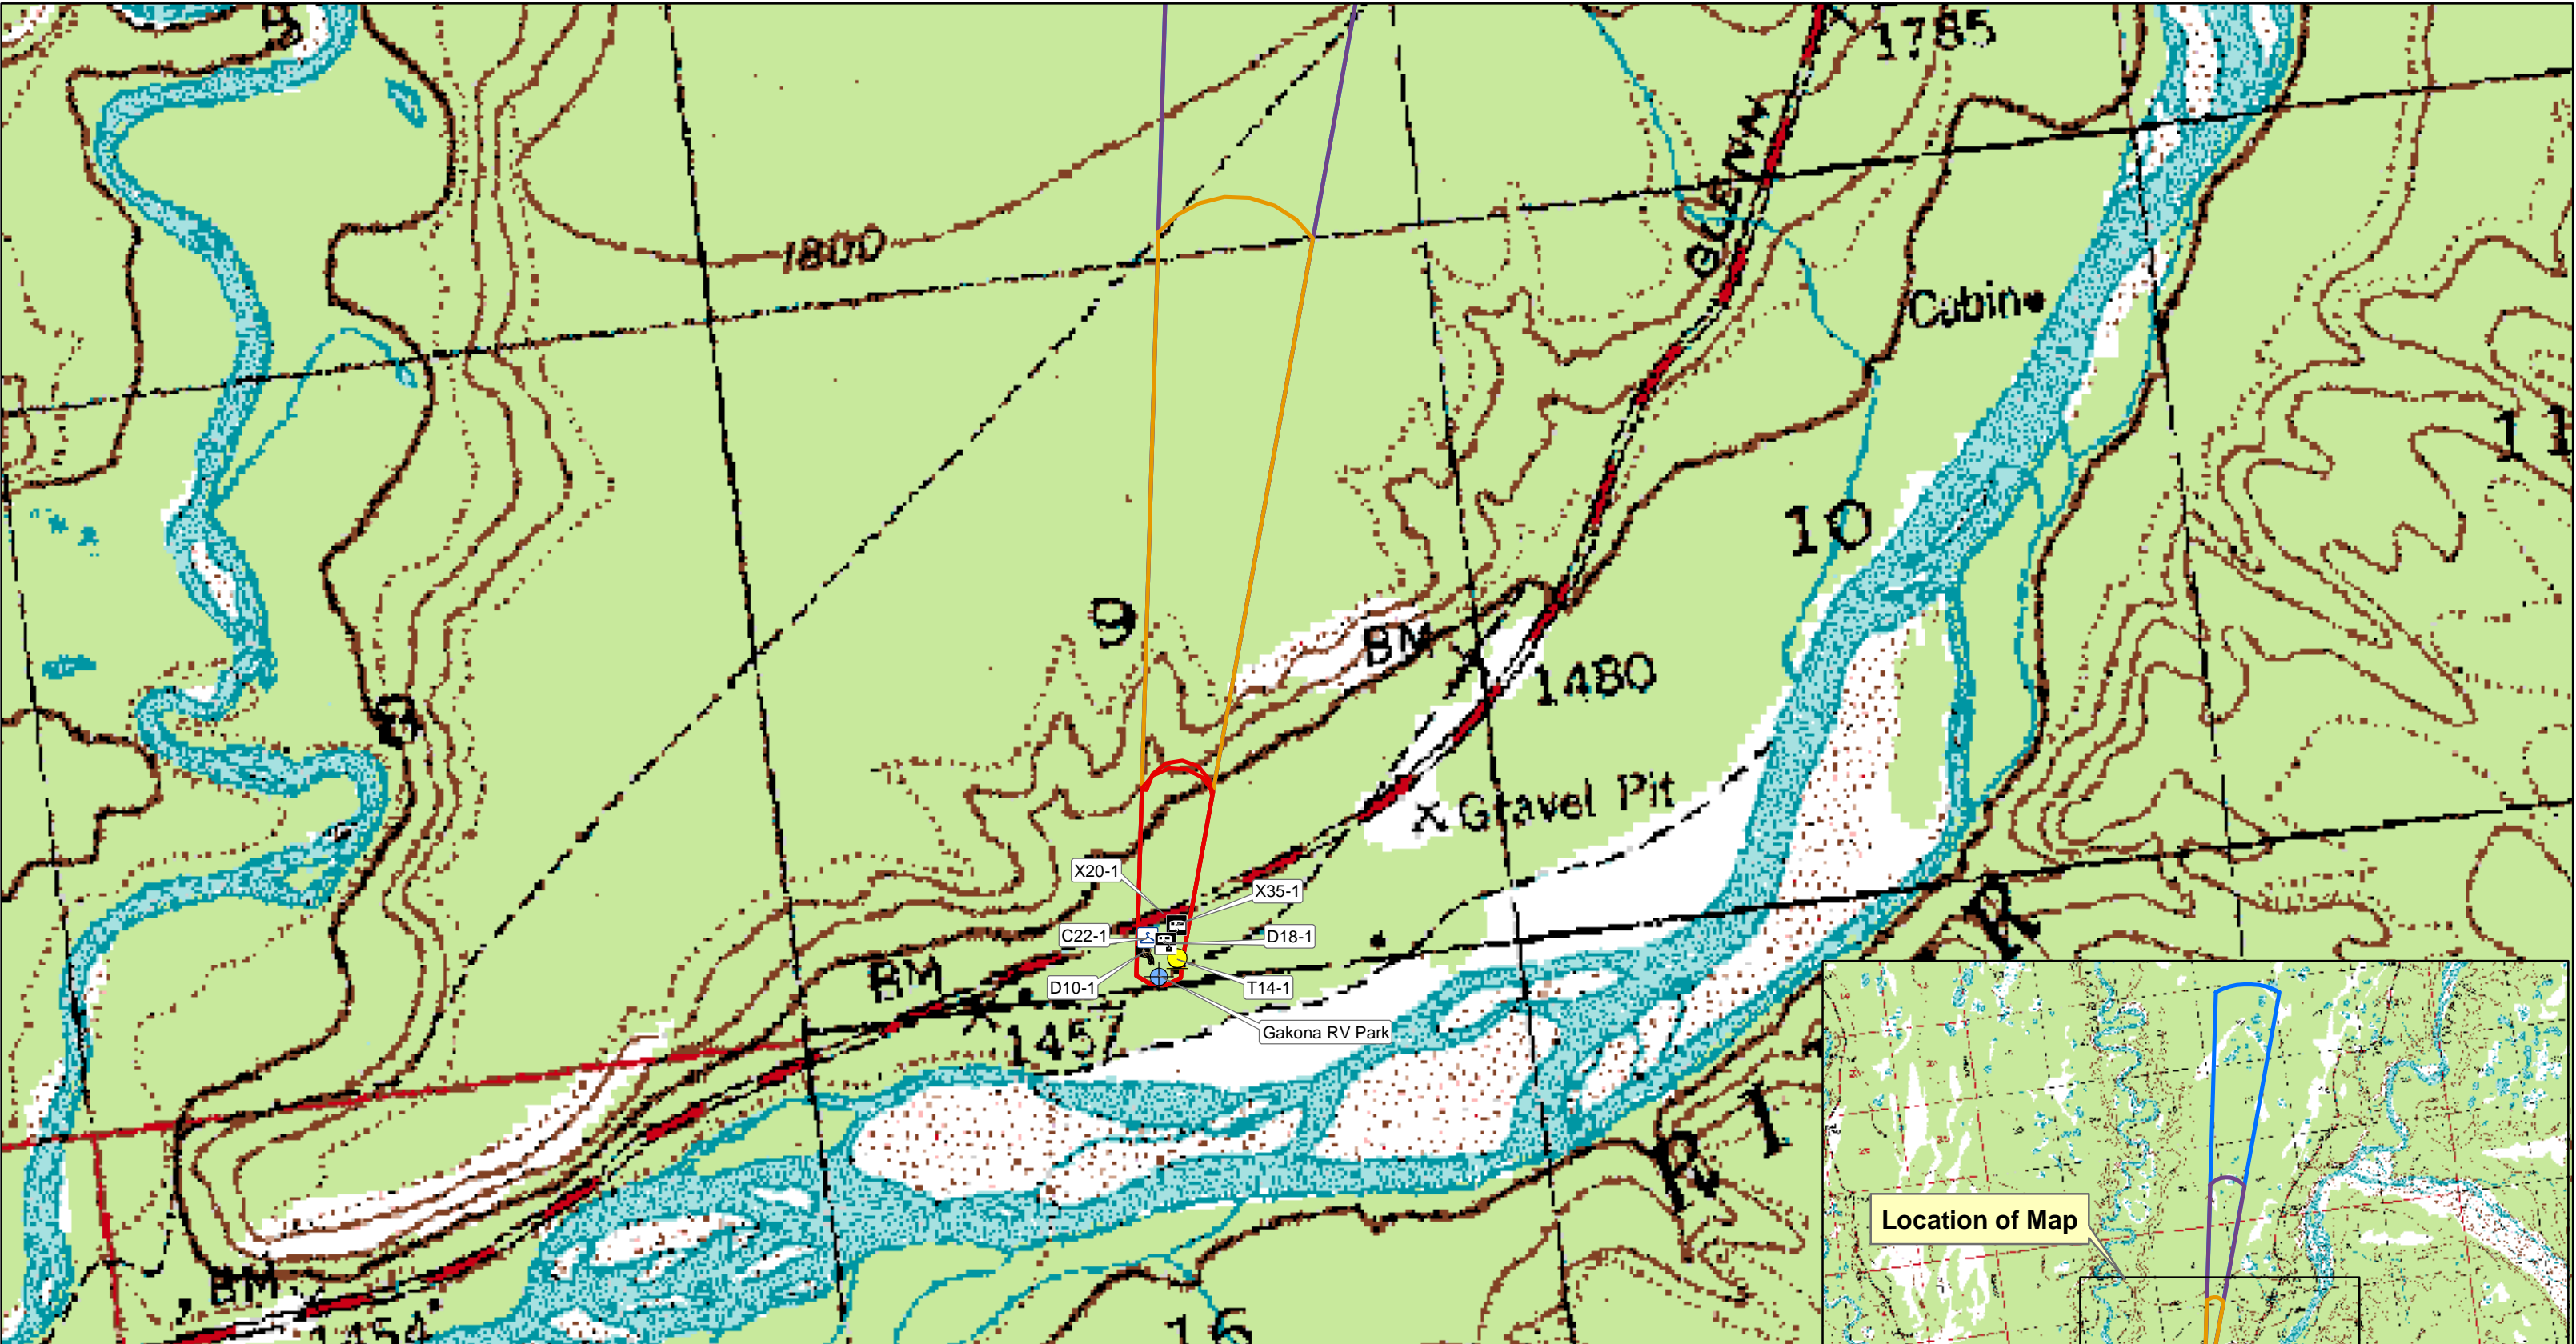
Map 2: Drinking Water Protection Areas for Kakagrana RV Park and Potential and Existing Sources of Contamination

The sources are displayed on Map 2 of Appendix C and summarized in Table 1 of Appendix B.

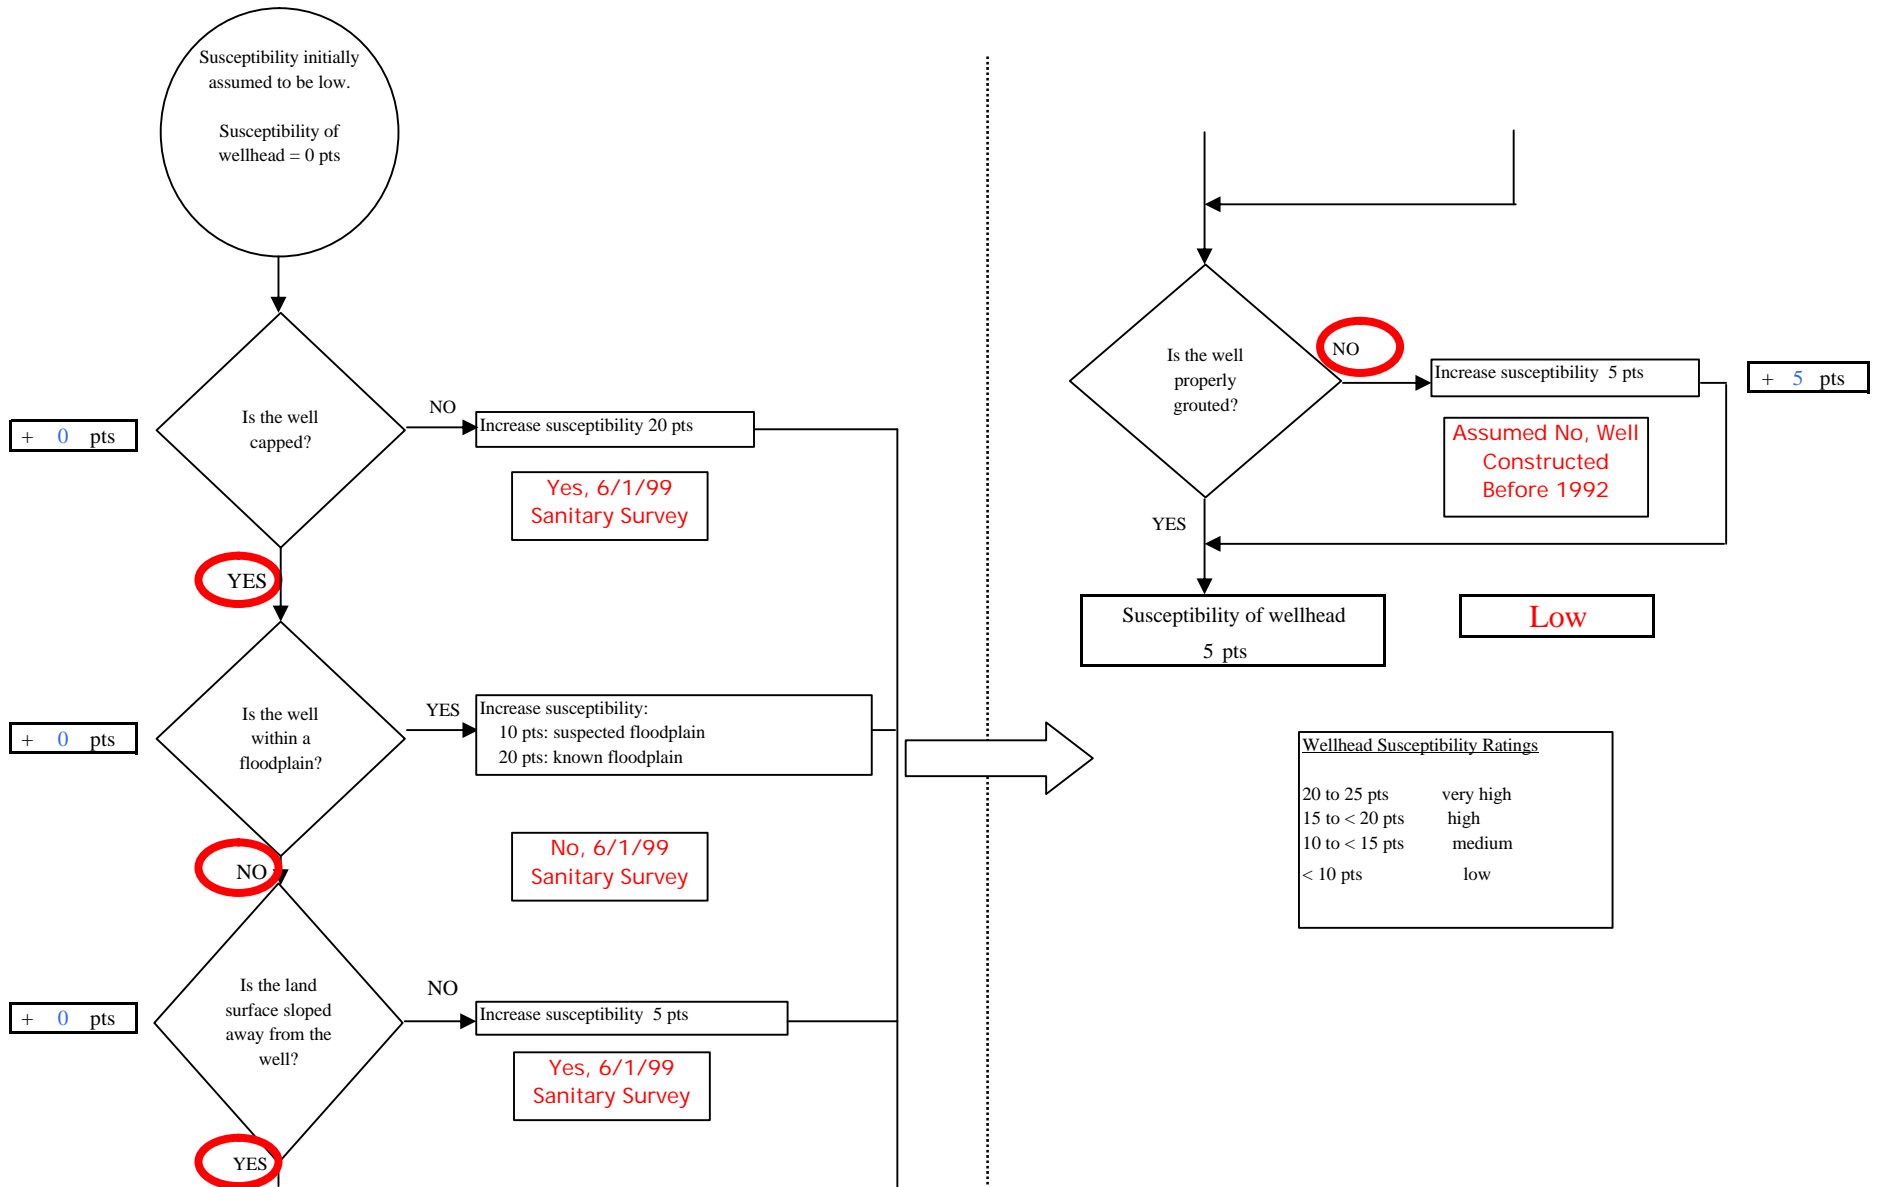
Chart 1. Susceptibility of the wellhead - Gakona RV Park

Susceptibility of the Wellhead (0 – 25 Points)
(Chart 1 of Appendix D)

Score	Rating
Susceptibility of the Wellhead	5	Low
Susceptibility of the Aquifer	16	High
Natural Susceptibility	21	Medium

Appendix D contains eight charts, which together form the ‘Vulnerability Analysis’ for a source water assessment for a public drinking water source. Chart 1 analyzes the ‘Susceptibility of the Wellhead’ to contamination by looking at the construction of the well and its surrounding area. Chart 2 analyzes the ‘Susceptibility of the Aquifer’ to contamination by looking at the naturally occurring attributes of the water source and influences on the groundwater system that might lead to contamination. Chart 3 analyzes ‘Contaminant Risks’ for the drinking water source with respect to bacteria and viruses. The ‘Contaminant Risks’ portion of the analysis considers potential sources of contaminants as well as a review of contamination that has or may have occurred, but has not arrived or been detected at the well. Lastly, Chart 4 contains the ‘Vulnerability Analysis for Bacteria and Viruses’. Charts 5 through 8 contain the Contaminant Risks and Vulnerability Analyses for nitrates and nitrites and volatile organic chemicals, respectively.

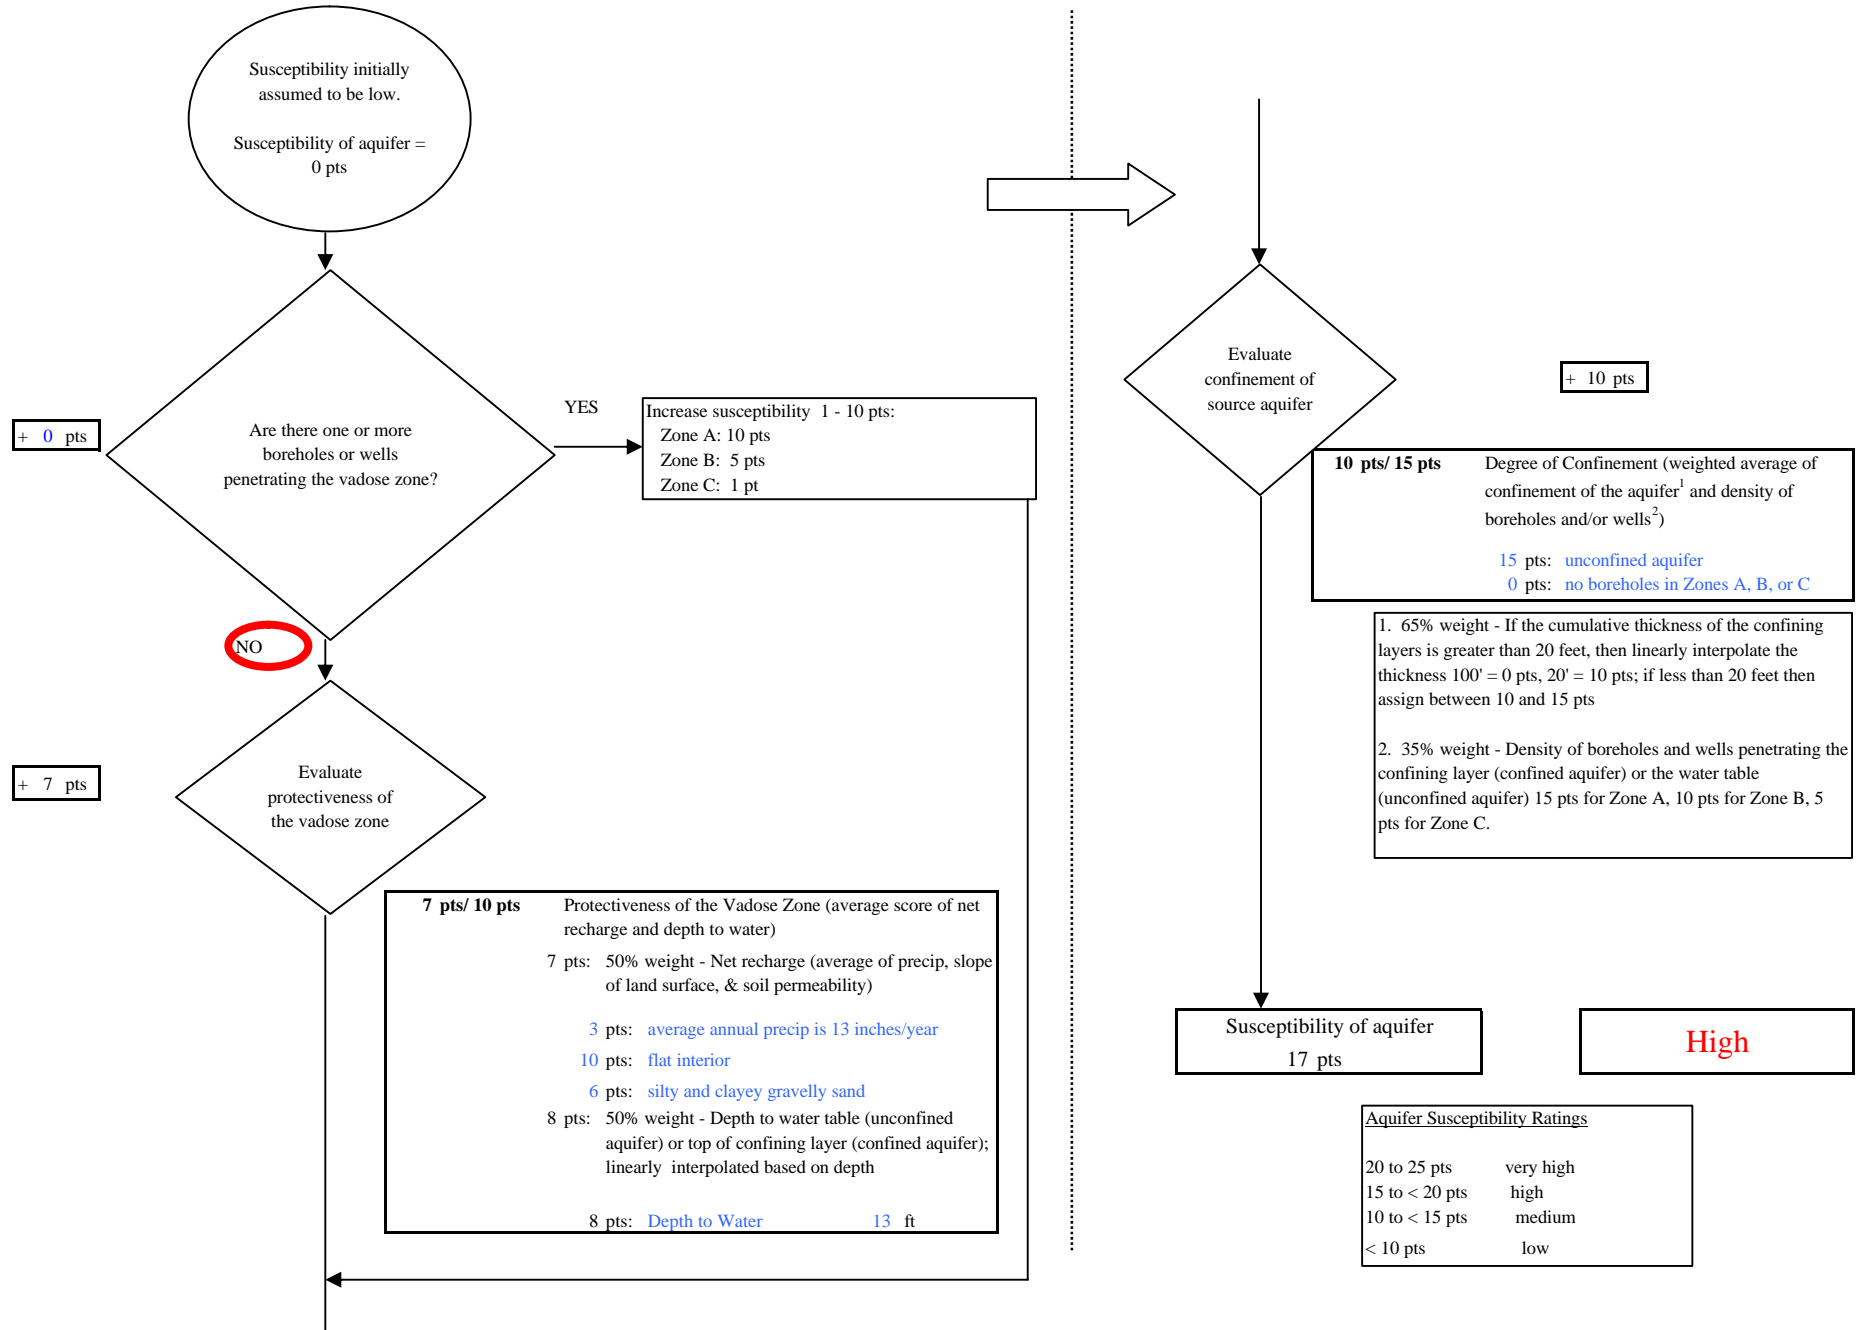
Chart 2. Susceptibility of the aquifer - Gakona RV Park

Susceptibility of the Aquifer (0 – 25 Points)
(Chart 2 of Appendix D)

We assume the well for Gakona RV Park is completed in an unconfined aquifer. Because unconfined aquifers are recharged by surface water and precipitation that migrates downward from the surface, contaminants at the surface have the potential to adversely impact this aquifer. Table 2 shows the Susceptibility scores and ratings for Gakona RV Park.

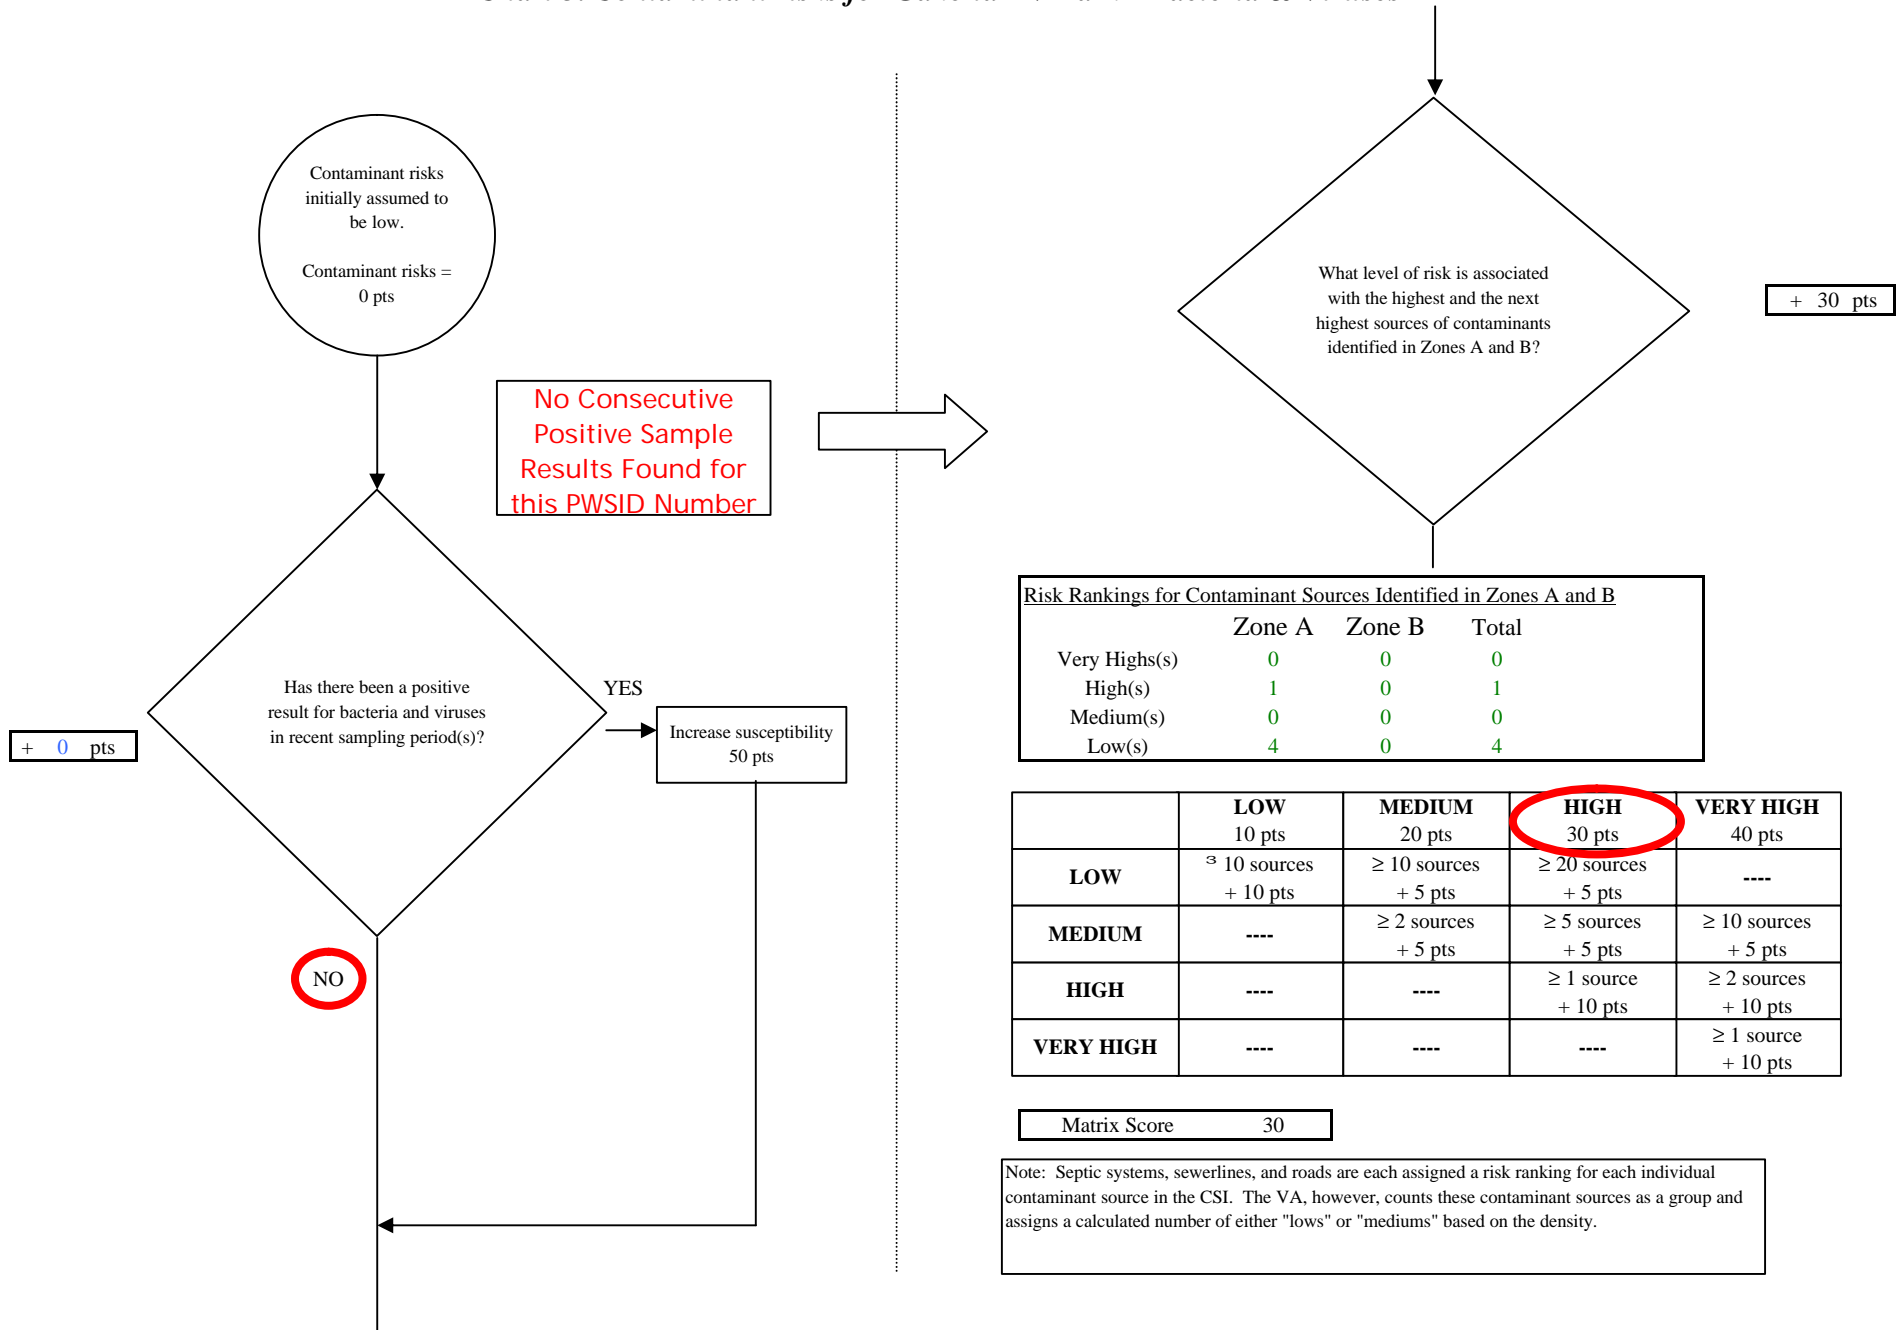
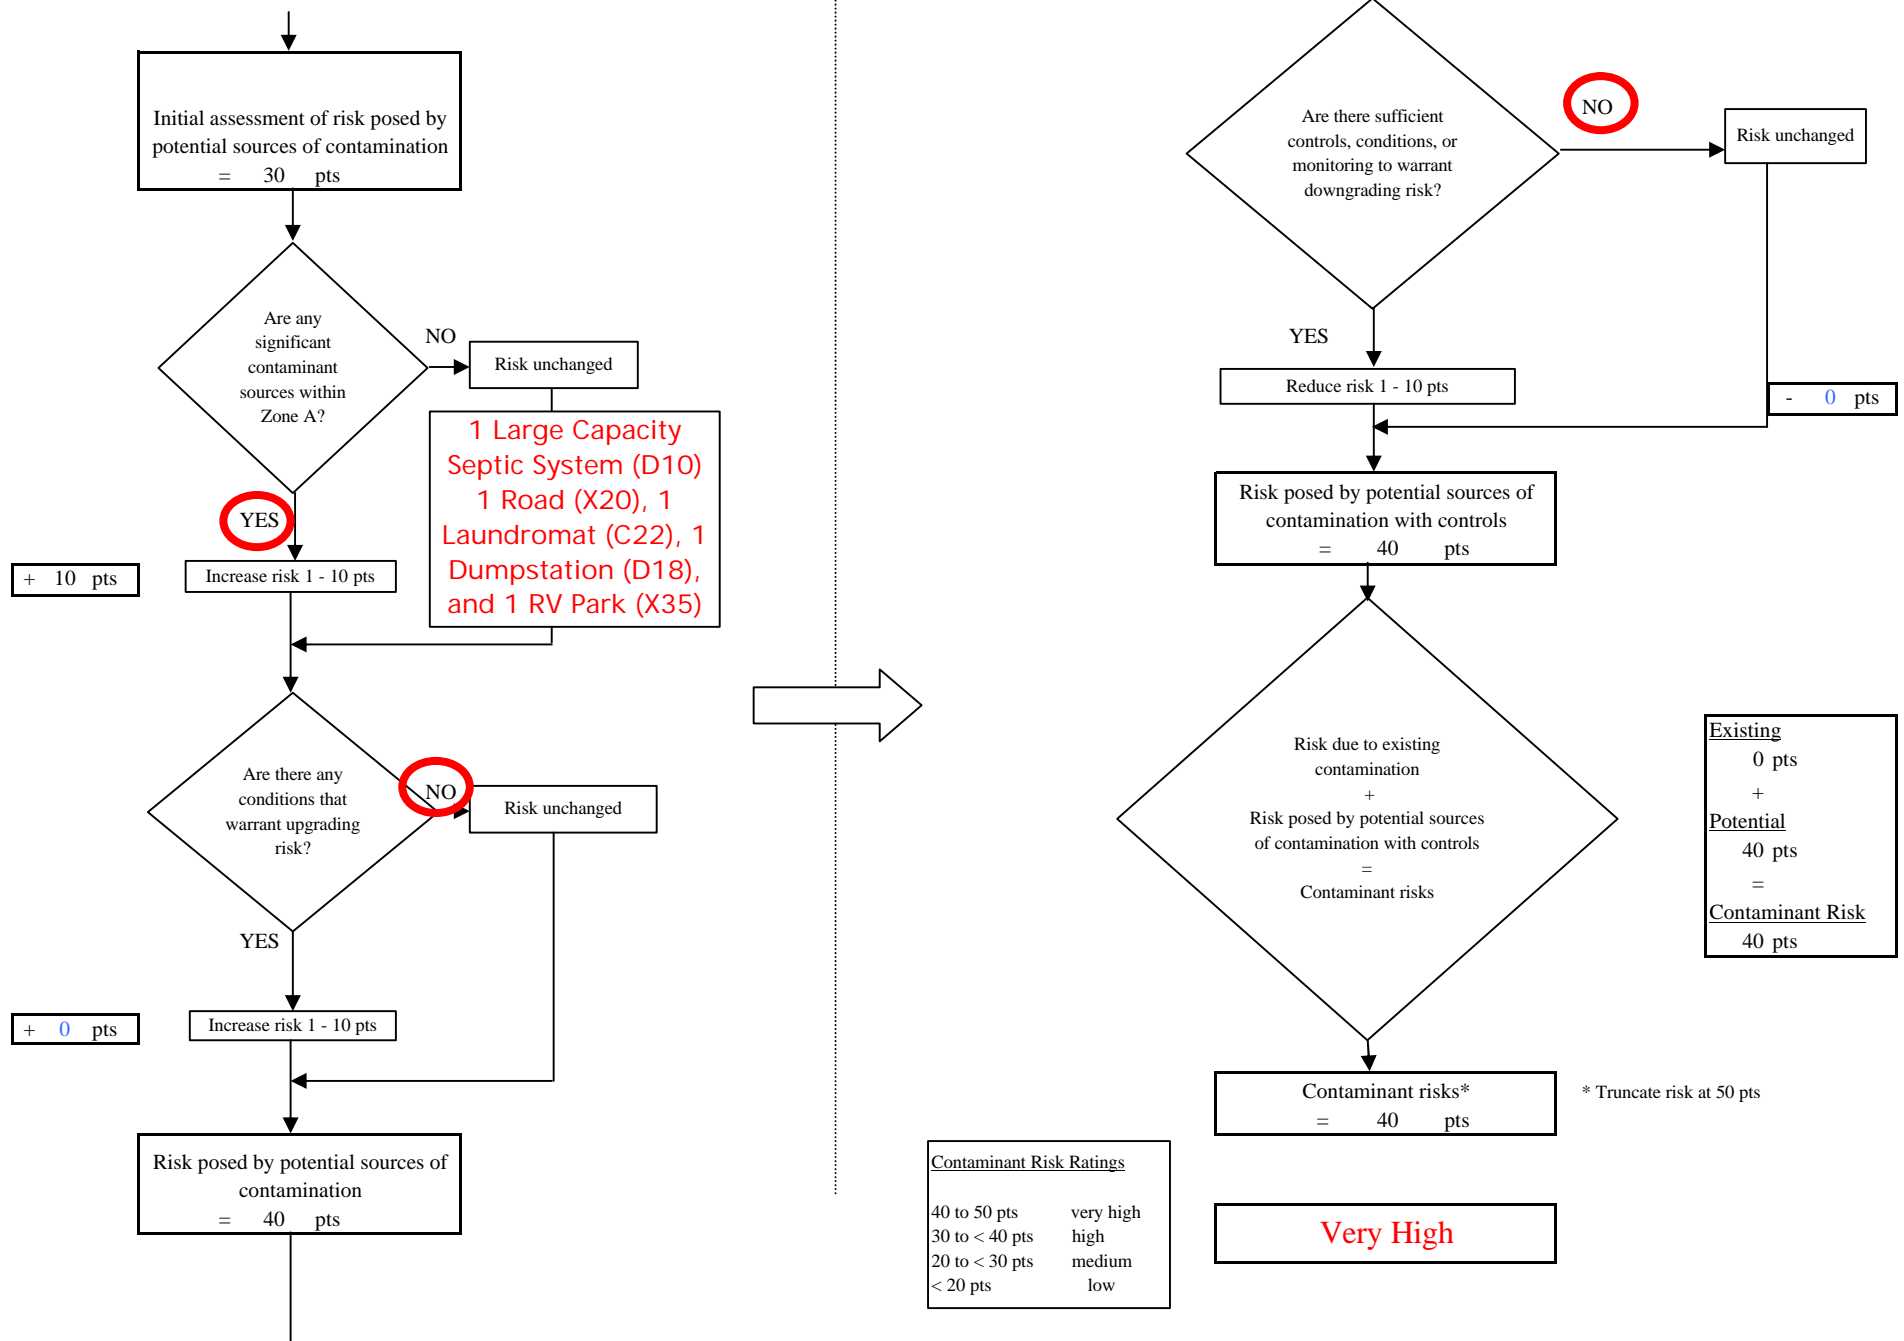
Chart 3. Contaminant risks for Gakona RV Park - Bacteria & Viruses

The contaminant risk for bacteria and viruses is **Very High** with laundromats (without dry cleaning); large-capacity septic systems; RV dump stations; paved highways and roads; and campgrounds and RV parks representing the risks to the drinking water well (See Chart 3 – Contaminant Risks for Bacteria and Viruses in Appendix D).

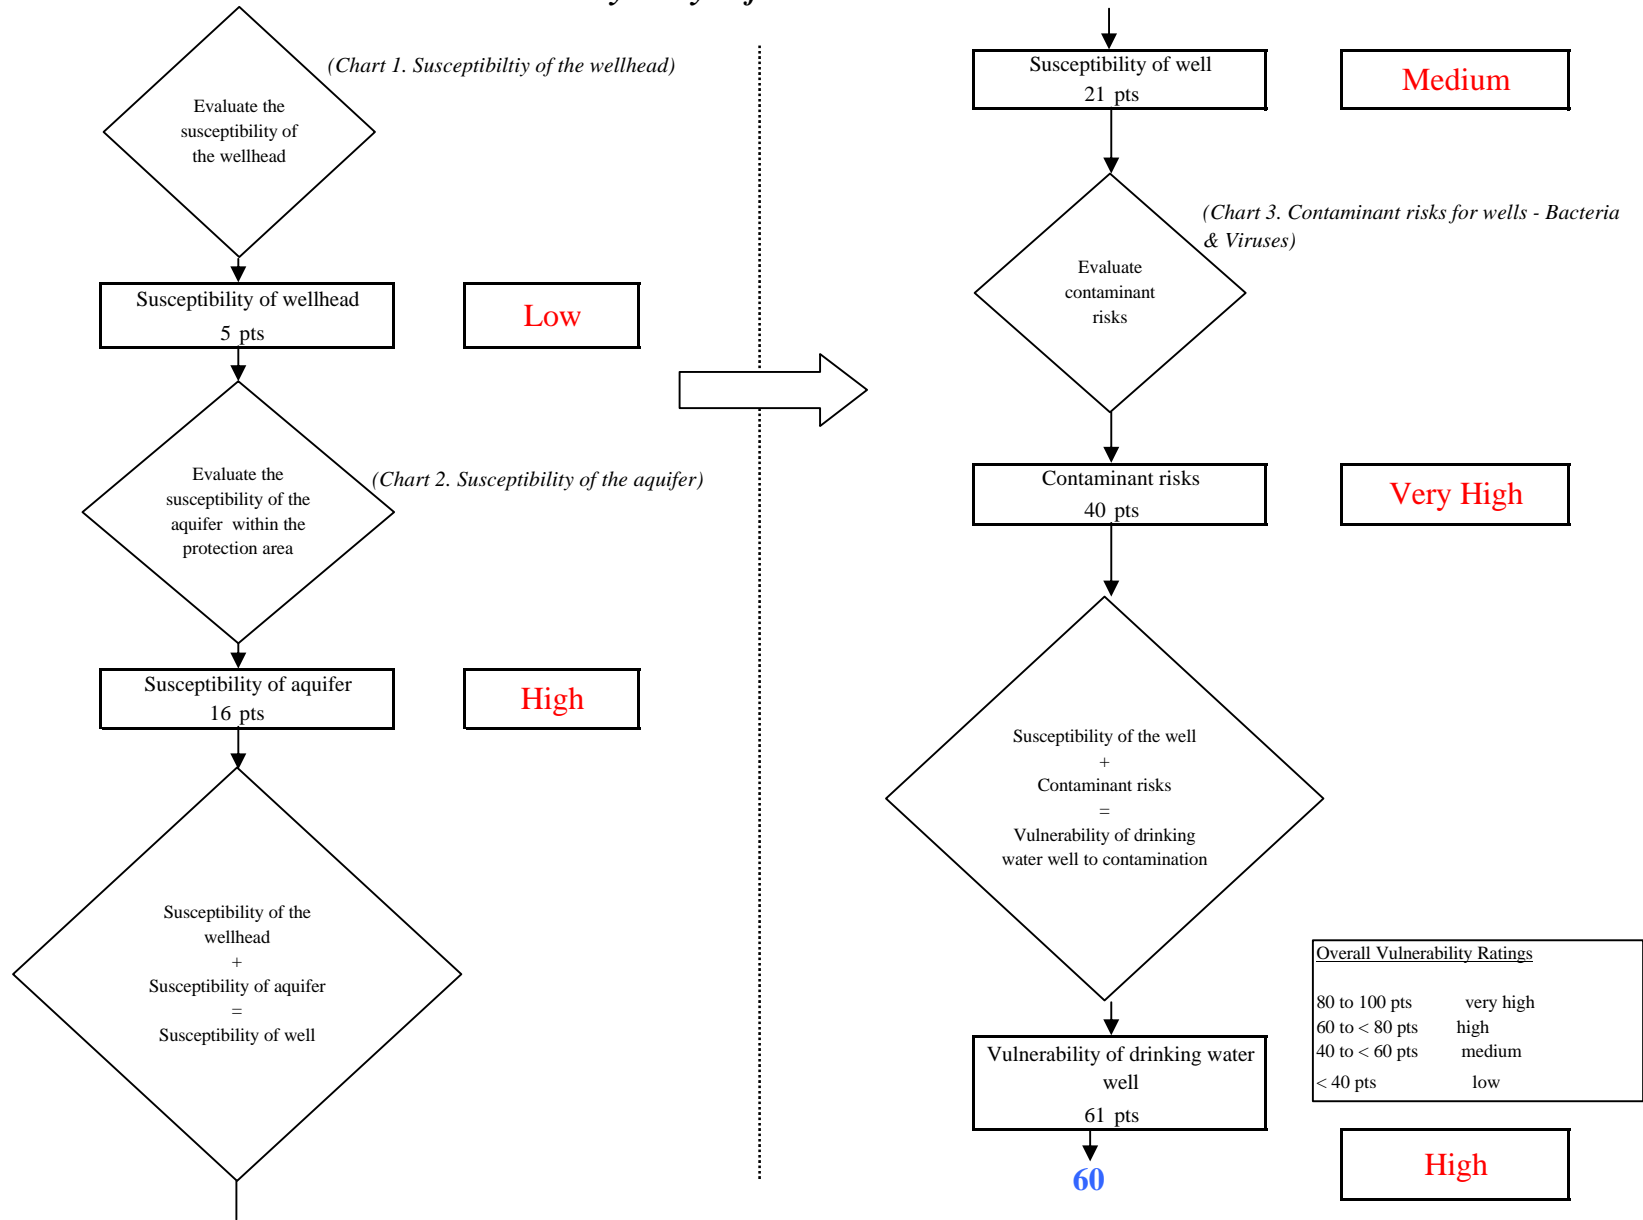
Chart 4. Vulnerability analysis for Gakona RV Park - Bacteria & Viruses

Only a small amount of bacteria and viruses are required to endanger public health. Recent sampling events indicated no recent positive results were detected for bacteria and viruses. However, after combining the contaminant risks with the overall natural susceptibility of the well, the vulnerability of the well to contamination by bacteria and viruses is **High**.
