Source Water Assessment

A Hydrogeologic Susceptibility and
Vulnerability Assessment for
Gakona RV Park,
Gakona, Alaska
PWSID #381359

DRINKING WATER PROTECTION PROGRAM REPORT NO. 925

Alaska Department of Environmental Conservation

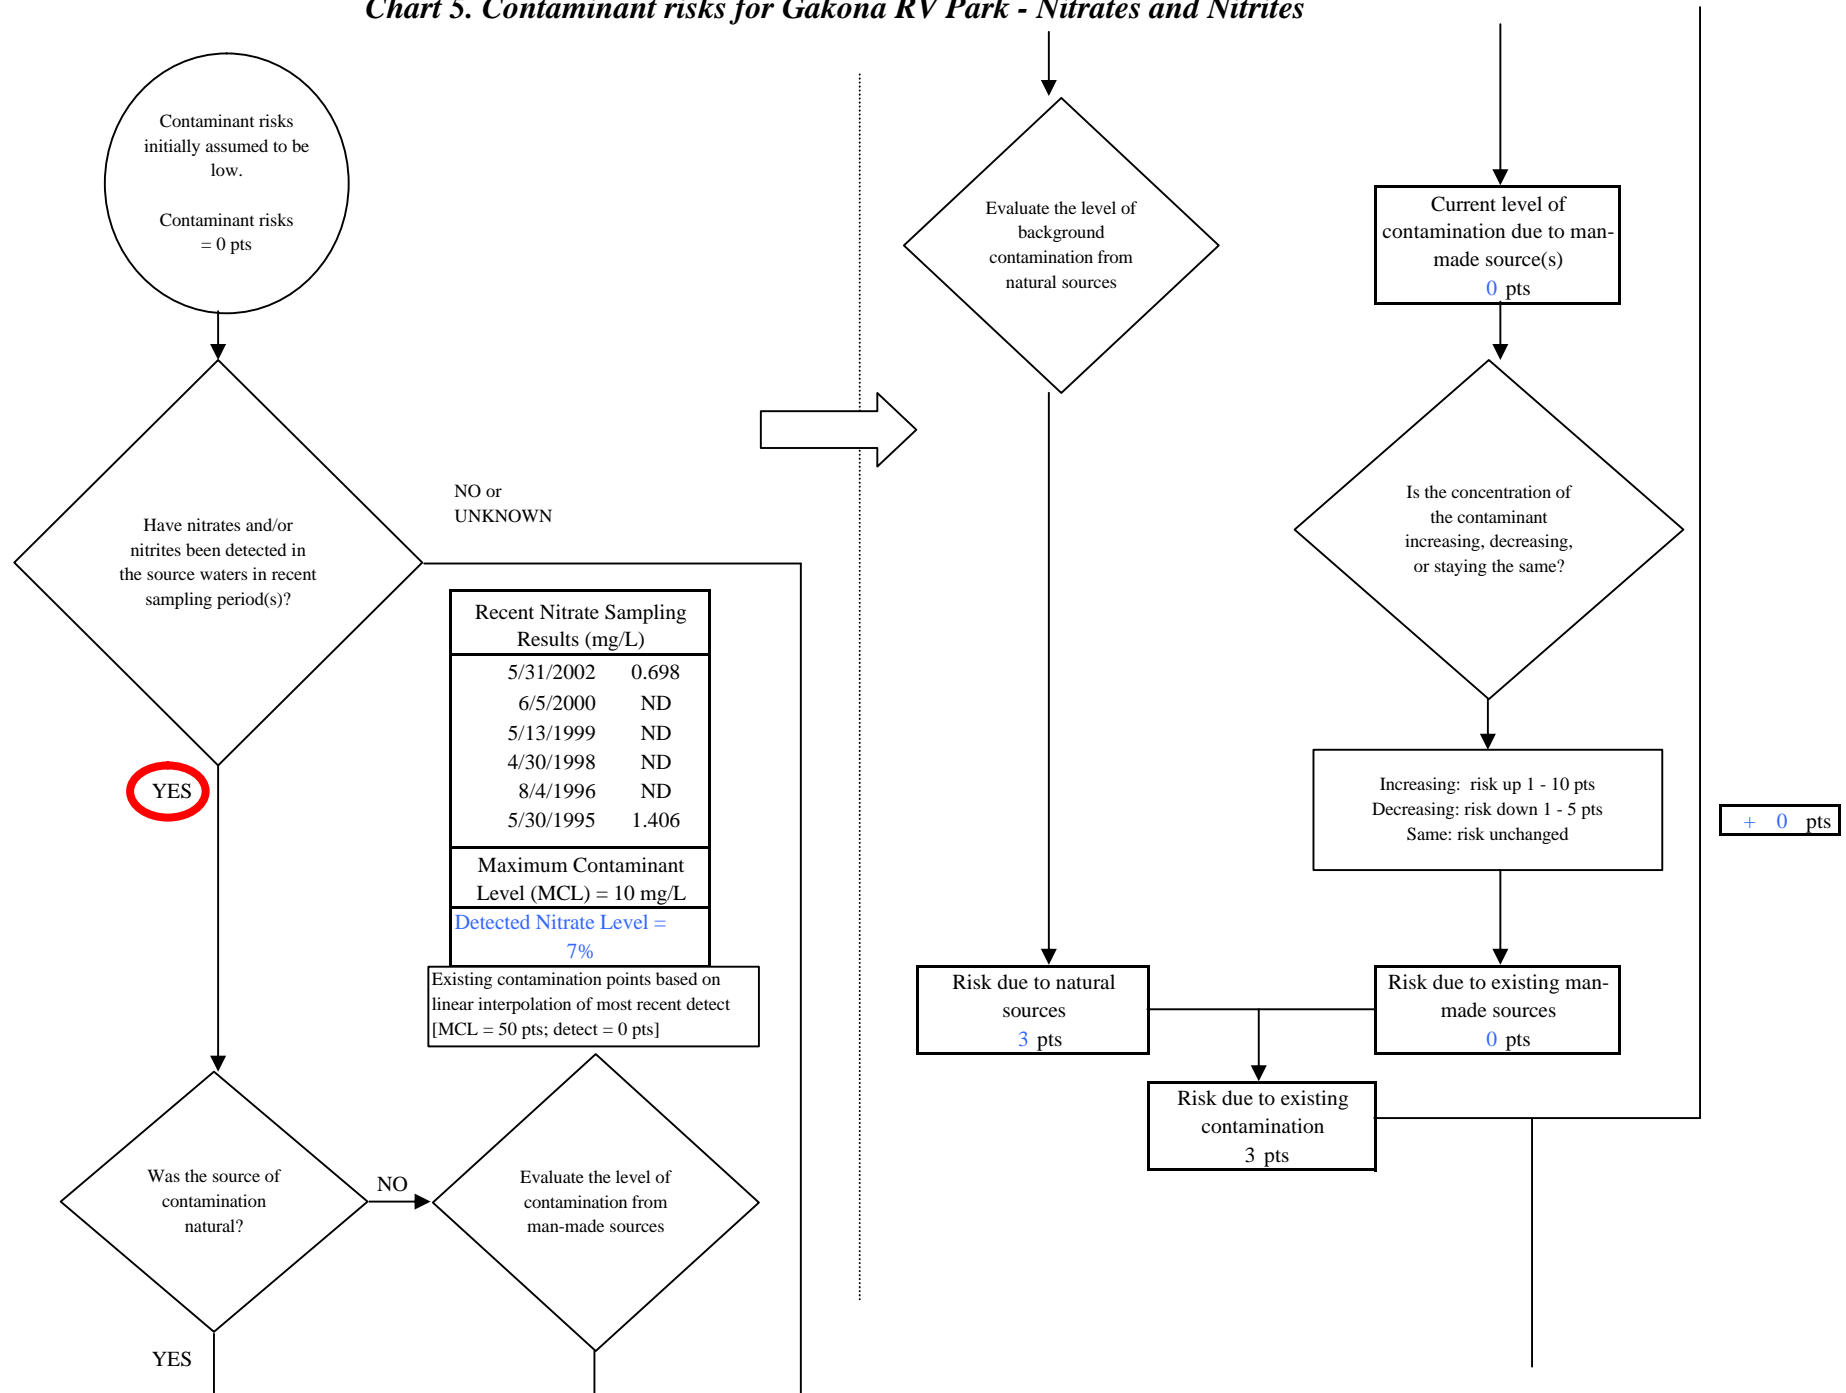
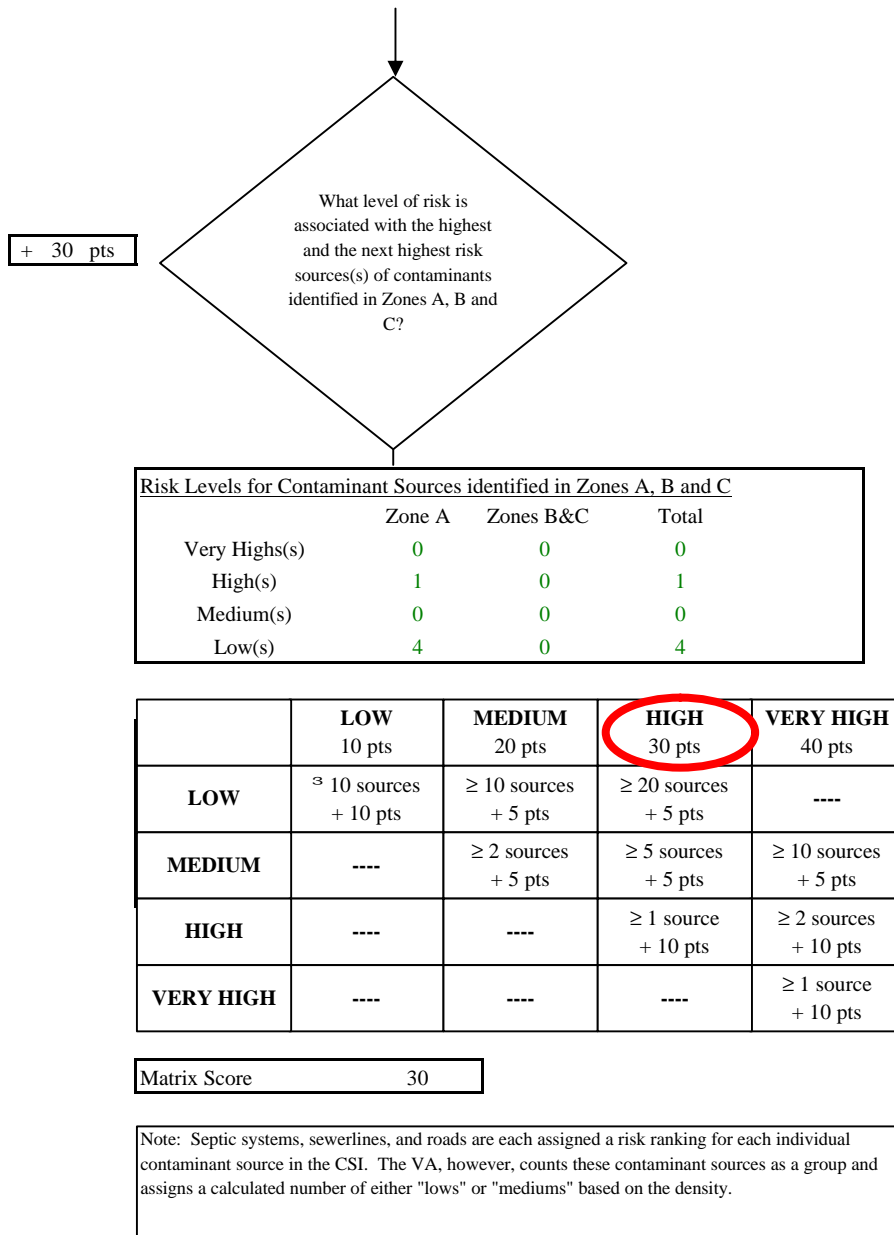
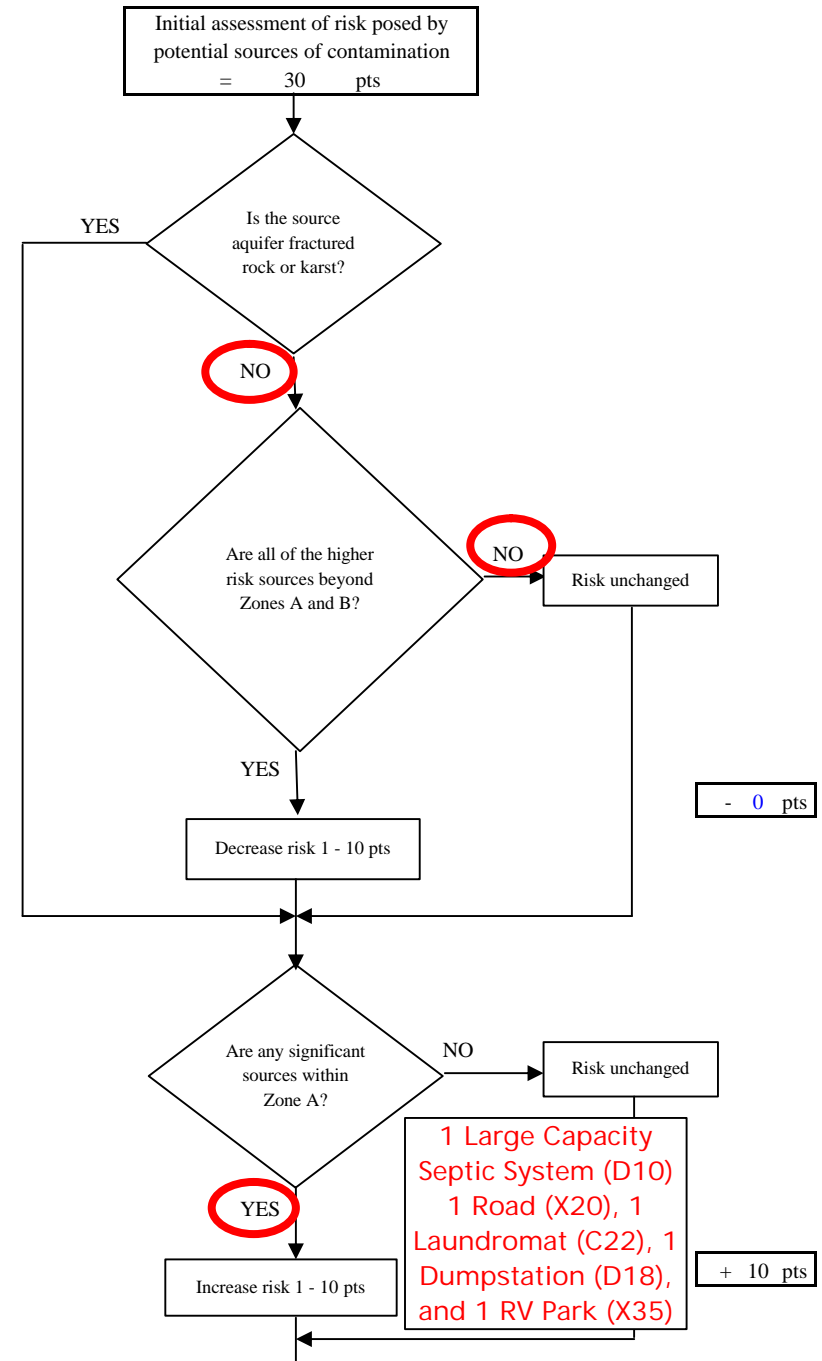
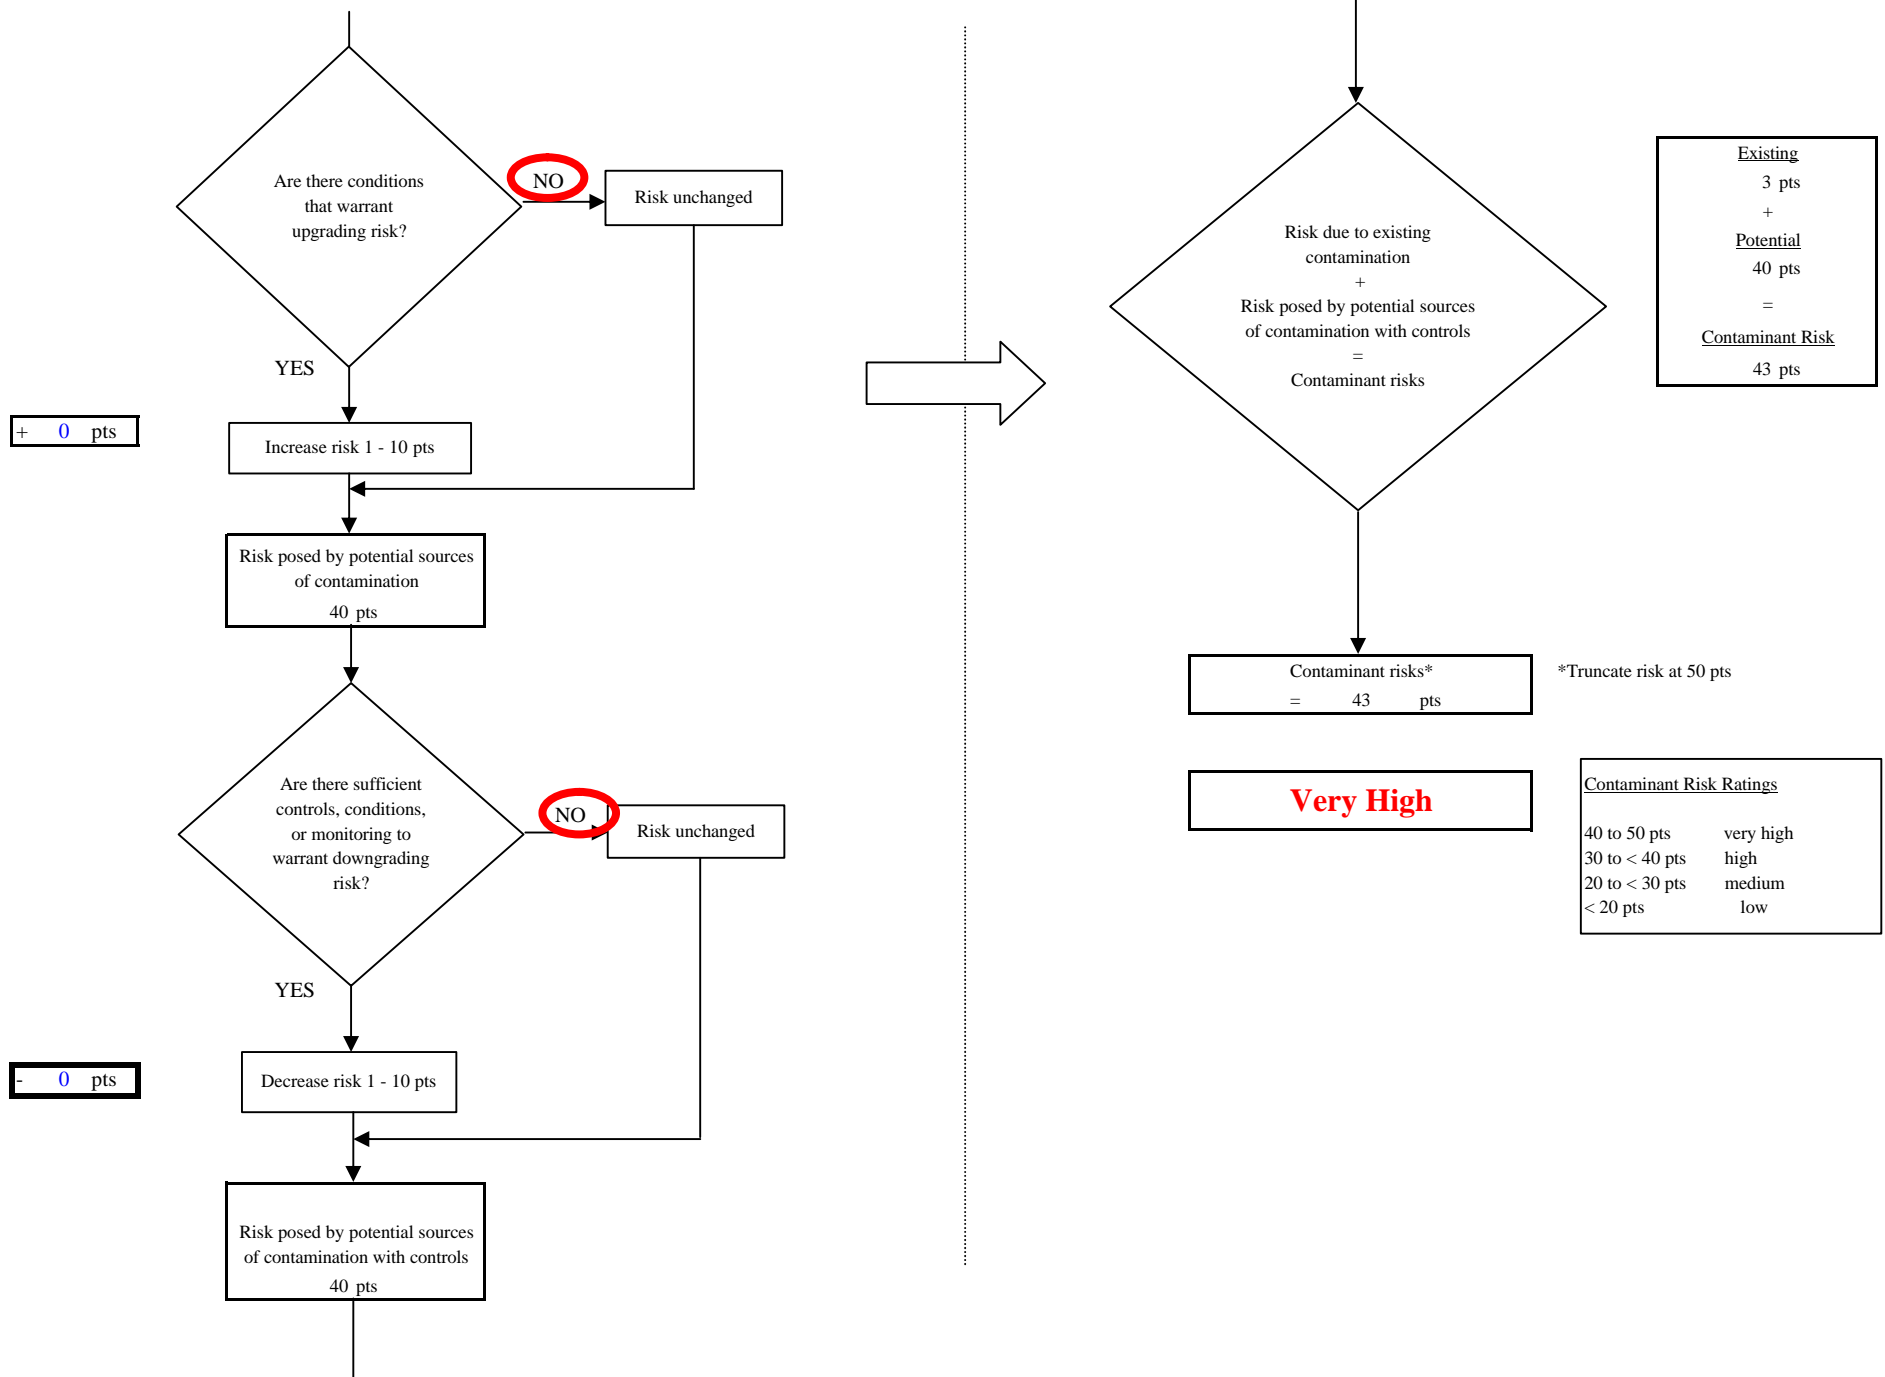
Chart 5. Contaminant risks for Gakona RV Park - Nitrates and Nitrites

The contaminant risk for nitrates and nitrites is **Very High** with laundromats (without dry cleaning); large-capacity septic systems; RV dump stations; paved highways and roads; and campgrounds and RV parks representing the risks to this source of public drinking water (See Chart 5 - Contaminant Risks for Nitrates and/or Nitrites in Appendix D).

Sampling history for Gakona RV Park indicates that nitrates have been detected in the water, but only in very low concentrations (at 0.40 mg/L on 6/20/00) or 4% of the Maximum Contaminant Level (MCL). The MCL is the maximum level of contaminant that is allowed to exist in drinking water and still be consumed by humans without harmful health effects. Due to the high solubility and weak retention by soil, nitrates are very mobile, moving at approximately the same rate as water.

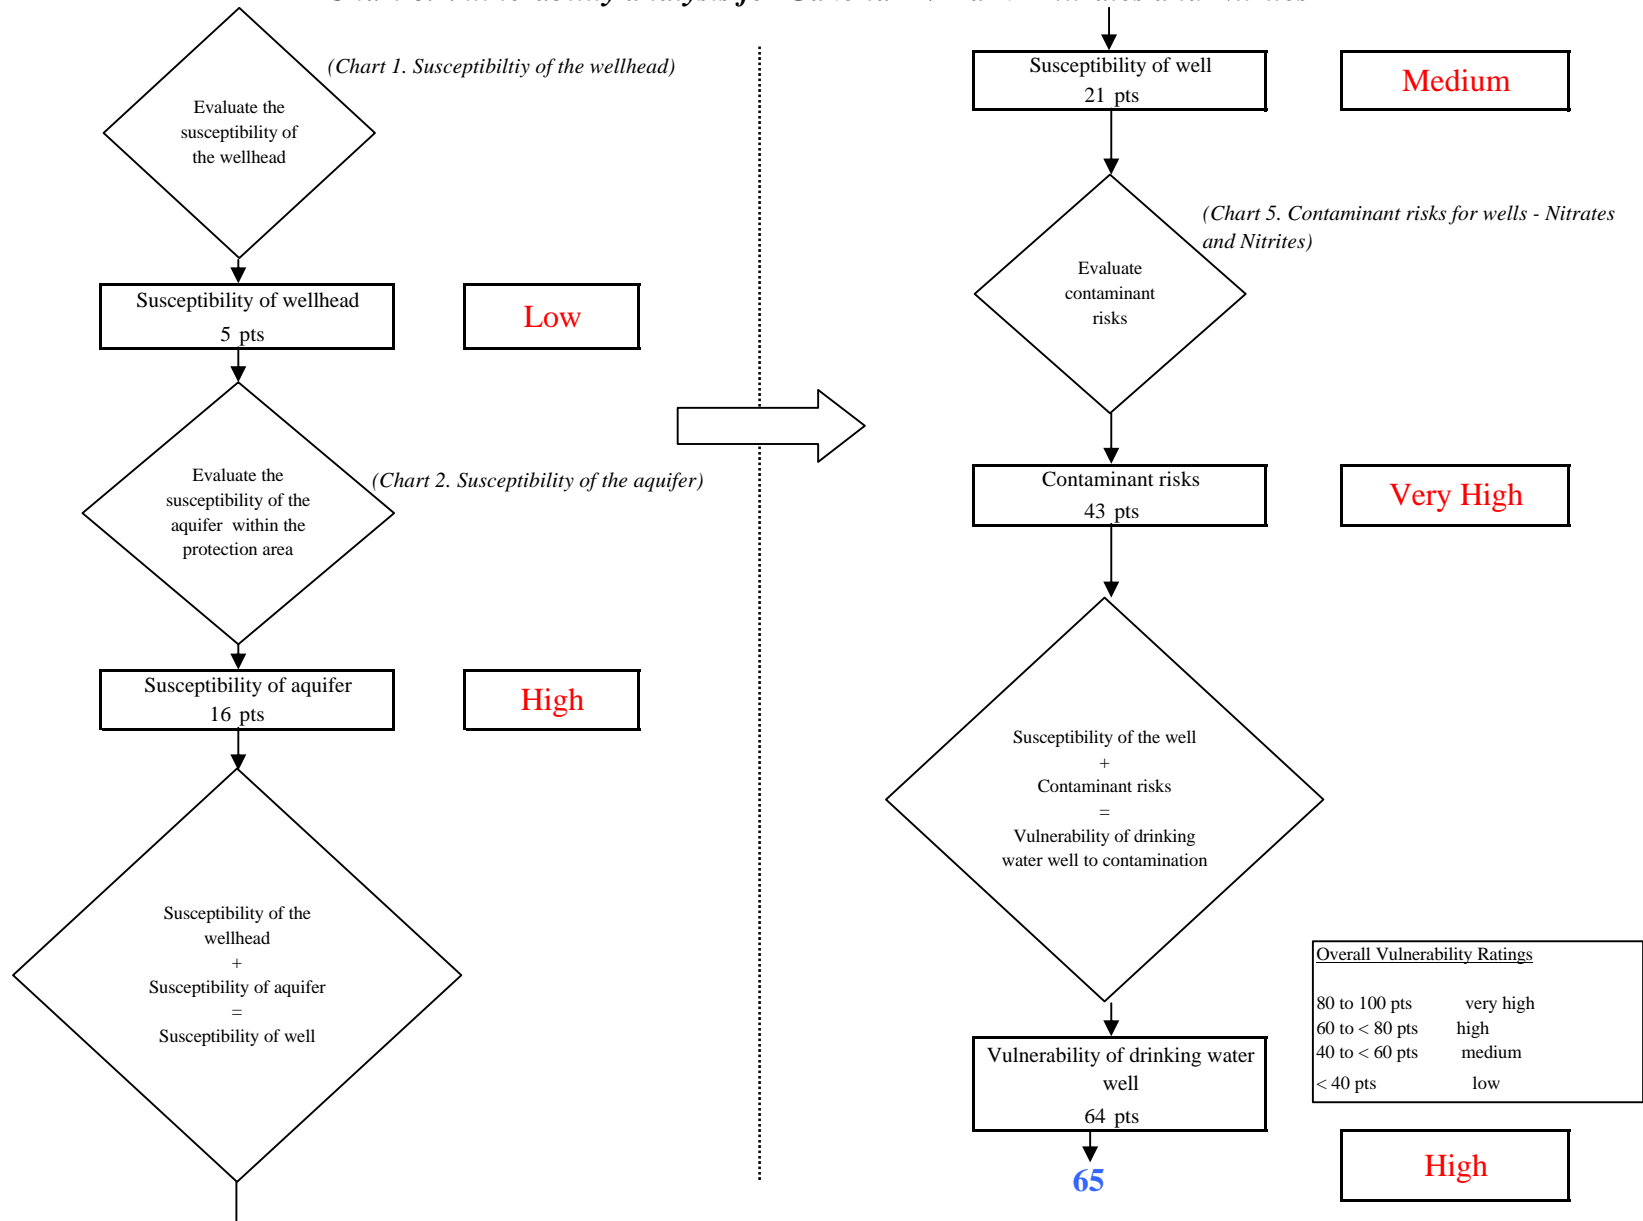
Chart 6. Vulnerability analysis for Gakona RV Park - Nitrates and Nitrites

After combining the contaminant risk for nitrates and nitrites with the natural susceptibility of the well, the overall vulnerability of the well to contamination by nitrates and nitrites is **High**.

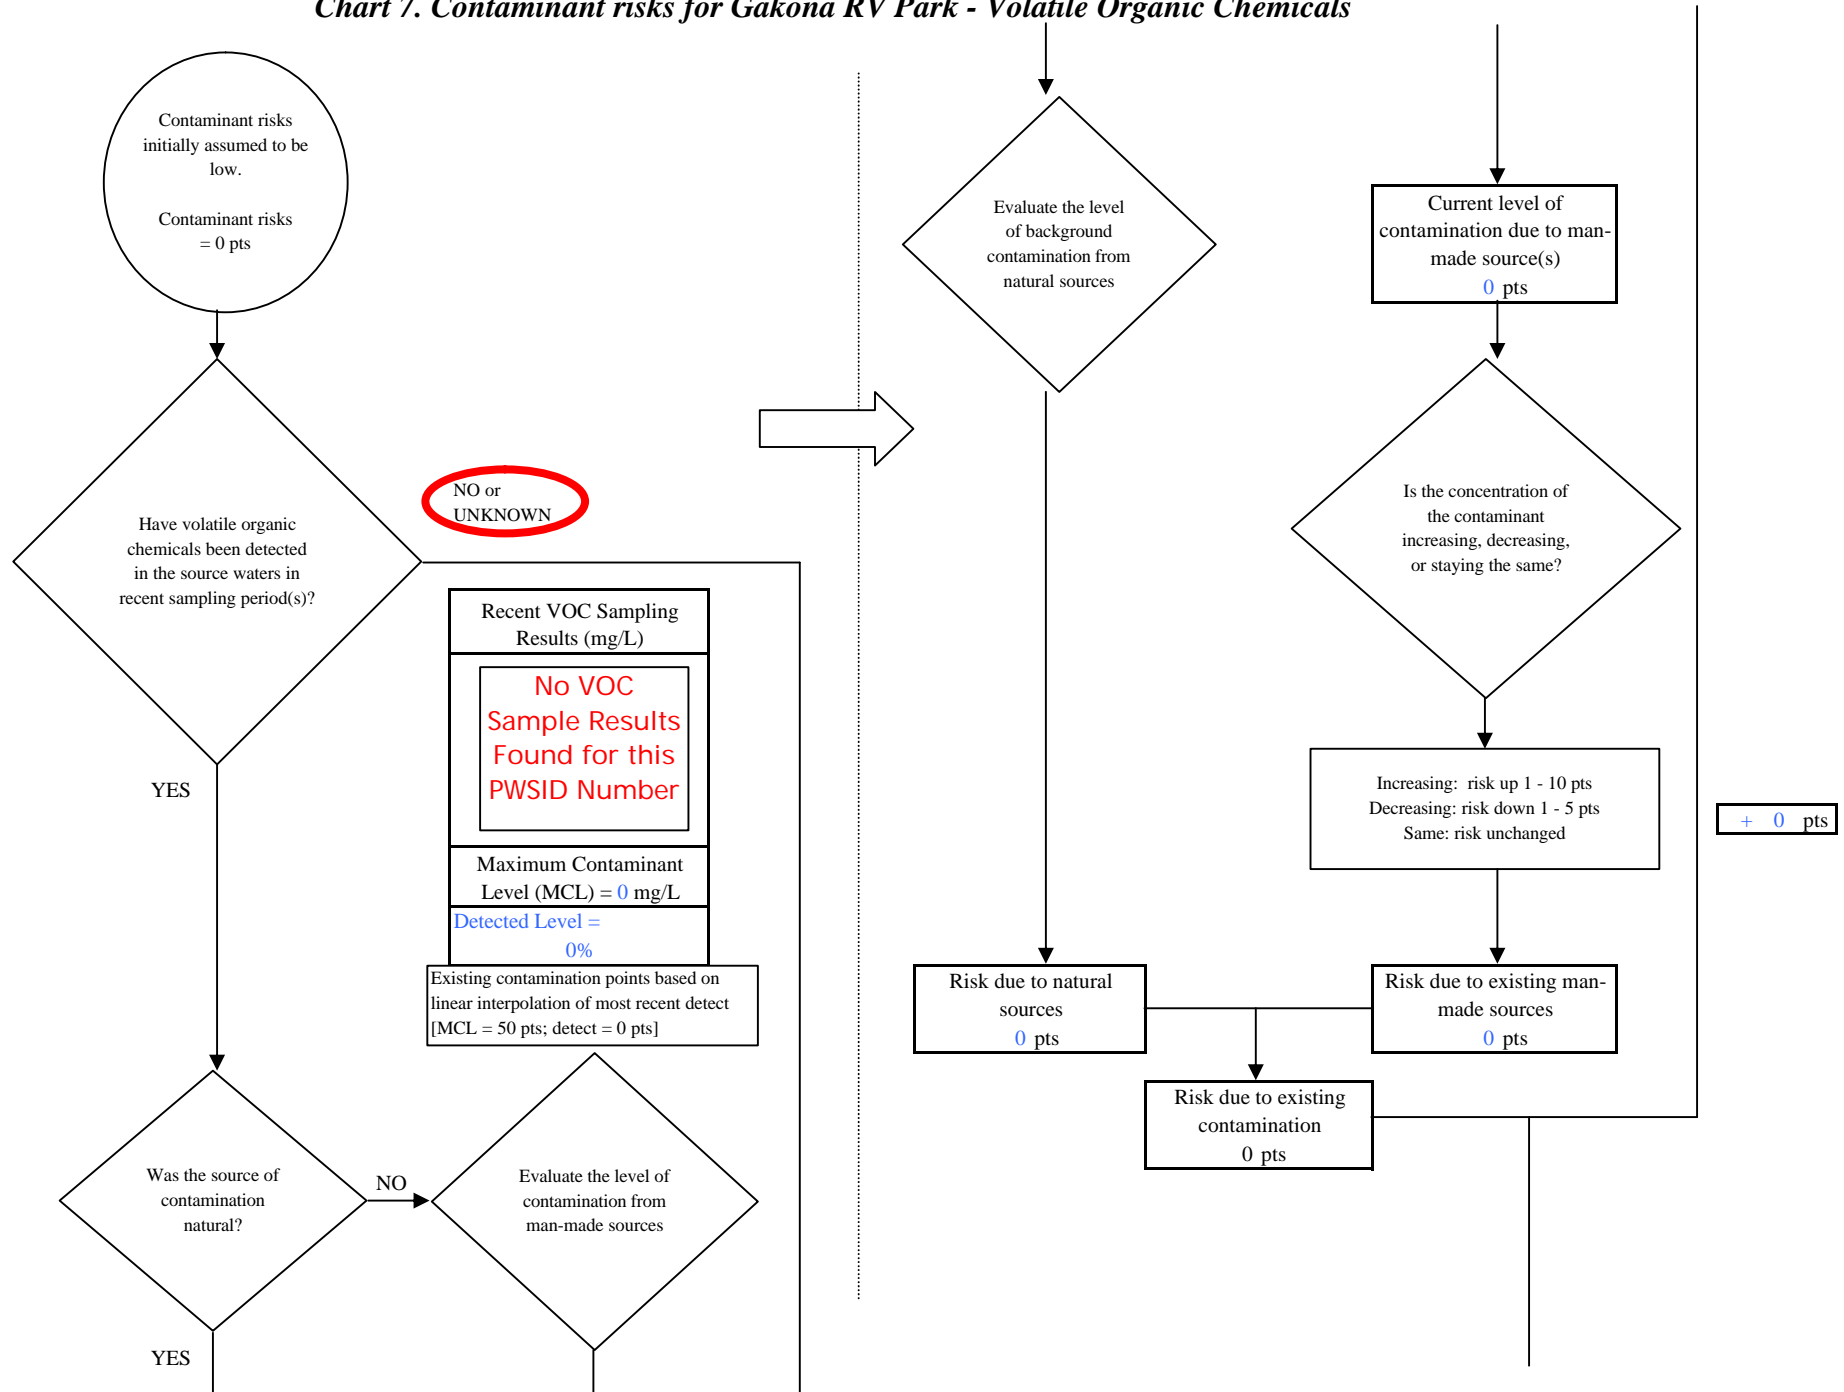
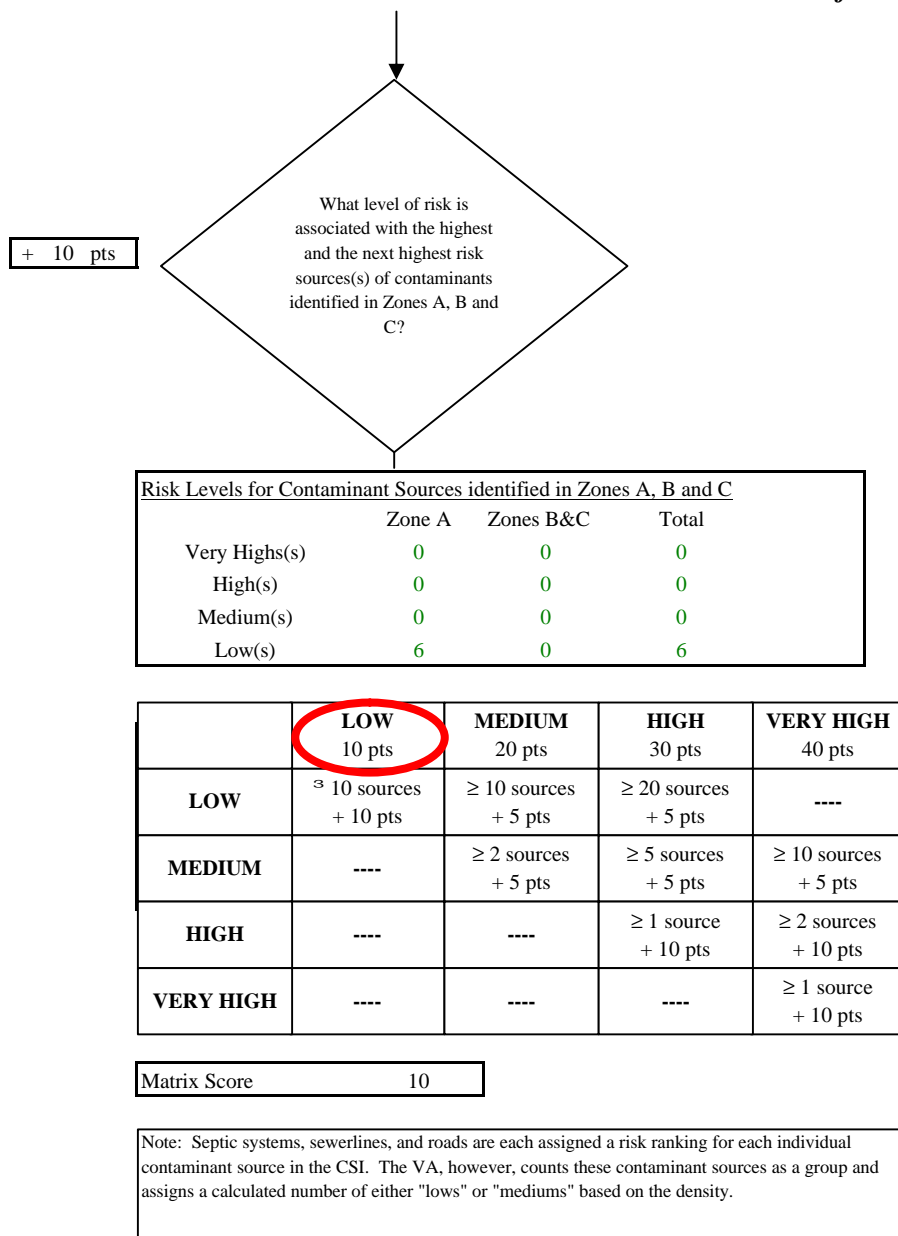
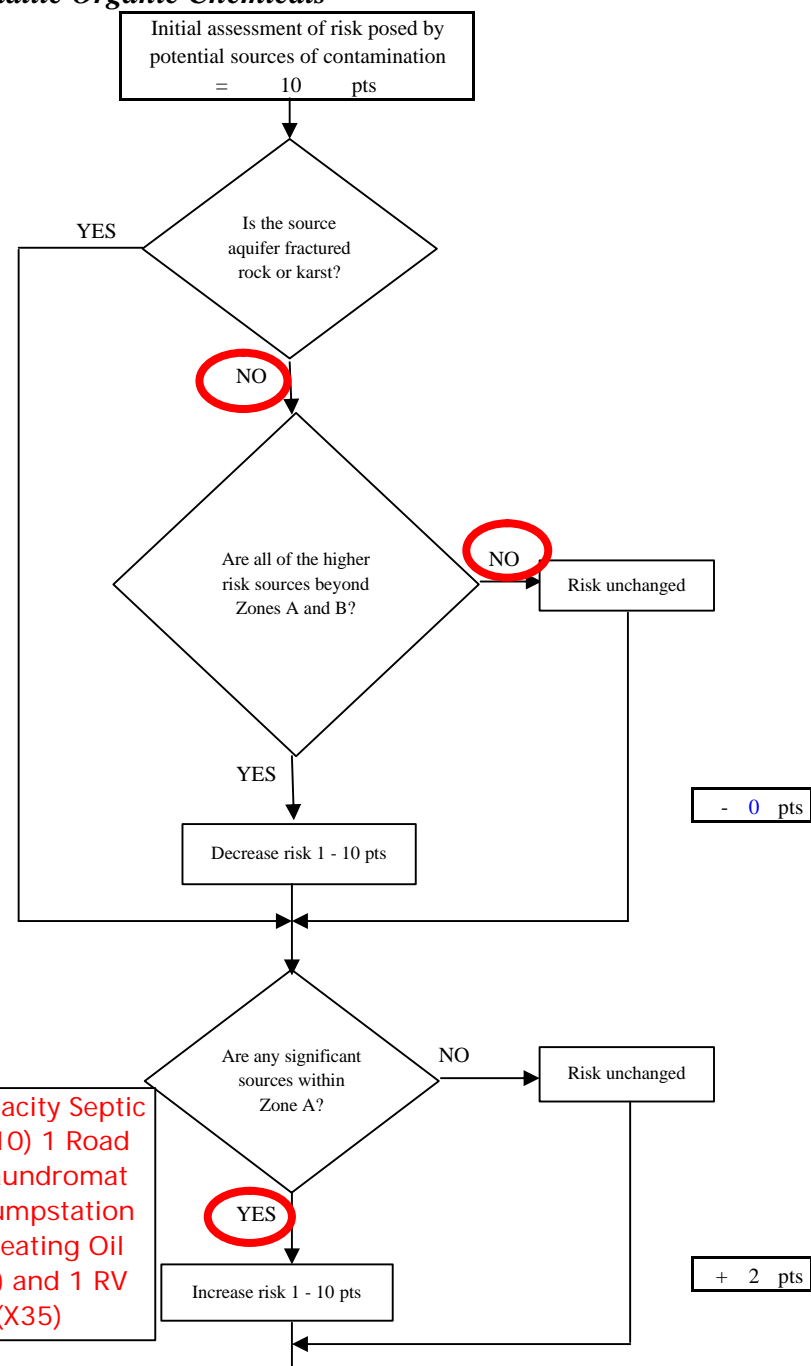
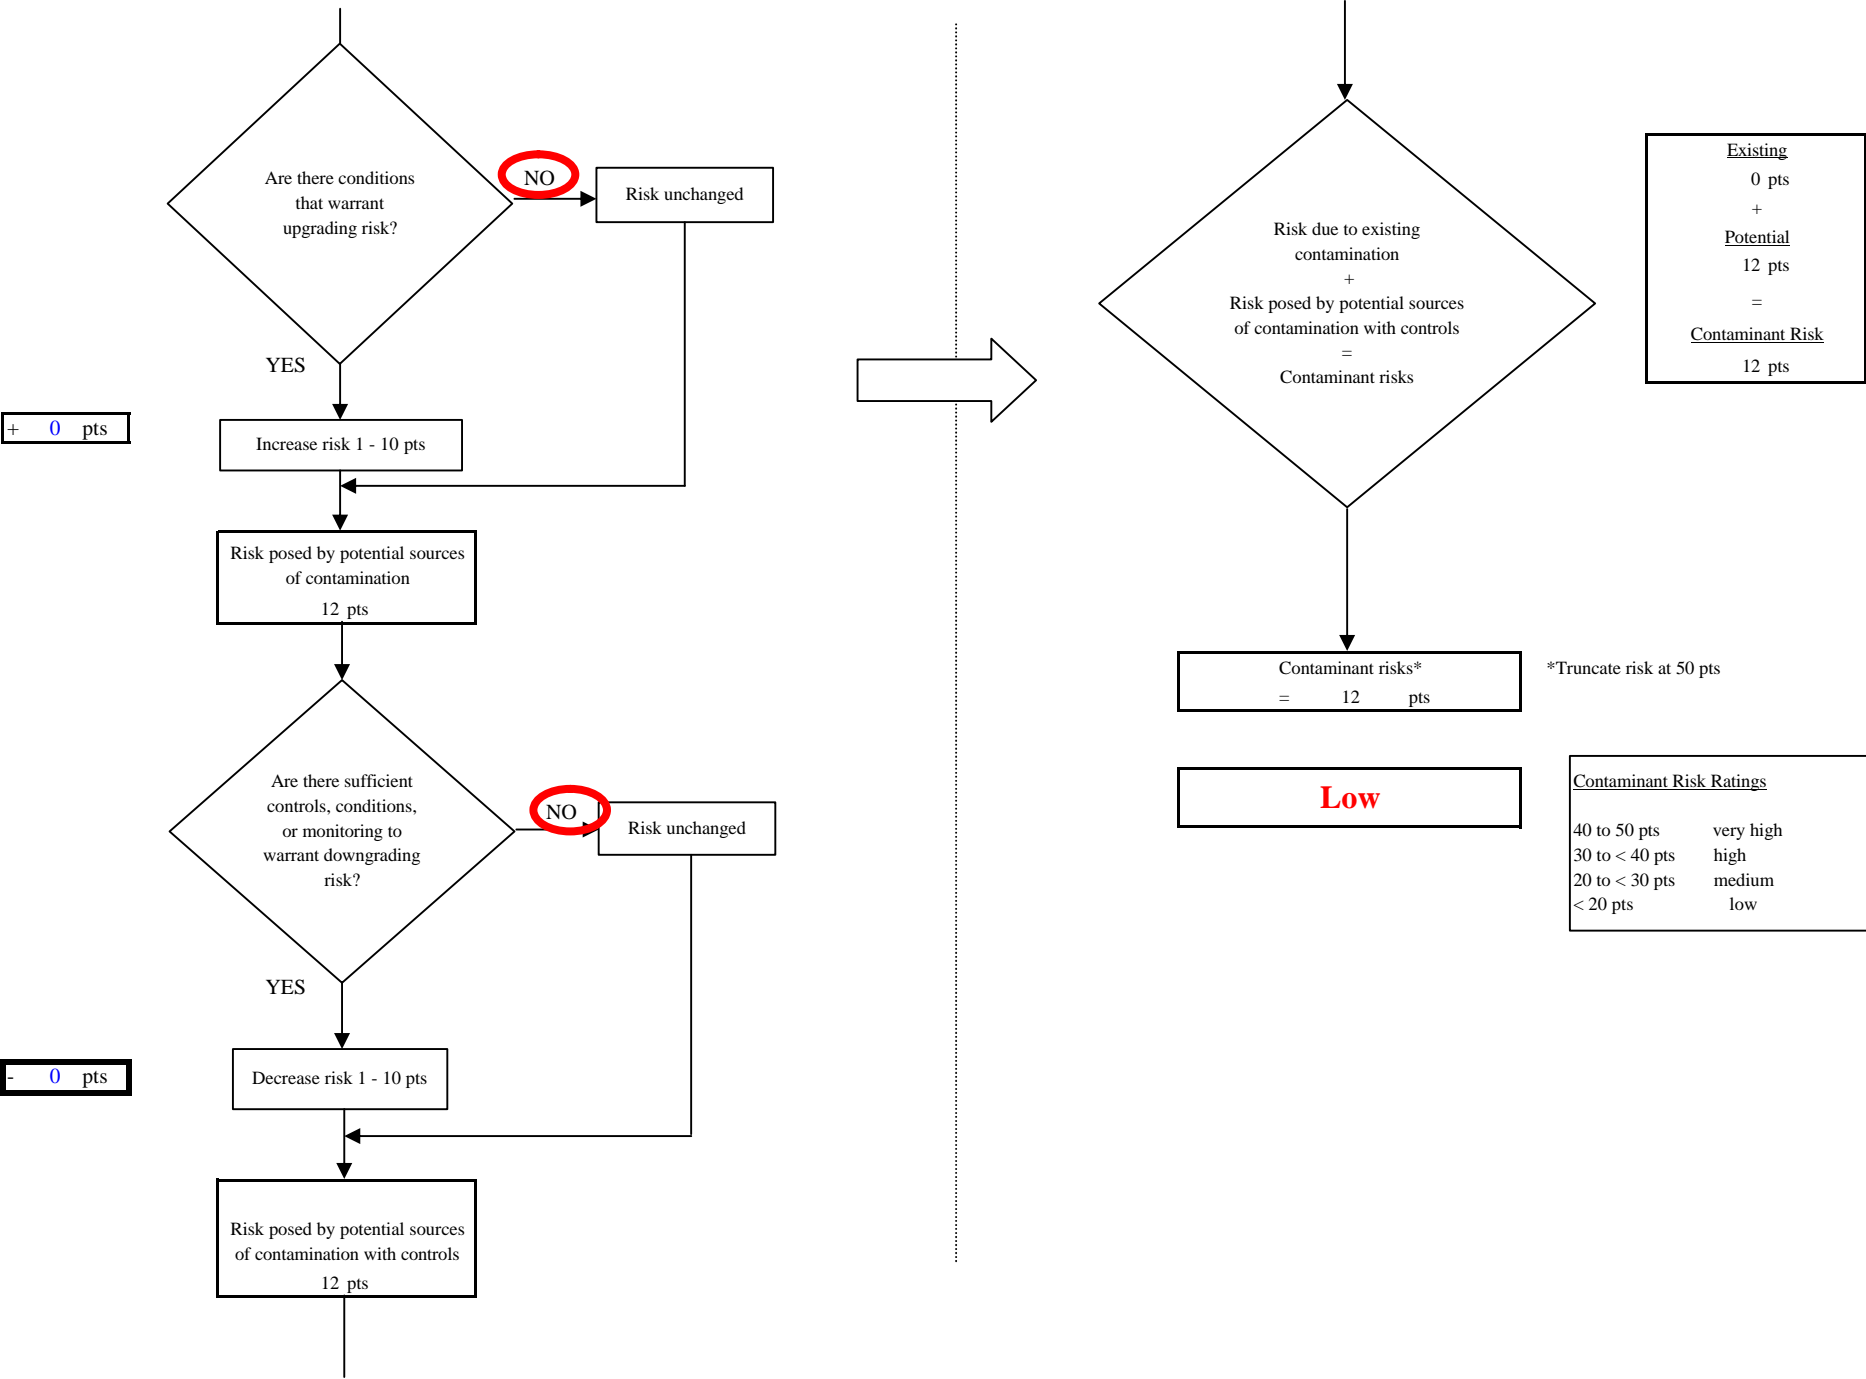
Chart 7. Contaminant risks for Gakona RV Park - Volatile Organic Chemicals

The contaminant risk for volatile organic chemicals is **Low** with laundromats (without dry cleaning); large-capacity septic systems; RV dump stations; aboveground heating oil tanks; paved highways and roads; and campgrounds and RV parks the only known risks for volatile organic chemicals (See Chart 7 – Contaminant Risks for Volatile Organic Chemicals in Appendix D).

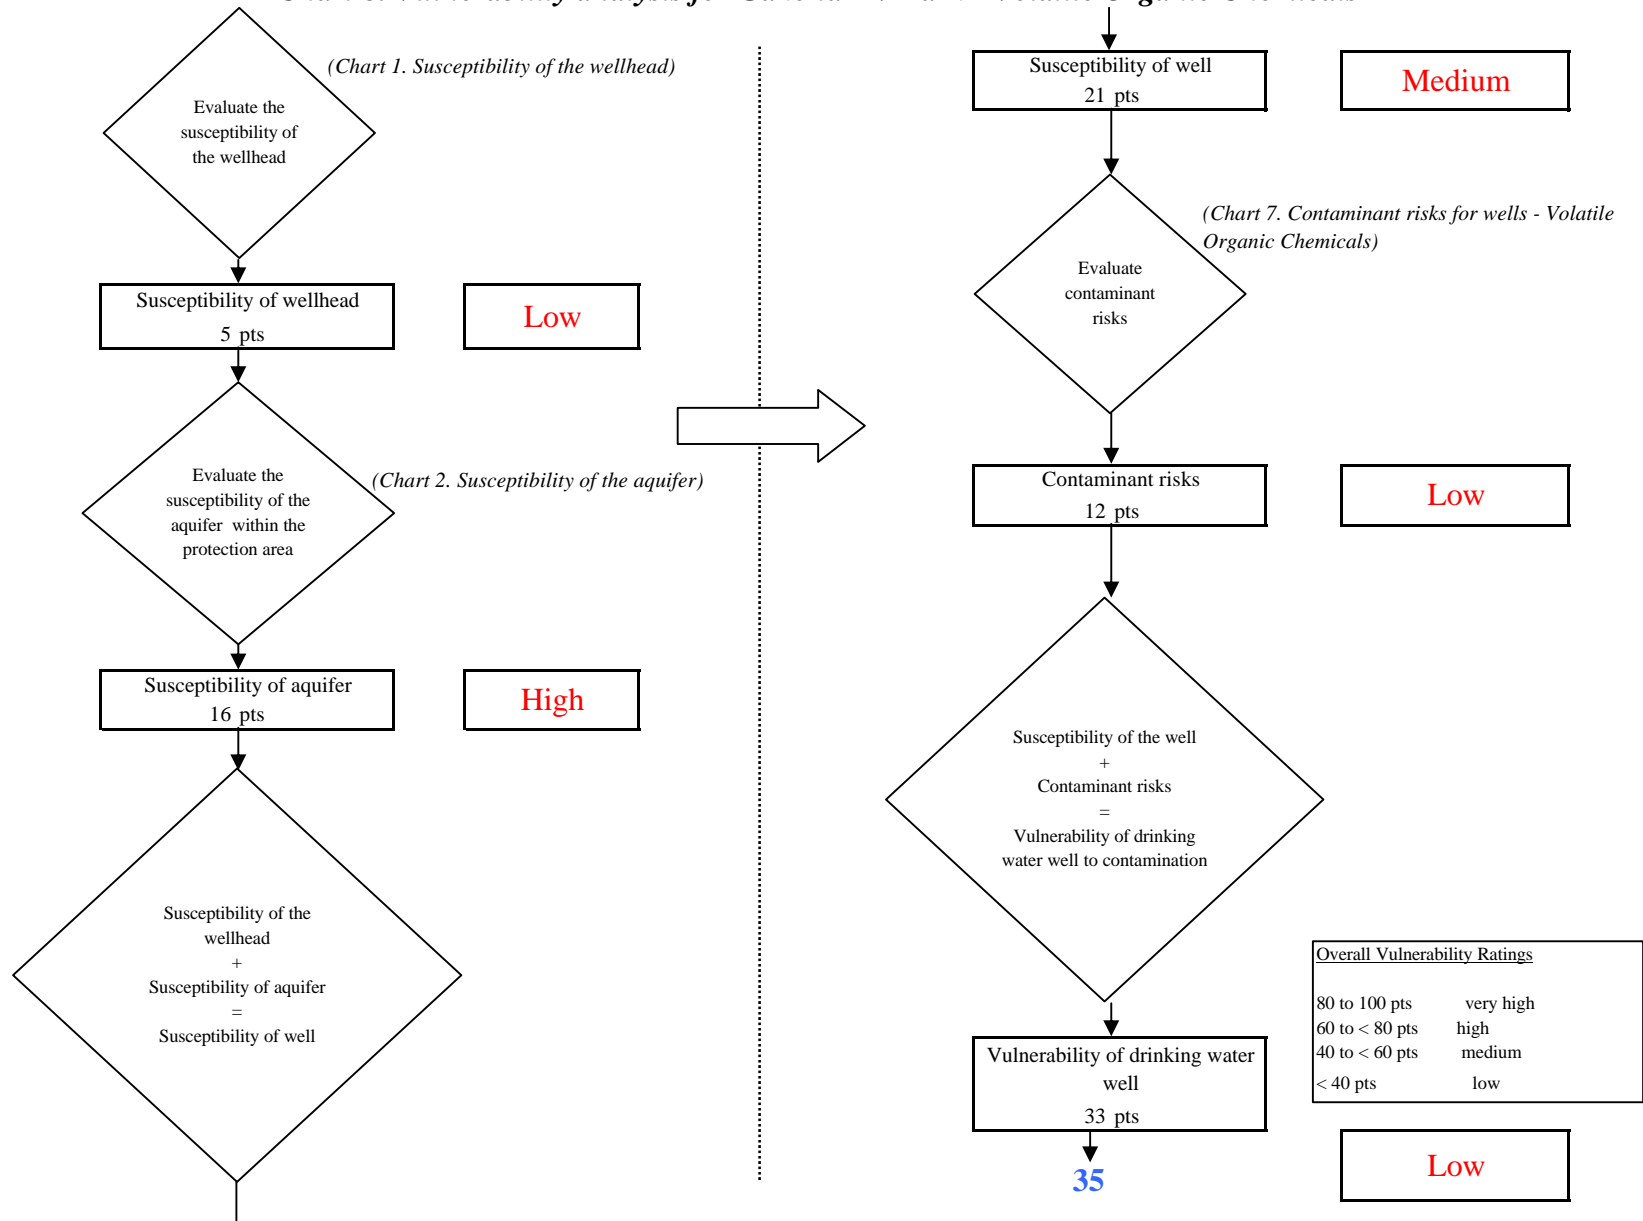
Chart 8. Vulnerability analysis for Gakona RV Park - Volatile Organic Chemicals

Recent sample data for the drinking water at Gakona RV Park indicates that volatile organic chemicals have not been detected in the water. However, after combining the contaminant risk for volatile organic chemicals with the natural susceptibility of the well, the overall vulnerability of the well to contamination by volatile organic chemicals is **Low**.
