Source Water Assessment

A Hydrogeologic Susceptibility and
Vulnerability Assessment for
Tolsona Lake Resort
Drinking Water System,
Glennallen, Alaska
Tolsona Lake Resort # 291368

DRINKING WATER PROTECTION PROGRAM REPORT 257
Alaska Department of Environmental Conservation

AUGUST 2002

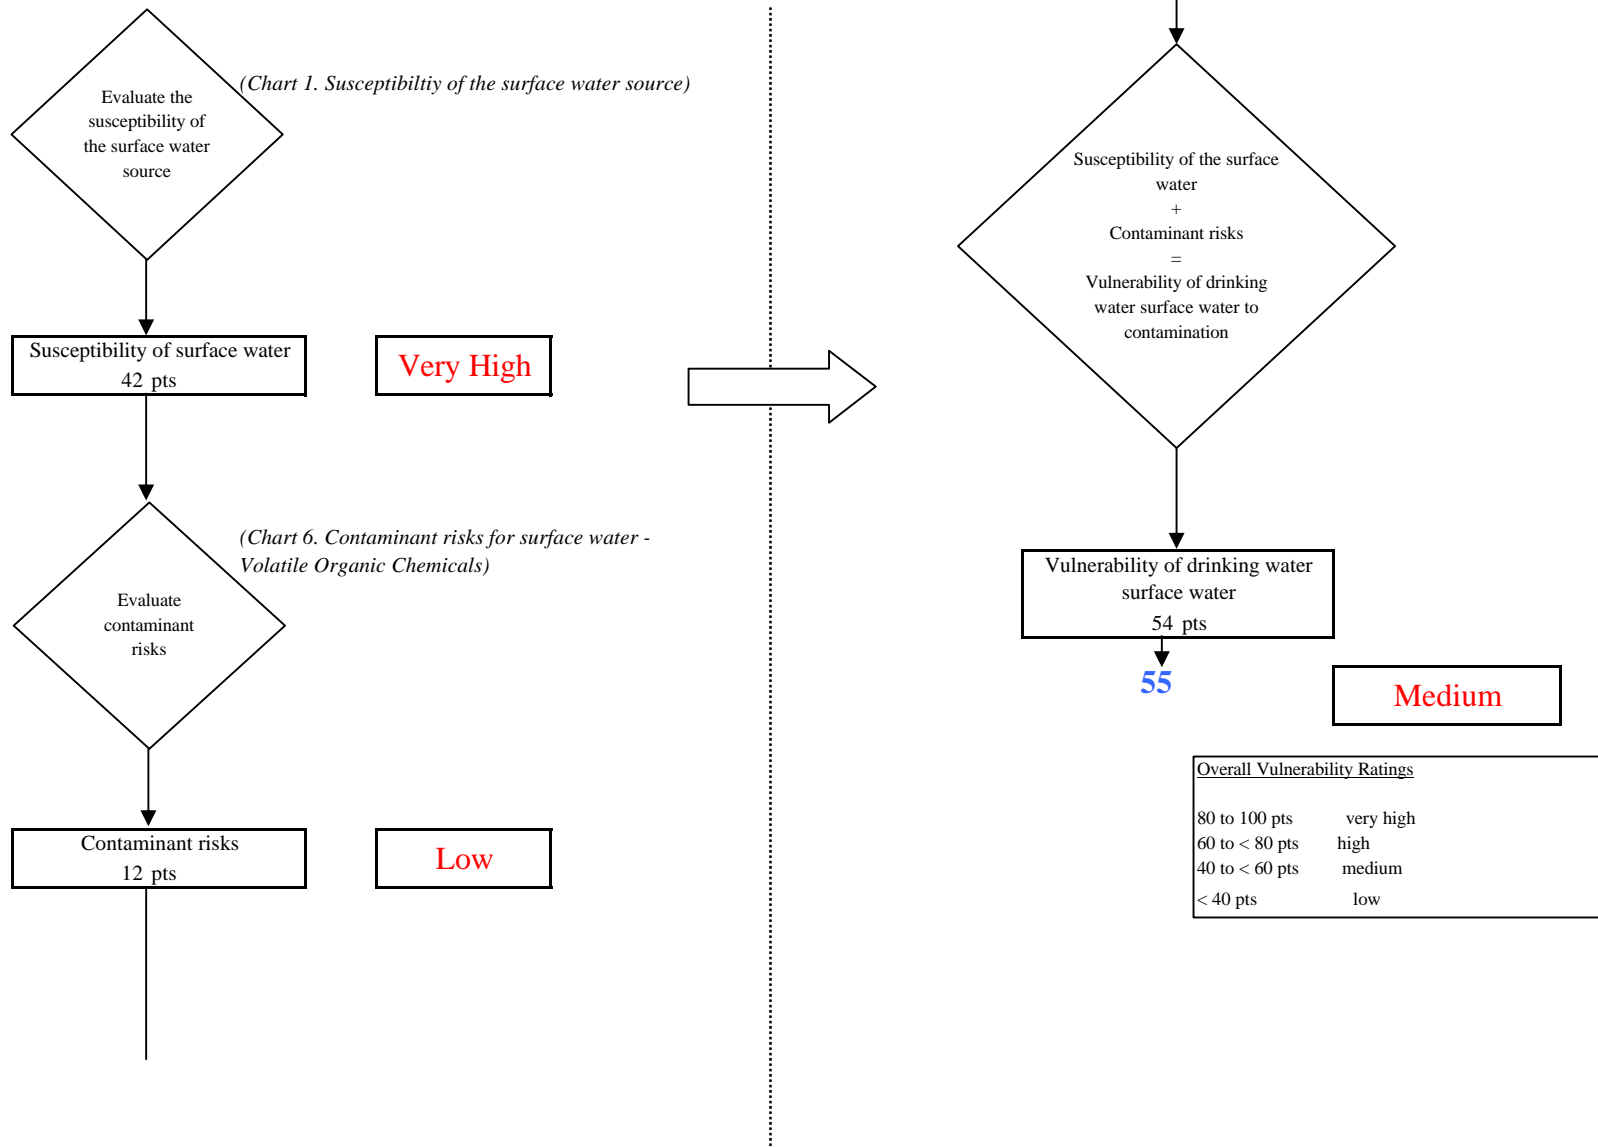
Chart 7. Vulnerability Analysis for Tolsona Lake Resort - Volatile Organic Chemicals
