Source Water Assessment

A Hydrogeologic Susceptibility and
Vulnerability Assessment for
Long Rifle Lodge
Drinking Water System,
Chickaloon, Alaska
Long Rifle Lodge # 226290

By Shannon & Wilson, Inc.

DRINKING WATER PROTECTION PROGRAM REPORT 247

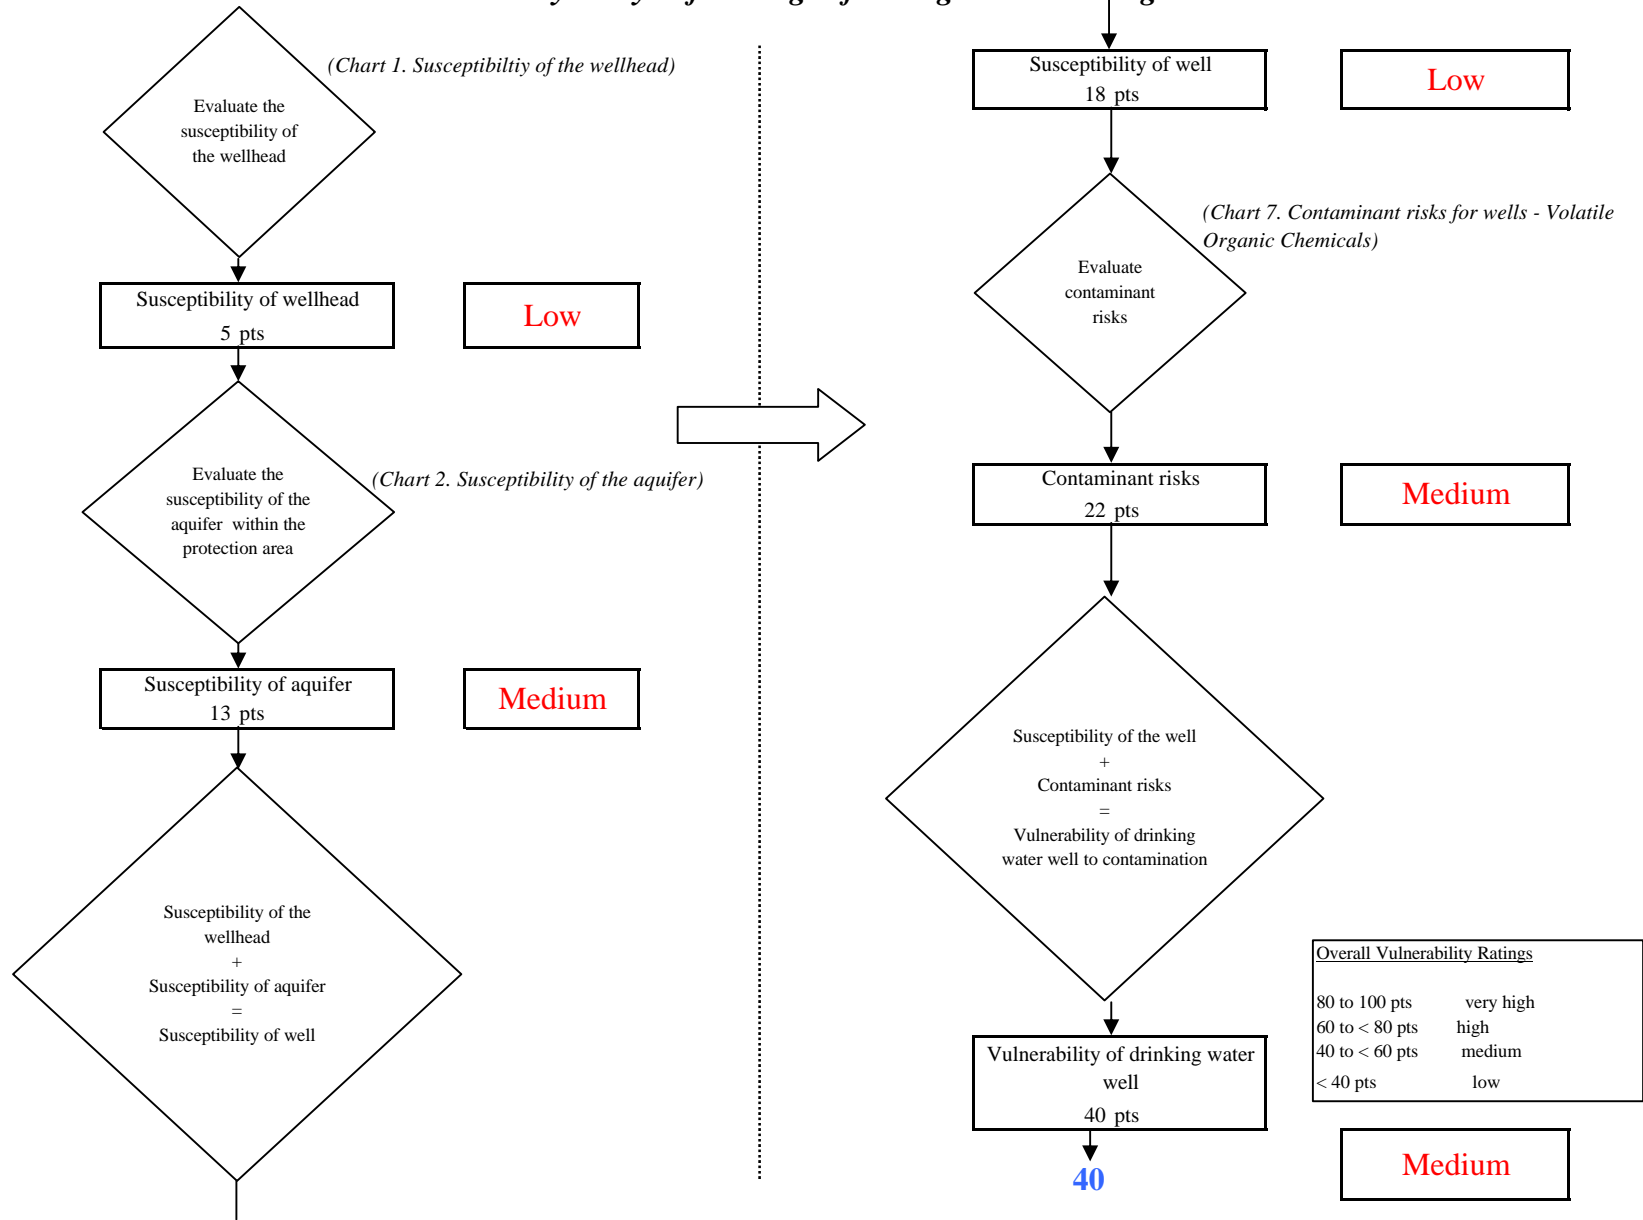
Chart 8. Vulnerability analysis for Long Rifle Lodge - Volatile Organic Chemicals
