Hydrogeologic Susceptibility and Vulnerability Assessment for  
Mid Valley Senior Center Drinking Water Well, Houston, Alaska

DRINKING WATER PROTECTION PROGRAM REPORT 83

By Shannon & Wilson, Inc.

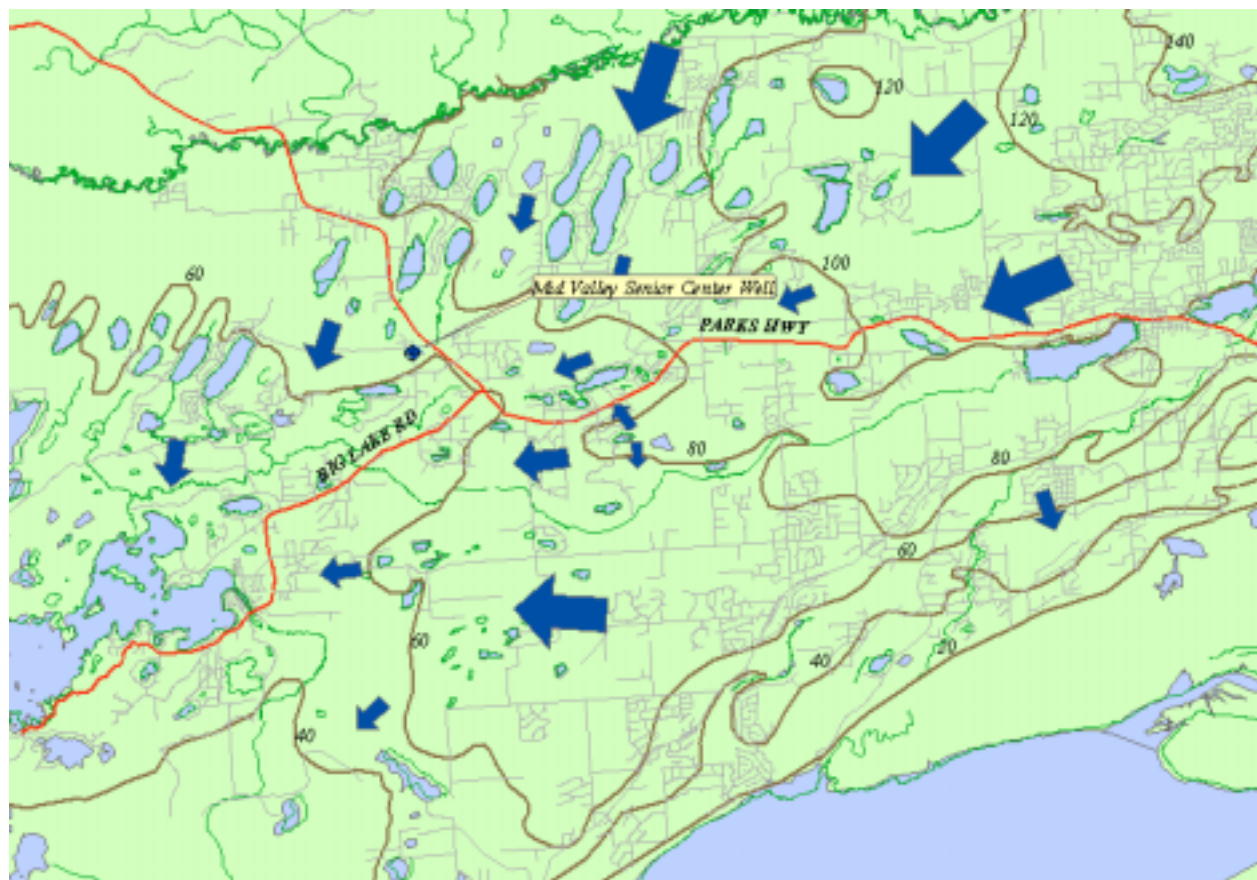
**Figure 2. Map showing regional ground-water flow in Matanuska-Susitna Valley. (Jokela, Munter and Evans, 1991)**

Groundwater flow in the confined aquifer is generally, north to south in the central region of the valley, toward the Matanuska River in the eastern region and the slope is predominantly northeast to northwest in the western region. The direction of groundwater flow in the upper unconfined aquifer's are more variable due to the influence from surficial topography as well as its close connection with surface water bodies. (*Jokela, Munter and Evans, 1991*) (Figure 2).
