Source Water Assessment

Blue Grouse Inn

Drinking Water System,

Kenai, Alaska

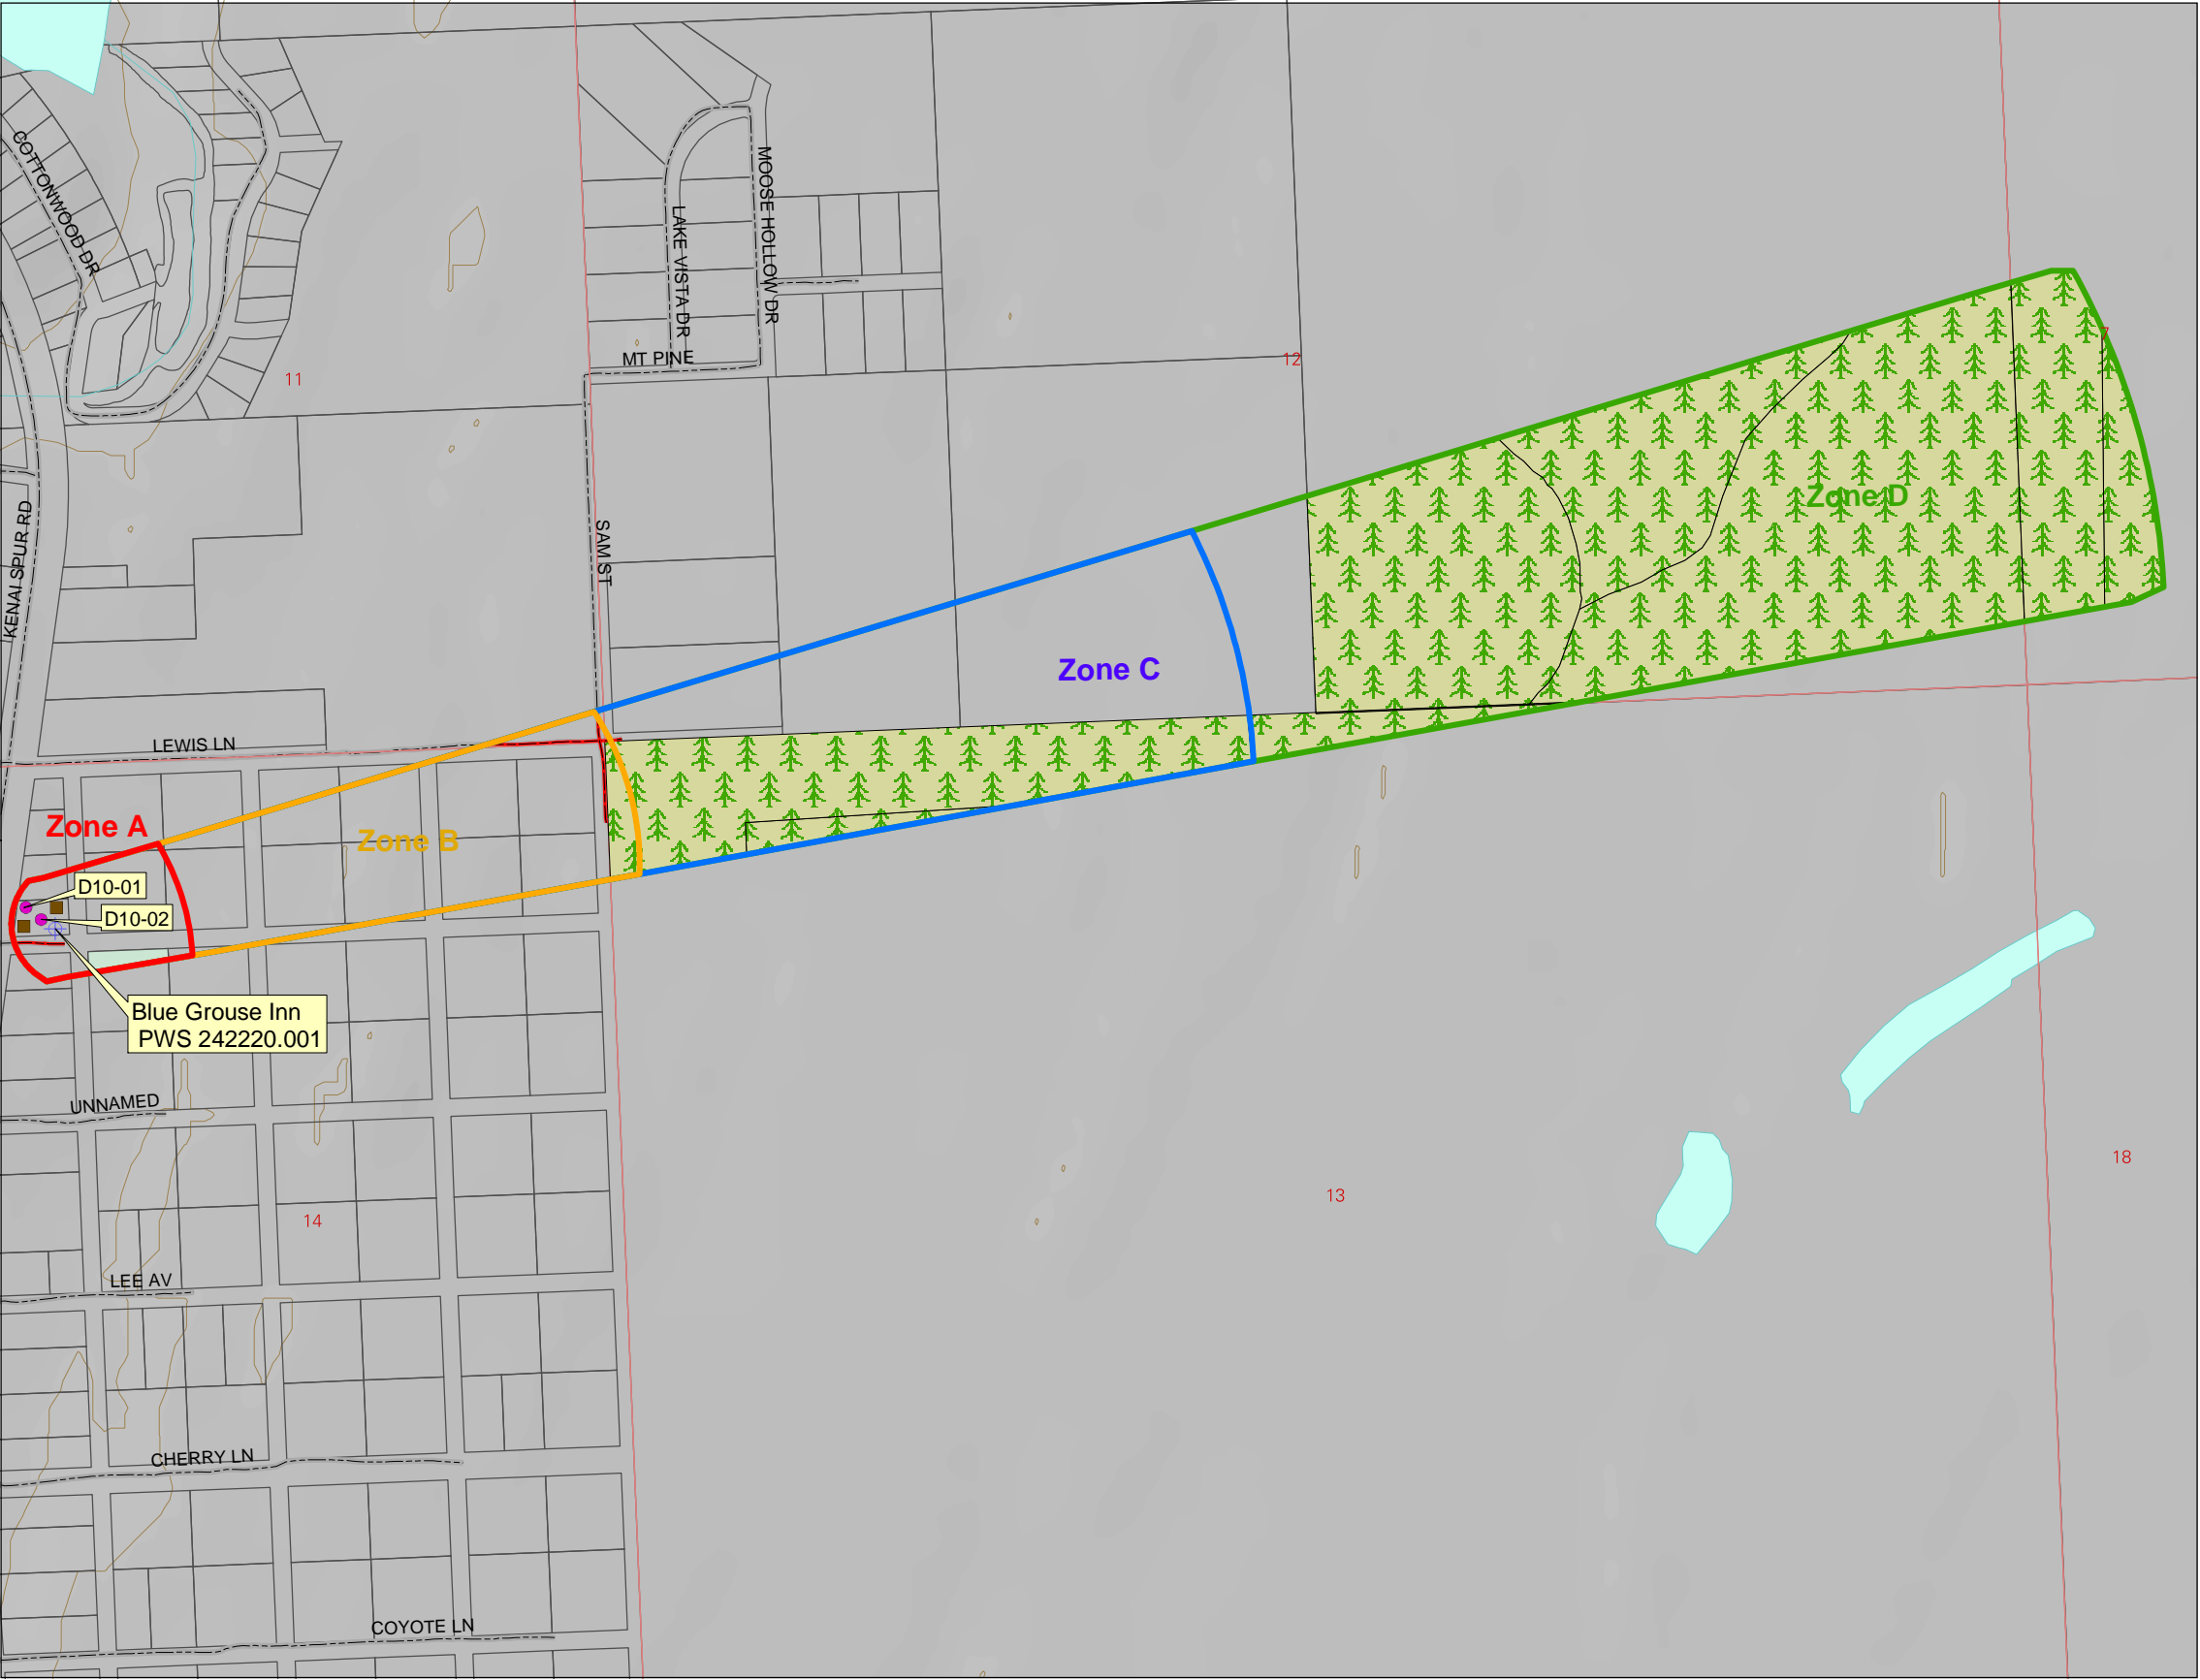
Appendix C Map 1

Drinking Water Protection Areas for the Public Water Well System for PWS #242220.001 Blue Grouse Inn
Showing Potential and Existing Sources of Contamination

The sources are displayed on Map 1 of Appendix C and summarized in Table 1 of Appendix B.

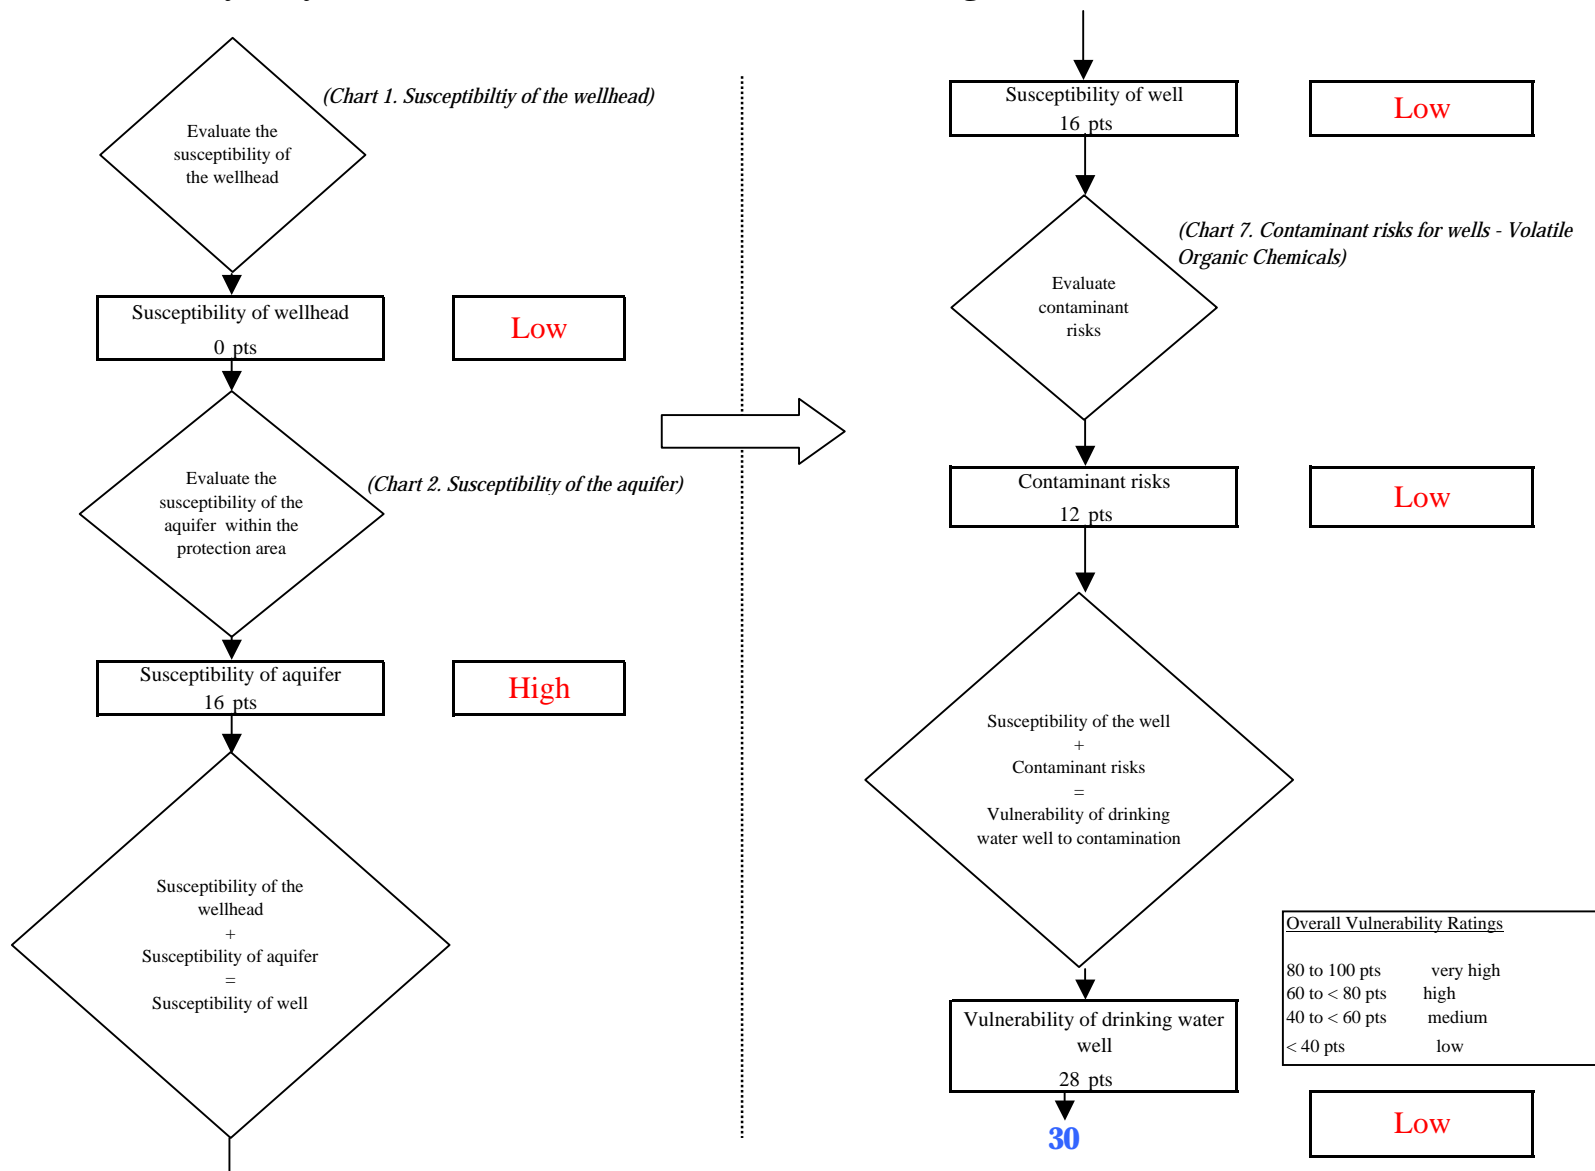
Chart 8. Vulnerability analysis for Blue Grouse Inn (242220.001) - Volatile Organic Chemicals

The drinking water at Blue Grouse Inn has not been sampled for volatile organic chemicals. After combining the contaminant risk for volatile organic chemicals with the natural susceptibility of the well, the overall vulnerability of the well to contamination is **Low**.
