Source Water Assessment

A Hydrogeologic Susceptibility and Vulnerability Assessment for LDS Salcha Chapel Public Drinking Water System, Salcha, Alaska PWSID # 372407.001

DRINKING WATER PROTECTION REPORT 1818

February, 2009

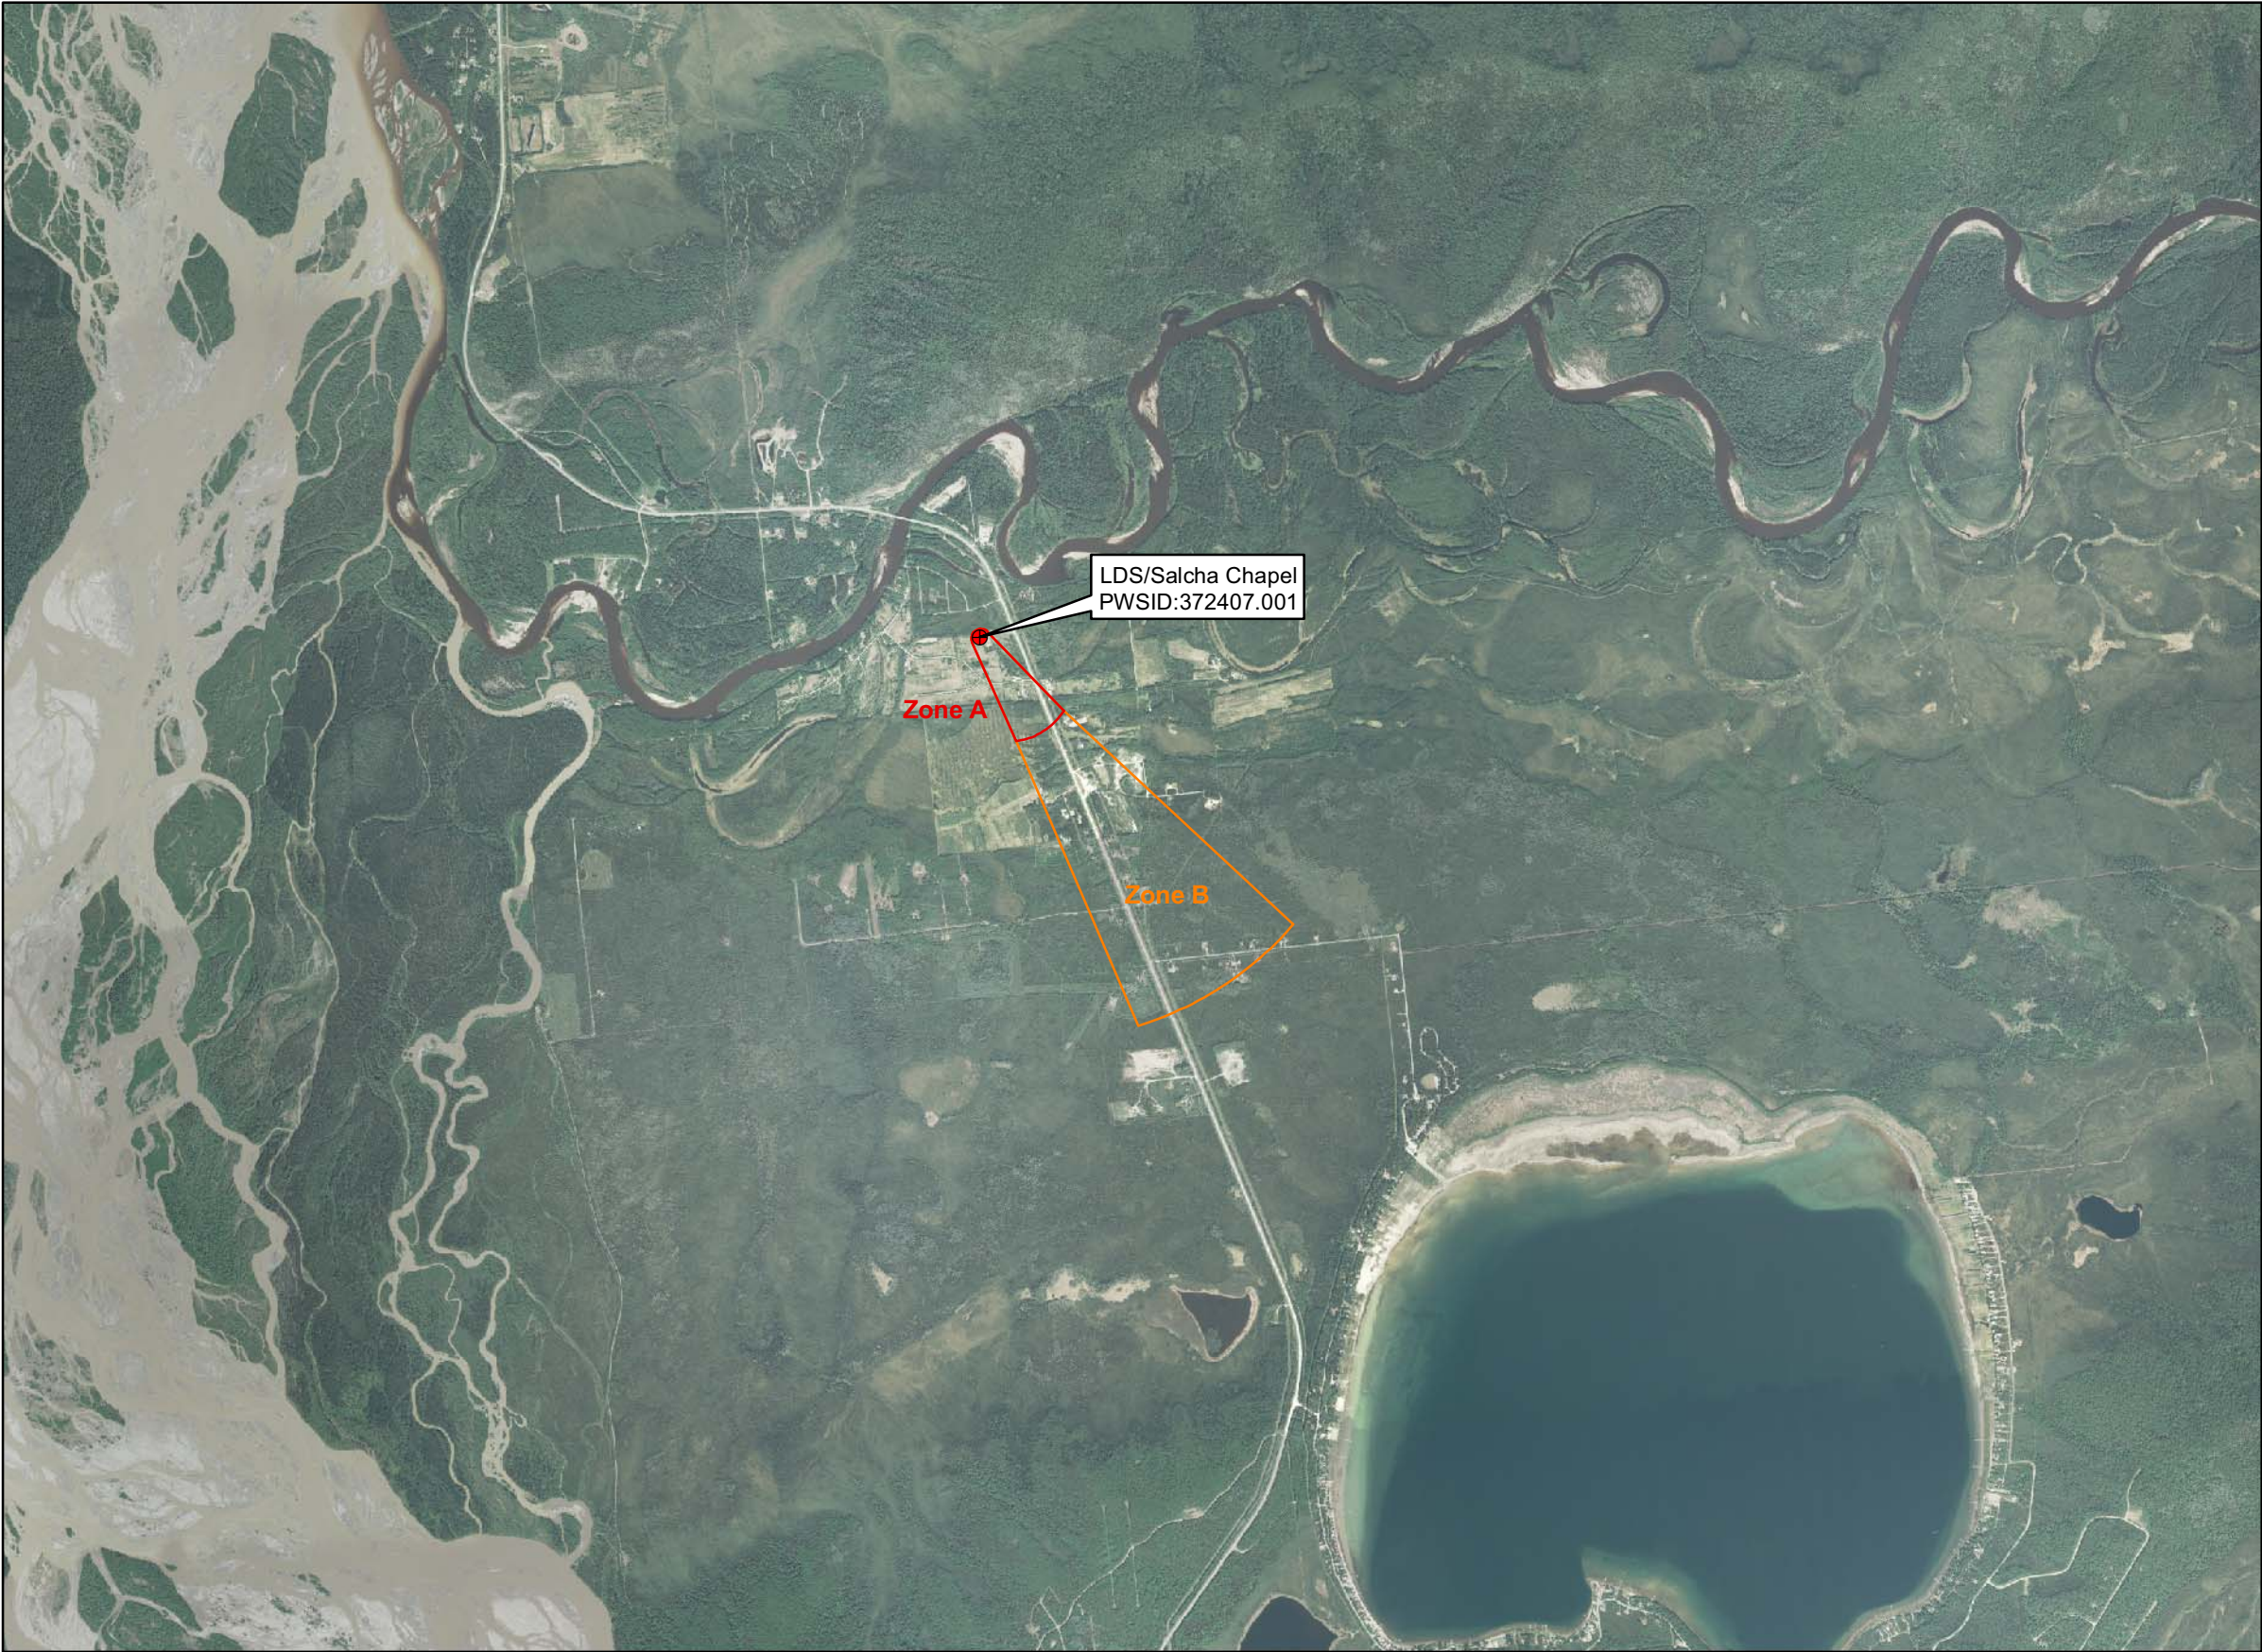
Appendix A Map A

The LDS Salcha Chapel public water system is a Class B (transient/non-community) water system. The system consists of one well located on the Richardson Highway in Salcha, Alaska (see Map A in Appendix A). Salcha is located 33 miles southeast of Fairbanks on the Richardson Highway and is within the Fairbanks North Star Borough. Average temperatures range from -19 to -2 degrees Fahrenheit in January and from 49 to 71 degrees Fahrenheit in July. The area receives 11.5 inches of precipitation annually, including 67.8 inches of snowfall (ADCCED, 2009).

The Drinking Water Protection Area for LDS Salcha Chapel was determined using an analytical calculation and includes Zones A and B (see Map A in Appendix A).

Public Water Well System for PWS #372407.001 LDS/Salcha Chapel
