Source Water Assessment

A Hydrogeologic Susceptibility and
Vulnerability Assessment for
Bird Creek Campground
Drinking Water System,
Turnagain Arm, Alaska
PWSID # 211261.001

By URS Corporation

DRINKING WATER PROTECTION PROGRAM REPORT # 328

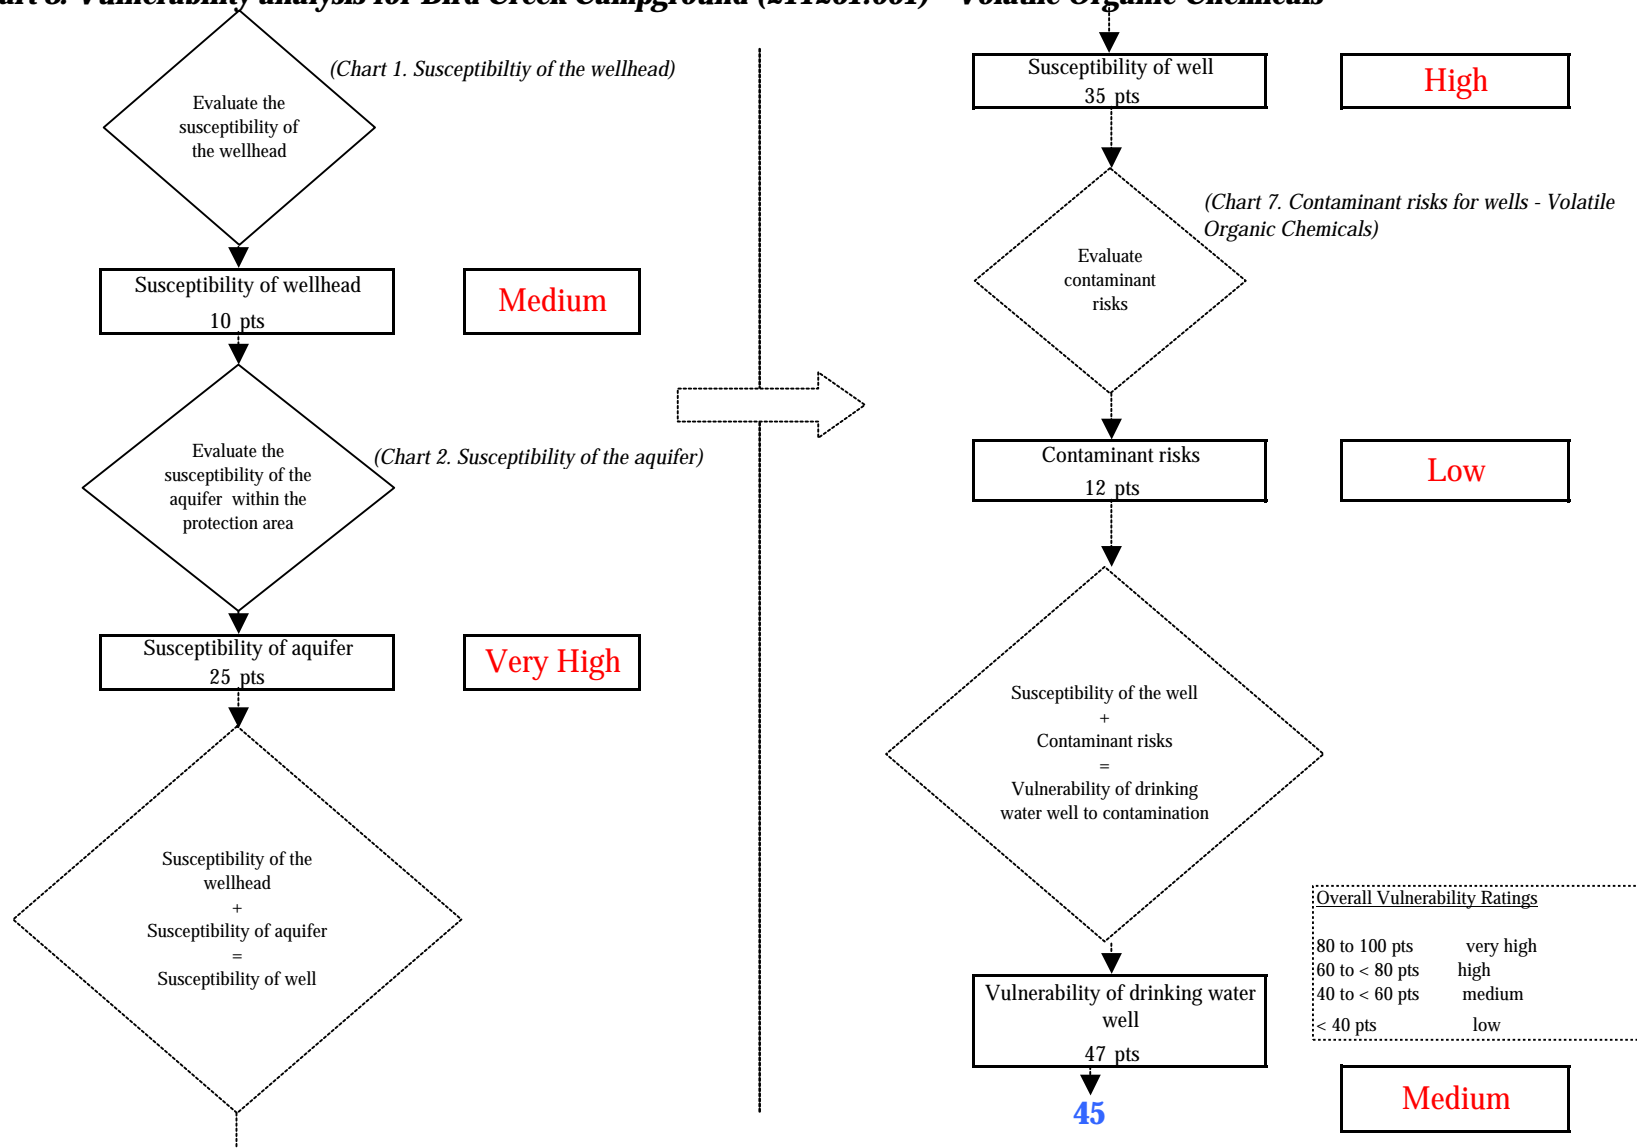
Chart 8. Vulnerability analysis for Bird Creek Campground (211261.001) - Volatile Organic Chemicals

Appendix D contains eight charts, which together form the ‘Vulnerability Analysis’ for a source water assessment for a public drinking water source. Chart 1 analyzes the ‘Susceptibility of the Wellhead’ to contamination by looking at the construction of the well and its surrounding area. Chart 2 analyzes the ‘Susceptibility of the Aquifer’ to contamination by looking at the naturally occurring attributes of the water source and influences on the groundwater system that might lead to contamination. Chart 3 analyzes ‘Contaminant Risks’ for the drinking water source with respect to bacteria and viruses. The ‘Contaminant Risks’ portion of the analysis considers potential sources of contaminants as well as a review of contamination that has or may have occurred, but has not arrived or been detected at the well. Lastly, Chart 4 contains the ‘Vulnerability Analysis for Bacteria and Viruses’. Charts 5 through 8 contain the Contaminant Risks and Vulnerability Analyses for nitrates and nitrites and volatile organic chemicals, respectively.
