River Flood Plains: Some Observations On Their Formation

GEOLOGICAL SURVEY PROFESSIONAL PAPER 282-C

By M. GORDON WOLMAN *and* LUNA B. LEOPOLD

PHYSIOGRAPHIC AND HYDRAULIC STUDIES OF RIVERS

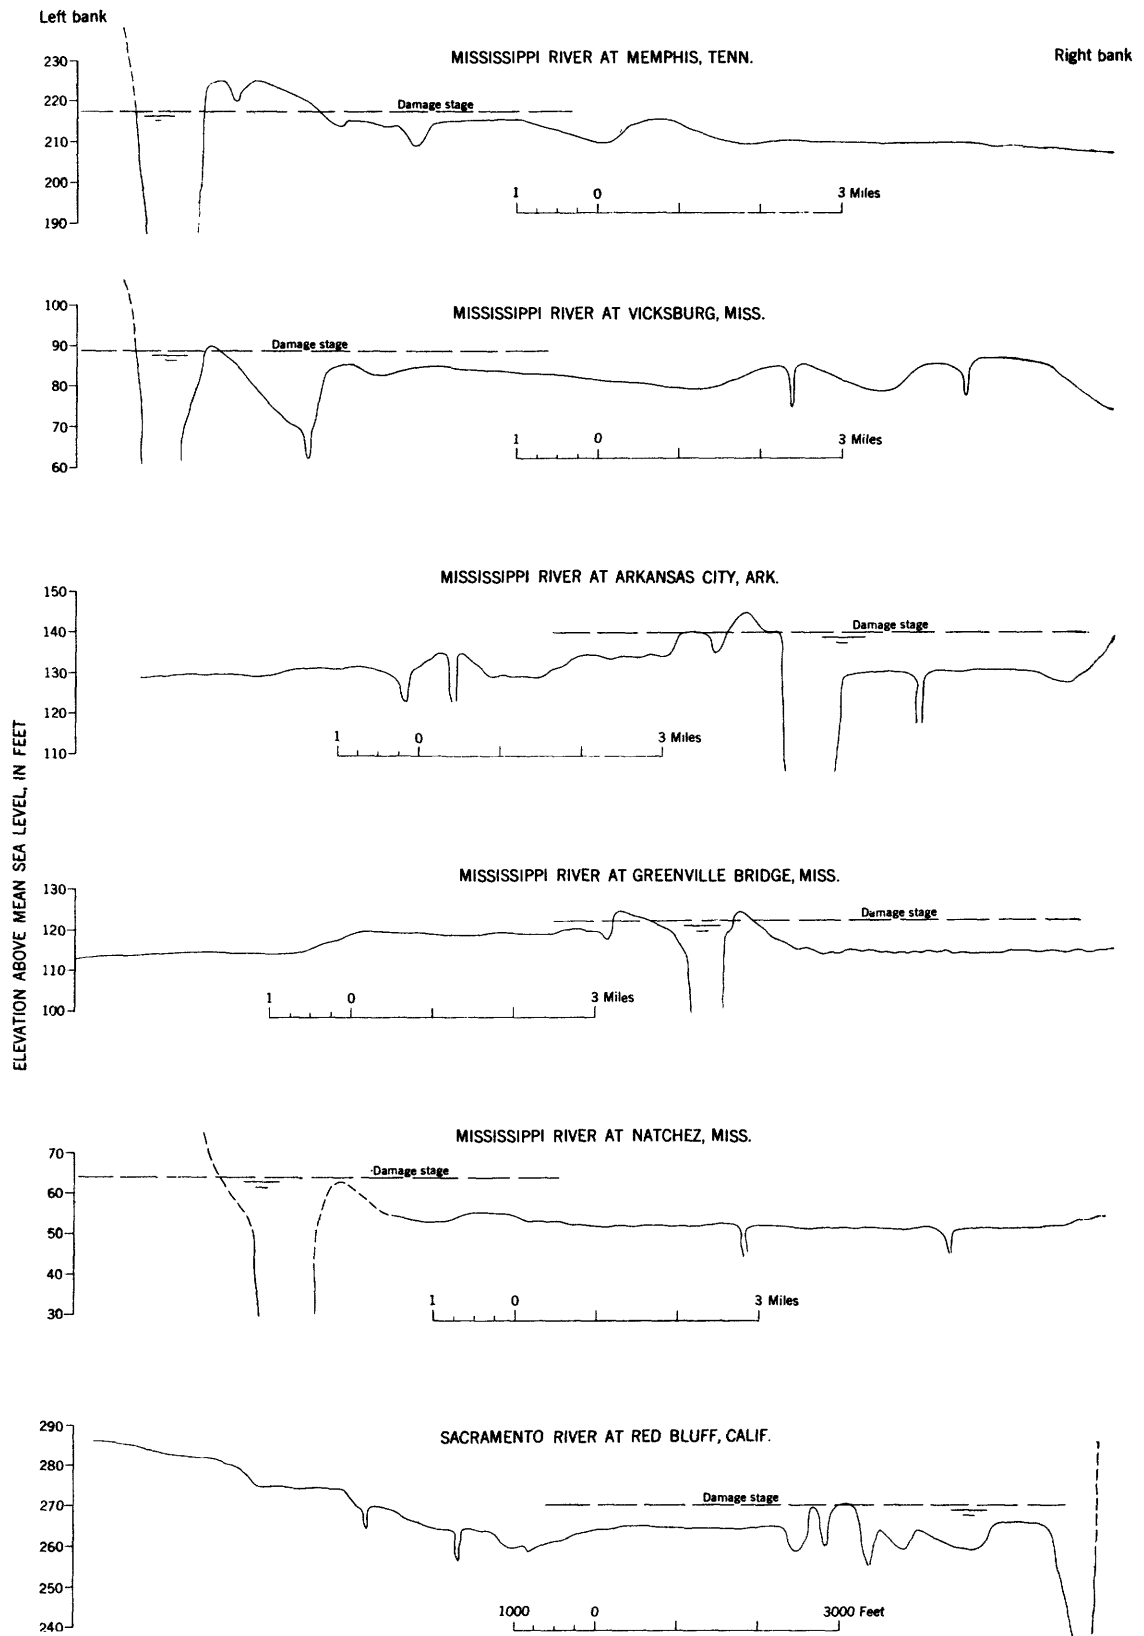
FIGURE 58.—Relation of flood-damage stage to elevation of flood plain at several river cross sections.

In order to establish the relation between the elevation of the flood-damage stage and the mean elevation of the flood plain, an effort has been made to compare the two at a number of cross sections for which data are available. These stations are listed in table 3. The flood-damage stage was obtained from records of the Corps of Engineers (1952) on the Mississippi River and of the Weather Bureau (1941). The mean height of the flood plain at each cross section was determined from profiles drawn from topographic maps having 5-foot contour intervals. Several of these cross sections are shown in figure 58.

The profiles of the Mississippi at Greenville Bridge, Natchez, and at Arkansas City in figure 58, clearly show a difference in elevation between the defined "flood stage" and the mean height of the flood plain. As can be seen on the cross sections, the difference appears to be due to the presence of natural levees adjacent to the river bank which raise the stage at which damage begins. The differences between the two stages are given in table 3. In some cases the damage stage may be equal to or below the elevation of the mean flood plain. In general, however, the damage stage is considerably above the level of the natural flood plain.

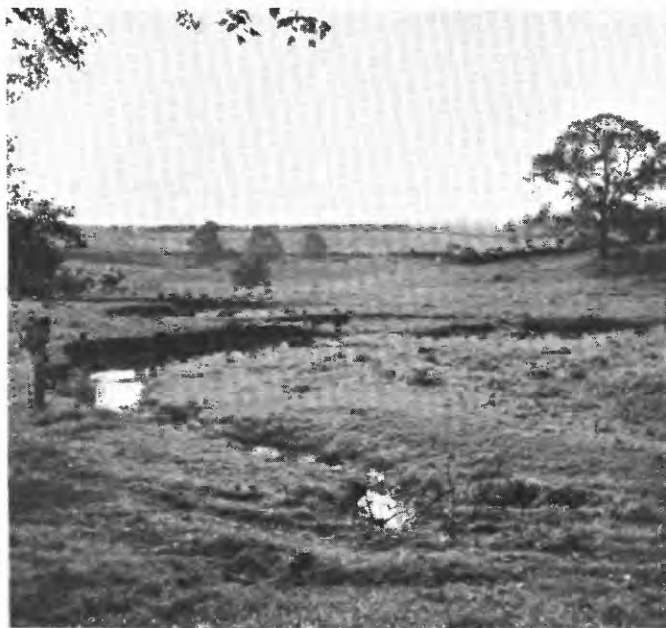
View downstream across the flood plain of Watts Branch near Rockville, Md. Point bar to the right of the channel in middle distance is shown in figure 59.

Figure 59 is a detailed map and plate 1 a photograph of a point bar on a meander of Watts Branch near Rockville, Md. At this point the stream drains about 4 square miles and its flood plain is about 270 feet wide. This flood plain is typical of many rivers in the eastern United States and illustrates the type of deposition and stratigraphy commonly found in this area.

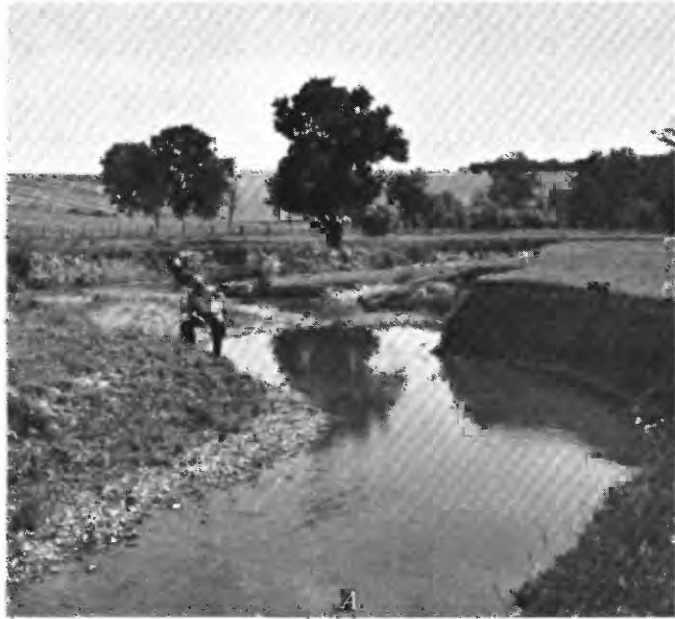
A, Point bar deposits and flood-plain surface adjacent to channel of Seneca Creek near Pratherstown, Md. The surfaces of point bars occur at various elevations up to the general level of the flood-plain surface.

At Watts Branch stations p, m, and n, on the larger of the two point bars in figure 60, are at an elevation very close to that of the flood-plain surface. Plate 2A is a reach of Seneca Creek near Pratherstown, Md., where different point bars composed of a wide variety of material are found to have surface elevations ranging successively from several feet below the flood-plain surface to the height of the surface itself.

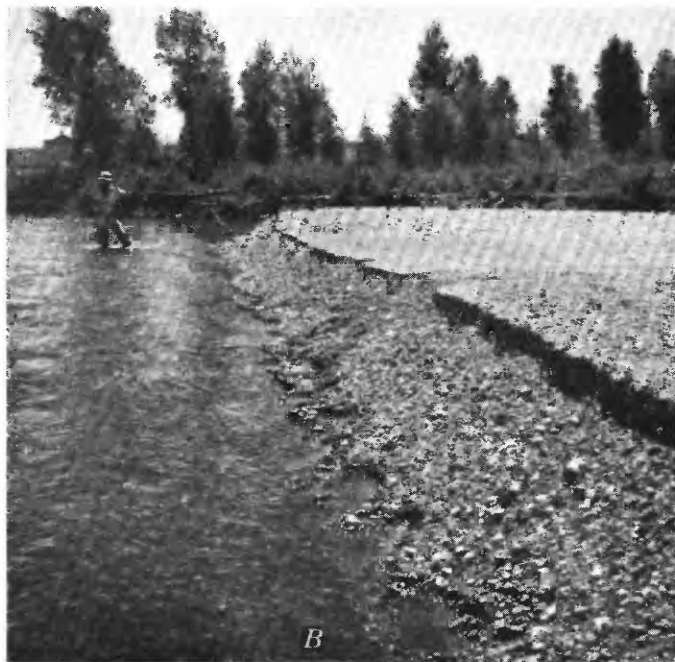
B, Flat-topped gravel bar in the New Fork River, 3 miles below Pinedale, Wyo. This bar occupies a position near the center of the channel of a braided river and emerges as an island at low flow. Bar surface is at same elevation as wooded flood plain seen in background.

Plate 2B shows a gravel bar deposited in the New Fork River near Pinedale, Wyo. This exceedingly flat-topped bar has a composition identical to that found in the flood plain which borders the stream in this reach. Furthermore, its surface is at the same level as the adjacent flood plain. Laboratory observations (Leopold and Wolman, 1957) suggest that such a bar develops by deposition within the channel, often as a linear deposit roughly along the center-line of the channel. As the upper surface of the submerged bar builds up near the water surface, the flat top is developed as a result of planation by currents and eddies when the depth of flow over the bar becomes relatively small. This same accordance of level and similarity of composition of bar and flood plain are also found on the Popo Agie River near Hudson, Wyo. The flood plains of these streams appear to be composed of coalescent bars each deposited originally within the stream channel. Overflow across these coalescent bars tends to leave a veneer of fine material on the gravel surface. This veneer, however, makes up a very small part of the total flood plain. In our study of point bars on Little Pipe Creek near Avondale, Md., the intimate relation between what is clearly a point bar and the level flood-plain surface was shown by a gravel lens that was continuous from the point bar into the adjacent flood plain.

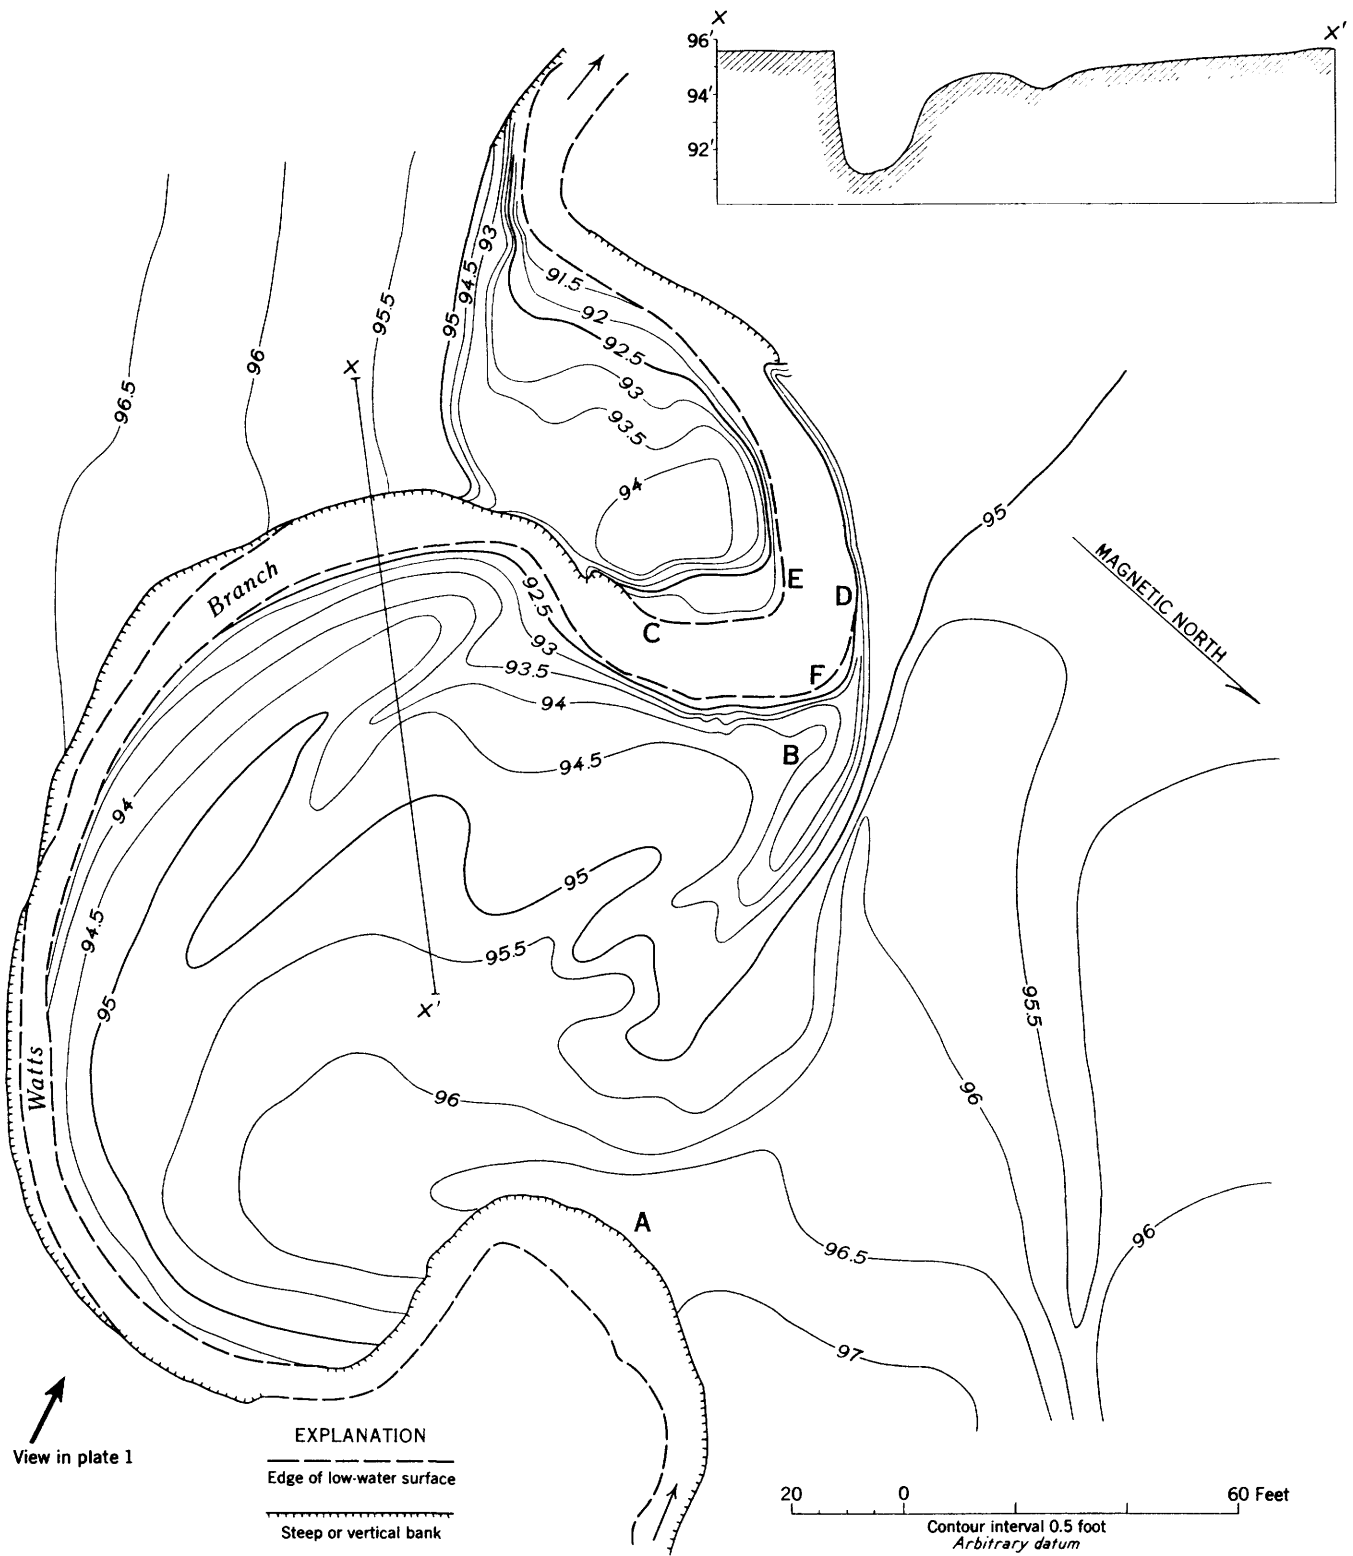
FIGURE 59.—Map and cross section of a typical point bar of the flood plain of Watts Branch, 1 mile northwest of Rockville, Md.

The map of Watts Branch presented in figure 59 might alone suggest that the surface of the point bar is generally lower than the overall flood plain. Our field observations on many rivers lead us to conclude that the point bar is actually built up to the level of the flood plain; that is, the so-called lateral deposit can be found at all elevations from the water surface to the flood-plain surface. The distinction between overbank and lateral deposits becomes quite vague at stages of flow during which water covers the entire point bar. Overbank flow, as used in this study, refers to stages above the level of the cut bank of the existing flood plain.

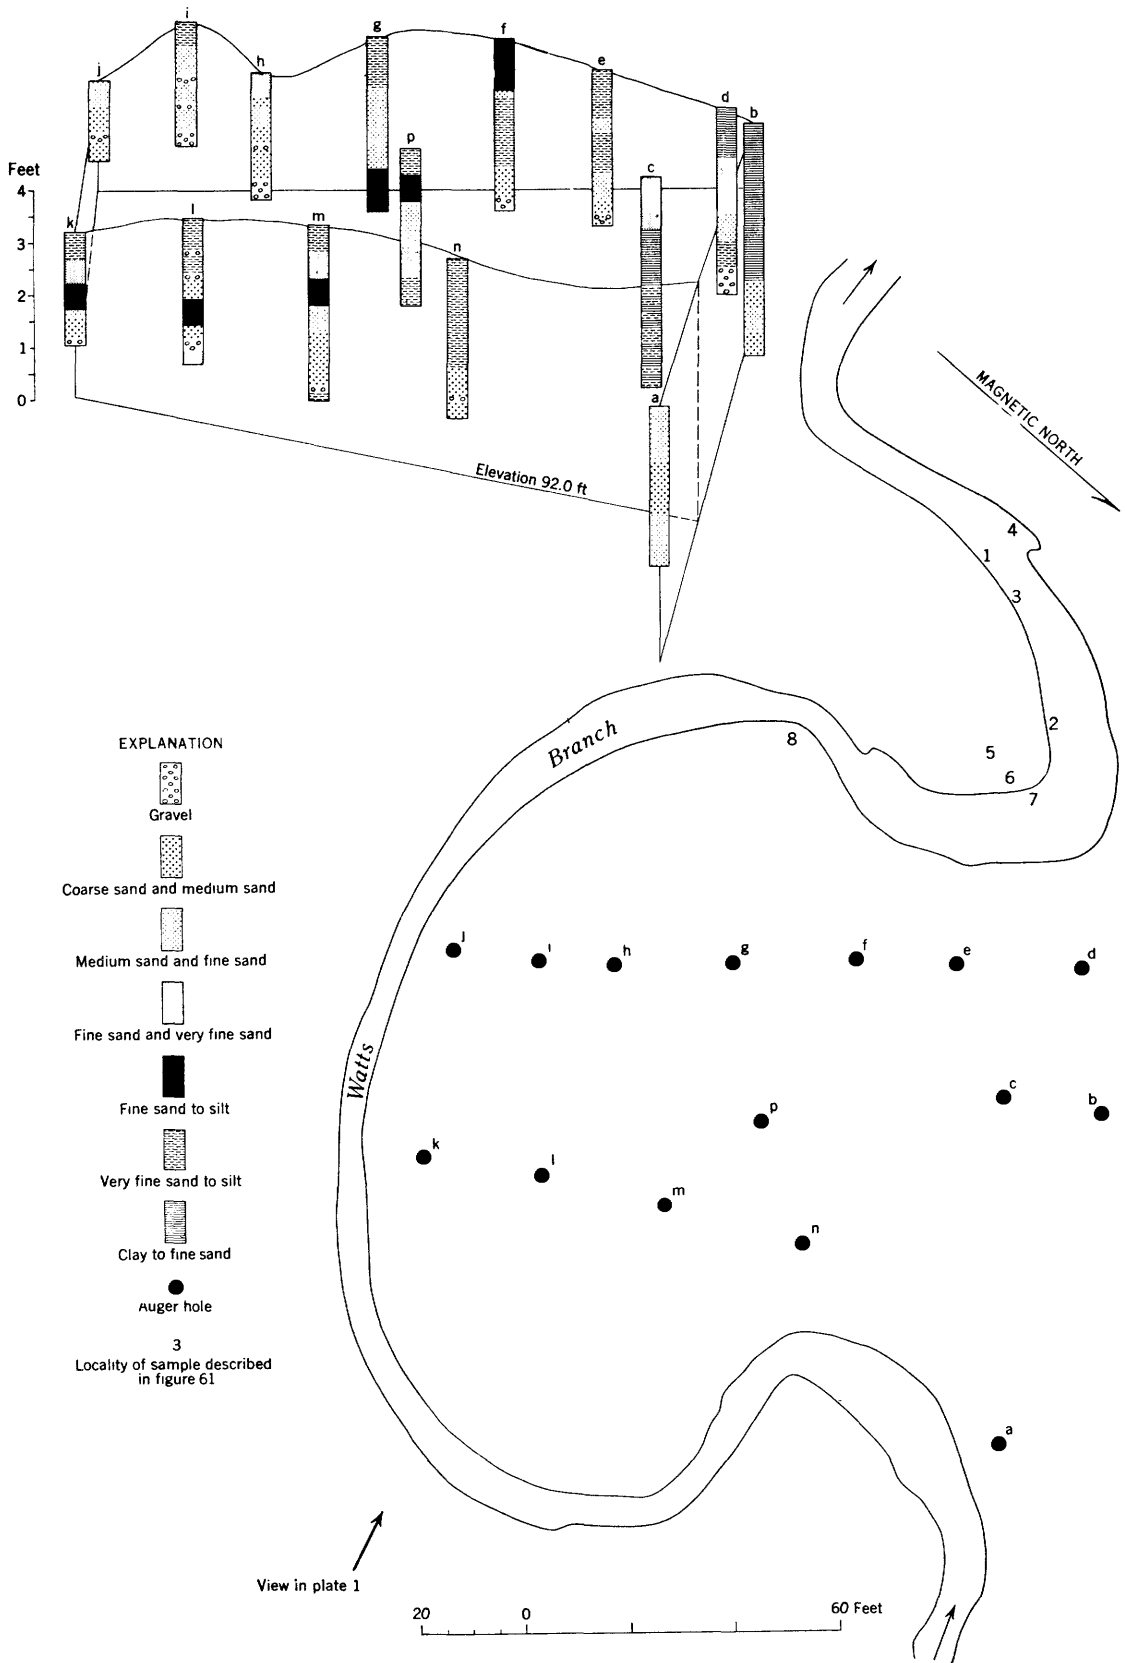
FIGURE 60.—Distribution of materials making up point bar in flood plain of Watts Branch near Rockville, Md. Map and photograph of this location appear in figure 59 and plate 1.

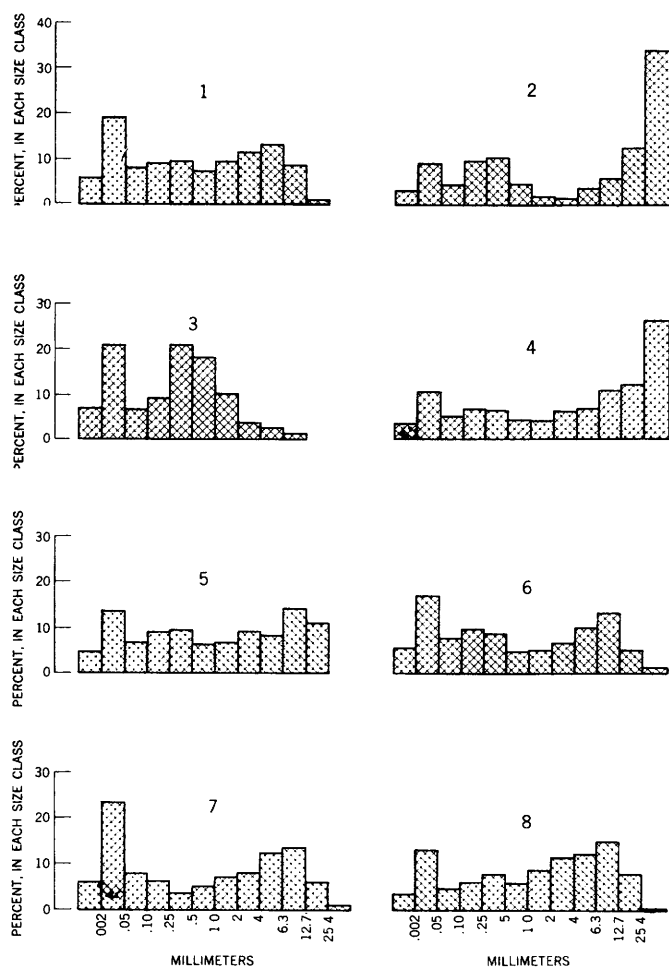
FIGURE 61.—Size distribution of samples from bed of Watts Branch, Rockville, Md. and from adjacent surface near stream margin. Localities of samples shown in figure 60.

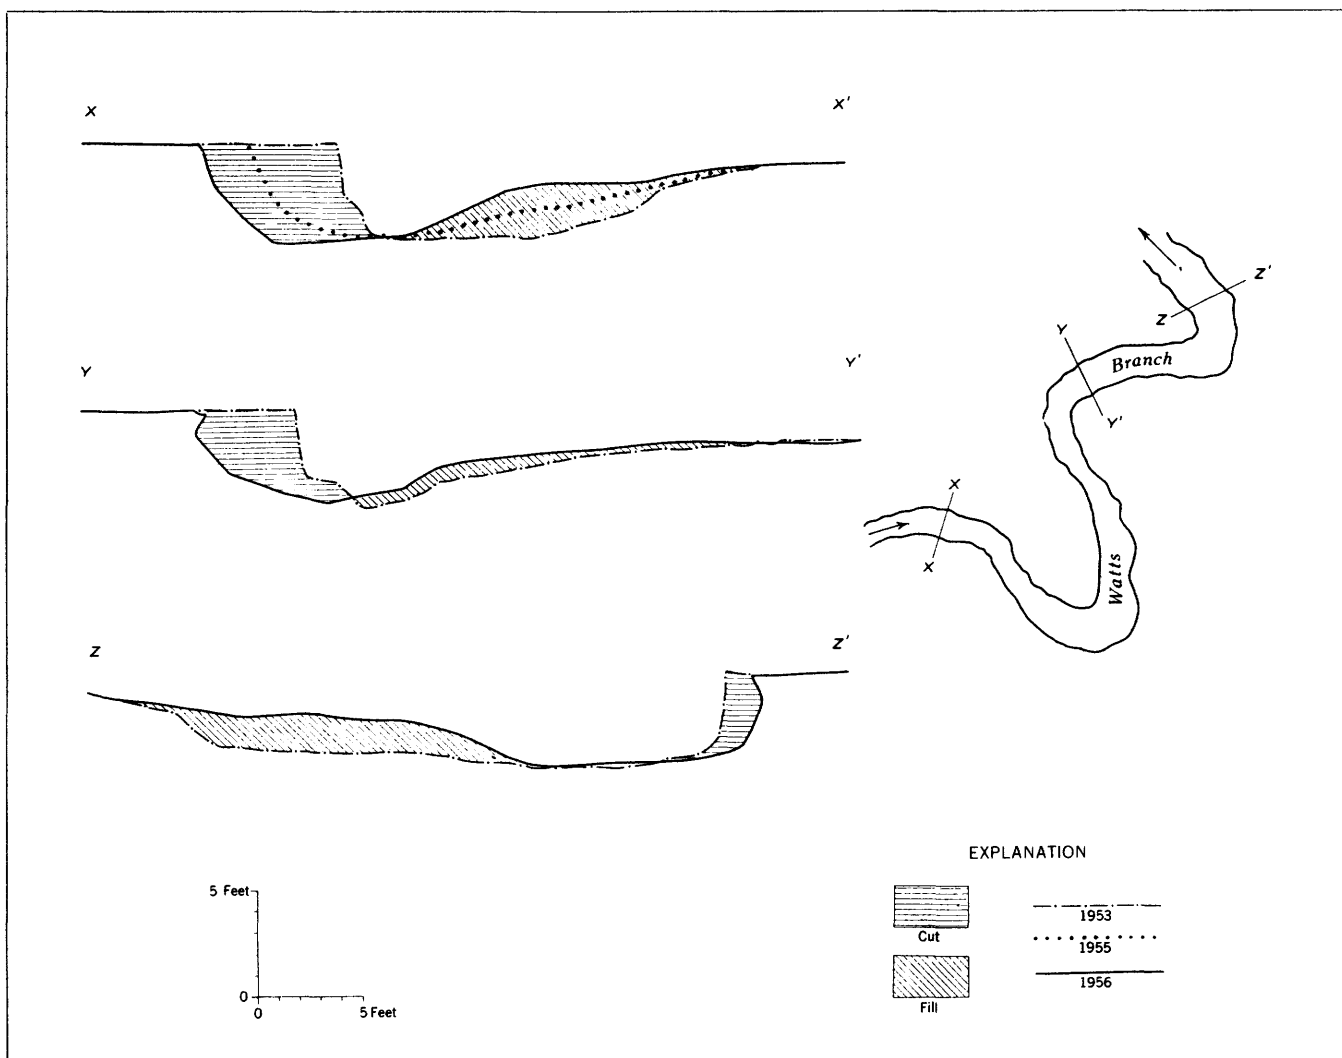
FIGURE 62.—Progressive erosion and deposition in measured cross sections of Watts Branch near Rockville, Md., from 1953 to 1956.

During 3 years of observation and measurement of this point bar on Watts Branch, we have recorded as much as 6 feet of lateral movement of the channel. Cross sections presented in figure 62 show that erosion of the steep or outside bank was accompanied by deposition on the opposite point bar. At cross section *X-X'* the amount of material deposited is roughly equivalent to the amount eroded. At *Y-Y'* erosion has exceeded deposition, while further downstream at *Z-Z'* during the period of observation deposition has exceeded erosion. We would not expect precise equivalence of erosion and deposition at an individual cross section during a short period of time. It is clear, however, that the eroding flood plain is being replaced by lateral or within-channel deposits.

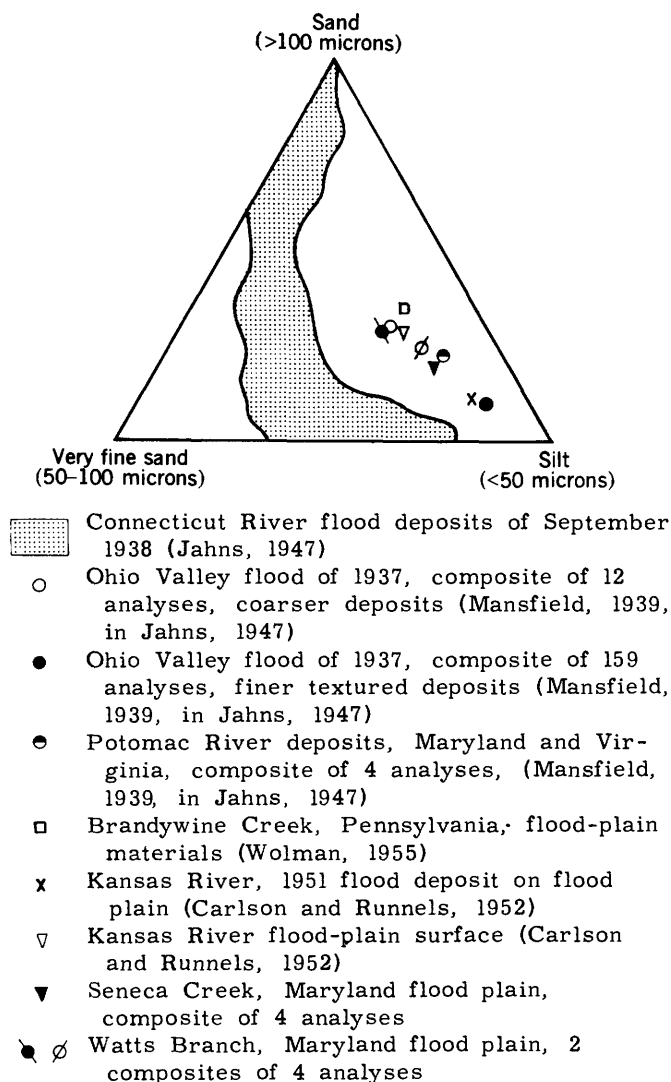
FIGURE 63.—Size distribution of flood deposits and flood-plain sediments (original diagram from Jahns, 1947).

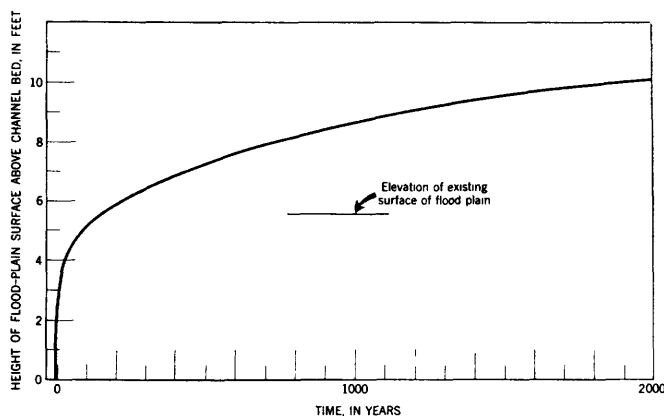
FIGURE 64.—Hypothetical formation and rate of increase in flood-plain elevation by overbank deposition. Graph shows increase in elevation with time on Brandywine Creek at Chadds Ford, Pa.

If a specific thickness of material were deposited on the flood plain every time a river overflowed its banks, it would be possible to compute the rate of rise of the flood-plain surface by the use of flood frequency data. Figure 64 is a plot of hypothetical flood-plain elevation against time on Brandywine Creek at Chadds Ford, Pa. It was constructed in the following way: The average number of days per year on which a given stage is equaled or exceeded was computed from the gaging station records. Assuming that each time the stream overflows a given level it deposits a specific thickness of material, the time required for the surface of a flood plain to reach a given elevation can be computed. In this example it was assumed that each increment consisted of a layer of sediment 0.005 foot thick (see table 5 for reasonableness of this assumption).

The most conspicuous feature in figure 64 is the rapid increase in elevation in the first 10 years. Although the rate decreases somewhat as the figure shows, in 170 years it would have been possible to construct a flood plain to its present height at Chadds Ford. From 80 to 90 percent of this construction would have taken place in the first 50 years.

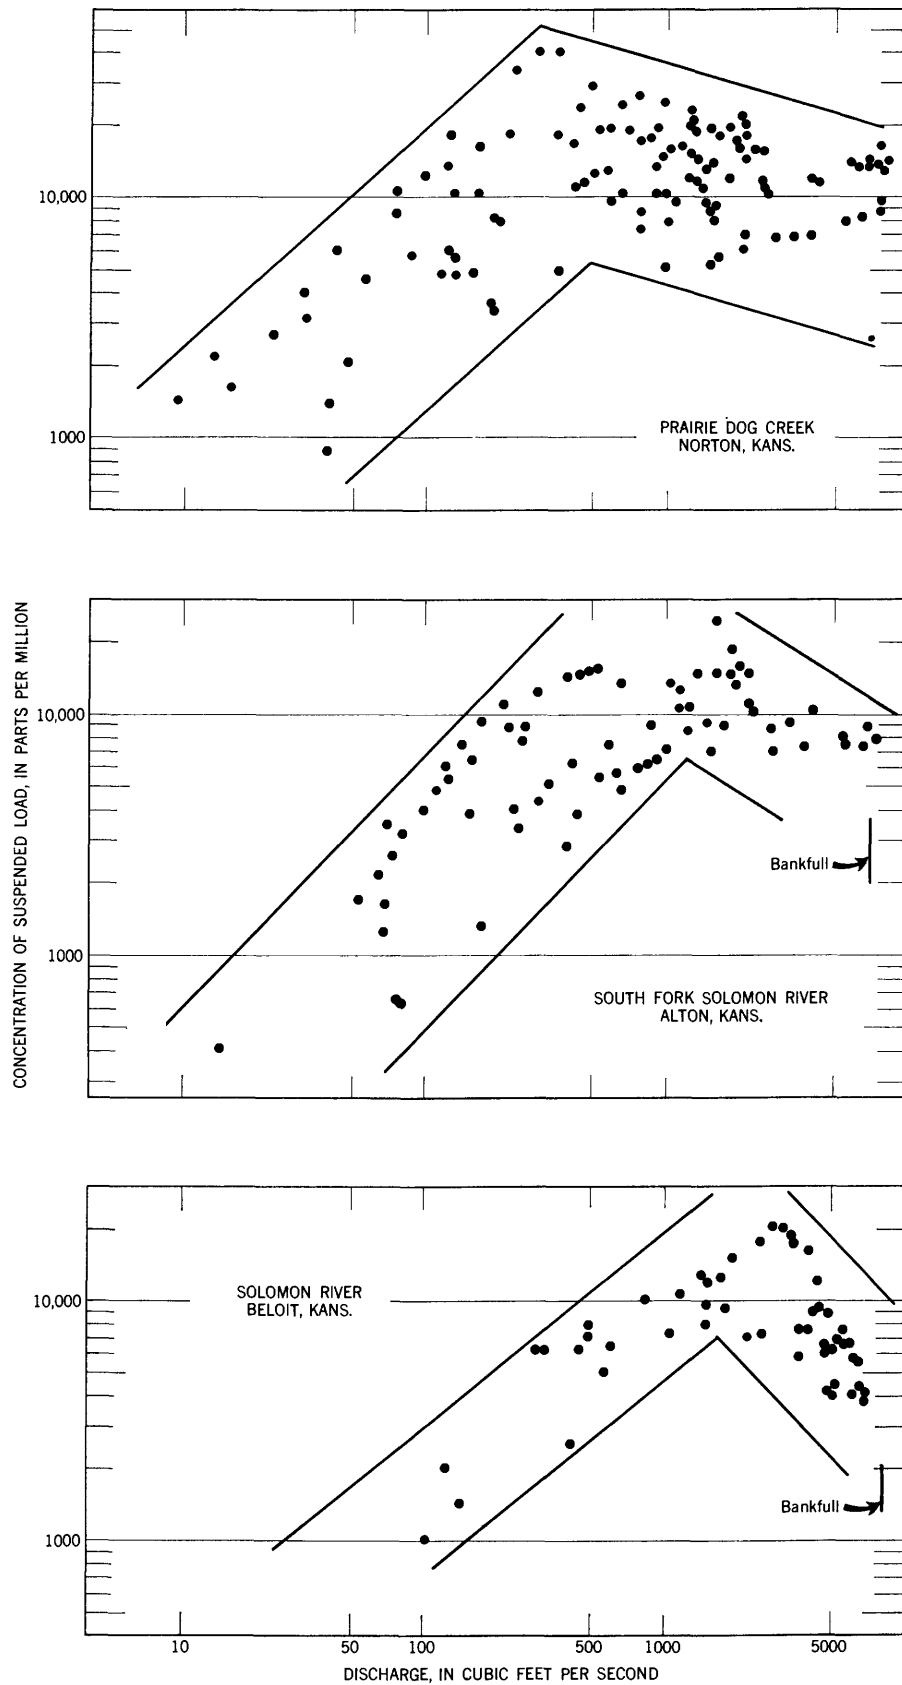
FIGURE 65.—Relation of sediment concentration to discharge in several rivers in Kansas.

It has been suggested that the decrease in concentration may result from deposition on the flood plain as a stream goes out of its banks. In the South Fork Solomon River at Alton, Kans., and in the Solomon River at Beloit, Kans. (fig. 65), the maximum sediment concentration occurs in discharges well below bankfull stage, and thus the decrease of concentration at high flow cannot be attributed to deposition on the flood plain. If we consider the fact that the load is primarily a function of the physiographic and climatic conditions in the contributing drainage area and, although correlated with discharge, is not a function of the discharge itself, it is by no means necessary that the highest concentrations be associated with the highest flows. The fact that high flows may not be associated with the highest sediment concentration may help to account for a paucity of deposition during these periods.

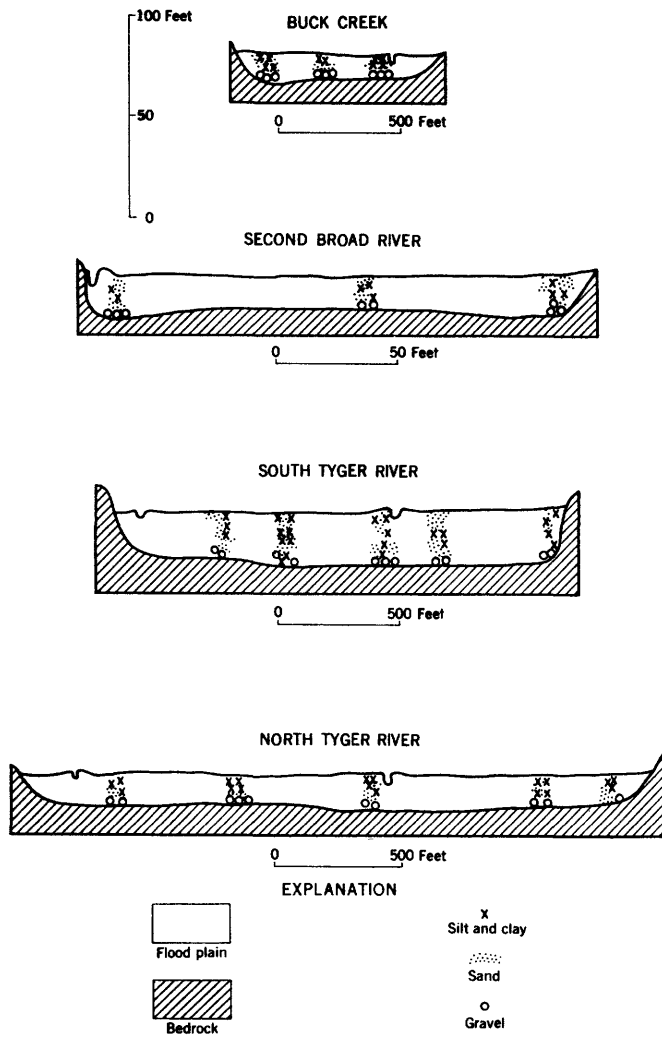
FIGURE 66.—Cross sections of river flood plains in North Carolina and South Carolina.

At first glance it might seem as if these sections are actually aggraded ones rather than stable, alluvial sequences. The following analysis, however, indicates first, that the distinction between the two is not easily made, and second, that the flood plains in figure 66 may well represent a single stable deposit.

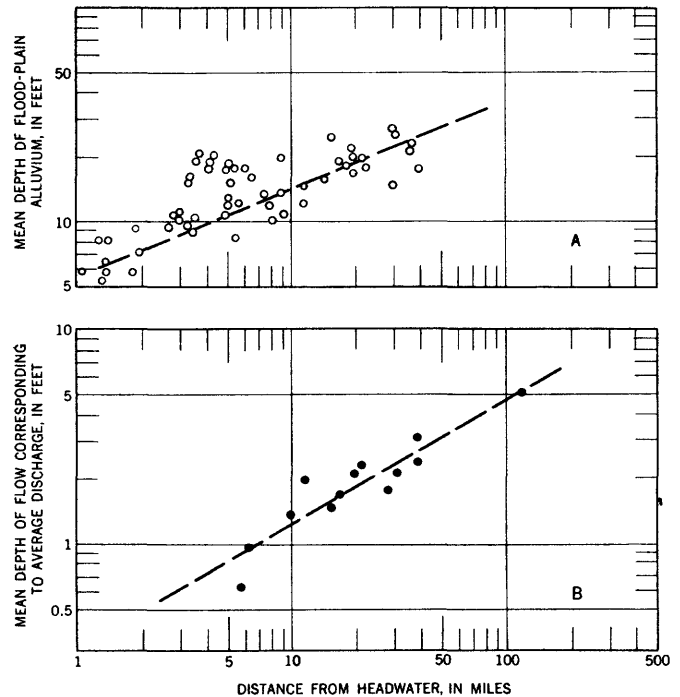
FIGURE 67.—Relation of distance from headwater divide to mean depth of flood-plain alluvium and to mean depth of flow at average discharge at selected localities in North Carolina and South Carolina.

Figure 67A is a graph of the depth of fill in valleys in the North and South Carolina region, plotted against the length of the valley from its headwaters to the given cross section. Although there is considerable
