APPENDIX S

Visual Resources

TABLE S-1

APPENDIX S-2a: AFFECTED ENVIRONMENT, IMPACTS, AND MITIGATION MEASURES AT KEY OBSERVATION POINTS

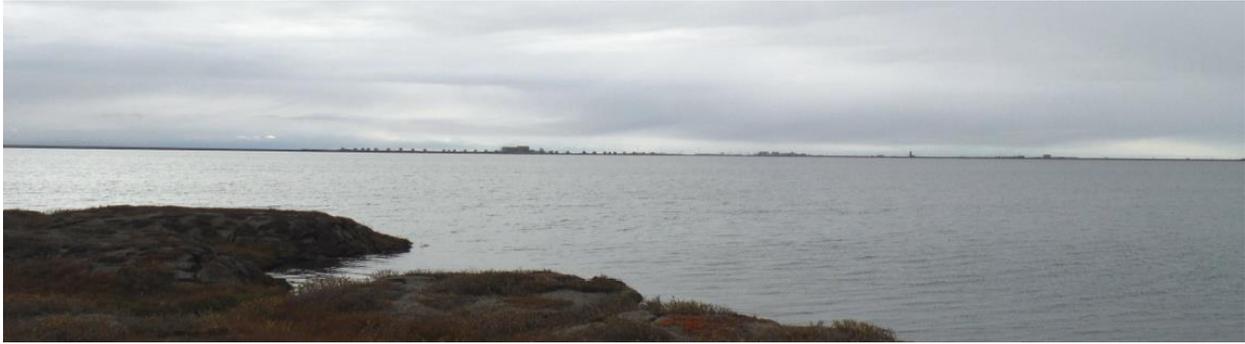
Figure S-2-1: KOP 1: Colleen Lake

KOP 1 (see table S-2-1) is in Deadhorse and is the view looking north across Colleen Lake near the northern terminus of the Dalton Highway at Airport Way (see figure S-2-1a). The flat, still waters of the lake mirror the colors of the sky. The lake and flat landforms contrast with the geometric forms of the industrial structures clustered irregularly along the distant lakeshore. Industrial structures in close proximity to the viewpoint reduce the scenic quality of the area. Vegetation consists of low plants in rough clumps. The dominant color in the area is provided by the vegetation, which ranges from green and brown with some seasonal yellows and reds. Nearby structures consist primarily of white, gray, and tan metal structures. No trees are visible from this KOP.

a. Existing Conditions

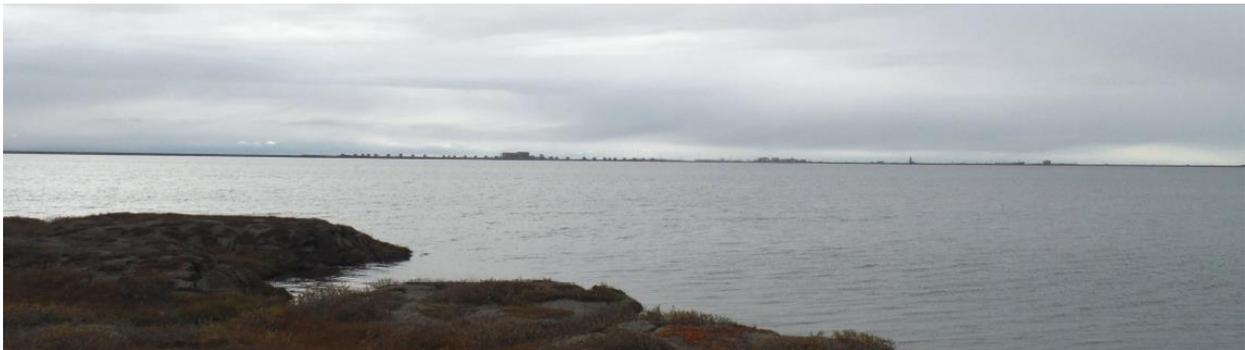
The Gas Treatment Facilities would be about 7.5 miles from KOP 1 on the opposite shore of Colleen Lake. Figures S.2.1-1b and S.2.1-1c show simulated future visual conditions from KOP 1.

c. After Reclamation

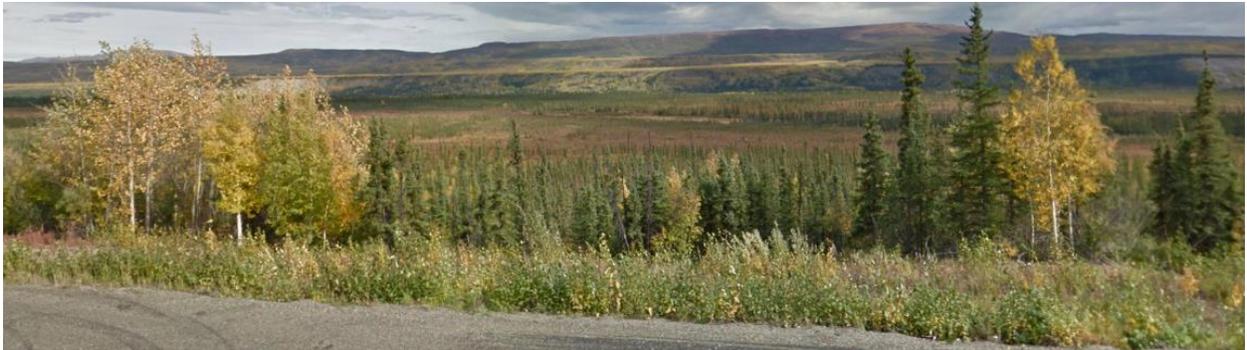
Figure S-2-16: KOP 2018-1: Healey Compressor Station

a. Existing Conditions

Due to the high use of the Parks Highway, the Project would be visible to a large number of travelers, although the average viewer would see this view for a brief period (see figure S-2-16c). Condensation plumes from the compressor station could also be visible under certain atmospheric conditions (see section S-2.1.1.1) in an area where no such plumes exist. Overall contrast would be moderate to strong, and visual impacts during operation would be moderate.

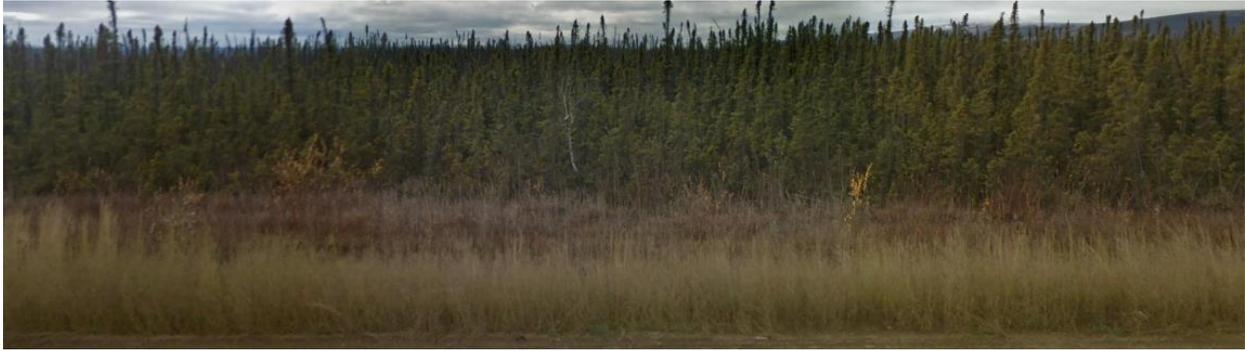
Figure S-2-17: KOP 2018-2: Ray River Compressor Station

a. Existing Conditions

S-2-17f, and S-2-17g). Condensation plumes from the compressor station could also be visible under certain atmospheric conditions (see section S-2.1.1.1) in an area where no such plumes exist. Overall, contrast would be moderate to strong and visual impacts during operation would be moderate.
