# **A Literature Review and Synthesis on the Effect of Pipeline Height on Caribou Crossing Success**

**BLM-Alaska Open File Report 106**  
April 2006

U. S. Department of the Interior  
Bureau of Land Management

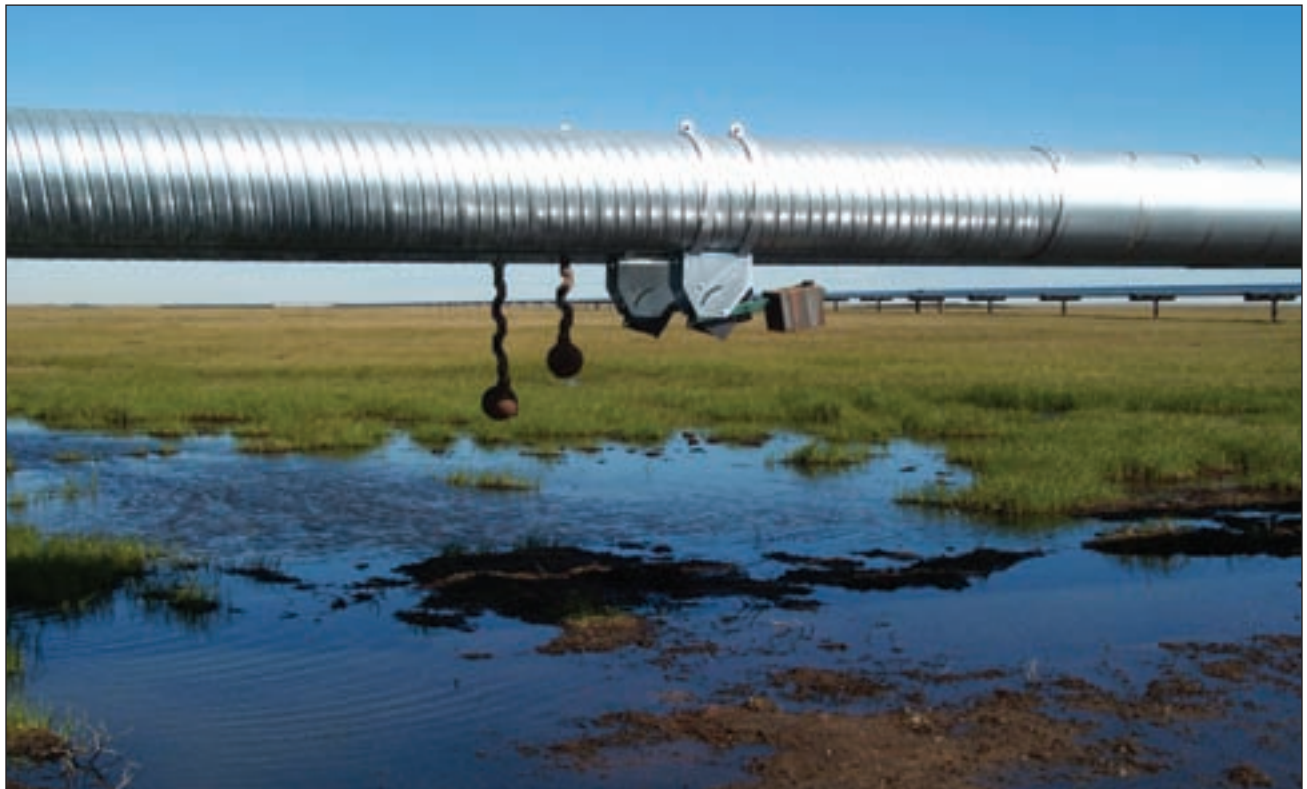
**Figure C-2.** Kuparuk DS-2L pipeline elevated to 1.5-m minimum height and showing older spherical style and newer “potato-masher” style of vibration oscillation dampeners, and reflectivity of standard sheathing. Photo by B. Lawhead, ABR, Inc. Copyright ConocoPhillips Alaska, Inc.

vibration dampers, or PVDs, and tuned vibration absorbers, or TVAs) often are attached to pipelines (Figure C-2). The older design of these devices consisted of a heavy metal sphere suspended by an articulated strap, but newer designs have been developed to avoid hanging down as far—as much as 94 cm (Coltrane and Lancot 2001)—beneath the pipeline. In some locations, the newer styles of oscillation dampeners have been attached to the top of pipelines instead of beneath them.

The reflectivity of the metal sheathing used to protect pipeline insulation (Figure C-2) has been identified as a concern by residents of Nuiqsut and other North Slope villages. Because of that concern, a nonreflective, dull-finished coating was used on the Kuparuk DS-3S (“Palm”) pipelines constructed in 2002 (Figure C-3). Thus far, those pipelines are the only ones with nonreflective sheathing in the North Slope oilfields, and no comparisons of crossing success with reflective-coated pipelines have been done.

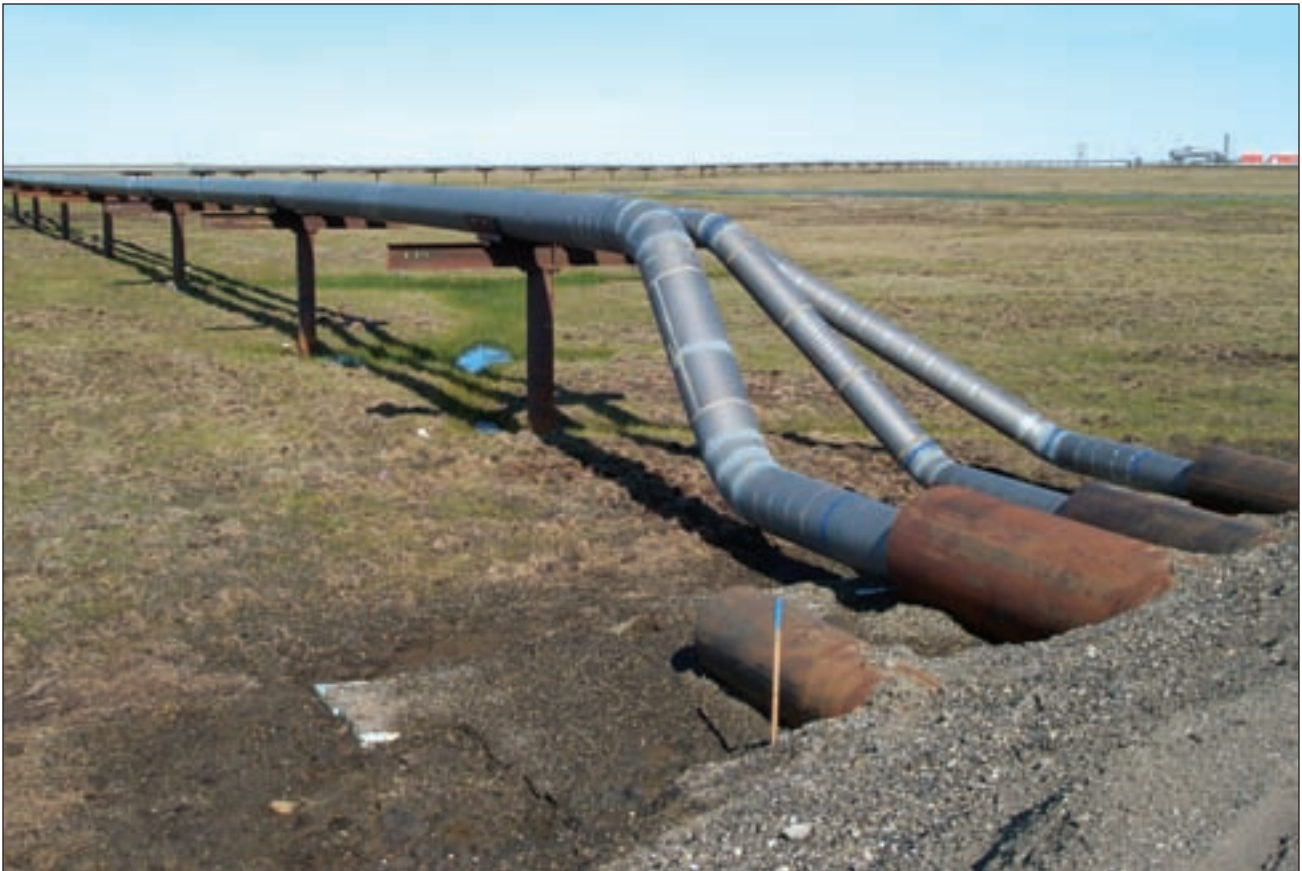
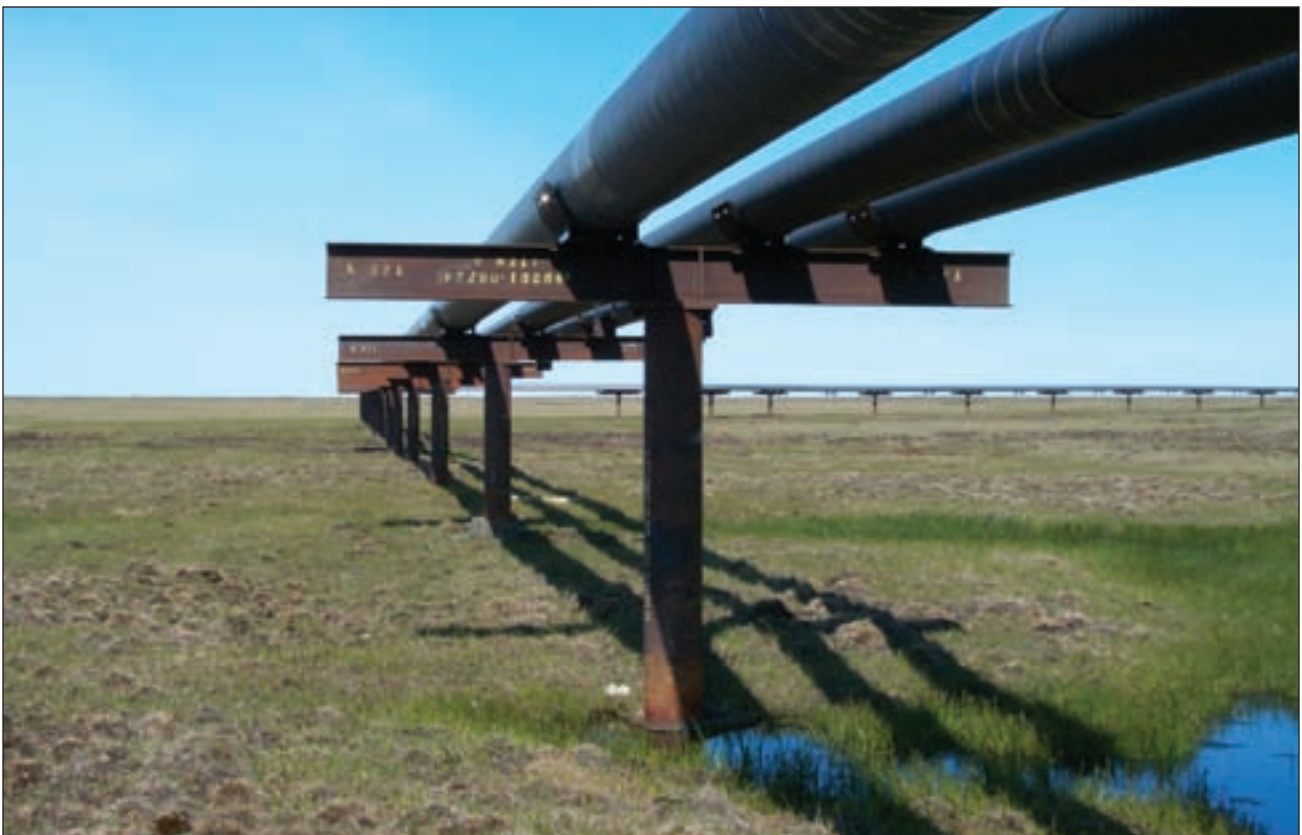
**Figure C-3.** Pipelines with nonreflective sheathing and elevated to a minimum height of 2.1 m, constructed in winter 2001–2002, Kuparuk DS-3S project, northern Alaska. Photos by B. Lawhead, ABR, Inc. Copyright ConocoPhillips Alaska, Inc.
