## **APPENDIX M**

### **Compensatory Mitigation Plan**

## MEMORANDUM

**Re:** Compensatory Mitigation Plan – Identified Revisions Planned

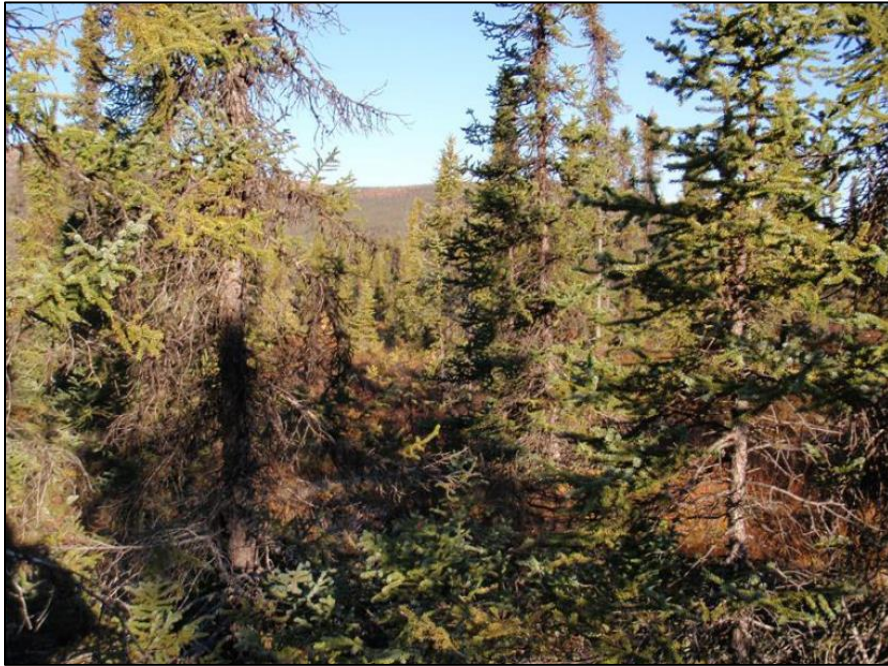
*Photo 1      Open Black Spruce Forest Vegetation Type*

Wetlands in the MA are dominated by Open Black Spruce Forest (OBSF) and Black Spruce Woodland (BSW) vegetation types. OBSF is characterized by the presence of an open canopy of trees and saplings dominated by black spruce (*Picea mariana*), with a predominantly ericaceous shrub understory. Understory species commonly found in both upland and wetland OBSF plots include alpine blueberry (*Vaccinium uliginosum*), marsh Labrador-tea (*Rhododendron tomentosum*), black crowberry (*Empetrum nigrum*), swamp birch (*Betula nana*), northern mountain-cranberry (*Vaccinium vitis-idaea*), Bigelow's sedge (*Carex bigelowii*), woodland horsetail (*Equisetum sylvaticum*), and cloudberry (*Rubus chamaemorus*). Typical Cowardin Classifications (Cowardin et al. 1979) include PFO4/SS1B and PSS4/SS1B (Photo 1) (Michael Baker 2016).

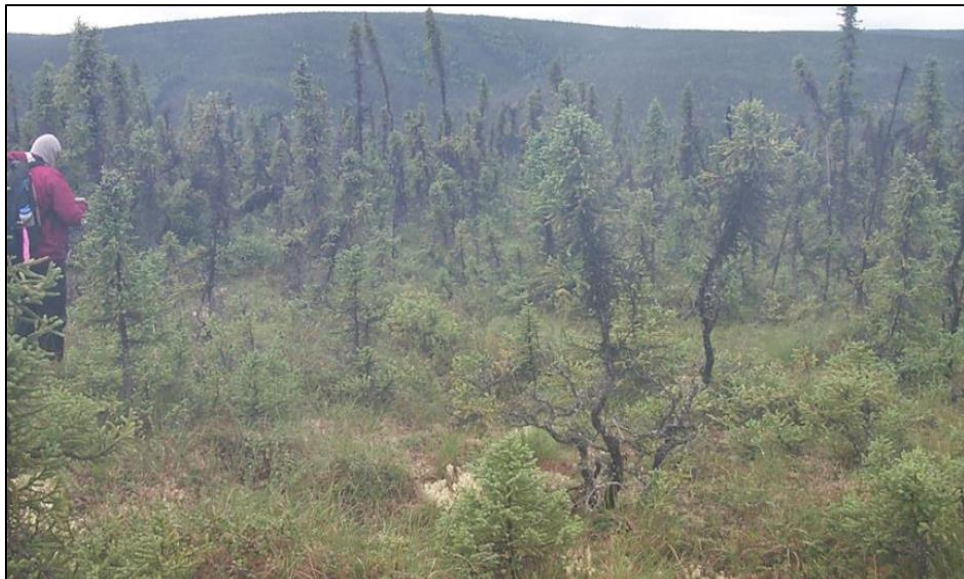
*Photo 2      Black Spruce Woodland Vegetation Type*

The BSW vegetation type is characterized by a sparse canopy (cover, 10 to 25-percent) of trees and saplings dominated by black spruce. Dominant understory species are typically the same as for OBSF. Typical Cowardin Classifications include PSS1/FO4B and PSS1/4B (Photo 2) (Michael Baker 2016).

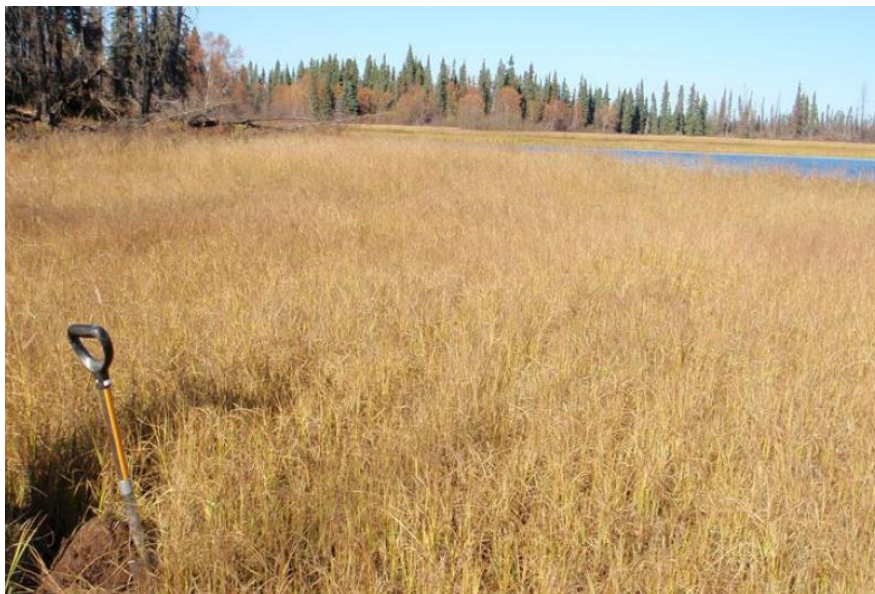
Photo 2      *Wet Herbaceous Vegetation, Middle Big River HUC-10*

In the Interior Alaska Lowlands MLRA (Headwaters Tatlawiksuk, Middle Big, and Windy Fork Middle Fork Kuskokwim Rivers HUC-10s), dominant vegetation in WH plots can include leafy tussock sedge and Russet-Bristle Cotton-Grass (*Eriophorum russeolum*). A variety of other sedges including Bigelow's sedge, mud sedge (*Carex limosa*), loose-flower alpine sedge, few-flower sedge (*Carex pauciflora*), and Northwest Territory sedge (*Carex utriculata*) can also be dominant (Photo 2) [Michael Baker 2016].

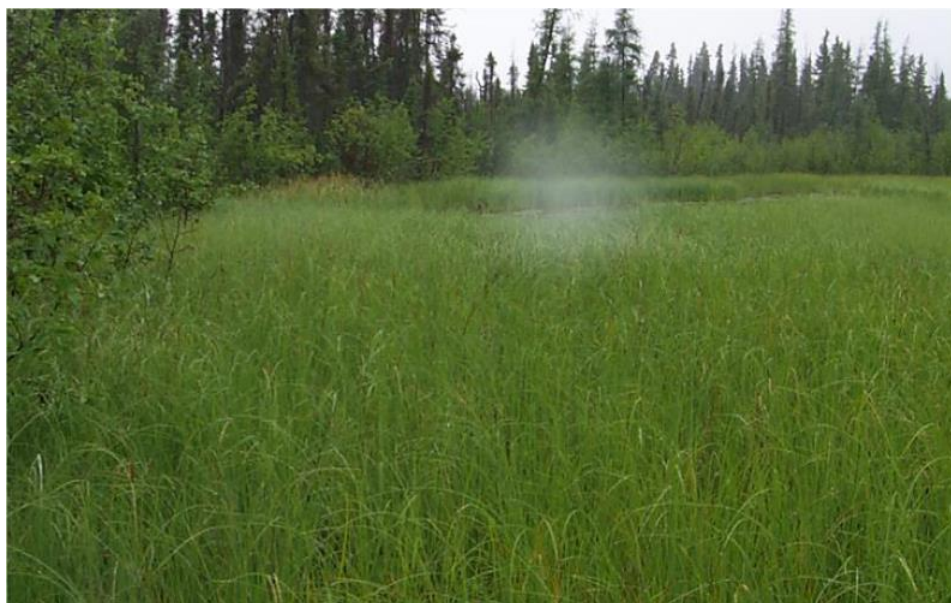
*Photo 3 Wet Herbaceous Vegetation, Crooked Creek HUC-10*

In the Yukon-Kuskokwim Highlands MLRA (Crooked Creek and Veahna Creek-Kuskokwim River HUC-10s), WH plots typically contain leafy tussock sedge, Northwest Territory sedge, bluejoint, and purple marshlocks as dominant plants (Photo 3) [Michael Baker 2016].

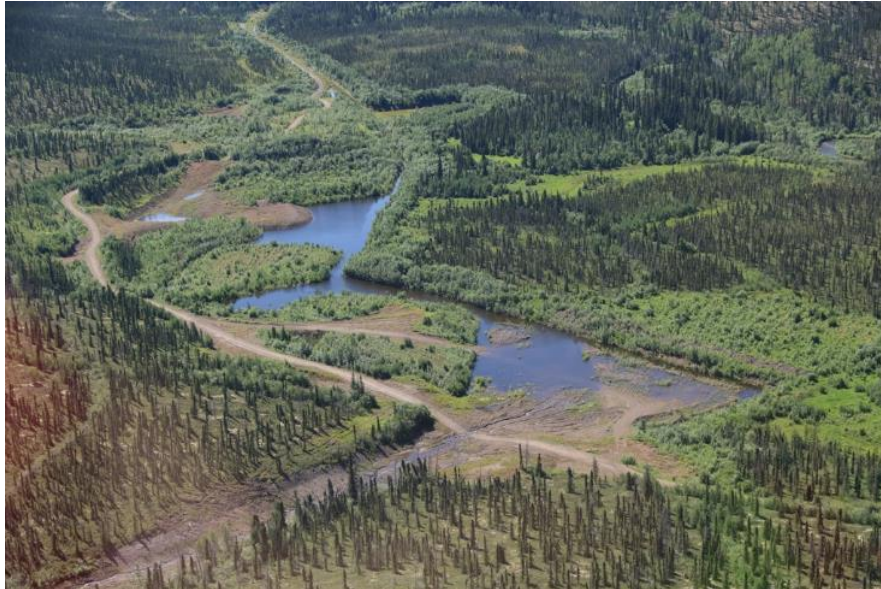
Photo 3      *Lower Ruby and Lower Queen Gulches Placer Disturbance (View Toward Southwest)*

The site hydrology is controlled by Crooked Creek, Donlin Creek and the following drainages: Quartz Gulch (761-acres), Snow Gulch (2,183-acres), Ruby Gulch (303-acres), and Queen Gulch (458-acres). Quartz, Snow (Photo 2), Ruby, and Queen gulches (Photo 3) have been extensively degraded in their lower reaches from placer mining activity beginning in 1910.

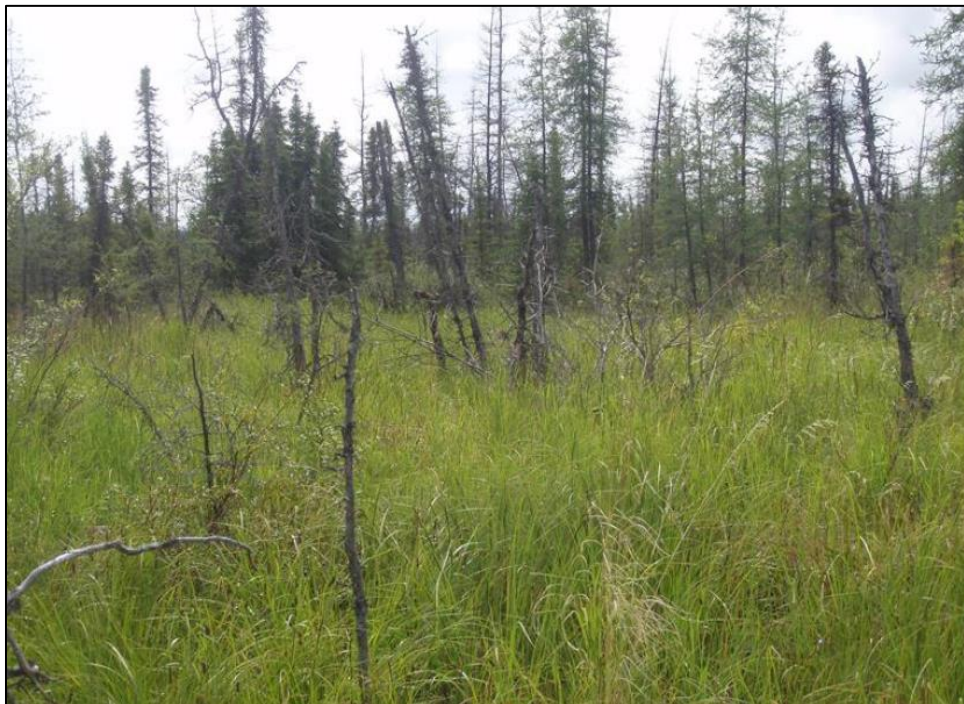
Photo 4      Wet Herbaceous Vegetation Type

- WH communities are typically dominated by hydrophytic herbaceous plants including bluejoint, leafy tussock sedge, purple marshlocks, cottongrass, and other sedges (*Carex spp.*). Total vegetative cover is typically greater than 70-percent (Photo 4).
- Species commonly found in wetland OAWS plots include speckled alder, Sitka/green Alder, diamond-leaf willow, Steven's Meadowsweet, alpine blueberry, and bluejoint. Total vegetative cover is typically greater than 90-percent (Photo 5).
- Species commonly found in wetland OWS plots include several species of willow depending on landscape position such as diamond-leaf willow, felt-leaf willow, and little-tree willow. Understory shrubs include swamp birch and alpine blueberry. Understory herbaceous species include bluejoint and purple marshlocks. Total vegetative cover is typically greater than 90-percent (Photo 6).
