ATTACHMENT B5 APPLICANT'S COMPENSATORY MITIGATION PLAN

Donlin Gold Project
Department of the Army Permit POA-1995-120
July 2018

Block 23. Avoidance, Minimization, and Compensation

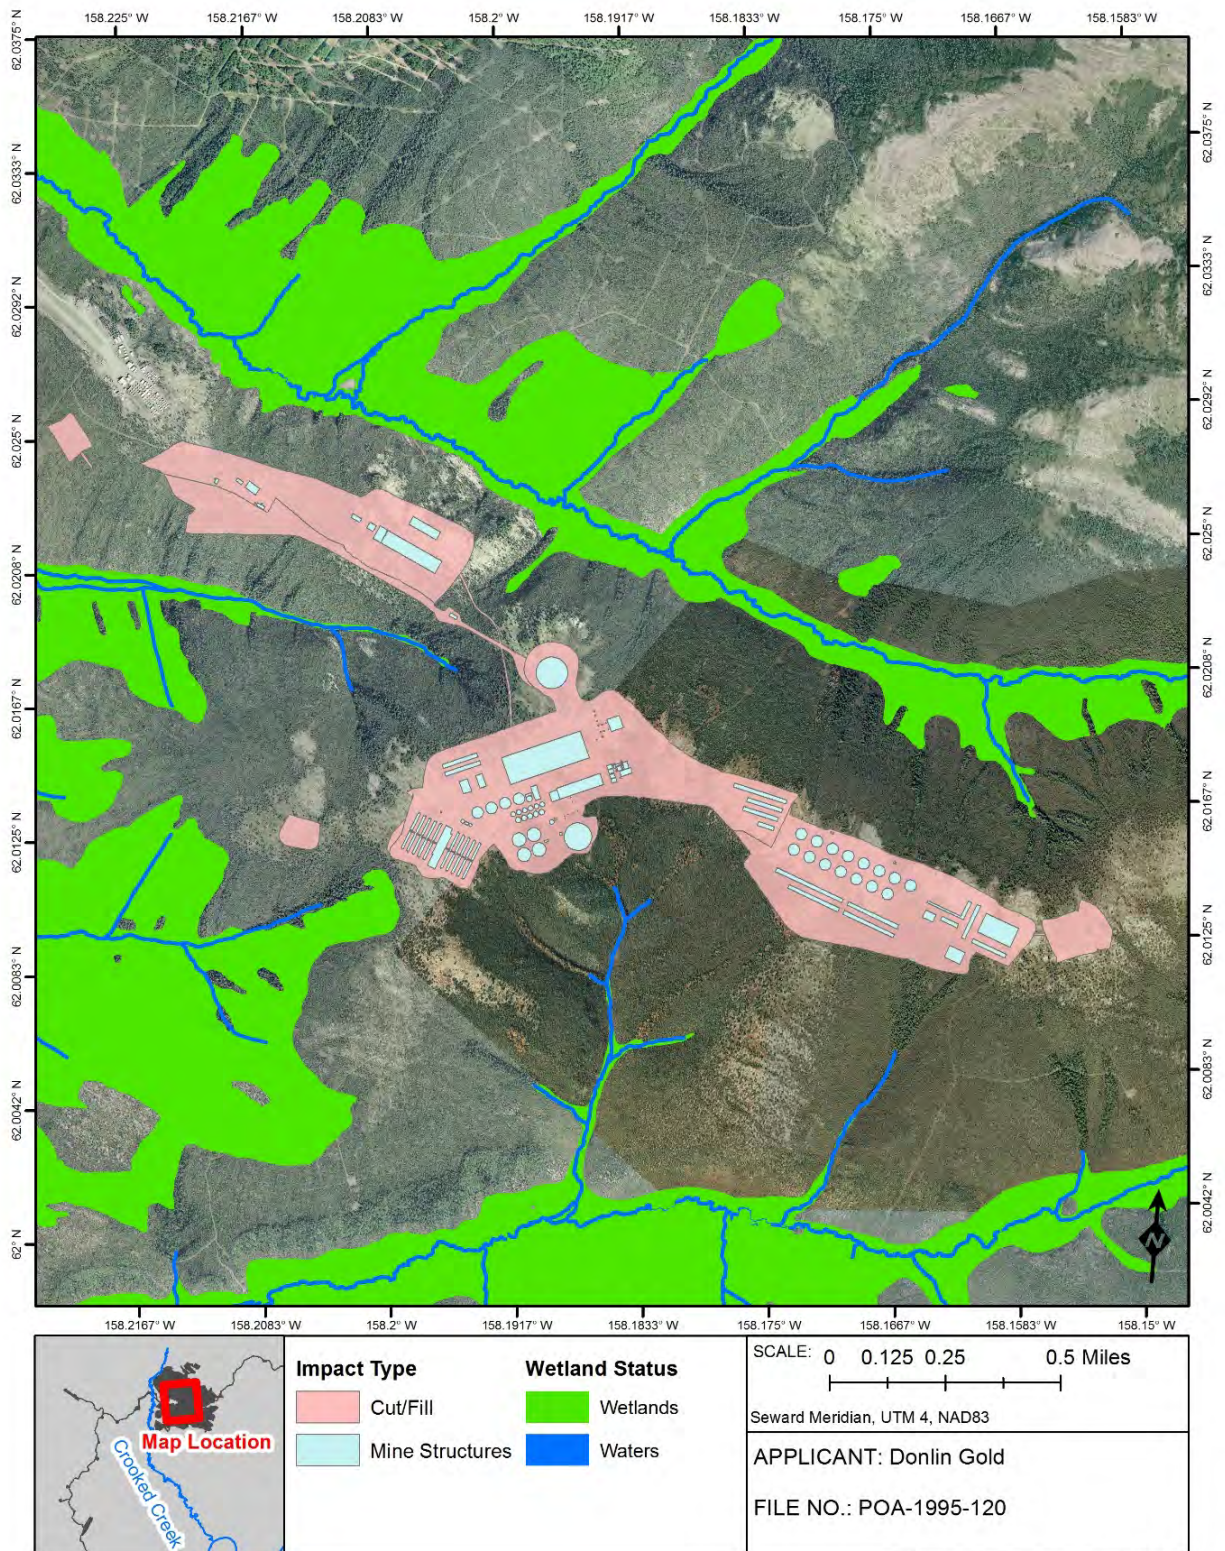
Figure 3 Mine Facilities Footprint

- Mine Roads – Mine roads are used to transport personnel, goods, and materials between mine facilities. These roads have been designed to meet traffic and safety requirements for the mine truck fleet. General design criteria for locating mine roads included: development of a two-lane transportation route that is suitable for mine trucks, safe transport of mine supplies with a grade of less than eight percent; minimizing construction and maintenance costs; geometrically designing roads with the lowest volumes of fill; minimizing drainage crossings and locating necessary crossings at hydrologically prudent locations; locating suitable material sites within proximity of the proposed project to minimize road construction cost and associated impacts of material site access roads; and avoidance and minimization of impacts to WOUS. The length of road access required was minimized by the compact design of the mine facilities, which shortened the distance between areas and minimized impacts to WOUS. Where practicable, mine roads were designed to reach multiple locations via the same access, and avoid the need for secondary roads and additional WOUS impacts.

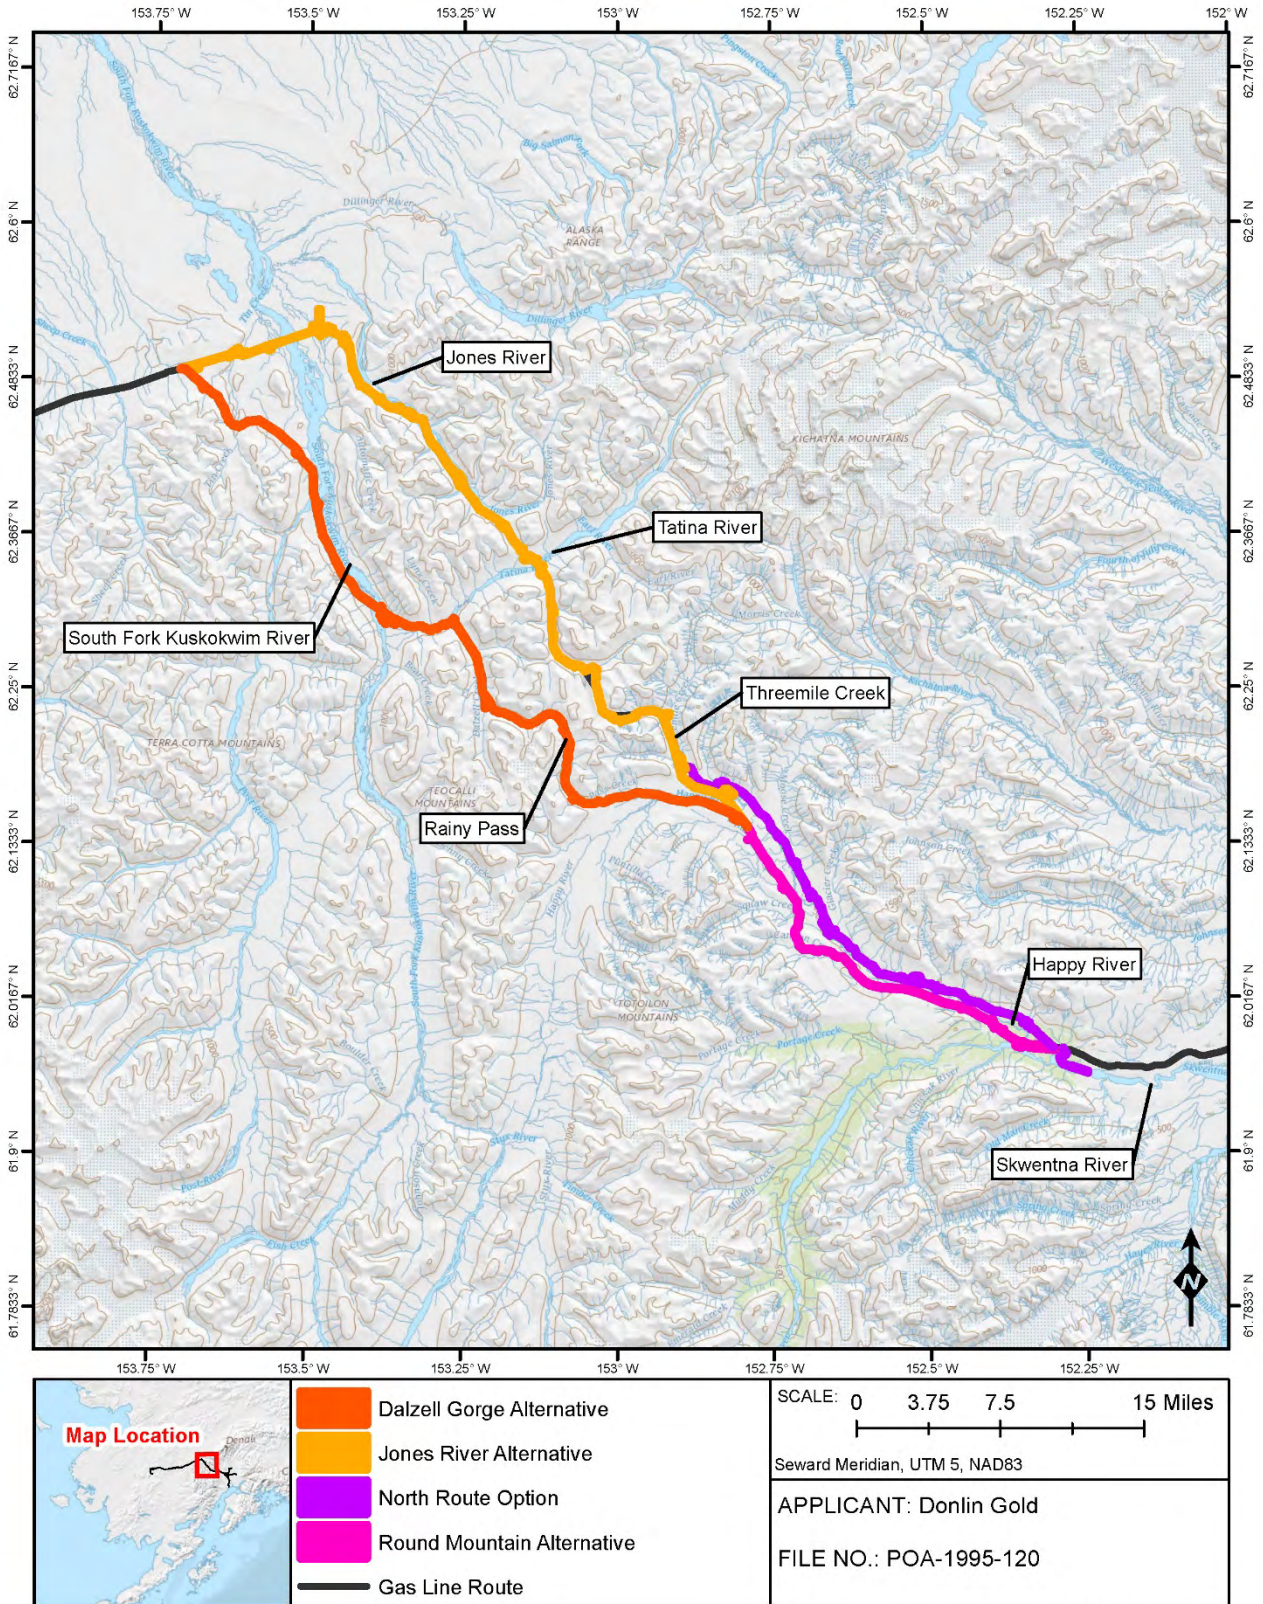
Figure 7 *Alaska Range Alternative Locations*

- Pipeline Area ROW Alternatives – Design considerations for the proposed pipeline route included selection of the shortest pipeline length possible to minimize Project footprint, while avoiding the following to the extent practicable: geotechnical hazards; hydrological hazards; known environmental and cultural sites, the Iditarod National Historic Trail (INHT); and potential land use conflict areas. The pipeline route and ROW design also considered seasonal construction schedules; constructability; and avoidance and minimization of impacts to WOUS. Several route alternatives were evaluated to traverse the Alaska Range, which is the largest geographical obstacle between the origin and terminus of the pipeline. The Jones River and Rainy Pass (Dalzell Gorge) routes were deemed practical, but the Jones River route was determined to be the preferred alternative to avoid geohazards in the Dalzell Gorge and potential land use conflicts with the INHT. The North Route avoids crossing the Happy and Skwentna Rivers, contains less WOUS impact acres and linear feet, and moves the PA ROW away from the INHT. Routing alternatives developed leading up to and through the Alaska Range are shown in Table 1 and Figure 7. Other re-routes avoided geohazards at the Castle Mountain and Denali Fault locations and the Susitna Flats State Game Refuge near the mouth of the Susitna River. Routes were moved higher on mountain sides and along ridgetops to avoid wetlands and streams along valley bottoms, as practicable.

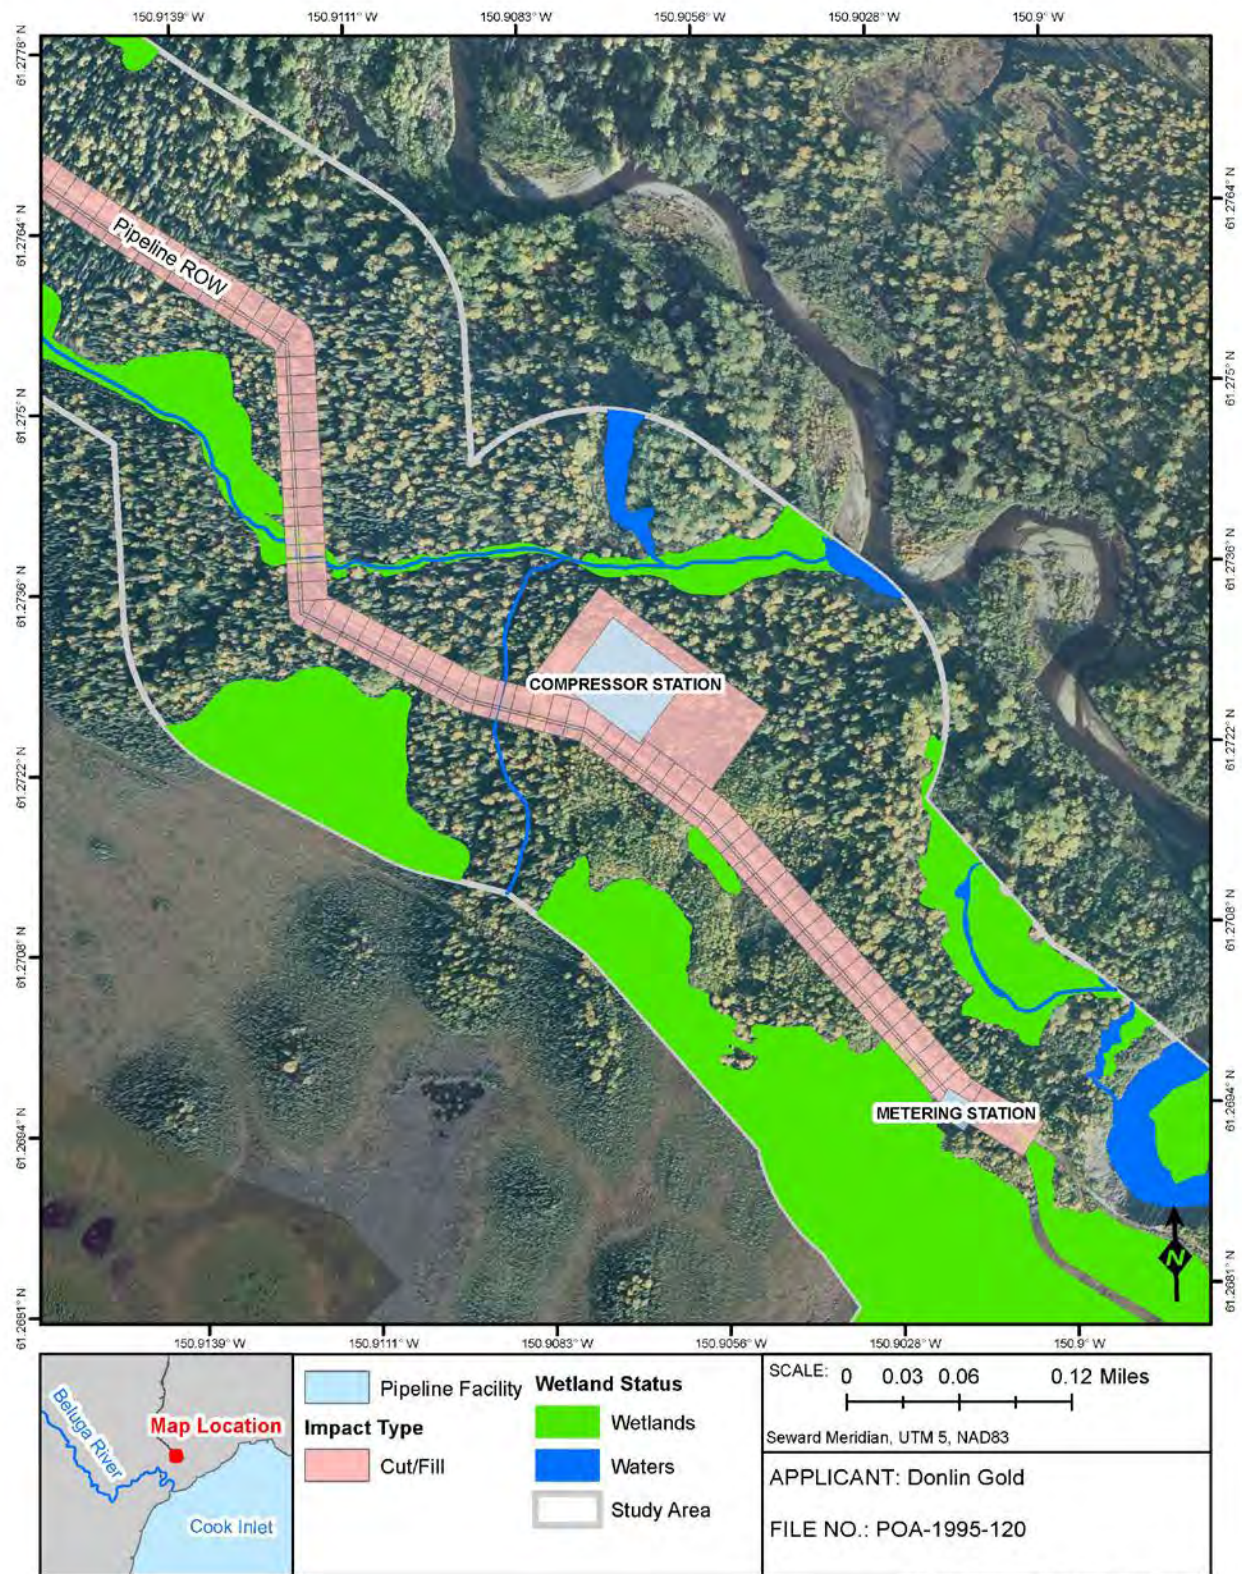
Figure 9 Compressor Station Location

- The compressor station (Figure 9) is sited at an existing previously disturbed area. The Kuskokwim River HDD crossing includes a pipe laydown area collocated with a material site (Figure 10). Figure 9 and Figure 10 illustrate the siting of these facilities in uplands to avoid wetlands and WOUS.

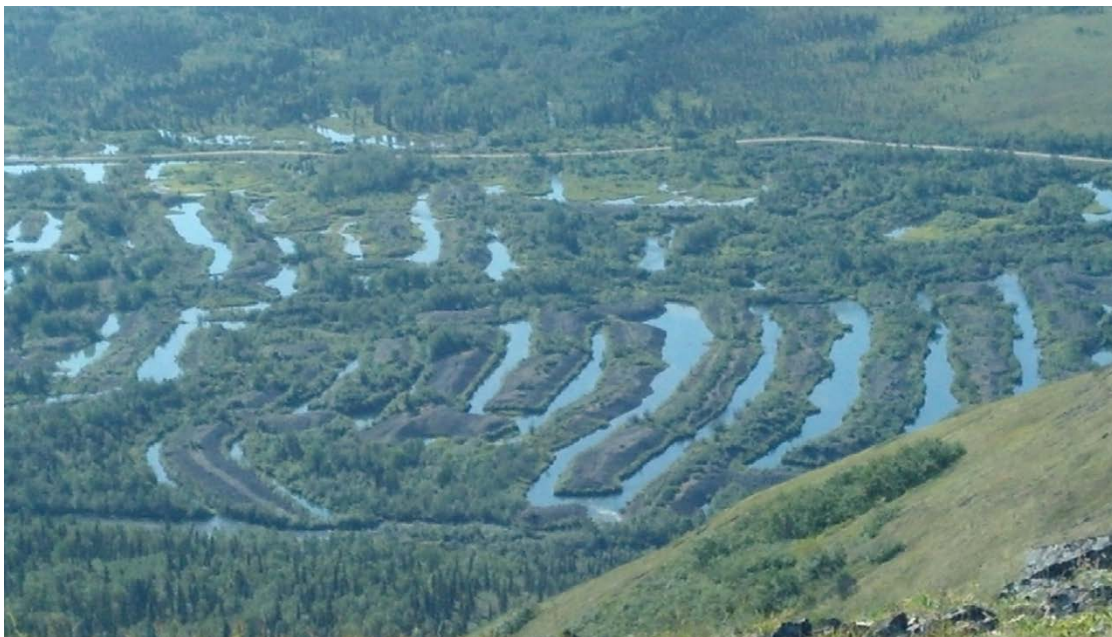
Photo 2 Tuluksak/Nyac Site

Existing dredge tailings and overburden are located throughout the historical Tuluksak River floodplain and form a circuitous maze of pools and low-flow waters. The high mounds of tailings and overburden left behind by dredge activity have forced the main Tuluksak River channel to the northern edge of the floodplain. Photo 2 shows the nature of the past mining activity and the current condition of the Tuluksak/Nyac site.

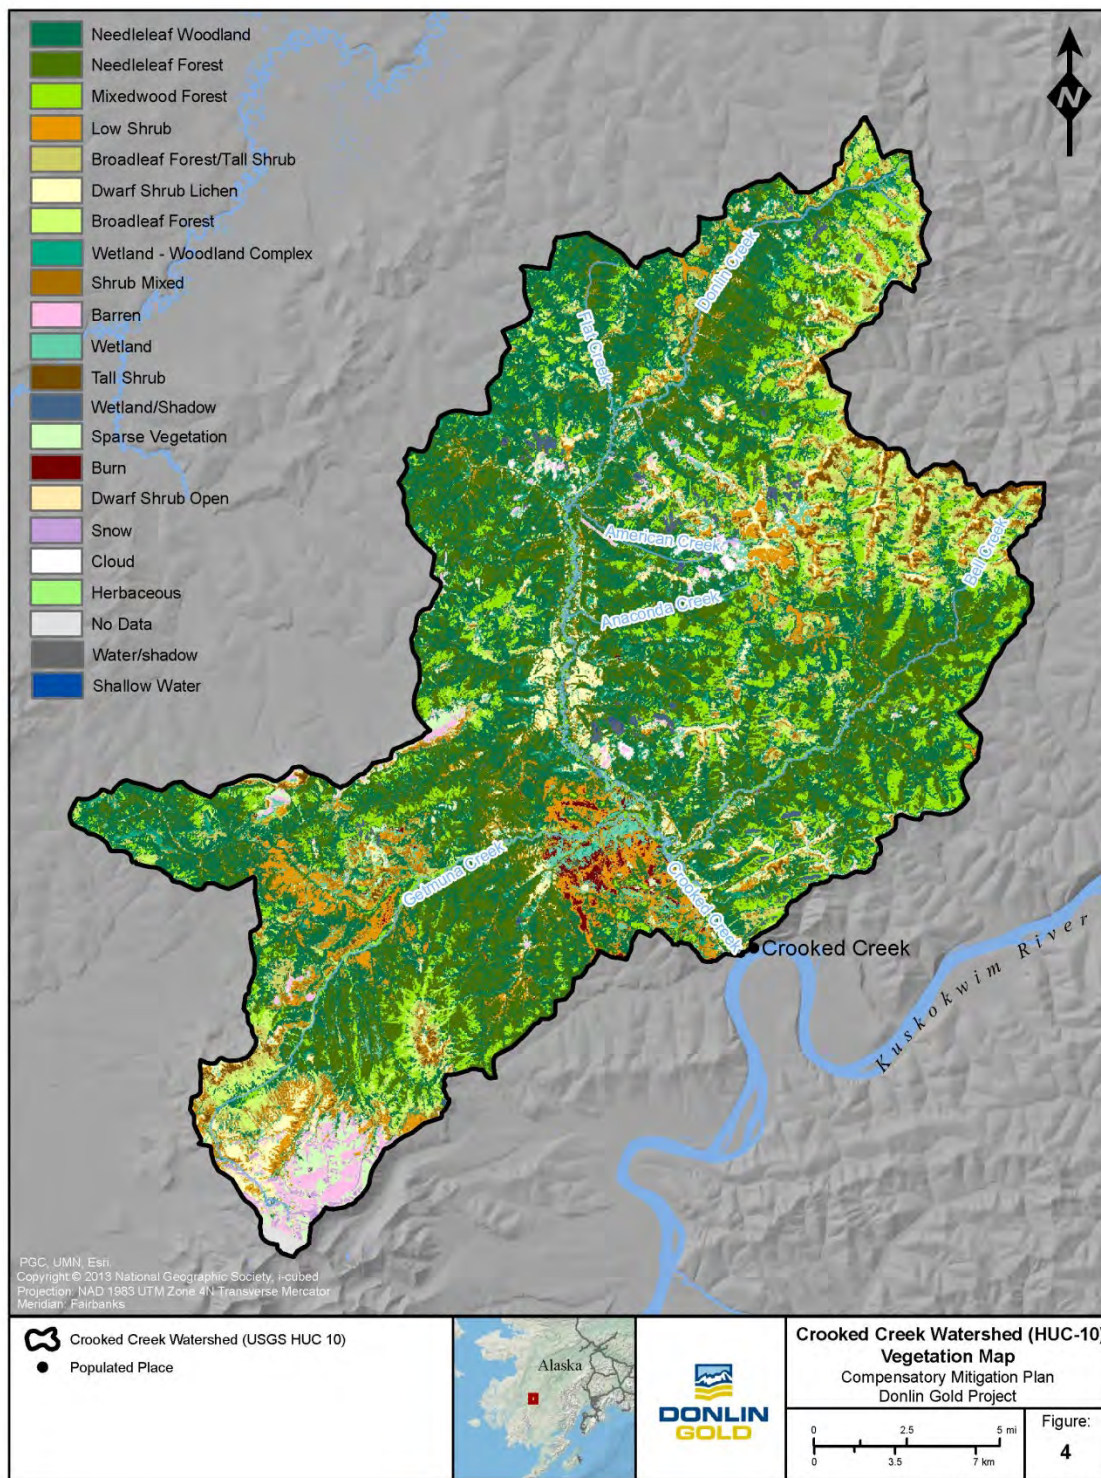
Figure 8 *Crooked Creek Watershed (HUC-10) Vegetation Map*

The Crooked Creek watershed landcover includes a mosaic of vegetated areas with a few barren locations, including disturbed areas. Landcover classification for the Crooked Creek watershed was derived from Landsat 7 ETM+ satellite imagery (2001-2002) and classified using the Alaska Vegetation Classification (Viereck et al. 1992) (Figure 8). The dominant vegetation is typical of Interior Alaska and includes needleleaf woodland and needleleaf forest, mixed wood forest, low shrub, and broadleaf forest/tall shrub. Table 14 provides a list and percentages of each landcover type found in the Crooked Creek watershed. At present, 3,579 acres (1.66 percent) of the Crooked Creek watershed are classified as barren. This includes approximately 164 acres (or 0.08 percent of the watershed) of anthropogenic ground disturbance that has resulted from historical placer mining, mine exploration activities, and the village of Crooked Creek.

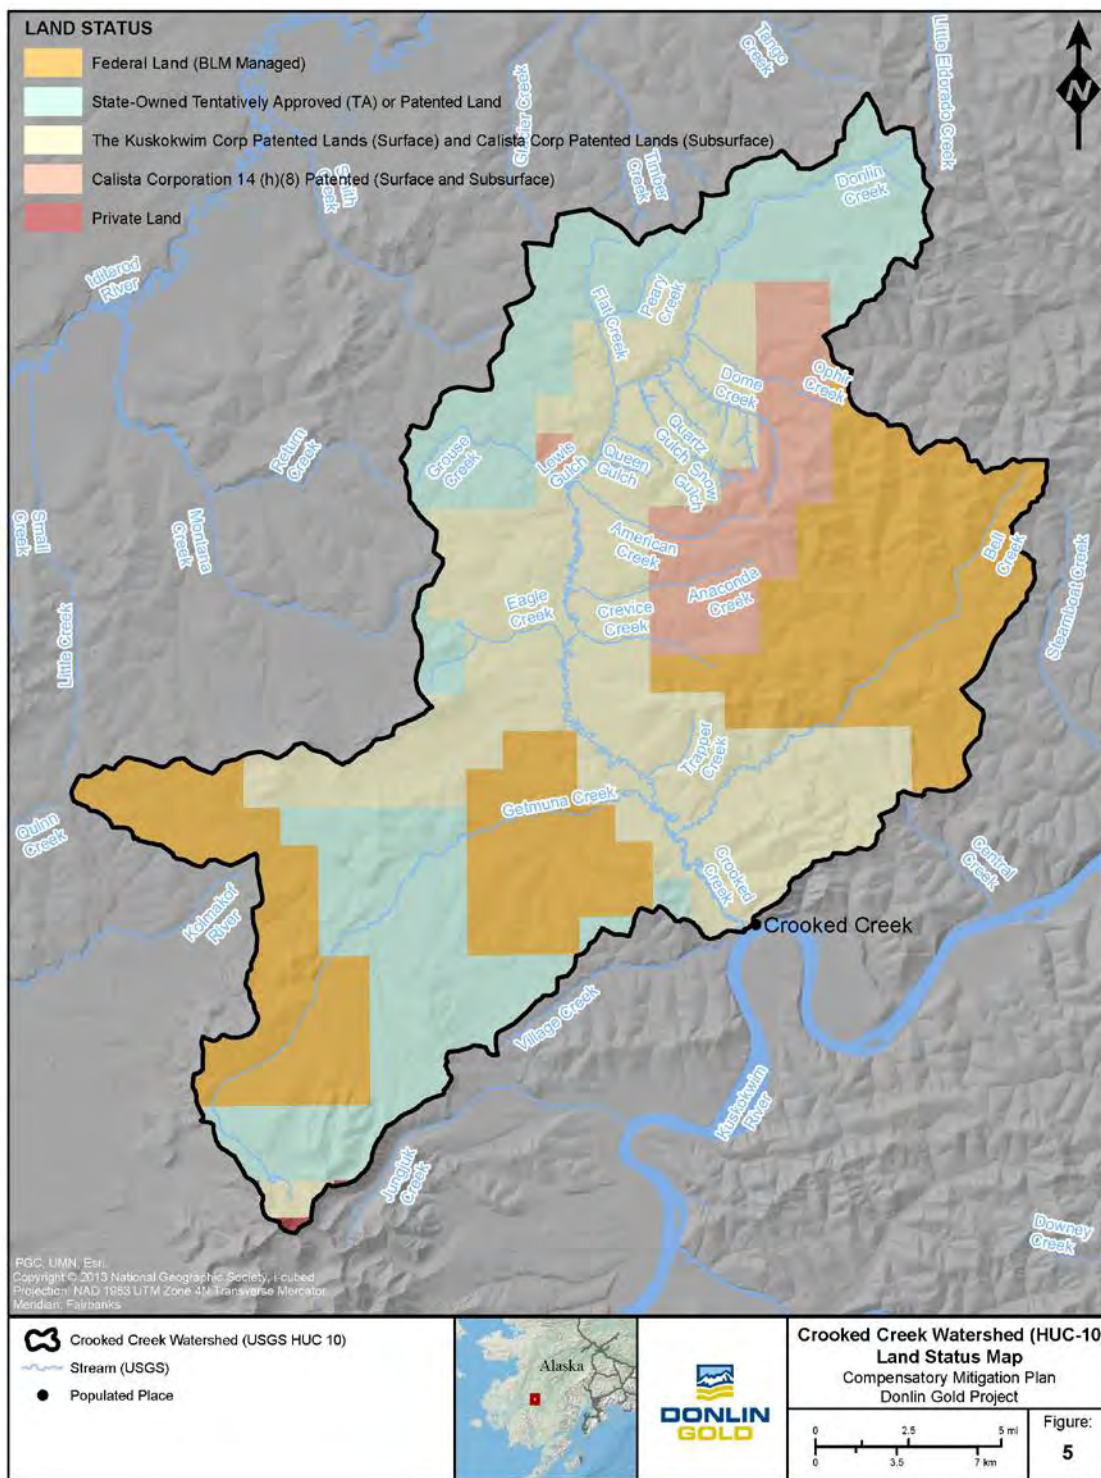
Figure 9 Crooked Creek Watershed (HUC-10) Land Status Map

The Crooked Creek land ownership in the watershed includes Federal and State public lands (58.8 percent), Alaska Native corporation lands (41.1 percent) (see Table 15 and Figure 9), and a small percentage of other private lands (0.1 percent). Alaska Native corporation lands are privately owned by TKC and Calista. TKC is the largest surface land owner in the watershed. Both Alaska Native corporations have the desire to realize economic benefits from their lands for their shareholders and other ANCSA corporations through responsible development. There are no established administrative boundaries within the watershed that would protect lands or wetlands from potential future development.

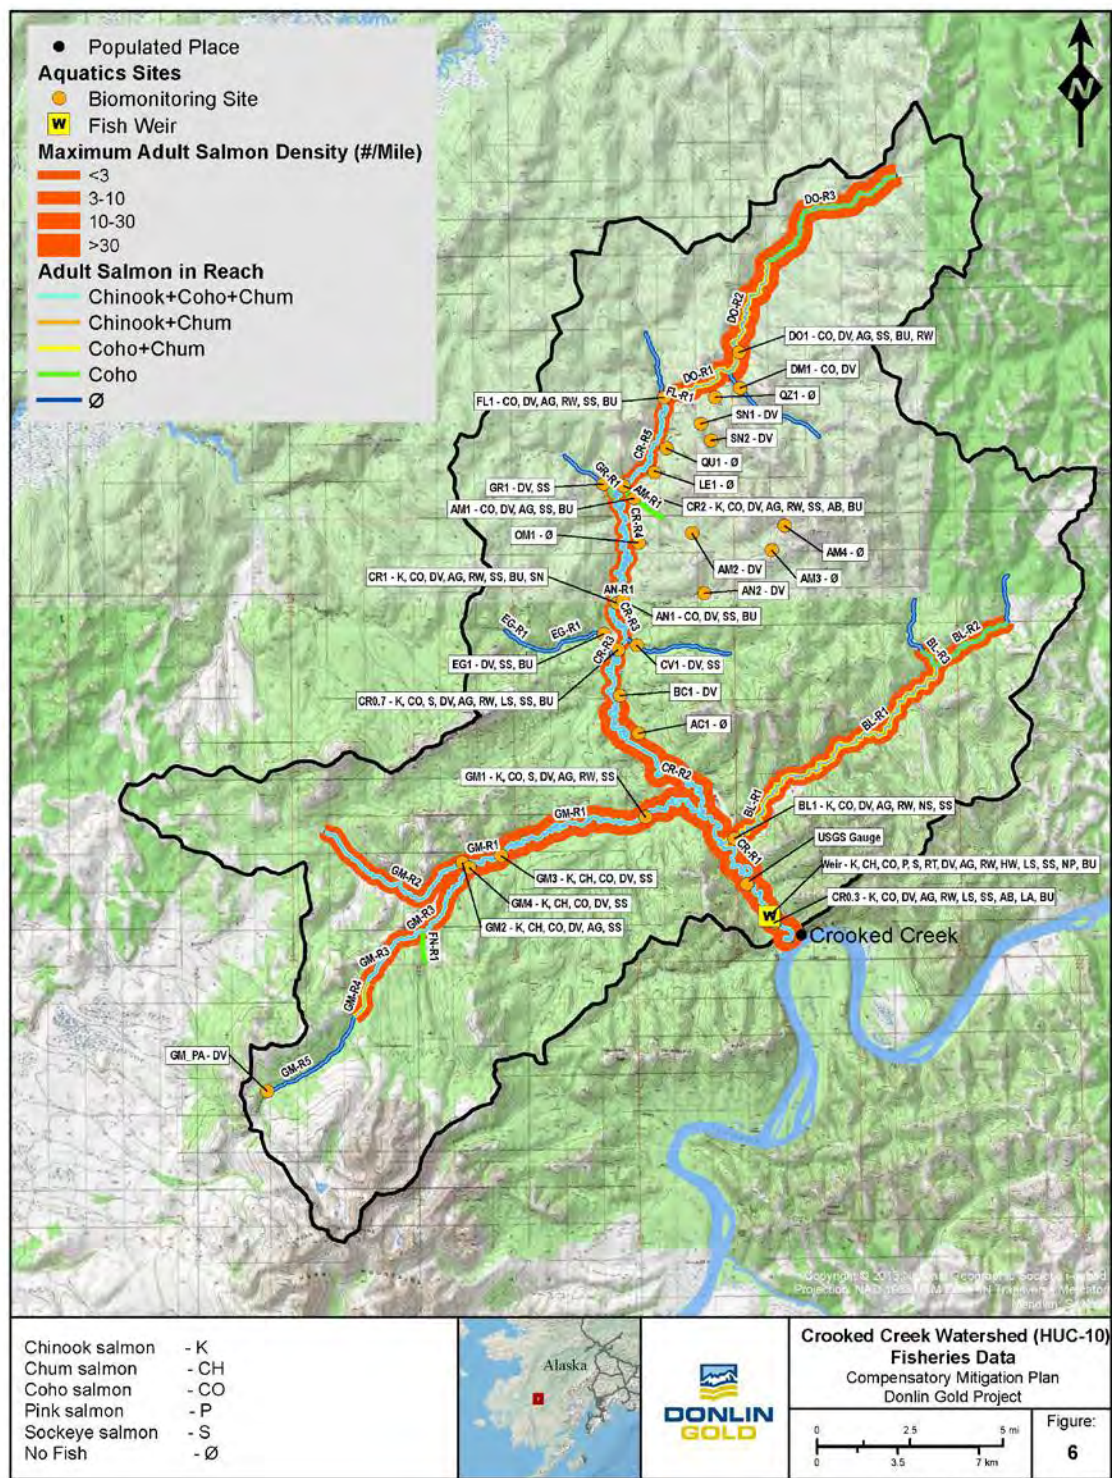
Figure 10 Crooked Creek Watershed (HUC-10) Fisheries Data

Fish species identified within the Crooked Creek watershed are presented in Table 17 by HUC-12 where data are available. A fish distribution map for the Crooked Creek watershed is provided as Figure 10. Fish population assessments within the Crooked Creek drainage show that the system supports spawning populations of Chinook, chum, and coho salmon. Since 2008, when the fish weir was constructed, limited numbers of sockeye salmon and pink salmon have also been documented. Neither Chinook salmon nor chum salmon have been documented in tributaries to Crooked Creek, except for the larger Donlin Creek and Getmuna Creek drainages. In contrast, limited numbers of coho salmon have been reported in a number of tributaries. Aerial adult salmon surveys determined that the watershed includes a total of 464,136 linear feet of salmon spawning reaches (Table 18). The longest salmon spawning stream reach in the watershed is Crooked Creek, but Getmuna Creek, Bell Creek, and Crooked Creek downstream from Getmuna Creek support the majority of overall documented salmon spawning.

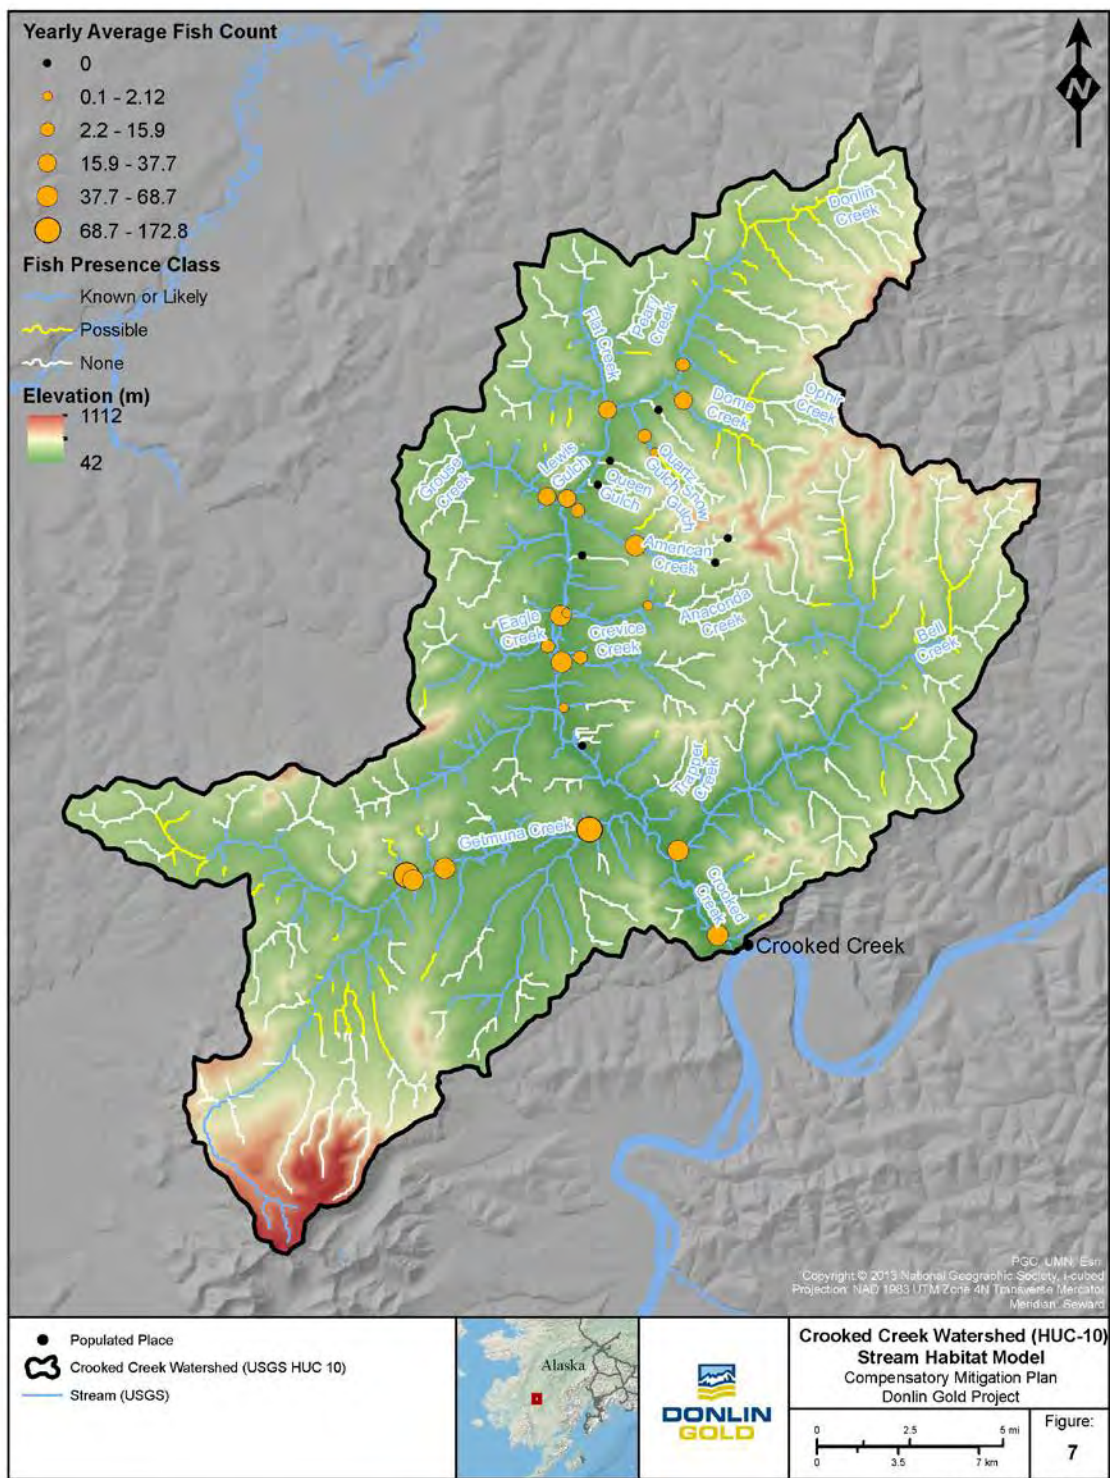
Figure 11 Crooked Creek Watershed (HUC-10) Stream Habitat Model Results

Figure 11 shows the results of the stream habitat model predictions.

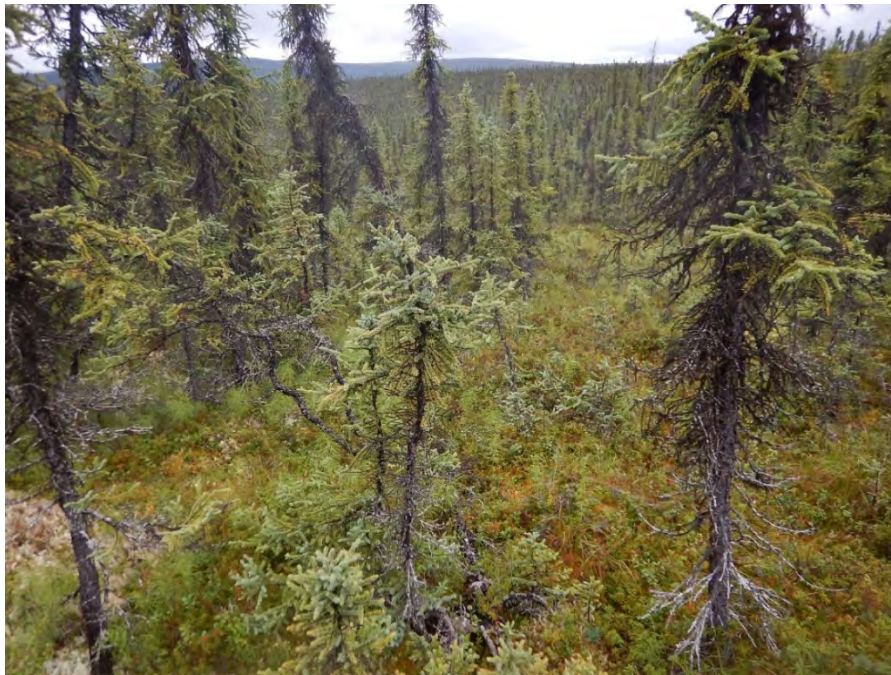
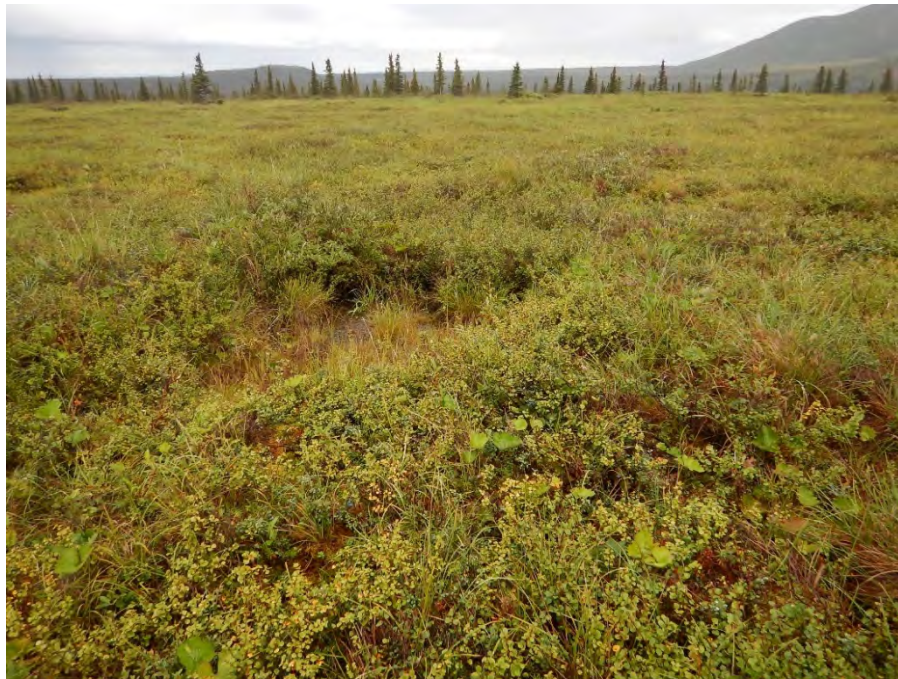
Flat HGM wetlands in the Project Area are almost exclusively organic soil flats. Vertical fluctuations are the dominant hydrodynamic in flat HGM wetlands. Photo 1 and Photo 2 are examples of flat HGM wetlands.

Photo 1 Black Spruce Flat (Organic Soil) HGM Wetland on Hillside, Mine Site, Crooked Creek Watershed

Photo 2 Low Shrub Tundra Flat (Organic Soil) HGM Wetland, Lower South Fork Kuskokwim River Watershed

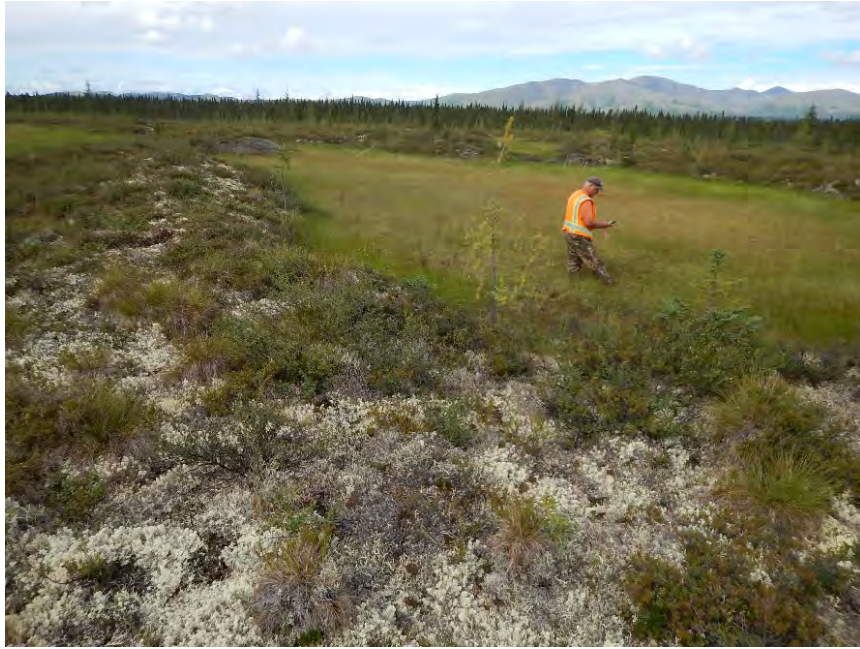
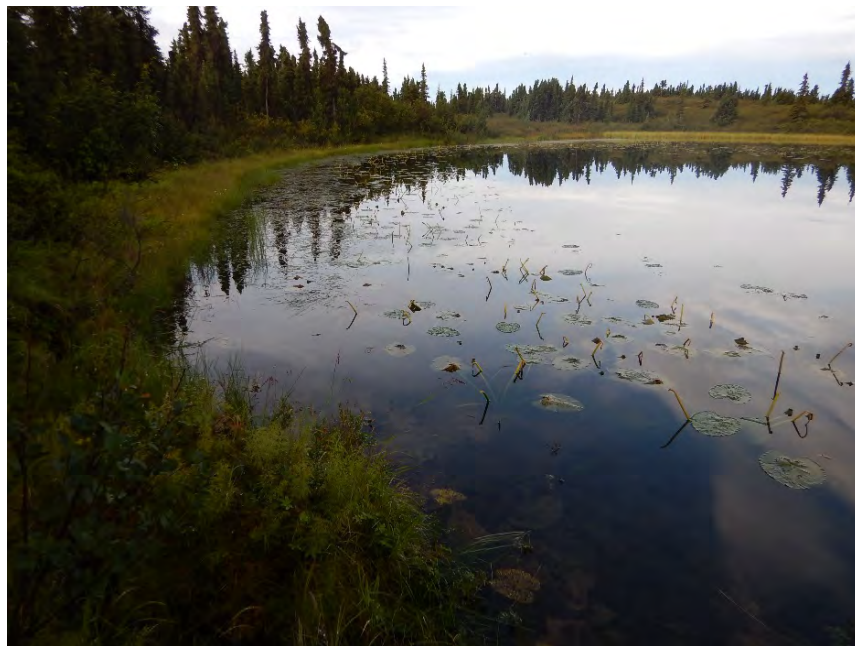
Depressional HGM wetlands occur as small bog or pond features embedded within large flat wetlands dominated by scrub black spruce. In the Project Area, they are evenly spaced, small shallow depressional features on terraces adjacent to Crooked Creek and other waters. Photo 3 and Photo 4 are examples of depressional wetlands.

Photo 3 Wet Herbaceous Depressional HGM Wetland, Headwaters Tatlawiksuk River Watershed

Photo 4 Open Water Depressional HGM Wetland, Middle Big River Watershed

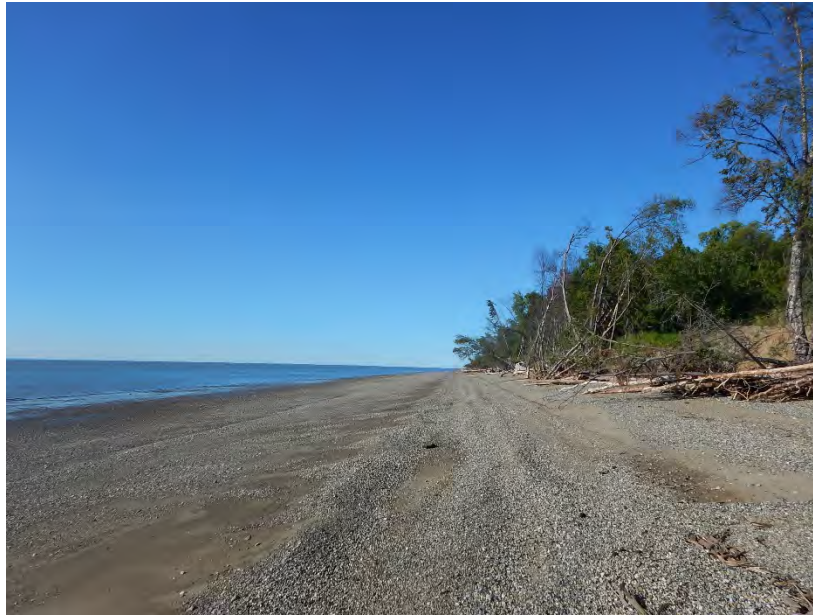
Photo 5 Open Water Coastal Fringe HGM Wetland, Old Tyonek Creek – Frontal Cook Inlet Watershed

Estuarine fringe wetlands are found along ocean or sea coastlines and in estuaries. The dominant source of water is bi-directional flow from tides, either through flooding or groundwater. Additional inputs can come from groundwater and precipitation. Water loss in estuarine fringe wetlands comes from tidal exchange, overland flow, or evapotranspiration. Organic matter can accumulate in the absence of erosive forces (ADEC and USACE 1999). Photo 5 shows a coastal fringe HGM wetland.

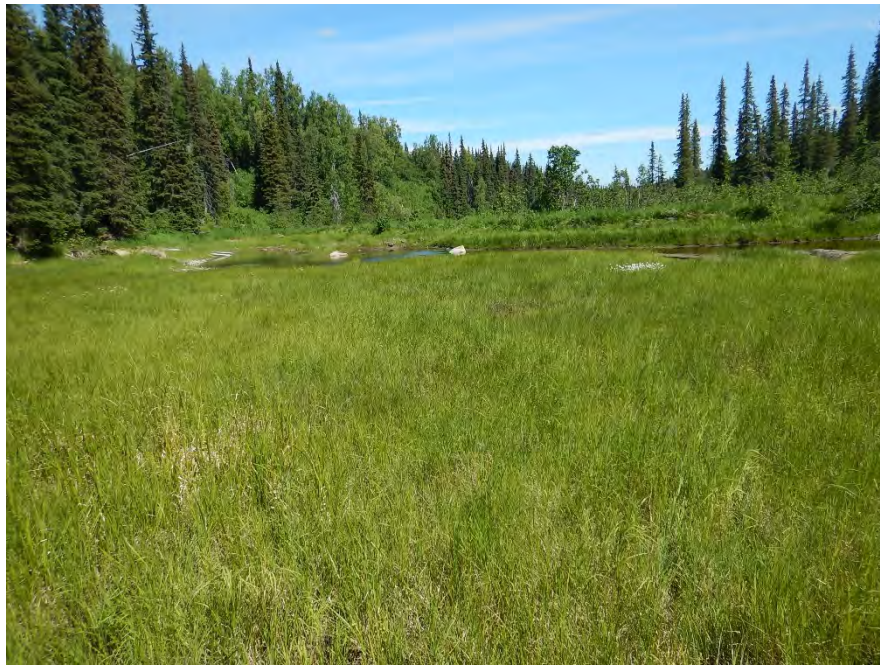
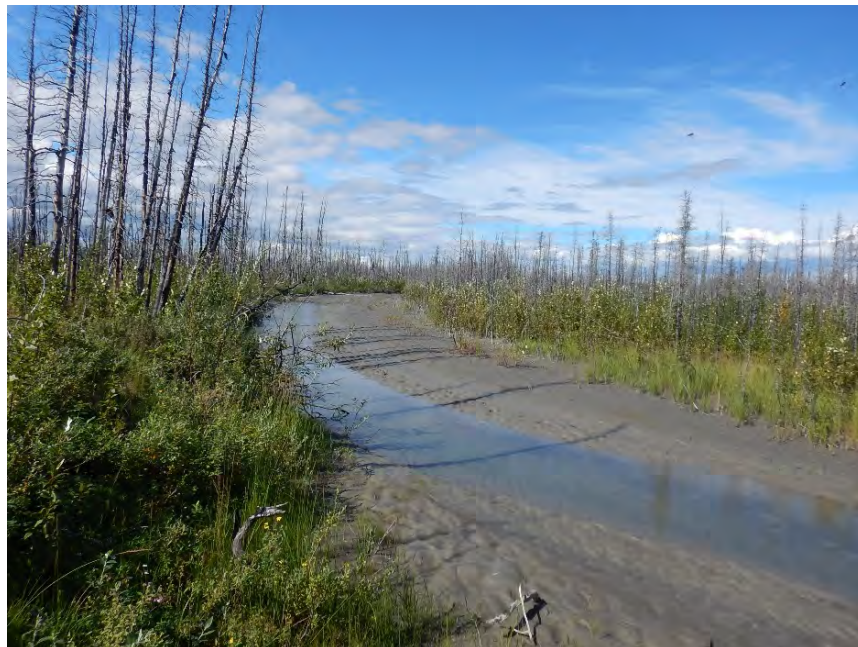
Photo 6 and Photo 7 are examples of riverine HGM wetlands.

Photo 6 Wet Herbaceous Riverine HGM Wetland, Johnson Creek Watershed

Photo 7 Open Willow Shrub Riverine HGM Wetland, Middle South Fork Kuskokwim River Watershed

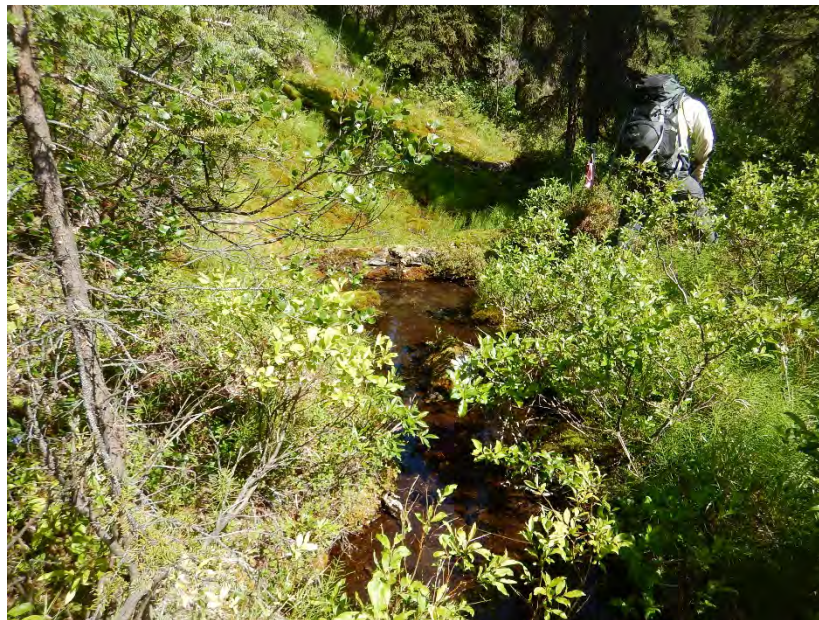
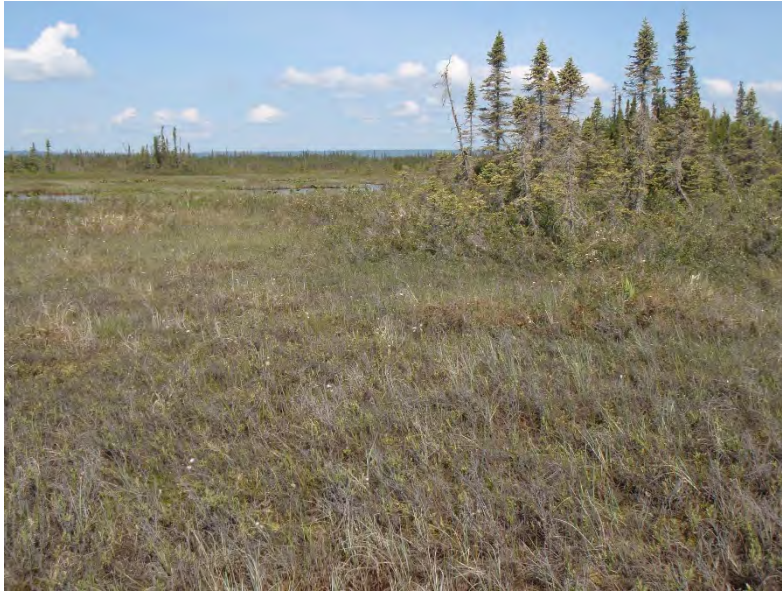
Slope wetlands are usually dominated by scrub black spruce with an understory of ericaceous shrubs and a dense mat of sphagnum moss. Black spruce forested wetlands are found at the base of slopes where hillsides become wetter. The Cowardin functional class includes both stunted scrub and full-size trees. Slope HGM wetlands include patterned fens, hillside seeps, spring-fed wetlands, and wetlands at the base of bluffs or hills where groundwater is discharged near the surface, and also includes flooded bottomland slope wetlands and string bogs in the Cook Inlet Basin. Slope HGM wetlands have downslope, unidirectional flow of water.

Photo 8 and Photo 9 are examples of slope HGM wetlands.

Photo 8 Open Willow Shrub Slope HGM Wetland, Happy River Watershed

Photo 9 Ericaceous Bog – String Bog, Slope HGM Wetland, Beluga River Watershed
