ATTACHMENT B5 APPLICANT'S COMPENSATORY MITIGATION PLAN

Donlin Gold Project
Department of the Army Permit POA-1995-120
July 2018

Block 23. Avoidance, Minimization, and Compensation

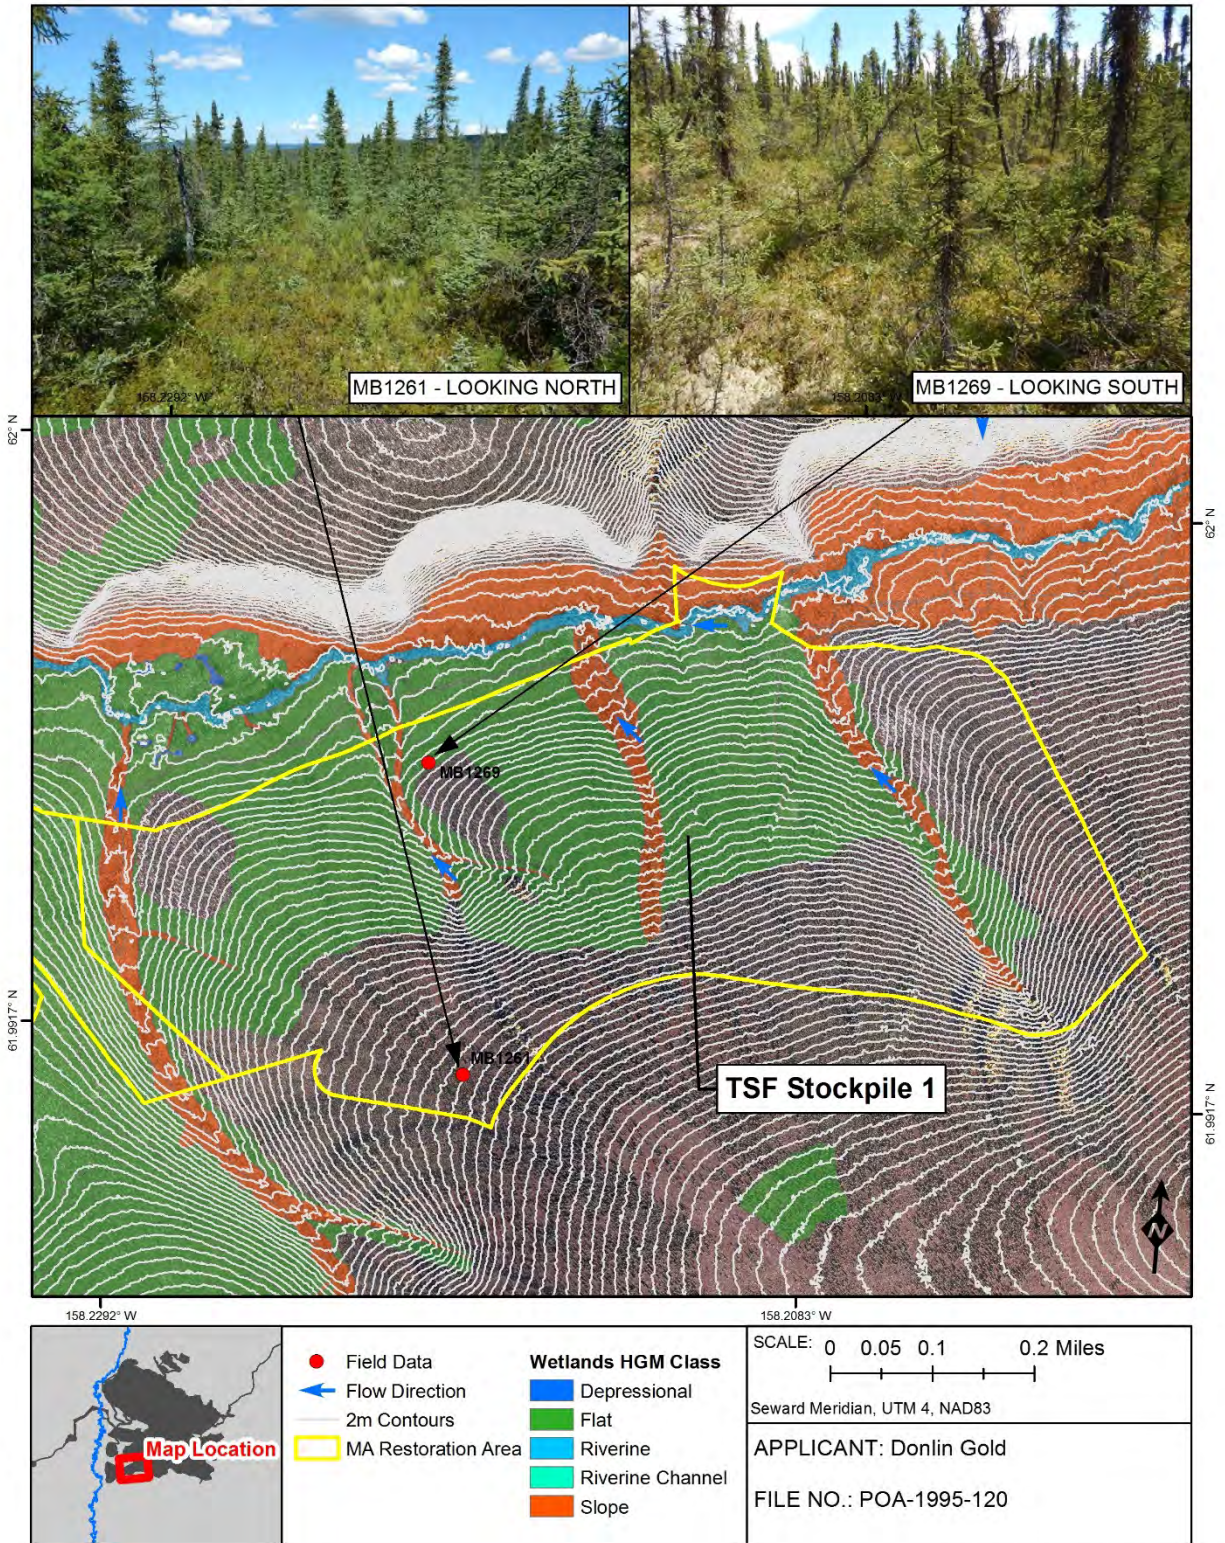
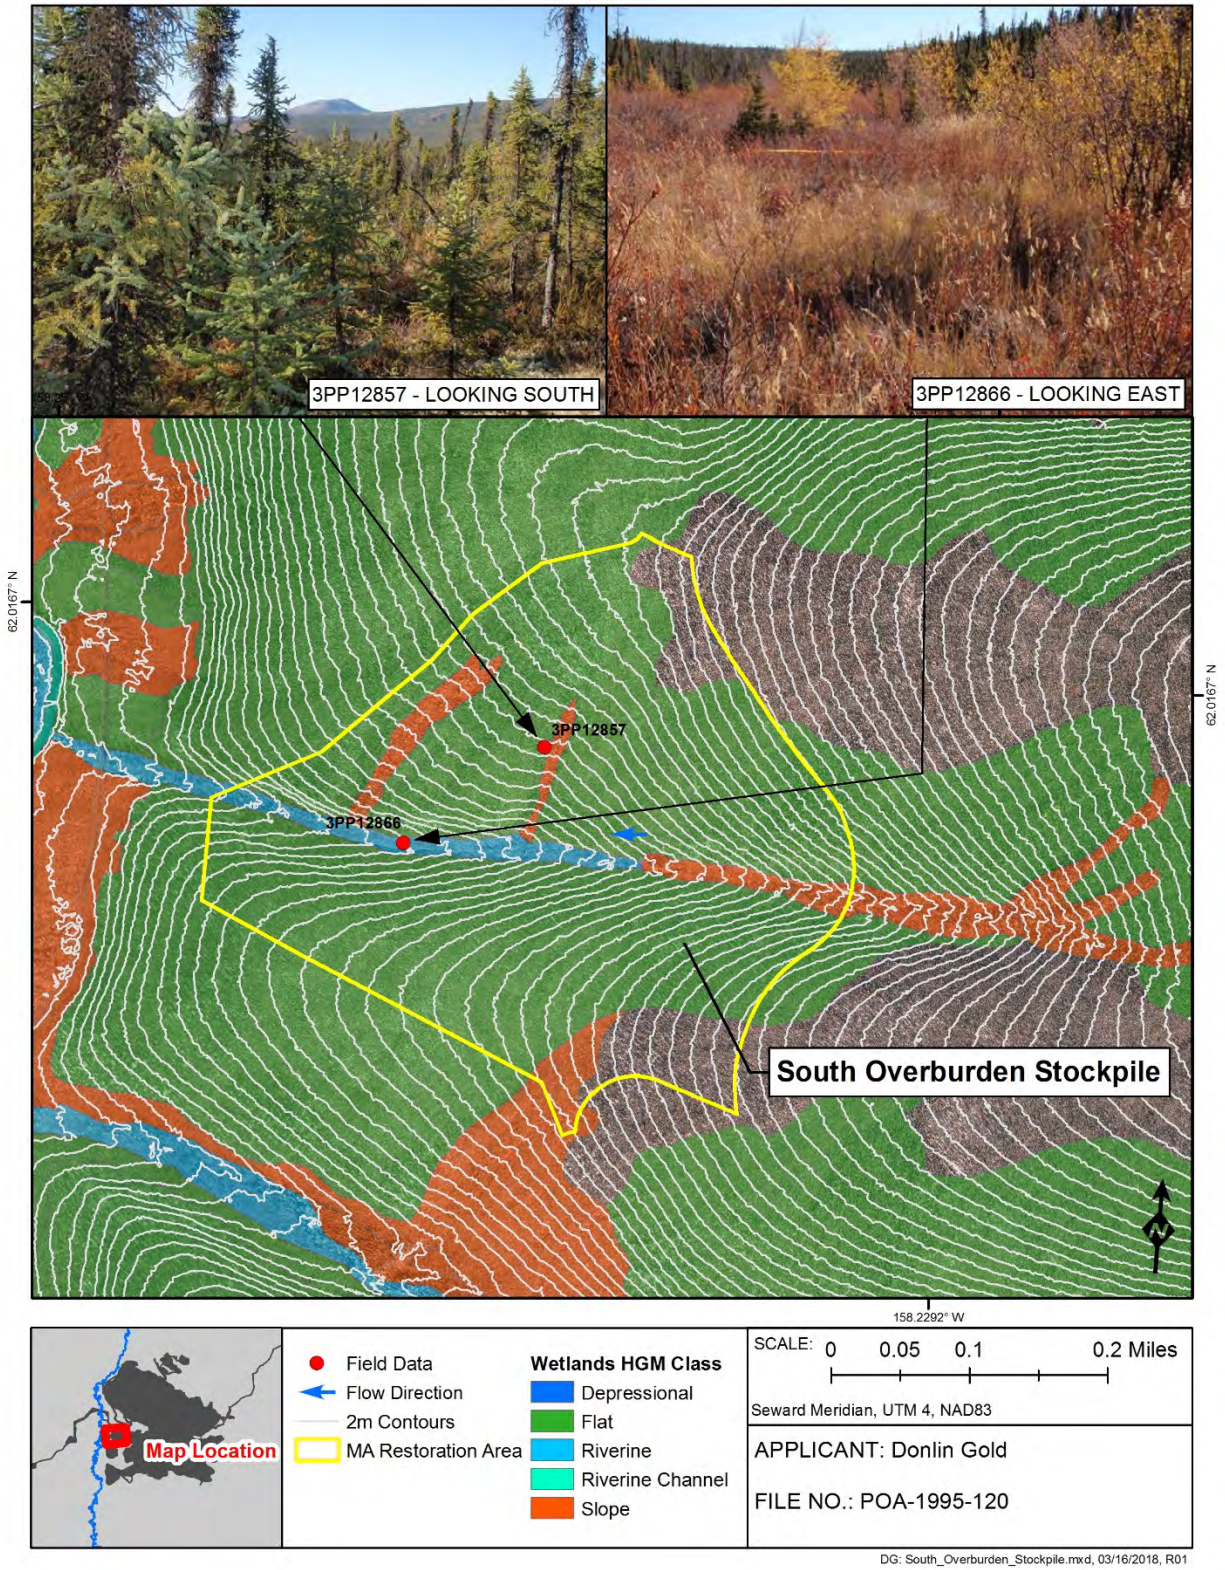
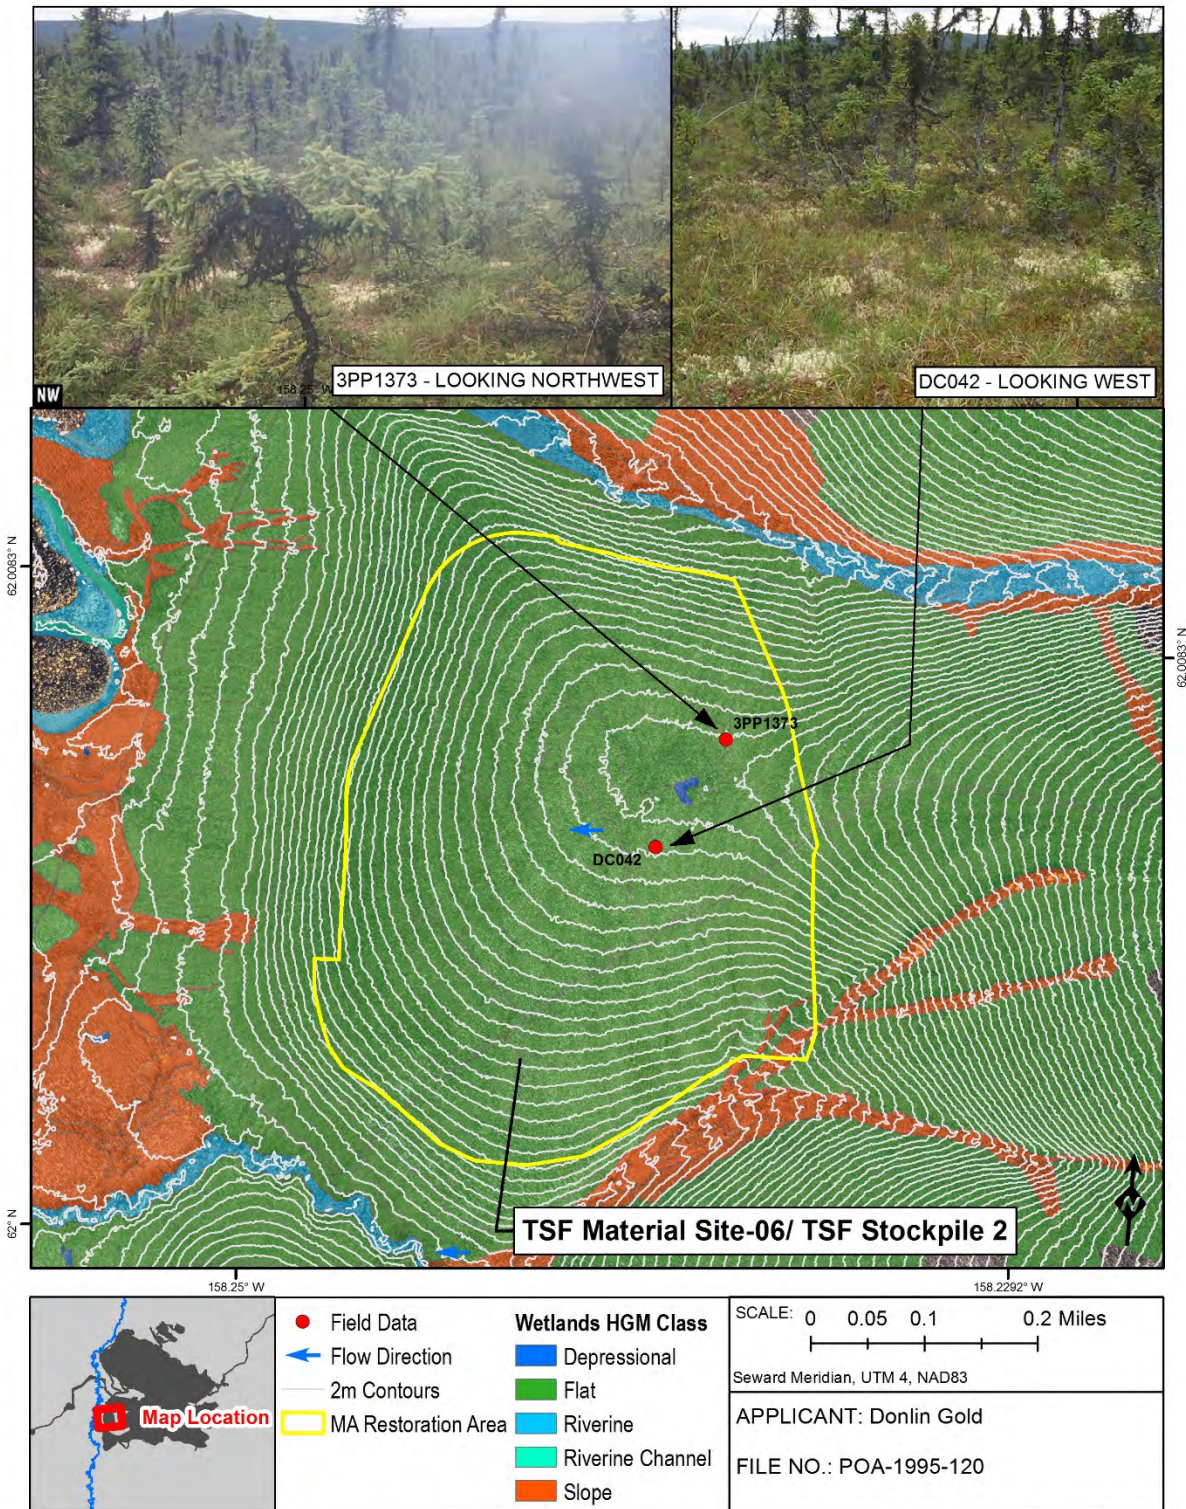
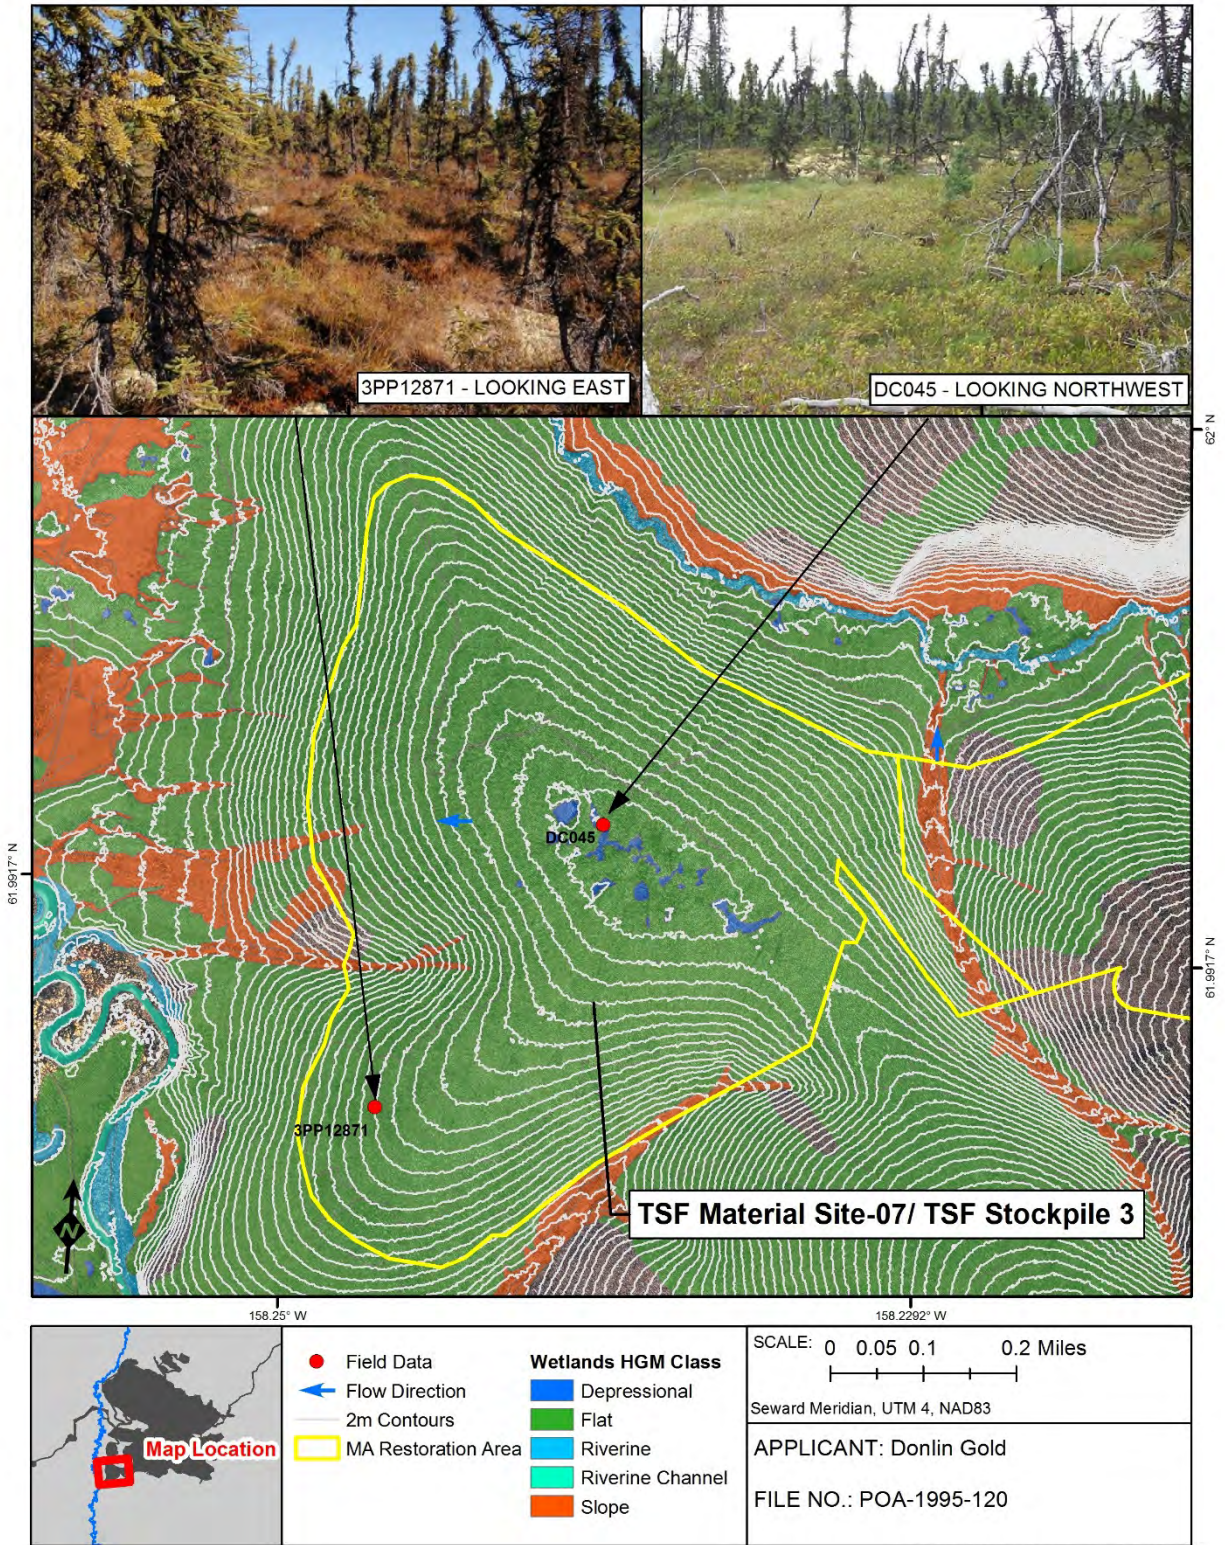
Once mine construction in the MA begins, TSF Stockpile 1 and the South Overburden Stockpile will be established for long-term storage of overburden and growth media (native soil material) collected during construction of other mine facilities. In addition, two material sites, TSF Material Sites 06 and 07, will be developed to source gravel for the construction of MA facilities. Once the gravel extraction is complete, these material sites will be used for long-term storage of overburden and growth media (as TSF Stockpiles 2 and 3).

At mine closure, the overburden and growth media will be removed and used for mine closure per State standards in other locations of the facility footprint. After removal of the stockpiles, the four storage areas will be restored to wetlands. Two of the stockpile locations (the former material sites) will be re-contoured as concave, depressional features, which will hold water. The other two stockpiles are located on precipitation-driven wetlands [flat hydrogeomorphic (HGM)] wetlands; see the Donlin Gold Compensatory Mitigation Plan (CMP) Attachment B for HGM information. In flat HGM wetlands, water perches on shallow frozen soils, creating saturated conditions. Water drawdowns in the MA will not affect these sites; permafrost found at these sites will remain after removal of the stockpiles and wetland vegetation will re-establish [BGC Engineering, Inc. (BGC) 2018].

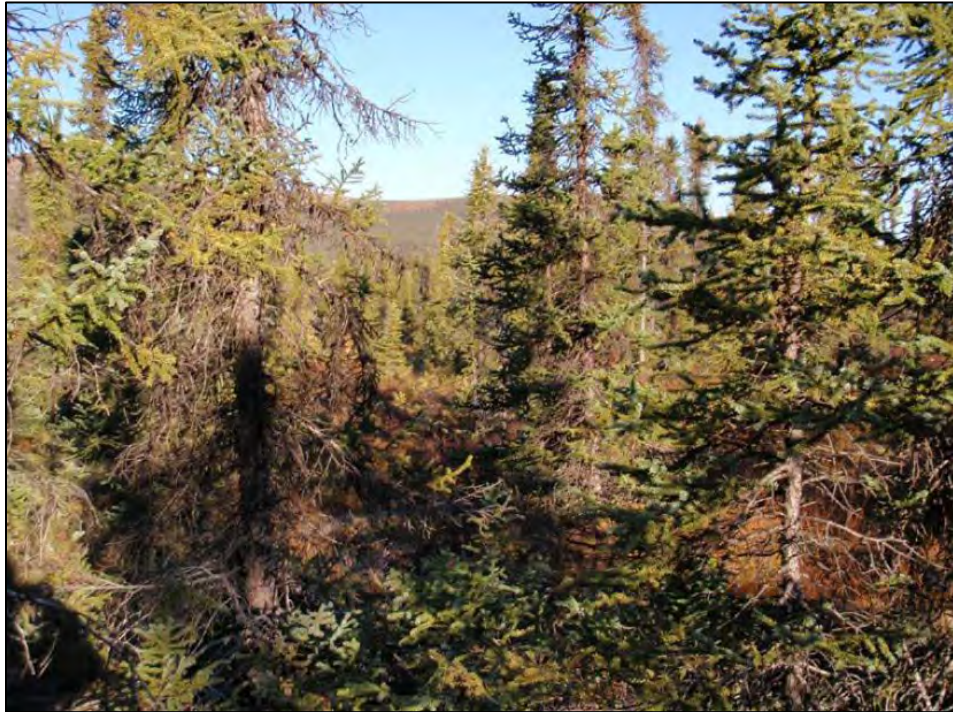
Photo 1 Open Black Spruce Forest Vegetation Type

Typical OBSF forested Cowardin classifications (Cowardin et al. 1979) include PFO4/SS1B and PSS4/1B (Photo 1) (all photos and Cowardin classifications are from the 2016 PJD; Michael Baker 2016). The BSW vegetation type is characterized by a sparse canopy (cover, 10 to 25 percent) of trees and saplings dominated by black spruce. Dominant understory species are typically the same as for OBSF. Typical spruce woodland Cowardin classifications include PSS1/FO4B and PSS1/4B (Photo 2).

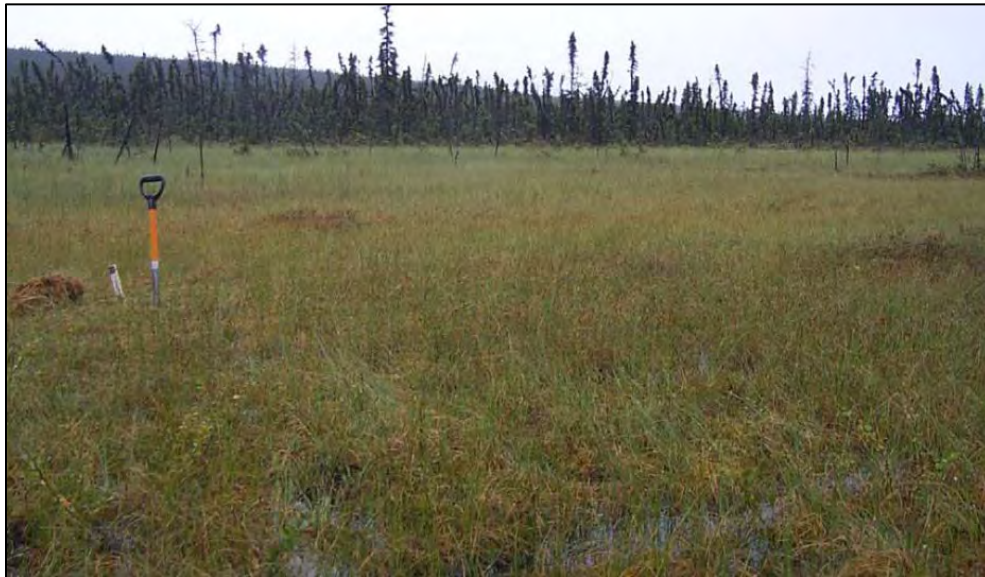
Photo 3 *Wet Herbaceous Vegetation Type*

After removal of the stockpiles, initial vegetation types will be the wet herbaceous (WH) vegetation type. This vegetation type is characterized by a sparse canopy of tree and saplings (cover, less than 10 percent), and an overall shrub cover of less than 25 percent (Photo 3). Dominant species for this vegetation type in the Crooked Creek watershed include leafy tussock sedge (*Carex aquatilis*), pumpkin-fruit sedge (*Carex rotundata*), purple marshlocks (*Comarum palustre*), water horsetail (*Equisetum fluviatile*), cottongrass (*Eriophorum* spp.), and bluejoint (*Calamagrostis canadensis*). These plots typically have a Cowardin classification of PEM1C. Restoration to the WH vegetation type will provide additional diversity within the black spruce forests of the area. WH vegetation types within the Crooked Creek watershed account for 0.7 percent of the 24,178 acres mapped (Michael Baker 2016).

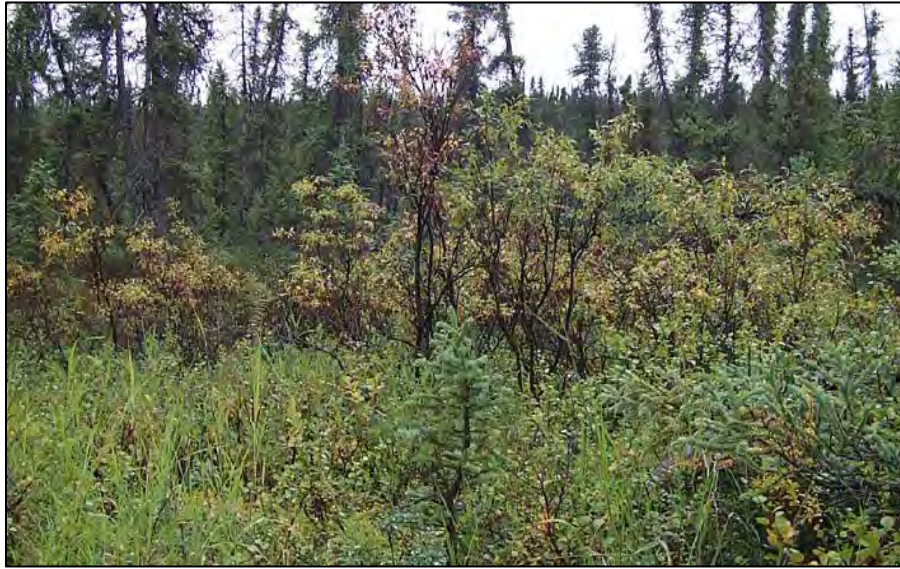
Photo 4 Open Alder Willow Shrub Vegetation

Areas flooded by the Snow Gulch freshwater reservoir will restore as open alder willow shrub (OAWS) and open willow shrub (OWS) vegetation types, similar to the understory of the existing valley bottom. Species commonly found in wetland OAWS plots include speckled alder (*Alnus incana*), Sitka/green alder (*Alnus viridus*), diamond-leaf willow (*Salix pulchra*), Steven's Meadowsweet (*Spiraea stevenii*), alpine blueberry, and bluejoint (Photo 4). Species commonly found in wetland OWS plots include several species of willow depending on landscape position, including diamond-leaf willow, felt-leaf willow (*Salix alaxensis*), and little-tree willow (*Salix arbusculoides*). Understory shrubs include swamp birch and alpine blueberry. Understory herbaceous species include bluejoint and purple marshlocks (Photo 5). Typical Cowardin classifications for OWS and OAWS are PSS1 and PSS1/EM1 with an A or C water regime.

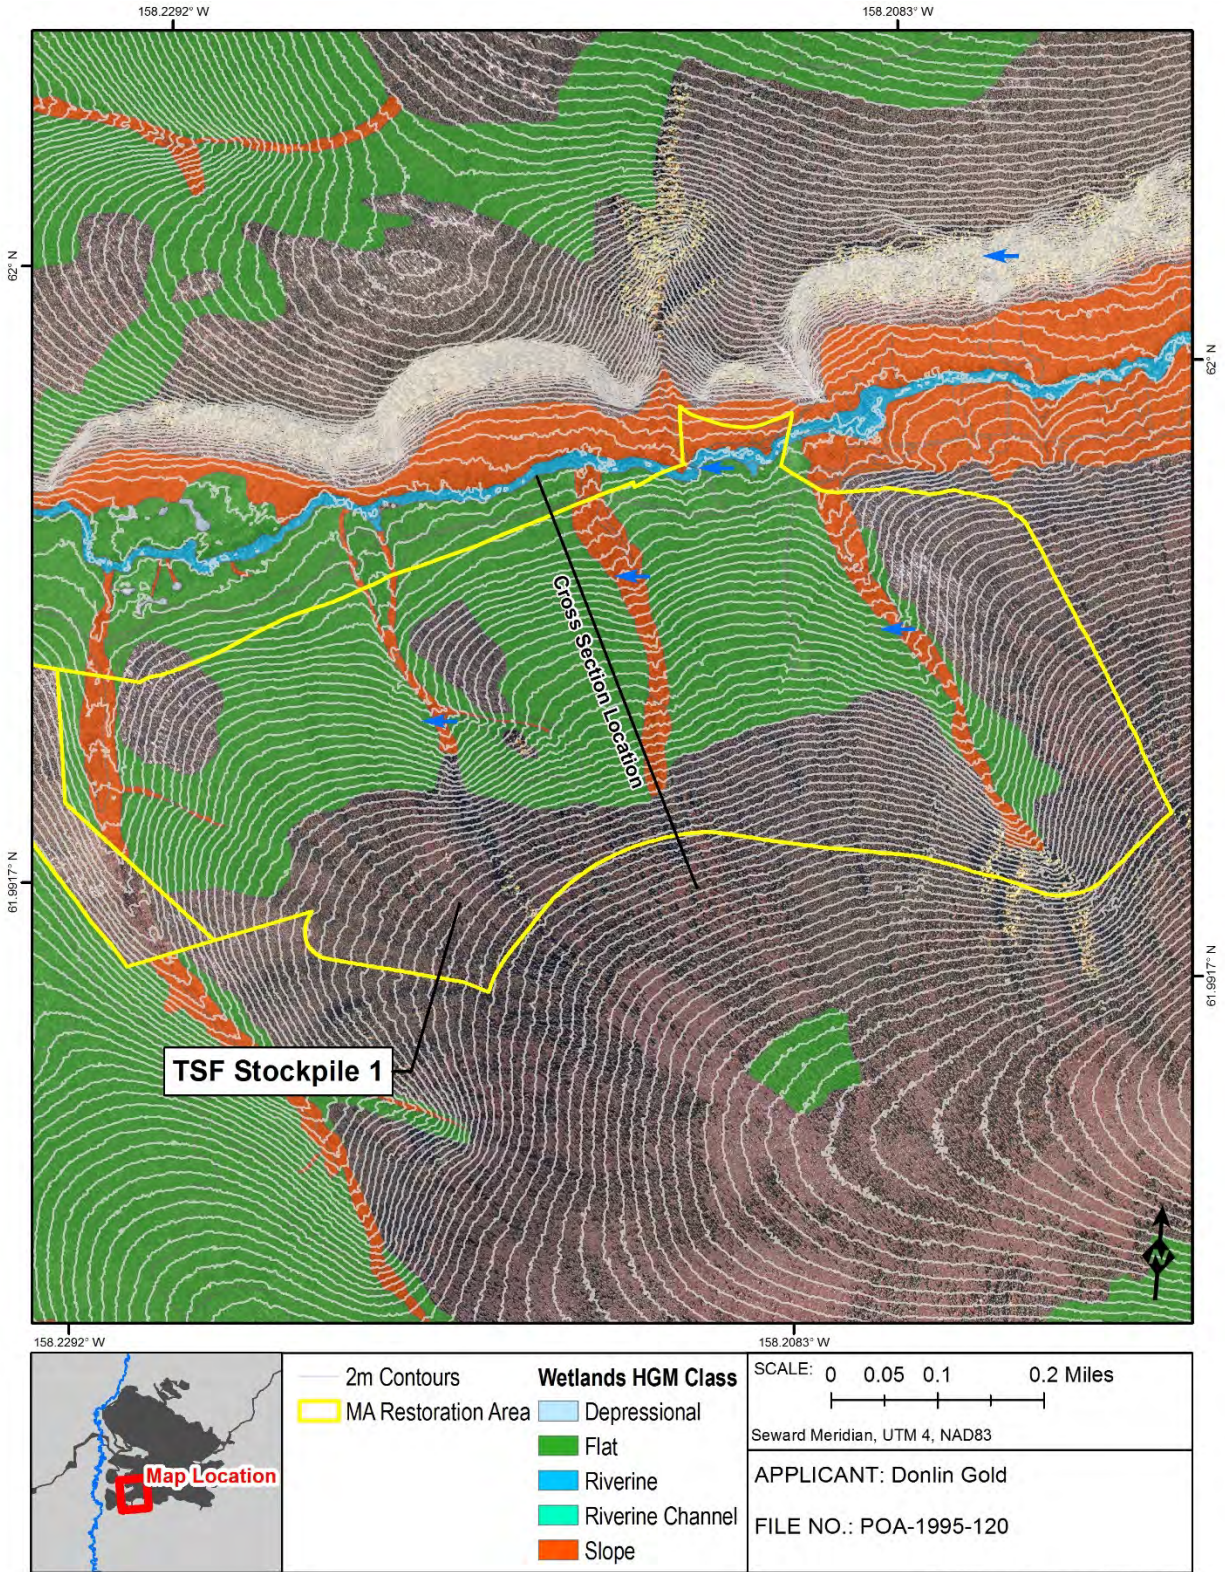
Figure 8 TSF Stockpile 1 MA Restoration

Figure 8 through Figure 12 are maps of the restoration sites post-mining. Cross-sections are provided for planning purposes (Figure 13 through Figure 16); the locations of the cross-sections are shown on the corresponding map figure.

Groundwater modeling for the TSF Stockpile 1 site shows available water for this site will not be impacted by mine site dewatering; groundwater conditions and surface runoff at closure will be comparable to current conditions (BGC 2018). Many of the holes drilled in this site's footprint encountered permafrost (BGC 2018). The wetlands within this site are flat HGM on the hillsides, and slope HGM in minor swales (Michael Baker 2016).

Permafrost is expected to remain after restoration, which will allow for precipitation-driven wetlands to re-form. In addition, when contours are re-established, the minor swales will re-form as minor drainages, with OWS and OAWS type wetland vegetation re-establishing. Swales and the concave areas at the bottom of the hillside adjacent to Anaconda Creek are expected to re-establish quickly, while the hillsides will take longer as precipitation collects, saturates, and reduces the soil horizons.

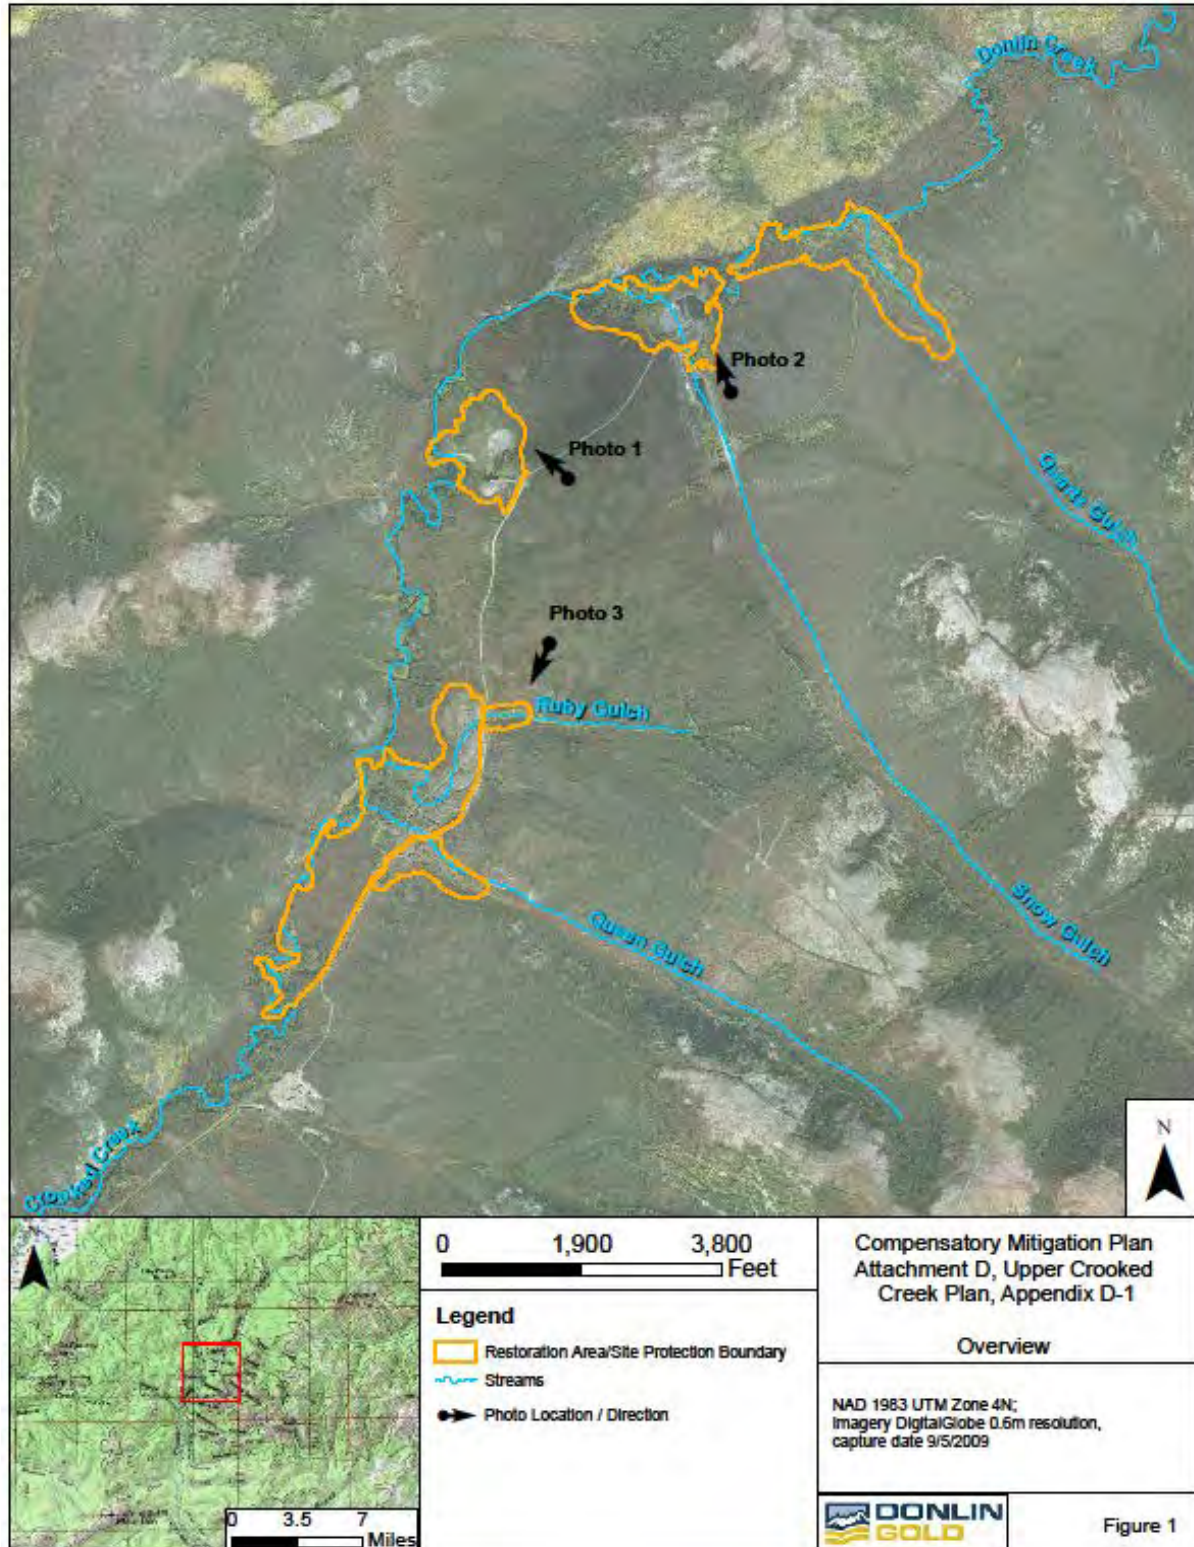
Figure 1 Upper Crooked Creek Permittee Responsible Mitigation Plan Area Overview

The objective of this Plan is to return naturally occurring, self-sustaining wetland and stream functions to the upper Crooked Creek watershed. The Plan fulfills this objective by re-establishing floodplains and stream channels to pre-placer mining parameters using a stream functional framework and reference reaches upgradient of the impacted areas. The total benefits from this plan are presented in Table 1.

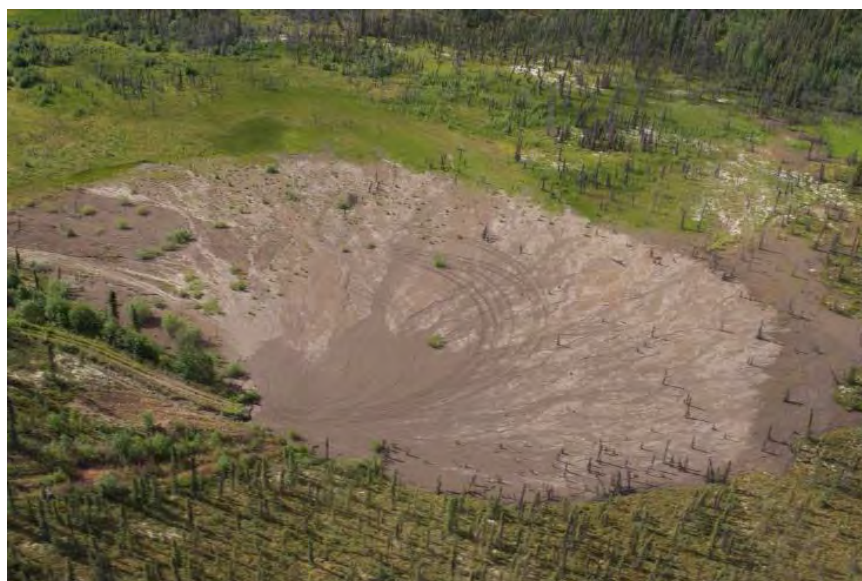
Photo 1 Placer Mining Wash Plant Tailings Area (View toward Northwest)

Historical gold placer mining has occurred in the proposed restoration areas since the early twentieth century. Placer tailings and overburden have been deposited in several locations within the various floodplains, causing adverse impacts to aquatic resources (Photo 1). Water diversion ditches were constructed, resulting in the channeling of surface and shallow groundwater flow from the original stream paths. An estimated 8,700 linear feet (1.64 miles) of stream channels have been mined and the abutting wetlands degraded. No placer mining is currently ongoing in any of the drainages. Photo 2 and Photo 3 show placer disturbance in lower Snow, Ruby, and Queen Gulches.

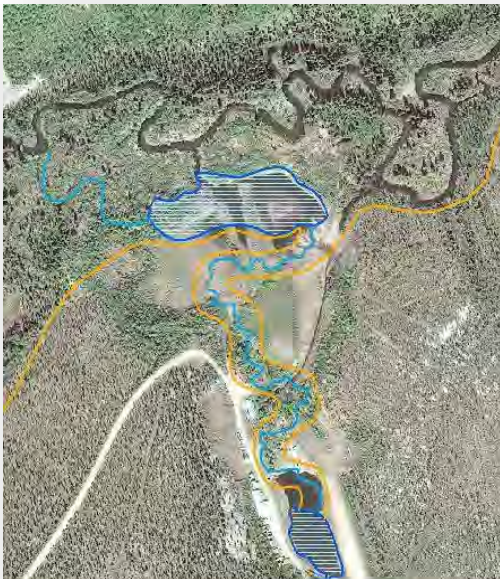
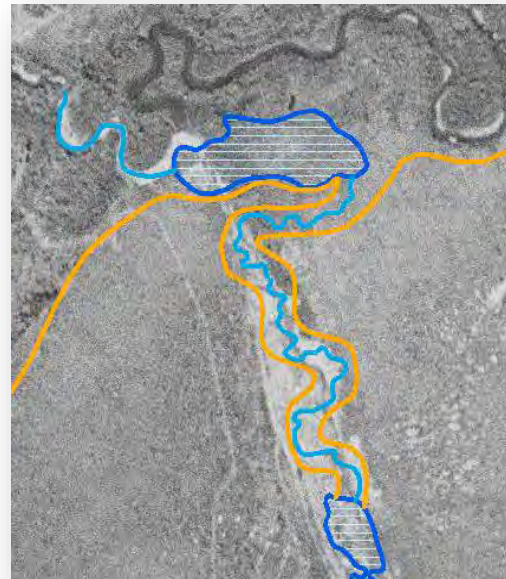
Figure 3 *Comparison of Recent and Historical Aerial Imagery for Snow Gulch Outlet to Donlin Creek*

Note: Post-construction stream channel and ponds shown on both images.

A portion of the historical connection between the lower pond and Donlin Creek will have to be re-excavated to remove placer tailings, but the remaining oxbow channel will be re-watered in its present condition. Reintroduced stream flows are expected to reform a small thalweg within the oversized and vegetated channel. These historical channels are typically incised less than 1.5 to 3 feet into the surrounding floodplain, which makes it difficult for beavers to completely block fish passage. Inclusion of historical channels in the completed channel design should protect the system from blockage by beavers, a problem that currently exists in the narrow, deeply incised ditch exiting the middle and lower ponds. The pond margins themselves will be returned to an elevation approximately equal to the surrounding floodplain, making blockage of fish passage by beaver dams difficult. It is assumed that the original floodplain vegetated mat will be encountered as the placer mining tailings are removed, which will both serve as a vertical indicator for excavation and provide substrate for the revegetation efforts.

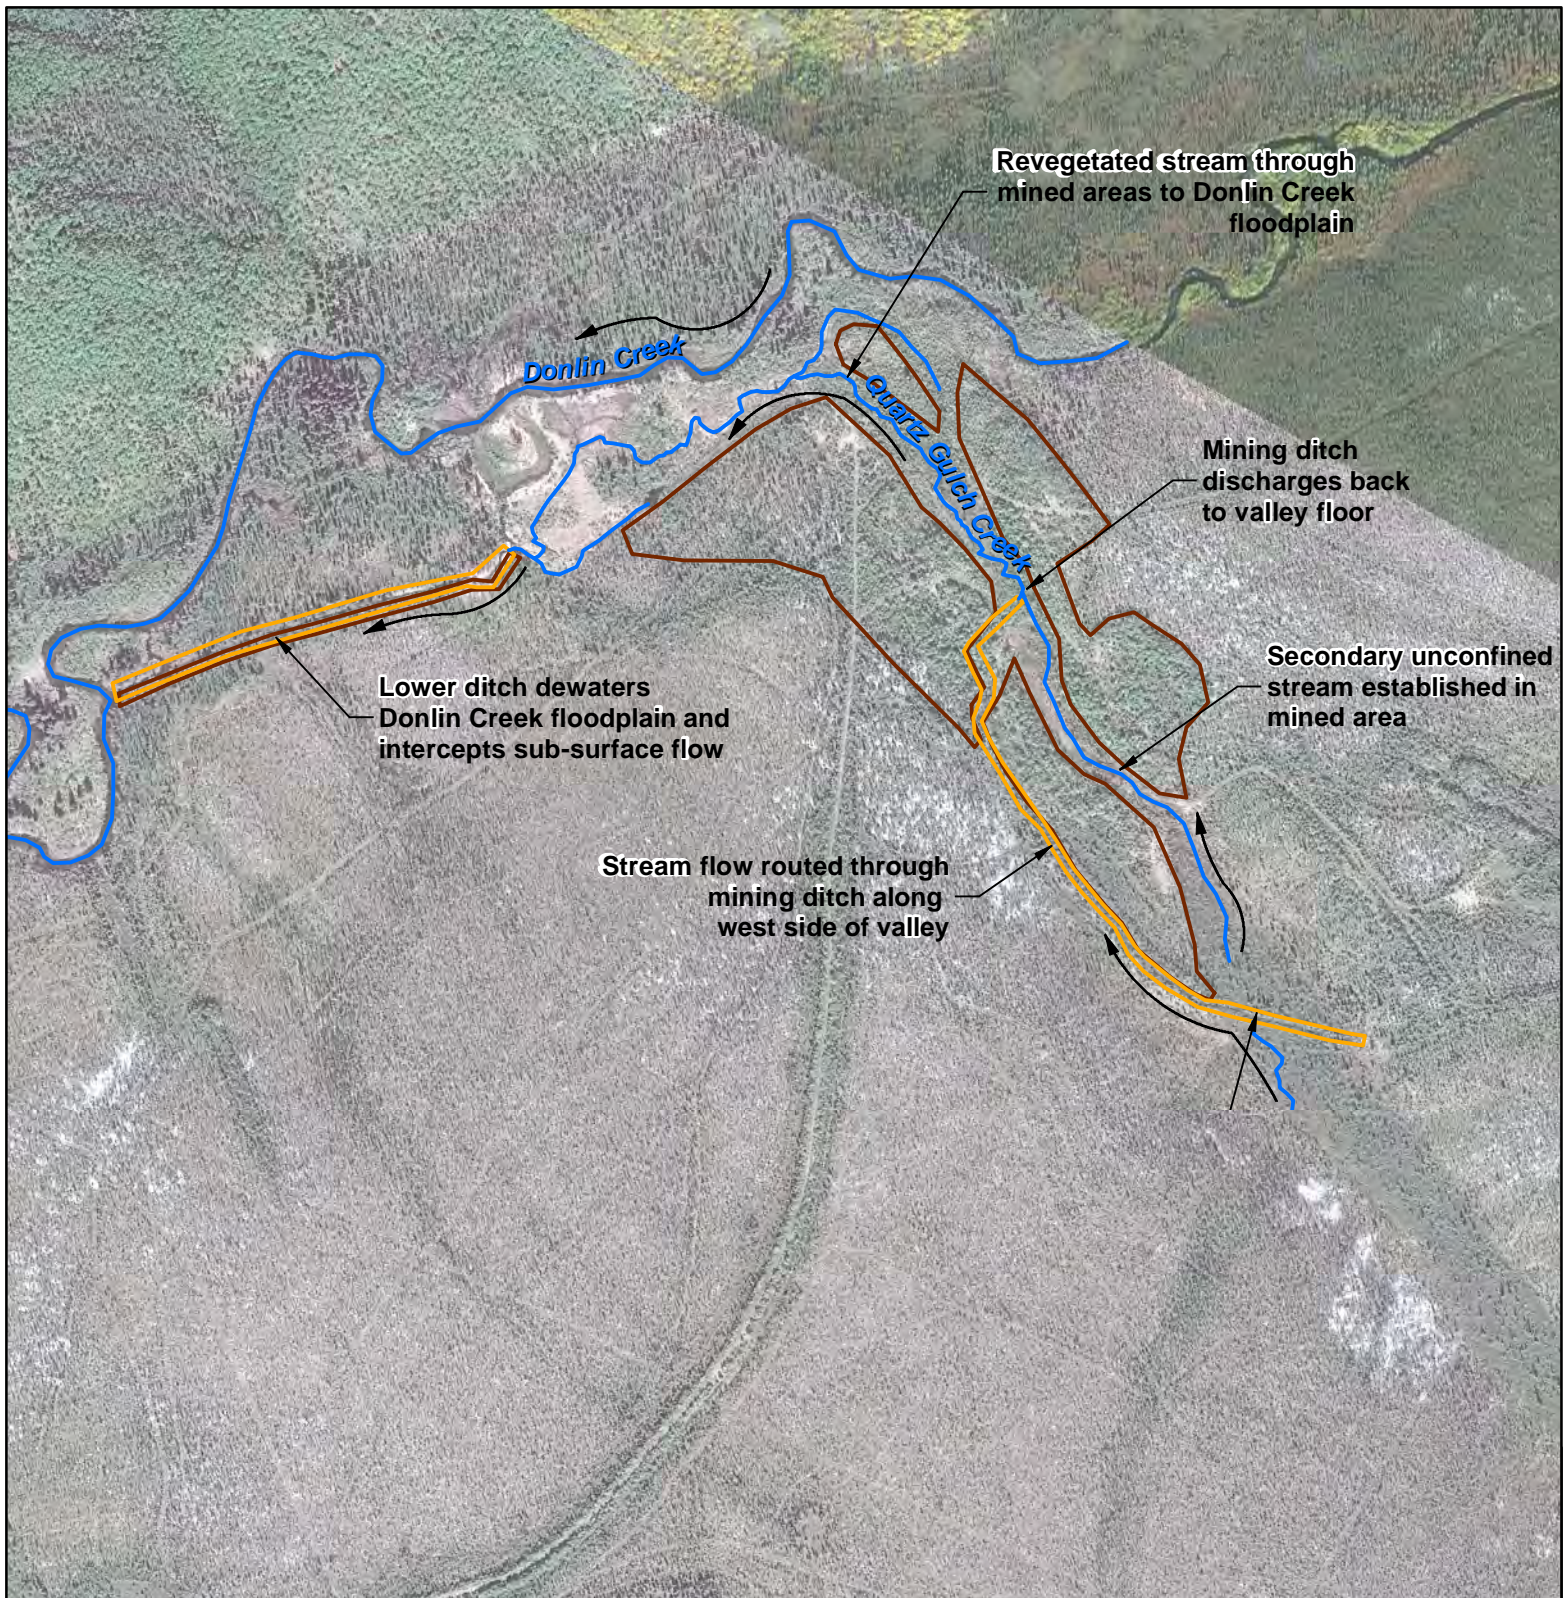
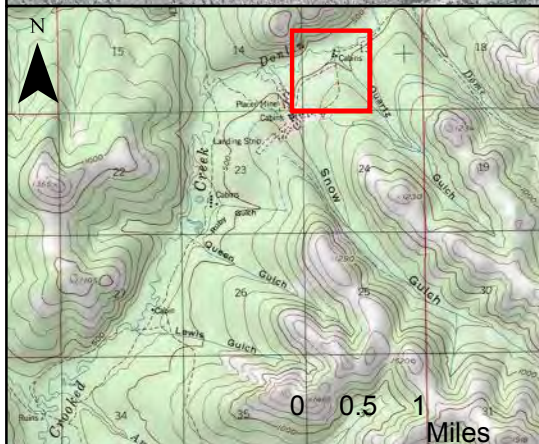
Figure 2

Existing Site Features

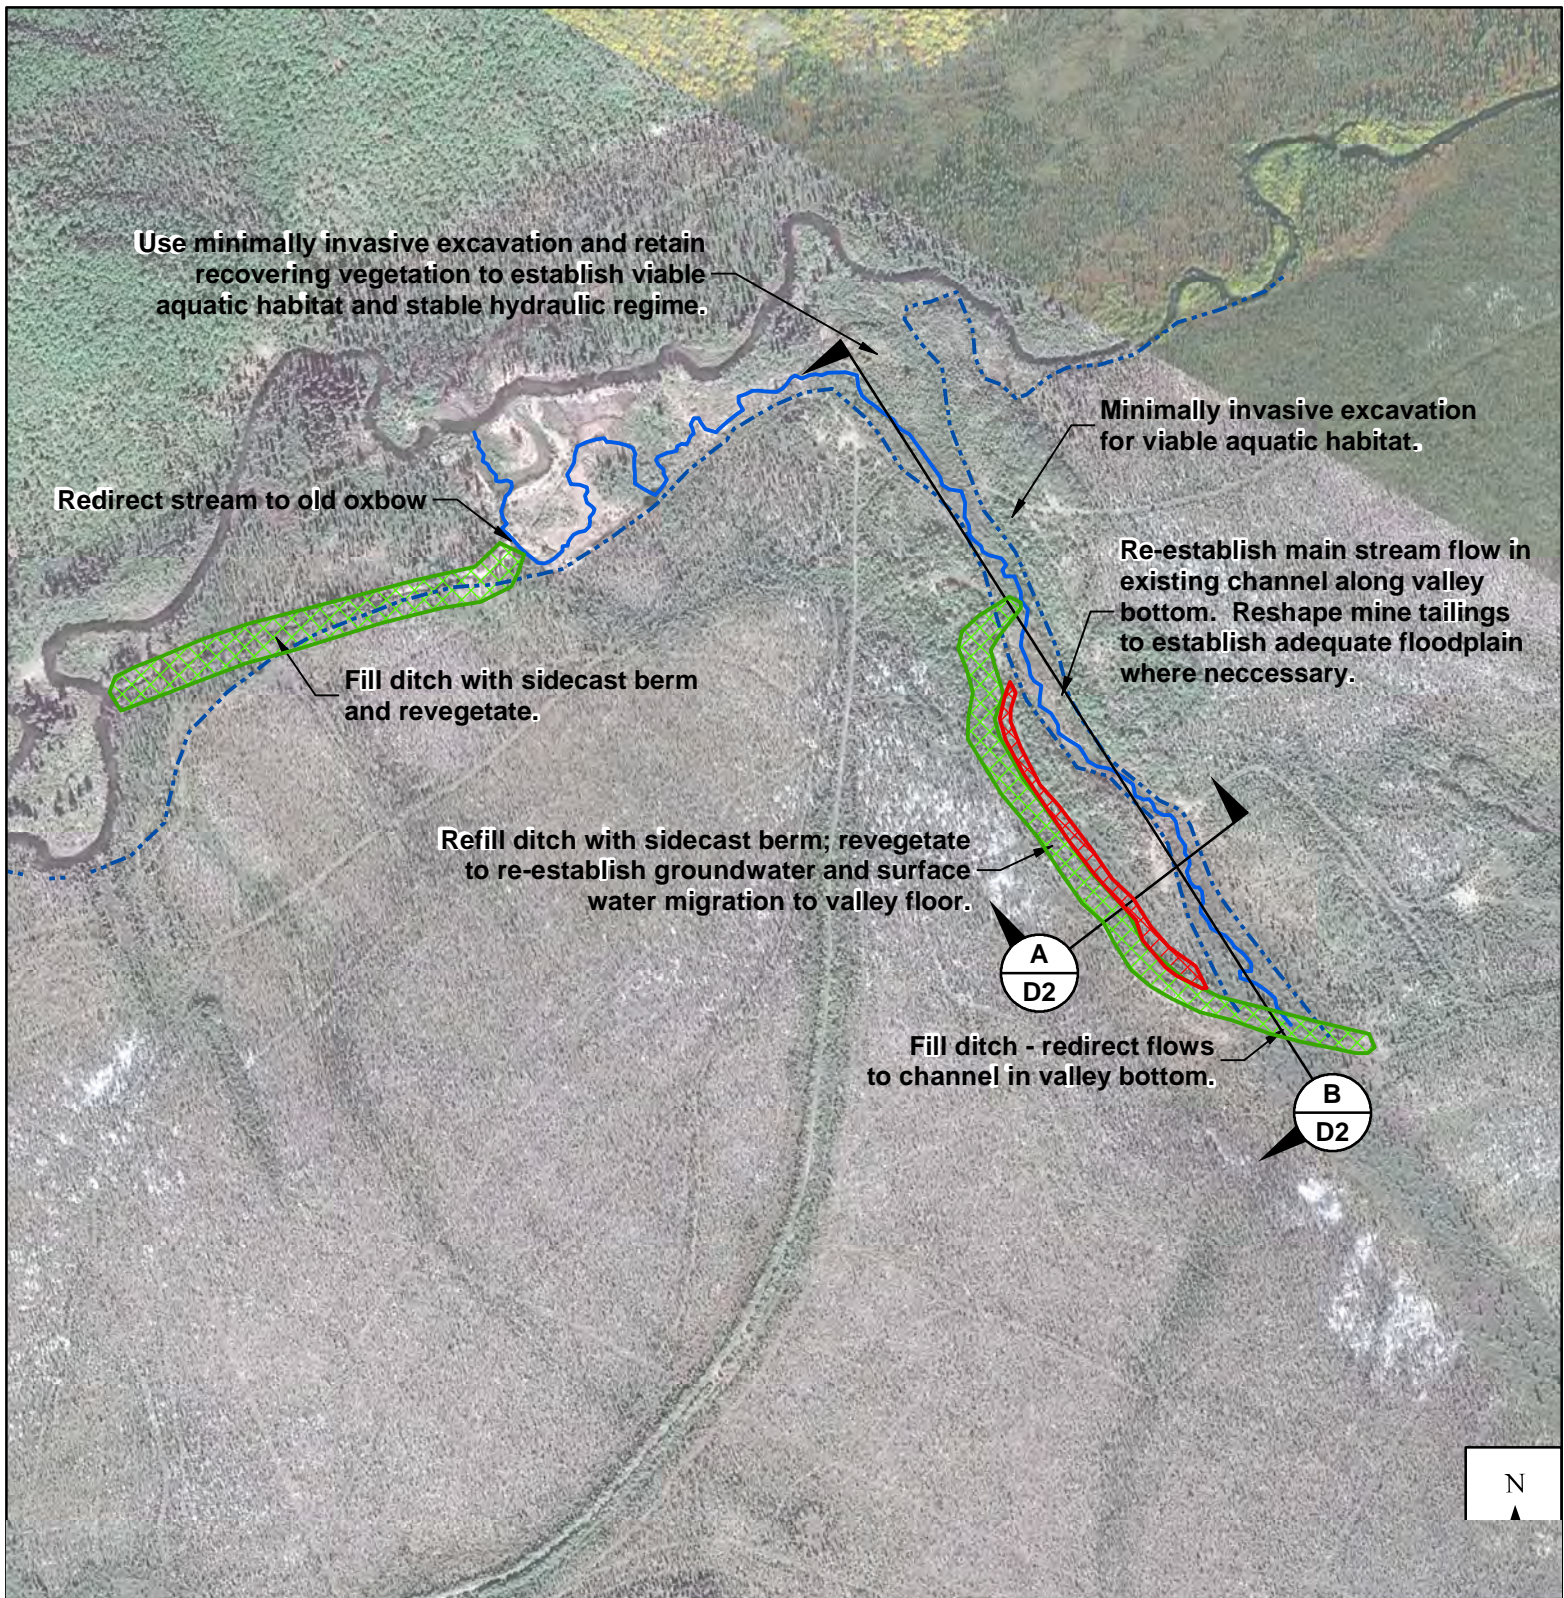
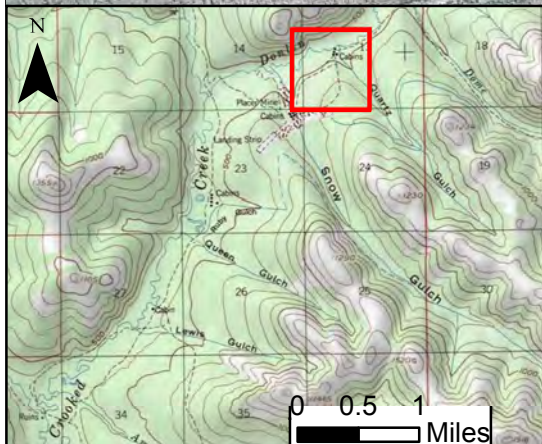
Figure 3

Grading Plan
