ATTACHMENT B5 APPLICANT'S COMPENSATORY MITIGATION PLAN

Donlin Gold Project
Department of the Army Permit POA-1995-120
July 2018

Block 23. Avoidance, Minimization, and Compensation

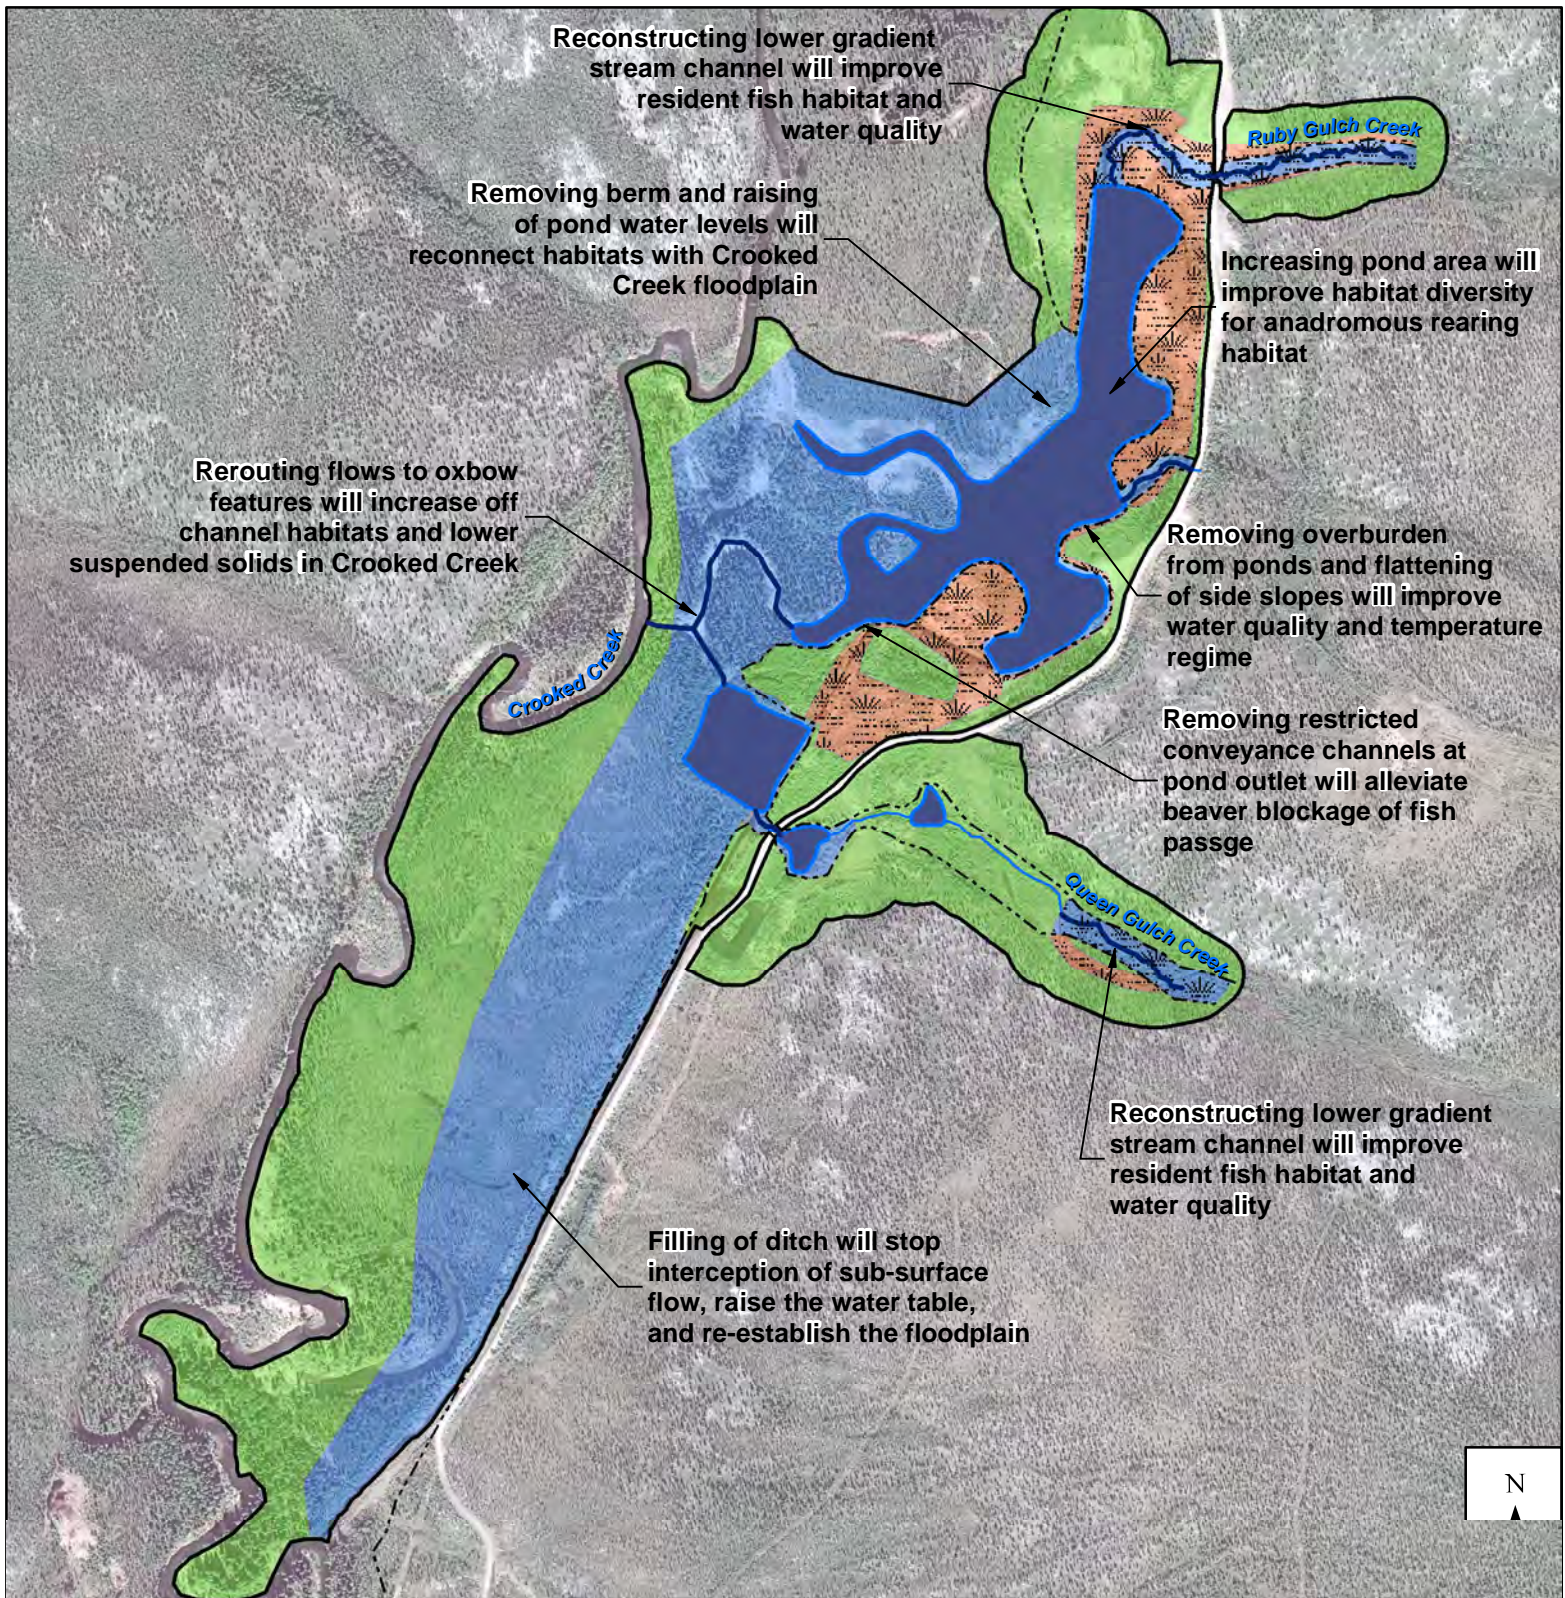
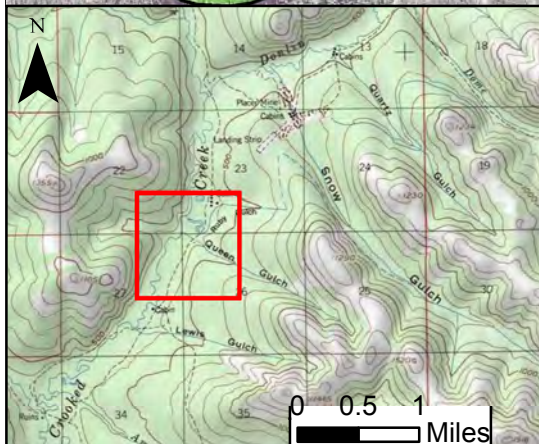
Figure 12 MA Snow Gulch Freshwater Reservoir

Subject to final design refinement, the following work plan sequence is proposed for Ruby and Queen Gulches. Appendix D-1, Figure 12 illustrates the components of this work plan. Appendix D-1, Figure 13 illustrates the proposed outcome of restoration. The work plan includes:

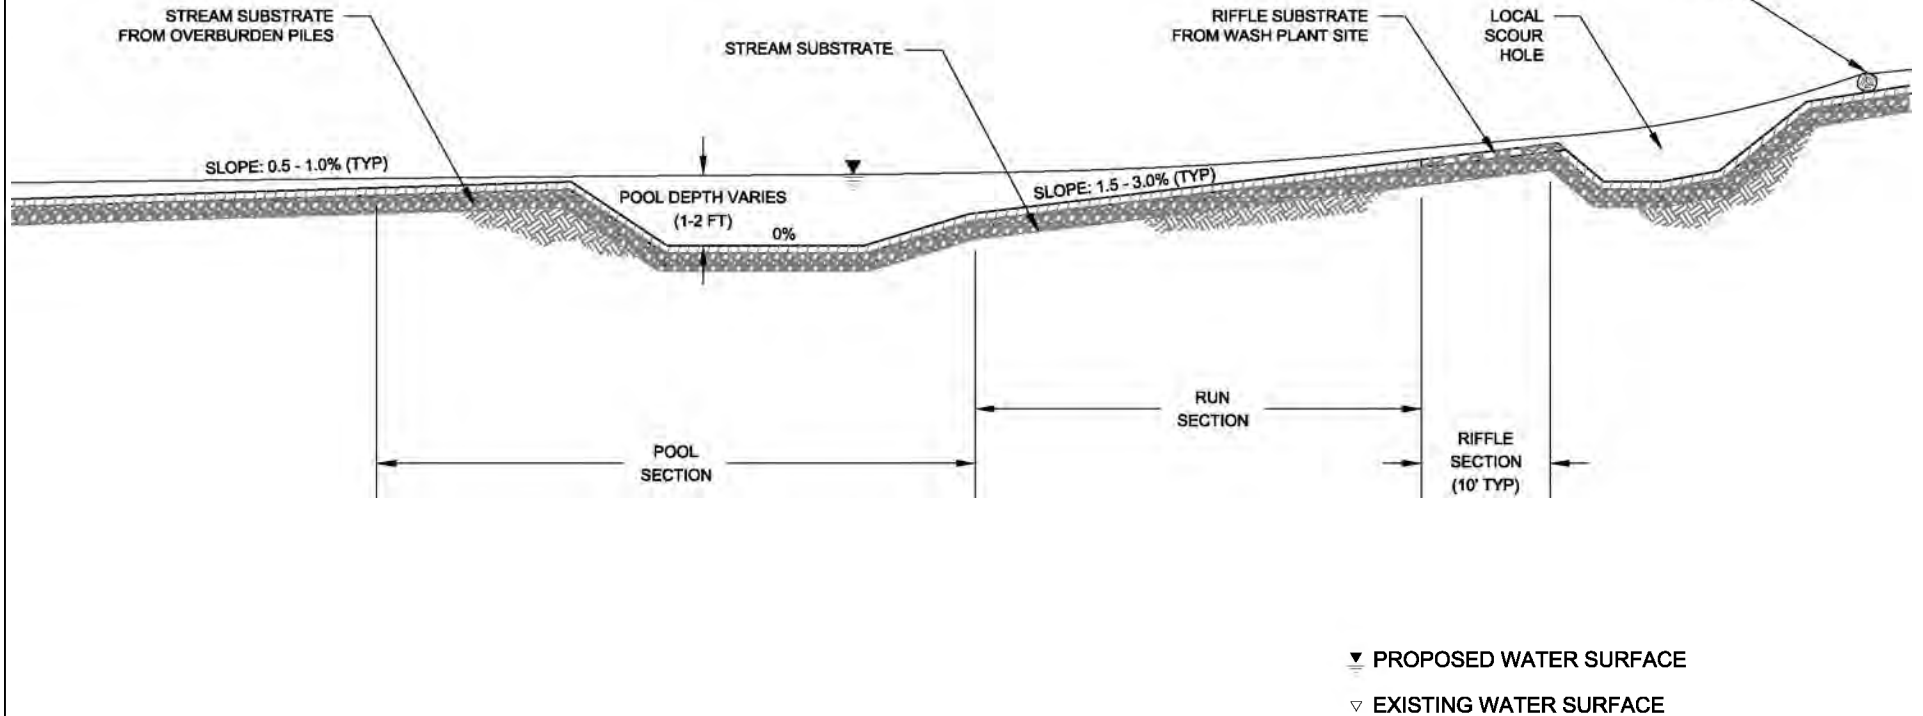
LARGE WOOD DEBRIS GRADE CONTROL STRUCTURE. STRUCTURES MAY OR MAY NOT BE INSTALLED IN EVERY SEQUENCE. SEE SHEET 28 FOR HABITAT & GRADE CONTROL STRUCTURE LOCATIONS.

TYPICAL STREAM CHANNEL PROFILE, RIFFLE-RUN-POOL

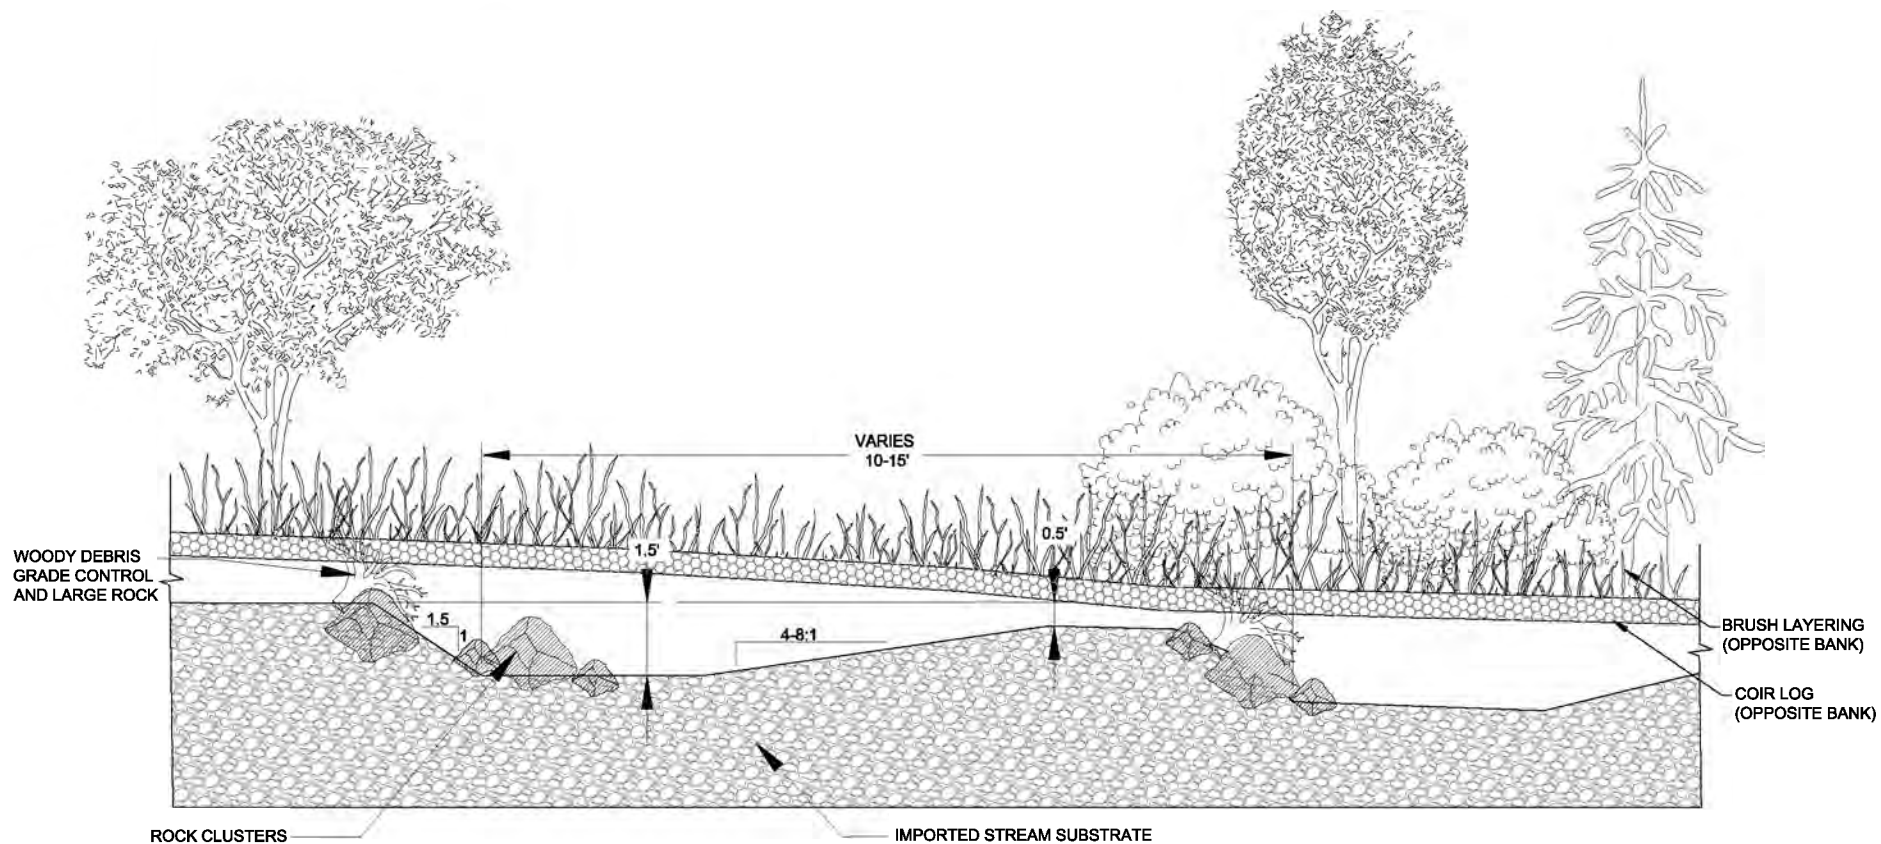
APPENDIX D-2 | SHEET 6

TYPICAL STREAM CHANNEL PROFILE, STEP-POOL

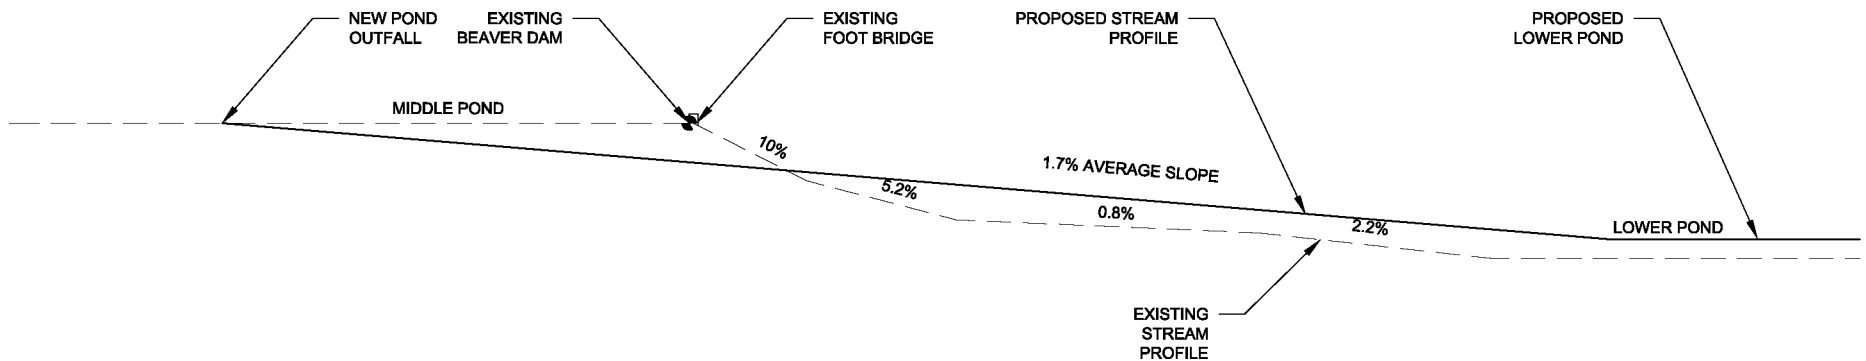
SNOW GULCH PROFILE F

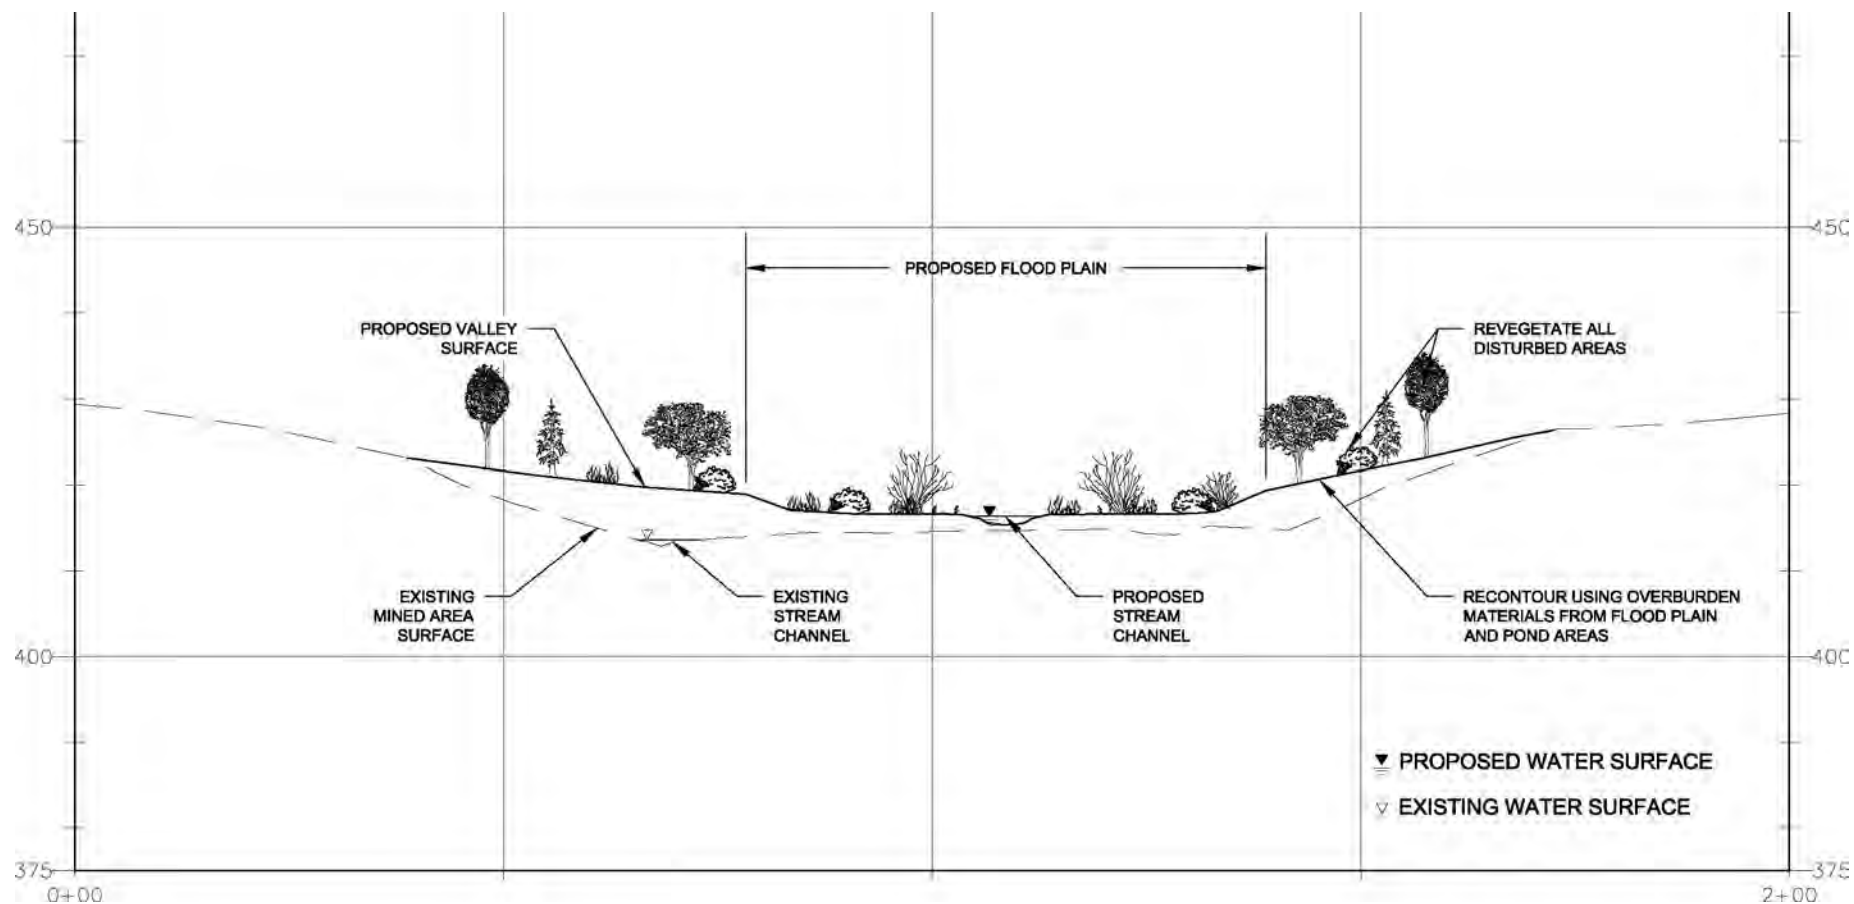
SHEET 11

RUBY GULCH TYPICAL SECTION G

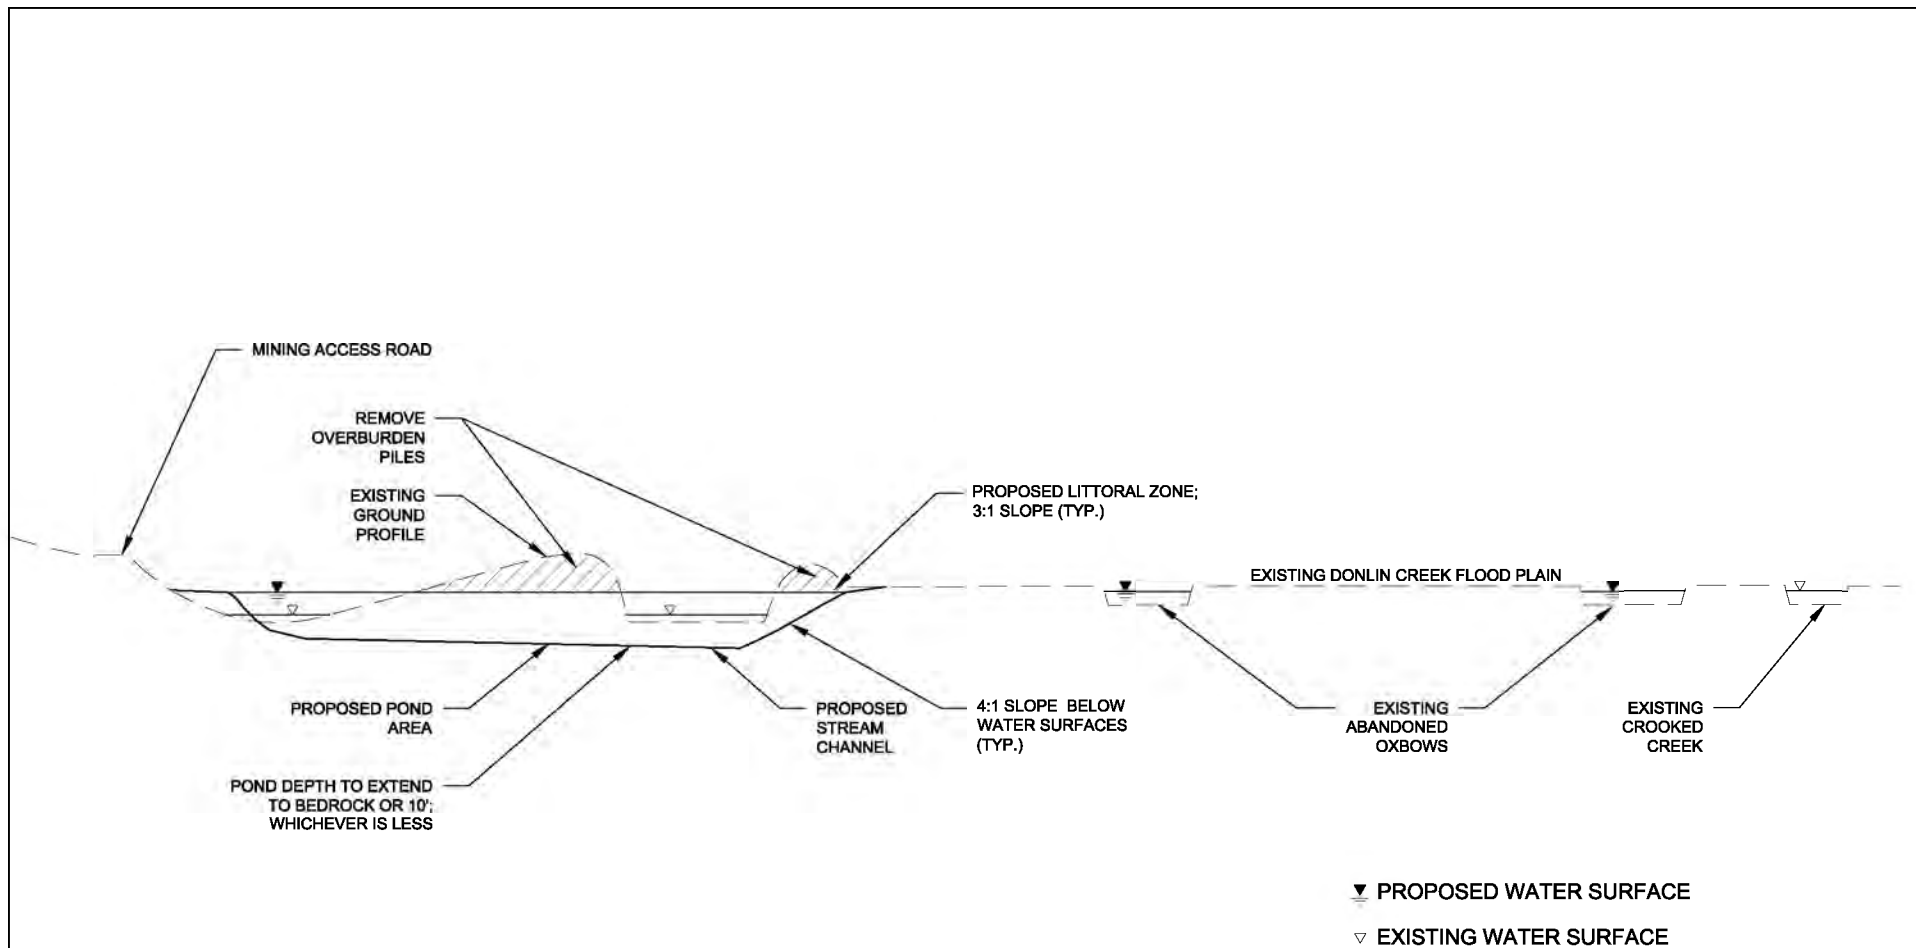
APPENDIX D-2 SHEET 12

RUBY-QUEEN TYPICAL SECTION H

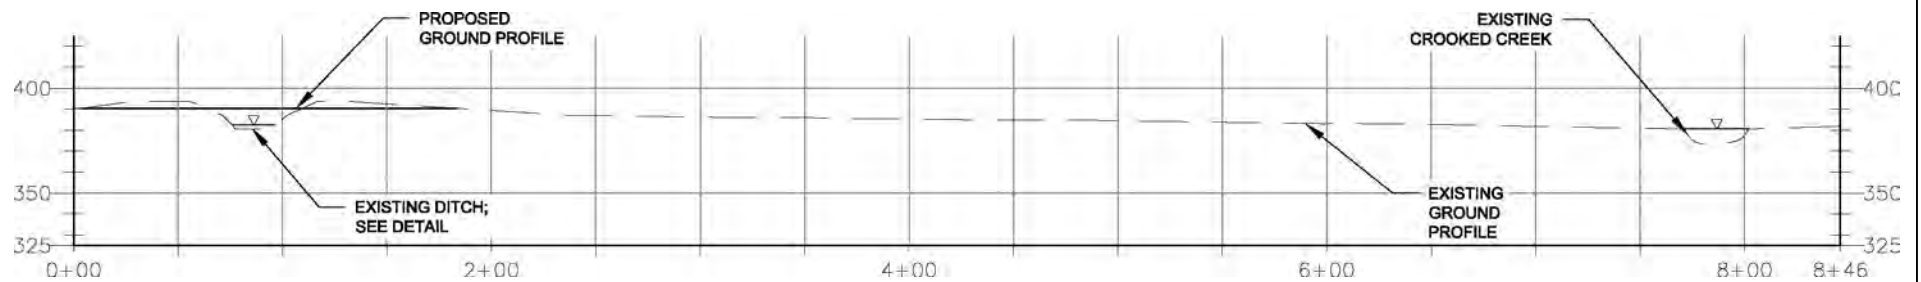
DITCH TYPICAL SECTION

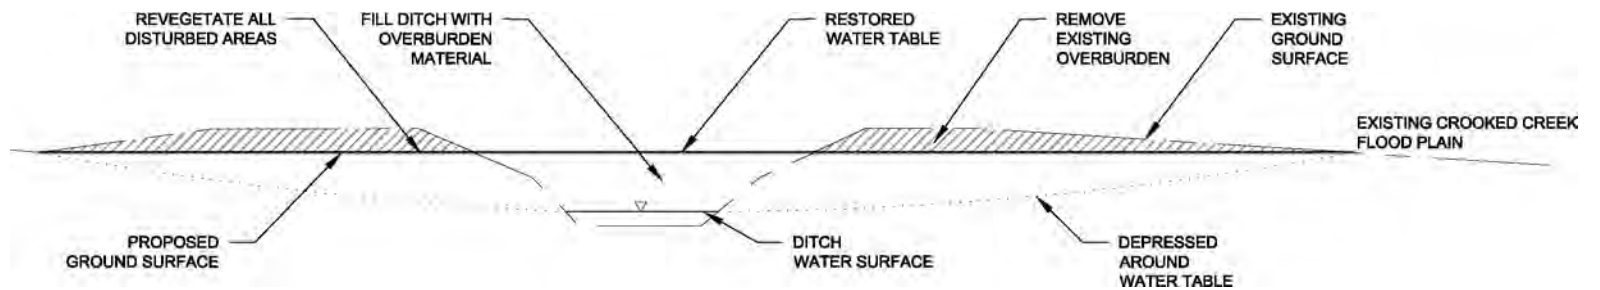
DITCH DETAIL

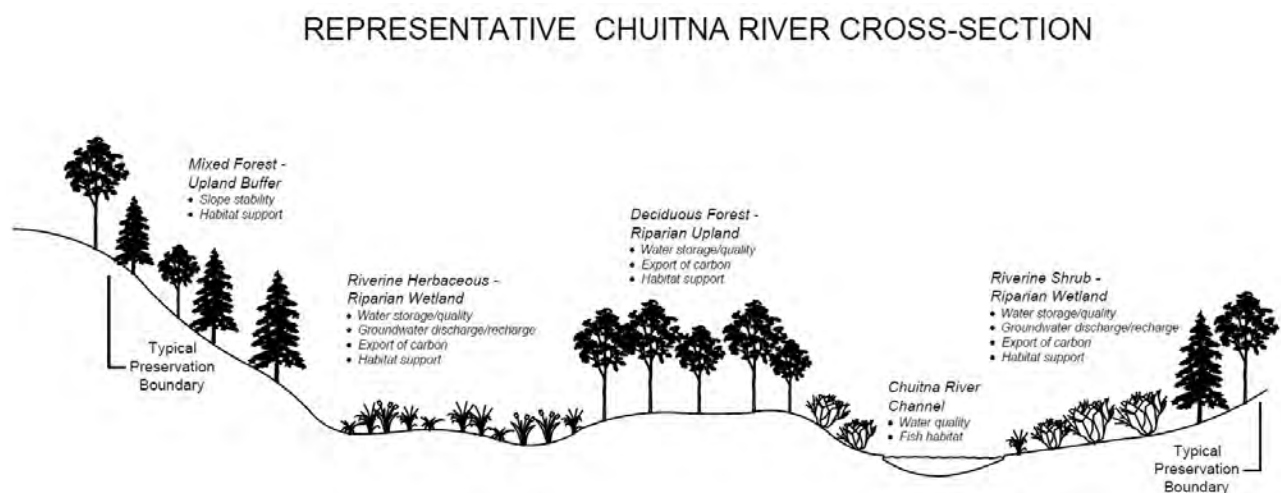
Figure 2 Representative Chuitna River Cross-Section in the Preservation Area

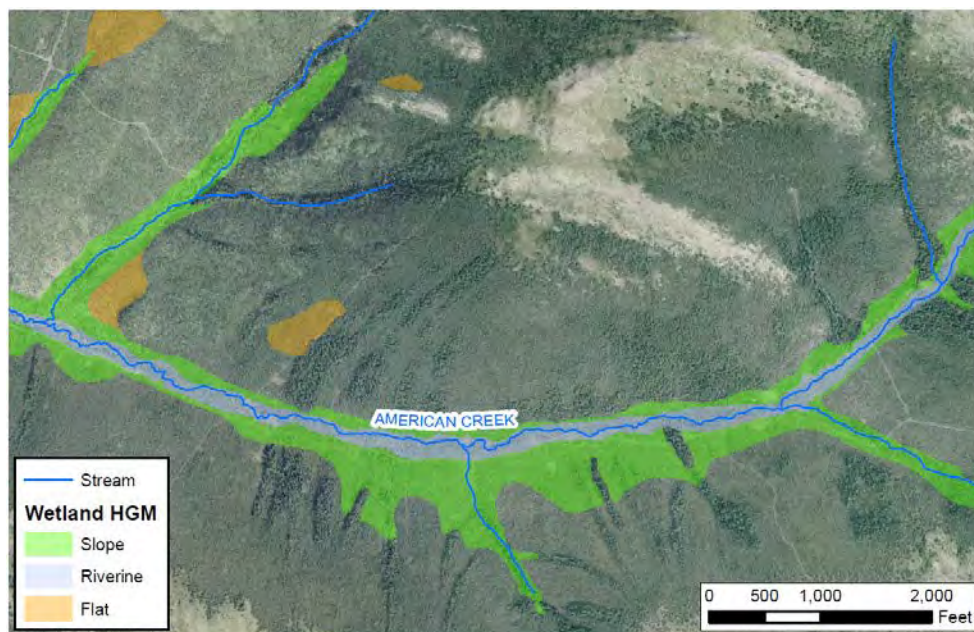
Photo 1 MA/TA Upper American Creek

The slope HGM wetlands within the MA/TA are associated with small groundwater and precipitation driven hillside drainages, headwater intermittent and perennial streams, and black spruce wetlands at the toeslopes of the hills adjacent to the floodplains of the various valley streams. Slope wetlands are not supporting a large stream system. The upper swales and hillside drainages are vegetated with willow and alder, with bluejoint (*Calamagrostis canadensis*) understories (Photo 1).

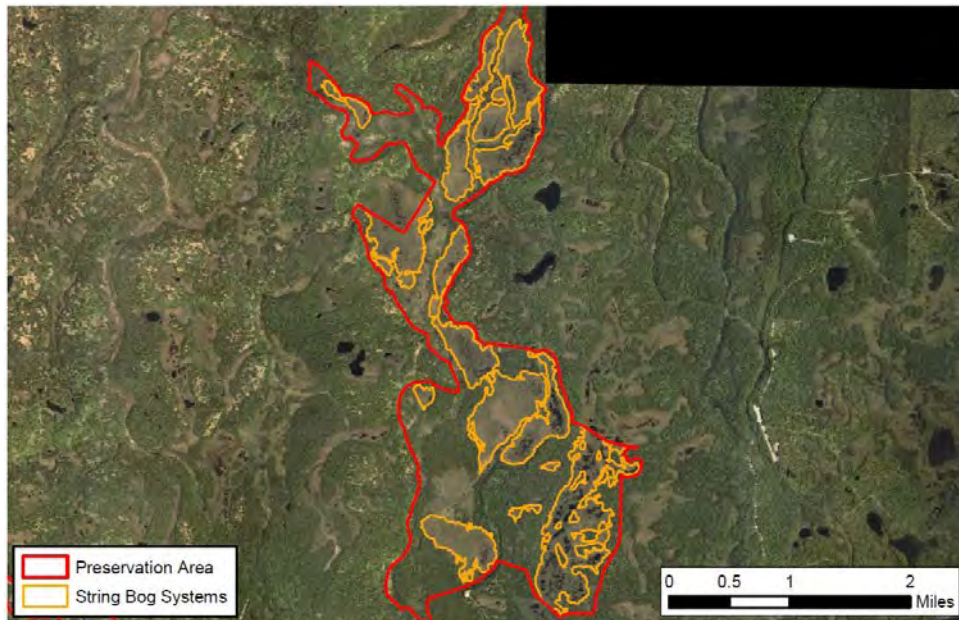
Photo 2 Preservation Area String Bog Systems Example

In comparison, Lone Creek, a tributary of the Chuitna River, flows through or drains most of the slope HGM wetlands, including the ericaceous shrub bog-string bog wetland systems in the Preservation Area. These wetlands provide habitat support, nutrient cycling, flood water storage, and contribute to the stream base flow and nutrient outputs of the Chuitna River. Photo 2 shows an example of string bog systems within the Preservation Area.

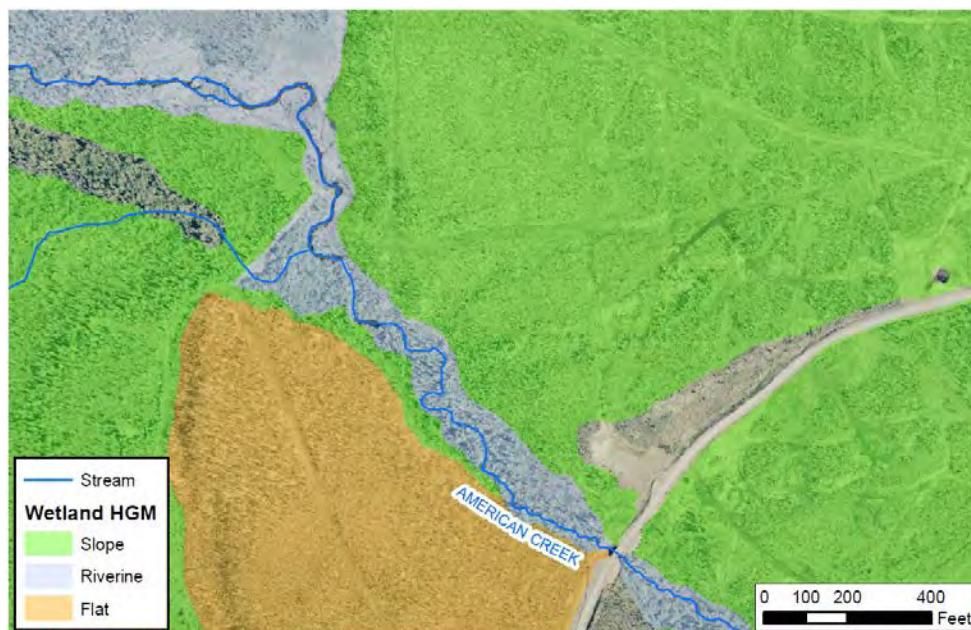
Photo 3 MA/TA American Creek Riverine HGM Floodplain

In the MA/TA, the American and Anaconda Creek drainages are small low-flow systems that appear to lack substantial winter flow. Each creek is associated with a narrow riverine HGM floodplain. The 160 acres of MA floodplains consist of willow, alder, and spruce/mixed forest types. Photo 3 shows the riverine HGM floodplain associated with the anadromous portion of American Creek.

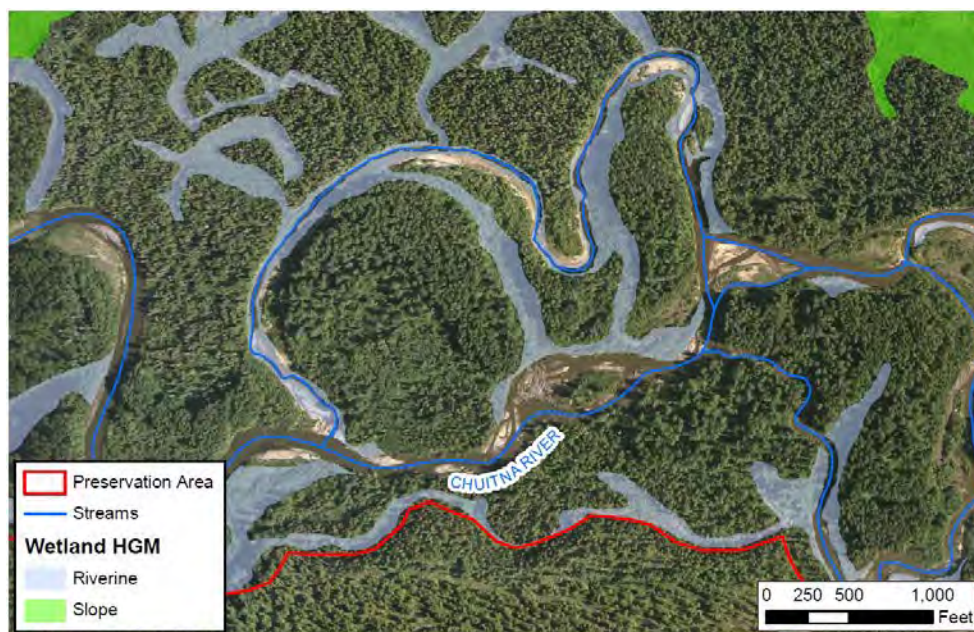
Photo 4 Preservation Area Riverine HGM Wetlands, Chuitna River

Compared to the MA/TA's low-flow streams and small associated floodplains, the Preservation Area provides over three times the riverine HGM floodplains, and these floodplains help support the salmon fisheries of the Chuitna River. Also associated with the wetland floodplains are the riparian uplands included in the Preservation Area, as shown in Photo 4.

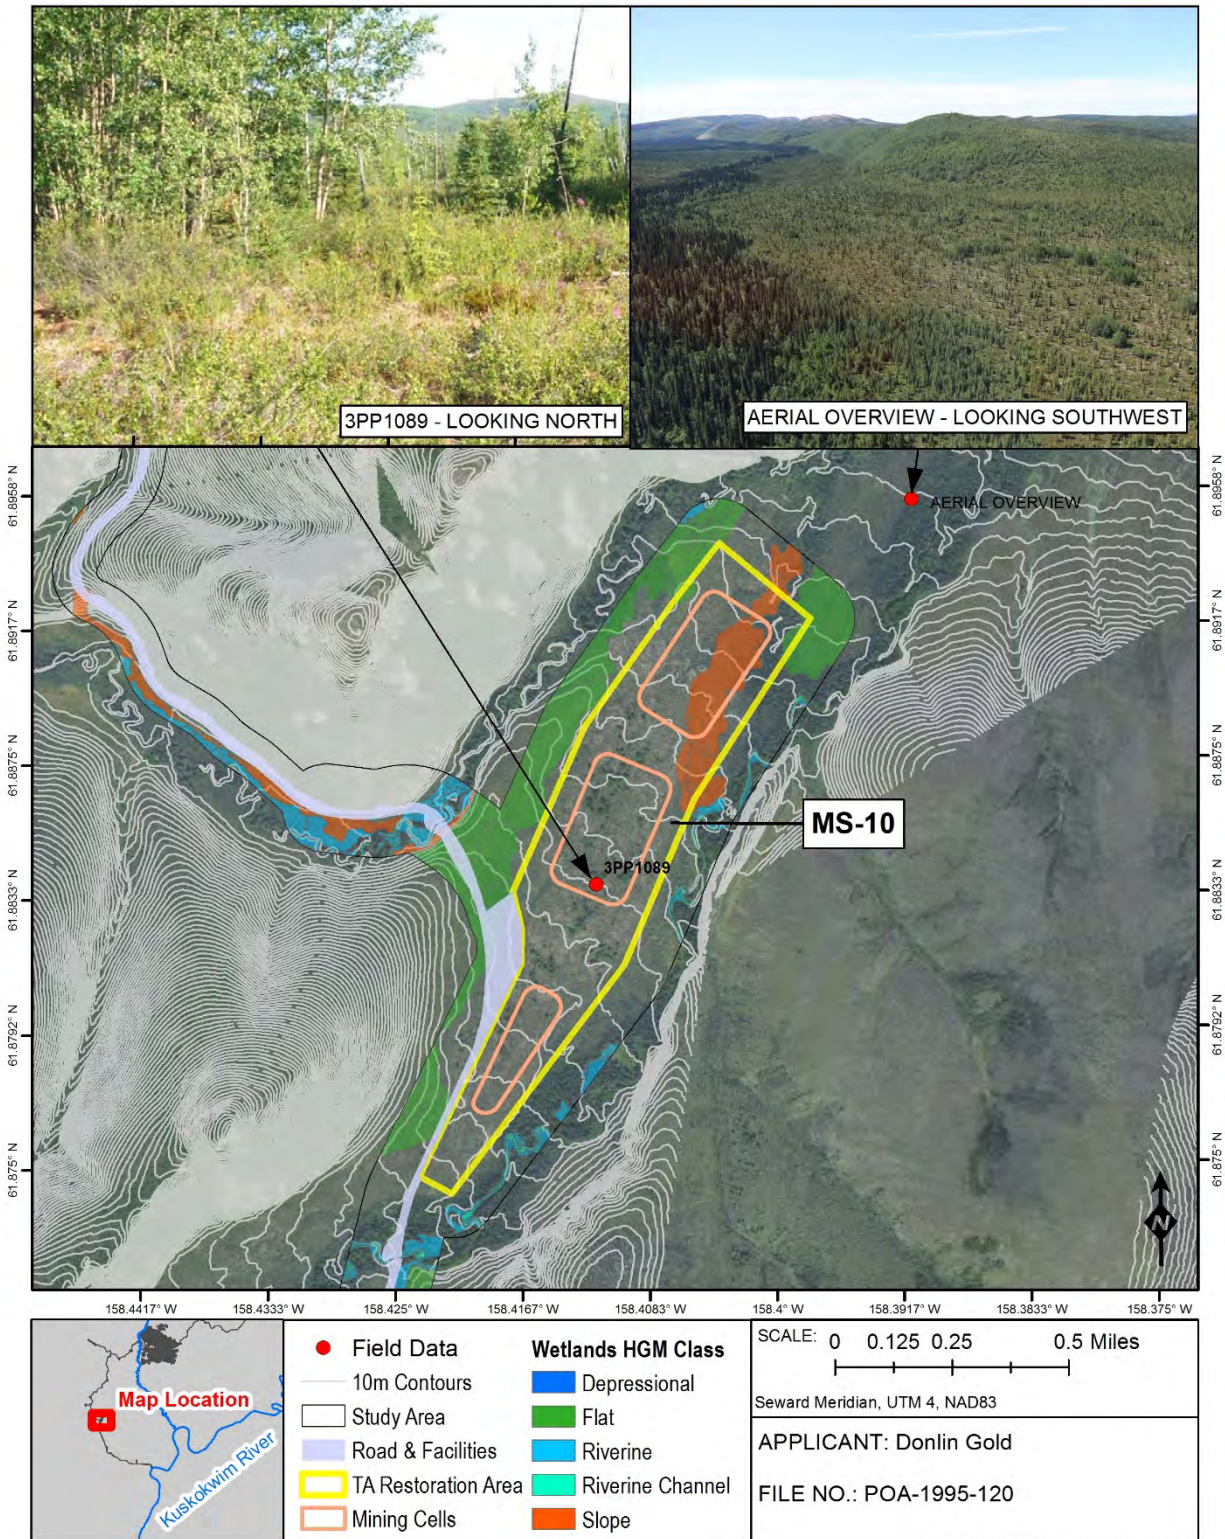
Figure 1 TA Material Site-10 Map and Site Photos

Material Site-10, in the Crooked Creek HUC-10, is on a terrace between the confluence of the North and South forks of Getmuna Creek. The site is 208.3 acres. Wetlands associated with an abandoned channel of the South Fork of Getmuna Creek are at the northeast end of the site and total 25.3 acres (Figure 1). Three material site areas (cells) will be excavated, totaling 75.9 acres. Each excavation is projected to intersect the water table; the depth of water in each cell will vary along the gradient of the land surface, from less than three feet to greater than 17 feet.

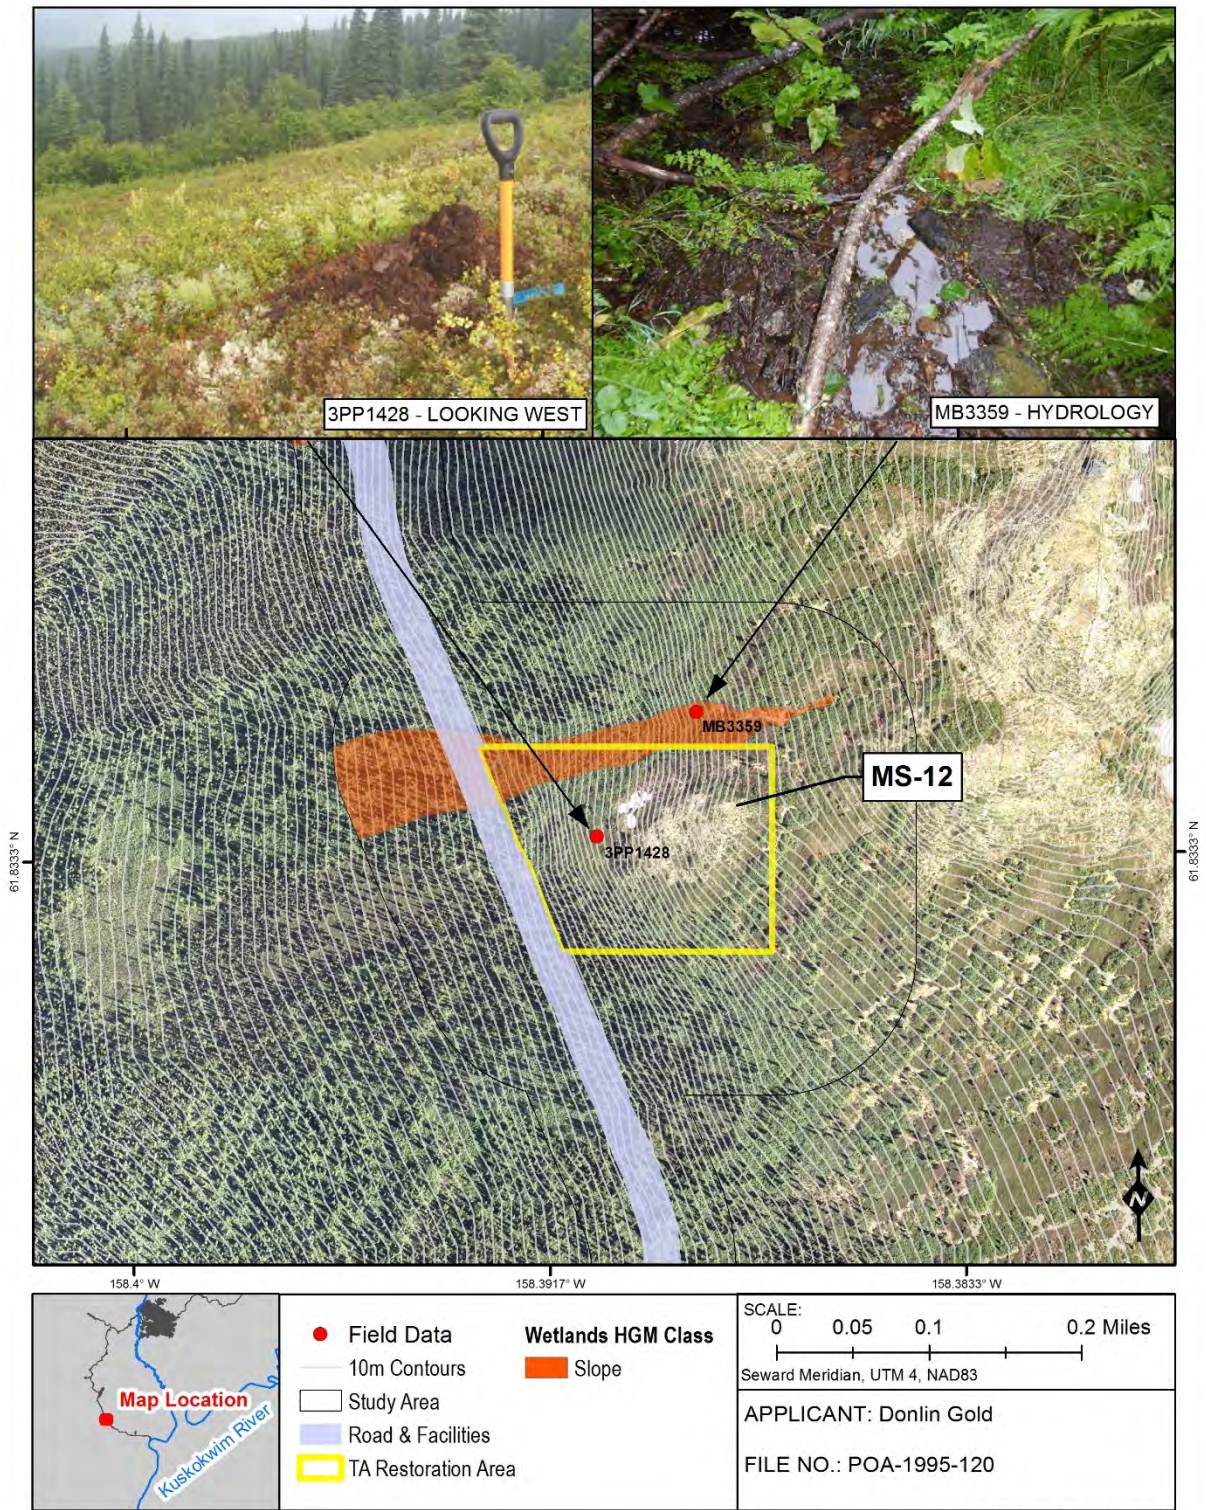
Figure 2 TA Material Site-12 Map and Site Photos

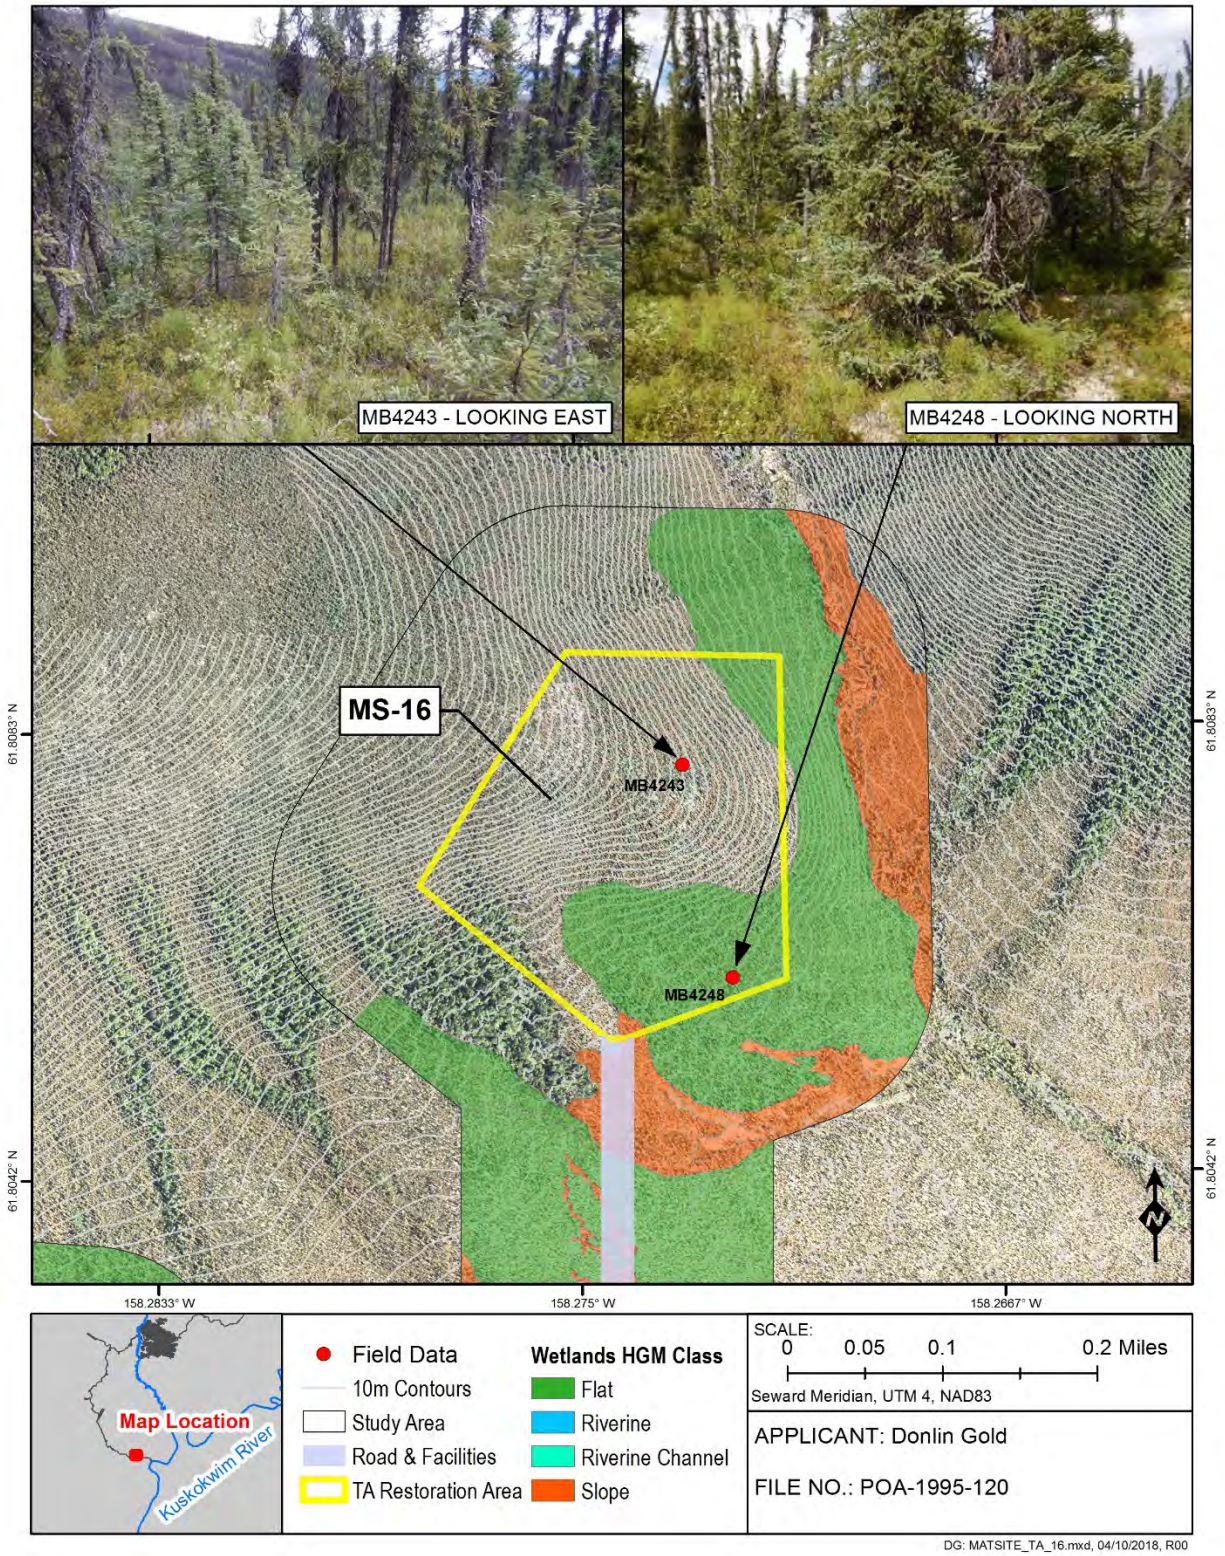
Figure 3 TA Material Site-16 Map and Site Photos

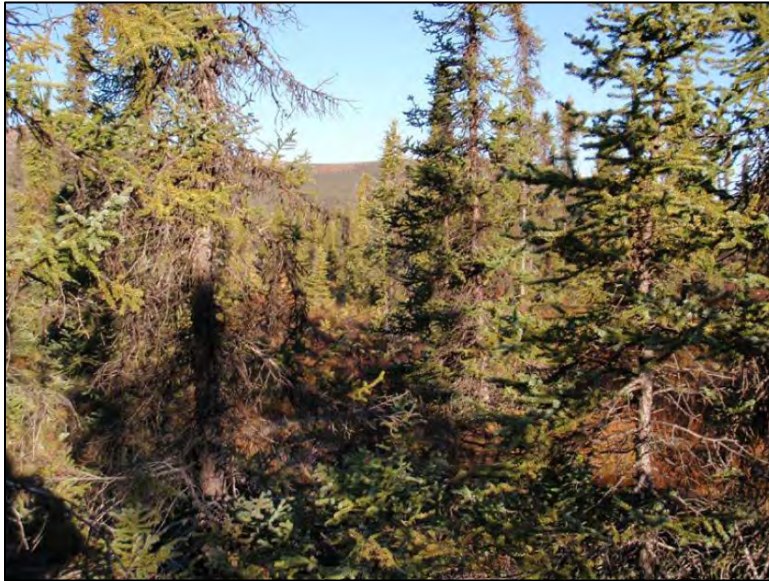
Photo 1 Open Black Spruce Forest Vegetation Type

Low shrub tundra (LST), open black spruce forest (OBSF) (Photo 1, all photos Michael Baker 2016) and black spruce woodland (BSW) (Photo 2) are the most prevalent wetland vegetation types in the TA material sites. Other wetland vegetation types present in the TA sites include closed alder shrub (CAS), woodland mixed forest (WMF), and open white spruce forest (OWSF). Vegetation types are described in the 2016 Preliminary Jurisdictional Determination (PJD) (Michael Baker 2016).

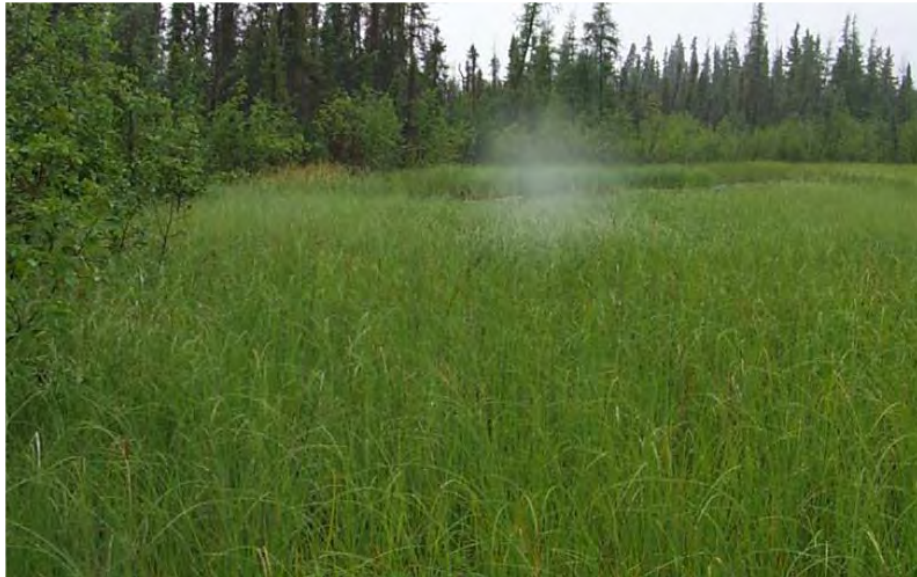
Photo 3 Wet Herbaceous Vegetation, Crooked Creek HUC-10

Following excavation, the material sites will be restored as permanently flooded to semi-permanently flooded waterbodies with wetland margins composed primarily of emergent vegetation with a vegetation classification of wet herbaceous (WH) (Photo 3). Excavation of material will create concave features that will hold water, thus creating the waterbodies and associated sedge/grass marshes adjacent to them.

In the Yukon-Kuskokwim Highlands Major Land Resources Area (MLRA) (Crooked Creek and Veahna Creek-Kuskokwim River HUC-10s), WH plots typically contain leafy tussock sedge (*Carex aquatilis*),

northwest territory sedge (*Carex utriculata*), bluejoint (*Calamagrostis canadensis*), and purple marshlocks (*Comarum palustre*) as dominant plants (Photo 3) (Michael Baker 2016).
