H-Petrof Point PP-001  
ASC# Uncataloged (WORKING FILE)

ADF&G MULTI-ASSESSMENT FORM  
1991 GENERAL ENTRY CHECKLIST

LOCATION: NUKA PASSAGE, PETROF POINT

ADF&G MULTI-ASSESSMENT DATA FORM

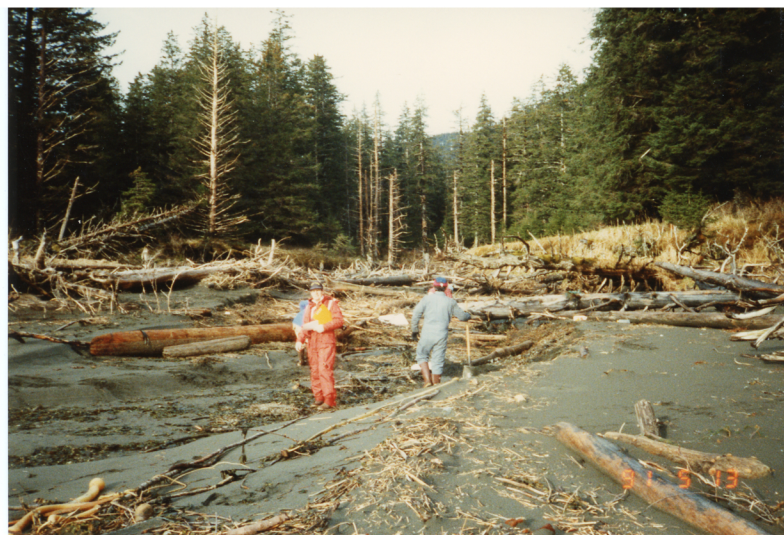
Segment No PP-1 Subdivision A  
Date 5/13/91 Log Frame No 9  
Photographer GARY SHIGENAKA  
Location PETROV POINT  
Comments SHOT OF PIT DUG IN SAND SUBSTRATE  
OF STREAM BED. PIT IS APPROX 1m DEEP. NO  
OIL FOUND.

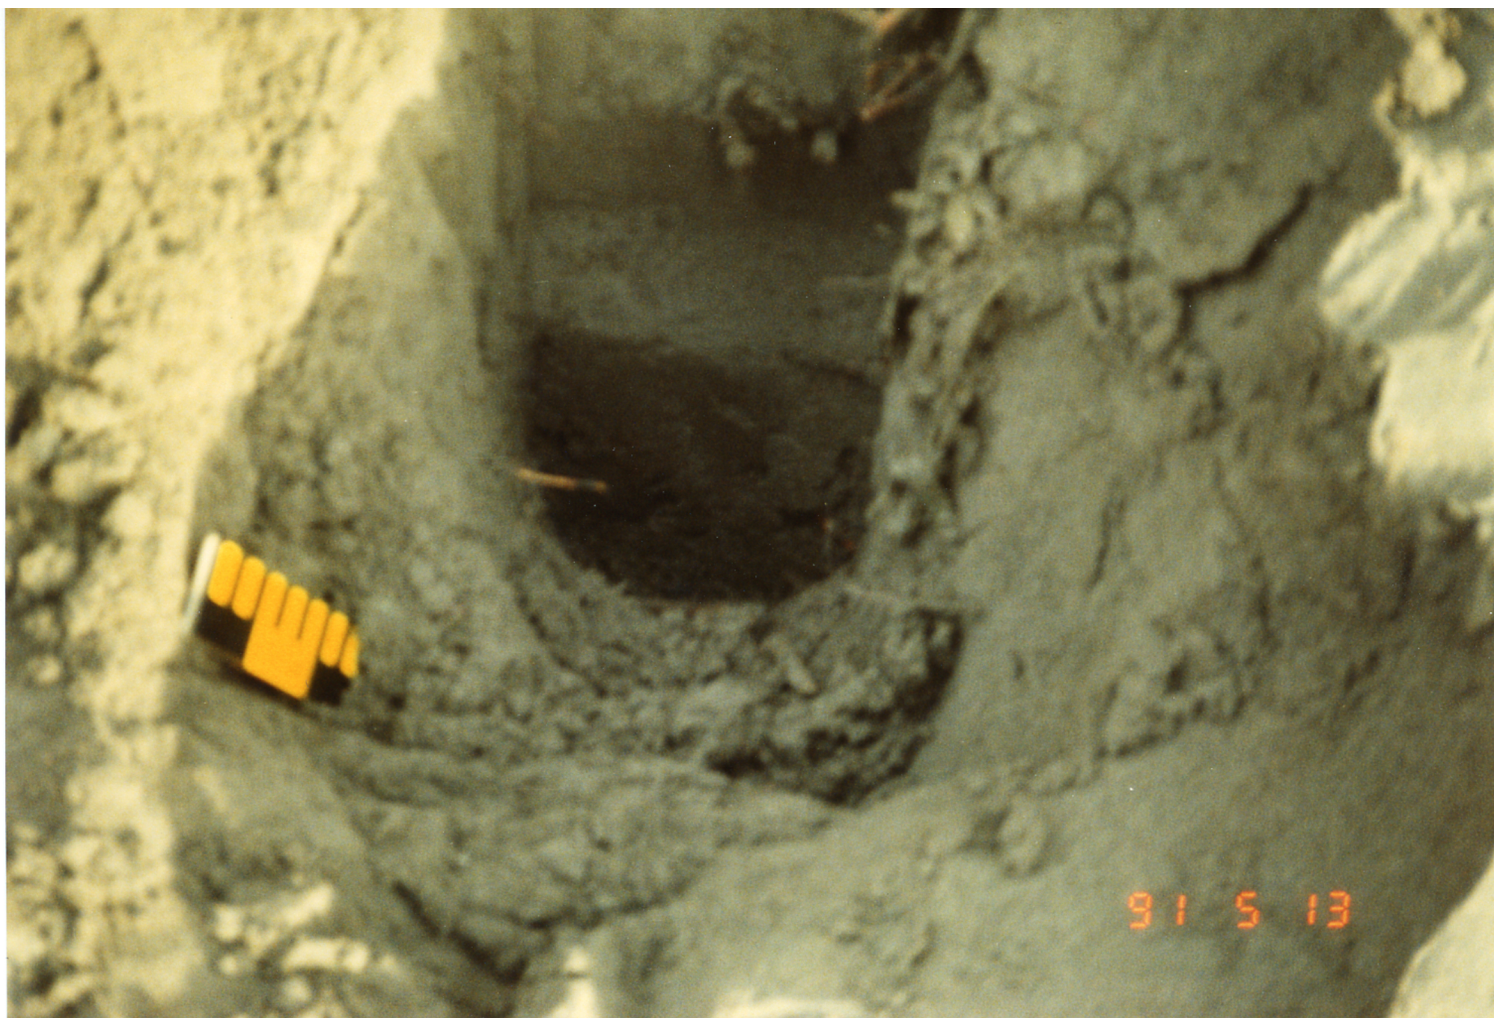
Roll No MAYSAP-6-13 Neg. No 7  
Control No 892 (Office Use Only)

ONLY ONE TAR PATTY WAS FOUND ON THIS SEGMENT, FOUND ON SAND WHICH BURIES  
STREAM CHANNEL. NUMEROUS (APPROX 20) PITS WERE DUG TO A MAXIMUM DEPTH OF  
1.5M. A LARGE QUANTITY OF SAND HAS BEEN DEPOSITED IN THE STREAM CHANNEL,  
HENCE THE GRAVEL.?? WHERE THE MOUSSE HAD BEEN OBSERVED IN THE PAST WAS  
BURIED. GOOD POSSIBILITY THAT THE MOUSSE IS BURIED IN SAND. MAY TURN UP  
LATER IN SEASON WITH RUN-OFF WHICH MAY ERODE BANKS/BERM. A LOT OF NEW WOOD  
(LOGS ETC.) HAS BEEN DEPOSITED IN THE CREEKBED OVER THE WINTER.

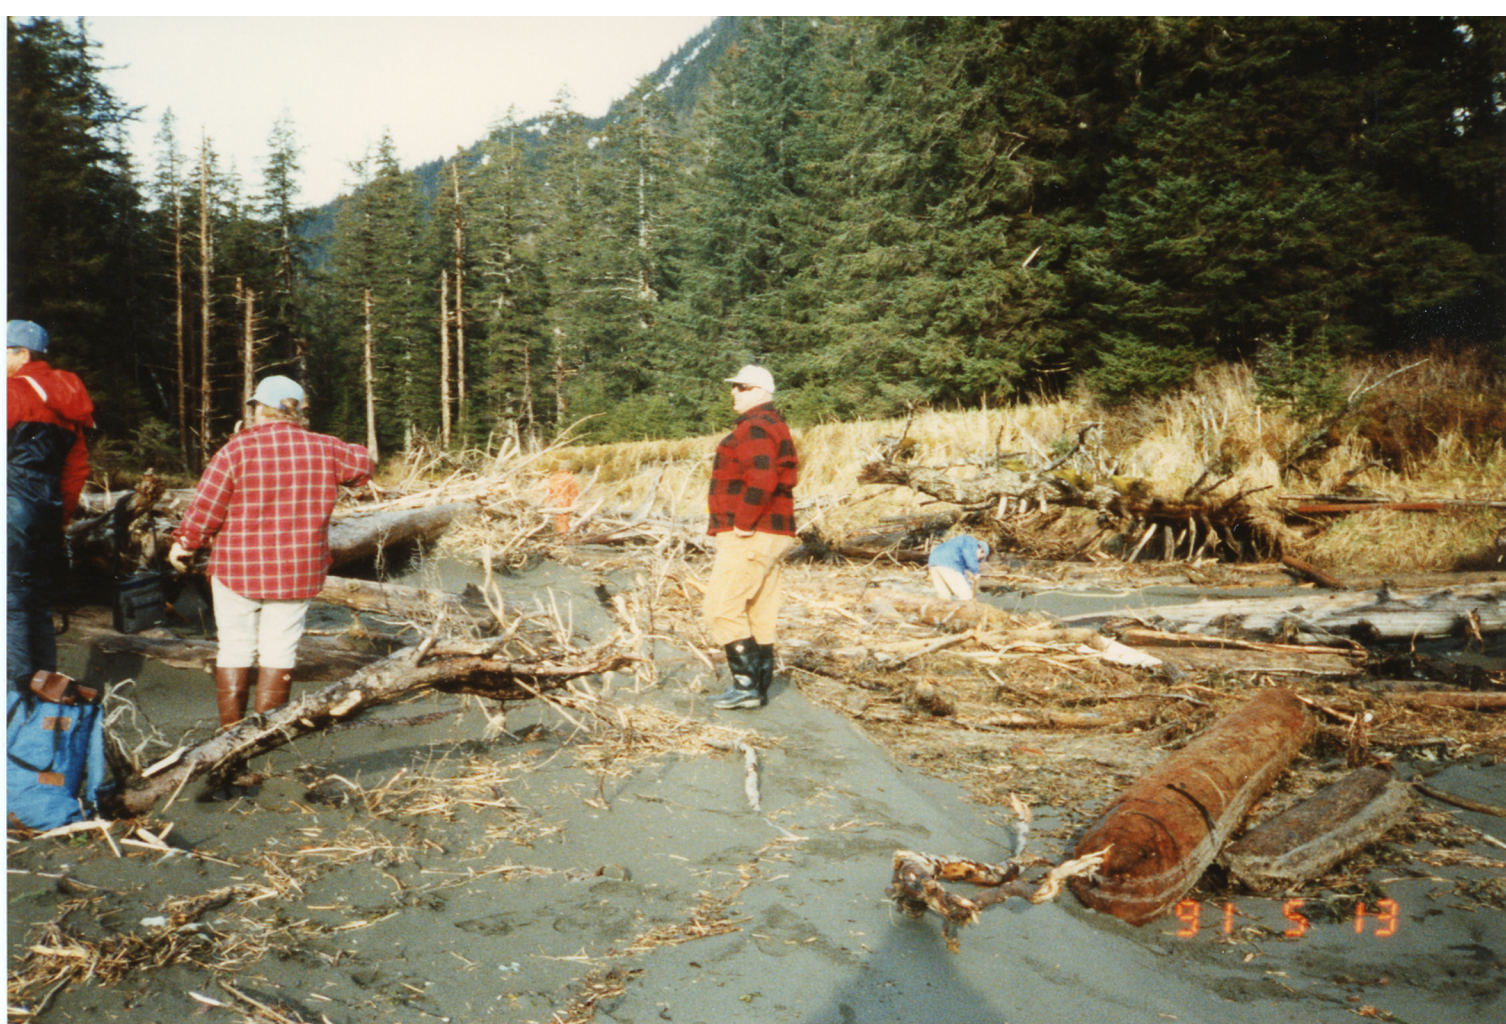
Roll No MAYSAP-6-13 Neg. No 6

Comments VIEW OF DRY STREAM BED (HAD BEEN  
IDENTIFIED AS ANADROMOUS), FACING TO THE  
NORTHWEST

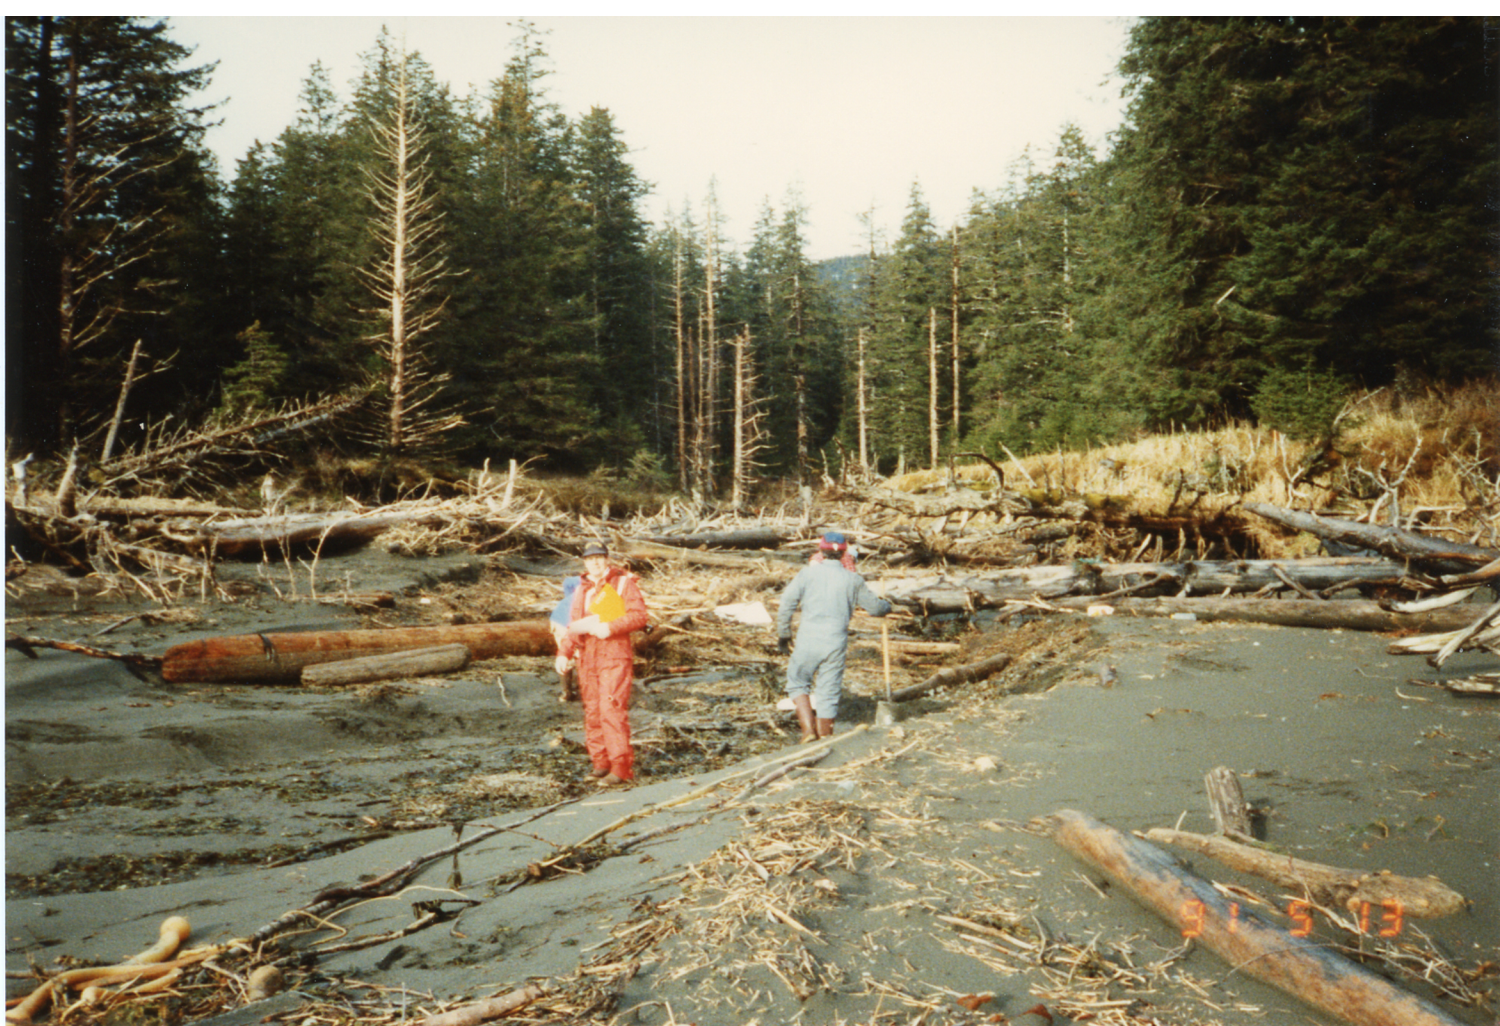
Roll No MAYSAP-6-13 Neg. No 8  
Control No 892 (Office Use Only)

Segment No PP-1 Subdivision A  
Date 5/13/91 Log Frame No 8  
Photographer GARY SHIGENAKA  
Location PETROV POINT  
Comments VIEW OF DRY STREAM BED, FACING  
WEST
