# 2010 Alaska Bridge Report

Kuskulana River Bridge, McCarthy Road

**Alaska Department of Transportation and Public Facilities**

**March 2011**

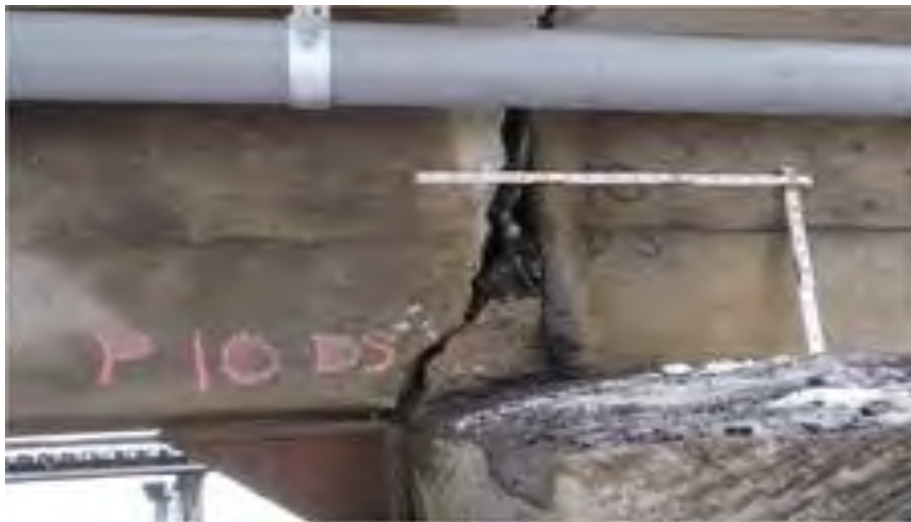
**Maintenance.** This includes ongoing tasks such as replacement of deteriorated bridge elements caused by rusting or spalling (flaking or crumbling concrete), overlaying damaged bridge decks, restoration of guardrails on the bridge approaches, or repairing or replacing faulty expansion joints. The Department's bridge crews conduct an annual preventive maintenance program.

Figure 6. Deteriorating Concrete Trail River Bridge

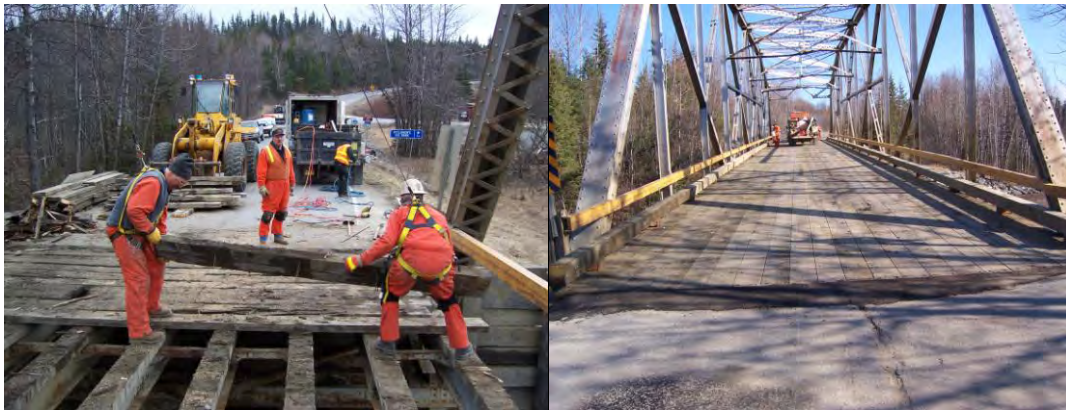
Figure 7. Re-Decking the Anchor River Bridge

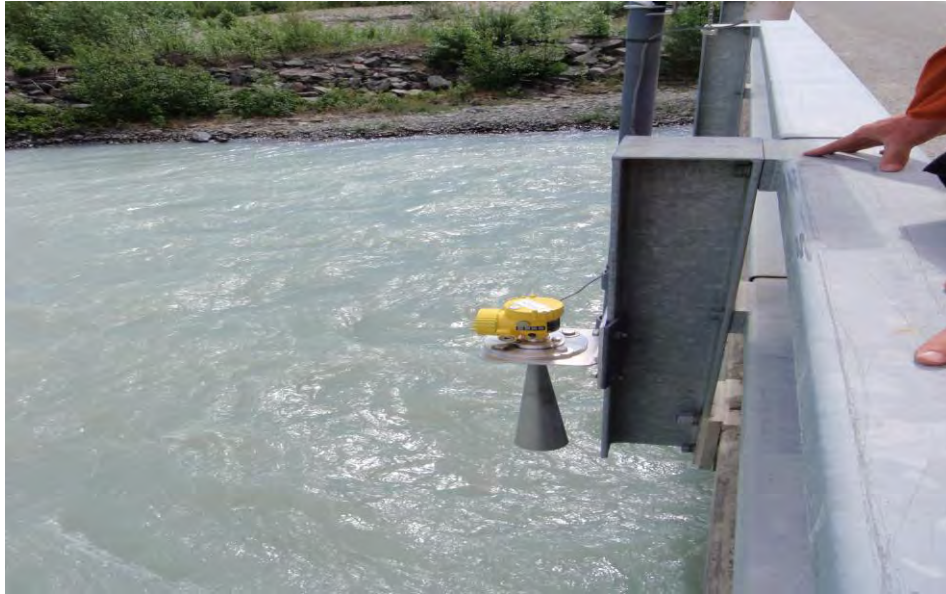
National Bridge Inspection Standards (23 CFR 650) require states to identify scour critical bridges and to prepare a plan of action to monitor scour conditions and to address potential deficiencies and critical findings. Bridge scour countermeasures may include increased inspection frequencies, the installation of active monitoring systems, and structural improvements to resist scour.

Figure 8. Active Scour Monitoring on the Tonsina River

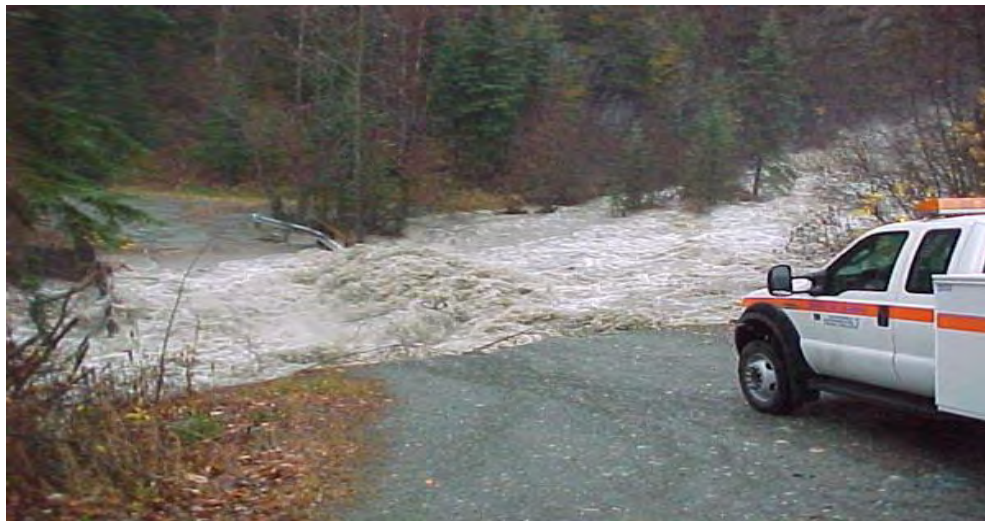
**Scour Monitoring and Retrofit.** The most common cause of bridge failures is from floods scouring bed material from around bridge foundations. “Scour” is the engineering term for the erosion caused by water removing the material surrounding a bridge foundation (the piers and abutments). Bridges that are structurally vulnerable to scour are termed “scour-critical”.

Figure 9. Example of Extreme Scouring at Liberty Falls Bridge, Chitina Campground

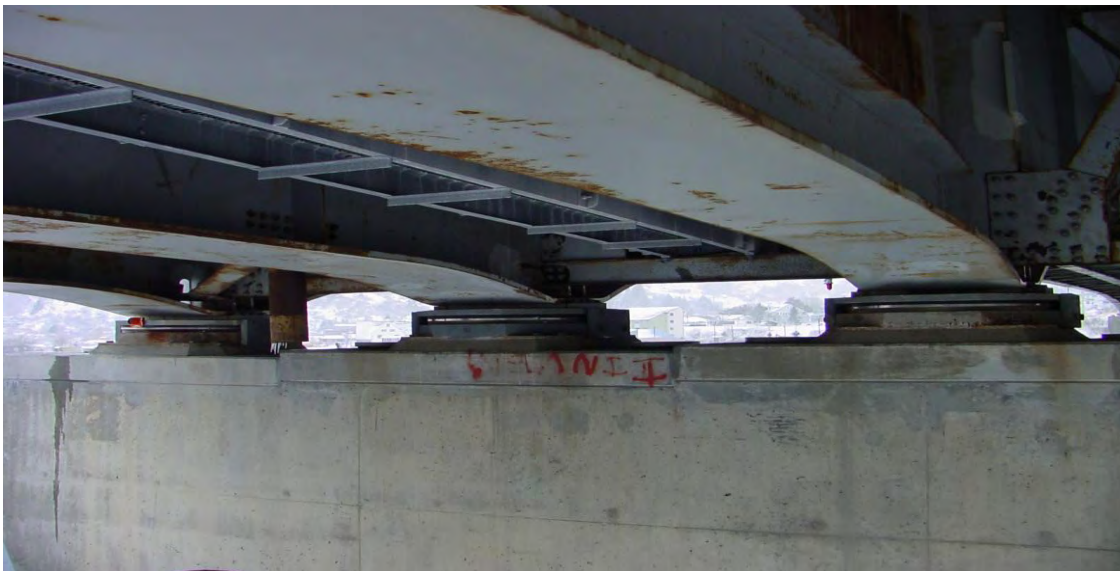
Consistent with national standards adopted by AASHTO (American Association of State Highway Traffic Officials), the Department retrofits bridges to prevent collapse during an earthquake, with public safety the foremost consideration. The Department designs new bridges to the “no collapse” standard contained in the current AASHTO specifications.

Figure 10. Seismic Retrofit using Friction Pendulum Bridge Bearings, Kodiak Harbor Channel Bridge

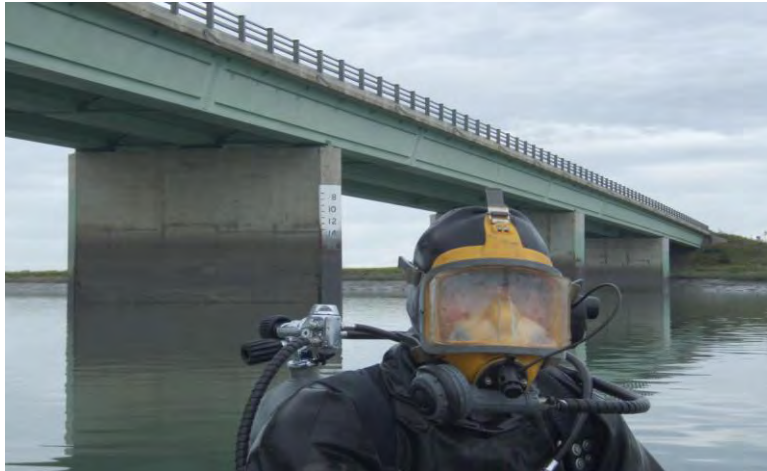
**Inspection.** Regular inspection of the state’s bridges provides up-to-date information on their physical condition, ensures public safety, and provides a factual basis for public investment in bridge preservation, replacement, and rehabilitation. Federal regulations mandate bridge inspections on a 24-month interval for the accessible portions of the bridge, and on a 60-month rotation for the underwater portion of bridges.

Figure 11. Contract Dive Inspector at the Kenai River Bridge

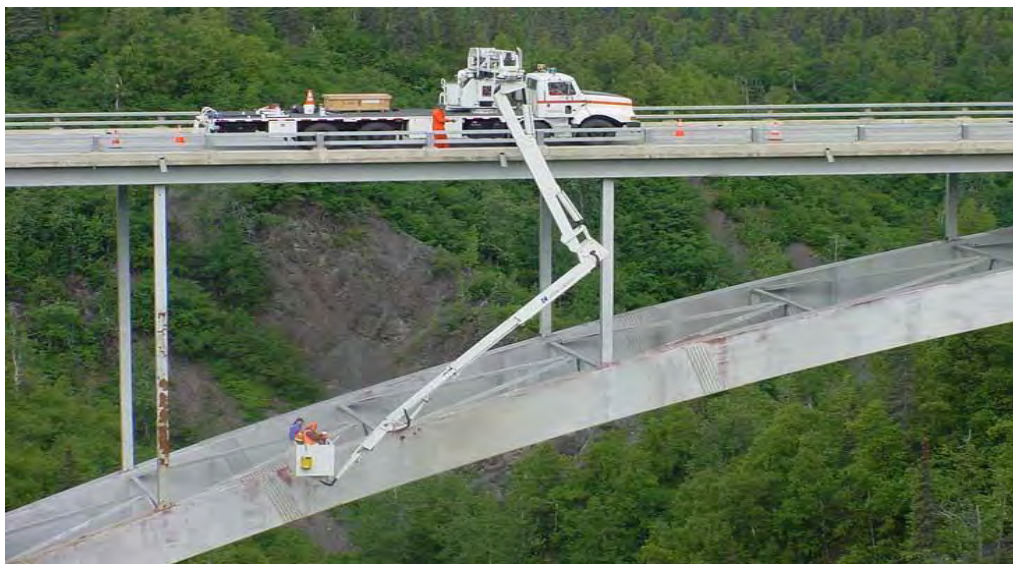
Figure 12. Bridge Inspection at Hurricane Gulch

Engineers may inspect smaller bridges on foot, while others require the use of a special "reach-all" vehicle with a jointed arm and bucket that allows access to otherwise unreachable locations. The length and size of a bridge, weather conditions, and location on the road system can vary the length of an inspection from an hour to as much as several days.

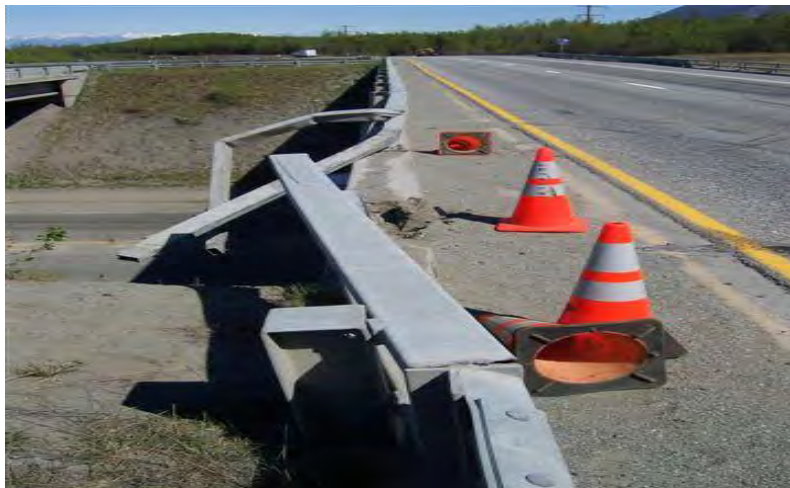
A bridge closure or posting of reduced load capacity typically occurs when advanced deterioration or impact damage reduces structural capacity below state legal loads. Regular inspections typically spot problems in time for implementation of corrective measures, making closure a last option. Currently, two DOT-owned bridges are closed to traffic, both on local roads. An additional fifty-three DOT-owned bridges have load and/or lane (ie, one-way traffic) restrictions (a number that includes eight seaplane float ramps). Three of these bridges are scheduled for replacement, and almost all the rest are on (relatively) low-volume rural or local routes.

Figure 13. Bridge Railing Damaged by a Vehicle Collision

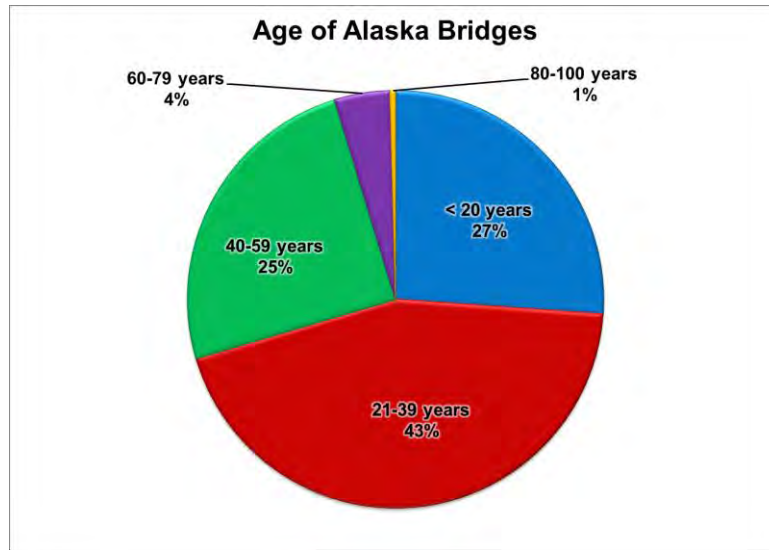
The state's bridge inventory continues to age. As of November 2010, 50% of publicly owned bridges in the state are 33 years or older and 10% are more than 50 years old. This indicates

Figure 13. Age of Alaska Bridges

that about one-third of the publicly owned bridges in the state are past the mid-point of their 50-75-year design life. Thus, it is critical to address the existing inventory of structurally deficient bridges, as over time, additional bridges are likely to show signs of distress as they age.

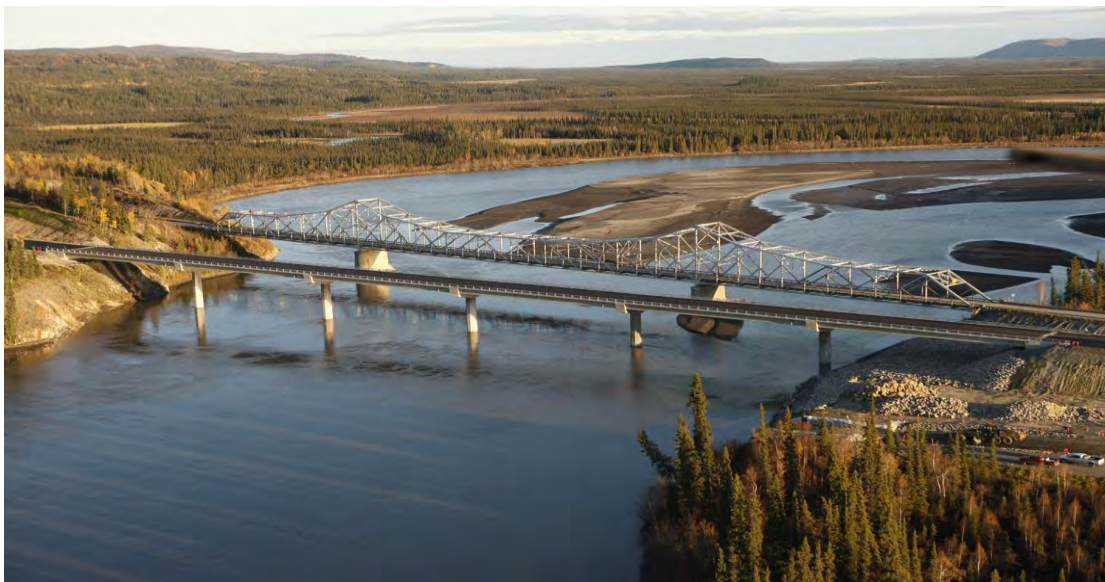
Figure 15. New and Old Tanana River Bridges

Bridge replacement projects, once authorized, can take a significant number of years to complete and to count toward a reduction in structural deficiency. The Tanana River Bridge on the Alaska Highway, completed in 2010, illustrates this fact. Despite being a high priority, and with several special steps taken to accelerate the project, the timeline below documents a seven-year effort before the bridge could be included in a measurement of satisfactory structural condition.

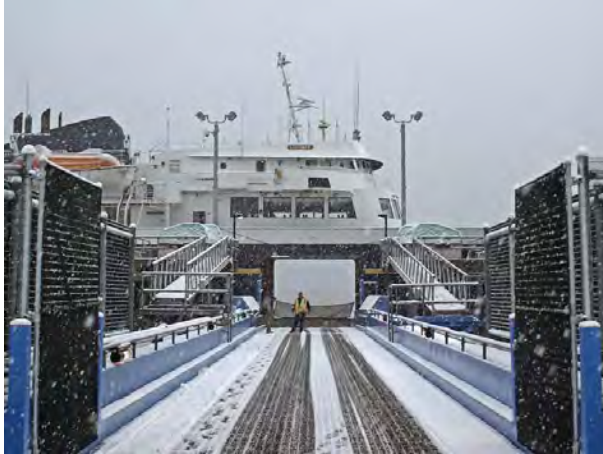
**Specialized Structures.** Significant travel occurs in the state via the state ferry system and by seaplane. The state's ferry vessels link to the uplands at state ferry terminals with ramps that

the FHWA classifies as bridges in the National Bridge Inventory System (NBIS). The FHWA classifies these specialized structures as functionally obsolete because they handle only one-way traffic at low speeds; however, they are well suited to their intended purpose and are safe to use.

Figure 18. Ferry Terminal Ramp

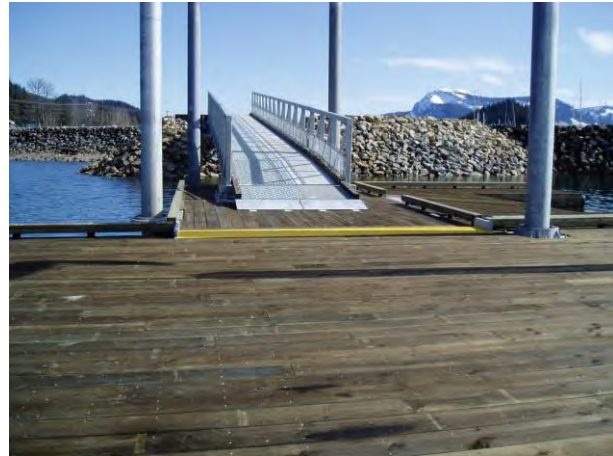
Figure 19. Hoonah Seaplane Float Ramp

Likewise, many seaplane floats in the state have drive-down ramps for delivering freight, passengers and luggage directly to the aircraft. These ramps, also in the NBIS, are not designed to FHWA bridge standards as they are usually one-lane wide, handle low volumes of traffic and only accommodate light-duty vehicles such as vans and pick-up trucks. Discussions with the FHWA may lead to de-listing seaplane float ramps from the NBIS. However de-listing would mean that another funding source is needed to keep up with inspections and rehabilitation or replacement needs.
