# FLOOD PLAIN INFORMATION

TALKEETNA RIVER - SUSITNA RIVER - CHULITNA RIVER

TALKEETNA , ALASKA

PREPARED FOR THE MATANUSKA-SUSITNA BOROUGH BY THE DEPT. OF THE ARMY,  
ALASKA DISTRICT, CORPS OF ENGINEERS, ANCHORAGE, ALASKA.

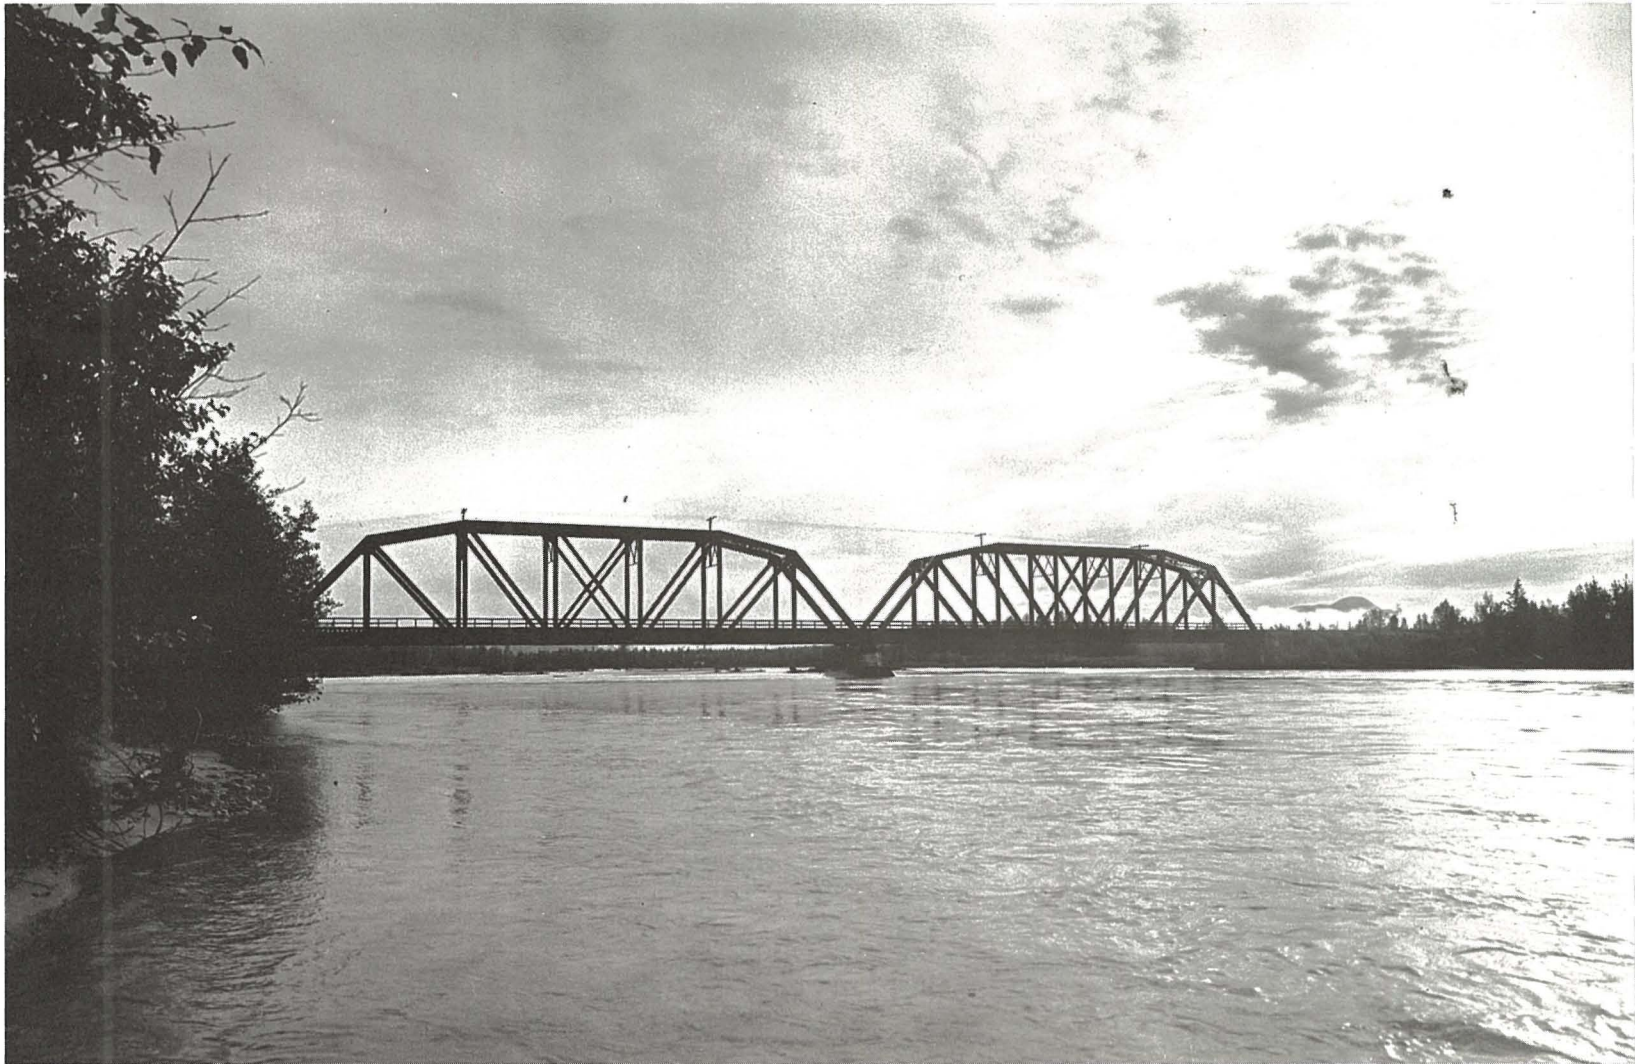
ALASKA RAILROAD BRIDGE, LOOKING UPSTREAM FROM NORTH BANK OF TALKEETNA RIVER  
FIGURE 1

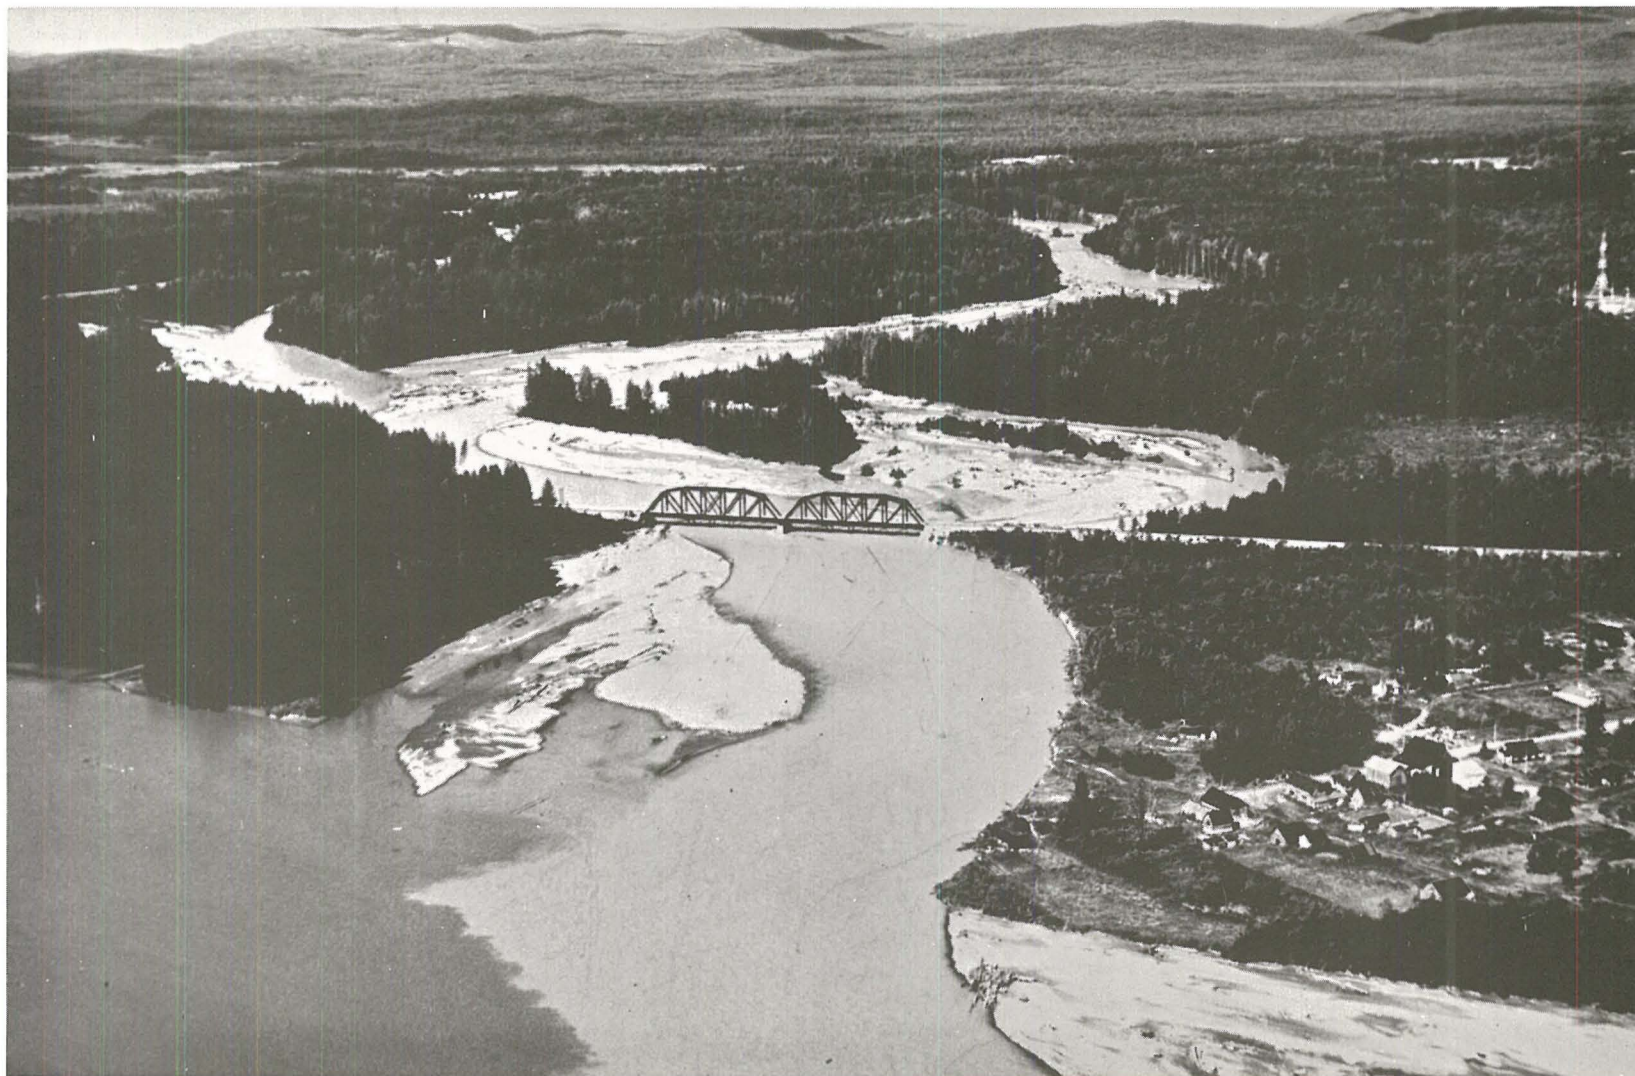
AERIAL VIEW OF TALKEETNA RIVER, LOOKING UPSTREAM, SHOWING  
NATURAL CONDITIONS OF THE RIVER IN AUGUST, 1949  
FIGURE 2

meander of the river and allowed the river to flow at right angles to the bridge. Figures 2 and 3 illustrate the before and after conditions.

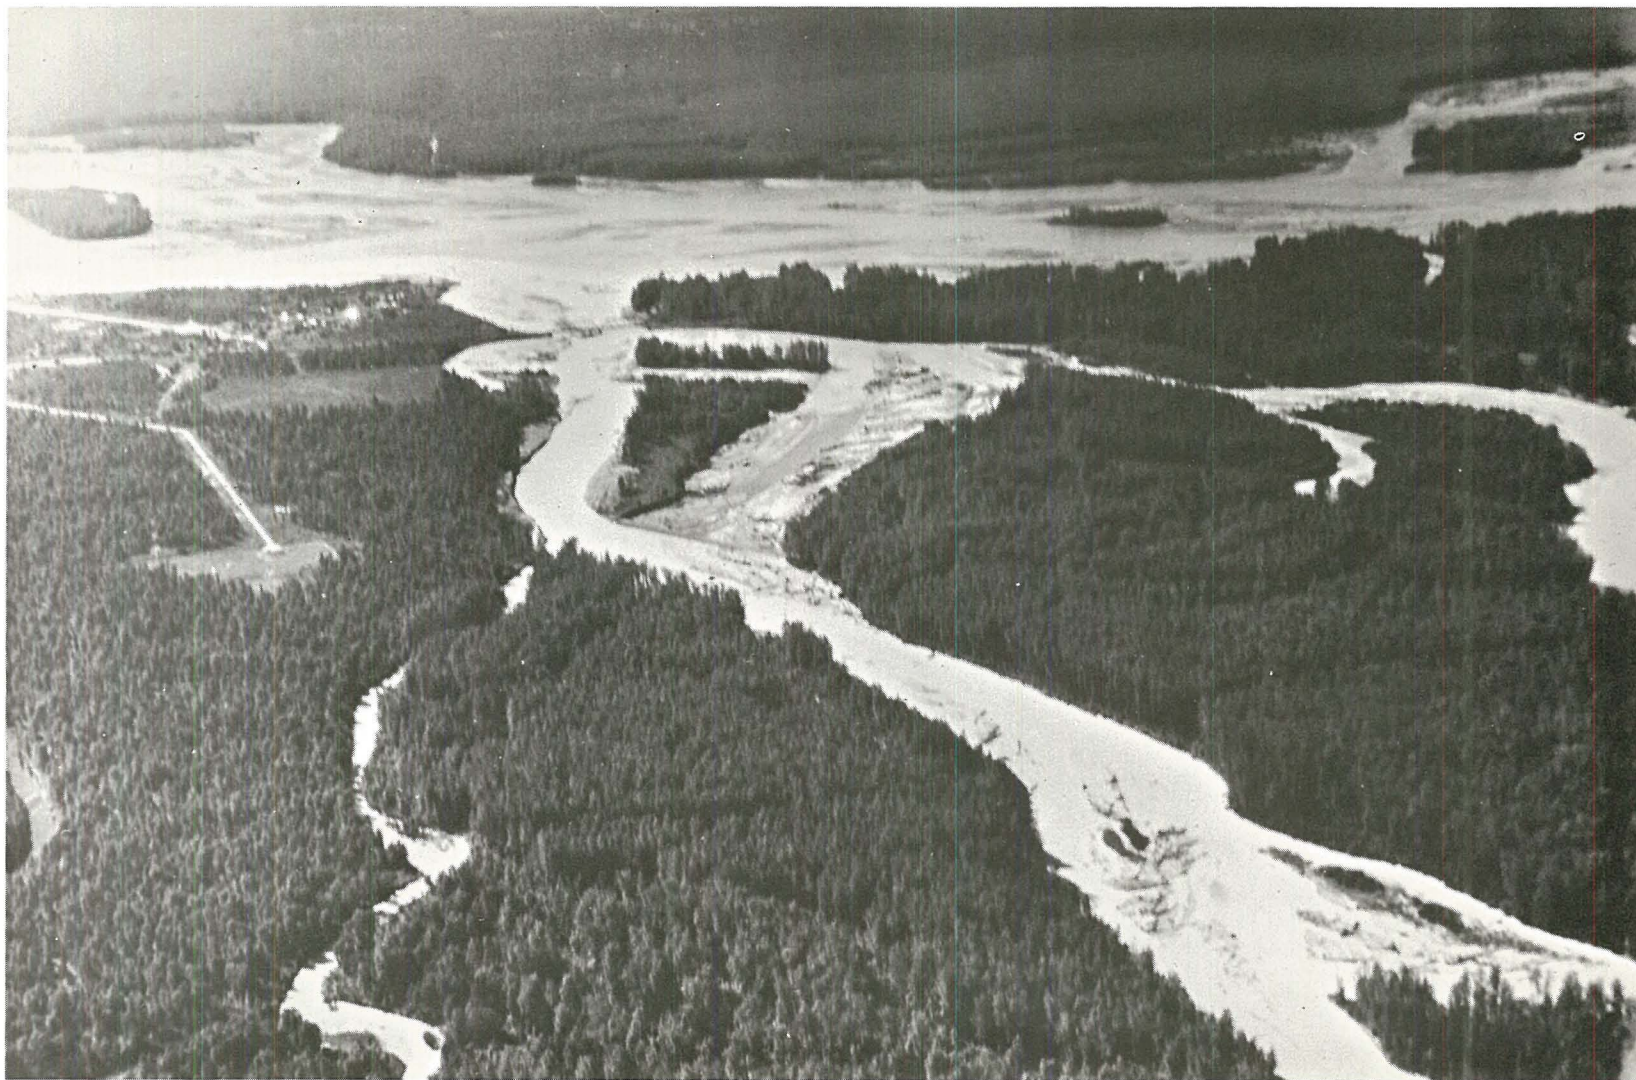
AERIAL VIEW OF TALKEETNA RIVER, AUGUST 1950, SHOWING THE CHANNEL CHANGE  
CONSTRUCTED BY THE ALASKA RAILROAD  
FIGURE 3

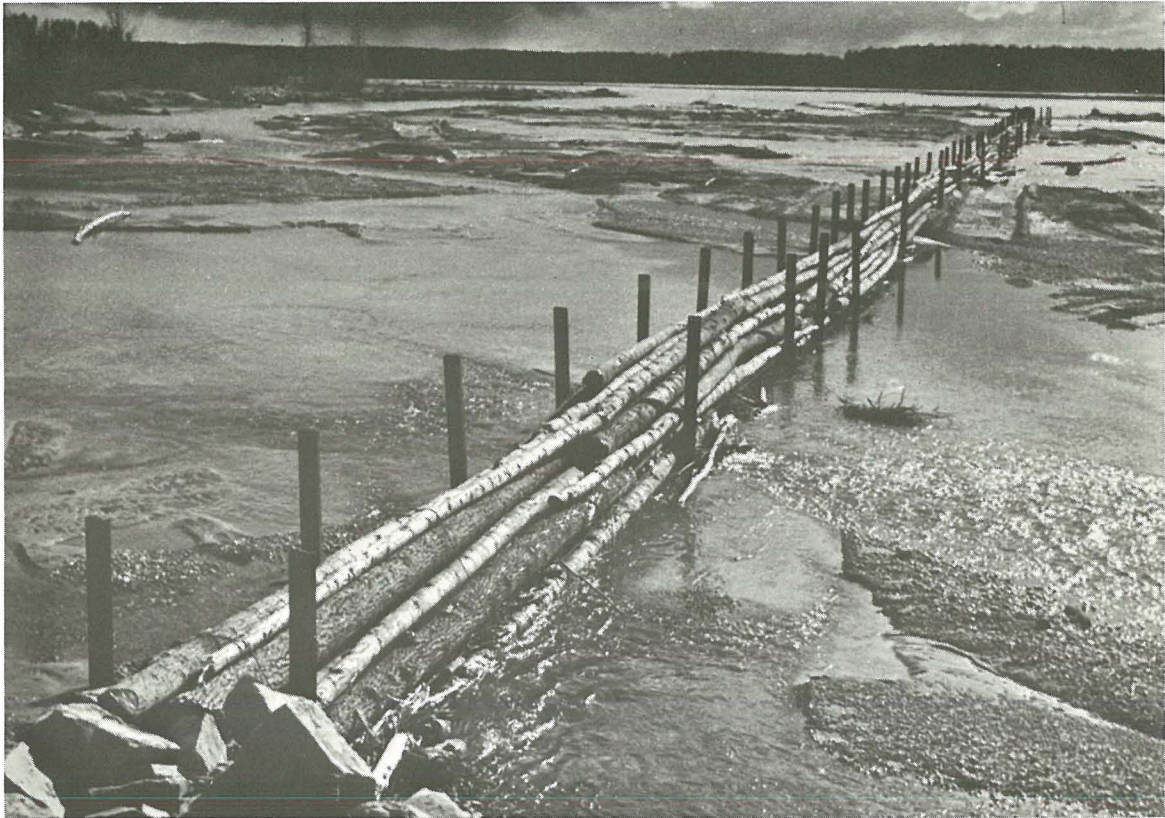
VIEW OF FASCINE FROM UPSTREAM END AS IT APPEARED IN MAY, 1951  
FIGURE 4

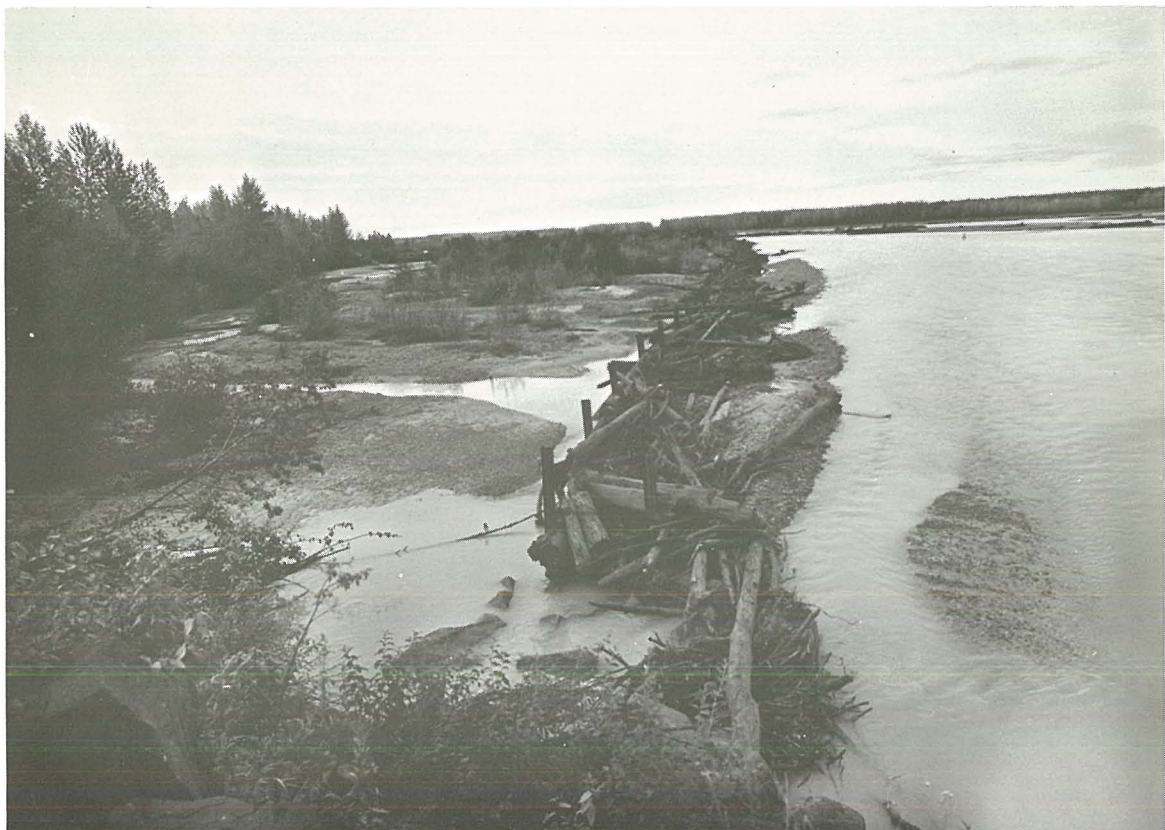
FASCINE AS IT APPEARS TODAY  
FIGURE 5

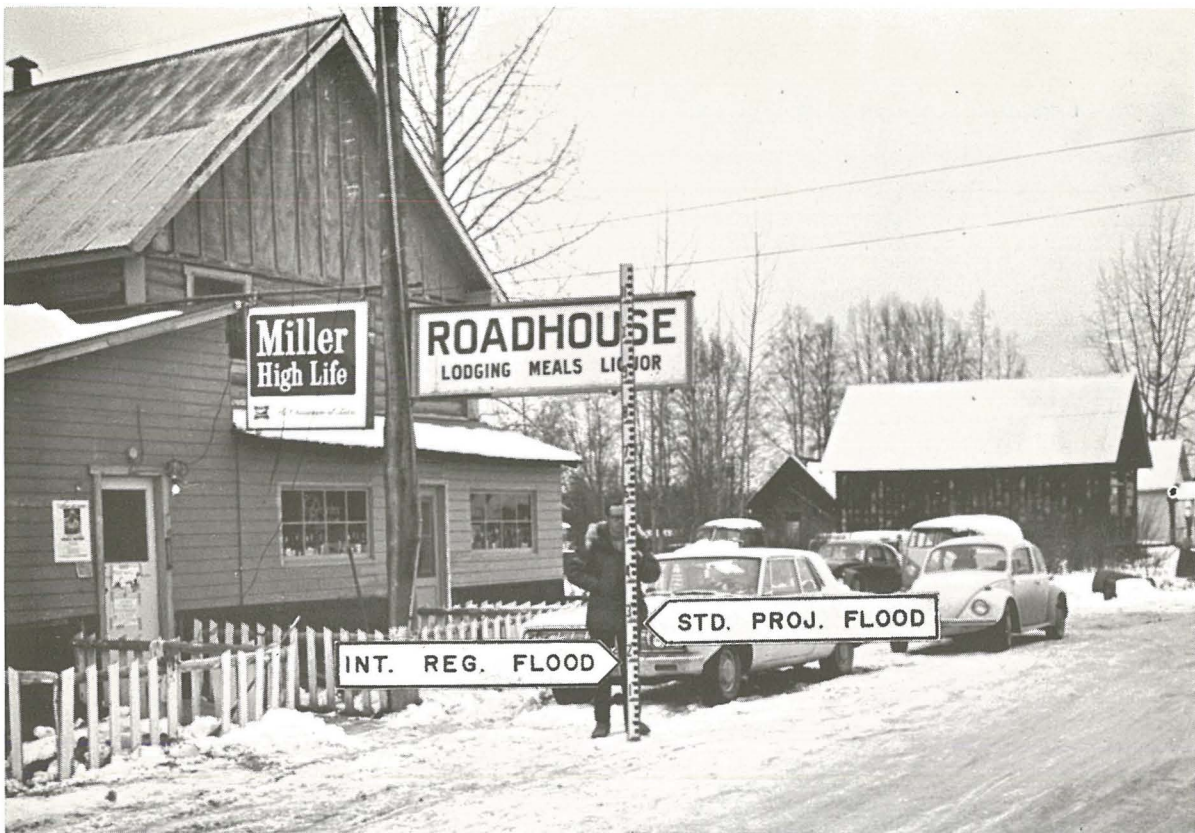
FUTURE FLOOD HEIGHTS AT THE ROADHOUSE ON THE MAIN STREET OF TALKEETNA  
FIGURE 7

Photographs, Future Flood Heights - The levels that the Intermediate Regional and Standard Project Floods are expected to reach at various locations in the village of Talkeetna are indicated on the following photographs.

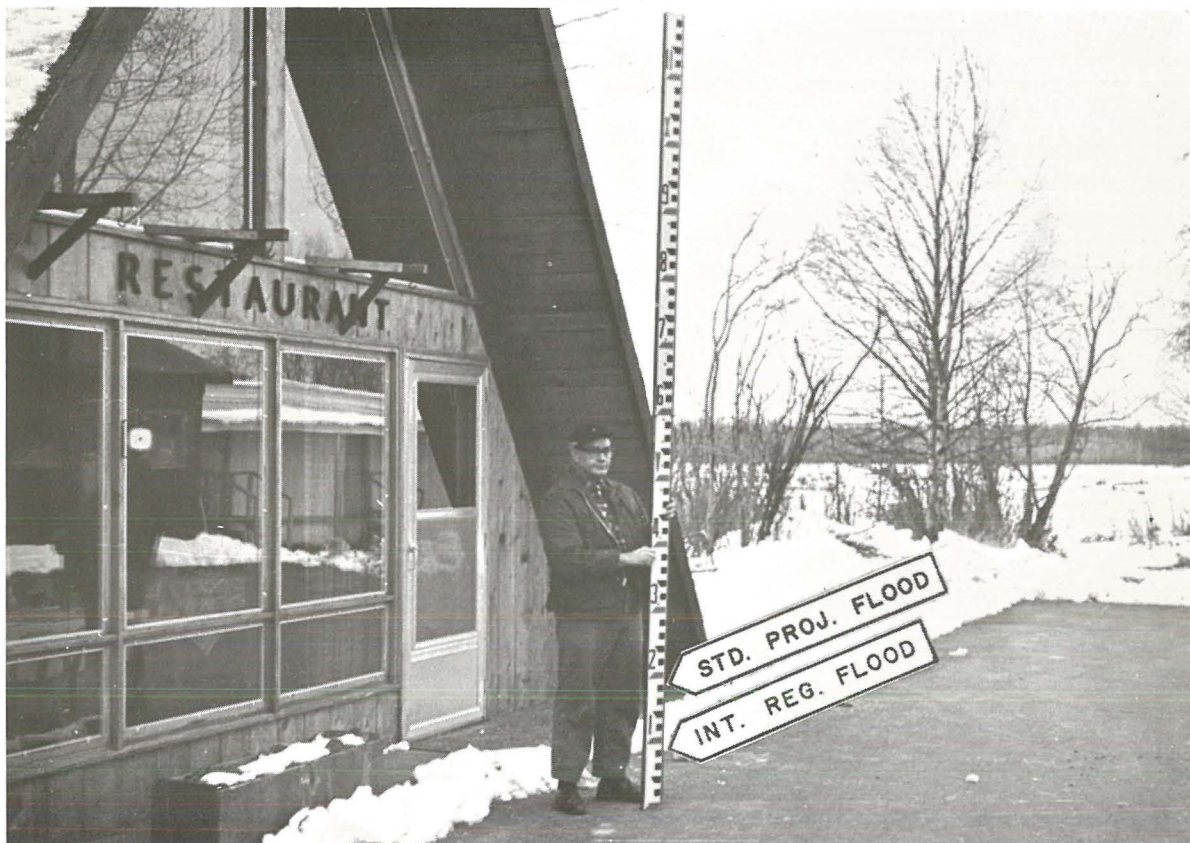
FUTURE FLOOD HEIGHTS AT THE TALKEETNA MOTEL AND RESTAURANT  
FIGURE 8

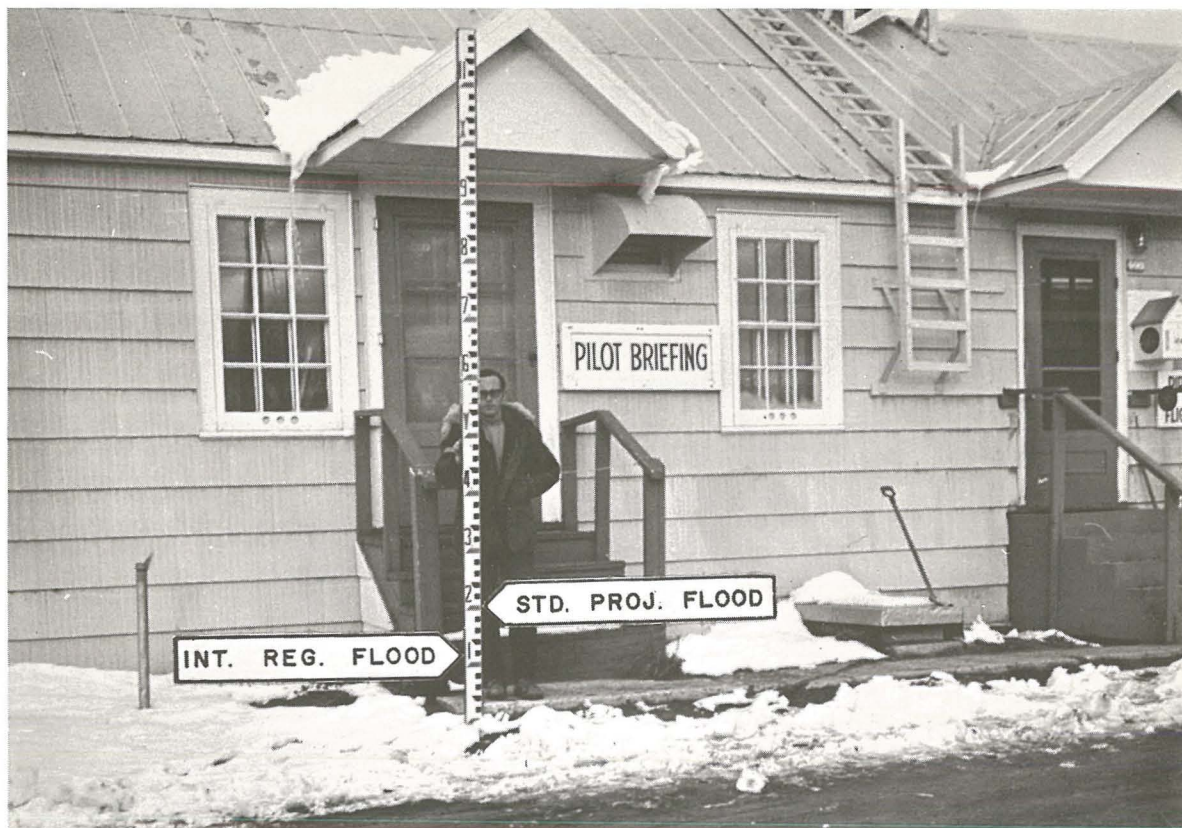
FUTURE FLOOD HEIGHTS AT THE TALKEETNA FSS.  
FIGURE 9

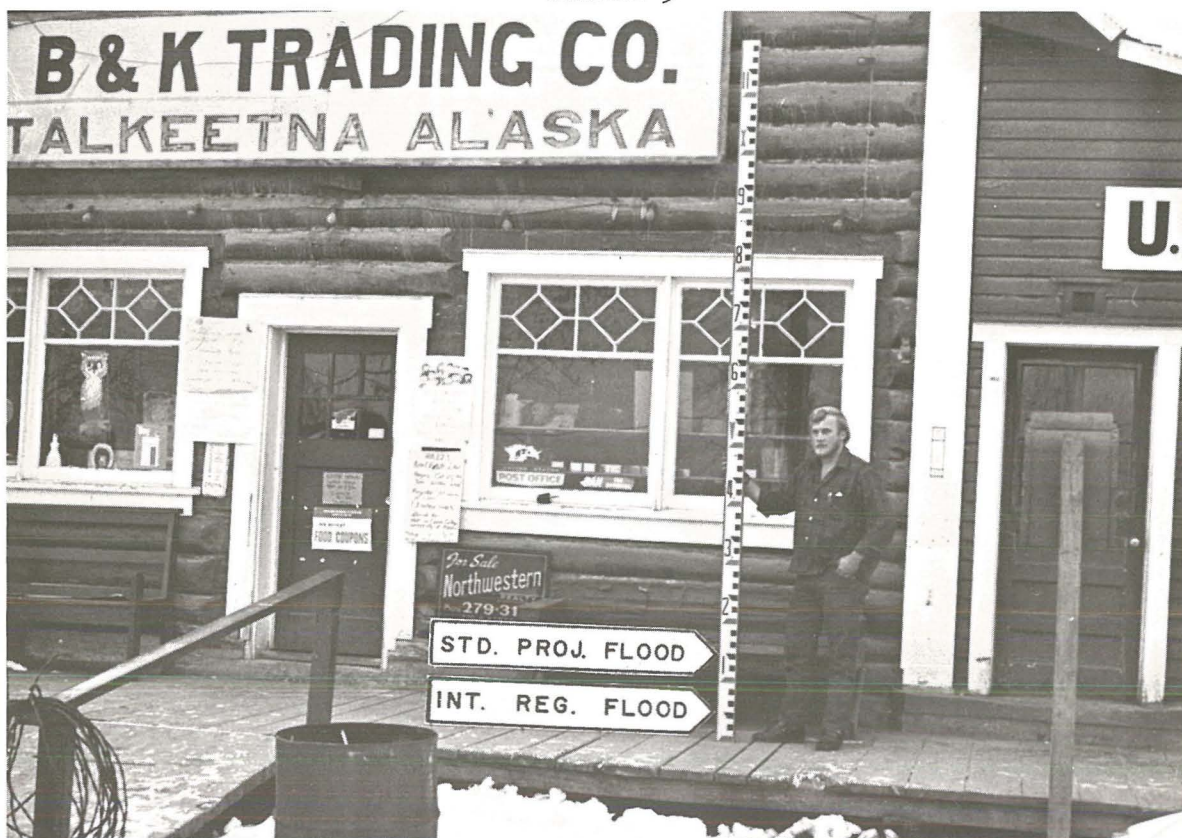
FUTURE FLOOD HEIGHTS AT THE B & K TRADING CO. - MAIN STREET, TALKEETNA.  
U. S. POST OFFICE TO THE RIGHT  
FIGURE 10

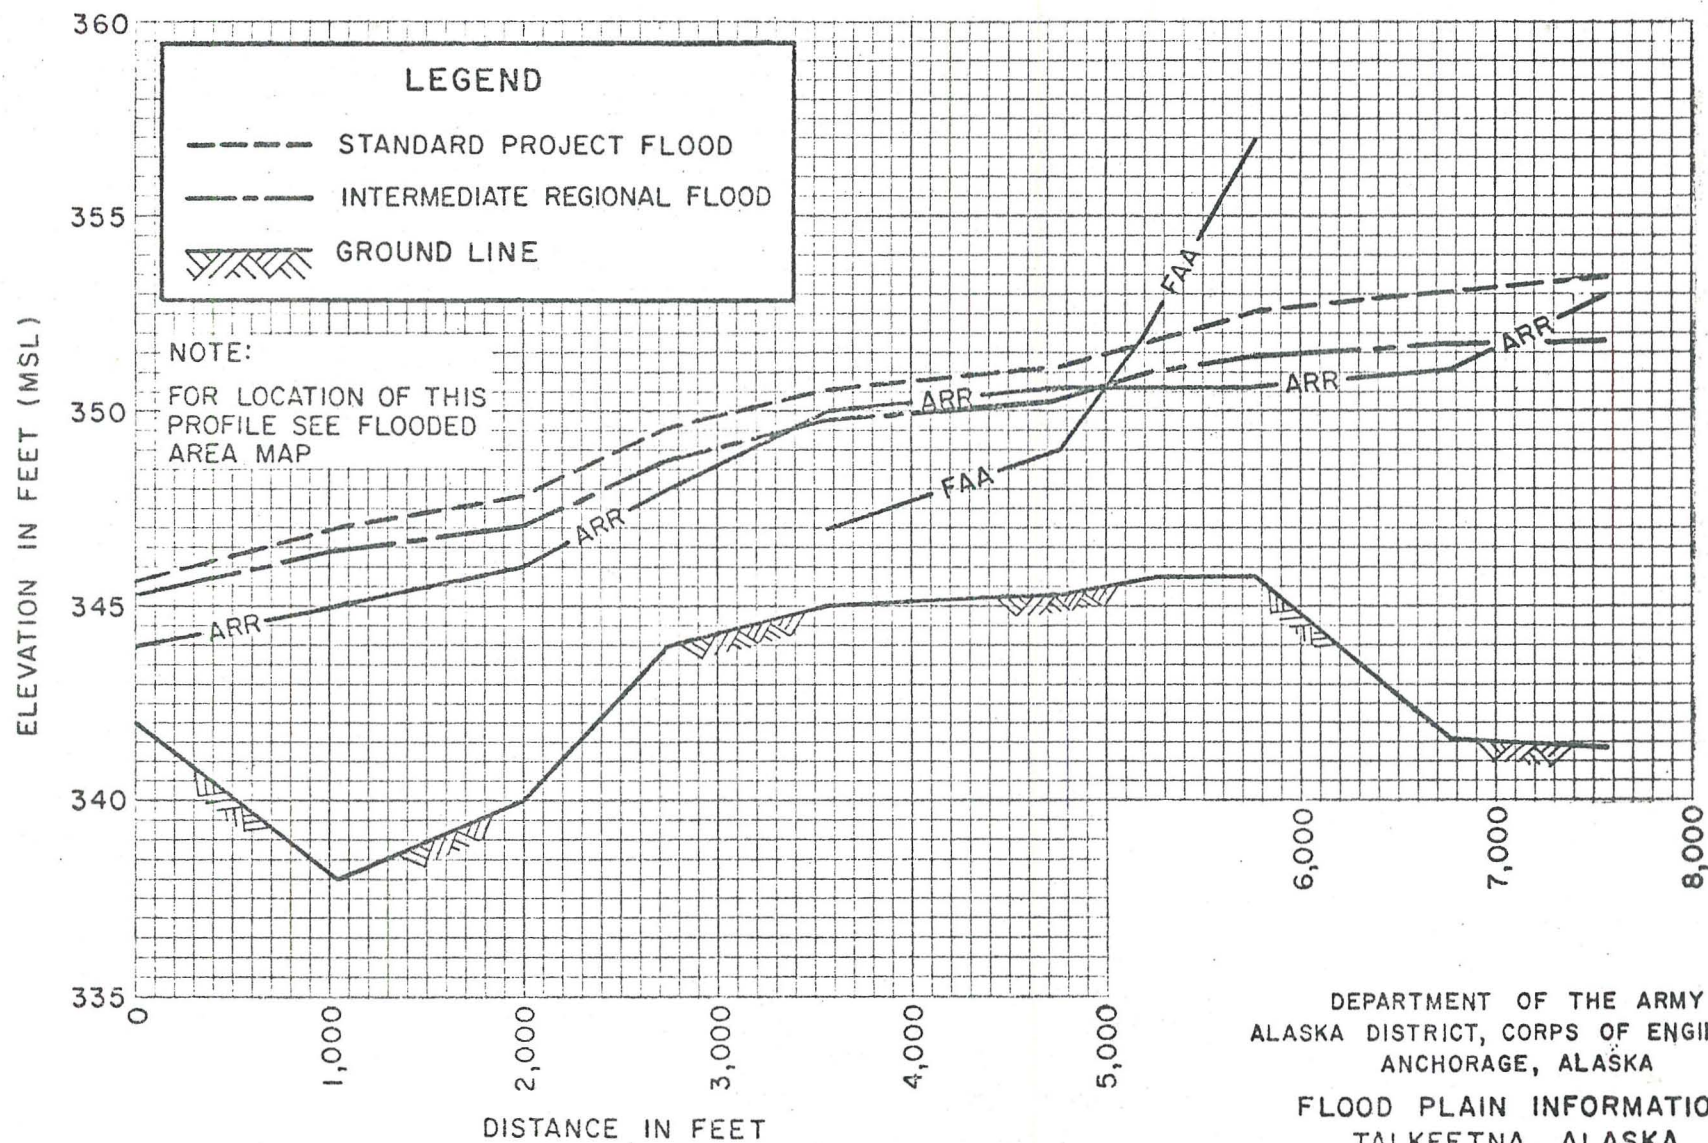
FLOOD PLAIN INFORMATION  
TALKEETNA, ALASKA  
SUPPLEMENTAL HIGH WATER PROFILE  
TALKEETNA RIVER OVERFLOW

ELEVATION IN FEET, SEA LEVEL DATUM

Damage would be even more severe during a Standard Project Flood due to the wider extent and greater depths of flooding, higher velocity flow and longer duration of flooding. Plates 4, 5 and 6 show water surface profiles of the IRF and SPF. Depth of flow in the channel can be estimated from these illustrations. Typical cross sections of the flood plain at selected locations, together with the water surface elevation and extent of the IRF and SPF, are shown on plates 7 and 8.

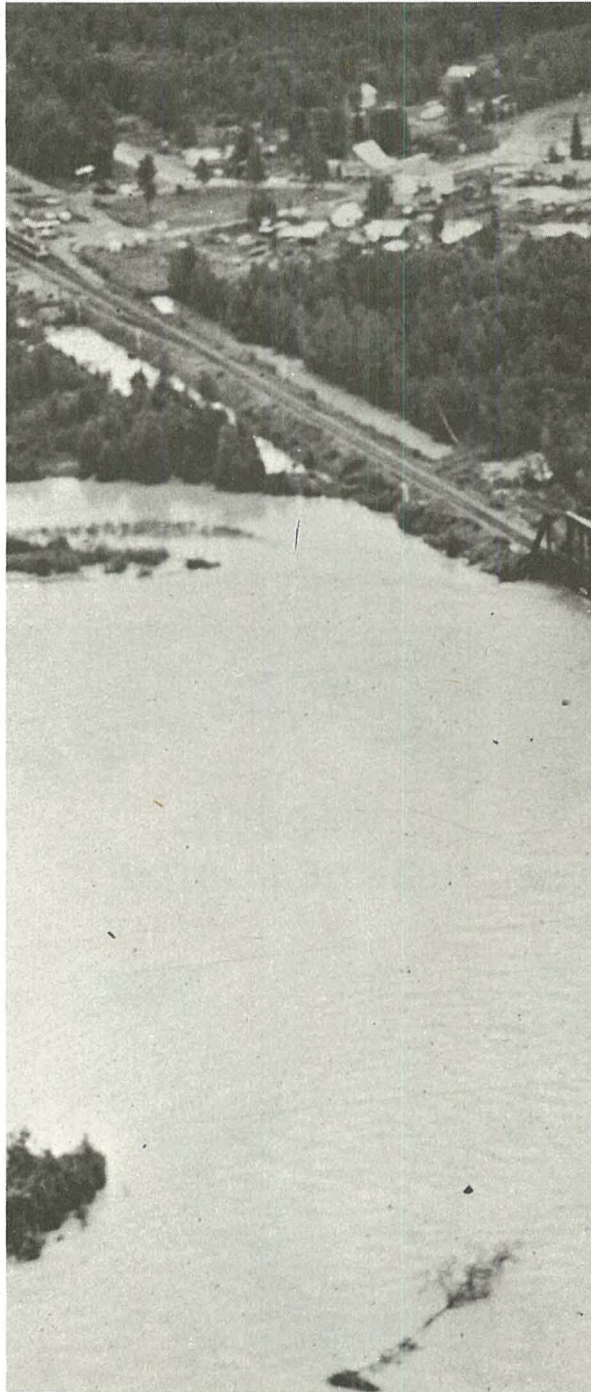
August 1971 flood at Talkeetna above the  
Alaska Railroad bridge.
