Phase 1 Final Draft Report Vol. 1

Aquatic Habitat & Instream Flow Project

ADF & G / Su Hydro 1981

SUSITNA HYDROELECTRIC PROJECT

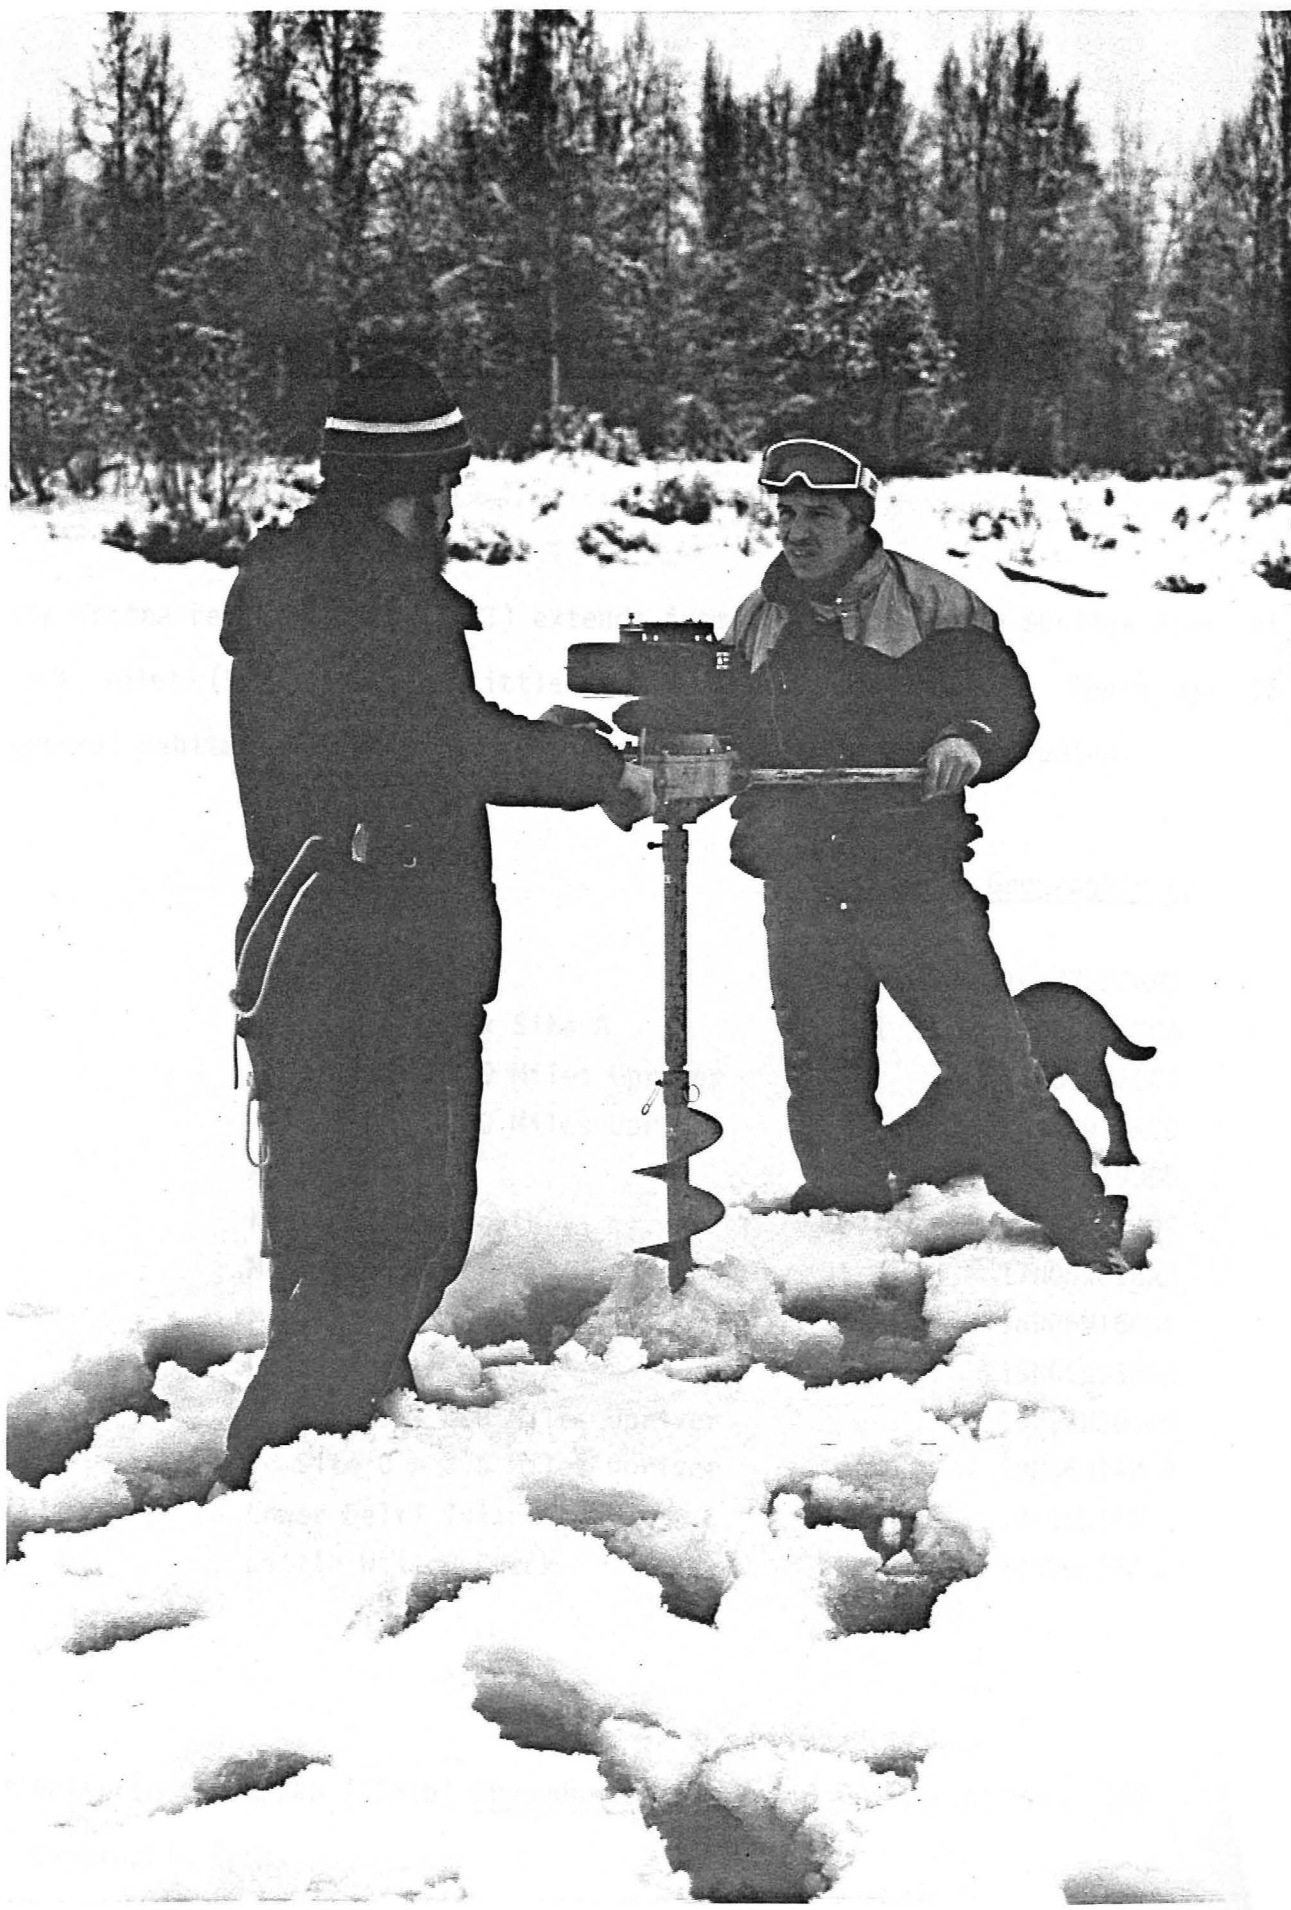
Plate 5. Use of an ice auger for winter sampling.

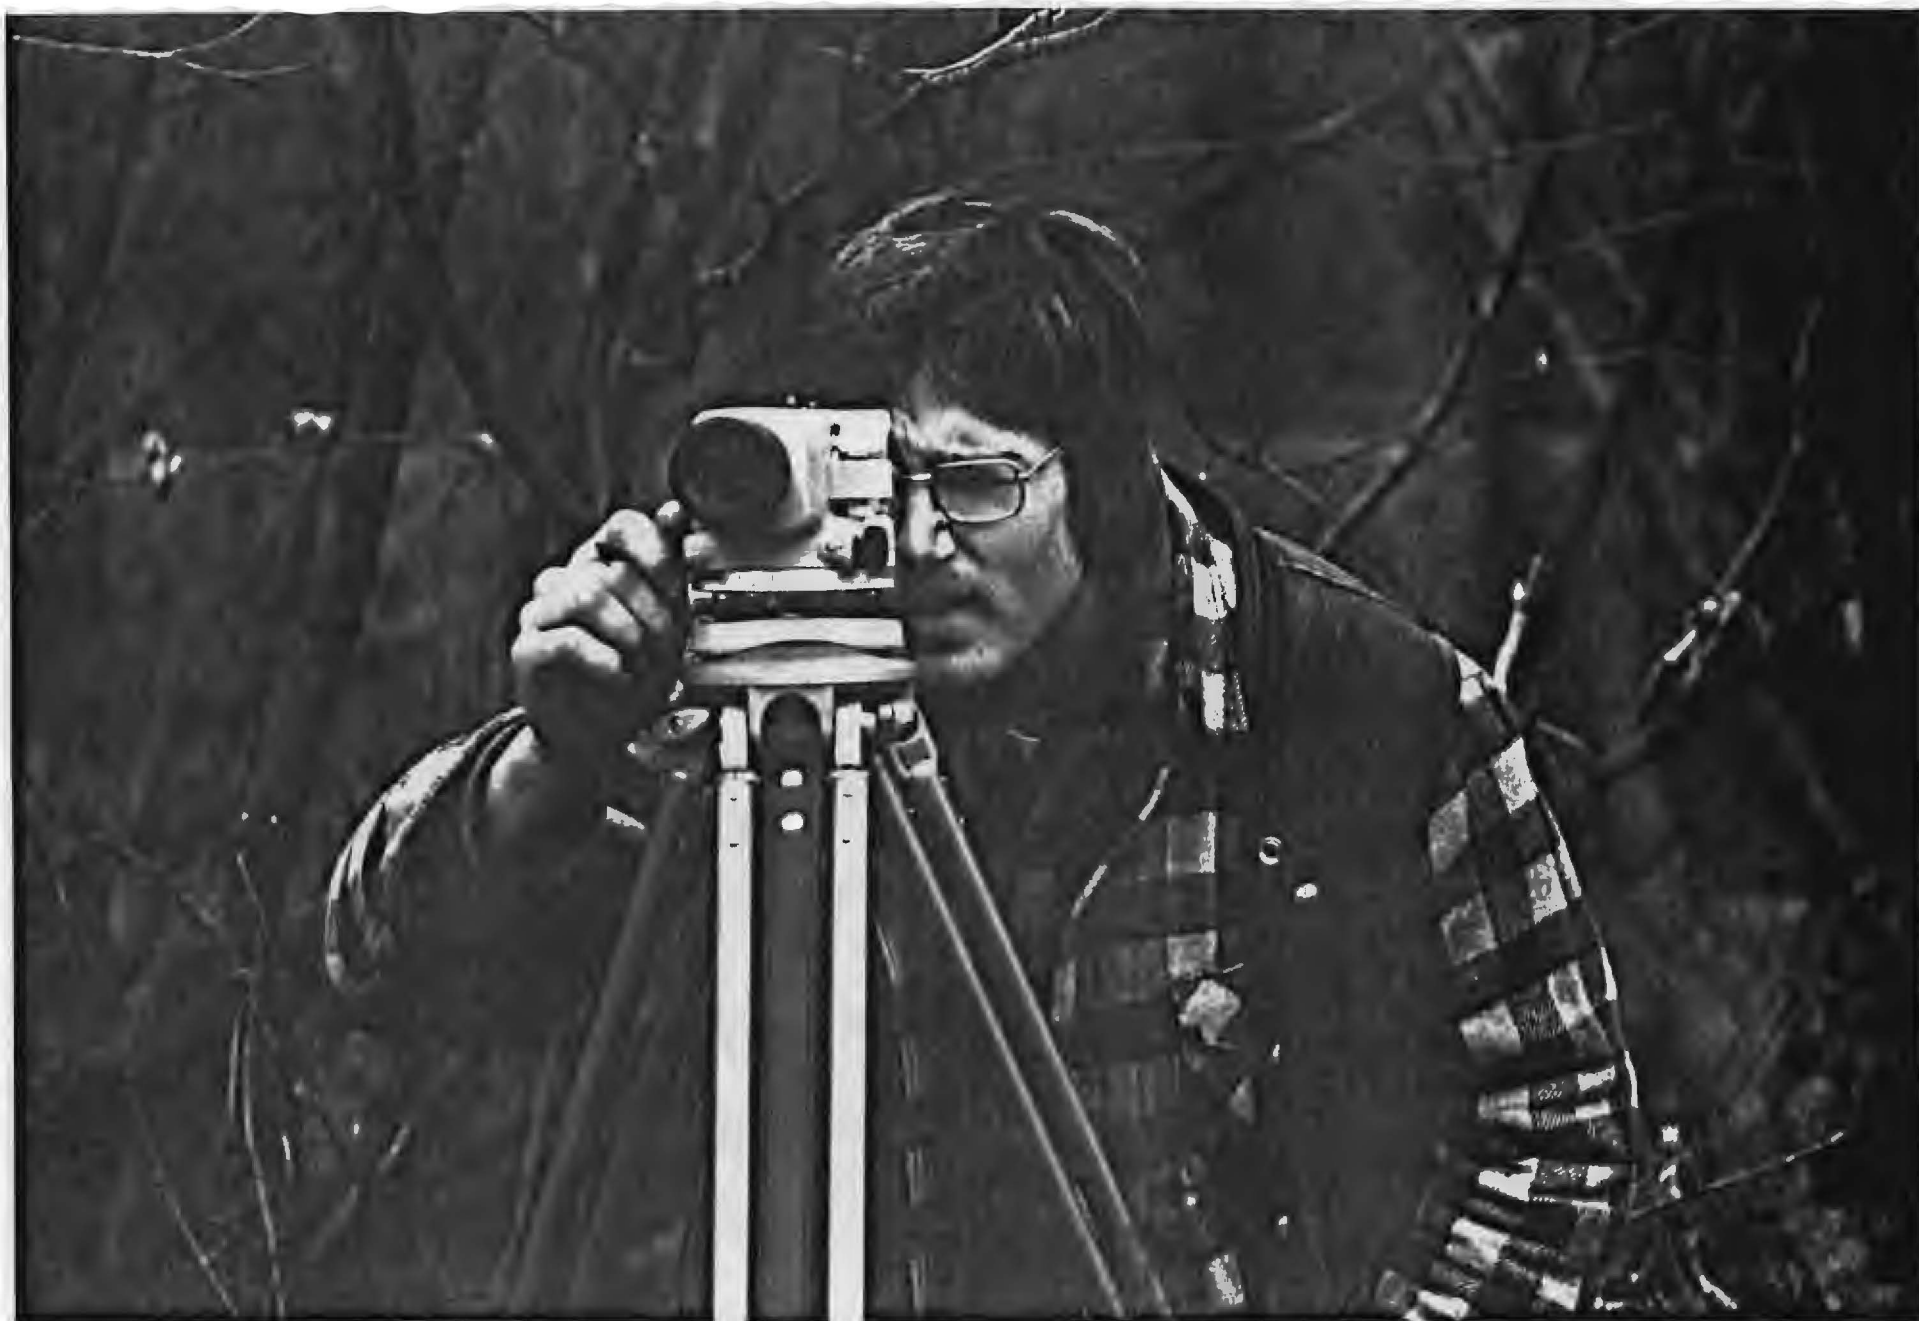
Plate 8. Use of a Leitz B-2 survey level for surveying in the selected habitat study sloughs.

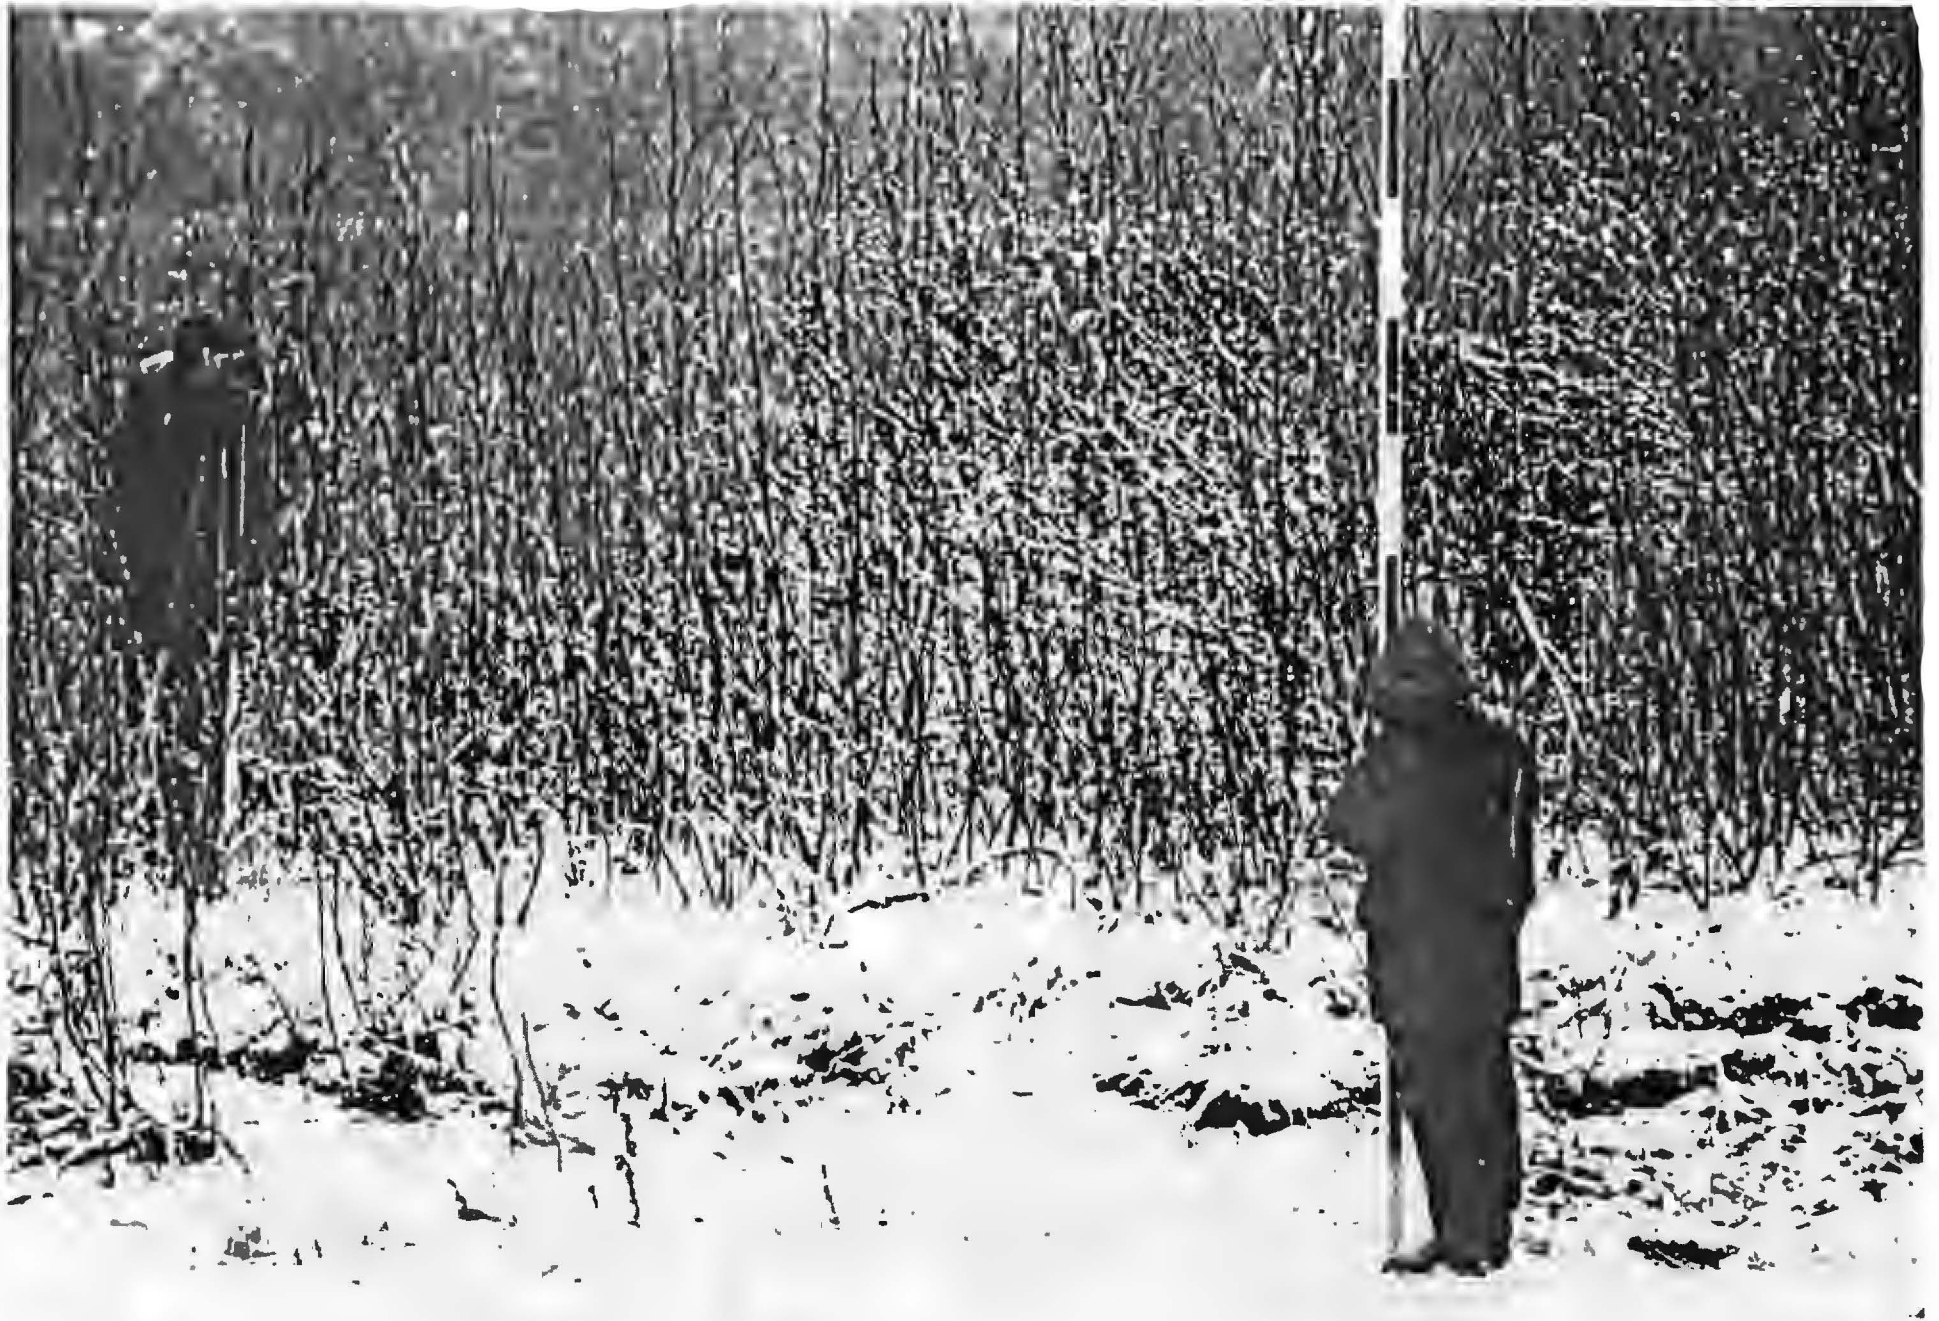
Plate 9. Surveying a transect line at Slough 8A.

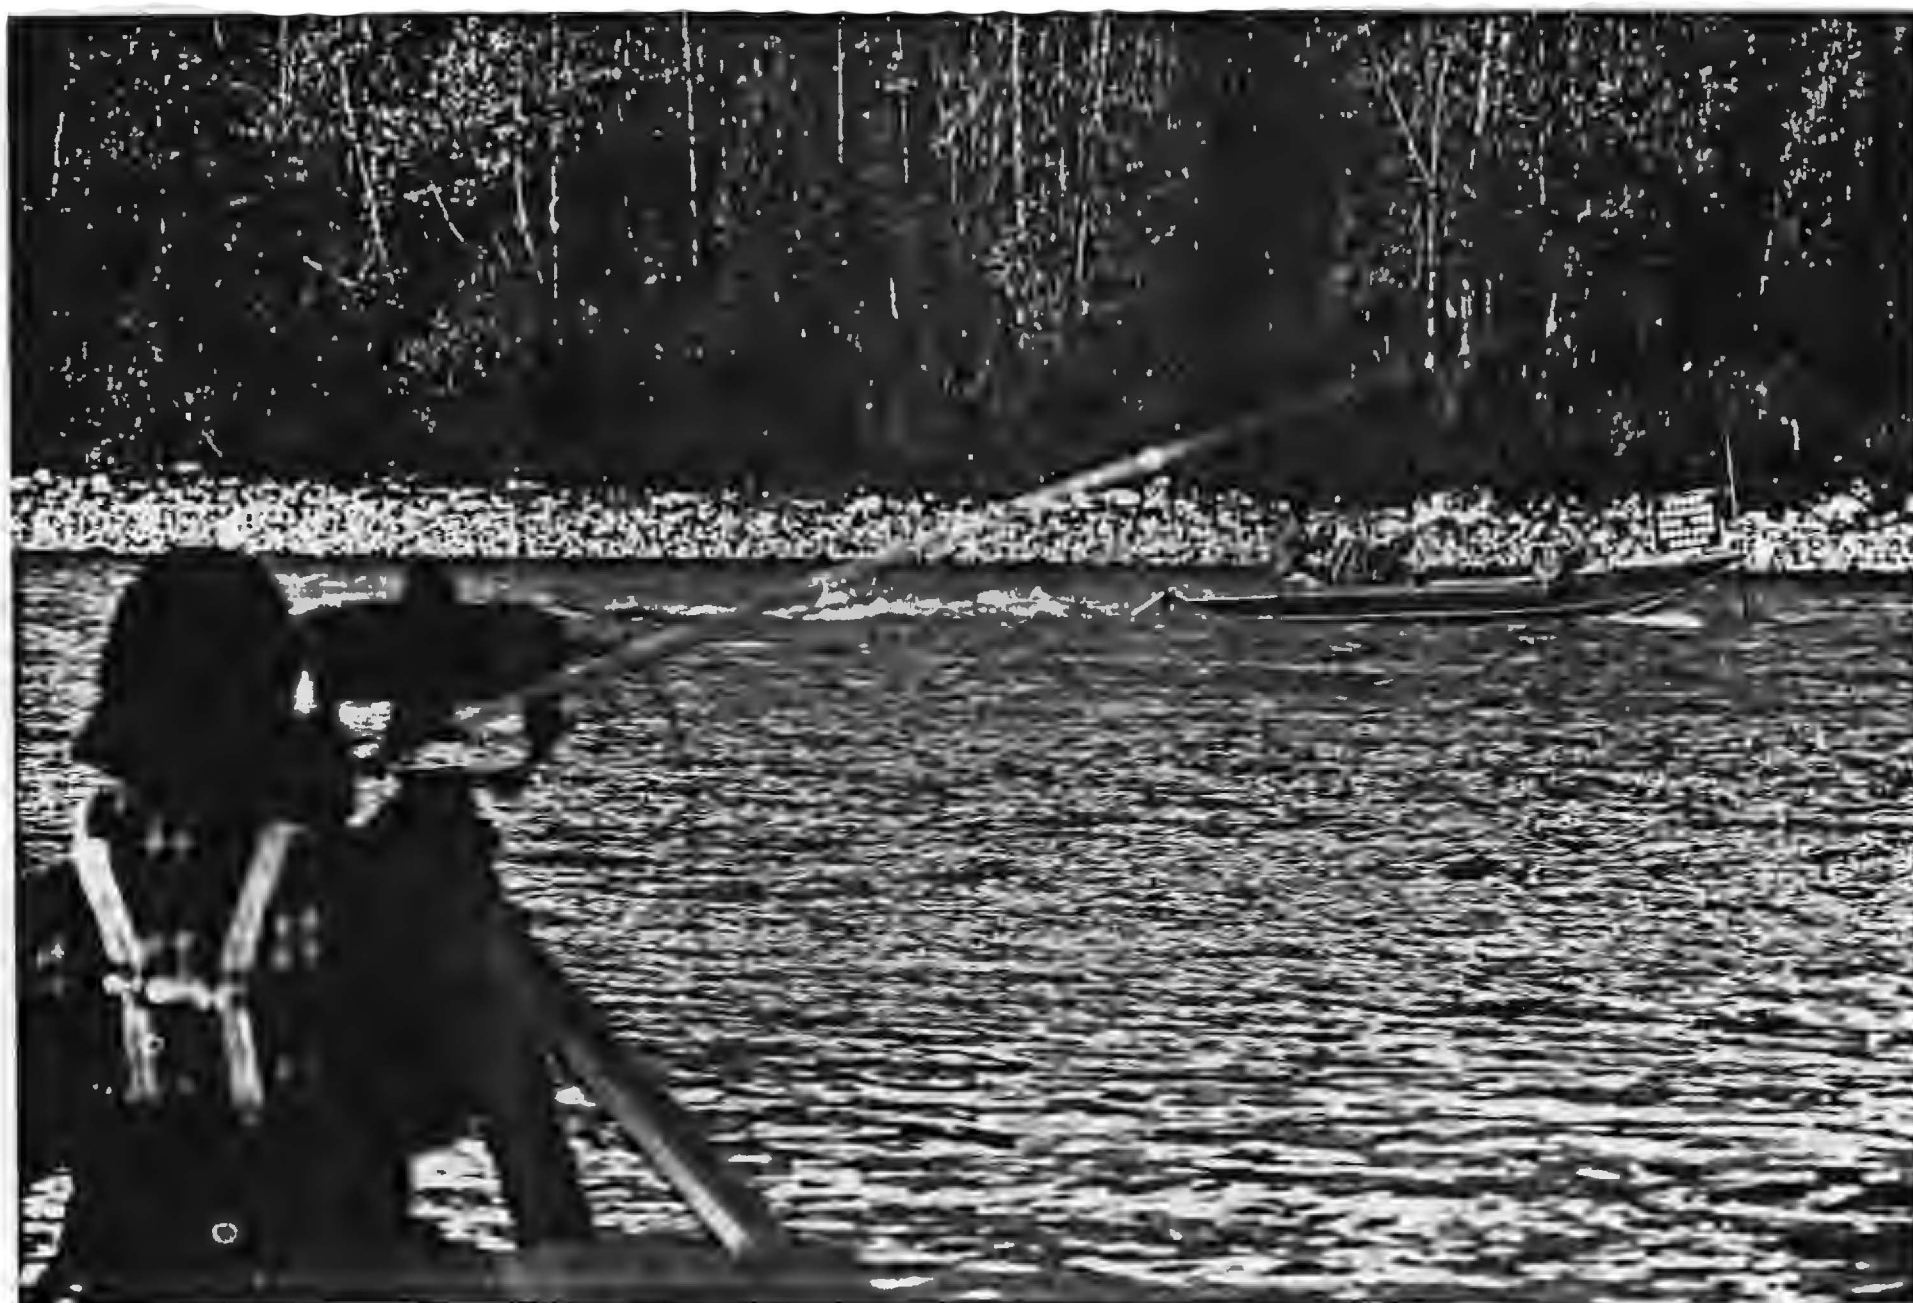
Plate 10. Use of an EDM distance finder for determining cross section profiles.
